Your Ref: TP/IP/01505/2018
Our Ref : CI/TPD18010656/Z

Fatal Accident Investigation Team

MECHANICAL INSPECTION REPORT OF MOTOR LORRY YN 3418P

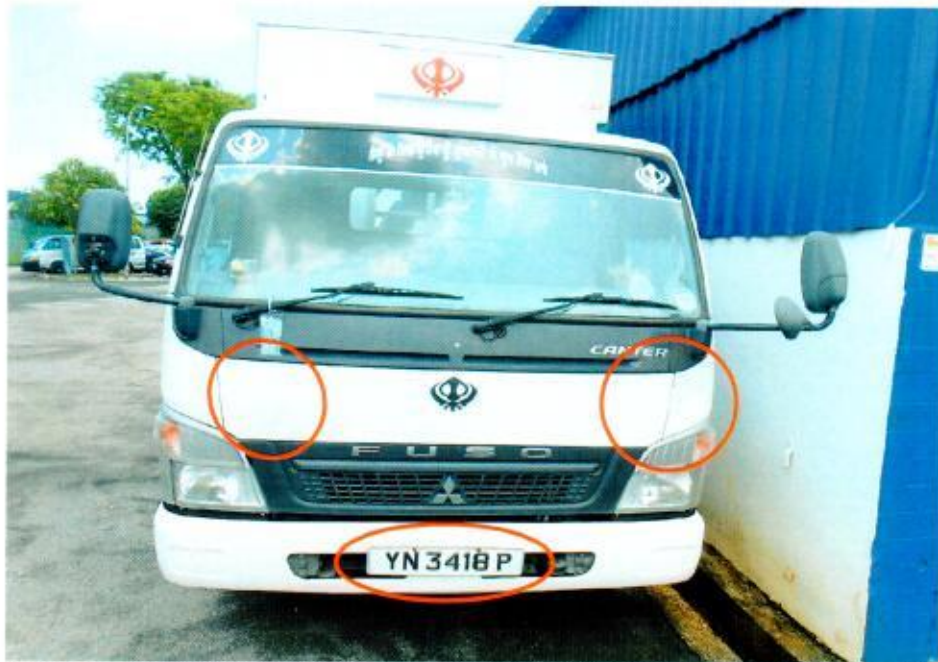
Photo 1 shows a general view of the front portion of the Motor Lorry at the time of our inspection. The Motor Lorry was observed to have sustained minor damage at its front left hand side panel; its right hand side panel; its number plate were amongst the body parts that were damaged as a result of the accident.

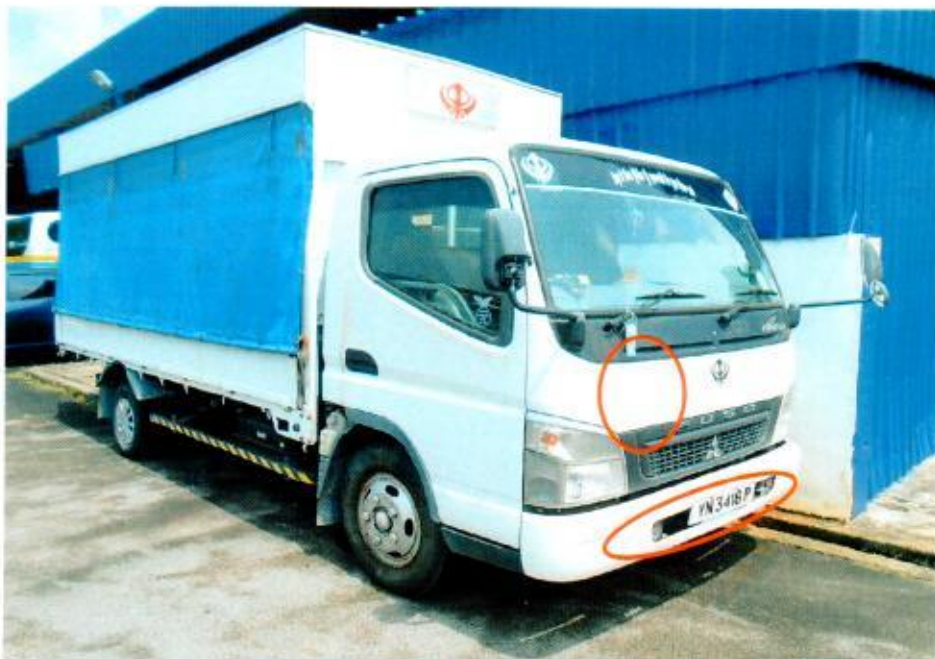
Photo 2 shows a general view of the front right of the Motor Lorry at the time of our inspection. The Motor Lorry was observed to have sustained minor damage at its front left hand side panel; its right hand side panel; its number plate were amongst the body parts that were damaged as a result of the accident.

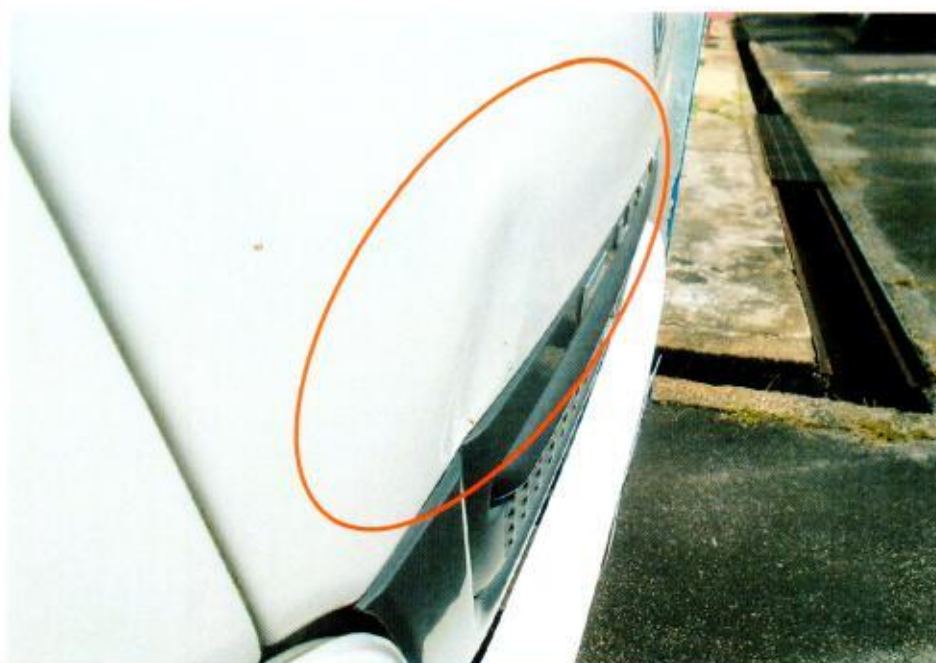
Photo 3 shows a dented portion on the right front panel at time of our inspection.

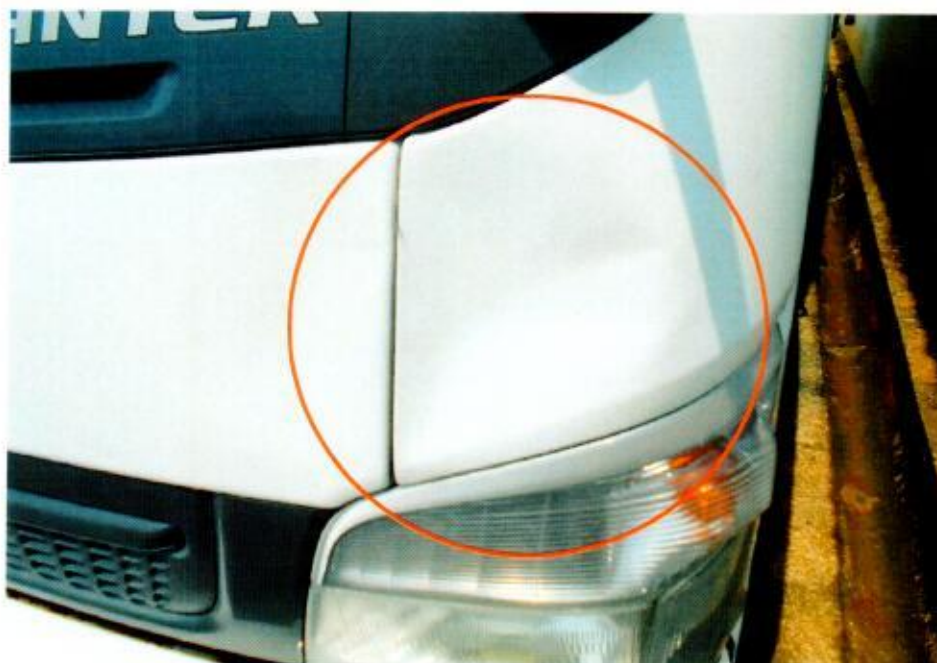
Photo 4 shows a dented portion on the left front panel at time of our inspection.

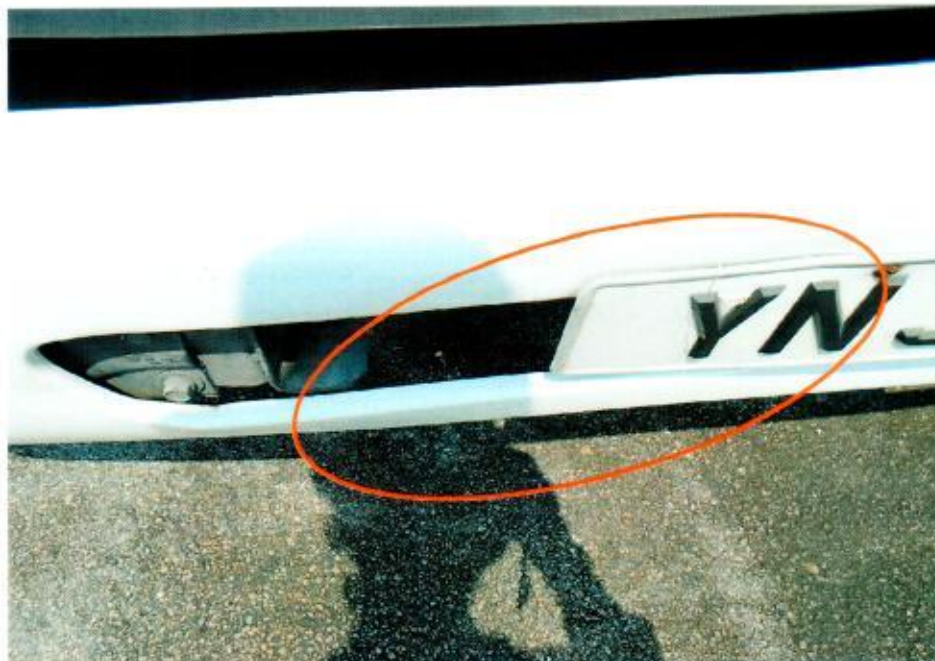
Photo 5 shows the damage sustained on the front number plate as a result of the accident.

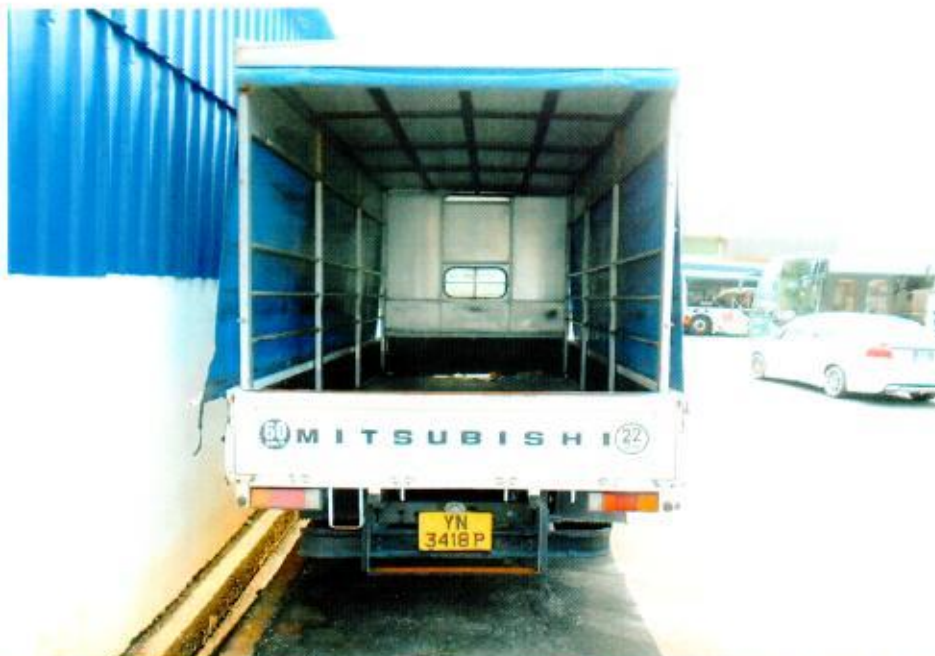
Photo 6 shows a general view of the Motor Lorry's rear body at the time of our inspection. There was no damage found to the rear portion of the Motor Lorry.

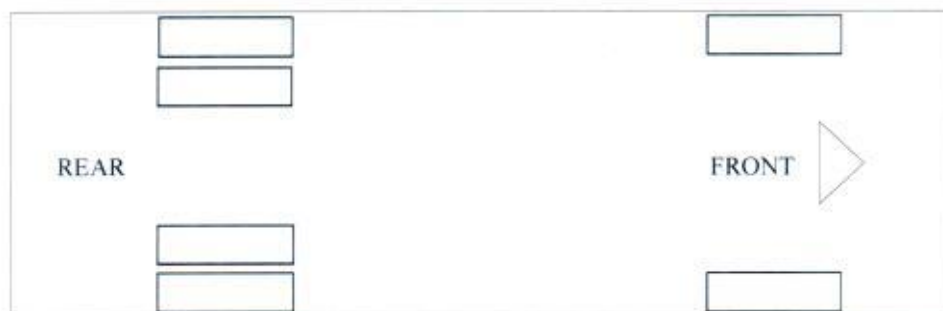
7. The 2 front tyres and 4 rear tyres of the Motor Lorry were observed to be in serviceable condition and sufficiently inflated for vehicular operation. We did not find any tear, cut or burst mark(s) on the outer and the inner sidewalls as well as across the tread of the 6 tyres. The tyre brand, tyre size and remaining tread depth of the 6 tyres of the Motor Lorry were recorded as follows:-

Yokohama Delivery Star 818
185 R14 C 8PR (6mm)

Kenda
7.00 – 16LT 12 PR (7mm)

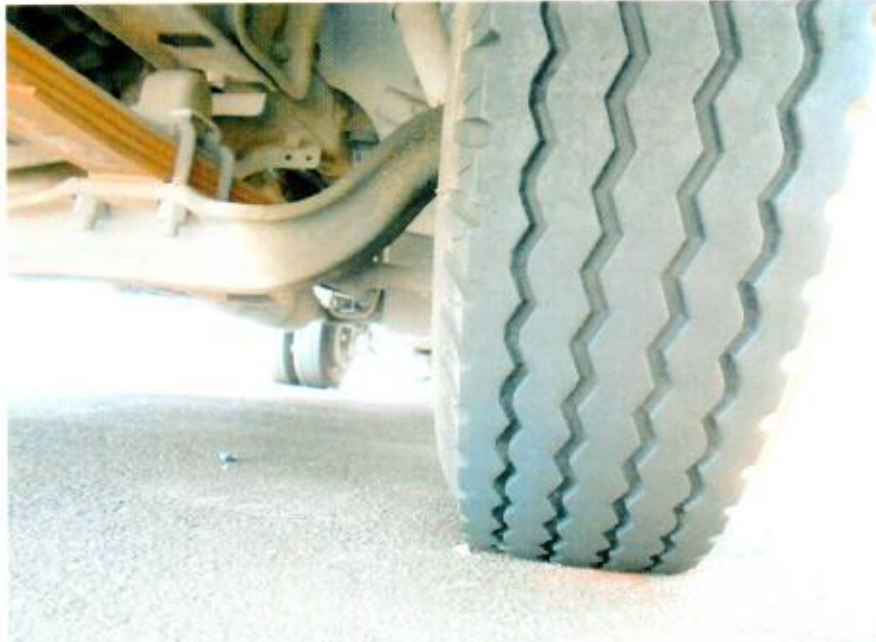
Photo 7 shows the condition of the front left tyre of the Motor Lorry, which was observed to be in serviceable condition with remaining tread depth of approximately 7mm. The tyre, which was wrapped around standard alloy wheel rim, was also observed to be sufficiently inflated for vehicular operation.

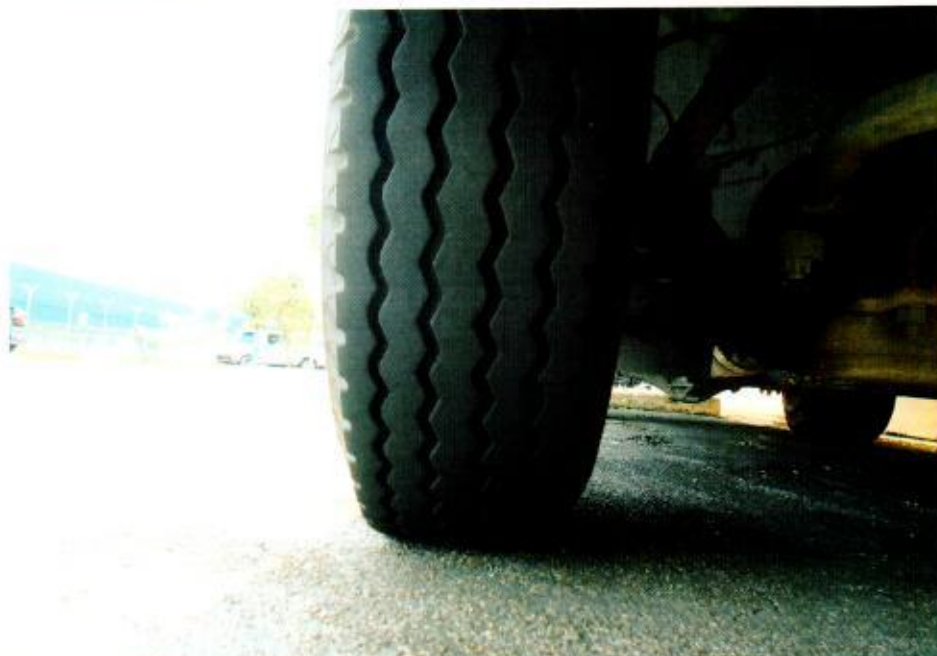
Photo 8 shows the condition of the front right tyre of the Motor Lorry, which was observed to be in serviceable condition with remaining tread depth of approximately 7mm. The tyre, which was wrapped around standard alloy wheel rim, was also observed to be sufficiently inflated for vehicular operation.

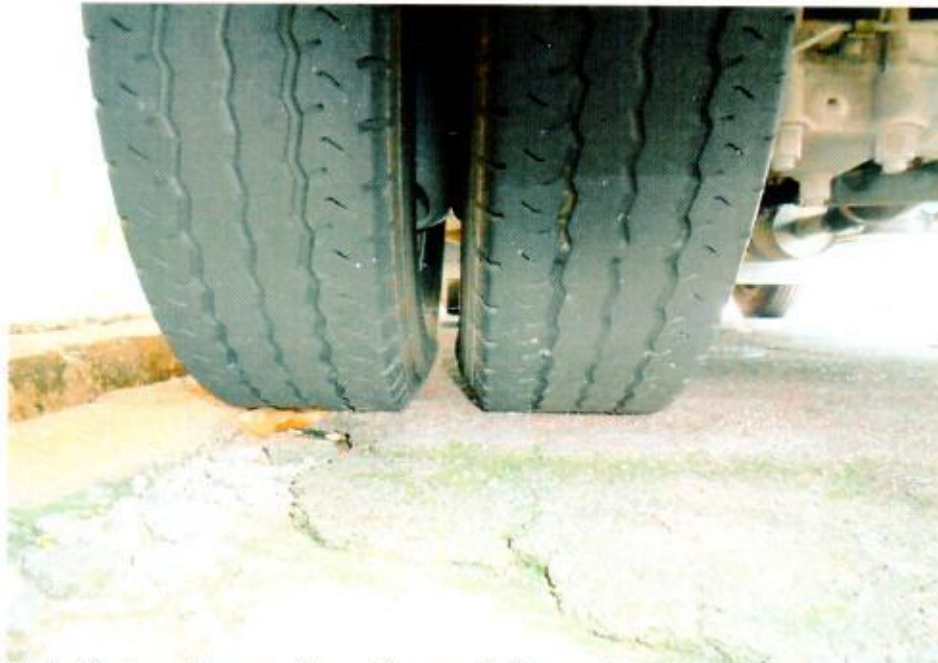
Photo 9 shows the condition of the rear left tyres of the Motor Lorry, which was observed to be in serviceable condition with remaining tread depth of approximately 6mm. The tyres, which were wrapped around standard alloy wheel rim, were also observed to be sufficiently inflated for vehicular operation.

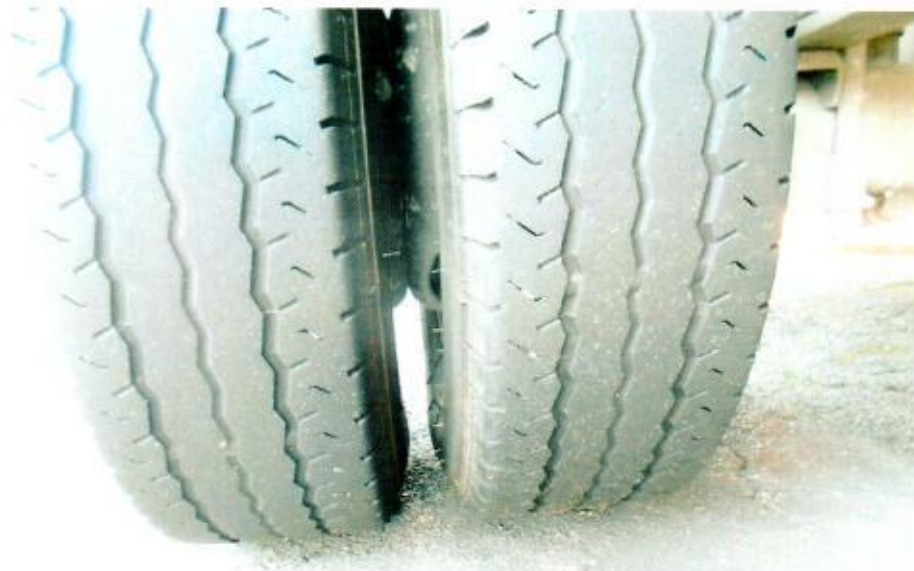
Photo 10 shows the condition of the rear right tyres of the Motor Lorry, which were observed to be in serviceable condition with remaining tread depth of approximately 6mm.

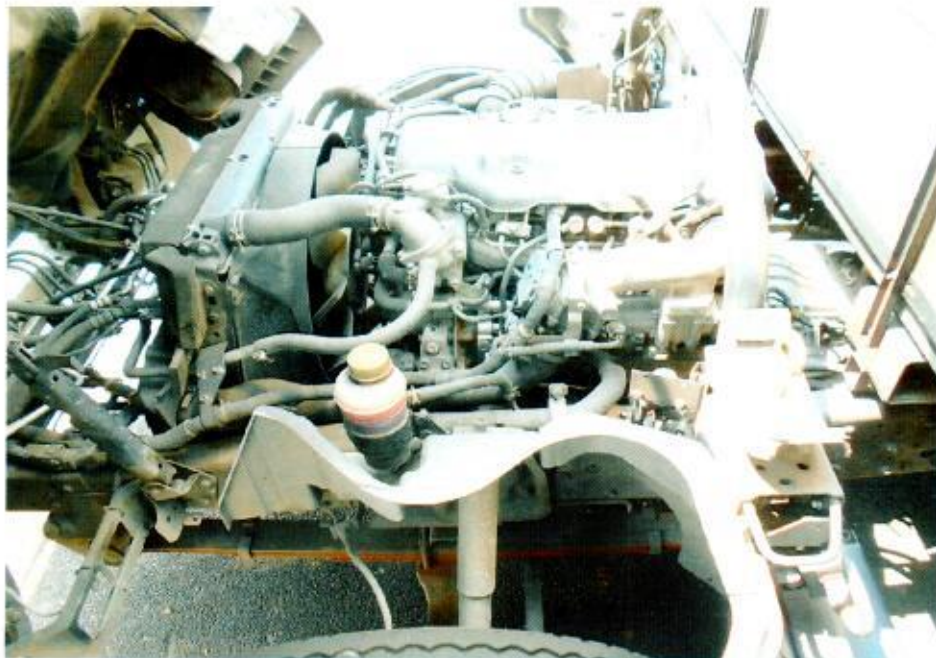
Photo 11 shows a general view of the Motor Lorry's engine compartment, which was accessed by lifting the front cabin of the Motor Lorry. The various parts and components inside the engine compartment were unaffected by the accident. There was also no sign(s) or indication(s) of fresh fluid leakage and/or fluid stain within the engine.

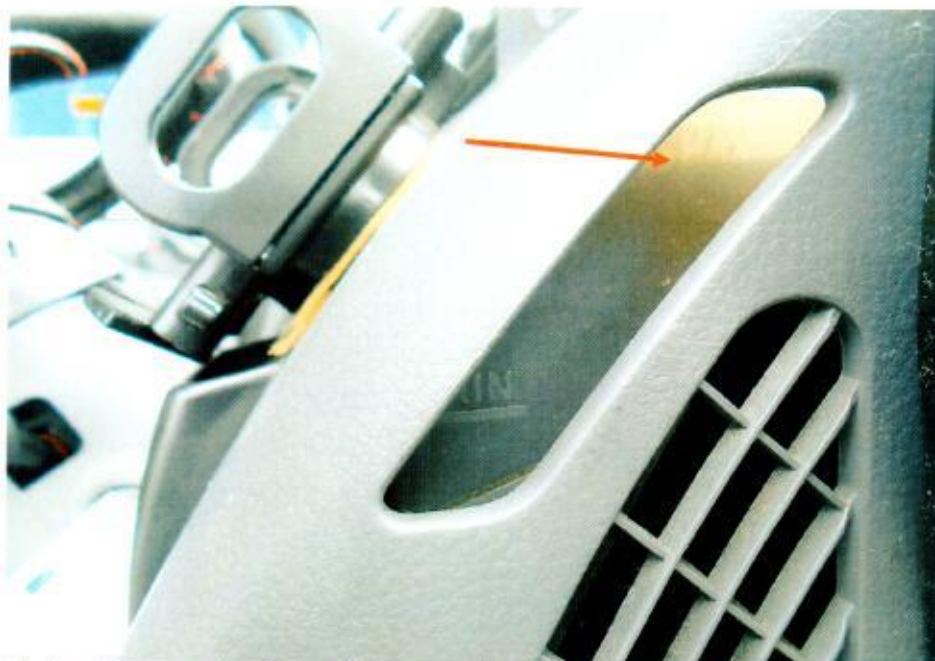
Photo 12 shows the brake fluid reservoir of the Motor Lorry at the time of our inspection. The brake fluid was observed to be of sufficient level and without any visible contamination (arrowed).

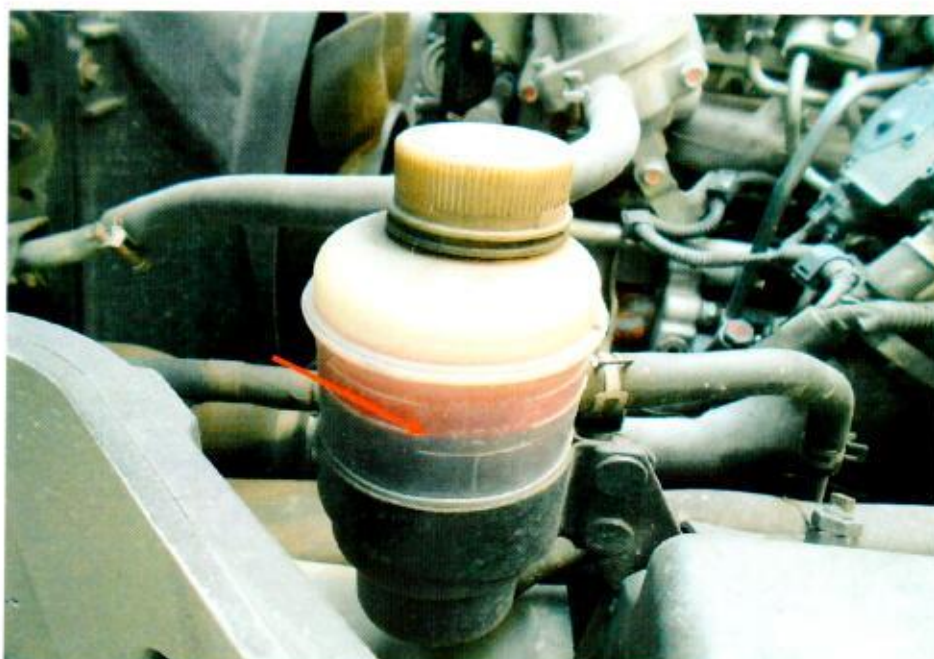
Photo 13 shows the power steering fluid reservoir of the Motor Lorry at the time of our inspection. power steering fluid was observed to be of sufficient level and without any visible contamination (arrowed).

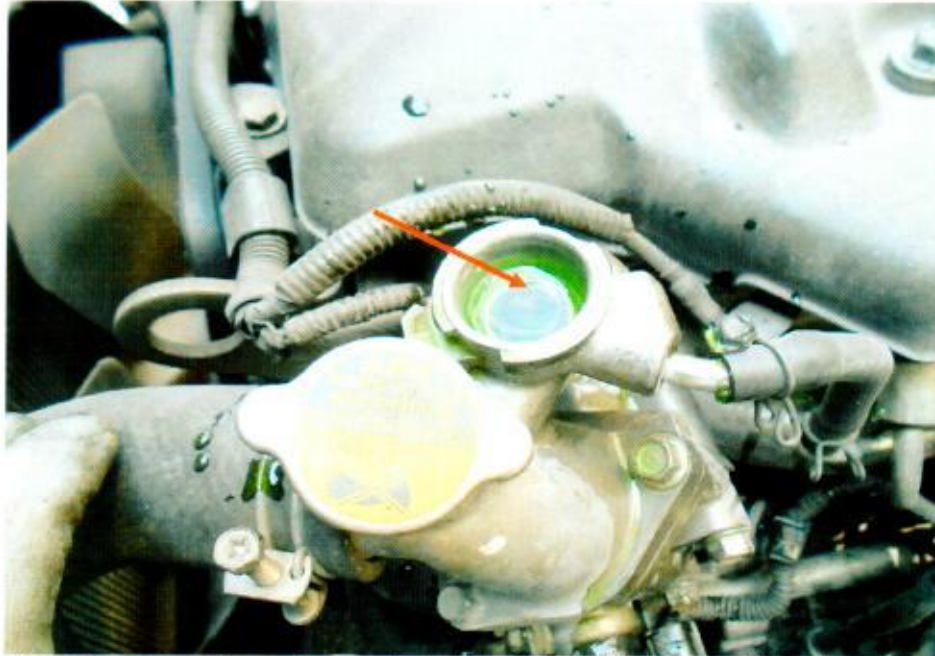
Photo 14 shows the engine coolant fluid of the Motor Lorry at the time of our inspection. It was observed to be of sufficient level and without any visible contamination (arrowed).

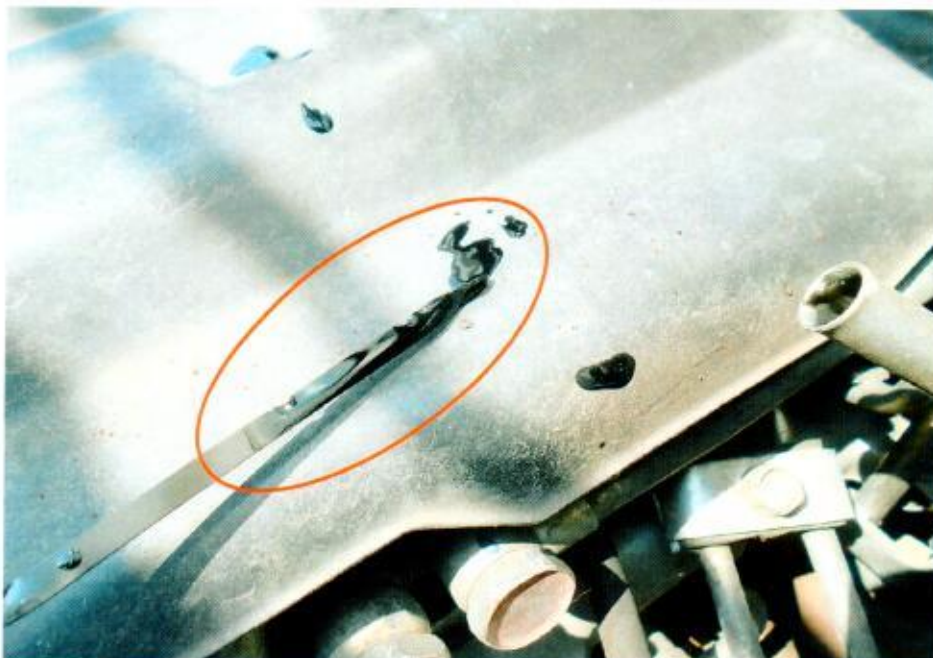
Photo 15 shows the engine dip stick of the Motor Lorry at the time of our inspection. The engine oil was observed to be of sufficient level and without any visible contamination (circled).

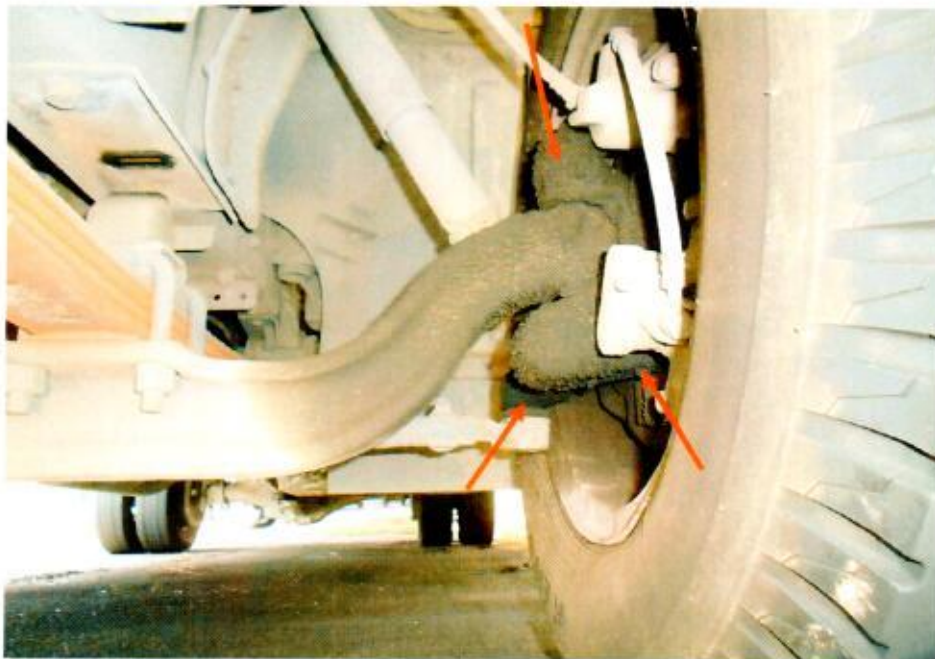
Photo 16 shows the various undercarriage components at the front left wheel of the Motor Lorry, in particular the steering tie rod end (arrowed). The various undercarriage components of the Motor Lorry were all found to be intact without any visible damage. There was also no sign of fluid stain(s) observed on the various undercarriage components.

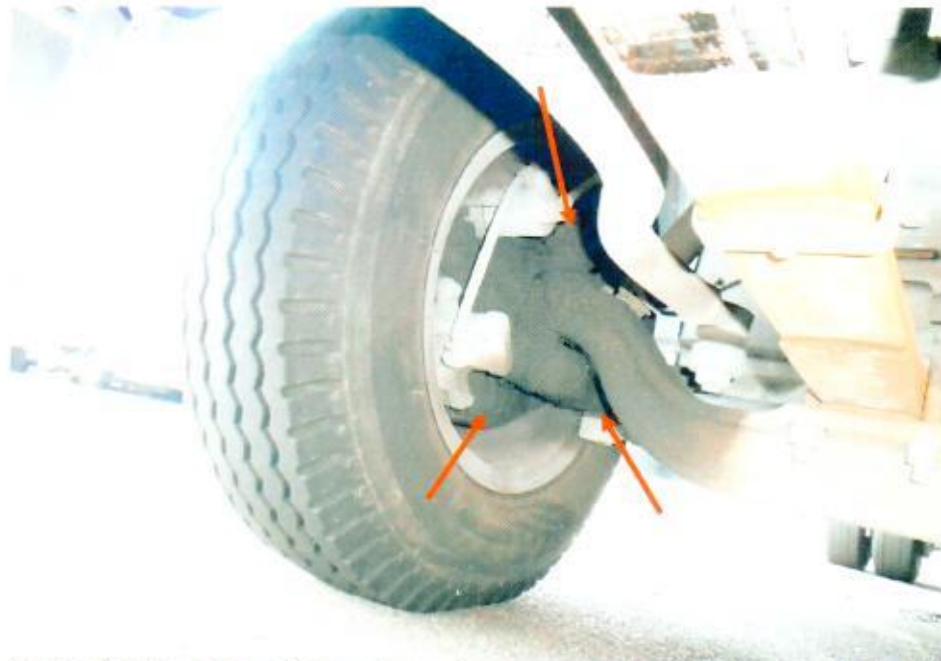
Photo 17 shows the various undercarriage components at the front right wheel of the Motor Lorry, in particular the steering tie rod end (arrowed). The various undercarriage components of the Motor Lorry were all found to be intact without any visible damage. There was also no sign of fluid stain(s) observed on the various undercarriage components.

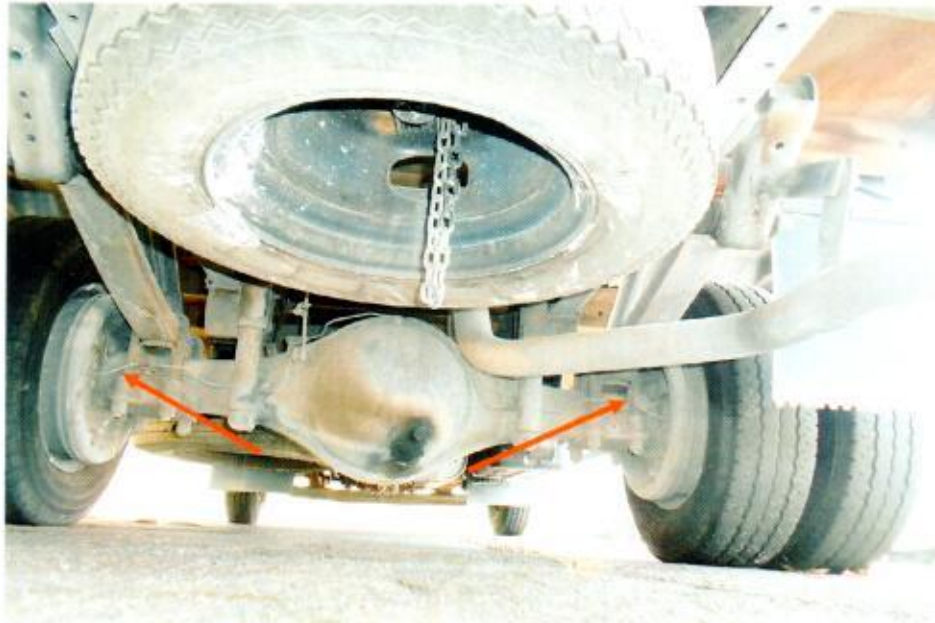
Photo 18 shows the various undercarriage components at the rear wheels of the Motor Lorry. There was no sign(s) of brake fluid leakage along the brake hoses and brake pipes.

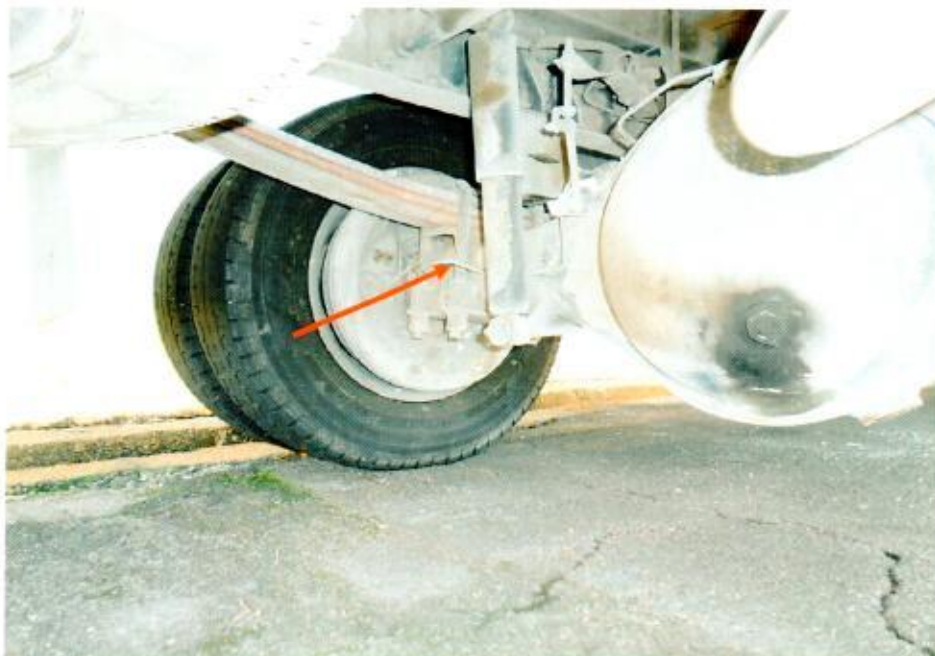
Photo 19 shows the brake hoses at the rear wheels of the Motor Lorry revealed that there was no sign(s) of brake fluid leakage along the brake hoses and brake pipes.
