Your Ref: TP/IP/26753/2018
Our Ref : CI/TPD18010659/Z

Fatal Accident Investigation Team

MECHANICAL INSPECTION REPORT OF MOTOR TAXI SHD 9756C

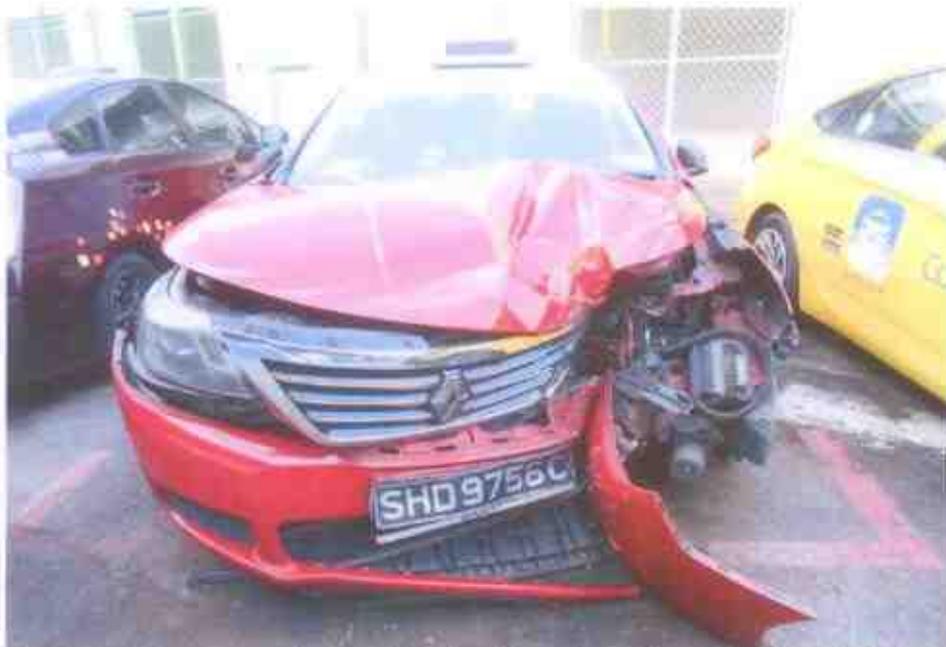
4. The mileage of the Motor Taxi at the time of our inspection was not recorded due to the damages sustained to the ignition system which is part of the engine system as a result of the accident.
5. The Motor Car had sustained extensive impact damage at its frontal portion. The impact force was significant, causing the various parts and components inside the engine compartment to be damaged. This had included its engine assembly and transmission assembly, which were both amongst the multiple parts and components inside the engine compartment that were pushed inwards, towards the rear of the Motor Taxi.

Photo 1 shows a general view of the frontal portion of the Motor Taxi at the time of our inspection. The Motor Taxi was observed to have sustained extensive impact damage at its frontal portion. The impact force was significant, causing the various parts and components inside the engine compartment to be damaged.

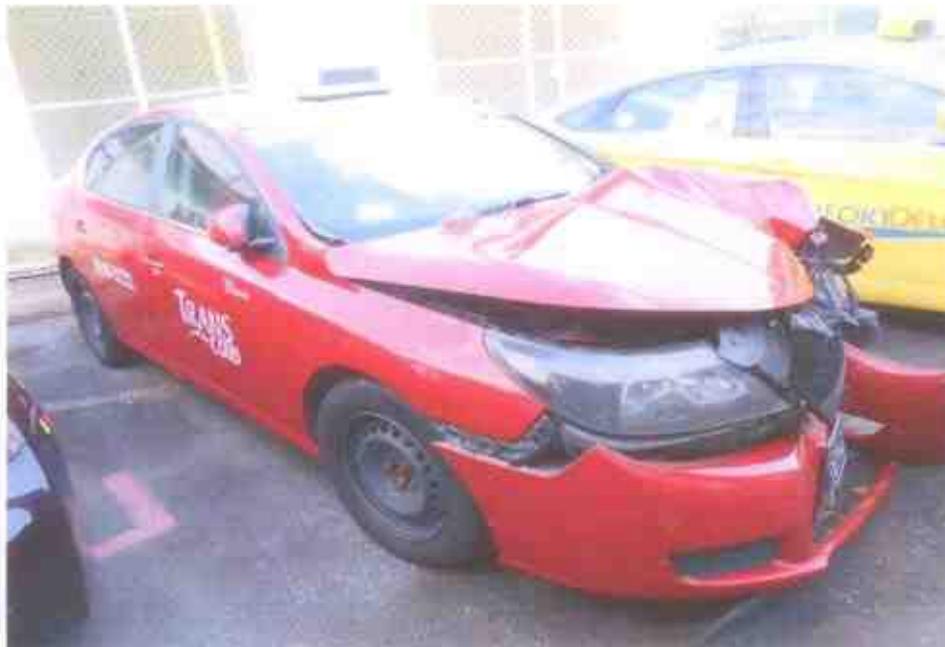
Photo 2 shows a general view of the front right portion of the Motor Taxi at the time of our inspection. The Motor Taxi was observed to have sustained extensive impact damage at its front right portion.

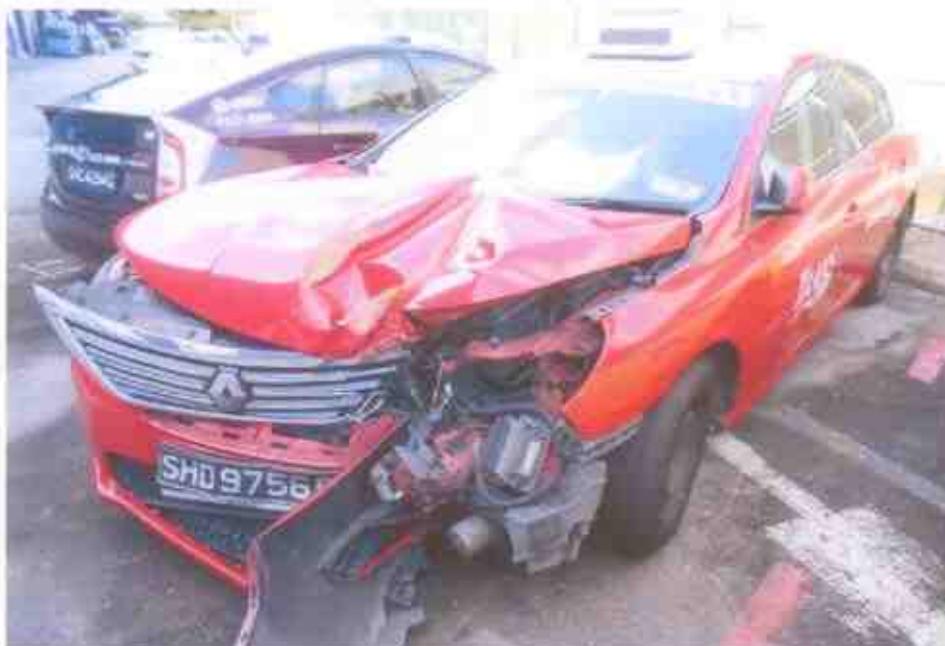
Photo 3 shows a general view of the front left portion of the Motor Taxi at the time of our inspection. The Motor Taxi was observed to have sustained extensive impact damage at its front left portion.

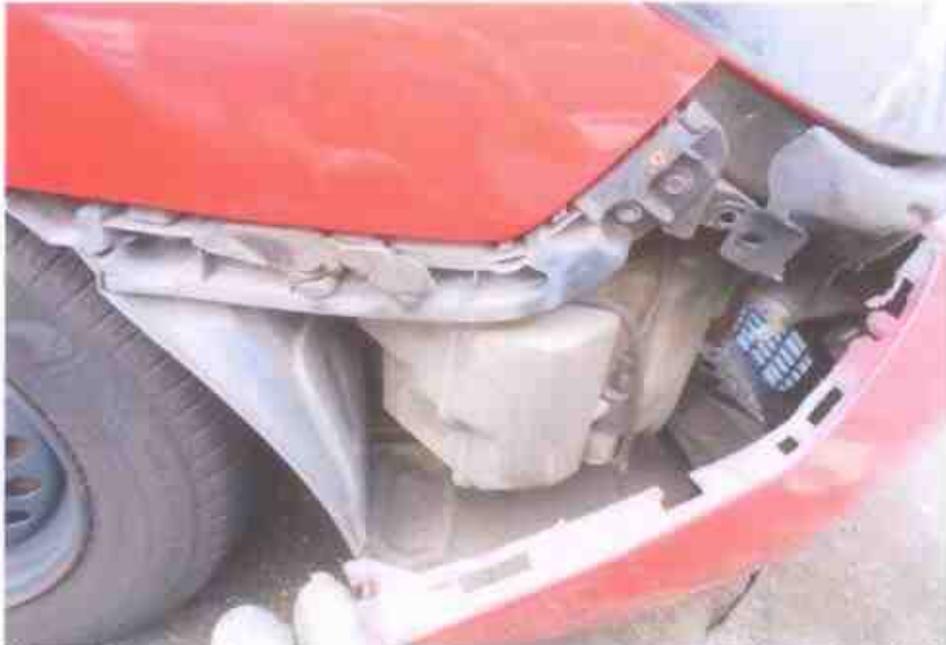
Photo 4 shows a closer view of the damage sustained on the front right of the Motor Taxi. The impact force was significant, causing the various parts and components inside the engine compartment to be pushed inwards, towards the rear of the Motor Taxi.

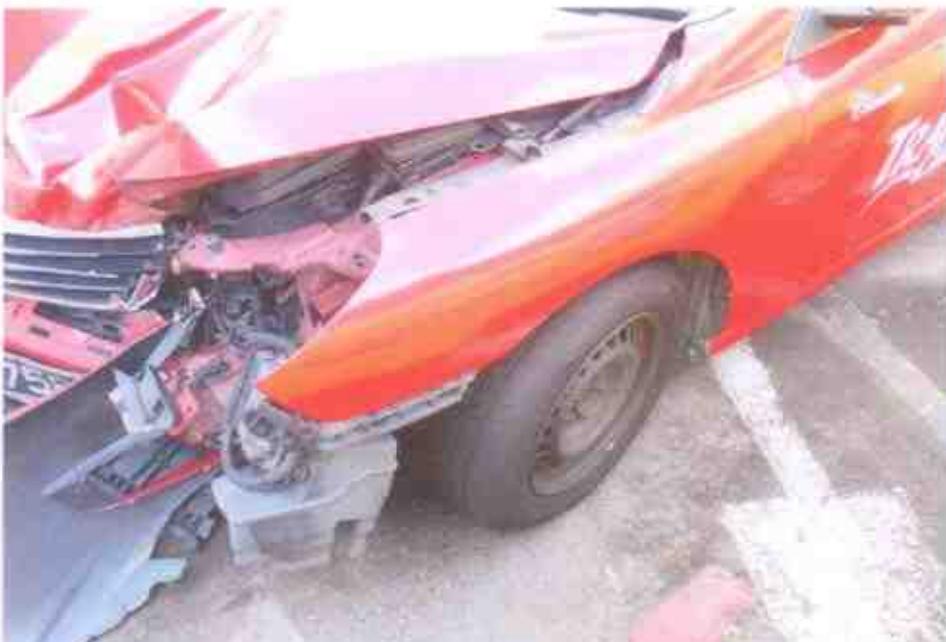
Photo 5 shows a closer view of the damage sustained on the front left of the Motor Taxi. The impact force was significant, causing the various parts and components inside the engine compartment to be pushed inwards, towards the rear of the Motor Taxi.

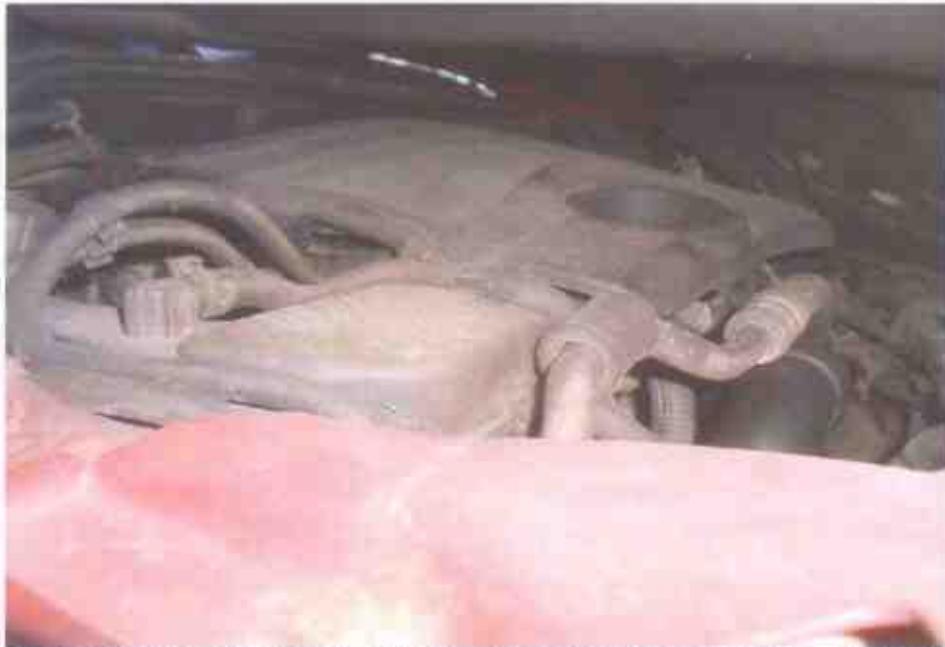
Photo 6 shows a closer view of the engine compartment of the Motor Taxi from the right hand side of the bonnet opening. The impact force was significant, causing the various parts and components inside the engine compartment to be pushed inwards, towards the rear of the Motor Taxi.

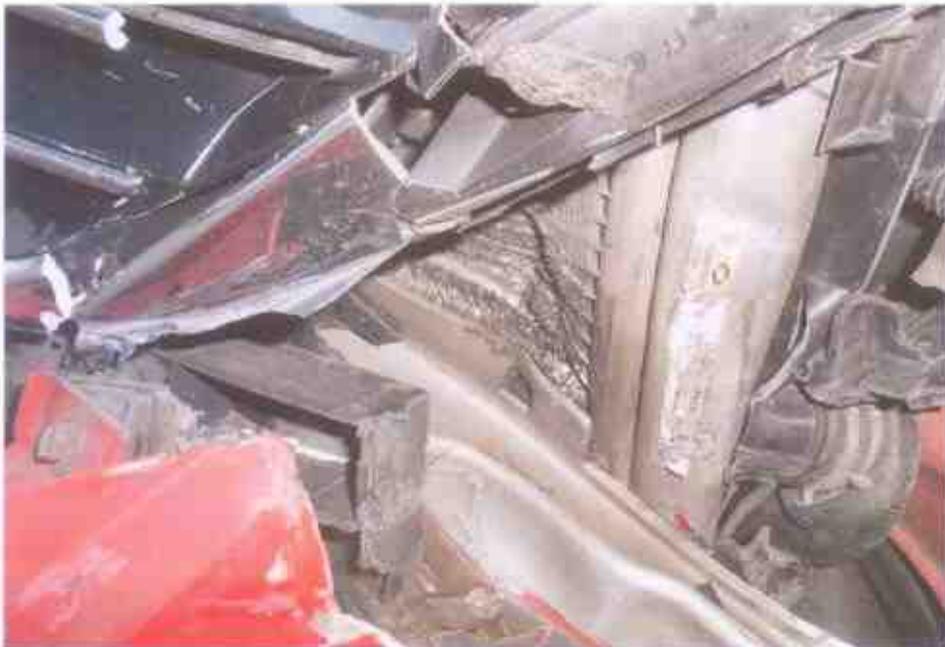
Photo 7 shows a closer view of the damaged radiator of the Motor Taxi from the front view. The impact force was significant, causing the various parts and components inside the engine compartment to be pushed inwards, towards the rear of the Motor Taxi.

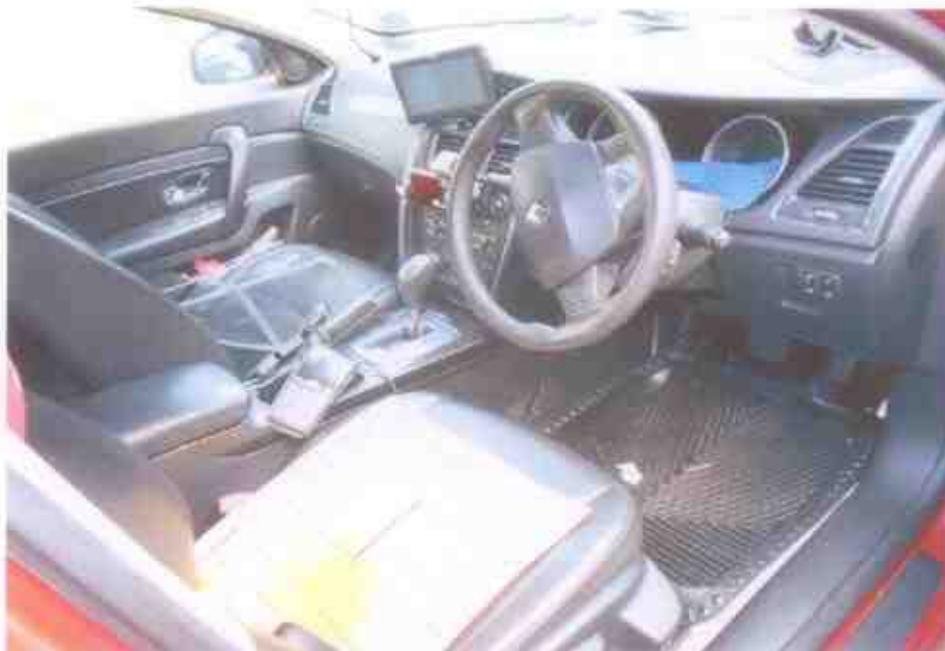
Photo 8 shows the interior portion of the Motor Taxi. The impact force did not affect the interior portion.

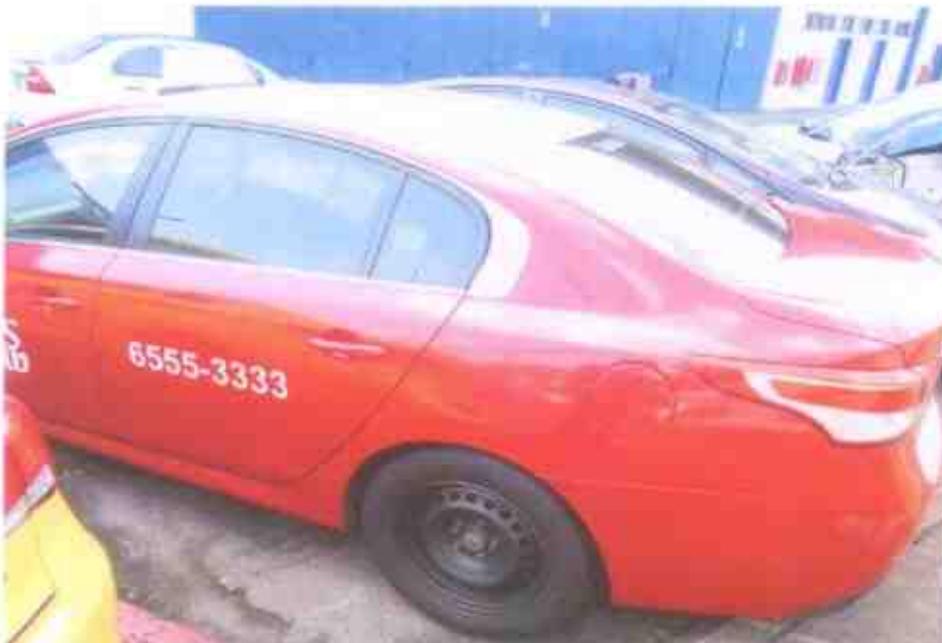
Photo 9 shows a general view of the rear left portion of the Motor Taxi at the time of our inspection. The rear portion was observed to be relatively unaffected by the accident.

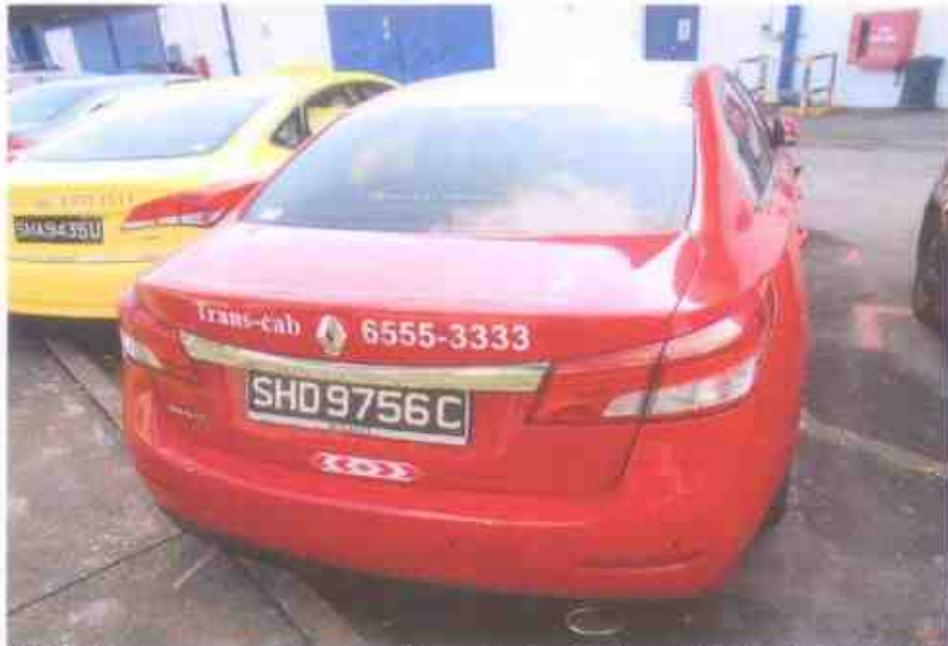
Photo 10 shows a general view of the rear right portion of the Motor Taxi at the time of our inspection. The rear portion was observed to be relatively unaffected by the accident.

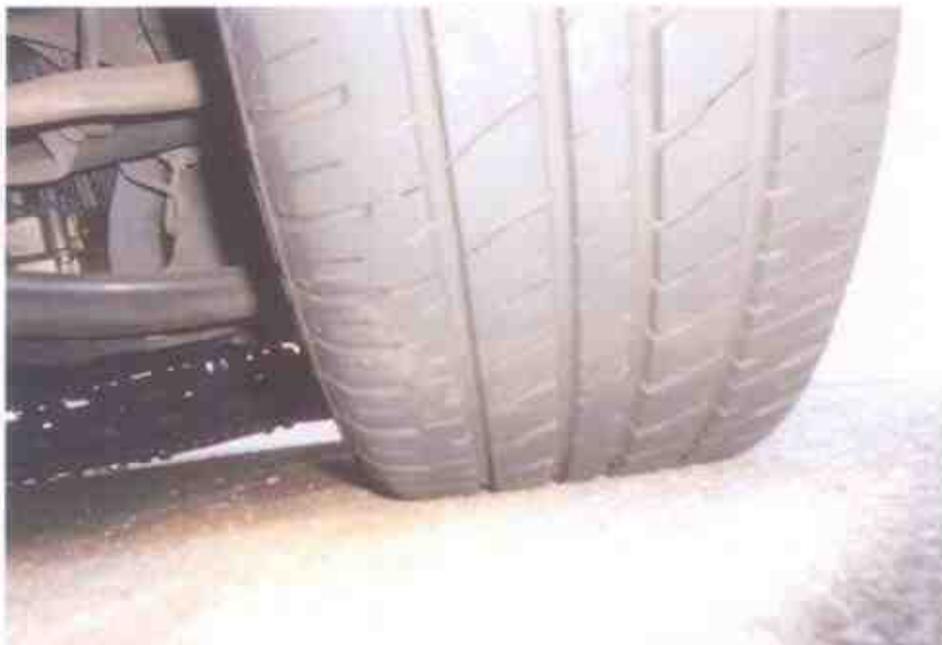
Photo 11 shows the condition of the front right tyre of the Motor Taxi, which was observed to be in serviceable condition with remaining tread depth of approximately 6mm. There was no tear, cut or burst mark(s) on the outer and the inner sidewalls as well as across the tread of this tyre.

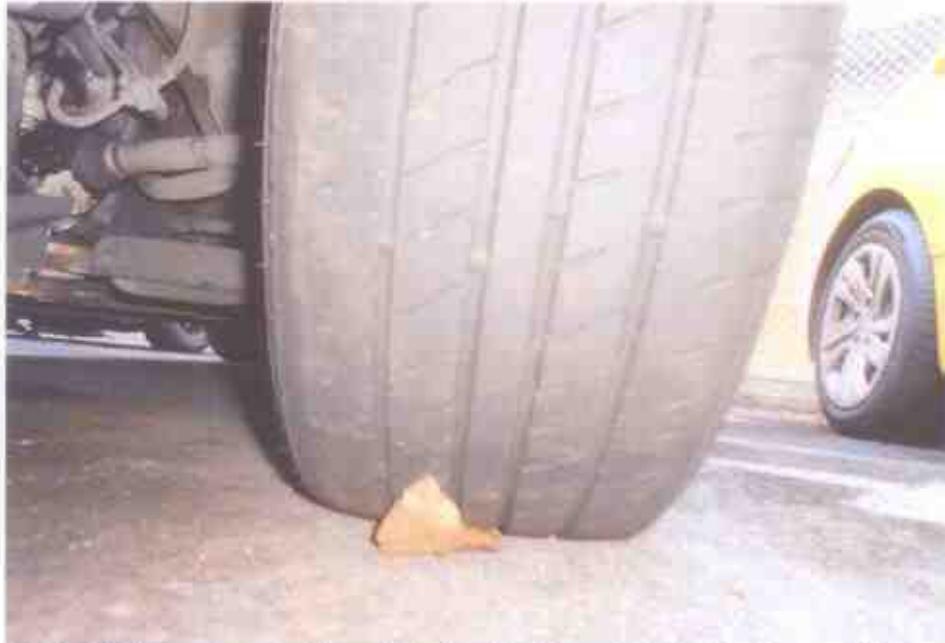
Photo 12 shows the condition of the front left tyre of the Motor Taxi, which was observed to be in serviceable condition with remaining tread depth of approximately 5mm. There was no tear, cut or burst mark(s) on the outer and the inner sidewalls as well as across the tread of this tyre, which was also sufficiently inflated for vehicular operation.

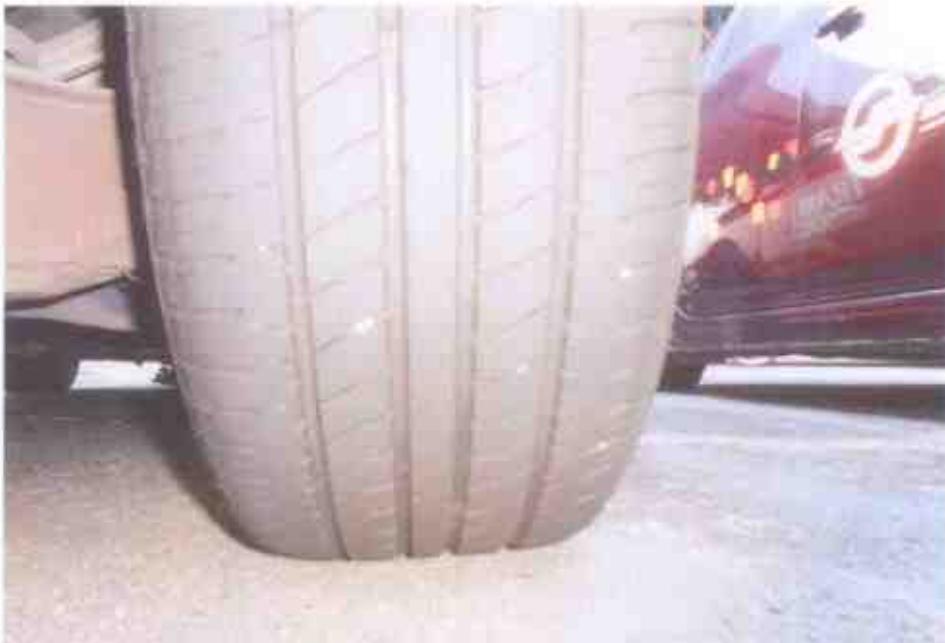
Photo 13 shows the condition of the rear right tyre of the Motor Taxi, which was observed to be in serviceable condition with remaining tread depth of approximately 5mm. There was also no tear, cut or burst mark(s) on the outer and the inner sidewalls as well as across the tread of this tyre.

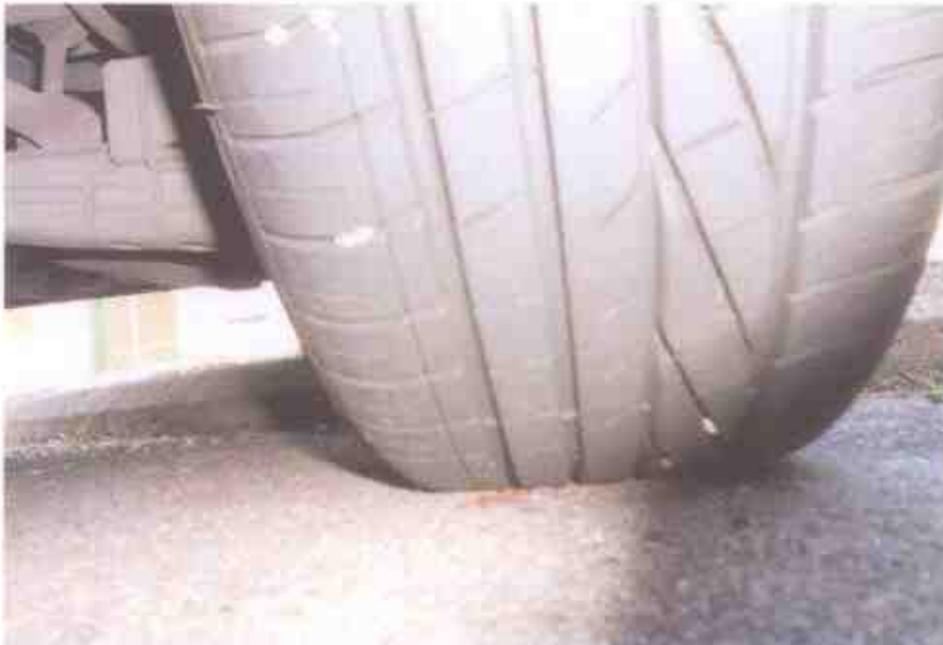
Photo 14 shows the condition of the rear left tyre of the Motor Taxi, which was observed to be in serviceable condition with remaining tread depth of approximately 5mm. There was also no tear, cut or burst mark(s) on the outer and the inner sidewalls as well as across the tread of this tyre.

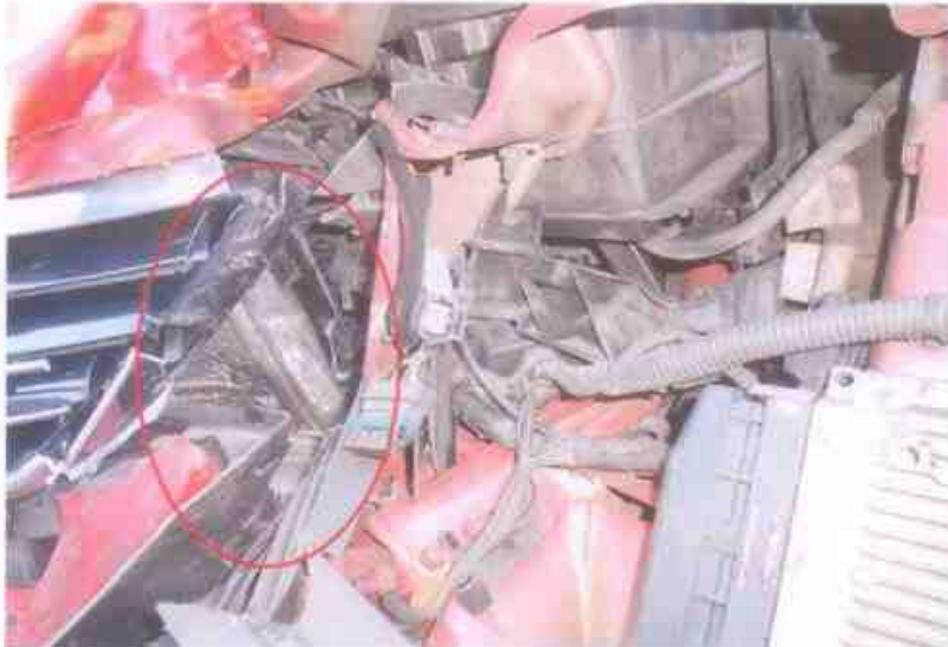
10. Leakage of the various operating fluids such as engine coolant was noted. Given the extent of damages to the engine compartment, the leakages were likely due to the accident. The engine undercarriage was however observed to be covered with fresh fluid, suggesting leakage of fluid. There was no accumulation of dust and/or dirt particles on the engine housing where the fluid stains had formed. This would indicate that the fluid leakage was a fresh leak and likely to be a result of the accident. We were therefore unable to comment whether these operating fluids were of sufficient level and without contamination for vehicular operation prior to the accident.

Photo 15 shows the close up view of the radiator of the Motor Taxi. Leakage of the engine coolant was seen. The radiator was observed to be broken due to the accident.

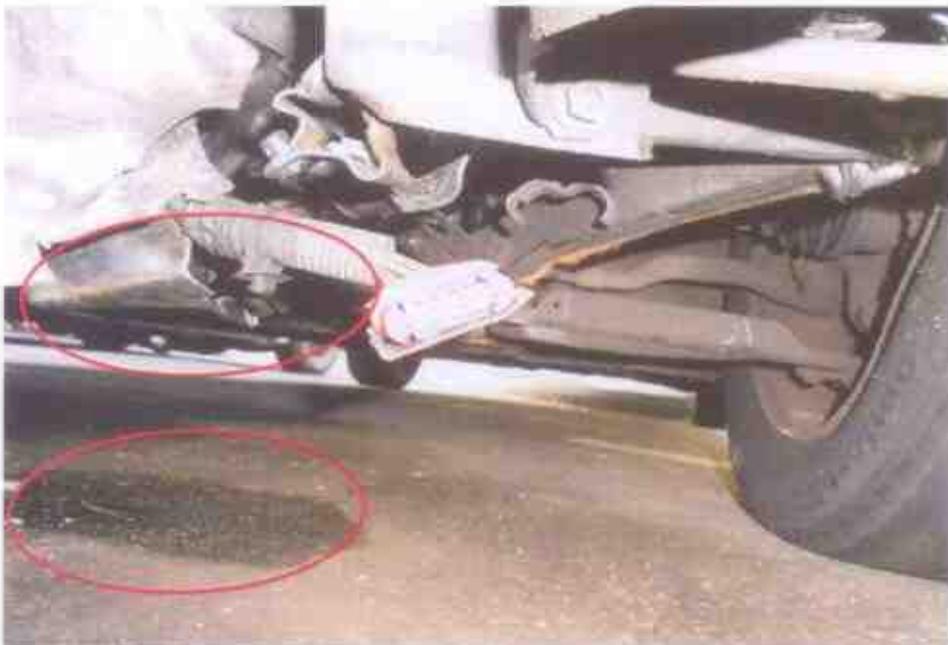
Photo 16 shows the close up view of the fluid leakage from the undercarriage at time of our inspection.

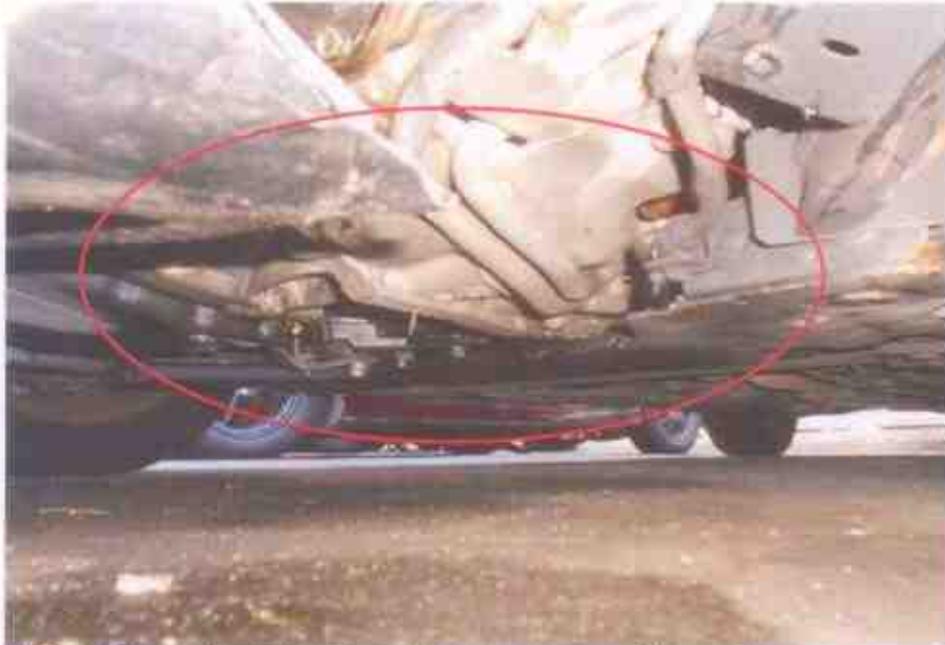
Photo 17 shows the leakage from the undercarriage of the engine area.

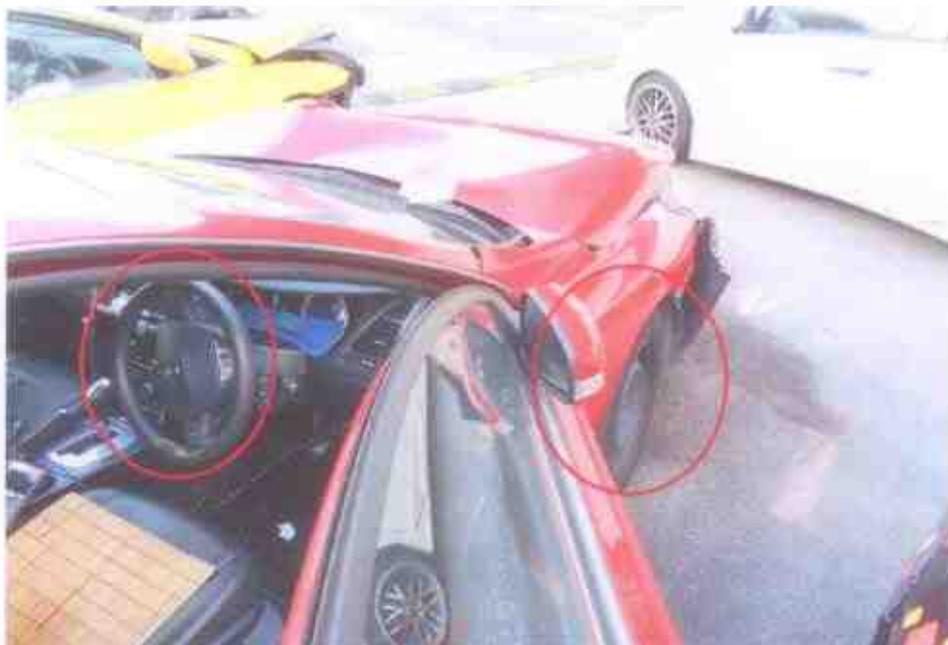
12. We were not able to conduct any tests on the steering system of the Motor Taxi. This was due to leakage of power steering fluid, as a result of the accident, as well as damage to several mechanical components of the steering system & engine system. See photo 18 below.

Photo 18 shows the misalignment of the steering wheel & the front tyre as a result of the accident's impact.

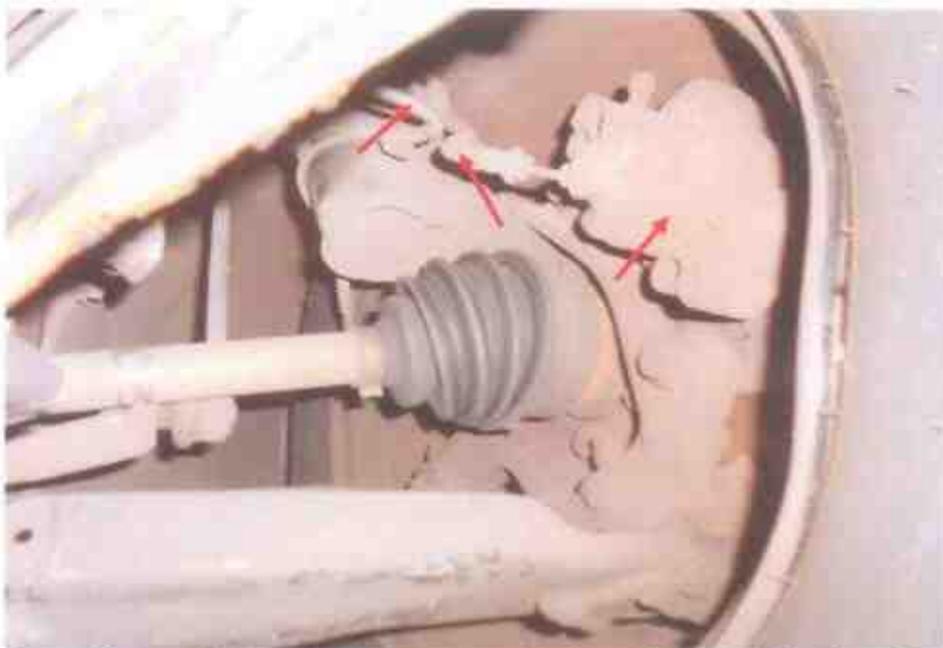
Photo 19 shows the braking components at the front left wheel of the Motor Taxi. We did not observe any leakage of brake fluid at the time of our inspection of the Motor Car.

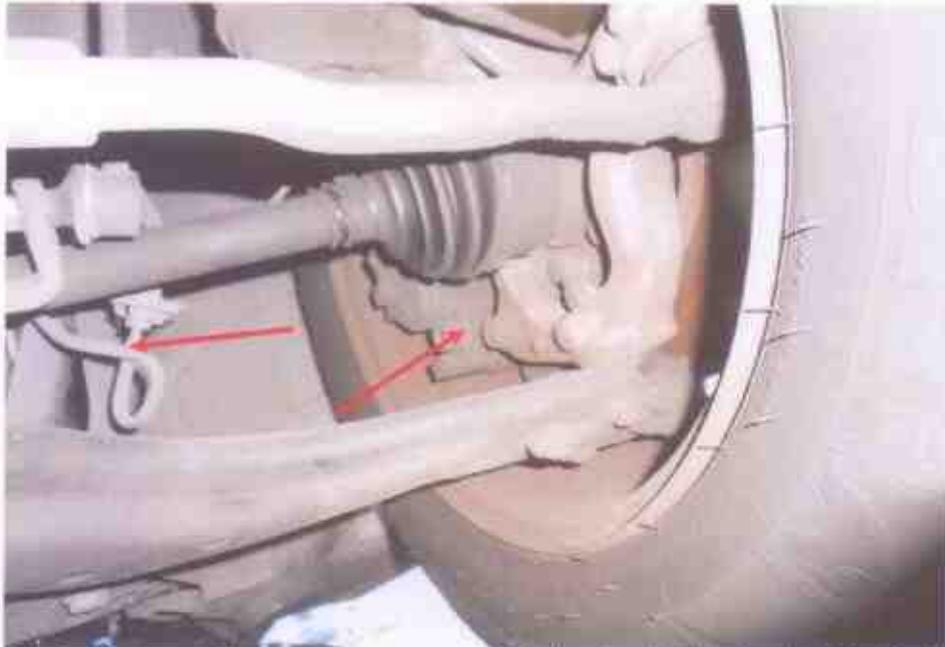
Photo 20 shows the braking components at the front right wheel of the Motor Taxi. We did not observe any leakage of brake fluid at the time of our inspection of the Motor Taxi.

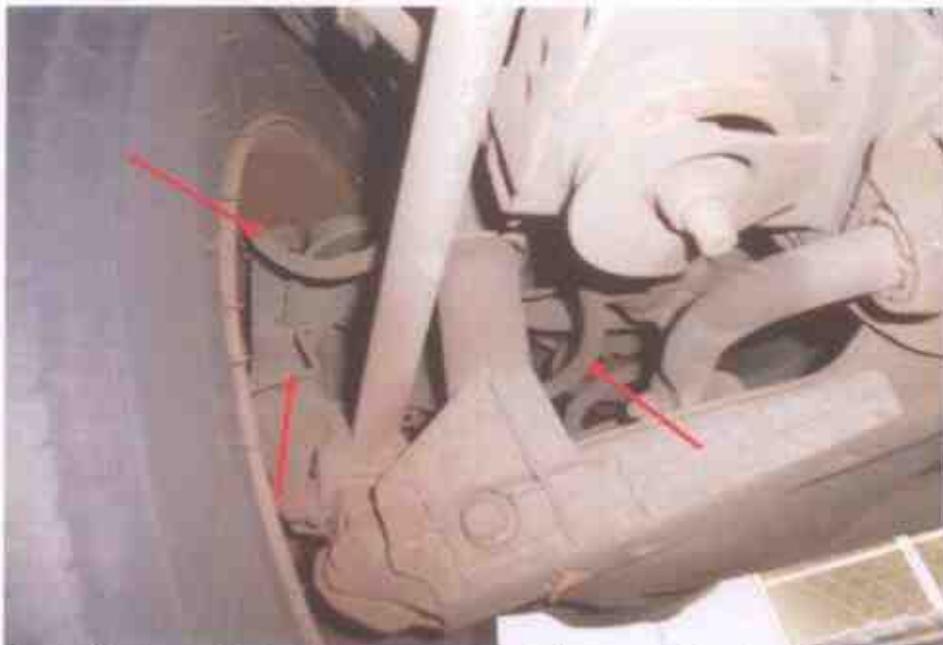
Photo 21 shows the braking components at the rear right wheel of the Motor Taxi. We did not observe any leakage of brake fluid at the time of our inspection of the Motor Taxi.

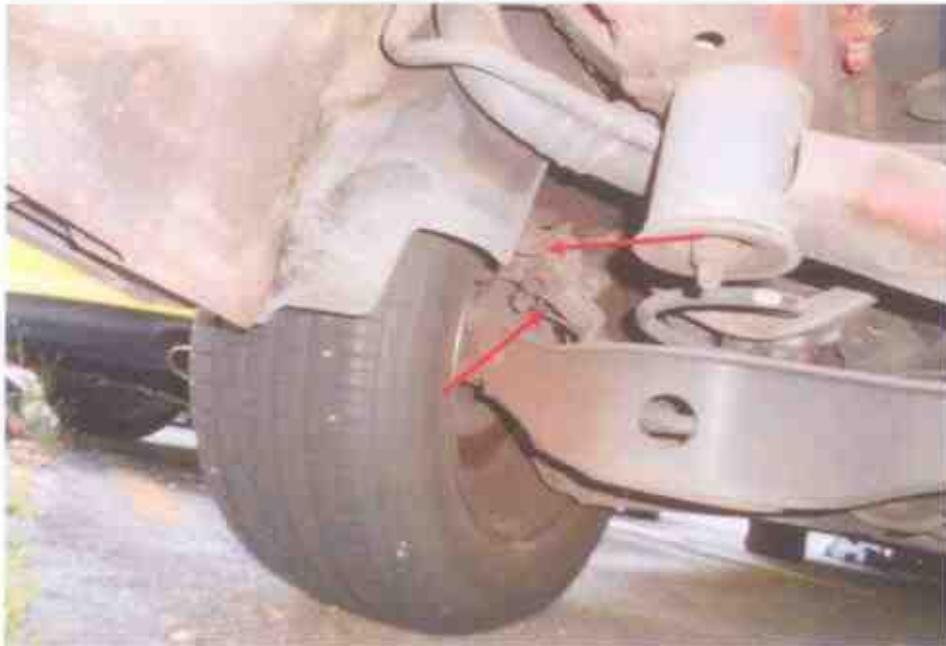
Photo 22 shows the braking components at the rear left wheel of the Motor Taxi. We did not observe any leakage of brake fluid at the time of our inspection of the Motor Taxi.
