Your Ref: TP/IP/15135/2018
Our Ref : CI/TPD18010660/Z

10th May 2018

MECHANICAL INSPECTION REPORT OF MOTOR TAXI SHC 4294G

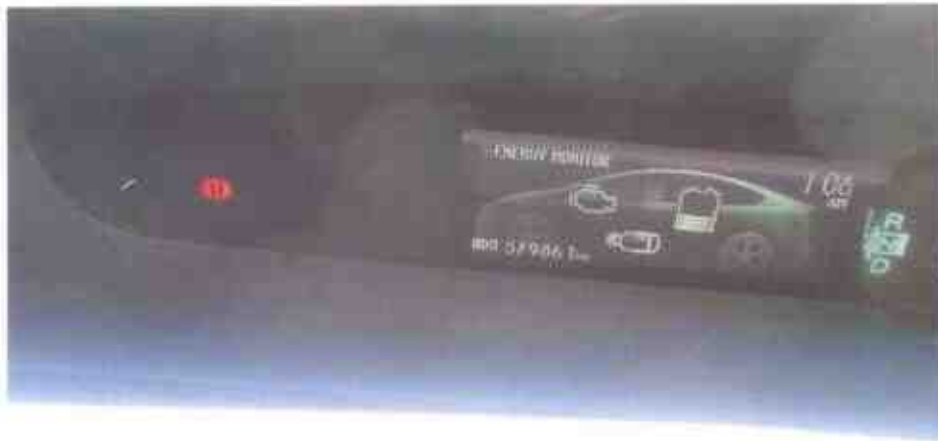
Photo 1 shows the mileage of the Motor Taxi was 579861 km.

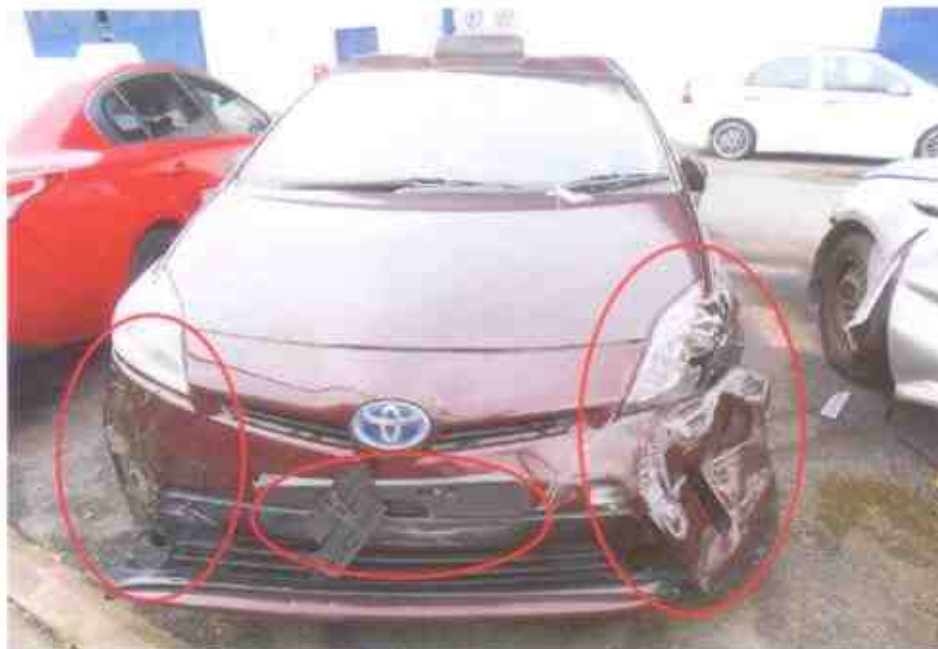
Photo 2 shows a general view of the front body of the Motor Taxi at the time of our inspection. The Motor Taxi was observed to have sustained with damages on the frontal portion as a result of the accident.

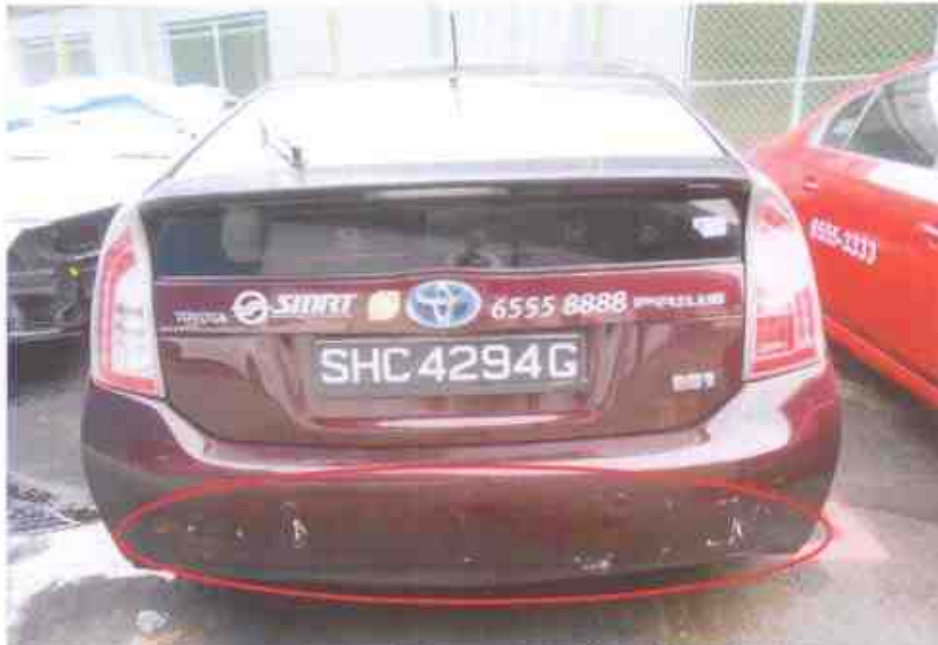
Photo 3 shows a general view of the rear body of the Motor Taxi at the time of our inspection. The Motor Taxi rear portion was observed to sustain multiple scratches likely due to the accident.

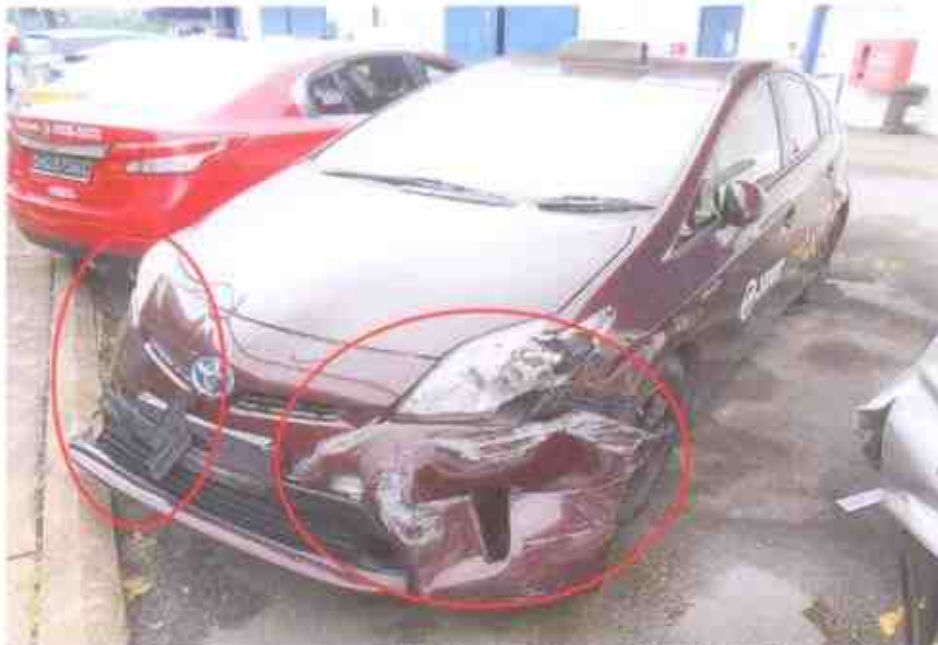
Photo 4 shows a general view of the front left body of the Motor Taxi at the time of our inspection. The Motor Taxi was observed to have sustained with damages on the front left portion as a result of the accident.

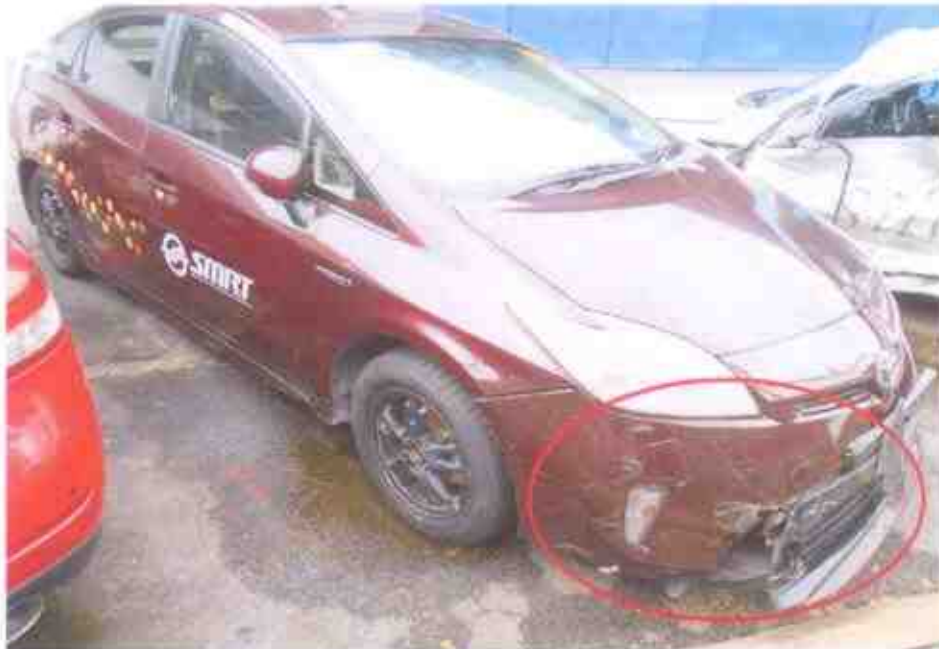
Photo 5 shows a general view of the front right body of the Motor Taxi at the time of our inspection. The Motor Taxi was observed to have sustained with damages on the front left portion as a result of the accident.

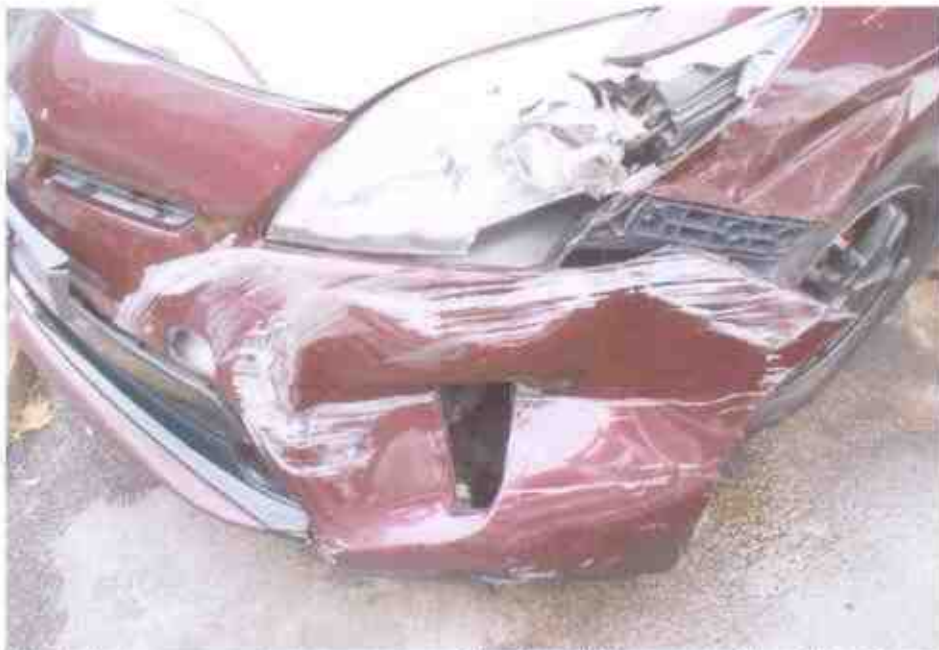
Photo 6 shows a semi close up view of the front left bumper of the Motor Taxi at the time of our inspection. The Motor Taxi had sustained damages at the front left bumper of the Motor Taxi.

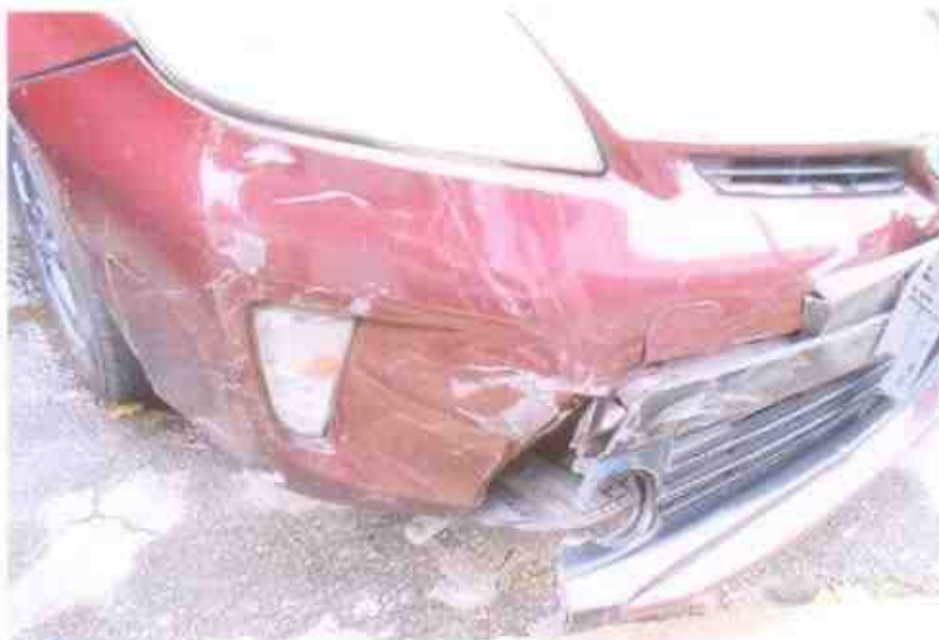
Photo 7 shows a semi close up view of the front right lower bumper of the Motor Taxi at the time of our inspection. The Motor Taxi had sustained damages at the front right lower bumper of the Motor Taxi as a result of the accident.

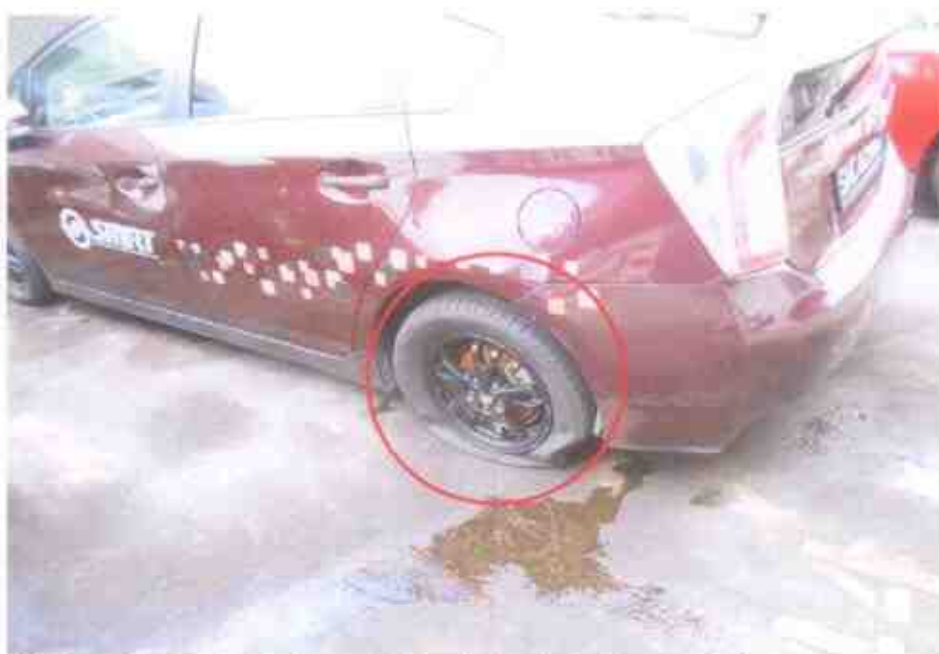
Photo 8 shows a deflated rear left tyre likely due to the accident's impact.

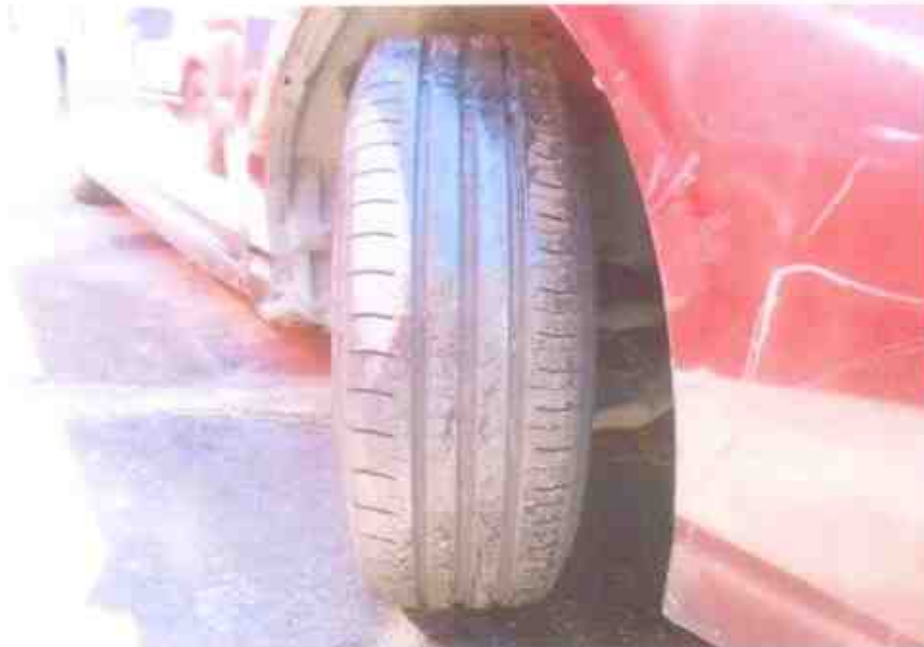
Photo 9 shows the condition of the front right tyre of the Motor Taxi, which was observed to be in serviceable condition. The remaining tread depth measured approximately around 7mm. There was no tear, cut or burst mark(s) on the outer and the inner sidewalls.

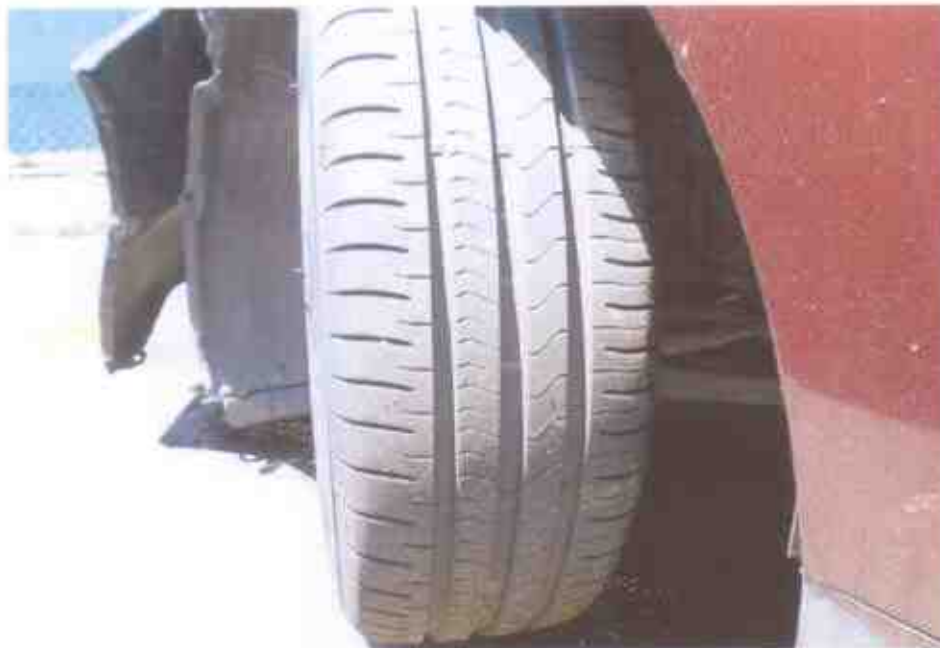
Photo 10 shows the condition of the front left tyre of the Motor Taxi, which was observed to be in serviceable condition with remaining tread depth of approximately 7mm. The tyre, which was wrapped around alloy wheel rim, was also observed to be sufficiently inflated for vehicular operation.

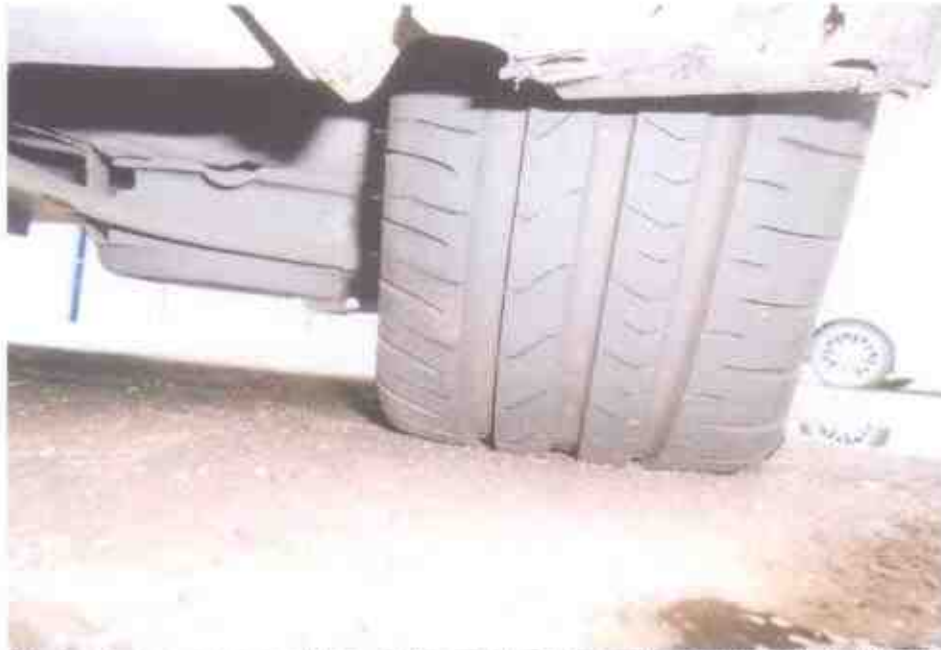
Photo 11 shows the condition of the rear left tyre of the Motor Taxi, which was observed to be deflated as a result of the accident. The remaining tread depth was approximately 5mm.

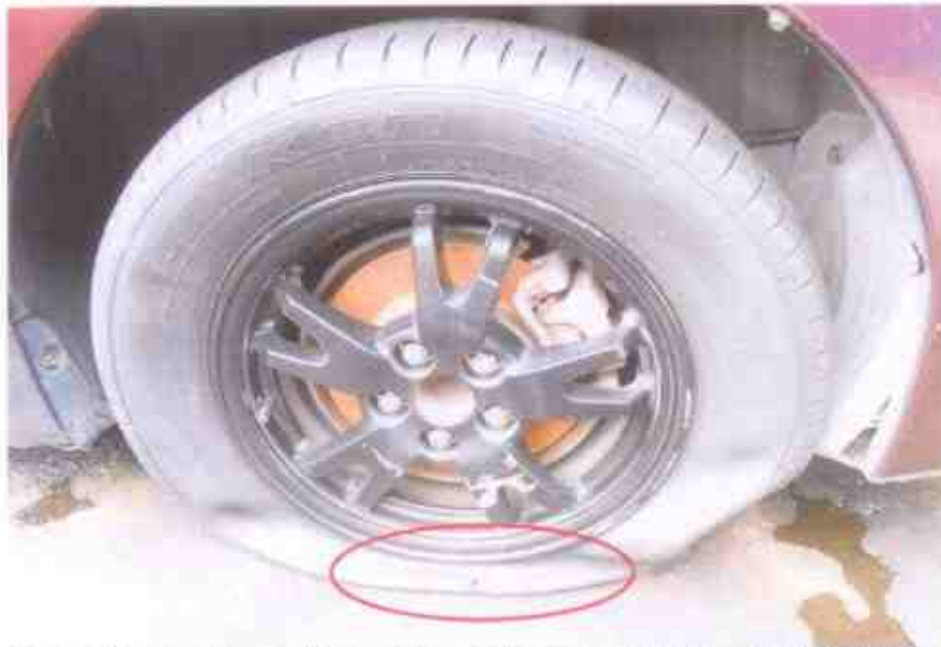
Photo 12 shows the condition of the rear left tyre of the Motor Taxi, which was observed to be deflated as a result of the accident. The remaining tread depth was approximately 5mm.

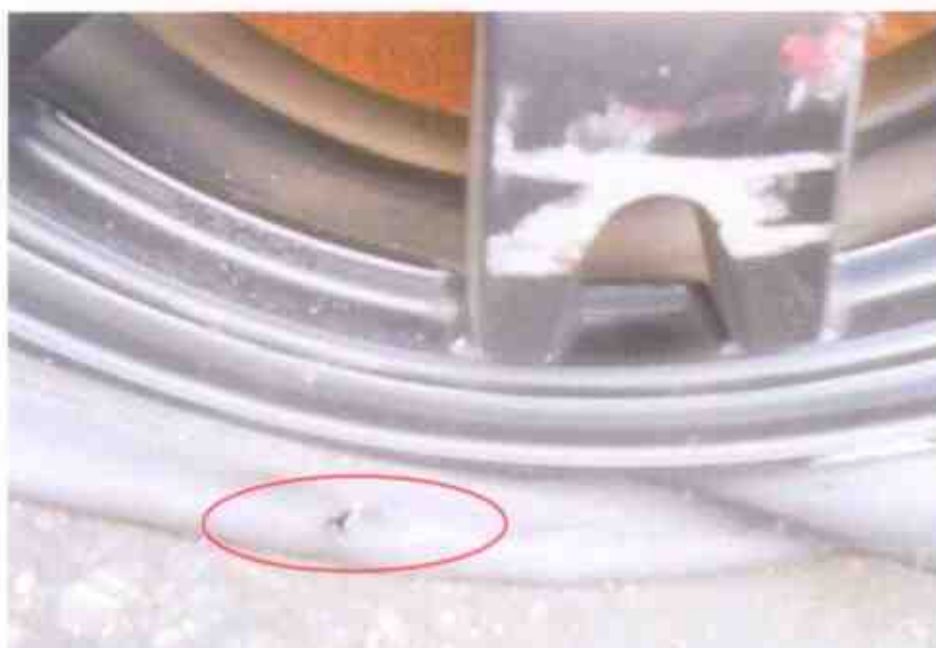
Photo 13 shows the close-up view of the rear left tyre of the Motor Taxi, which was observed to be deflated. Further observation found that the tyre was torn on the outer sidewalls as a result of the accident.

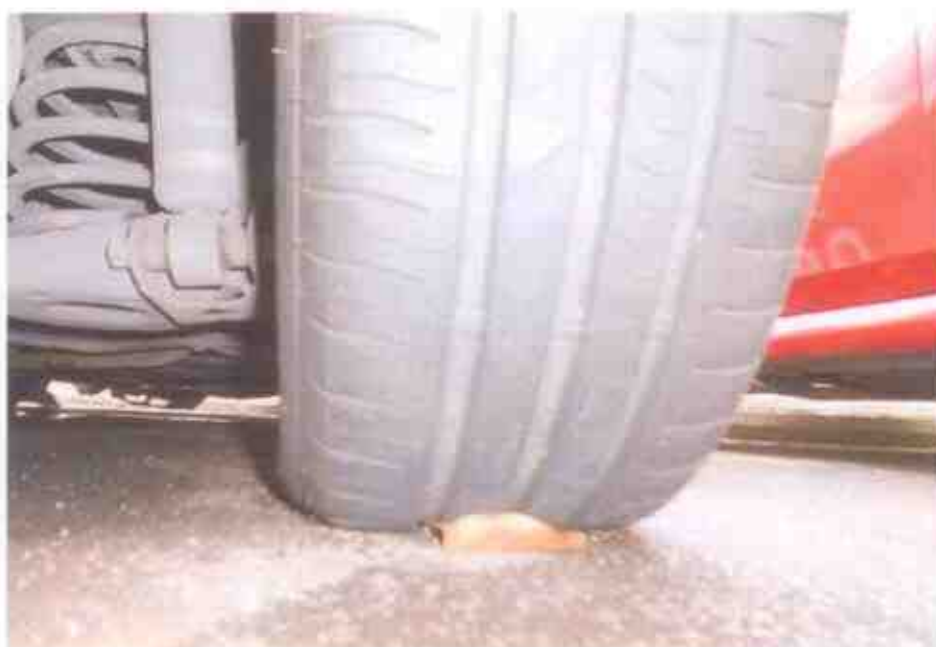
Photo 14 shows the condition of the rear right tyre of the Motor Taxi, which was observed to be in serviceable condition with remaining tread depth of approximately 7mm. There was also no tear, cut or burst mark(s) on the outer and the inner sidewalls.

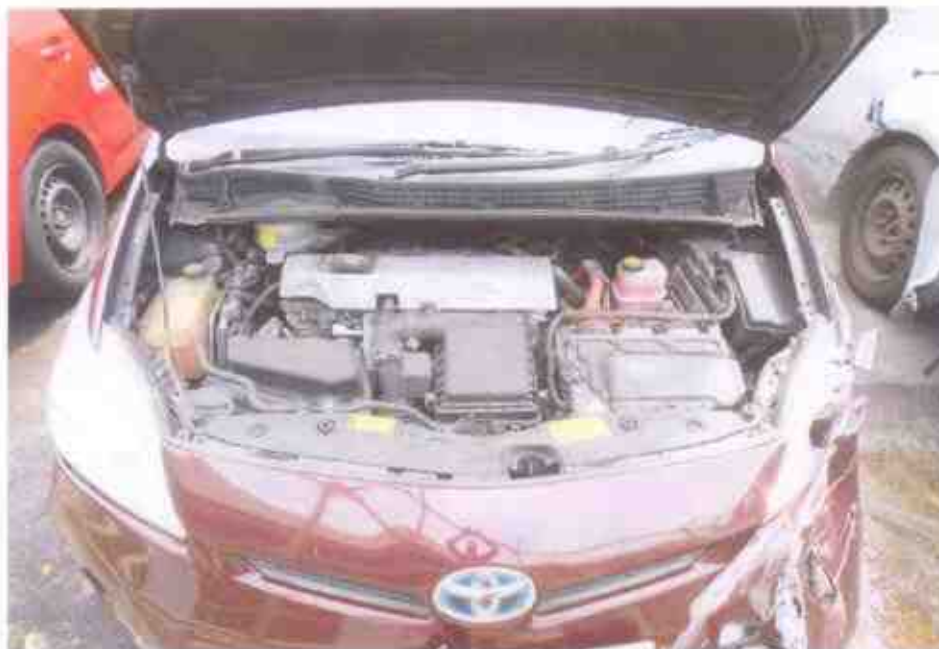
Photo 15 shows a general view of the Motor Car's engine compartment. The various parts and components inside the engine compartment were unaffected by the accident. There was also no sign(s) or indication(s) of fluid leakage and/or fluid stain within the engine compartment.

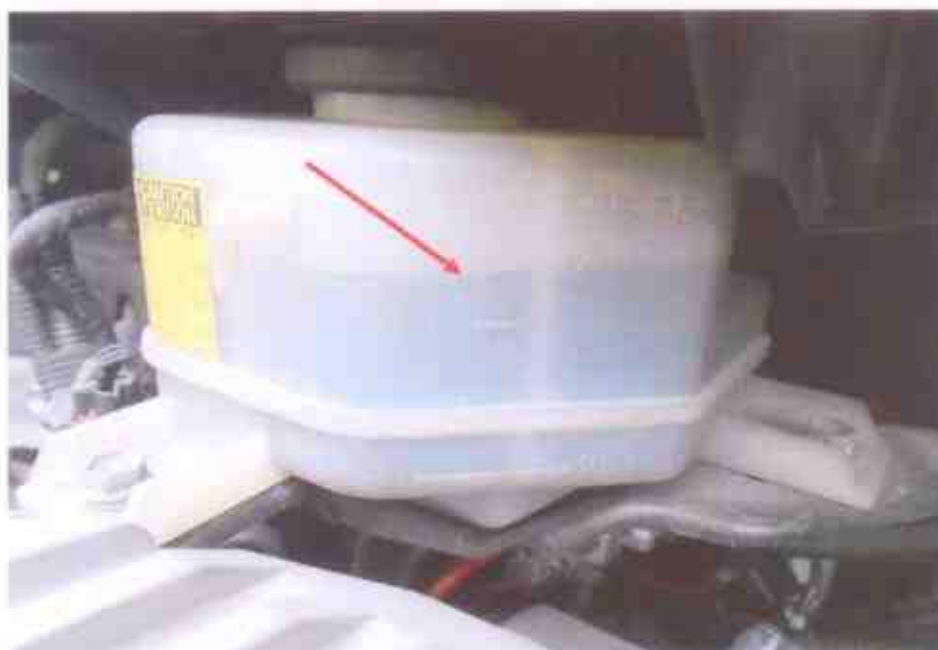
Photo 16 shows the brake fluid reservoir of the Motor Taxi at the time of our inspection. The brake fluid was observed to be of sufficient level (arrowed) and without any visible contamination.

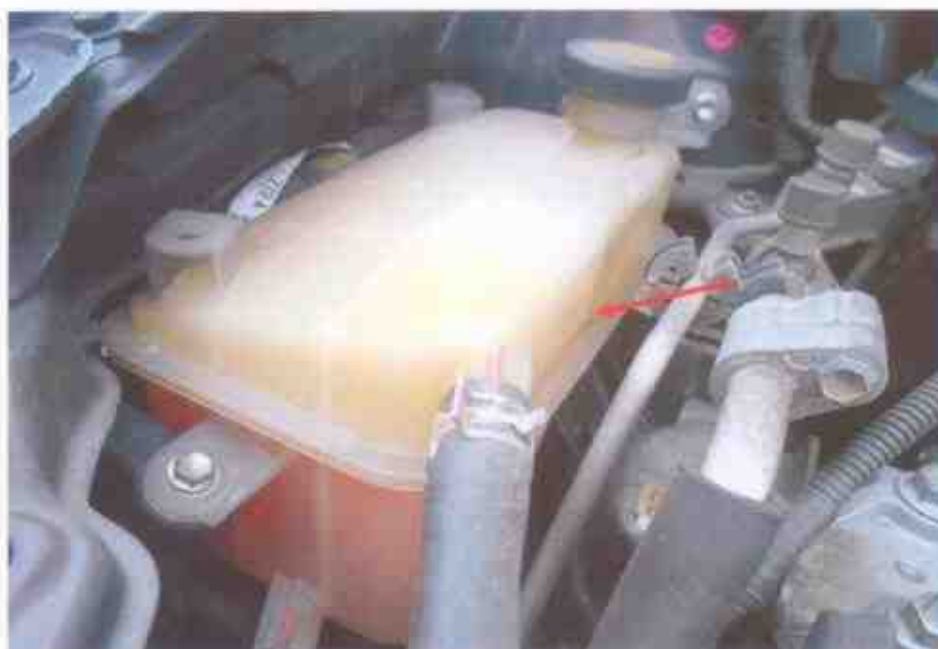
Photo 17 shows the engine coolant fluid reservoir of the Motor Taxi at the time of our inspection. The engine coolant fluid was observed to be of sufficient level and without any visible contamination.

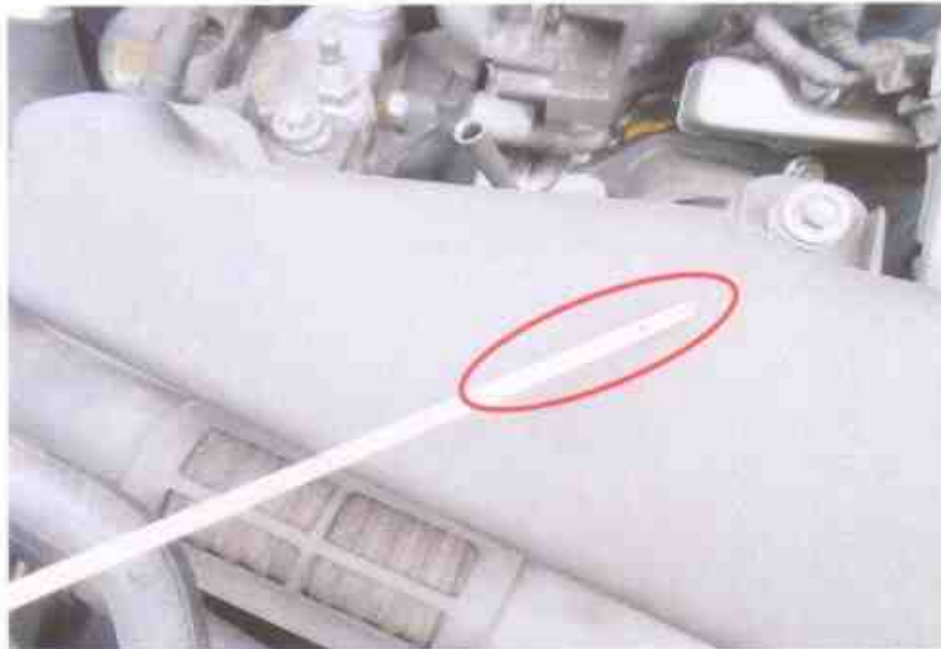
Photo 18 shows the engine oil dip stick of the Motor Taxi at the time of our inspection. The engine oil was observed to be of sufficient level and without any visible contamination.

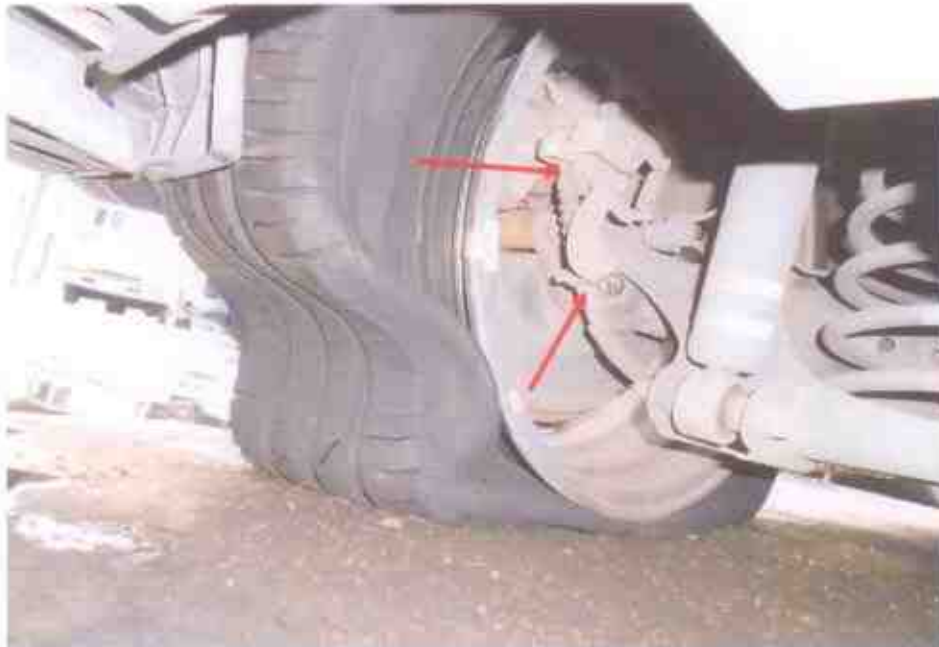
Photo 19 shows the brake hose (arrowed) at the rear left wheel of the Motor Taxi. We did not observe any leakage of brake fluid at the time of our inspection of the Motor Taxi. Our visual inspection of the various mechanical components of the Motor Taxi's braking system revealed all to be intact and without visible damage.

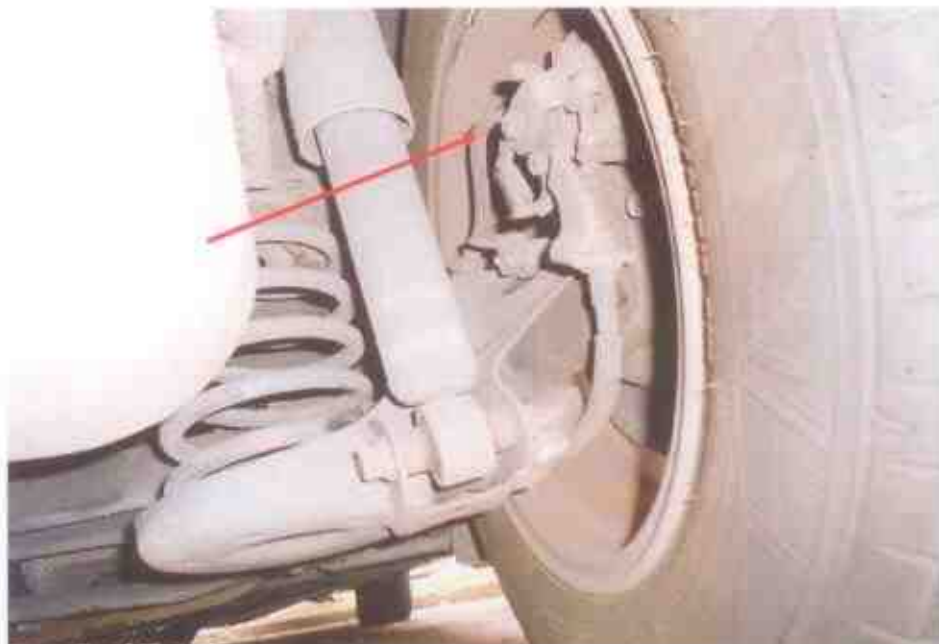
Photo 20 shows the brake hose (arrowed) at the rear right wheel of the Motor Taxi. We did not observe any leakage of brake fluid at the time of our inspection of the Motor Taxi. Our visual inspection of the various mechanical components of the Motor Taxi's braking system, including its brake calliper (circled), revealed all to be intact and without visible damage.

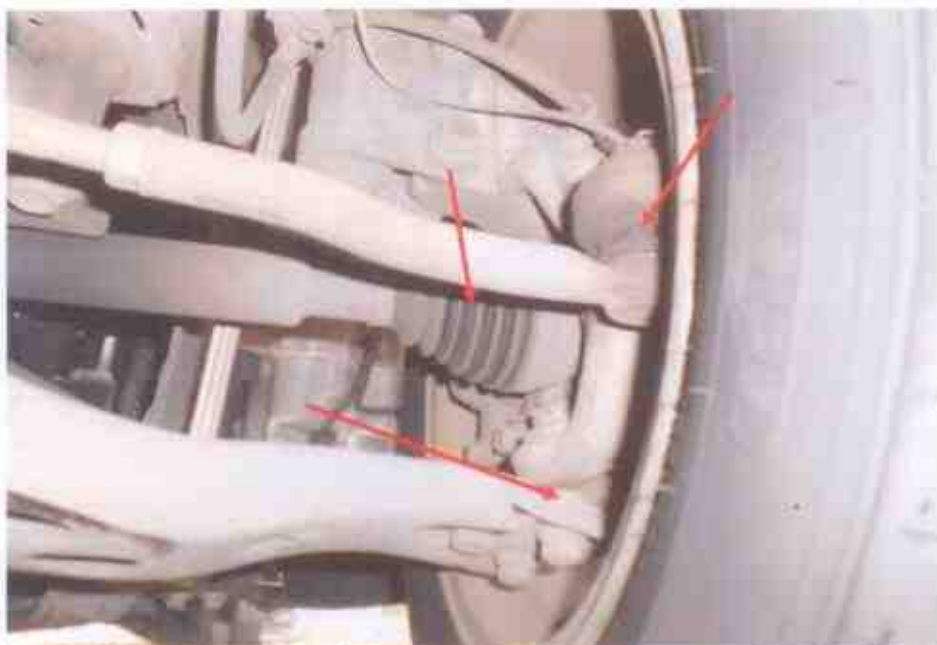
Photo 21 shows the various undercarriage components at the front right wheel of the Motor Taxi, in particular the steering tie rod (arrowed). The various steering components were all found to be intact, suggesting that the steering system of the Motor Taxi was likely to be in serviceable condition.

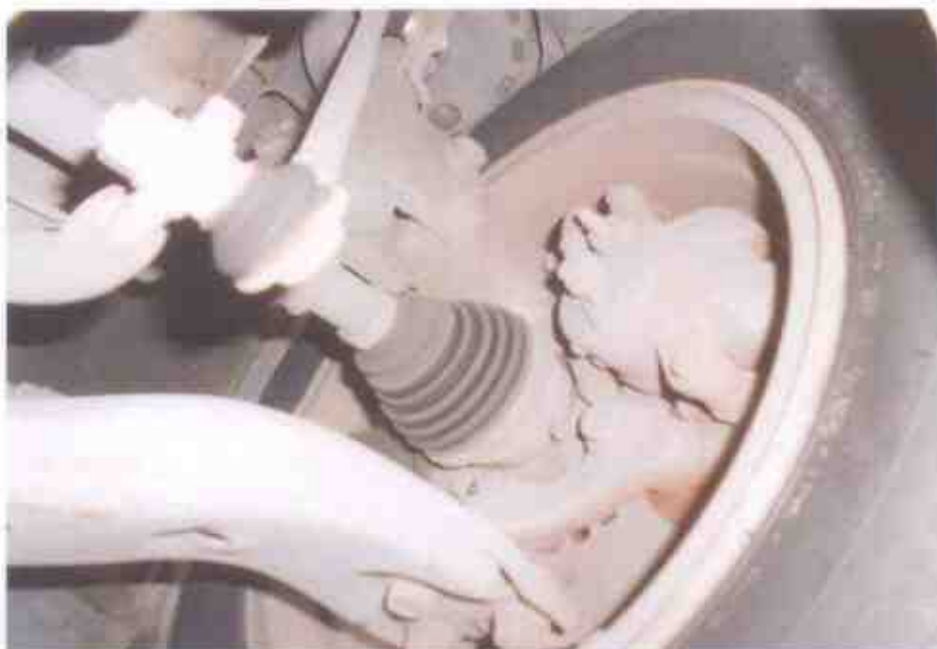
Photo 22 shows the steering system at the front left wheel of the Motor Taxi. We did not observe any leakage of brake fluid at the time of our inspection of the Motor Taxi. Our visual inspection of the various mechanical components of the Motor Taxi's braking system revealed all to be intact and without visible damage, indicating that the braking system was likely to be in serviceable condition at the material time of accident.

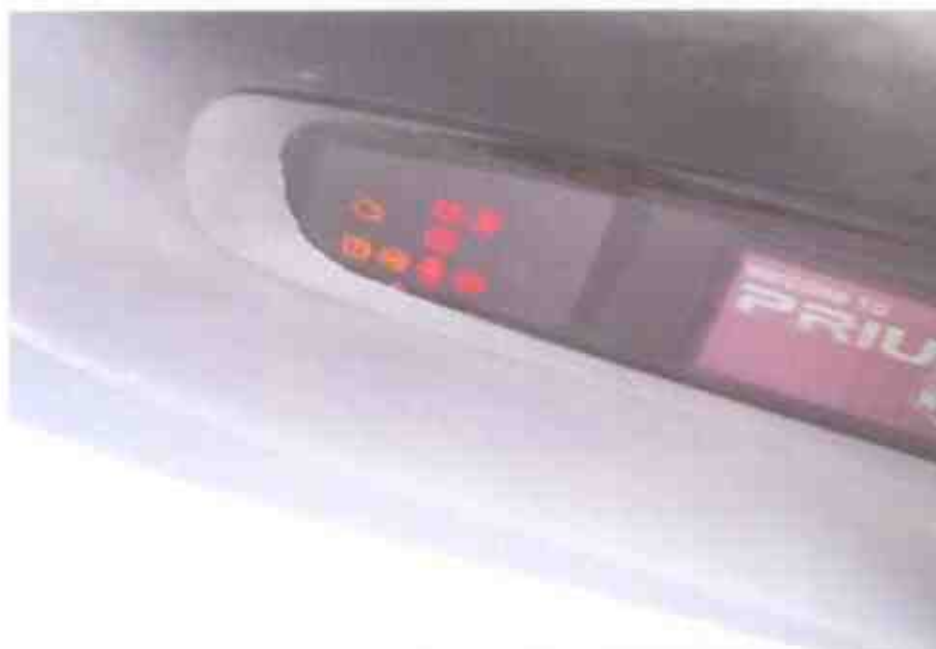
Photo 23 shows the warning lights for the various electronic operating systems of the Motor Taxi appearing on its instrument panel during the self-test when the engine is cranked, in particular the ABS light and SRS light.

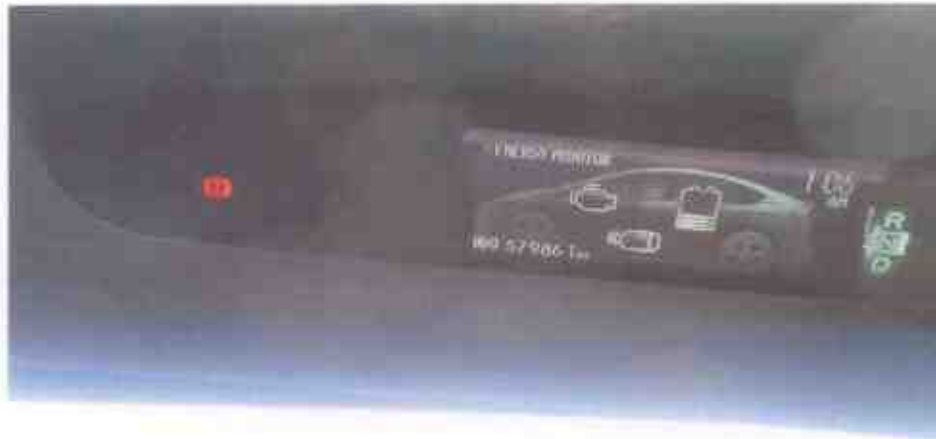
Photo 24 shows warning indicators disappearing from the instrument panel of the Motor Taxi after the engine was cranked. This would suggest that the electronic operating systems of the Motor Taxi were successfully initiated normally.

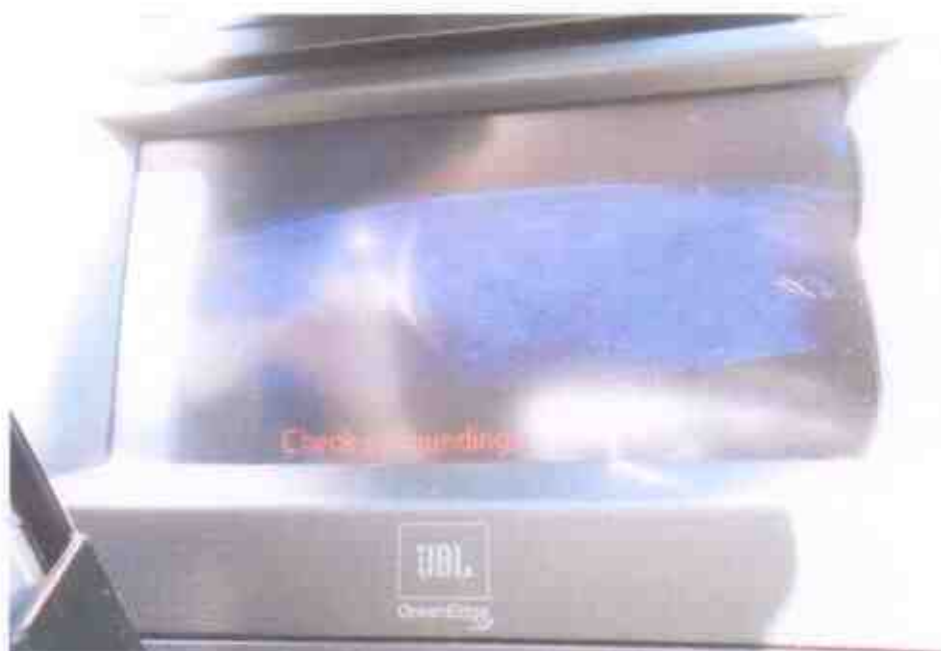
Photo 25 shows reverse sensor camera on the LCD panel of the Motor Taxi while performing operational test. This would suggest that it was able to move forward and backward normally.

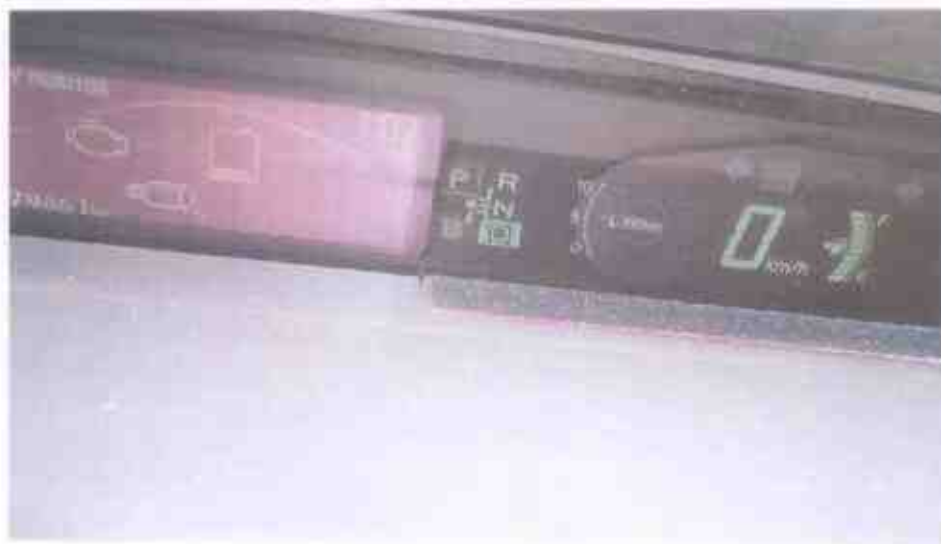
Photo 26 shows drive mode on the LCD panel of the Motor Taxi while performing operational test. This would suggest that it was able to move forward and backward normally.
