Your Ref: TP/IP/21429/2018
Our Ref : CI/TPD18010663/Z

06th August 2018

MECHANICAL INSPECTION REPORT OF MOTOR VAN GBD 6631U.

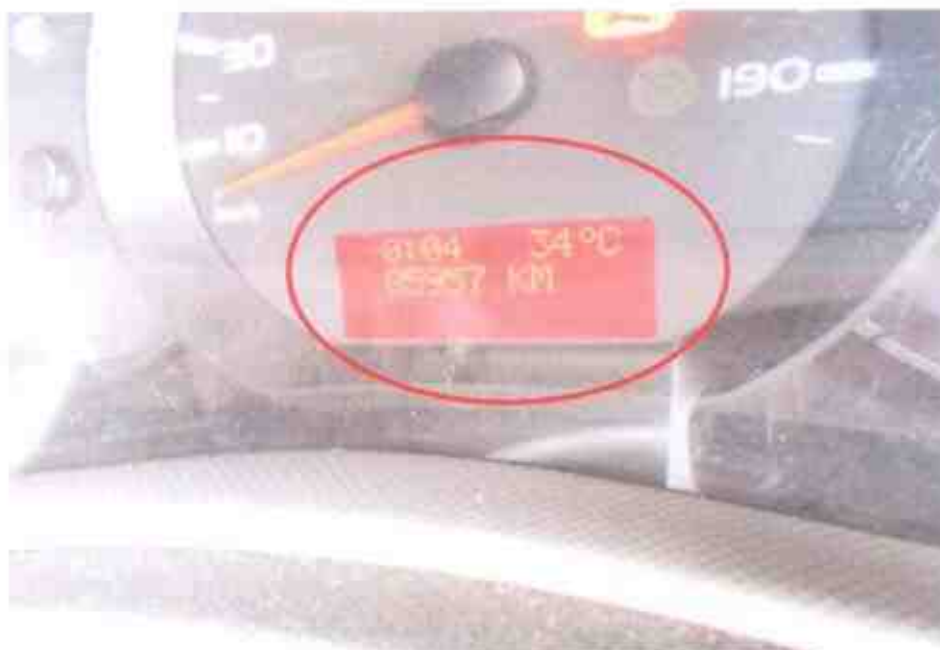
Photo 1 shows the mileage of the Motor Van was 85957km.

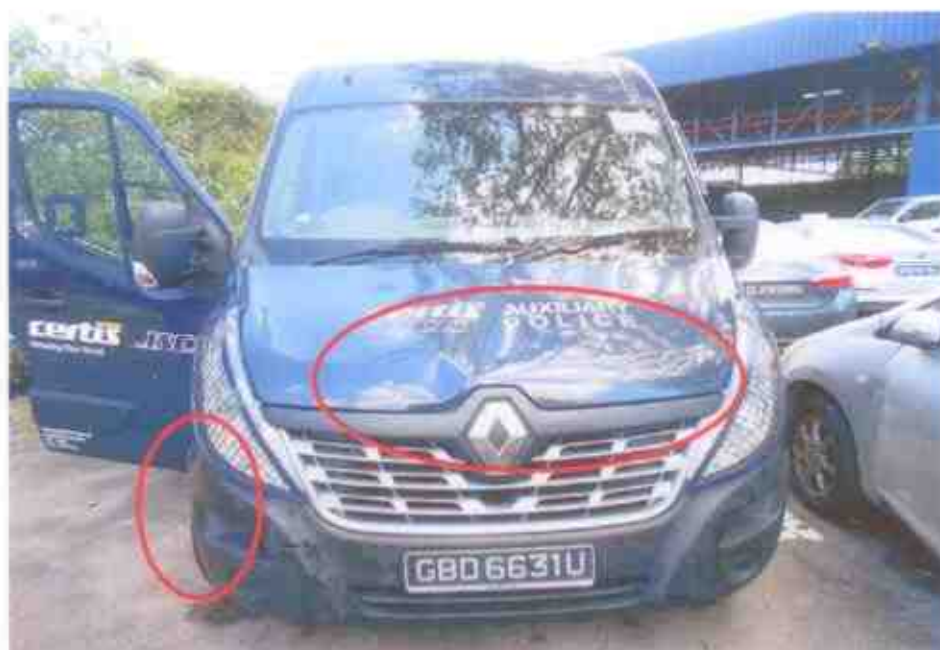
Photo 2 shows a general view of the front body of the Motor Van at the time of our inspection. The Motor Van was observed to sustained minor damage at the front bonnet & right lower bumper.

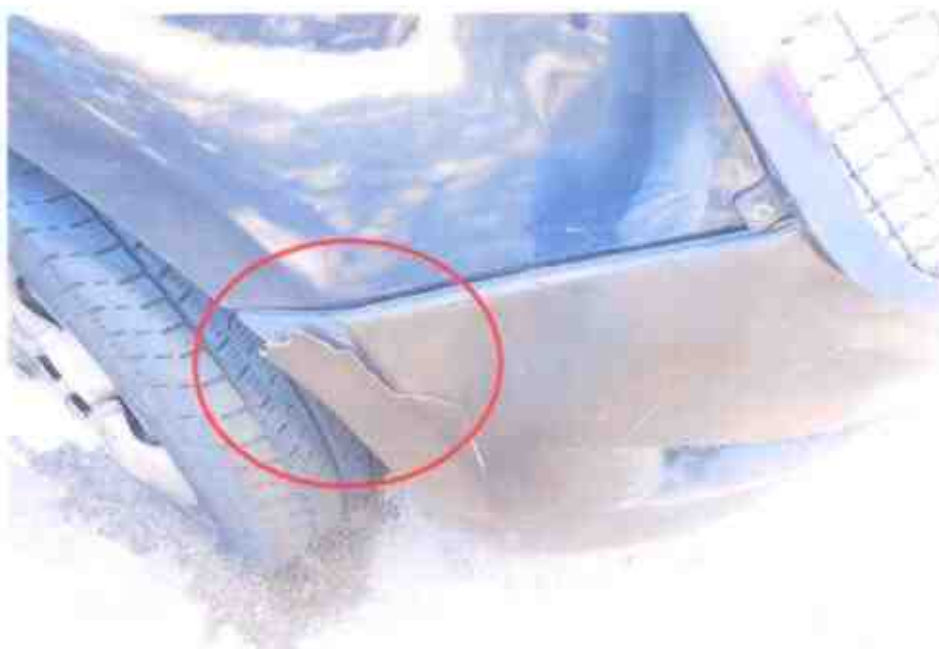
Photo 3 shows a close-up view of the damages on the front right lower bumper of the Motor Van at the time of our inspection. It was observed to have sustained with minor damage likely due to the accident.

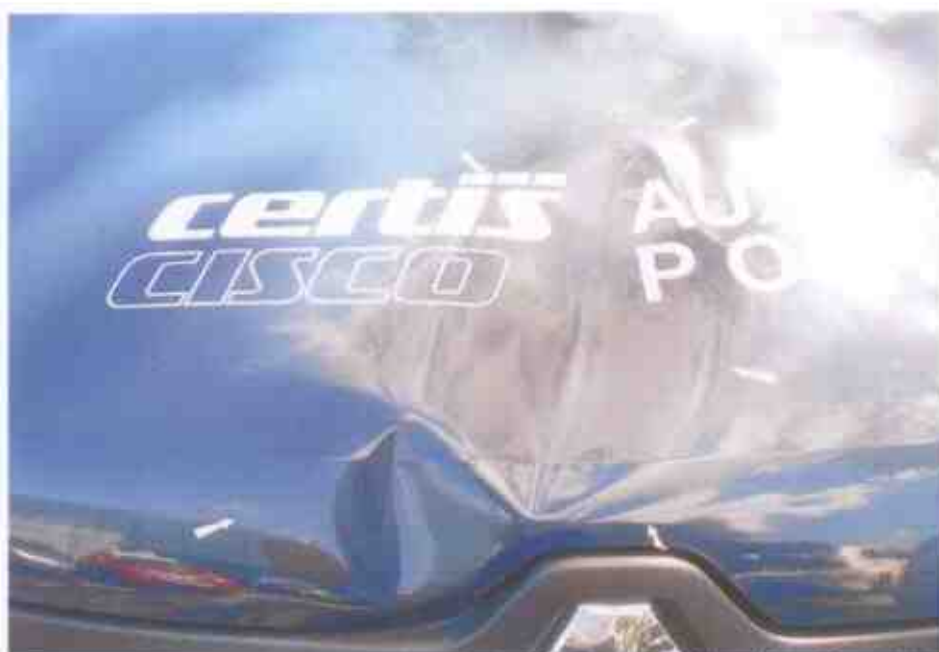
Photo 4 shows a semi-close-up view of the front bonnet of the Motor Van at the time of our inspection. It was observed to be corrugated due to the accident.

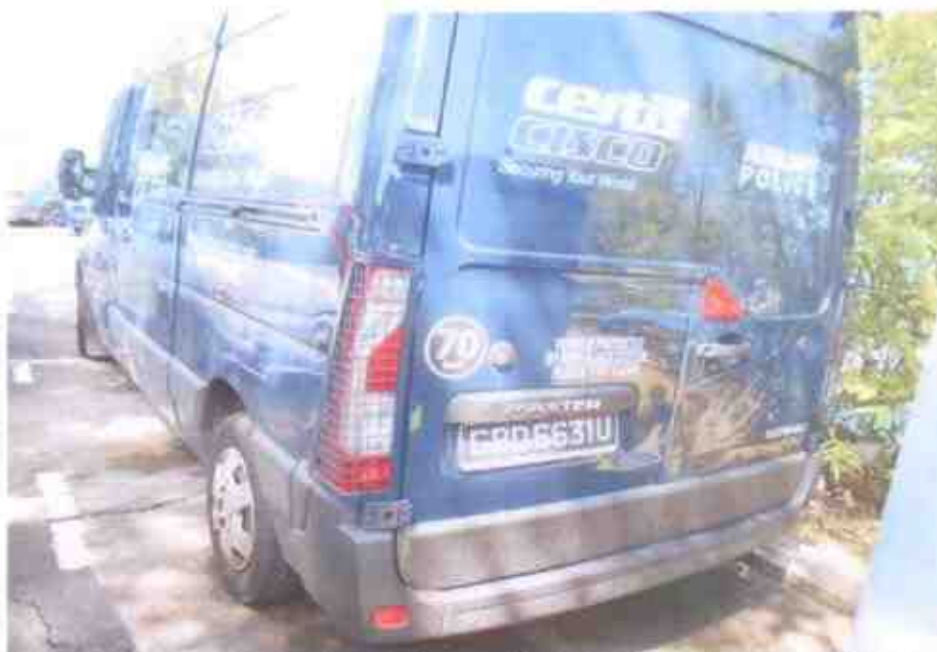
Photo 5 shows a general view of the rear left body of the Motor Van at the time of our inspection. The Motor Van was observed to be in good general condition at time of inspection.

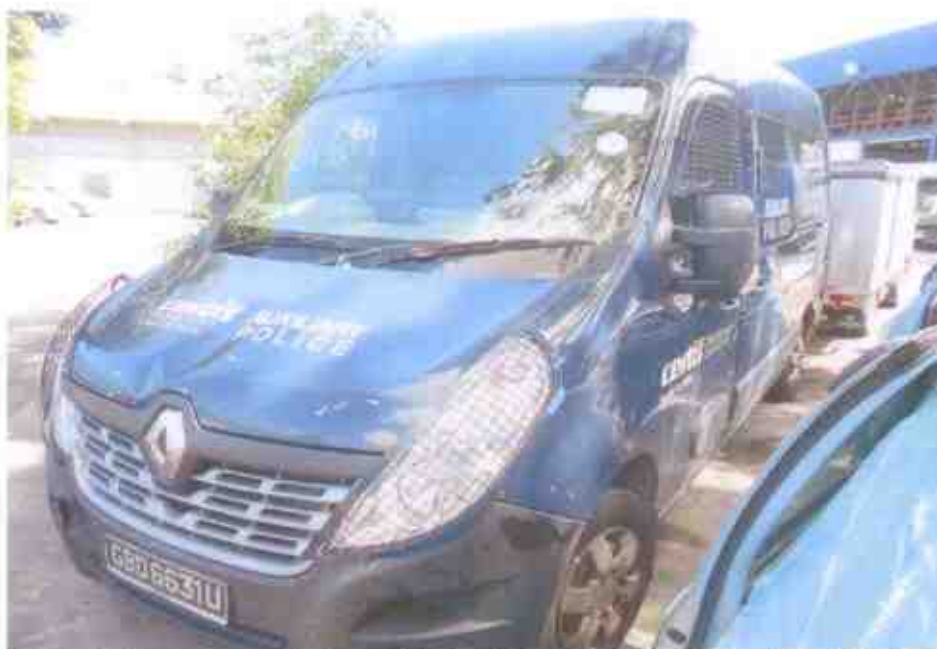
Photo 6 shows a general view of the front left body of the Motor Van at the time of our inspection. The Motor Van was observed to have sustained with minor damages likely due to the accident's impact.

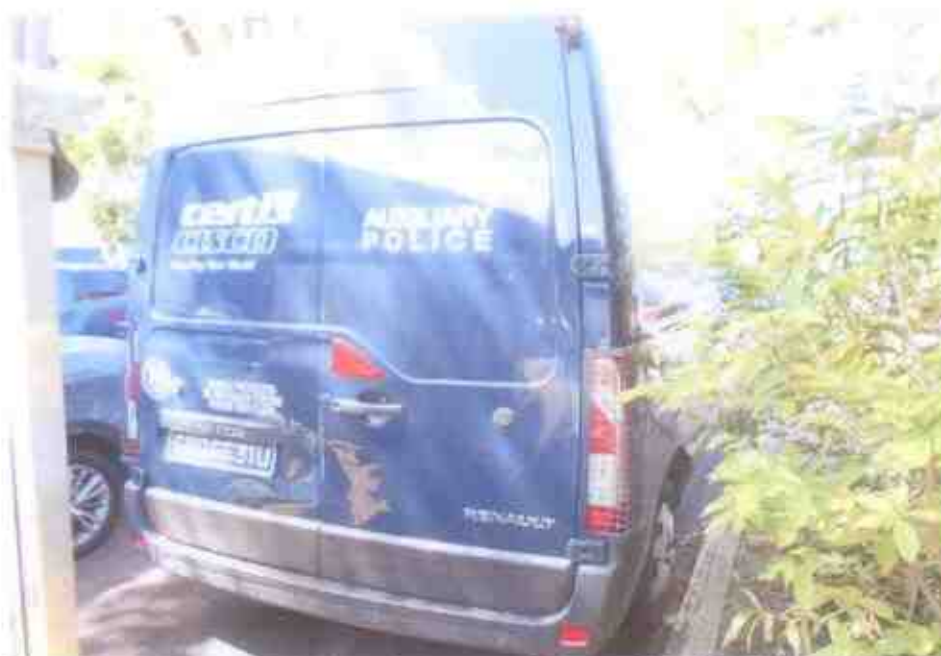
Photo 7 shows a general view of the rear left body of the Motor Van at the time of our inspection. The Motor Van was observed to be in good general condition at time of inspection.

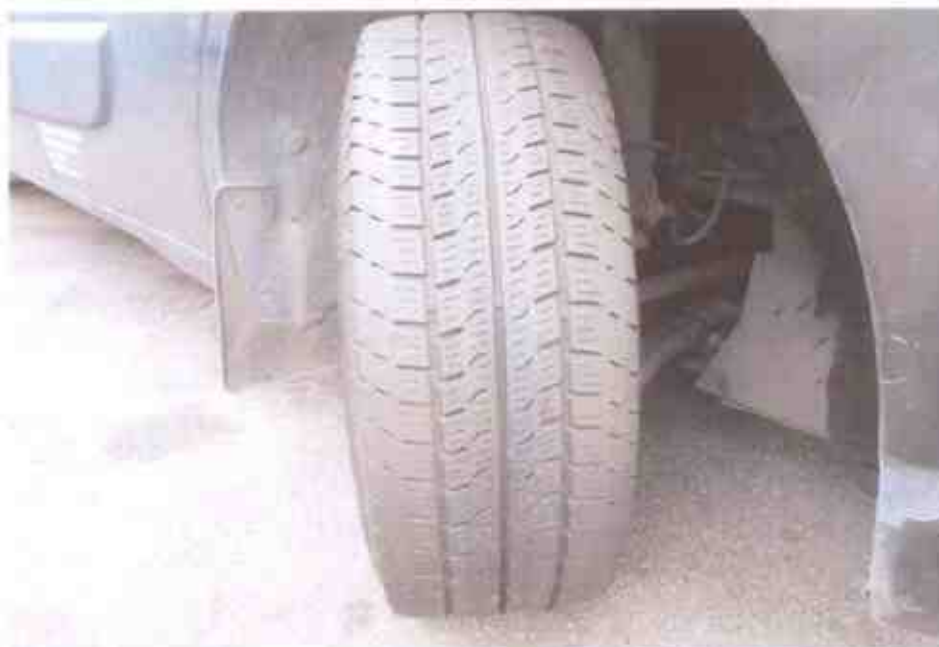
Photo 8 shows the condition of the front right tyre of the Motor Van, which was observed to be in serviceable condition with remaining tread depth of approximately 5mm. The tyres were all observed to be sufficiently inflated for vehicular operation with no tear, cut or burst mark(s) on the outer and the inner sidewalls as well as across the tread.

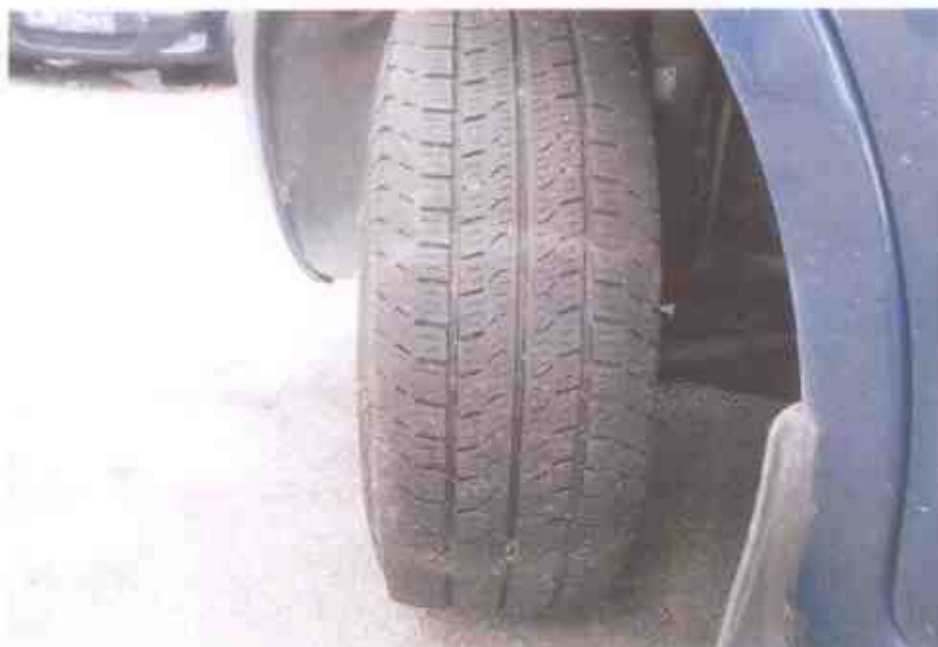
Photo 9 shows the condition of the front left tyre of the Motor Van, which was observed to be in serviceable condition with remaining tread depth of approximately 5mm. The tyre, which was wrapped around standard wheel rim, was also observed to be sufficiently inflated for vehicular operation.

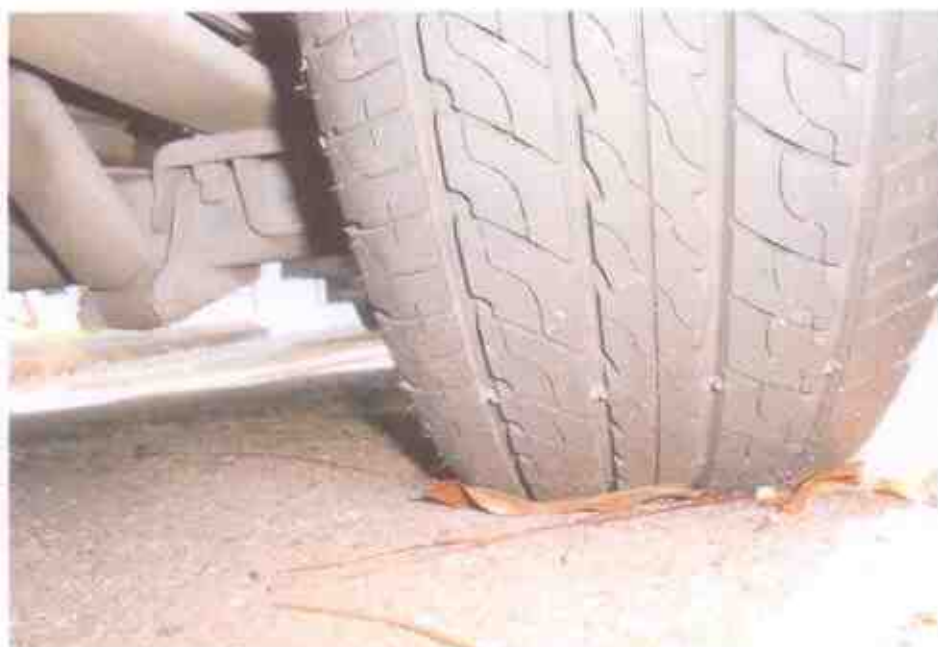
Photo 10 shows the condition of the rear left tyre of the Motor Van, which was observed to be in serviceable condition with remaining tread depth of approximately 7mm. The tyre, which was wrapped around standard wheel rim, was also observed to be sufficiently inflated for vehicular operation. There was also no significant damage found on the 4 wheel rims of the Motor Van.

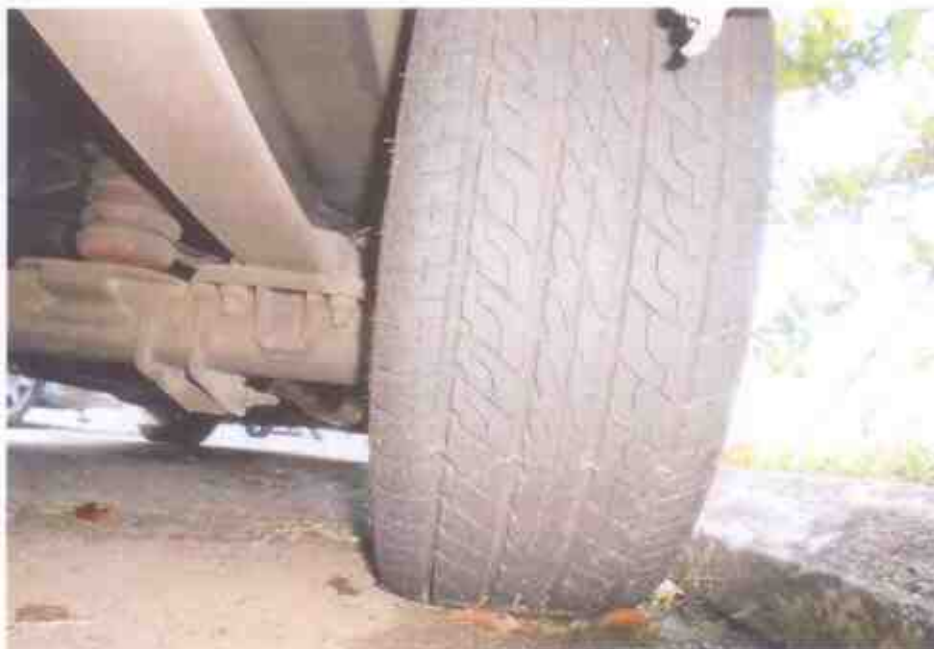
Photo 11 shows the condition of the rear right tyre of the Motor Van, which was observed to be in serviceable condition with remaining tread depth of approximately 8mm. There was also no tear, cut or burst mark(s) on the outer and the inner sidewalls as well as across the tread of the tyre, which was also sufficiently inflated for vehicular operation.

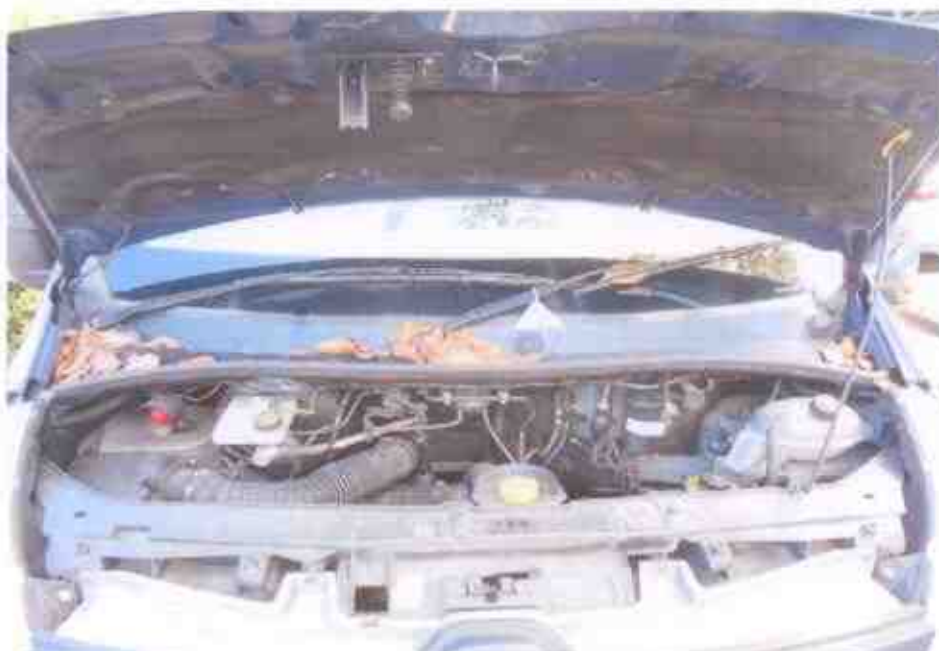
Photo 12 shows a general view of the Motor Van's engine compartment. The various parts and components inside the engine compartment were unaffected by the accident. There was also no sign(s) or indication(s) of fluid leakage and/or fluid stain within the engine compartment.

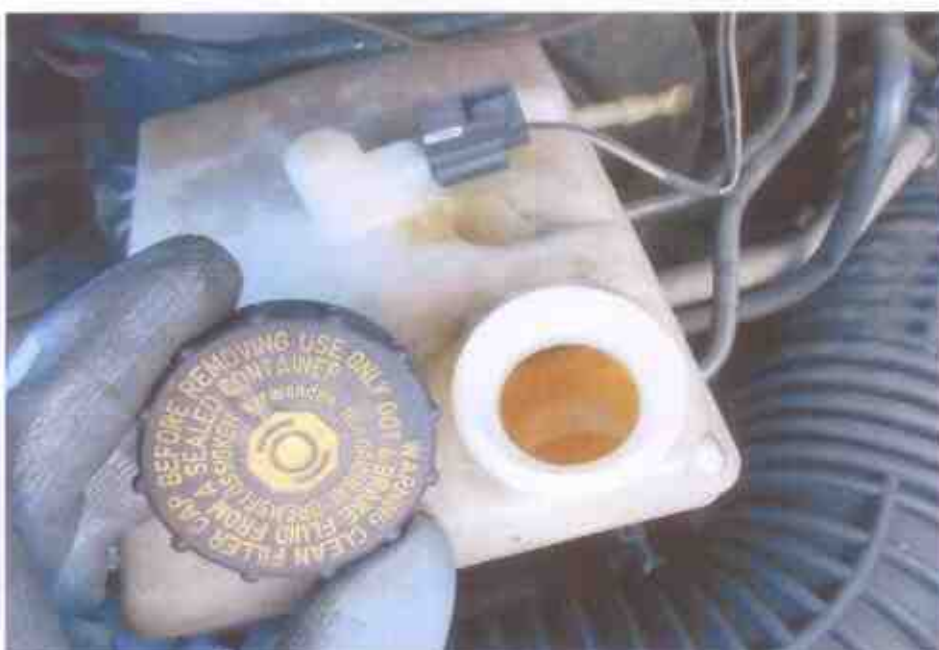
Photo 13 shows the brake fluid reservoir of the Motor Van at the time of our inspection. The brake fluid was observed to be of sufficient level and without any visible contamination.

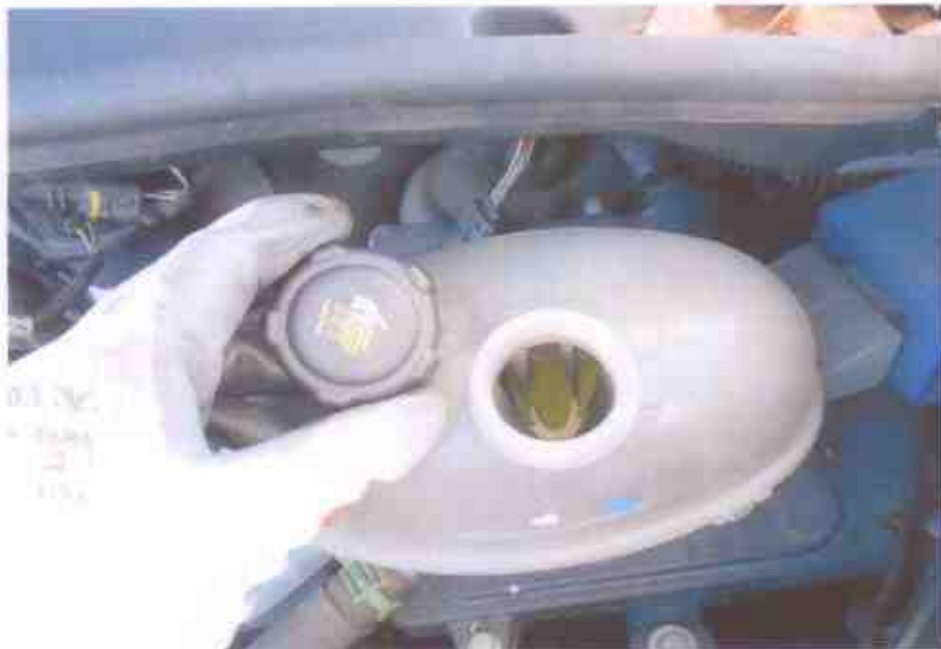
Photo 14 shows the engine coolant reservoir of the Motor Van at the time of our inspection. The engine coolant was observed to be of sufficient level and without any visible contamination.

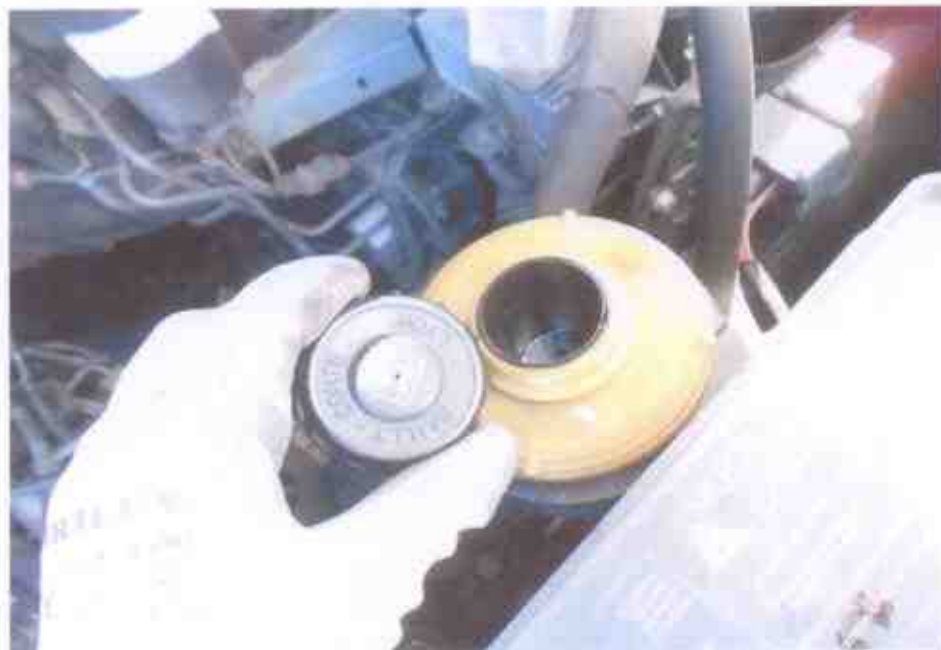
Photo 15 shows the power steering reservoir of the Motor Van at the time of our inspection. It was observed to be of sufficient level and without any visible contamination.

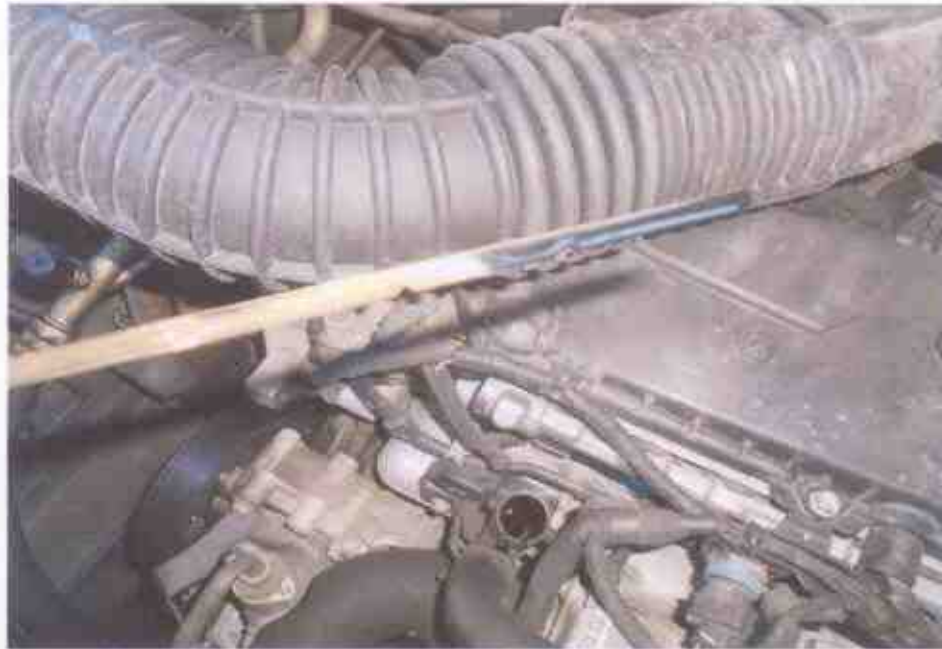
Photo 16 shows the engine dip stick of the Motor Van at the time of our inspection. The engine oil was observed to be of sufficient level and without any visible contamination.

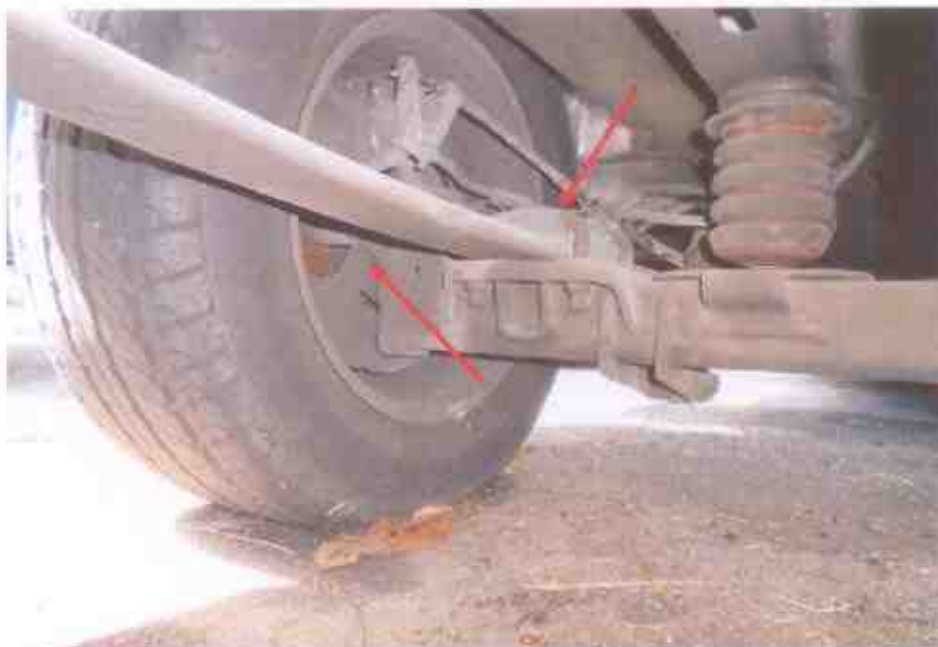
Photo 17 shows the various undercarriage components at the rear left wheel of the Motor Van, in particular the brake hose (arrowed). We did not observe any leakage of brake fluid at the time of our inspection of the Motor Van.

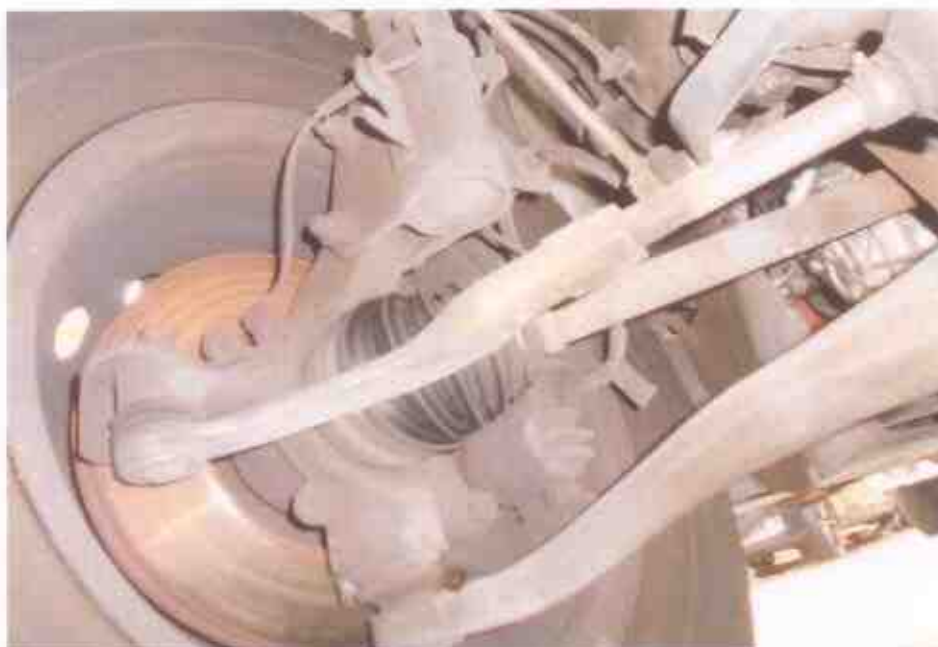
Photo 18 shows the brake hose at the front left wheel of the Motor Van. We did not observe any leakage of brake fluid. Our visual inspection of the various mechanical components of the Motor Van's braking system revealed all to be intact and without visible damage, indicating that the braking system was likely to be in serviceable condition at the material time of accident.

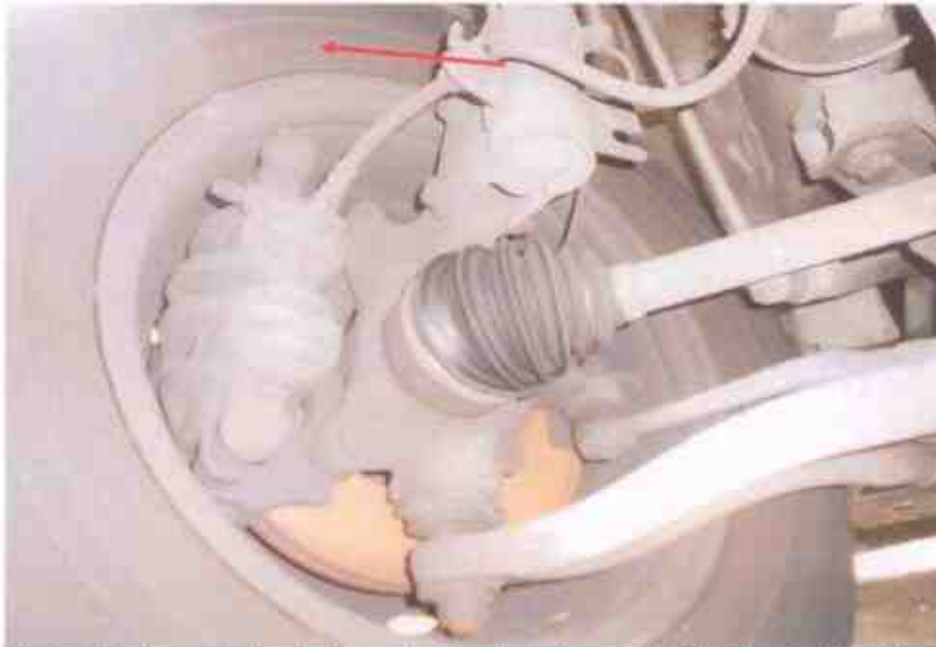
Photo 19 shows the brake hose (arrowed) at the front right wheel of the Motor Van. We did not observe any leakage of brake fluid at the time of our inspection of the Motor Van. Our visual inspection of the various mechanical components of the Motor Van's braking system, including its brake calliper, revealed all to be intact and without visible damage.

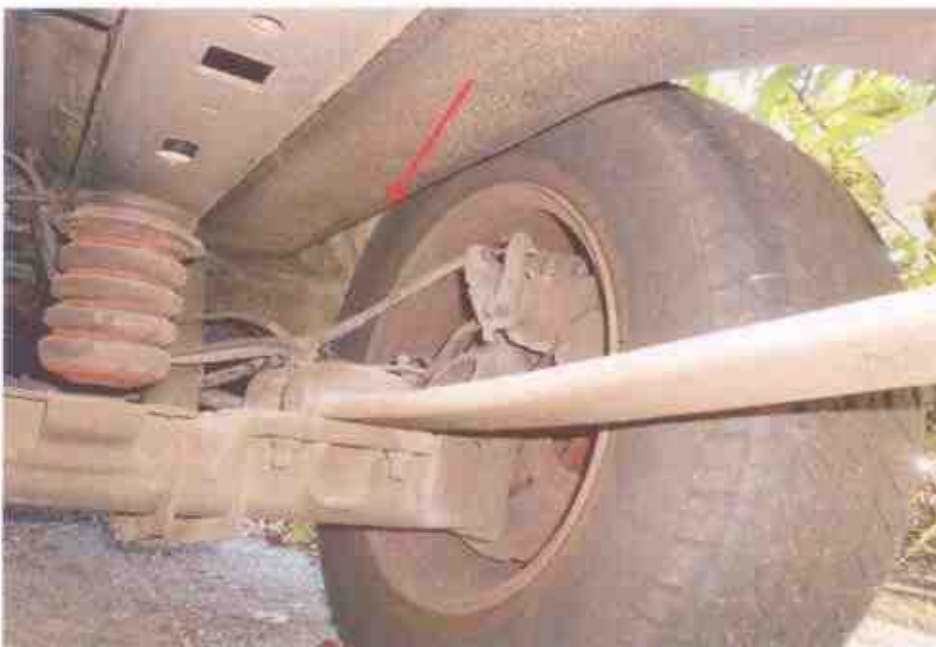
Photo 20 shows the various undercarriage components at the rear right wheel of the Motor Van. The various steering components were all found to be intact, suggesting that the steering system of the Motor Van was likely to be in serviceable condition at the material time of accident. There was also no sign of fluid stain(s) observed on the various undercarriage components at the 4 wheels of the Motor Van.

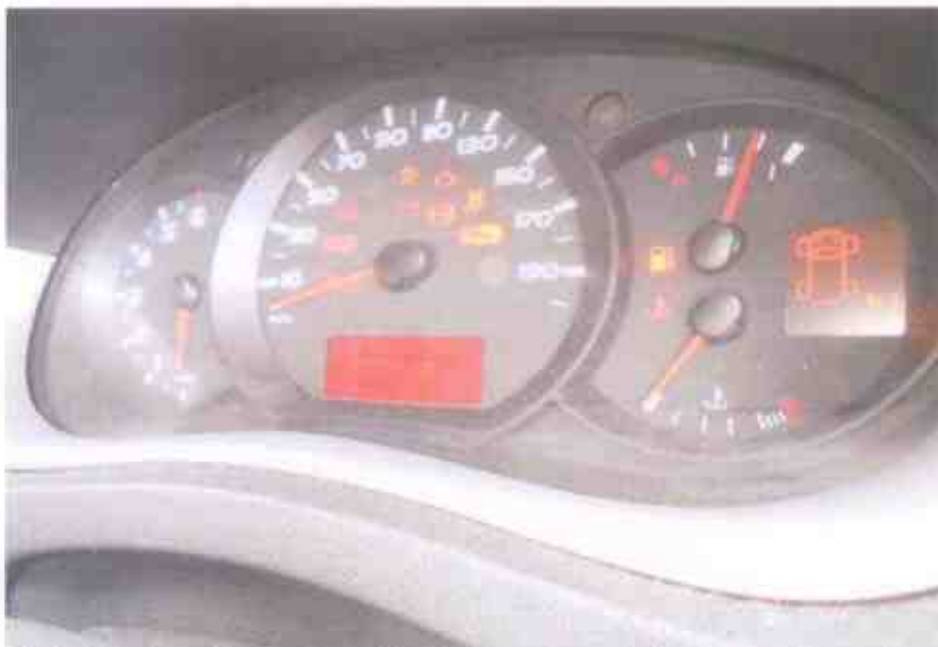
Photo 21 shows the warning lights for the various electronic operating systems of the Motor Car appearing on its instrument panel during the self-test when the engine was cranked.

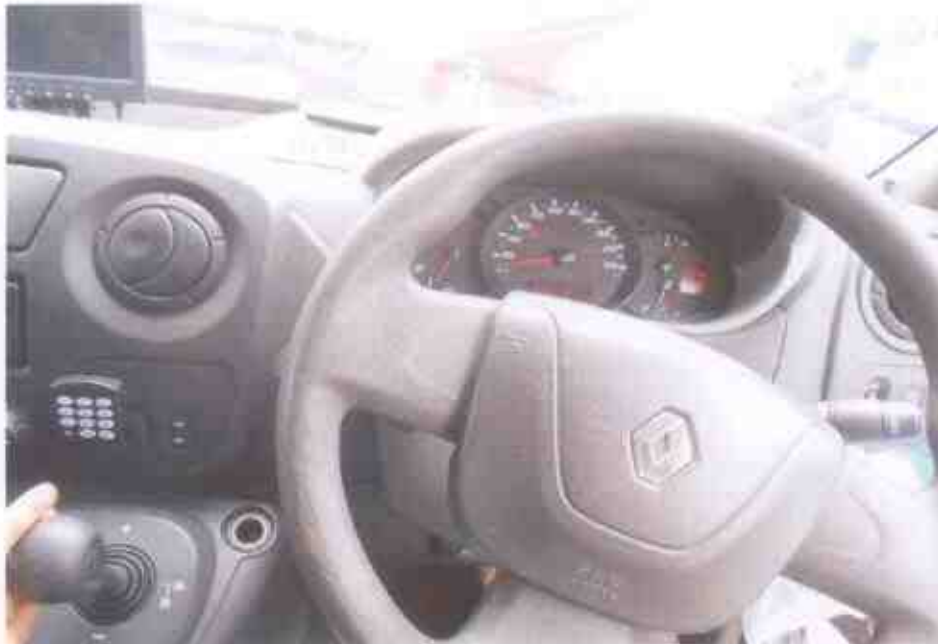
Photo 22 shows no warning lights illuminated on the instrument panel of the Motor Van after the engine was cranked. This would suggest that there was no abnormality to the various electronic operating systems of the Motor Car.

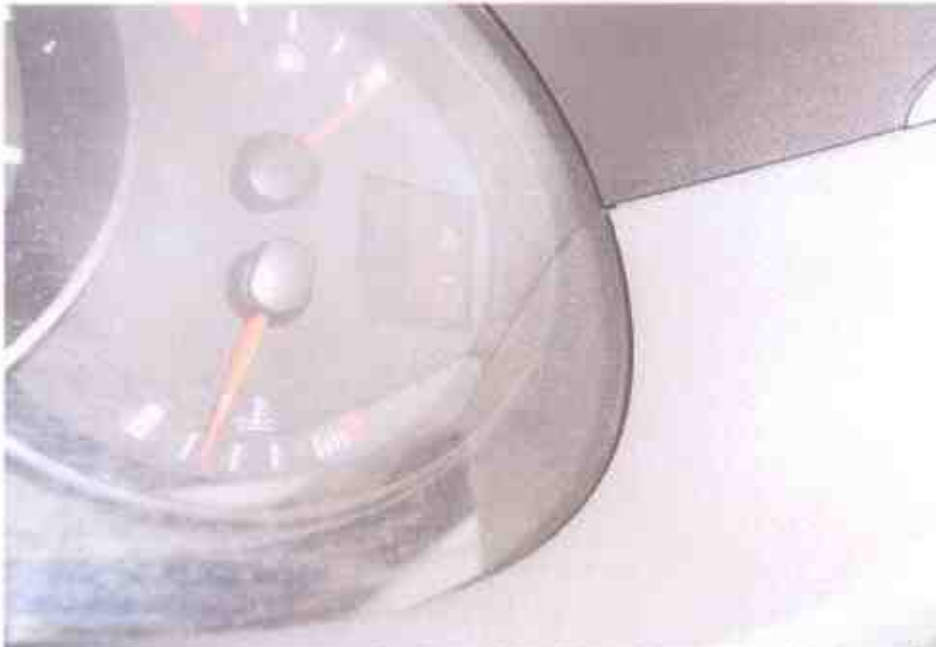
Photo 23 shows a short operational test of the Motor Van, to primarily determine whether there was any abnormality to its various operating systems like its engine system, its transmission system, steering system and braking system was subsequently carried out. The test was conducted by driving the Motor Van forward, stopping, before reversing and coming to a stop again.

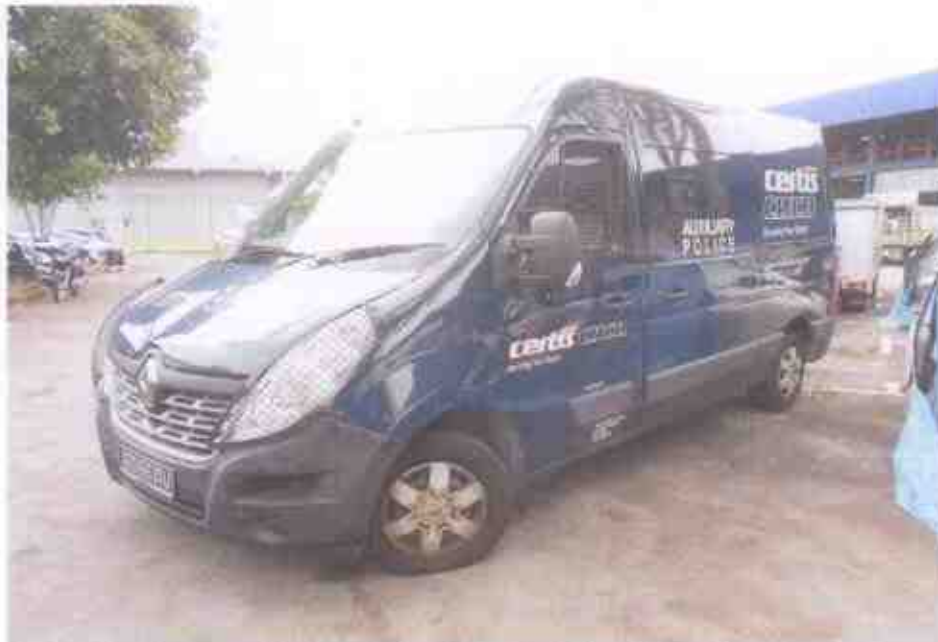
Photo 24 shows a short operational test of the Motor Van, the test was conducted by driving the Motor Van forward, stopping, before reversing and coming to a stop again.
