Your Ref: TP/IP/24215/2018
Our Ref : CI/TPD18010664/Z

25th June 2018

Fatal Accident Investigation Team

MECHANICAL INSPECTION REPORT OF MOTOR CAR SJM 3610H

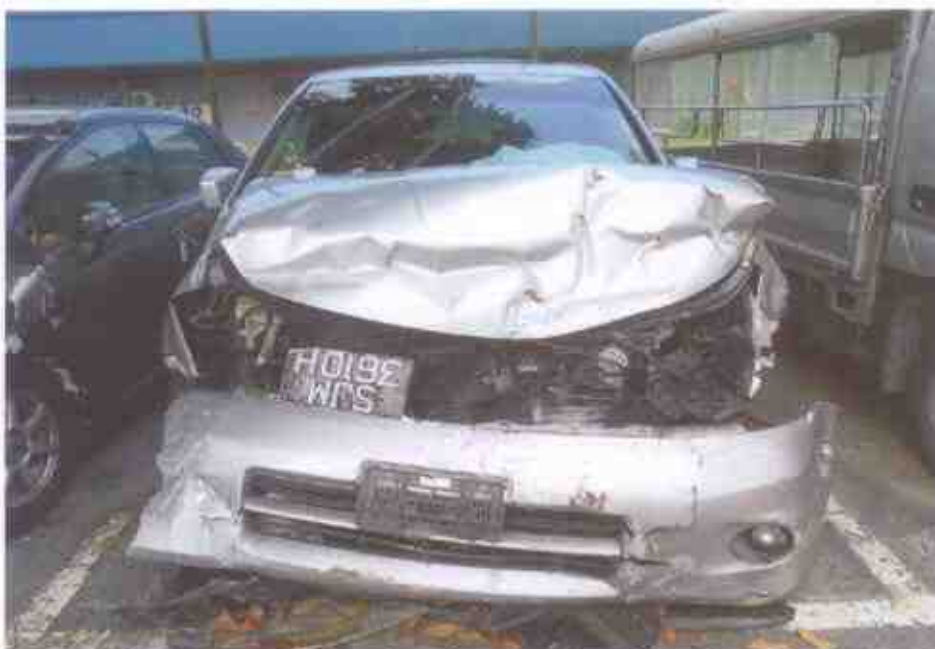
Photo 1 shows a general view of the frontal portion of the Motor Car at the time of our inspection. The Motor Car was observed to have sustained extensive impact damage at its frontal portion. The impact force was significant, causing the various parts and components inside the engine compartment to be damaged.

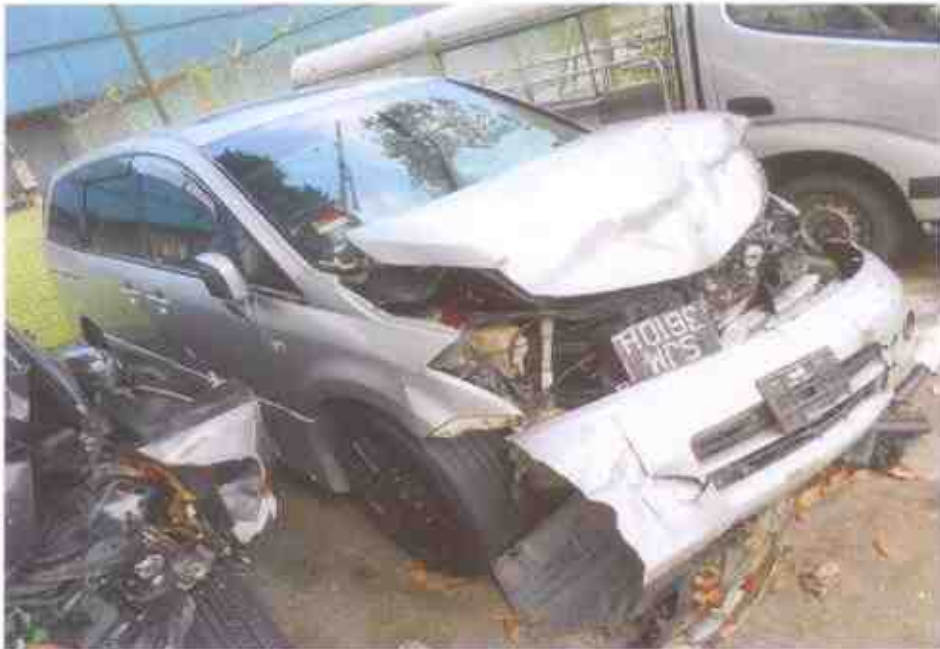
Photo 2 shows a general view of the front right portion of the Motor Car at the time of our inspection. The Motor Car was observed to have sustained extensive impact damage at its frontal portion.

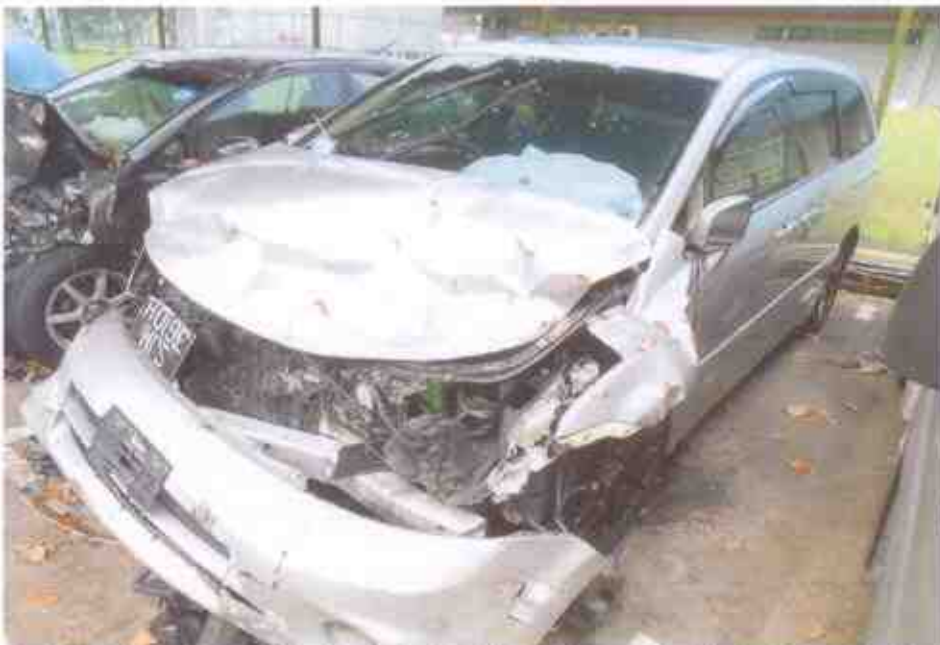
Photo 3 shows a general view of the front left portion of the Motor Car at the time of our inspection. The Motor Car was observed to have sustained with extensive impact damage at its frontal portion.

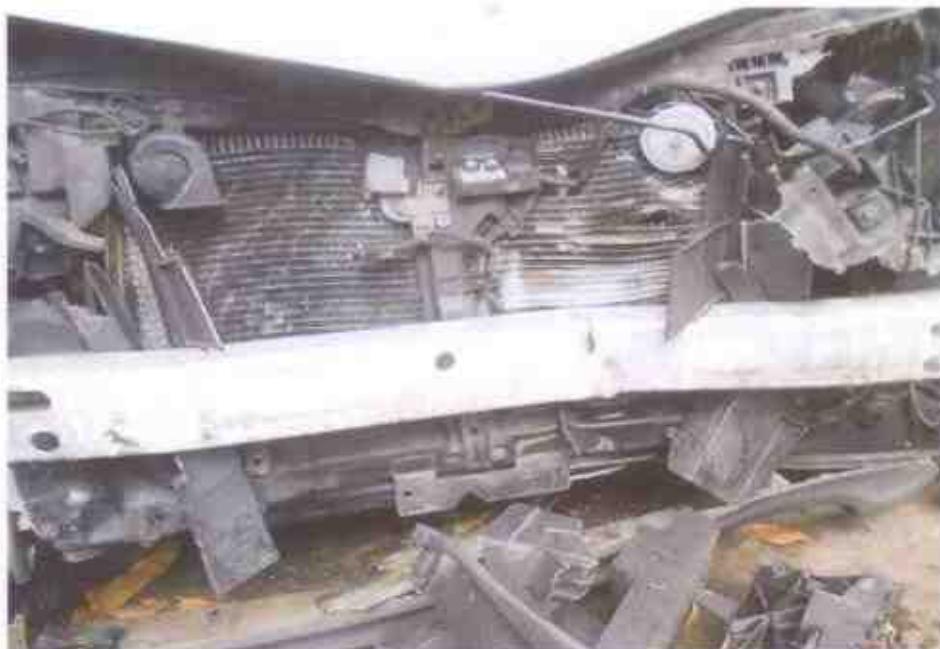
Photo 4 shows a closer view of the damage at the frontal portion of the Motor Car's engine. The impact force was significant, causing the various parts and components inside the engine compartment to be pushed inwards, towards the rear of the Motor Car.

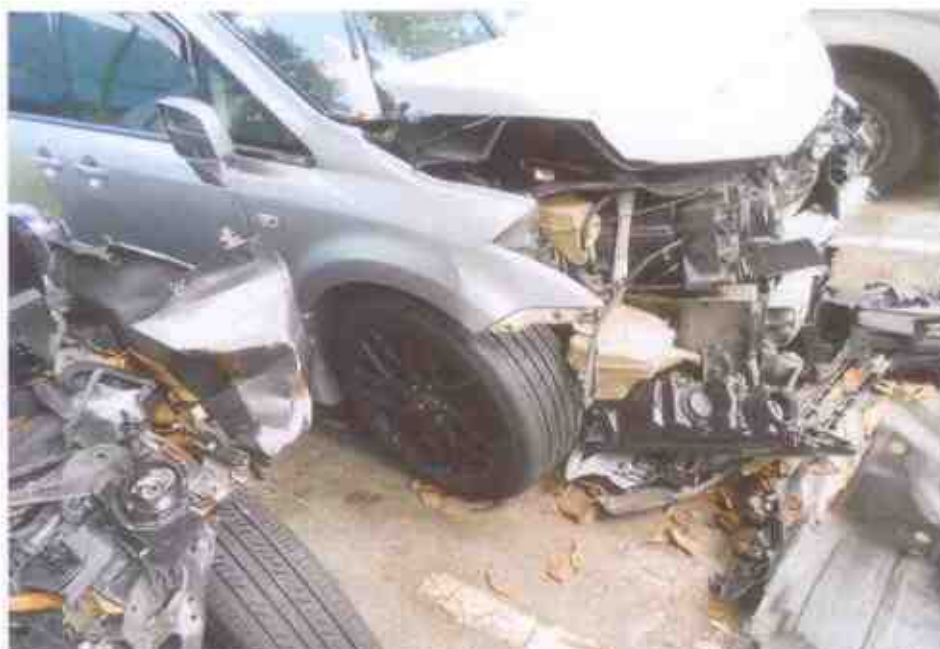
Photo 5 shows a closer view of the damage at the frontal right portion of the Motor Car. The impact force was significant, causing the various parts and components inside the engine compartment to be pushed inwards, towards the rear of the Motor Car.

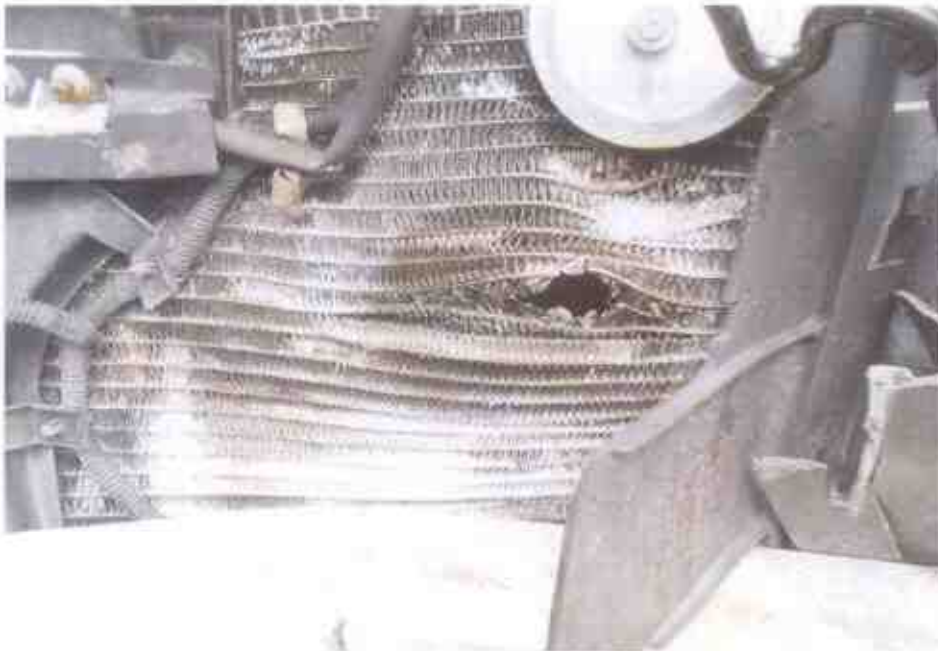
Photo 6 shows a closer view of the damage at the frontal portion of the Motor Car. The impact force was significant, causing extensive damage to the radiator.

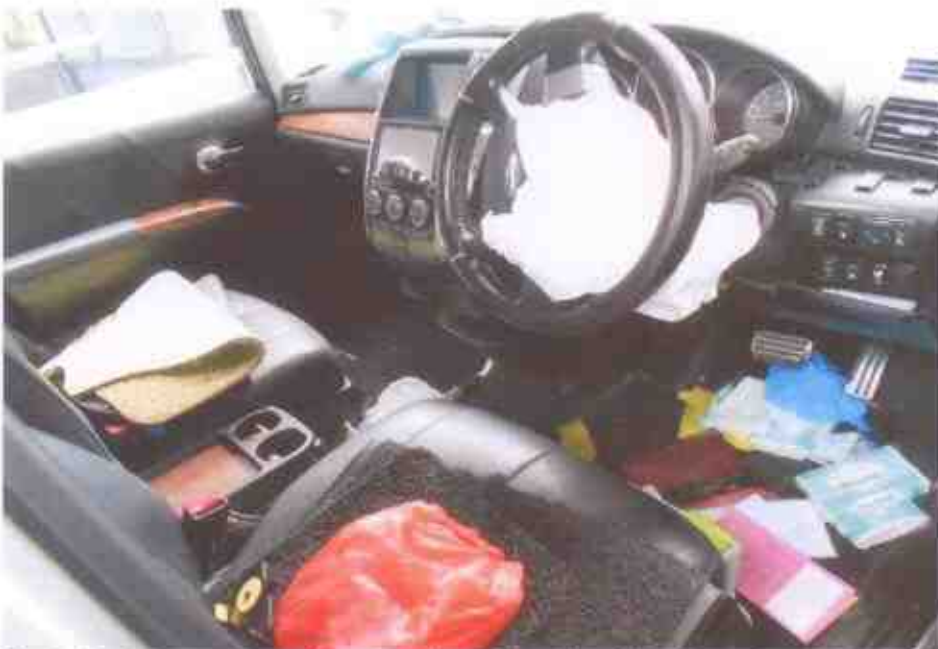
Photo 7 shows a closer view of the interior cabin of the Motor Car. The impact force didn't cause damages to the interior cabin. However, it activated both driver's & passenger's airbag at time of impact.

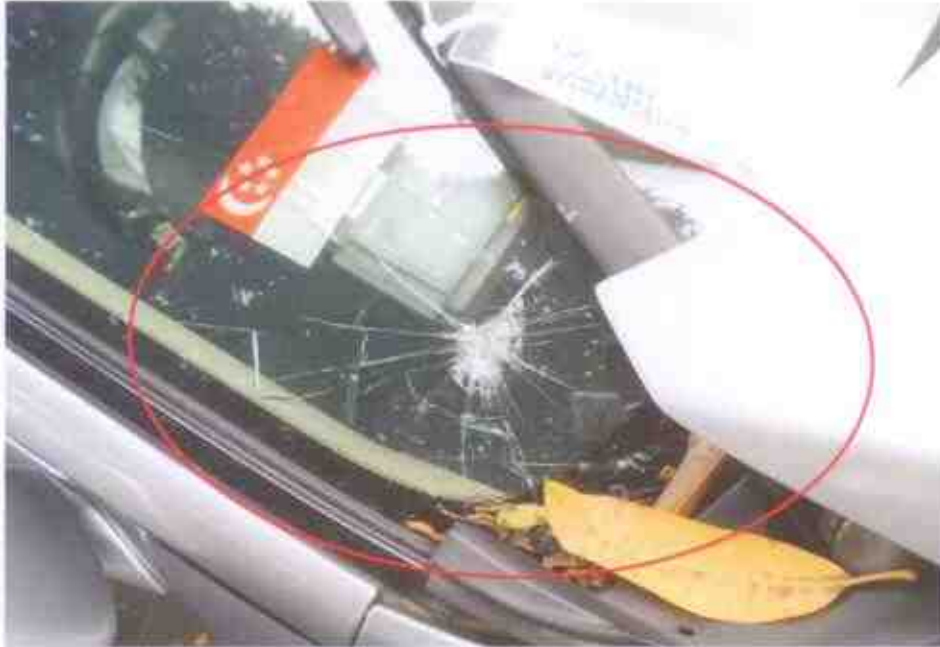
Photo 8 shows a closer view of the damage at the windscreen area of the Motor Car. The impact force was significant, causing the windscreen to sustain cracked.

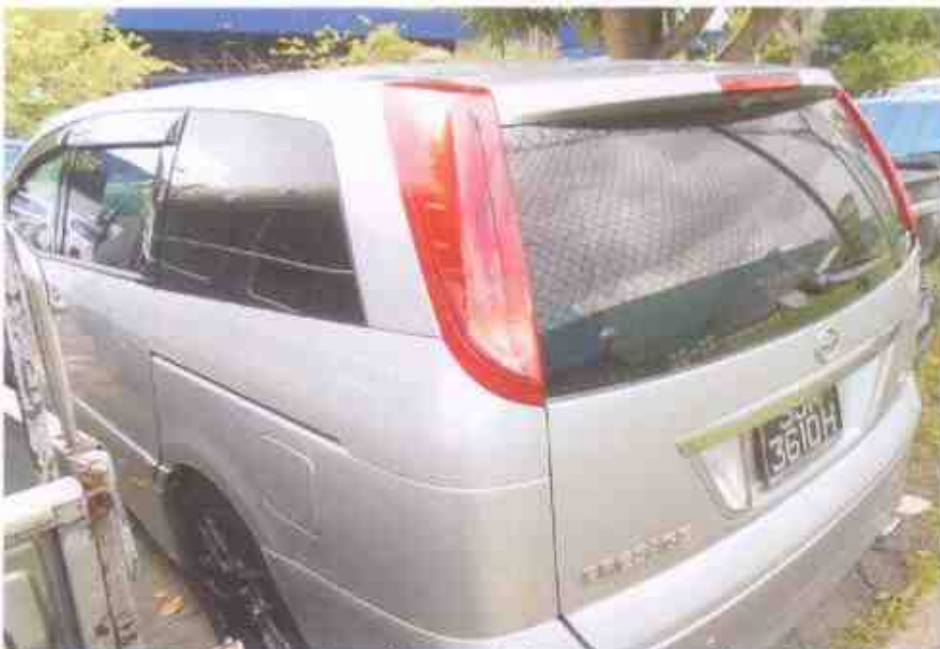
Photo 9 shows a general view of the rear left portion of the Motor Car. The rear portion was observed to be in good condition, no damages found at time of our inspection.

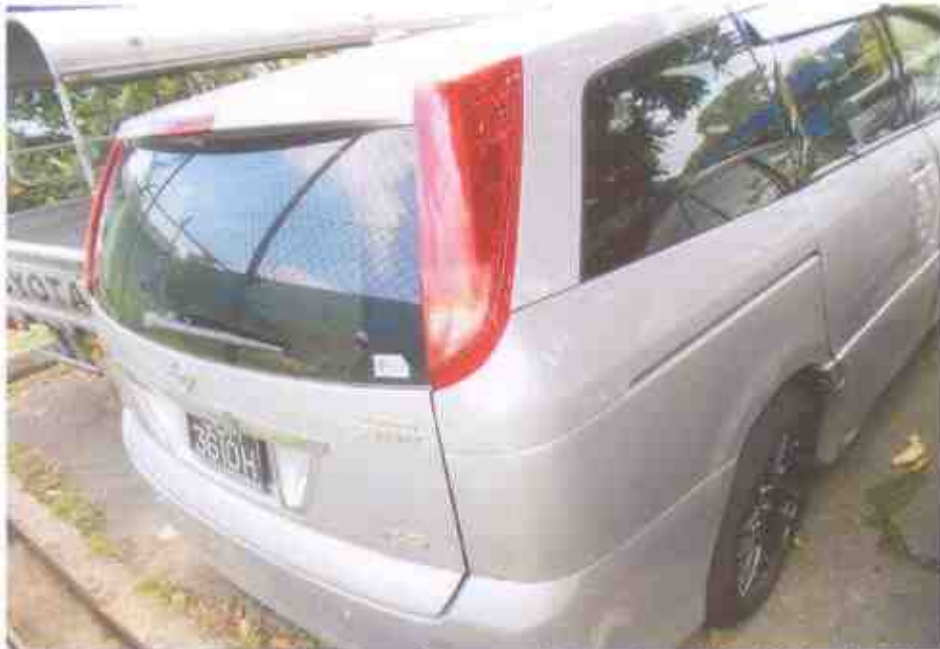
Photo 10 shows a general view of the rear right portion of the Motor Car. The rear portion was observed to be in good condition, no damages found on the Motor Car's body at time of our inspection. However, we found that the rear right tyre was deflated due to the accident.

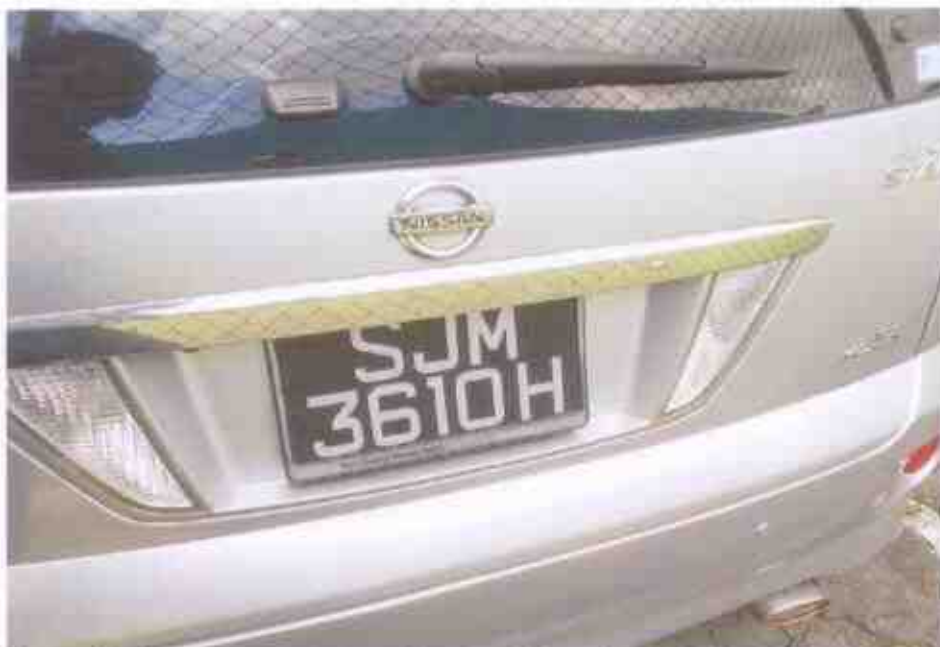
Photo 11 shows a general view of the rear left portion of the Motor Car. The rear portion was observed to be in good condition, no damages found at time of our inspection.

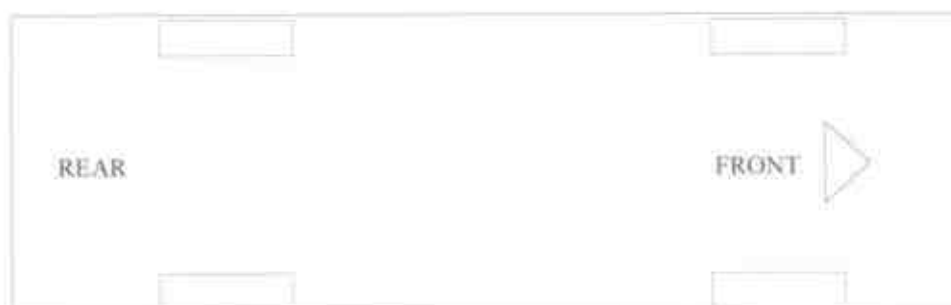
Yokohama advan dB decibel
235/50R18 (6mm)

Yokohama advan dB decibel
235/50R18 (8mm)
(Alloy rim sustained chipped at the
outer side)

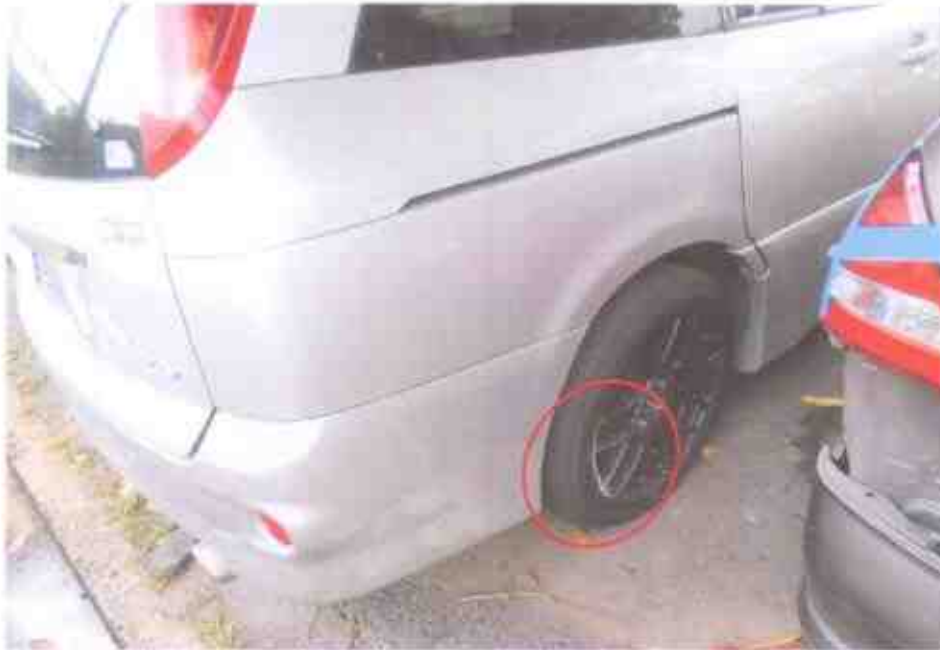
9. The 4 tyres were observed to be wrapped around alloy wheel rims. However, the rear right alloy wheel rims were observed to have sustained with chipped off on the outer side likely due to the accident's impact collision. See photo 12 to 17 below.

Photo 12 shows the general condition of the rear right tyre of the Motor Car. The alloy rim was observed to be chipped off at the side due to the accident's impact.

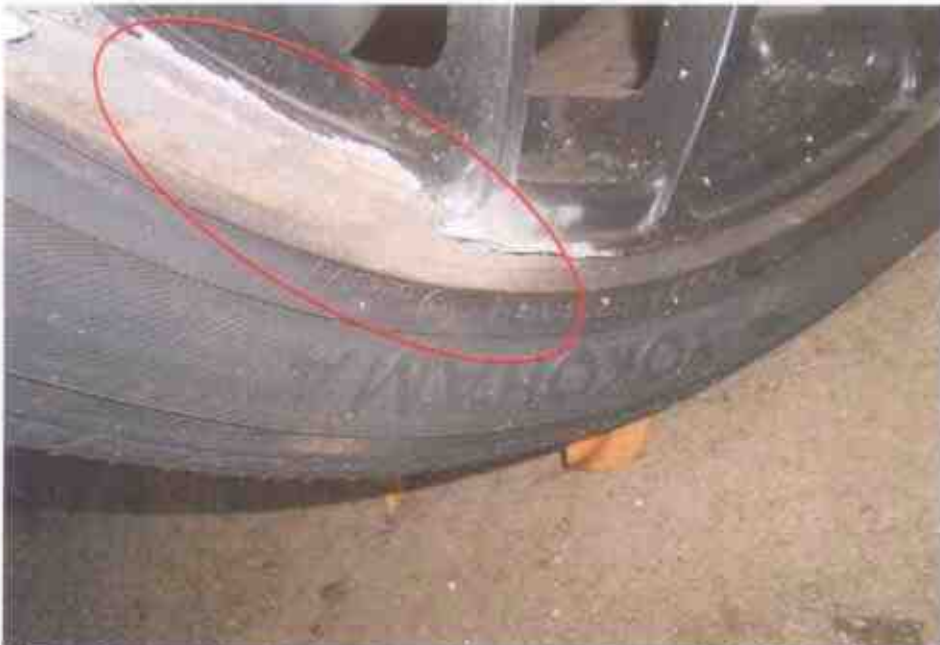
Photo 13 shows the close-up view of the rear right tyre of the Motor Car. The alloy rim was observed to be chipped off at the side due to the accident's impact.

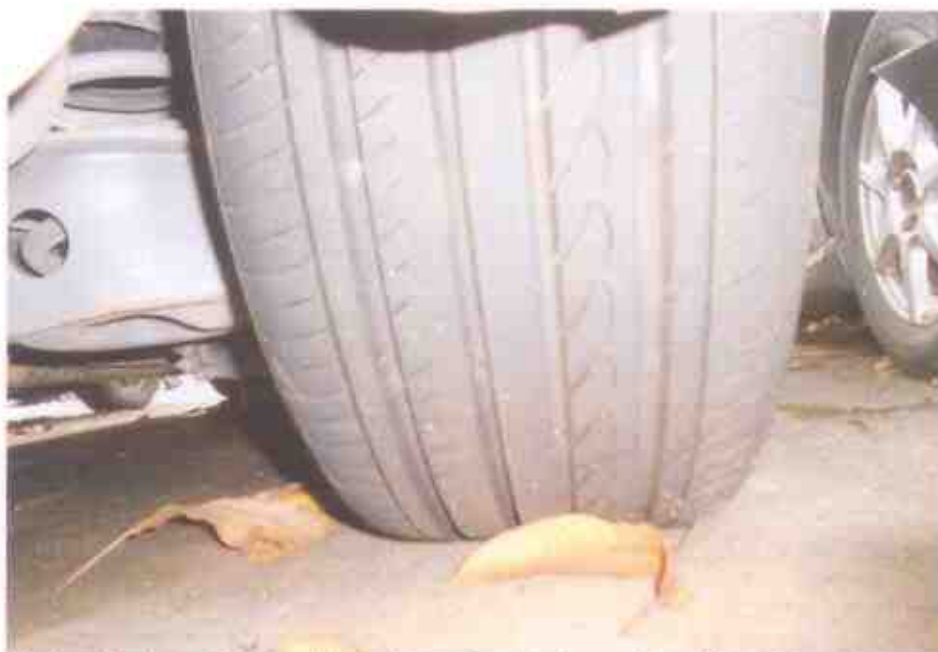
Photo 14 shows the condition of the rear right tyre of the Motor Car. The tread patterns were obvious visually. The remaining tread depth of the rear right tyre was approximately 8mm.

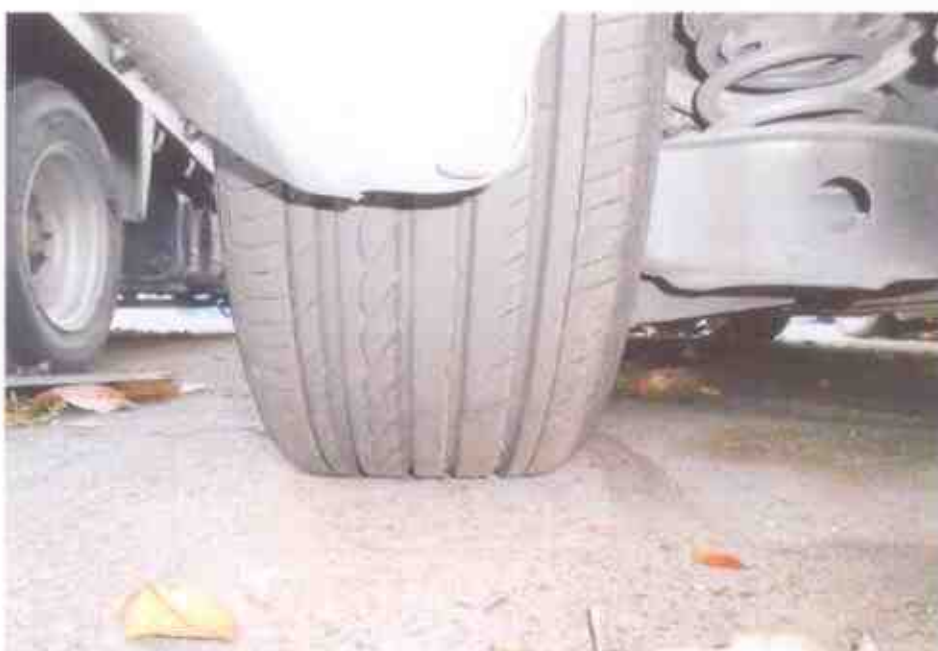
Photo 15 shows the condition of the rear left tyre of the Motor Car. The tread patterns were obvious visually. The remaining tread depth of the rear left tyre was approximately 6mm.

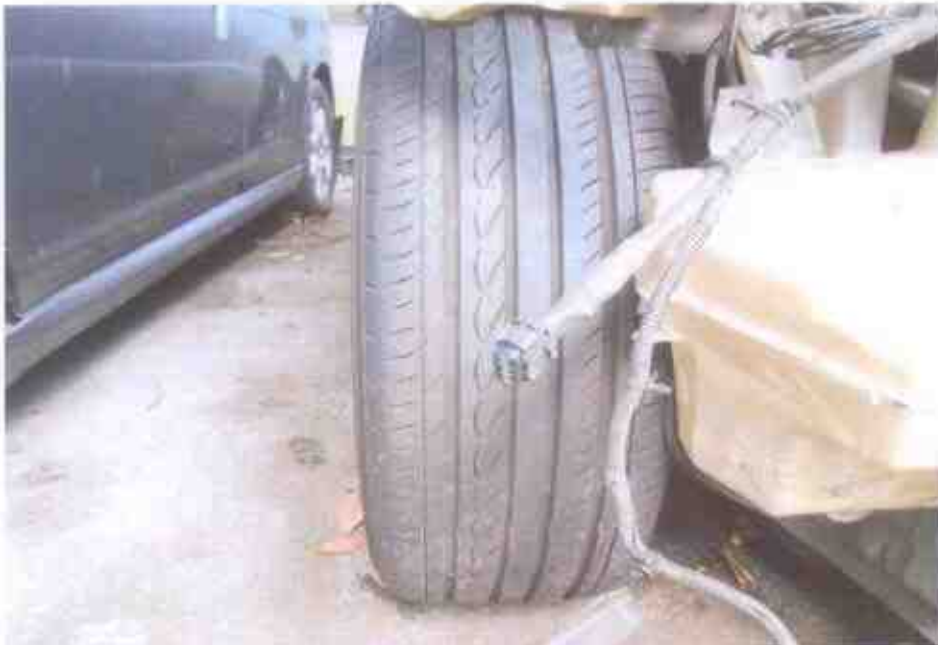
Photo 16 shows the condition of the front right tyre of the Motor Car. The tread patterns were obvious visually. The remaining tread depth of the rear left tyre was approximately 6mm.

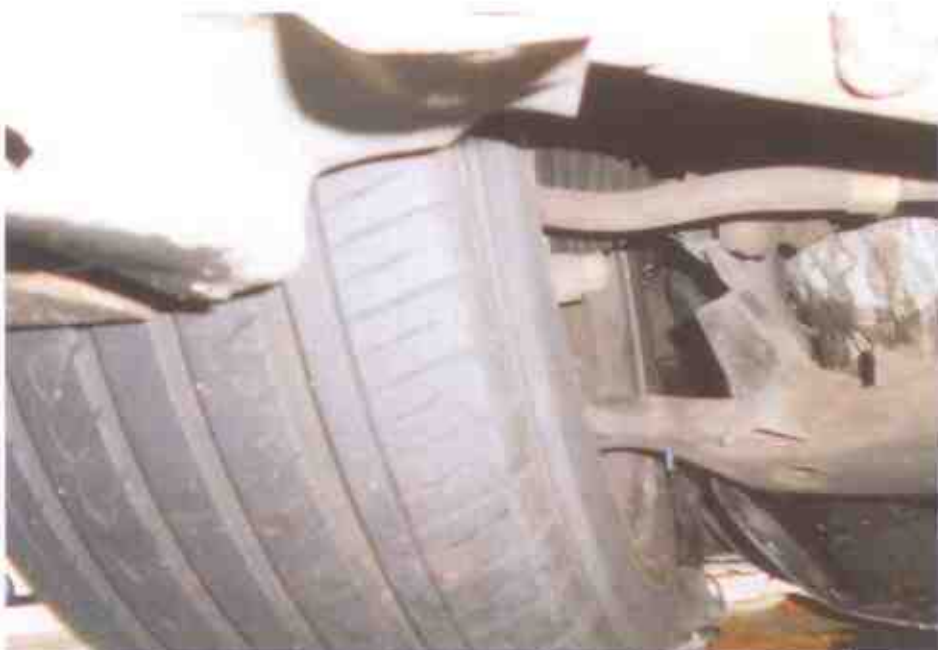
Photo 17 shows the condition of the front left tyre of the Motor Car. The tread patterns were obvious visually. The remaining tread depth of the front left tyre was approximately 6mm.

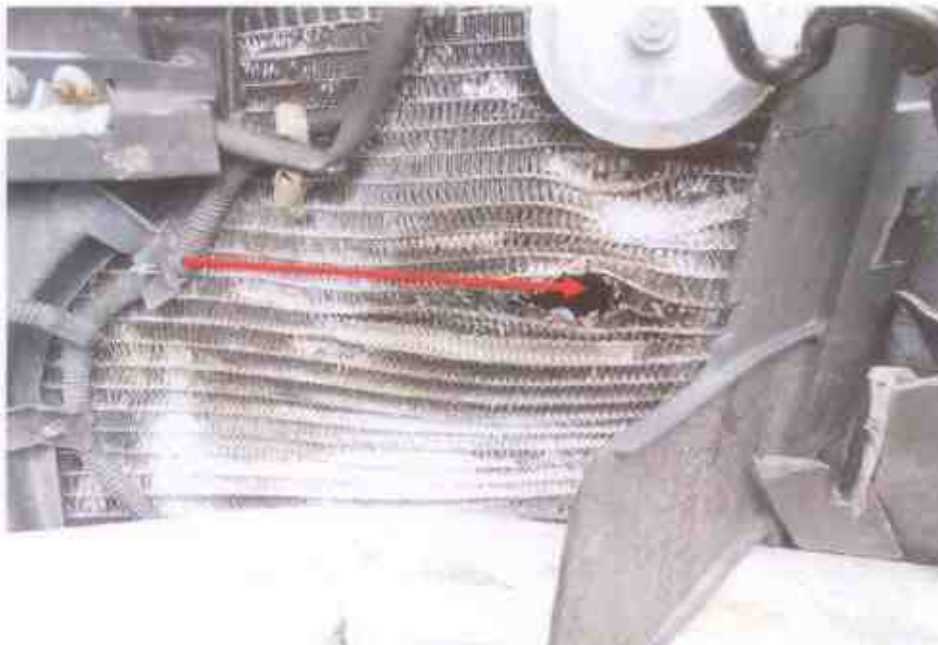
Photo 18 shows the close up view of the radiator's tank that was observed to be damaged likely due to the accident impact.

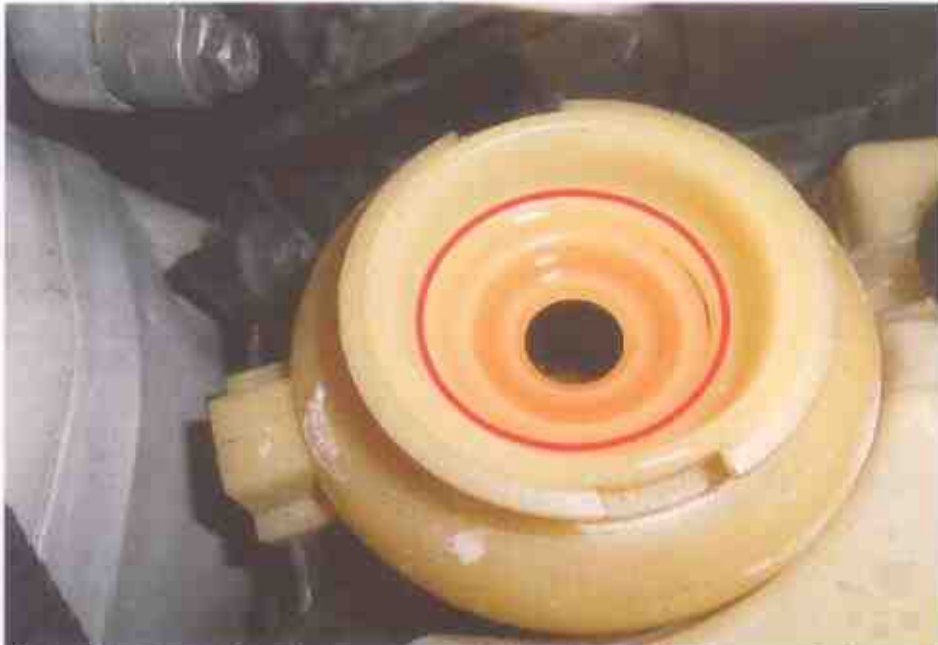
Photo 19 shows the close up view of the steering fluid reservoir that was insufficient (leakage) likely due to the accident impact.

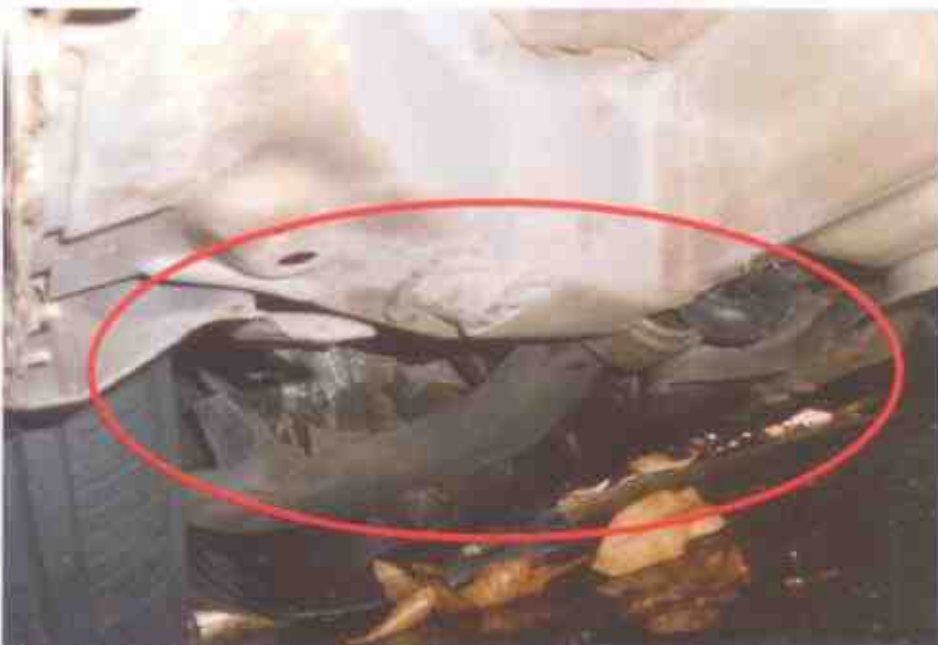
Photo 20 shows the close up view of the fluid leakage at the undercarriage area likely due to the accident impact.

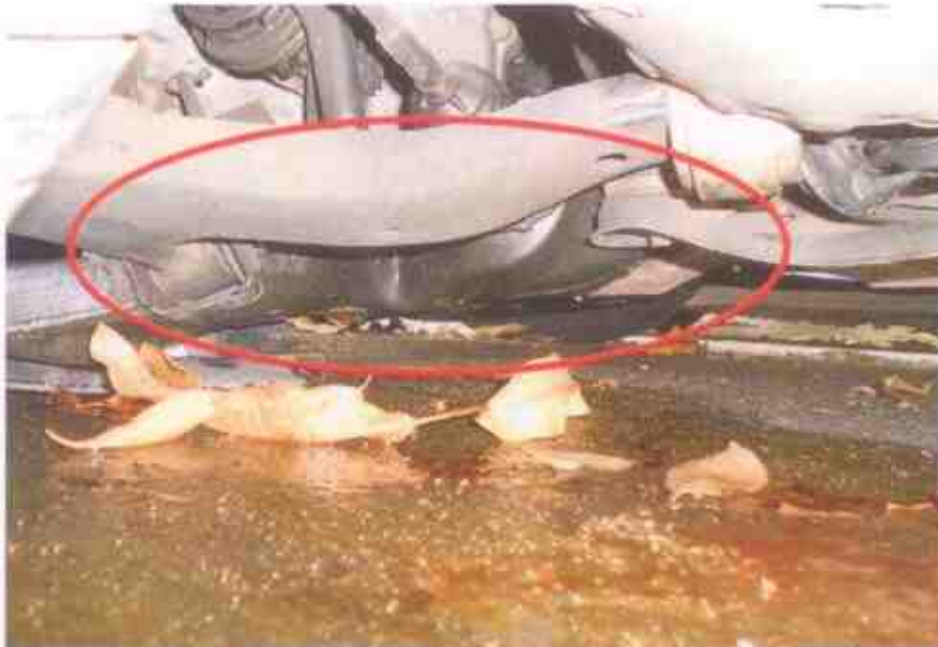
Photo 21 shows the close up view of the fluid leakage at the undercarriage area likely due to the accident impact.

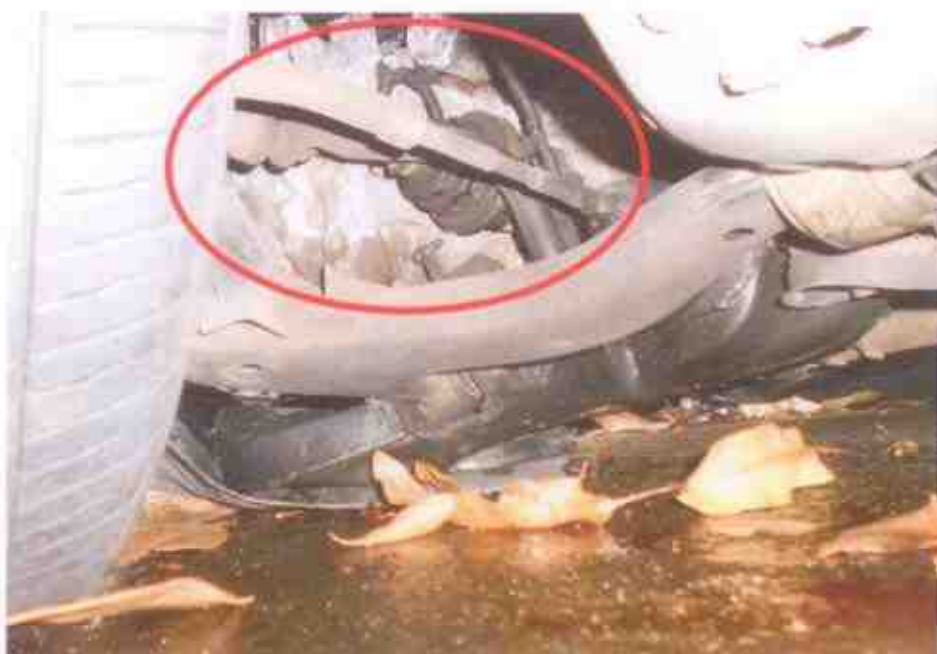
Photo 22 shows a close up view on the front right drive shaft of the Motor Car. We were not able to conduct any tests on the steering system of the Motor Car due to the damage to this components, as well as leakage of power steering fluid.

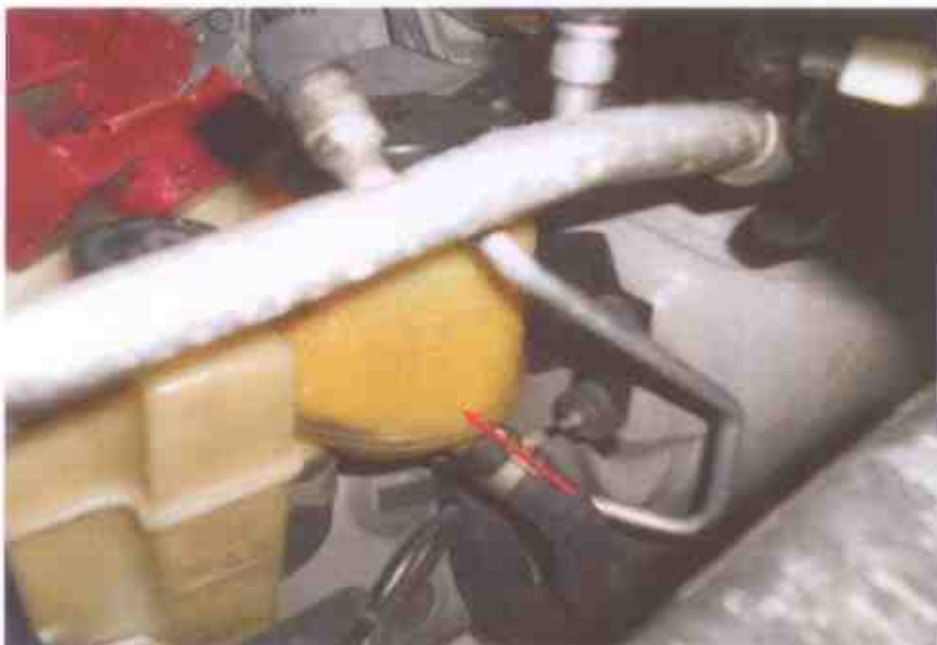
Photo 23 shows the power steering fluid reservoir of the Motor Car was observed to be insufficient level due to leakage of fluids.

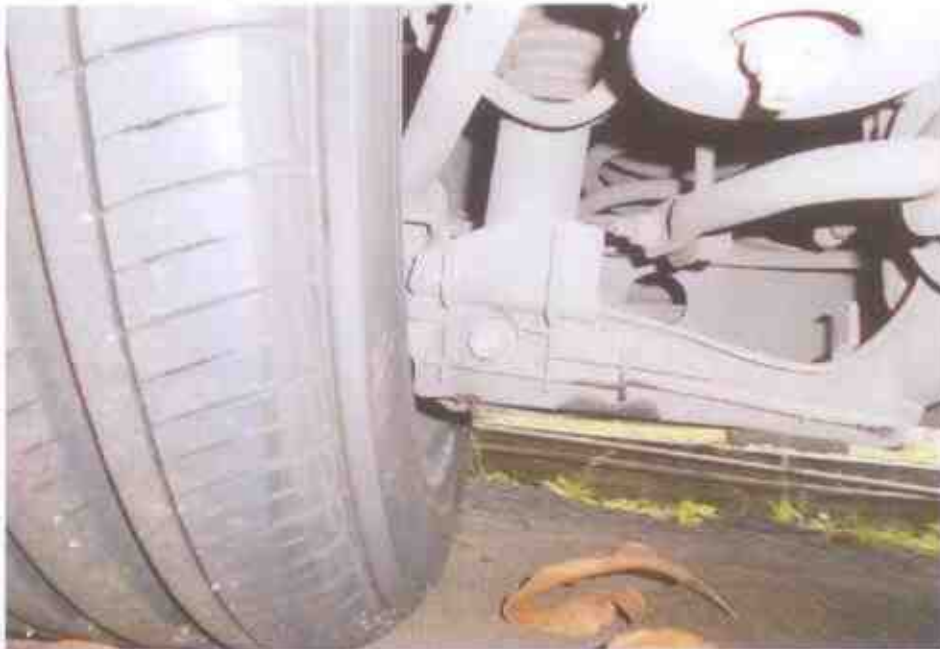
Photo 24 shows the braking & steering components at the rear right wheel of the Motor Car. We did not observe any leakage of brake fluid at the time of our inspection of the Motor Car.

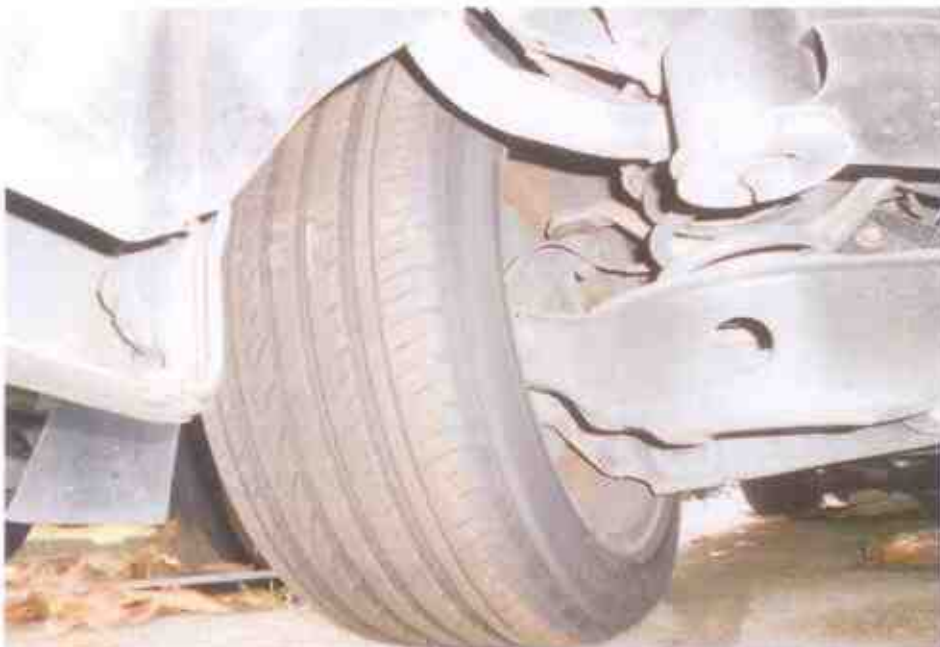
Photo 25 shows the braking & steering components at the rear left wheel of the Motor Car. We did not observe any leakage of brake fluid at the time of our inspection of the Motor Car.

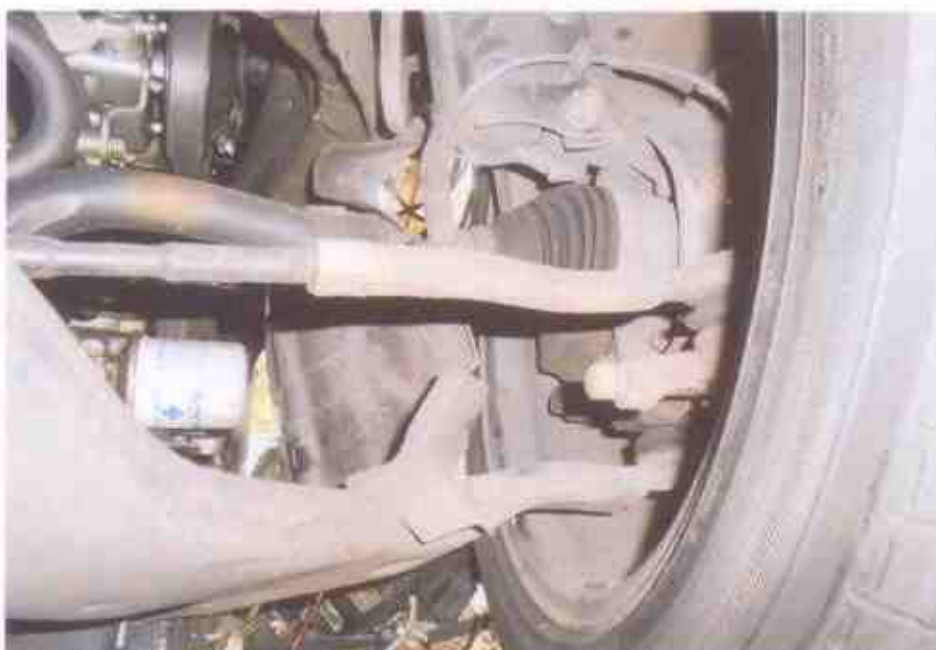
Photo 26 shows the braking & steering components at the front right wheel of the Motor Car. We did not observe any leakage of brake fluid at the time of our inspection of the Motor Car. However, the steering system was observed to be damaged due to the accident's impact.

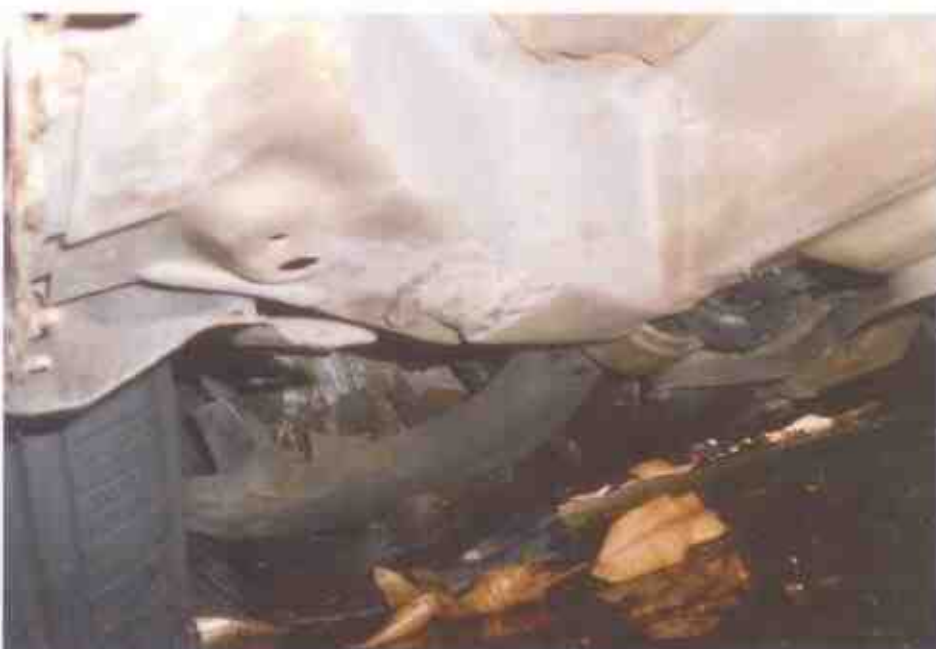
Photo 27 shows the braking & steering components at the front left wheel of the Motor Car. We did observe fluid leakage at the time of our inspection of the Motor Car. The steering system was also observed to be damaged due to the accident's impact.

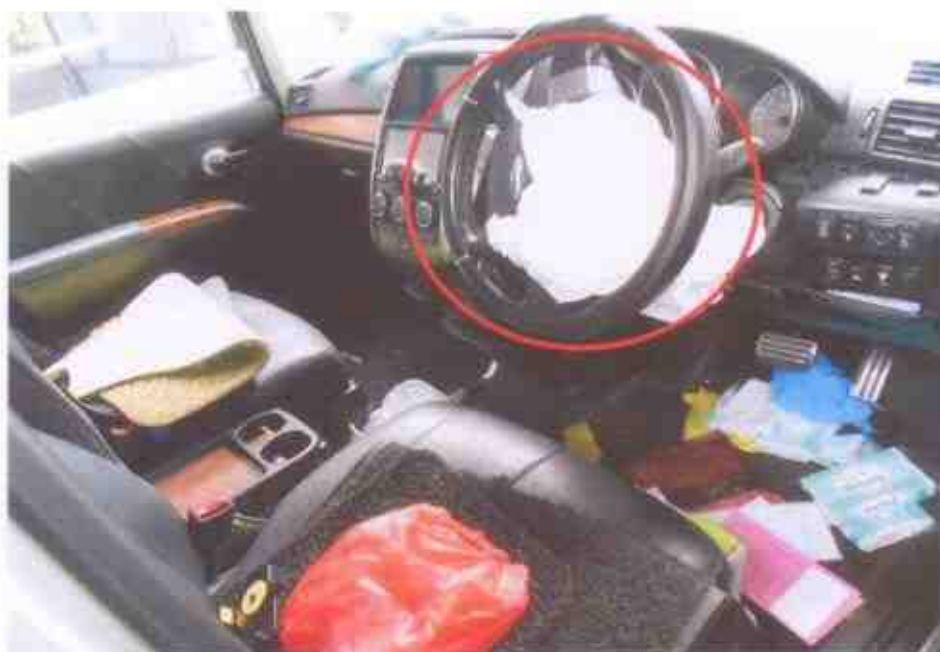
Photo 28 shows the Supplemental Restraint System (SRS) of the Motor Car was however likely to be in normal operating condition at the material time of the accident. The evidence of the deployed driver's airbag indicates that the impact sensors and control module of the Motor Car's SRS were all in serviceable condition at the material time of accident.

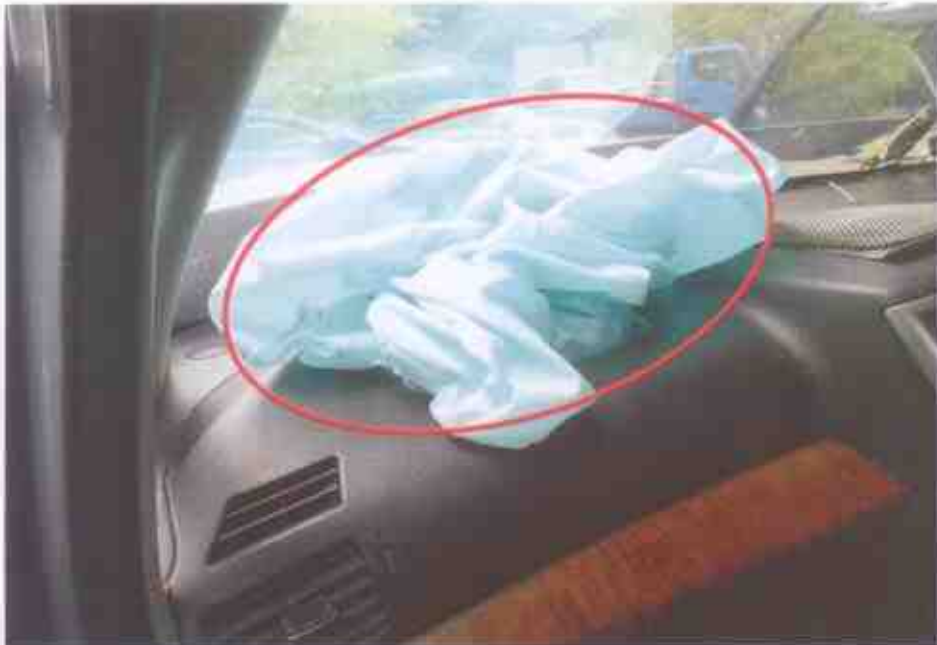
Photo 29 shows the Supplemental Restraint System (SRS) of the Motor Car was however likely to be in normal operating condition at the material time of the accident. The evidence of the deployed front passenger's airbag indicates that the impact sensors and control module of the Motor Car's SRS were all in serviceable condition at the material time of accident.
