Your Ref: TP/IP/24215/2018
Our Ref : CI/TPD18010665/Z

07th August 2018

MECHANICAL INSPECTION REPORT OF MOTOR TAXI SHB 8858J

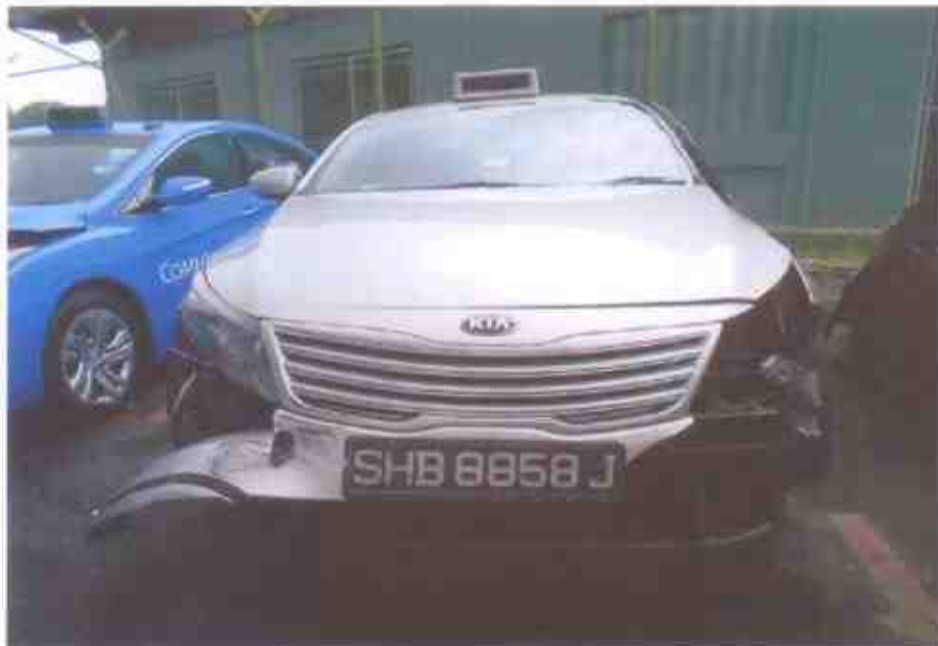
Photo 1 shows a general view of the frontal portion of the Motor Taxi at the time of our inspection. The Motor Taxi was observed to have sustained extensive impact damage at its frontal, left & rear portion. The impact force was significant, causing the various parts and components to be damaged as a result of the accident.

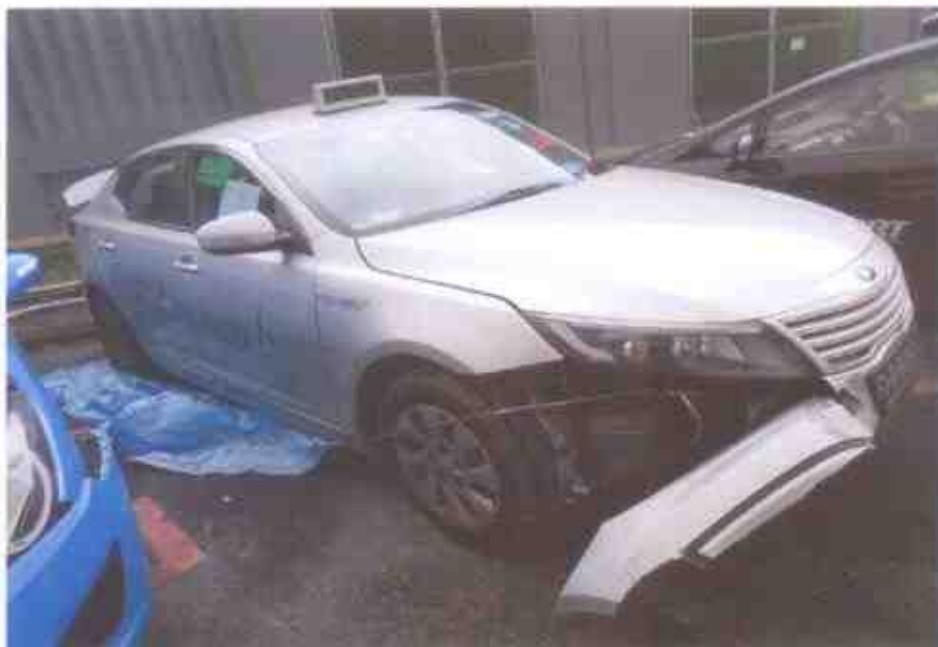
Photo 2 shows a general view of the front right portion of the Motor Taxi at the time of our inspection. The Motor Taxi was observed to have sustained extensive impact damage at its front right portion.

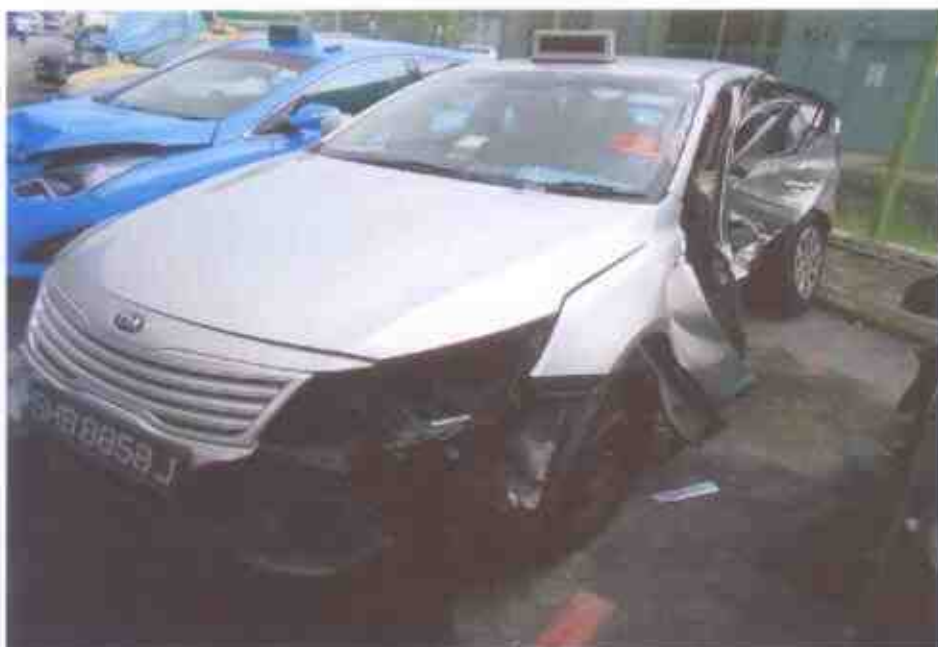
Photo 3 shows a general view of the front left portion of the Motor Taxi at the time of our inspection. The Motor Taxi was observed to have sustained extensive impact damage at its front left portion.

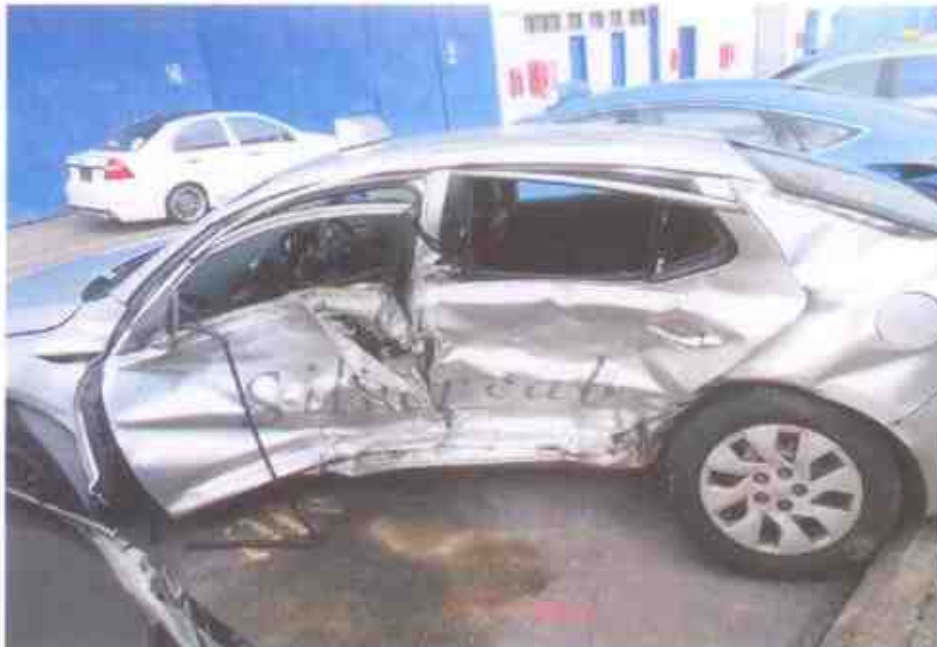
Photo 4 shows a closer view of the damage sustained on the left portion of the Motor Taxi. The impact force was significant, causing the left portion of the Motor Taxi to be pushed inwards, towards the right of the Motor Taxi.

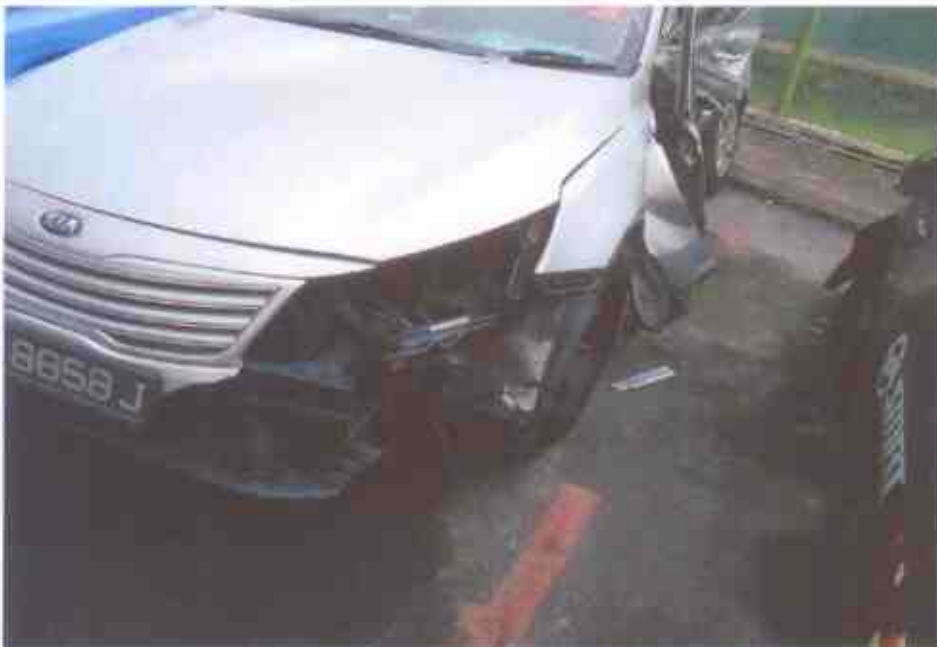
Photo 5 shows a closer view of the damage sustained on the front left of the Motor Taxi. The impact force was significant, causing the various parts and components inside the engine compartment to be damaged.

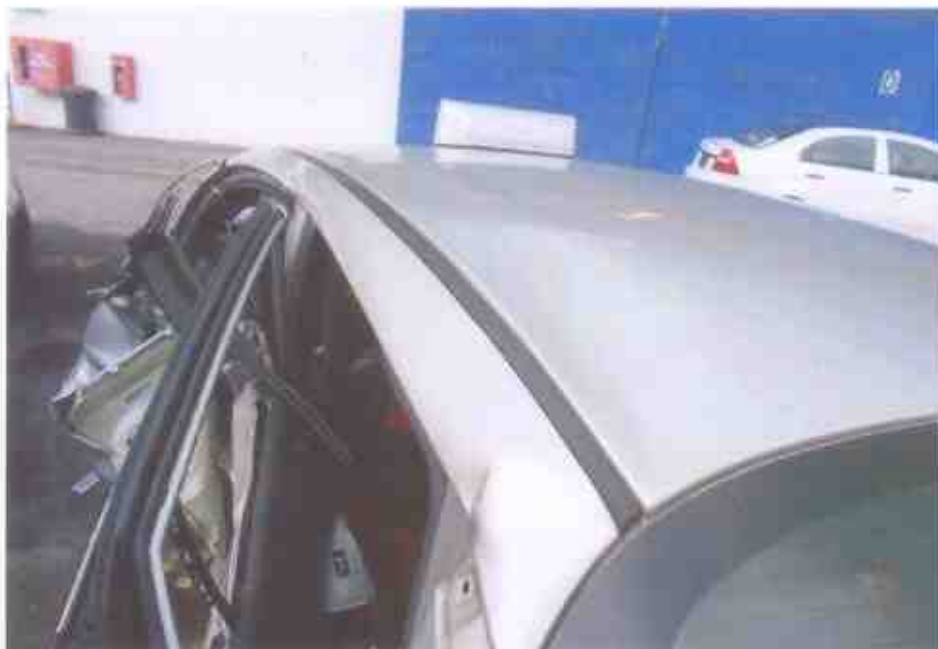
Photo 6 shows a closer view of the Motor Taxi roof top. The impact force was significant, causing it to be corrugated.

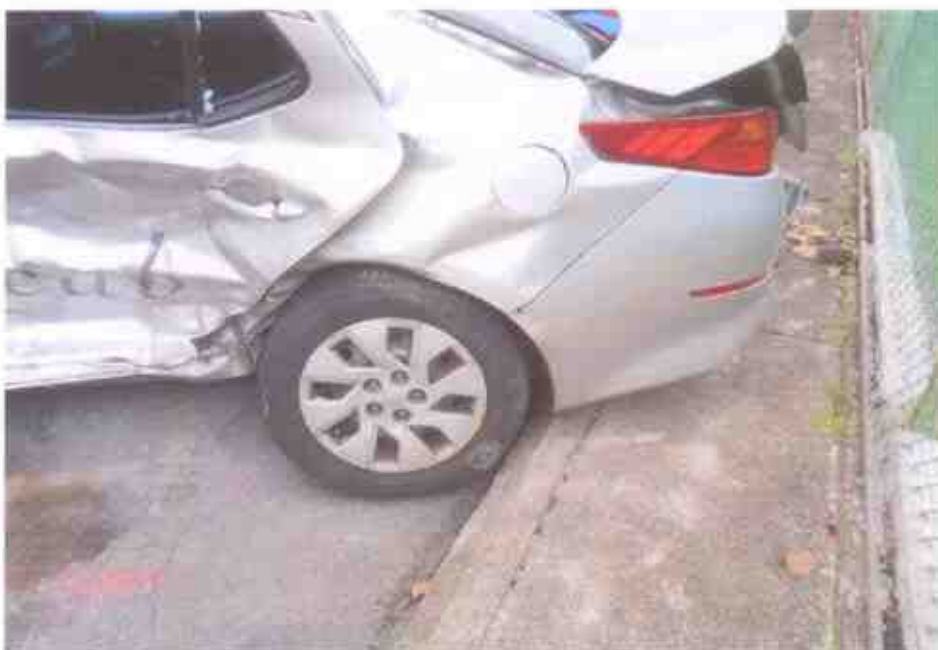
Photo 7 shows a closer view of the damaged rear boot lid. The impact force was significant, causing it to be misaligned due to the accident's impact.

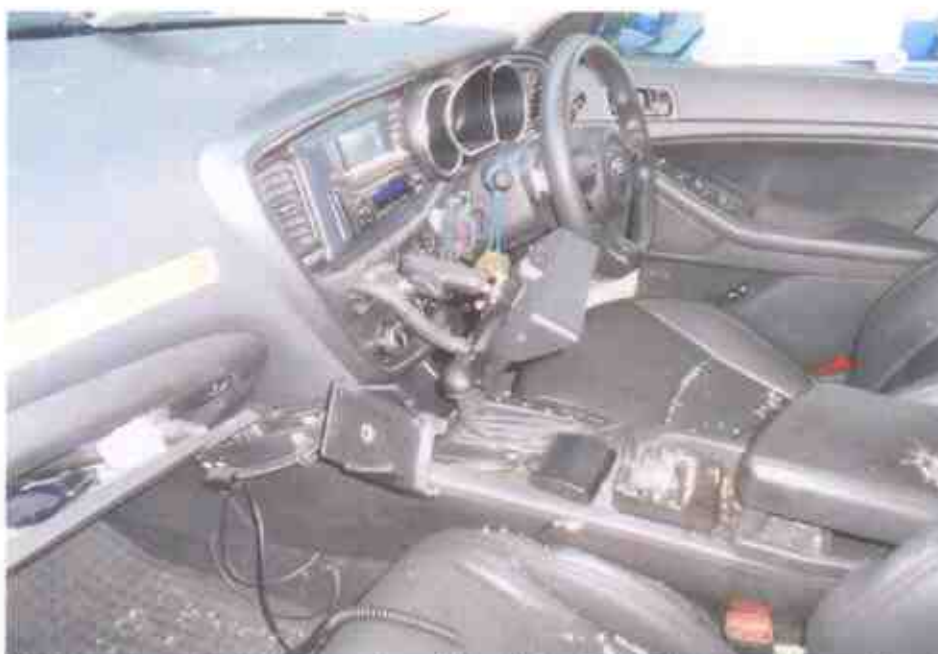
Photo 8 shows the interior portion of the Motor Taxi. The impact force did not affect the interior portion.

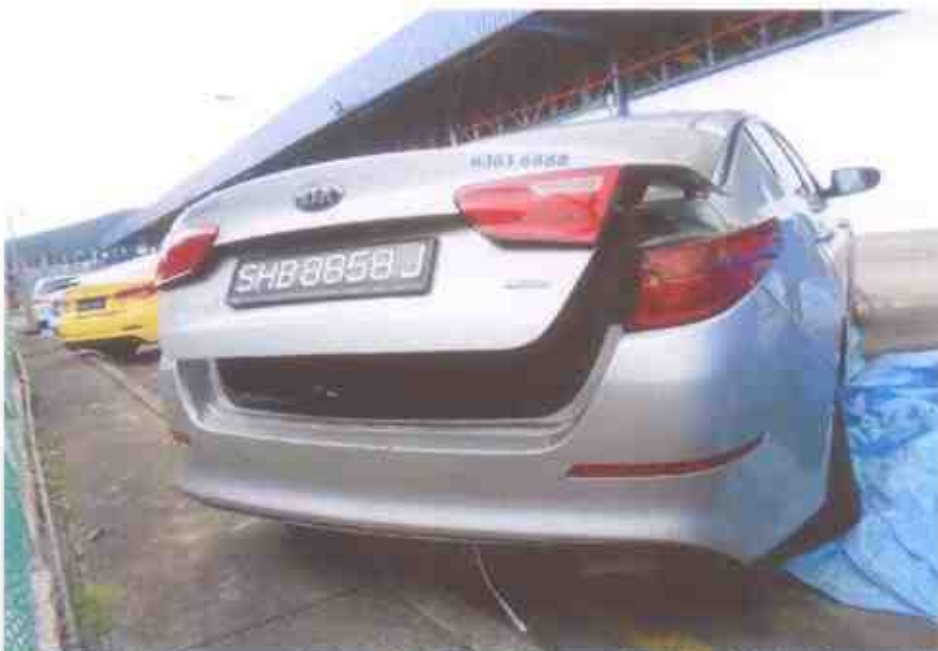
Photo 9 shows a general view of the rear right portion of the Motor Taxi at the time of our inspection. The rear portion was observed to have minor misalignment by the accident.

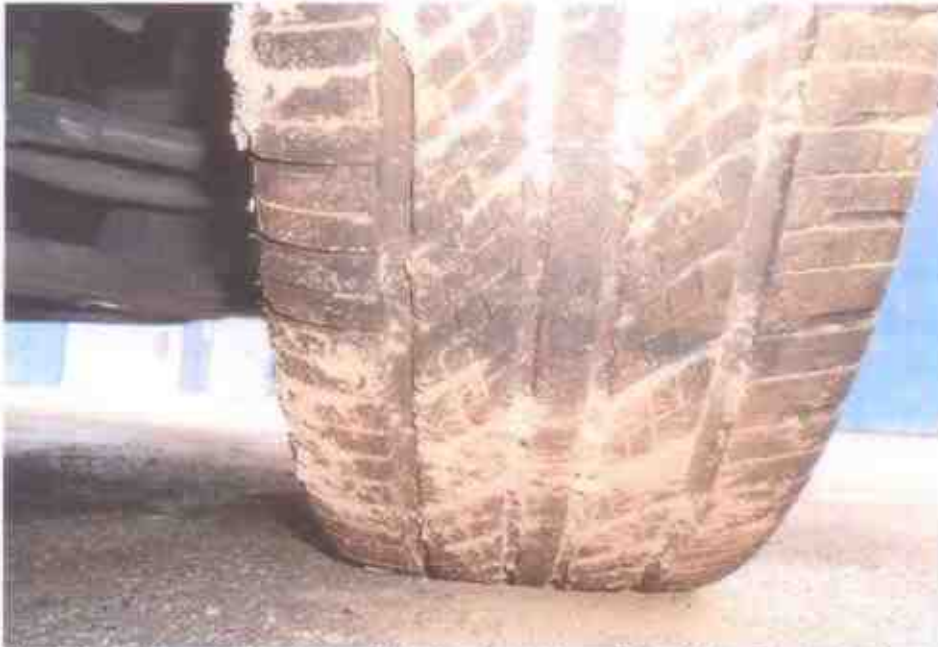
Photo 10 shows the condition of the front right tyre of the Motor Taxi, which was observed to be in serviceable condition with remaining tread depth of approximately 3mm. There was no tear, cut or burst mark(s) on the outer and the inner sidewalls as well as across the tread of this tyre.

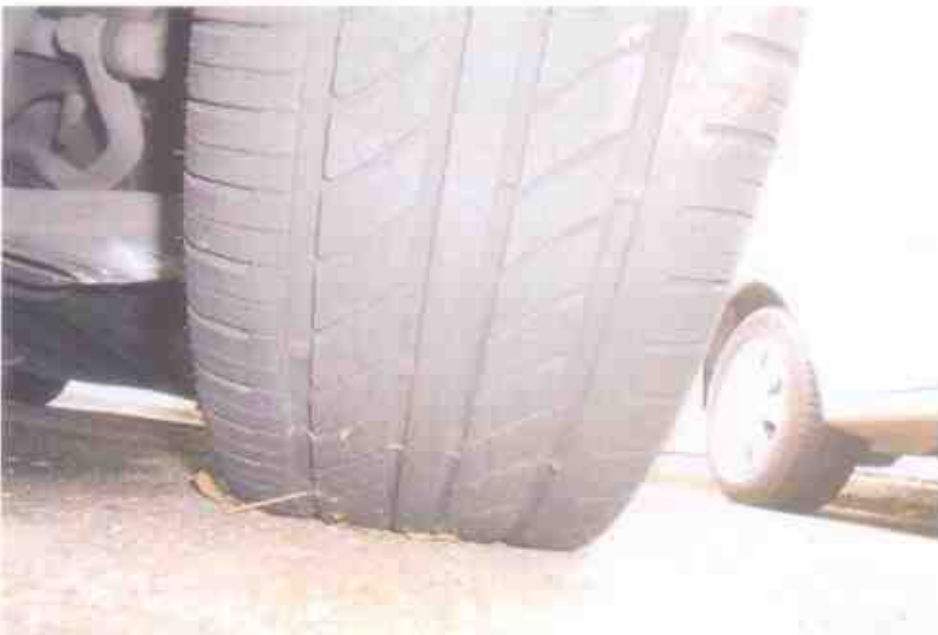
Photo 11 shows the condition of the front left tyre of the Motor Taxi, which was observed to be in serviceable condition with remaining tread depth of approximately 4mm. There was no tear, cut or burst mark(s) on the outer and the inner sidewalls as well as across the tread of this tyre, which was also sufficiently inflated for vehicular operation.

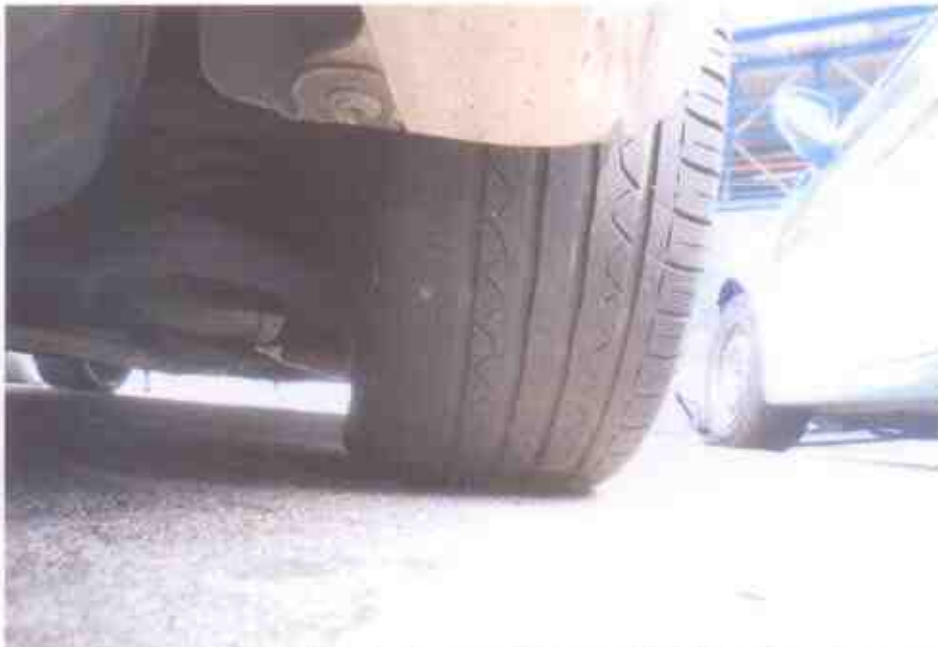
Photo 12 shows the condition of the rear right tyre of the Motor Taxi, which was observed to be in serviceable condition with remaining tread depth of approximately 4mm. There was also no tear, cut or burst mark(s) on the outer and the inner sidewalls as well as across the tread of this tyre.

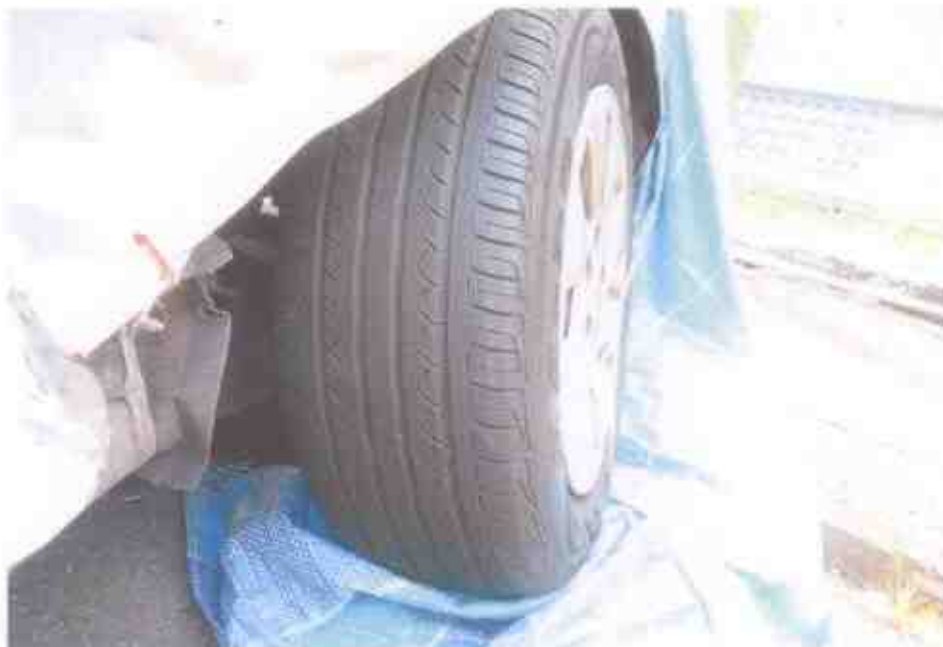
Photo 13 shows the condition of the rear left tyre of the Motor Taxi, which was observed to be in serviceable condition with remaining tread depth of approximately 3mm. There was also no tear, cut or burst mark(s) on the outer and the inner sidewalls as well as across the tread of this tyre.

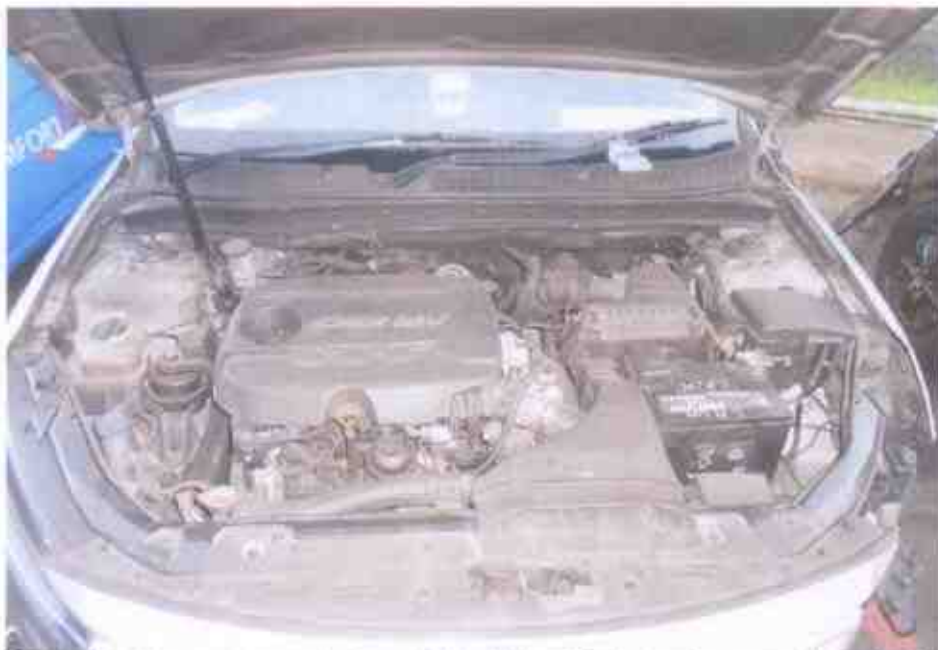
Photo 14 shows a general view of the Motor Car's engine compartment. The various parts and components inside the engine compartment were unaffected by the accident. There was also no sign(s) or indication(s) of fluid leakage and/or fluid stain within the engine compartment.

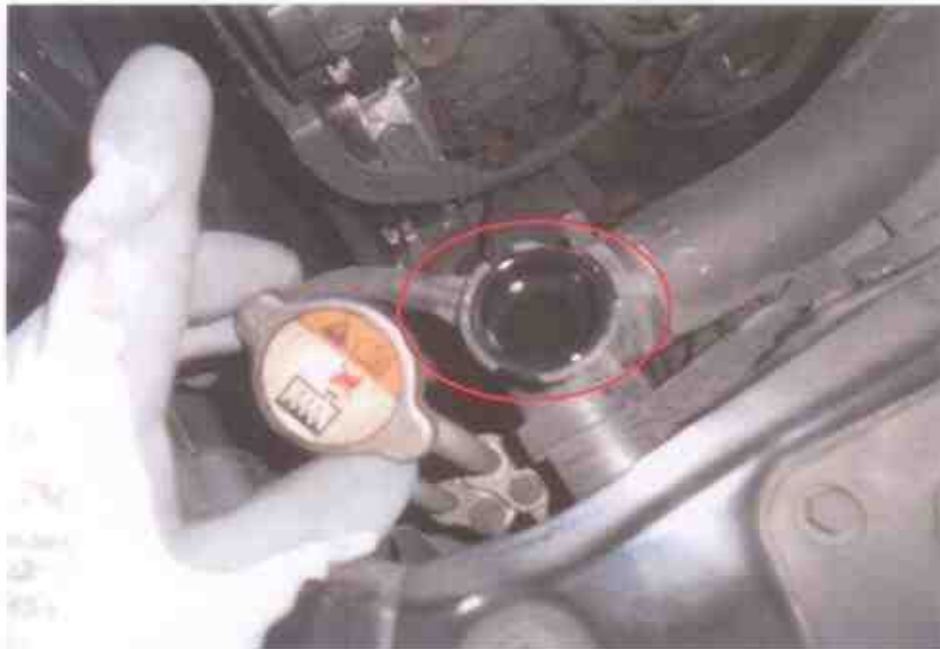
Photo 15 shows the close up view of the engine coolant that was seen with sufficient level not affected by the accident's impact.

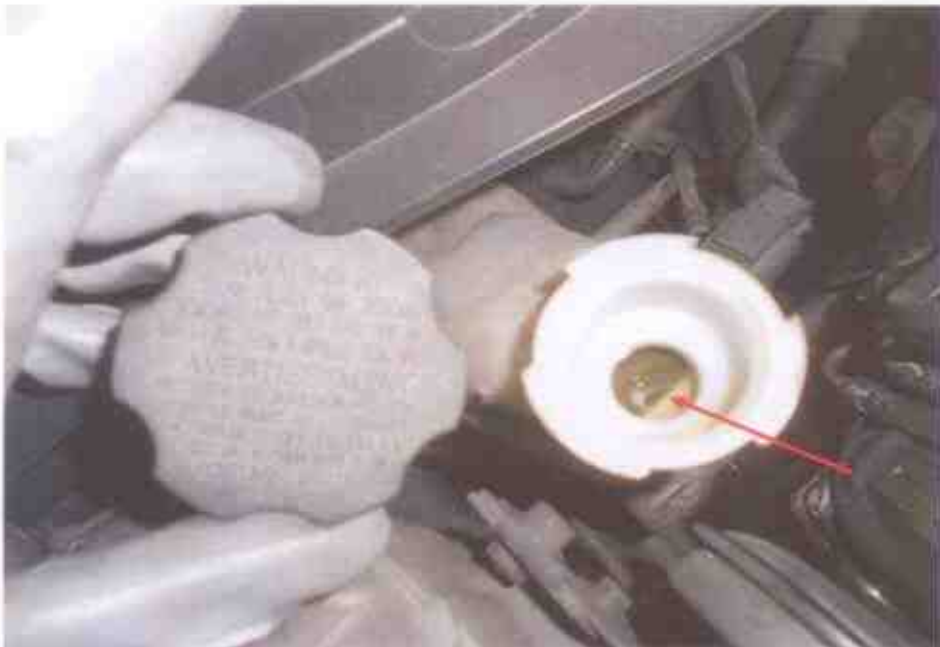
Photo 16 shows the close up view of the brake fluid that was seen with sufficient level not affected by the accident's impact.

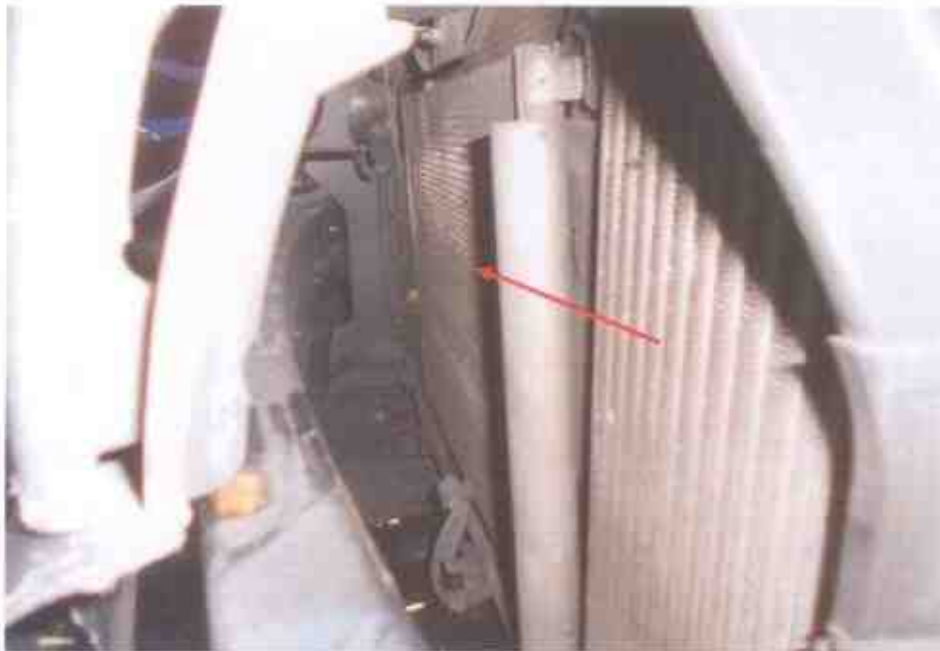
Photo 17 shows the close up view of the radiator that was not affected by the accident's impact

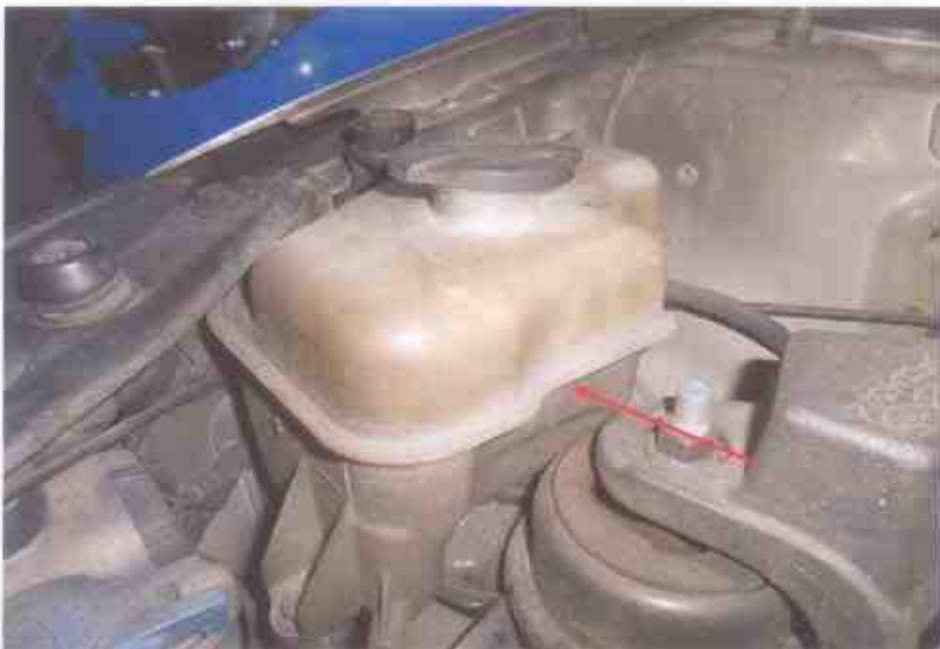
Photo 18 shows the close up view of the engine coolant reservoir that was seen with sufficient level not affected by the accident's impact.

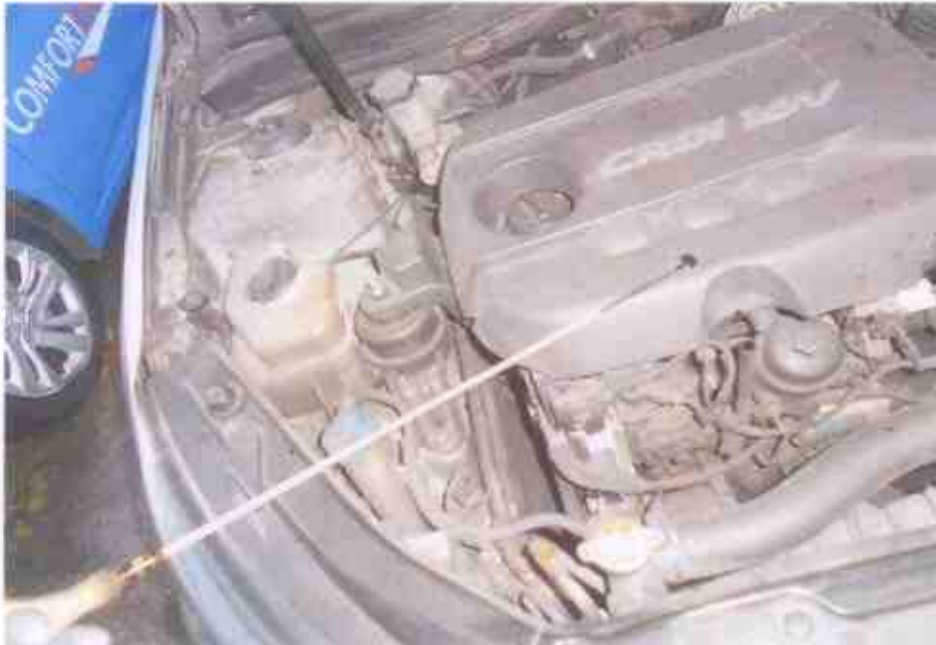
Photo 19 shows the engine oil dip stick of the Motor Taxi at the time of our inspection. The engine oil was observed to be of sufficient level and without any visible contamination.

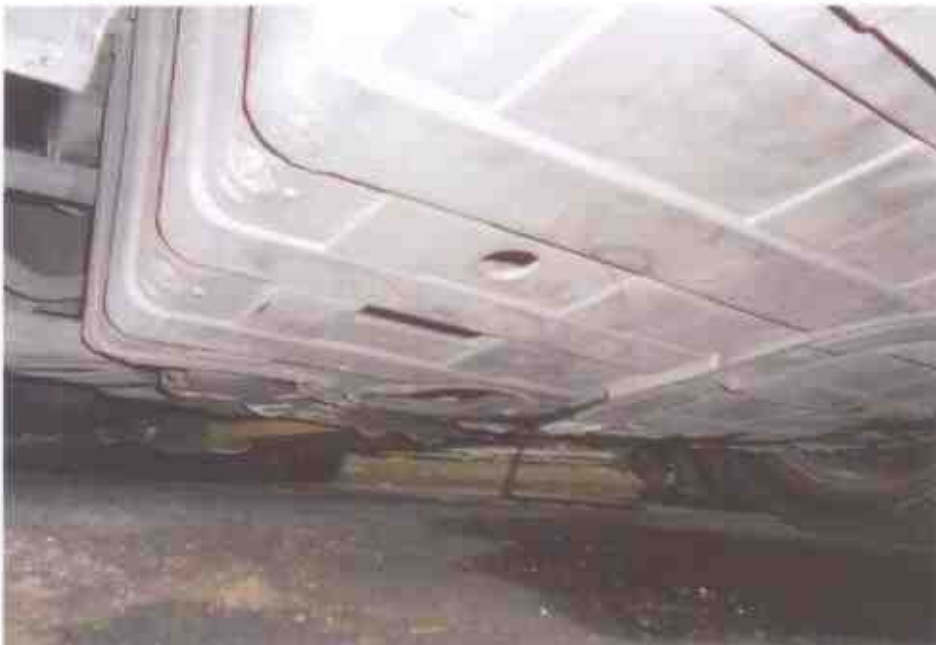
Photo 20 shows the undercarriage of the engine area. It was observed to be unaffected by the accident's impact.

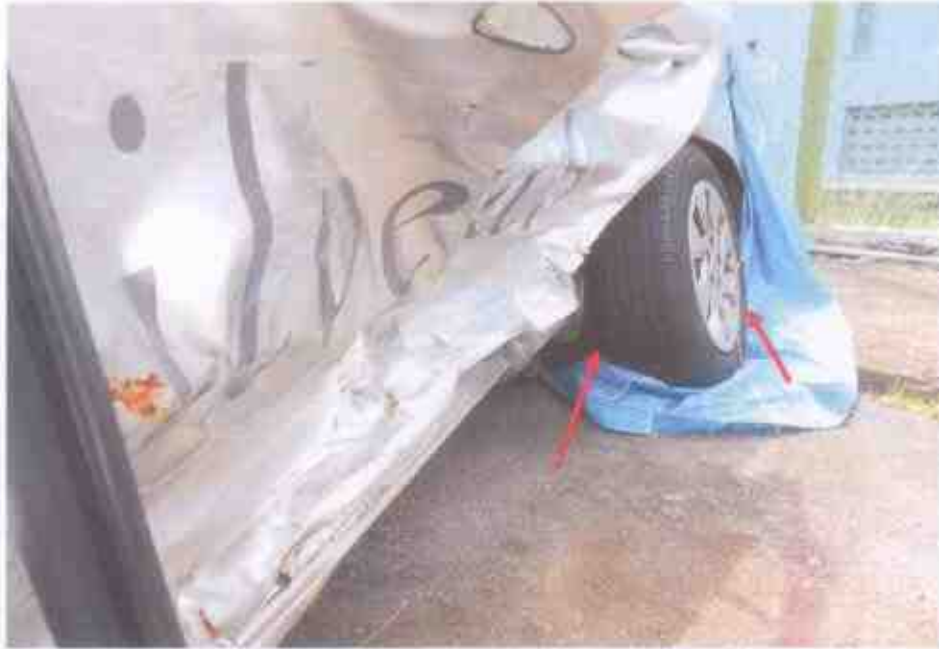
12. We were not able to conduct any tests on the steering system of the Motor Taxi. This was due to the damages sustained as a result of the accident, as well as damage to several mechanical components of the steering system. See photo 21 & 22 below.

Photo 21 shows the misalignment at the rear left wheel of the Motor Taxi.

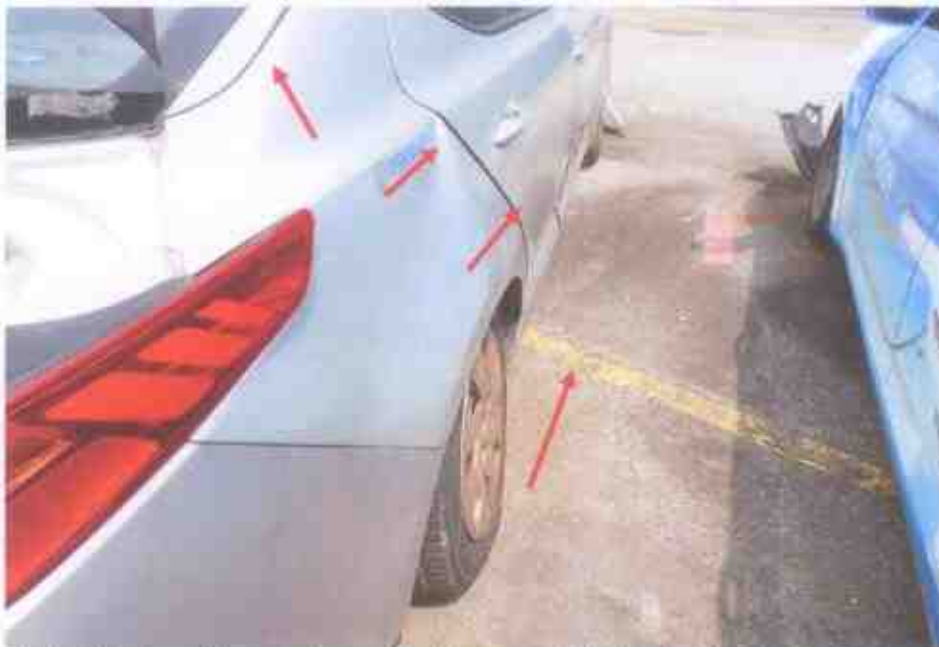
Photo 22 shows the misalignment at the rear right wheel of the Motor Taxi as a result of the accident's impact collision.

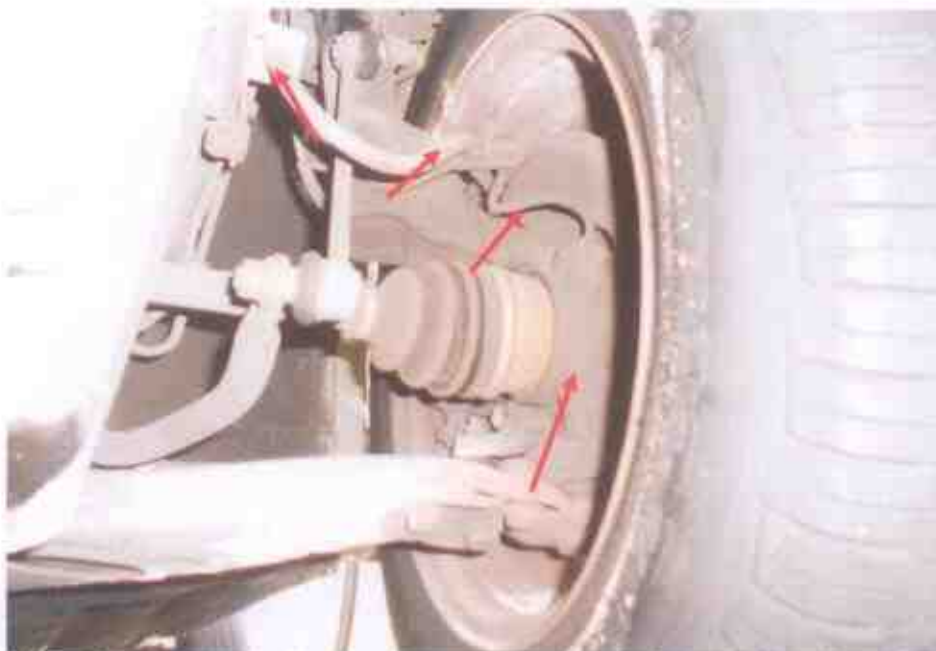
Photo 23 shows the braking components at the front left wheel of the Motor Taxi. We did not observe any leakage of brake fluid at the time of our inspection of the Motor Car.

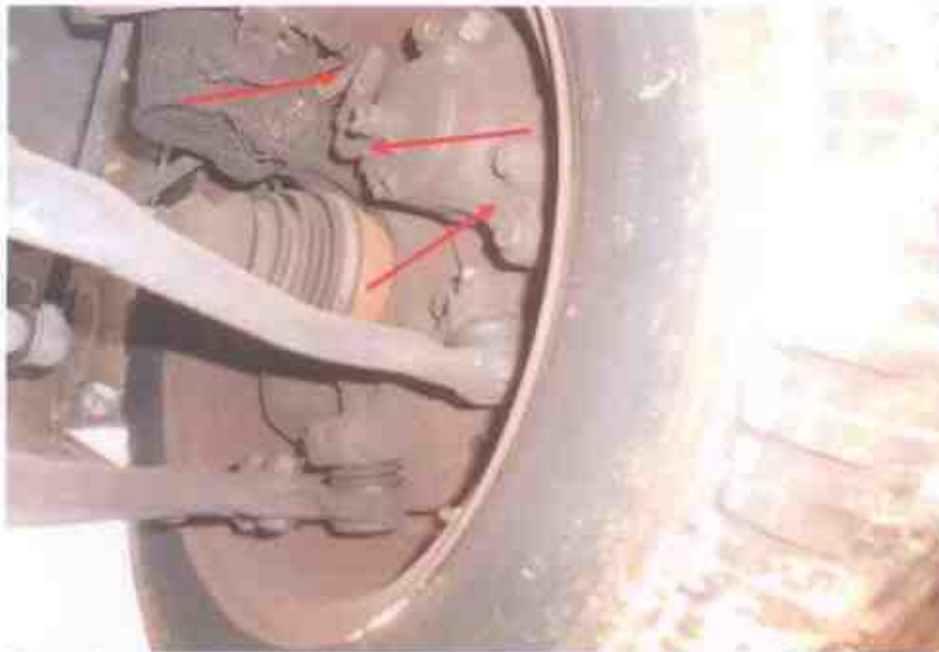
Photo 24 shows the braking components at the front right wheel of the Motor Taxi. We did not observe any leakage of brake fluid at the time of our inspection of the Motor Taxi.

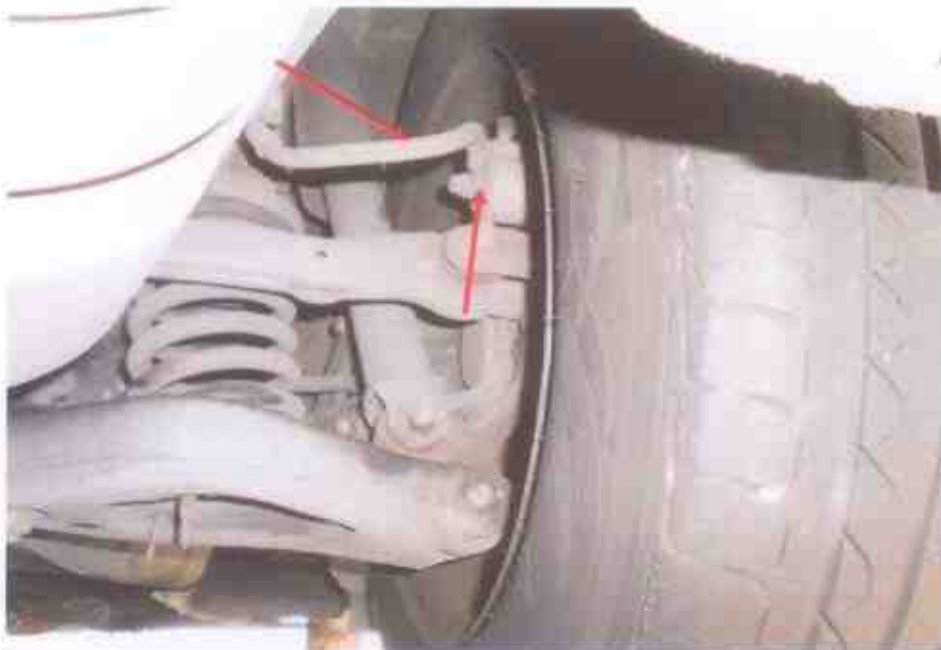
Photo 25 shows the braking components at the rear right wheel of the Motor Taxi. We did not observe any leakage of brake fluid at the time of our inspection of the Motor Taxi.

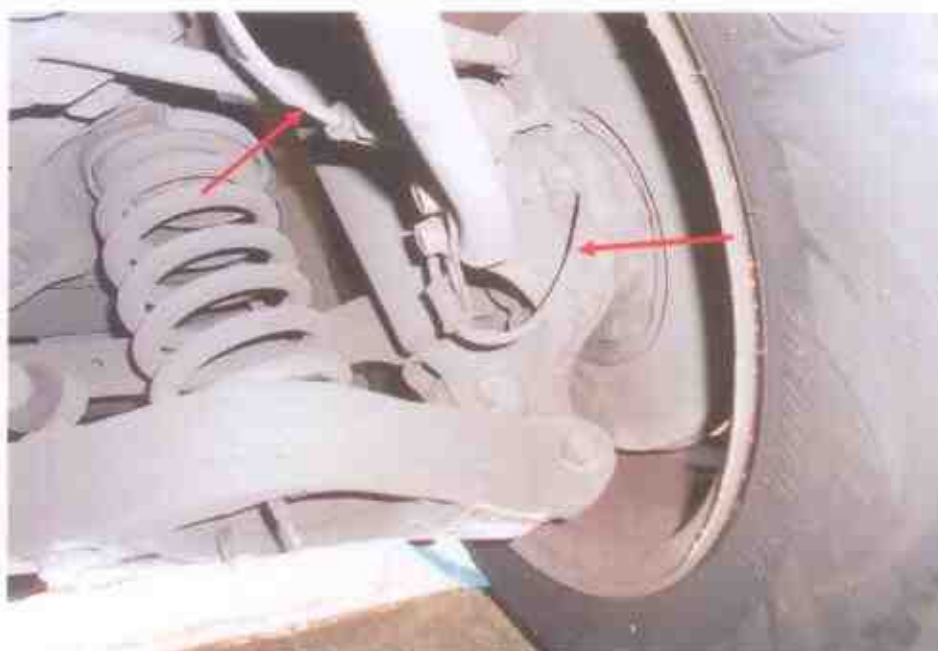
Photo 26 shows the braking components at the rear left wheel of the Motor Taxi. We did not observe any leakage of brake fluid at the time of our inspection of the Motor Taxi.
