PRO PLUS AUTOMOBILE ENGINEERS (Inspection photographs)

FU842E [SDU1996L] - Submitted by: AIG Asia Pacific Insurance Pte. Ltd. (SG)

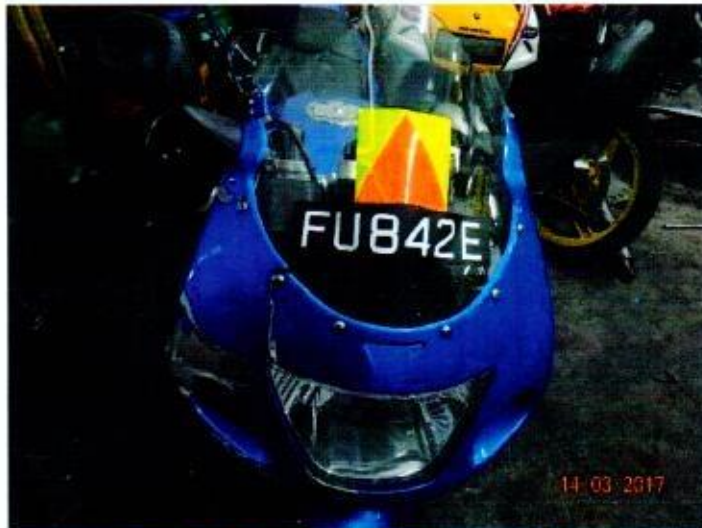
7/22: Photographs of Damaged Items

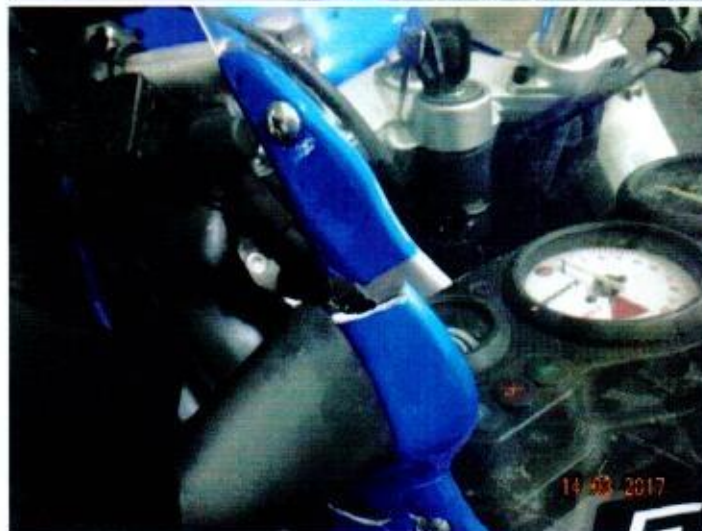
8/22: Photographs of Damaged Items

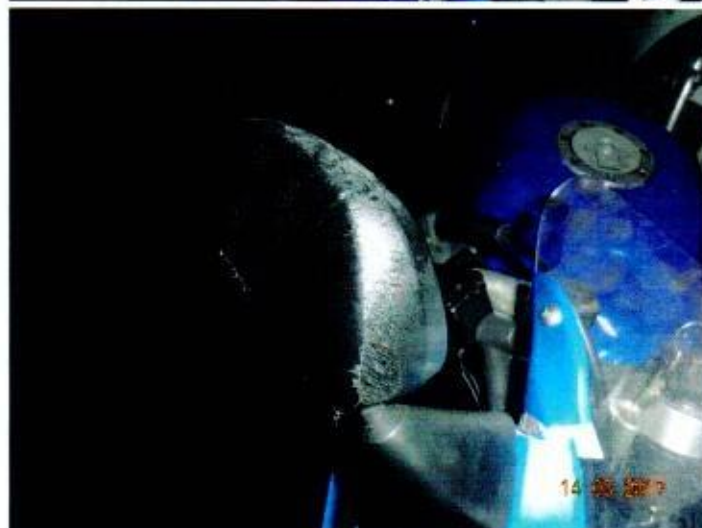
9/22: Photographs of Damaged Items

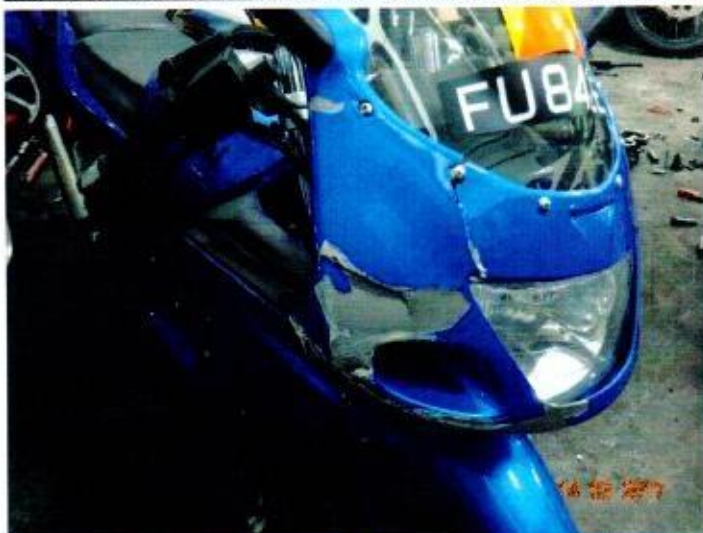
10/22: Photographs of Damaged Items

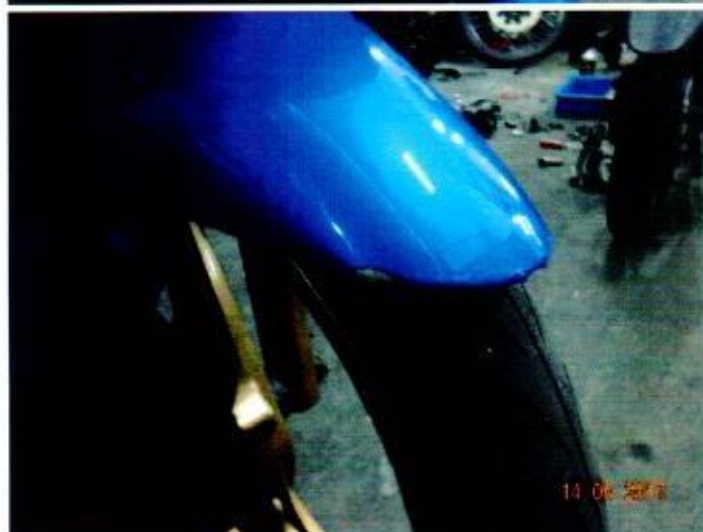
11/22: Photographs of Damaged Items

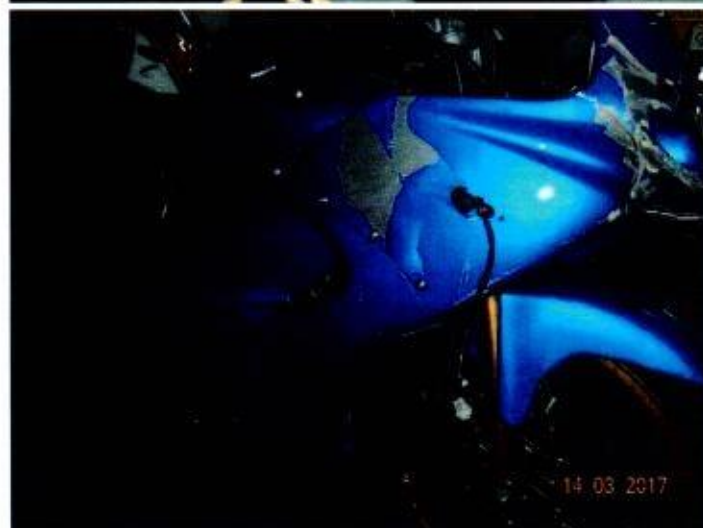
12/22: Photographs of Damaged Items

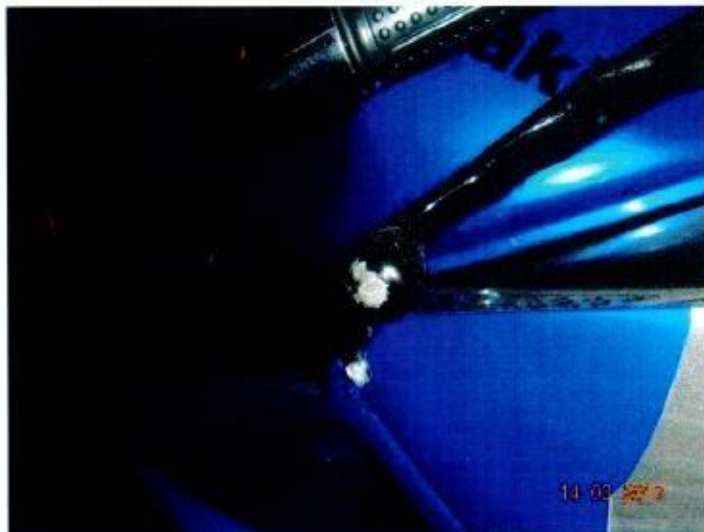
13/22: Photographs of Damaged Items

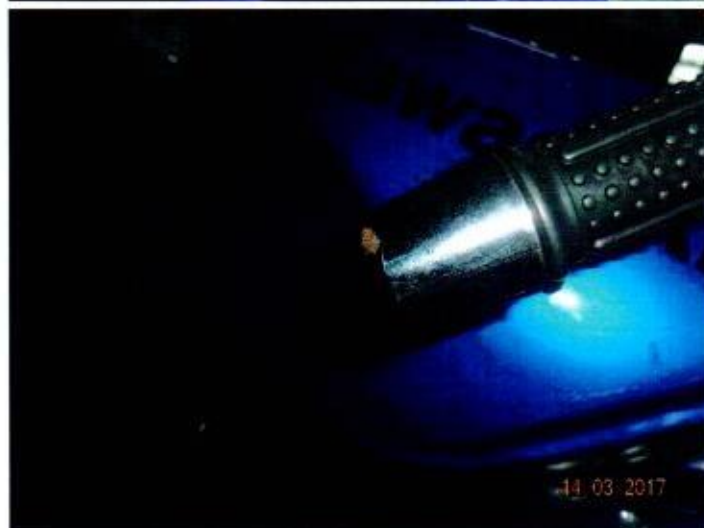
14/22: Photographs of Damaged Items

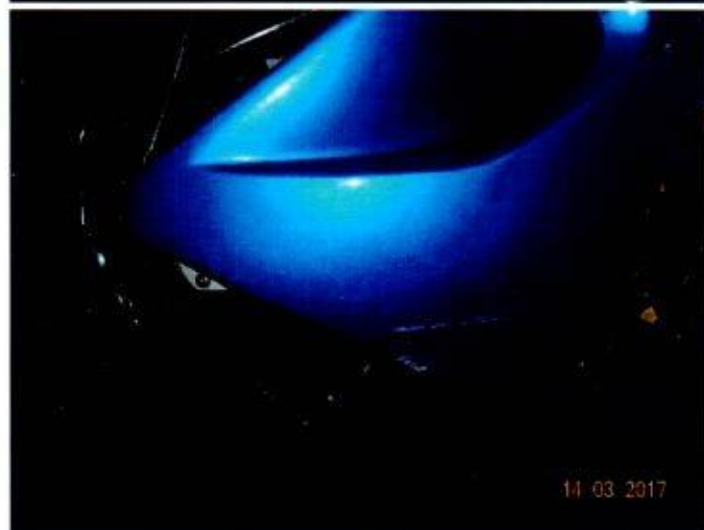
15/22: Photographs of Damaged Items

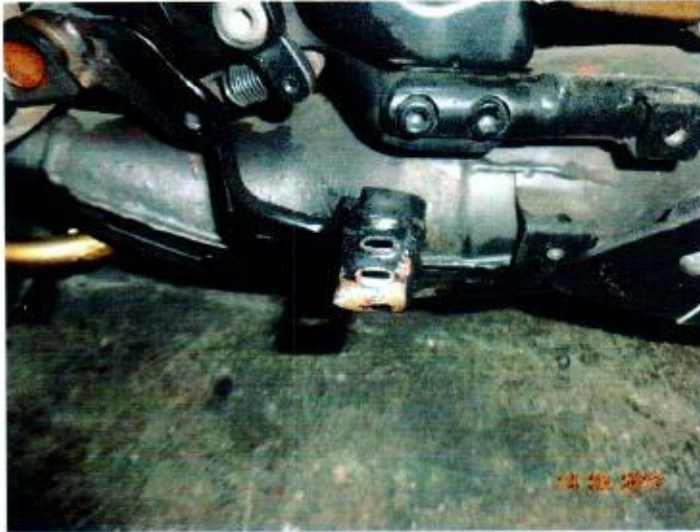
16/22: Photographs of Damaged Items

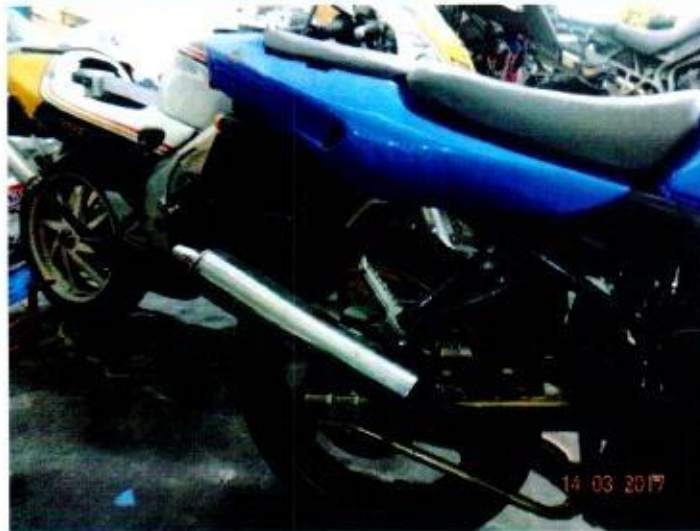
17/22: Photographs of Damaged Items

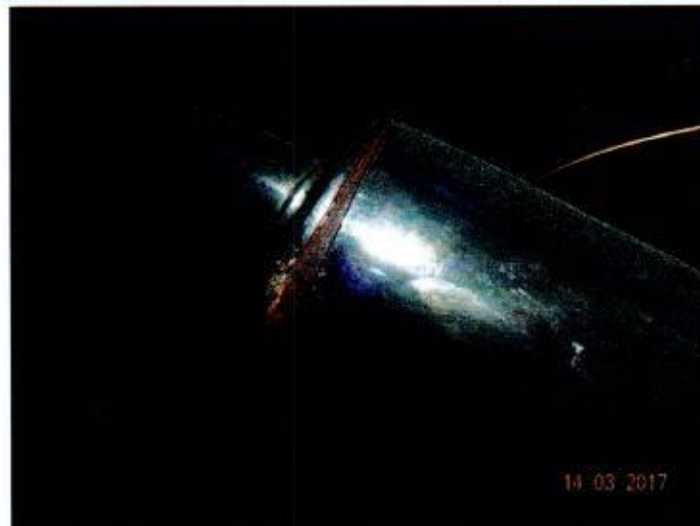
18/22: Photographs of Damaged Items

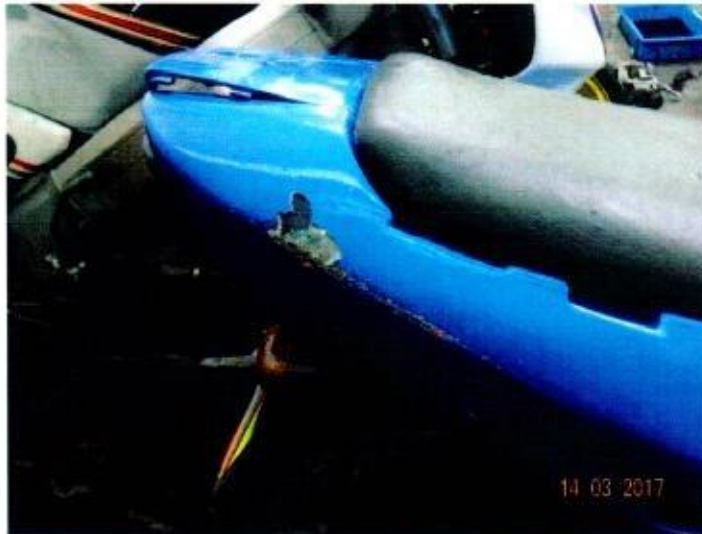
19/22: Photographs of Damaged Items

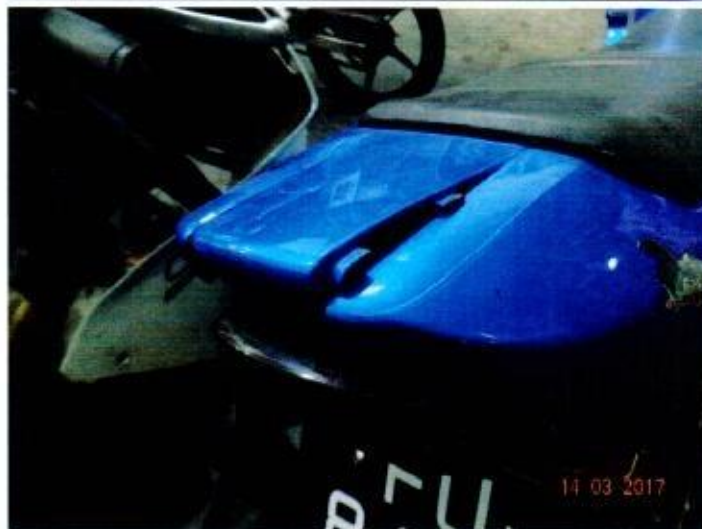
20/22: Photographs of Damaged Items

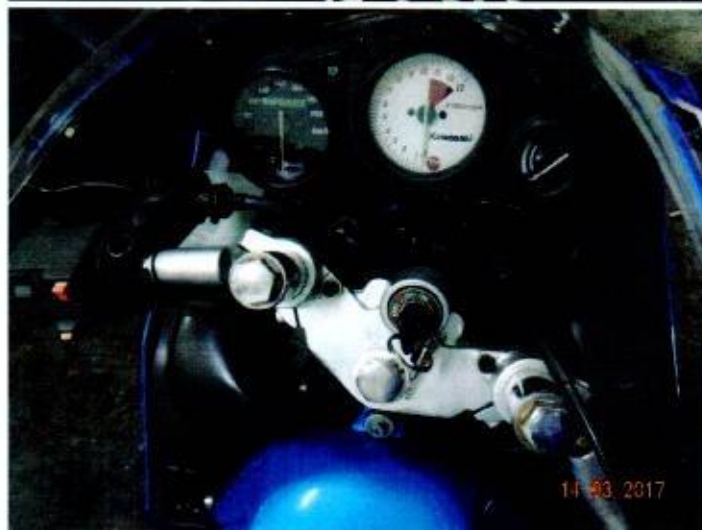
21/22: Photographs of Damaged Items

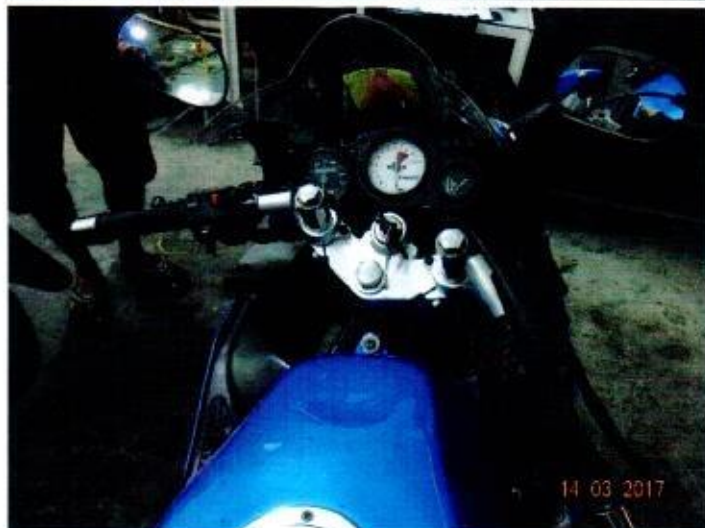
22/22: Photographs of Damaged Items
