Your Ref: S8M00KG1  
Our Ref : CS/ASM18010777/N

18 June 2018

**TECHNICAL INVESTIGATION REPORT OF FIRE INCIDENT INVOLVING THE INSURED VEHICLE SKG 6679K ON 11 JUNE 2018**

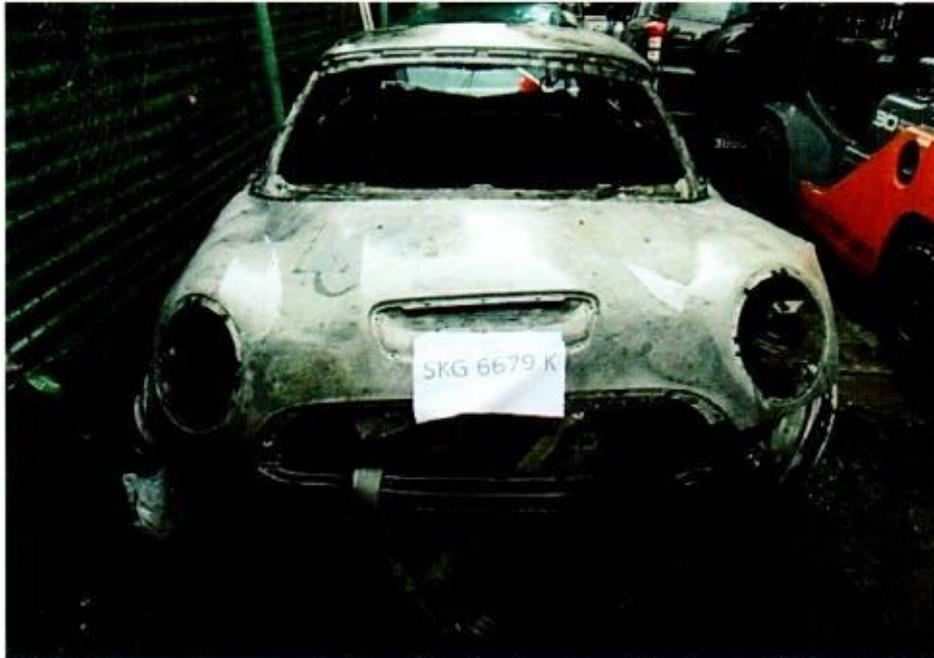
**Photo 1** shows the general view of the front portion of the Insured Vehicle at the time of our inspection. The Insured Vehicle was observed to have sustained extensive fire damage all around. Its engine compartment and interior compartment were completely burnt. Rust had accumulated all over the Insured Vehicle as a result of exposure to environmental condition for a period of time.

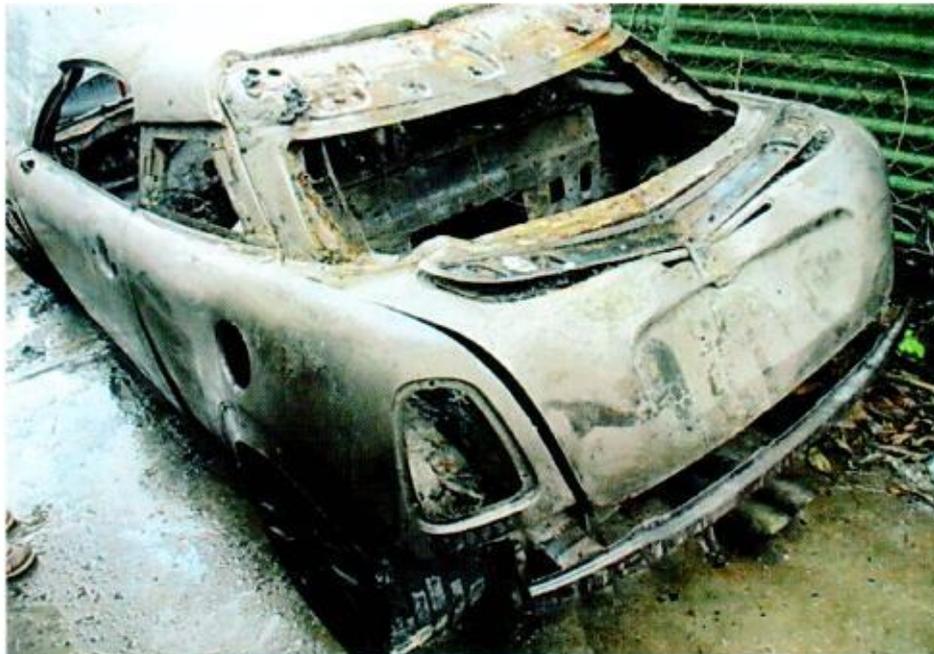
**Photo 2** shows the general view of the left rear body of the Insured Vehicle at the time of our inspection. The Insured Vehicle was observed to have sustained extensive fire damage all around. Rust had accumulated all over the Insured Vehicle as a result of exposure to environmental condition for a period of time.

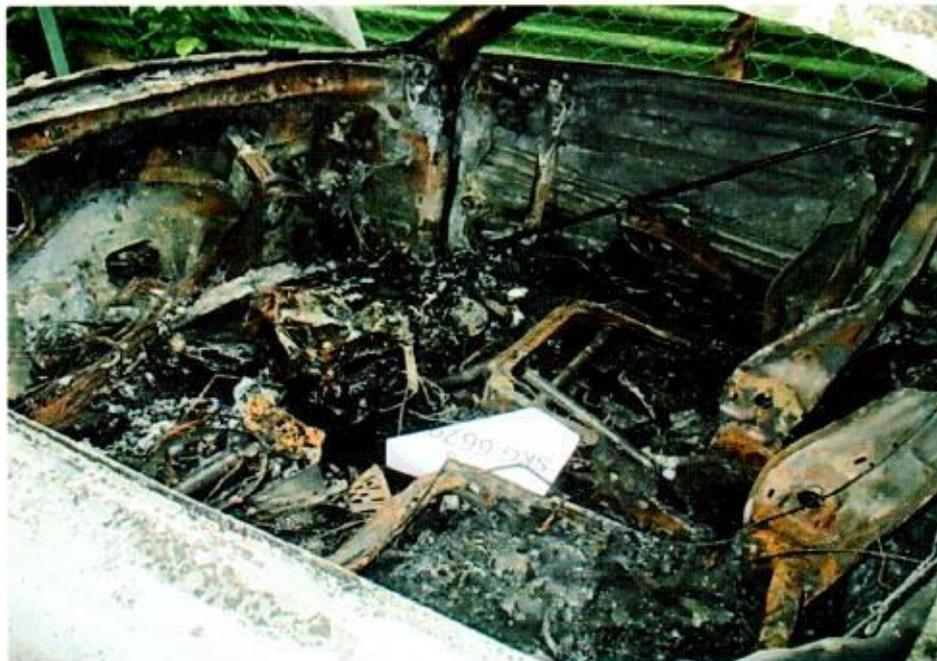
**Photo 3** shows the general view of the interior of the Insured Vehicle at the time of our inspection. Its interior compartment was completely burnt.

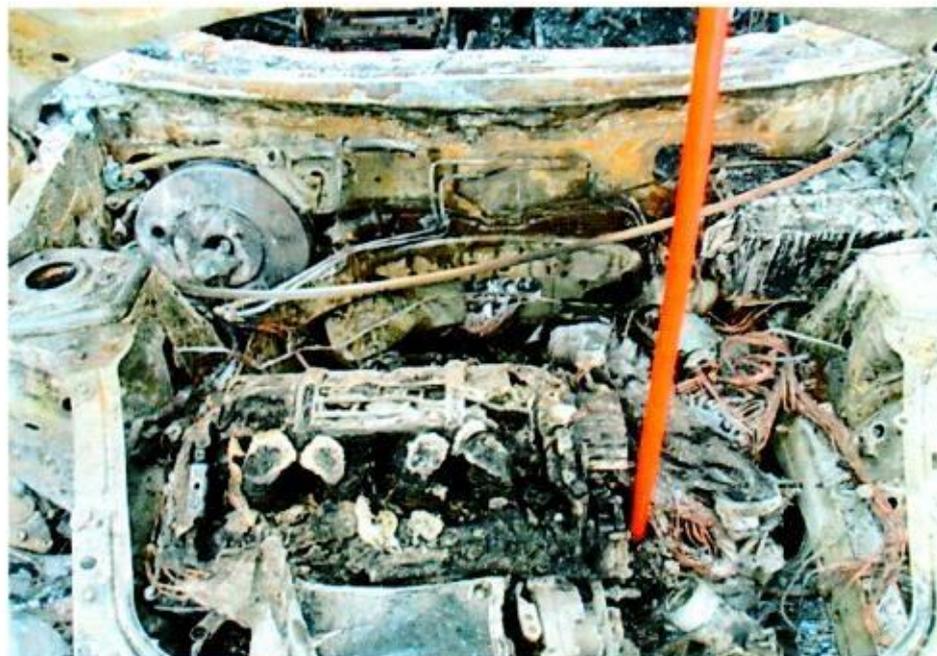
**Photo 4** shows the engine compartment of the Insured Vehicle at the time of our inspection. The entire engine compartment of the Insured Vehicle was observed to be severely burnt. Most of the parts inside the engine compartment were found to be burnt and/or melted as a result of the fire.

7. For this particular case, the fire appears to have originated within the engine compartment of the Insured Vehicle as this was the area where the damage of fire nature was most severe.

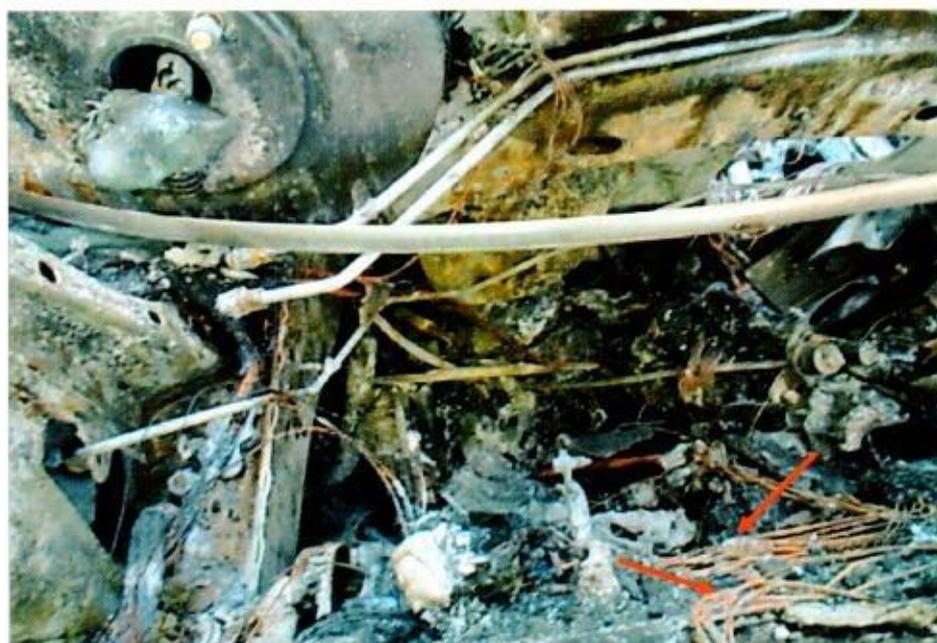
8. Upon closer examination of the centre portion of the engine compartment, which was where the fire to the Insured Vehicle had likely started, we had found faint traces of greenish residue on several stretches of wirings. These wirings were original factory fitted wirings that were around the centre portion of the engine compartment. The presence of greenish residue indicates internal heating of copper wires, a sign of an electrical short circuit occurring. The greenish residue is normally left behind from oxidation as a result of chemical reaction involving the copper wires. This physical evidence would appear to suggest that the cause of fire to the Insured Vehicle could have possibly been due to electrical in nature. See photos 5 - 7 below.

**Photo 5** shows the factory fitted wirings around the centre portion of the engine compartment which is near to the vicinity where the fire to the Insured Vehicle had likely started. We observed faint traces of greenish residue on some of these wirings (arrowed).

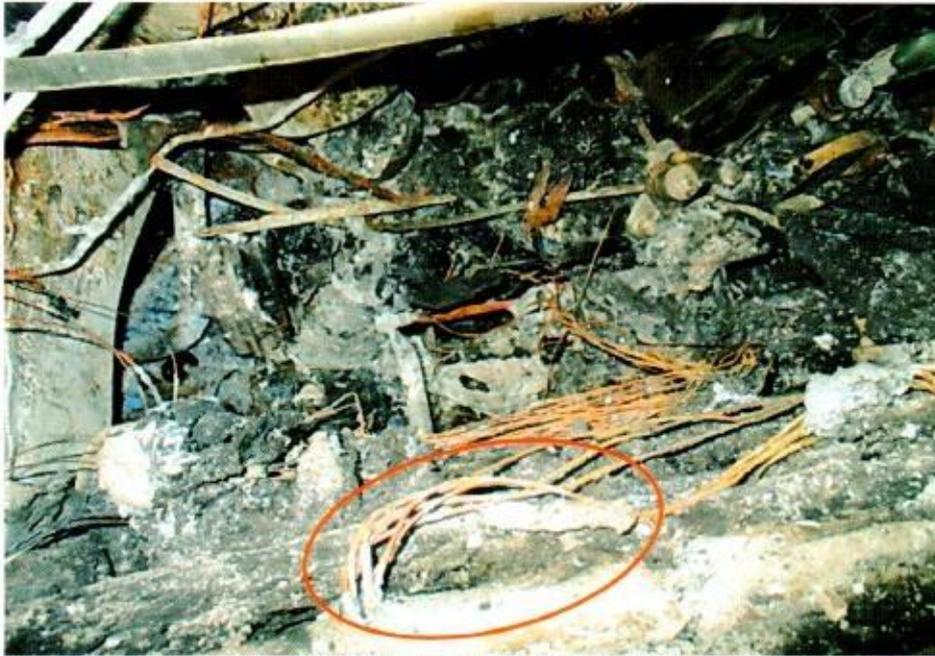
**Photo 6** shows a closer view of the wirings around the centre portion of the engine compartment. We observed faint traces of greenish residue on some of these wirings (circled). This seems to suggest the occurrence of an electrical short circuit.

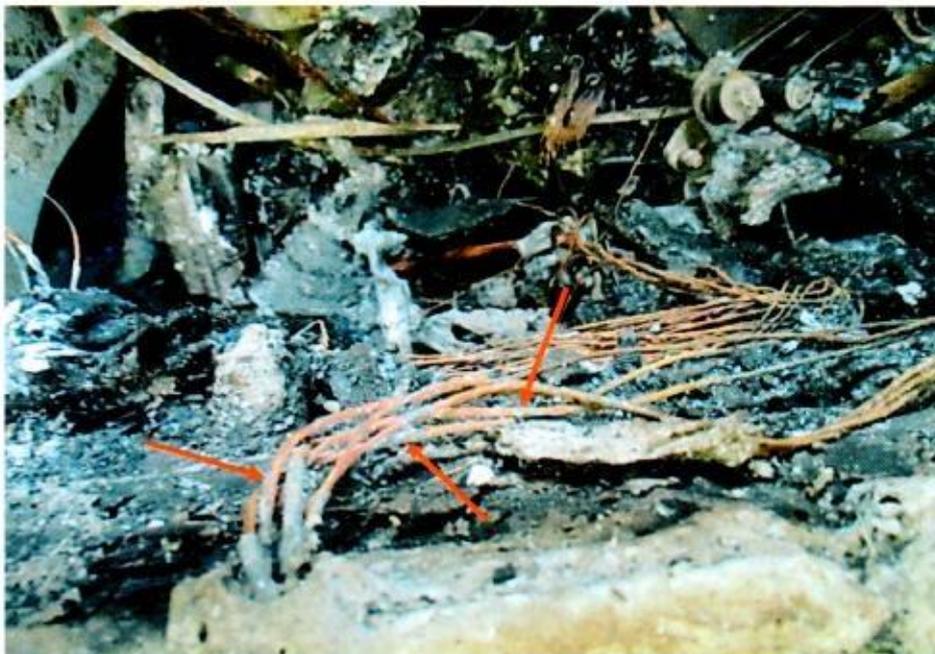
**Photo 7** shows a close up view of the greenish residue found on the wirings around the centre portion of the engine compartment (arrowed). The presence of greenish residue indicates internal heating of copper wires, a sign of an electrical short circuit.

27. Having investigated and technically analysed the damages of burnt nature to the Insured Vehicle, we are of the view that the cause of fire to the Insured Vehicle was of electrical in nature. For this particular case, the fire had originated along the wirings inside the engine compartment, somewhere around the centre portion of the engine compartment. The wirings were original factory fitted wirings of the Insured Vehicle.

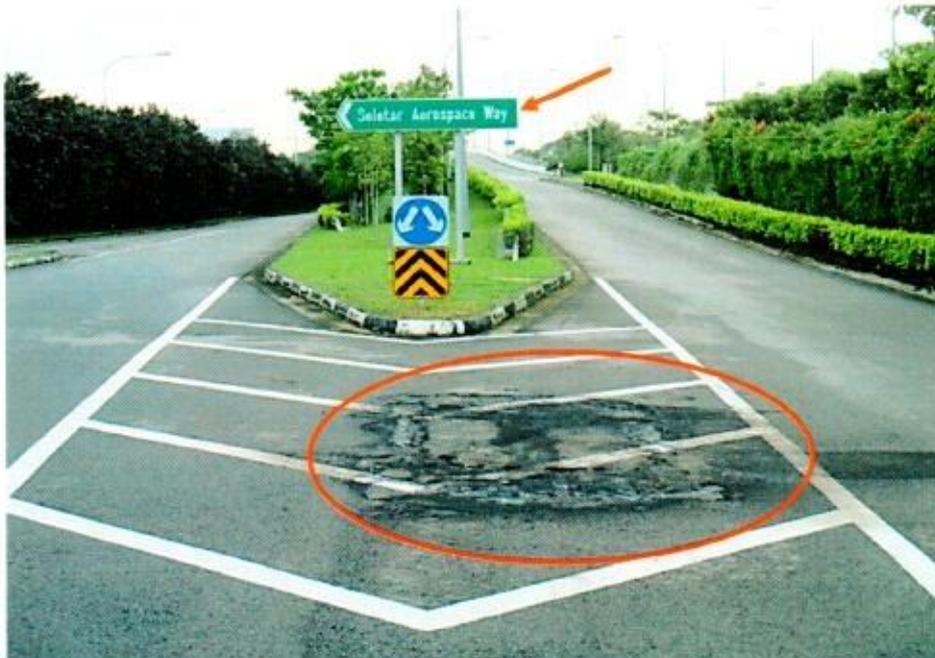
**Photo 8** shows the split road of Jalan Kayu and Seletar Aerospace Way (arrowed) after TPE. We noticed that the immediate vicinity was not monitored by traffic camera(s). The Insured Vehicle was positioned on the chevron markings when the fire broke out (circled).

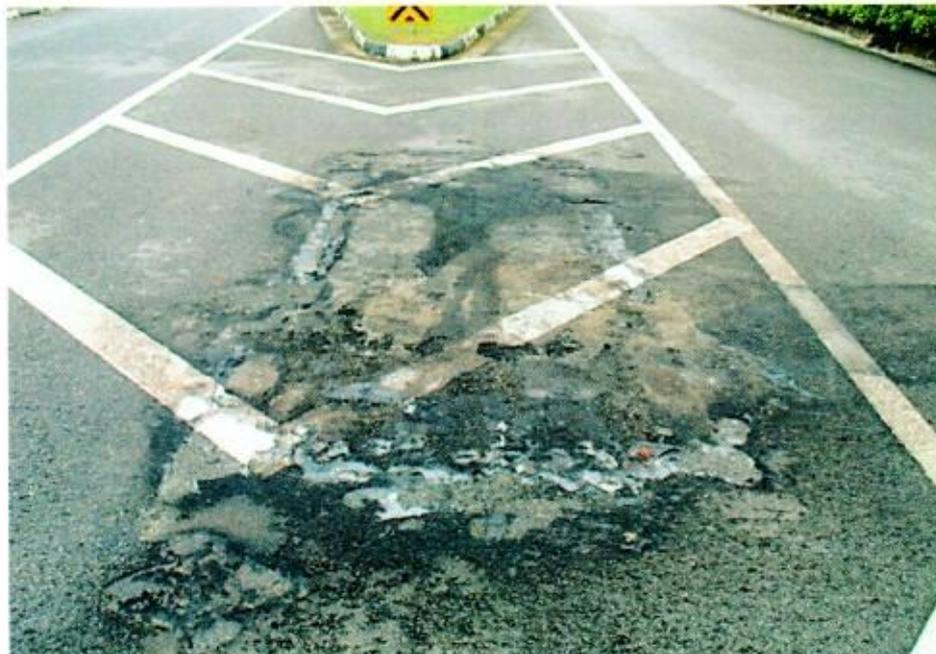
**Photo 9** shows the burnt marks and/or burnt residual remains on the ground where the Insured Vehicle was positioned when the fire broke out.

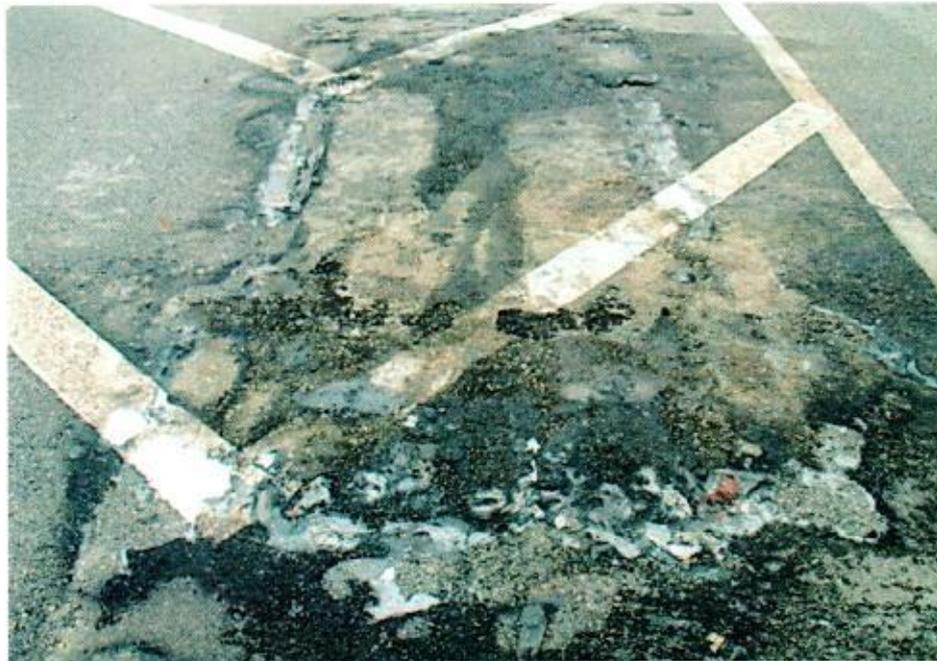
**Photo 10** shows a close up view of the burnt marks and/or burnt residual remains on the ground where the Insured Vehicle was positioned when the fire broke out.

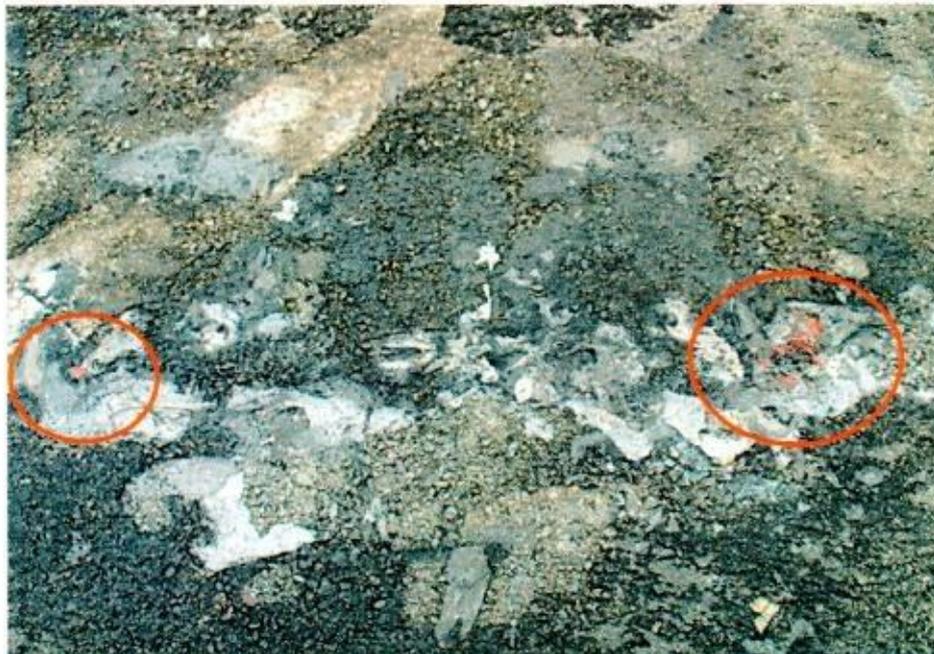
**Photo 11** shows a close up view of the burnt residual remains on the ground where the Insured Vehicle was positioned (circled).

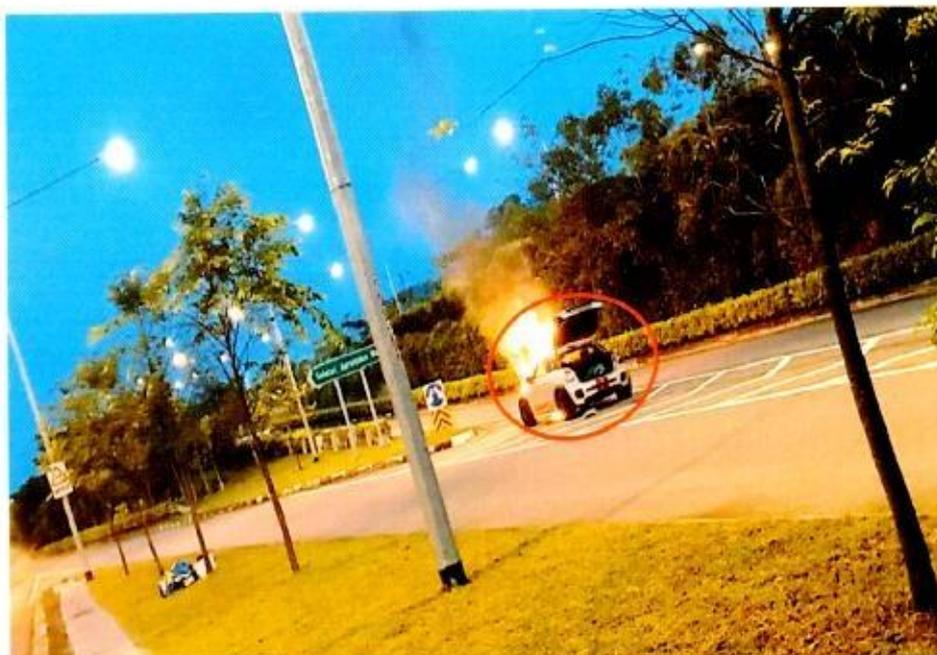
**Photo 12** shows the Insured Vehicle on fire before the arrival of the SCDF. In general, the information that could be gathered from this photograph had corresponded to the events that were related to us by Mr Tan, which is he had stopped the Insured Vehicle on the chevron markings after TPE along the split road of Jalan Kayu and Seletar Aerospace Way when the fire broke out (circled).

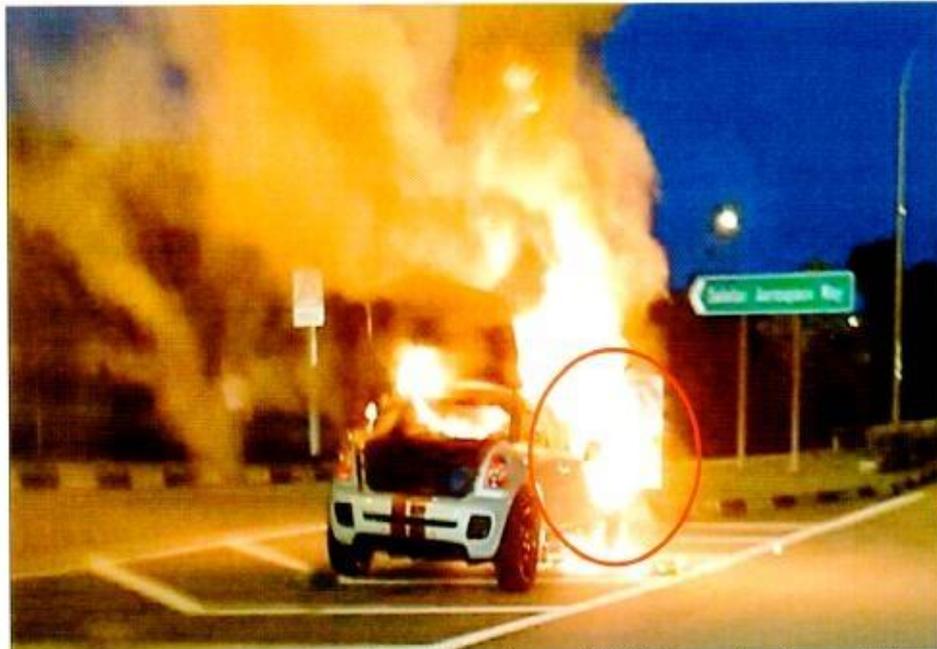
**Photo 13** shows the rear portion of the Insured Vehicle as the fire got bigger before the arrival of the SCDF. In general, the information that could be gathered from this photograph had corresponded to the events that were related to us by Mr Tan, which is the fire had started from the front portion of the Insured Vehicle (circled).

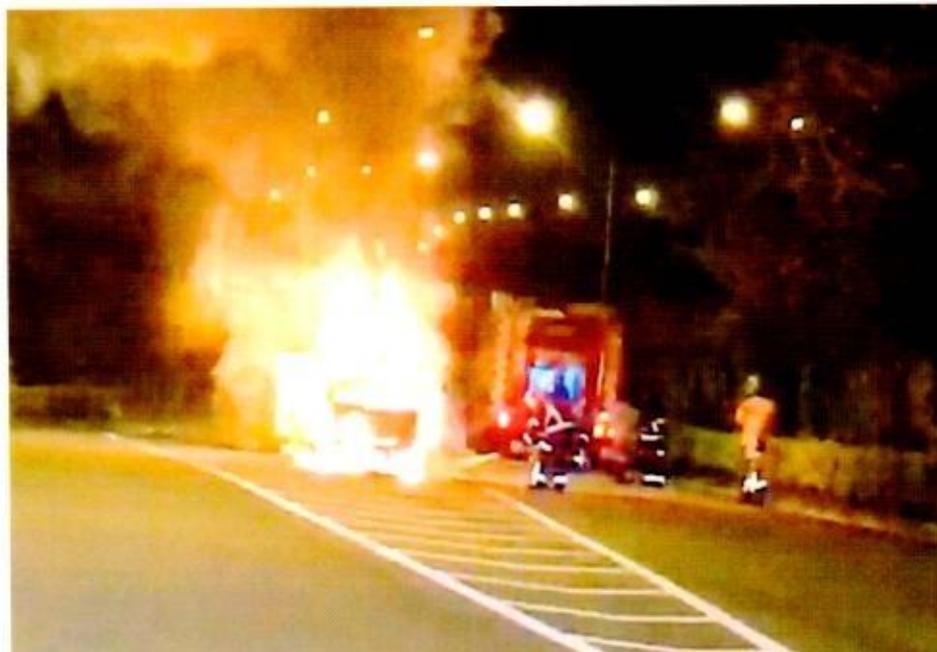
**Photo 14** shows firefighters attempting to put out the fire to the Insured Vehicle.

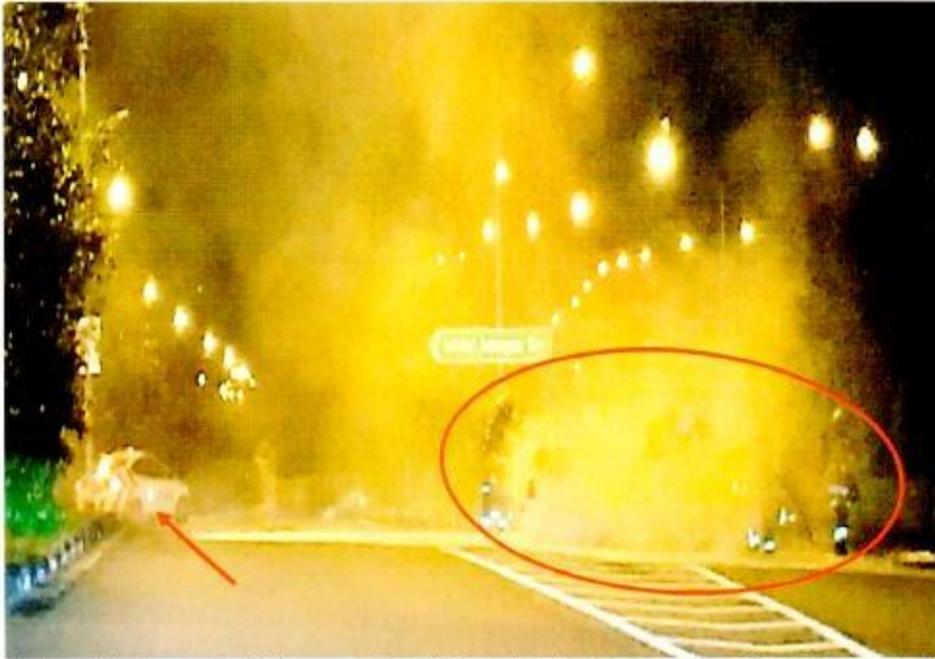
**Photo 15** shows firefighters extinguishing the last remnants of the fire (circled). In general, the information that could be gathered from this photograph had corresponded to the events that were related to us by Mr Tan, which is the police (arrowed) and SCDF were present at the incident location.

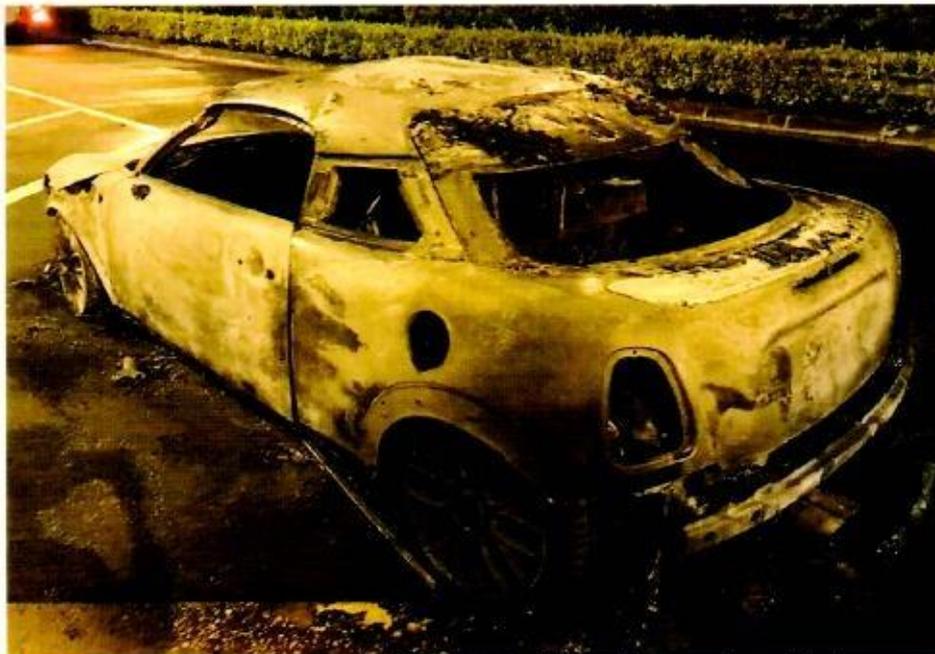
**Photo 16** shows the Insured Vehicle after the fire had been extinguished.
