Your Ref: S8M00KG1
Our Ref : CS/ASM18010777/N

18 June 2018

TECHNICAL INVESTIGATION REPORT OF FIRE INCIDENT INVOLVING THE INSURED VEHICLE SKG 6679K ON 11 JUNE 2018

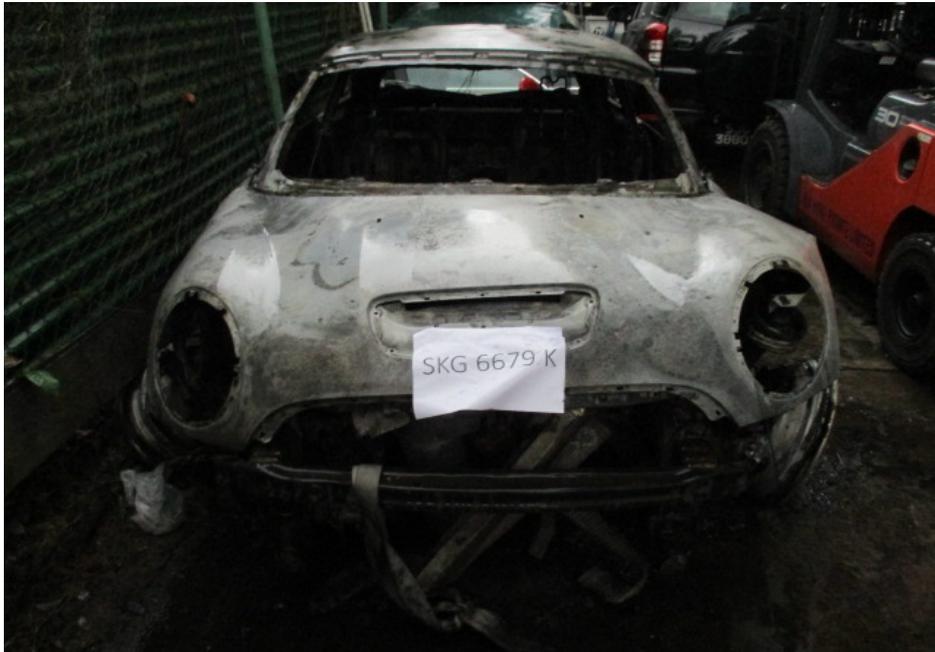
Photo 1 shows the general view of the front portion of the Insured Vehicle at the time of our inspection. The Insured Vehicle was observed to have sustained extensive fire damage all around. Its engine compartment and interior compartment were completely burnt. Rust had accumulated all over the Insured Vehicle as a result of exposure to environmental condition for a period of time.

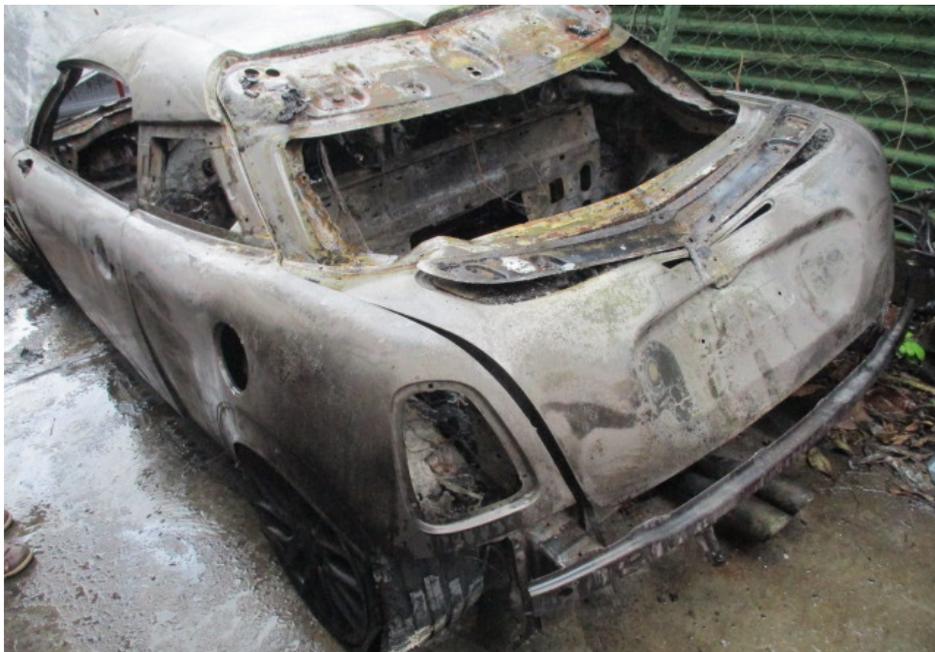
Photo 2 shows the general view of the left rear body of the Insured Vehicle at the time of our inspection. The Insured Vehicle was observed to have sustained extensive fire damage all around. Rust had accumulated all over the Insured Vehicle as a result of exposure to environmental condition for a period of time.

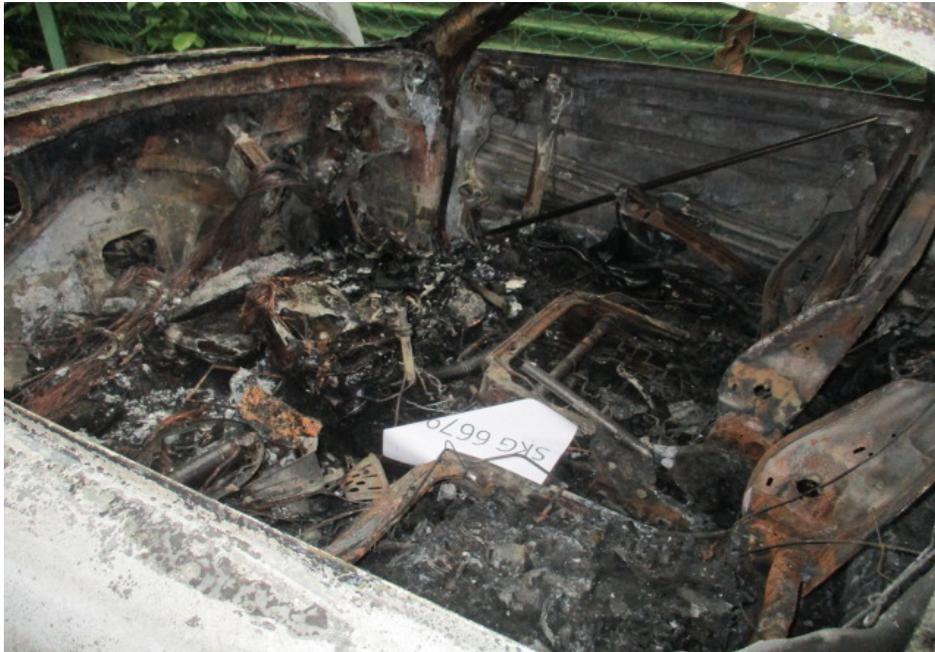
Photo 3 shows the general view of the interior of the Insured Vehicle at the time of our inspection. Its interior compartment was completely burnt.

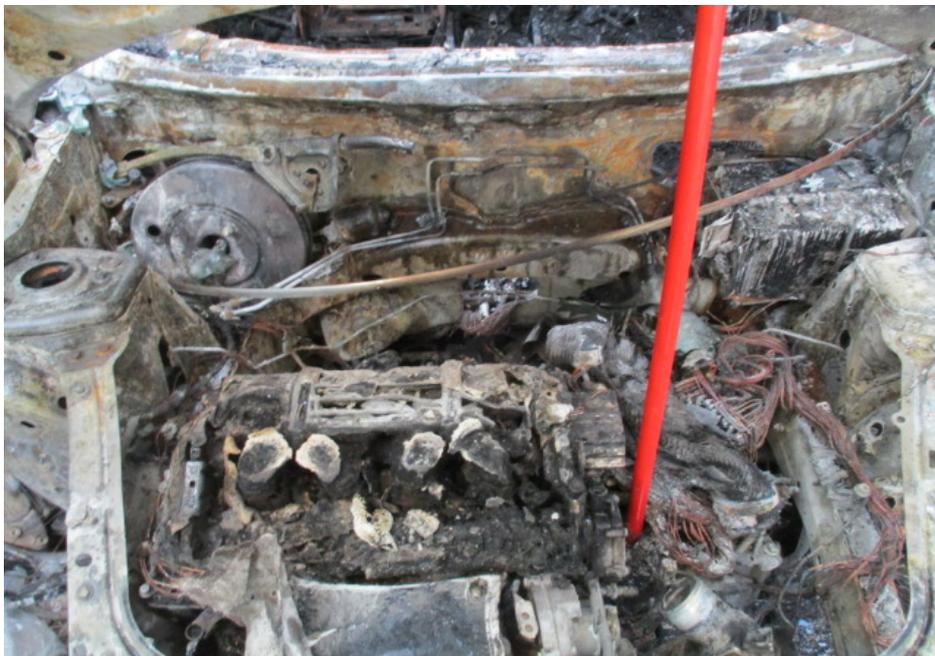
Photo 4 shows the engine compartment of the Insured Vehicle at the time of our inspection. The entire engine compartment of the Insured Vehicle was observed to be severely burnt. Most of the parts inside the engine compartment were found to be burnt and/or melted as a result of the fire.

7. For this particular case, the fire appears to have originated within the engine compartment of the Insured Vehicle as this was the area where the damage of fire nature was most severe.

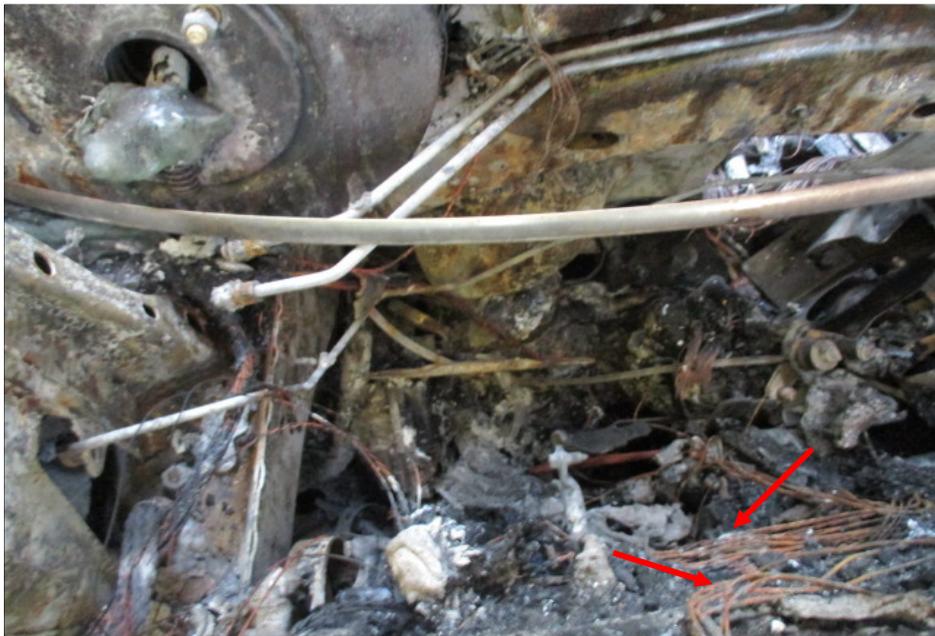
8. Upon closer examination of the centre portion of the engine compartment, which was where the fire to the Insured Vehicle had likely started, we had found faint traces of greenish residue on several stretches of wirings. These wirings were original factory fitted wirings that were around the centre portion of the engine compartment. The presence of greenish residue indicates internal heating of copper wires, a sign of an electrical short circuit occurring. The greenish residue is normally left behind from oxidation as a result of chemical reaction involving the copper wires. This physical evidence would appear to suggest that the cause of fire to the Insured Vehicle could have possibly been due to electrical in nature. See photos 5 - 7 below.

Photo 5 shows the factory fitted wirings around the centre portion of the engine compartment which is near to the vicinity where the fire to the Insured Vehicle had likely started. We observed faint traces of greenish residue on some of these wirings (arrowed).

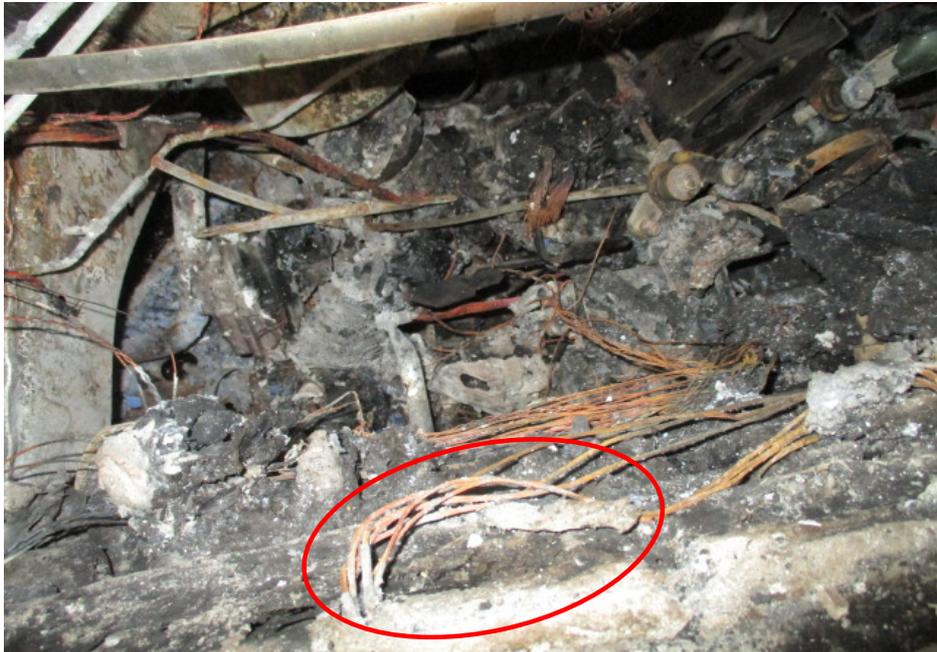
Photo 6 shows a closer view of the wirings around the centre portion of the engine compartment. We observed faint traces of greenish residue on some of these wirings (circled). This seems to suggest the occurrence of an electrical short circuit.

25. The possibility of the fire being due to electrical in nature would then seem more likely given that engine overheating and external factors would both seem unlikely. The fire being due to electrical in nature is also supported by the condition of the wirings that were found in the engine compartment of the Insured Vehicle, which was earlier discussed in paragraph 8 above.

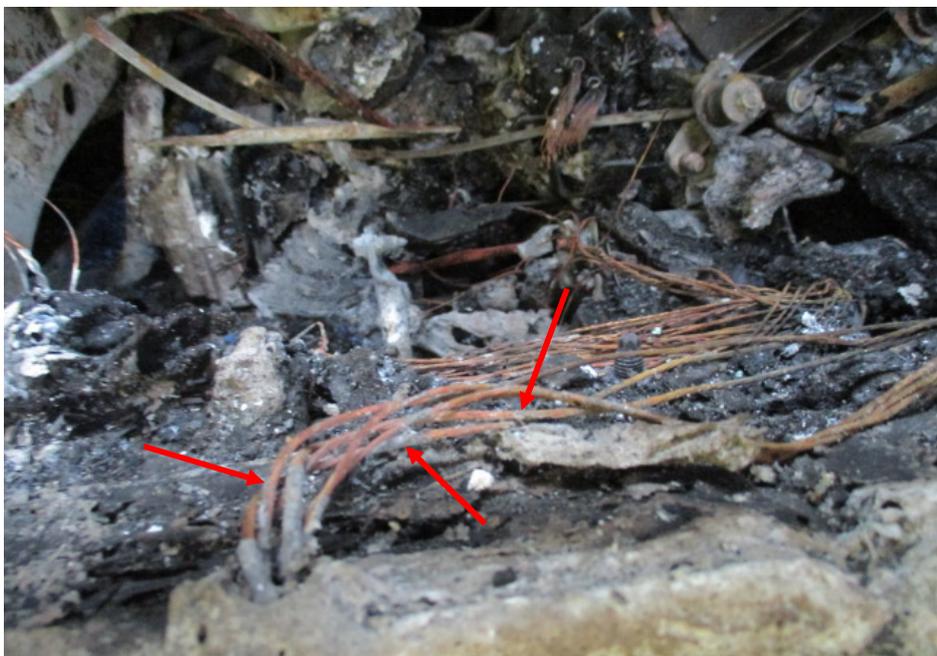
Photo 7 shows a close up view of the greenish residue found on the wirings around the centre portion of the engine compartment (arrowed). The presence of greenish residue indicates internal heating of copper wires, a sign of an electrical short circuit.

27. Having investigated and technically analysed the damages of burnt nature to the Insured Vehicle, we are of the view that the cause of fire to the Insured Vehicle was of electrical in nature. For this particular case, the fire had originated along the wirings inside the engine compartment, somewhere around the centre portion of the engine compartment. The wirings were original factory fitted wirings of the Insured Vehicle.

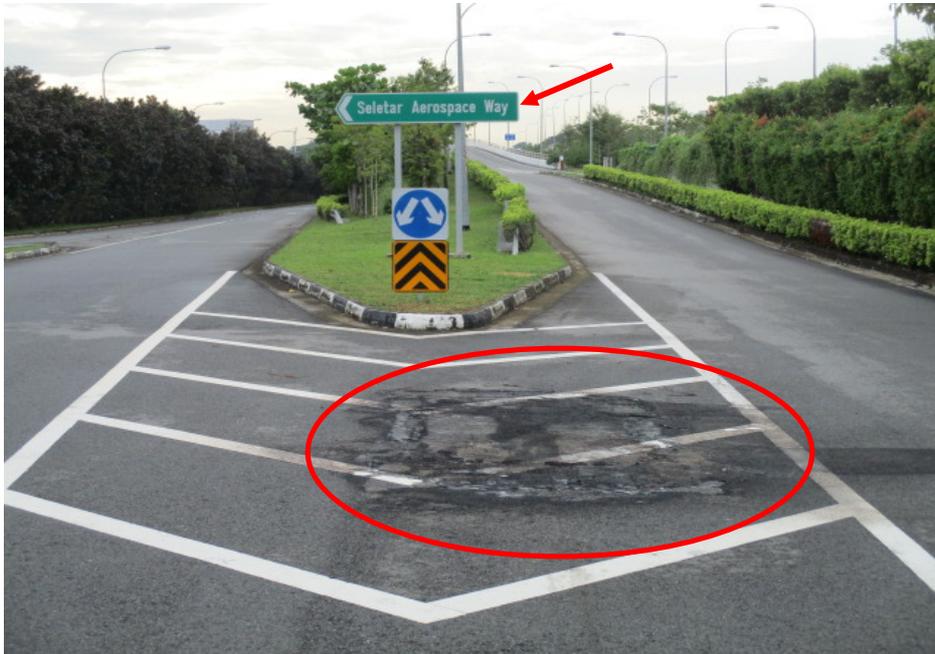
Photo 8 shows the split road of Jalan Kayu and Seletar Aerospace Way (arrowed) after TPE. We noticed that the immediate vicinity was not monitored by traffic camera(s) The Insured Vehicle was positioned on the chevron markings when the fire broke out (circled).

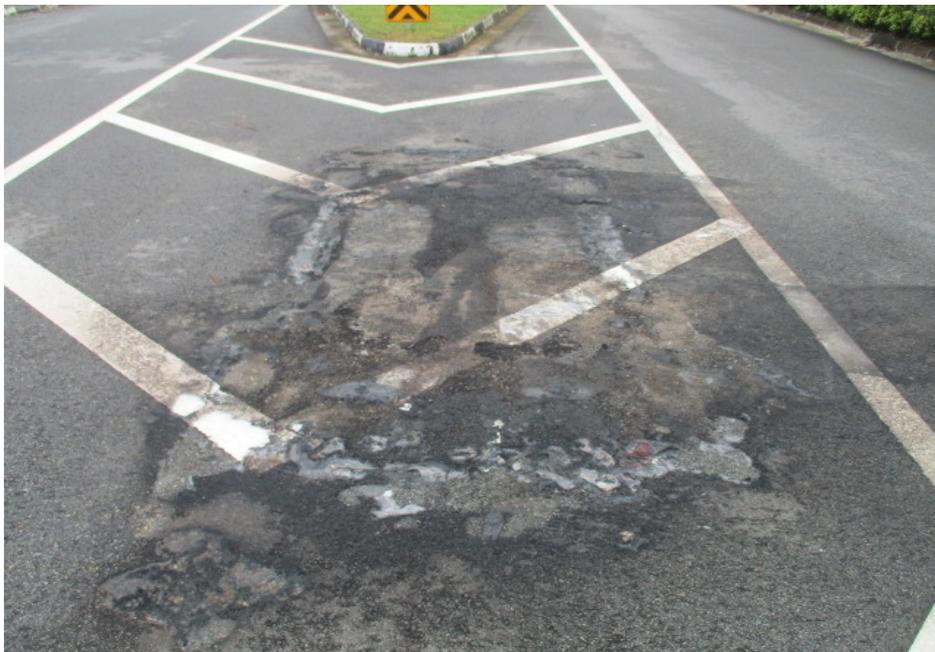
Photo 9 shows the burnt marks and/or burnt residual remains on the ground where the Insured Vehicle was positioned when the fire broke out.

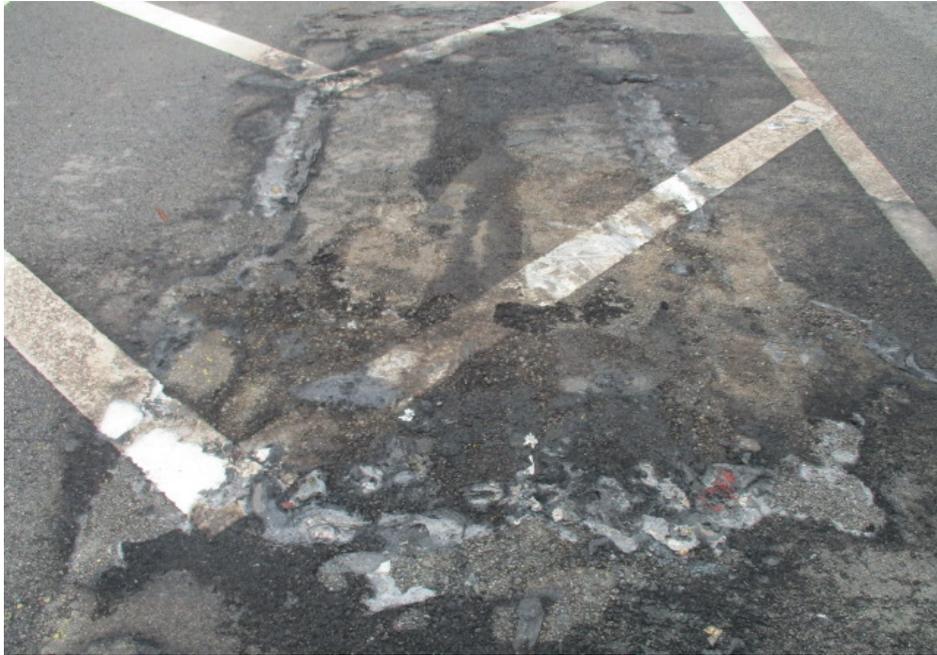
Photo 10 shows a close up view of the burnt marks and/or burnt residual remains on the ground where the Insured Vehicle was positioned when the fire broke out.

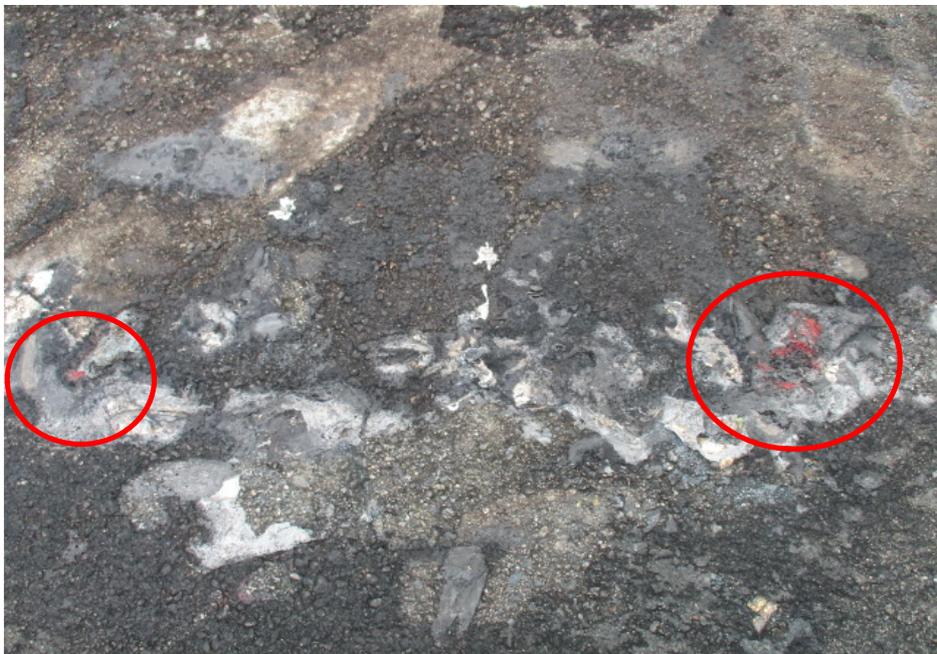
Photo 11 shows a close up view of the burnt residual remains on the ground where the Insured Vehicle was positioned (circled).

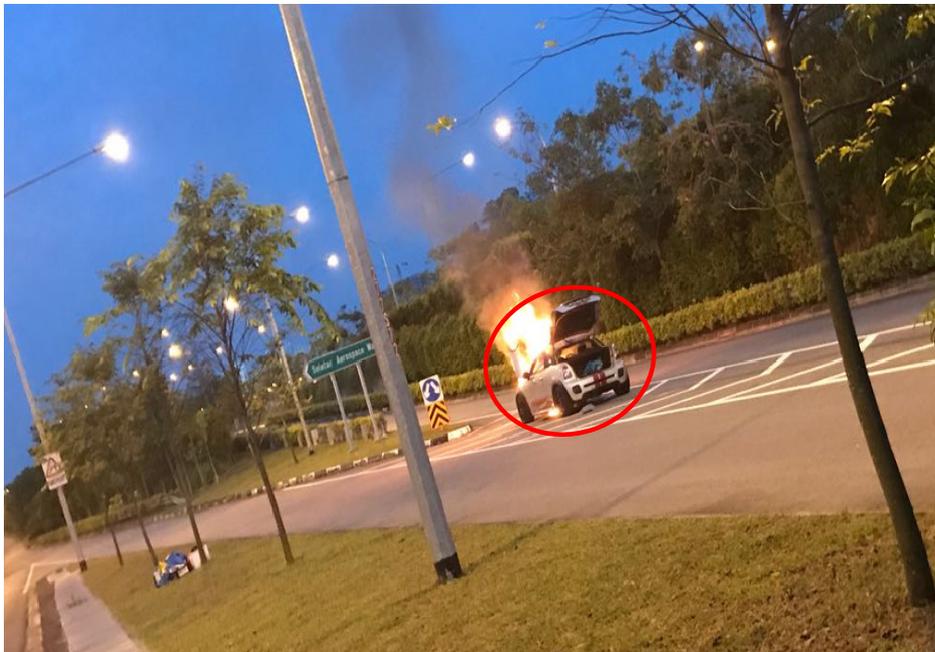
Photo 12 shows the Insured Vehicle on fire before the arrival of the SCDF. In general, the information that could be gathered from this photograph had corresponded to the events that were related to us by Mr Tan, which is he had stopped the Insured Vehicle on the chevron markings after TPE along the split road of Jalan Kayu and Seletar Aerospace Way when the fire broke out (circled).

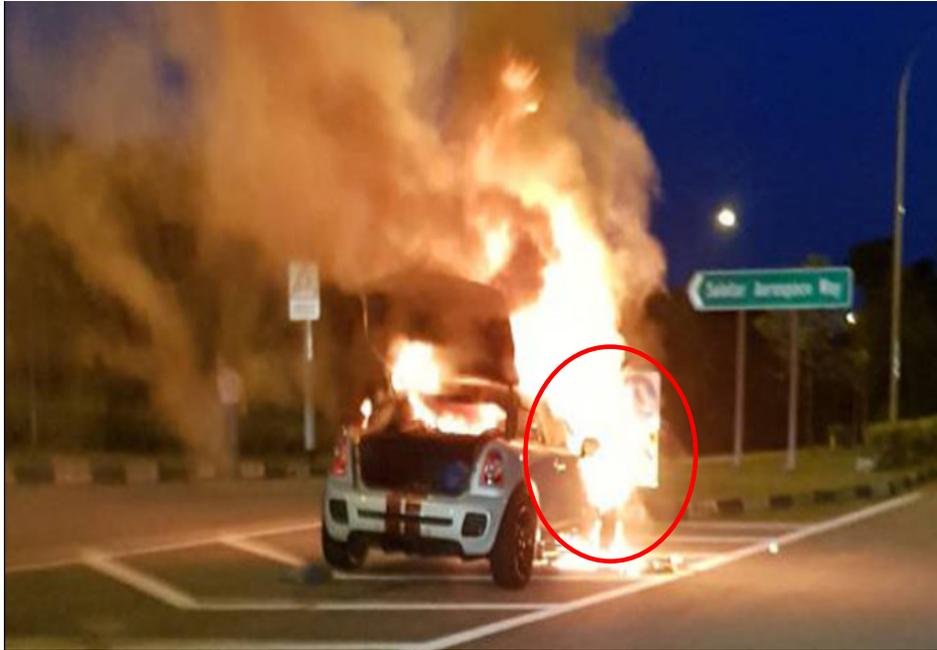
Photo 13 shows the rear portion of the Insured Vehicle as the fire got bigger before the arrival of the SCDF. In general, the information that could be gathered from this photograph had corresponded to the events that were related to us by Mr Tan, which is the fire had started from the front portion of the Insured Vehicle (circled).

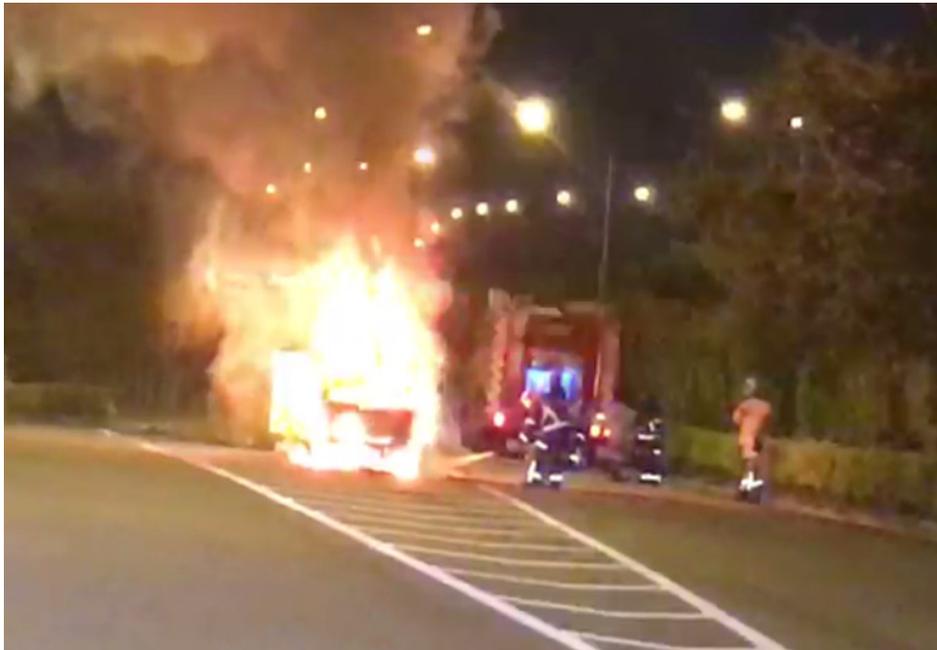
Photo 14 shows firefighters attempting to put out the fire to the Insured Vehicle.

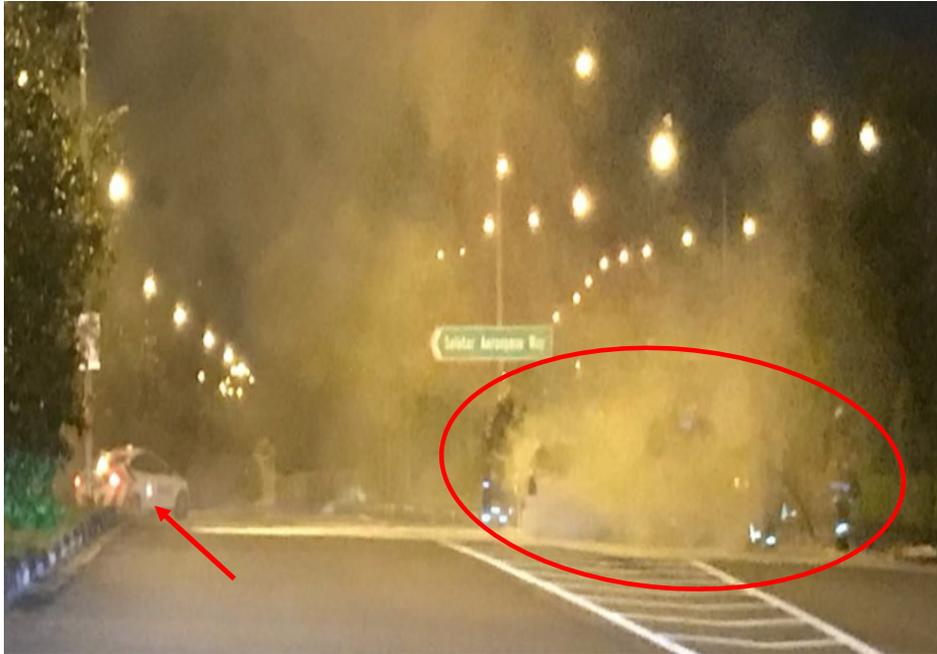
Photo 15 shows firefighters extinguishing the last remnants of the fire (circled). In general, the information that could be gathered from this photograph had corresponded to the events that were related to us by Mr Tan, which is the police (arrowed) and SCDF were present at the incident location.

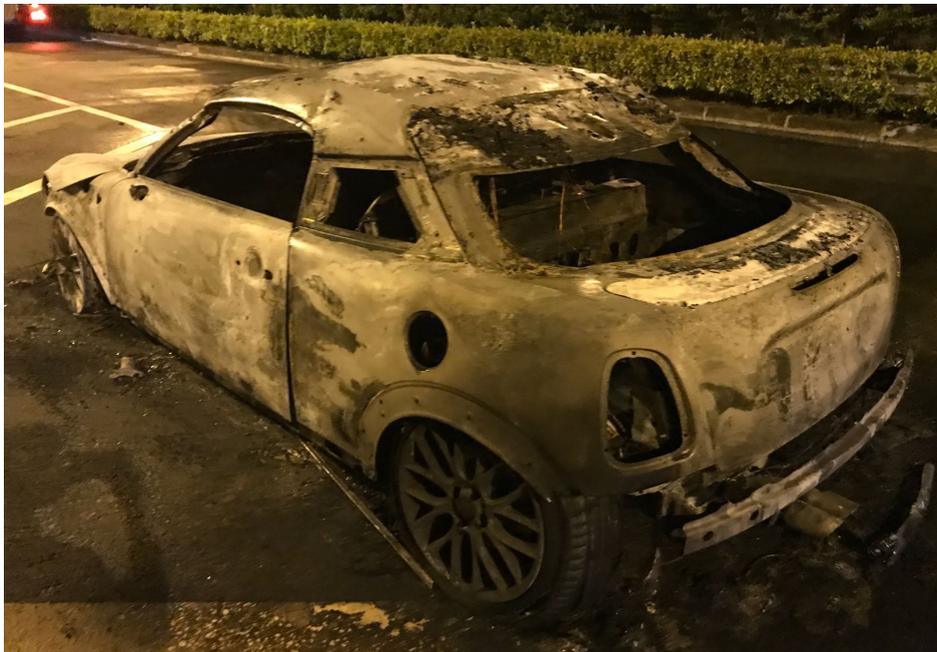
Photo 16 shows the Insured Vehicle after the fire had been extinguished.
