From: Veron Chen (LKKAuto)
Sent: Thursday, 27 September 2018 2:20 PM
To: 'Manivel Priyadarshini'; Marcus Chua (LKKAuto)
Cc: 'Mekavathanan Sarangapani'; SUR; KKLau; Olivia Lau (LKKAuto)
Subject: RE: India ref : MCT17100005/01/MP - KW ref : SHK/KW00229.0636/prr (III) - ACC INV SGL9619K & SHA3745P ON 1.10.17

Item number 8 – headlamp

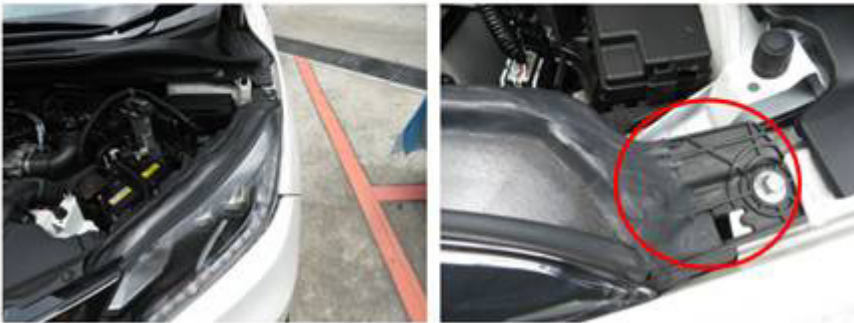
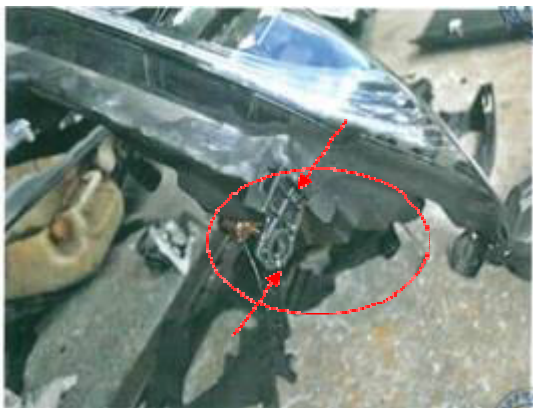
Headlamp LH was intact.- **video footage shows no impact to headlamp LH**

HEADLAMP LH NO DAMAGE

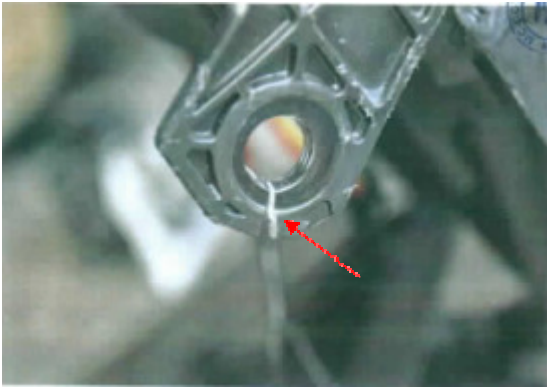
LH headlamp cracked due to impact.

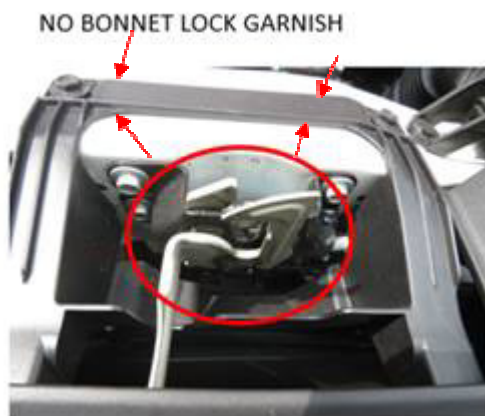
Arrow show is Bonnet lock garnish

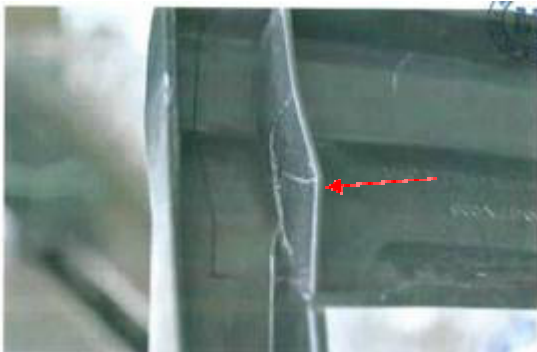
Bonnet lock garnish damage

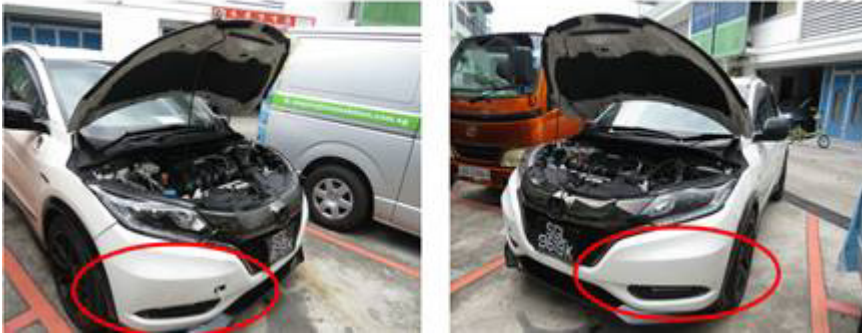
FRONT BUMPER SIDE GARNISH (NO DAMAGE)

This is front bumper fog lamp cover or fog lamp garnish NOT bumper side garnish

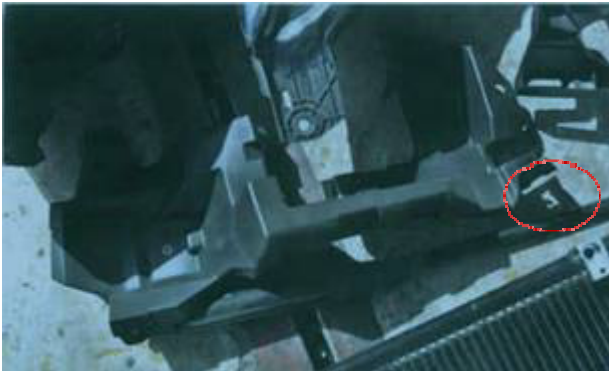
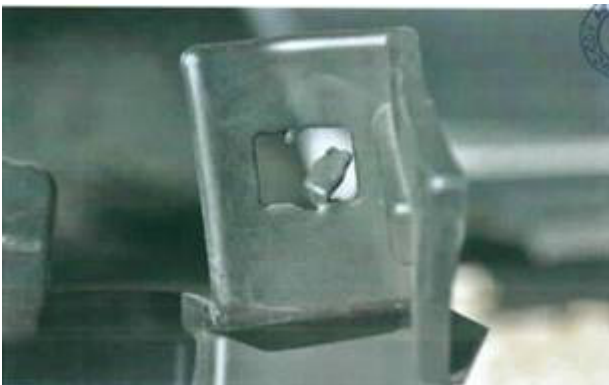
Front bumper side garnish damage

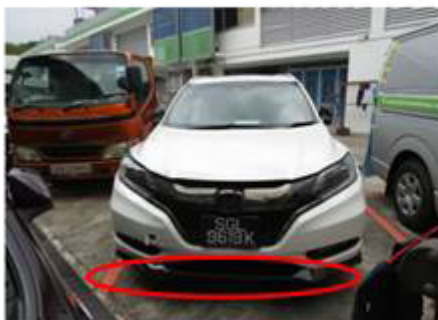
FRONT BUMPER LOWER LID

front bumper lower lid was intact with the bumper.

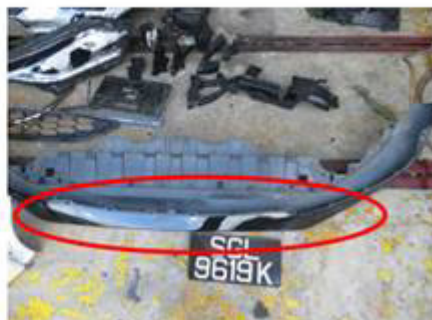
FRONT BUMPER LOWER LID NO DAMAGE

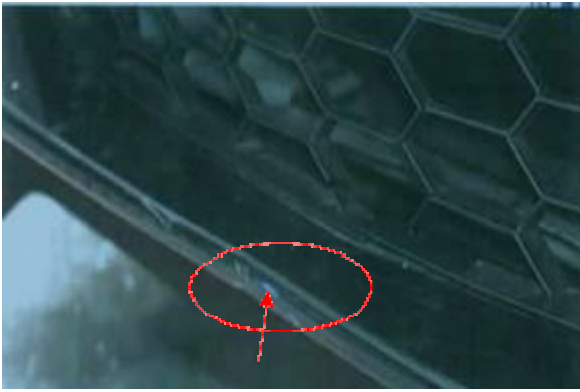
Front bumper lower lip dented

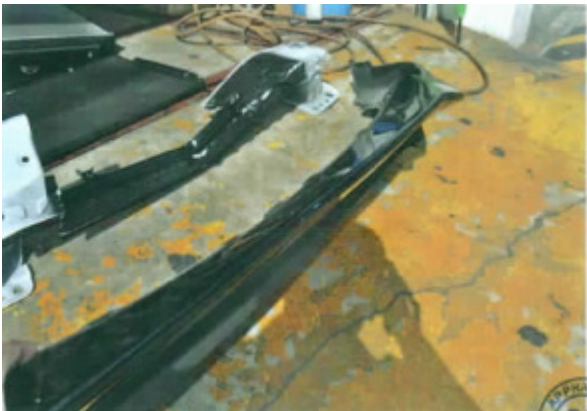
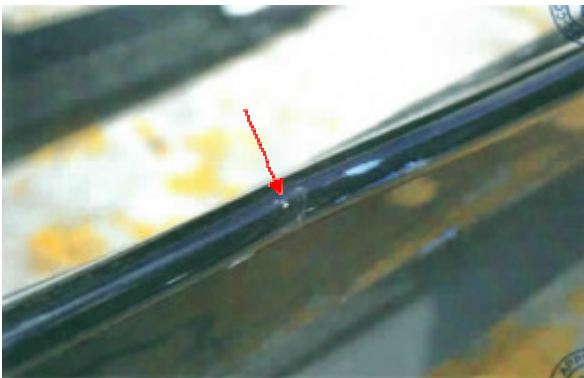
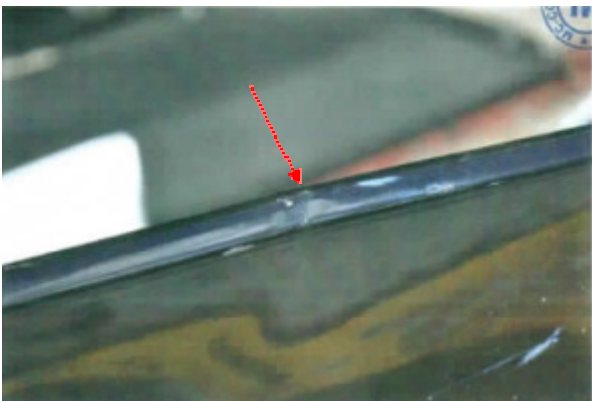
Dismantle photos of front bumper lower lip as below

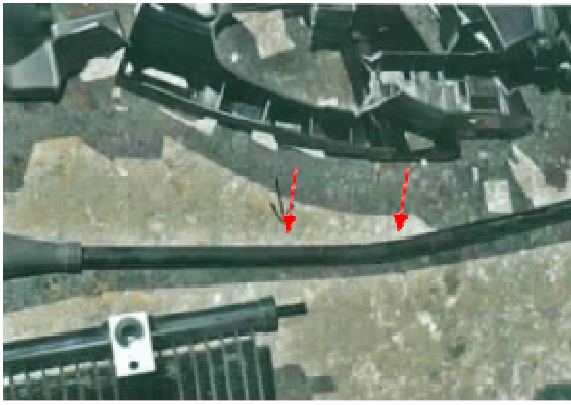
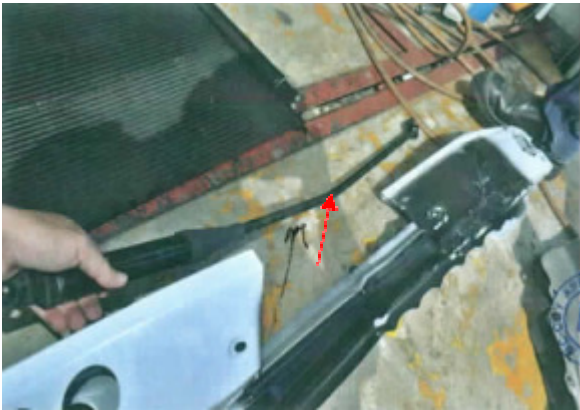
Front bumper inner damper-damage

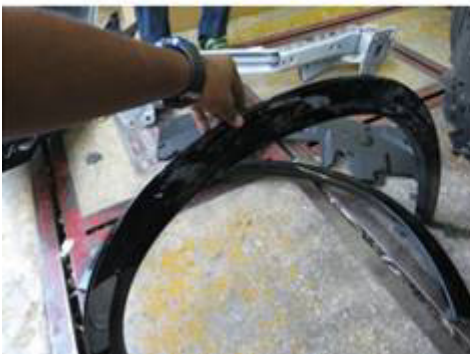
FENDER ARCH GARNISH NO DAMAGE

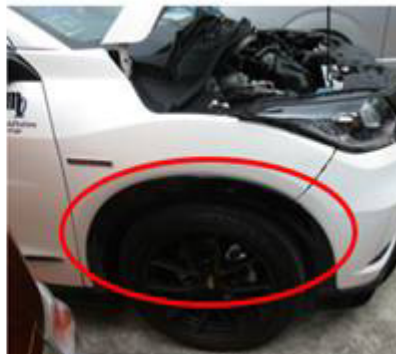
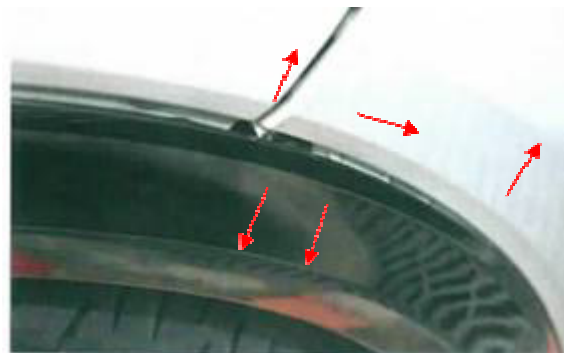
FENDER ARCH GARNISH RH

Front RH fender arch garnish already give way

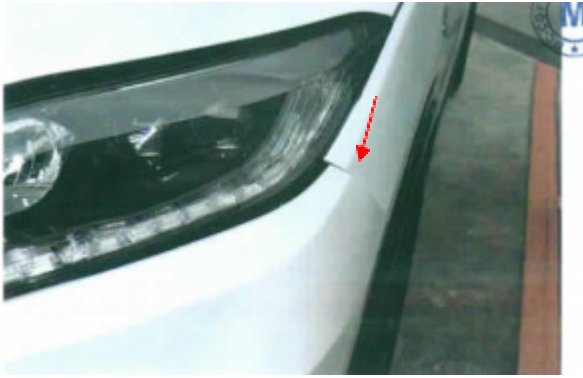
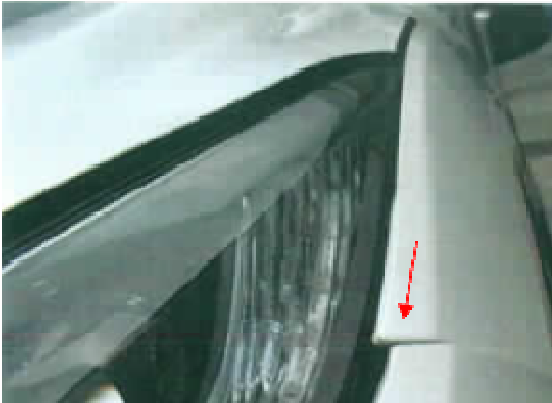
Front n/s fender, arch garnish retainer give way, have impact.

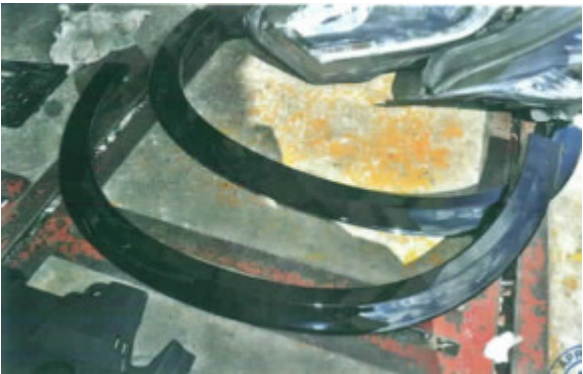
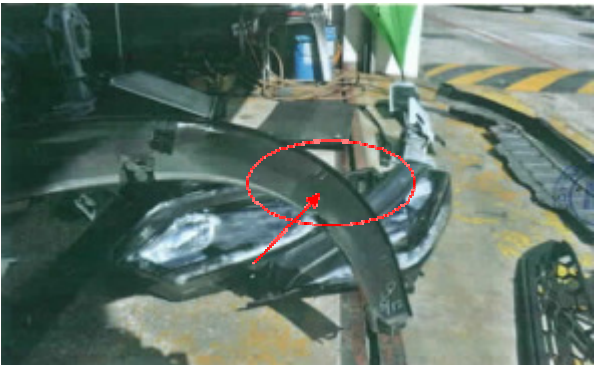
Fender arch garnish Torn/Deformed

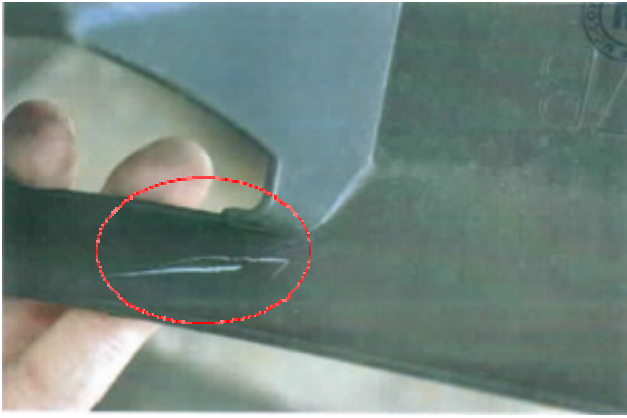
Front support top garnish damage
