Your Ref: S8M00KSY
Our Ref :CS/ASM18011048/D

22 June 2018

M/s AXA Insurance Pte Ltd
8 Shenton Way #24-01
AXA Tower
Singapore 068811
(Motor Claims Department)

**TECHNICAL INVESTIGATION REPORT OF FIRE INCIDENT INVOLVING THE
INSURED VEHICLE SJJ 8000B ON 14 JUNE 2018**

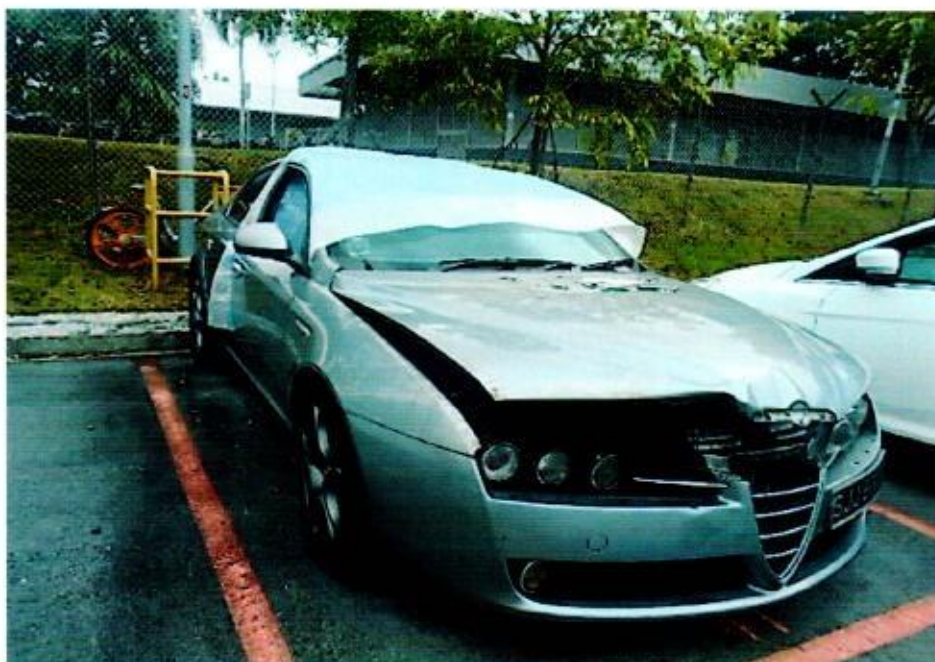
Photo 1 shows a general view of the front right body of the Insured Vehicle at the time of inspection. The Insured Vehicle was observed to have sustained fire damage at its frontal body. Its front bumper, front bonnet, front grille, front right headlamp and front right fender were amongst the body parts that were found to have been burnt as a result of the fire.

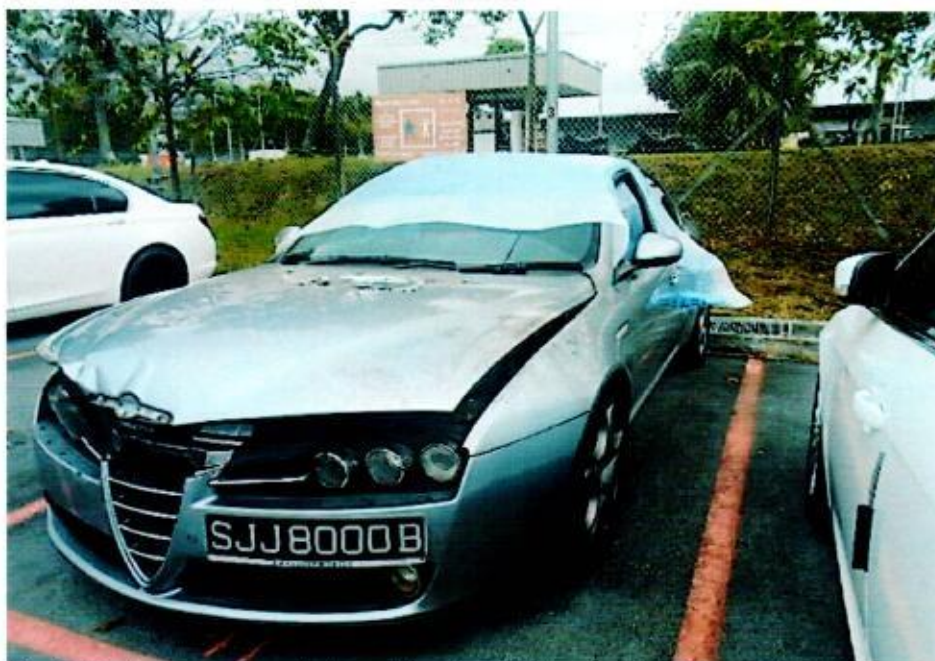
Photo 2 shows a general view of the front left body of the Insured Vehicle at the time of inspection. The Insured Vehicle was observed to have sustained fire damage at its frontal body. Its front bumper, front left fender, front left headlamp, front bonnet and front windscreen were amongst the body parts that were found to have been burnt as a result of the fire.

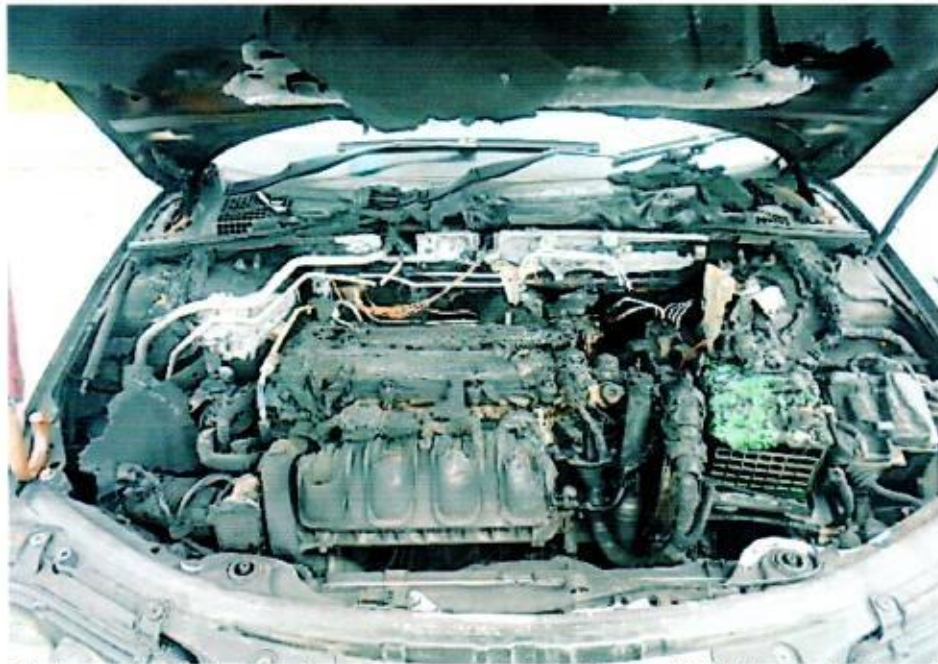
Photo 3 shows the engine compartment of the Insured Vehicle at the time of inspection. Almost all the parts inside the engine compartment were observed to be burnt and/or melted as a result of the fire. These parts had included its radiator, air condenser, cooling fan, intake manifold, fuse box, battery, air duct, hoses and pipes amongst others.

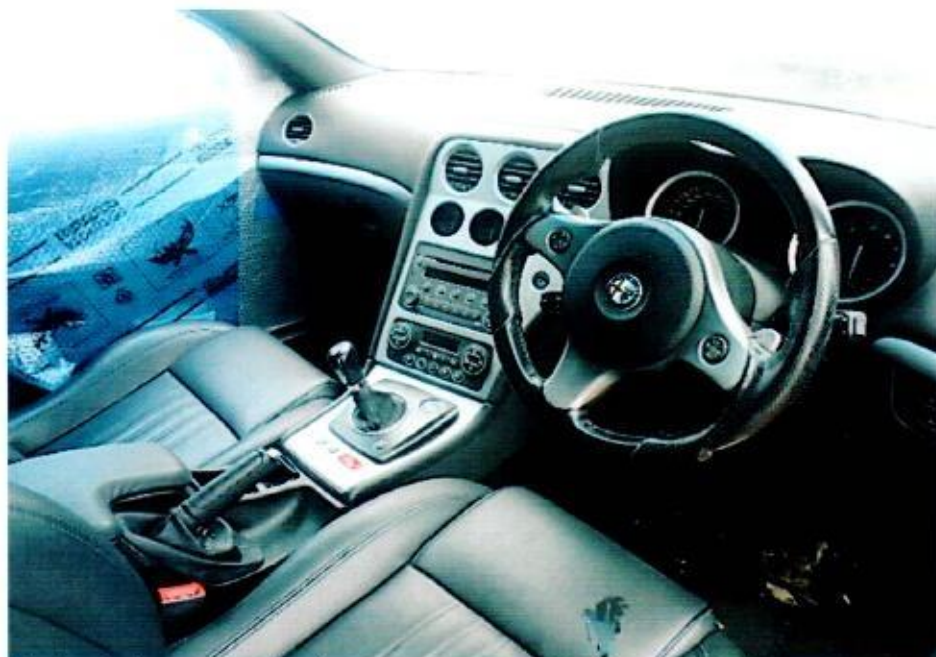
Photo 4 shows the interior compartment of the Insured Vehicle, which was unaffected by the incident.

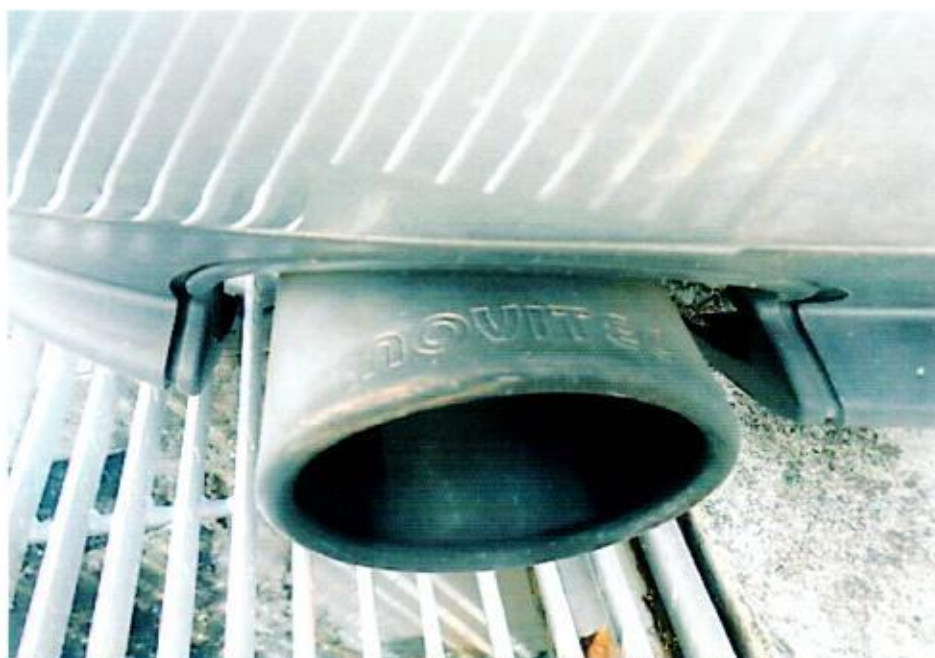
Photo 5 shows the rear exhaust muffler of the Insured Vehicle. The rear exhaust muffler fitted on the Insured Vehicle is non-original. The brand of the rear exhaust muffler was observed to be "Novitec".

14. Mr Chan informed me that he has not done any modification and/or fitted any electrical components on the Insured Vehicle. He is aware of the non-original rear exhaust muffler, which he advised was fitted by the previous owner. There is also a LTA certification letter for the non-original rear exhaust muffler.

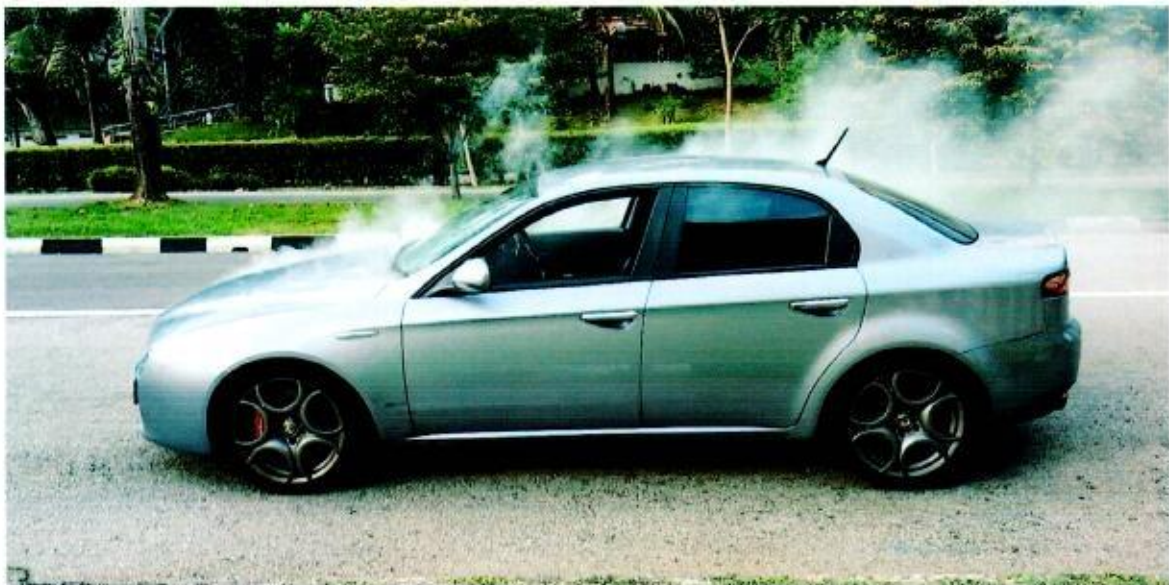
Photo 6 shows the Insured Vehicle at the incident location with white smoke emitting out from the gaps surrounding its front bonnet. There was no unusual foreign material(s) and/or object(s) on the ground in the immediate area of where the Insured Vehicle had stopped.

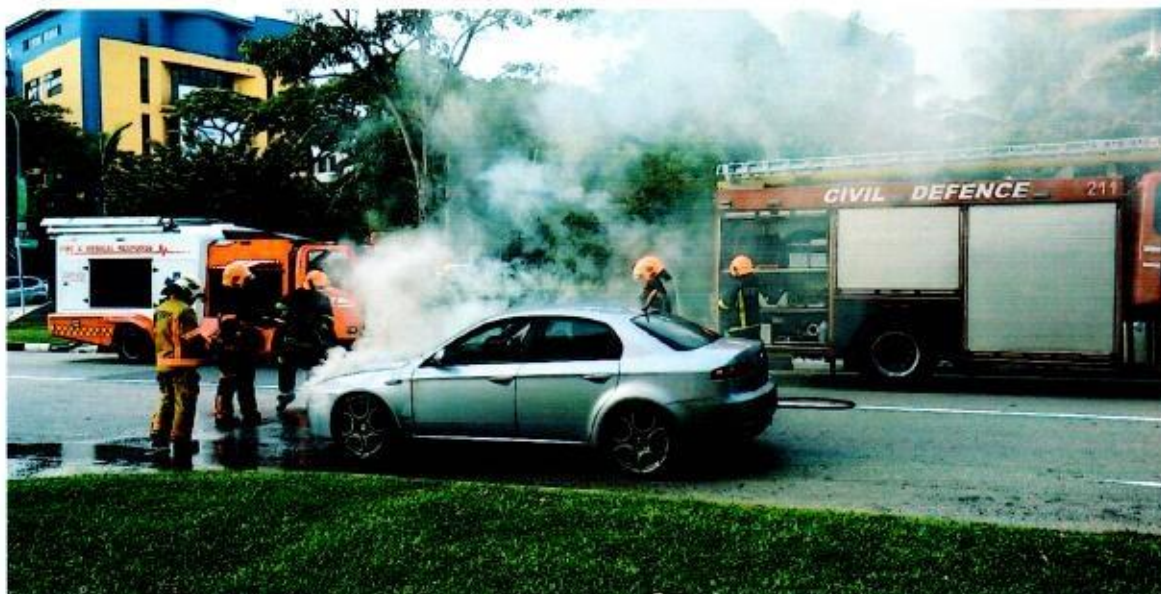
Photo 7 shows the Insured Vehicle at the incident location with smoke coming out from its frontal portion. In general, the observations gathered from my review of the incident scene photographs had corresponded to the information gathered from Mr Chan when I spoke to him.

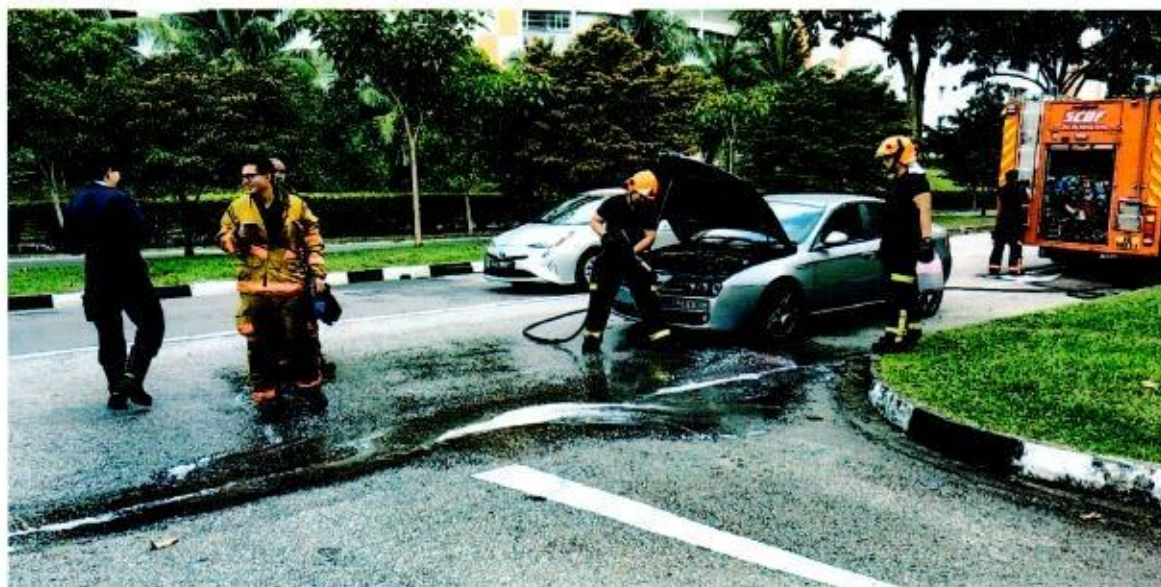
Photo 8 shows the Insured Vehicle at the incident location after the fire was extinguished. In general, the observations gathered from my review of the incident scene photographs had corresponded to the information gathered from Mr Chan when I spoke to him.

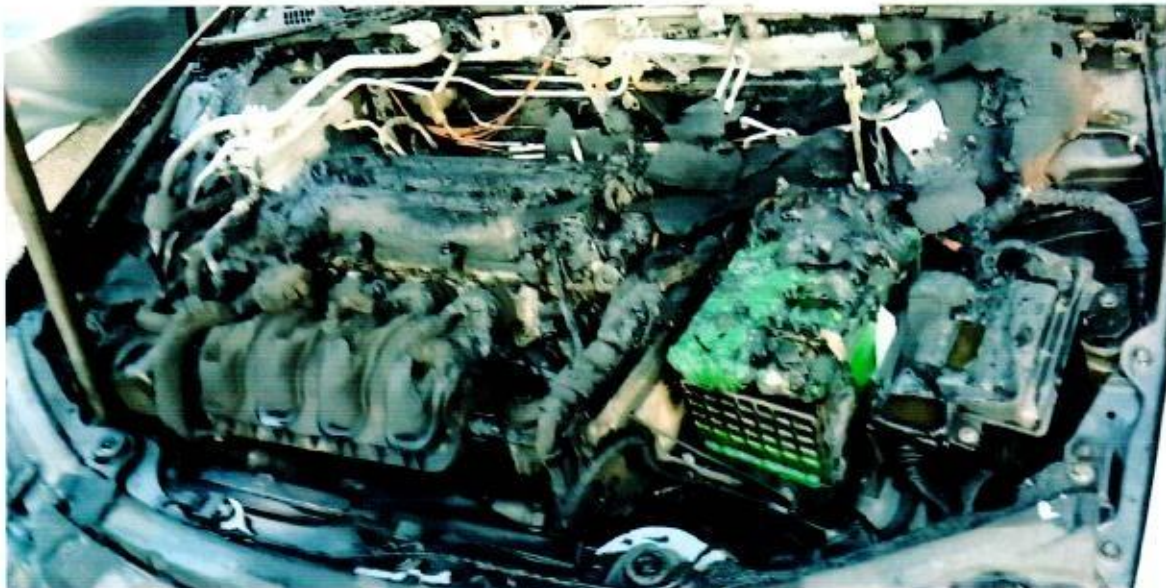
Photo 9 shows the engine compartment of the Insured Vehicle after the fire was extinguished by SCDF personnel. The damage of burnt nature to the Insured Vehicle had corresponded to the damages as seen by me during my inspection of the Insured Vehicle.

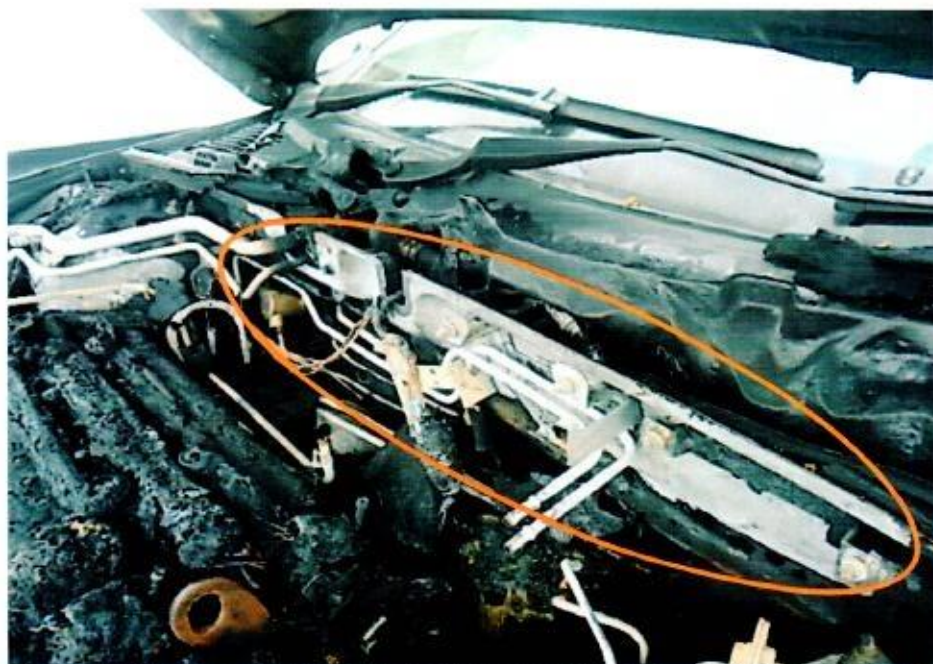
24. Firstly, high heat intensity burn marks (whitish burn marks) were found on the firewall panel, towards the rear of the engine compartment. These whitish burn marks are a result of exposure to prolong heat intensity. Rust would normally start to develop around these areas soon after a fire as prolonged exposure to high heat intensity usually causes steel/metal material body parts to be exposed to natural environmental condition. Given this burn pattern, the origin of fire can then be determined to be at the rear centre area of the engine compartment.

Photo 10 shows the whitish burn marks (circled) that were found on the firewall panel, towards the rear of the Insured Vehicle's engine compartment. Such whitish burn marks are a result of exposure to prolong heat intensity. The fire to the Insured Vehicle can then be established to have originated around the rear centre of the engine compartment.

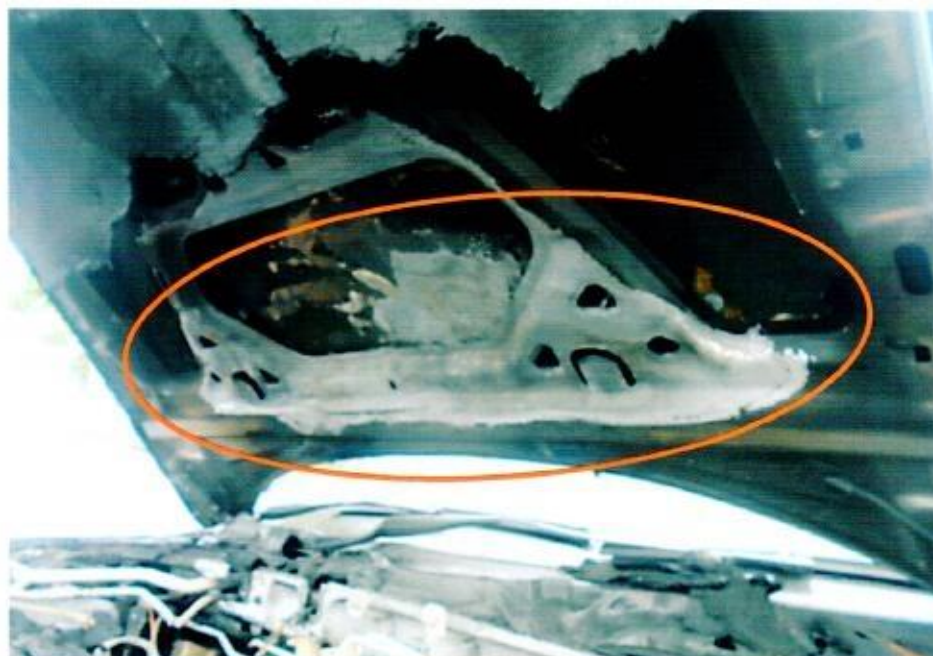
25. Correspondingly, the underside of the front bonnet directly above the firewall panel was found with similar high heat intensity burn marks (whitish burn marks). This follows the characteristic of heat rising upwards. The burn pattern to the underside of the front bonnet further supports my earlier comment of the fire originating at the rear centre area of the engine compartment. See photo 10 & 11 below.

Photo 11 shows the whitish burn marks (circled) that were found on the underside of the front bonnet, directly above the firewall panel where similar high heat intensity burn marks (whitish burn marks) were found. This burn pattern to the underside of the front bonnet supports my comment of the fire originating at the rear centre area of the engine compartment of the Insured Vehicle.

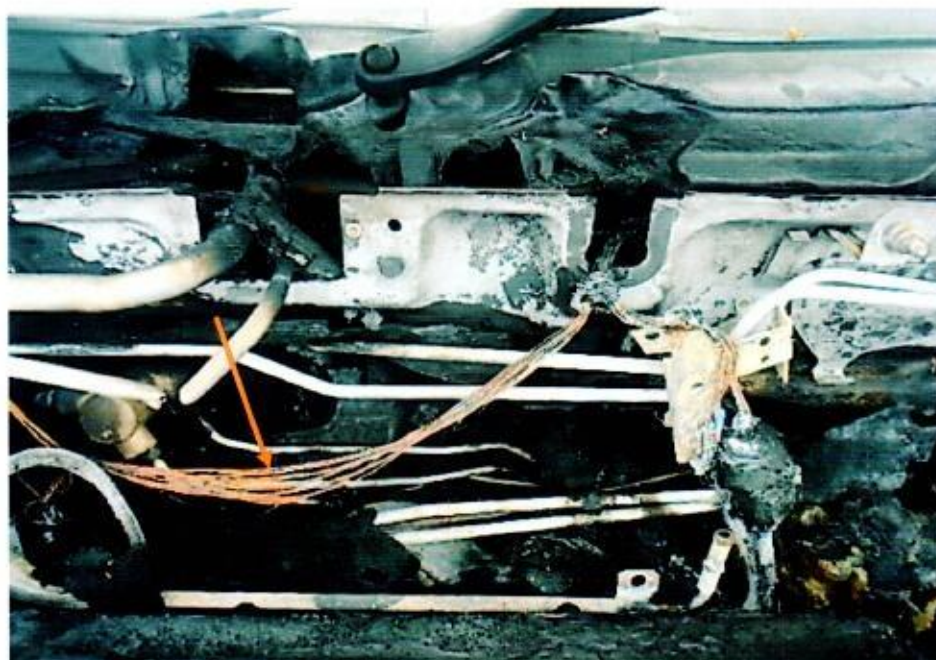
26. My examination of the rear centre area of the engine compartment, during my inspection of the Insured Vehicle, revealed wirings that were completely burned to its bare copper state. The bright reddish colour of the copper wires suggest that the wirings were exposed to high heat. Such condition normally indicates internal heating of copper wires which is a sign of an electrical short circuit occurring. The same wirings were also noted to be bright reddish in colour immediately after the fire was extinguished as seen from the incident scene photographs taken by Mr Chan. Hence the physical condition of the wirings at the area where the fire had originated indicates that the cause of fire to the Insured Vehicle was due to electrical in nature. See photo 12 & 13 below.

Photo 12 shows the wirings at the rear centre area of the Insured Vehicle's engine compartment. The wirings (arrowed) were found to be completely burned to its bare copper state. The bright reddish colour of the copper wires suggest that the wirings were exposed to high heat. Such condition normally indicates internal heating of copper wires which is a sign of an electrical short circuit occurring.

31. Having investigated and technically analysed the damages of burnt nature to the Insured Vehicle, I am of the view that the cause of fire to the Insured Vehicle was of electrical in nature. For this particular case, the fire had originated along the wiring inside the engine compartment, at the rear centre area of the engine compartment. The wiring was an original factory wiring harness.
32. I did not find any evidence which had suggested that the cause of fire to the Insured Vehicle was due to poor maintenance and/or recurring electrical problem.
33. There was no additional electronic and/or electrical component(s) fitted on the Insured Vehicle at the time of my inspection of the Insured Vehicle. It was however fitted with a non-original rear exhaust muffler, which was approved by LTA. The fitting of this non-original rear exhaust muffler did cause and/or contribute to the fire.

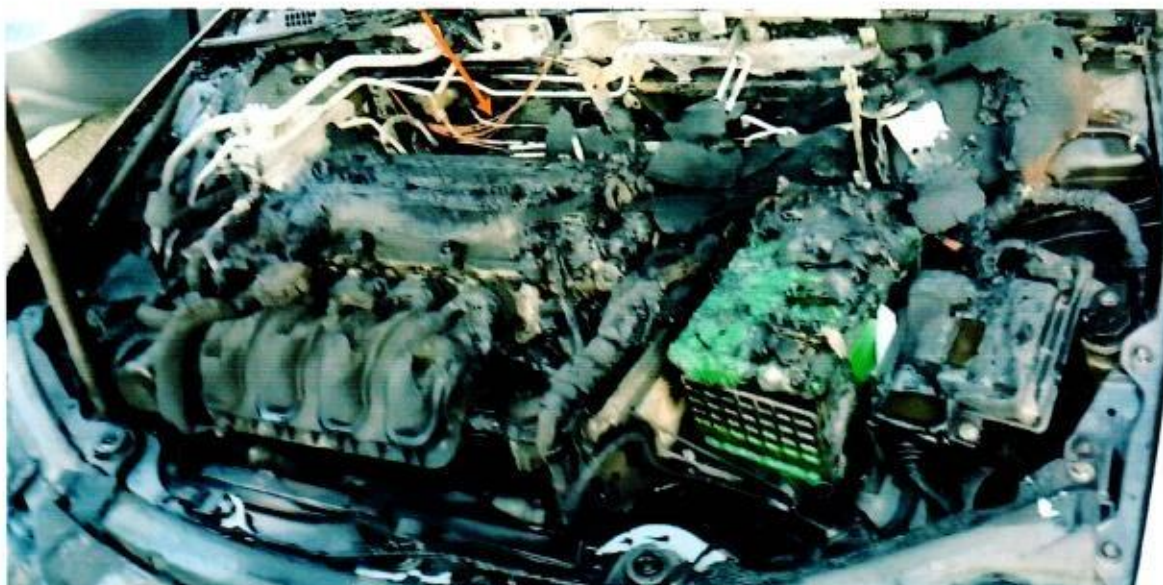
Photo 13 shows the engine compartment of the Insured Vehicle immediately after the fire was extinguished. This was from photographs taken by Mr Chan at the incident location. The same wirings (arrowed) as photograph 12 were noted to be bright reddish in colour immediately after the fire. Such condition suggest that the wirings were exposed to high heat, indicating internal heating of copper wires. This is a sign of an electrical short circuit occurring.
