Your Ref: AC180189
Our Ref : CI/III18011169/N

4 June 2018

**TECHNICAL REPORT OF AUTO TRANSMISSION GEARBOX DAMAGE
CLAIM FOR THE MOTOR BUS PC 4769J**

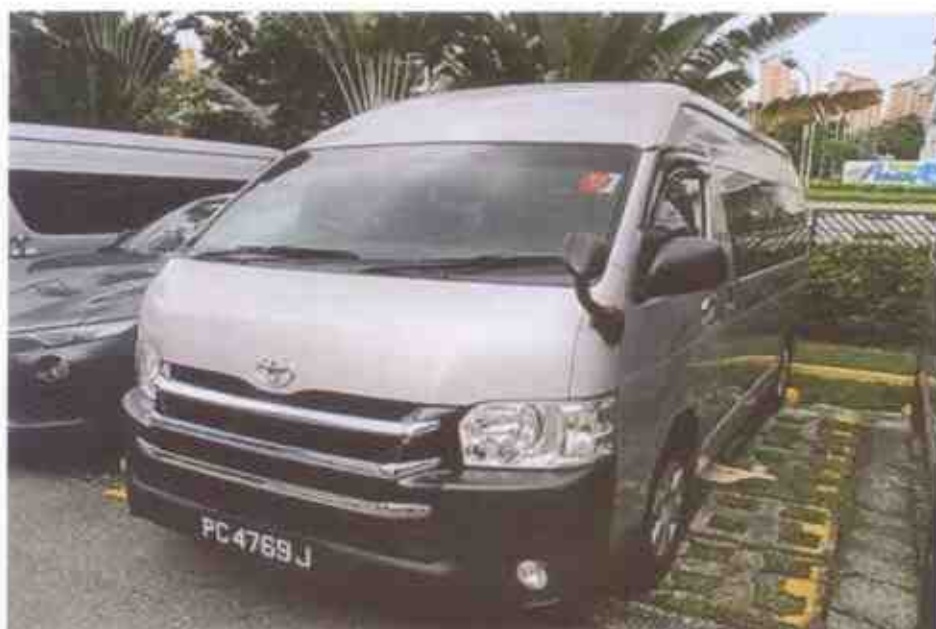
10. The Motor Bus was observed to be in good general condition. Our visual examination of its exterior body revealed no loose exterior fittings or connections. We observed that the 'brake override system failure' warning light had appeared on the instrument panel of the Motor Bus after its ignition was switched on.

Photo 1 shows a general view of the Motor Bus at the time of our physical inspection at Vicom. The Motor Bus was observed to be in good general condition with no loose exterior fittings or connections.

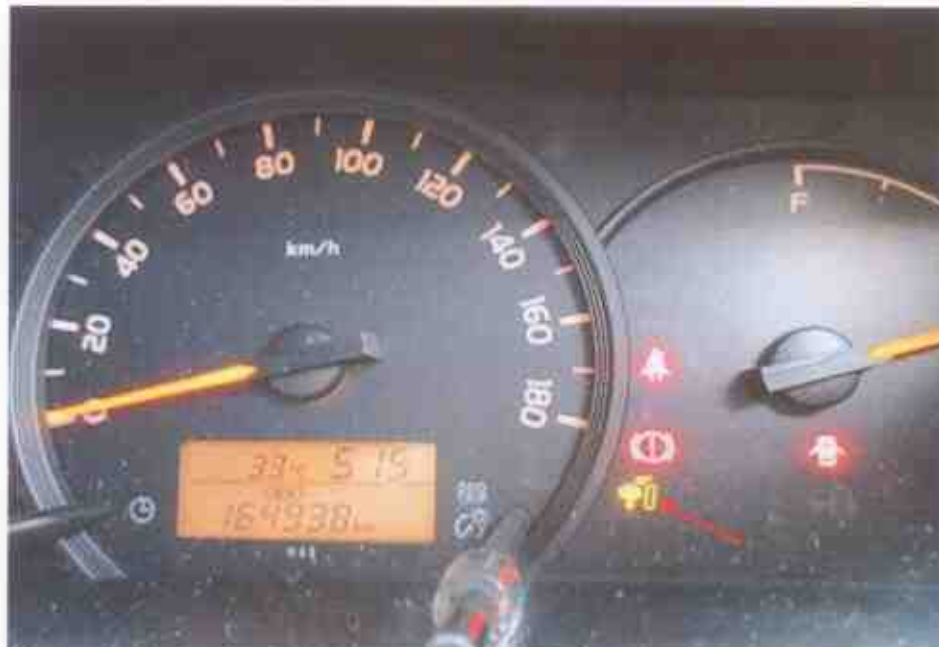
Photo 2 shows the 'brake override system failure' warning light that had appeared on the instrument panel of the Motor Bus after its ignition was switched on (arrowed).

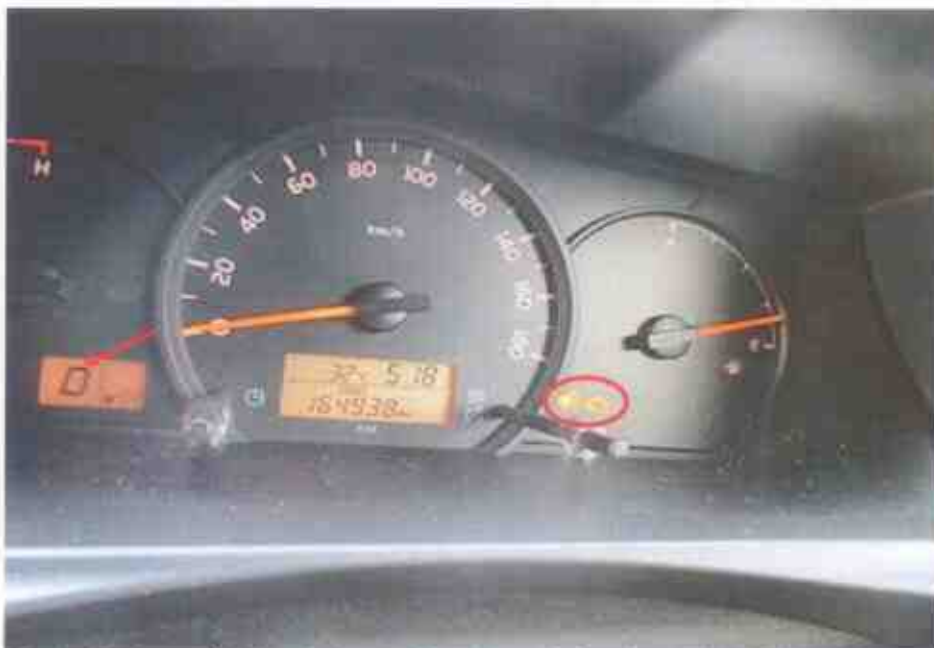
11. Upon starting up the engine and engaging the Motor Bus to 'drive' mode, both the 'brake override system failure' warning light and 'check engine' warning light had appeared on the instrument panel of the Motor Bus.

Photo 3 shows the brake 'override system failure' warning light and 'check engine' warning light that had appeared on the instrument panel of the Motor Bus (circled) after its engine was started and the gear was engaged to 'drive' mode (arrowed).

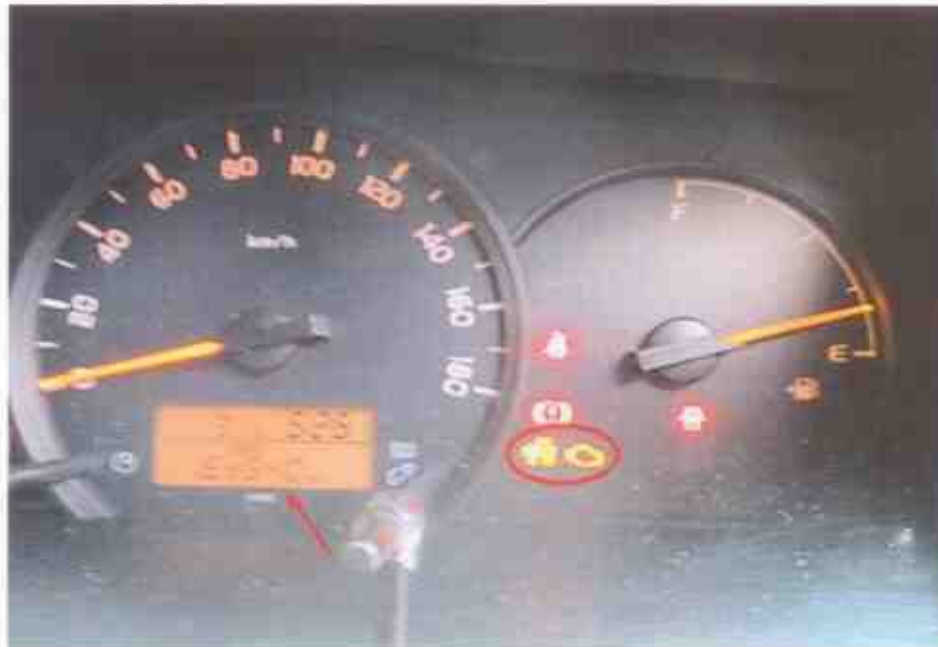
Photo 4 shows the 'brake override system failure' warning light and 'check engine' warning light that were still visible on the instrument panel of the Insured Vehicle (circled) after performing the short operational test of approximately 2km based on the odometer reading (arrowed). The results of the short operational test corroborated with Mr Joe's complaint, which is the gears of the transmission system could not be automatically shifted.

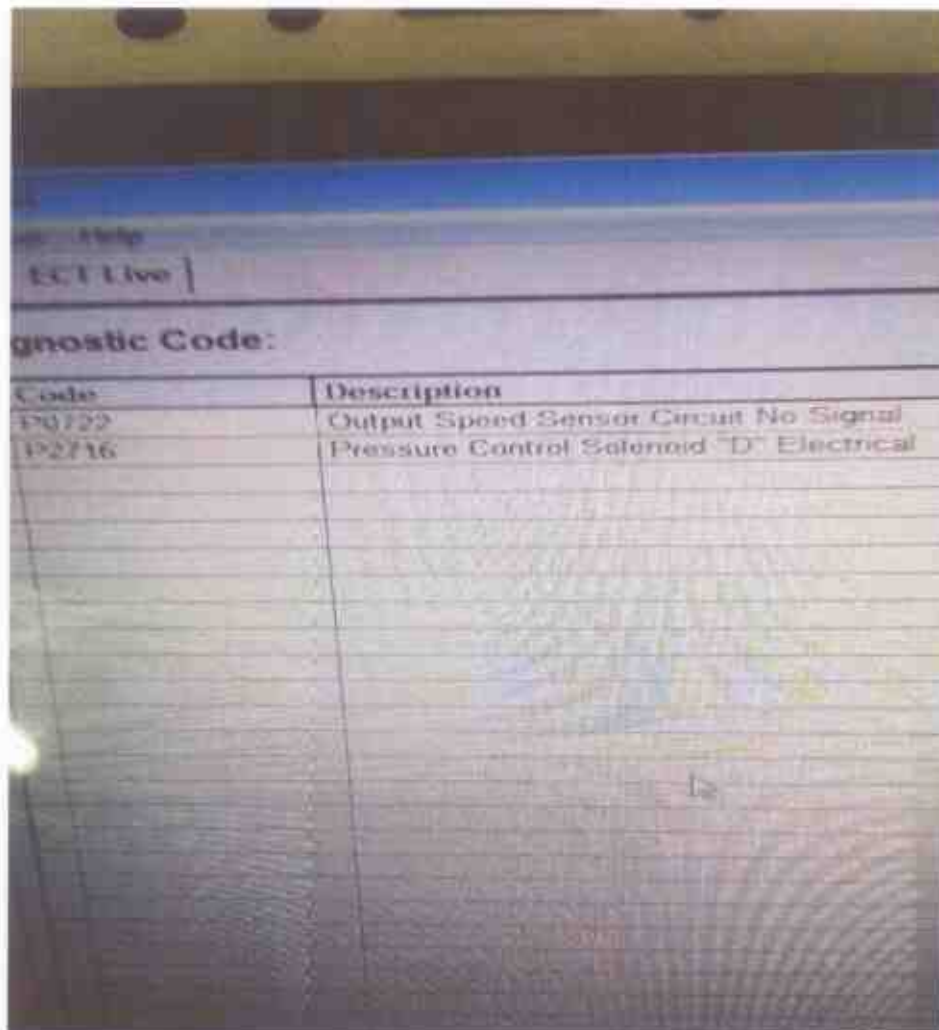
Photo 5 shows the recorded fault codes relating to the transmission system of the Motor Bus. The fault codes were P0722 and P2716 respectively.

- Our checks and enquiries revealed that fault code P0722 was related to a malfunction within the transmission output speed sensor (herein referred to as "TOSS") circuit of the Motor Bus. Fault code P2716 was for an electrical error pertaining to the pressure control solenoid 'D' of the Motor Bus. These fault codes are a generic transmission diagnostic trouble code (DTC) and typically apply to on-board diagnostics (OBD)-II vehicles equipped with an automatic transmission system.

17. Briefly, the purpose of the TOSS is to provide the Powertrain Control Module (herein referred to as "**PCM**") with a signal that indicates the speed of the transmission output shaft rotation. The PCM uses these readings to control the shift solenoids. The solenoids direct fluid between various hydraulic circuits and change the transmission gear ratio at the appropriate time. Based on the vehicle and the transmission configuration the TOSS may also control the speedometer reading. An automatic transmission system is controlled by bands and clutches that change gears by having fluid pressure in the right place at the right time. This process starts with the TOSS. Fault code P0722 is set by the PCM when it is not seeing a signal from the TOSS. Symptoms of this malfunction may include illumination of the vehicle's 'Check Engine' light, non- shifting or rough shifting of the vehicle's transmission.

18. When the P2716 fault code is set, the PCM has detected a problem with the Transmission Pressure Control Solenoid (herein referred to as "**TPCS**") 'D'. The purpose of the TPCS 'D' is to control the pressure of the fluid for the proper operation of an automatic transmission. The PCM receives an electronic signal based on the pressure within the solenoids. Based on the signals from associated devices monitoring the speed of the vehicle, the PCM controls the pressure solenoids to direct fluid at the appropriate pressure to various hydraulic circuits that change the transmission gear ratio at the correct time. The fault code P2716 is set by the PCM when the TPCS 'D' is experiencing an electrical malfunction. Symptoms of this electrical malfunction may include illumination of the vehicle's 'Check Engine' light, the vehicle enters limp mode, transmission slips when shifting, transmission overheating and/or transmission catches in gear.

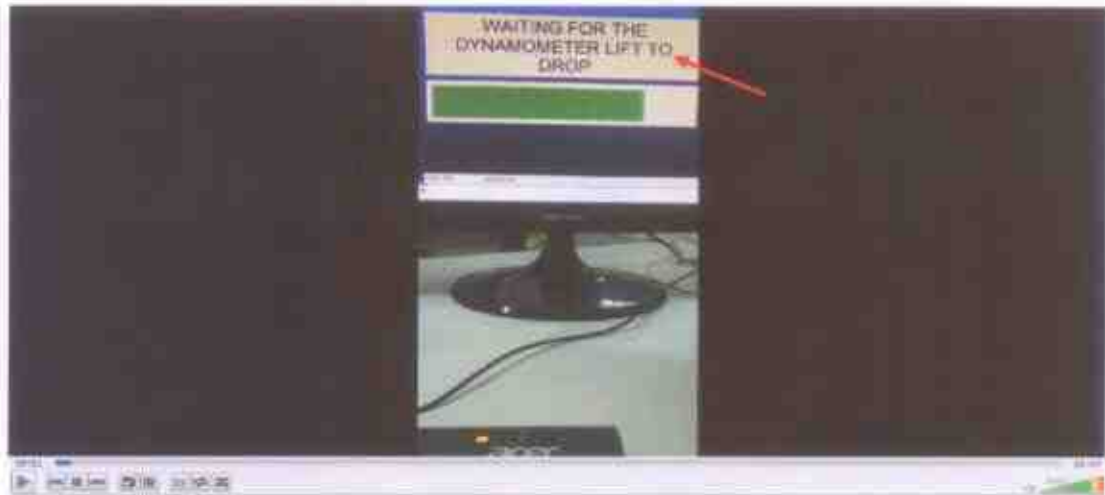
Screenshot 1 of the video recording shows the dynamometer lift being dropped on the rear wheels of the Motor Bus (as it is a rear-wheel drive) before the commencement of the CDST (arrowed).

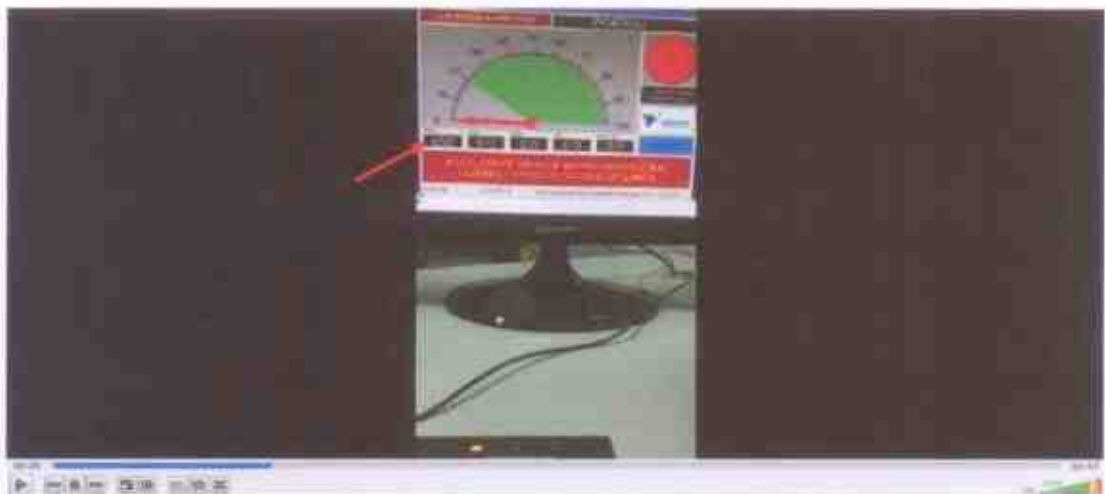
Screenshot 2 of the video recording shows the transmission of the Motor Bus in 'neutral' mode with the engine running as the speed is at '0' kmph and the rpm is idling at 852 (arrowed).

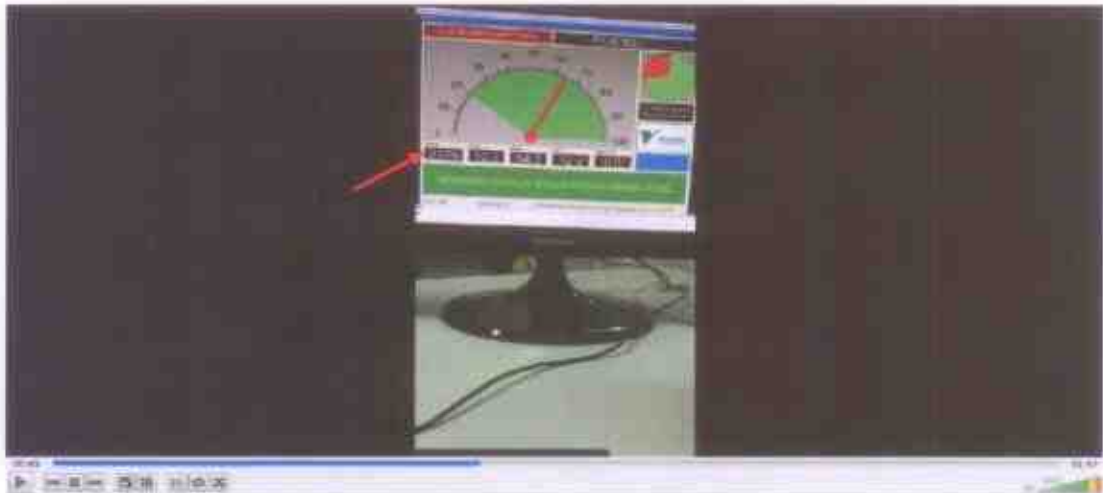
Screenshot 3 of the video recording shows the maximum rpm of 2158 achieved by the Motor Bus as the vehicle speed is maintained within the green zone (arrowed).

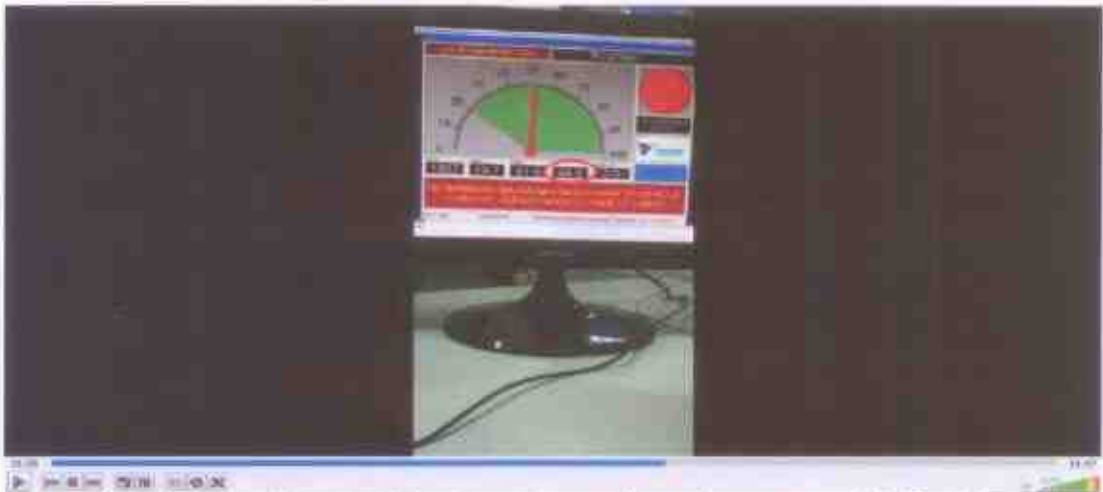
Screenshot 4 of the video recording shows the maximum horsepower of 44.9 achieved by the Motor Bus as the vehicle speed is maintained within the green zone (circled).

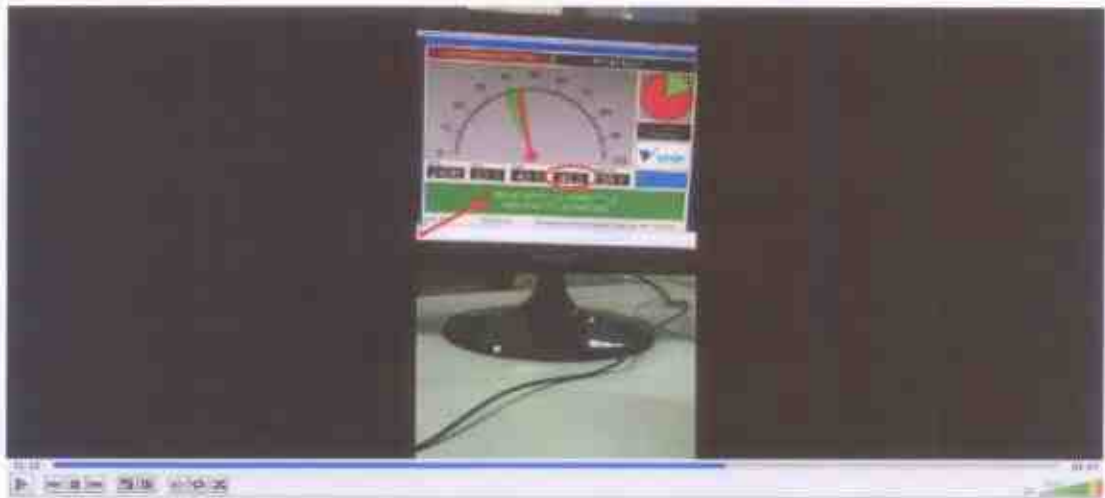
Screenshot 5 of the video recording shows a stabilized horsepower of 40.3 achieved by the Motor Bus (circled) as full throttle is maintained within the green zone (arrowed).

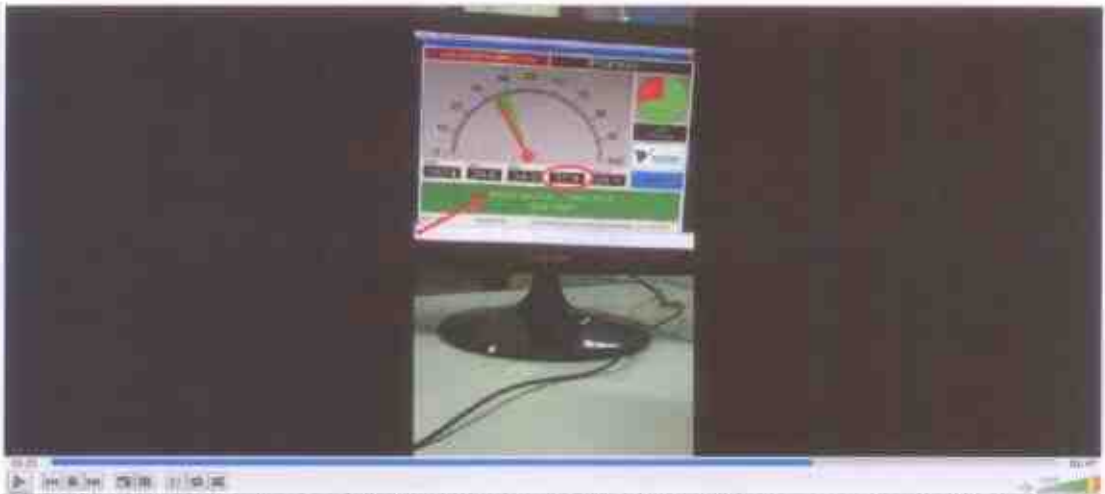
Screenshot 6 of the video recording shows a stabilized horsepower of 33.8 achieved by the Motor Bus (circled) as 90% throttle is maintained within the green zone (arrowed).

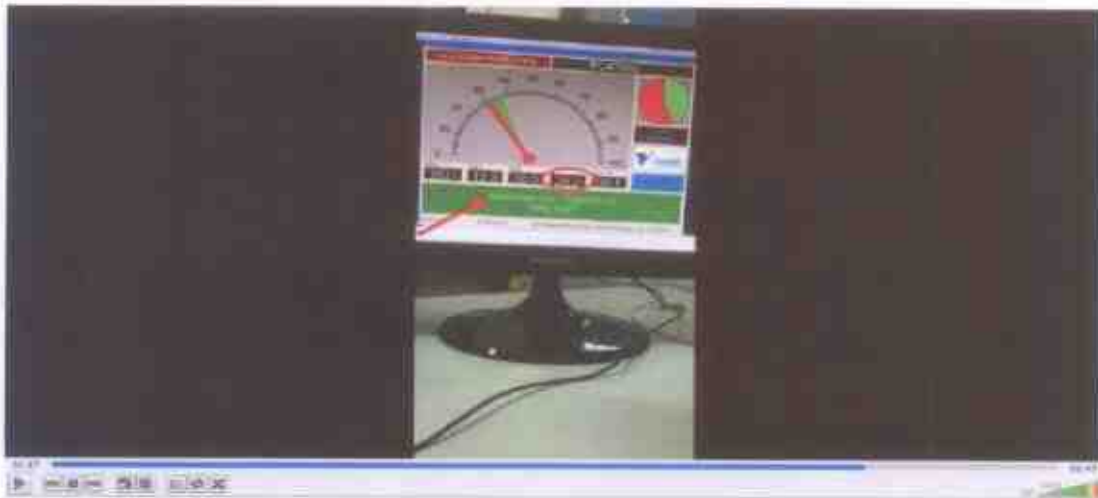
Screenshot 7 of the video recording shows a stabilized horsepower of 29.2 achieved by the Motor Bus (circled) as 80% throttle is maintained within the green zone (arrowed).

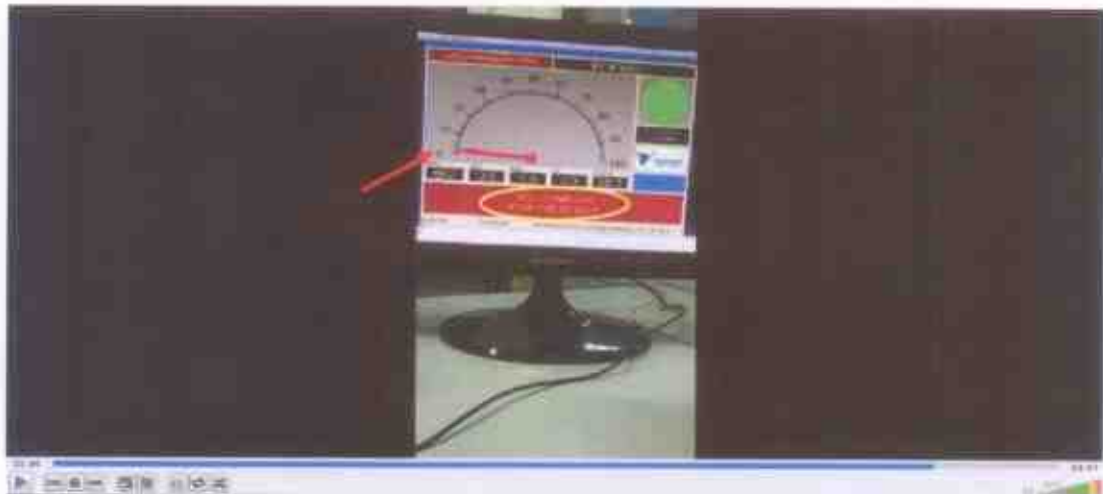
Screenshot 8 of the video recording shows the completion of the CDST (circled) and a reduction in vehicle speed as the accelerator pedal is released (arrowed).
