Your Ref: TP/IP/16203/2018  
Our Ref :CI/TPD18011297/Z

**Fatal Accident Investigation Team**  
Traffic Police Department  
Singapore Police Force  
10 Ubi Avenue 3  
Singapore 408865

### **MECHANICAL INSPECTION REPORT OF MOTORCYCLE FBG 7253E**

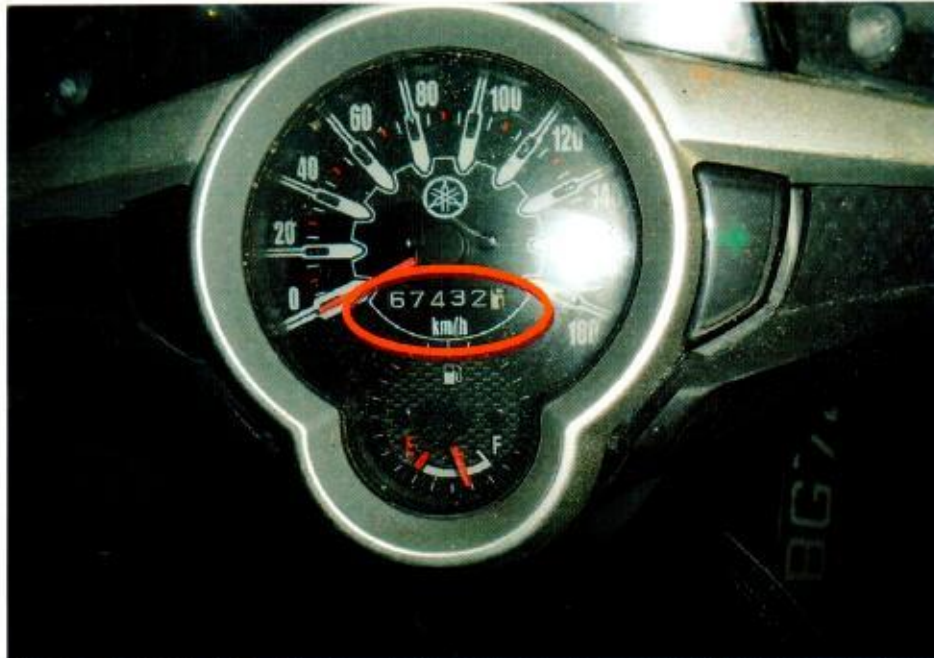
**Photo 1** shows the mileage at the time of inspection was recorded to be 674321km.

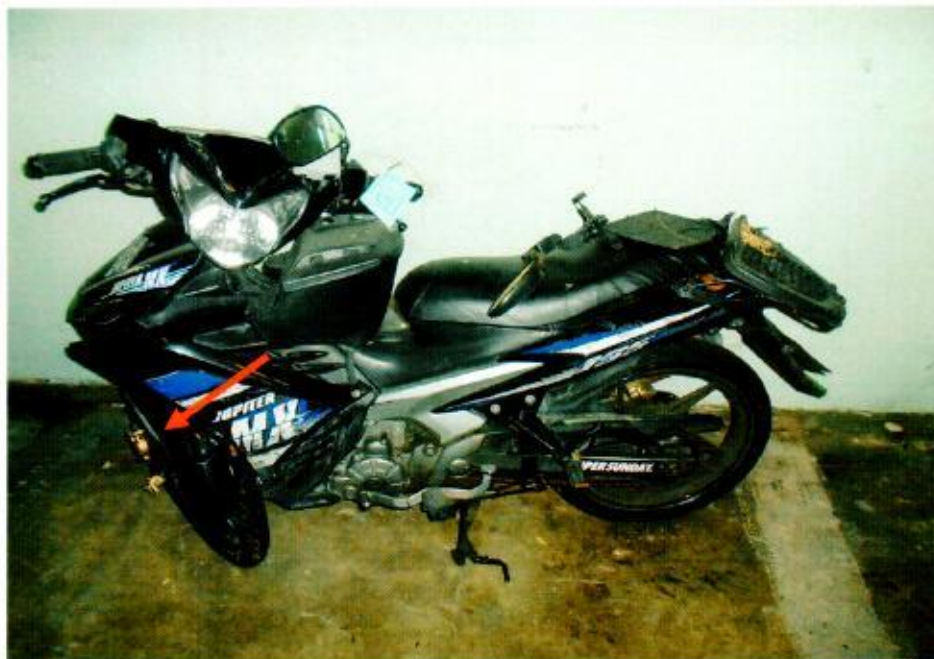
1. We refer to your request dated 20<sup>th</sup> June 2018 to conduct a physical inspection of a motorcycle bearing registration number FBG 7253E (herein referred to as "**Motorcycle**"), which was involved in a fatal road traffic accident on 11<sup>th</sup> March 2018.
2. The purpose of this inspection is to primarily determine if there was any possible mechanical failure to the Motorcycle that may have contributed to the accident.
3. Following the request, we had carried out a physical inspection of the Motorcycle on 20<sup>th</sup> June 2018 at the premises of Traffic Police vehicle pound, 517 Airport Road Singapore 539942. We now set out below my observations and comments with respect to this inspection.

**Photo 2** shows a general view of the front left body of the Motorcycle at the time of our inspection. The Motorcycle was observed to be sustained with relatively extensive impact due to the accident collision. Amongst the body parts damaged was its front fork (arrowed), which was observed to be bent inwards.

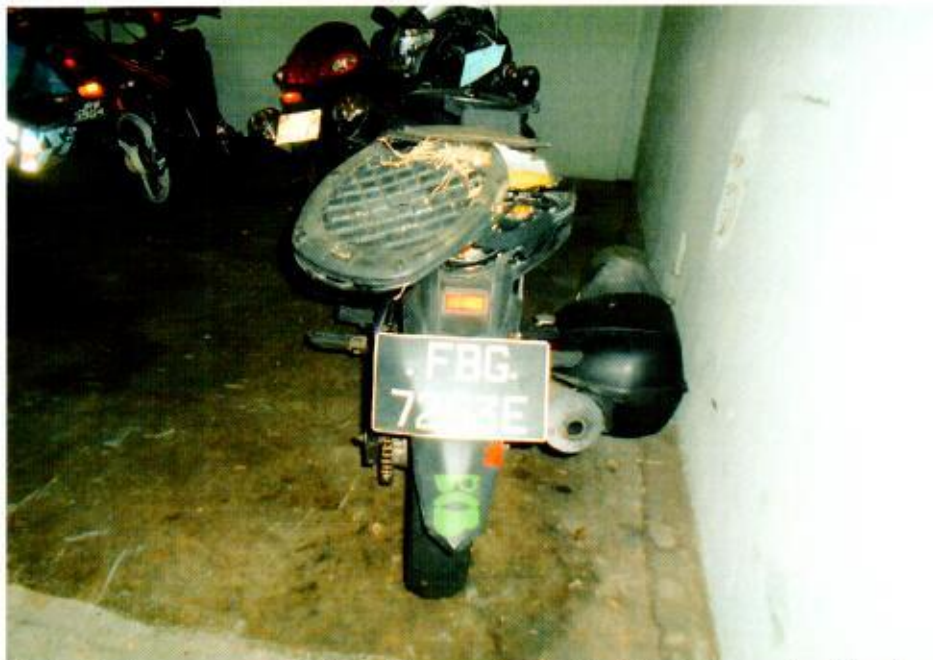
**Photo 3** shows a general view of the rear left body of the Motorcycle at the time of our inspection. The Motorcycle was observed to have sustained damages at the frontal portion, along both its left side, right side and rear portion.

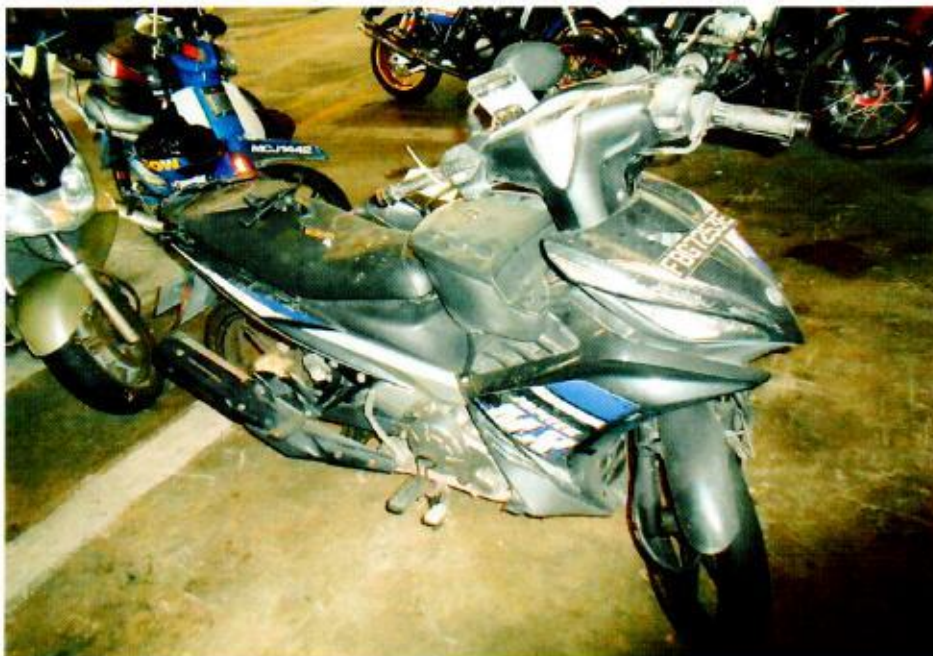
**Photo 4** shows a general view of the frontal portion of the Motorcycle at the time of our inspection. The Motorcycle was observed to be sustained with relatively extensive impact due to the accident collision.

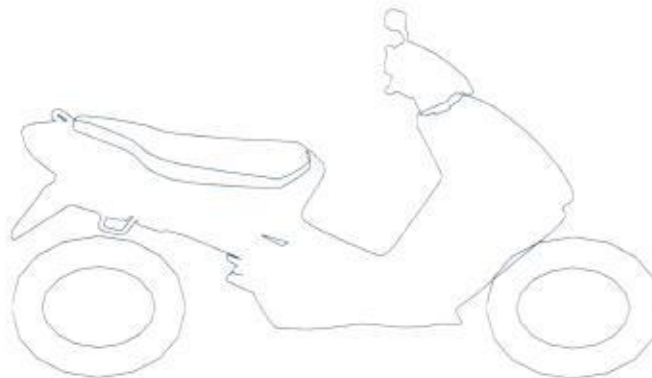
6. The condition of the Motorcycle's front tyre was observed to be in serviceable condition whereas the rear tyre was found to be deflated likely due to the accident impact. However, the tread pattern of the 2 tyres was clearly visible. We did not observe any tear, burst mark(s) and/or punctured hole(s) on the sidewalls as well as across the tread of the 2 tyres. The front tyre was observed to be sufficiently inflated for vehicular operation. The tyre brand, tyre size and remaining tread depth of the 2 tyres were recorded as follows:-

Maxxis 80/90 - 17 (4mm)

Maxxis 90/80 - 17 (4mm)

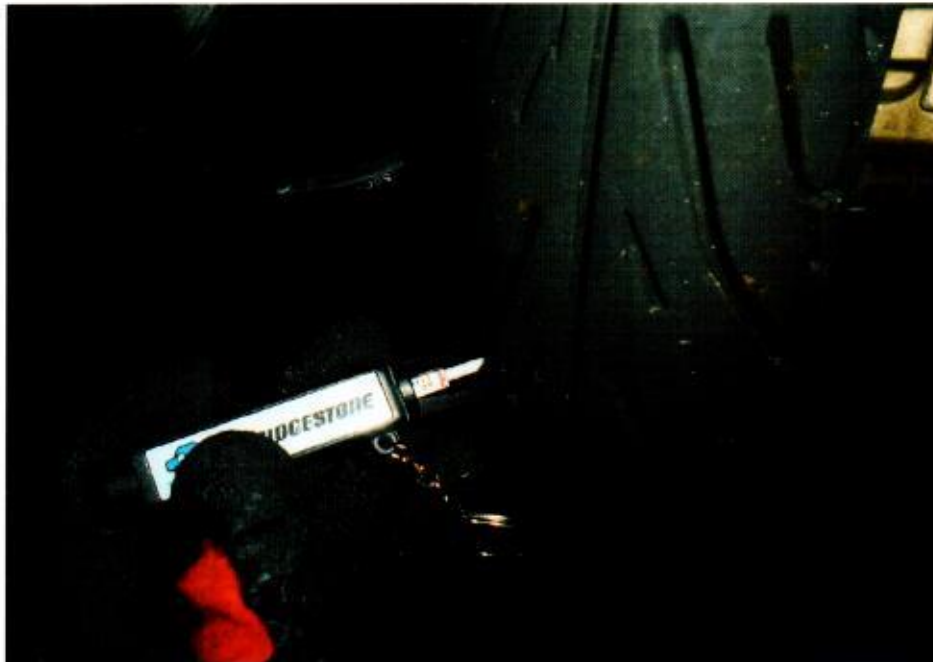
**Photo 5** shows the front tyre of the Motorcycle at the time of our inspection. The rear tyre was observed to be in serviceable condition with remaining tread depth of approximately 4mm. The tyre was also observed to be sufficiently inflated for vehicular operation. There was no significant damage observed on the rear wheel rim & tyre.

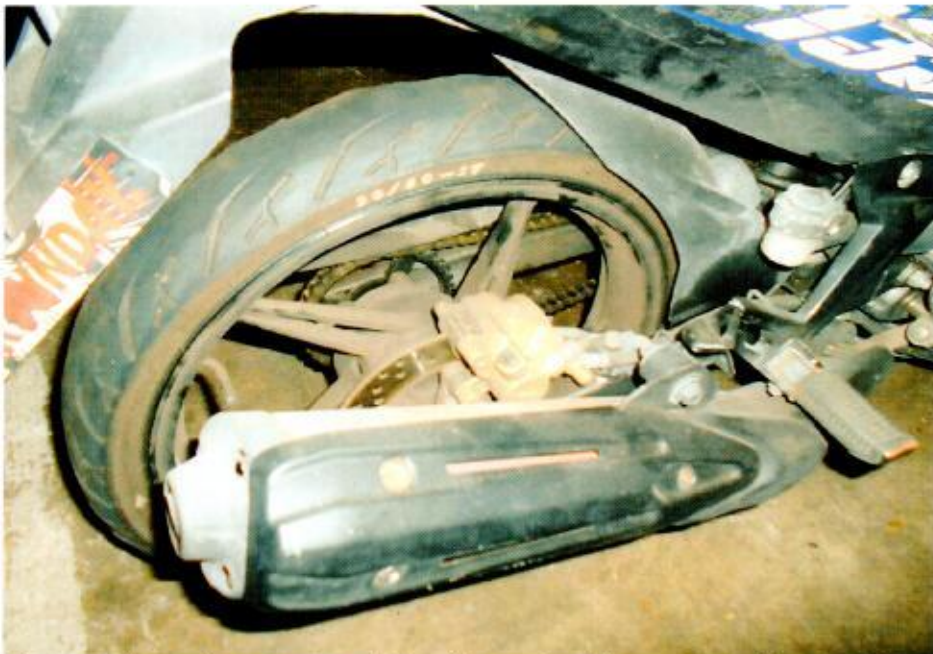
**Photo 6** shows the rear tyre of the Motorcycle. The pattern of the tread was clearly visible. There was no tear, burst mark(s) and/or punctured hole(s) on the sidewalls as well as across the tread of the front tyre. Except further observation found that the rear tyre that was deflated likely due to the accident's collision impact.

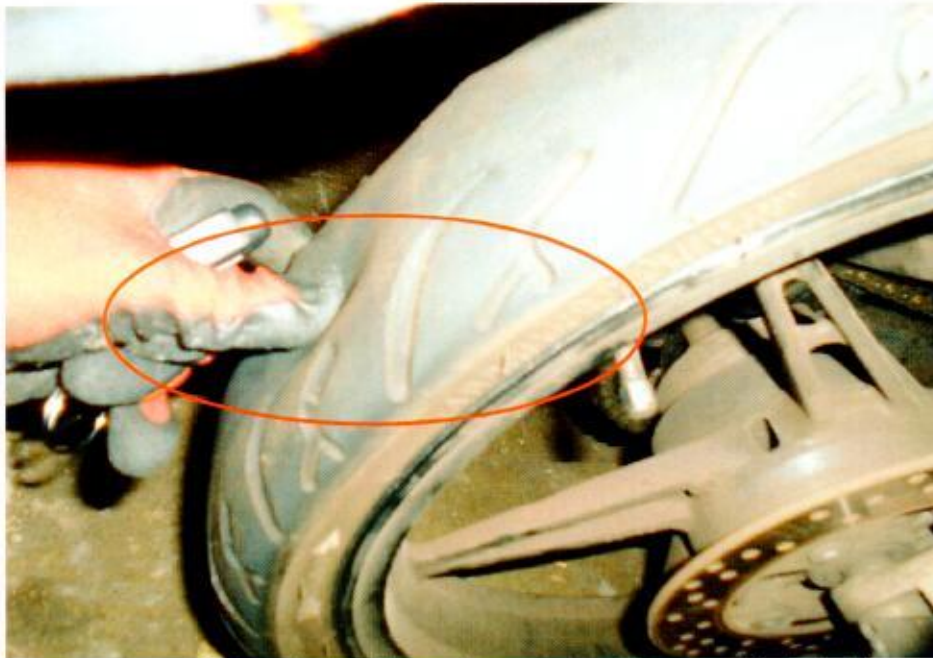
7. The tyres were wrapped around alloy wheel rims that were found to be without any significant damage despite the rear tyre was deflated likely due to the accident's collision impact at the material time of the accident. See photo 5- 7 below

**Photo 7** shows further observation on the rear tyre that was deflated at time of our inspection due to damage front rim likely caused by the accident collision impact.

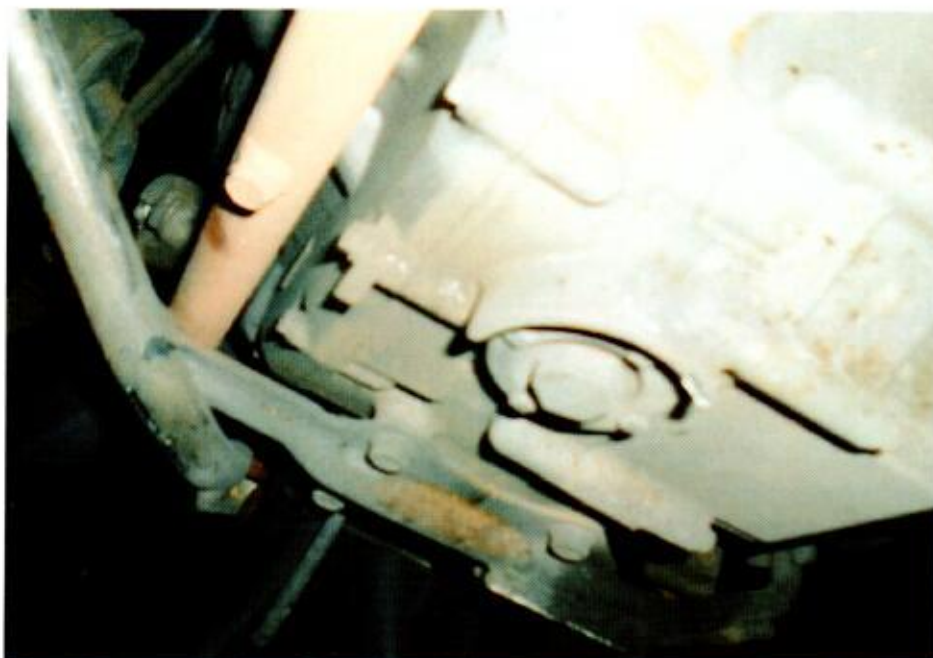
8. Upon examination of the Motorcycle's engine area, we had observed that the various engine related parts and components were intact with no visible damage. There was also no sign(s) or indication(s) of fluid leak observed around the engine area of the Motorcycle.
9. The gear chain of the motorcycle was found to be intact without any misalignment. It was also adequately lubricated for operating purposes. Free play tension test was also conducted & found adequately acceptable. See photo 8 – 10 below.

**Photo 8** shows no sign(s) or indication(s) of fluid leakage stain observed around the engine undercarriage area of the Motorcycle.

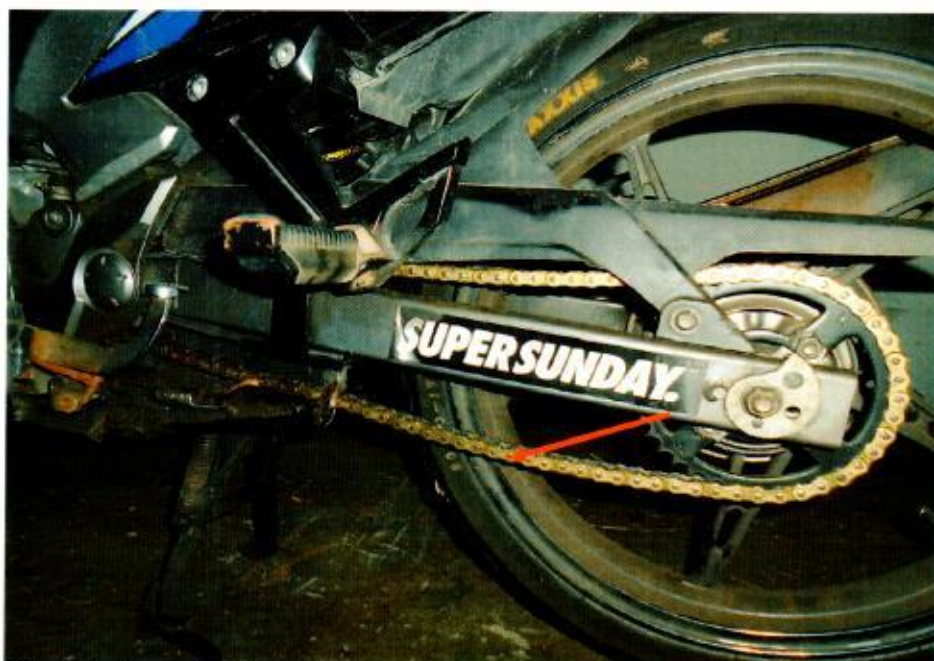
**Photo 9** shows the general view of the gear train (arrowed) of the Motorcycle, which was observed to be intact with no misalignment. It was also adequately lubricated for operating purposes.

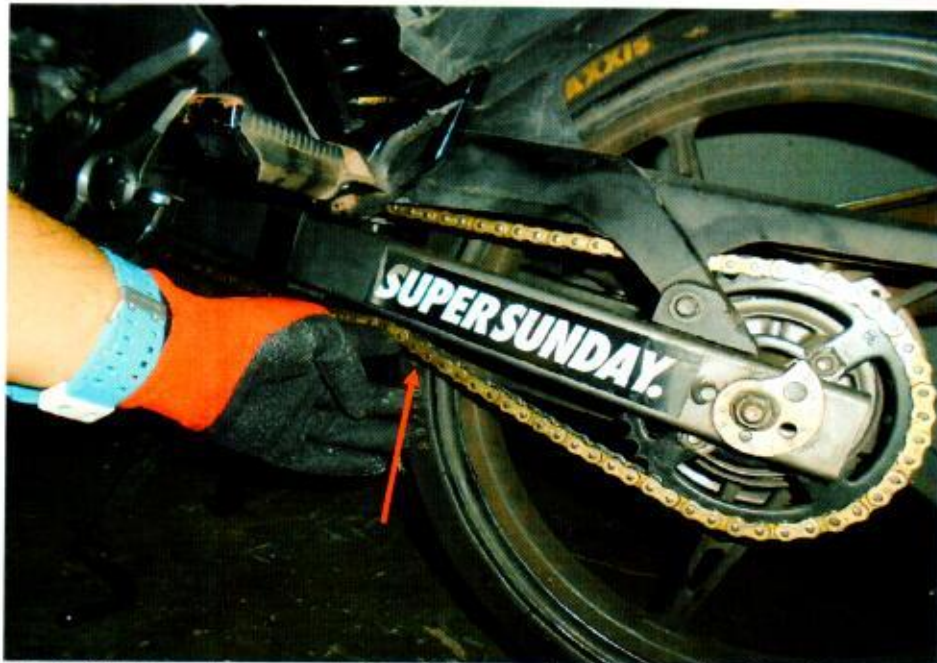
Photo 10 shows the general view of the gear train (arrowed) of the Motorcycle, which was observed to be intact with no misalignment. It was also adequately lubricated for operating purposes. Free play tension was also observed & found adequately acceptable.

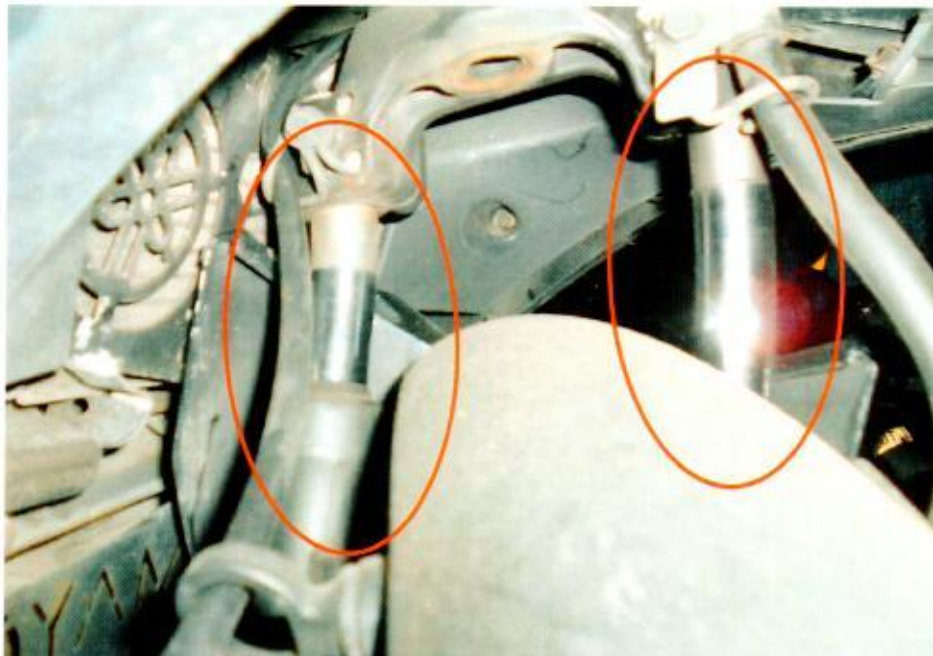
10. For this case, we were not able to conduct any test(s) on the steering system of the Motorcycle due to the damage on its front fork. The front fork was found to be buckled inwards as a result of the accident, hence causing the whole steering system to be in a state of immobility.
11. The braking system of the Motorcycle was observed to be of a full hydraulic type, where hydraulic (brake fluid) pressure controls the brake for the front wheel and rear wheel. The brake for the front wheel is engaged by pulling the brake lever at the right side of the Motorcycle's handle bar while the brake for the rear wheel is engaged by stepping on the brake pedal at the right side foot rest of the Motorcycle.

**Photo 11** shows the front fork (arrowed) was observed to be buckled inwards as a result of the accident. Hence, we are not able to conduct any tests on the steering system of the Motorcycle.

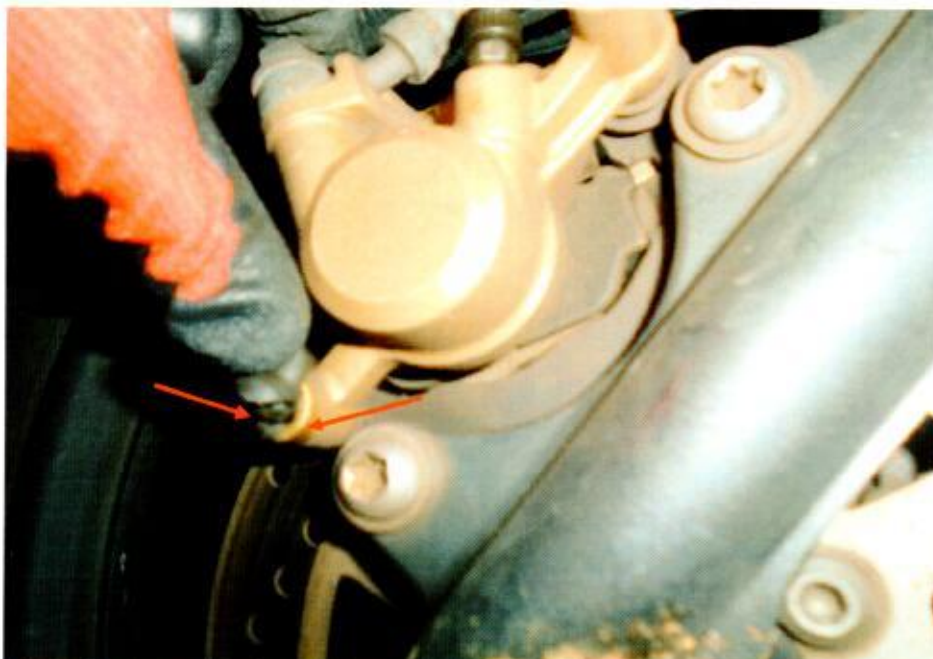
12. A static brake test was only able to be conducted on the Motorcycle's rear brake. A little spin to the rear tyre by hand followed by stepping on the rear pedal brake resulted in the tyre stop spinning. This would indicate that the rear brake responded to the braking action hence to be in serviceable condition. Our checks on the brake fluid had also indicated that the brake fluid was of sufficient level for operational purposes, and without contamination. Whereas for the front brake, we were unable to conduct any static test due to the brake fluid leakage that was found on the front brake calliper due to the accident.

**Photo 12** shows the front brake calliper, front brake disc and front brake hose of the Motorcycle, which are all part of the components in the front brake system of the Motorcycle. Our further observation had revealed that leakage to the brake fluid was found at the brake calliper area (arrowed) due to the accident.

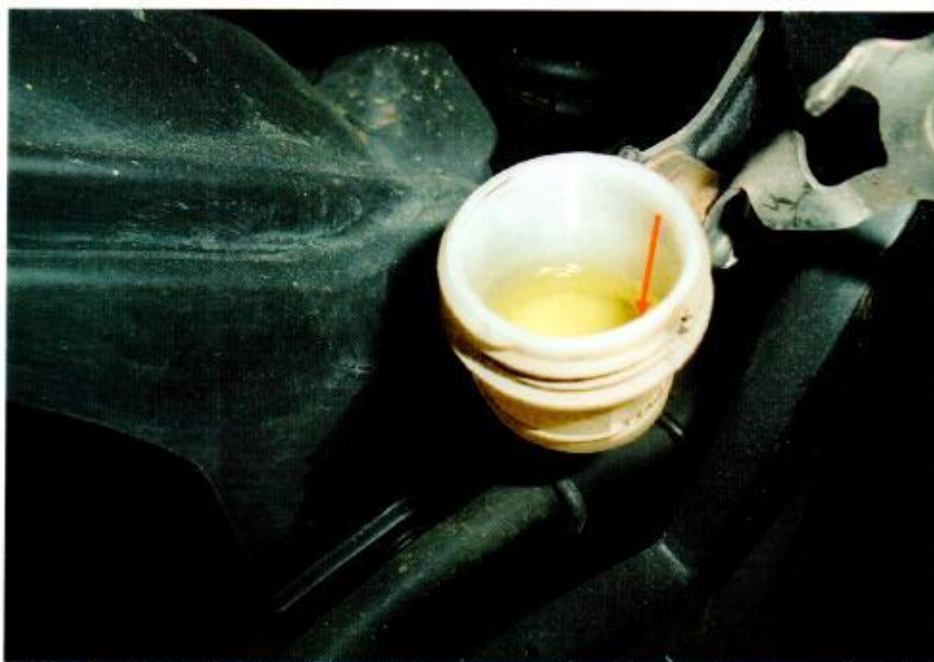
**Photo 13** shows the rear brake fluid reservoir of the Motorcycle. It was found to be at a sufficient level at time our inspection.

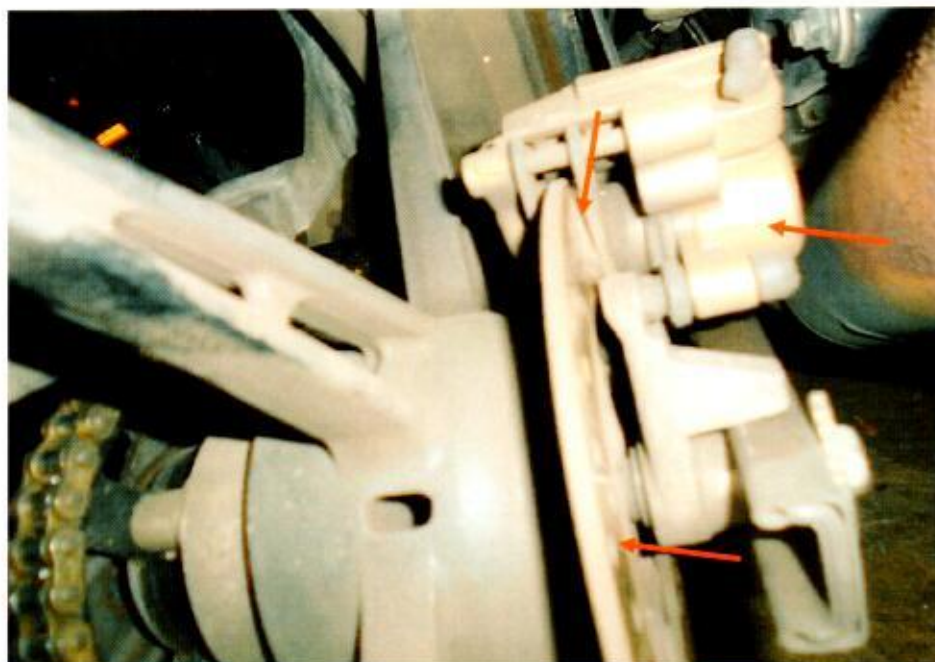
**Photo 14** shows the rear brake calliper, brake disc and brake hose of the Motorcycle (arrowed), which are all part of the components in the rear brake system of the Motorcycle reveal all to be intact and without damage.
