**Charn's Customcraft  
1010 Bukit Merah Lane 3  
Singapore 159724**

**Claim Reference:**  
**Assessment Number: CC000002**  
**Version: CHARNCUS/1**  
**Date Calculated: 20/06/2018 08:18**

**Full Report - V1**  
**Registration: SJX3261Z**  
**Printed: 20/06/2018 15:19**

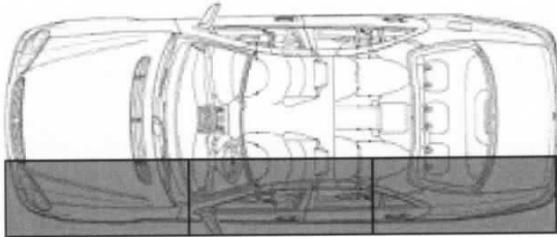
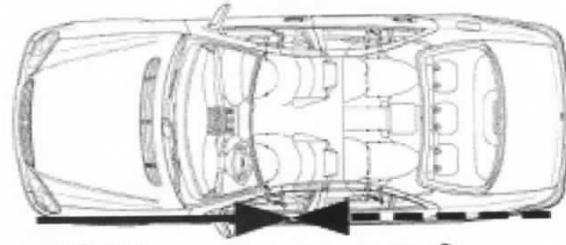
Primary Impact →  
 Secondary Impact - - - - - →

WU	Cost Price (\$)
42700-SNA)	R + R LEFT FRONT WHEEL	2.0	9.00
42700-SNA)	FIT AND BALANCE LEFT FRONT TYRE (WHEEL REMOVED)	5.0	22.50
NN	FRONT BUMPER R&R / NEW PARTS	25.0*	112.50
NN	L/F HEADLAMP CPL R&R / NEW PARTS	9.0*	40.50
NN	L/F WING R&R / NEW PARTS	15.0*	67.50
NN	L/DOOR MIRROR R&R / NEW PARTS	10.0*	45.00
NN	REAR BUMPER R&R / NEW PARTS	10.0*	45.00
1481	REPAIR LEFT FRONT DOOR	30.0*	135.00
1781	REPAIR L/R DOOR	20.0*	90.00
3481	REPAIR L/R SIDE PANEL	50.0*	225.00
