Your Ref: D18004775MFSH  
Our Ref : CI/FCI18011332/N

20 June 2018

### **MECHANICAL INSPECTION REPORT OF MOTOR TAXI SHC 592Y**

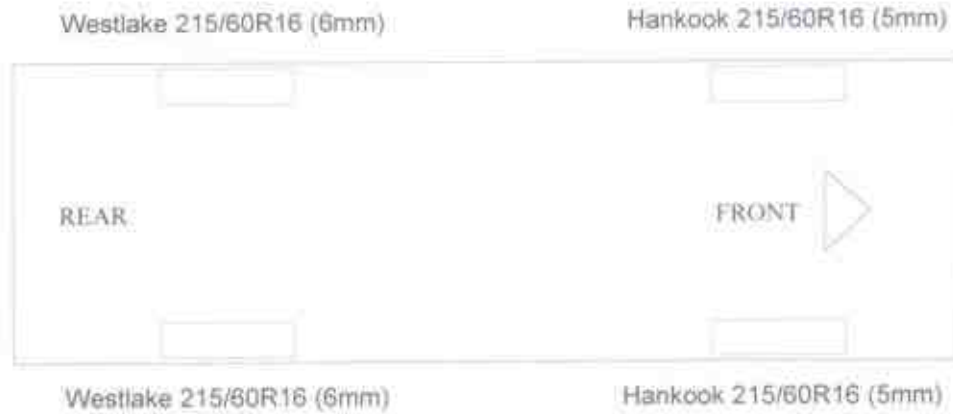
6. The condition of the Motor Taxi's 4 tyres was observed to be in serviceable condition. We did not find any tear, cut or burst mark(s) on the outer and the inner sidewalls as well as across the tread of the 4 tyres. The 4 tyres were observed to be sufficiently inflated for vehicular operation. The tyre brand, tyre size and remaining tread depth of the 4 tyres were recorded as follows:-

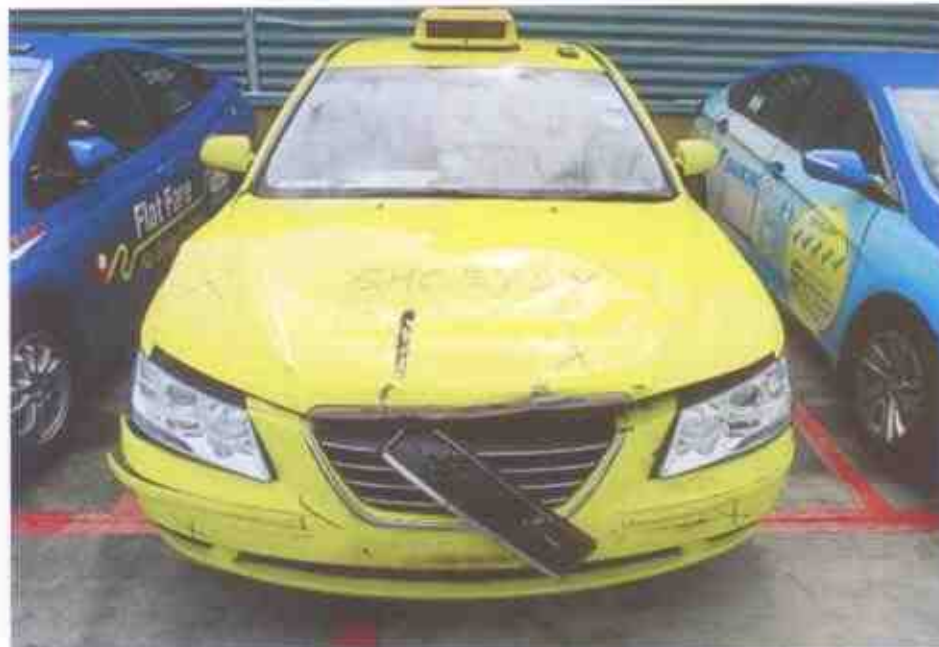
4. The mileage of the Motor Taxi at the time of our inspection was 789,014km.
5. The Motor Taxi had sustained relatively minor impact damage that was confined to its frontal portion. Its front bumper was observed to have been dislodged; its front number plate had broken off; the front number plate holder had cracked; its front bonnet had dents as well as a vertical tear and the right side panel was observed to be dented.

Photo 1 shows a general view of the front body of the Motor Taxi at the time of our inspection. The Motor Taxi had sustained relatively minor impact damage that was confined to its frontal portion. Its front bumper was observed to have been dislodged, its front number plate had broken off, the front number plate holder had cracked, its front bonnet was bent at the right portion and had dents as well as a vertical tear and the right side panel was observed to be dented. The mileage of the Motor Taxi was recorded to be 789,014km.

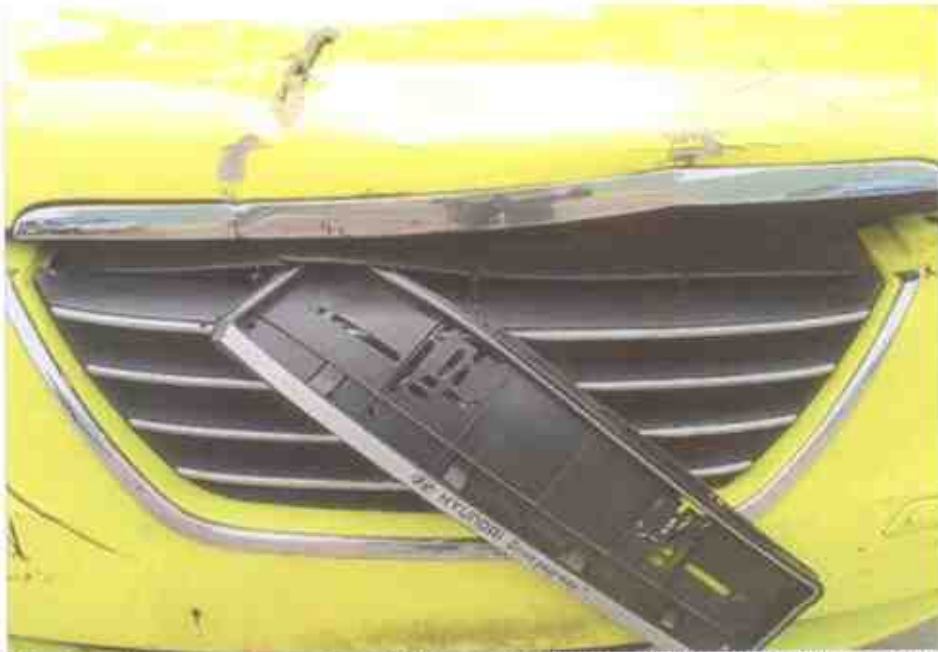
**Photo 2** shows a closer view of the cracked front number plate holder of the Motor Taxi at the time of our inspection.

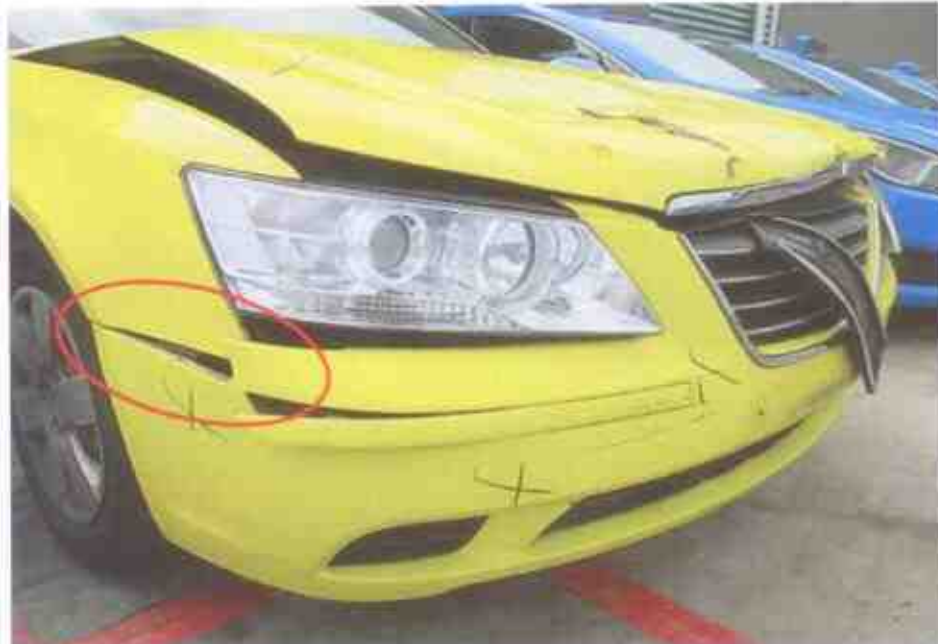
**Photo 3** shows a closer view of the dislodgement observed at the right corner of the front bumper of the Motor Taxi at the time of our inspection (circled).

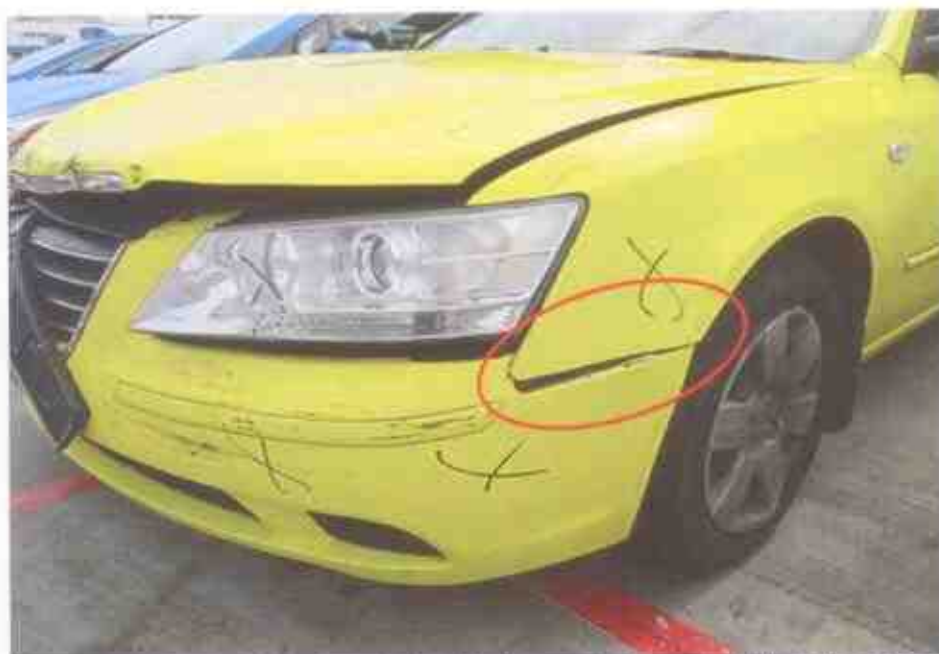
**Photo 4** shows a closer view of the dislodgement observed at the left corner of the front bumper of the Motor Taxi at the time of our inspection (circled).

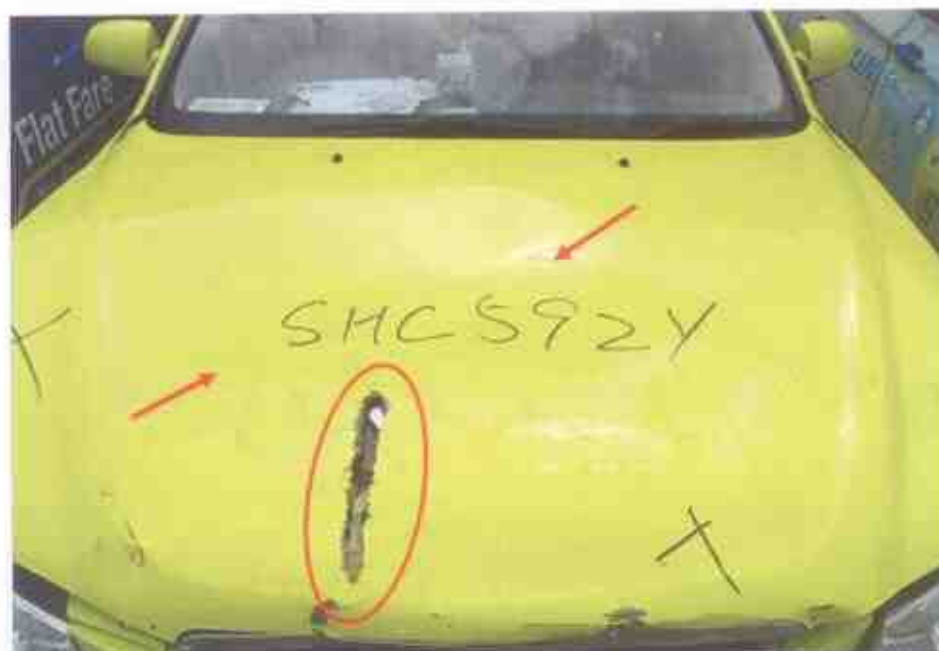
**Photo 5** shows a closer view of the dents (arrowed) as well as a vertical tear (circled) observed on the front bonnet of the Motor Taxi at the time of our inspection.

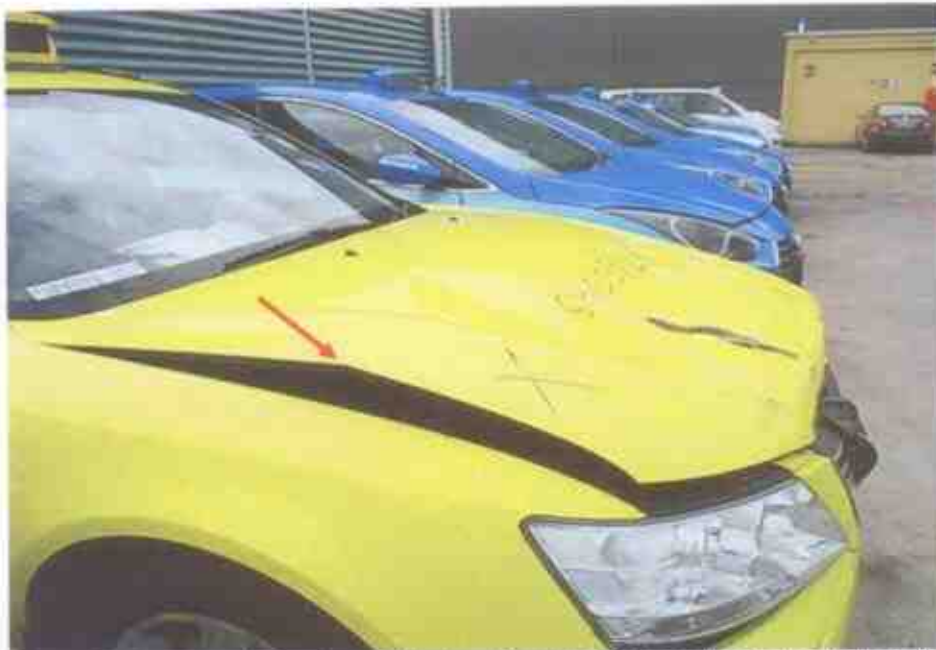
**Photo 6** shows a closer view of the bent front bonnet of the Motor Taxi at the time of our inspection (arrowed).

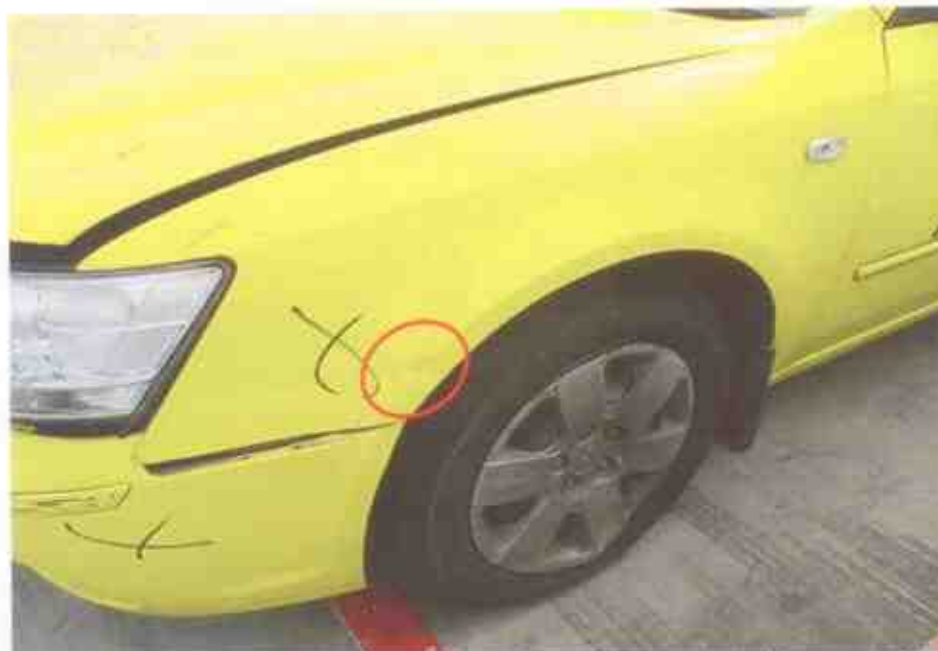
**Photo 7** shows a closer view of the dent observed at the right side panel of the Motor Taxi at the time of our inspection (circled).

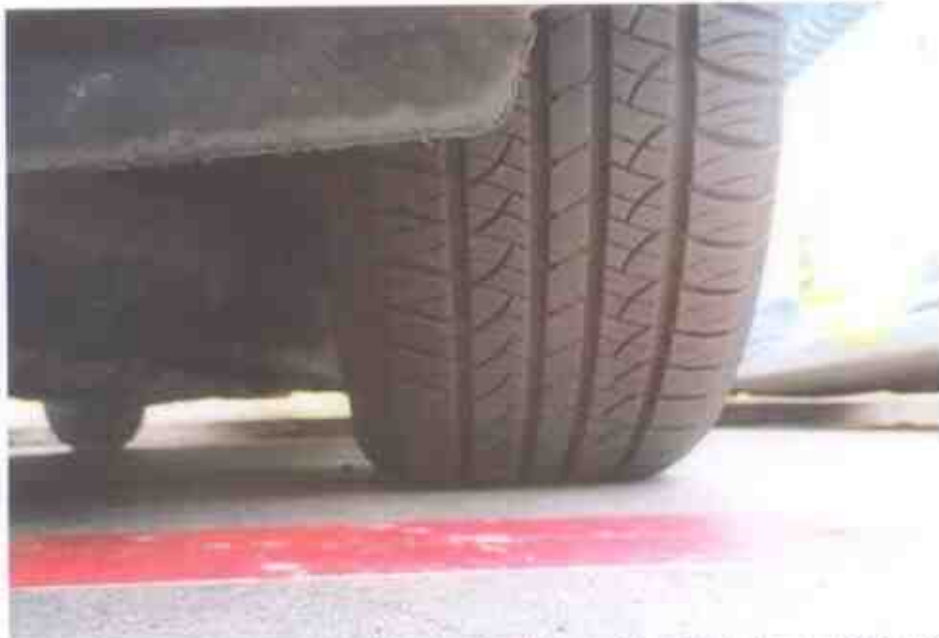
**Photo 8** shows the condition of the front right tyre of the Motor Taxi, which was observed to be in serviceable condition with remaining tread depth of approximately 5mm. The tyre, which was wrapped around standard wheel rim, was also observed to be sufficiently inflated for vehicular operation.

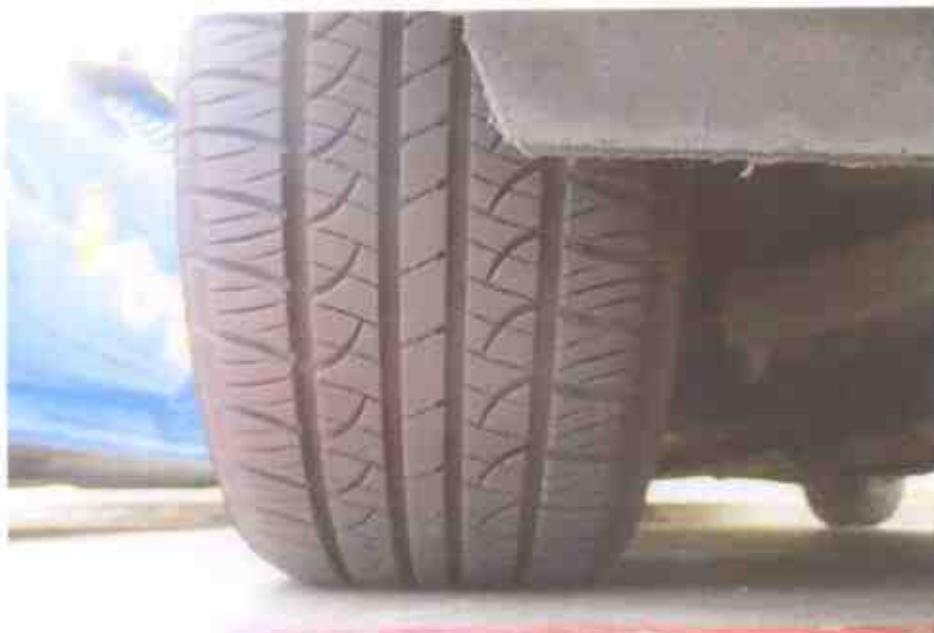
**Photo 9** shows the condition of the front right tyre of the Motor Taxi, which was observed to be in serviceable condition with remaining tread depth of approximately 5mm. The tyre, which was wrapped around standard wheel rim, was also observed to be sufficiently inflated for vehicular operation. The 4 wheel caps fitted on the outer side of the wheel rims of the Motor Taxi were found to be with kerb grazing type of damage.

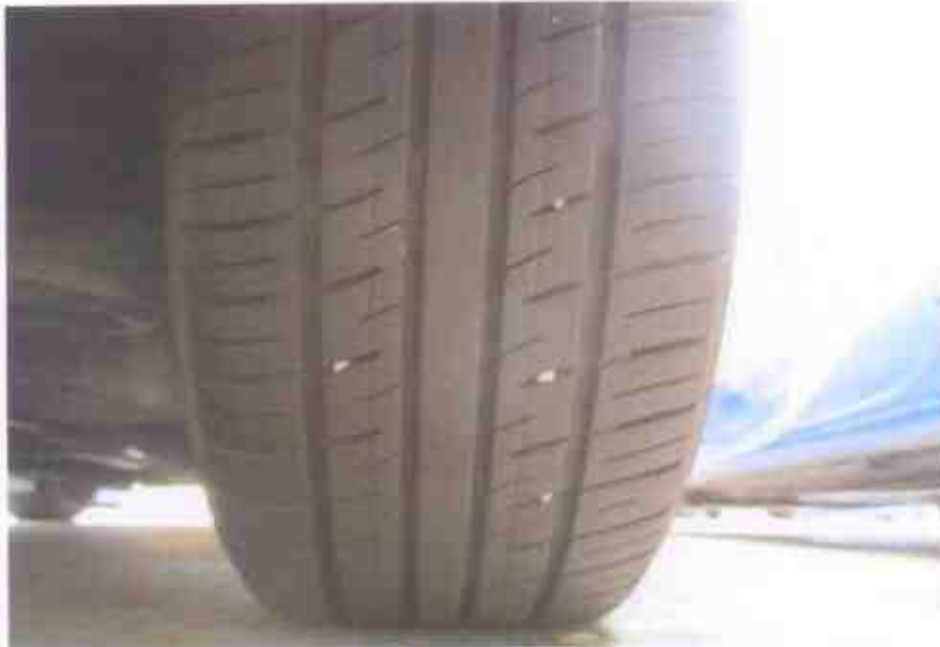
**Photo 10** shows the condition of the rear right tyre of the Motor Taxi, which was observed to be in serviceable condition with remaining tread depth of approximately 6mm. The tyre, which was wrapped around standard wheel rim, was also observed to be sufficiently inflated for vehicular operation.

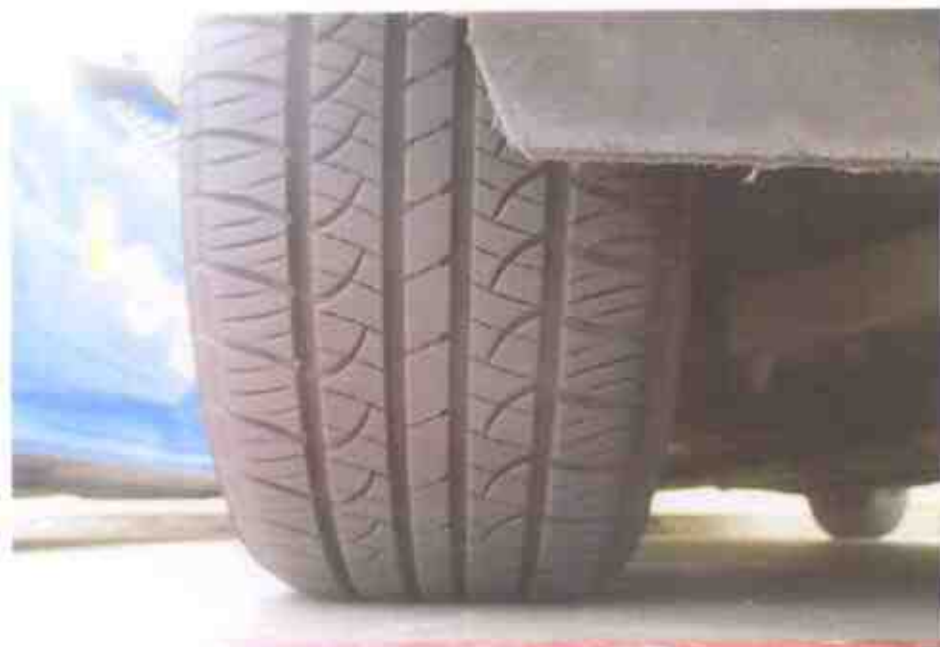
**Photo 11** shows the condition of the rear left tyre of the Motor Taxi, which was observed to be in serviceable condition with remaining tread depth of approximately 6mm. The tyre, which was wrapped around standard wheel rim, was also observed to be sufficiently inflated for vehicular operation.

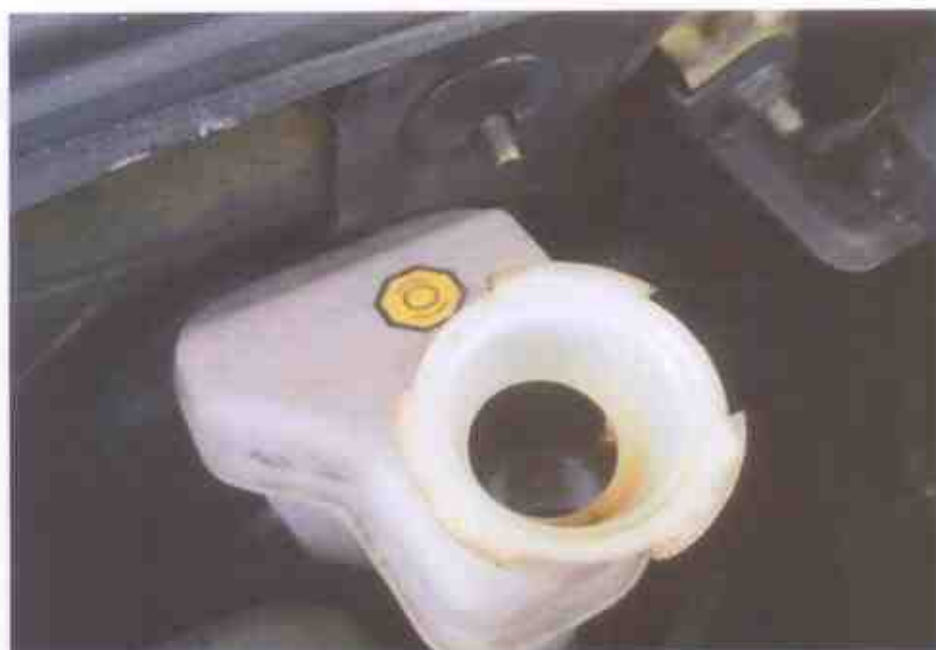
Photo 12 shows the brake fluid reservoir of the Motor Taxi at the time of our inspection. The brake fluid was observed to be of sufficient level and without any visible contamination.

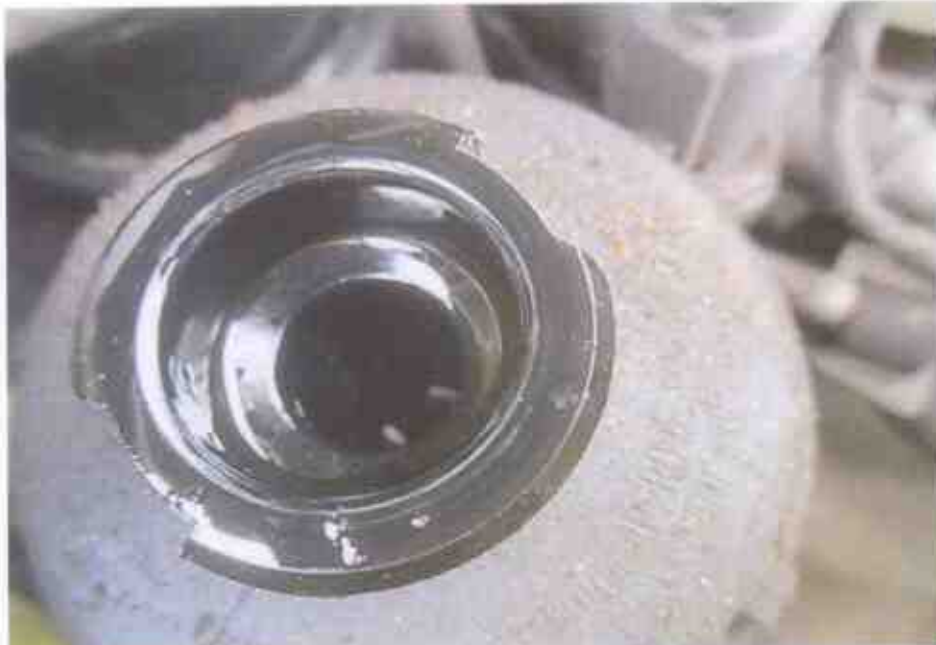
**Photo 13** shows the power steering fluid reservoir of the Motor Taxi at the time of our inspection. The power steering fluid was observed to be of sufficient level and without any visible contamination.

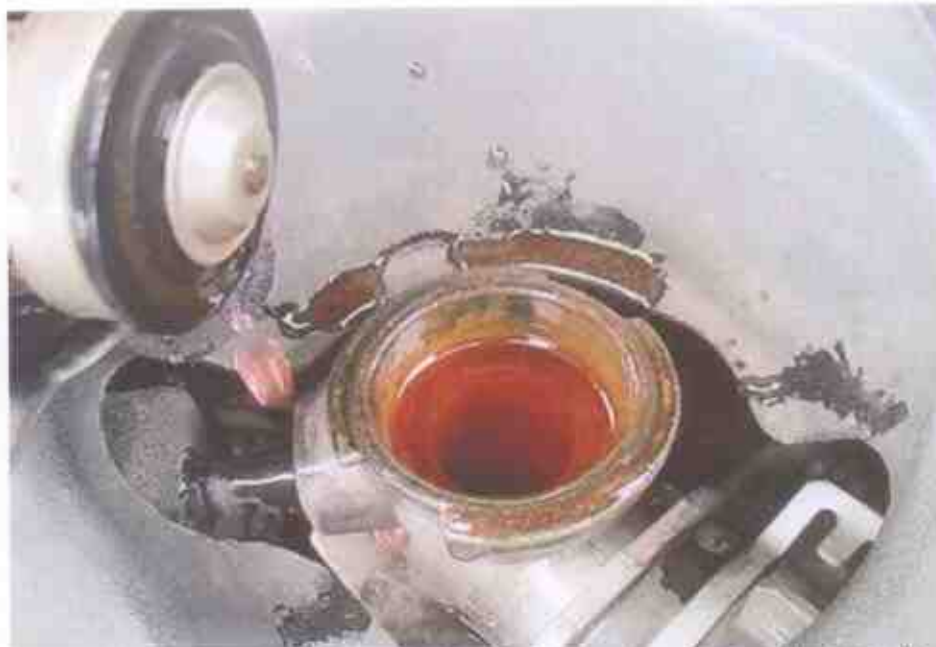
**Photo 14** shows checks being carried out to the engine coolant of the Motor Taxi at the time of our inspection. The engine coolant was observed to be of sufficient level and without any visible contamination.

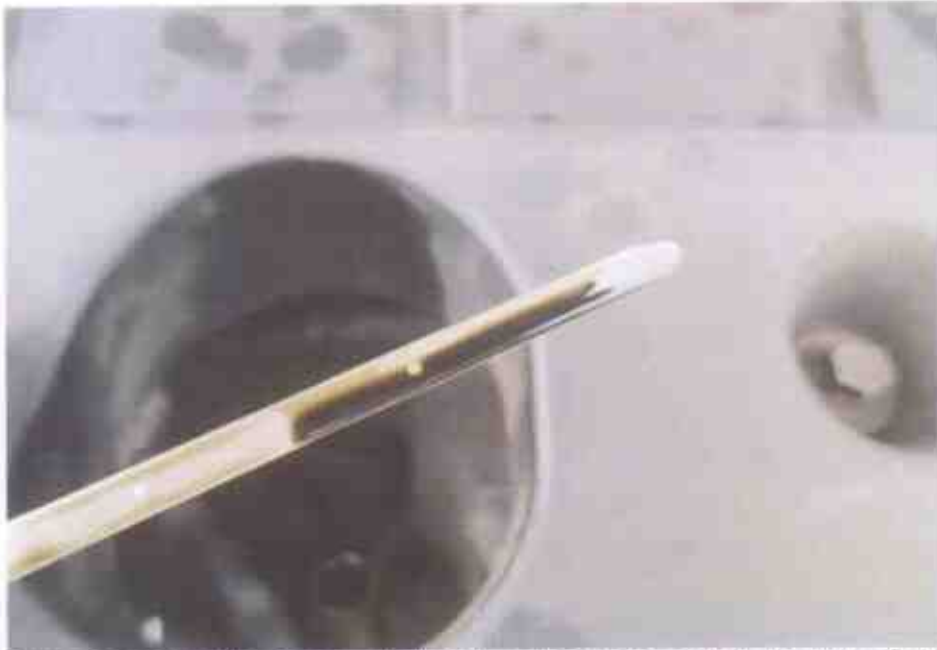
**Photo 15** shows the engine oil dipstick of the Motor Taxi at the time of our inspection. The engine oil was observed to be of sufficient level and without any visible contamination.

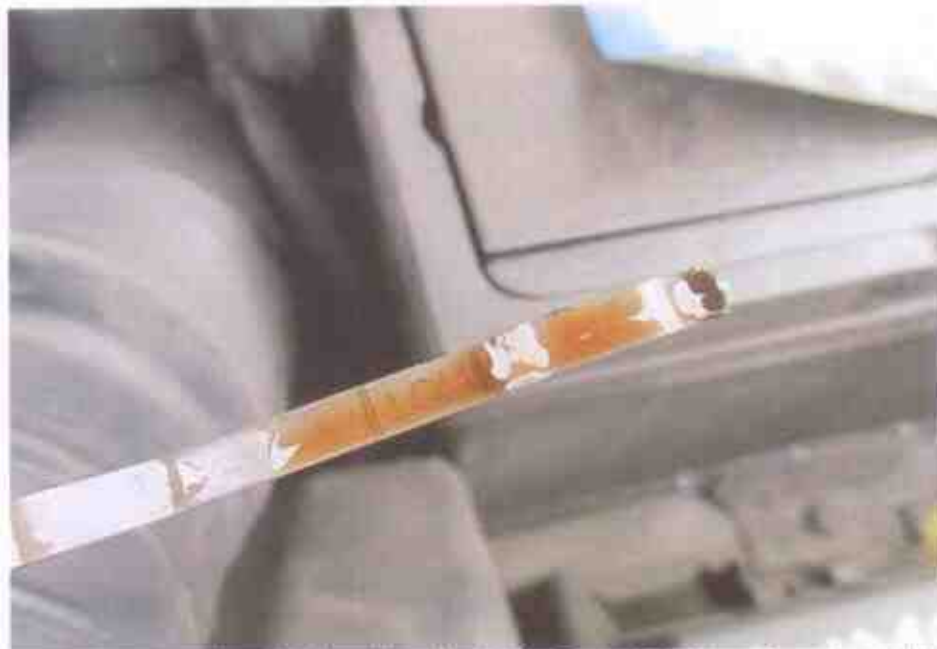
**Photo 16** shows the ATF dipstick of the Motor Taxi at the time of our inspection. The ATF was observed to be of sufficient level and without any visible contamination.

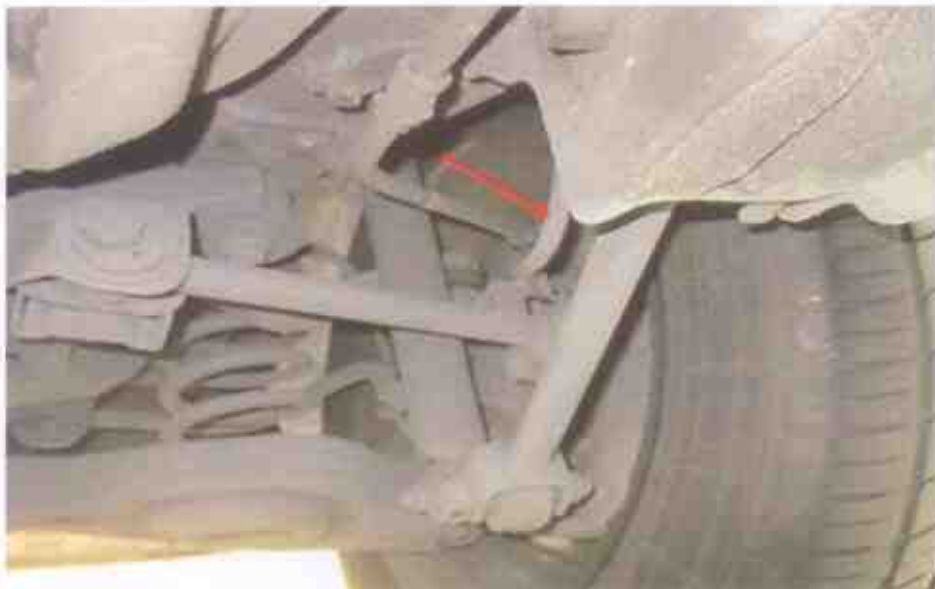
**Photo 17** shows the brake hose/pipe (arrowed) at the rear left wheel of the Motor Taxi. We did not observe any leakage of brake fluid at the time of our inspection of the Motor Taxi. Static tests of the Motor Taxi's braking system had indicated that there was no internal leakage of pressure/vacuum. Hence the braking system was likely to be in serviceable condition at the material time of accident. The undercarriage components of the Motor Taxi were also all found to be intact and without any visible damage.

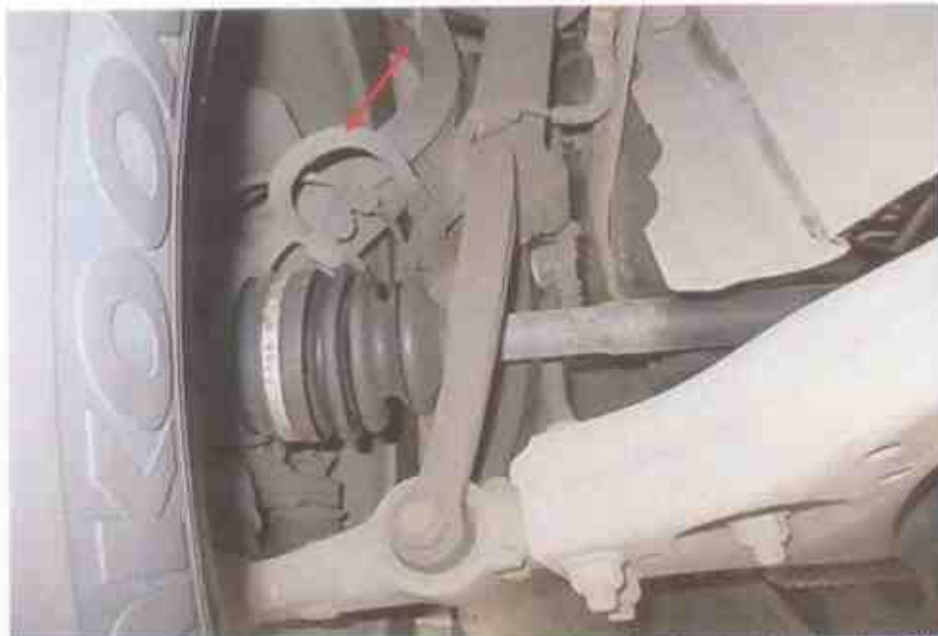
**Photo 18** shows the brake hose/pipe (arrowed) at the front right wheel of the Motor Taxi. No leakage of brake fluid was observed. Visual examination of the various components of the braking system like the brake caliper, brake booster, brake pedal etc had revealed all to be intact and without visible damage.

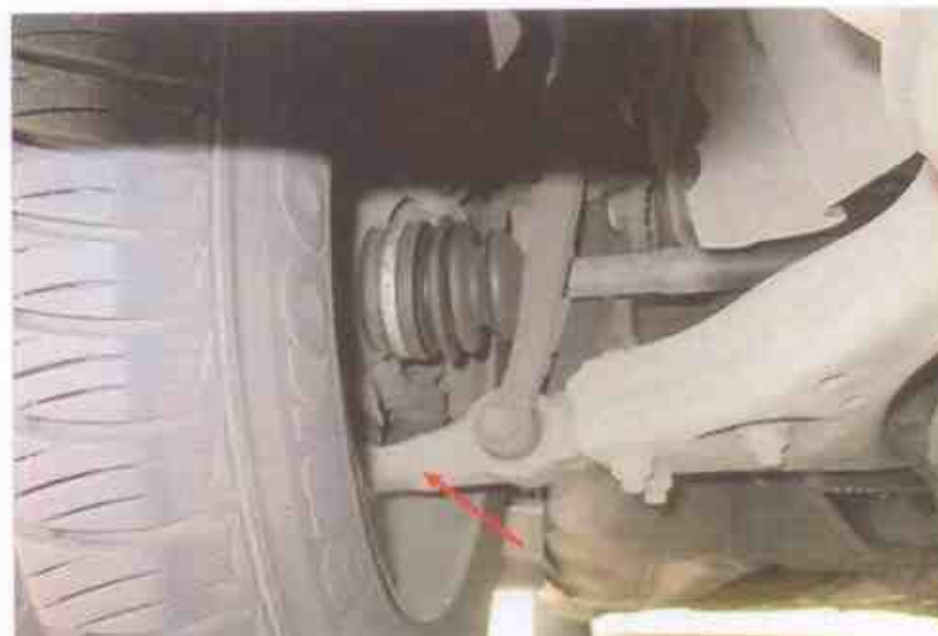
**Photo 19** shows the various undercarriage components at the front right wheel of the Motor Taxi, in particular the steering tie rod (arrowed). The various steering components were all found to be intact, suggesting that the steering system of the Motor Taxi was likely to be in serviceable condition at the material time of accident. There was also no sign of fluid stain observed on the various undercarriage components at the front right wheel of the Motor Taxi.

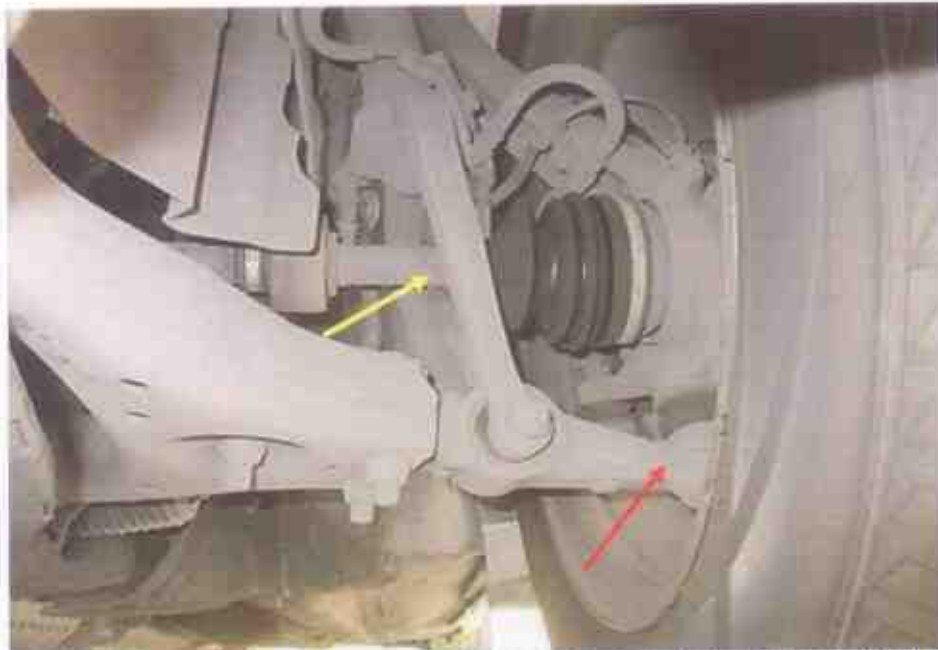
Photo 20 shows the various undercarriage components at the front left wheel of the Motor Taxi, which had included the steering tie rod (red arrow) and left drive shaft (yellow arrow). The various undercarriage components of the Motor Taxi were all found to be intact without any visible damage.

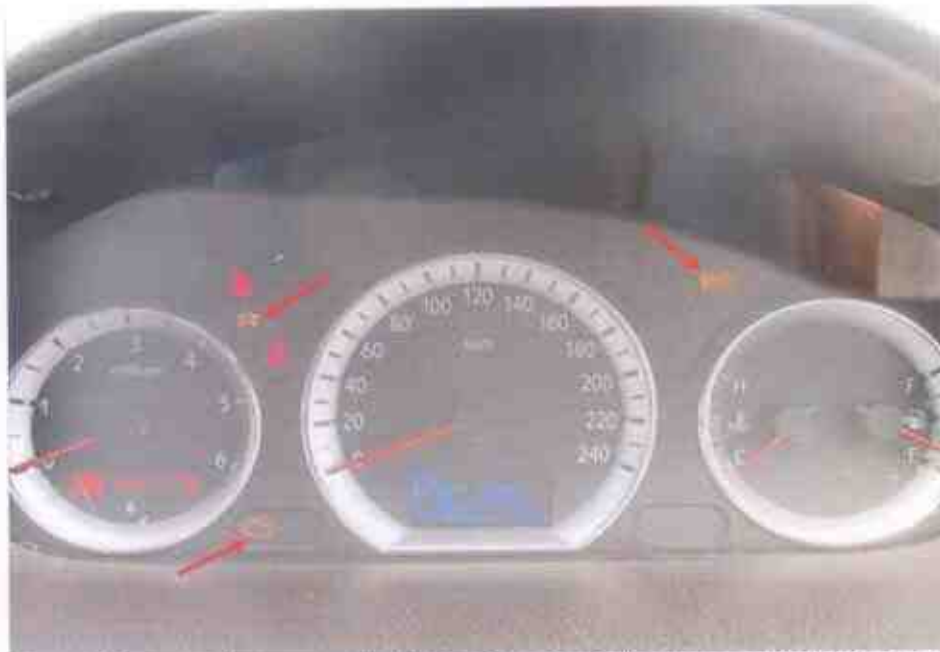
**Photo 21** shows the warning lights for the various electronic operating systems and indicators of the Motor Taxi appearing on its instrument panel during the self-test when the engine is cranked, in particular the ABS light, glow plugs indicator and engine warning light (arrowed).

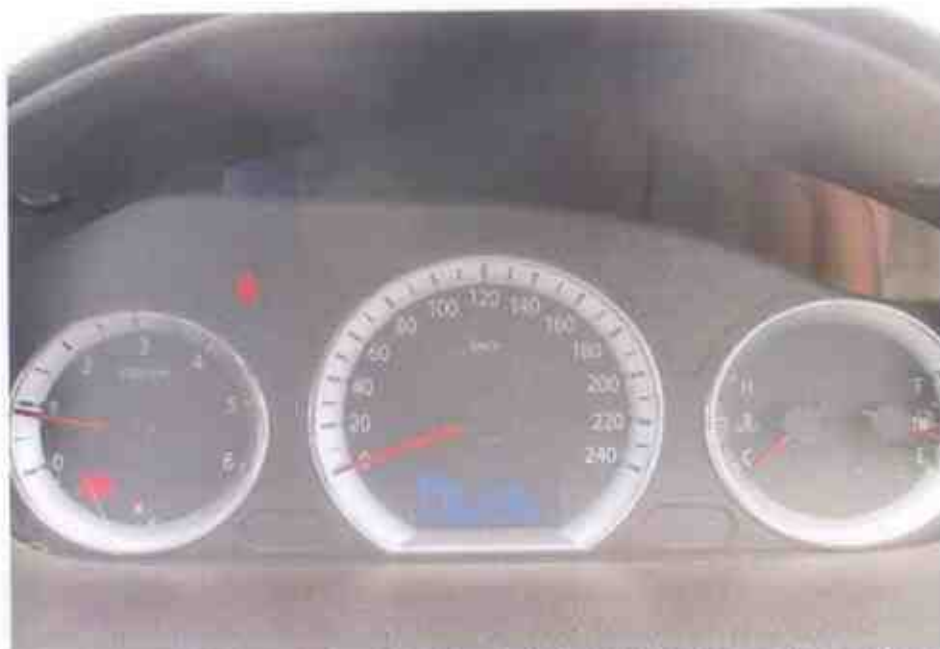
**Photo 22** shows no warning lights illuminated on the instrument panel of the Motor Taxi after the engine was cranked. This would suggest that there was no abnormality to the various electronic operating systems of the Motor Taxi, like the ABS, engine and glow plugs.
