MECHANICAL INSPECTION REPORT OF MOTOR CAR SJG 4315K

1. We refer to your request on 20th June 2018 to conduct a physical inspection of a motor car bearing registration number SJG 4315K (herein referred to as "**Motor Car**"), which was involved in a fatal road traffic accident on 14th May 2018.
2. The objective of the inspection is to determine if there was any possible mechanical failure to the Motor Car that may have contributed to the accident.
3. Following the request, we had carried out a physical inspection of the Motor Car on 20th July 2018 at the premises of Traffic Police vehicle pound, 517 Airport Road Singapore 539942. We now set out below our observations and comments with respect to this inspection.

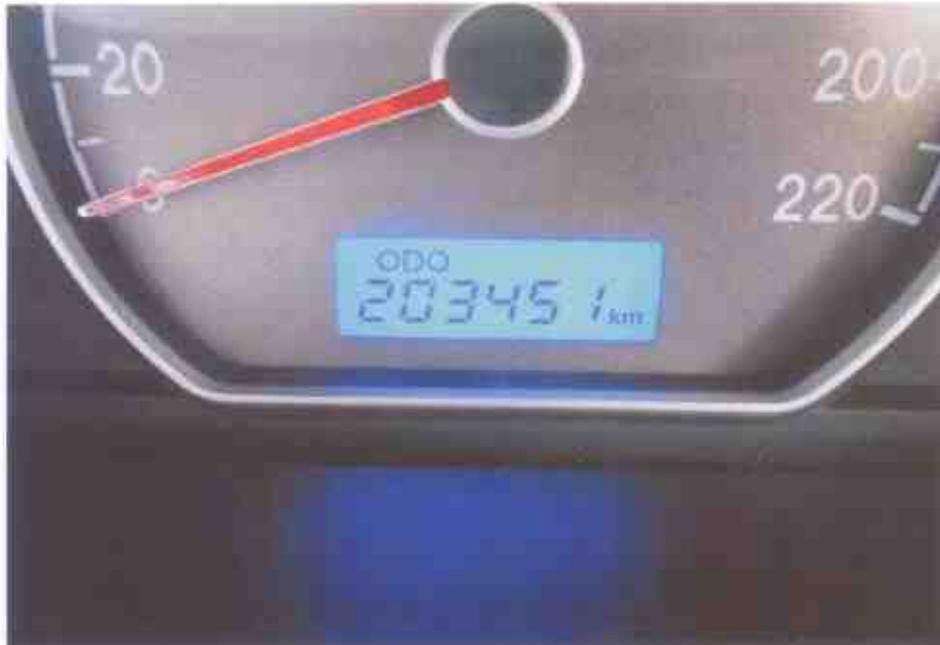
Photo 1 shows the mileage of the Motor Car was 203451 km.

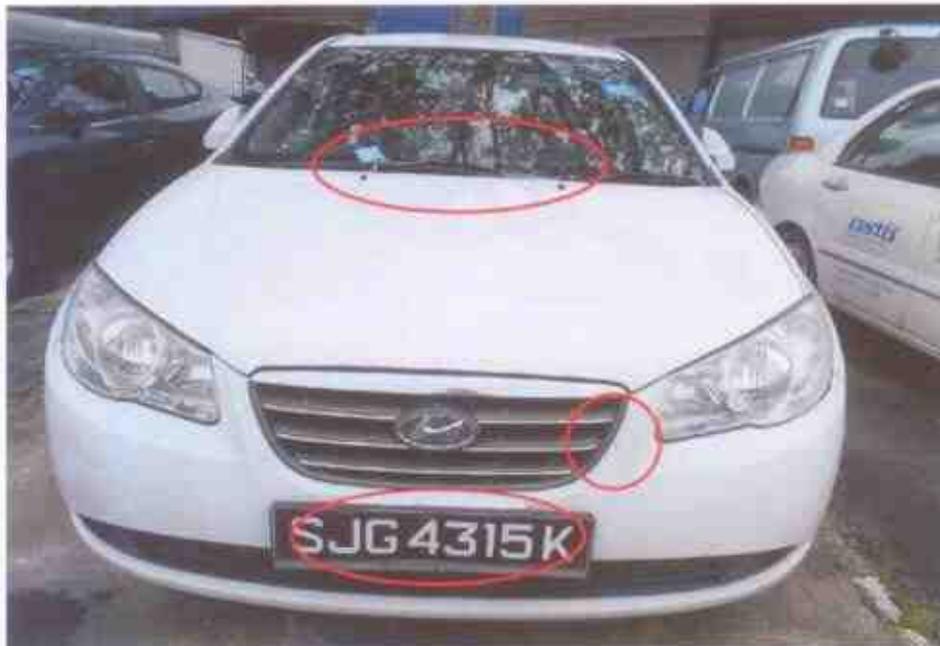
Photo 2 shows a general view of the front body of the Motor Car at the time of our inspection. The Motor Car was observed to be in good general condition except for minor damages at the frontal portion.

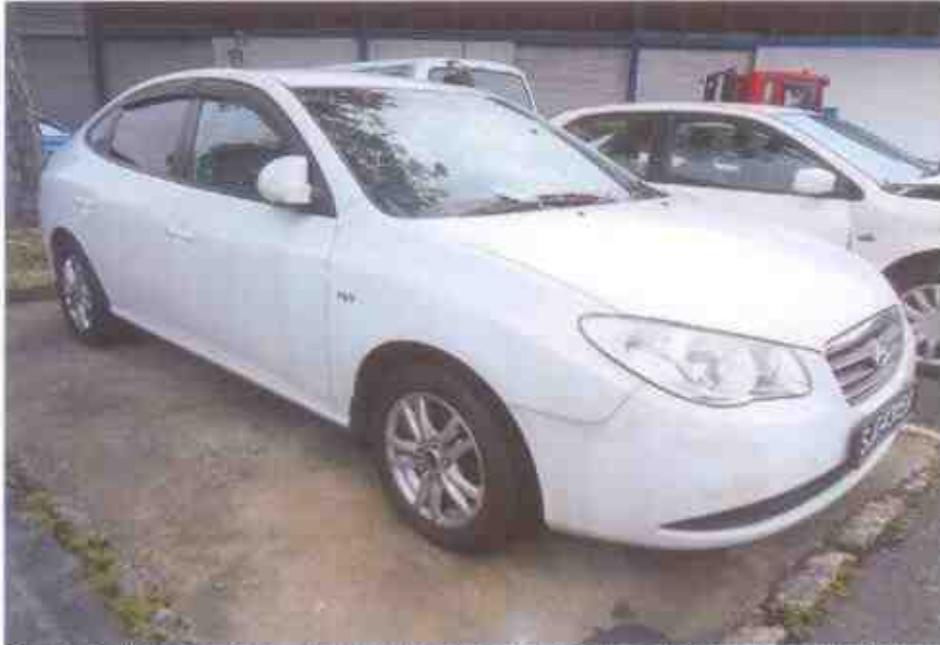
Photo 3 shows a general view of the right front body of the Motor Car at the time of our inspection. The Motor Car was observed to be in good general condition except for minor damages at the frontal portion.

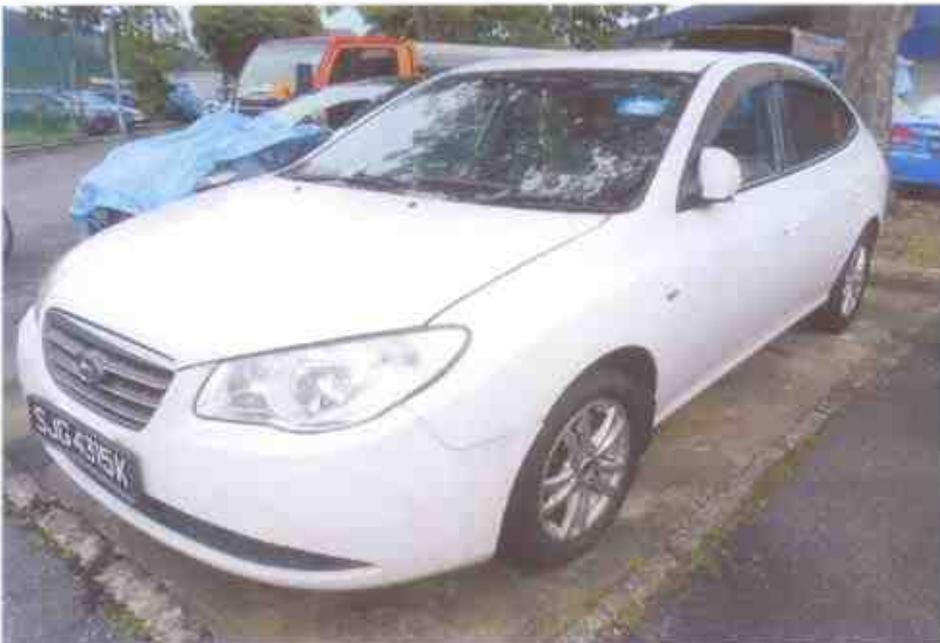
Photo 4 shows a general view of the front left body of the Motor Car at the time of our inspection. The Motor Car was observed to be in good condition unaffected by the accident.

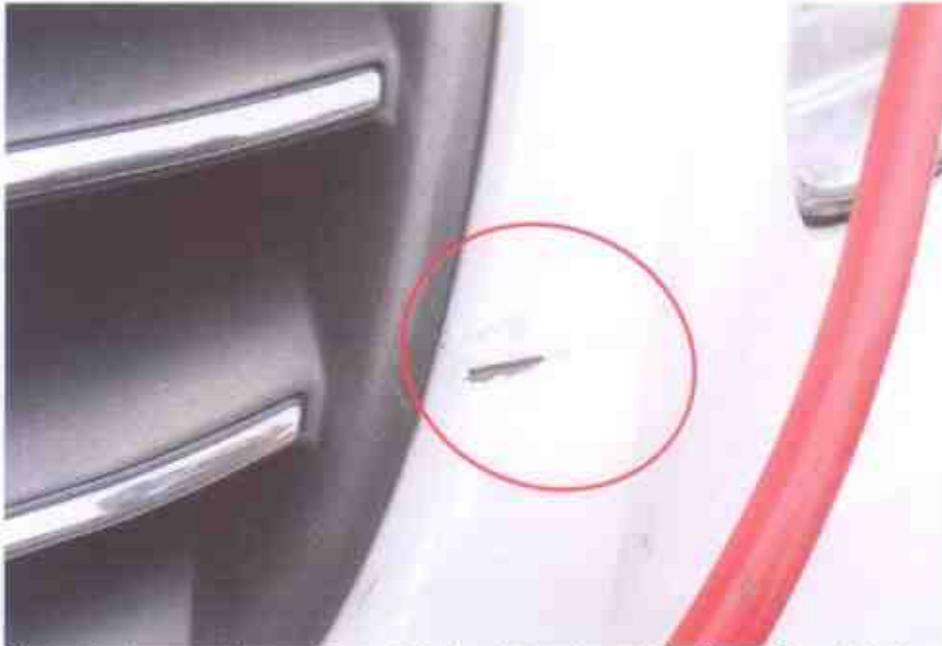
4. The mileage of the Motor Car at the time of our inspection was 203451 km.
5. The Motor Car had sustained a relatively minor impact damages that was confined to its front portion. The licence plate, front bumper & front windshield were observed to have sustained impact damages amongst others.
6. This was likely due to the consistency of the accident's case facts that the Motor Car (SJG 4315K) that was making a right turn along Ang Mo Kio Avenue 3 junction of Serangoon North Avenue 1 collided onto a pedestrian who was crossing from his left to right side while it was still green mane for the pedestrian favour. See photo 1 to 8 below.

Photo 5 shows a close up view of the frontal portion of the Motor Car at the time of our inspection. It had sustained damages due to the accident.

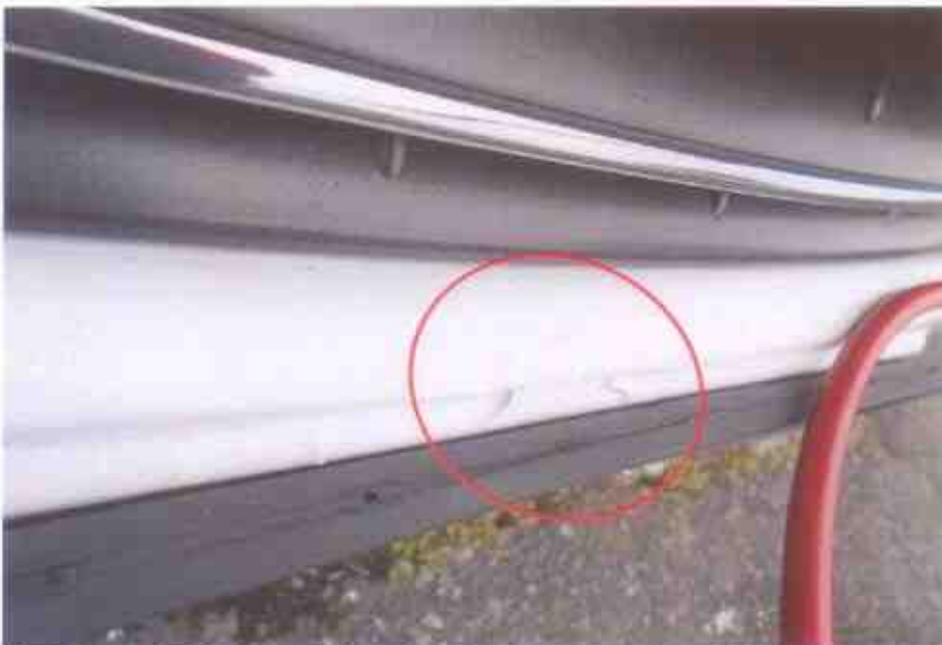
Photo 6 shows a close up view of the frontal portion above the licence plate of the Motor Car at the time of our inspection. It had sustained damages due to the accident.

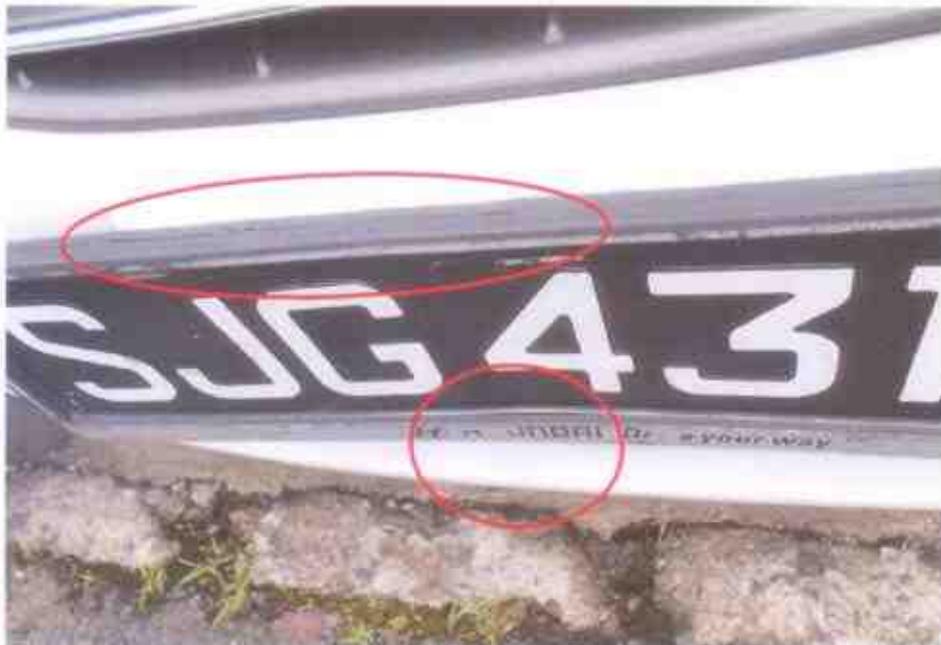
Photo 7 shows a close up view of the frontal portion at the licence plate of the Motor Car at the time of our inspection. It had sustained damages due to the accident.

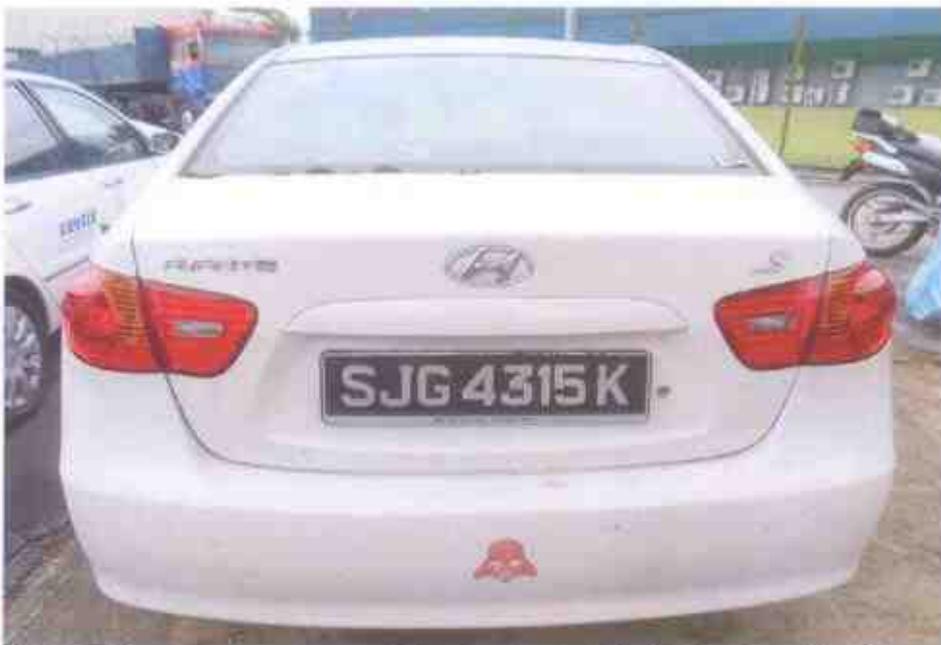
Photo 8 shows a general view of the rear body of the Motor Car at the time of our inspection. The Motor Car was observed to be in good general condition.

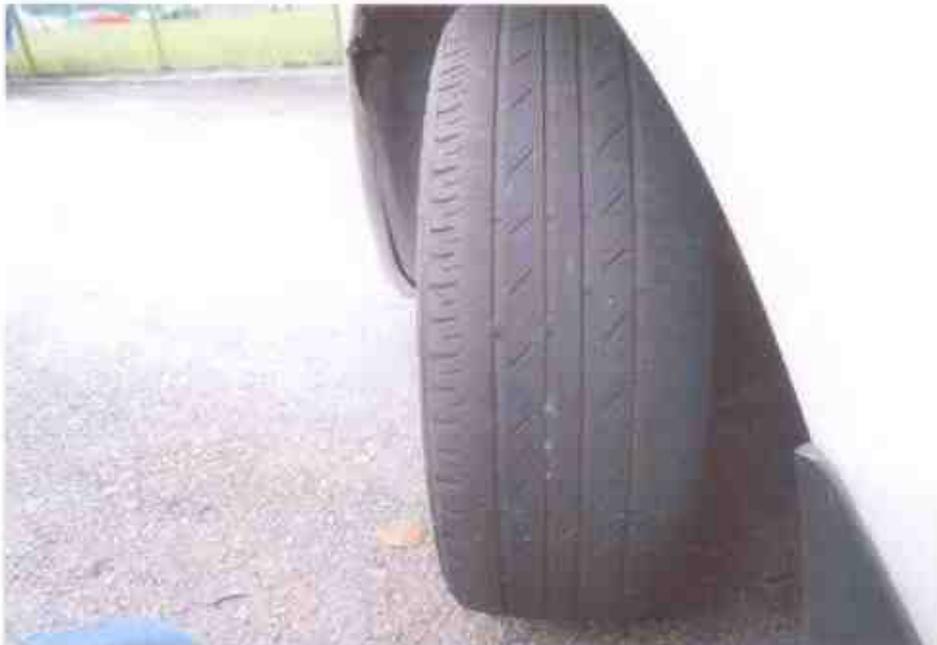
Photo 9 shows the condition of the front left tyre of the Motor Car, which was observed to be in serviceable condition with remaining tread depth of approximately 2mm. The tyre was also observed to be sufficiently inflated for vehicular operation.

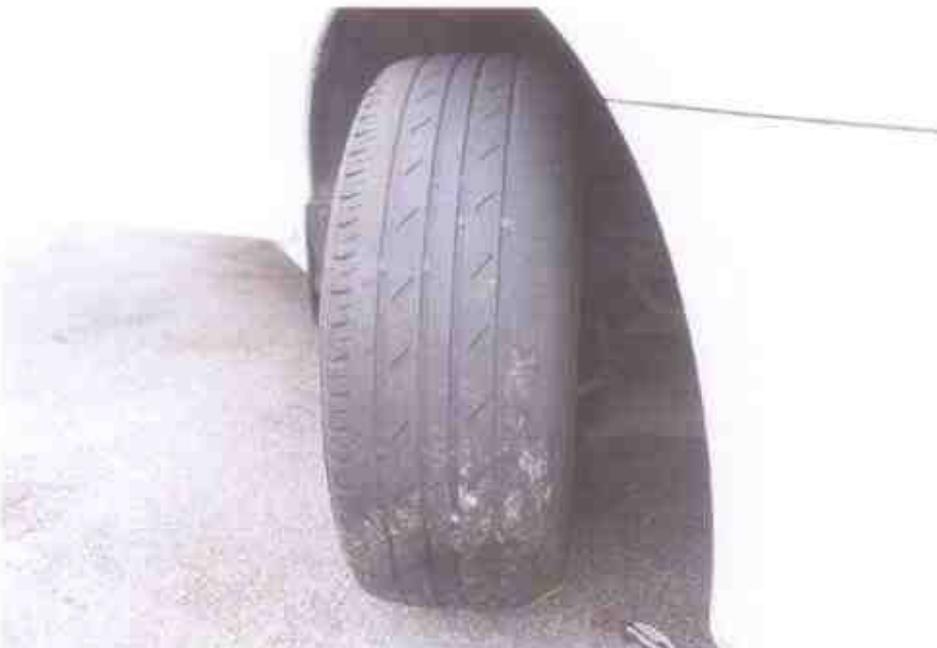
Photo 10 shows the condition of the front right tyre of the Motor Car, which was observed to be in serviceable condition with remaining tread depth of approximately 3mm. The tyre was also observed to be sufficiently inflated for vehicular operation.

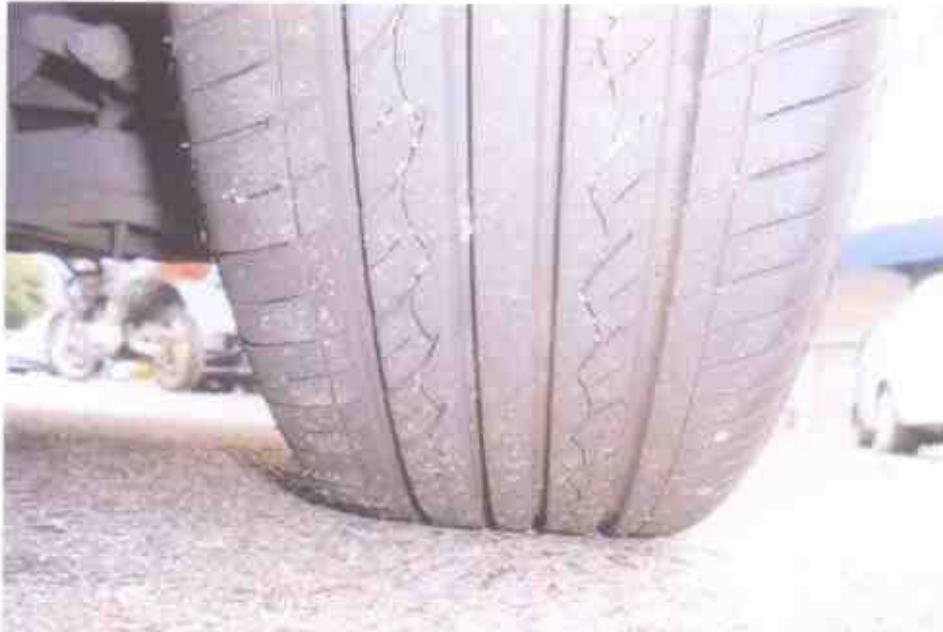
Photo 11 shows the condition of the rear left tyre of the Motor Car, which was observed to be in serviceable condition with remaining tread depth of approximately 6mm. The tyre was also observed to be sufficiently inflated for vehicular operation.

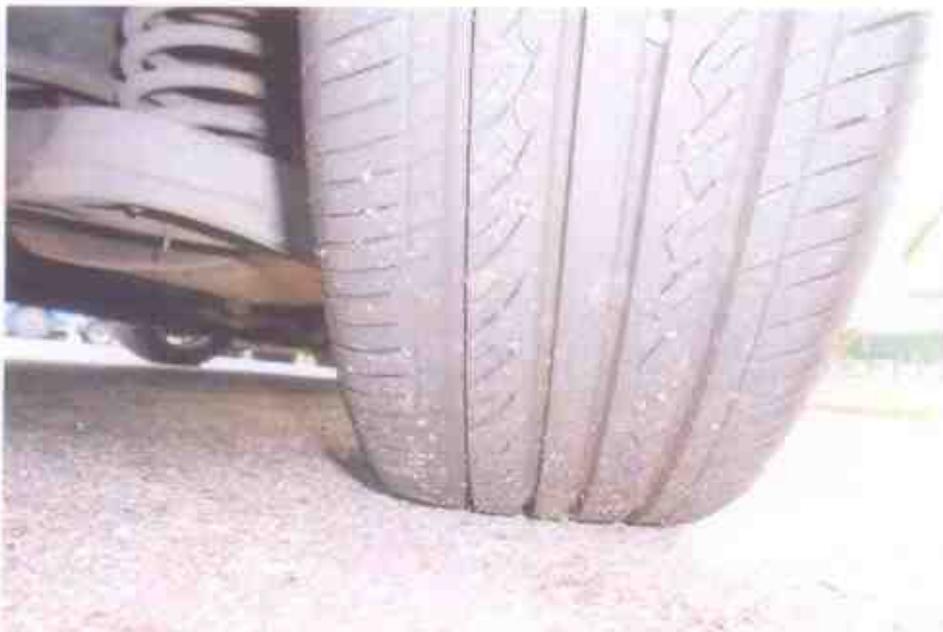
Photo 12 shows the condition of the rear right tyre of the Motor Car, which was observed to be in serviceable condition with remaining tread depth of approximately 6mm.

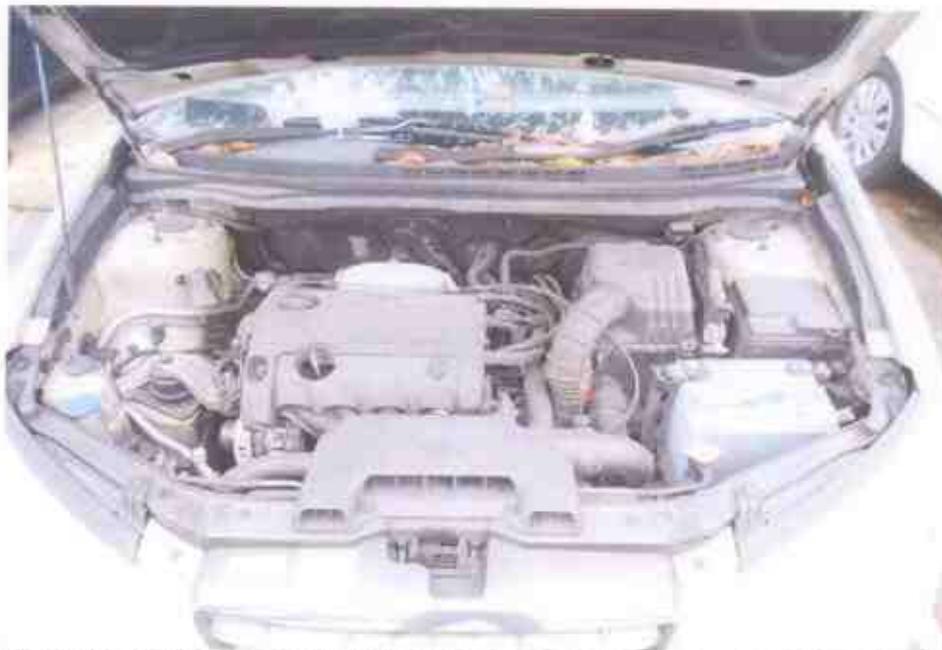
Photo 13 shows a general view of the Motor Car's engine compartment. The various parts and components inside the engine compartment were unaffected by the accident. There was also no sign(s) or indication(s) of fluid leakage and/or fluid stain within the engine compartment.

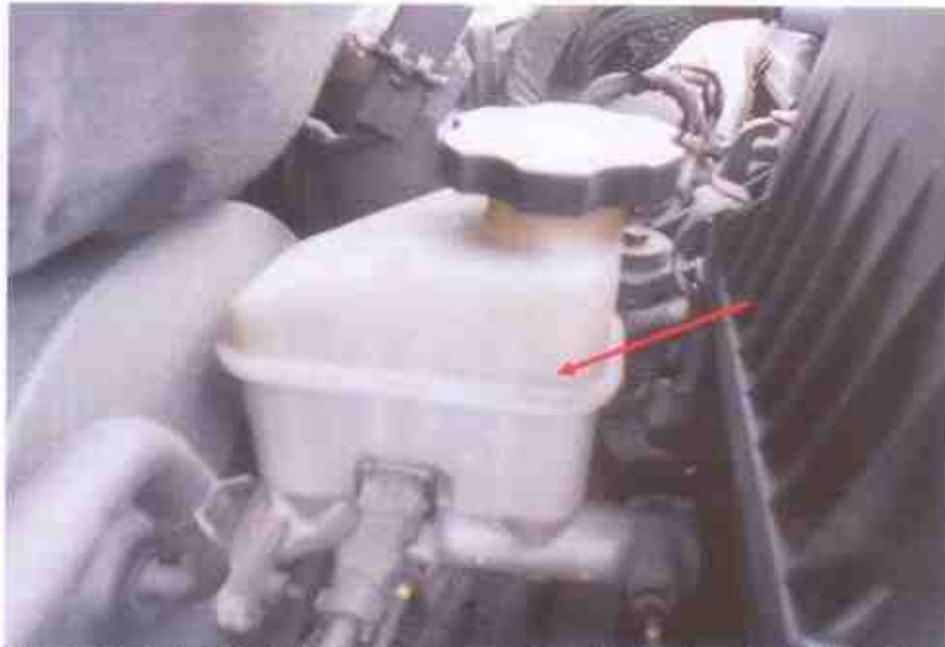
Photo 14 shows the brake fluid reservoir of the Motor Car at the time of our inspection. The brake fluid was observed to be of sufficient level (arrowed) and without any visible contamination.

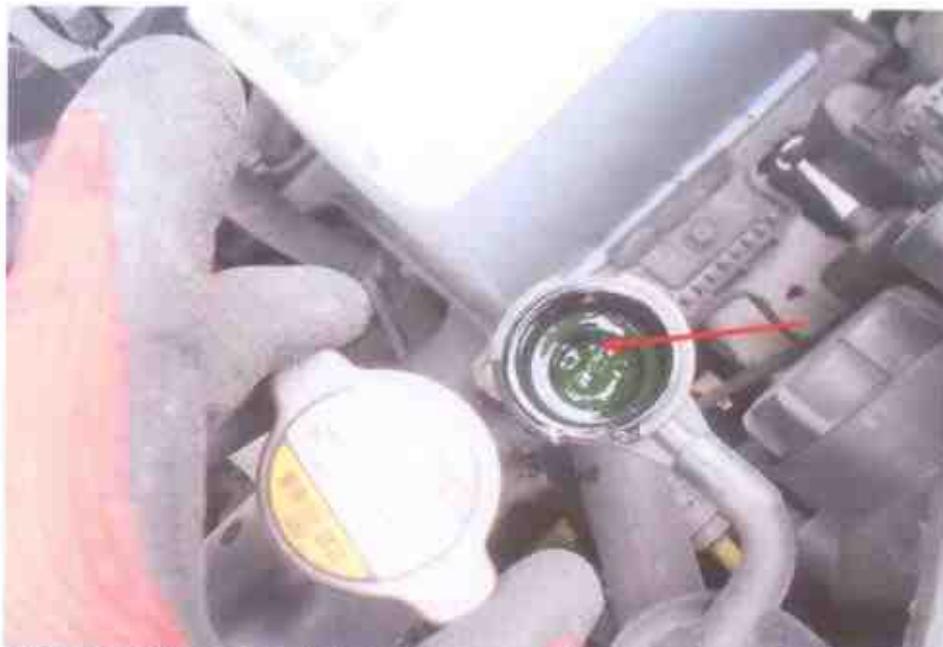
Photo 15 shows the coolant fluid reservoir of the Motor Car at the time of our inspection. The coolant fluid was observed to be of sufficient level and without any visible contamination.

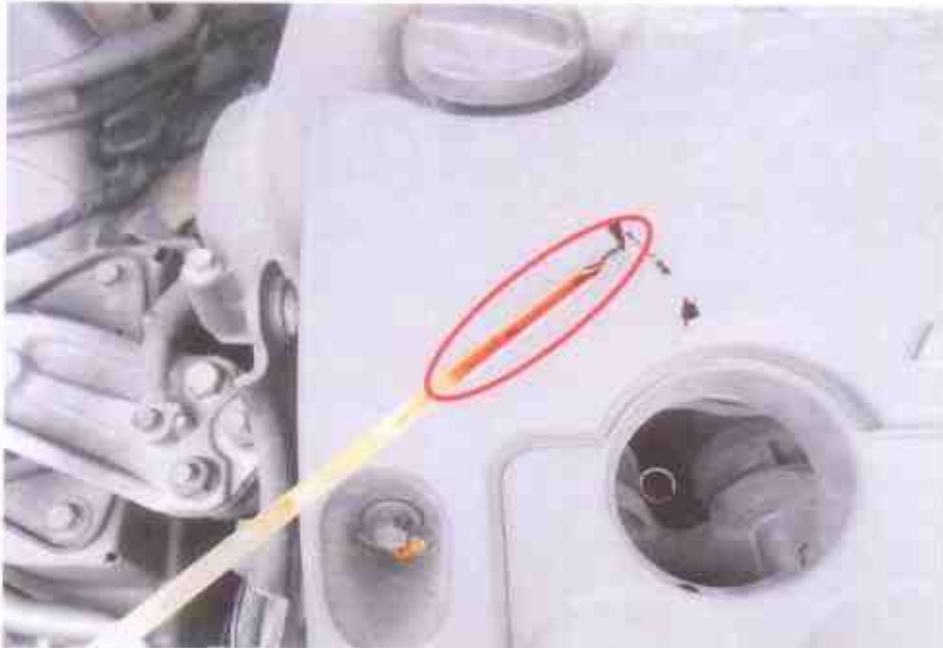
Photo 16 shows the engine oil dip stick of the Motor Car at the time of our inspection. The engine oil was observed to be of sufficient level and without any visible contamination.

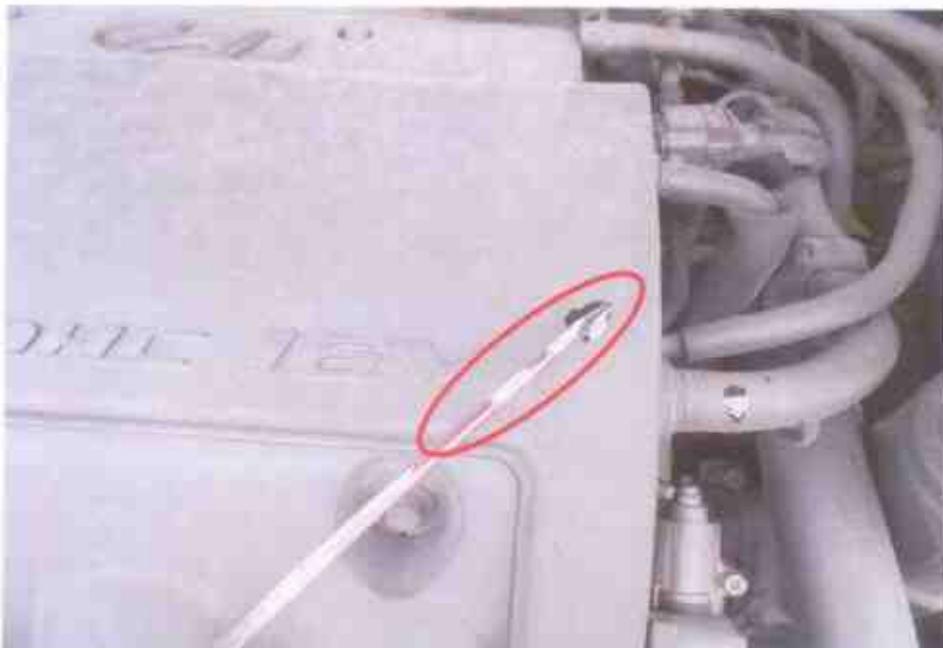
Photo 17 shows the transmission oil dip stick of the Motor Car at the time of our inspection. It was observed to be of sufficient level and without any visible contamination.

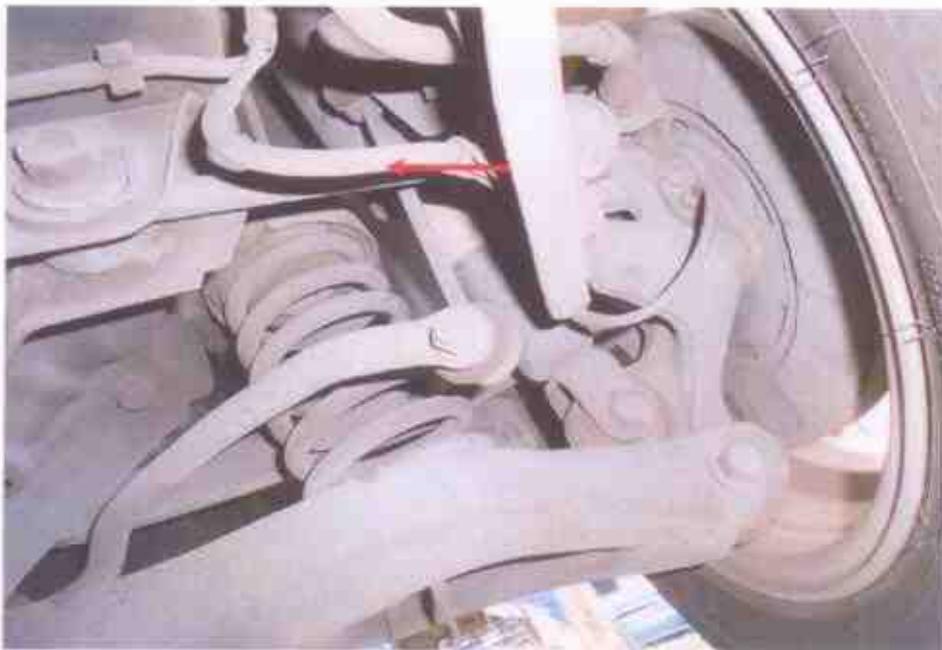
Photo 18 shows the brake hose (arrowed) at the rear left wheel of the Motor Car. Our visual inspection of the various mechanical components of the Motor Car's braking system revealed all to be intact and without visible damage, indicating that the braking system was likely to be in serviceable condition at the material time of accident.

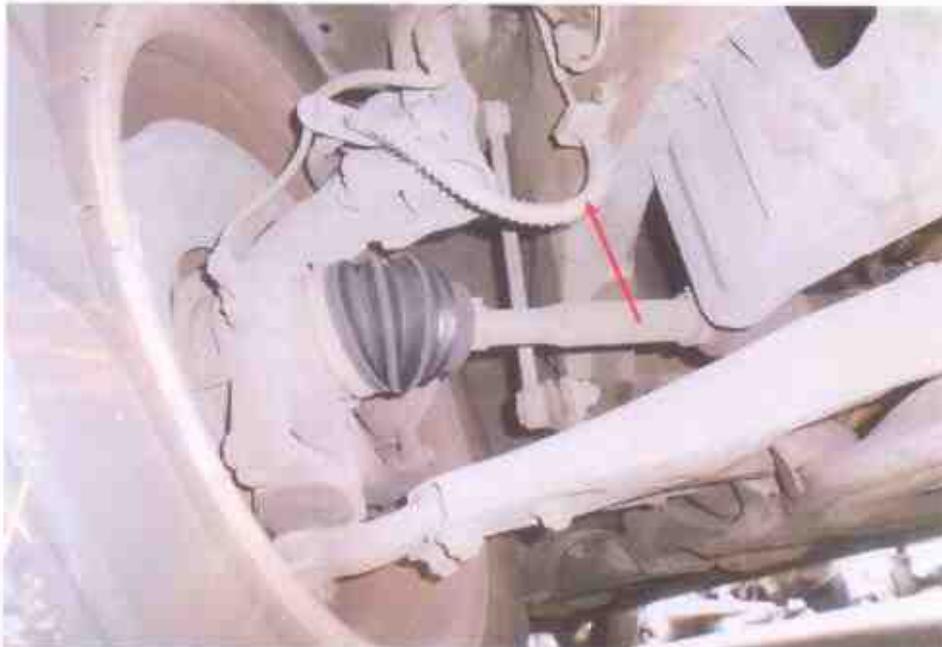
Photo 19 shows the brake hose (arrowed) at the front right wheel of the Motor Car. Our visual inspection of the various mechanical components of the Motor Car's braking system, including its brake calliper, revealed all to be intact and without visible damage, indicating that the braking system was likely to be in serviceable condition at the material time of accident.

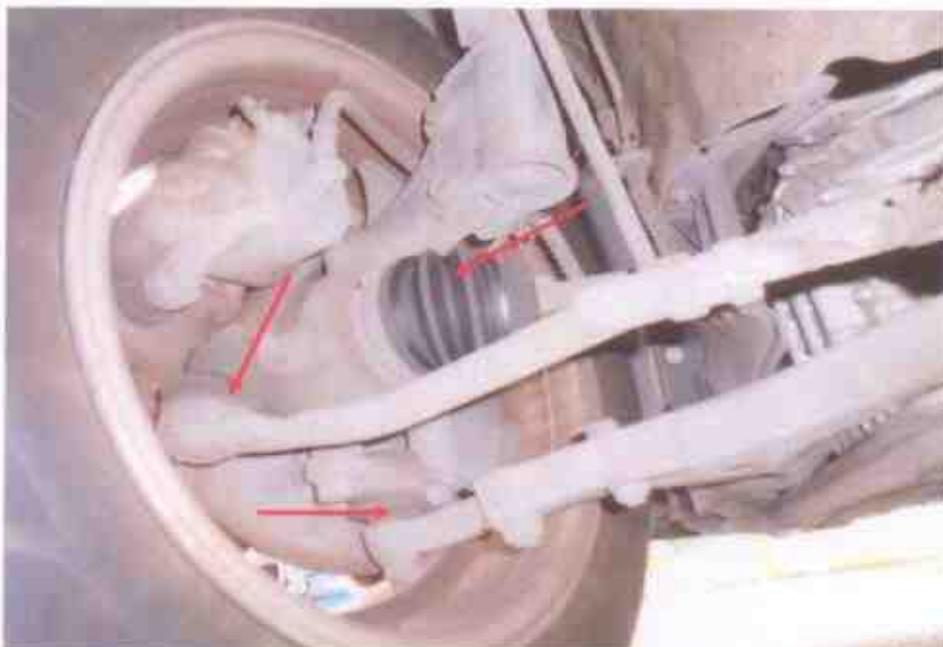
Photo 20 shows the various undercarriage components at the front left wheel of the Motor Car, in particular the steering tie rod (arrowed). The various steering components were all found to be intact, suggesting that the steering system of the Motor Car was likely to be in serviceable condition.

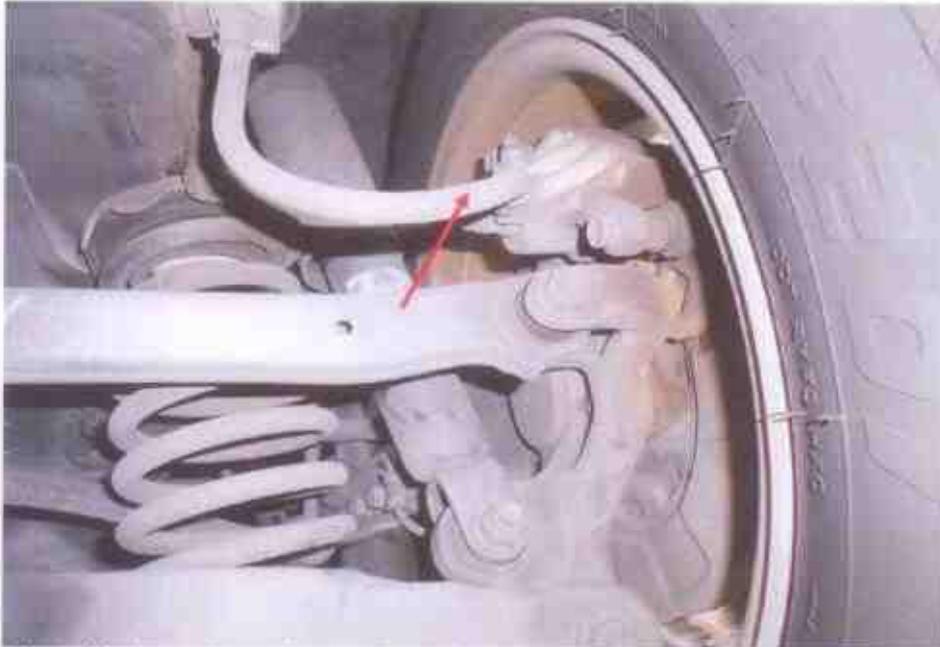
Photo 21 shows the various undercarriage components at the rear right wheel of the Motor Car. We did not observe any leakage of brake fluid at the time of our inspection of the Motor Car. Our visual inspection of the various mechanical components of the Motor Car's braking system revealed all to be intact and without visible damage, indicating that the braking system was likely to be in serviceable condition at the material time of accident.

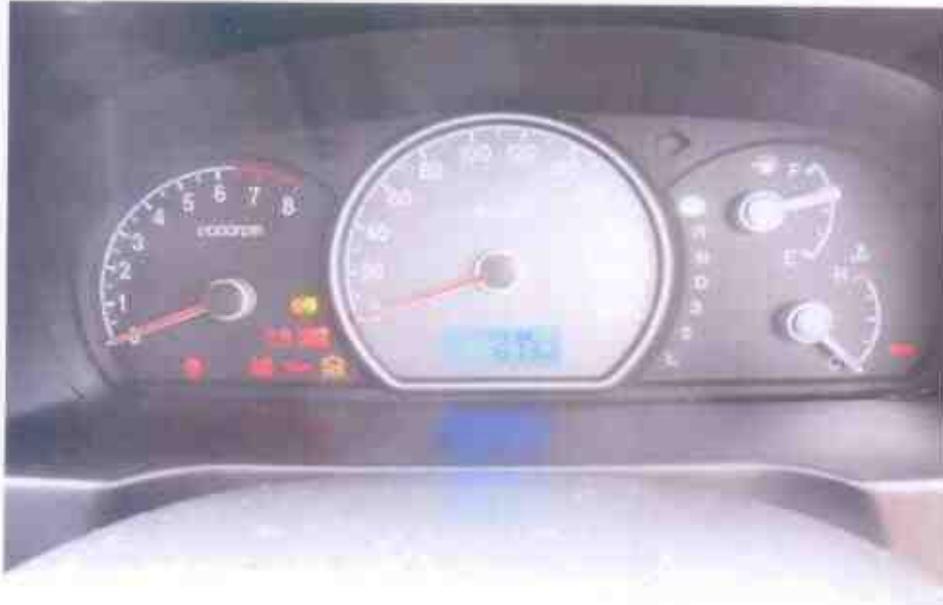
Photo 22 shows the warning lights for the various electronic operating systems of the Motor Car appearing on its instrument panel during the self-test when the engine is cranked, in particular the ABS light and SRS light.

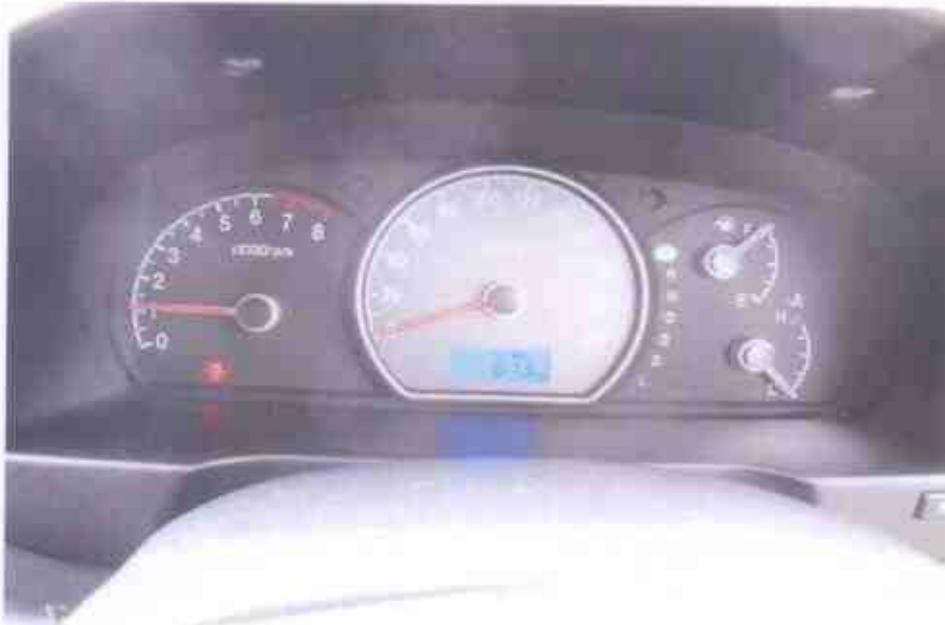
Photo 23 shows no warning lights illuminated on the instrument panel of the Motor Car after the engine was cranked. This would suggest that there was no abnormality to the various electronic operating systems of the Motor Car, like the ABS and SRS.
