Your Ref: TP/IP/20925/2018
Our Ref : CI/TPD18011338/Z

16th January 2019

MECHANICAL INSPECTION REPORT OF MOTOR CAR SJV 9541L

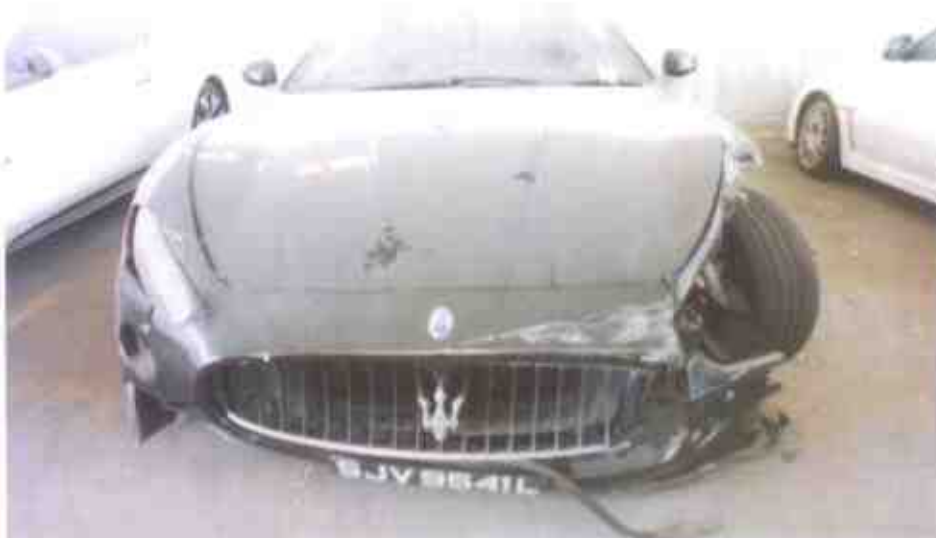
Photo 1 shows a general view of the frontal portion of the Motor Car at the time of our inspection. The Motor Car was observed to have sustained extensive impact damage at its frontal left & right portion. The impact force was significant, causing the various parts and components to be damaged as a result of the accident.

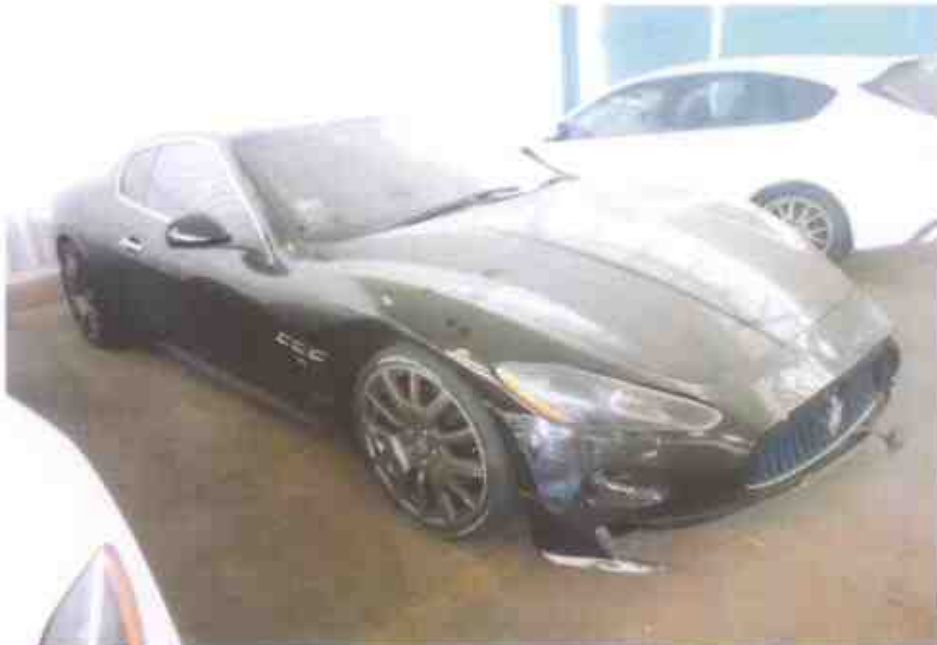
Photo 2 shows a general view of the front right portion of the Motor Car at the time of our inspection. The Motor Car was observed to have sustained damages caused by the accident's impact.

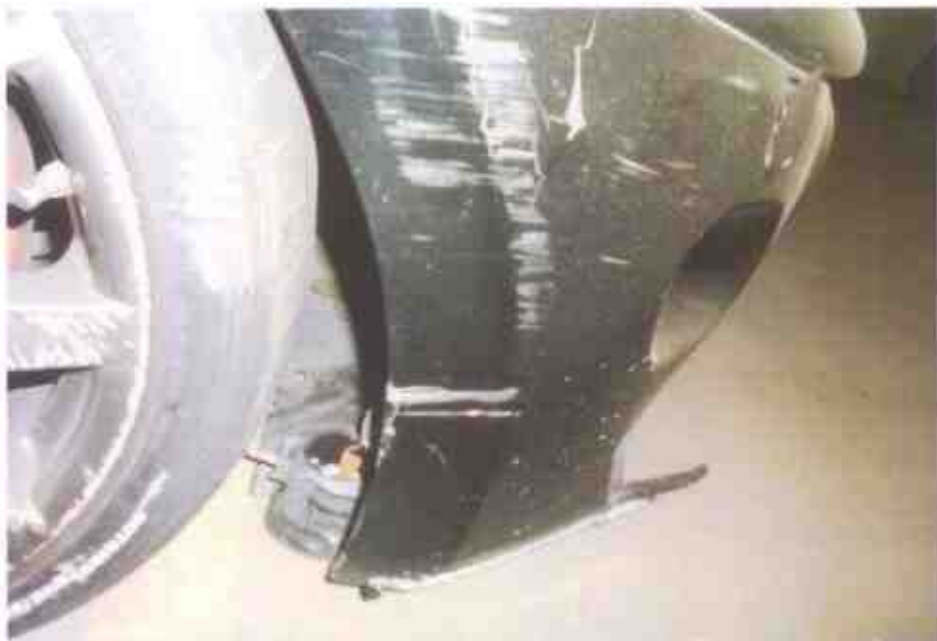
Photo 3 shows a semi close-up view of the front right portion of the Motor Car at the time of our inspection. The Motor Car was observed to have sustained damages caused by the accident's impact.

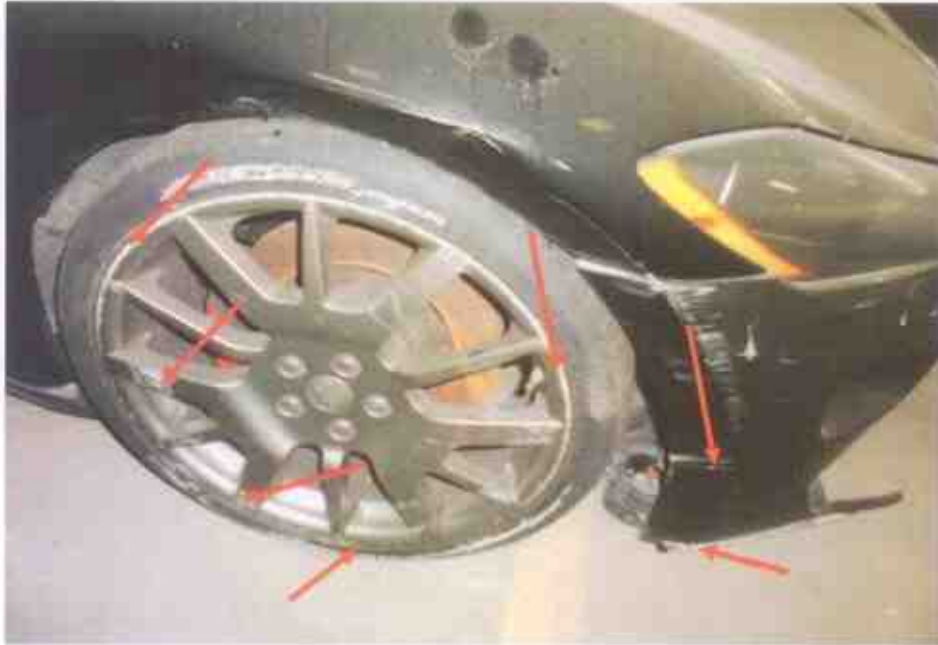
Photo 4 shows the damages at the front right side wheel & front lower right bumper of the Motor Car. Such damages were likely caused by road kerb grazing at the material time of the accident.

20. The damage on the front right was likely caused by the Motor Car grazing against the road kerb along the right of Jalan Kelabu Asap. As the damage pattern of the front right wheel rim is that of powdery residue that is normally associated to grazing concrete object such as road kerb. This would have also occurred before the Motor Car's collision with the parked vehicles given its final rest position.

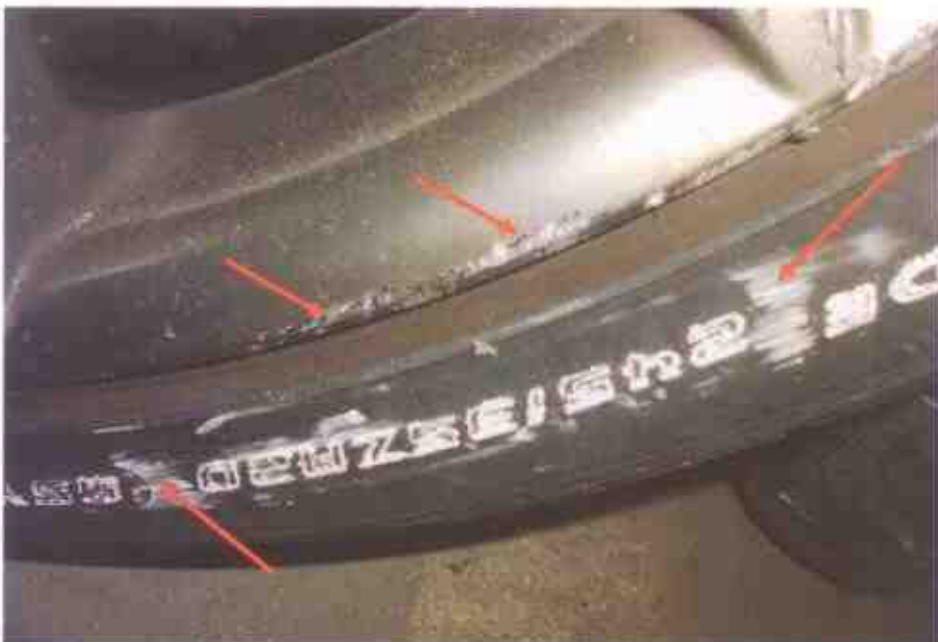
Photo 5 shows a close-up view of the damages at the front right side wheel of the Motor Car. Such damages were likely caused by road kerb grazing at the material time of the accident.

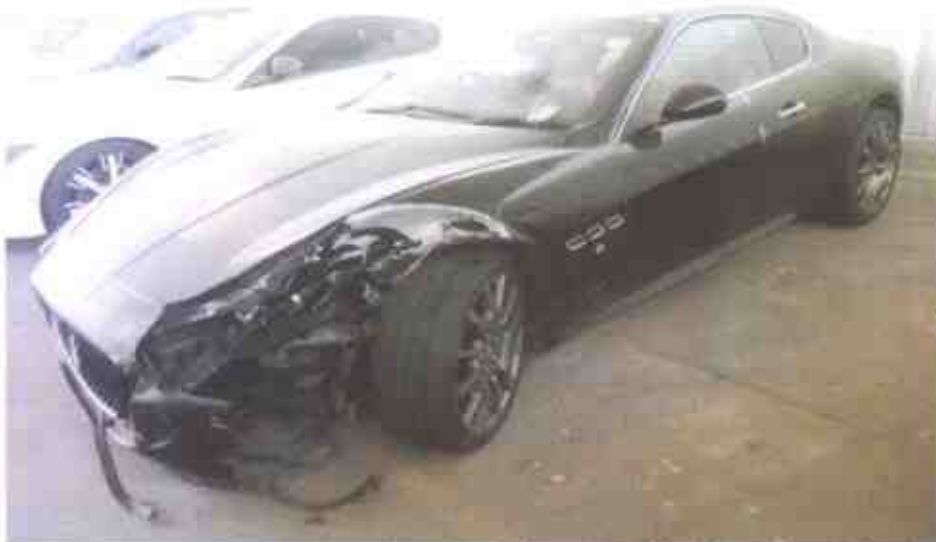
Photo 6 shows a general view of the front left portion of the Motor Car at the time of our inspection. The Motor Car was observed to have sustained extensive impact damage at its front left portion.

19. Furthermore, there were damages found on the left front & right front of the Motor Car, with the left front being caused by collision with the parked Motor Car along the left side of Jalan Kelabu Asap.

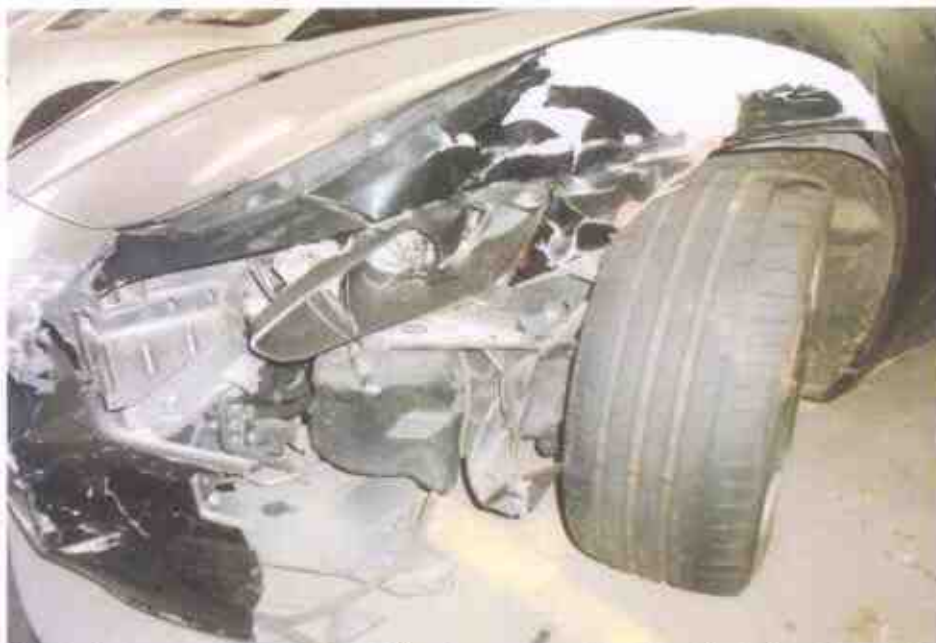
Photo 7 shows a closer view of the damage sustained on the left portion of the Motor Car. The impact force was significant, causing the left portion of the Motor Car to be pushed inwards as a result of the accident.

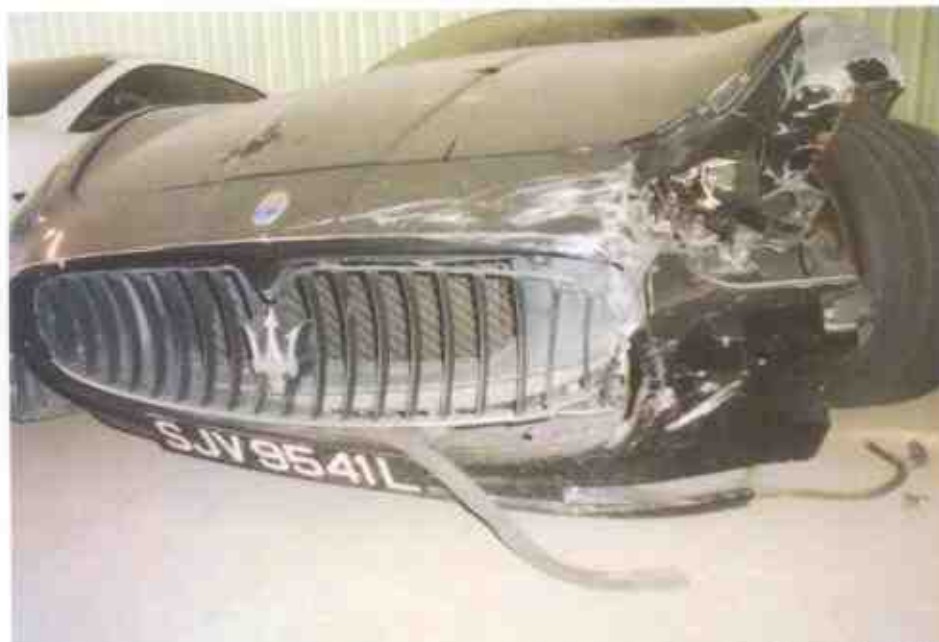
Photo 8 shows a closer view of the damage sustained on the front left of the Motor Car. The impact force was significant, causing the various parts and components such as front bumper, front grille amongst others to be damaged due to the accident's collision impact.

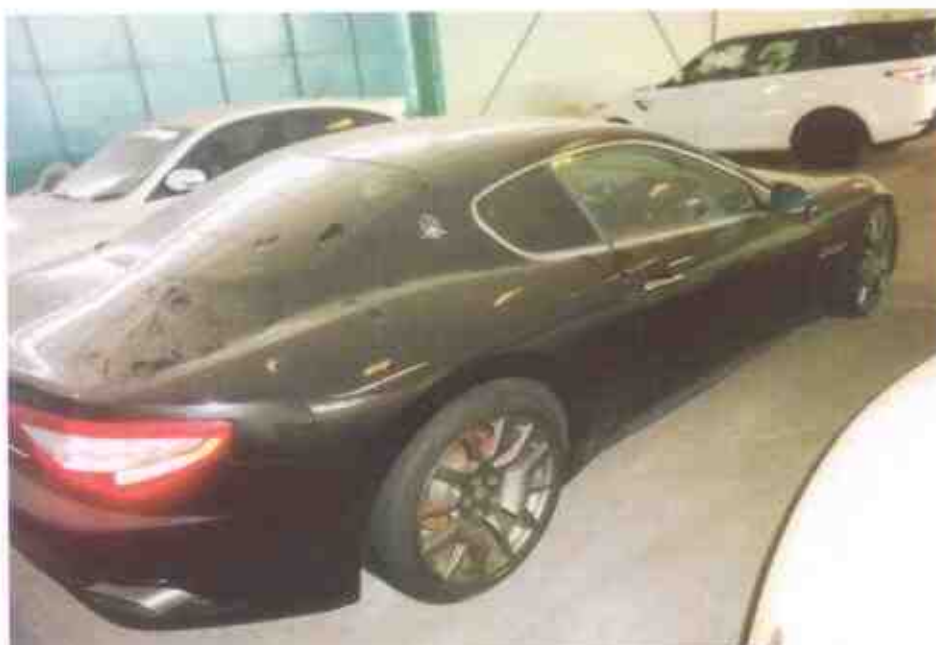
Photo 9 shows a general view of the rear right portion of the Motor Car at the time of our inspection. The rear right portion was observed to be in good condition unaffected by the accident.

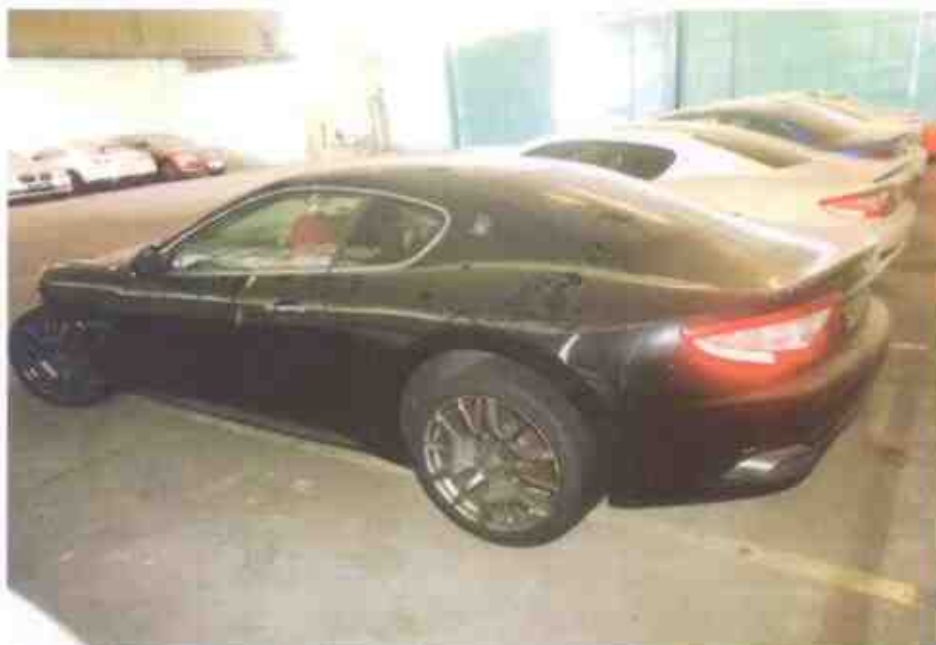
Photo 10 shows a general view of the rear left portion of the Motor Car at the time of our inspection. The rear left portion was observed to be in good condition unaffected by the accident.

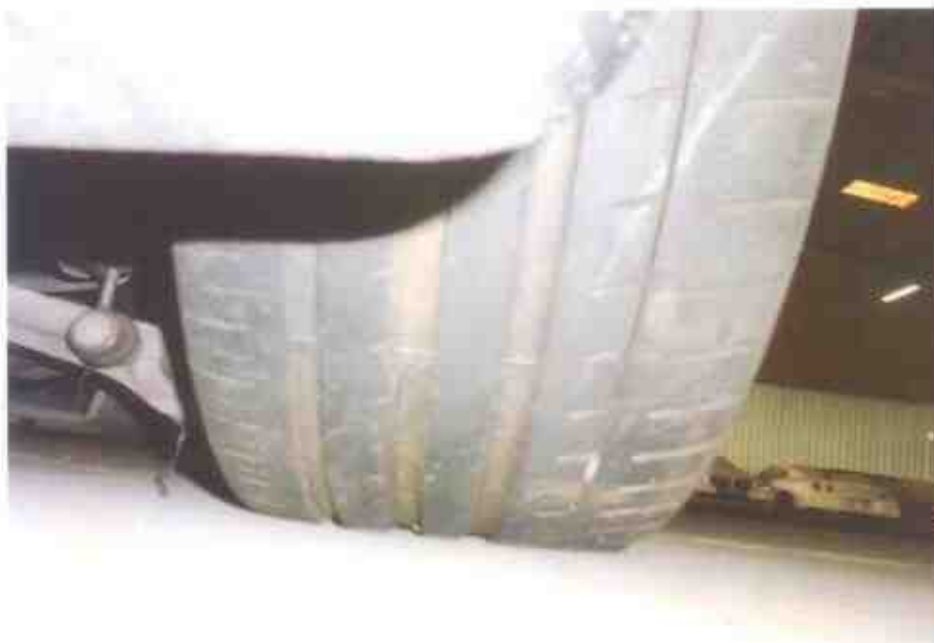
Photo 11 shows the condition of the front right tyre of the Motor Car, which was observed to be in serviceable condition with remaining tread depth of approximately 4mm. There was no tear, cut or burst mark(s) on the outer and the inner sidewalls as well as across the tread of this tyre.

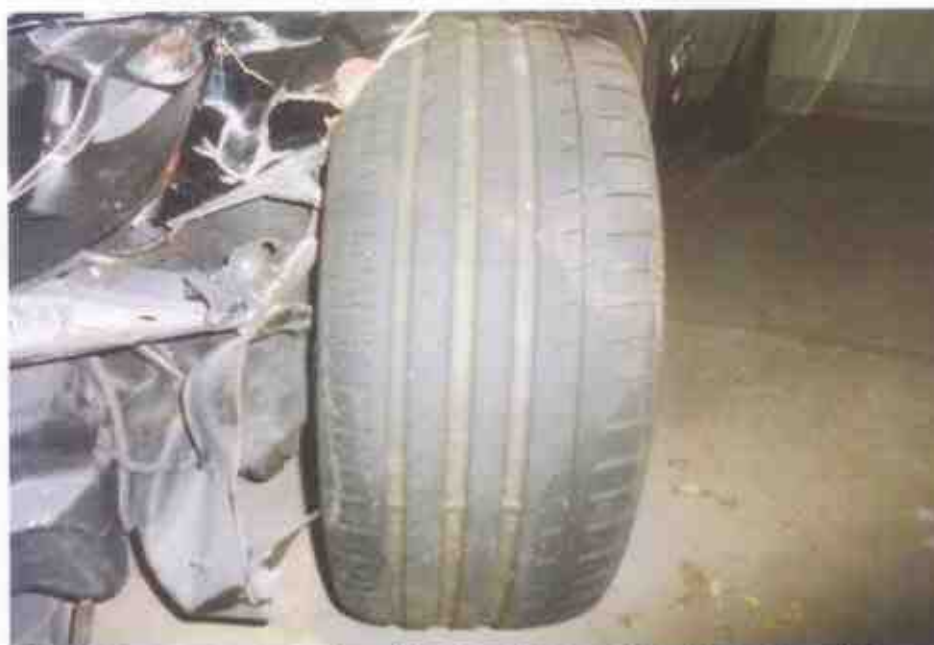
Photo 12 shows the condition of the front left tyre of the Motor Car, which was observed to be in serviceable condition with remaining tread depth of approximately 5mm. There was no tear, cut or burst mark(s) on the outer and the inner sidewalls as well as across the tread of this tyre, which was also sufficiently inflated for vehicular operation.

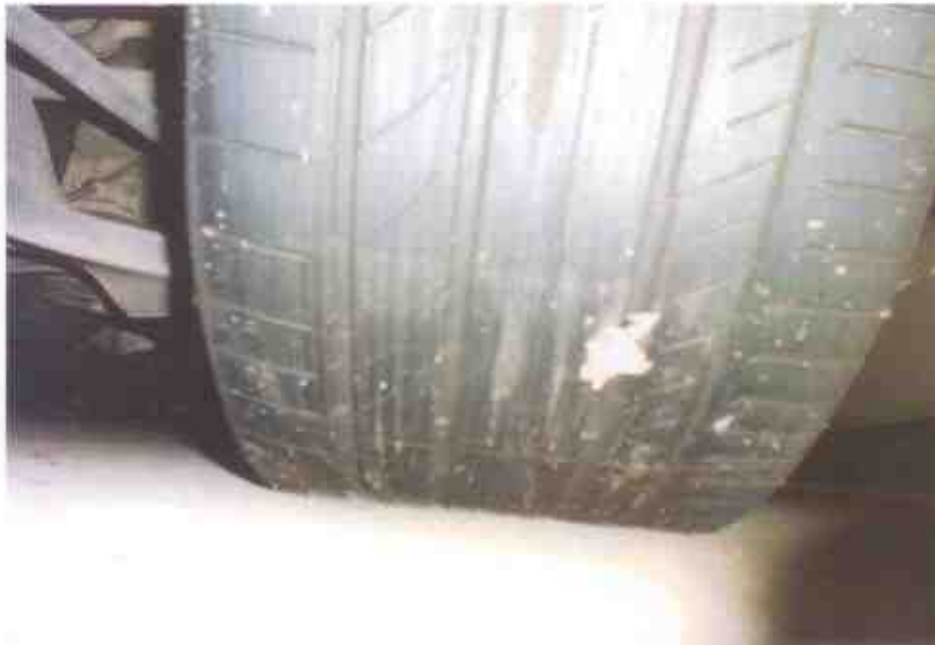
Photo 13 shows the condition of the rear right tyre of the Motor Car, which was observed to be in serviceable condition with remaining tread depth of approximately 3mm. There was also no tear, cut or burst mark(s) on the outer and the inner sidewalls as well as across the tread of this tyre.

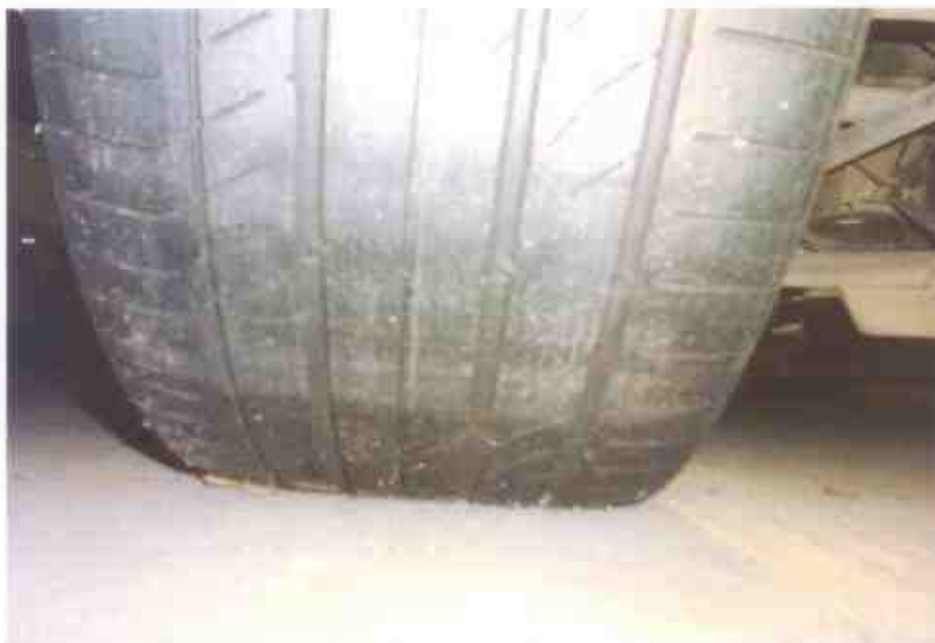
Photo 14 shows the condition of the rear left tyre of the Motor Car, which was observed to be in serviceable condition with remaining tread depth of approximately 3mm. There was also no tear, cut or burst mark(s) on the outer and the inner sidewalls as well as across the tread of this tyre.

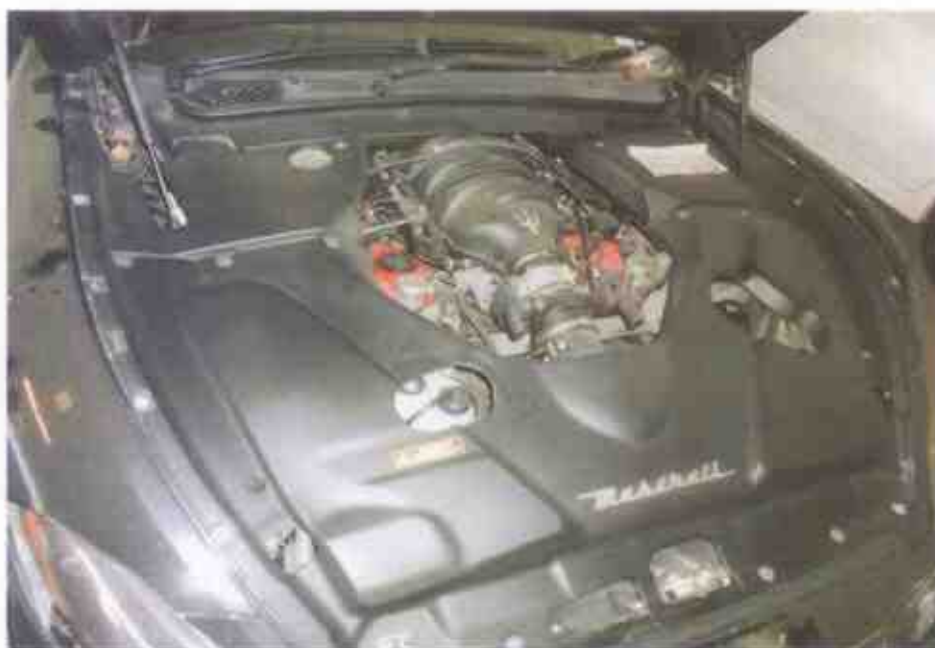
Photo 15 shows a general view of the Motor Car's engine compartment. The various parts and components inside the engine compartment were unaffected by the accident. There was also no sign(s) or indication(s) of fluid leakage and/or fluid stain within the engine compartment.

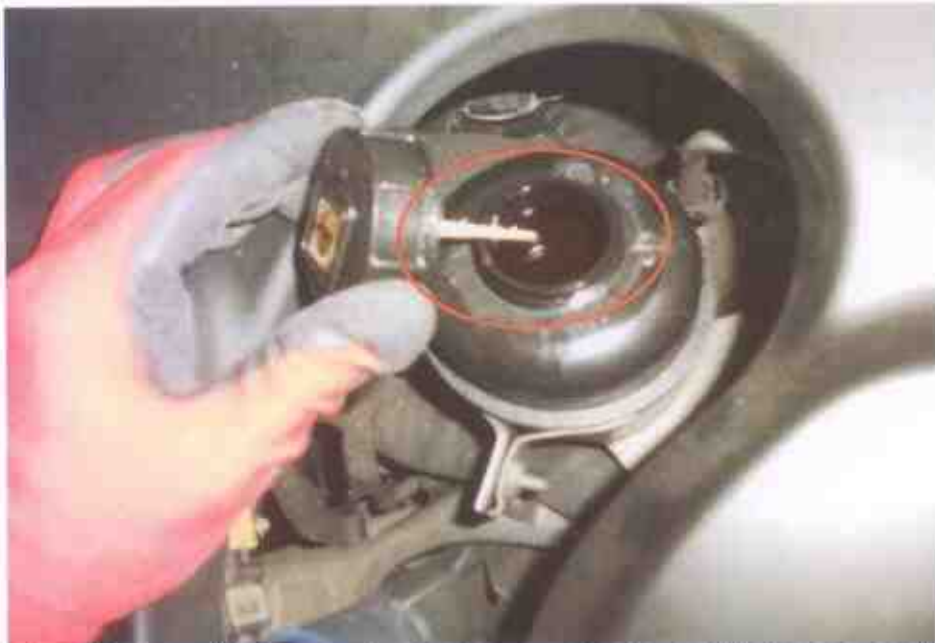
Photo 16 shows the close up view of the power steering fluid that was seen with sufficient level not affected by the accident's impact

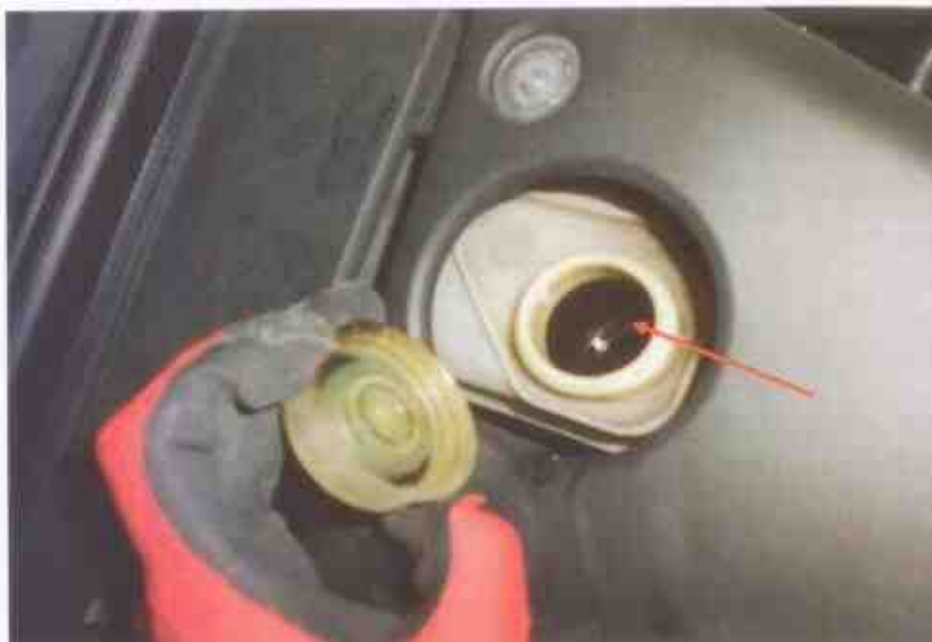
Photo 17 shows the close up view of the brake fluid that was seen with sufficient level not affected by the accident's impact.

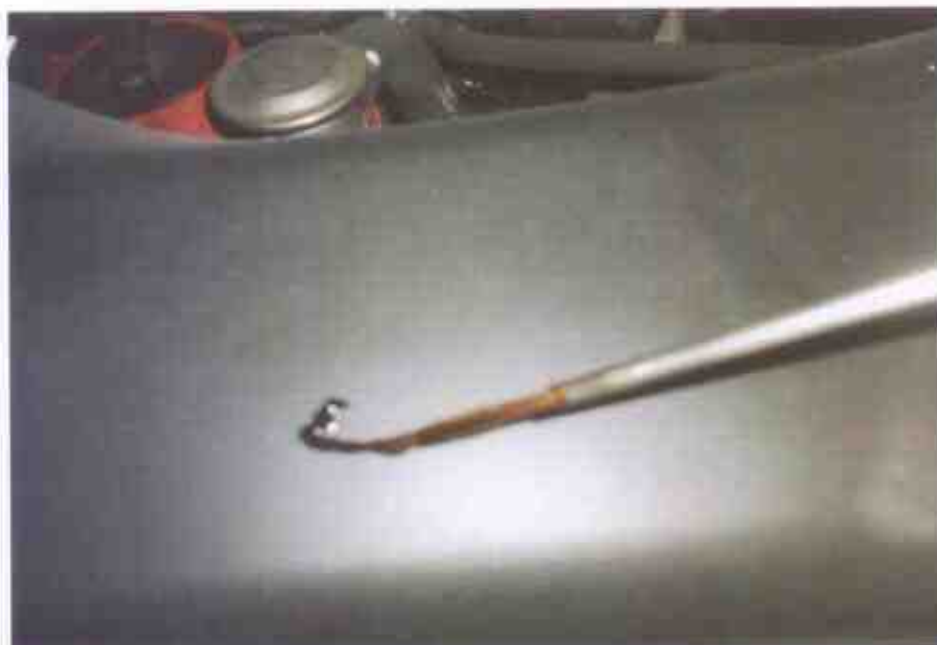
Photo 18 shows the engine oil dip stick of the Motor Car at the time of our inspection. The engine oil was observed to be of sufficient level and without any visible contamination.

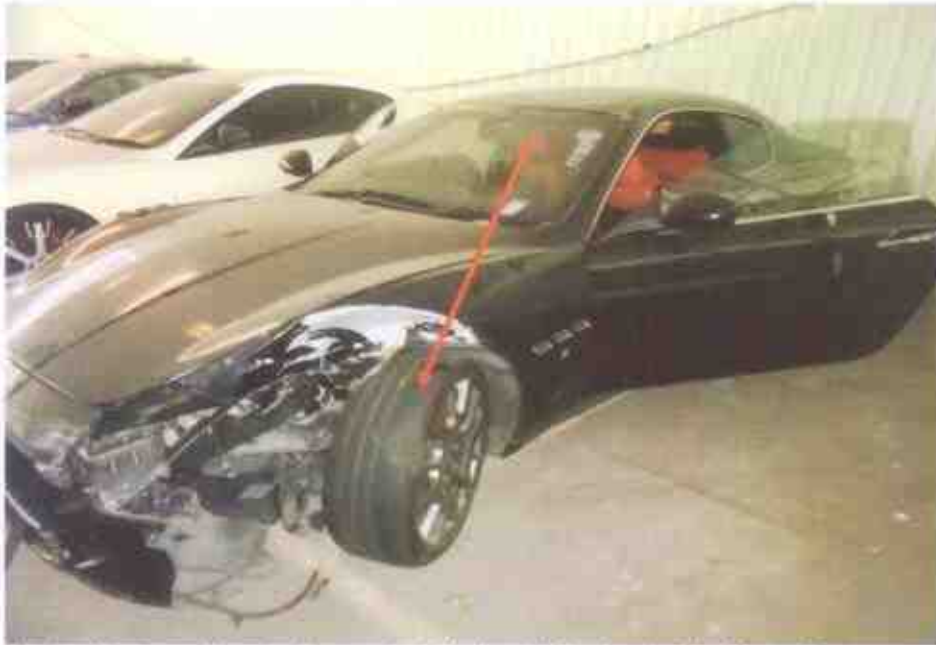
Photo 19 shows the misalignment at the front left wheel of the Motor Car.

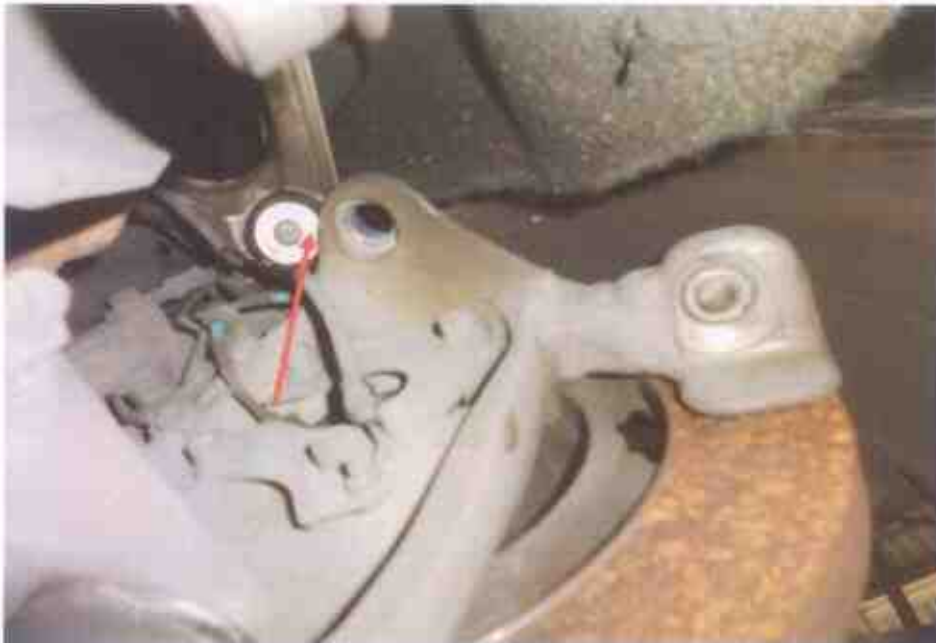
Photo 20 shows the dislodged upper arm that was observed to be damaged likely due to the accident's impact.

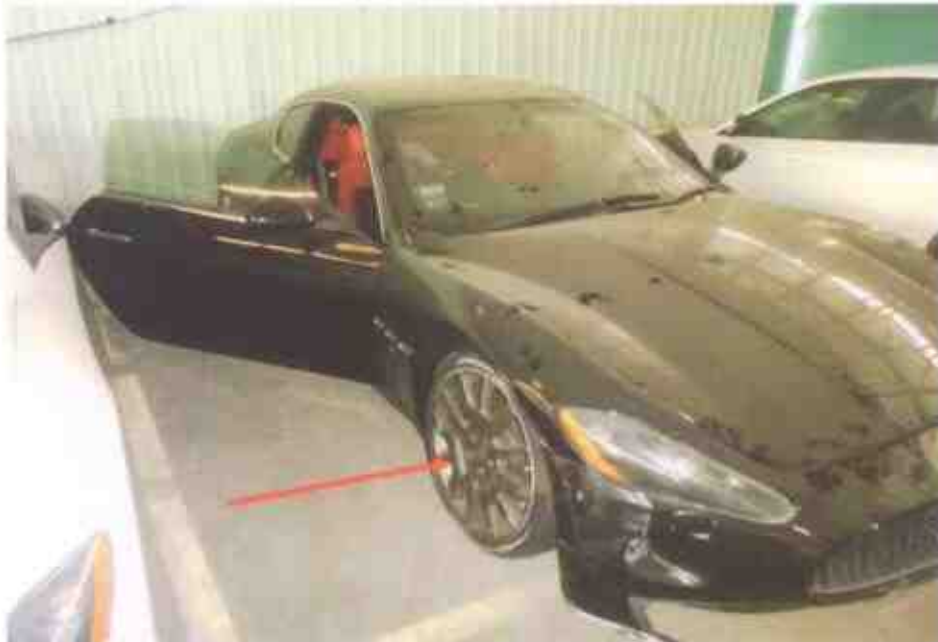
Photo 21 shows the correct alignment at the front right side wheel of the Motor Car. However, further investigation found broken supporting part (upper arm) likely due to the accident's collision impact.

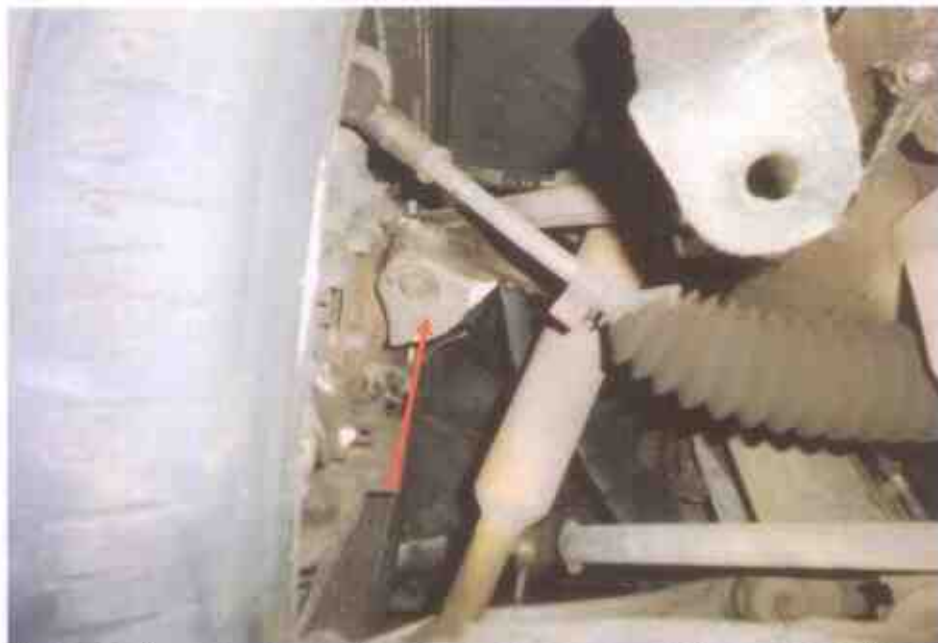
Photo 22 shows the front right side wheel upper arm that was observed to be broken/damaged likely due to the accident's impact.

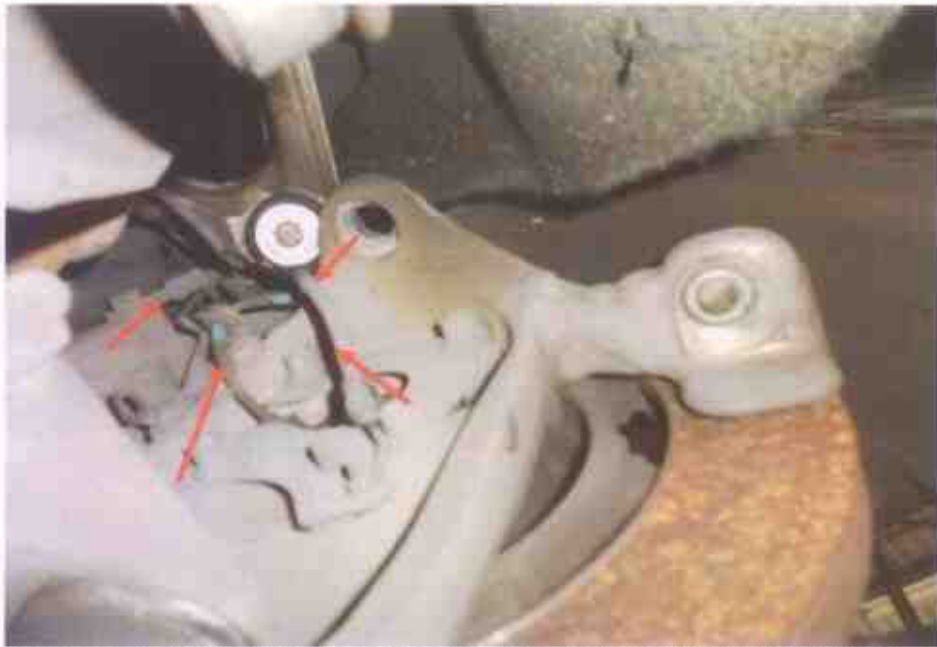
Photo 23 shows the braking components at the front left wheel of the Motor Taxi. We did not observe any leakage of brake fluid at the time of our inspection of the Motor Car.

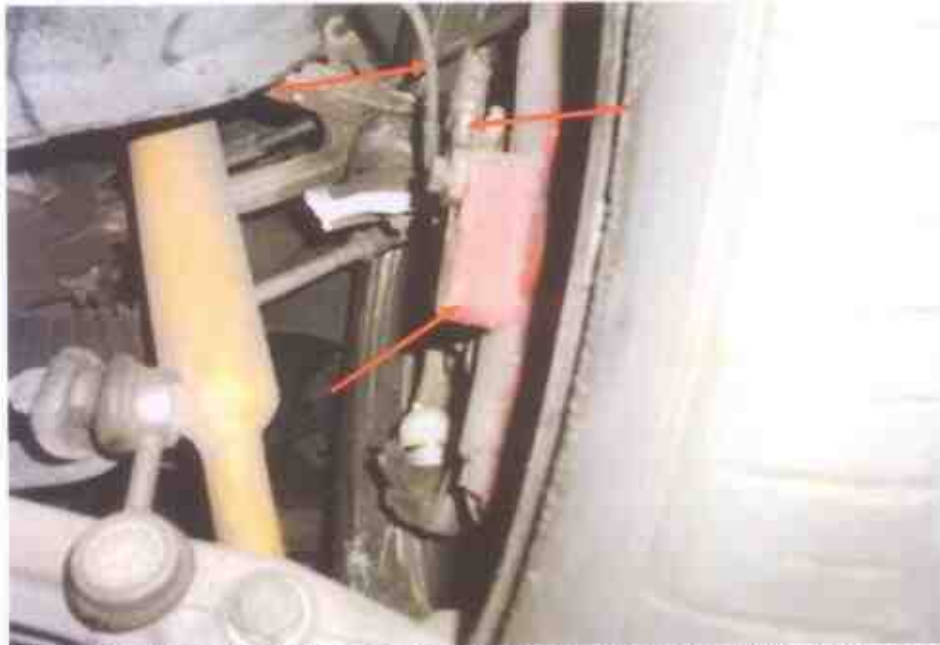
Photo 24 shows the braking components at the front right wheel of the Motor Car. We did not observe any leakage of brake fluid at the time of our inspection of the Motor Car.

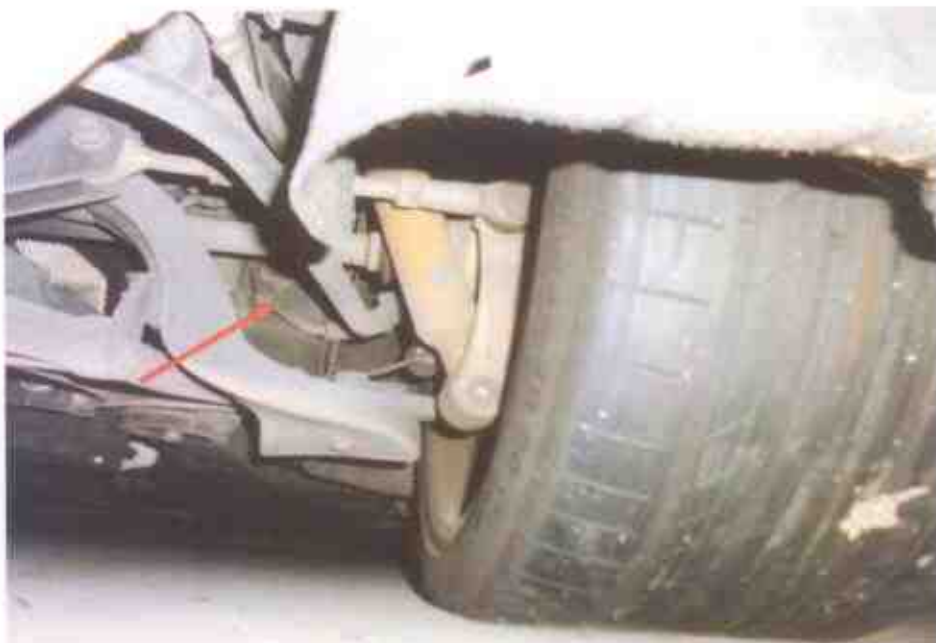
Photo 25 shows the braking components at the rear right wheel of the Motor Car. We did not observe any leakage of brake fluid at the time of our inspection of the Motor Car.

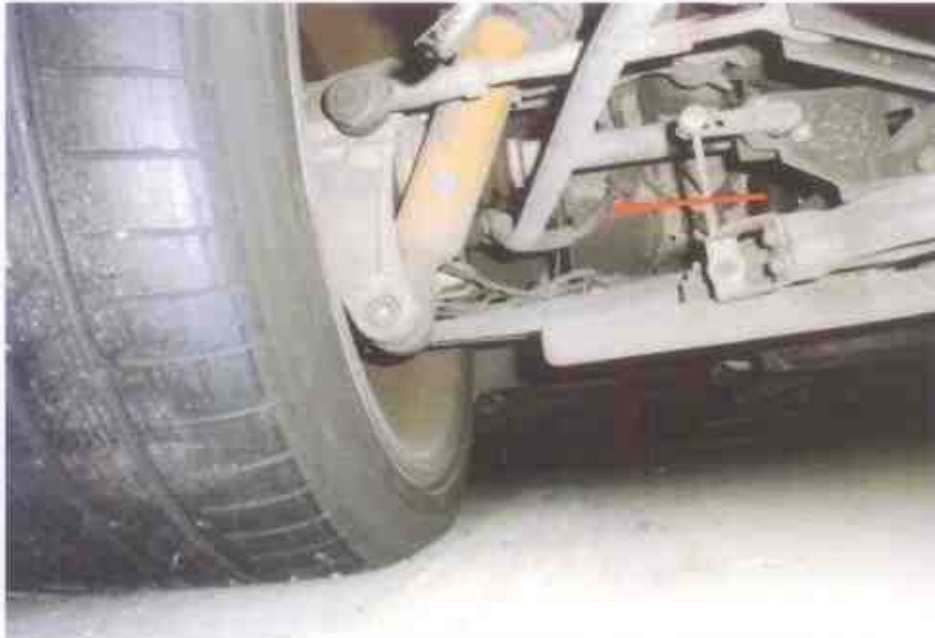
Photo 26 shows the braking components at the rear right wheel of the Motor Car. We did not observe any leakage of brake fluid at the time of our inspection of the Motor Car.
