Your Ref: TP/IP/22879/2018  
Our Ref : CI/TPD18011339/Z

**Fatal Accident Investigation Team**  
Traffic Police Department  
Singapore Police Force  
10 Ubi Avenue 3  
Singapore 408865

#### **MECHANICAL INSPECTION REPORT OF MOTOR BUS PC 6692H.**

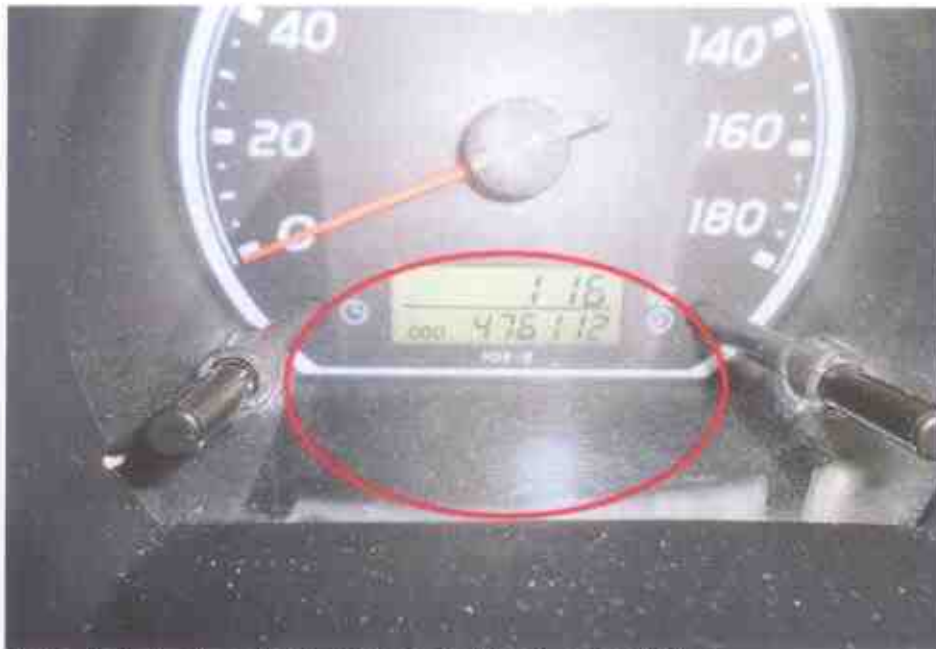
Photo 1 shows the mileage of the Motor Bus was 476112km.

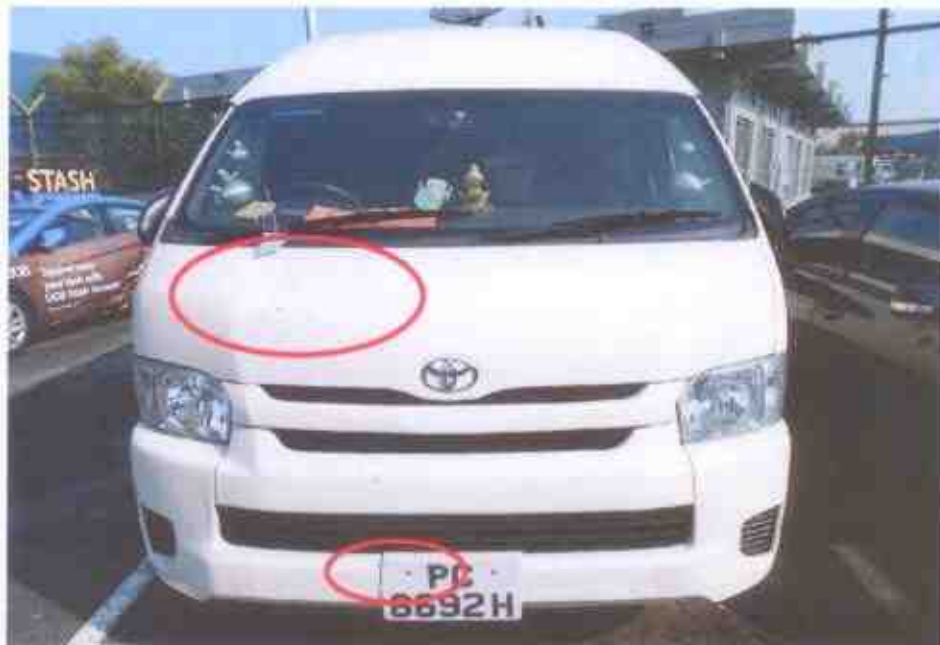
Photo 2 shows a general view of the front right body of the Motor Bus at the time of our inspection. The Motor Bus was observed to sustained minor damage at the front right panel & lower bumper.

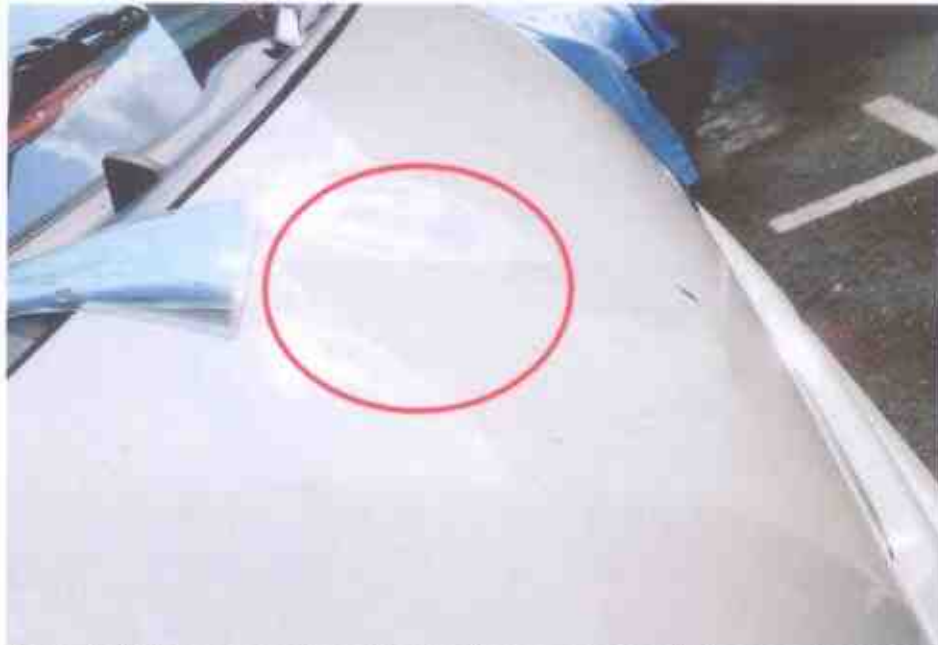
**Photo 3** shows a close-up view of the dent on the front left panel of the Motor Bus at the time of our inspection. It was observed to have sustained with minor damage likely due to the accident.

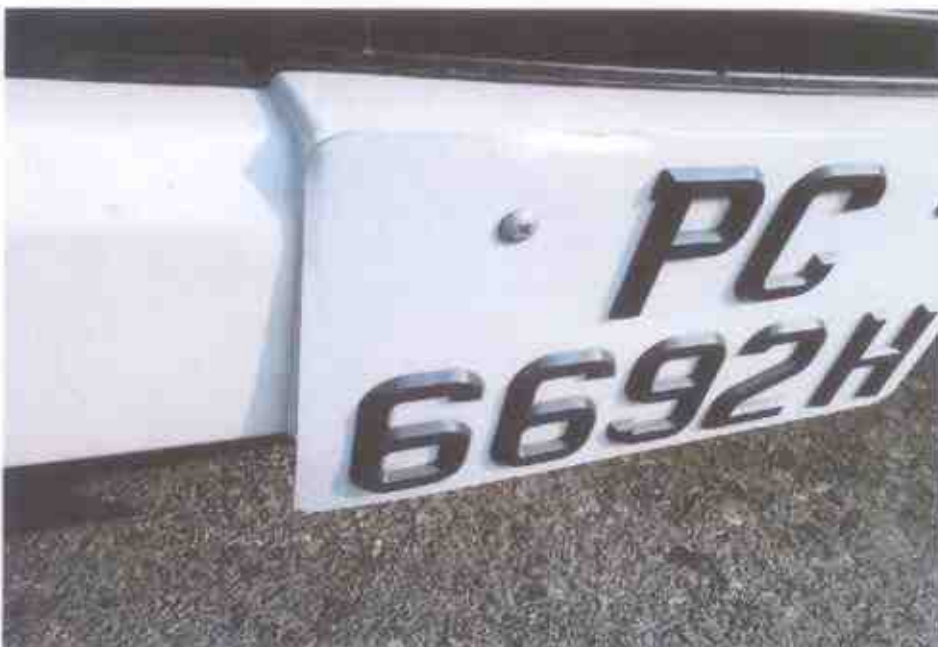
**Photo 4** shows a close-up view of the dent on the front licence plate of the Motor Bus at the time of our inspection. It was observed to have sustained with minor damage likely due to the accident.

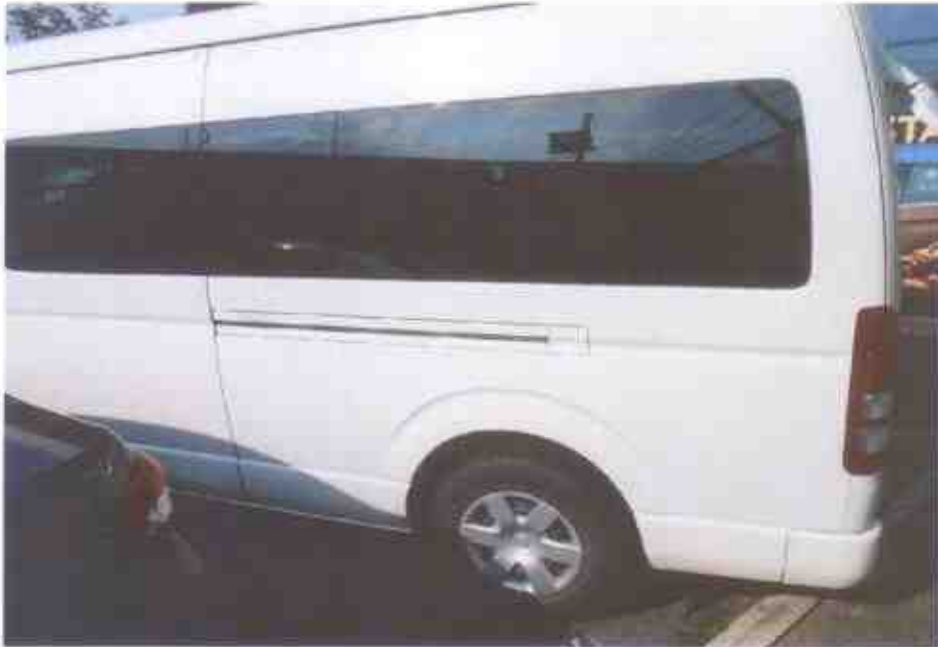
**Photo 5** shows a general view of the rear left body of the Motor Bus at the time of our inspection. The Motor Bus was observed to be in good general condition at time of inspection.

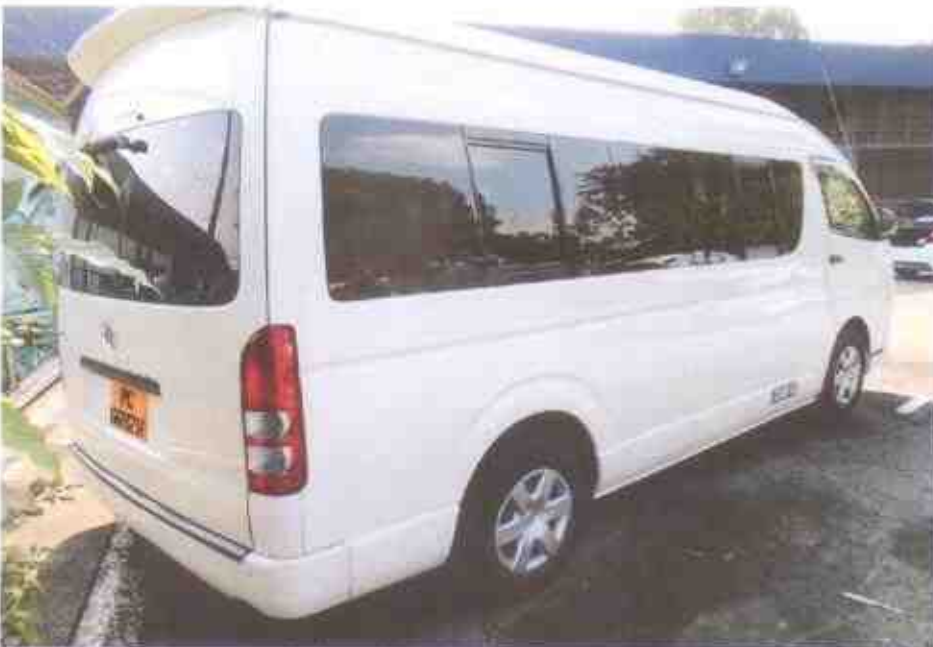
**Photo 6** shows a general view of the rear right body of the Motor Bus at the time of our inspection. The Motor Bus was observed to be in good general condition at time of inspection.

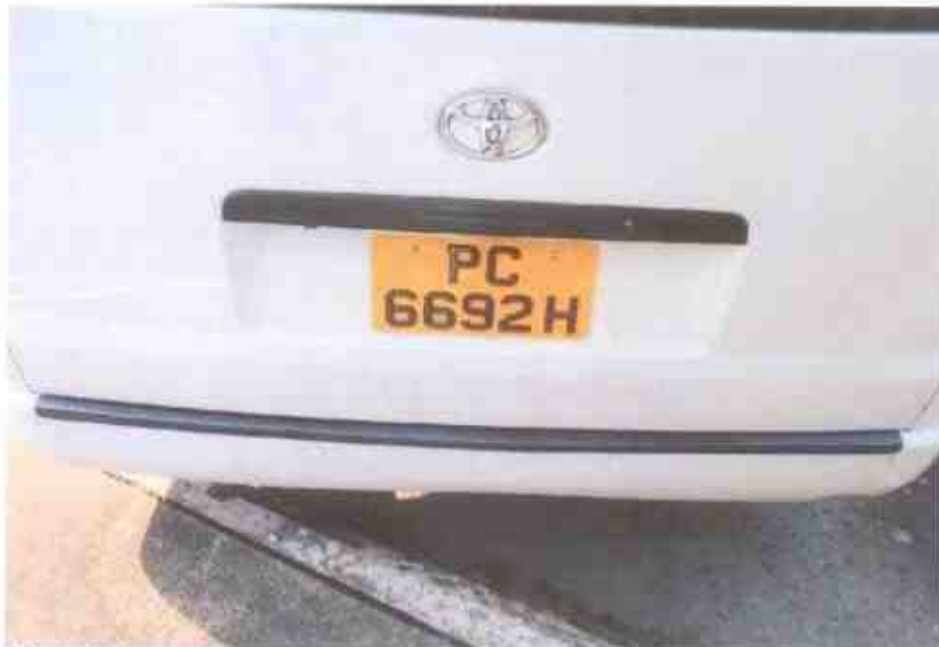
**Photo 7** shows a general view of the rear body of the Motor Bus at the time of our inspection. The Motor Bus was observed to be in good general condition at time of inspection.

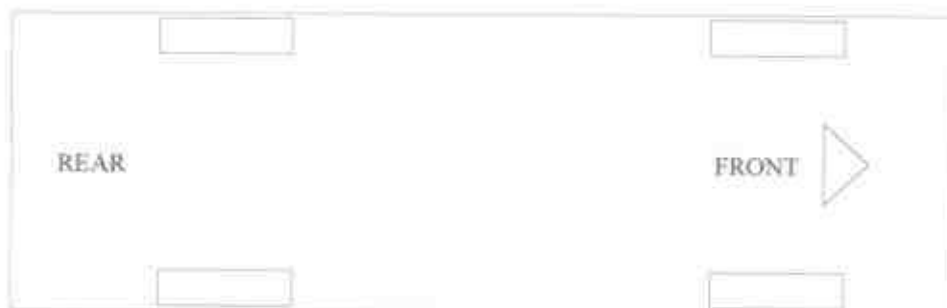
7. The 4 tyres were observed to be in serviceable condition and sufficiently inflated for vehicular operation. We did not find any tear, cut or burst mark(s) on the outer and the inner sidewalls as well as across the tread of the 4 tyres. The tyre brand, tyre size and remaining tread depth of the 4 tyres of the Motor Bus were recorded as follows:-

Dunlop SP175n 195/80R15 (7mm)

Dunlop SP175n 195/80R15 (8mm)

Dunlop SP175n 195/80R15 (6mm)

Bridgestone RD-613 Steel195/80R15  
(8mm)

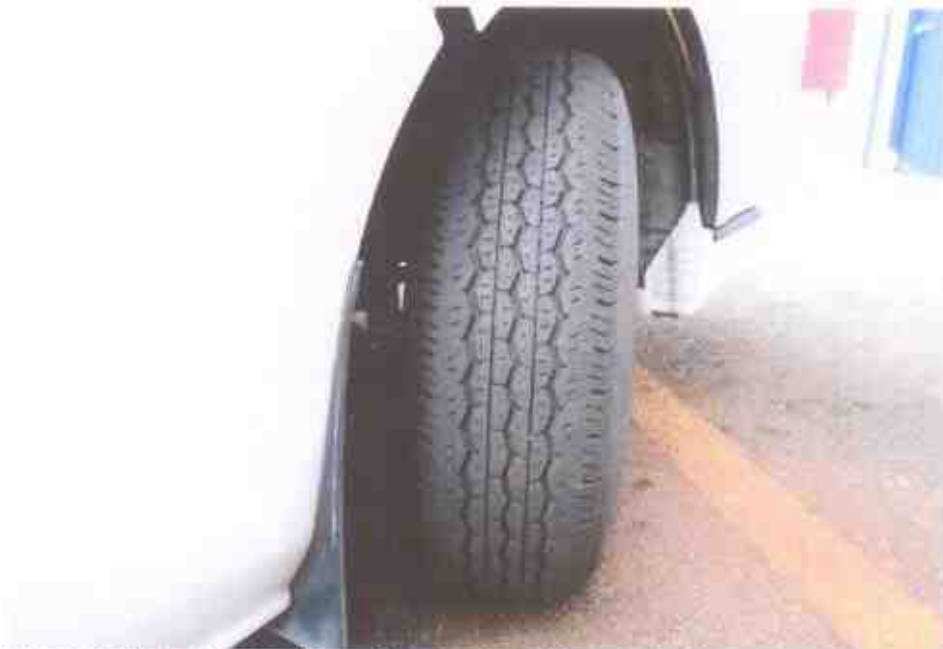
Photo 8 shows the condition of the front right tyre of the Motor Bus, which was observed to be in serviceable condition with remaining tread depth of approximately 8mm. The tyres were all observed to be sufficiently inflated for vehicular operation with no tear, cut or burst mark(s) on the outer and the inner sidewalls as well as across the tread.

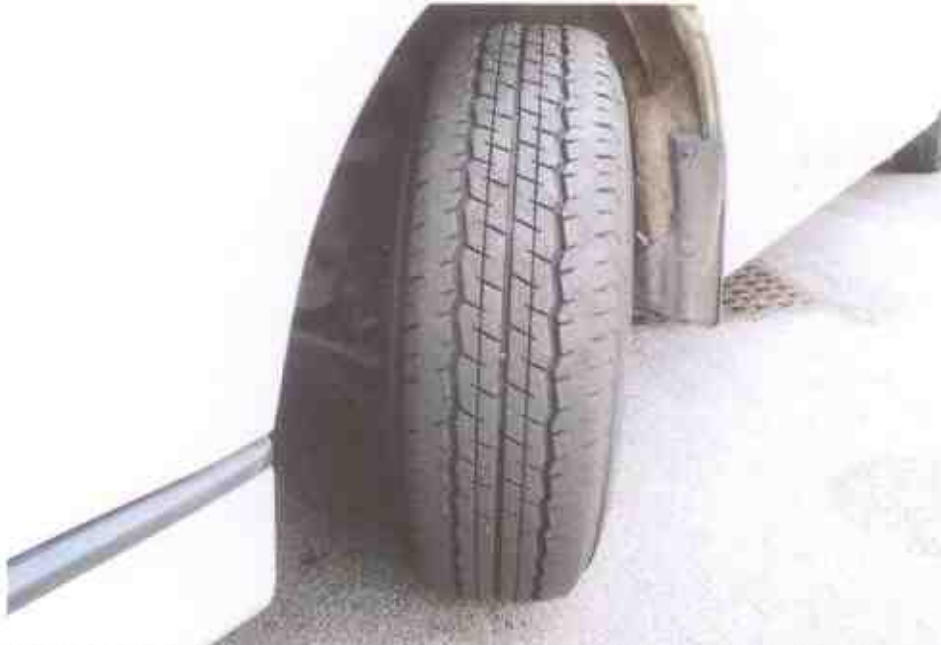
**Photo 9** shows the condition of the front left tyre of the Motor Bus, which was observed to be in serviceable condition with remaining tread depth of approximately 8mm. The tyre, which was wrapped around standard wheel rim, was also observed to be sufficiently inflated for vehicular operation.

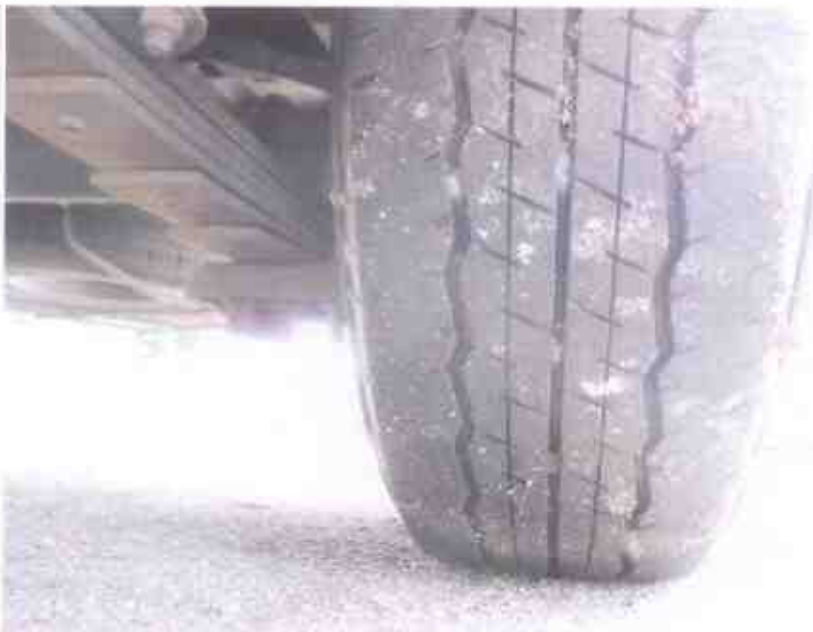
**Photo 10** shows the condition of the rear left tyre of the Motor Bus, which was observed to be in serviceable condition with remaining tread depth of approximately 7mm. The tyre, which was wrapped around standard wheel rim, was also observed to be sufficiently inflated for vehicular operation. There was also no significant damage found on the 4 wheel rims of the Motor Bus.

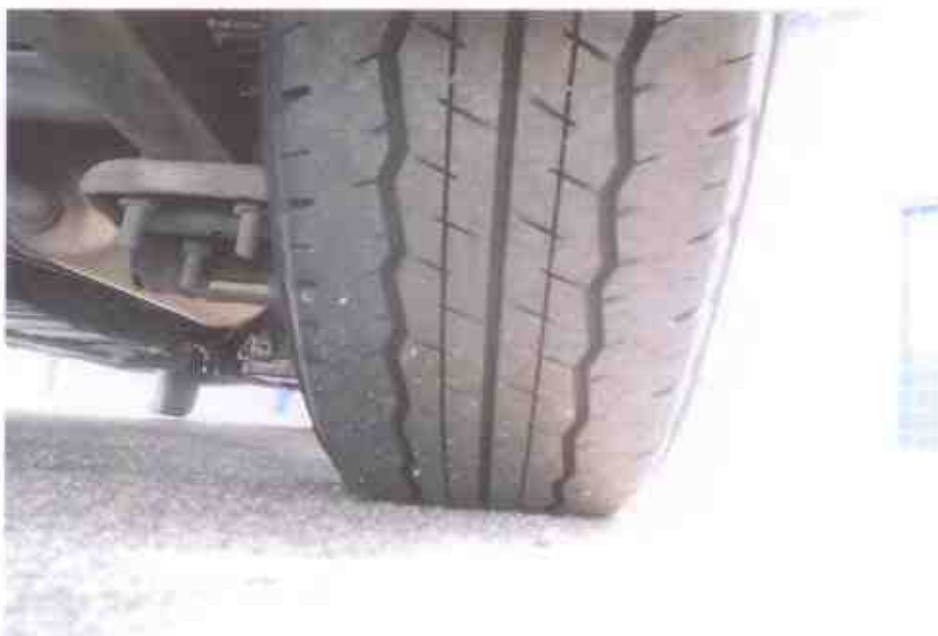
**Photo 11** shows the condition of the rear right tyre of the Motor Bus, which was observed to be in serviceable condition with remaining tread depth of approximately 6mm. There was also no tear, cut or burst mark(s) on the outer and the inner sidewalls as well as across the tread of the tyre, which was also sufficiently inflated for vehicular operation.

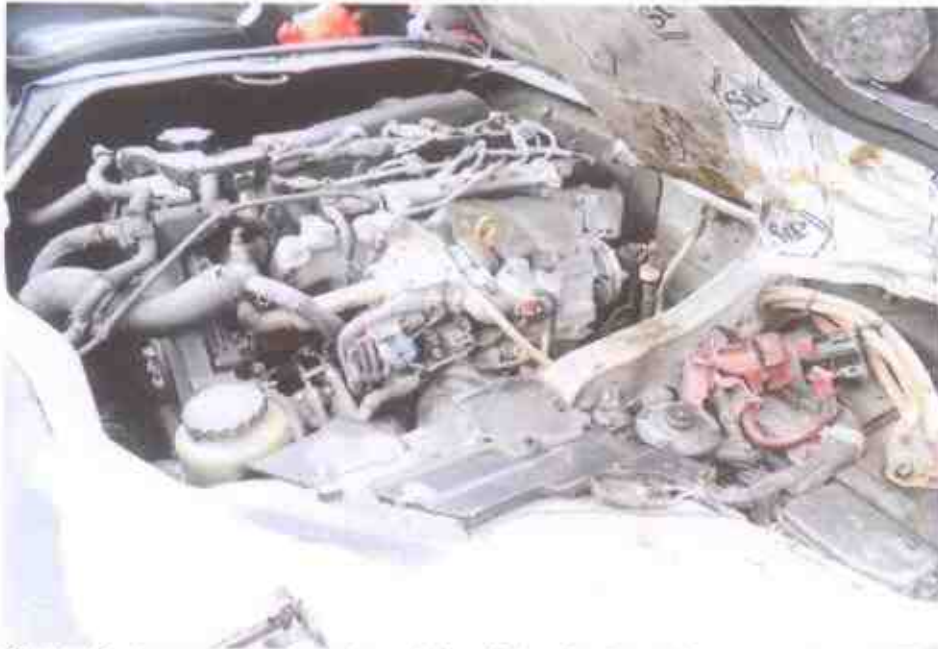
Photo 12 shows a general view of the Motor Bus's engine compartment. The various parts and components inside the engine compartment were unaffected by the accident. There was also no sign(s) or indication(s) of fluid leakage and/or fluid stain within the engine compartment.

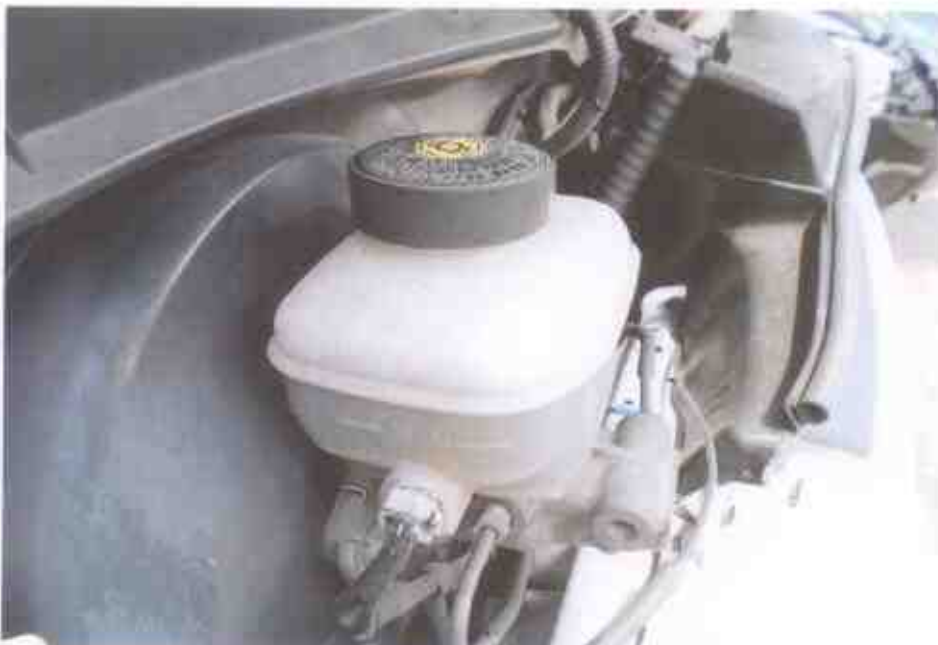
Photo 13 shows the brake fluid reservoir of the Motor Bus at the time of our inspection. The brake fluid was observed to be of sufficient level and without any visible contamination.

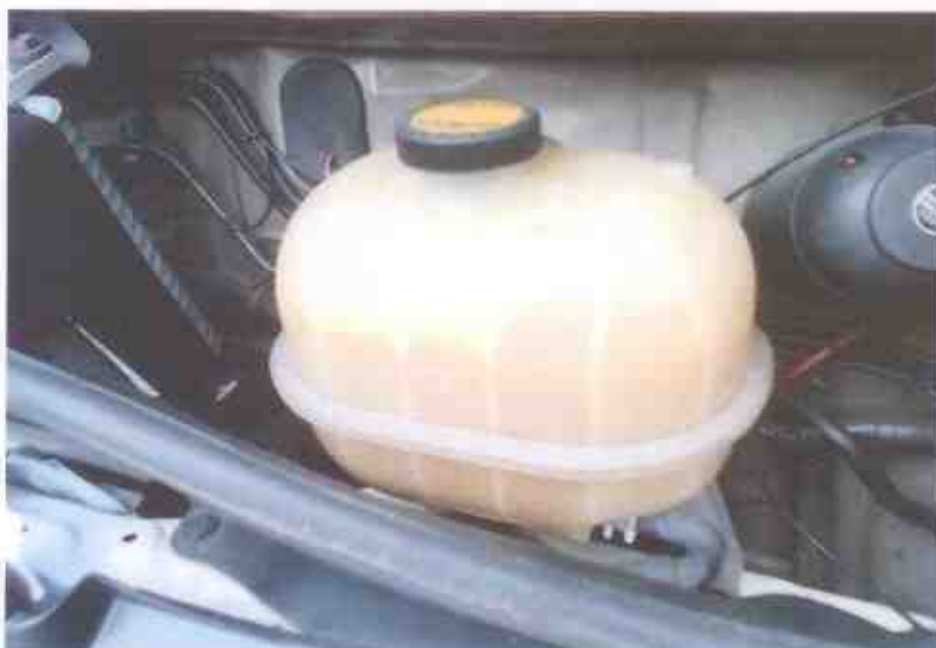
**Photo 14** shows the engine coolant reservoir of the Motor Bus at the time of our inspection. The engine coolant was observed to be of sufficient level and without any visible contamination.

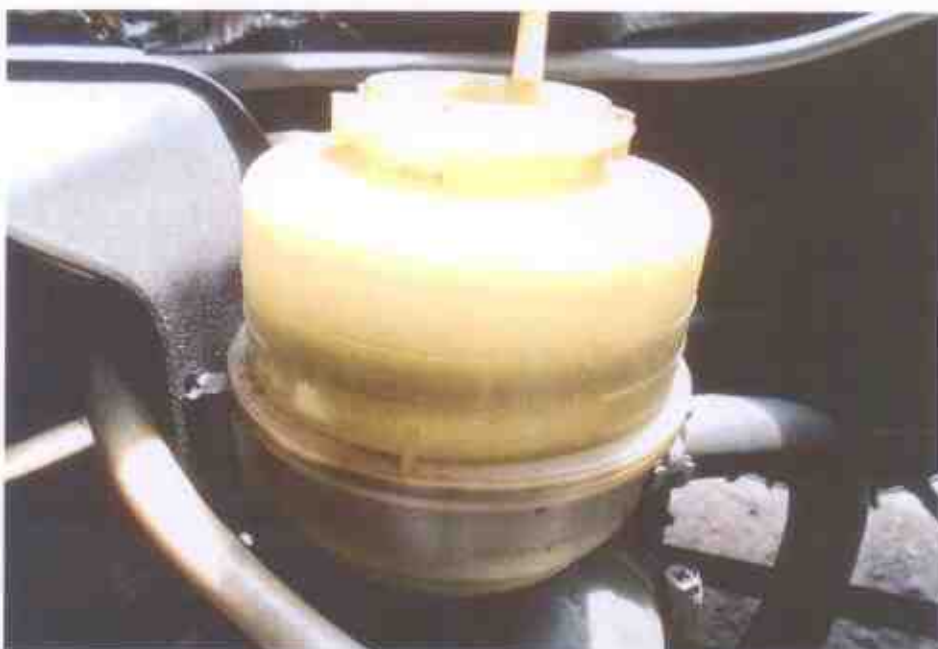
**Photo 15** shows the power steering reservoir of the Motor Bus at the time of our inspection. It was observed to be of sufficient level and without any visible contamination.

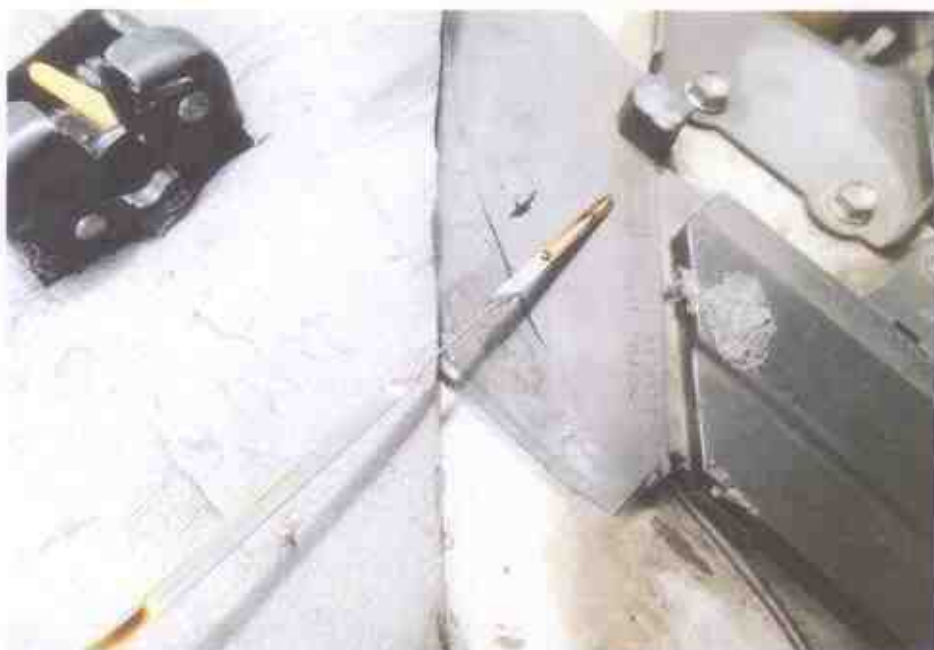
**Photo 16** shows the engine dip stick of the Motor Bus at the time of our inspection. The engine oil was observed to be of sufficient level and without any visible contamination.

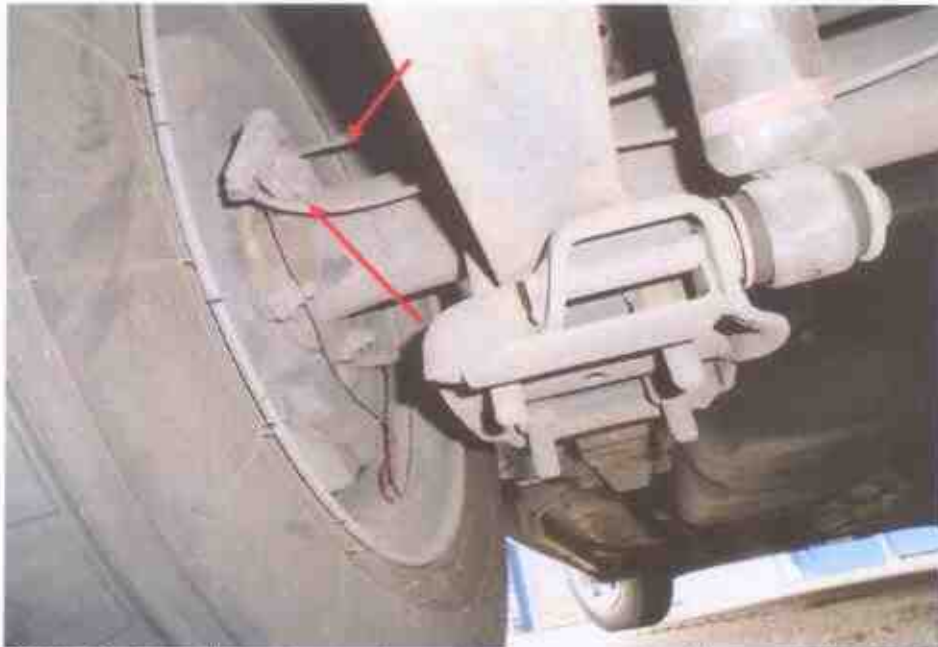
**Photo 17** shows the various undercarriage components at the rear left wheel of the Motor Bus; in particular the brake hose (arrowed). We did not observe any leakage of brake fluid at the time of our inspection of the Motor Bus.

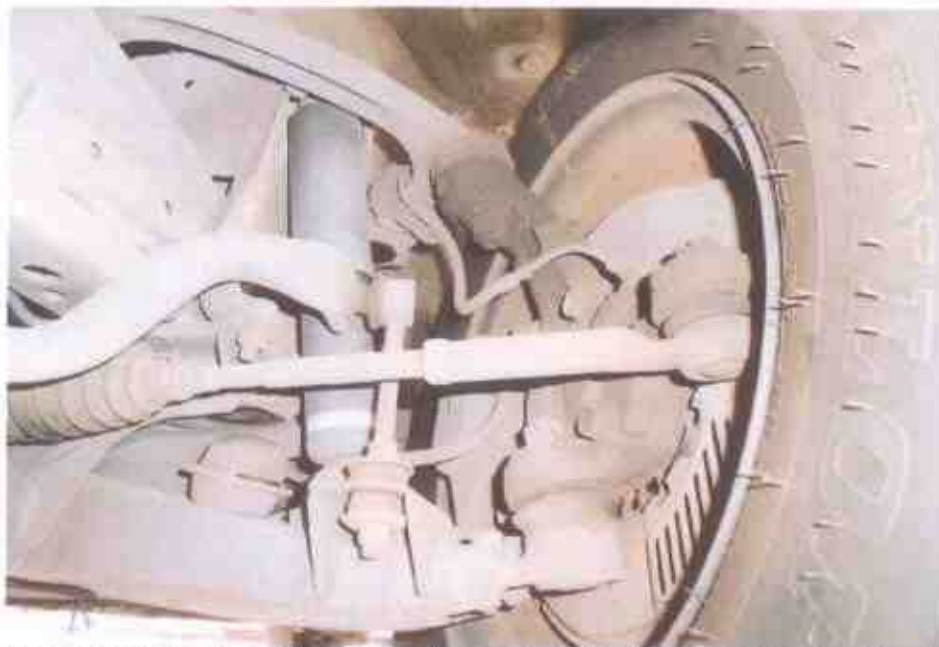
**Photo 18** shows the brake hose at the front left wheel of the Motor Bus. We did not observe any leakage of brake fluid. Our visual inspection of the various mechanical components of the Motor Bus's braking system revealed all to be intact and without visible damage, indicating that the braking system was likely to be in serviceable condition at the material time of accident.

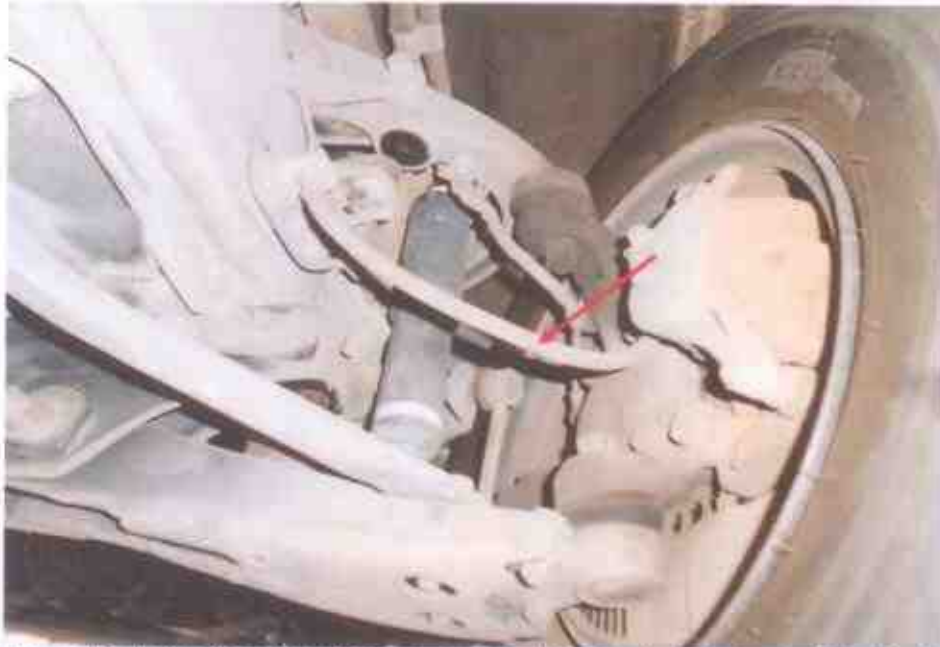
**Photo 19** shows the brake hose (arrowed) at the front right wheel of the Motor Bus. We did not observed any leakage of brake fluid at the time of our inspection of the Motor Bus. Our visual inspection of the various mechanical components of the Motor Van's braking system, including its brake calliper, revealed all to be intact and without visible damage.

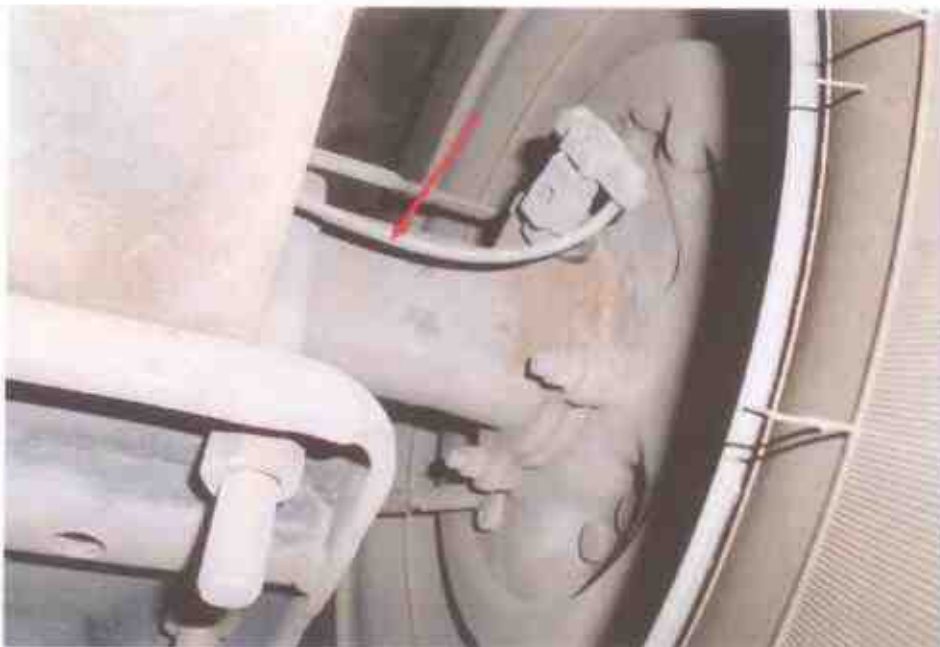
**Photo 20** shows the various undercarriage components at the rear right wheel of the Motor Bus. The various steering components were all found to be intact, suggesting that the steering system of the Motor Bus was likely to be in serviceable condition at the material time of accident. There was also no sign of fluid stain(s) observed on the various undercarriage components at the 4 wheels of the Motor Van.

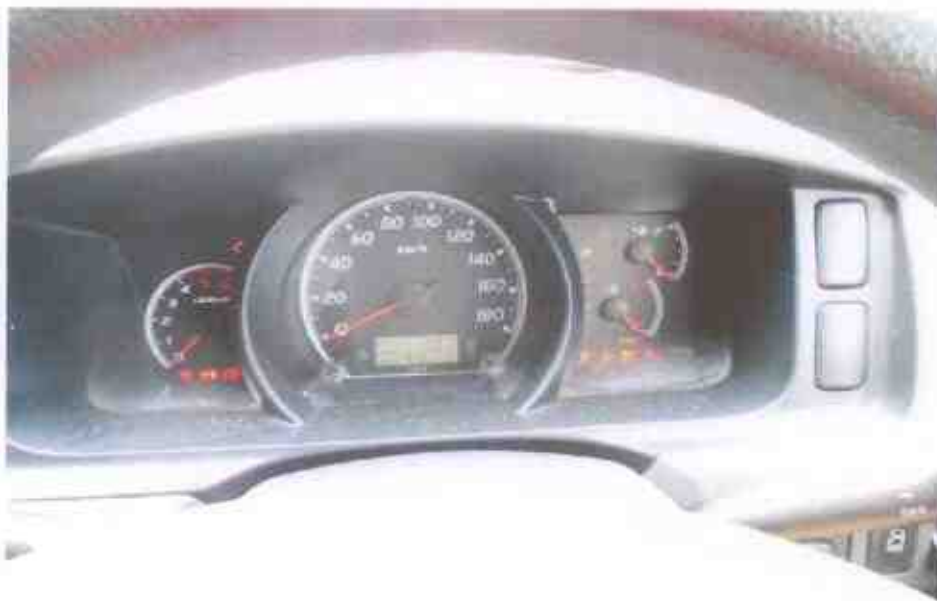
**Photo 21** shows the warning lights for the various electronic operating systems of the Motor Bus appearing on its instrument panel during the self-test when the engine was cranked.

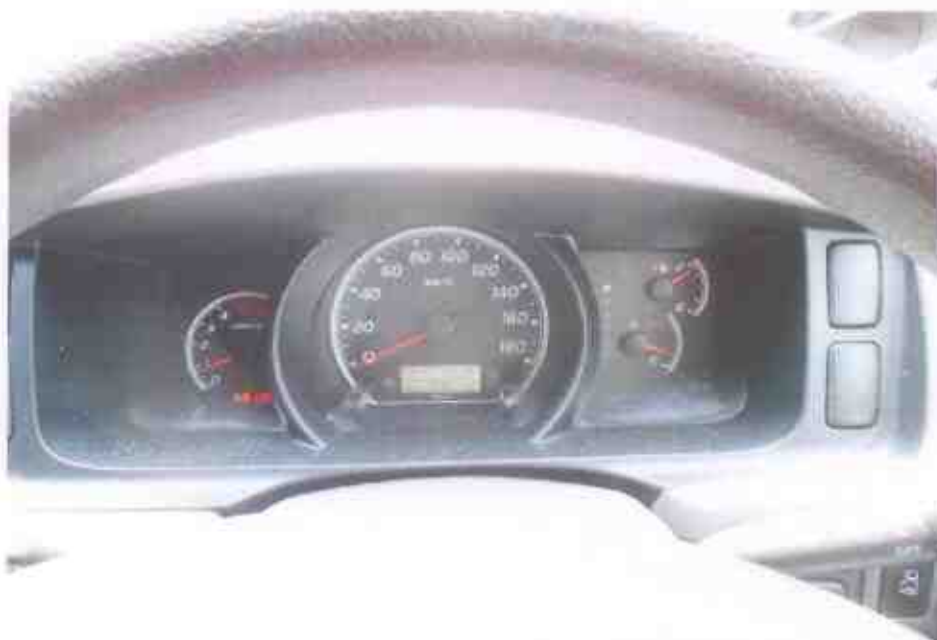
Photo 22 shows no warning lights illuminated on the instrument panel of the Motor Bus after the engine was cranked. This would suggest that there was no abnormality to the various electronic operating systems of the Motor Car except for only ABS warning light stayed lighted up.

18. Notwithstanding that the Anti-Locking Braking System (ABS) warning light lighted up, the braking system was found to be in working condition as the Motor Bus was able to slow down and come to a complete stop upon depressing of the brake pedal during our short operational test.

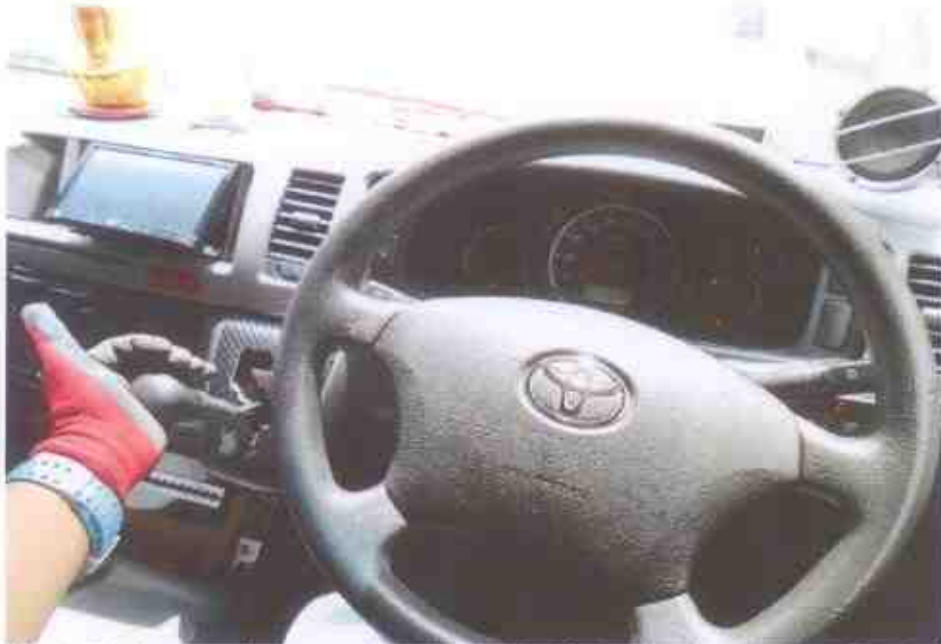
**Photo 23** shows a short operational test of the Motor Bus, to primarily determine whether there was any abnormality to its various operating systems like its engine system, its transmission system, steering system and braking system was subsequently carried out. The test was conducted by driving the Motor Bus forward, stopping, before reversing and coming to a stop again.

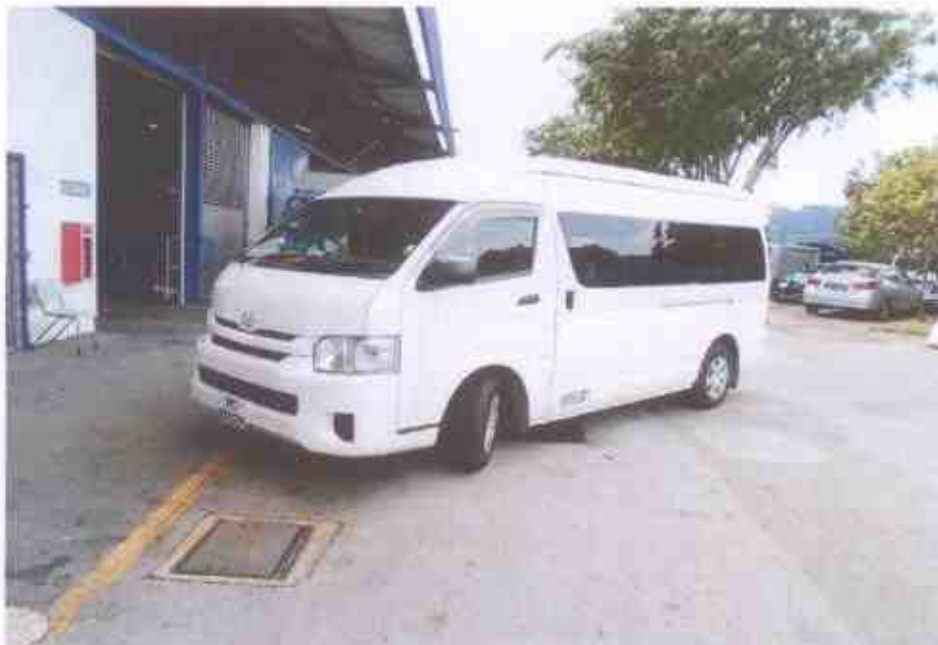
**Photo 24** shows a short operational test of the Motor Bus, the test was conducted by driving the Motor Bus forward, stopping, before reversing and coming to a stop again.
