Your Ref: TP/IP/28005/2018
Our Ref : CI/TPD18011340/Z

17th August 2018

MECHANICAL INSPECTION REPORT OF MOTOR BUS SBS 8360J

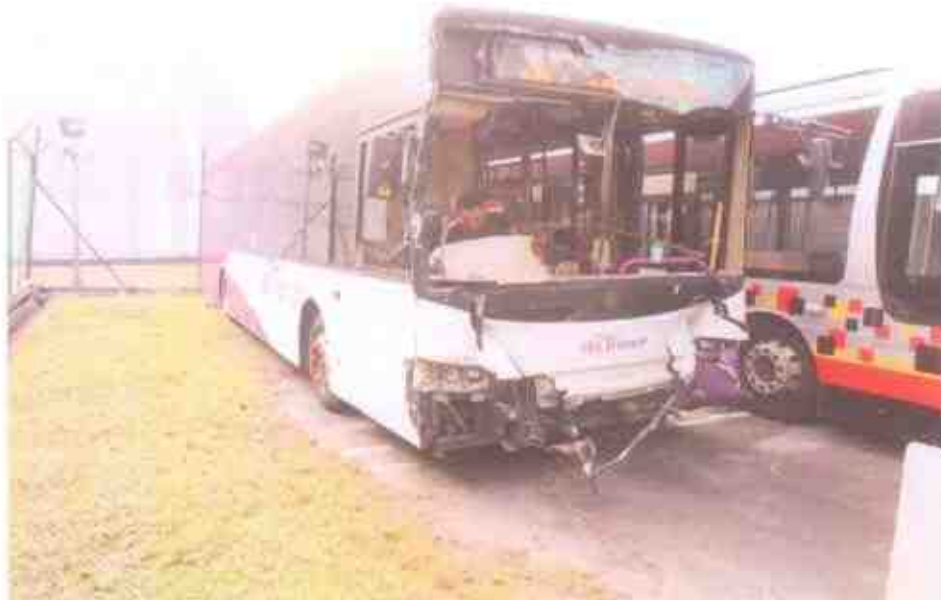
4. The mileage of the Motor Bus at the time of our inspection was recorded as 884906km.
5. The Motor Bus was observed to have sustained damages at its frontal portion. Its front lower bumper was observed to be dislodged; its front left & right headlamp was observed to be damaged; its entire windshield was observed to shattered, dislodged & missing from the original installation; its dashboard was pushed inwards towards the rear of the Motor Bus; the driver's window glass was found shattered & missing; its front floor board near the front passenger door was corrugated; misalignment of the front passenger door was noted at time of our inspection.
6. The damages were consistent with the accidents case fact that the Motor Bus collided head to rear with a stationary SMRT Motor Bus hence sustained with such damages mentioned. See photo 1 – 7 below.

Photo 1 shows a general view of the front body of the Motor Bus at the time of our inspection. The Motor Bus was observed to have sustained damages at its front portion as a result of the accident's collision.

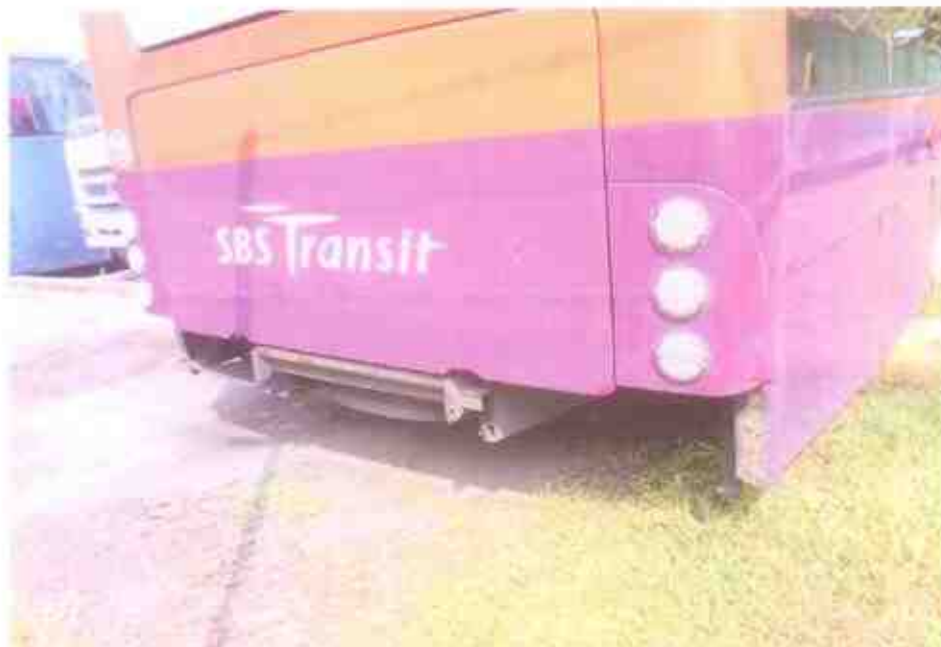
Photo 2 shows a general view of the rear portion of the Motor Bus at the time of our inspection. The Motor Bus was observed to be in good condition unaffected by the accident. The rear bumper was dismantled for towing purposes.

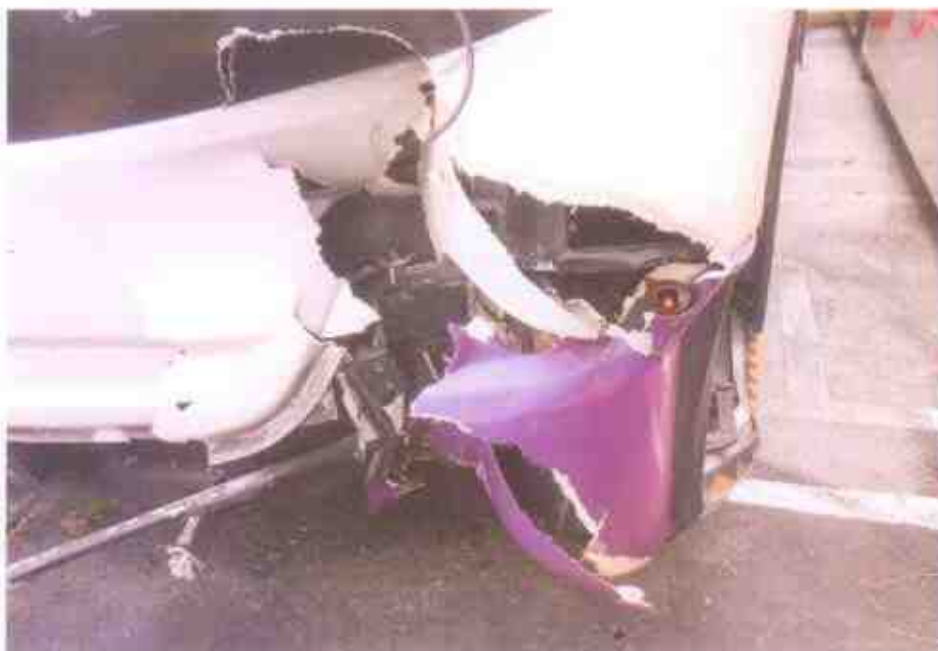
Photo 3 shows a close-up view of the front left body of the Motor Bus at the time of our inspection. The Motor Bus was observed to sustained damages due to the accident's impact.

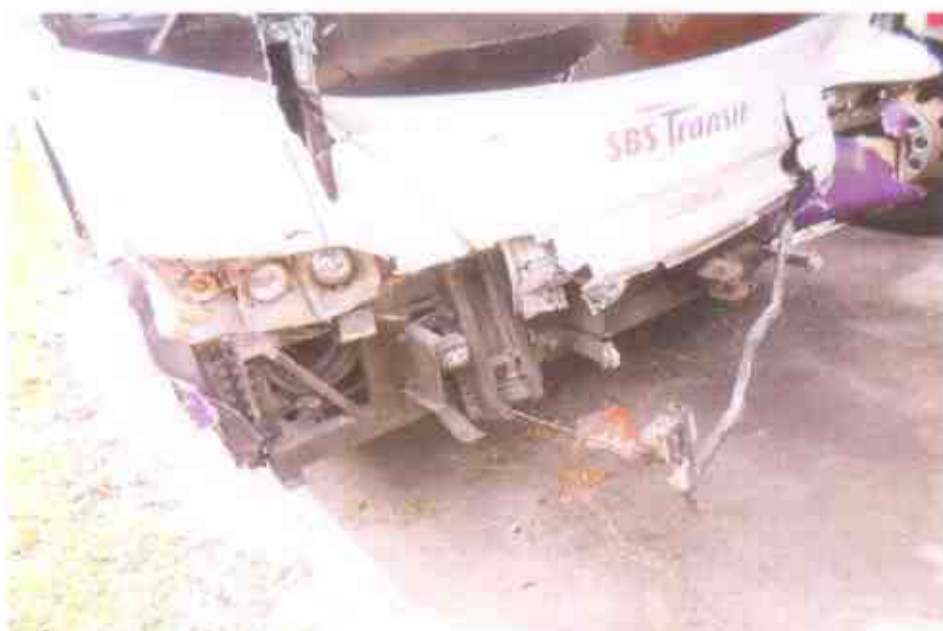
Photo 4 shows a close-up view of the front right body of the Motor Bus at the time of our inspection. The Motor Bus was observed to sustained damages due to the accident's impact.

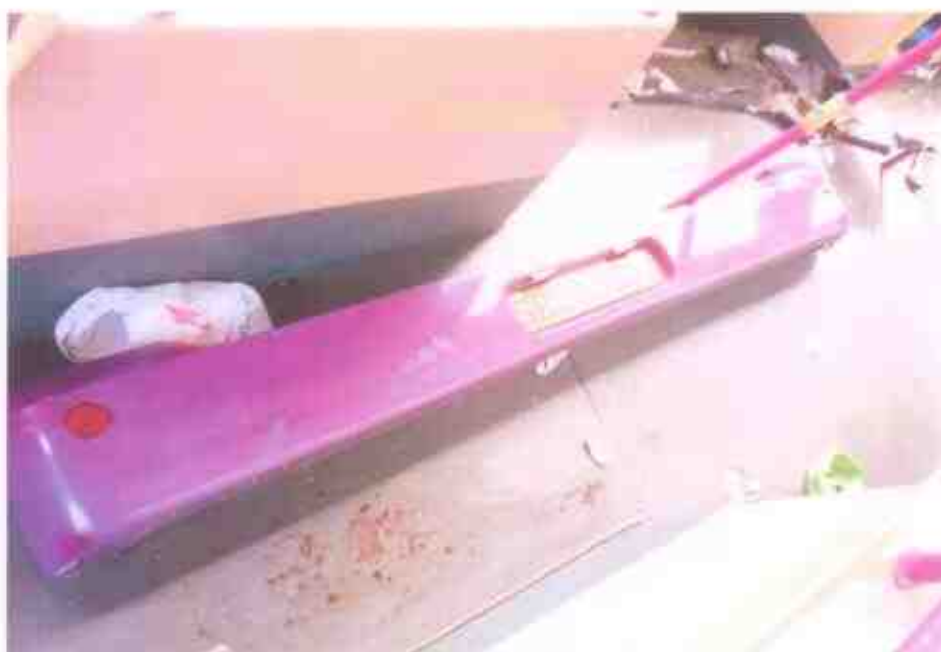
Photo 5 shows a close-up view of the dismantled rear bumper from the Motor Bus.

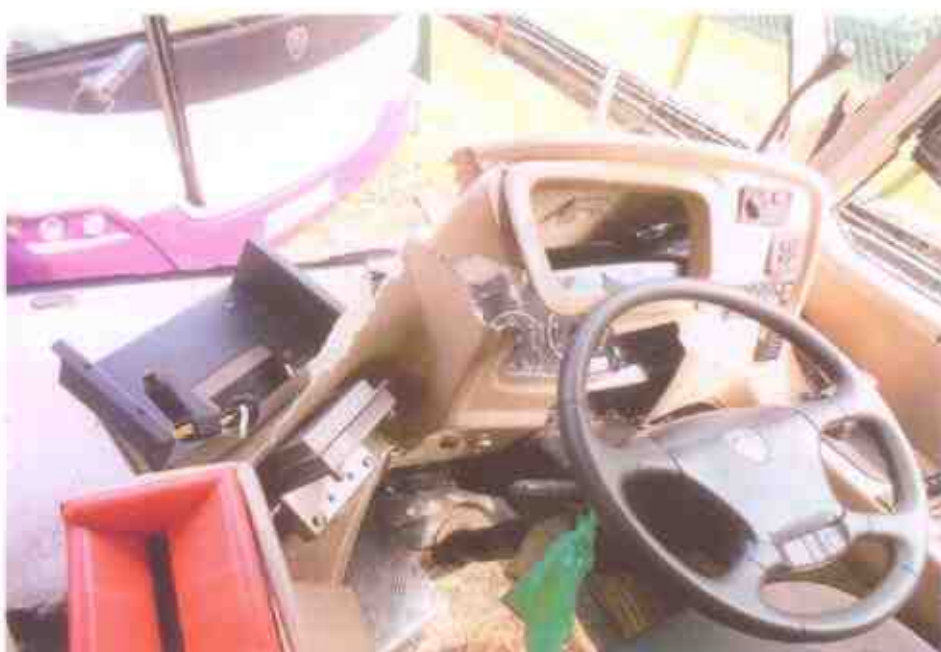
Photo 6 shows a close-up view of the Motor Bus's dashboard that was observed to be damaged due to the accident's impact.

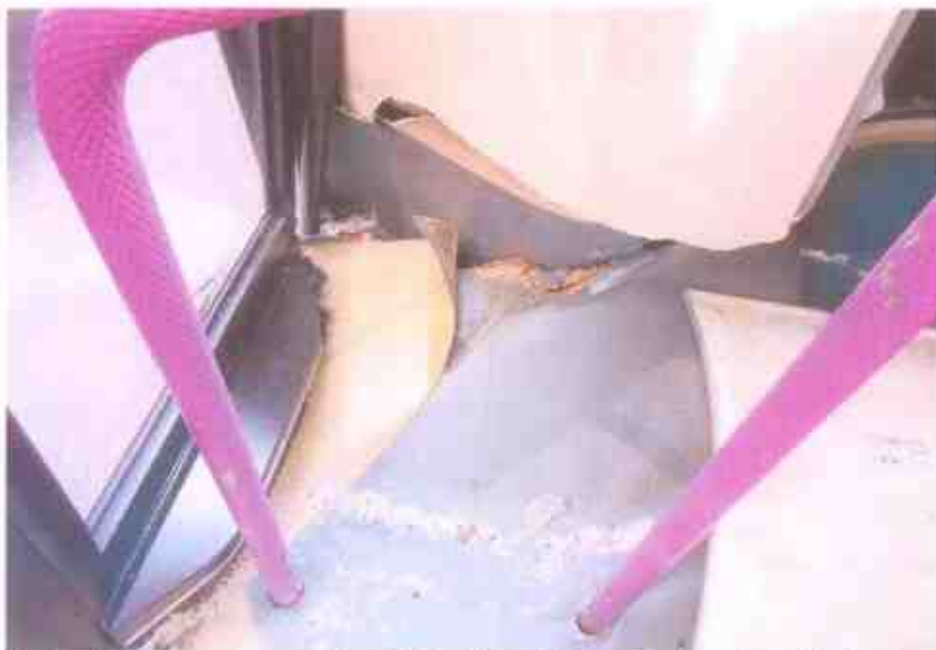
Photo 7 shows a close-up view of the Motor Bus's floor board next to the front passenger's glass door that was observed to be damaged due to the accident's impact.

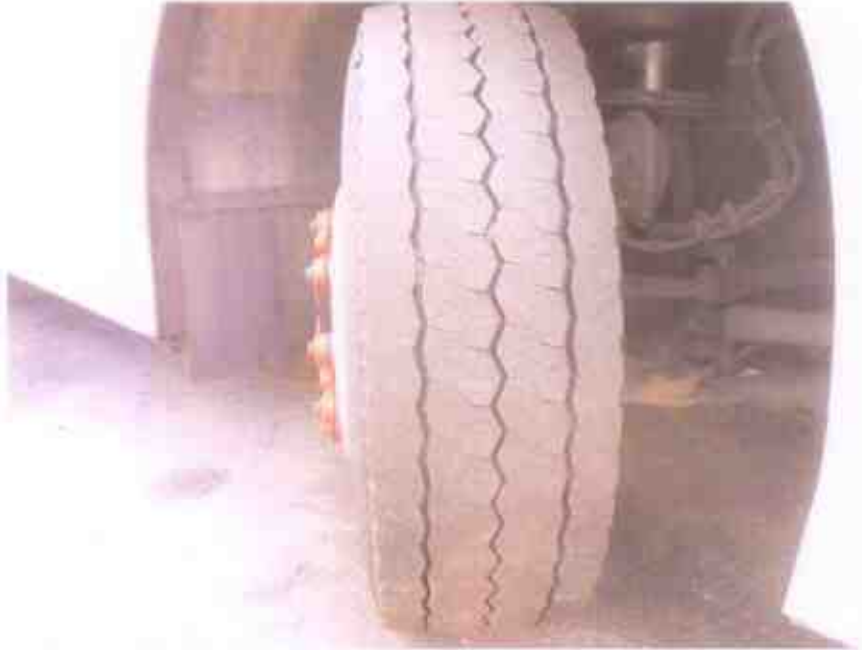
Photo 8 shows the condition of the front right tyre of the Motor Bus, which was observed to be in serviceable condition with remaining tread depth of approximately 8mm. The tyre was also observed to be sufficiently inflated for vehicular operation.

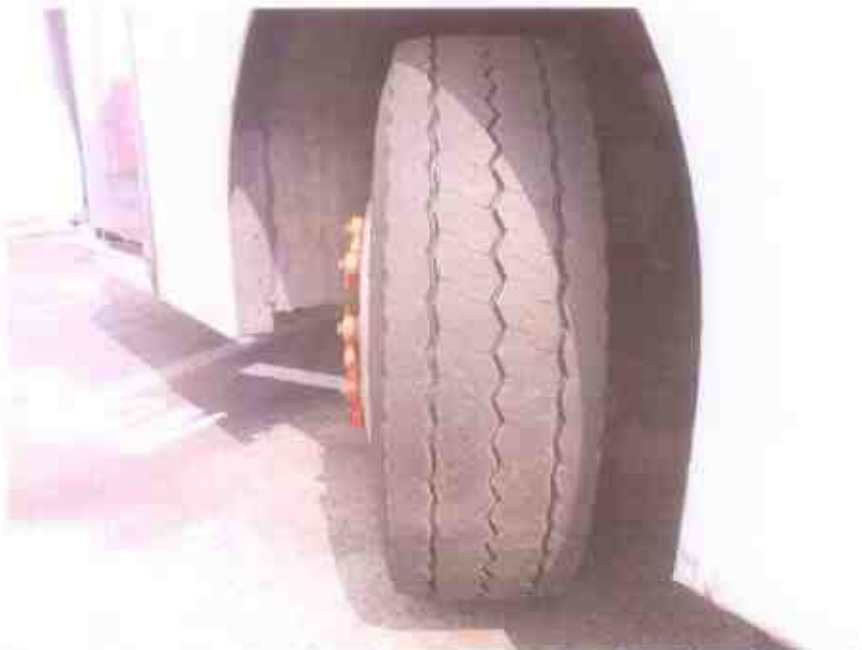
Photo 9 shows the condition of the front left tyre of the Motor Bus, which was observed to be in serviceable condition with remaining tread depth of approximately 9mm. The tyre was also observed to be sufficiently inflated for vehicular operation.

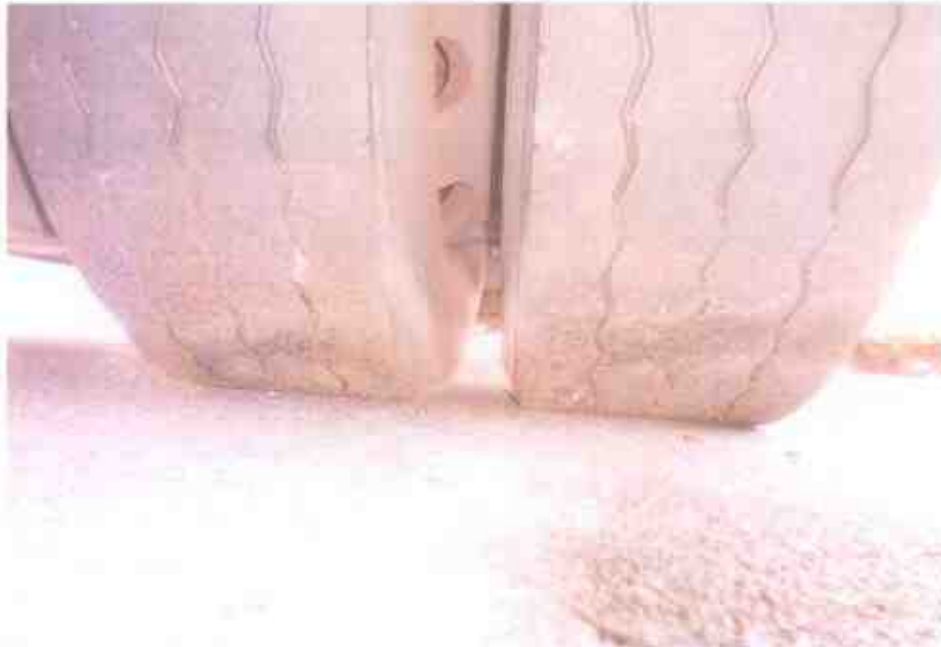
Photo 10 shows the condition of the rear right tyres of the Motor Bus, which were observed to be in serviceable condition with remaining tread depth of approximately 6mm. The tyres, which were wrapped around standard alloy wheels rims, were also observed to be sufficiently inflated for vehicular operation.

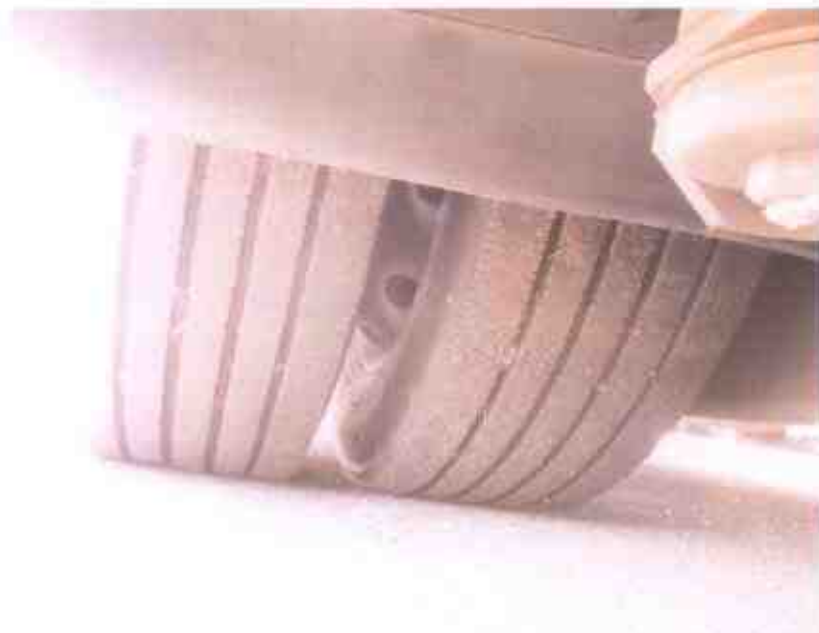
Photo 11 shows the condition of the rear left tyres of the Motor Bus, which were observed to be in serviceable condition with remaining tread depth of approximately 8mm. The tyres, which were wrapped around standard alloy wheel rims, were also observed to be sufficiently inflated for vehicular operation.

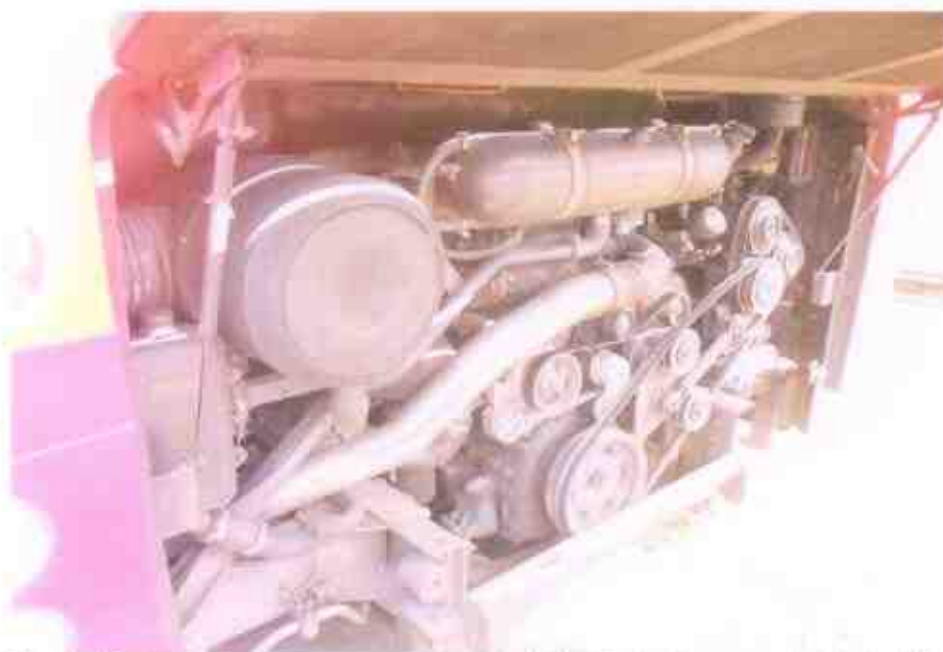
Photo 12 shows the engine compartment of the Motor Bus was located at the rear of the Motor Bus.

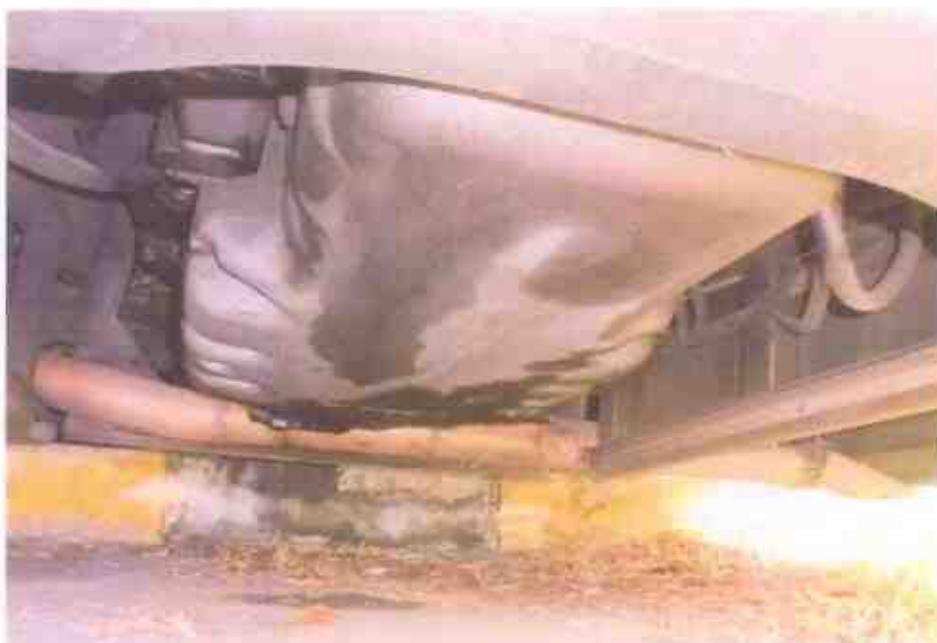
11. Our subsequent checks on the underside of the Motor Bus reveals some fluid stain sighted under the engine compartment. Further investigation found that the fluid stain was a pre-existed prior the accident & not a fresh fluid. This was due to some dirt observed on the fluid stain. Conclusively, it is not likely to be related to the accident. Visually, the various undercarriage components of the Motor Bus were observed to be intact and without any visible damage except for the damages caused by the accident. See photo 12 – 17 below.

Photo 13 shows the engine undercarriage of the Motor Bus. Some pre-existed fluid was observed at time of our inspection.

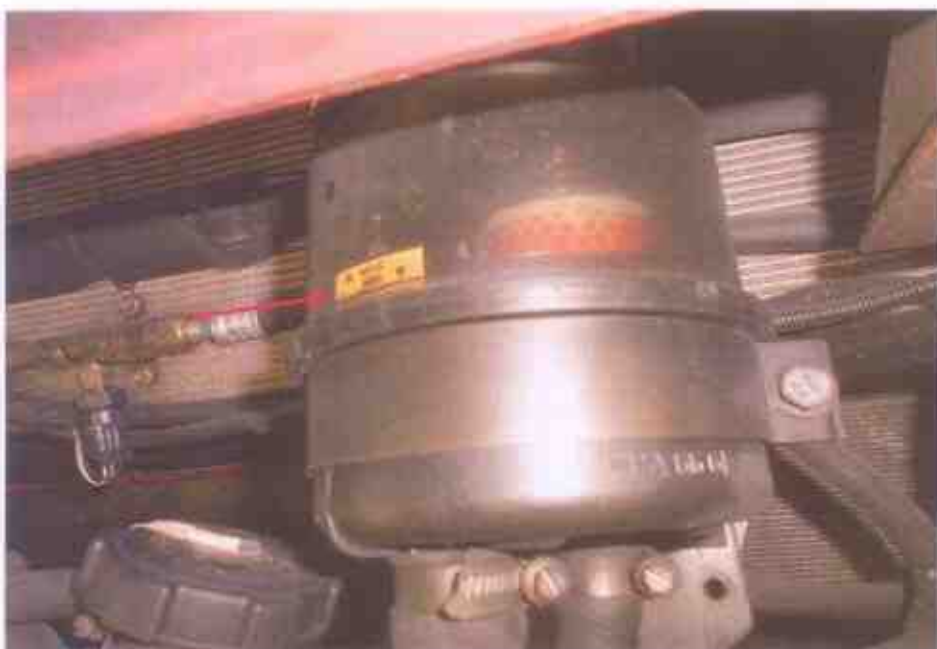
Photo 14 shows the steering fluid of the Motor Bus. It was observed to be of sufficient level without any contamination at time of our inspection.

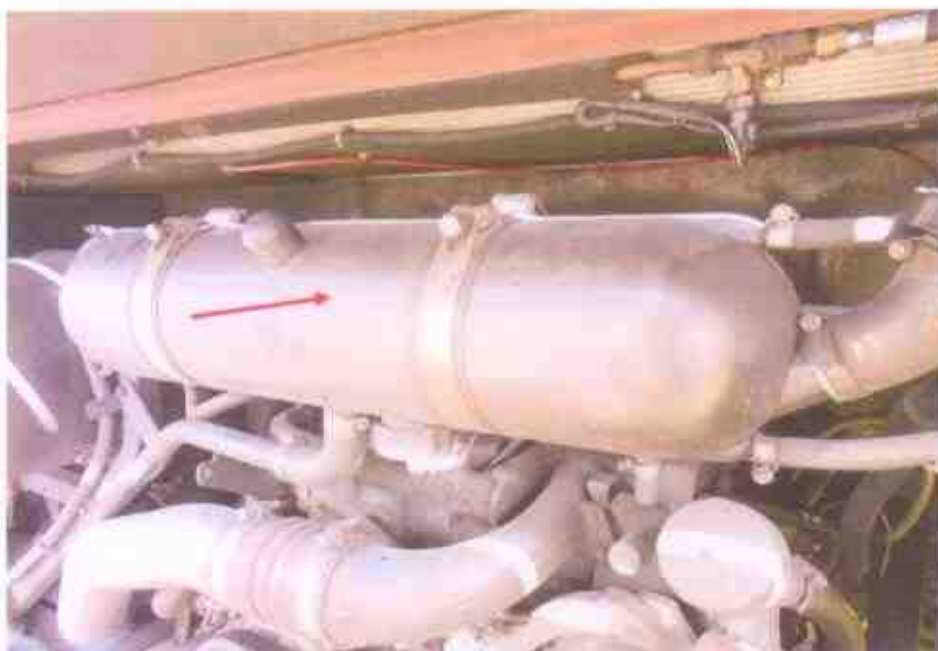
Photo 15 shows the engine coolant cylinder of the Motor Bus. It was observed to be of sufficient level without any contamination at time of our inspection.

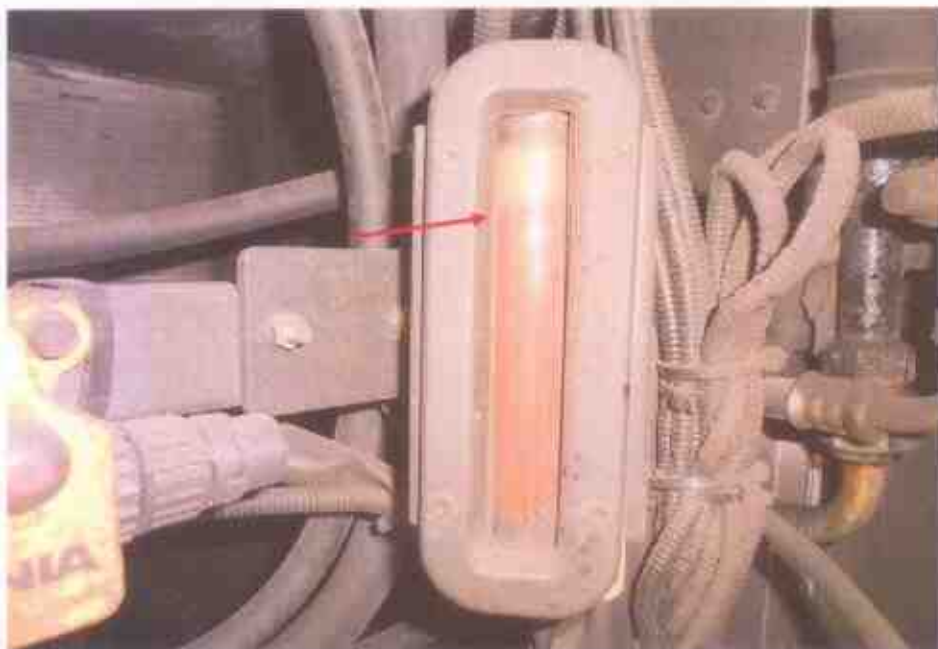
Photo 16 shows the engine coolant indicator of the Motor Bus. It was observed to be of sufficient level without any contamination at time of our inspection.

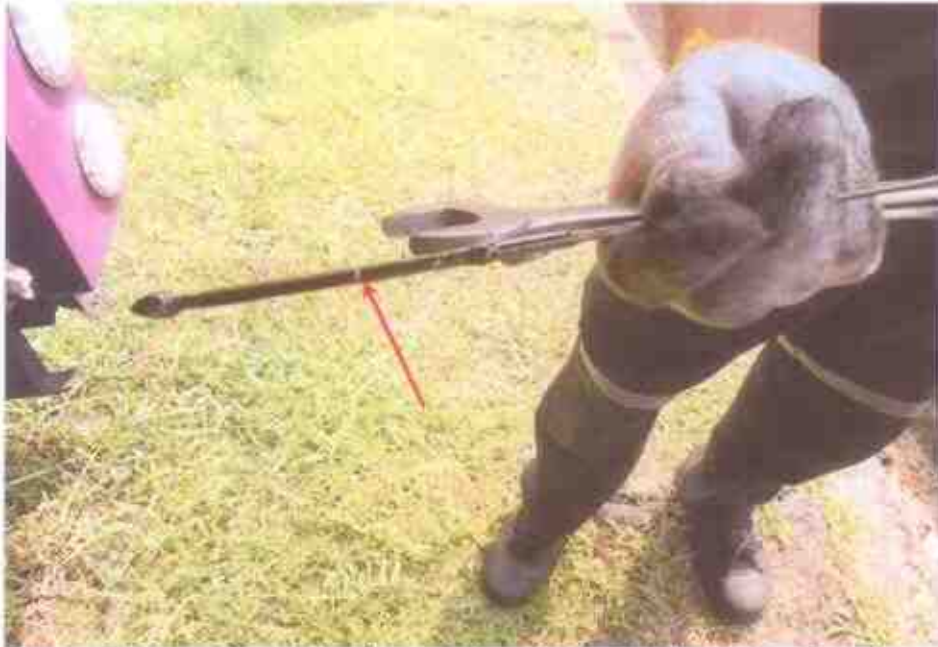
Photo 17 shows the engine fluid on the dip stick of the Motor Bus. It was observed to be of sufficient level without any contamination at time of our inspection.

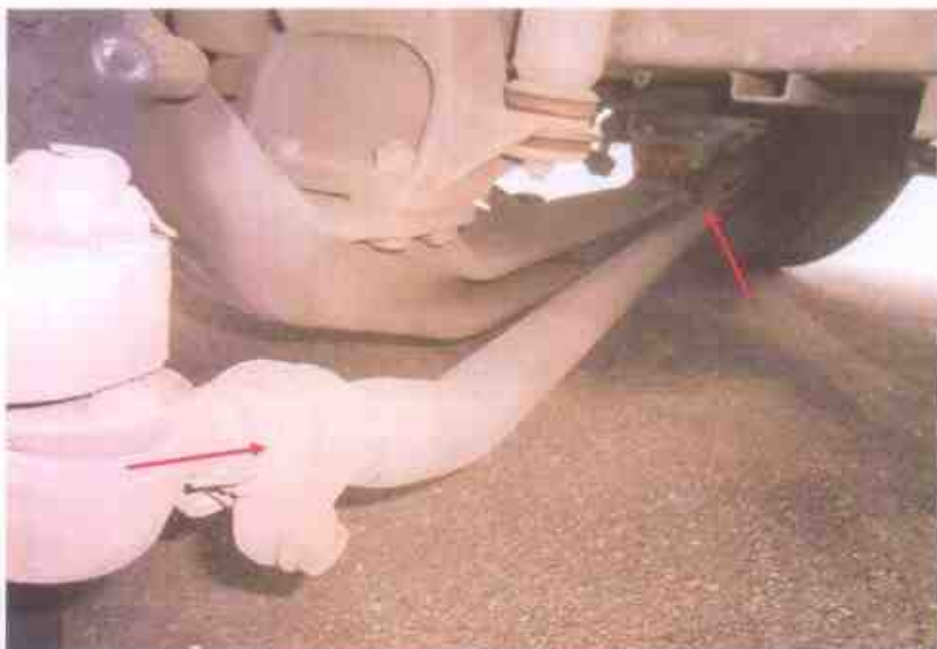
Photo 18 shows some of the mechanical components (arrowed) of the Motor Bus's steering system. Our visual check on the various mechanical components of the steering system revealed all to be intact and in good condition. The steering system of the Motor Bus likely to be in serviceable condition at the time of accident.

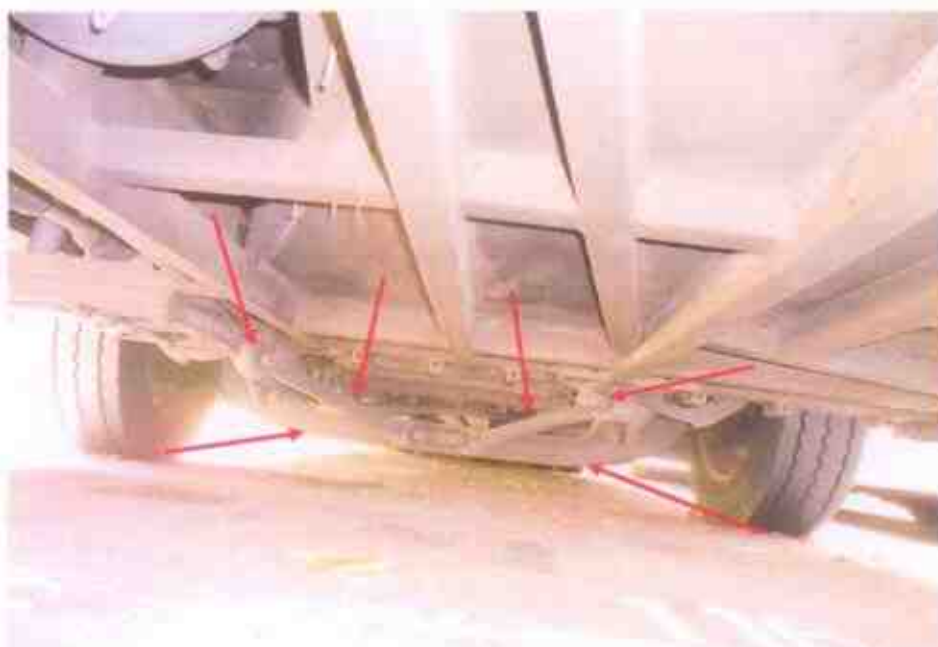
Photo 19 shows the undercarriage components at the front steering system of the Motor Bus. The various undercarriage components of the Motor Bus were all observed to be intact and without any visible damage. This had included the steering rack and steering ball joints (arrowed) of the Motor Bus, which were observed to be securely attached to the front left wheel and front right wheel.

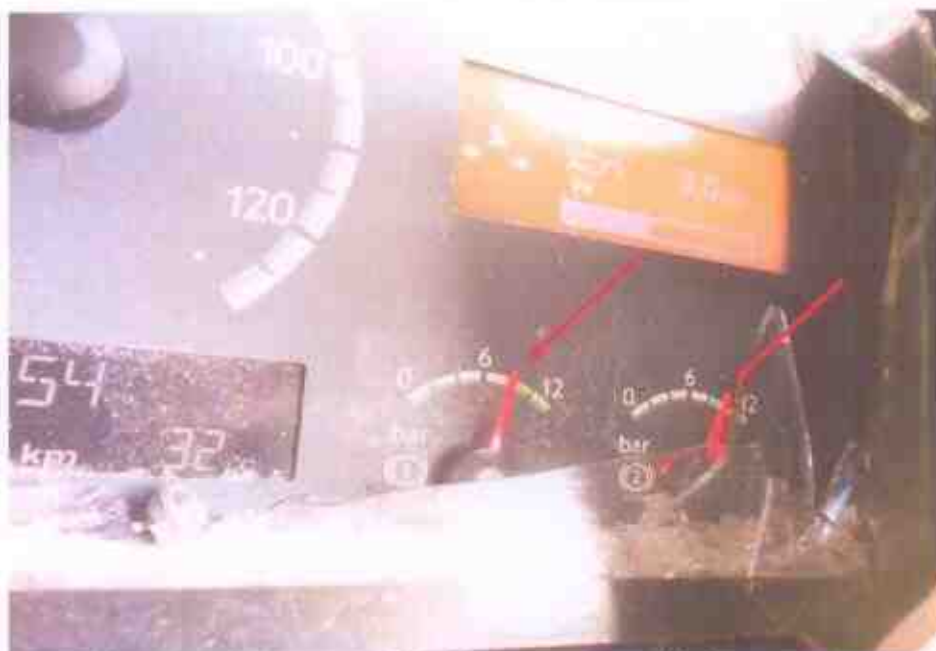
- 14.2 numbers of air tanks in particular were observed to be also in serviceable condition. Air built up to the fullest level which is level 10 (On the display panel) for both air tanks for operational ready status after a warming up session prior the operational test. Both air tanks were monitored for about 10 minutes for an observation of any abnormalities. Both air tanks pressure found to be normal without any drop in pressure during the course of our monitoring session. This would indicate that there was no leak of air pressure from the air braking system of the Motor Bus. See photo 20 below.

Photo 20 shows pressure tank 1 & tank 2 were observed to be pressurised up to 10bars after the engine start-up. No drop in the pressure after a few minutes which means there's no air leakage from the air-braking system.

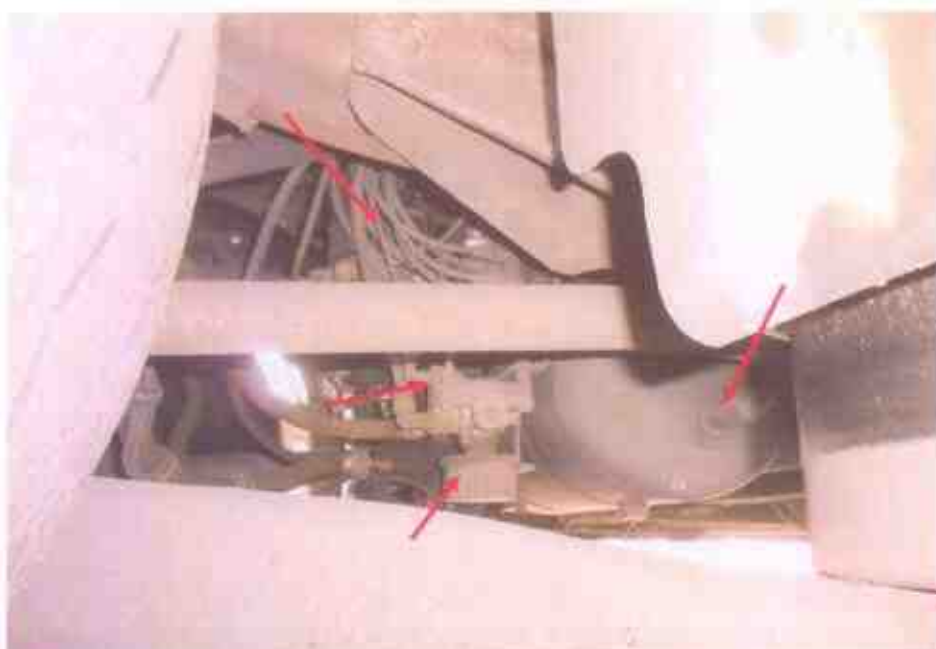
Photo 21 shows a general view of the air tank, valves, pipes and hoses, which are some of the components for the air-assisted braking system of the Motor Bus. This was at the underside of the Motor Bus's body. There were no damages observed at time of our inspection.

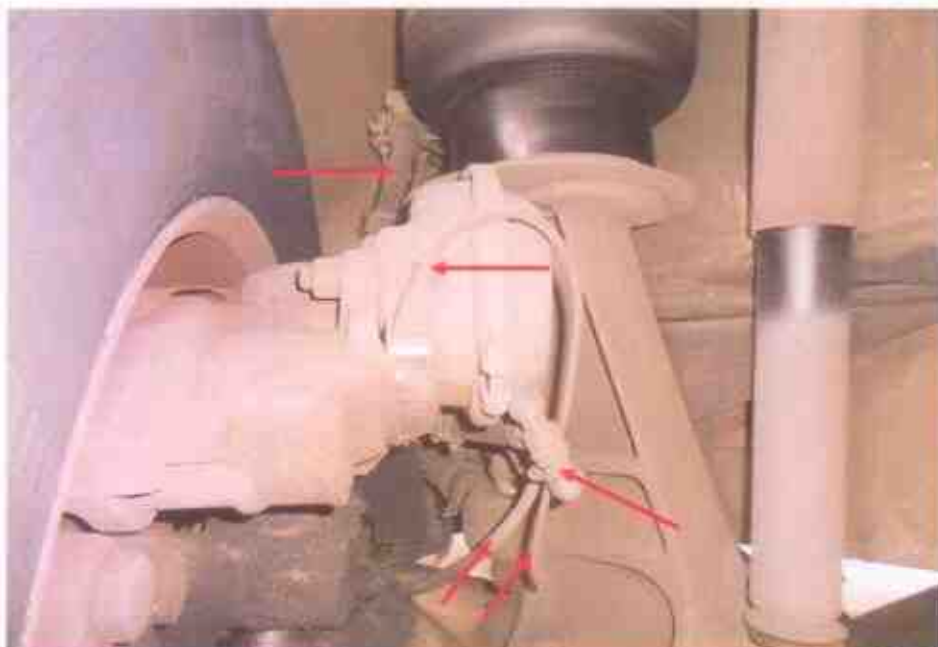
Photo 22 shows some of the mechanical components (arrowed) of the Motor Bus's braking system. Our visual check on the various mechanical components revealed all to be intact and in good condition. It was in serviceable condition at the time of accident.

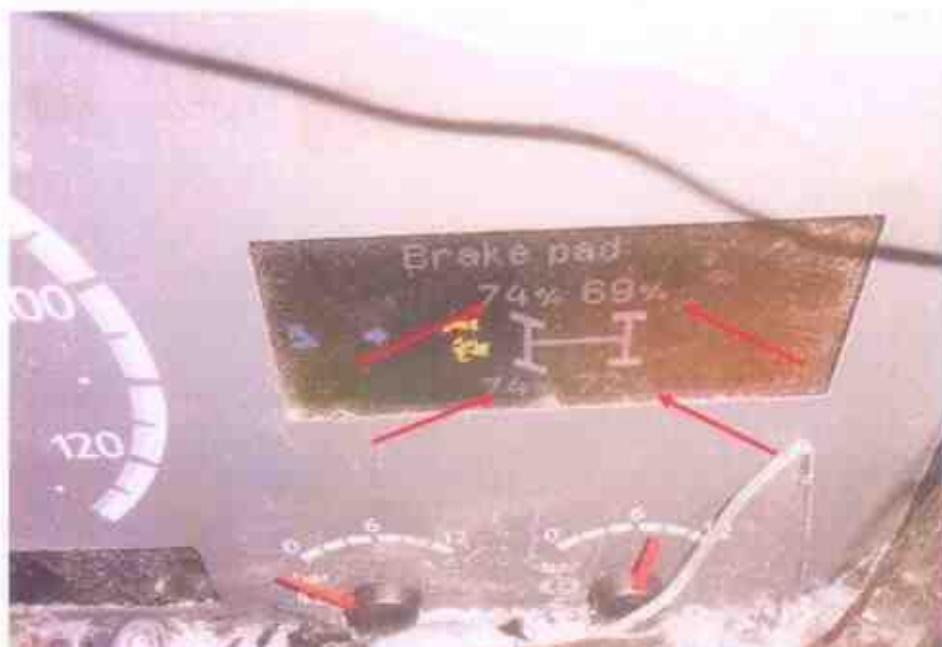
Photo 23 shows the brake pad on the electronic indicator of the Motor Bus's braking system. It shows the material percentage of the brake pad which indicating an acceptable range on the frictional material prior the accident.

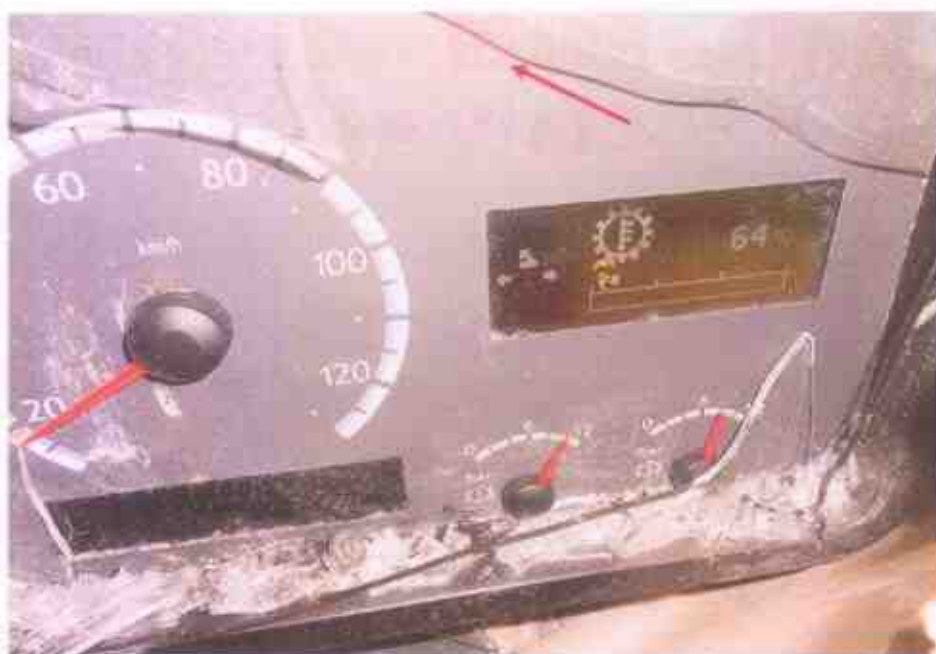
Photo 24 shows the warning lights for the various electronic operating systems of the Motor Bus appearing on its instrument panel during the self-test when the engine was cranked.

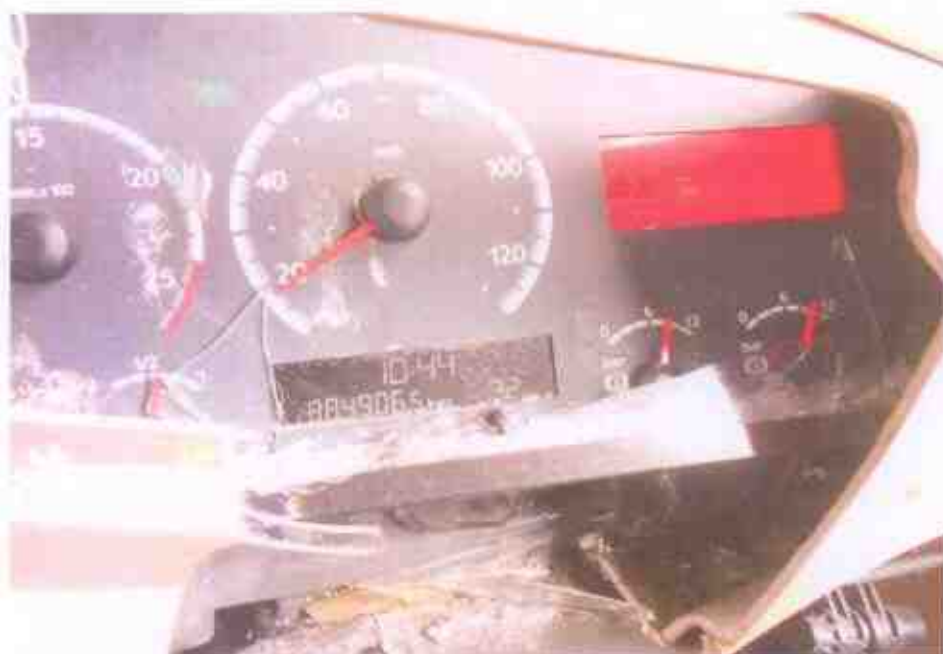
Photo 25 shows the indicators at the driver's seat, these systems were in working condition. This can be established from the warning lights disappearing from the instrument panel after the self-test. However, only the Anti-Locking Braking System (ABS) stayed lighted up amongst others.

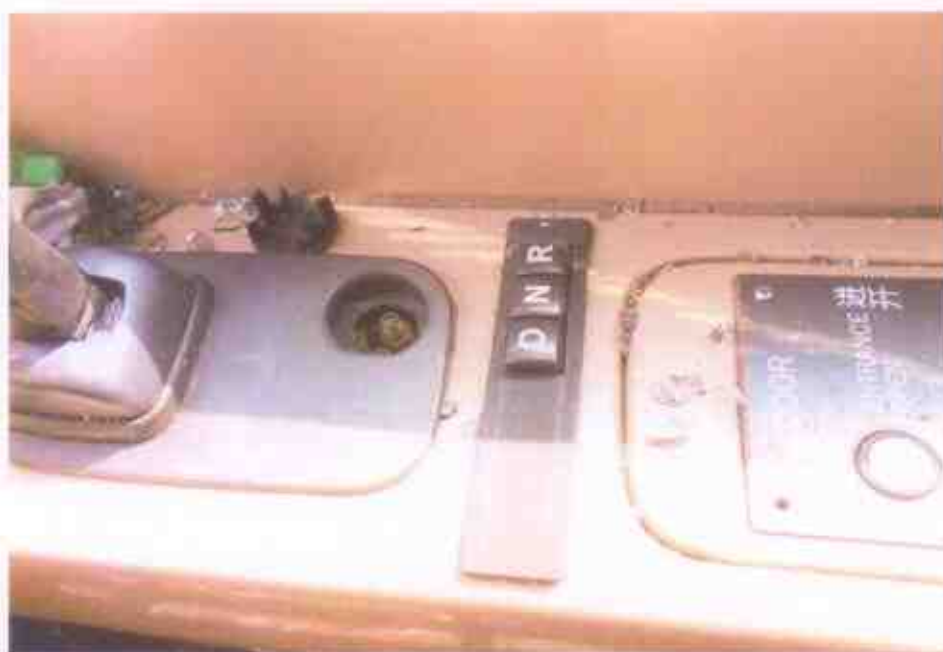
Photo 26 shows the operational selectors at the driver's seat. It was observed to be unaffected by the accident's collision. Hence enabling an operational test to be conducted via activating the selectors.

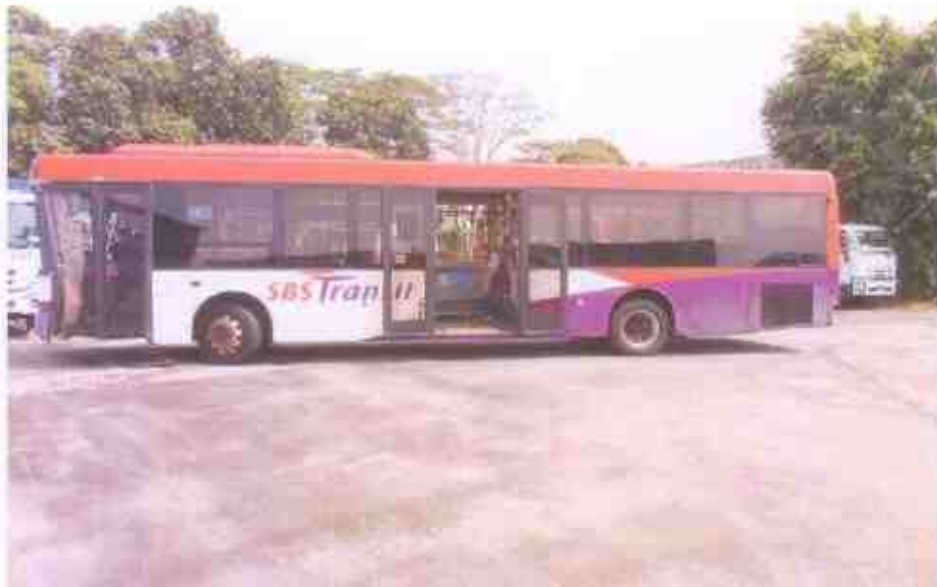
Photo 28 shows the operational test on the Motor Bus. SBS driver were able to move the Motor Bus forward, backward, turning left & right & stopping without any abnormalities
