Your Ref: TP/IP/22369/2018  
Our Ref : CI/TPD18011344/Z

30<sup>th</sup> July 2018

**MECHANICAL INSPECTION REPORT OF MOTOR BUS PC 6045B.**

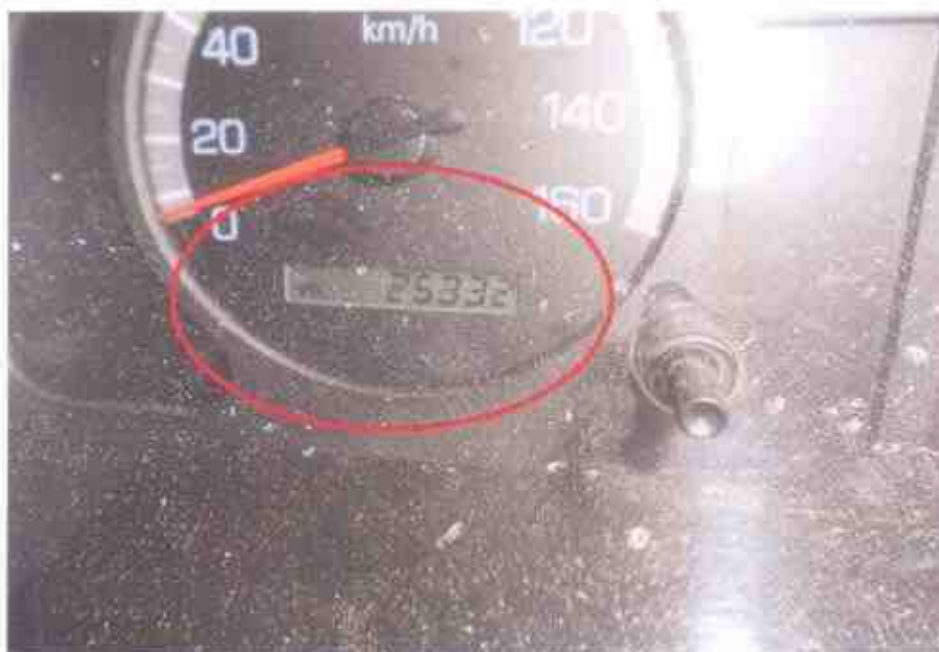
Photo 1 shows the mileage of the Motor Bus was 25332km.

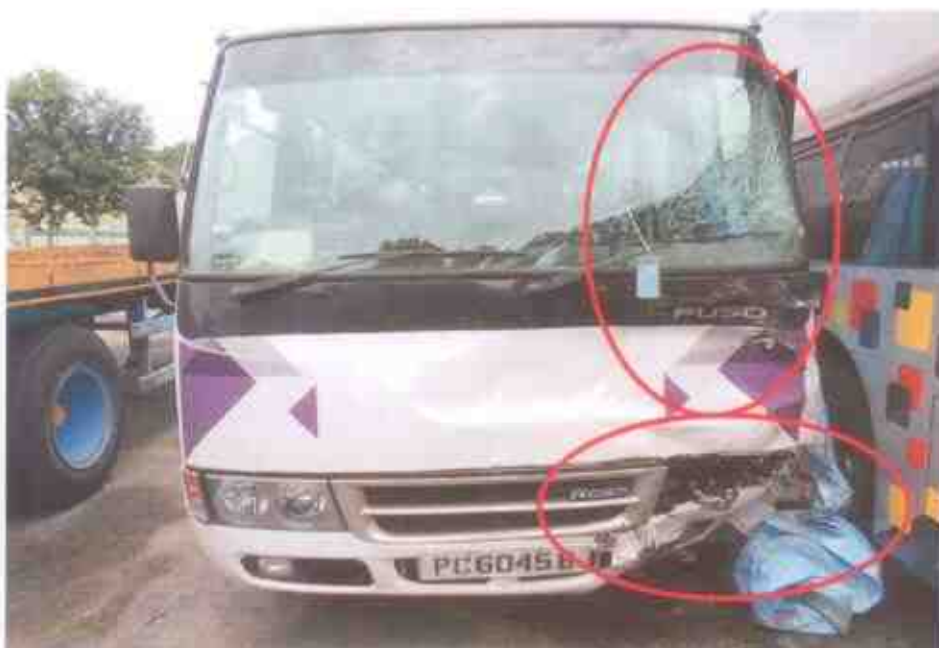
1. We refer to your request on 24<sup>th</sup> April 2018 to conduct a physical inspection of a Motor Bus bearing registration number PC 6045B (herein referred to as "**Motor Bus**"), which was involved in a fatal road traffic accident on 10<sup>th</sup> April 2018.
2. The objective of this inspection is to determine if there was any possible mechanical failure to the Motor Bus that may have contributed to the accident.
3. Following the request, we had carried out a physical inspection of the Motor Bus on 24<sup>th</sup> May 2018 at the premises of Traffic Police vehicle pound, 517 Airport Road Singapore 539942. We now set out below our observations and comments with respect to this inspection.

Photo 2 shows a general view of the front right body of the Motor Bus at the time of our inspection. The Motor Bus was observed to sustained damages at the front left portion due to the accident's impact.

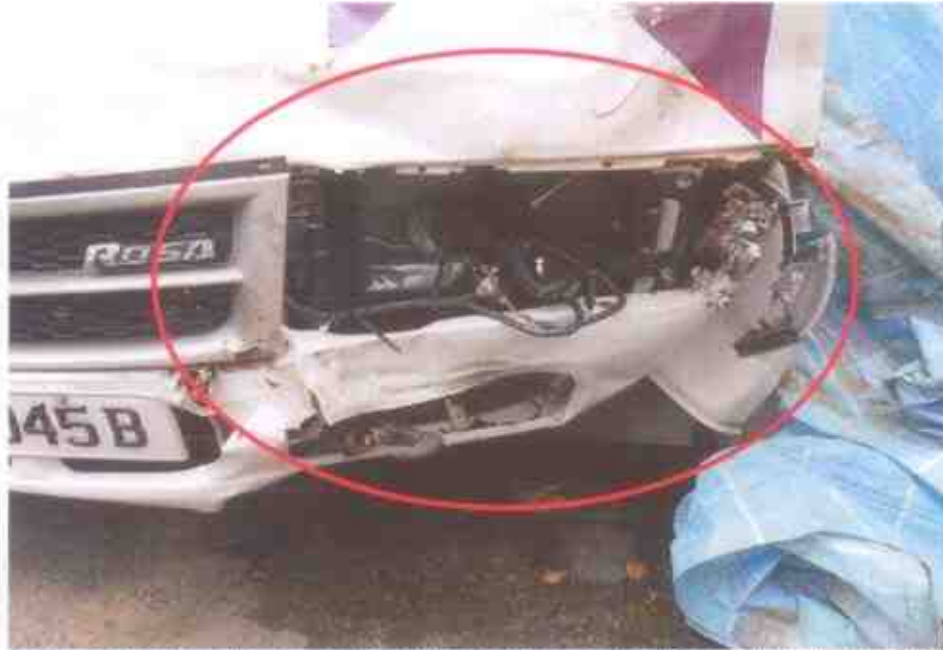
**Photo 3** shows a close-up view of the damages on the left side headlamp of the Motor Bus at the time of our inspection. It was likely due to the accident's impact collision.

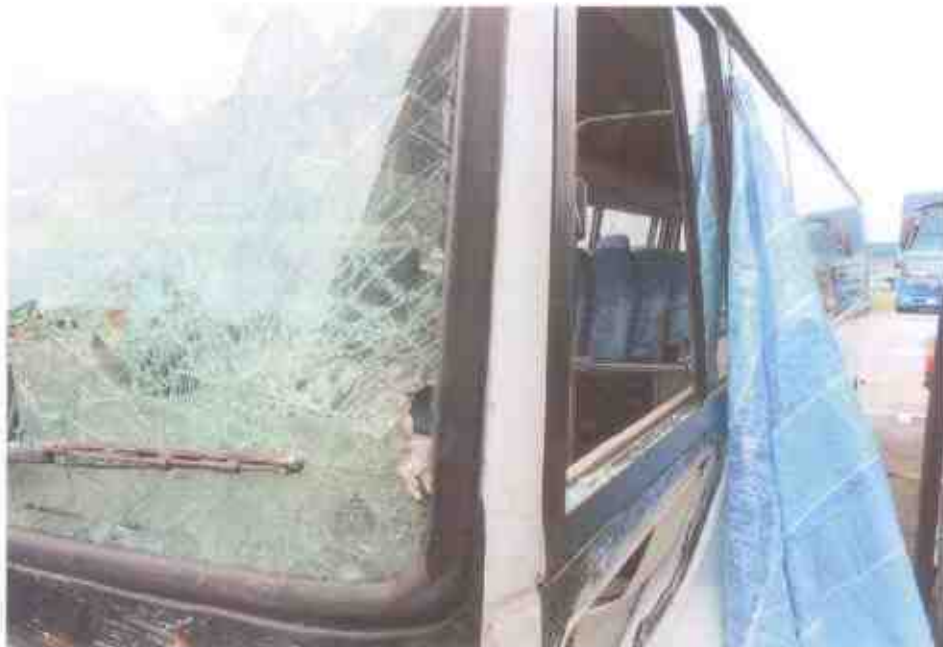
**Photo 4** shows a close-up view of the shattered windshield & left side window glass of the Motor Bus at the time of our inspection. It was likely due to the accident's impact collision.

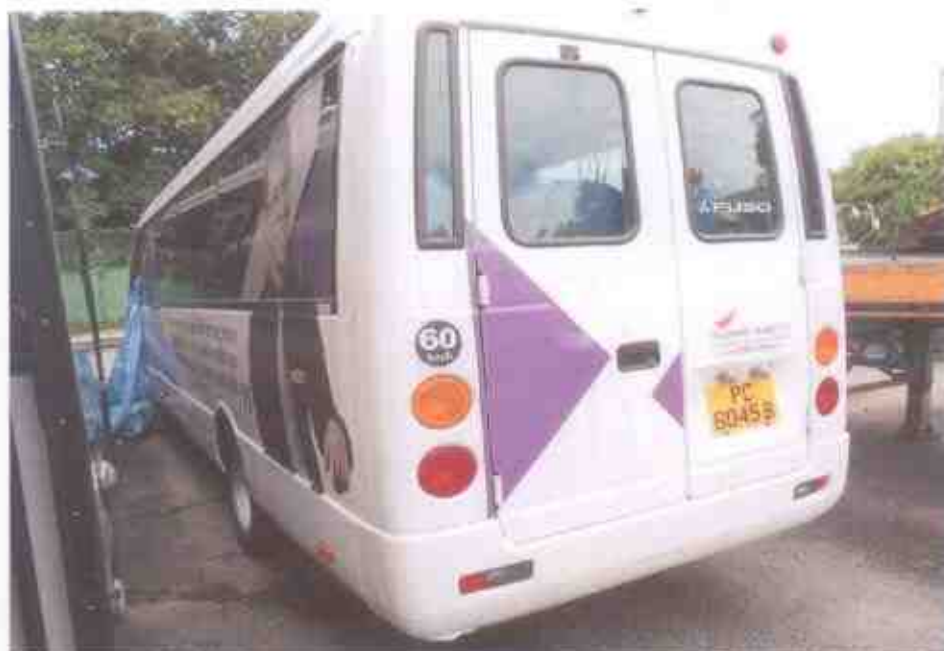
**Photo 5** shows a general view of the rear left body of the Motor Bus at the time of our inspection. The Motor Bus was observed to be in good general condition at time of inspection.

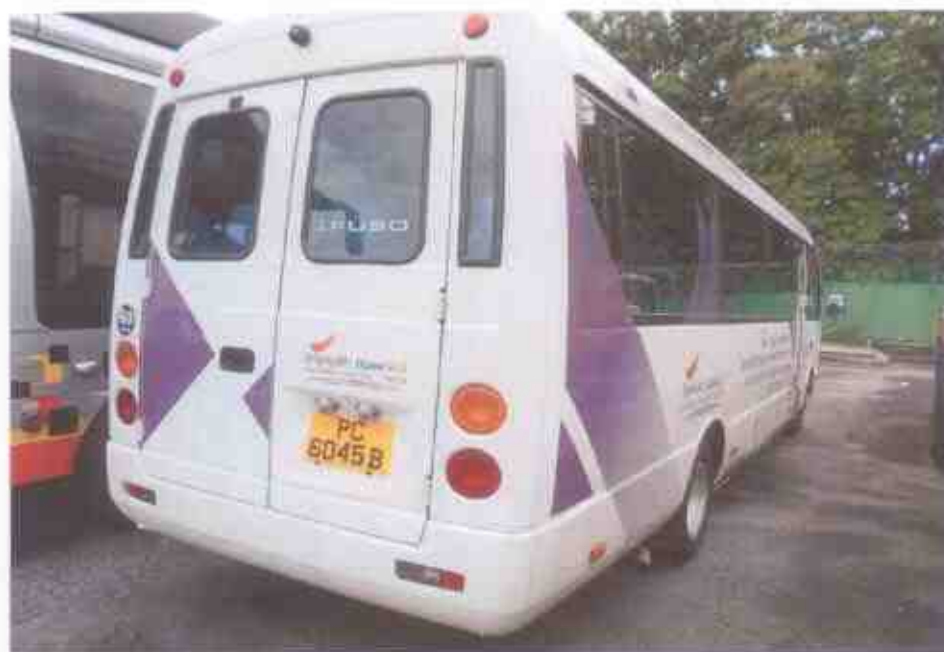
**Photo 6** shows a general view of the rear right body of the Motor Bus at the time of our inspection. The Motor Bus was observed to be in good general condition at time of inspection.

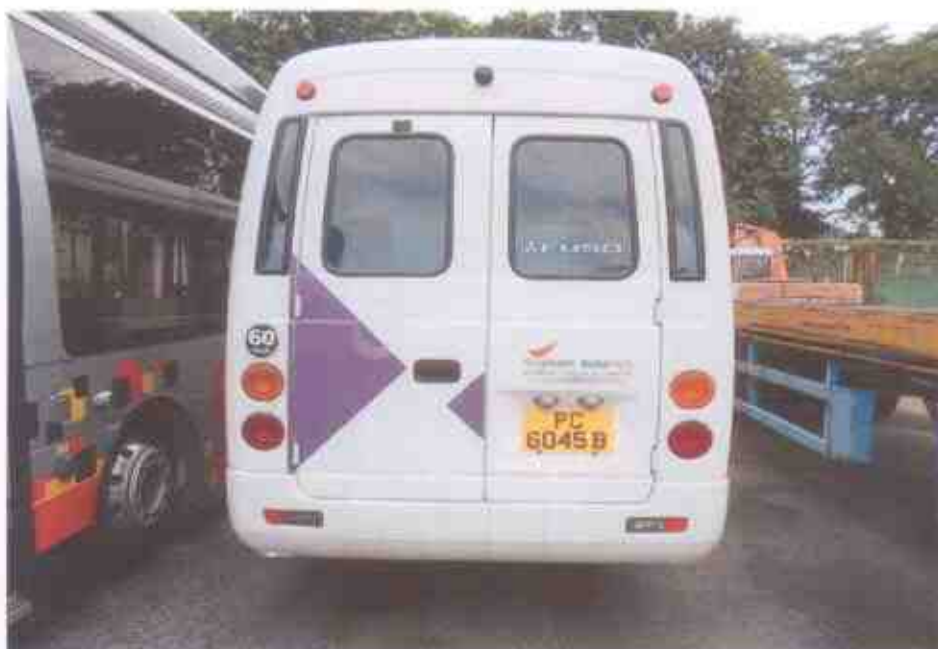
Photo 7 shows a general view of the rear body of the Motor Bus at the time of our inspection. The Motor Bus was observed to be in good general condition at time of inspection.

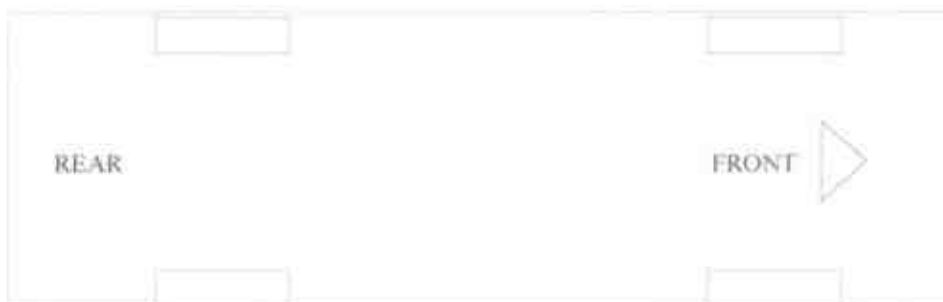
7. The 4 tyres were observed to be in serviceable condition and sufficiently inflated for vehicular operation. We did not find any tear, cut or burst mark(s) on the outer and the inner sidewalls as well as across the tread of the 4 tyres. The tyre brand, tyre size and remaining tread depth of the 4 tyres of the Motor Bus were recorded as follows:-

Yokohama Super Steel RY208  
205/85R16 (4mm)

Condor AL 4000  
7.00R16c (5mm)

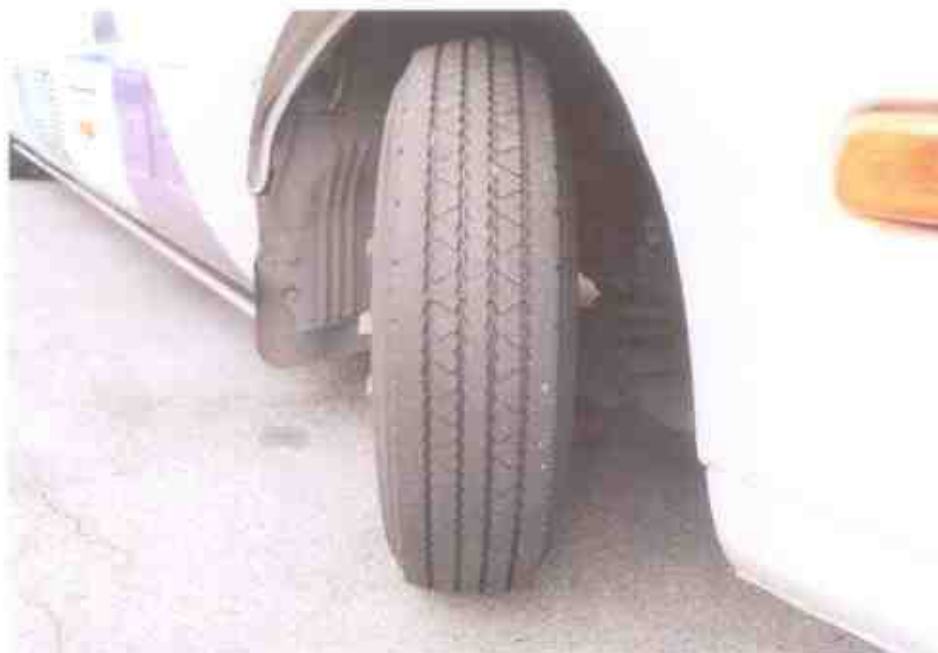
**Photo 8** shows the condition of the front right tyre of the Motor Bus, which was observed to be in serviceable condition with remaining tread depth of approximately 5mm. The tyres were all observed to be sufficiently inflated for vehicular operation with no tear, cut or burst mark(s) on the outer and the inner sidewalls as well as across the tread.

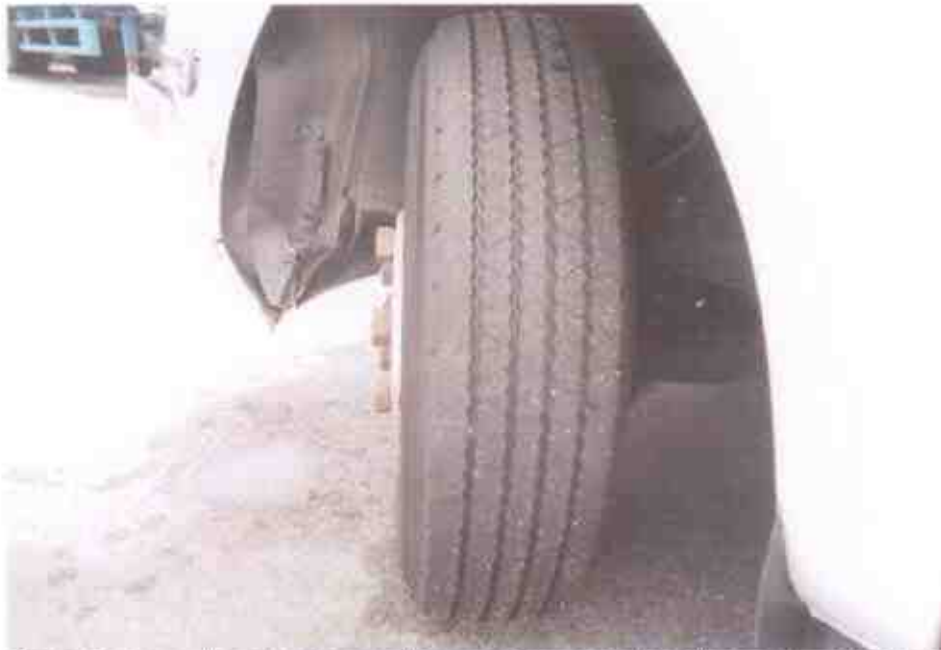
**Photo 9** shows the condition of the front left tyre of the Motor Bus, which was observed to be in serviceable condition with remaining tread depth of approximately 5mm. The tyre, which was wrapped around standard wheel rim, was also observed to be sufficiently inflated for vehicular operation.

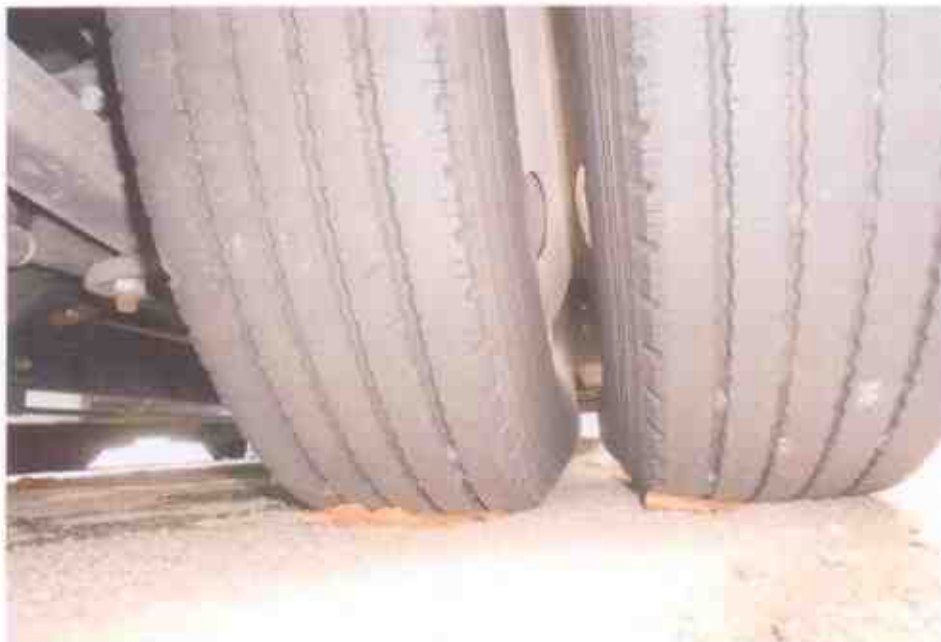
**Photo 10** shows the condition of the rear left tyre of the Motor Bus, which was observed to be in serviceable condition with remaining tread depth of approximately 4mm. The tyre, which was wrapped around standard wheel rim, was also observed to be sufficiently inflated for vehicular operation. There was also no significant damage found on the 4 wheel rims of the Motor Bus.

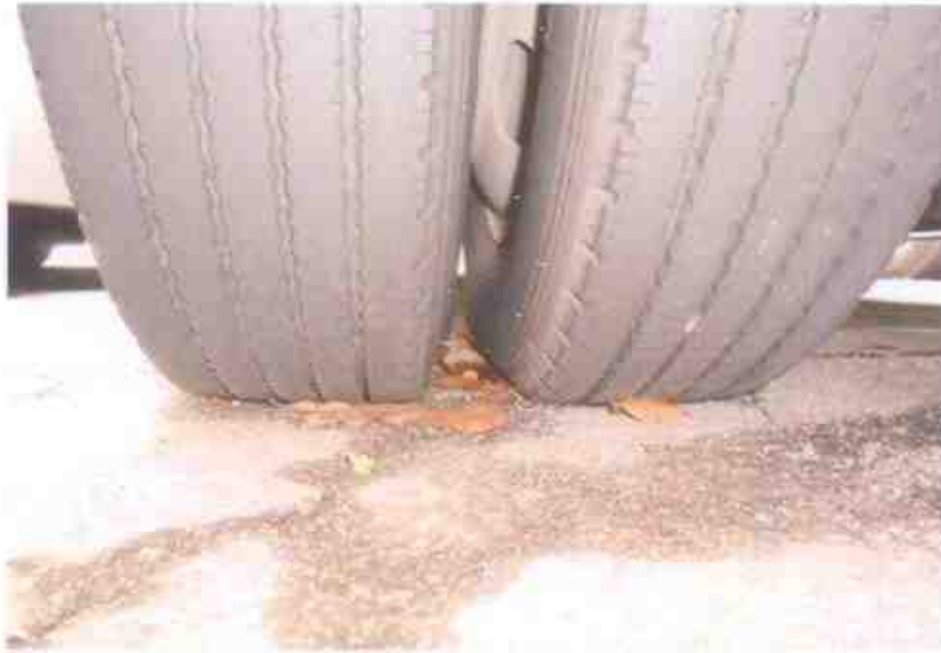
**Photo 11** shows the condition of the rear right tyre of the Motor Bus, which was observed to be in serviceable condition with remaining tread depth of approximately 4mm. There was also no tear, cut or burst mark(s) on the outer and the inner sidewalls as well as across the tread of the tyre, which was also sufficiently inflated for vehicular operation.

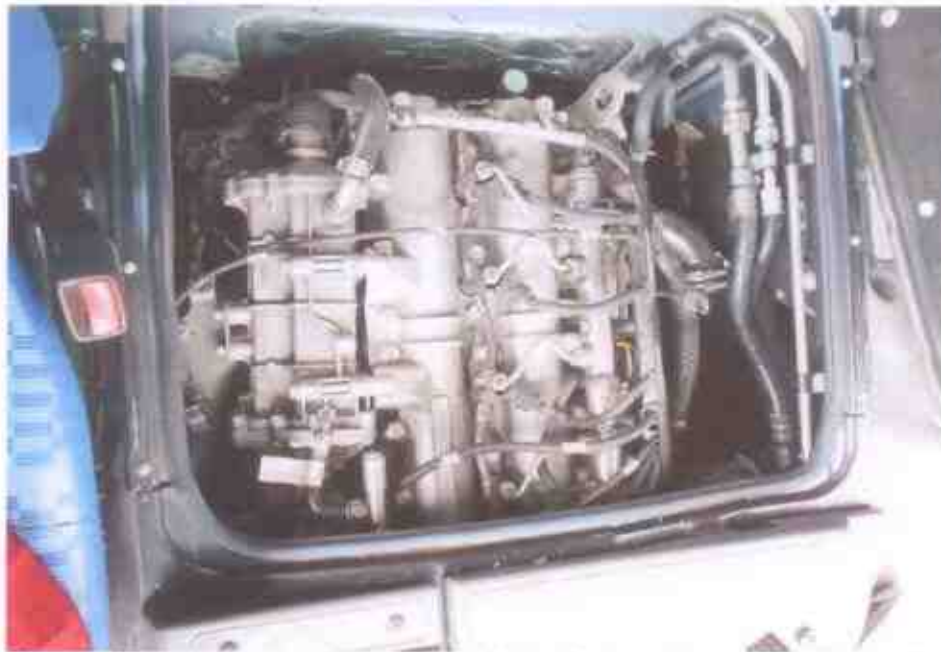
**Photo 12** shows a general view of the Motor Bus's engine compartment. The various parts and components inside the engine compartment were unaffected by the accident. There was also no sign(s) or indication(s) of fluid leakage and/or fluid stain within the engine compartment.

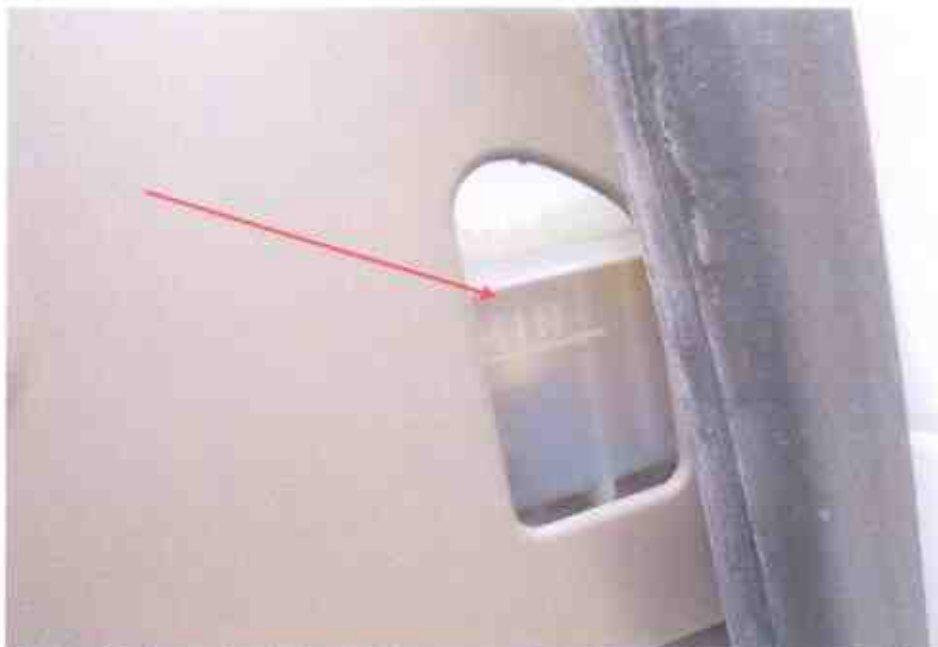
**Photo 13** shows the brake fluid reservoir of the Motor Bus at the time of our inspection. The brake fluid was observed to be of sufficient level and without any visible contamination.

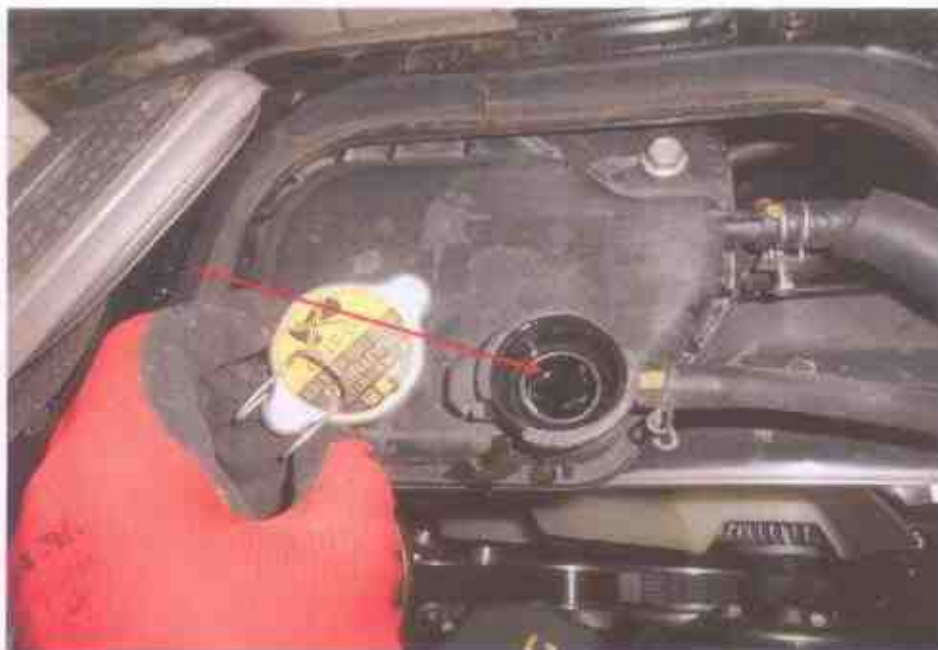
**Photo 14** shows the engine coolant reservoir of the Motor Bus at the time of our inspection. The engine coolant was observed to be of sufficient level and without any visible contamination.

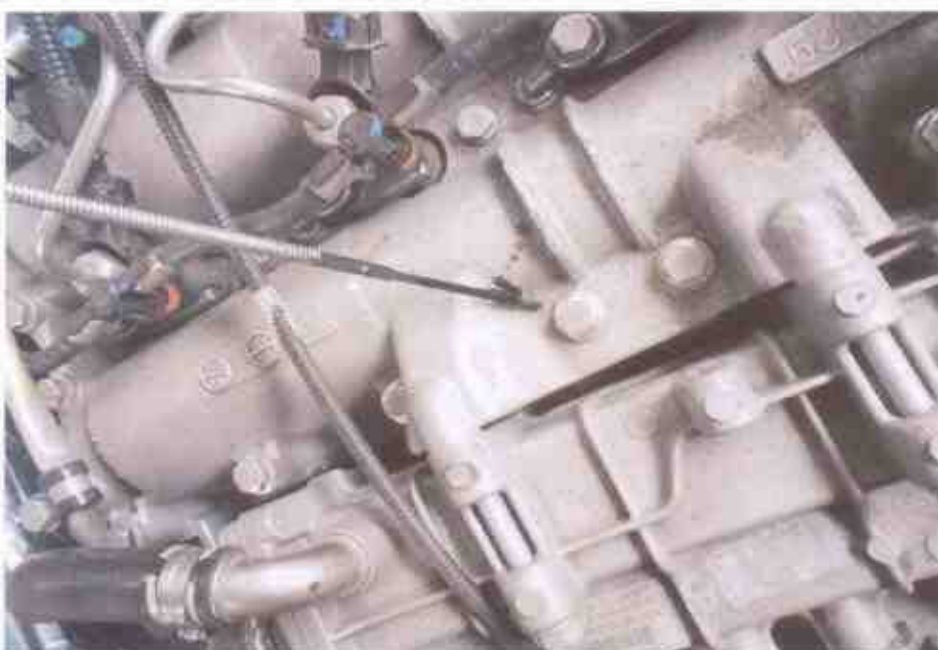
**Photo 15** shows the engine dip stick of the Motor Bus at the time of our inspection. The engine oil was observed to be of sufficient level and without any visible contamination.

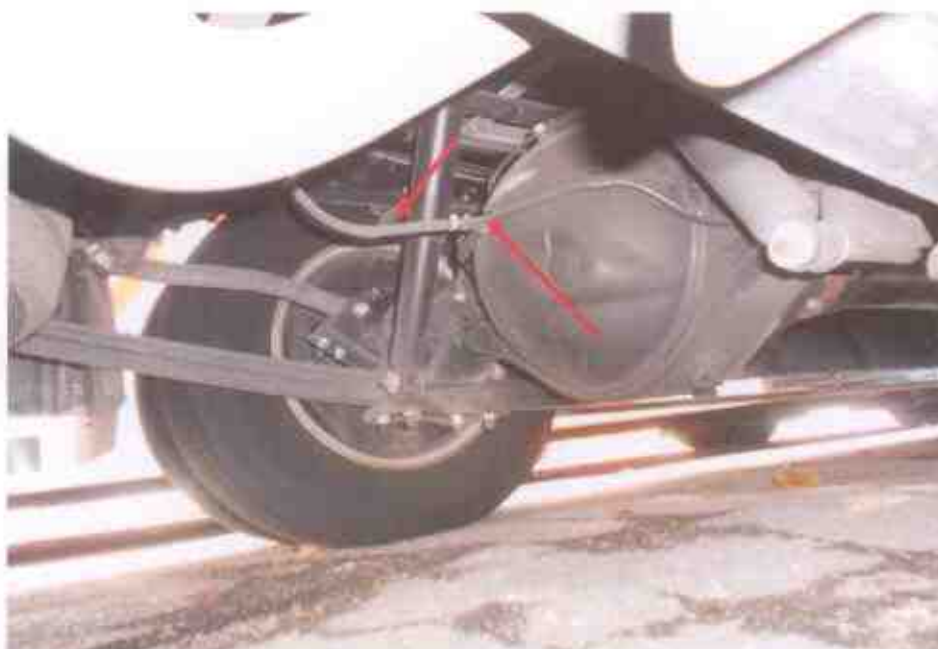
Photo 16 shows the various undercarriage components at the rear left wheel of the Motor Bus, in particular the brake hose (arrowed). We did not observe any leakage of brake fluid at the time of our inspection of the Motor Bus.

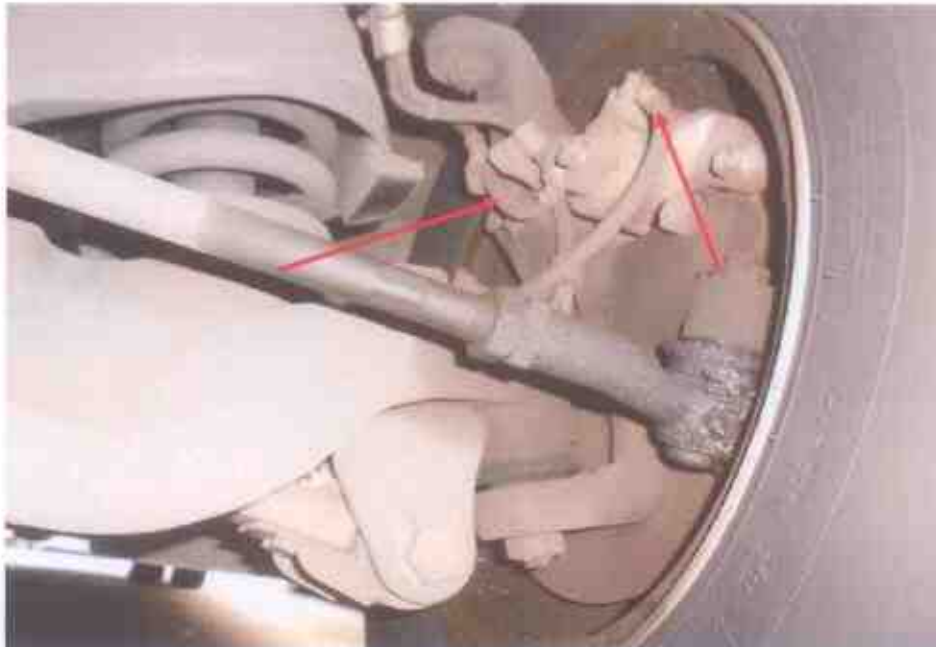
**Photo 17** shows the brake hose at the front left wheel of the Motor Bus. We did not observe any leakage of brake fluid. Our visual inspection of the various mechanical components of the Motor Bus's braking system revealed all to be intact and without visible damage, indicating that the braking system was likely to be in serviceable condition at the material time of accident.

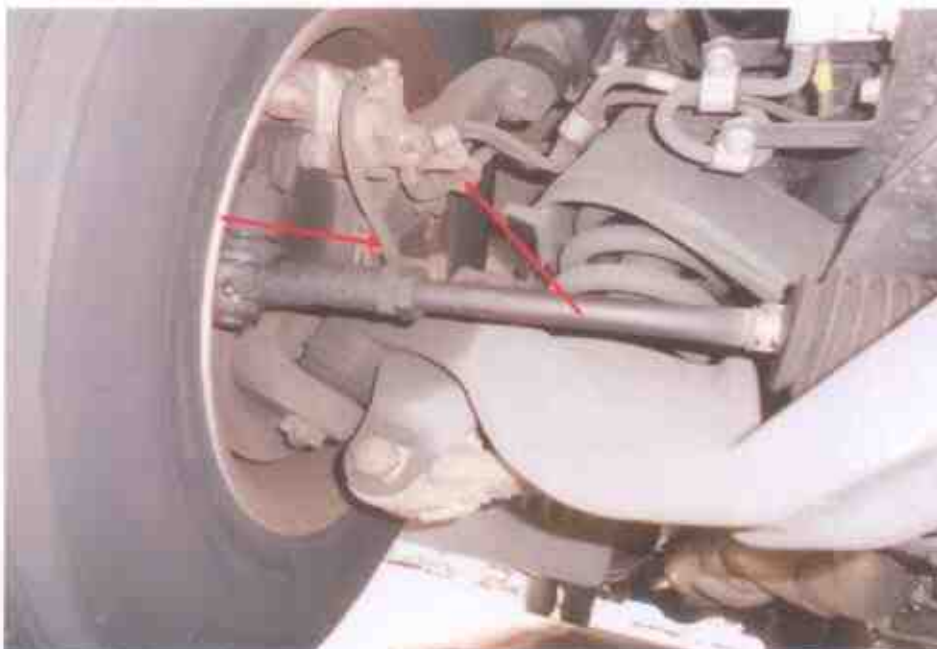
**Photo 18** shows the brake hose (arrowed) at the front right wheel of the Motor Bus. We did not observed any leakage of brake fluid at the time of our inspection of the Motor Bus. Our visual inspection of the various mechanical components of the Motor Van's braking system, including its brake calliper, revealed all to be intact and without visible damage.

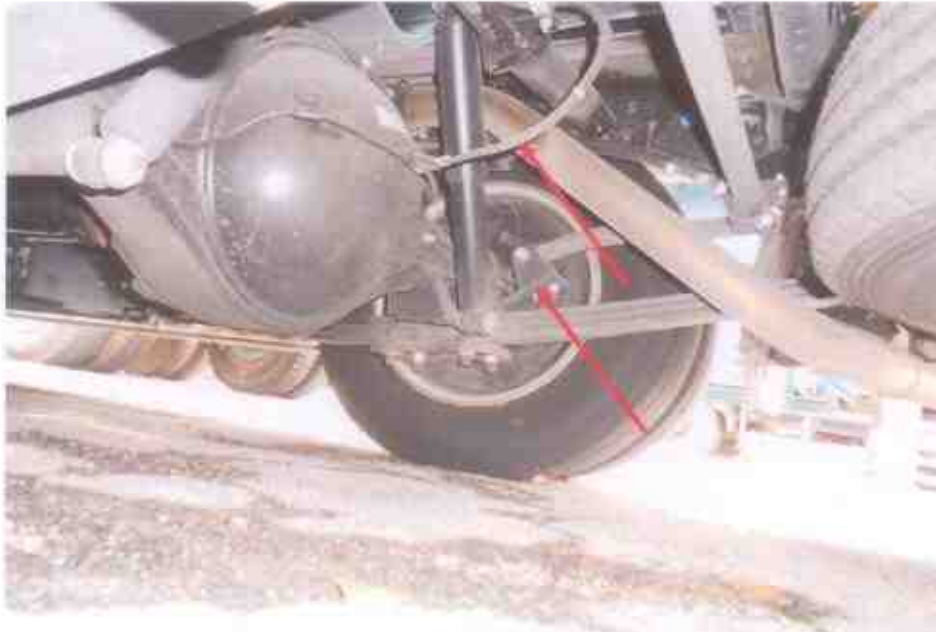
**Photo 19** shows the various undercarriage components at the rear right wheel of the Motor Bus. The various steering components were all found to be intact, suggesting that the steering system of the Motor Bus was likely to be in serviceable condition at the material time of accident. There was also no sign of fluid stain(s) observed on the various undercarriage components at the 4 wheels of the Motor Van.

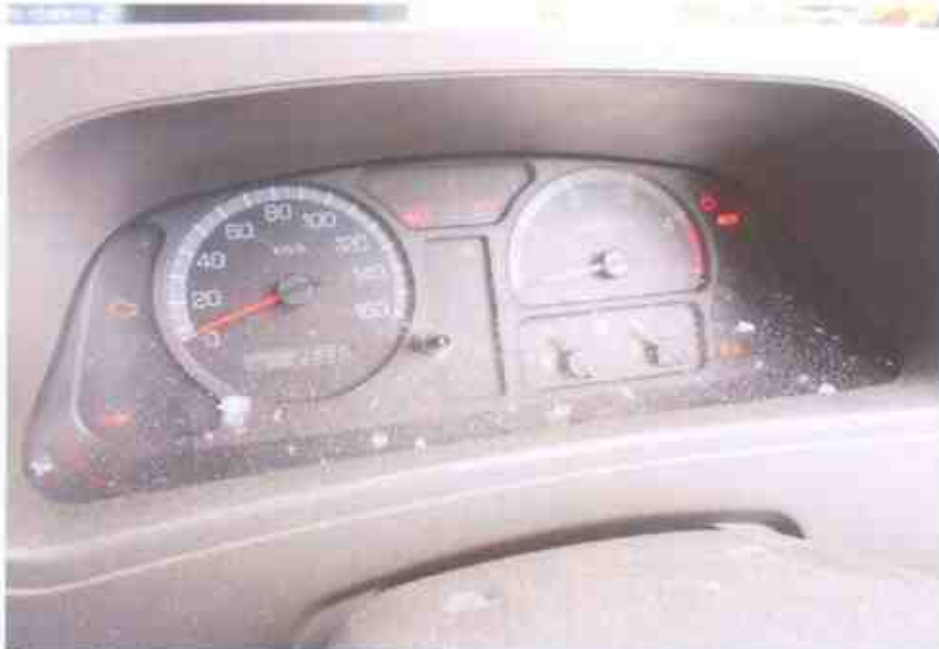
**Photo 20** shows the warning lights for the various electronic operating systems of the Motor Bus appearing on its instrument panel during the self-test when the engine was cranked.

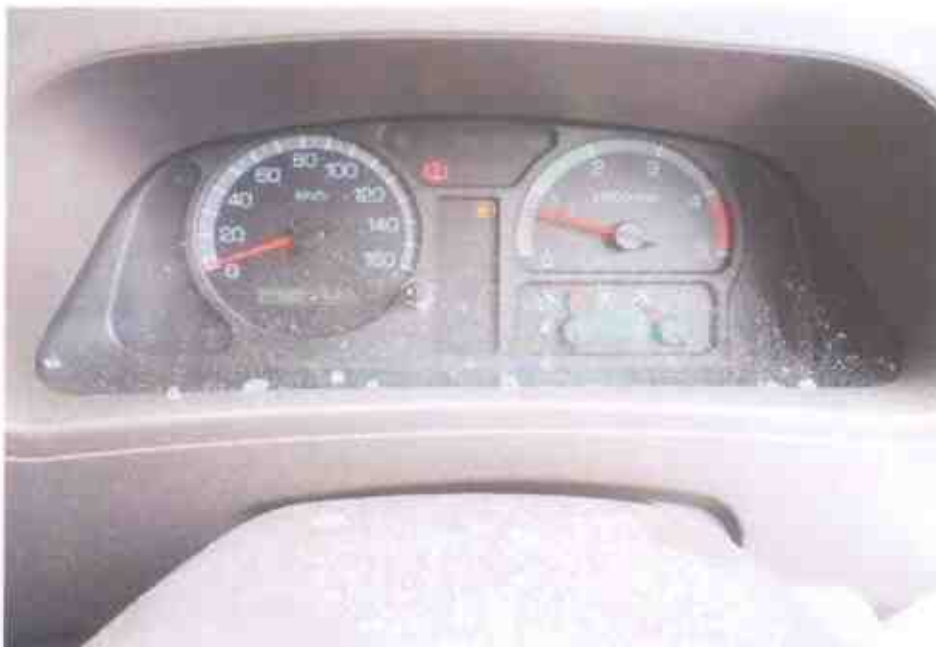
**Photo 21** shows no warning lights illuminated on the instrument panel of the Motor Bus after the engine was cranked. This would suggest that there was no abnormality to the various electronic operating systems of the Motor Car.

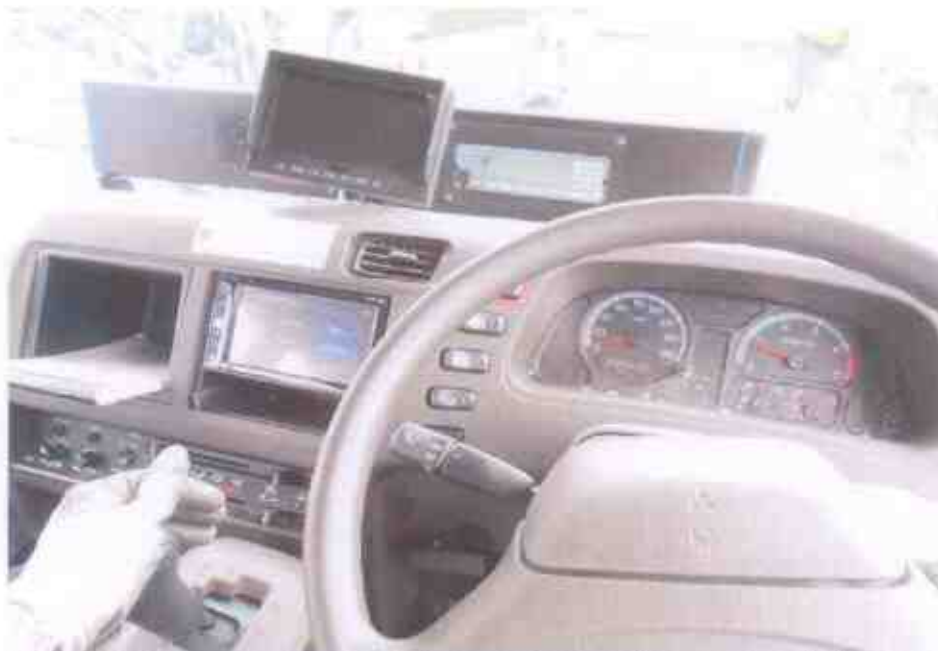
Photo 22 shows a short operational test of the Motor Bus, to primarily determine whether there was any abnormality to its various operating systems like its engine system, its transmission system, steering system and braking system was subsequently carried out. The test was conducted by driving the Motor Bus forward, stopping, before reversing and coming to a stop again.

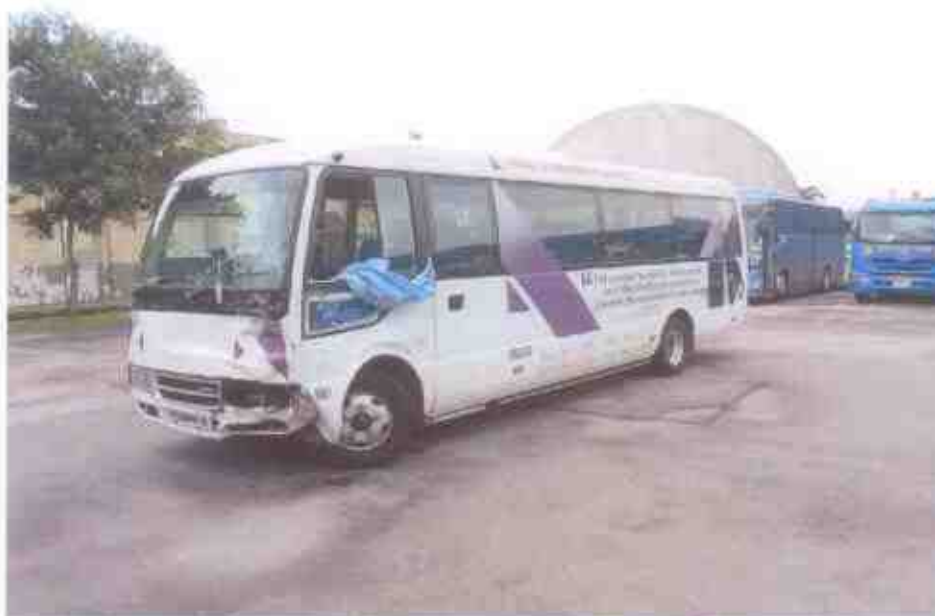
**Photo 23** shows a short operational test of the Motor Bus, the test was conducted by driving the Motor Bus forward, stopping, before reversing and coming to a stop again.
