30th July 2018

Fatal Accident Investigation Team

MECHANICAL INSPECTION REPORT OF MOTOR LORRY YN 1690G

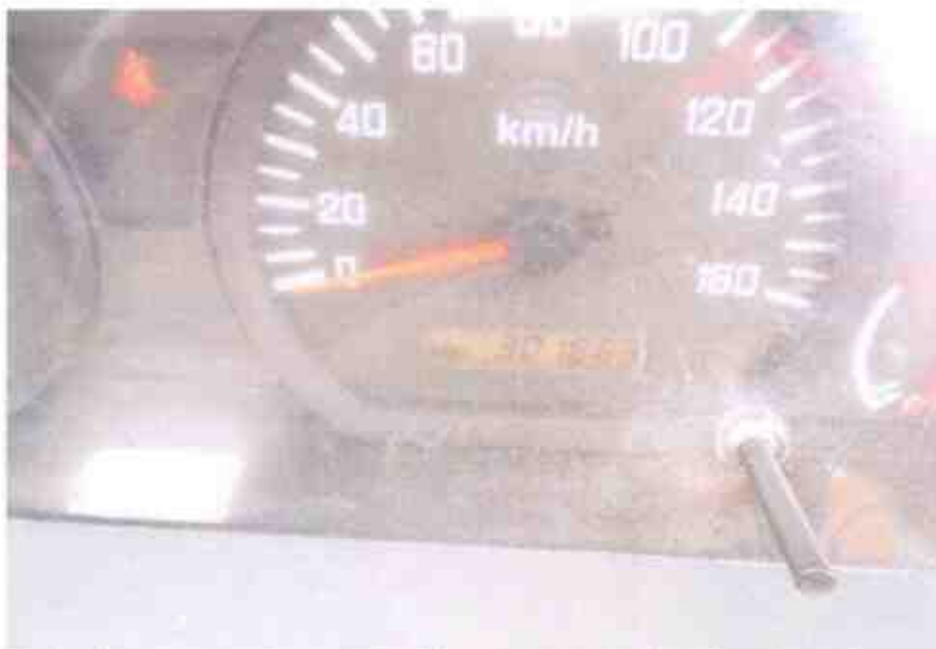
Photo 1 shows the mileage of the Motor Lorry at the time of our inspection was recorded as 301869km.

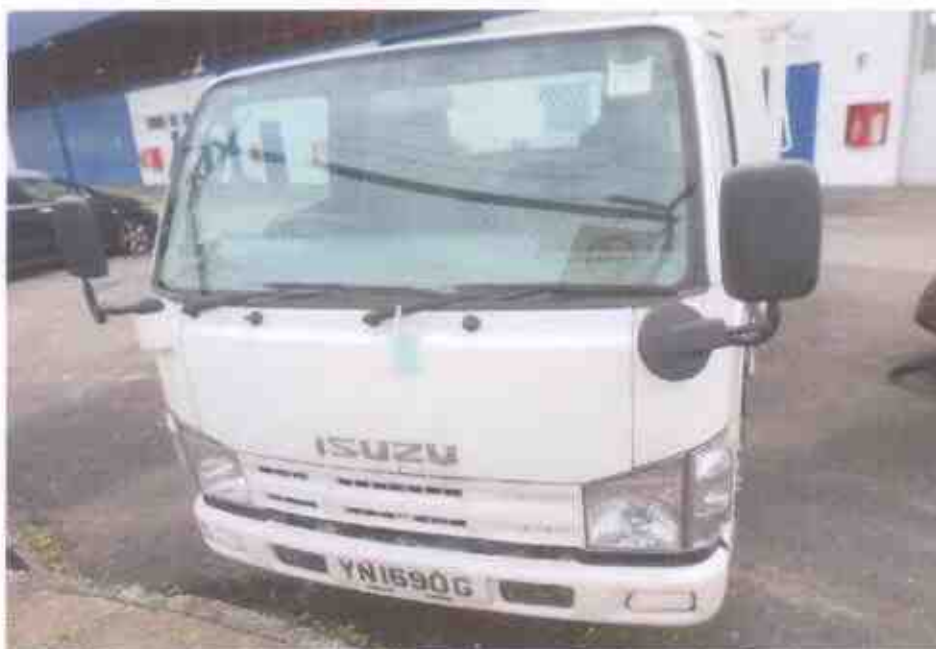
Photo 2 shows a general view of the front portion of the Motor Lorry at the time of our inspection. The Motor Lorry was observed to be in good condition unaffected by the accident.

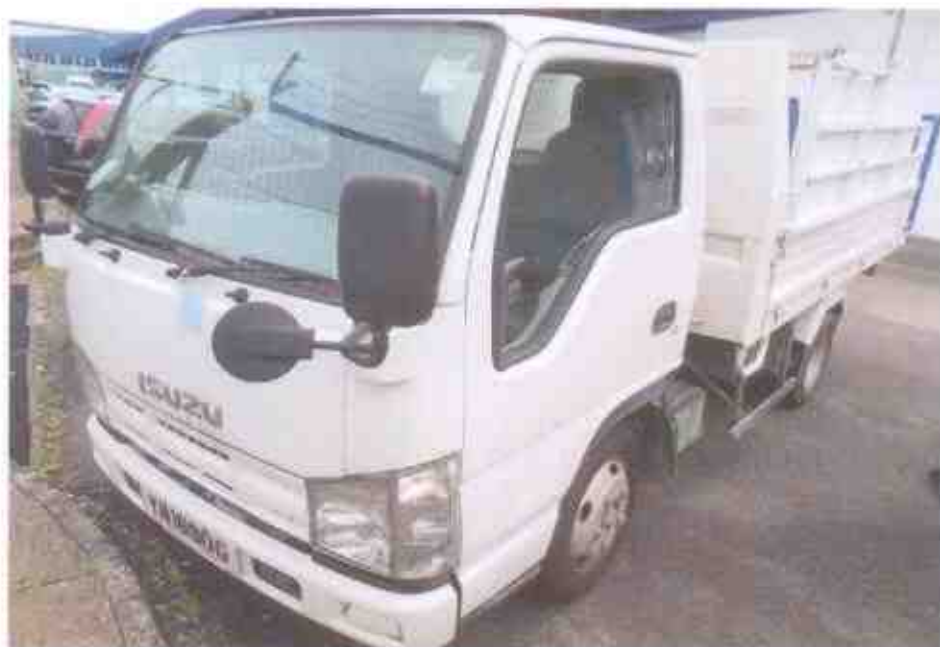
Photo 3 shows a general view of the front left portion of the Motor Lorry at the time of our inspection. The Motor Lorry was observed to be in good condition unaffected by the accident.

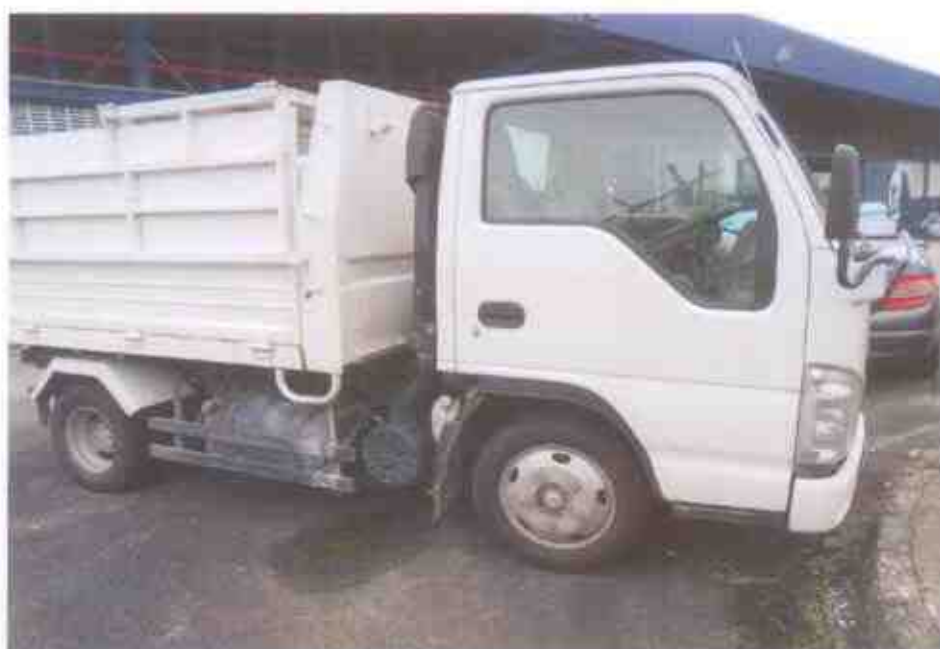
Photo 4 shows a general view of the front right portion of the Motor Lorry at the time of our inspection. The Motor Lorry was observed to be in good condition unaffected by the accident.

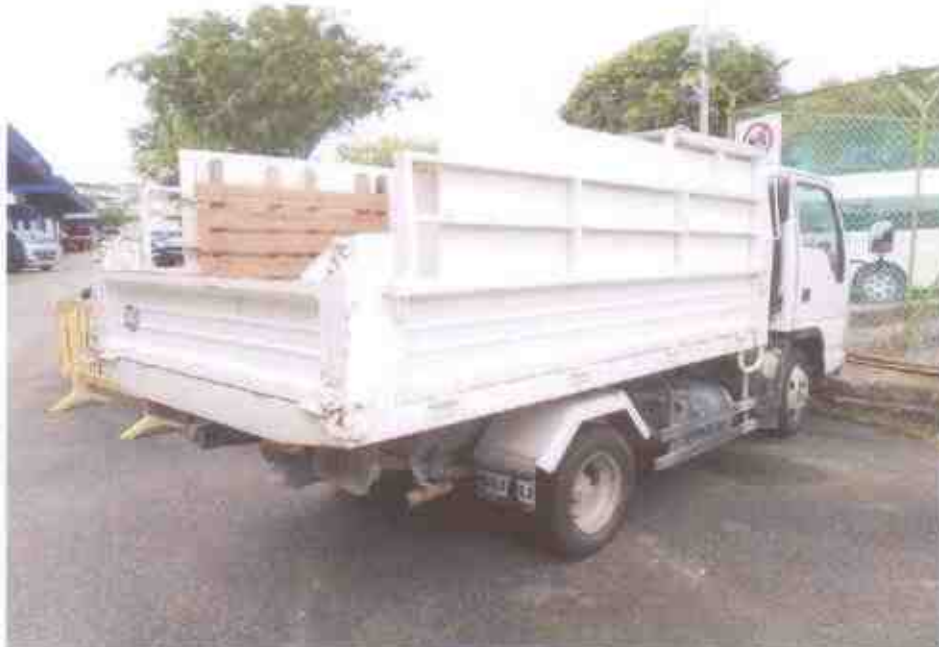
Photo 5 shows a general view of the rear right portion of the Motor Lorry at the time of our inspection. The Motor Lorry was observed to be in good condition unaffected by the accident.

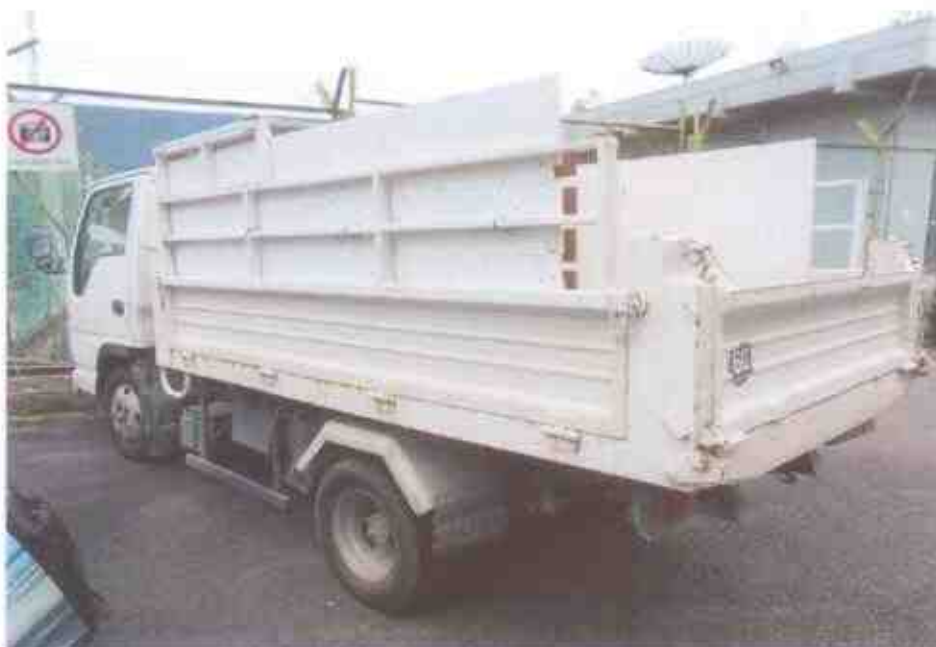
Photo 6 shows a general view of the rear left portion of the Motor Lorry at the time of our inspection. The Motor Lorry was observed to be in good condition unaffected by the accident.

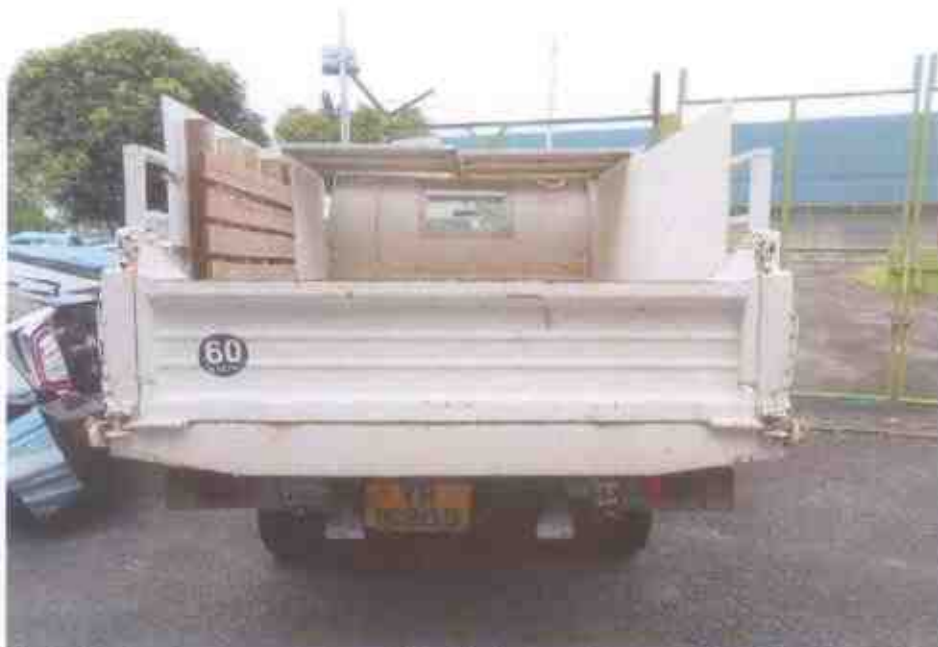
Photo 7 shows a general view of the Motor Lorry's rear body at the time of our inspection. There was no damage found to the rear portion of the Motor Lorry.

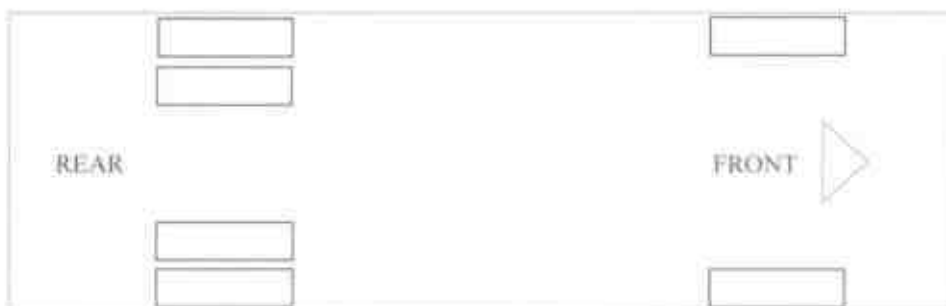
7. The 2 front tyres and 4 rear tyres of the Motor Lorry were observed to be in serviceable condition and sufficiently inflated for vehicular operation. We did not find any tear, cut or burst mark(s) on the outer and the inner sidewalls as well as across the tread of the 6 tyres. The tyre brand, tyre size and remaining tread depth of the 6 tyres of the Motor Lorry were recorded as follows:-

GT radial Maxmiler Pro
155 R12c (7mm)

Bridgestone R202
205/70 R16c (6mm)

Yokohama Delivery Star 818 155
R12c (7mm)

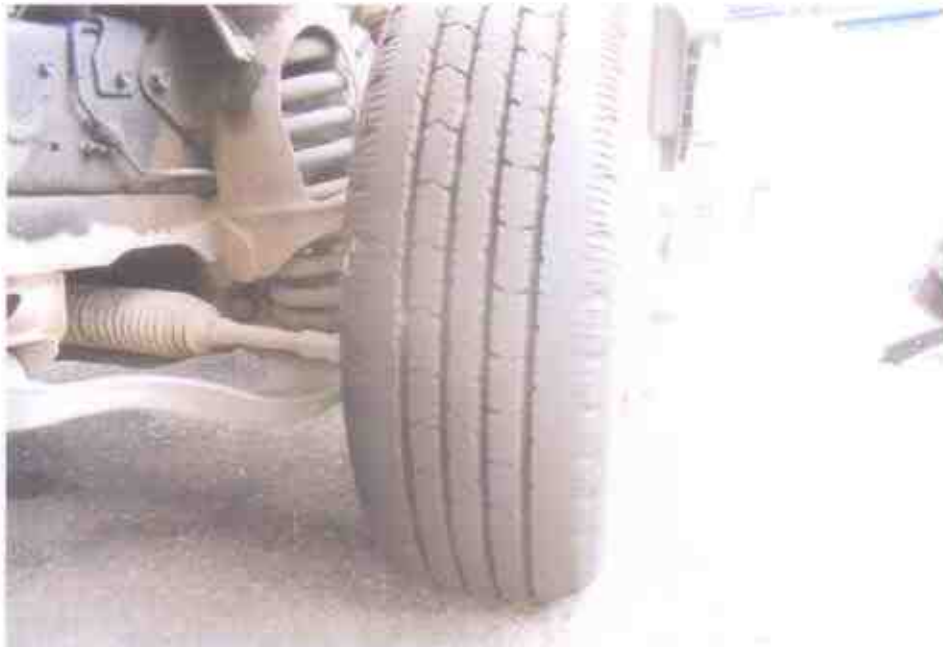
Photo 8 shows the condition of the front left tyre of the Motor Lorry, which was observed to be in serviceable condition with remaining tread depth of approximately 6mm. The tyre, which was wrapped around standard steel wheel rim, was also observed to be sufficiently inflated for vehicular operation.

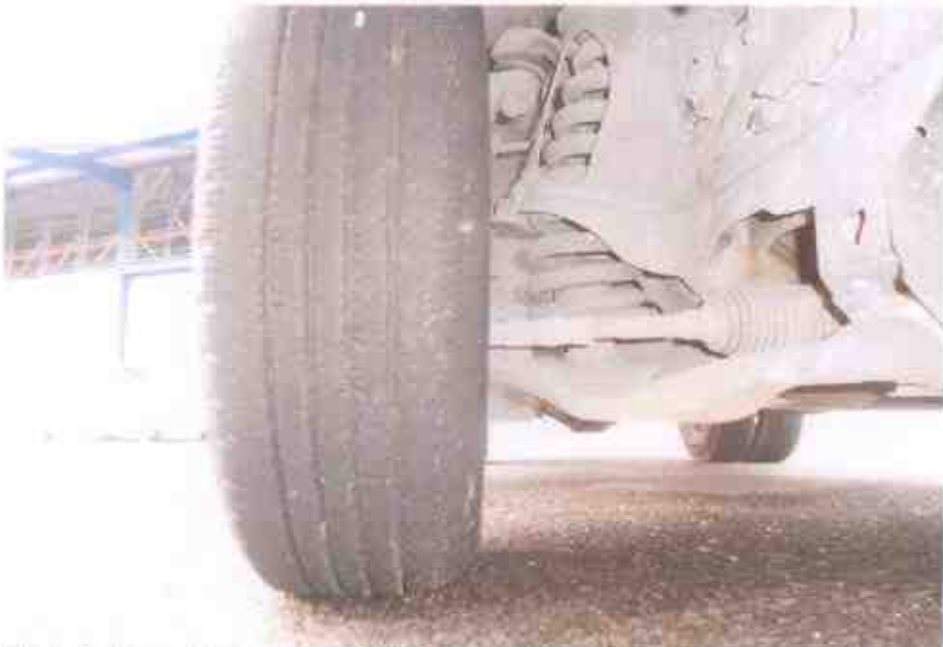
Photo 9 shows the condition of the front right tyre of the Motor Lorry, which was observed to be in serviceable condition with remaining tread depth of approximately 6mm. The tyre, which was wrapped around standard steel wheel rim, was also observed to be sufficiently inflated for vehicular operation.

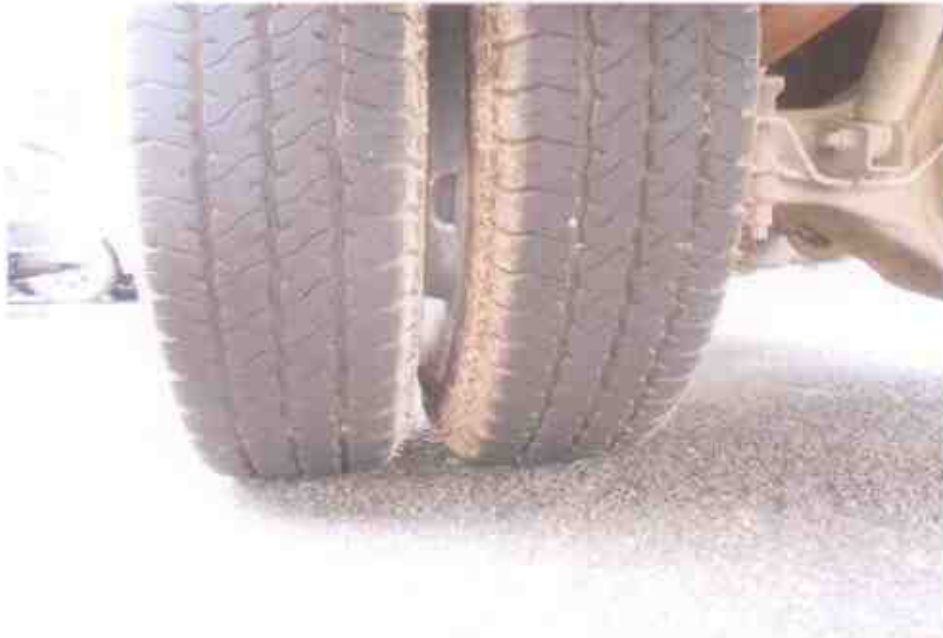
Photo 10 shows the condition of the rear left tyres of the Motor Lorry, which was observed to be in serviceable condition with remaining tread depth of approximately 7mm. The tyres, which were wrapped around standard steel wheel rim, were also observed to be sufficiently inflated for vehicular operation.

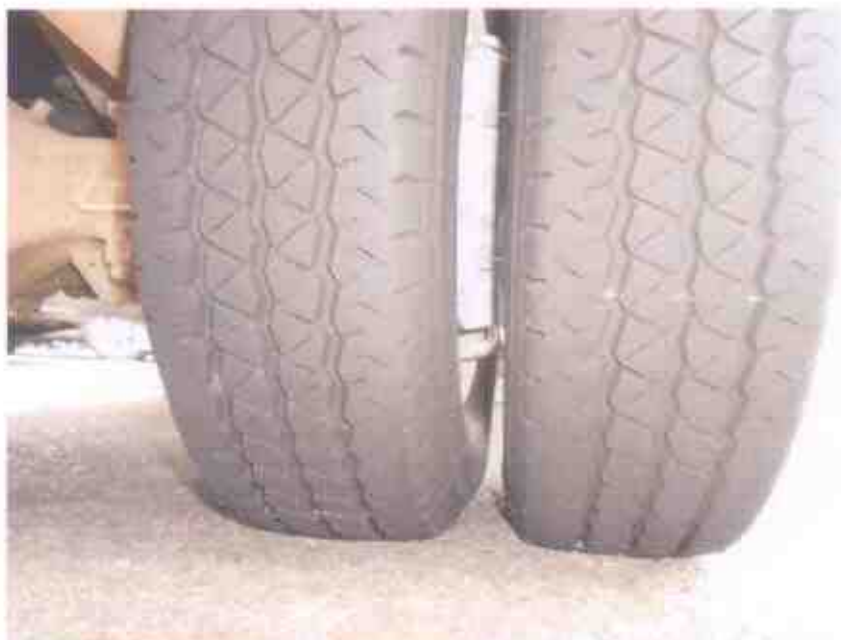
Photo 11 shows the condition of the rear right tyres of the Motor Lorry, which were observed to be in serviceable condition with remaining, tread depth of approximately 7mm.

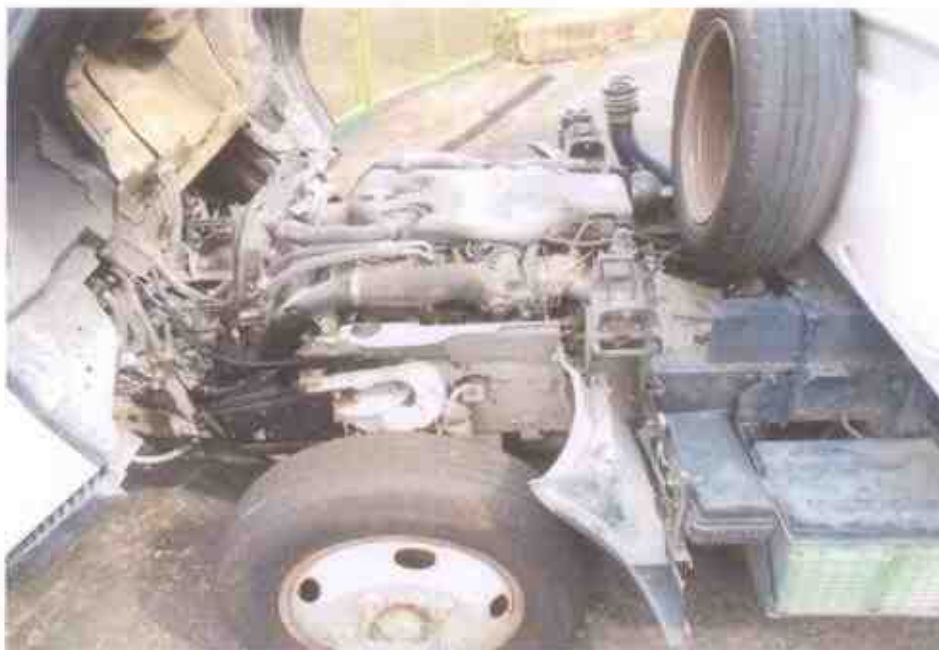
Photo 12 shows a general view of the Motor Lorry's engine compartment, which was accessed by lifting the front cabin of the Motor Lorry. The various parts and components inside the engine compartment were unaffected by the accident. There was also no sign(s) or indication(s) of fresh fluid leakage and/or fluid stain within the engine.

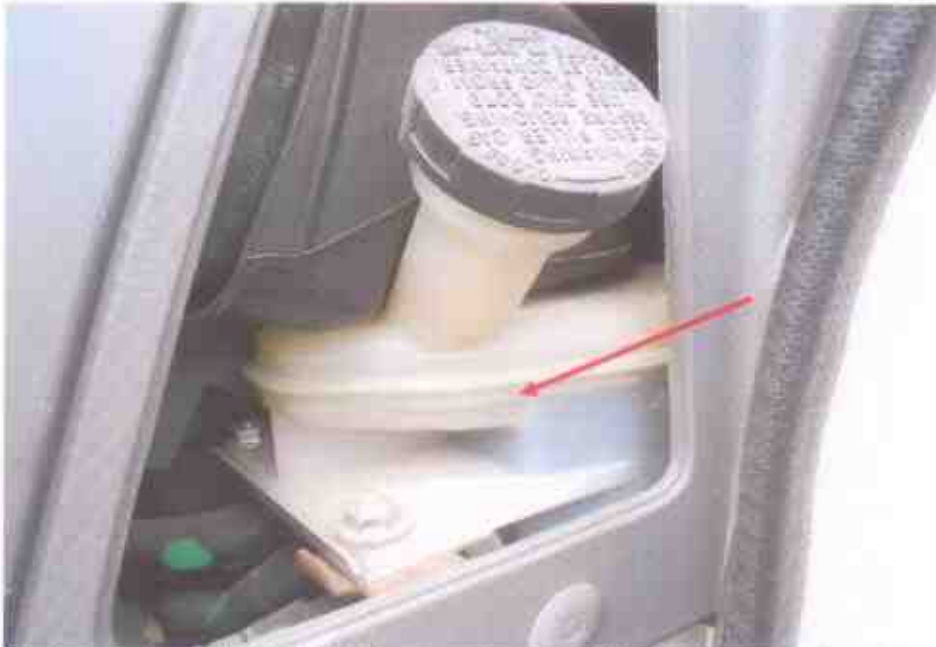
Photo 13 shows the brake fluid reservoir of the Motor Lorry at the time of our inspection. The brake fluid was observed to be of sufficient level and without any visible contamination (arrowed).

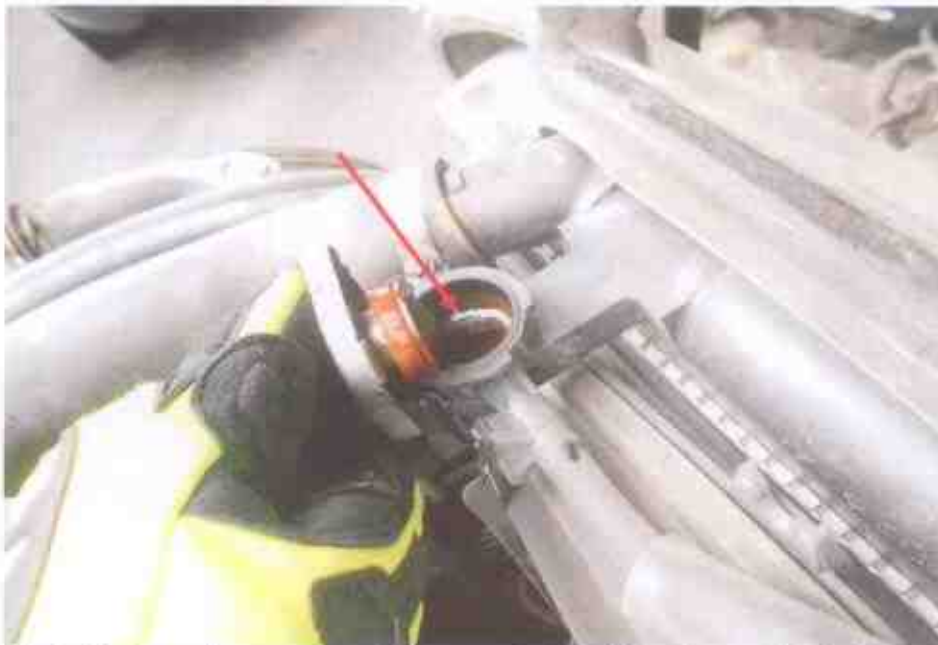
Photo 14 shows the engine coolant reservoir of the Motor Lorry at the time of our inspection. The engine coolant was observed to be of sufficient level and without any visible contamination (arrowed).

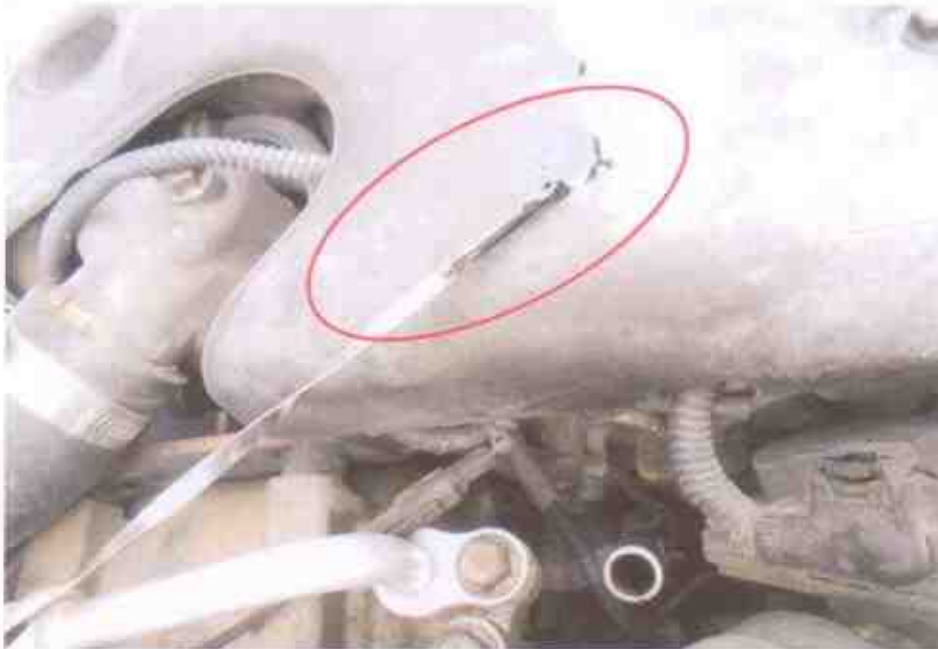
Photo 15 shows the engine dip stick of the Motor Lorry at the time of our inspection. The engine oil was observed to be of sufficient level and without any visible contamination (circled).

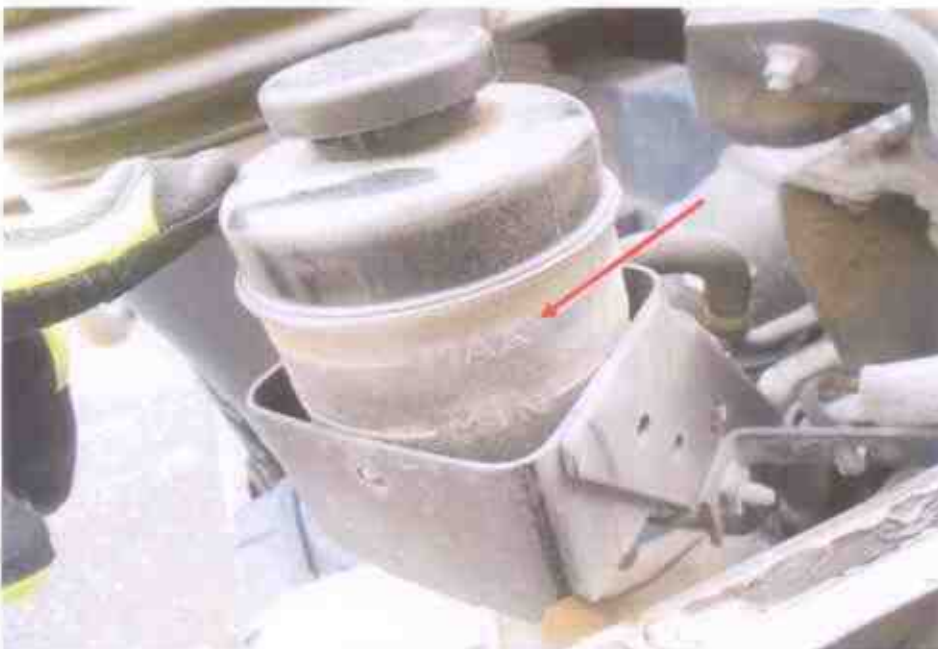
Photo 16 shows the transmission fluid of the Motor Lorry at the time of our inspection. It was observed to be of sufficient level and without any visible contamination (circled).

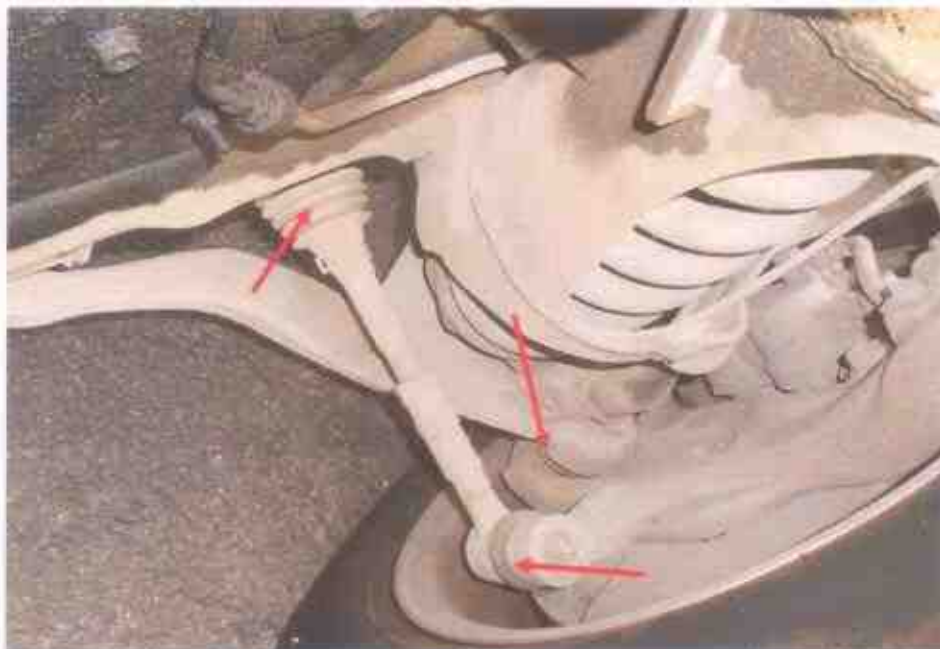
Photo 17 shows the various undercarriage components at the front left wheel of the Motor Lorry, in particular the steering tie rod end (arrowed). The various undercarriage components of the Motor Lorry were all found to be intact without any visible damage. There was also no sign of fluid stain(s) observed on the various undercarriage components.

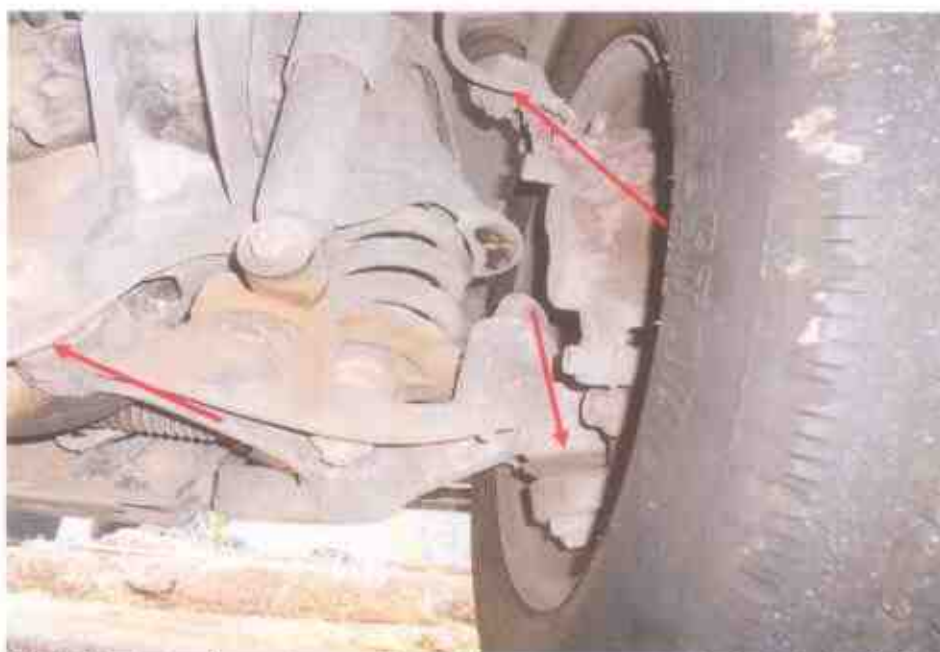
Photo 18 shows the various undercarriage components at the front right wheel of the Motor Lorry, in particular the steering tie rod end (arrowed). The various undercarriage components of the Motor Lorry were all found to be intact without any visible damage. There was also no sign of fluid stain(s) observed on the various undercarriage components.

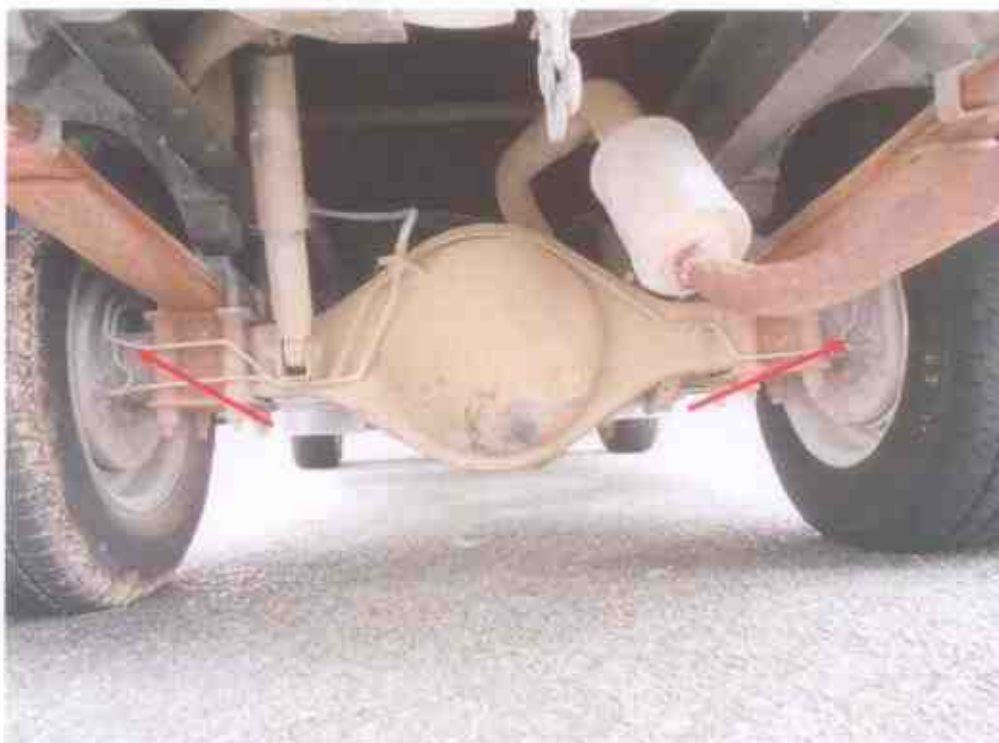
15. Checks on the brake shoes (brake pads) at the rear wheels of the Motor Lorry revealed that the brake shoes (brake pads) were in serviceable condition with sufficient frictional material for operational purposes. In general, our visual inspection of the mechanical components of the Motor Lorry's braking system appear to suggest that its braking system was in serviceable condition at the material time of accident. See photo 19 below.

Photo 19 shows the various undercarriage components at the rear wheels of the Motor Lorry. There was no sign(s) of brake fluid leakage along the brake hoses and brake pipes.

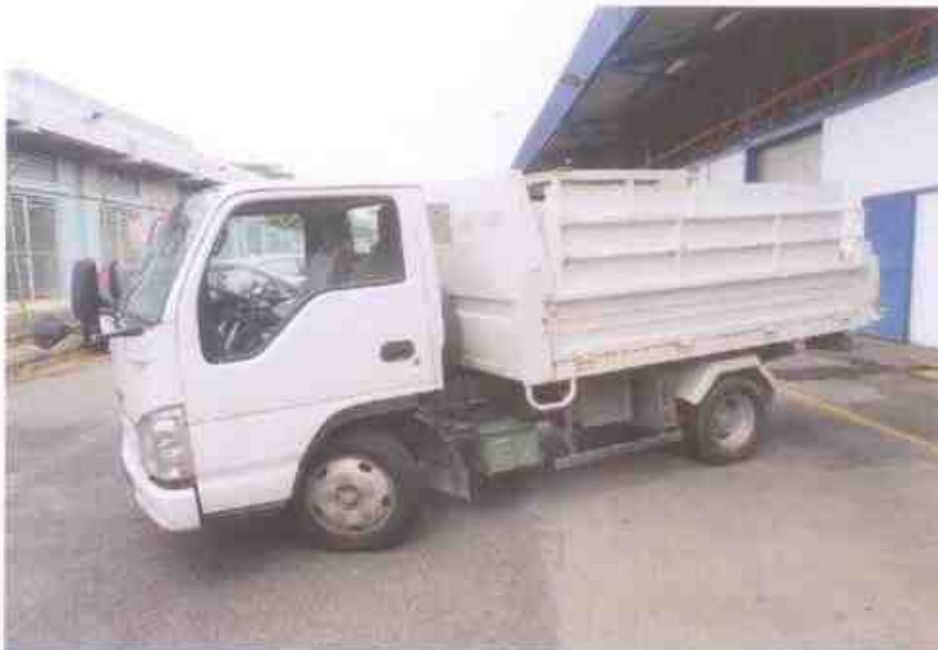
18. During the operational test, the various transmission gears of the Motor Lorry were able to be engaged without any difficulty by stepping on the clutch pedal and manually shifting the gear lever. There were no abnormal sound heard and/or abnormal behaviour of the Motor Lorry's engine system. It was able to move forward and backward normally. The braking system was also found to be in working condition as the Motor Lorry was able to slow down and come to a complete stop upon depressing of the brake pedal. See photo 20 below.

Photo 21 shows the operational test on the Motor Lorry. It was observed to be in serviceable condition. Operational test such as moving forward, turn left & right and also braking test on the Motor Lorry was conducted successfully.
