Your Ref: TP/IP/26803/2018  
Our Ref : CI/TPD18011347/Z

20<sup>th</sup> August 2018

**Fatal Accident Investigation Team**

**MECHANICAL INSPECTION REPORT OF MOTOR LORRY YP 6558M**

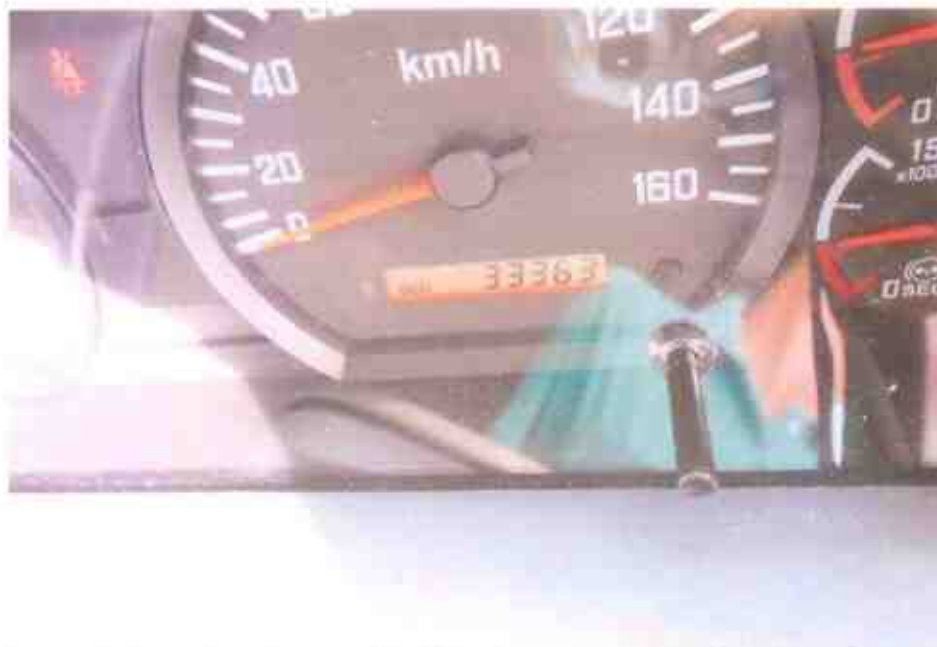
**Photo 1** shows the mileage of the Motor Lorry at the time of our inspection was recorded as 33363km.

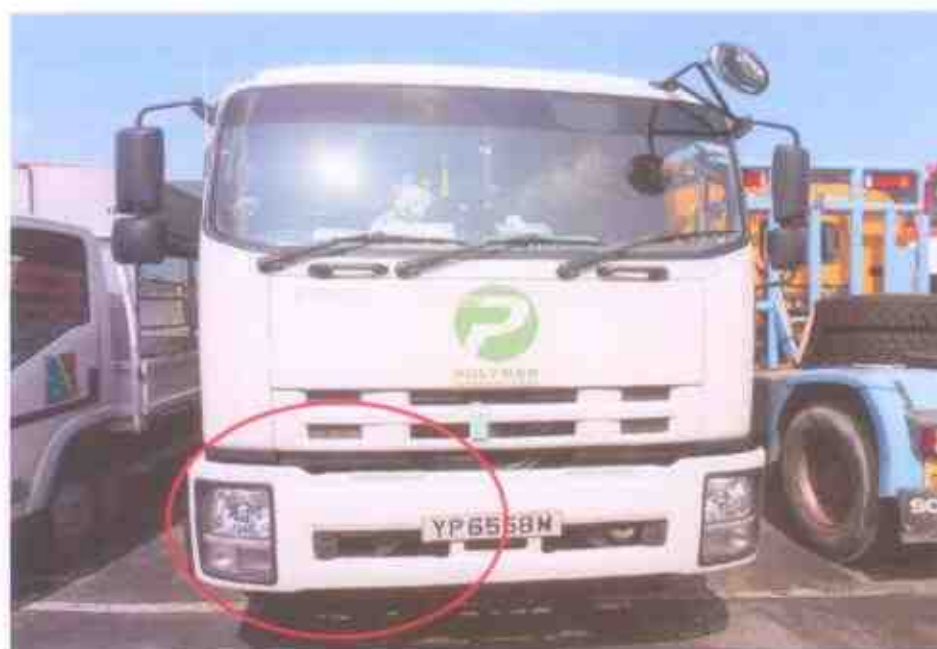
**Photo 2** shows a general view of the front portion of the Motor Lorry at the time of our inspection. The Motor Lorry was observed to have sustained minor impact at its front right bumper. Only stain marks was observed on the front right bumper as a result of the accident.

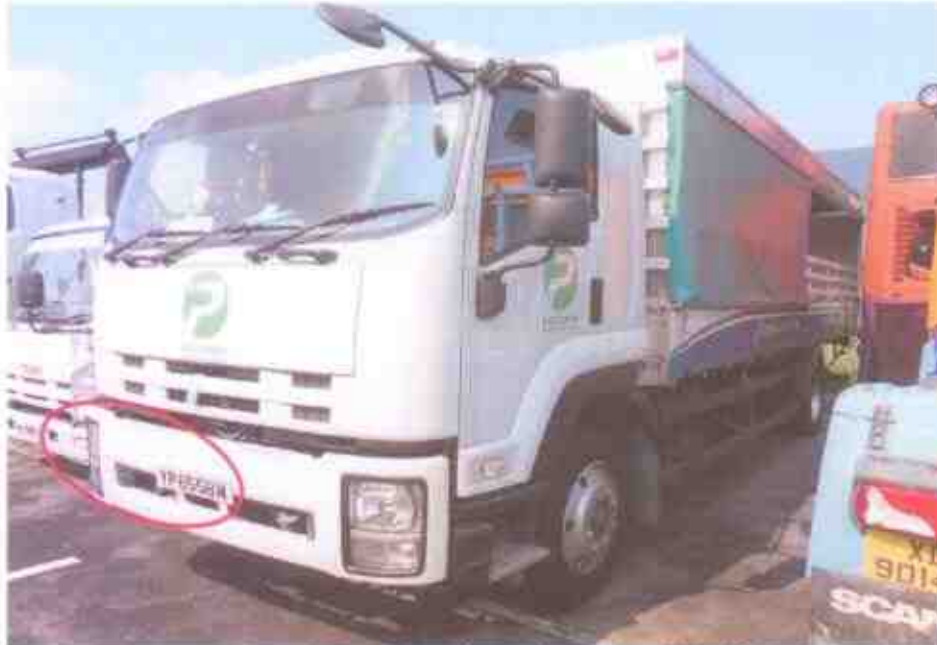
Photo 3 shows a general view of the front left portion of the Motor Lorry at the time of our inspection. The Motor Lorry was observed to have sustained minor impact at its front right bumper. Only stain marks were observed on the front right bumper as a result of the accident.

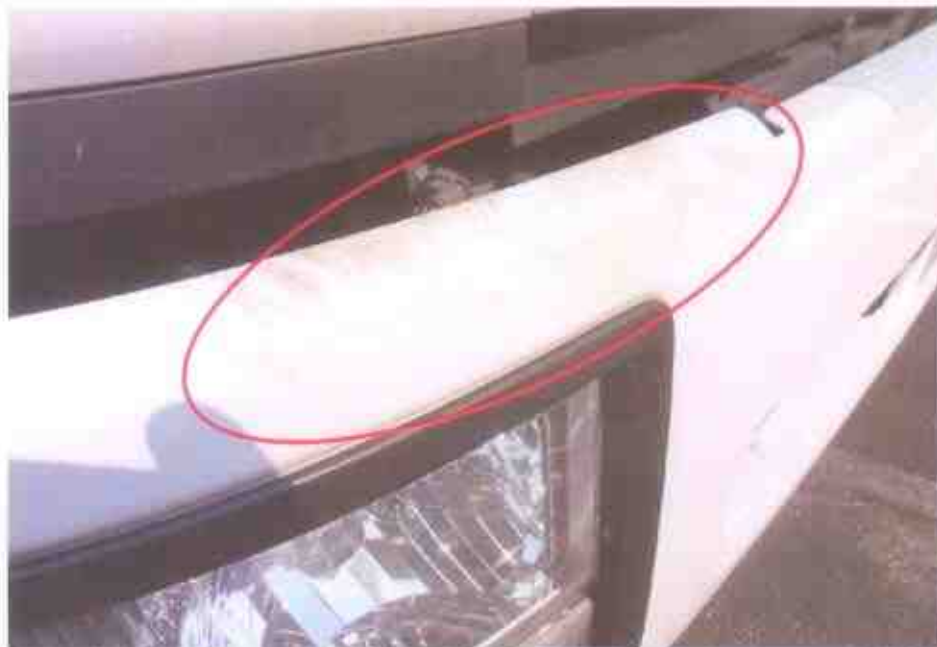
Photo 4 shows a minor stain mark on the front right side bumper as a result of the accident.

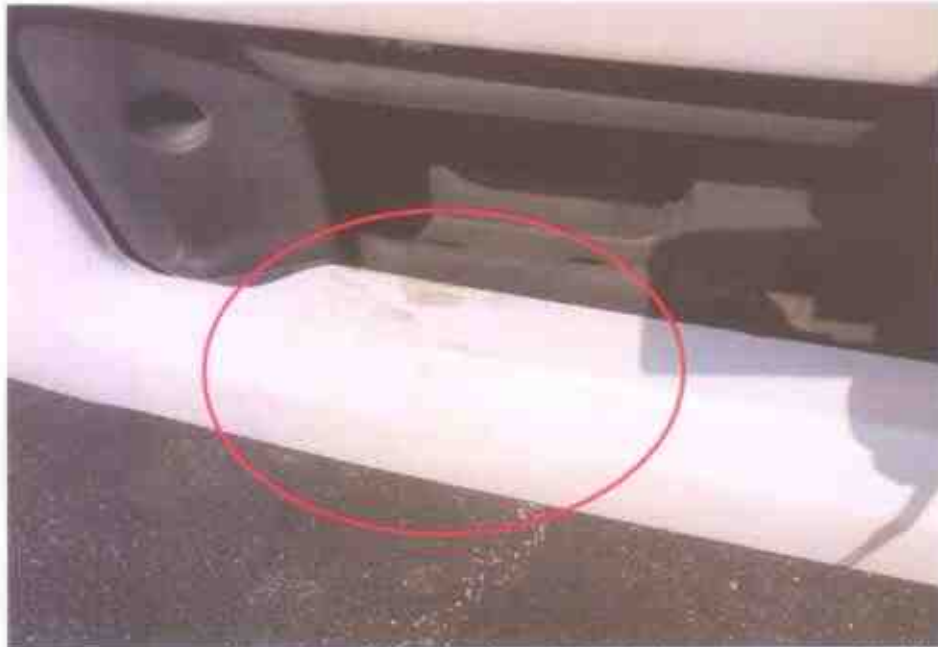
**Photo 5** shows a minor stain mark on the front right side bumper as a result of the accident

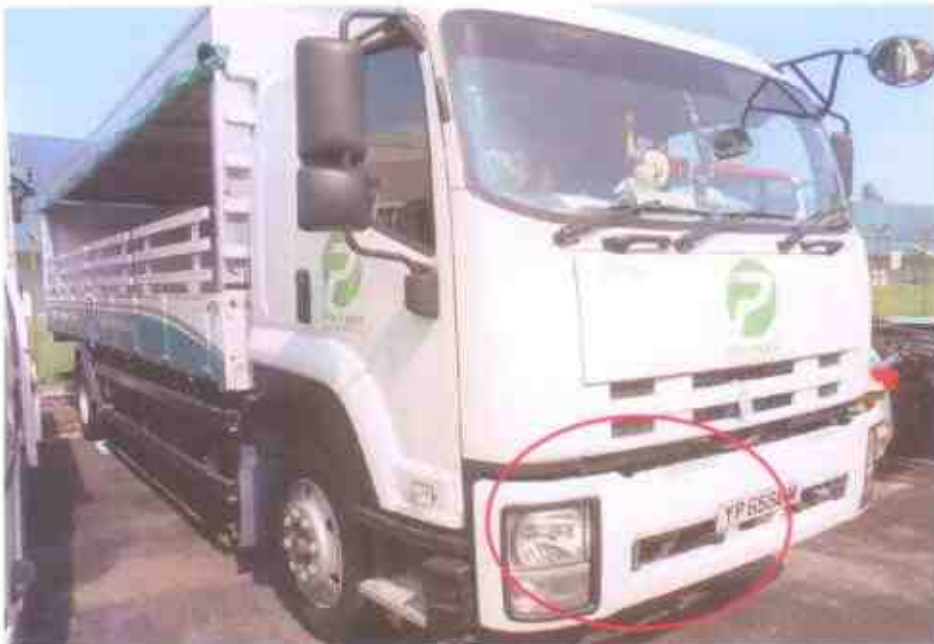
**Photo 6** shows a general view of the front right portion of the Motor Lorry at the time of our inspection. The Motor Lorry was observed to have sustained minor impact at its front right bumper. Only stain marks was observed on the front right bumper as a result of the accident.

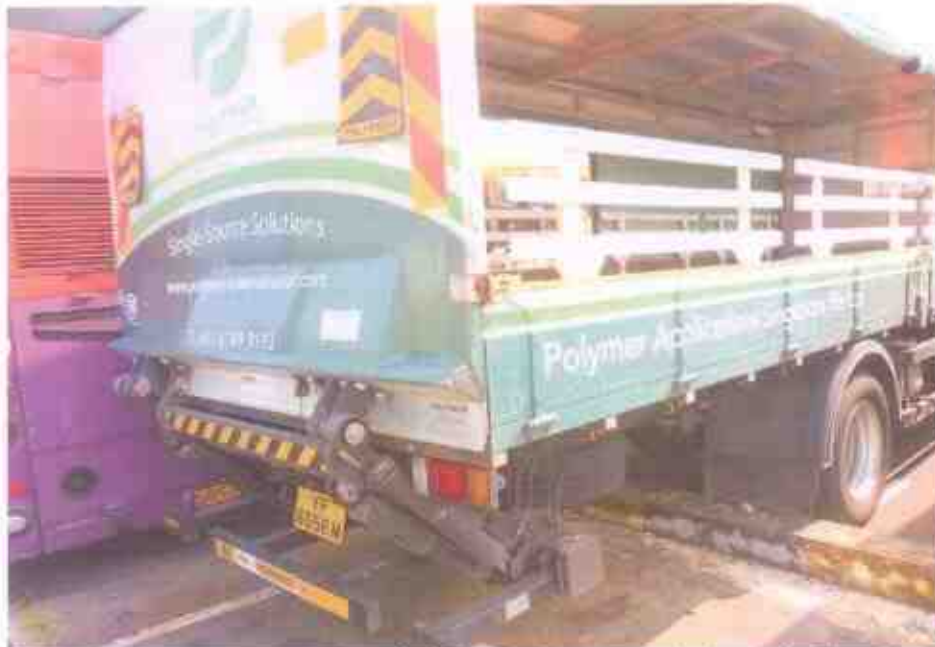
Photo 7 shows a general view of the Motor Lorry's rear body at the time of our inspection. There was no damage found to the rear portion of the Motor Lorry.

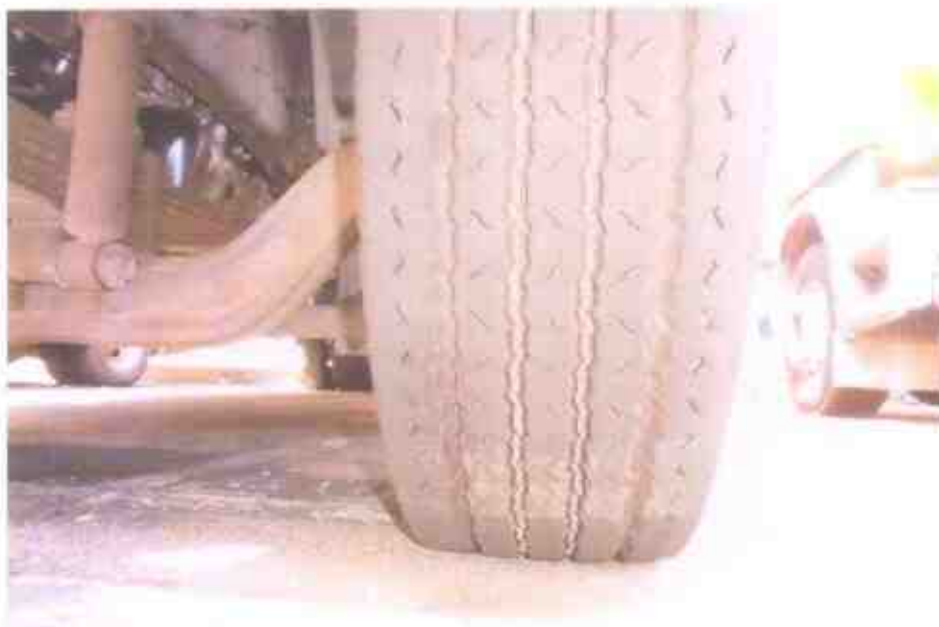
**Photo 8** shows the condition of the front left tyre of the Motor Lorry, which was observed to be in serviceable condition with remaining tread depth of approximately 7mm. The tyre, which was wrapped around standard alloy wheel rim, was also observed to be sufficiently inflated for vehicular operation.

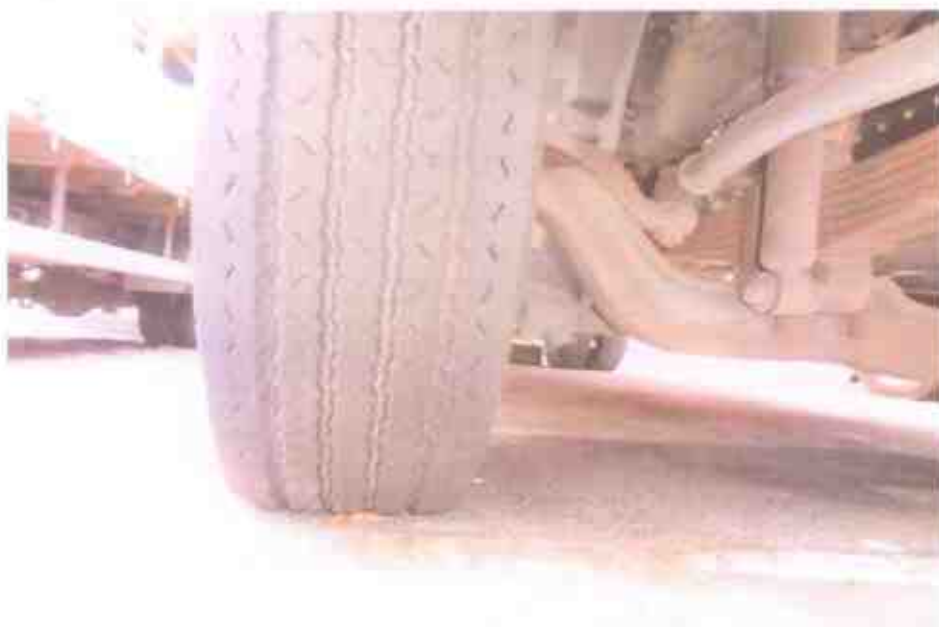
**Photo 9** shows the condition of the front right tyre of the Motor Lorry, which was observed to be in serviceable condition with remaining tread depth of approximately 8mm. The tyre, which was wrapped around standard alloy wheel rim, was also observed to be sufficiently inflated for vehicular operation.

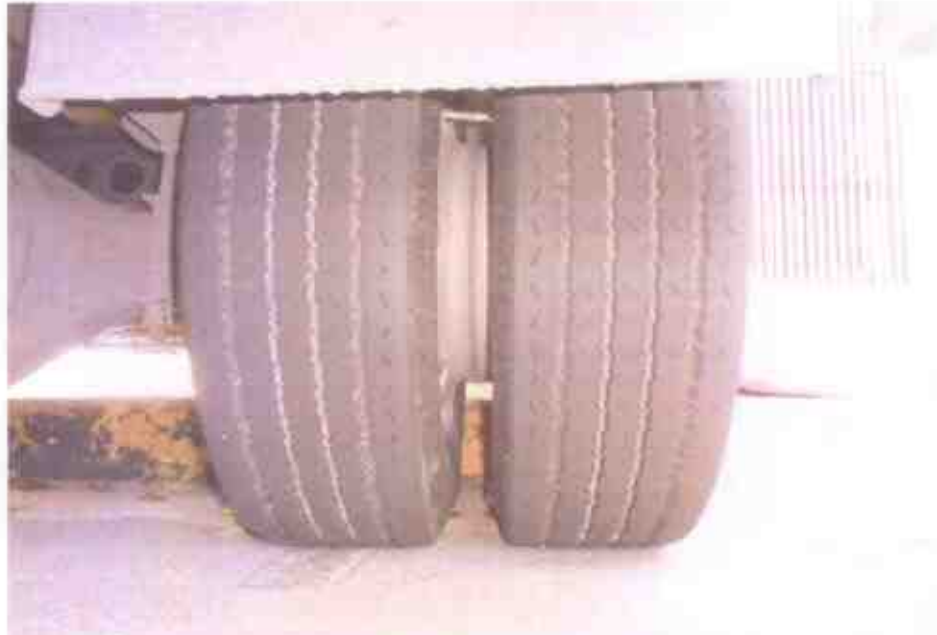
**Photo 10** shows the condition of the rear left tyres of the Motor Lorry, which was observed to be in serviceable condition with remaining tread depth of approximately 8mm. The tyres, which were wrapped around standard alloy wheel rim, were also observed to be sufficiently inflated for vehicular operation.

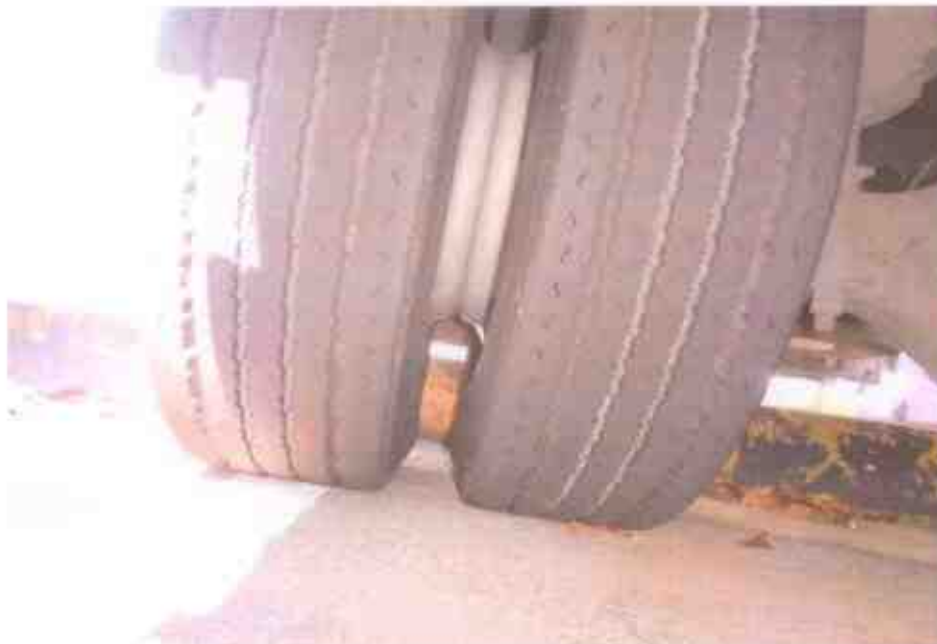
**Photo 11** shows the condition of the rear right tyres of the Motor Lorry, which were observed to be in serviceable condition with remaining tread depth of approximately 9mm.

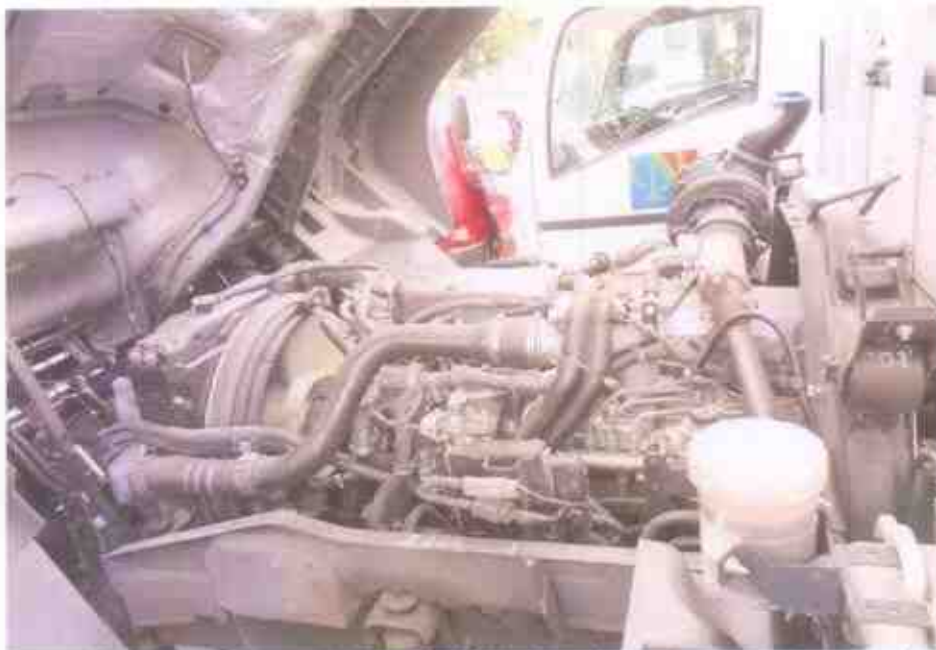
**Photo 12** shows a general view of the Motor Lorry's engine compartment, which was accessed by lifting the front cabin of the Motor Lorry. The various parts and components inside the engine compartment were unaffected by the accident. There was also no sign(s) or indication(s) of fresh fluid leakage and/or fluid stain within the engine.

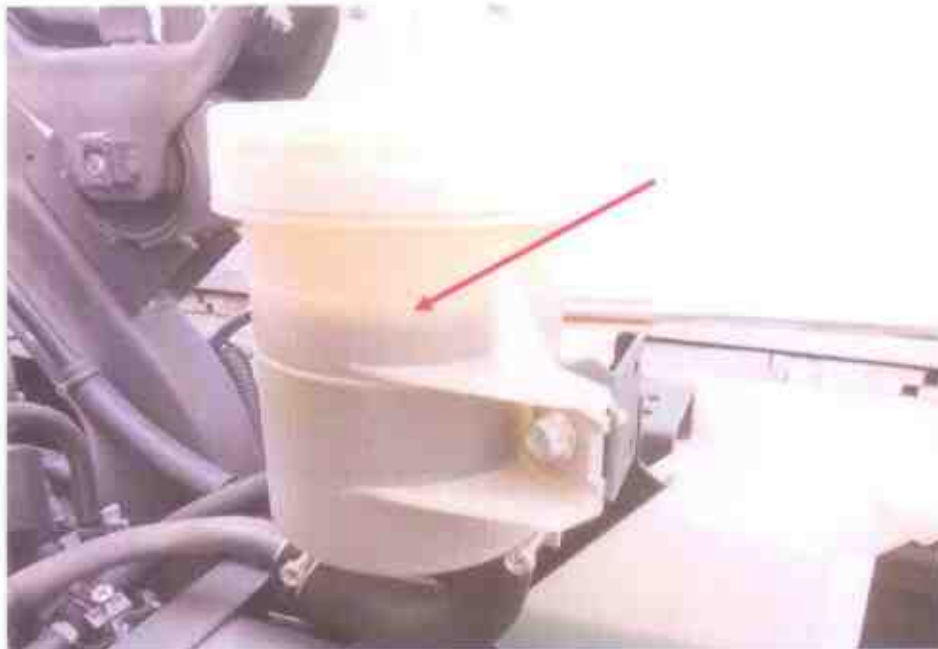
**Photo 13** shows the power steering fluid reservoir of the Motor Lorry at the time of our inspection. It was observed to be of sufficient level and without any visible contamination (arrowed).

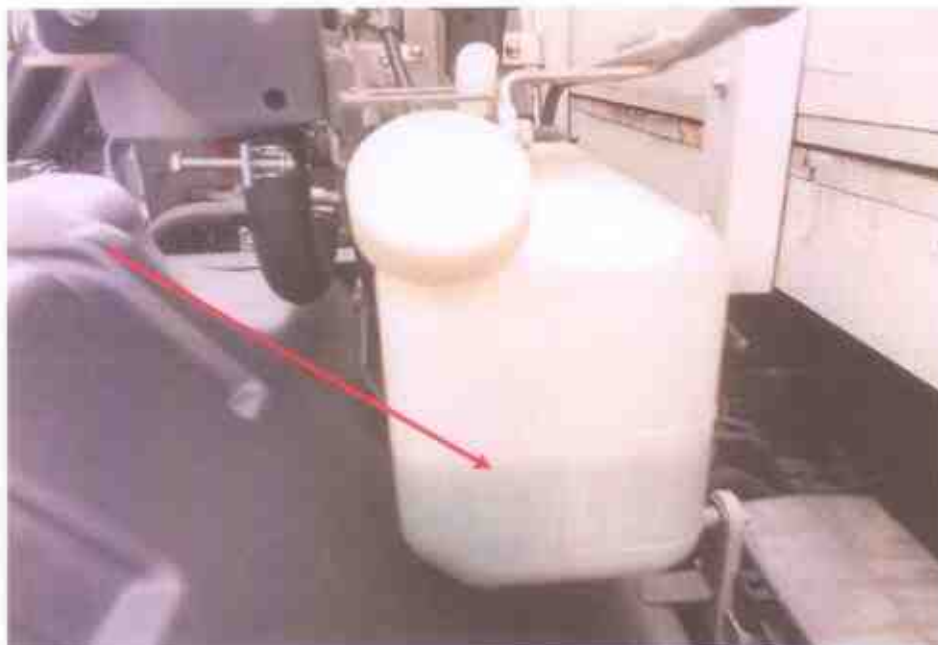
**Photo 14** shows the engine coolant reservoir of the Motor Lorry at the time of our inspection. The engine coolant was observed to be of sufficient level and without any visible contamination (arrowed).

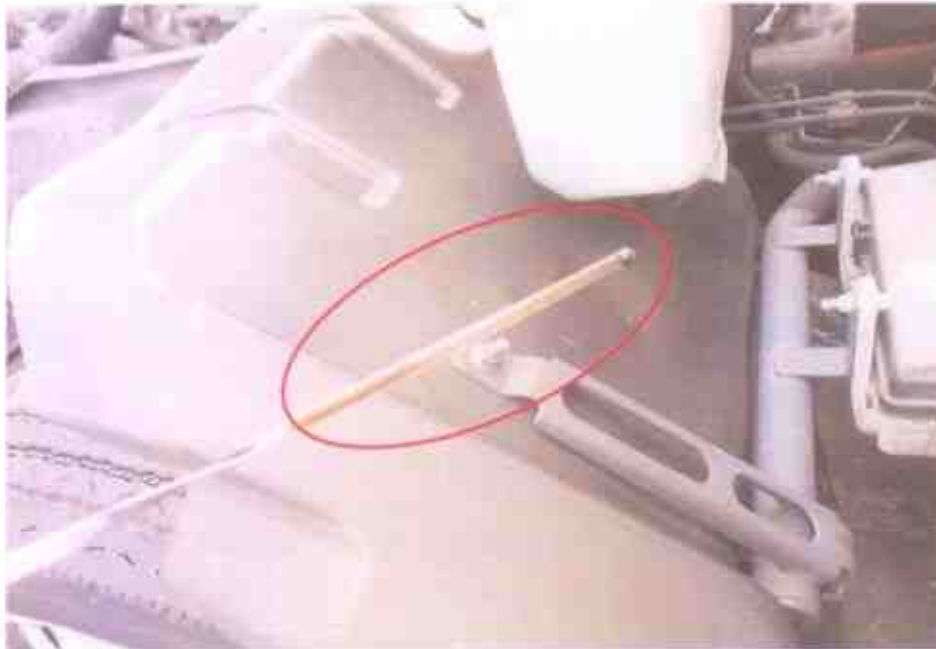
**Photo 15** shows the engine dip stick of the Motor Lorry at the time of our inspection. The engine oil was observed to be of sufficient level and without any visible contamination (circled).

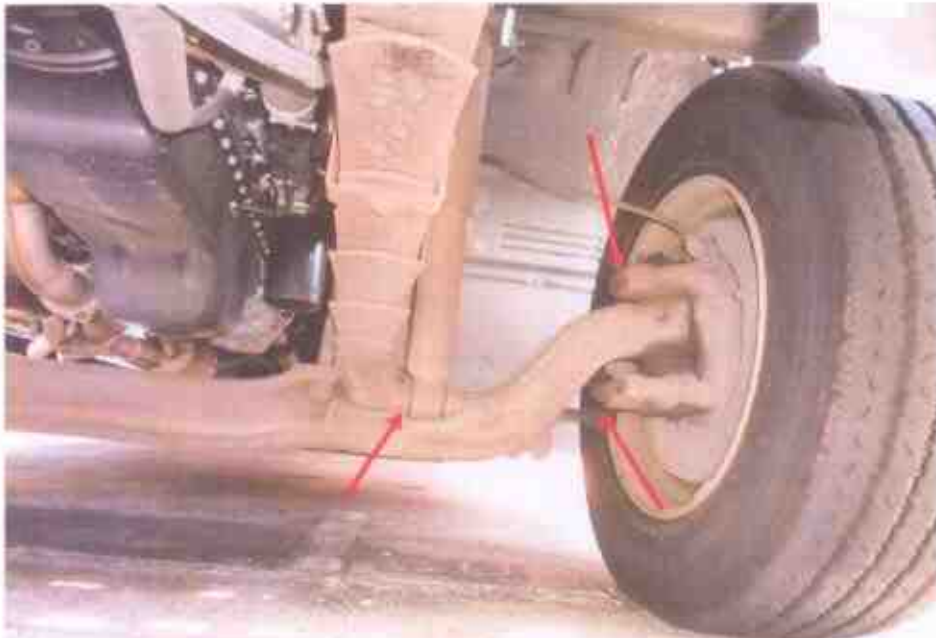
**Photo 16** shows the various undercarriage components at the front left wheel of the Motor Lorry, in particular the steering tie rod end (arrowed). The various undercarriage components of the Motor Lorry were all found to be intact without any visible damage. There was also no sign of fluid stain(s) observed on the various undercarriage components.

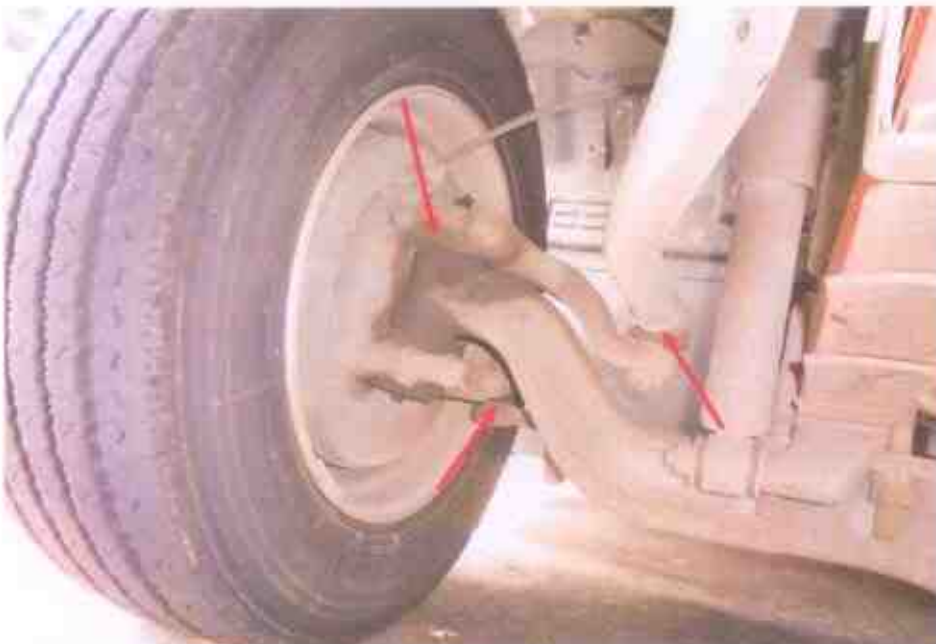
**Photo 17** shows the various undercarriage components at the front right wheel of the Motor Lorry, in particular the steering tie rod end (arrowed). The various undercarriage components of the Motor Lorry were all found to be intact without any visible damage. There was also no sign of fluid stain(s) observed on the various undercarriage components.

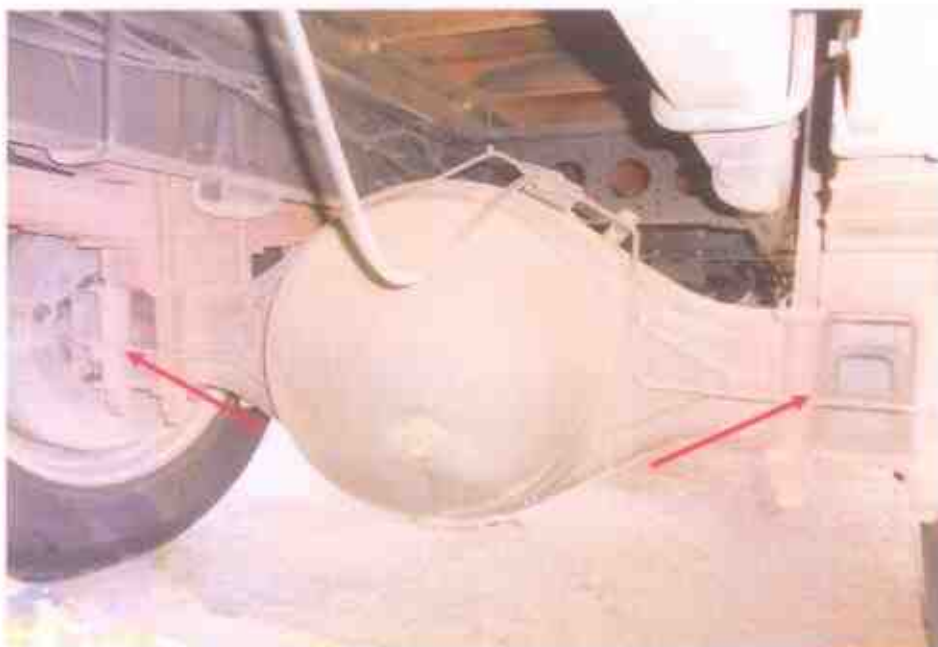
**Photo 18** shows the various undercarriage components at the rear wheels of the Motor Lorry. There was no sign(s) of brake fluid leakage along the brake hoses and brake pipes.

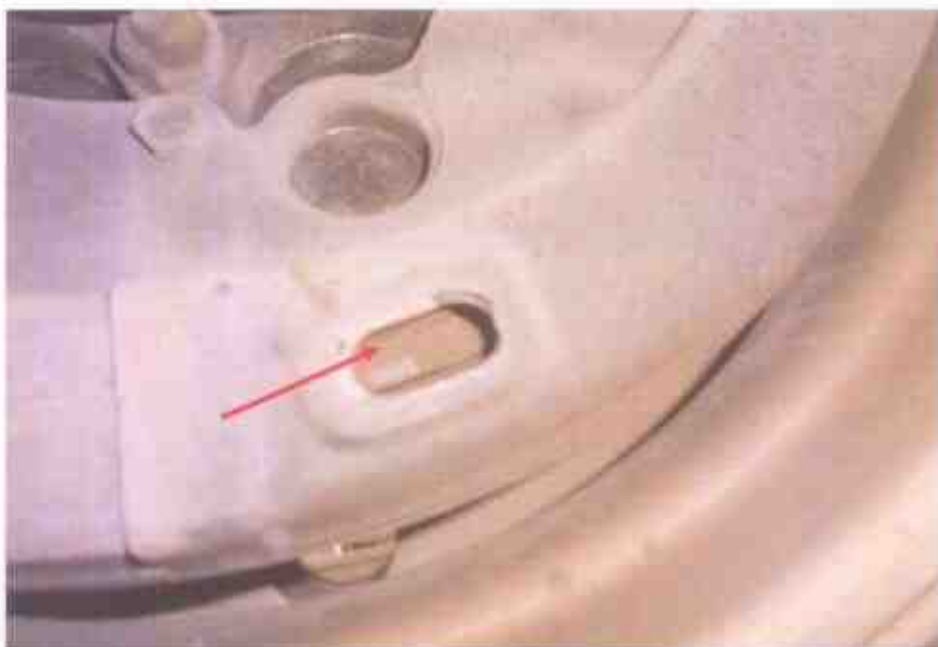
**Photo 19** shows the brake shoes (brake pads) at the rear wheels of the Motor Lorry revealed that the brake shoes (brake pads) were in serviceable condition with sufficient frictional material for operational purposes.

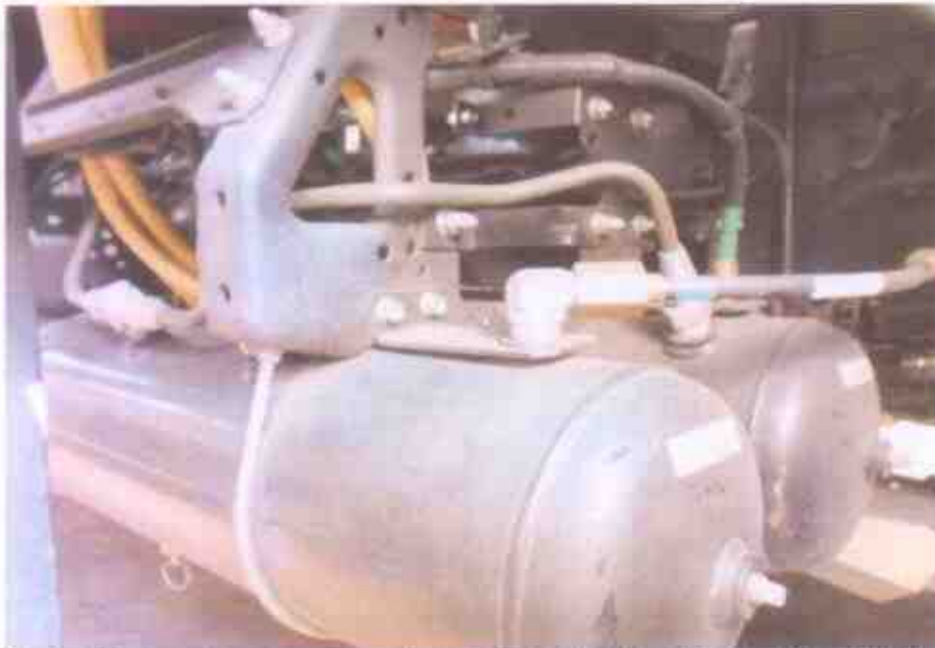
**Photo 20** shows the air pressure tank of the Motor Lorry. It was observed to be unaffected by the accident. No air leakage was found at time of our inspection.

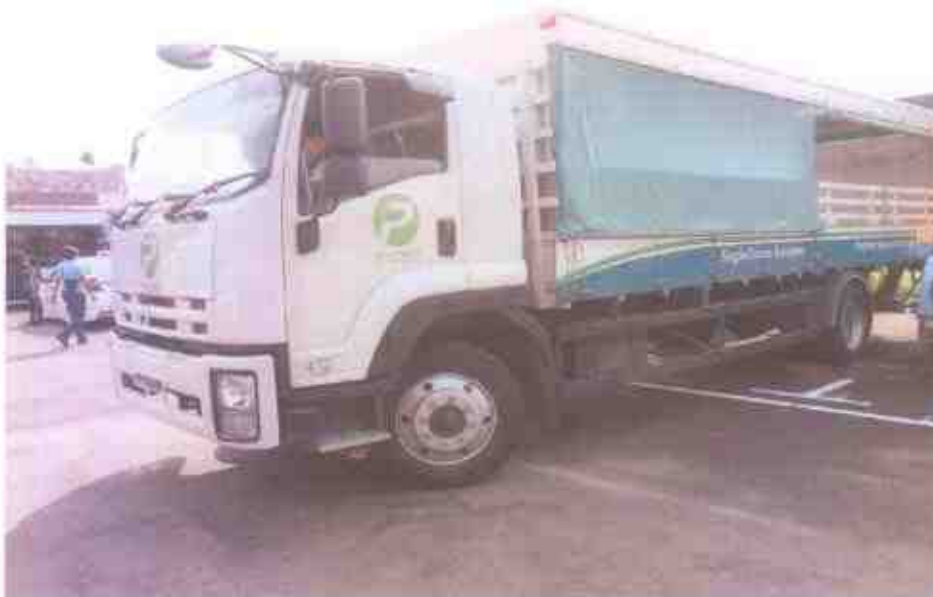
**Photo 21** shows the operational test on the Motor Lorry. It was observed to be in serviceable condition. Operational test such as moving forward, turn left & right and also braking test on the Motor Lorry was conducted successfully.
