Your Ref : TP/IP/25131/2018
Our Ref : CI/TPD18011348/Z

21st August 2018

MECHANICAL INSPECTION REPORT OF MOTORCYCLE FX 7859X

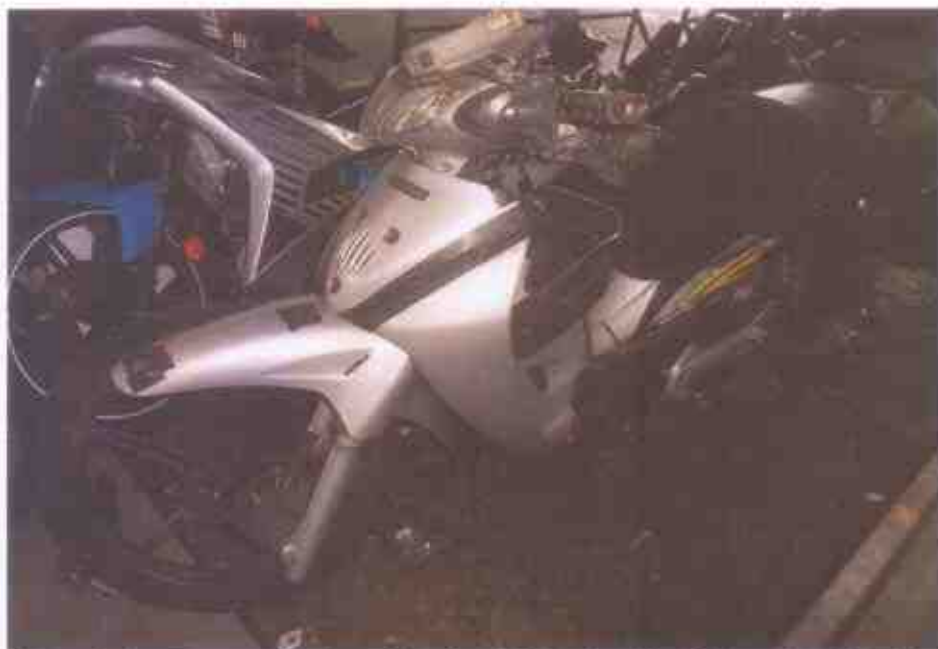
Photo 1 shows a general view of the front left body of the Motorcycle at the time of our inspection. The Motorcycle was observed to be sustained with relatively extensive impact due to the accident collision. Amongst the body parts damaged was its front fork, which was observed to be dislocated.

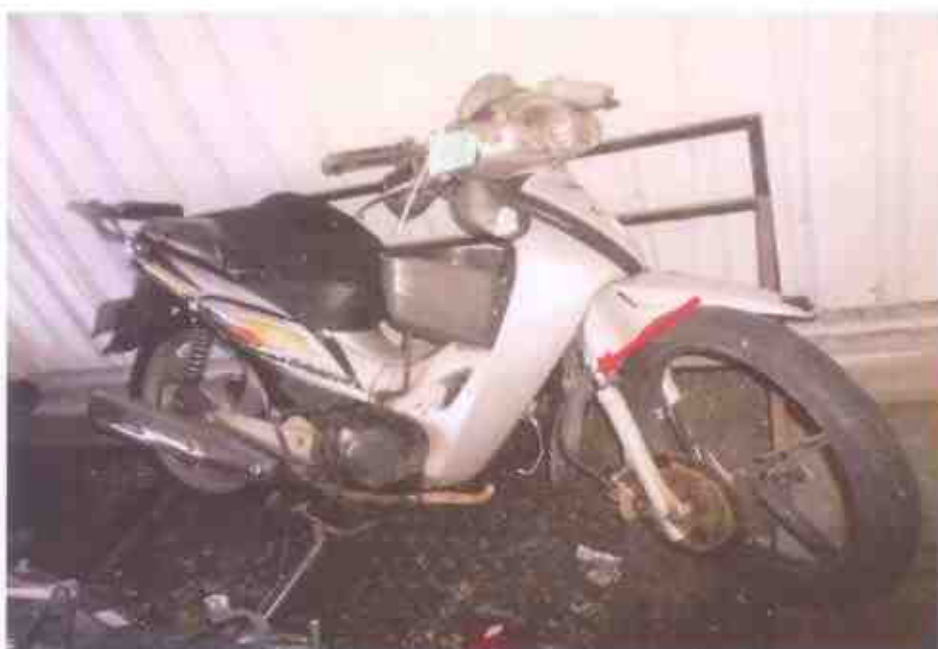
Photo 2 shows a general view of the front right body of the Motorcycle at the time of our inspection. The Motorcycle was observed to be sustained with relatively extensive impact due to the accident collision. Amongst the body parts damaged was its front fork (arrowed), which was observed to be dislocated.

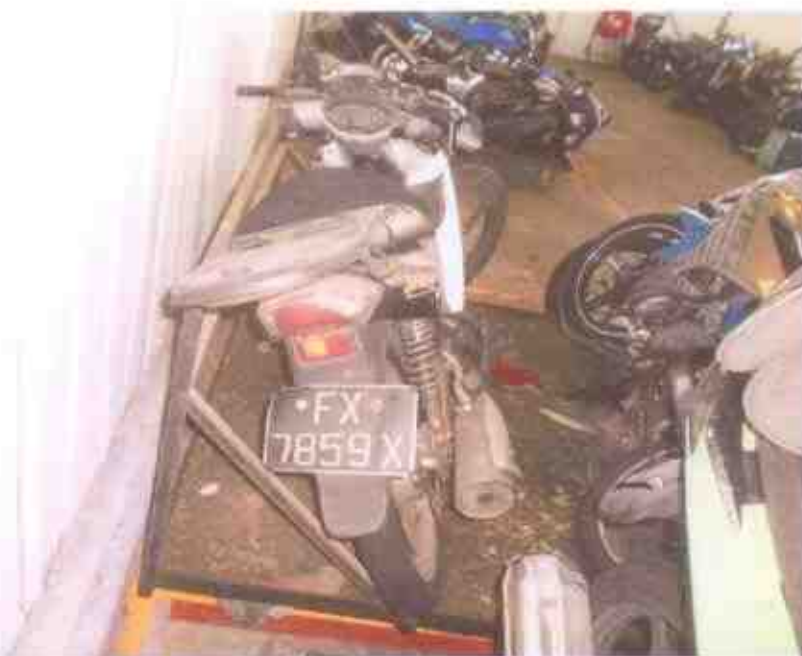
Photo 3 shows a general view of the rear left body of the Motorcycle at the time of our inspection. The Motorcycle was observed to have sustained minor damages at the rear portion as a result of the accident.

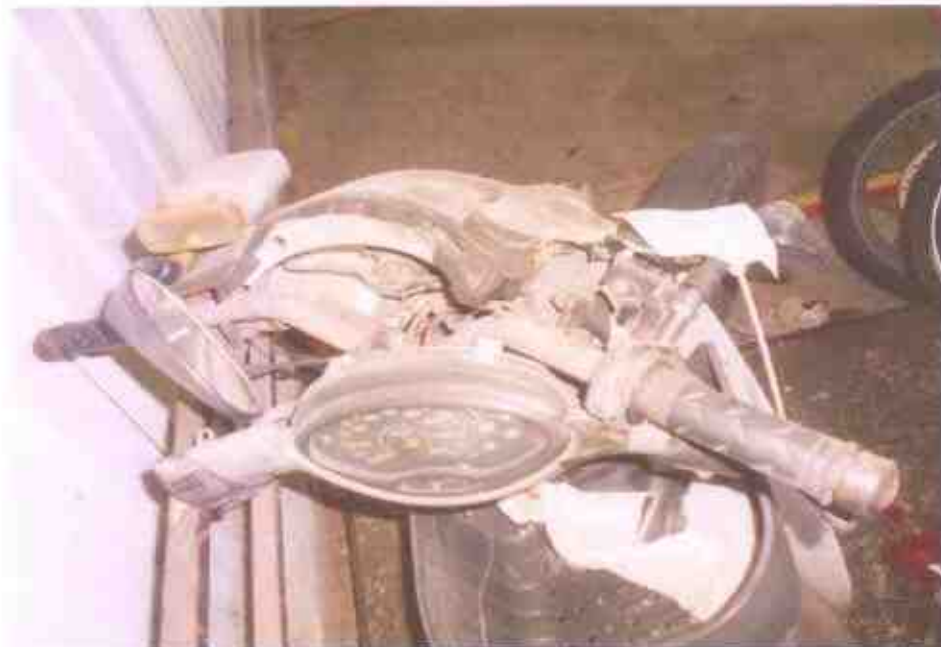
Photo 4 shows a general view of the dislodged speedometer, dislocated handle bar & damaged wing mirrors of the Motorcycle at the time of our inspection. The Motorcycle was observed to be sustained with relatively extensive impact due to the accident collision.

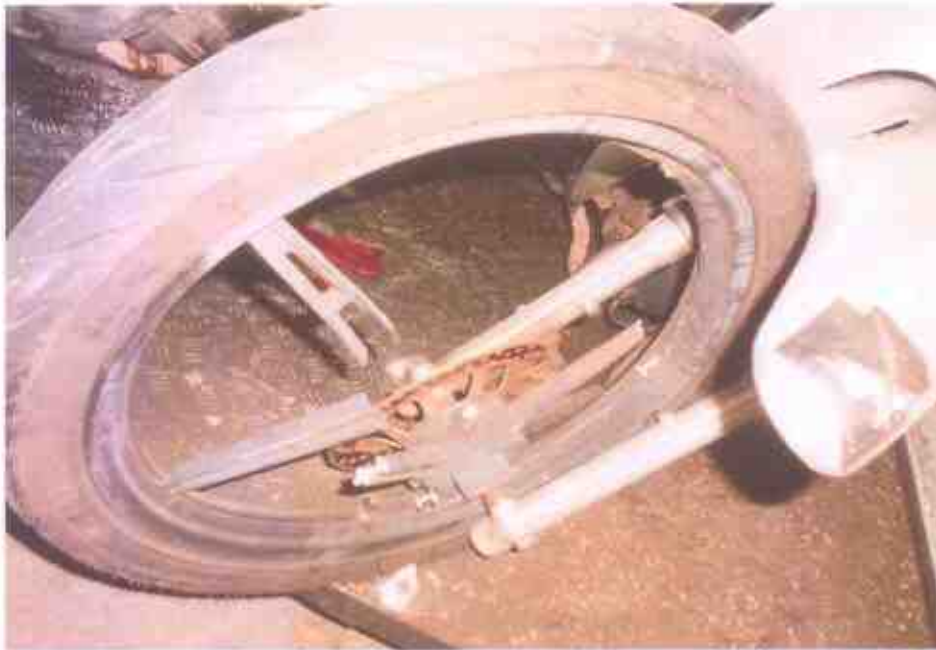
7. The rear tyre was wrapped around an alloy wheel rim that was found to be without any significant damage. Whereas for the front tyre was observed to be wrapped around an alloy wheel rim that was found to be broken into several pieces due to the accident's collision impact at the material time of the accident. See photo 5 & 6 below

Photo 5 shows the front tyre of the Motorcycle at the time of our inspection. The front tyre was observed to be in serviceable condition with remaining tread depth of approximately 2mm. However, the wheel rim was observed to be broken into several pieces due to the accident's impact collision.

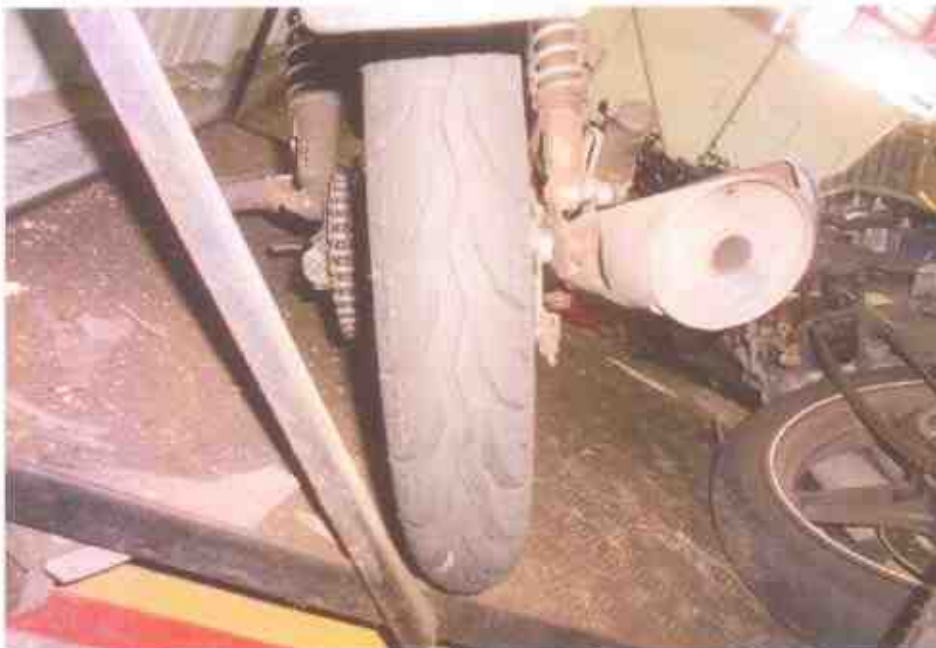
Photo 6 shows the rear tyre of the Motorcycle. The pattern of the tread was clearly visible. There was no tear, burst mark(s) and/or punctured hole(s) on the sidewalls as well as across the tread of the front tyre. The front tyre was observed to be in serviceable condition with remaining tread depth of approximately 4mm.

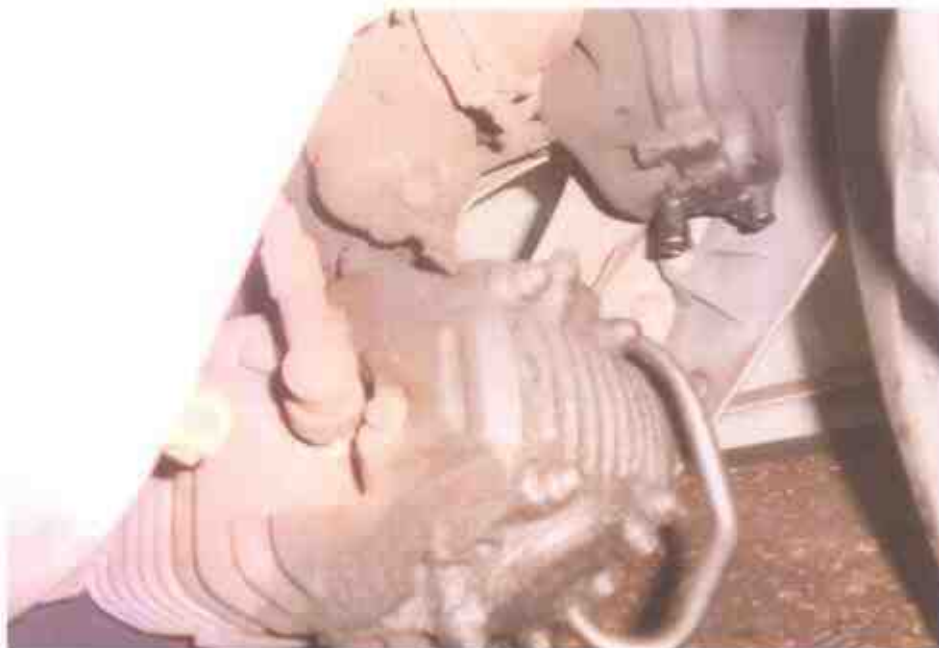
8. Upon examination of the engine area of the Motorcycle, we had observed that the various engine related parts and components were intact with no visible damage. The engine underside was however observed to be covered with fluid, suggesting leakage of fluid. There was no accumulation of dust and/or dirt particles on the engine housing where the fluid stains had formed. This would indicate that the fluid leakage was a fresh leak and likely to be a result of the accident.
9. The gear chain of the motorcycle was found to be intact without any misalignment. It was also adequately lubricated for operating purposes. Free play tension test was also conducted & found adequately acceptable. See photo 7 – 9 below.

Photo 7 shows sign(s) or indication(s) of fluid leakage stain observed around the engine undercarriage area of the Motorcycle.

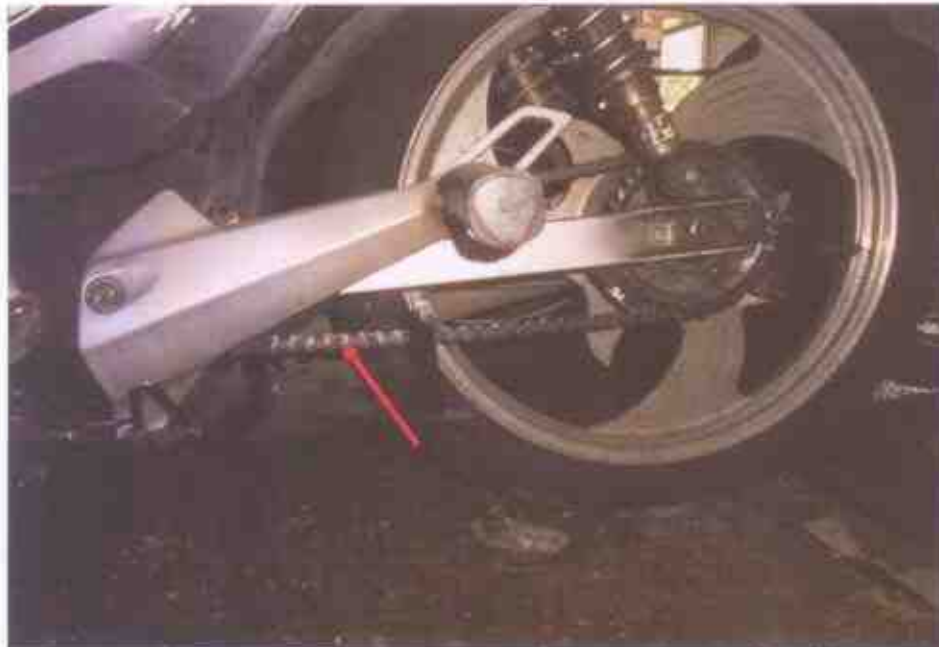
Photo 8 shows the general view of the gear train (arrowed) of the Motorcycle, which was observed to be intact with no misalignment. It was also adequately lubricated for operating purposes.

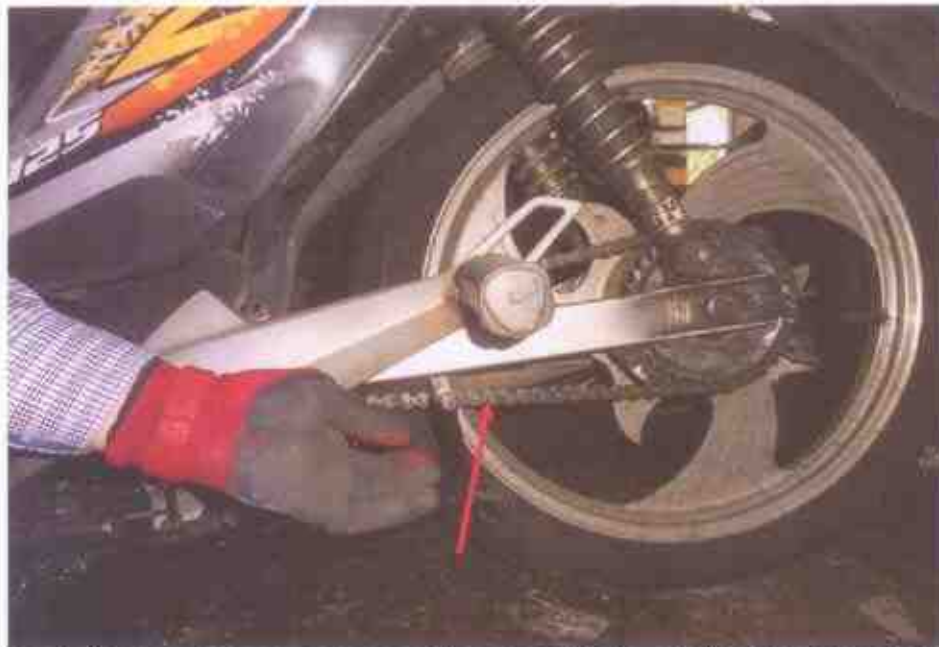
Photo 9 shows the general view of the gear train (arrowed) of the Motorcycle, which was observed to be intact with no misalignment. It was also adequately lubricated for operating purposes. Free play tension was also observed & found adequately acceptable.

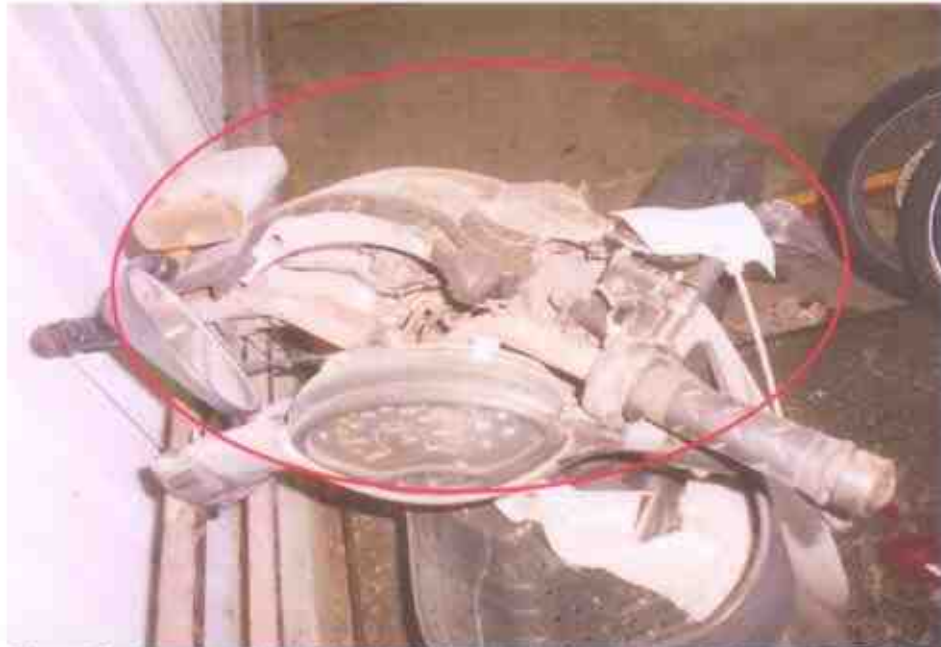
10. For this case, we were not able to conduct any test(s) on the steering system of the Motorcycle due to the damage on its handle bar, front wheel rim & steering system. It was found to be dislocated & broken as a result of the accident, hence causing the whole steering system to be in a state of immobility.

Photo 10 shows the front fork (circled) was observed to be dislocated as a result of the accident. Hence, we are not able to conduct any tests on the steering system of the Motorcycle.

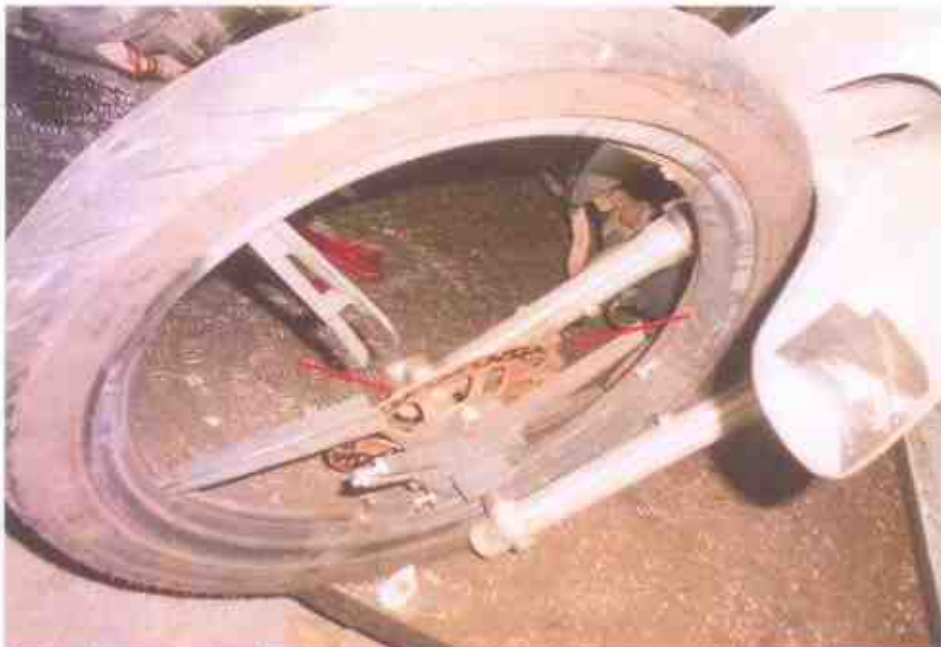
Photo 11 shows the front brake calliper, front brake disc and front brake hose of the Motorcycle, which are all part of the components in the front brake system of the Motorcycle. Our further observation had revealed that it was not affected although damages found on the wheel rim.

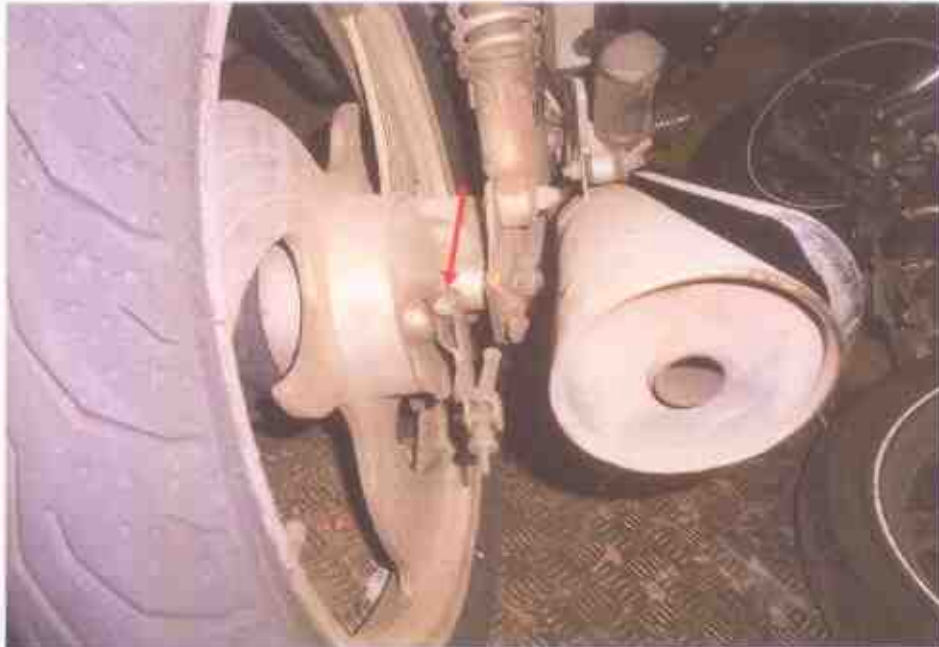
Photo 12 shows the rear brake of the Motorcycle. It was found to be unaffected by the accident.

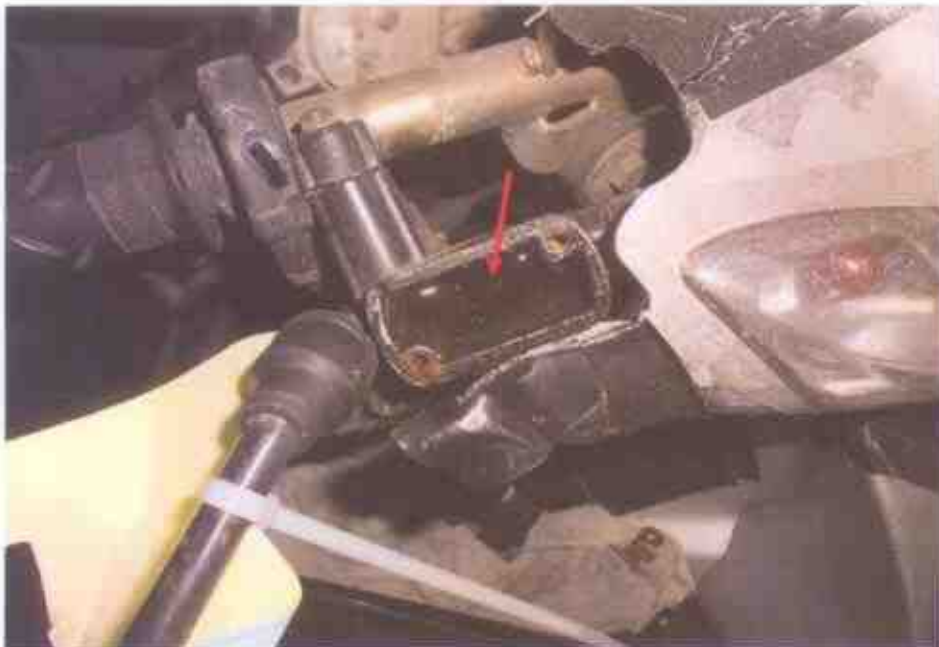
12. A static brake test was unable to be conducted on the Motorcycle's both front & rear brake due to the damages sustained. The front hand brake lever was found to be broken & rear brake pedal was found bent as a result of the accident's impact collision. However, our checks on the brake fluid had indicated that the brake fluid was of sufficient level for operational purposes, and without contamination.

Photo 13 shows the front brake fluid reservoir that was found to be sufficient level despite broken hand brake lever due to the accident.
