Your Ref: TP/IP/02043/2018
Our Ref : CI/TPD18011350/Z

Fatal Accident Investigation Team
Traffic Police Department
Singapore Police Force
10 Ubi Avenue 3
Singapore 408865

MECHANICAL INSPECTION REPORT OF MOTORCYCLE FE 4054Y

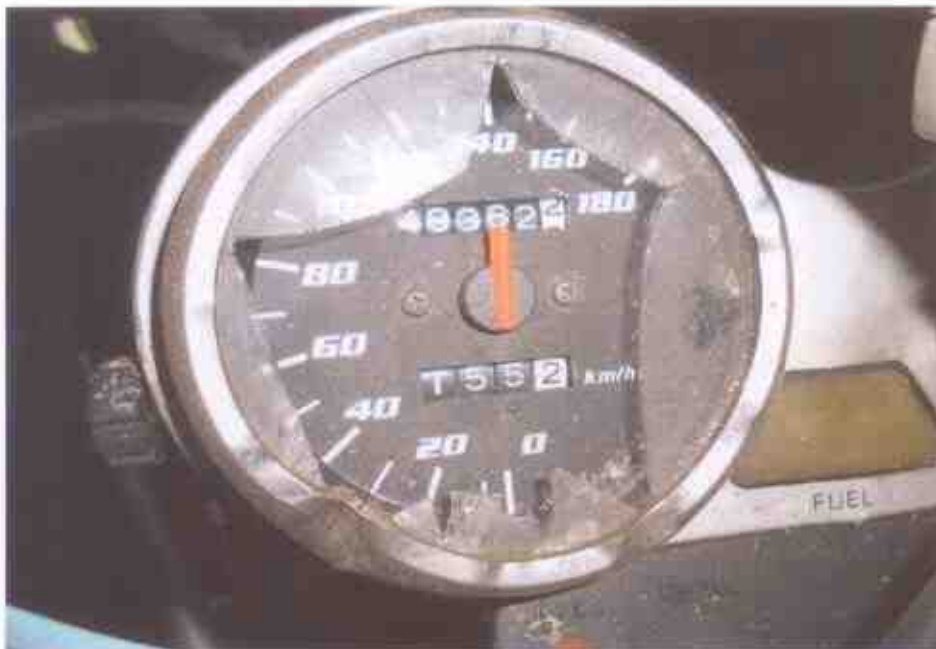
Photo 1 shows the mileage of the Motorcycle at the time of our inspection was recorded at 483622km.

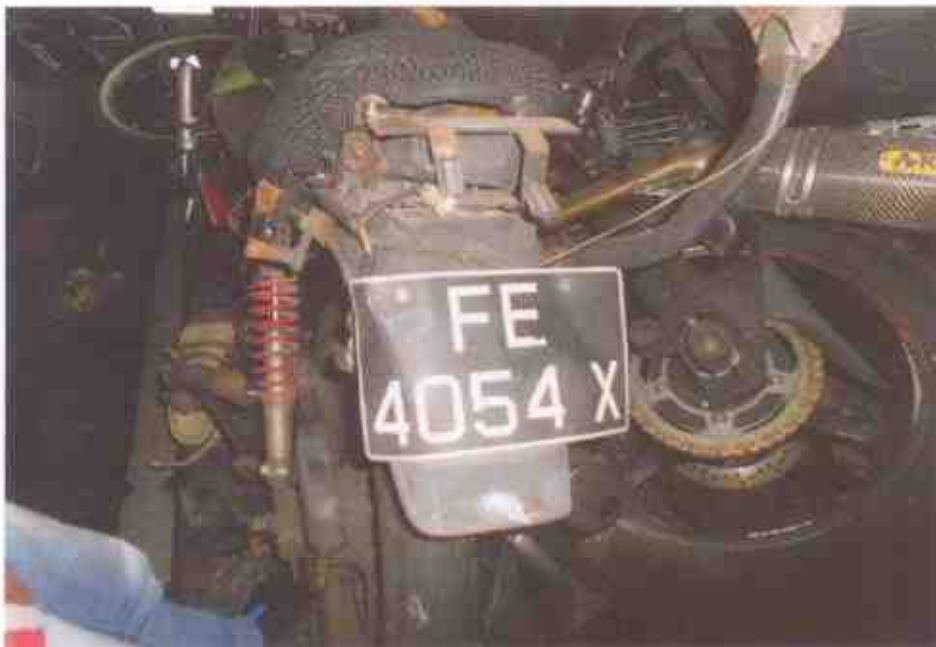
Photo 2 shows the Motorcycle number plate for identification.

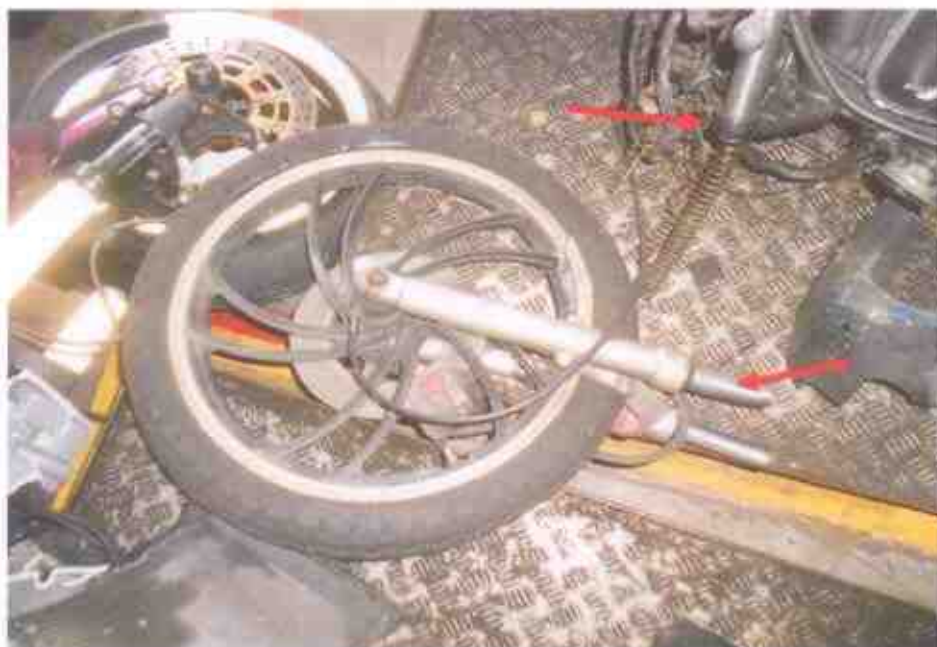
Photo 3 shows a general view of the front right body of the Motorcycle at the time of our inspection. The Motorcycle was observed to have sustained with relatively extensive impact due to the accident collision. Amongst the body parts damaged was its front fork (arrowed), which was observed to be broken into 2 pieces.

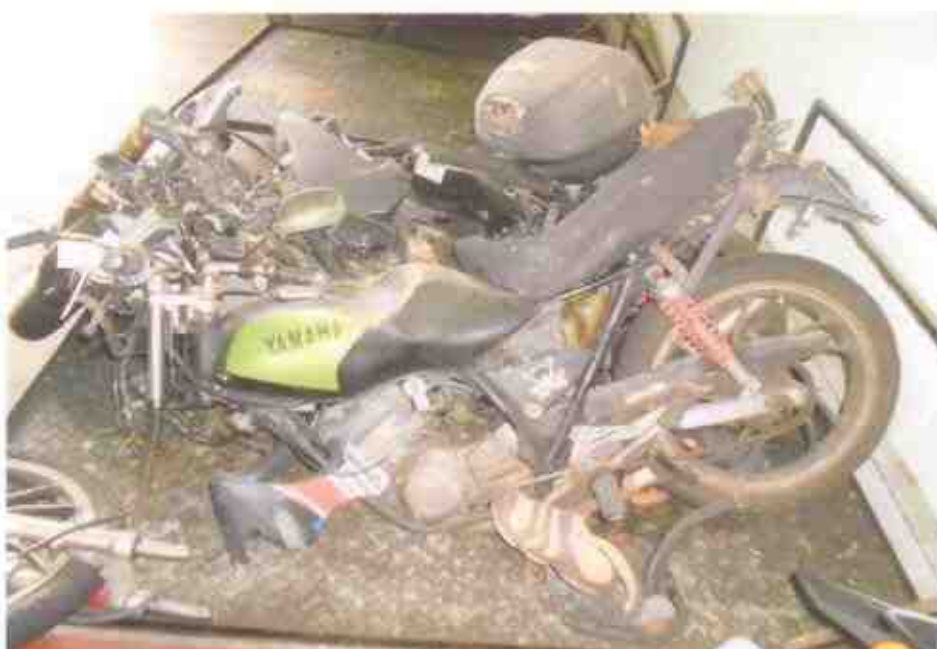
Photo 4 shows a general view of the rear left body of the Motorcycle at the time of our inspection. The Motorcycle was observed to have sustained damages at the frontal portion, rear portion, along both its left side and right side.

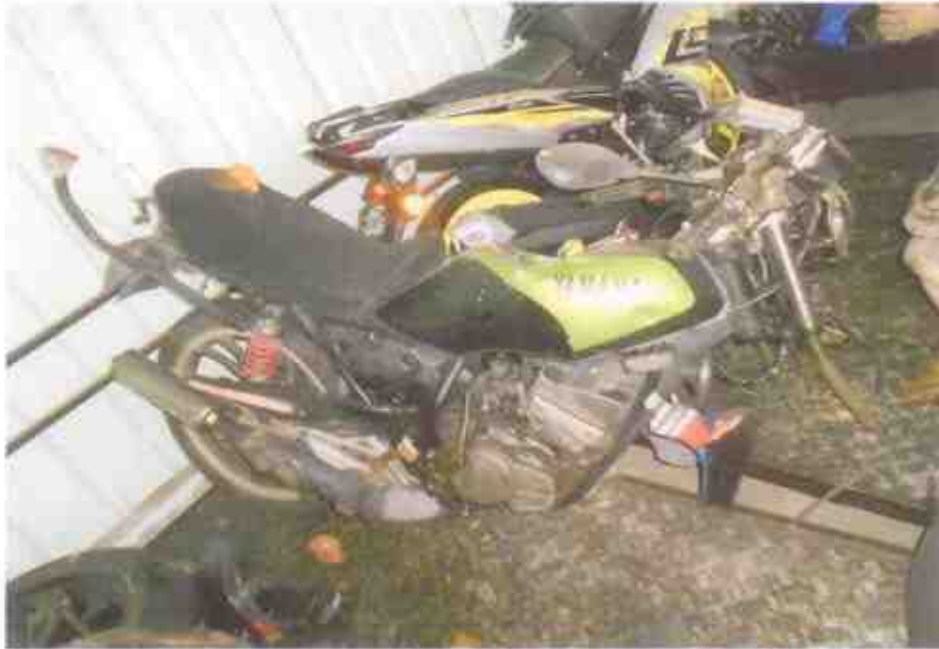
Photo 5 shows a general view of the Motorcycle at the time of our inspection. The Motorcycle was observed to have sustained relatively extensive impact due to the accident collision.

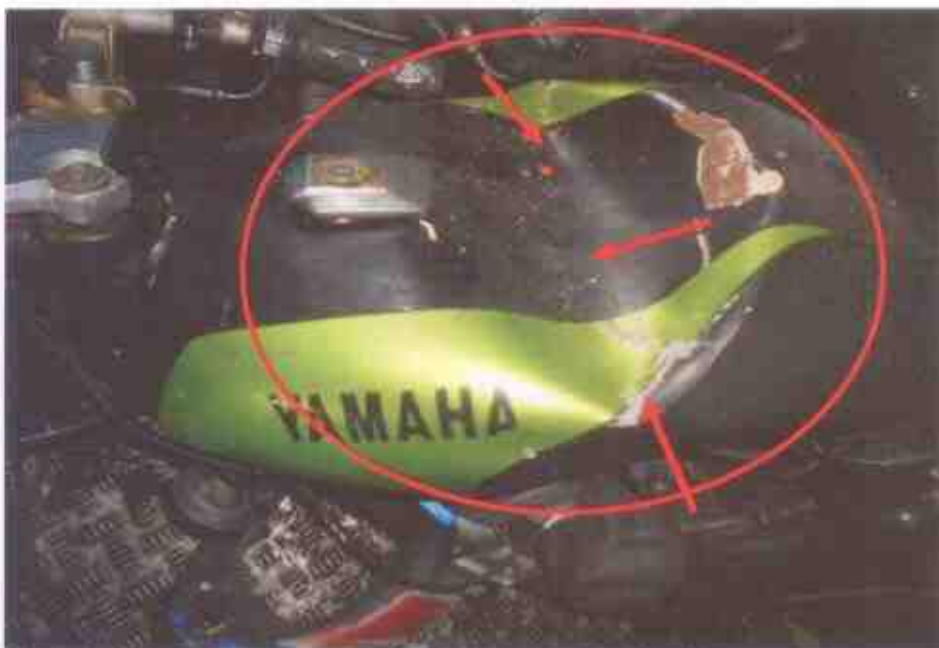
Photo 6 shows a close-up view of the frontal portion of the Motorcycle at the time of our inspection. The Motorcycle was observed to have sustained relatively extensive impact including damages to the fuel tank due to the accident collision.

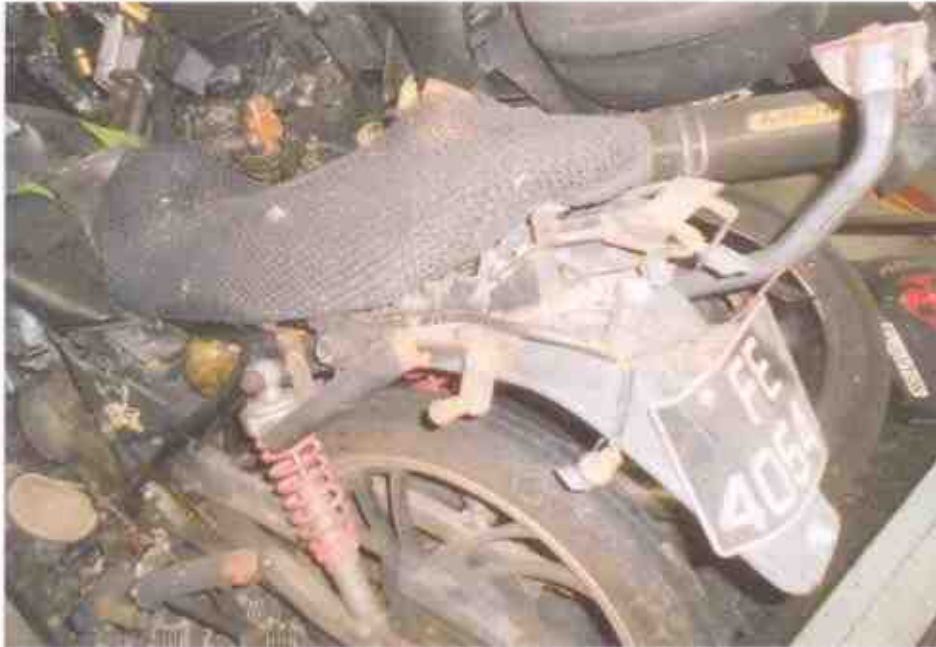
Photo 7 shows a close-up view of the rear portion of the Motorcycle at the time of our inspection. The Motorcycle was observed to have sustained relatively extensive impact due to the accident collision.

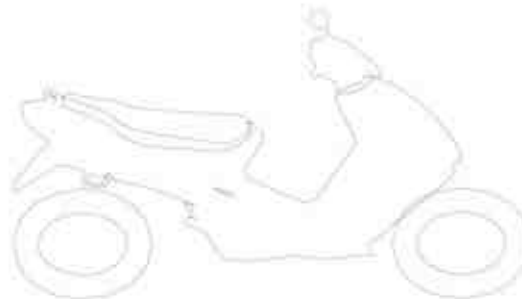
FKR Epsilon 90/90 – 18(3mm)

Dunlop 80/90 - 18 (4mm)

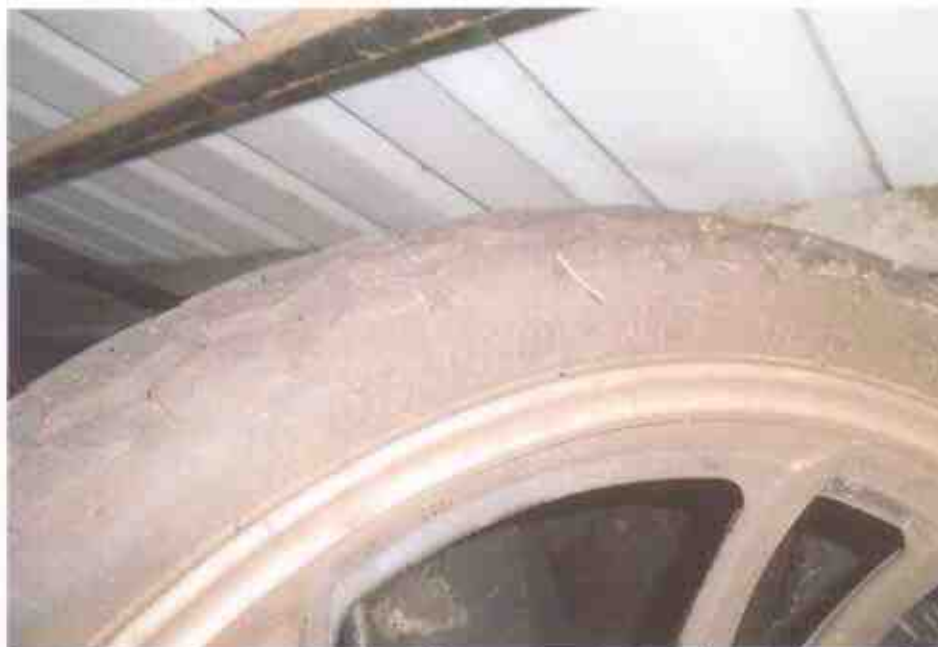
Photo 8 shows the rear tyre of the Motorcycle at the time of our inspection. The rear tyre was observed to be in serviceable condition with remaining tread depth of approximately 3mm. The tyre was also observed to be sufficiently inflated for vehicular operation. There was no significant damage observed on the rear wheel rim & tyre.

18. The condition of the Motorcycle's rear tyre was observed to be in serviceable condition. The tread pattern of the rear tyre was clearly visible. We did not observe any tear, burst mark(s) and/or punctured hole(s) on the sidewalls as well as across the tread of the rear tyre. Its tread depth was measured & found to be around approximately 3mm.

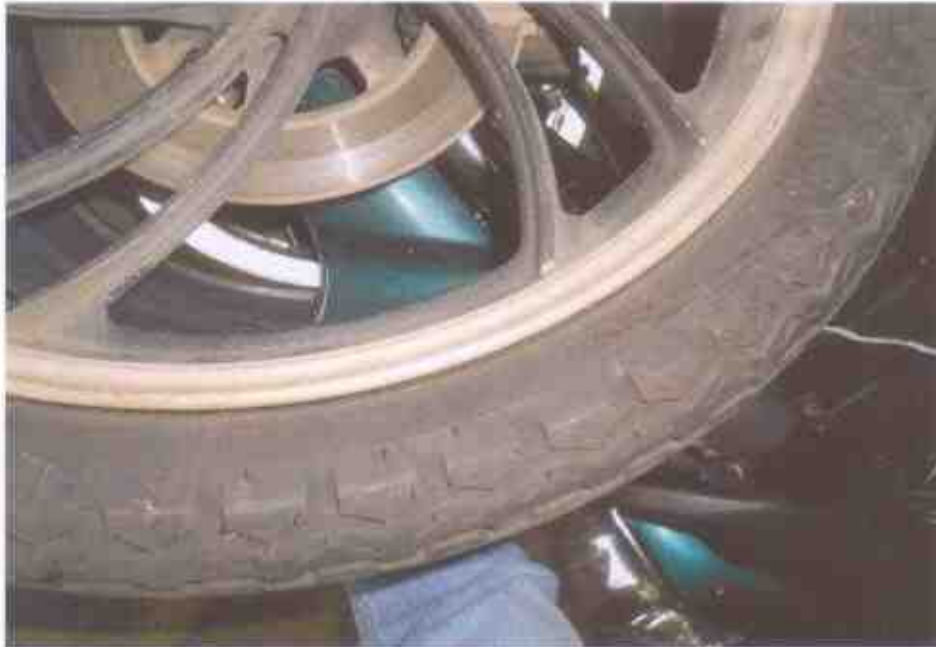
Photo 9 shows the front tyre of the Motorcycle at the time of our inspection. The pattern of the tread was clearly visible. There was no tear, burst mark(s) and/or punctured hole(s) on the sidewalls as well as across the tread of the front tyre.

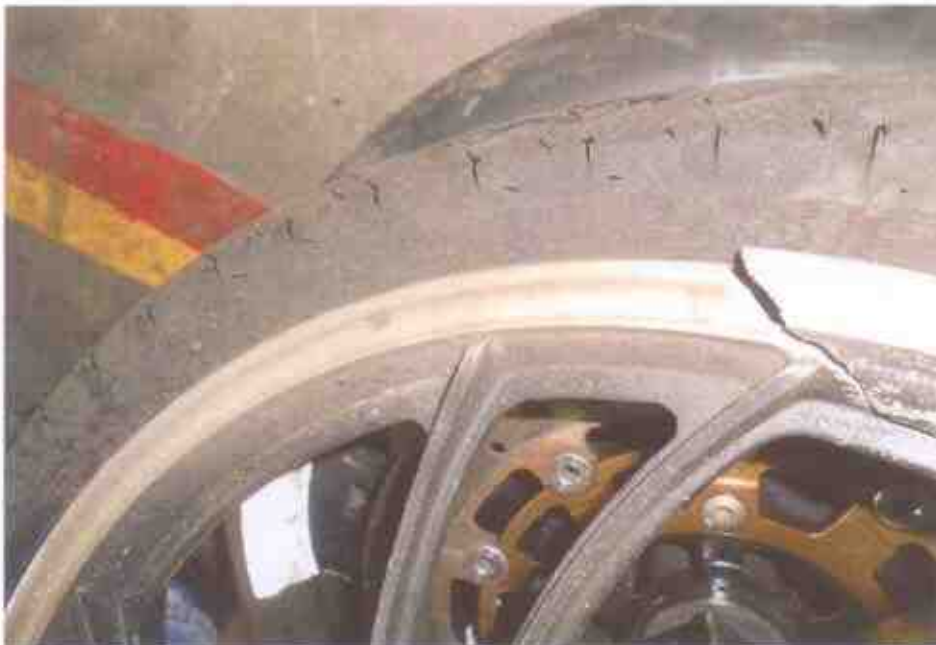
Photo 10 shows the cracked wheel rim on front tyre of the Motorcycle at the time of our inspection.

19. As for the front tyre, it was found to be deflated likely due to the cracked wheel rim as a result of the accident's collision. However, the tread pattern of the front tyre was clearly visible with tread depth of 4mm. We did not observe any tear, burst mark(s) and/or punctured hole(s) on the sidewalls as well as across the tread of the front tyre.

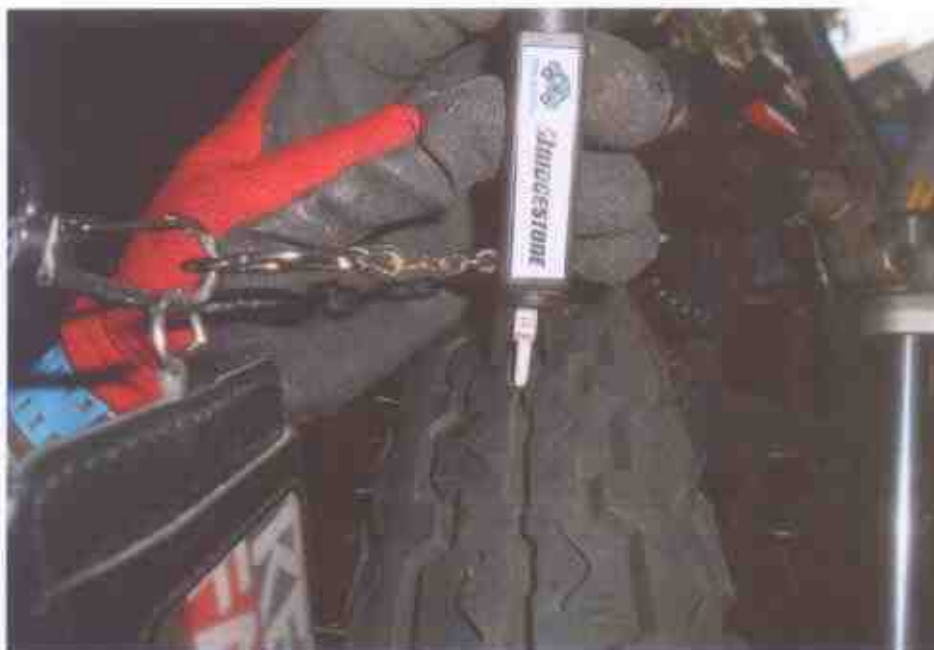
Photo 11 shows the front tyre of the Motorcycle at the time of our inspection. The pattern of the tread was measured and found to be around 4mm & the thread was clearly visible.

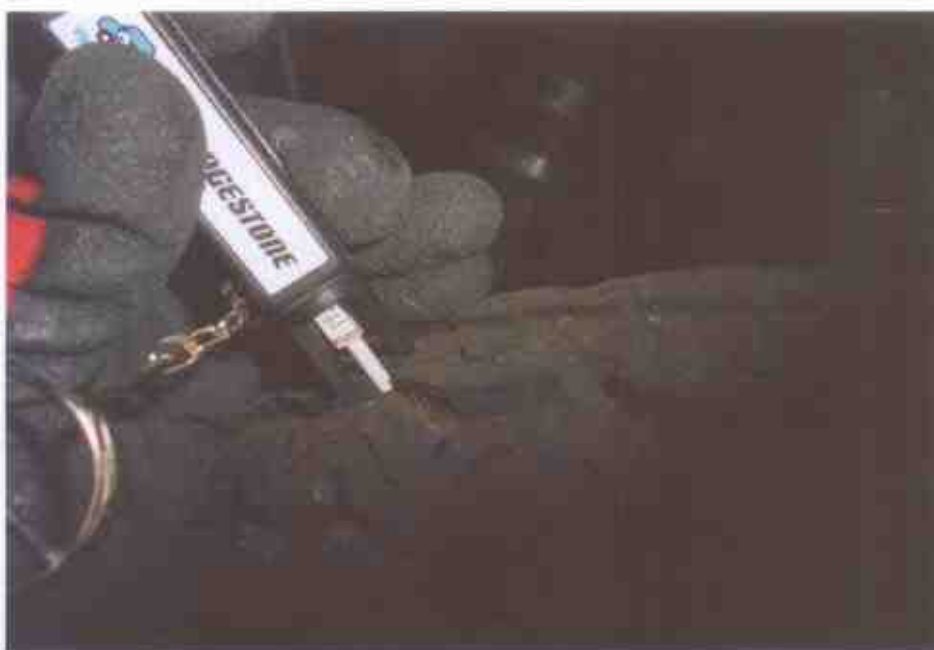
Photo 12 shows the rear tyre of the Motorcycle at the time of our inspection. The pattern of the tread was measured and found to be around 3mm & the thread was clearly visible.

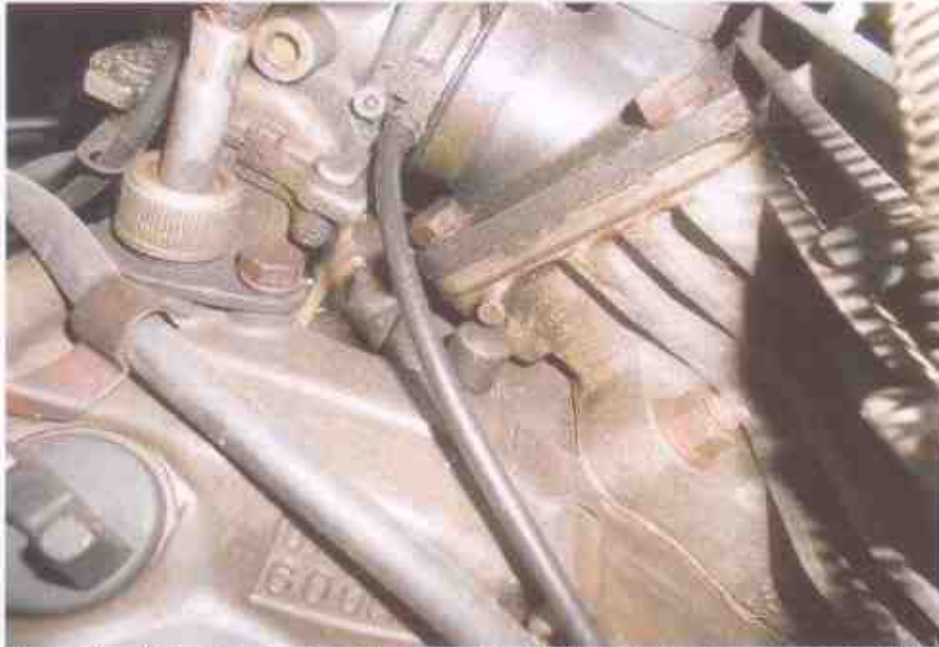
Photo 14 shows sign(s) or indication(s) of fluid leakage observed around the engine's area of the Motorcycle.

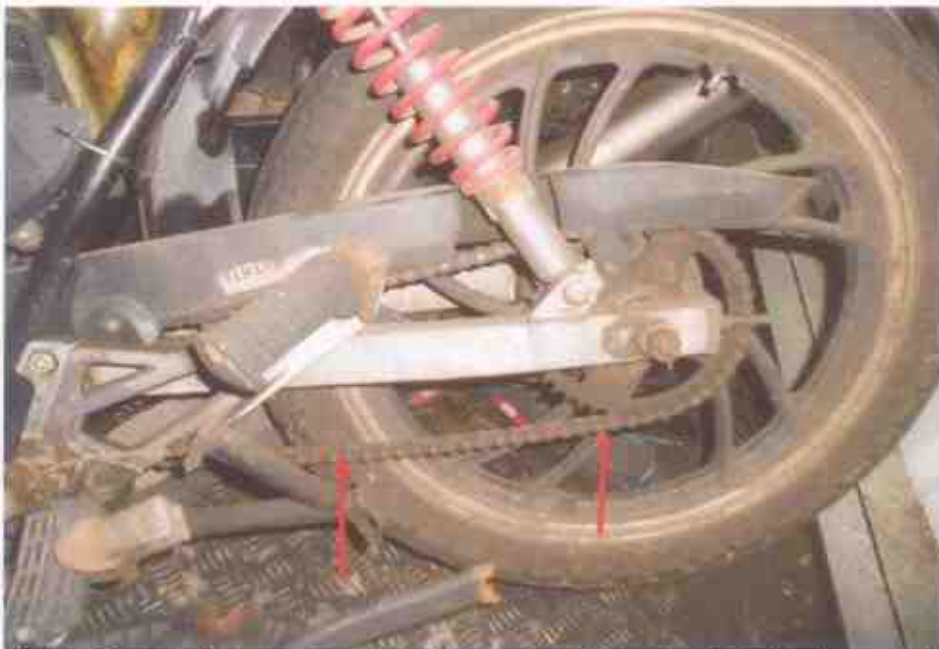
Photo 15 shows the general view of the gear train (arrowed) of the Motorcycle, which was observed to be intact with no misalignment. It was also adequately lubricated for operating purposes.

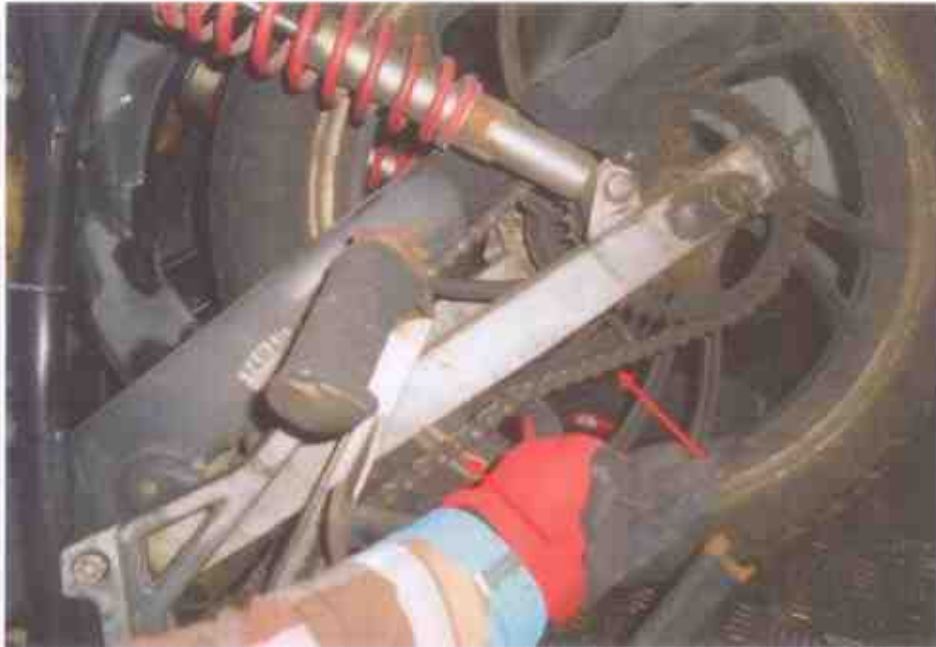
Photo 16 shows the general view of the gear train (arrowed) of the Motorcycle, which was observed to be intact with no misalignment. It was also adequately lubricated for operating purposes.

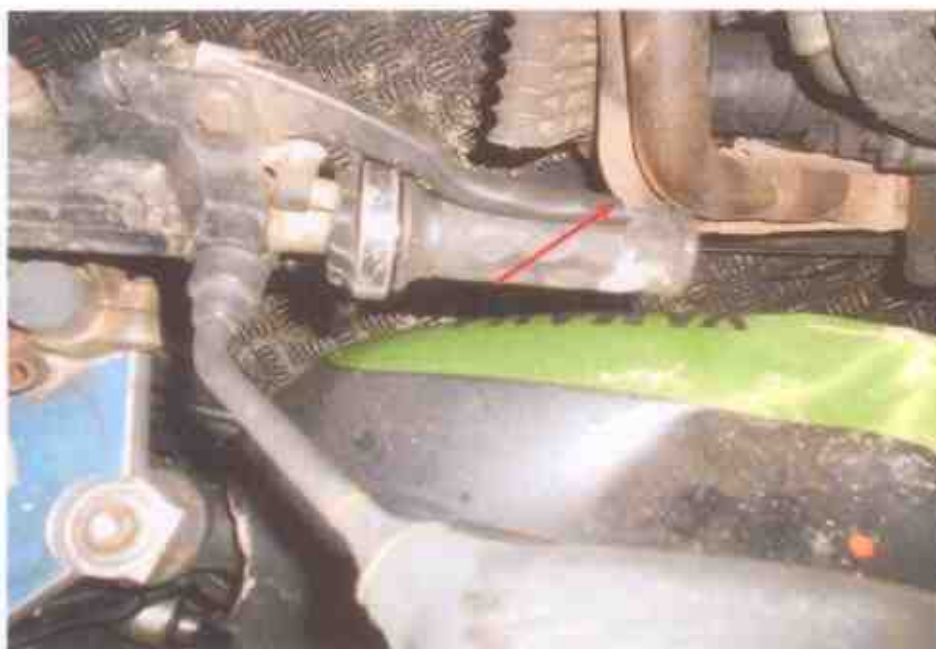
Photo 17 shows the hand brake lever (arrowed) was observed to be broken due to the result of the accident. Hence, we are unable to conduct any tests on the braking system of the Motorcycle.

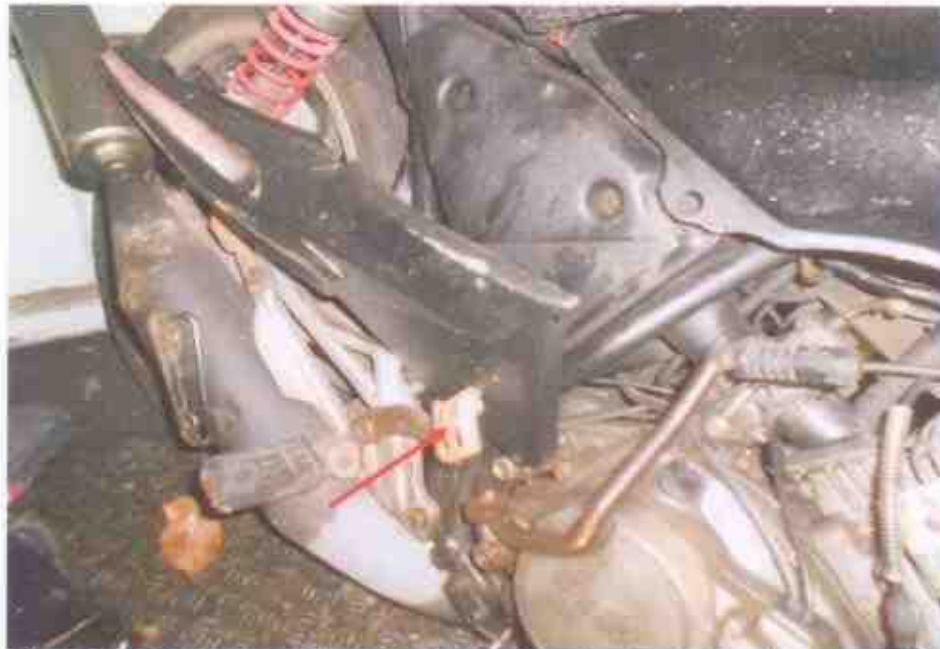
Photo 18 shows the rear brake pedal (arrowed) was observed to be crushed inwards as a result of the accident. Hence, we are unable to conduct any tests on the braking system of the Motorcycle.

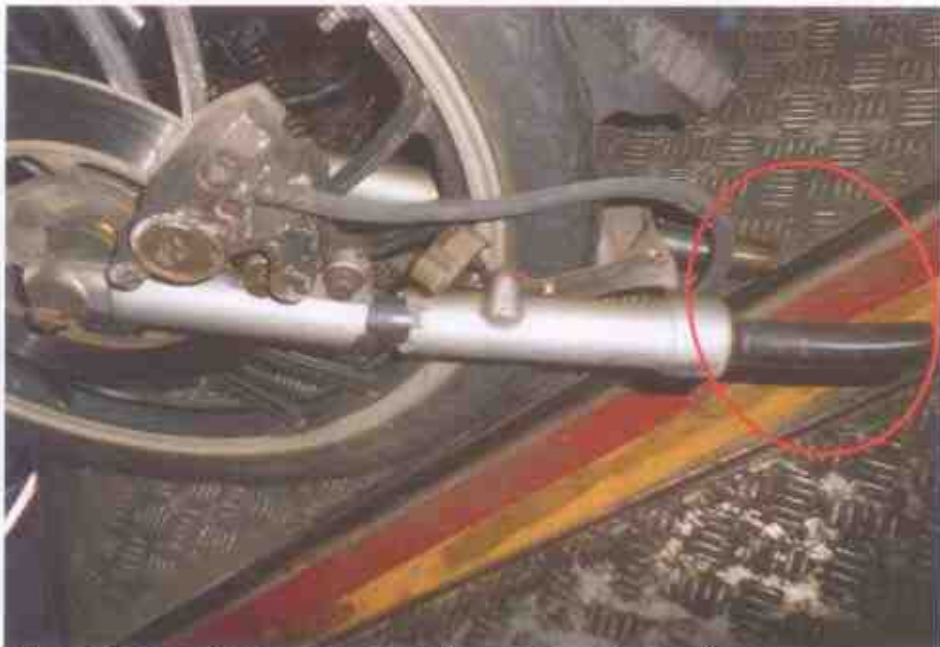
Photo 19 shows the front fork (circled) was observed to be dislodged as a result of the accident. Hence, we are unable to conduct any tests on the steering system of the Motorcycle.

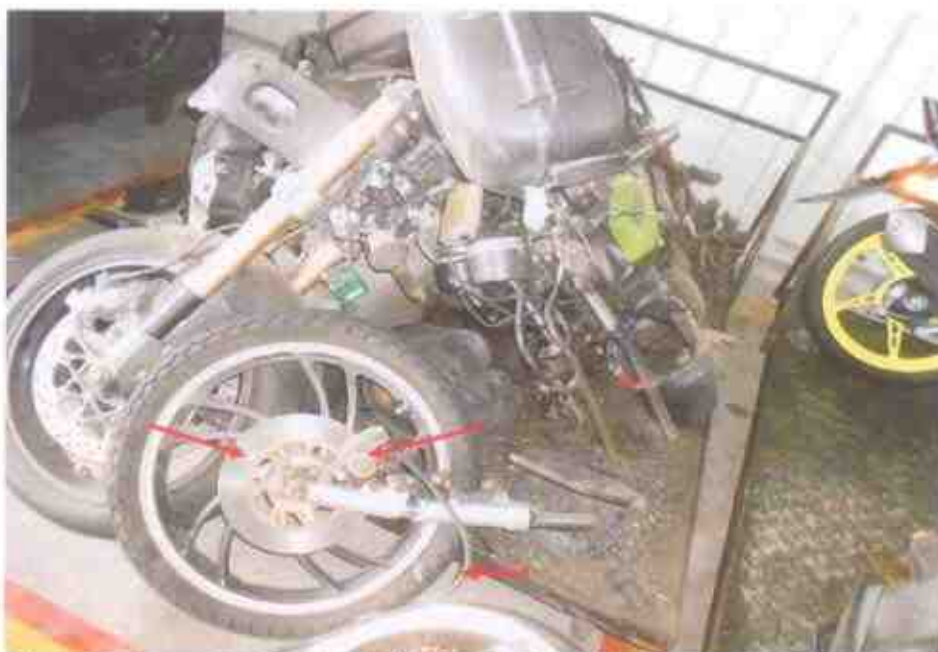
Photo 20 shows the front brake calliper and front brake disc of the Motorcycle (arrowed in red), which are all part of the components in the front brake system of the Motorcycle. Our visual checks of these various components had revealed all to be intact with no visible damage except for a cut brake fluid hose due to the accident.

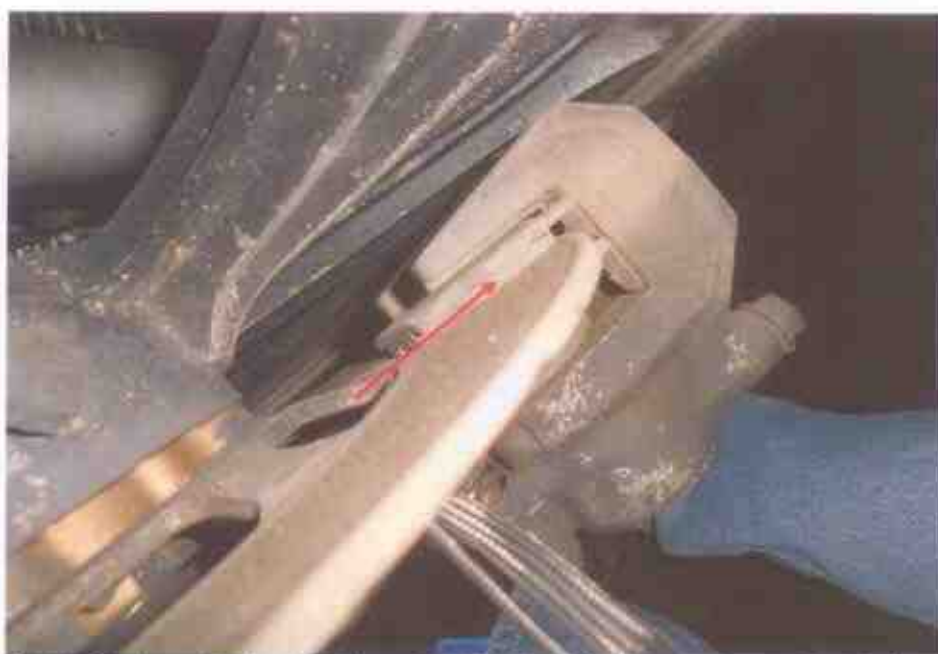
Photo 21 shows the front brake pad, which is part of the components in the front brake system of the Motorcycle. Our visual checks had revealed that it was still in serviceable condition, intact with no visible damage & sufficient frictional padding.

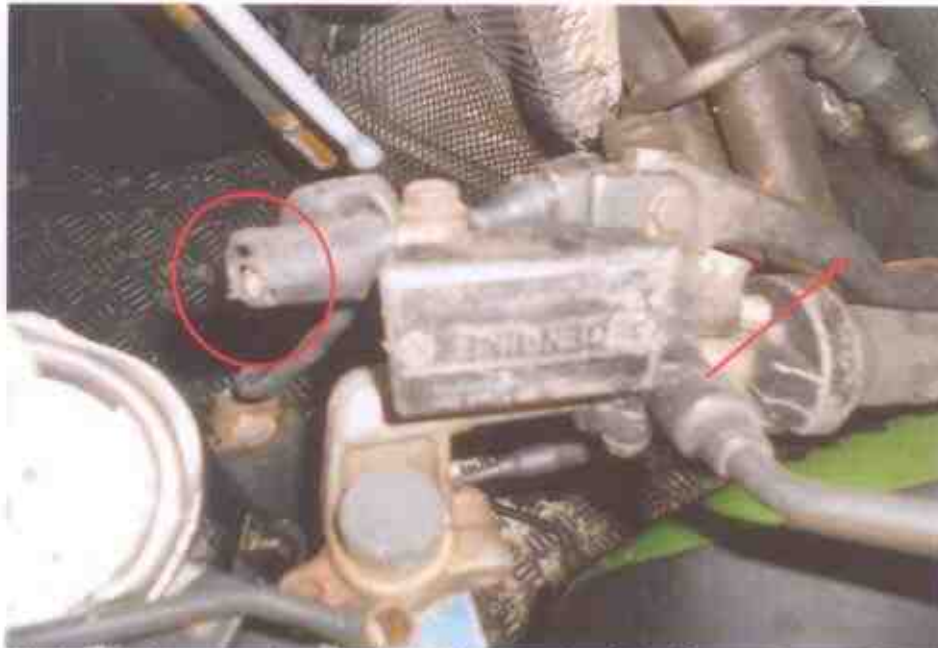
Photo 22 shows the front brake fluid reservoir of the Motorcycle which was observed to be with cut brake fluid hose & damaged brake lever caused by the accident's collision.

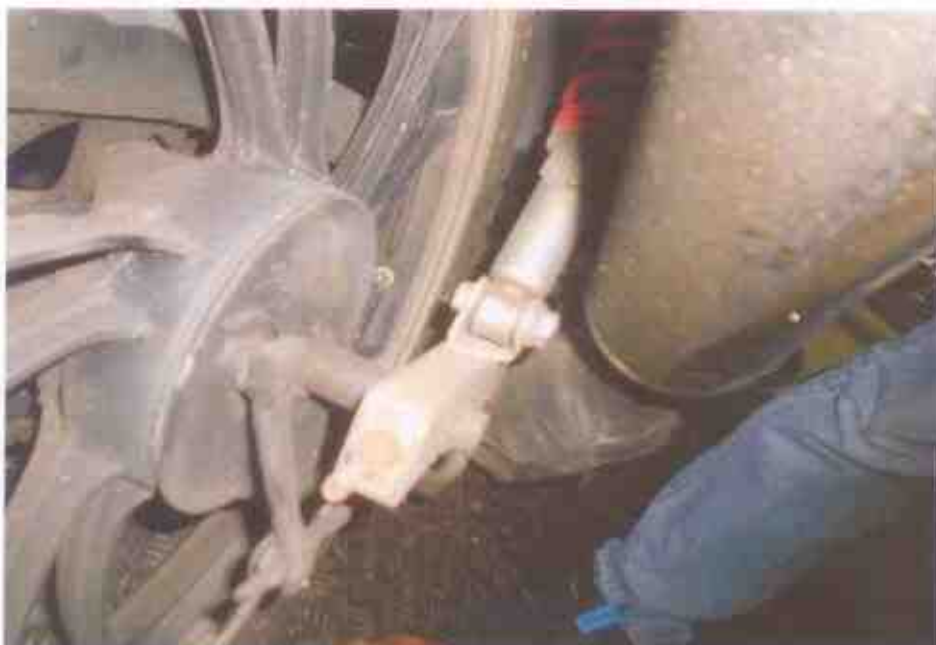
Photo 23 shows the rear brake components of the Motorcycle which was observed to be in serviceable condition. No damages was found at time of our inspection.
