Your Ref: TP/IP/02043/2018
Our Ref :CI/TPD18011351/Z

Fatal Accident Investigation Team
Traffic Police Department
Singapore Police Force
10 Ubi Avenue 3
Singapore 408865

MECHANICAL INSPECTION REPORT OF MOTORCYCLE JPW 6319

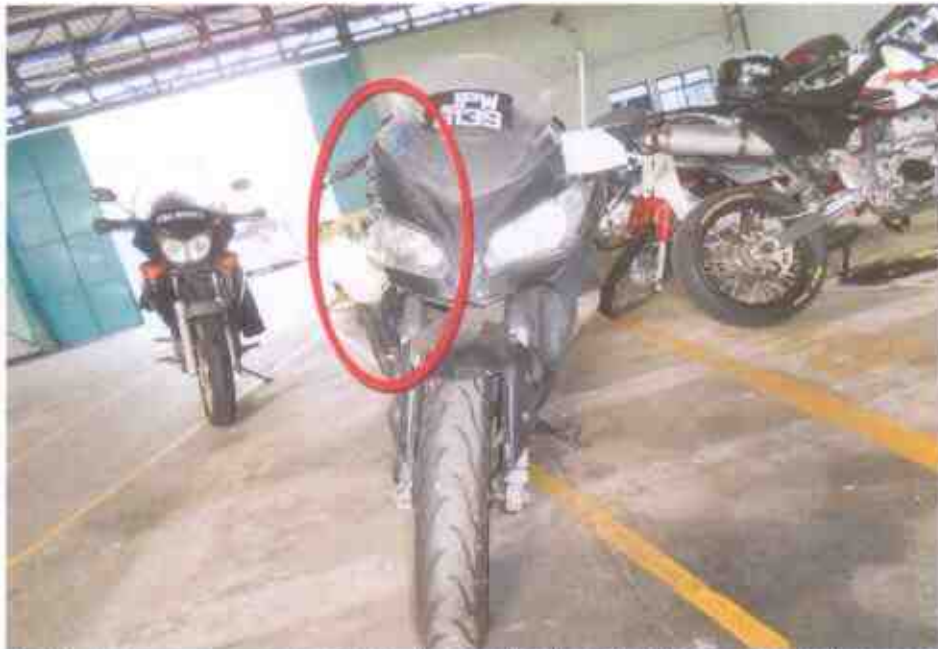
Photo 1 shows a general view of the front body of the Motorcycle at the time of our inspection. The Motorcycle was observed to be sustained with relatively extensive impact due to the accident collision. Amongst the body parts damaged was its steering system (circled), which was observed to be bent inwards.

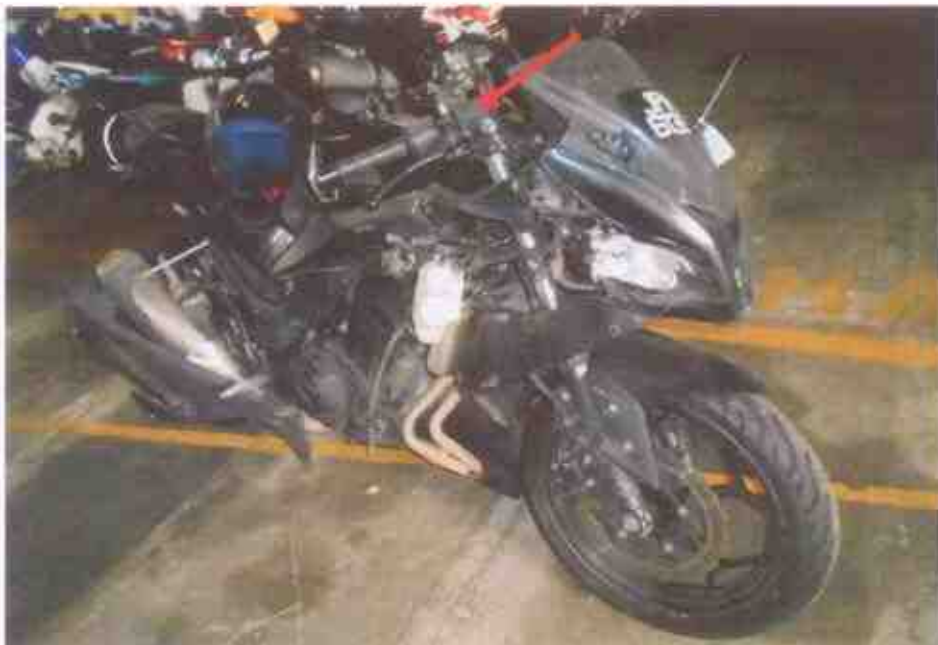
Photo 2 shows a general view of the front right body of the Motorcycle at the time of our inspection. The Motorcycle was observed to be sustained with relatively extensive impact due to the accident collision. Amongst the body parts damaged was its handle bar-steering system (arrowed), which was observed to be bent inwards.

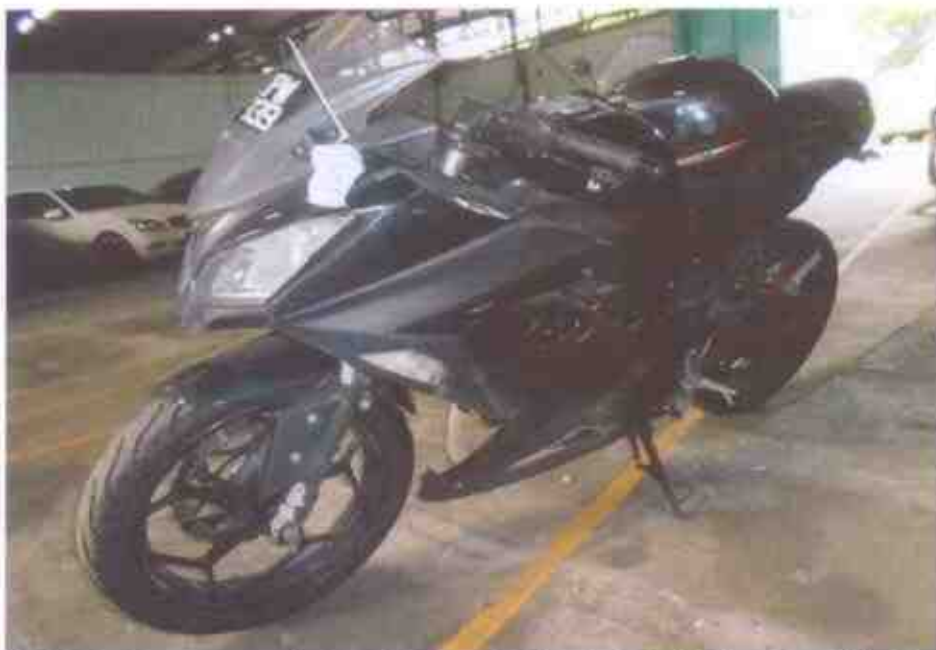
Photo 3 shows a general view of the rear left body of the Motorcycle at the time of our inspection. The Motorcycle was observed to have sustained damages at the frontal & rear portion, along both its left side and right side.

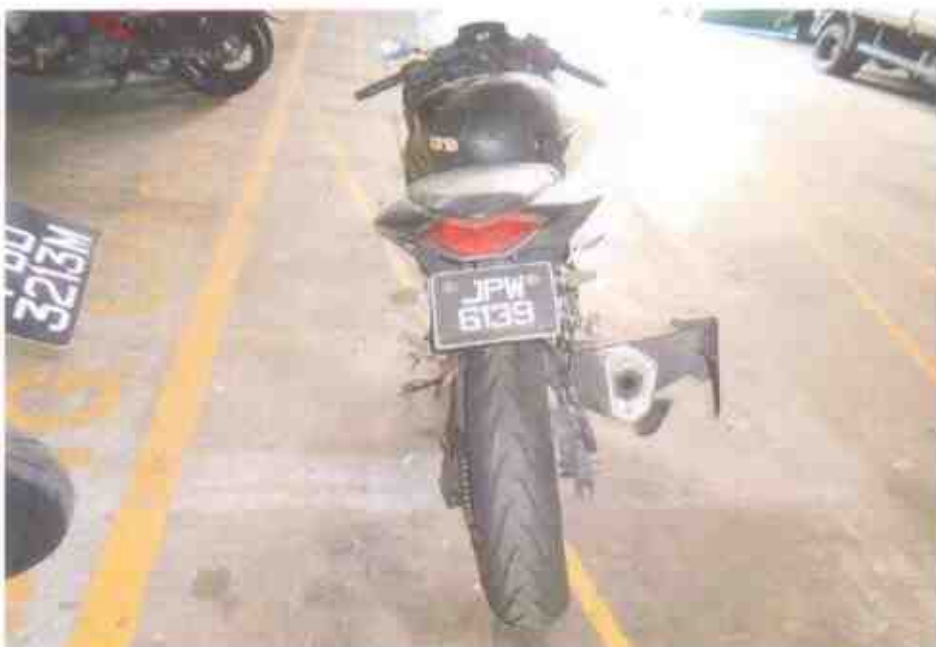
Photo 4 shows a general view of the rear portion of the Motorcycle at the time of our inspection. It was observed to be in good condition not affected by the accident's impact.

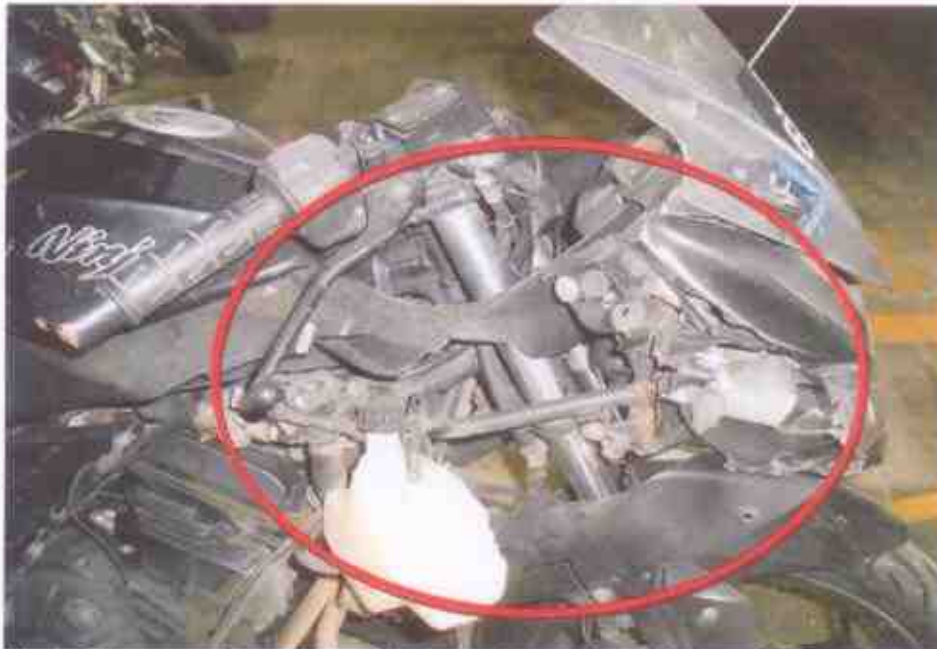
Photo 5 shows a close-up view of the head lamp & side fairing of the Motorcycle at the time of our inspection. It was observed to have sustained with damages due to the accident collision.

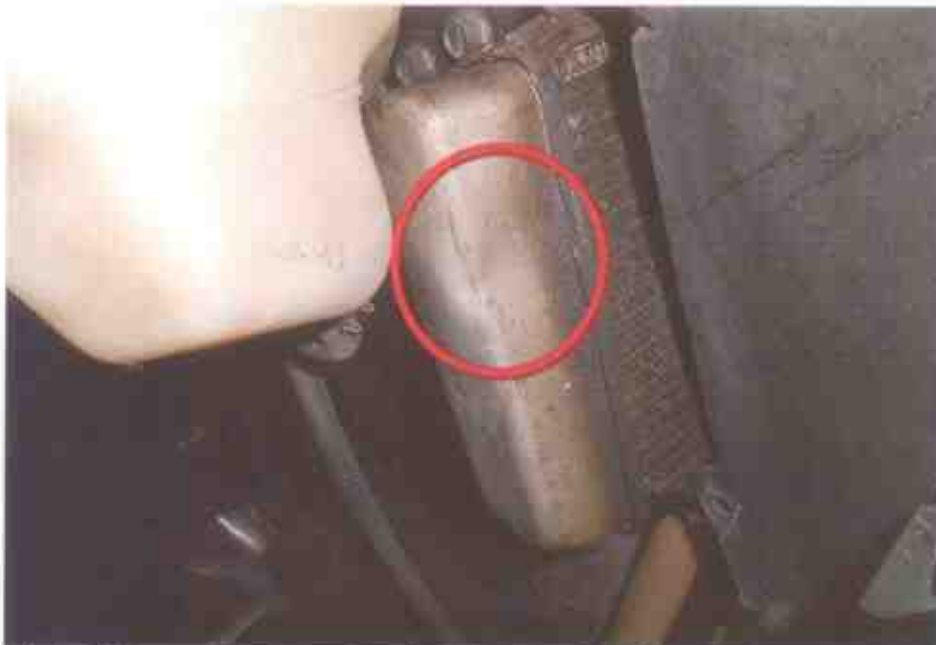
Photo 6 shows a close-up view of the radiator of the Motorcycle at the time of our inspection. It was observed to have sustained with damages due to the accident collision.

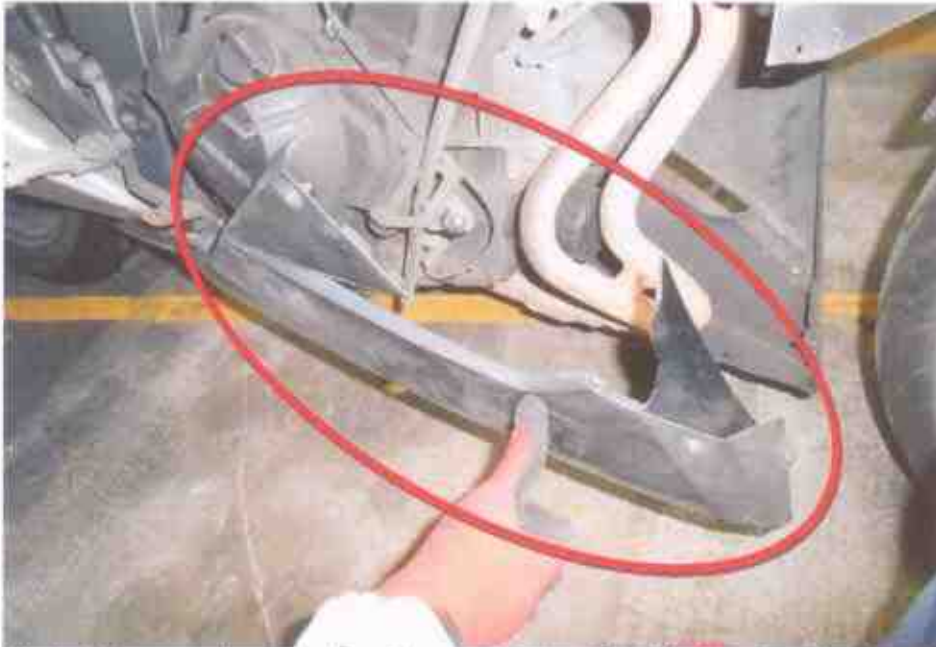
Photo 7 shows a close-up view of the side fairing of the Motorcycle at the time of our inspection. It was observed to have sustained with damages due to the accident collision.

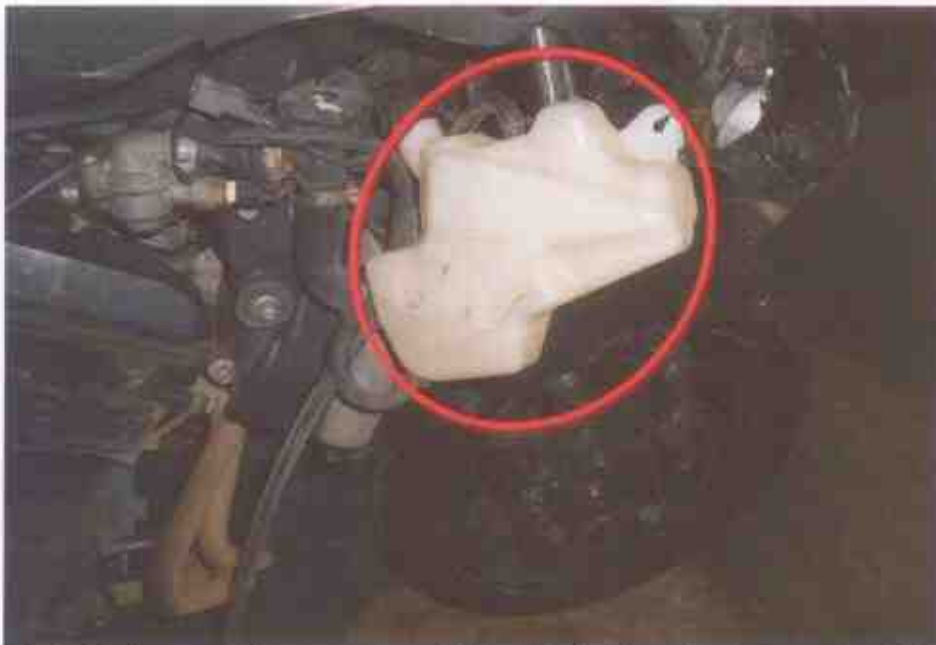
Photo 8 shows a close-up view of the dislodged coolant reservoir of the Motorcycle at the time of our inspection. It was observed to have sustained with damages due to the accident collision.

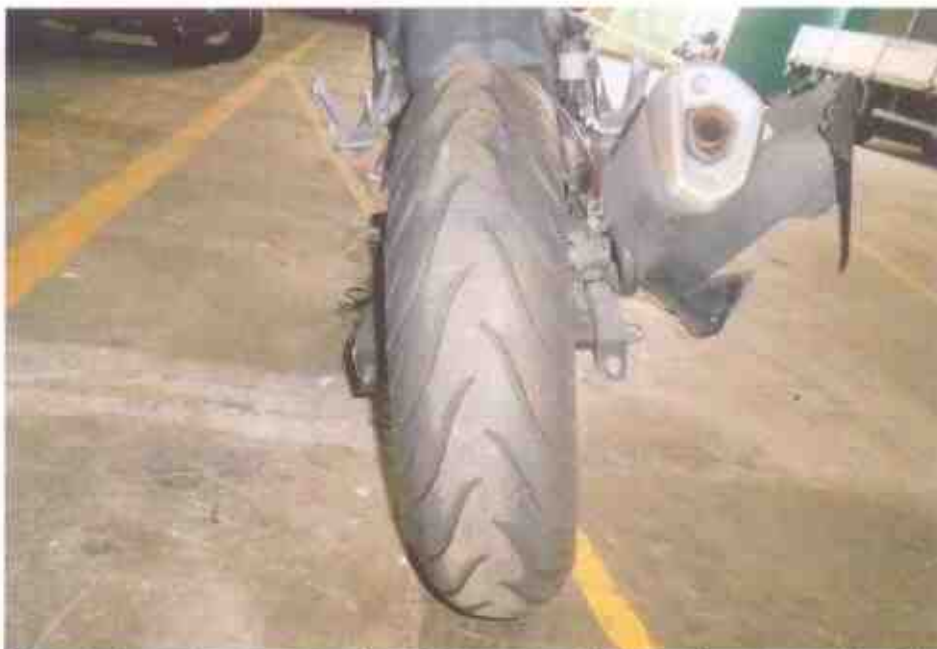
Photo 9 shows the rear tyre of the Motorcycle at the time of our inspection. The rear tyre was observed to be in serviceable condition with remaining tread depth of approximately 3mm. The tyre was also observed to be sufficiently inflated for vehicular operation. There was no significant damage observed on the rear wheel rim & tyre.

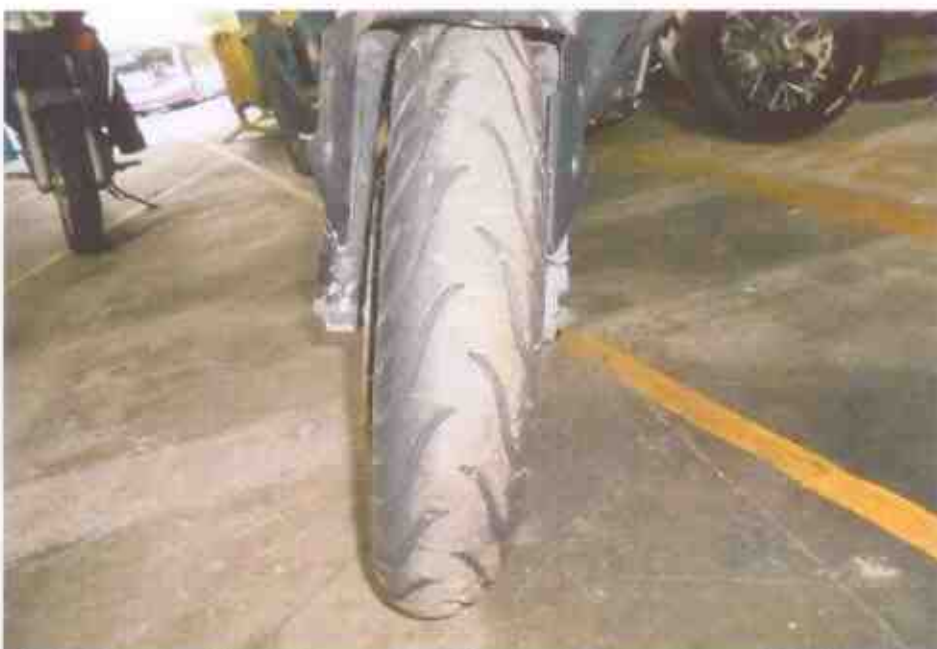
Photo 10 shows the front tyre of the Motorcycle. The pattern of the tread was clearly visible. There was no tear, burst mark(s) and/or punctured hole(s) on the sidewalls as well as across the tread of the front tyre.

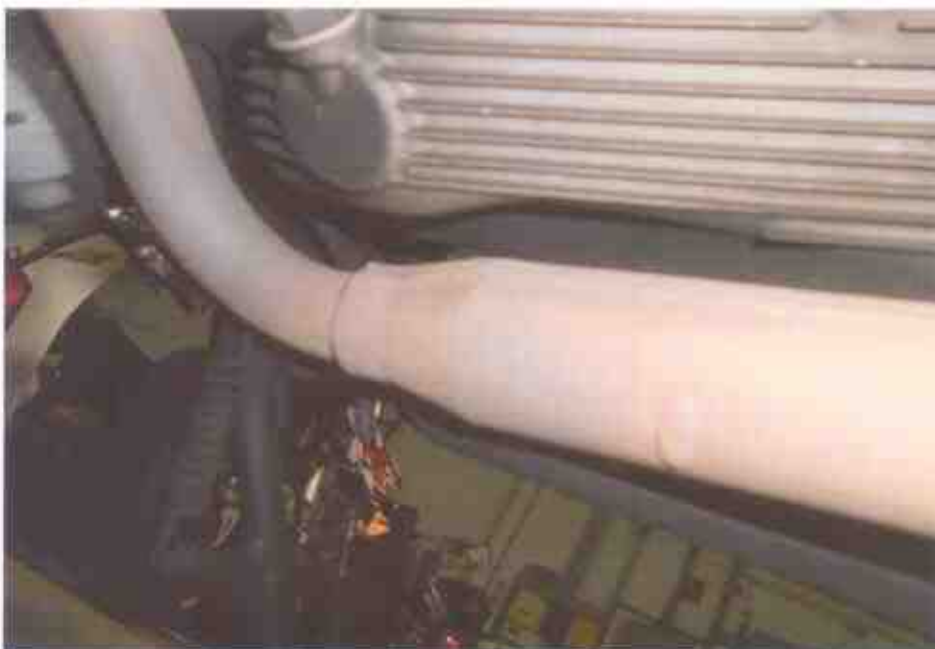
Photo 11 shows no sign(s) or indication(s) of fluid leakage stain observed around the engine undercarriage area of the Motorcycle.

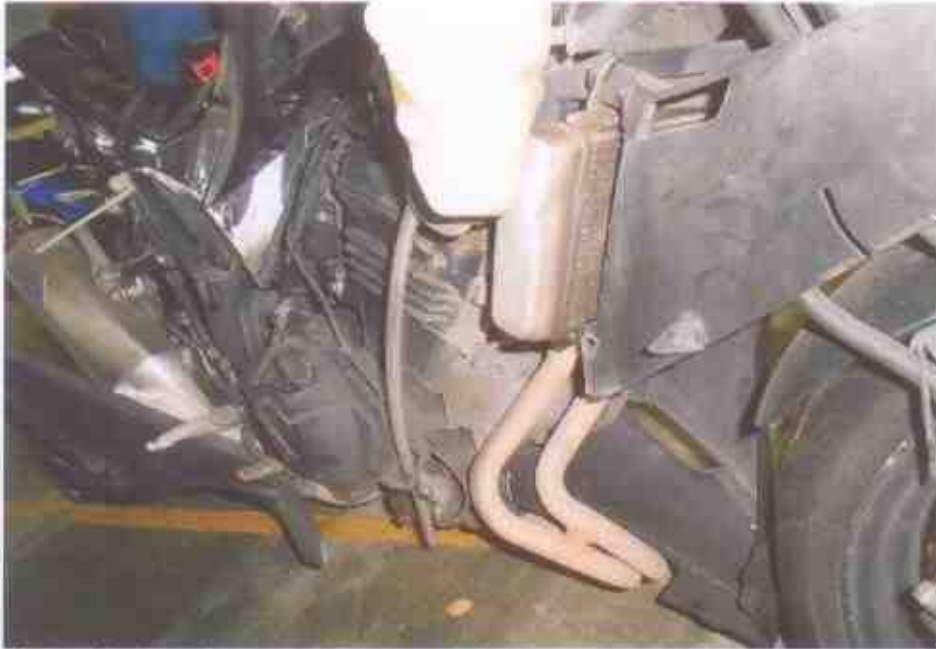
Photo 12 shows the semi-close view of the engine compartment. It was observed to be intact & undamaged unaffected by the accident's impact.

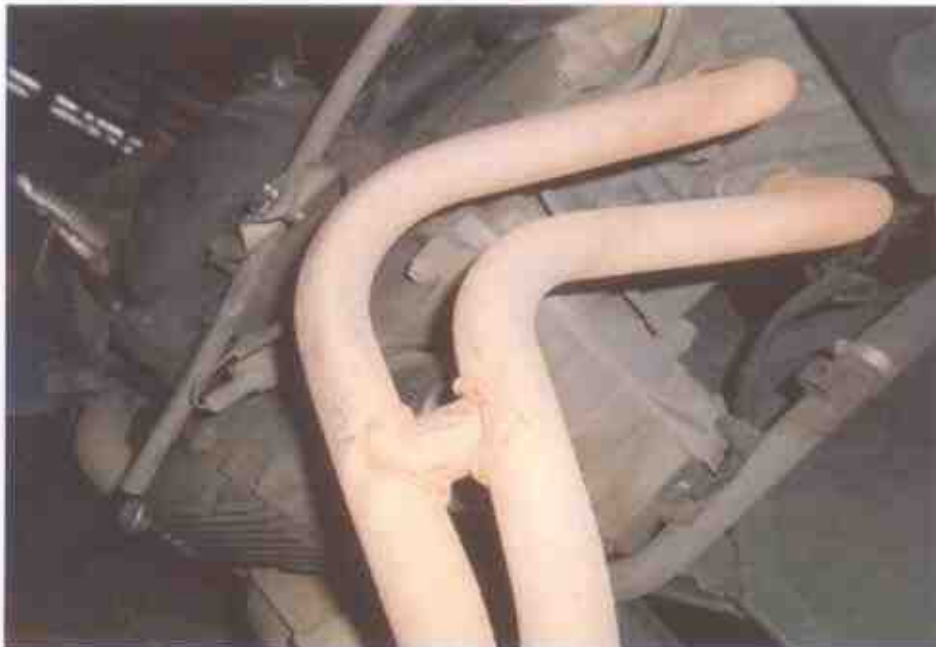
Photo 13 shows the close up view of the undercarriage. It was not affected by the accident's collision impact. No sign of fluid leakage found at time of our inspection.

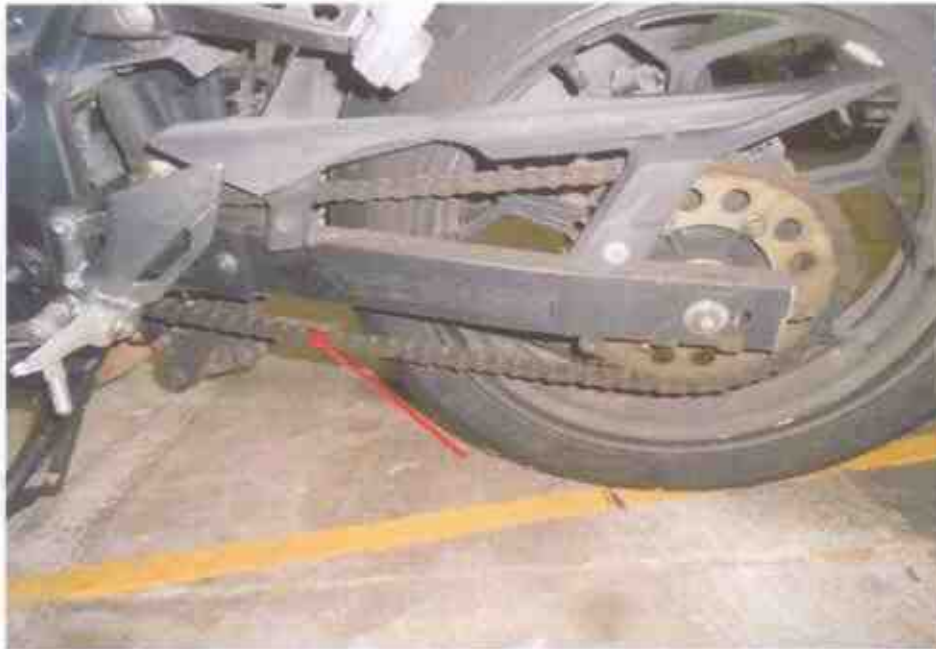
Photo 14 shows the general view of the gear train (arrowed) of the Motorcycle, which was observed to be intact with no misalignment. It was also adequately lubricated for operating purposes.

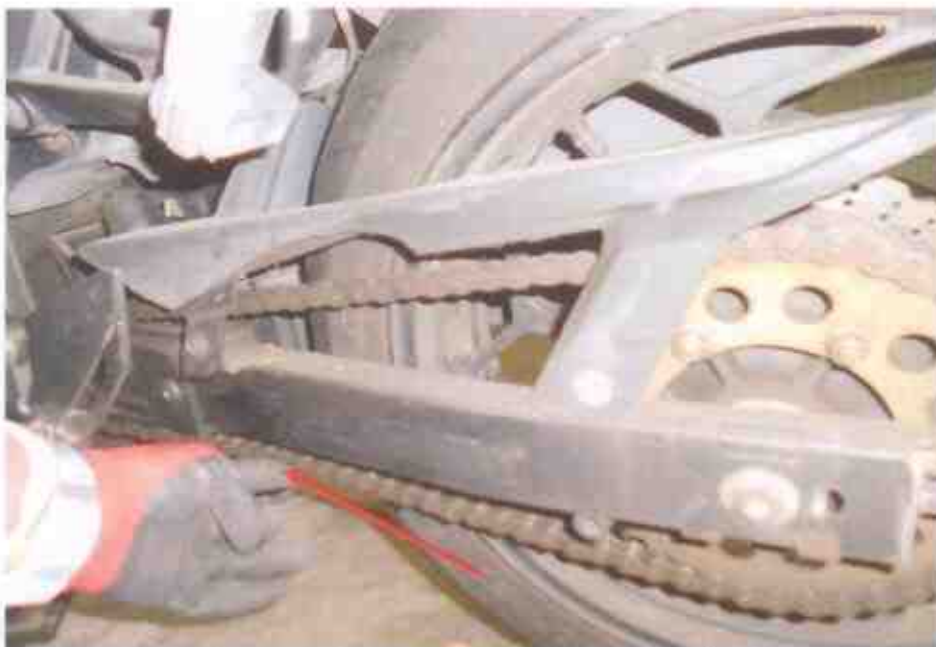
Photo 15 shows the general view of the gear train (arrowed) of the Motorcycle, which was observed to be intact with no misalignment. It was also adequately lubricated for operating purposes. Free play tension was also observed & found adequately acceptable.

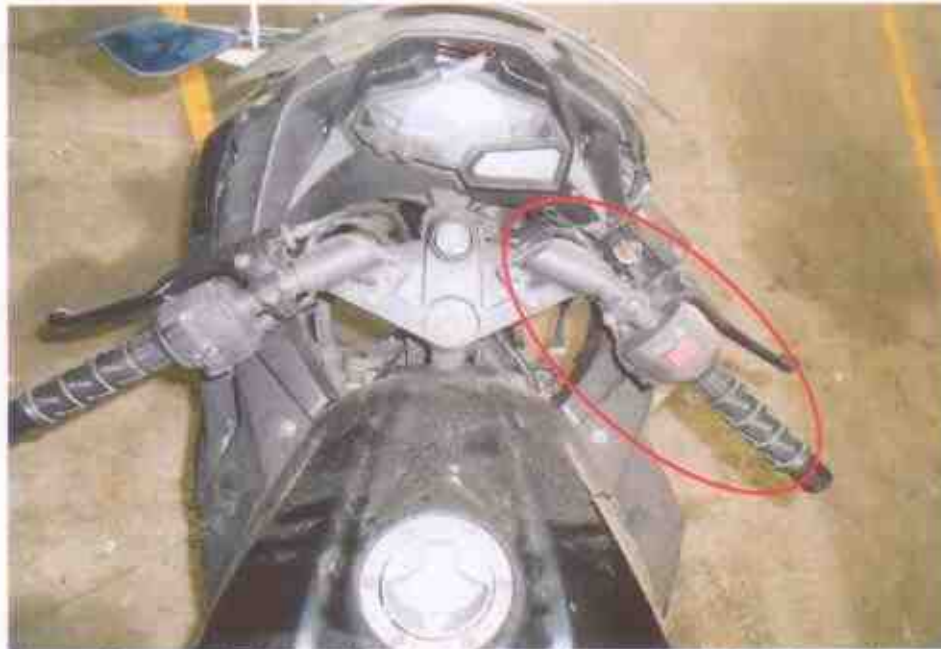
11. For this case, we were not able to conduct any test(s) on the steering system of the Motorcycle due to the damage on its handle bar. It was found to be bent inwards as a result of the accident, hence causing the whole steering system to be in an abnormal condition.

Photo 16 shows the handle bar (circled) was observed to be bent inwards as a result of the accident. Hence, we are not able to conduct any tests on the steering system of the Motorcycle.

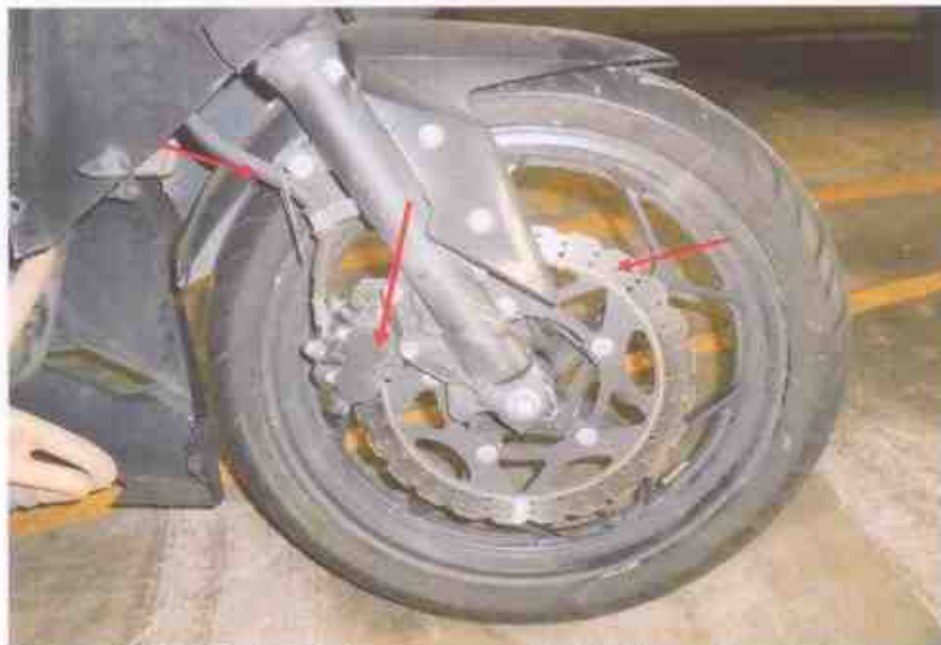
Photo 17 shows the front brake calliper, front brake disc and front brake hose of the Motorcycle (arrowed), which are all part of the components in the front brake system of the Motorcycle. Our visual checks of these various components had revealed all to be intact with no visible damage. No leakage of brake fluid was also observed.

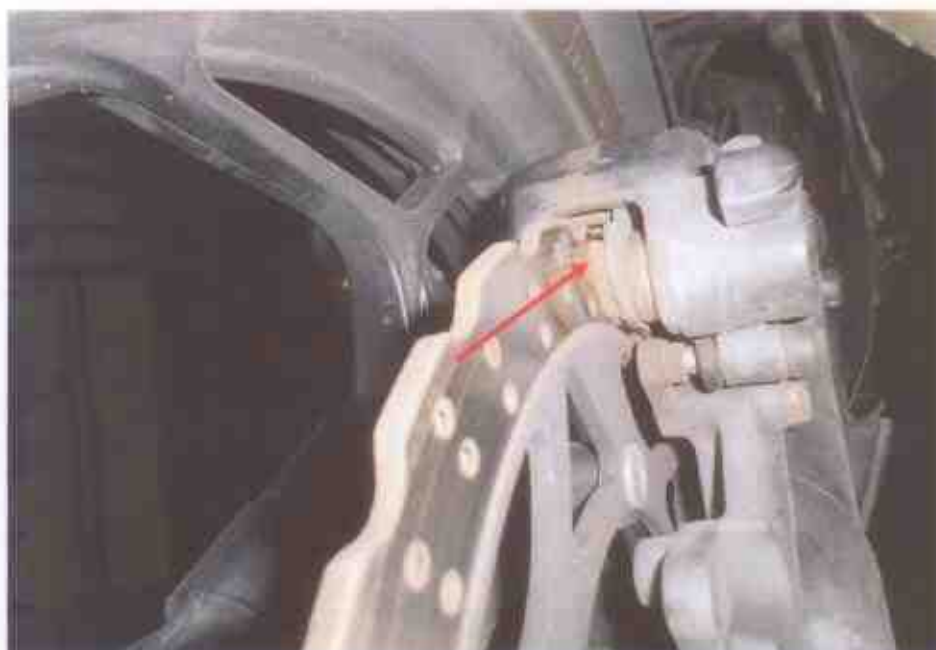
Photo 18 shows the front wheel of the Motorcycle. The type of brake system for the rear wheel was of hydraulic type, controlled by the hand brake lever of the Motorcycle. Our checks of the calliper (arrowed) & brake pad which are all part of the components in the rear brake system of the Motorcycle reveal all to be intact and without damage.

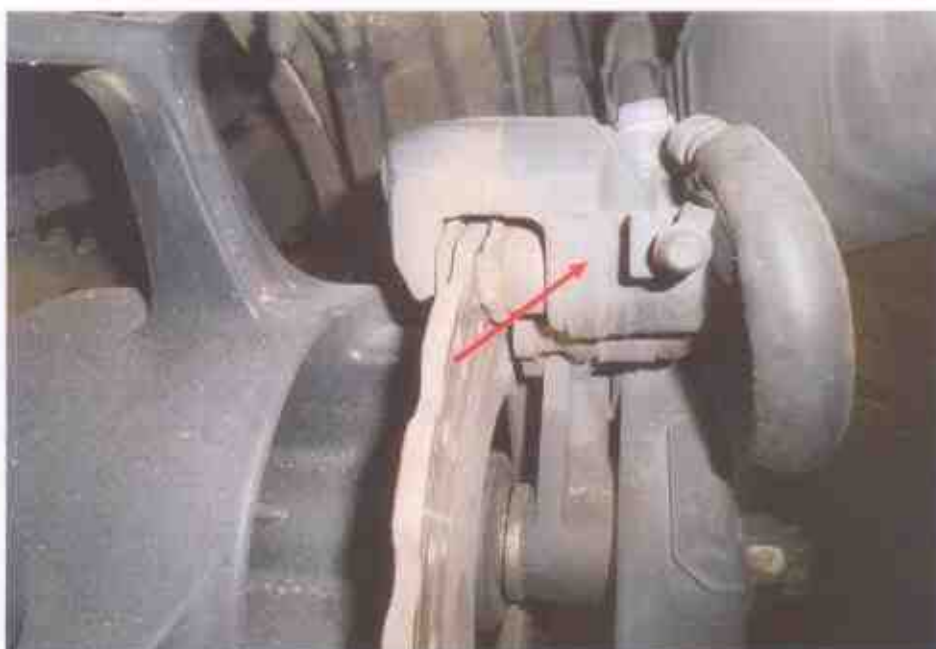
Photo 19 shows the rear wheel of the Motorcycle. The type of brake system for the rear wheel was of hydraulic type, controlled by the brake foot pedal of the Motorcycle. Our checks of the calliper (arrowed) & brake pad which are all part of the components in the rear brake system of the Motorcycle reveal all to be intact and without damage.

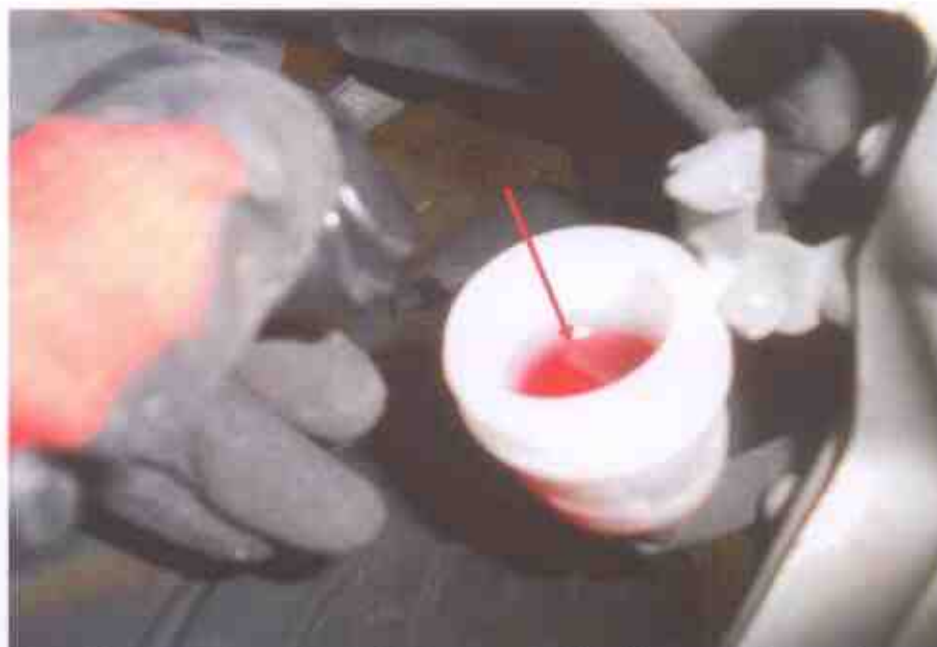
Photo 20 shows the rear brake fluid reservoir of the Motorcycle. It was observed to be of sufficient level without any contamination at time of our inspection.

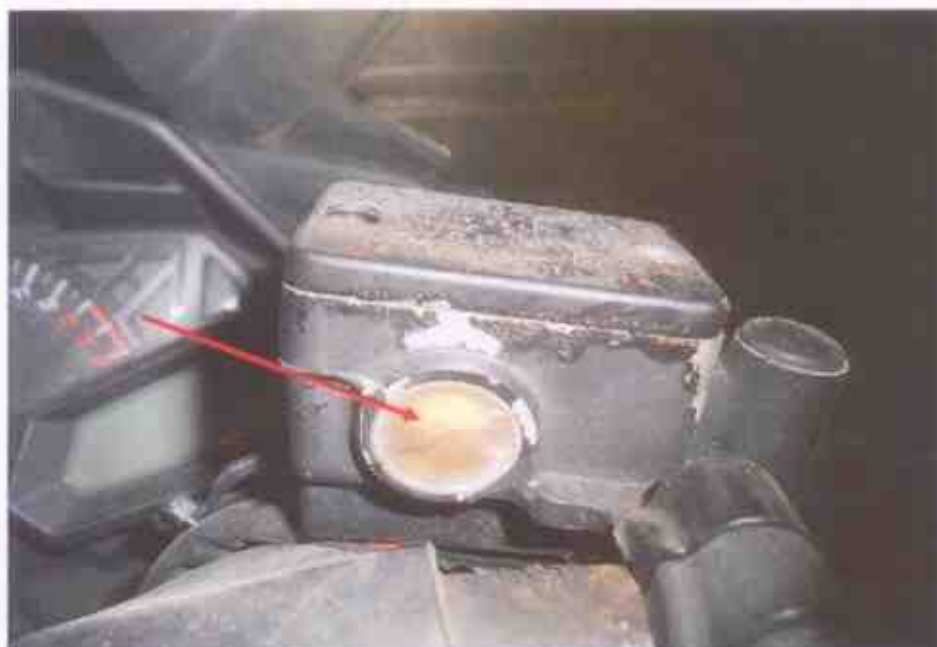
Photo 21 shows the front brake fluid reservoir of the Motorcycle. It was observed to be of sufficient level without any contamination at time of our inspection.
