Auto  
Consultants  
Pte Ltd

28<sup>th</sup> August 2018

**Fatal Accident Investigation Team**

**MECHANICAL INSPECTION REPORT OF MOTOR BUS SMB 1607D**

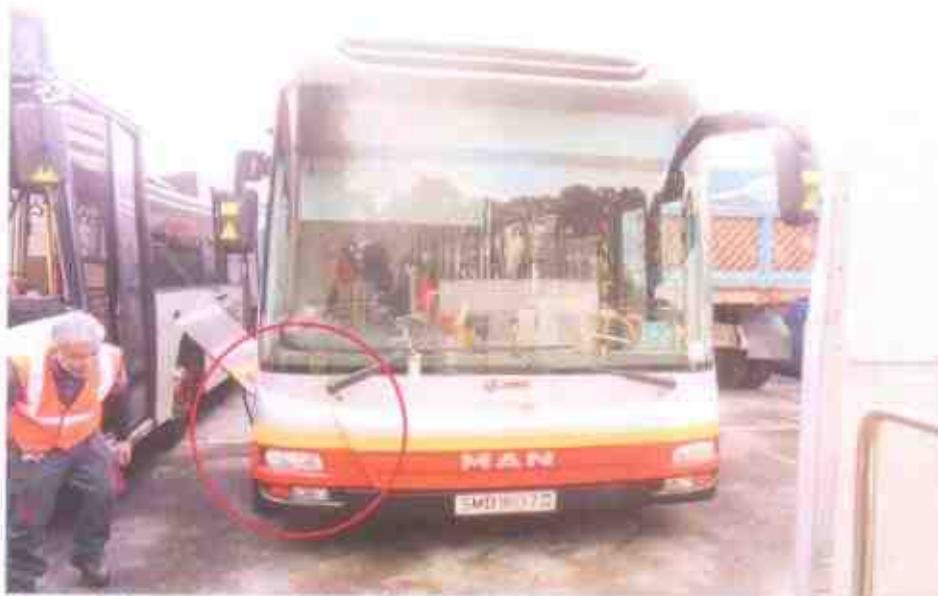
Photo 1 shows a general view of the Motor Bus that sustained minor damages at its front right portion as a result of the accident's collision.

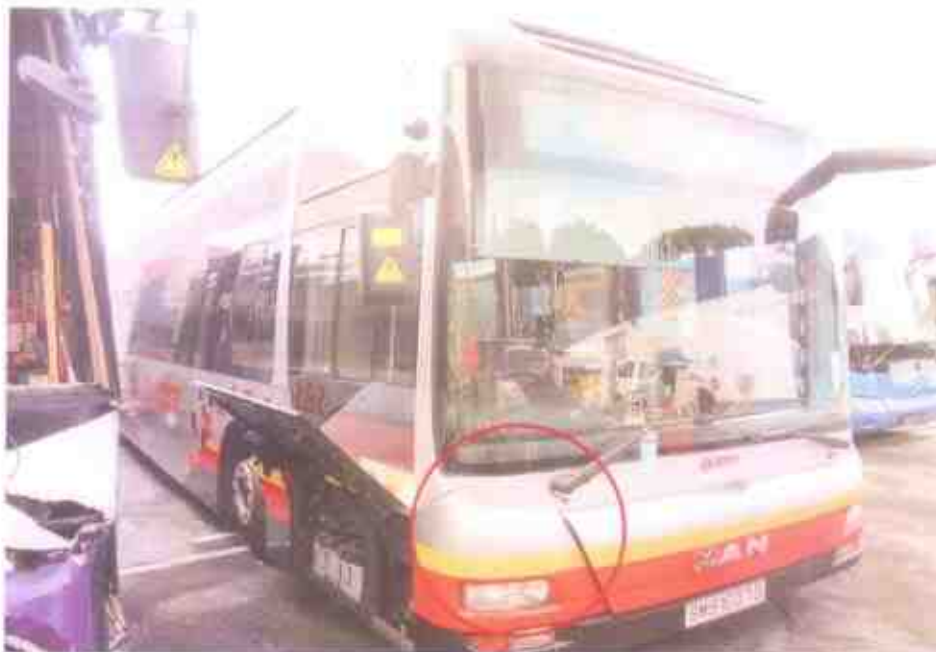
Photo 2 shows a general view of the Motor Bus that sustained minor damages at its front right portion as a result of the accident's collision.

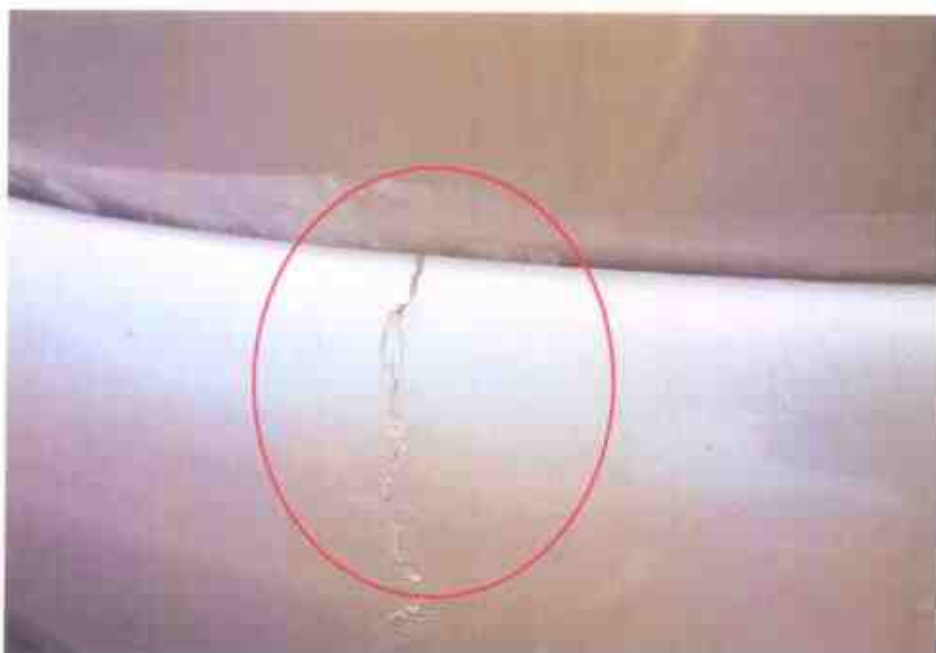
Photo 3 shows a close-up view of the front right body of the Motor Bus at the time of our inspection. The Motor Bus was observed to sustained minor damages due to the accident's impact.

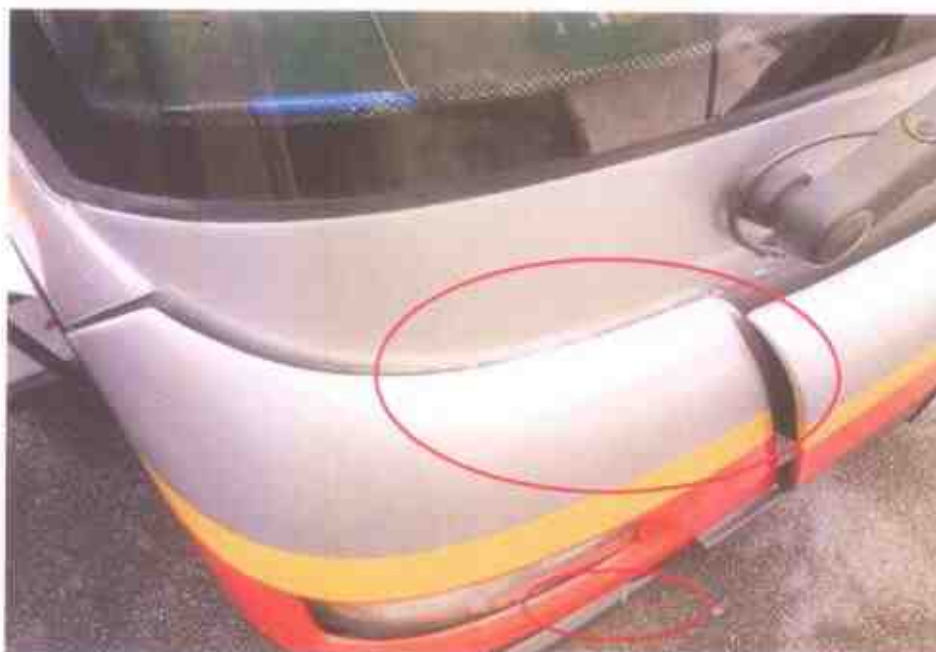
Photo 4 shows a semi close-up view of the front right body of the Motor Bus at the time of our inspection. The Motor Bus was observed to sustained minor damages due to the accident's impact.

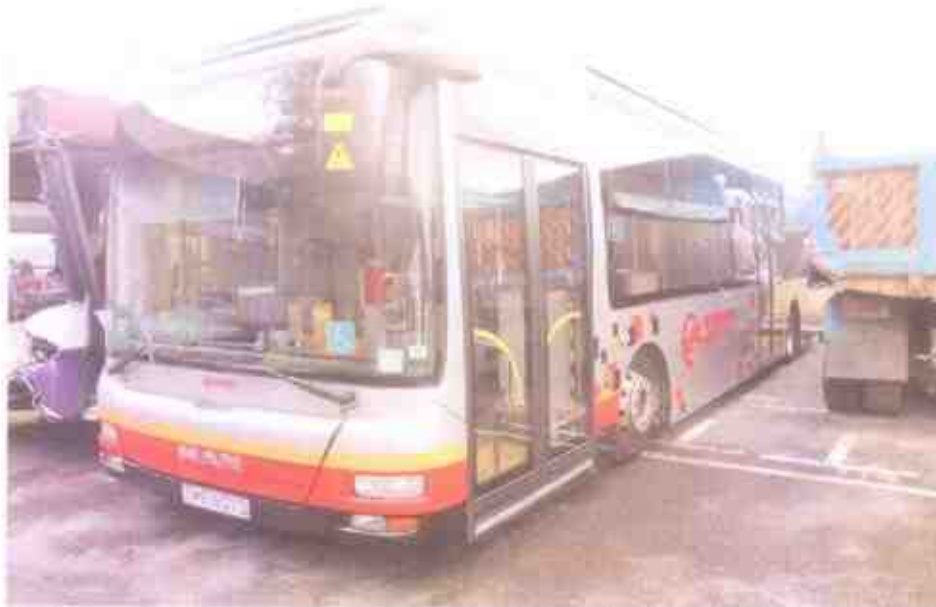
**Photo 5** shows a general view of the Motor Bus front left portion that was observed to be in good condition unaffected by the accident's impact.

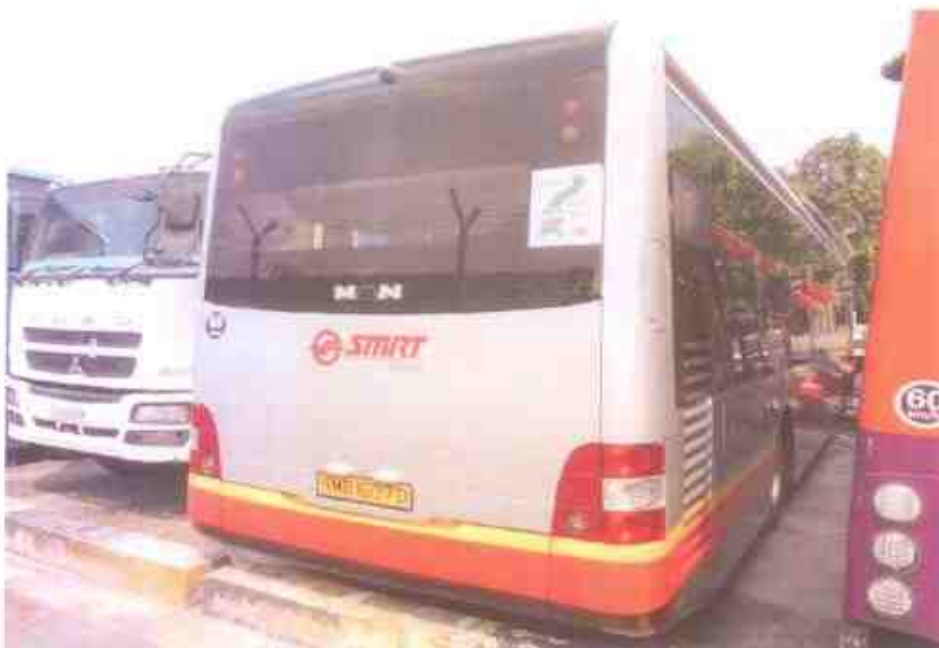
**Photo 6** shows a general view of the Motor Bus rear portion that was not affected by the accident's collision.

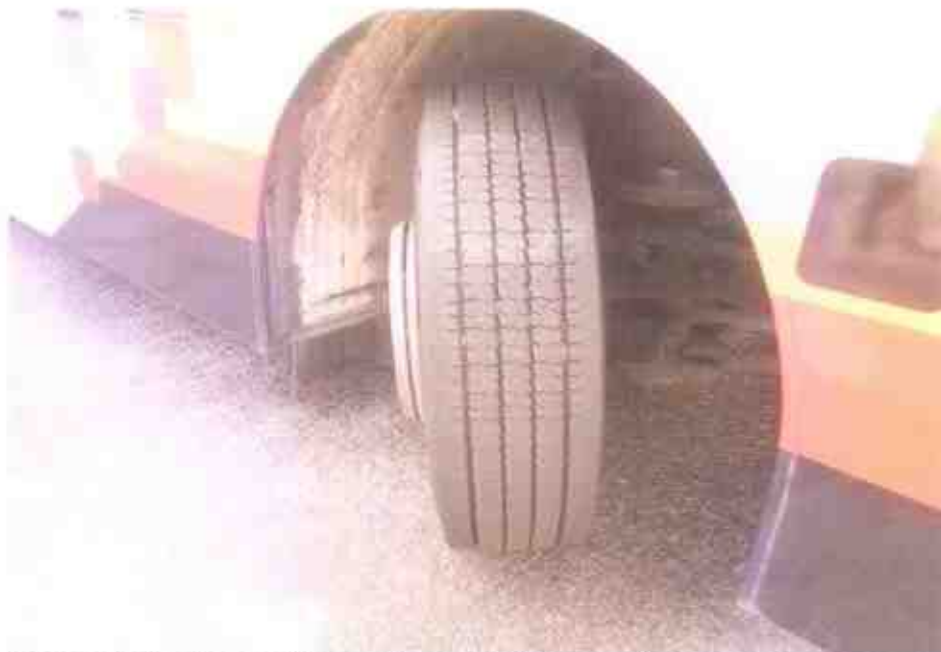
**Photo 7** shows the condition of the front right tyre of the Motor Bus, which was observed to be in serviceable condition with remaining tread depth of approximately 9mm. The tyre was also observed to be sufficiently inflated for vehicular operation.

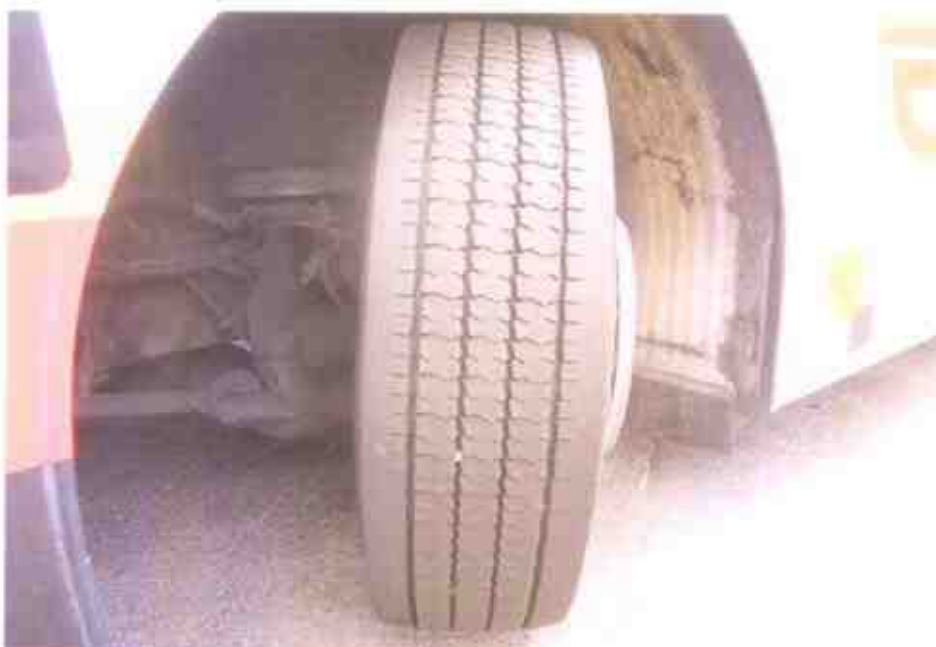
**Photo 8** shows the condition of the front left tyre of the Motor Bus, which was observed to be in serviceable condition with remaining tread depth of approximately 9mm. The tyre was also observed to be sufficiently inflated for vehicular operation.

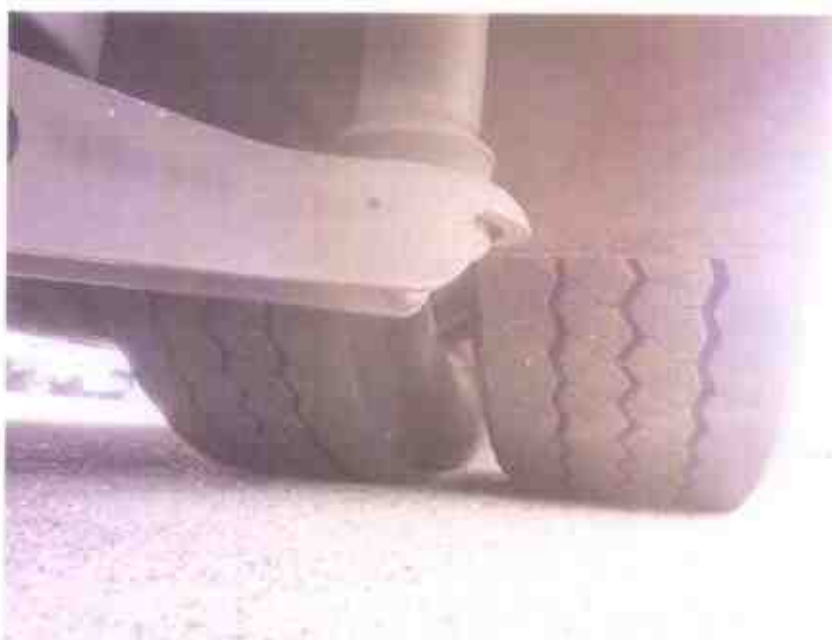
**Photo 9** shows the condition of the rear right tyres of the Motor Bus, which were observed to be in serviceable condition with remaining tread depth of approximately 9mm. The tyres, which were wrapped around standard alloy wheels rims, were also observed to be sufficiently inflated for vehicular operation.

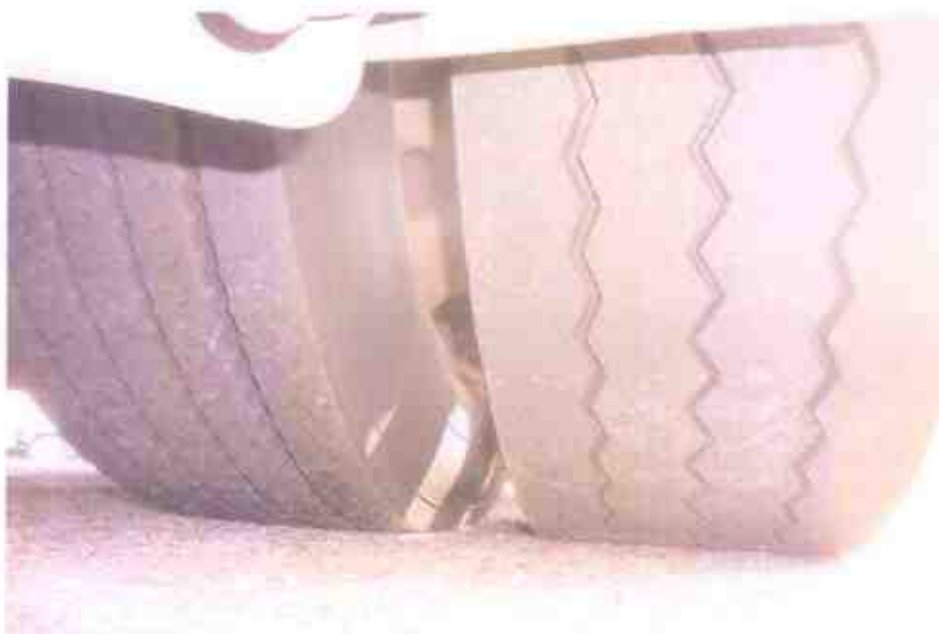
**Photo 10** shows the condition of the rear left tyres of the Motor Bus, which were observed to be in serviceable condition with remaining tread depth of approximately 8mm. The tyres, which were wrapped around standard alloy wheel rims, were also observed to be sufficiently inflated for vehicular operation.

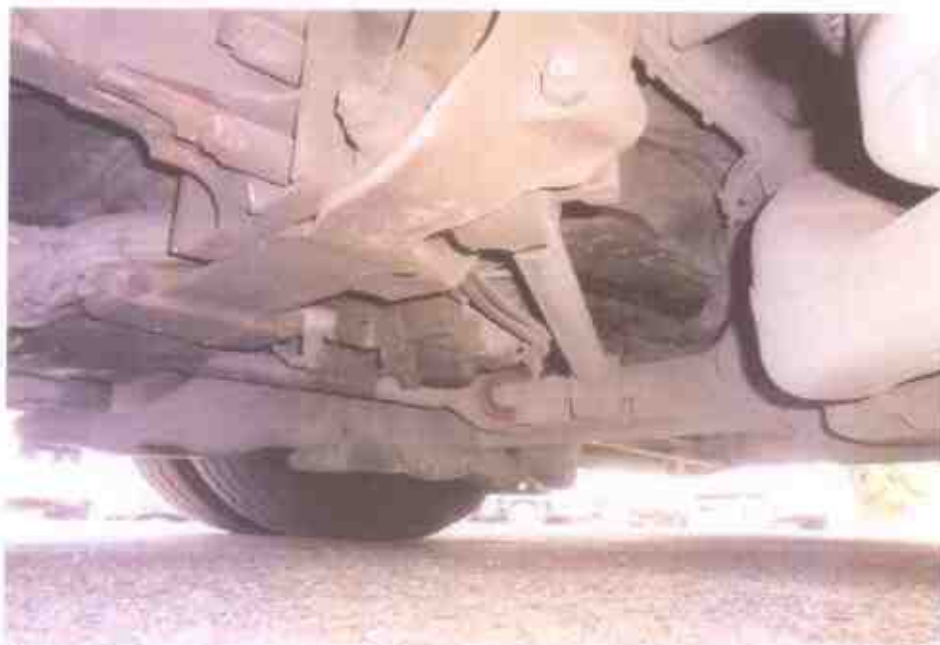
11. Our subsequent checks on the underside of the Motor Bus reveals some fluid stain sighted under the engine compartment. Further investigation found that the fluid stain was a pre-existed prior the accident & not a fresh fluid. This was due to some dirt observed on the fluid stain. Conclusively, it is not likely to be related to the accident. Visually, the various undercarriage components of the Motor Bus were observed to be intact and without any visible damage except for the damages caused by the accident. See photo 11 – 16 below.

**Photo 12** shows the engine undercarriage of the Motor Bus. Some pre-existed fluid was observed at time of our inspection.

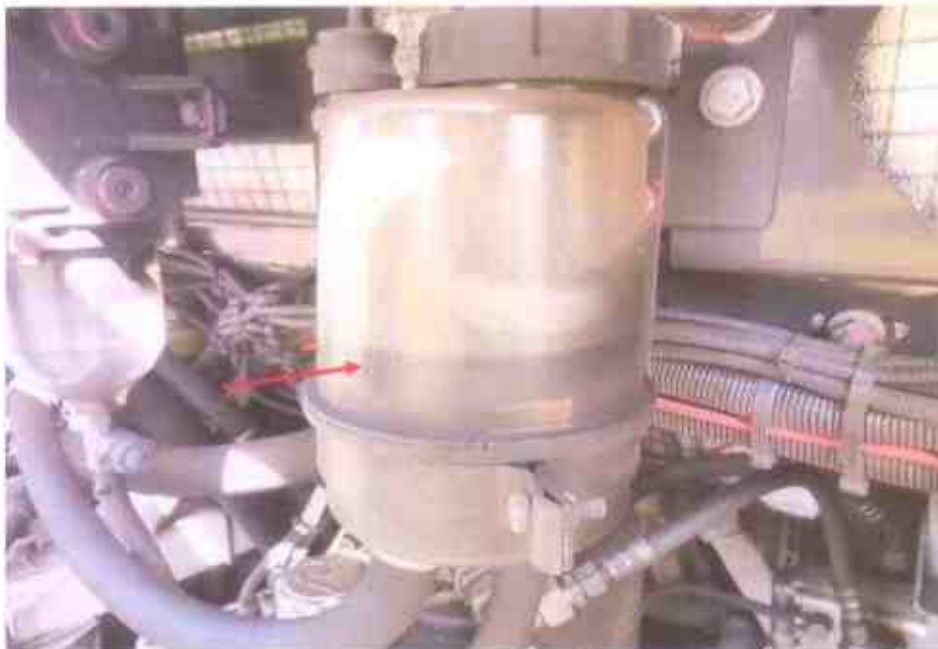
**Photo 13** shows the steering fluid of the Motor Bus. It was observed to be of sufficient level without any contamination at time of our inspection.

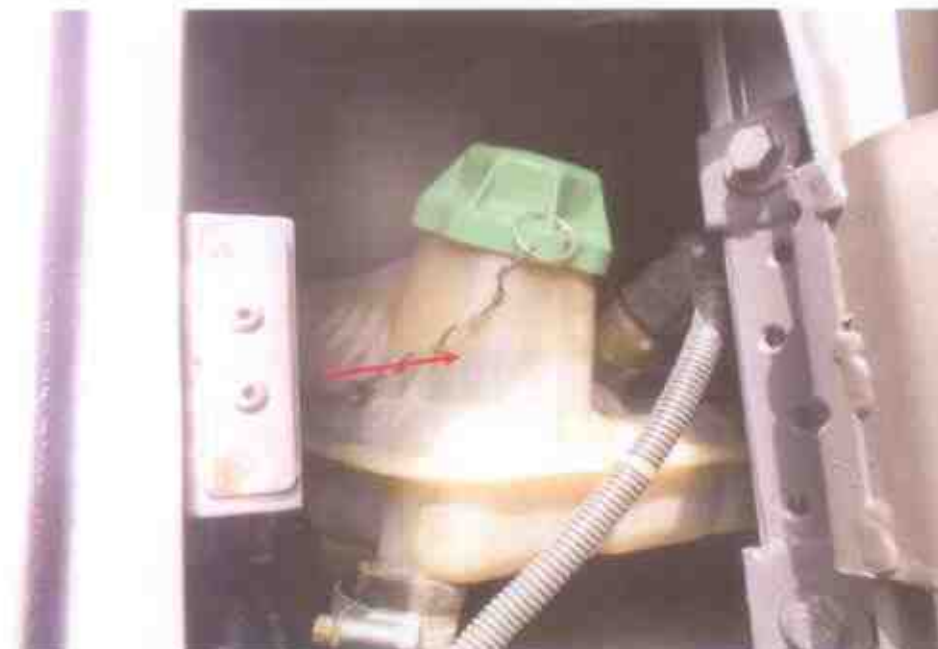
**Photo 14** shows the engine coolant cylinder of the Motor Bus. It was observed to be of sufficient level without any contamination at time of our inspection.

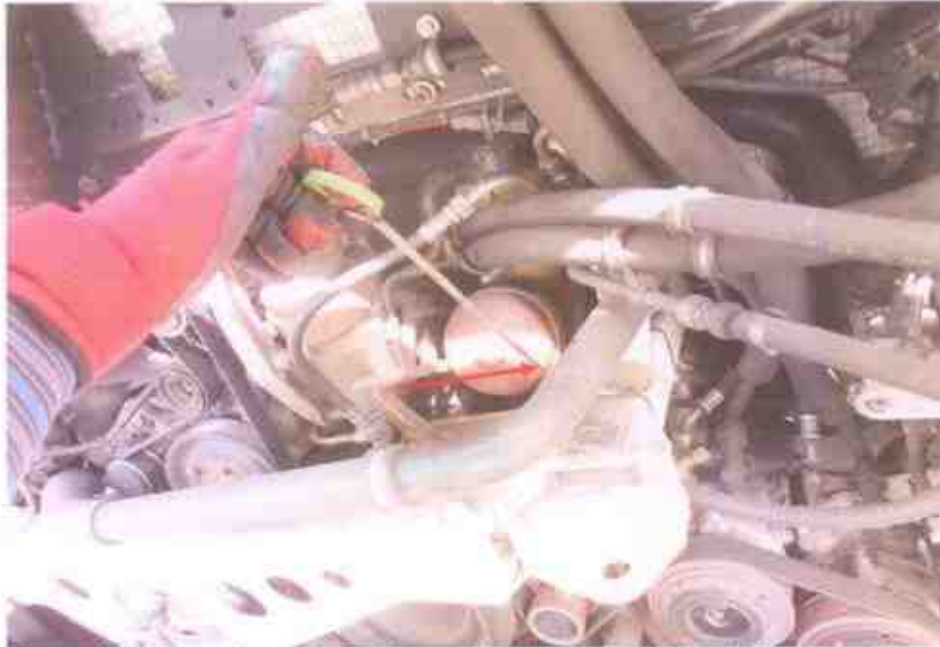
**Photo 15** shows the engine fluid on the dip stick of the Motor Bus. It was observed to be of sufficient level without any contamination at time of our inspection.

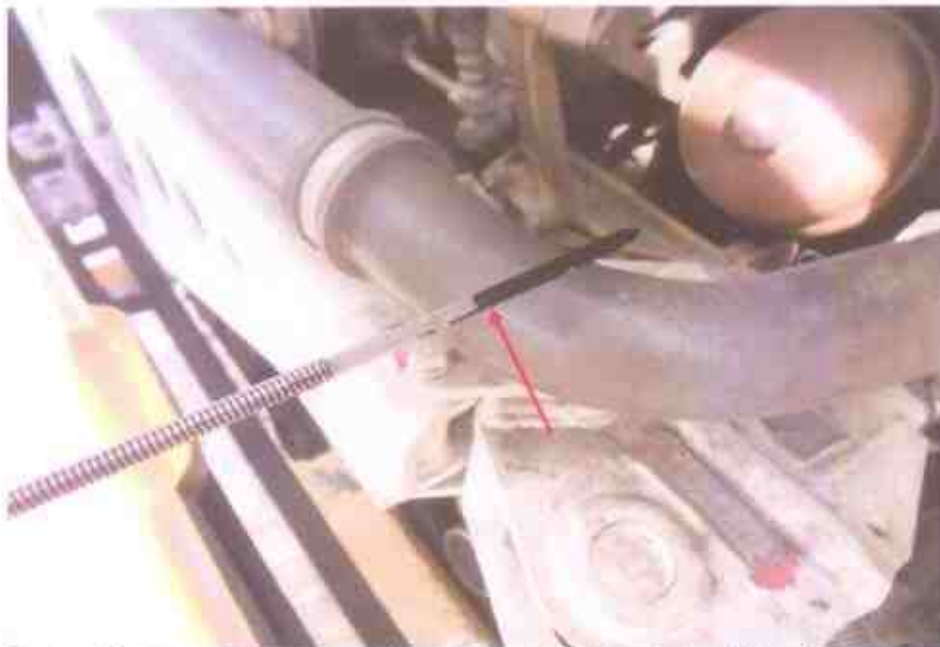
**Photo 16** shows the engine fluid on the dip stick of the Motor Bus. It was observed to be of sufficient level without any contamination at time of our inspection.

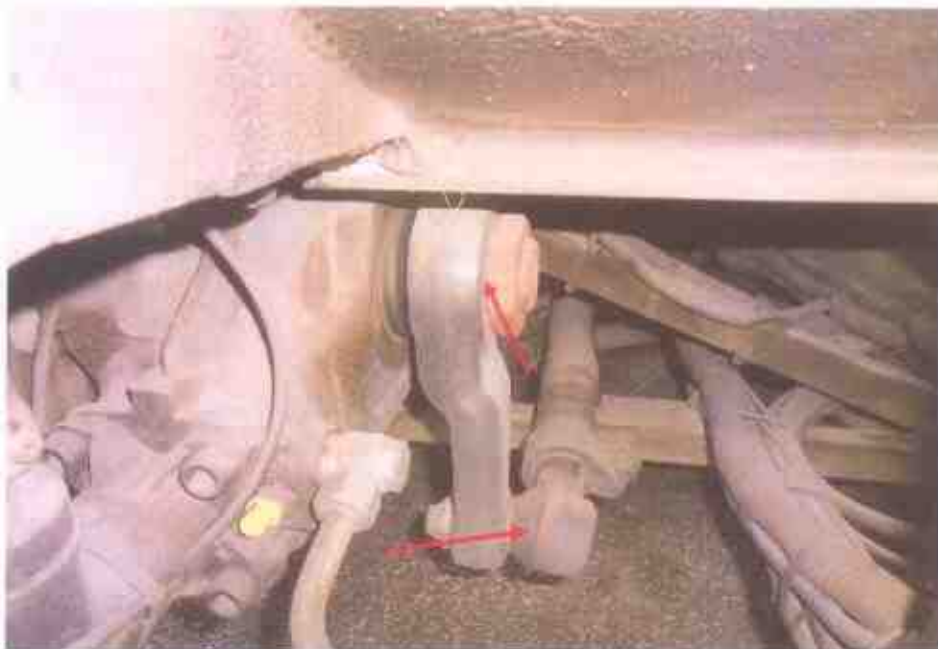
Photo 17 shows some of the mechanical components (arrowed) of the Motor Bus's steering system. Our visual check on the various mechanical components of the steering system revealed all to be intact and in good condition. The steering system of the Motor Bus likely to be in serviceable condition at the time of accident.

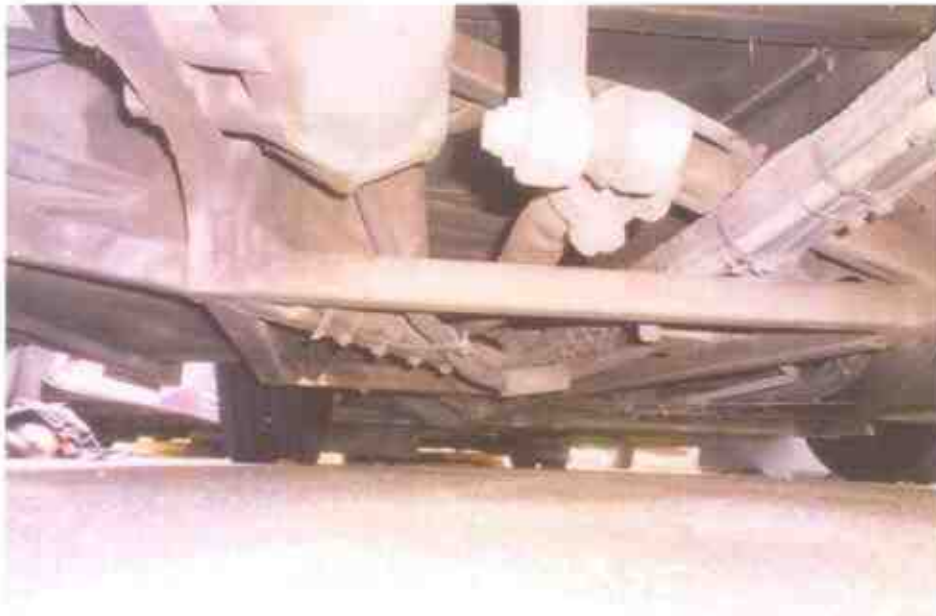
**Photo 18** shows the undercarriage components from front to rear steering system of the Motor Bus. The various undercarriage components of the Motor Bus were all observed to be intact and without any visible damage. This had included the transmission system of the Motor Bus, which were observed to be securely attached to the rear wheels.

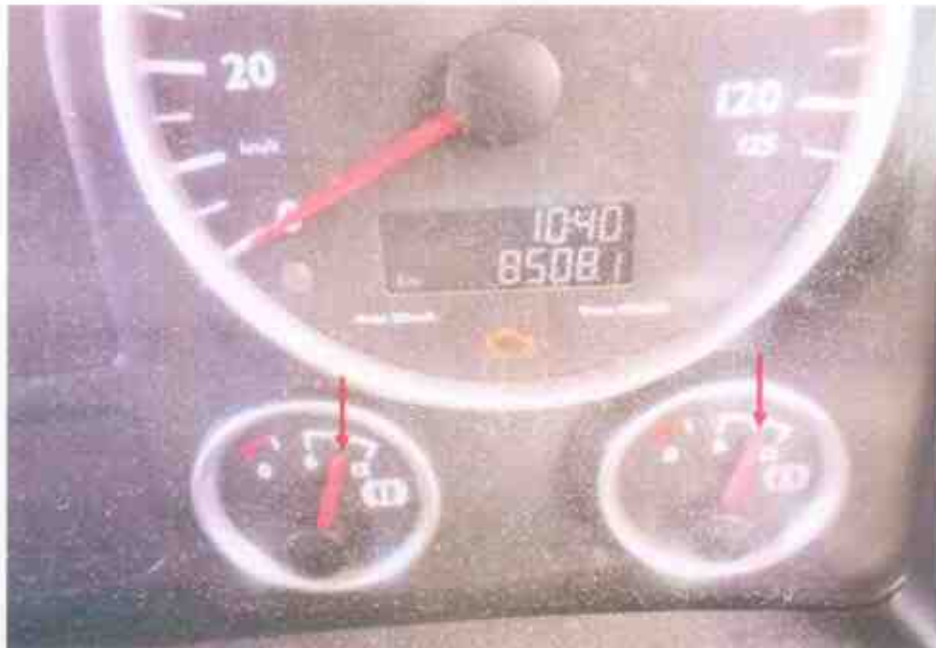
14. 2 numbers of air tanks in particular were observed to be also in serviceable condition. Air built up to the fullest level which is level 10 (On the display panel) for both air tanks for operational ready status after a warming up session prior the operational test. Both air tanks were monitored for about 10 minutes for an observation of any abnormalities. Both air tanks pressure found to be normal without any drop in pressure during the course of our monitoring session. This would indicate that there was no leak of air pressure from the air braking system of the Motor Bus. See photo 19 below.

Photo 19 shows pressure tank 1 & tank 2 were observed to be pressurised up to 10bars after the engine start-up. No drop in the pressure after a few minutes which means there's no air leakage from the air-braking system.

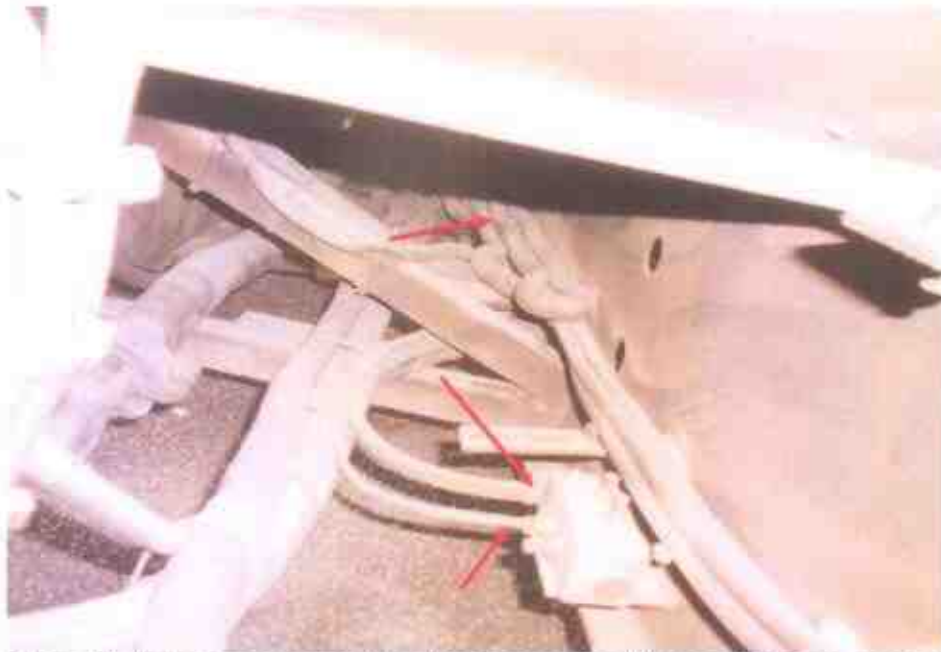
**Photo 20** shows a general view of the air pipes and hoses, which are some of the components for the air-assisted braking system of the Motor Bus. This was at the underside of the Motor Bus's body. There were no damages observed at time of our inspection.

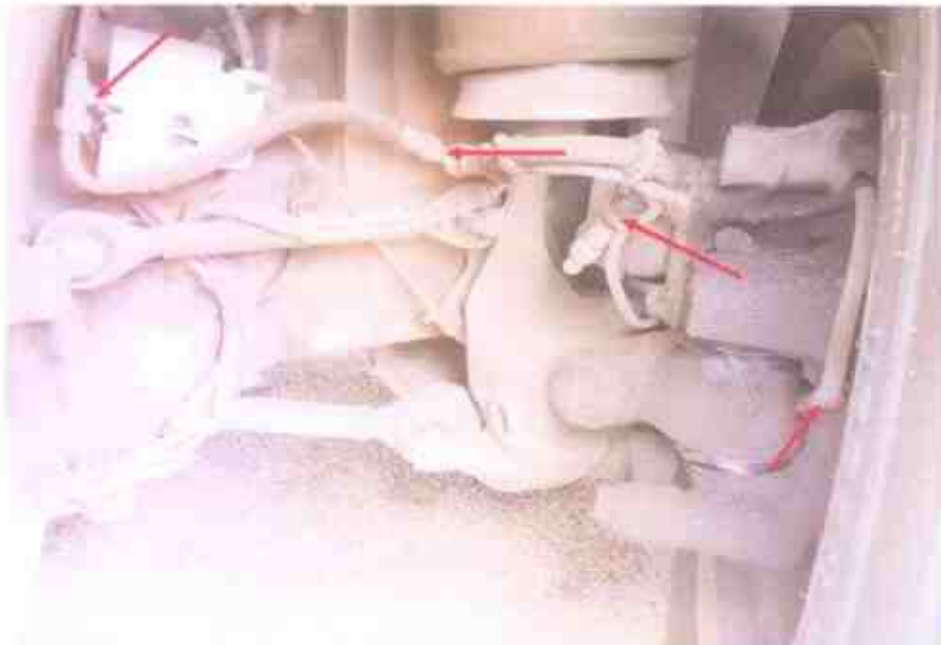
**Photo 21** shows some of the mechanical components (arrowed) of the Motor Bus's braking system. Our visual check on the various mechanical components revealed all to be intact and in good condition. It was in serviceable condition at the time of accident.

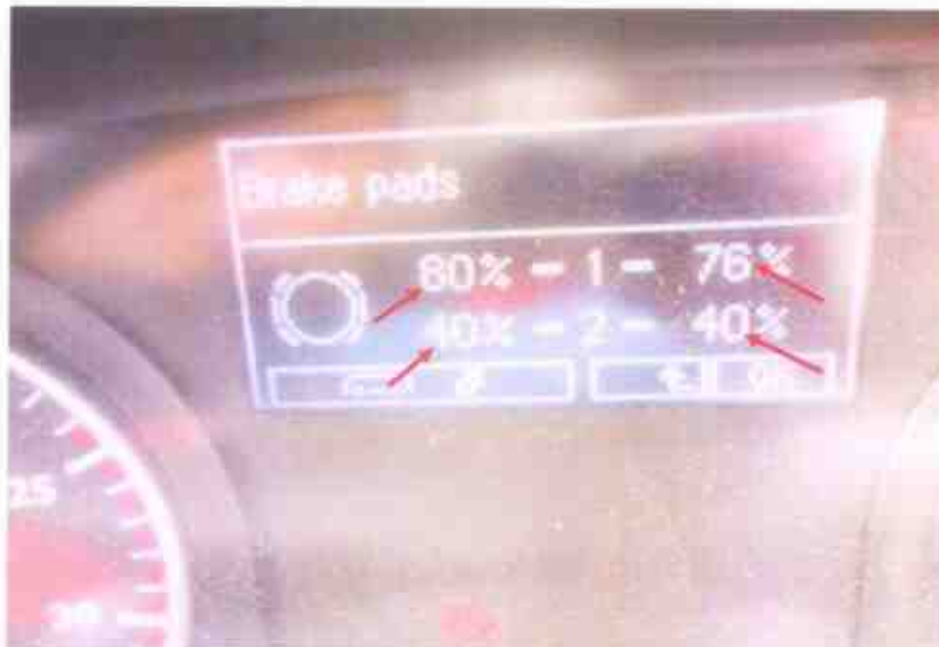
**Photo 22** shows the brake pad on the electronic indicator of the Motor Bus's braking system. It shows the material percentage of the brake pad which indicating an acceptable range on the frictional material prior the accident.

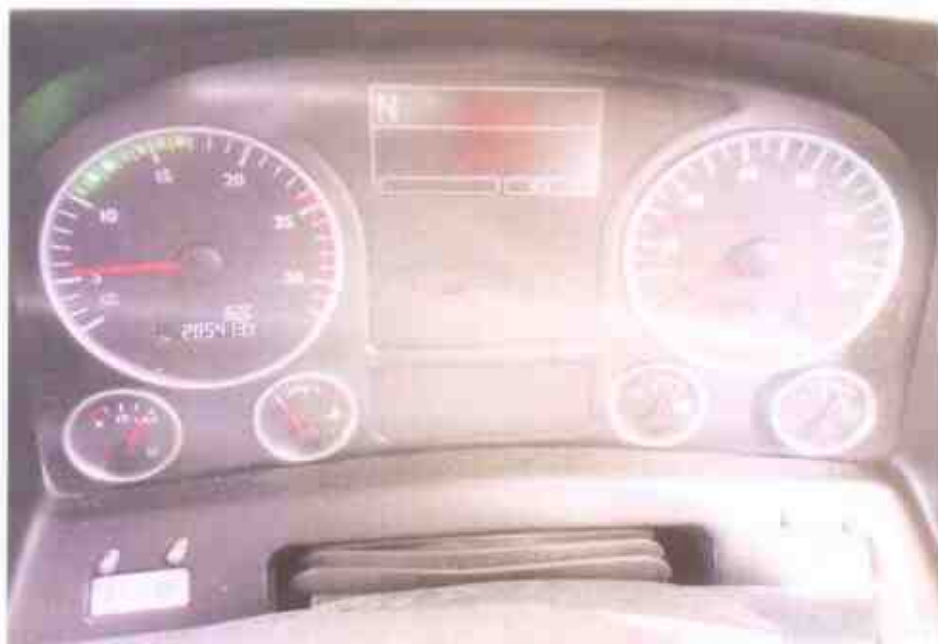
**Photo 24** shows the indicators at the driver's seat, these systems were in working condition. This can be established from the warning lights disappearing from the instrument panel after the self-test.

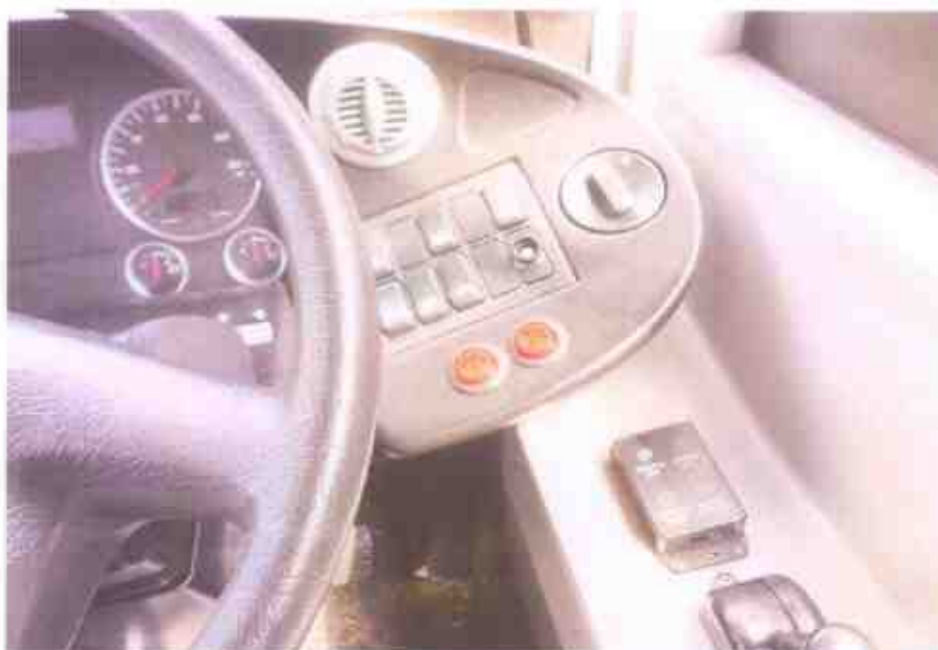
**Photo 25** shows the operational selectors at the driver's seat. It was observed to be unaffected by the accident's collision. Hence enabling an operational test to be conducted via activating the selectors.

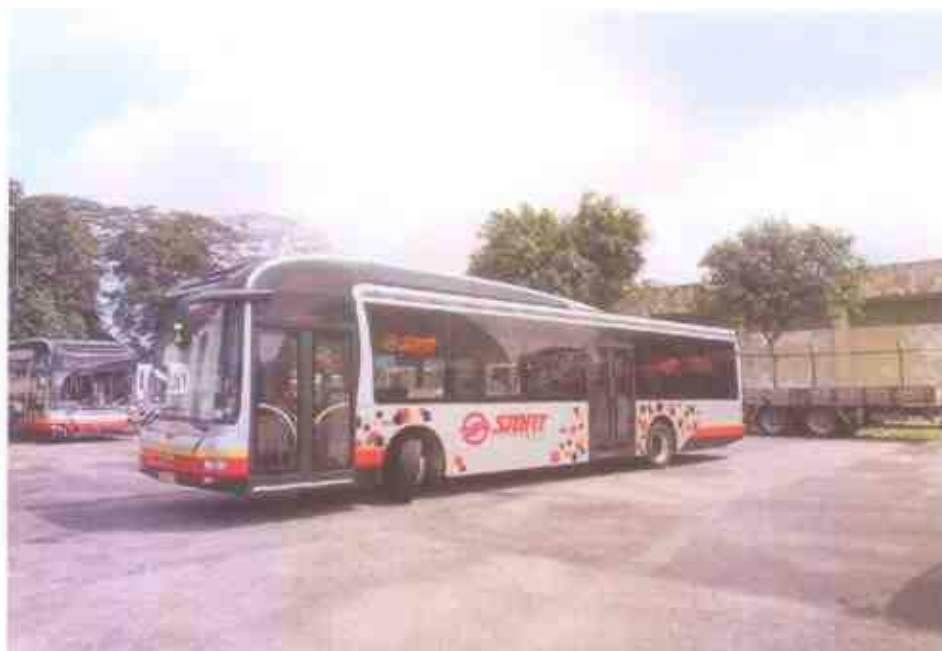
Photo 27 shows the operational test on the Motor Bus. SMRT driver were able to move the Motor Bus forward, backward, turning left & right & stopping without any abnormalities.
