Your Ref: TP/IP/28997/2018
Our Ref :CI/TPD18011353/Z

28th August 2018

MECHANICAL INSPECTION REPORT OF MOTORCYCLE JRK 2938

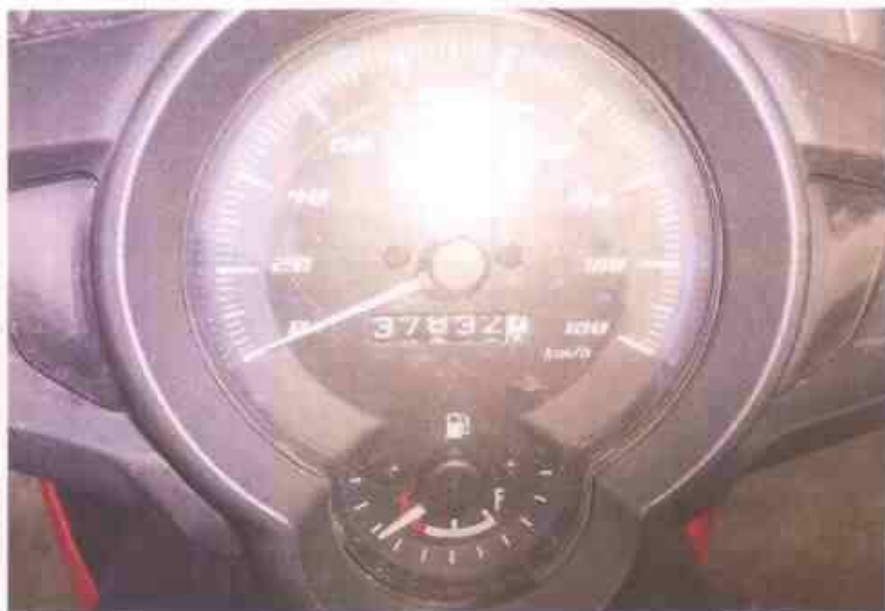
Photo 1 shows a close-up view of the mileage meter at time of our inspection. The mileage was recorded at 378327km.

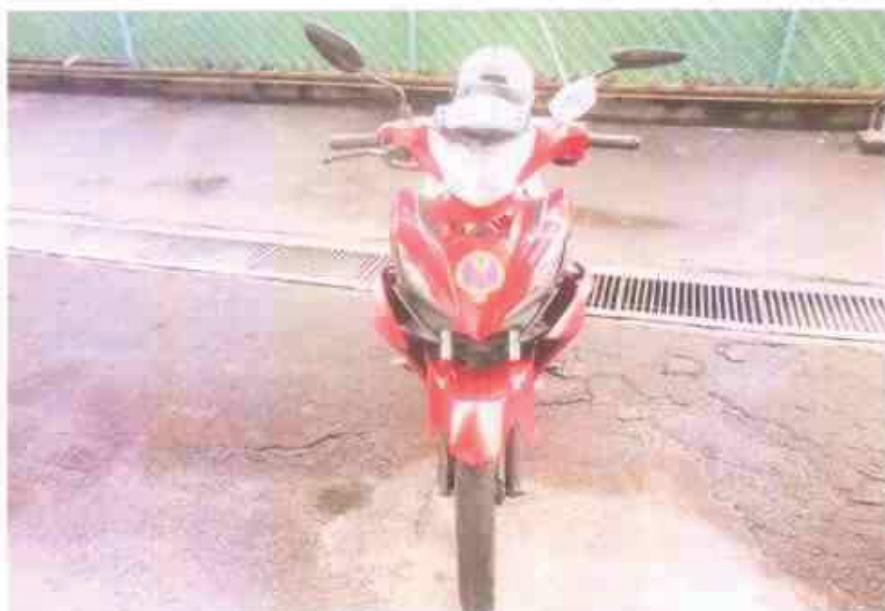
4. The mileage of the Motorcycle recorded at time of our inspection was 378327km.
5. The Motorcycle was observed to have sustained minor damages at the frontal portion. The body parts that were found to have been damaged include its front left & right hand side fairing and rear left signal lamp amongst others as a result of the accident.

Photo 2 shows a general view of the front body of the Motorcycle at the time of our inspection. The Motorcycle was observed to have sustained relatively minor damages at time of inspection. The damages were observed to be confined to its left & right side of the front fairing.

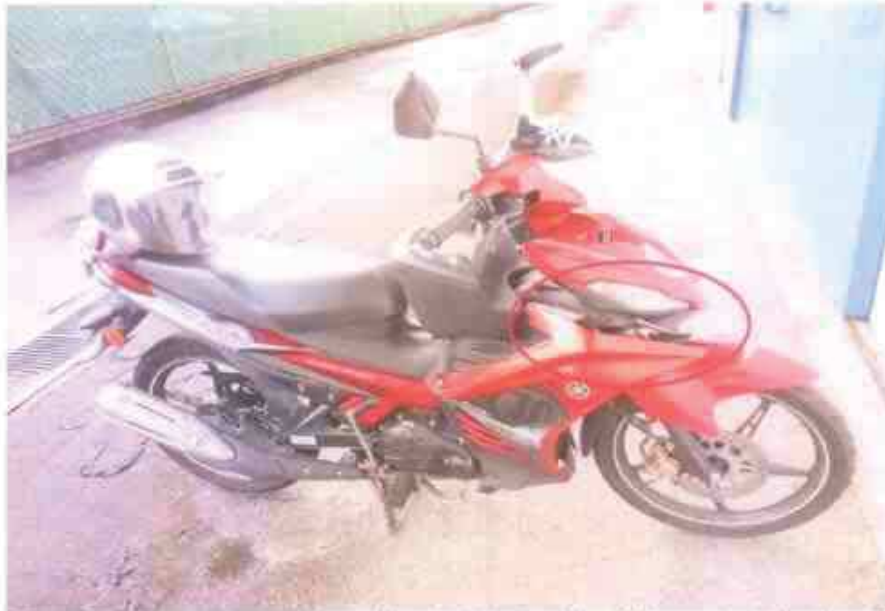
Photo 3 shows a general view of the right body of the Motorcycle at the time of our inspection. The Motorcycle was observed to have sustained relatively minor damages on the right side fairing at time of our inspection.

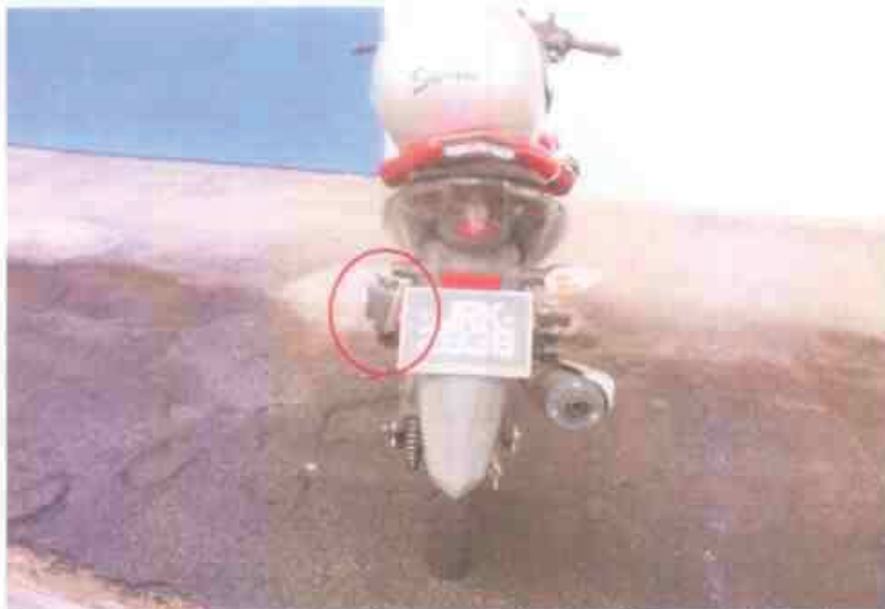
Photo 4 shows a general view of the rear body of the Motorcycle at the time of our inspection. The Motorcycle was observed to have sustained relatively minor damage on the left side signal lamp at time of our inspection.

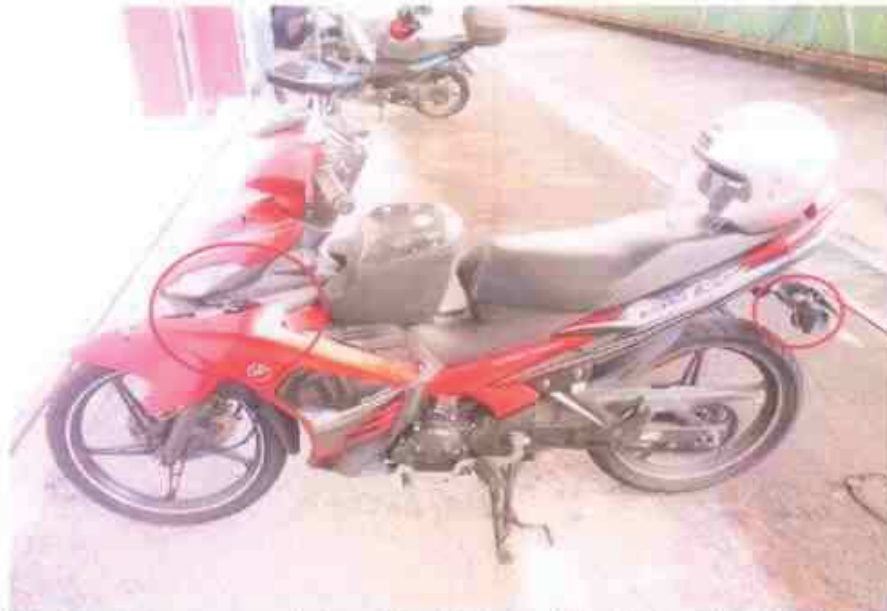
Photo 5 shows a general view of the left body of the Motorcycle at the time of our inspection. The Motorcycle was observed to have sustained relatively minor damages on the left side fairing at time of our inspection.

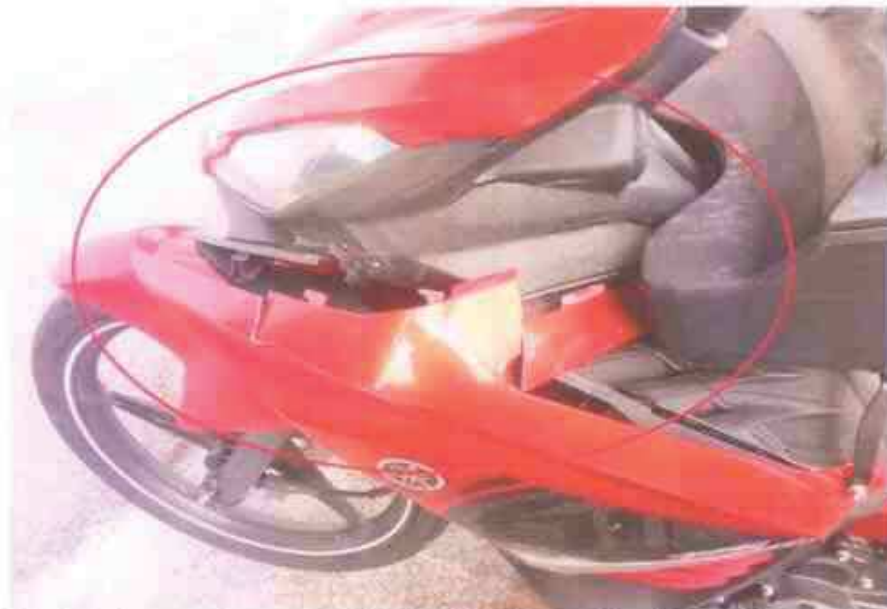
Photo 6 shows a closer view of the front left fairing of the Motorcycle at the time of our inspection. The Motorcycle was observed to have sustained with relatively minor damages due to the accident collision. (Circled)

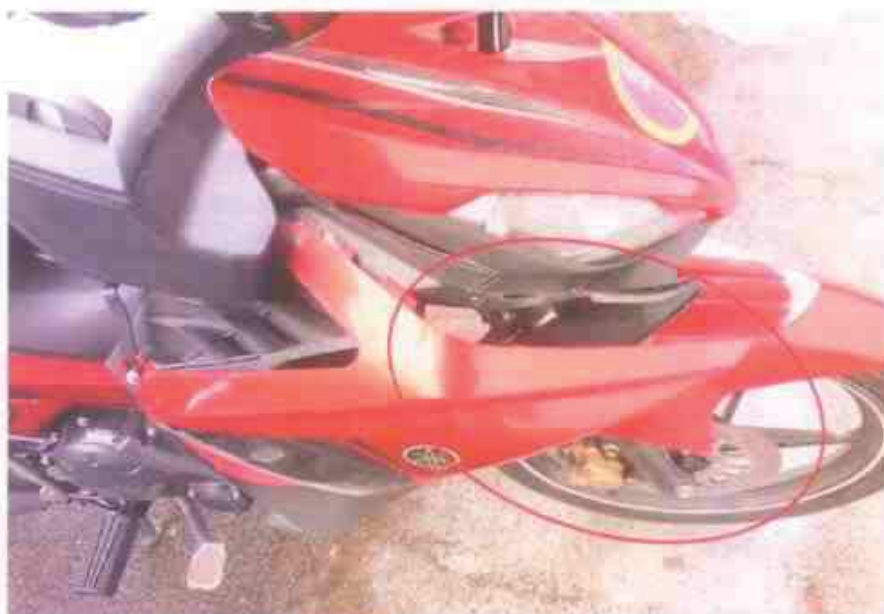
Photo 7 shows a closer view of the front right fairing of the Motorcycle at the time of our inspection. The Motorcycle was observed to have sustained with relatively minor damages due to the accident collision. (Circled)

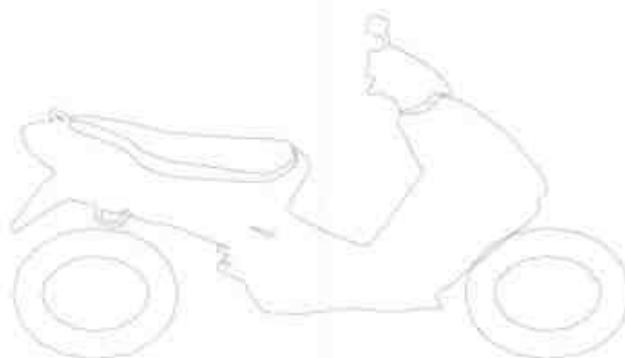
7. The condition of the Motorcycle's 2 tyres was observed to be in serviceable condition. The tread pattern of the 2 tyres was clearly visible. We did not observe any tear, burst mark(s) and/or punctured hole(s) on the sidewalls as well as across the tread of the 2 tyres. The 2 tyres were both observed to be sufficiently inflated for vehicular operation. The tyre brand, tyre size and remaining tread depth of the 2 tyres were recorded as follows:-

Maxxis Diamond MA-3D
90/80 - R17 (4mm)

Vee Rubber
70/90 - R17 (3mm)

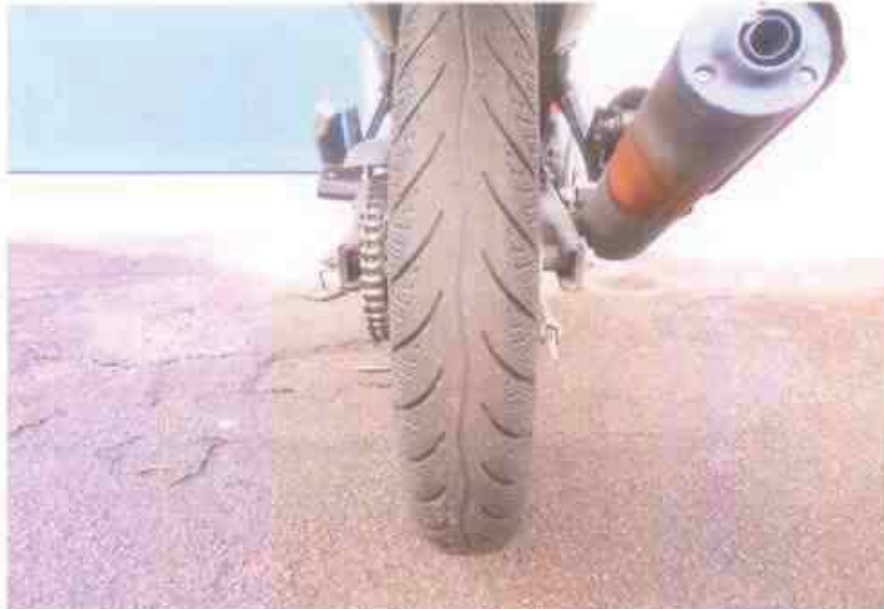
Photo 8 shows the rear tyre of the Motorcycle. The rear tyre was observed to be in serviceable condition with remaining tread depth of approximately 4mm. The tyre was also observed to be sufficiently inflated for vehicular operation.

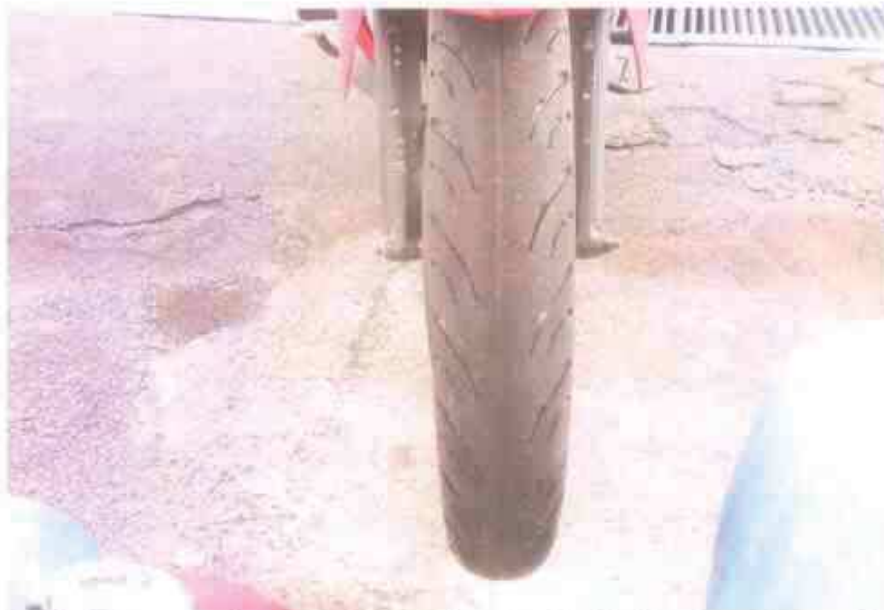
Photo 9 shows the front tyre of the Motorcycle. The front tyre was observed to be in serviceable condition with remaining tread depth of approximately 3mm. The tyre was also observed to be sufficiently inflated for vehicular operation.

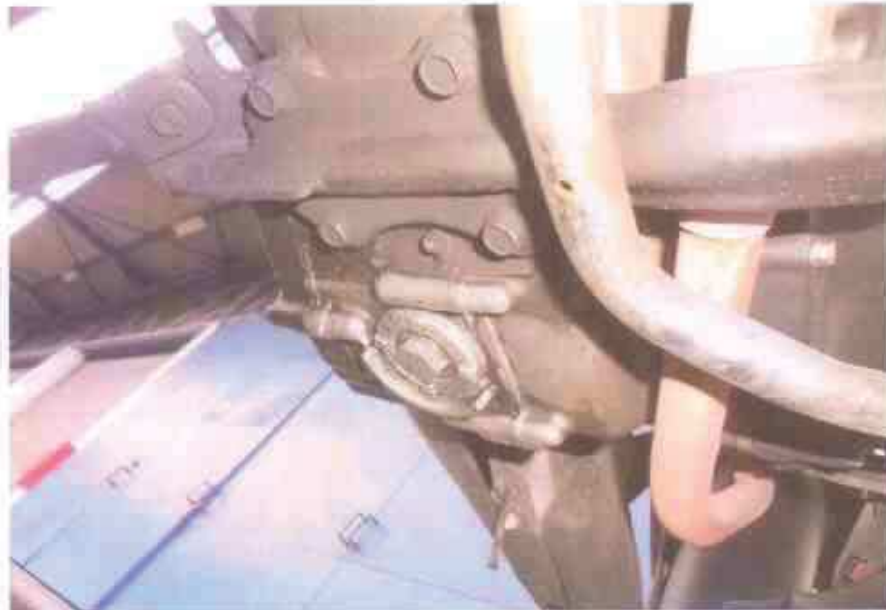
Photo 10 shows no sign(s) or indication(s) of fluid leak observed around the underside of the engine area of the Motorcycle.

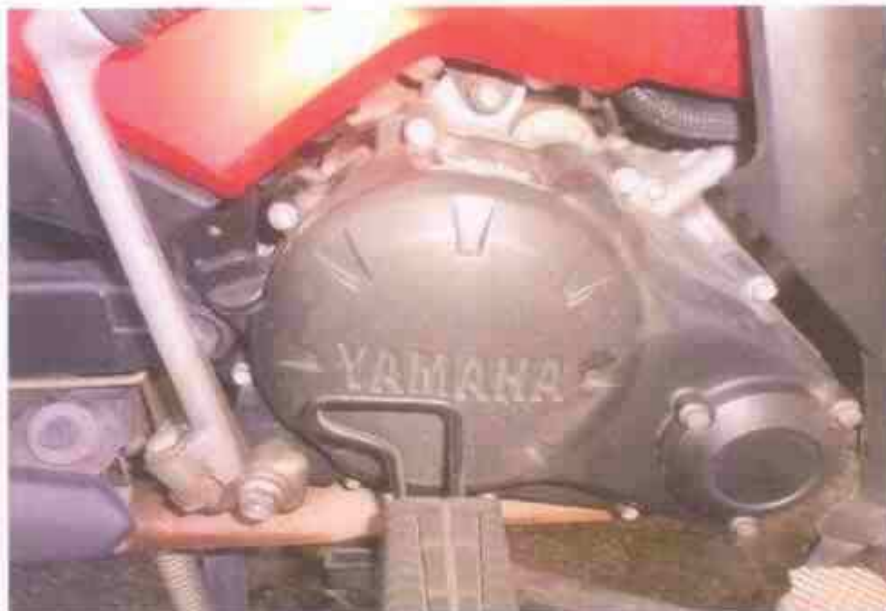
Photo 11 shows no sign(s) or indication(s) of fluid leakage stain observed around the engine area of the Motorcycle.

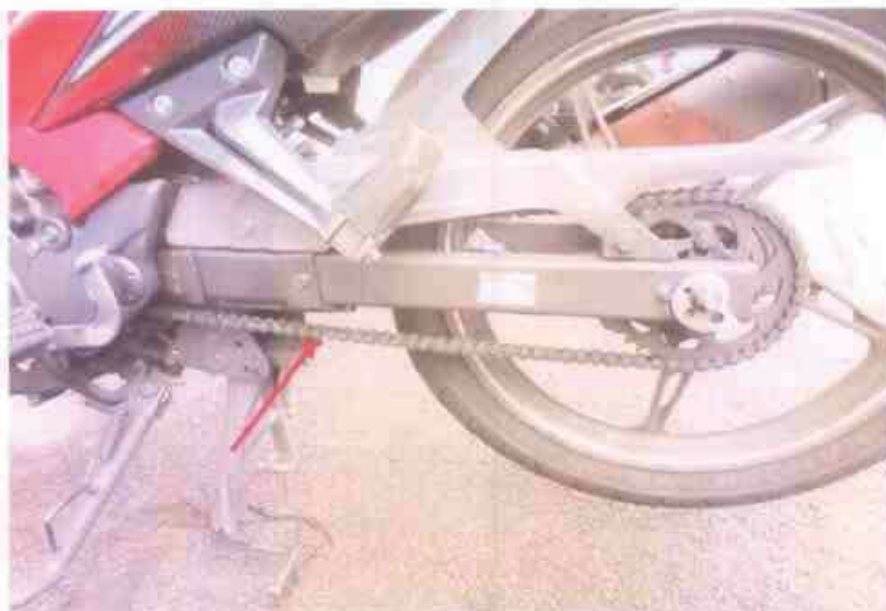
Photo 12 shows the general view of the gear train (arrowed) of the Motorcycle, which was observed to be intact with no misalignment. It was also adequately lubricated for operating purposes.

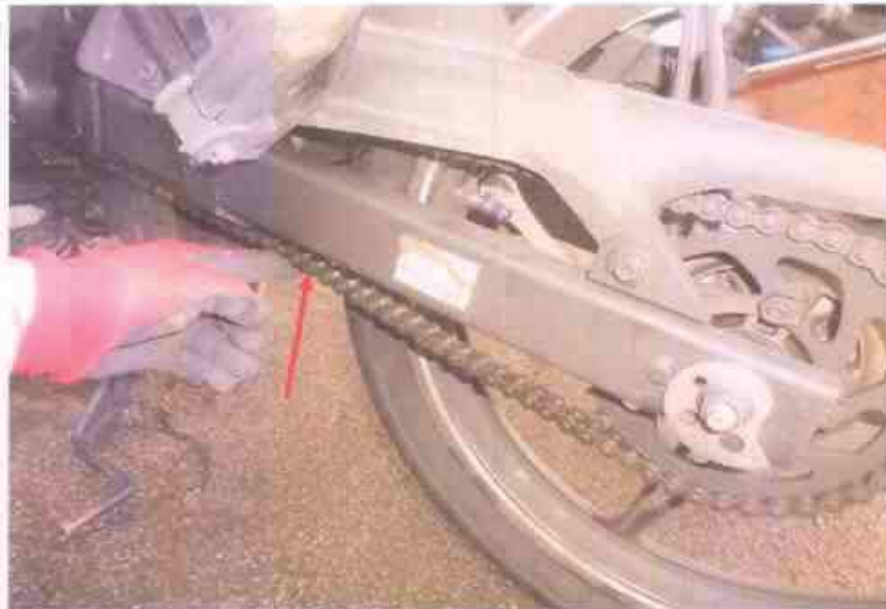
Photo 13 shows the general view of the gear train (arrowed) of the Motorcycle, which was observed to be intact with no misalignment. It was also adequately lubricated for operating purposes. Free play tension was also observed & found adequately acceptable.

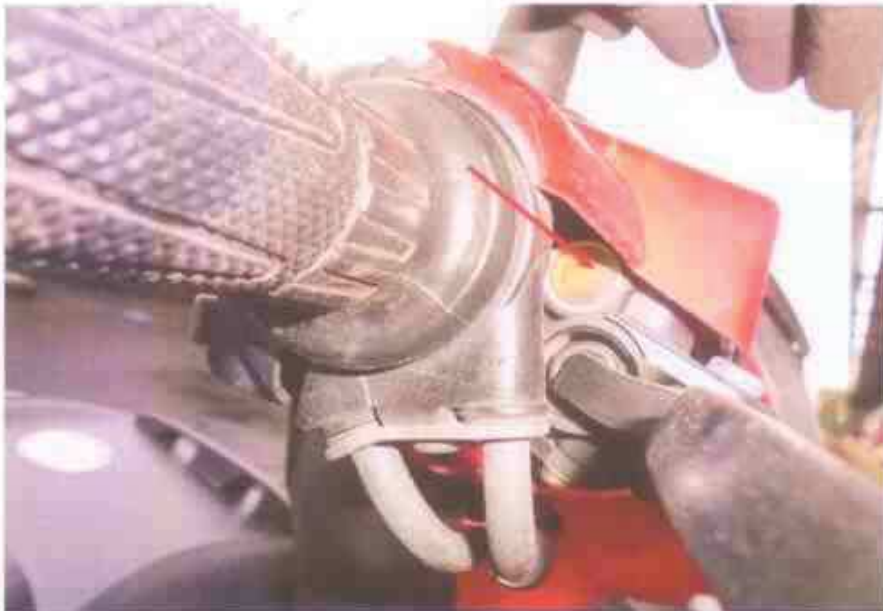
Photo 14 shows our checks on the brake fluid (front) reservoir had also indicated that the brake fluid was of sufficient level for operational purposes, and without contamination.

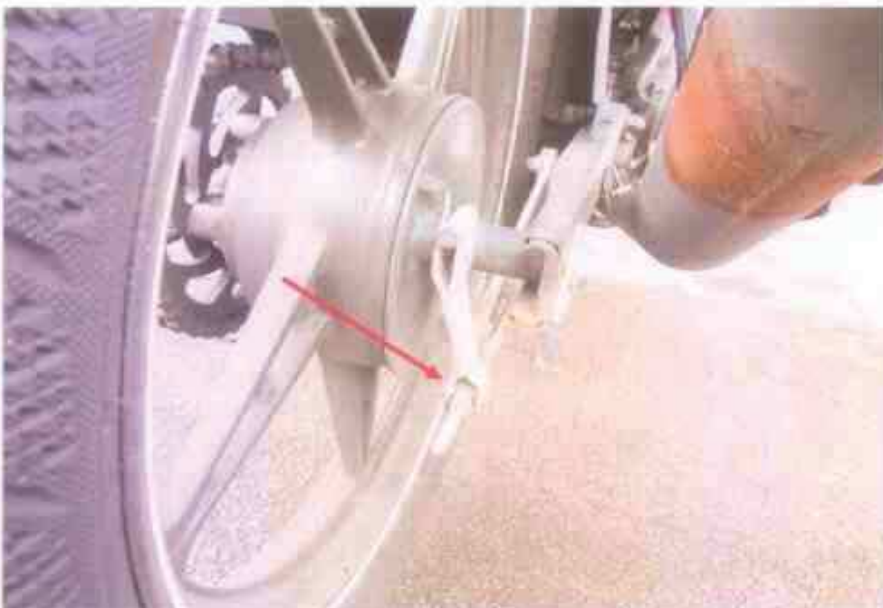
Photo 15 shows our checks on the brake fluid (rear) reservoir had also indicated that the brake fluid was of sufficient level for operational purposes, and without contamination.

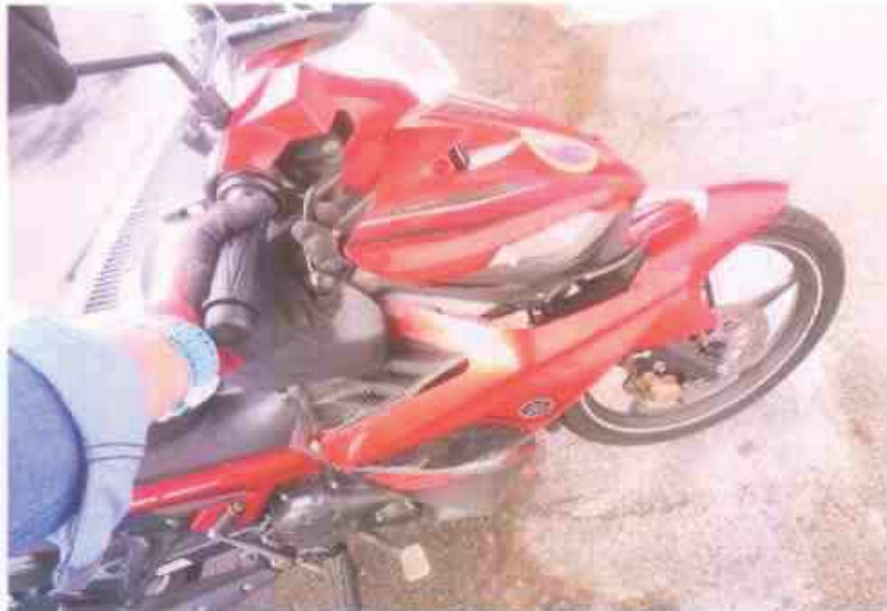
Photo 16 shows testing of the braking of the front brake in progress. There was some resistance felt (spongy like feel) upon pressing the brake lever.

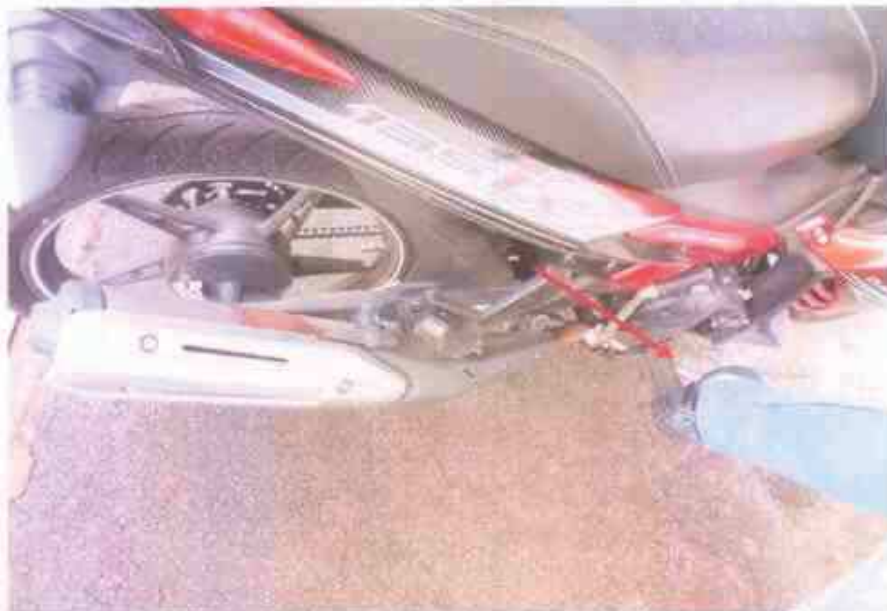
Photo 17 shows testing of the braking of the rear brake in progress. There was some resistance felt (spongy like feel) upon stepping on the brake pedal.

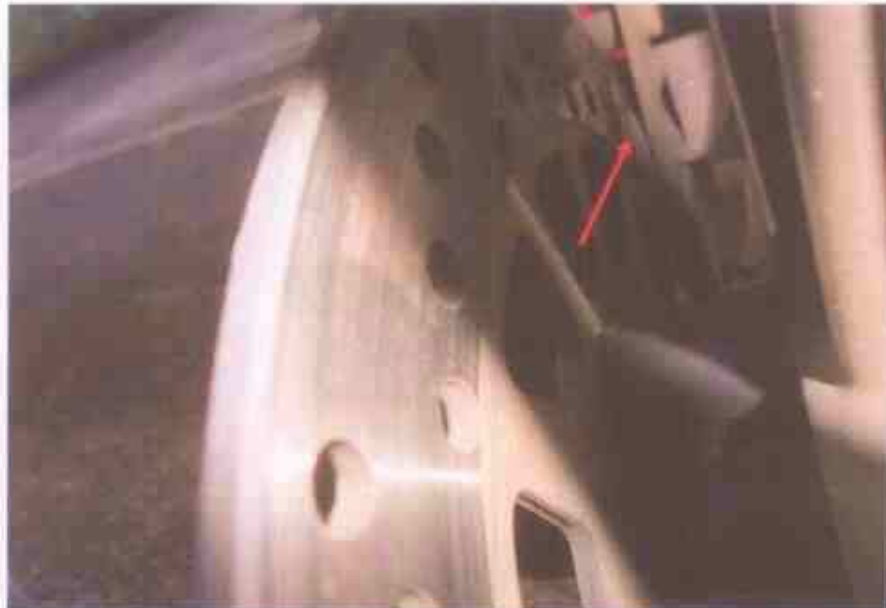
Photo 18 shows the front brake pad at time of our inspection. The frictional material was observed to be sufficient for operational purposes.
