Your Ref: TP/IP/30413/2018
Our Ref :CI/TPD18011354/Z

27th August 2018

MECHANICAL INSPECTION REPORT OF MOTORCYCLE FBD 9969B

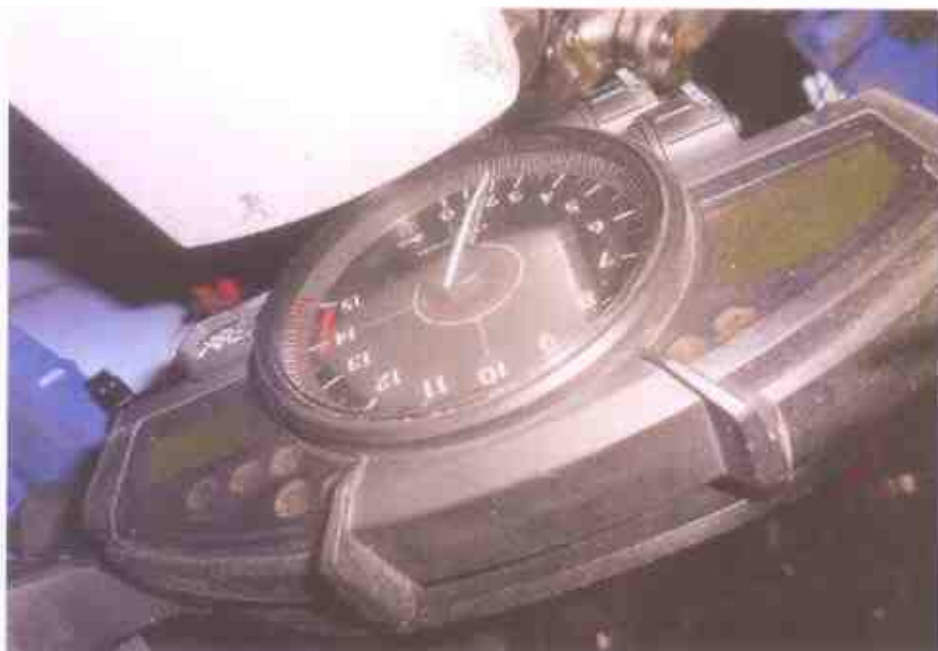
4. The mileage of the Motorcycle was not recorded at time of inspection due to the severe damages to the ignition system as a result of the accident.
5. The Motorcycle was observed to have sustained severe damages at the frontal portion, rear portion & along both its left side and right side. The body parts that were found to have been damaged includes its missing front head lamp, ERP unit & bracket, handle bar, front wing mirrors, seat assembly, fuel tank and rear portion amongst others. Its front forks assemblies were also observed to be dislodged as a result of the accident.

Photo 1 shows the speedo meter of the Motorcycle. The mileage was not recorded at time of inspection due to the severe damages to the ignition system as a result of the accident.

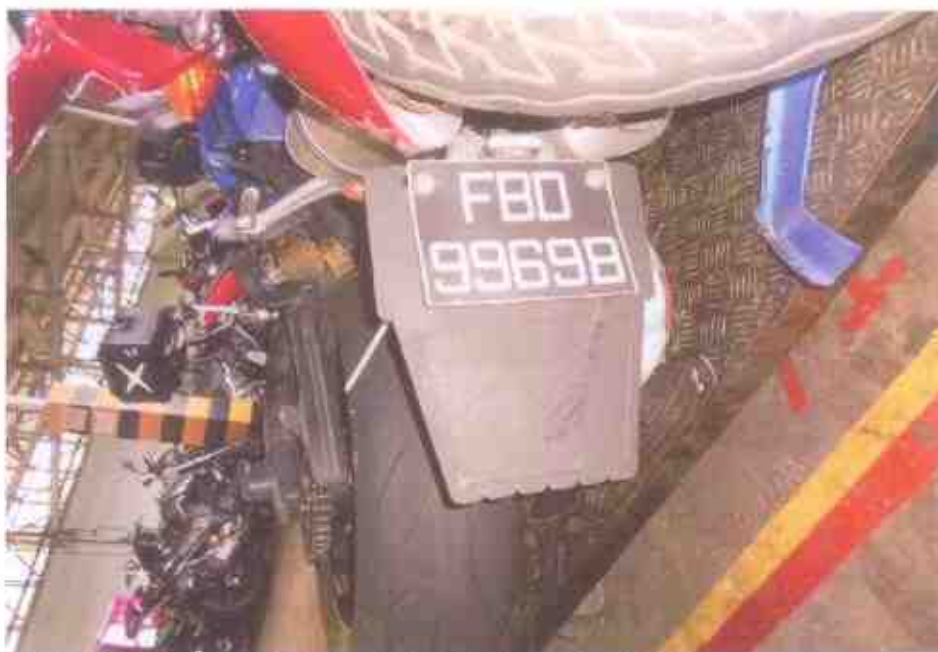
Photo 2 shows the Motorcycle number plate for identification.

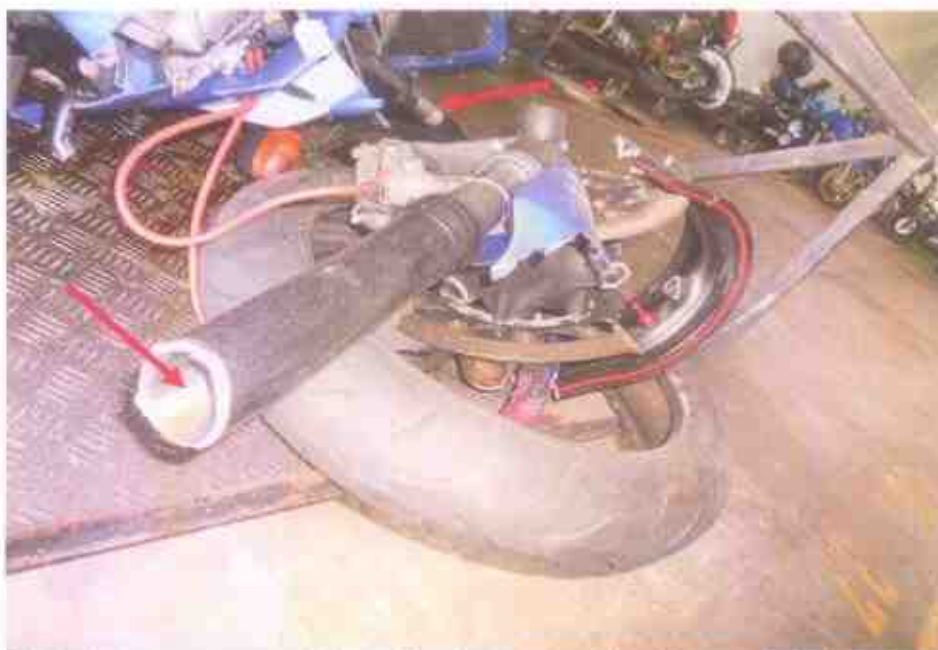
Photo 3 shows a general view of the front body of the Motorcycle at the time of our inspection. The Motorcycle was observed to have sustained with relatively extensive impact due to the accident collision. Amongst the body parts damaged was its front fork (arrowed), which was observed to be dislodged from the Motorcycle body.

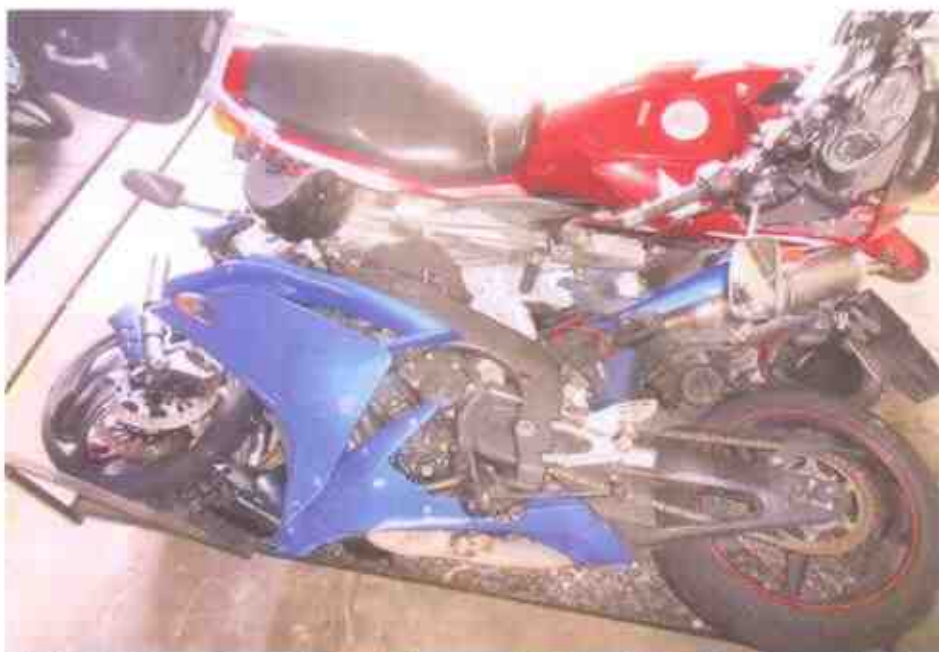
Photo 4 shows a general view of the rear left body of the Motorcycle at the time of our inspection. The Motorcycle was observed to have sustained damages at the frontal portion, rear portion, along both its left side and right side.

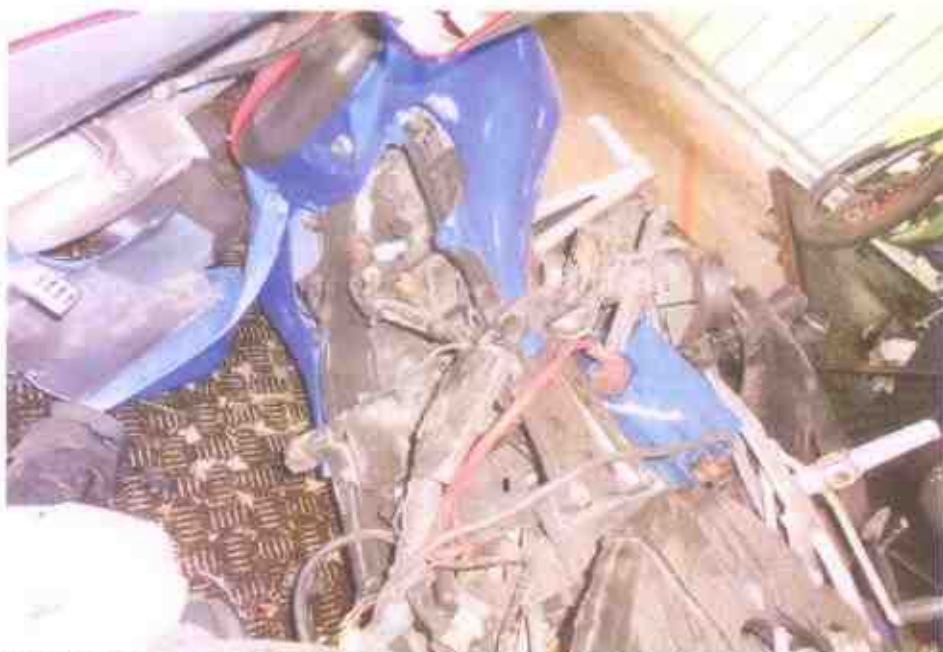
Photo 5 shows a general view of the Motorcycle at the time of our inspection. The Motorcycle was observed to have sustained relatively extensive impact due to the accident collision.

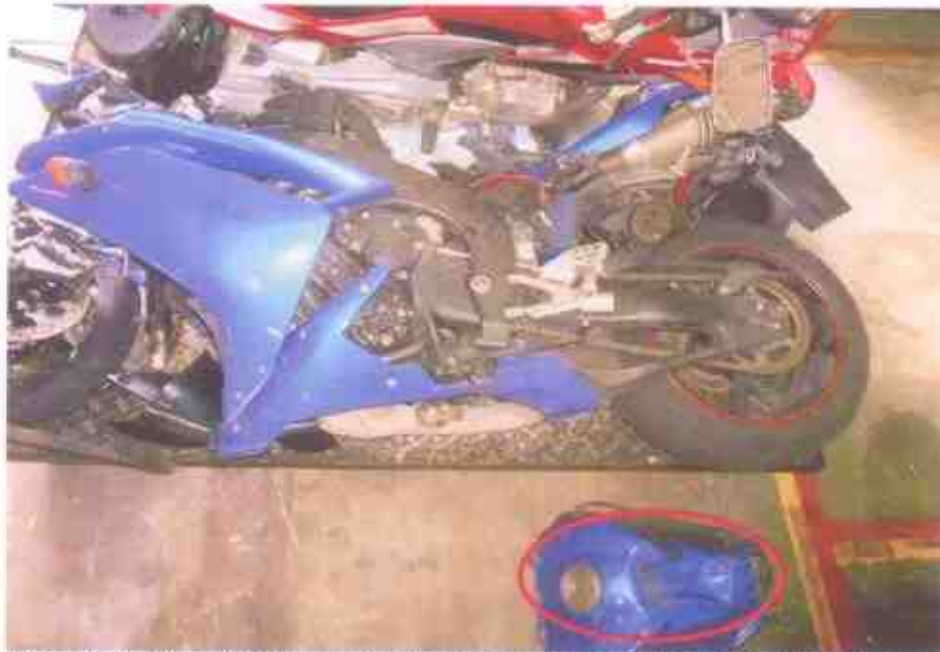
Photo 6 shows a close-up view of the frontal portion of the Motorcycle at the time of our inspection. The Motorcycle was observed to have sustained relatively extensive impact including damages to the fuel tank due to the accident collision.

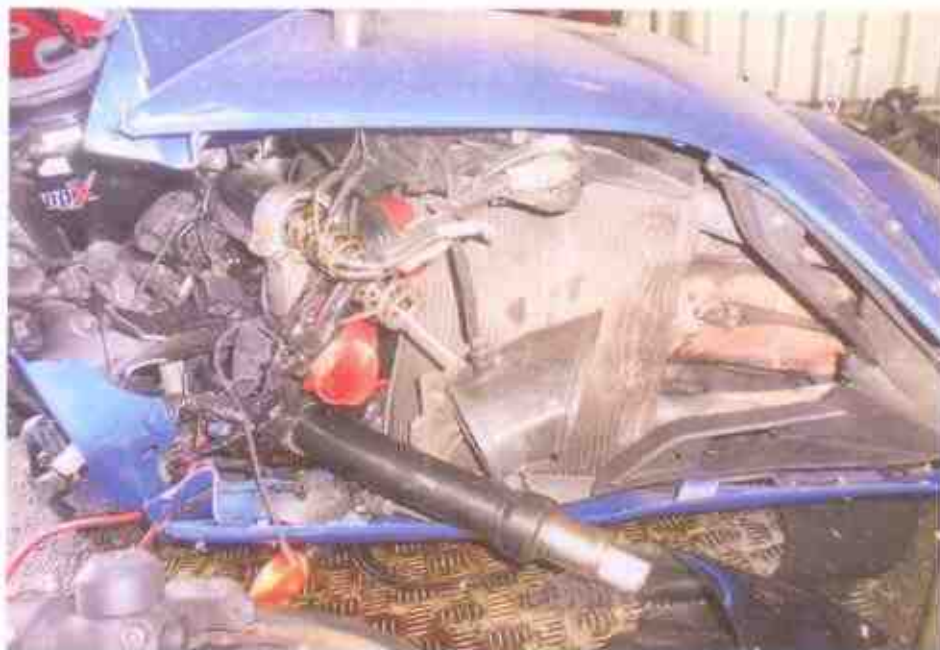
Photo 7 shows a close-up view of the front portion of the Motorcycle at the time of our inspection. The Motorcycle engine components such as radiator, front fork & other components were observed to have sustained relatively extensive impact due to the accident collision.

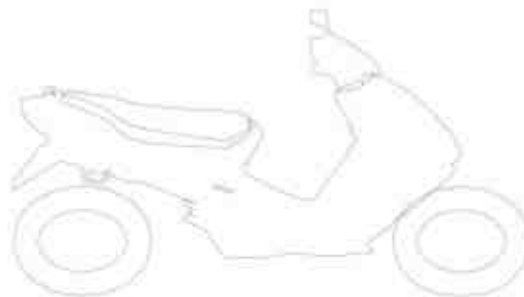
Bridgestone Battlax HyperSport
190/55 ZR 17(3mm)

Bridgestone Battlax HyperSport
120/70 ZR 17(4mm)

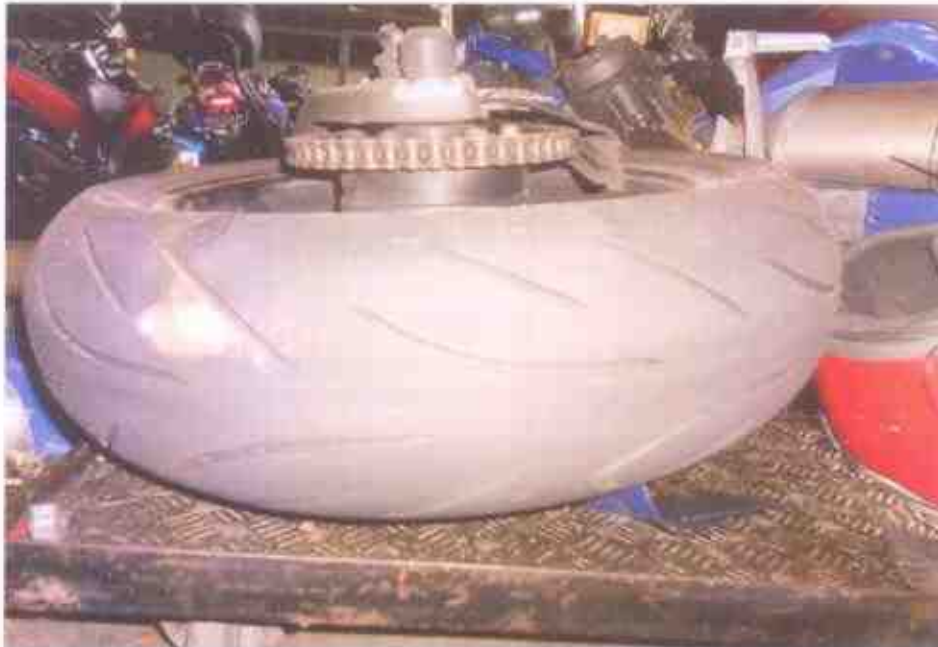
Photo 8 shows the rear tyre of the Motorcycle at the time of our inspection. The rear tyre was observed to be in serviceable condition with remaining tread depth of approximately 3mm. The tyre was also observed to be sufficiently inflated for vehicular operation. There was no significant damage observed on the rear wheel rim & tyre.

19. The condition of the Motorcycle's rear tyre was observed to be in serviceable condition. The tread pattern of the rear tyre was clearly visible. We did not observe any tear, burst mark(s) and/or punctured hole(s) on the sidewalls as well as across the tread of the rear tyre. Its tread depth was measured & found to be around approximately 3mm.

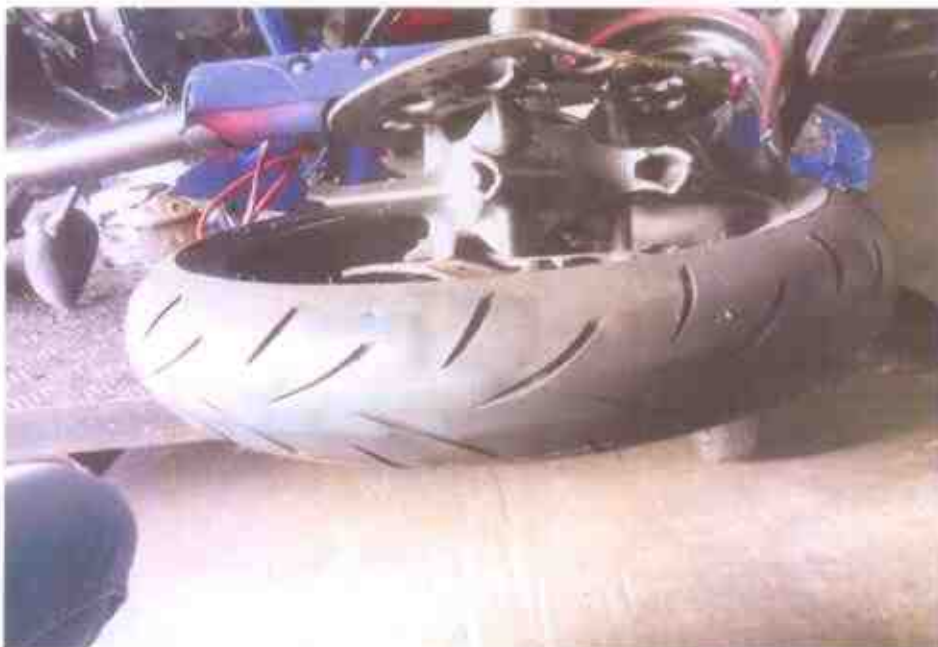
Photo 9 shows the front tyre of the Motorcycle and the tread pattern was clearly visible. There was no tear, burst mark(s) and/or punctured hole(s) on the sidewalls as well as across the tread of the front tyre with remaining tread depth of approximately 4mm. However, the wheel rim was observed to be broken & the tyre was dislodged from the wheel rim as a result of the accident.

20. As for the front tyre, it was found to be dislodged from the wheel rim due to the cracked wheel rim as a result of the accident's collision. However, the tread pattern of the front tyre was clearly visible with tread depth of 4mm. We did not observe any tear, burst mark(s) and/or punctured hole(s) on the sidewalls as well as across the tread of the front tyre.

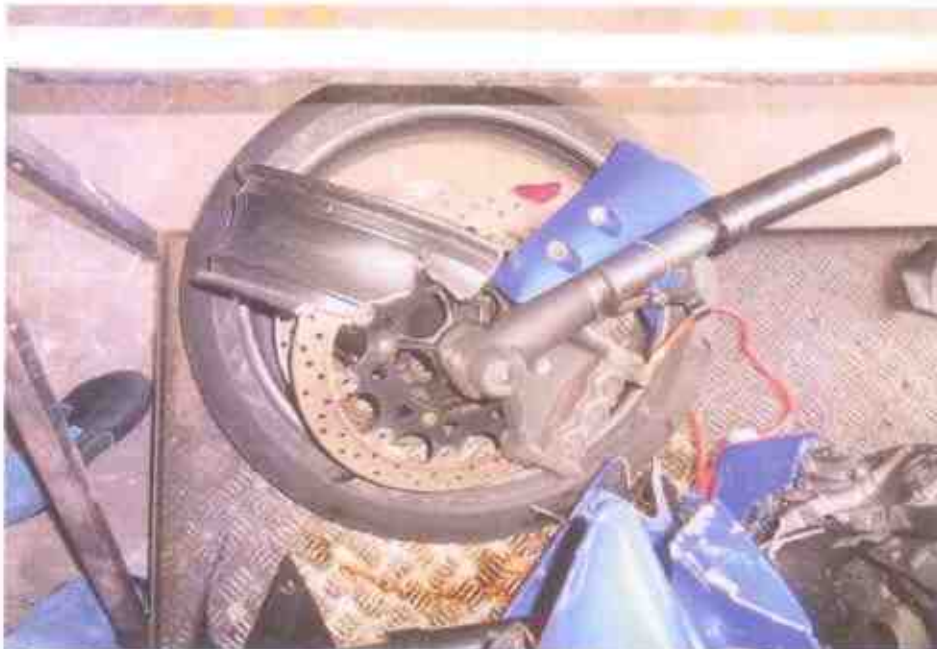
Photo 10 shows the cracked wheel rim on front tyre of the Motorcycle at the time of our inspection.

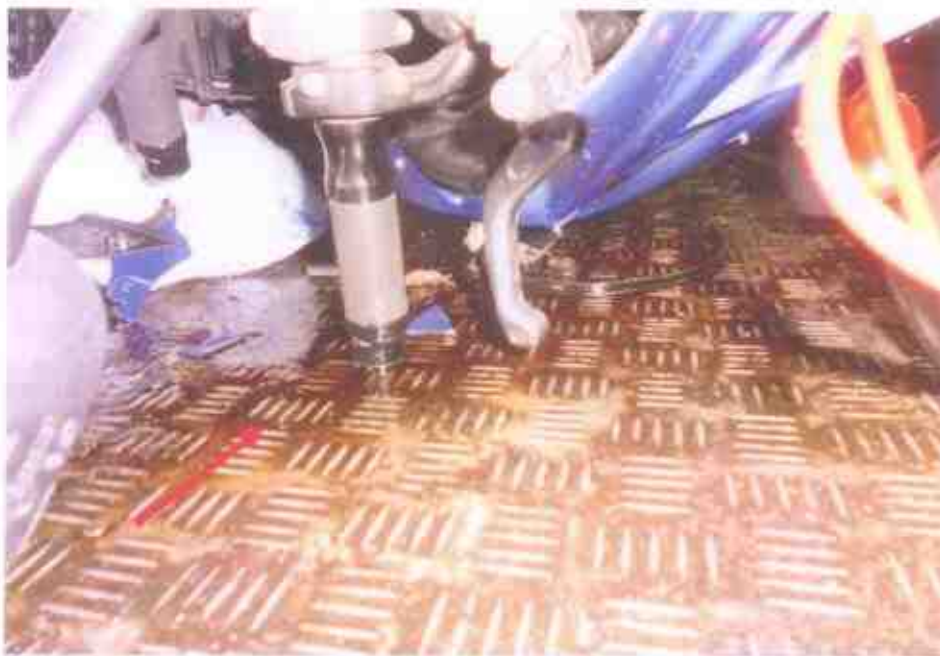
Photo 11 shows sign(s) or indication(s) of fluid leakage observed on the floor around the engine's underside area of the Motorcycle.

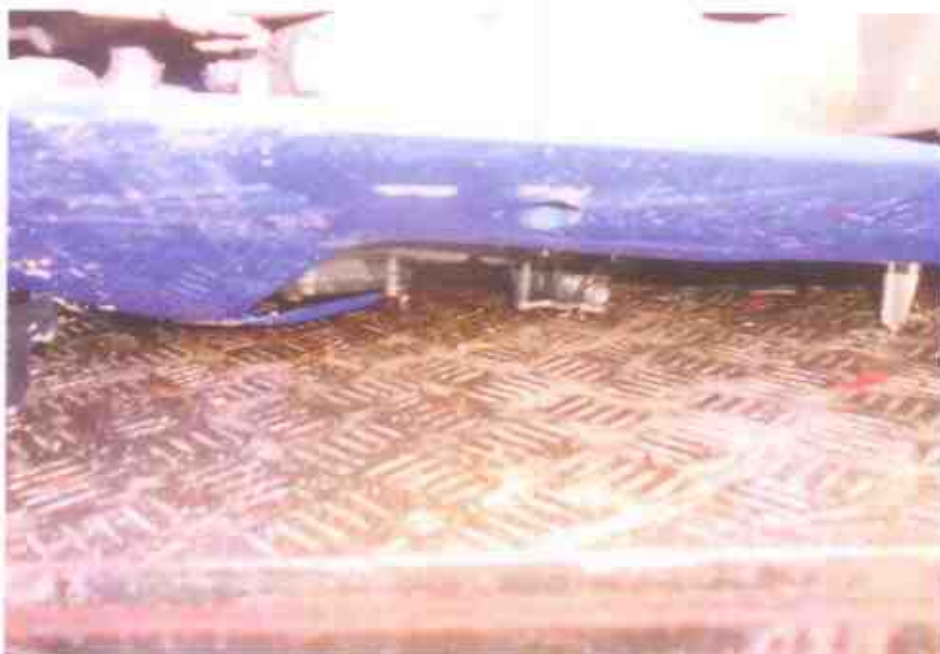
Photo 12 shows sign(s) or indication(s) of fluid leakage observed on the floor around the engine's area of the Motorcycle.

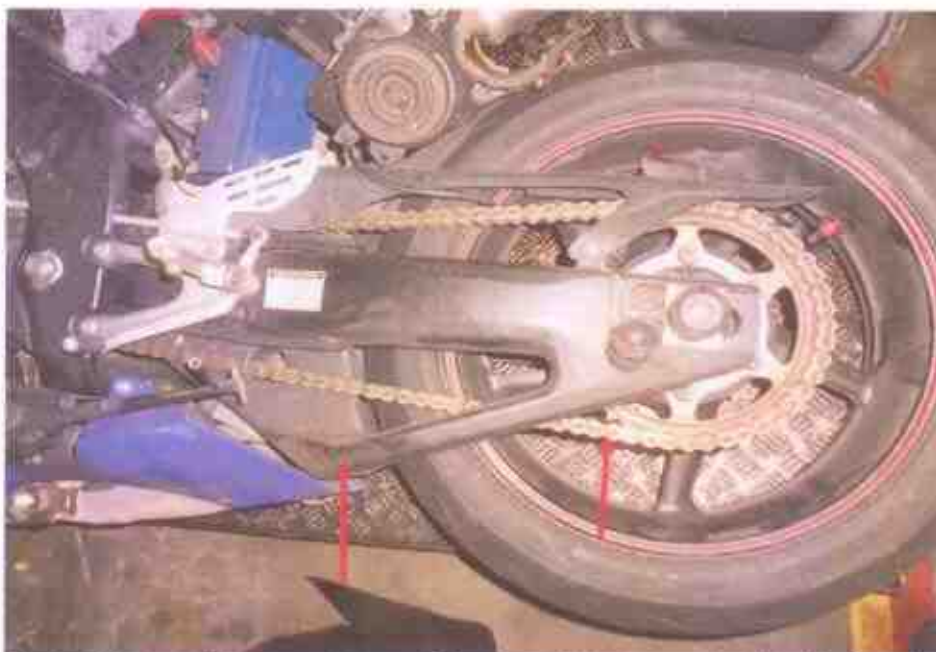
Photo 13 shows the general view of the gear train (arrowed) of the Motorcycle, which was observed to be intact with no misalignment. It was also adequately lubricated for operating purposes.

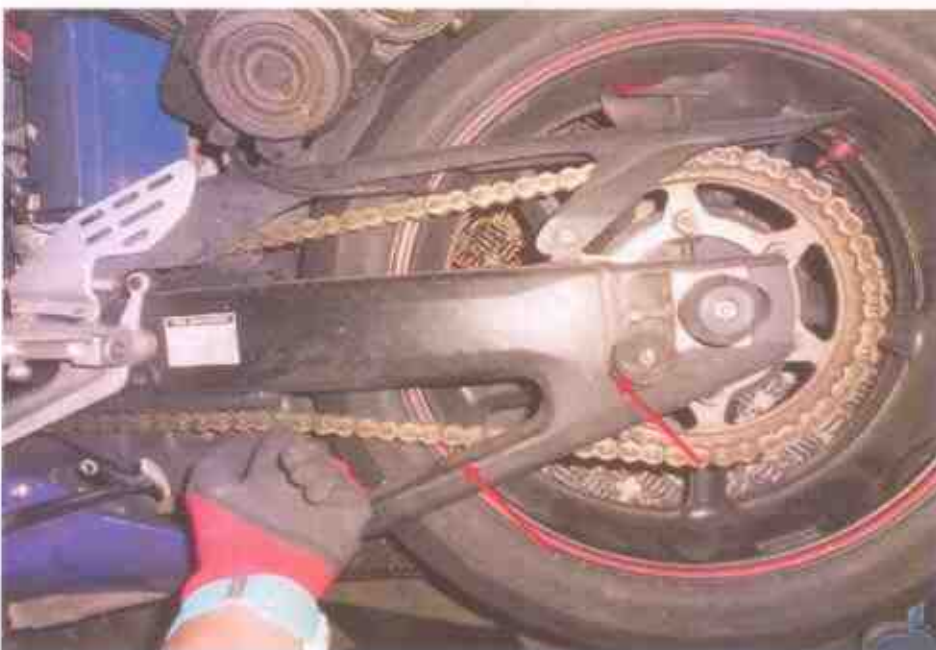
Photo 14 shows the general view of the gear train (arrowed) of the Motorcycle, which was observed to be intact with no misalignment. It was also adequately lubricated for operating purposes.

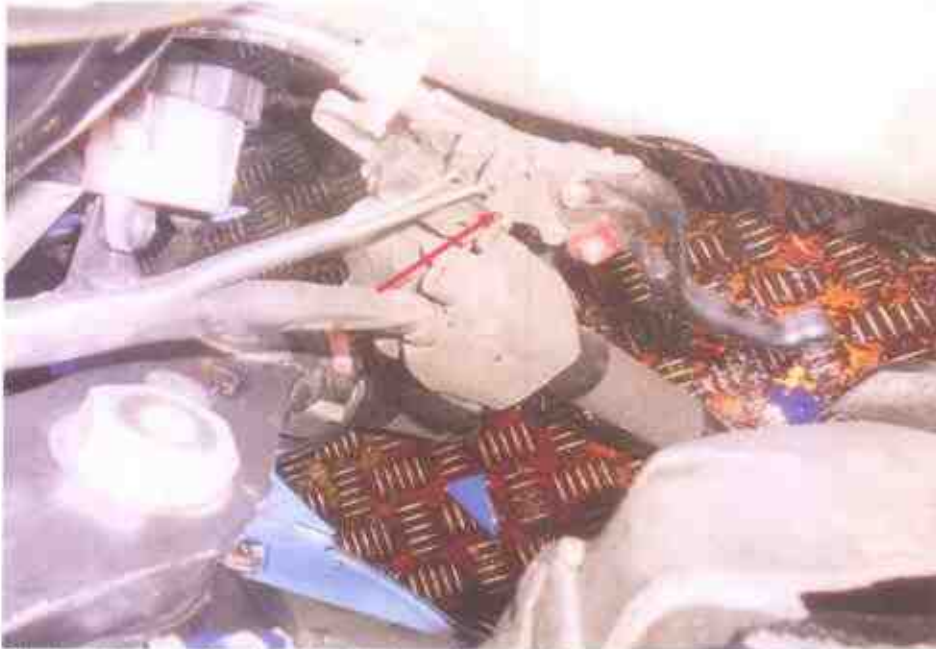
Photo 15 shows the hand brake lever (arrowed) was observed to be broken due to the result of the accident. Hence, we are unable to conduct any tests on the braking system of the Motorcycle.

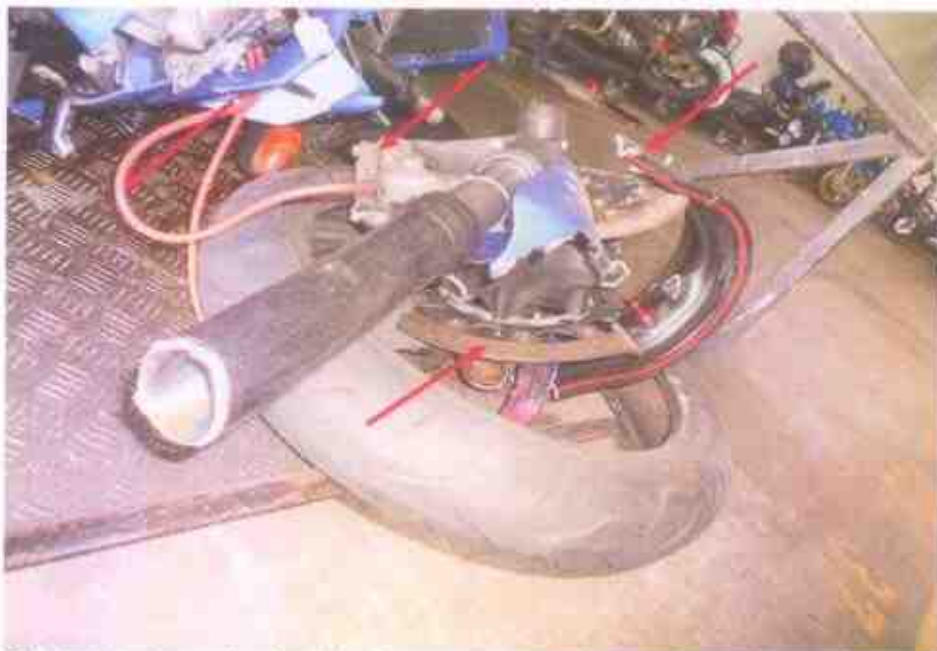
Photo 16 shows the front brake components (arrowed) was observed to be crushed as a result of the accident. Hence, we are unable to conduct any tests on the braking system of the Motorcycle.

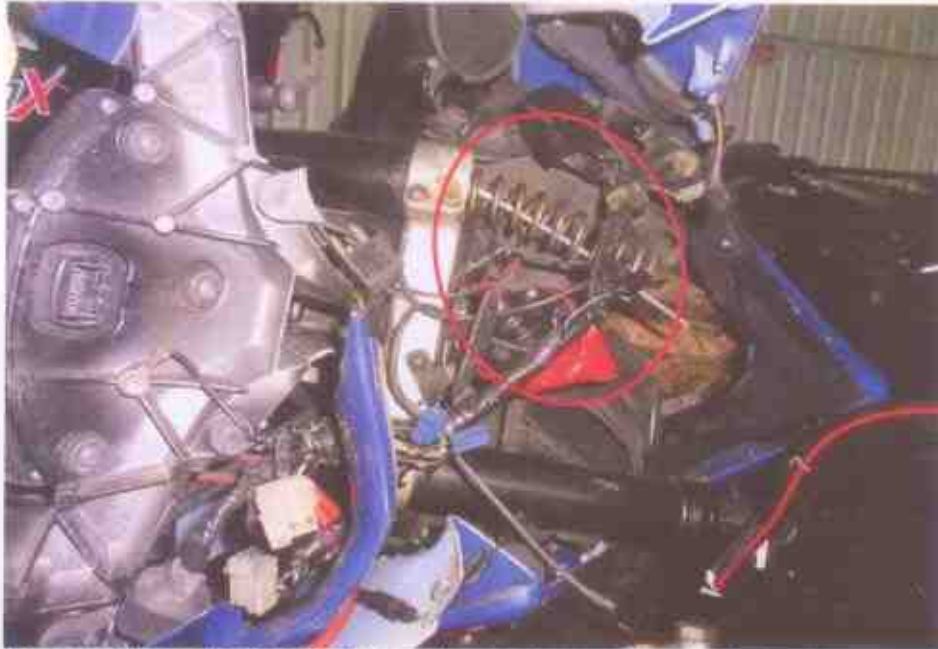
13. For this case, we were not able to conduct any test(s) on the steering system of the Motorcycle due to the damages on its front fork. The front fork was found to be damaged (dislodged) as a result of the accident, hence causing the whole steering system to be in a state of immobility.

Photo 17 shows the front fork (circled) was observed to be dislodged as a result of the accident. Hence, we are unable to conduct any tests on the steering system of the Motorcycle.

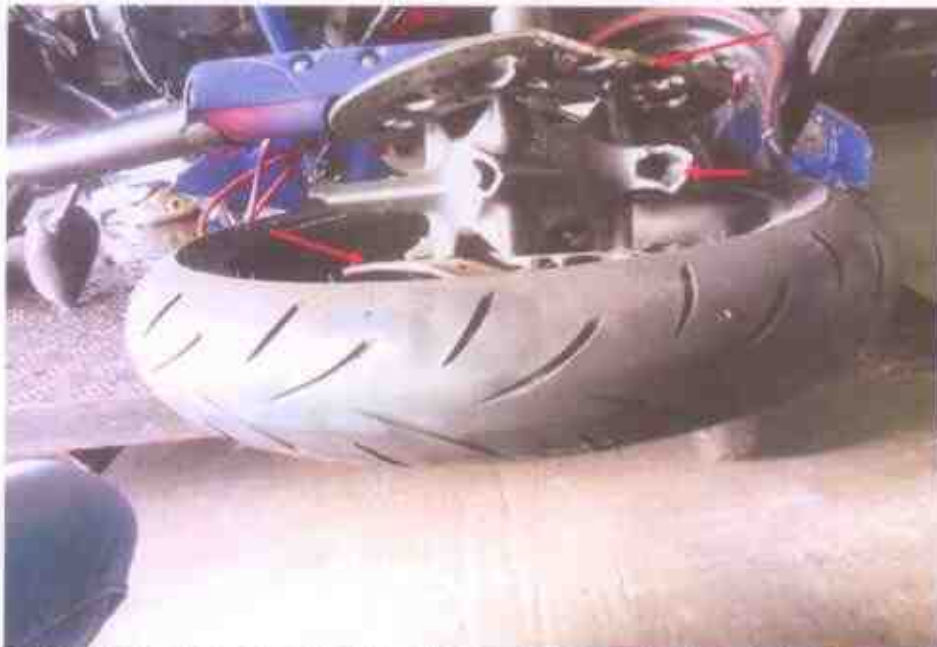
Photo 18 shows the front brake calliper and front brake disc of the Motorcycle (arrowed in red), which are all part of the components in the front brake system of the Motorcycle. Our visual checks of these various components had revealed all to be affected due to the accident's impact collision.

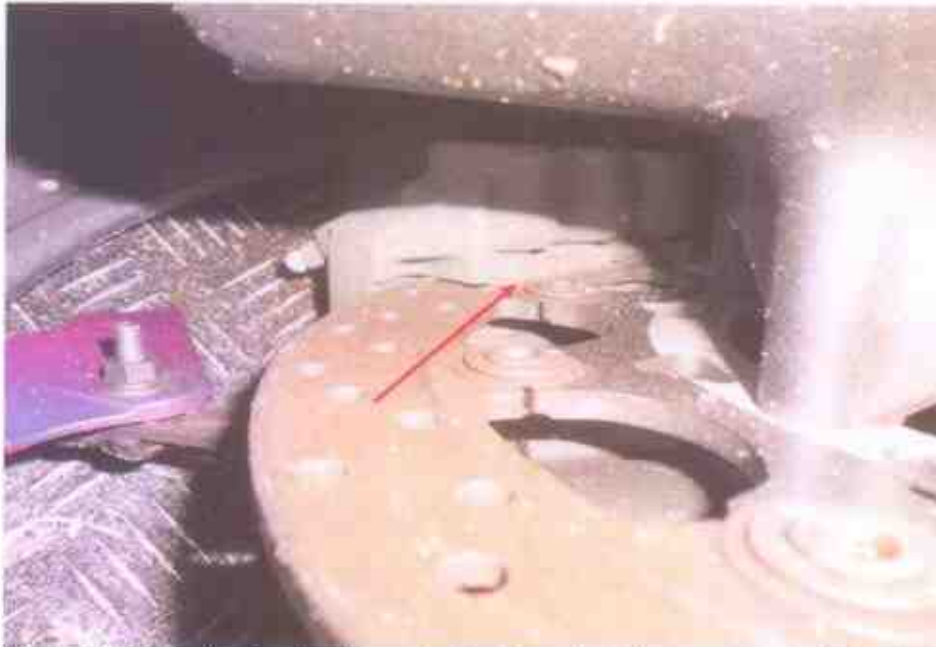
Photo 19 shows the front brake pad, which is part of the components in the front brake system of the Motorcycle. Our visual checks had revealed that it was still in serviceable condition, intact with no visible damage & sufficient frictional padding.

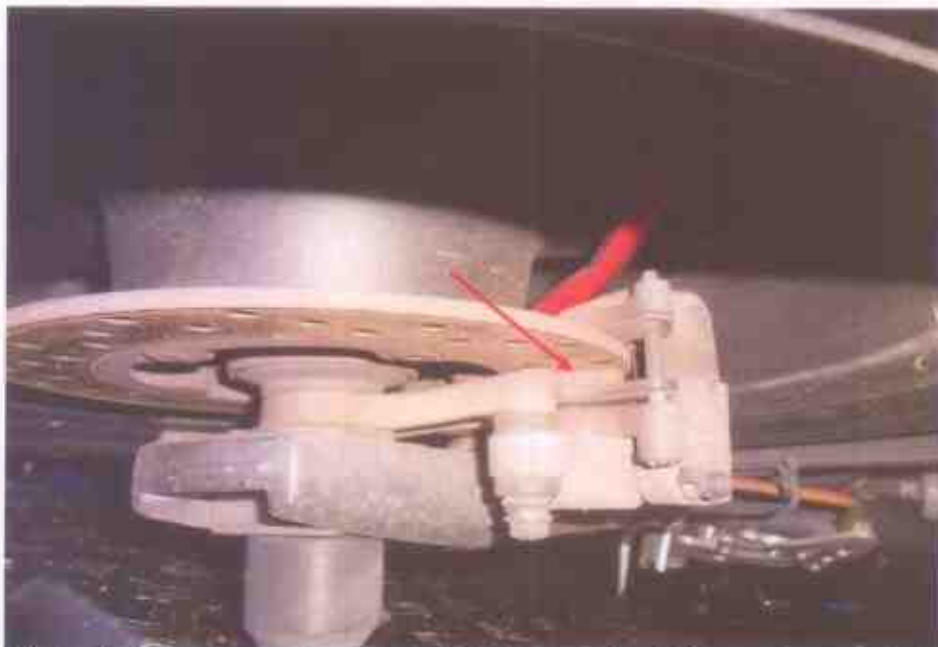
Photo 20 shows the rear brake pad of the Motorcycle which was observed to be in serviceable condition. No damages were found at time of our inspection to the rear braking components.
