Your Ref: TP/IP/29687/2017  
Our Ref : CI/TPD18011355/Z

**Fatal Accident Investigation Team**  
Traffic Police Department  
Singapore Police Force  
10 Ubi Avenue 3  
Singapore 408865

### **MECHANICAL INSPECTION REPORT OF MOTORCYCLE FBM 30X**

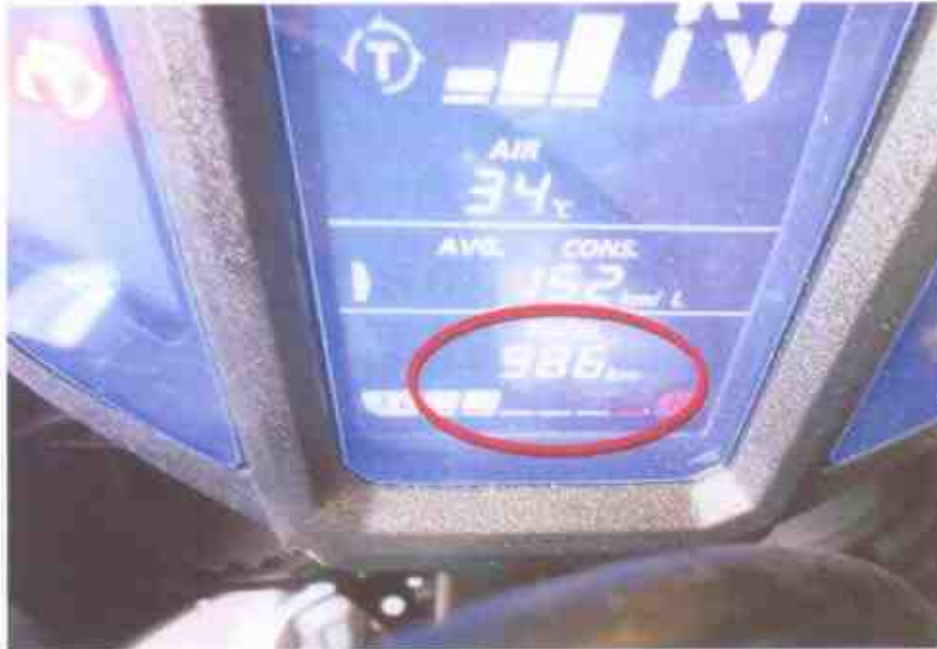
**Photo 1** shows the speedo-meter of the Motorcycle where the mileage recorded at 986km.

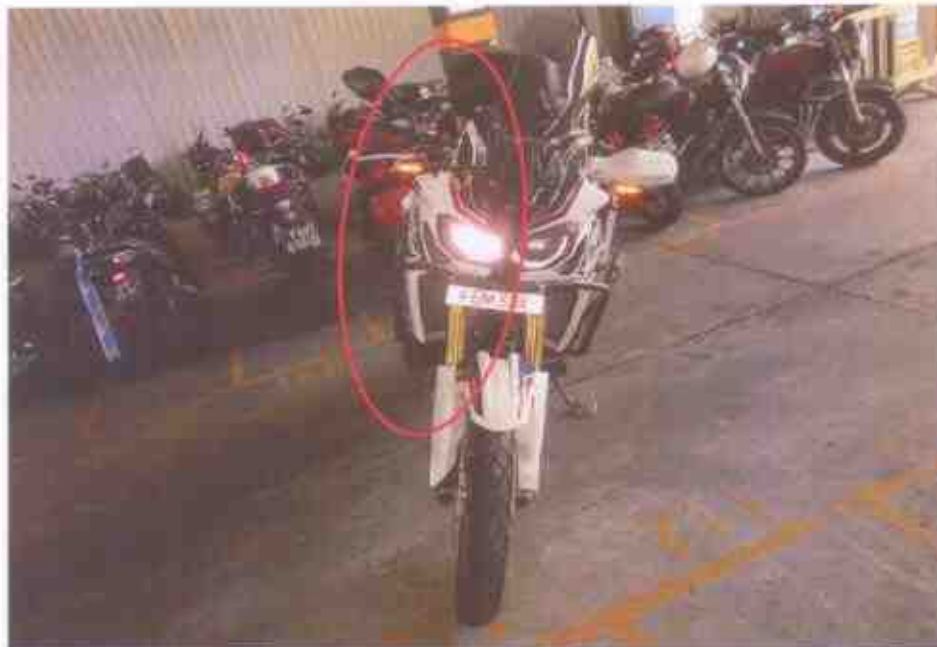
**Photo 2** shows a general view of the front portion of the Motorcycle at the time of our inspection. The Motorcycle was observed to be sustained with relatively minor impact due to the accident collision. (Circled)

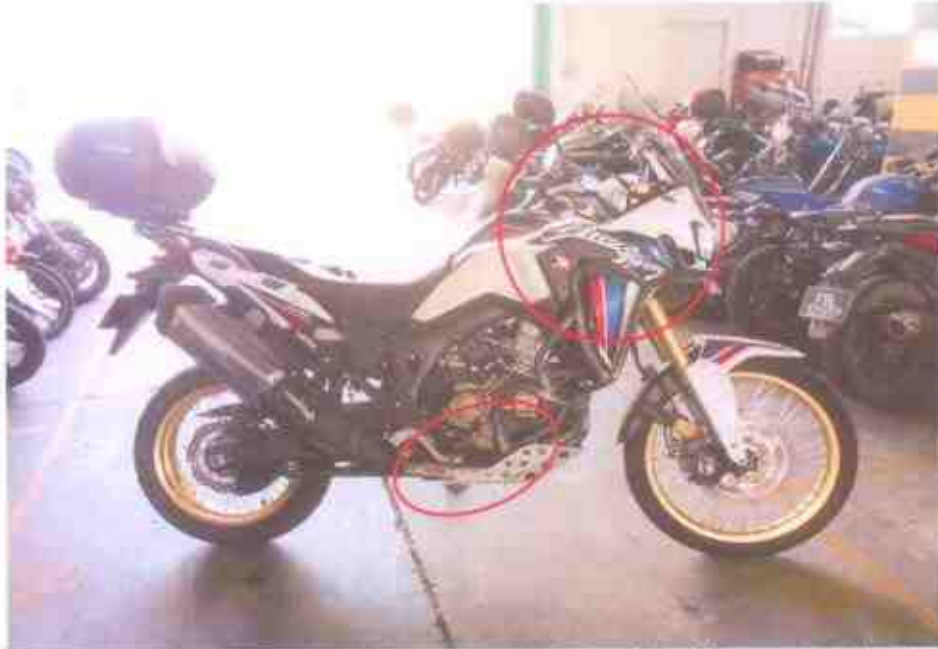
**Photo 3** shows a general view of the rear right body of the Motorcycle at the time of our inspection. The Motorcycle was observed to have sustained minor damages at the frontal right side. (Circled)

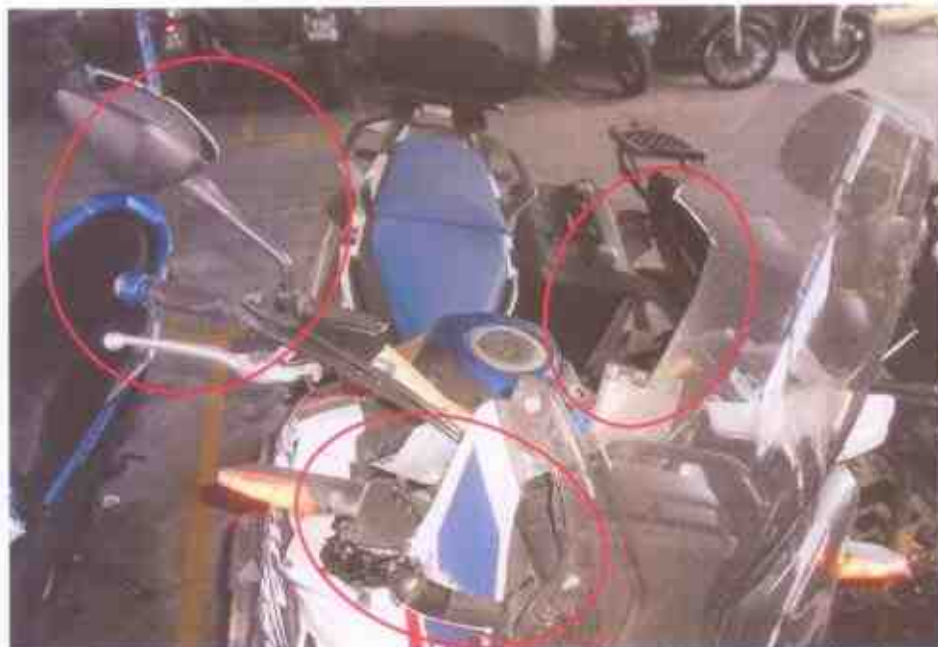
**Photo 4** shows a closer view of the frontal portion of the Motorcycle at the time of our inspection. The Motorcycle was observed to be sustained with relatively minor impact due to the accident collision. (Circled)

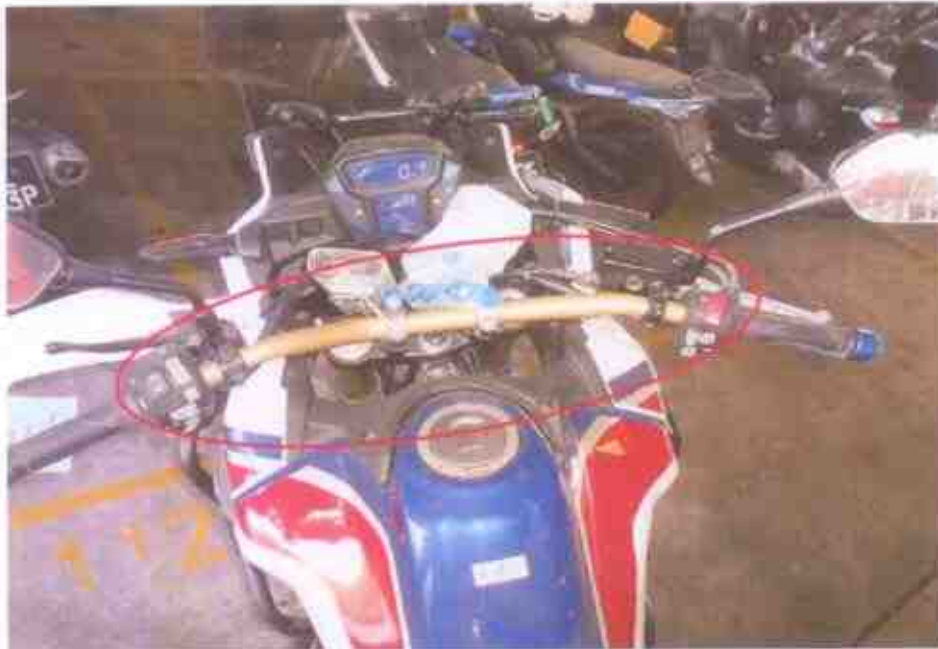
**Photo 5** shows a closer view of the handle bar of the Motorcycle at the time of our inspection. It was observed to be misaligned from the front fork due to the accident collision. (Circled)

15. Basing on our physical inspection of the Motorcycle, it appears that the steering system was not in serviceable condition. Its front fork & handle bar was found to be misaligned likely due to the accident's impact collision.

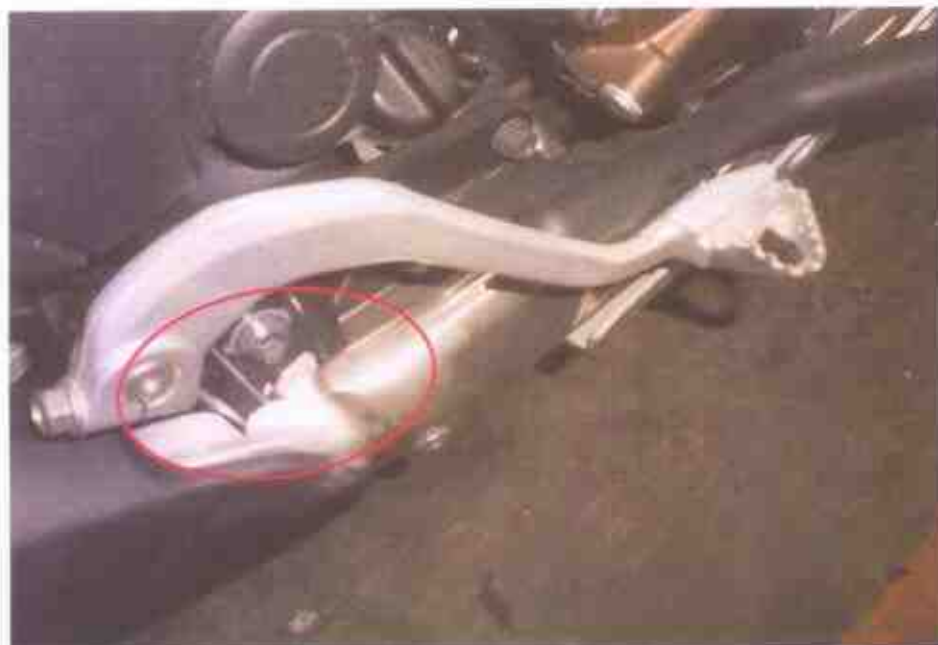
**Photo 6** shows a closer view of the rider's foot rest on the right side of the Motorcycle at the time of our inspection. It was observed to be broken due to the accident collision. (Circled)

14. For this case, we were unable to carry out operational test of the Motorcycle's braking system. This was due to the misalignment of the steering system & broken right foot rest where the rider utilizes as support for applying the rear brake as a result of the accident's collision impact.

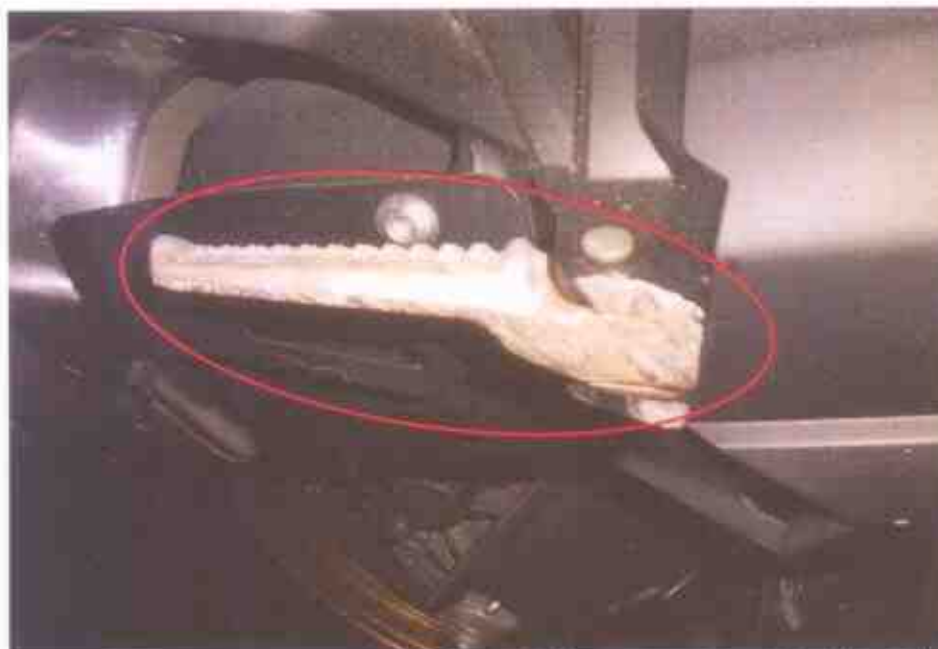
**Photo 7** shows a closer view of the pillion's foot rest on the right side of the Motorcycle at the time of our inspection. It was observed to sustained deep scratches due to the accident collision. (Circled)

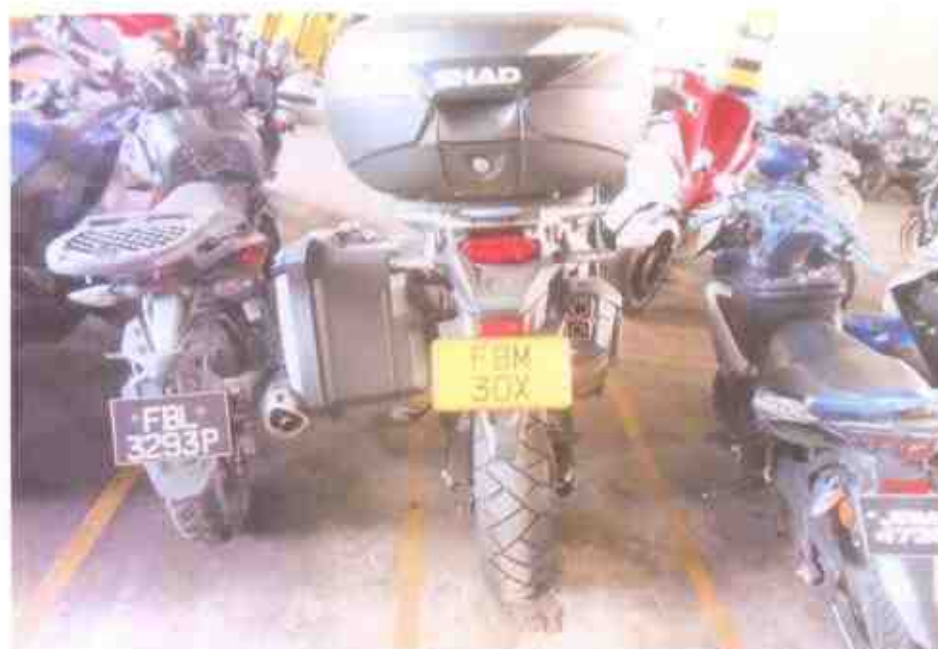
**Photo 8** shows a rear view of the Motorcycle at the time of our inspection. It's was observed to be in good condition unaffected by the accident collision.

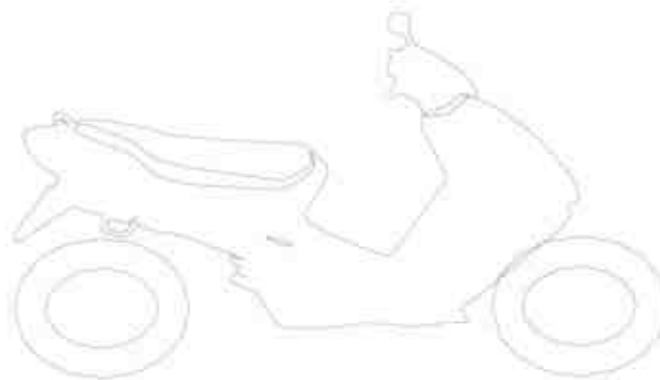
Dunlop Trailmax D610F  
150/70 - 18 (7mm)

Dunlop Trailmax D610F  
90/90 - 21 (7mm)

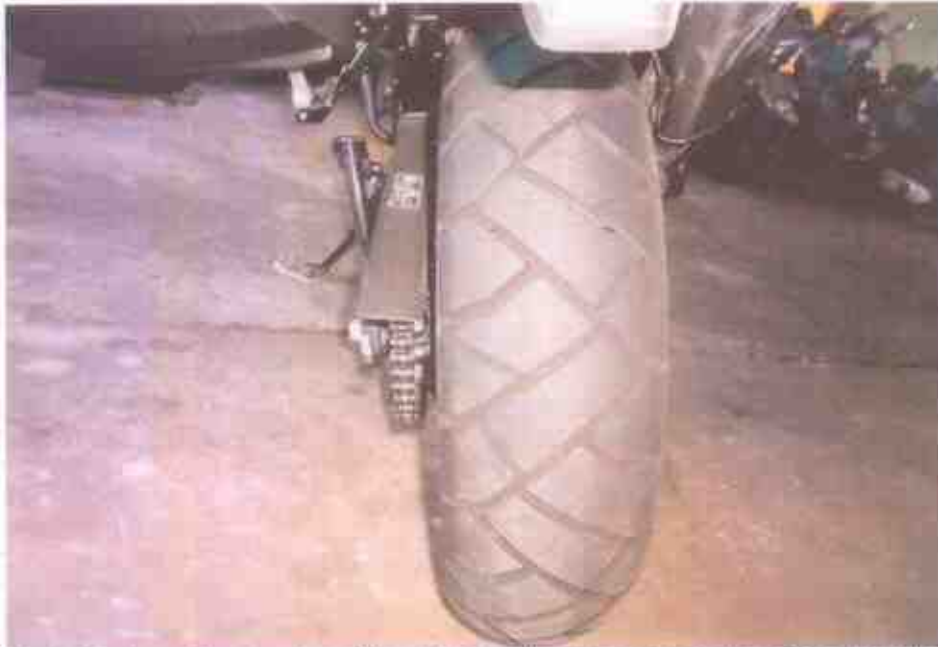
**Photo 9** shows the rear tyre of the Motorcycle. The rear tyre was observed to be in serviceable condition with remaining tread depth of approximately 7mm. The tyre was also observed to be sufficiently inflated for vehicular operation.

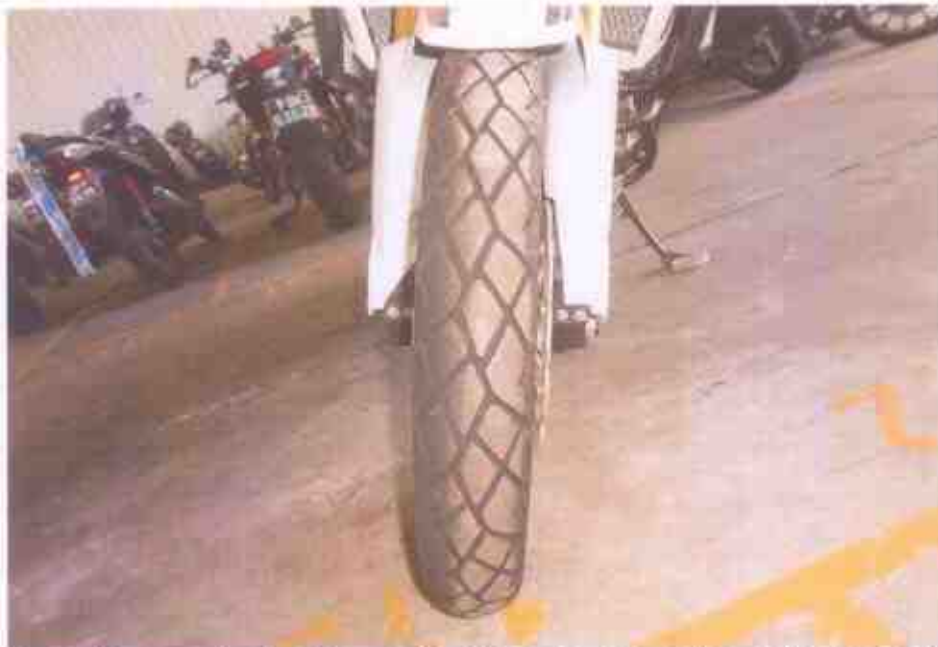
**Photo 10** shows the front tyre of the Motorcycle. The pattern of the tread was clearly visible with remaining tread depth of approximately 7mm. There was no tear, burst mark(s) and/or punctured hole(s) on the sidewalls as well as across the tread of the front tyre.

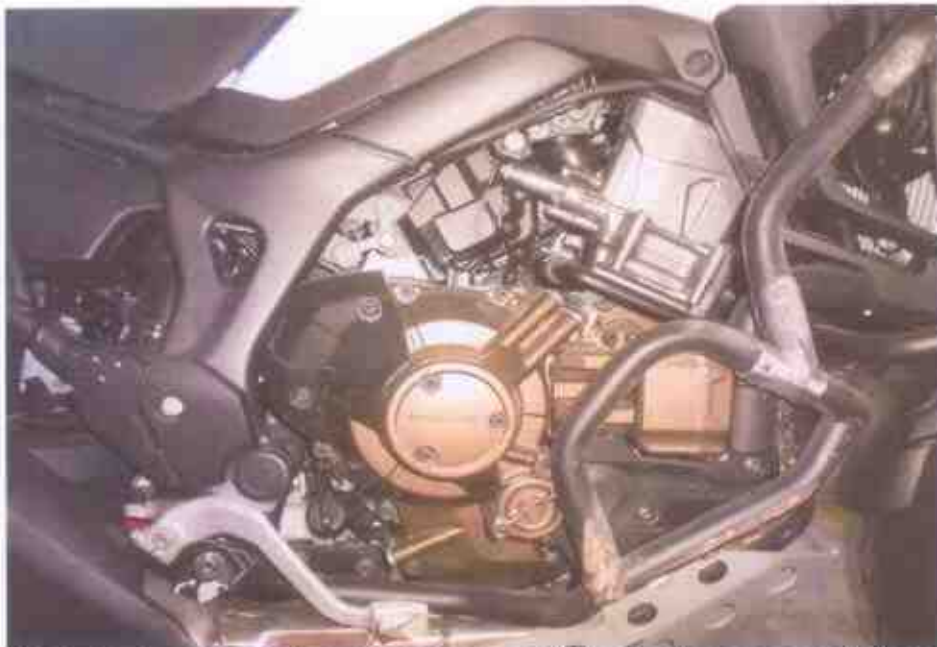
**Photo 11** shows no sign(s) or indication(s) of fluid leak observed around the top side of the engine area of the Motorcycle.

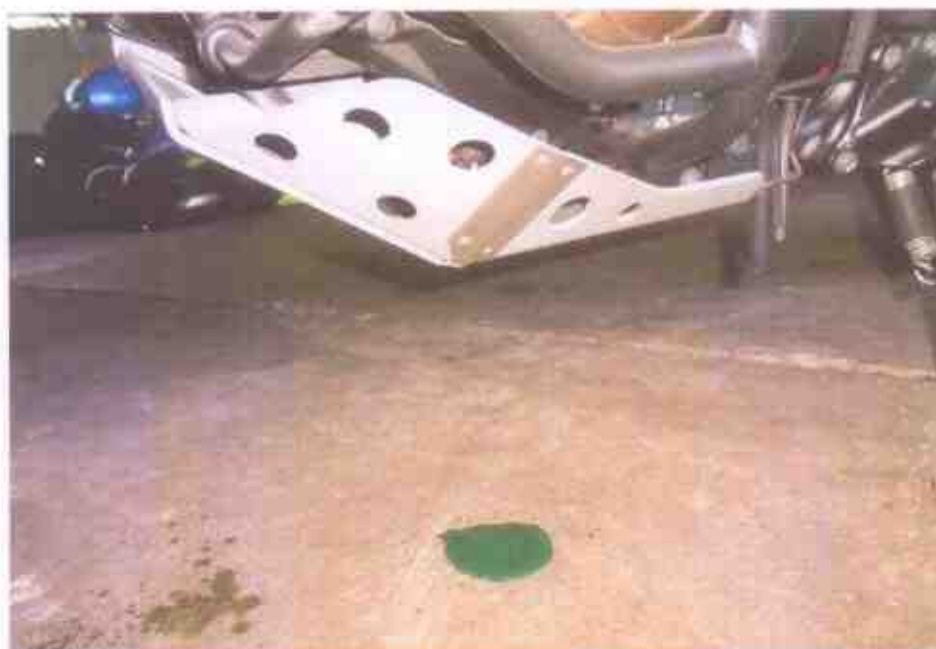
**Photo 12** shows sign(s) or indication(s) of fluid leakage was observed around the underside of the engine area of the Motorcycle. The fluid was believe to be engine coolant gushed out from the underside of the engine compartment upon cranking of the Motor Cycle.

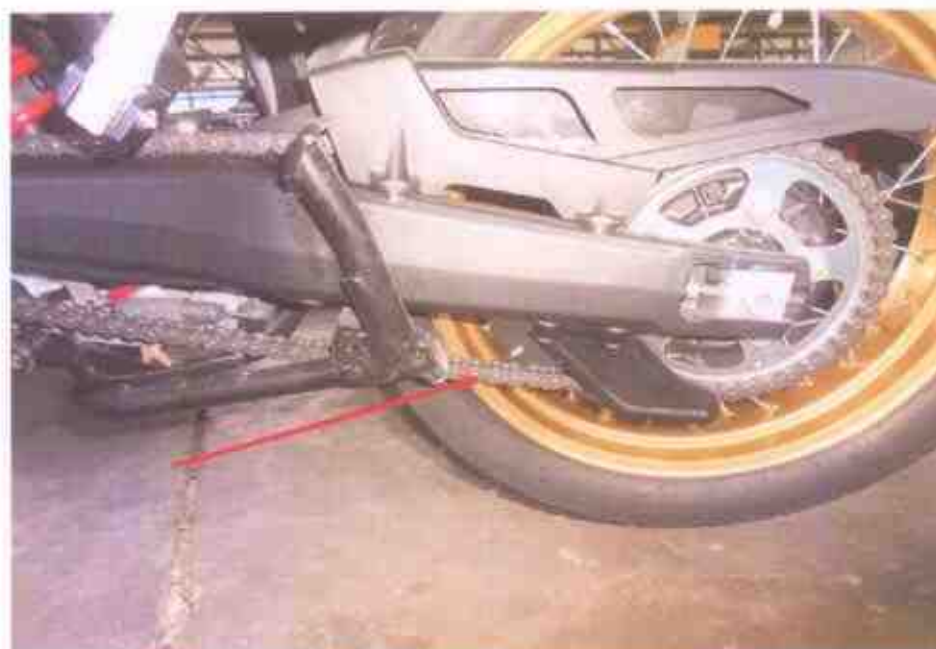
**Photo 13** shows the general view of the gear train (arrowed) of the Motorcycle, which was observed to be intact with no misalignment. It was also adequately lubricated for operating purposes.

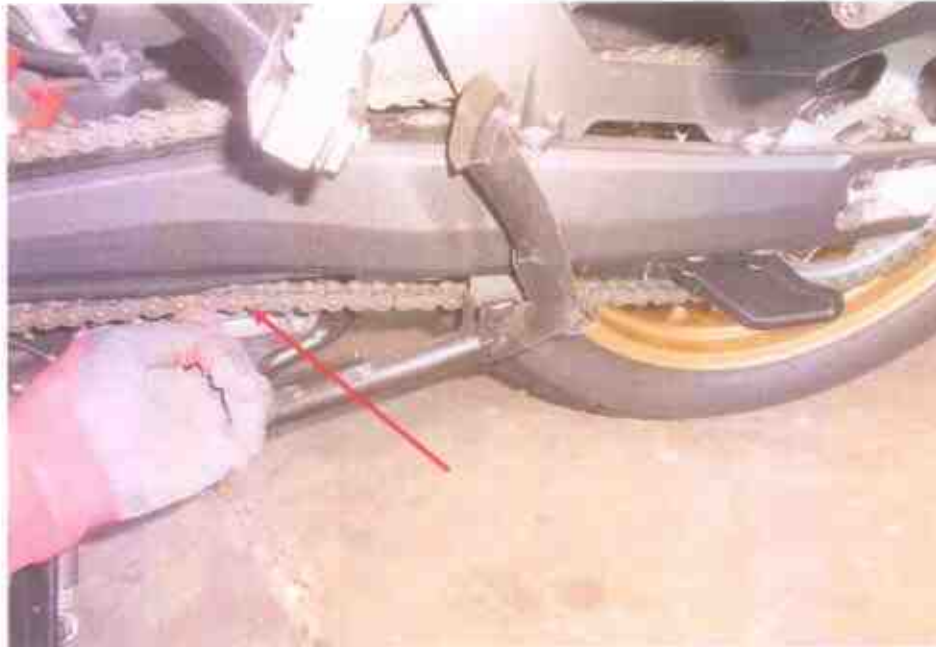
**Photo 14** shows the general view of the gear train (arrowed) of the Motorcycle, which was observed to be intact with no misalignment. It was also adequately lubricated for operating purposes. Free play tension was also observed & found adequately acceptable.

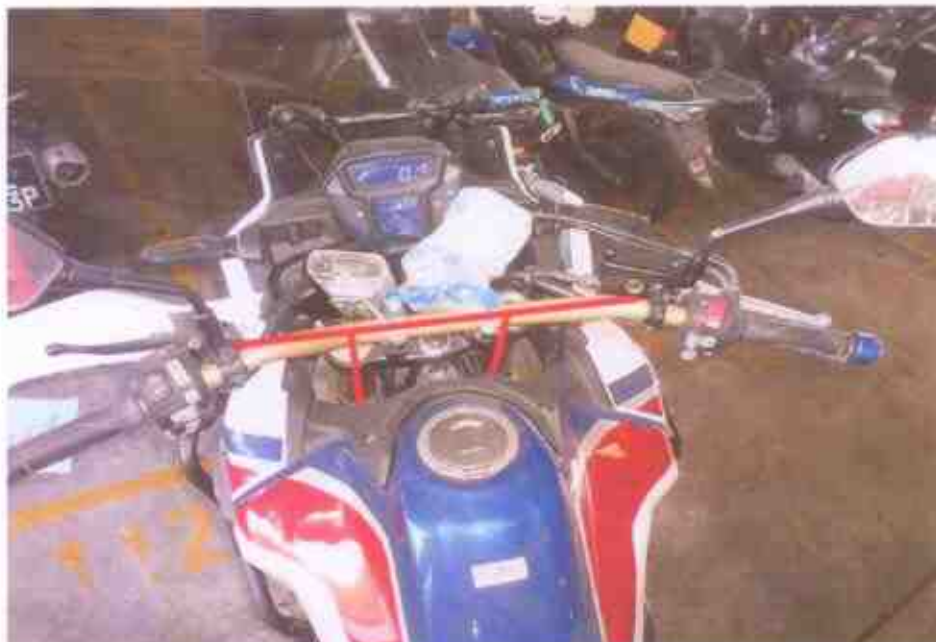
Photo 15 shows the steering system was observed to be slightly bent likely due to the accident's impact.

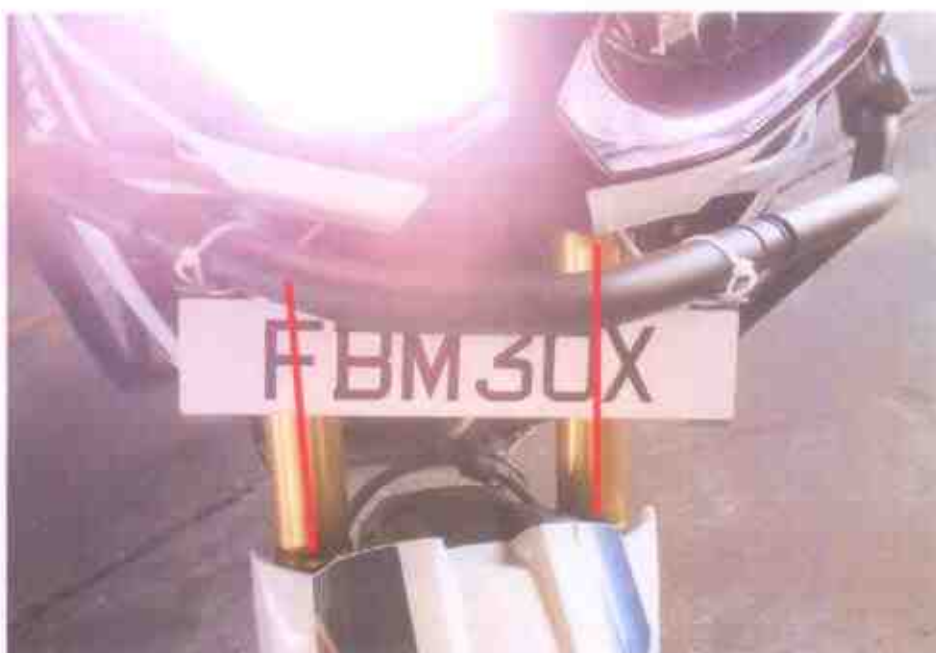
11. Our checks on the various steering components of the Motorcycle had revealed that its steering system was in not serviceable condition. Its front fork was found to be slightly bent likely due to the accident's impact collision.
12. The braking system of the Motorcycle was observed to be of a full hydraulic type, where hydraulic (brake fluid) pressure controls the brake for the front wheel and rear wheel. The brake for the front wheel is engaged by pulling the brake lever at the right side of the Motorcycle's handle bar while the brake for the rear wheel is engaged by stepping on the brake pedal at the right side foot rest of the Motorcycle.

Photo 16 shows the front fork was observed to be slightly bent likely due to the accident's impact.

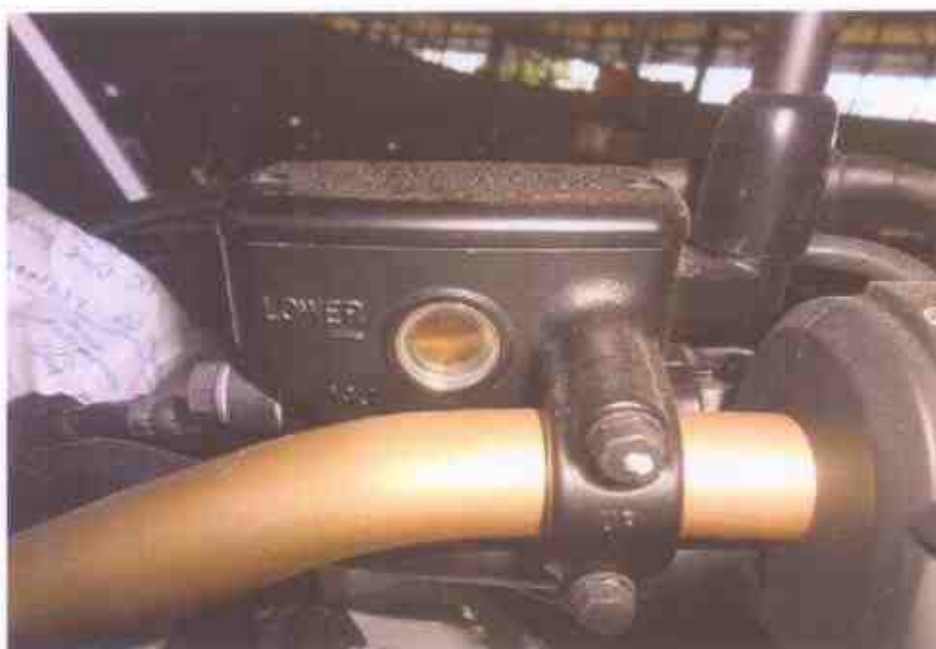
Photo 17 shows the brake fluid reservoir for front brake observed to be sufficient at time of our inspection.

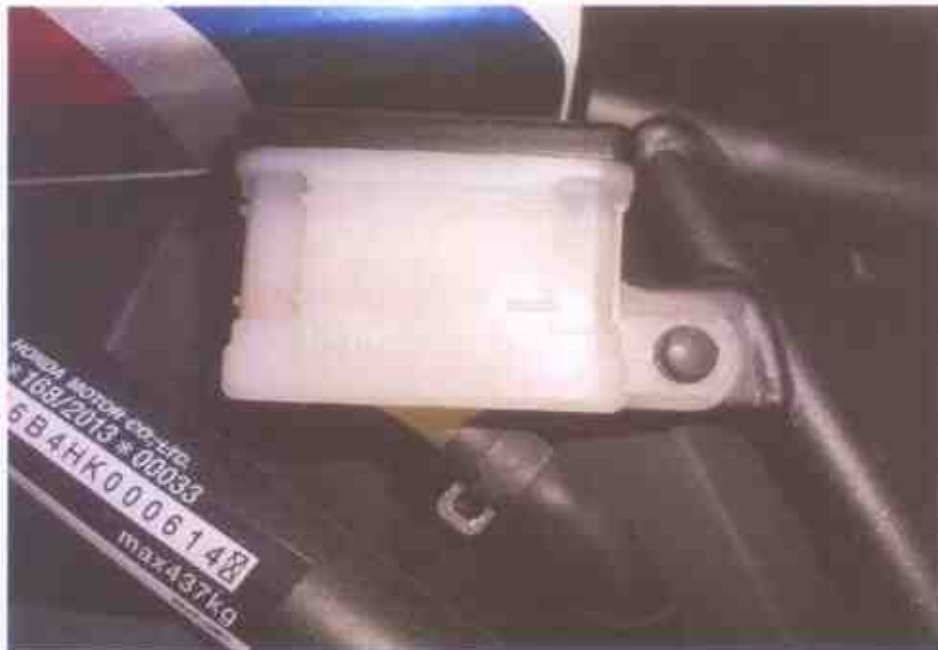
**Photo 18** shows the brake fluid reservoir for rear brake observed to be sufficient at time of our inspection.

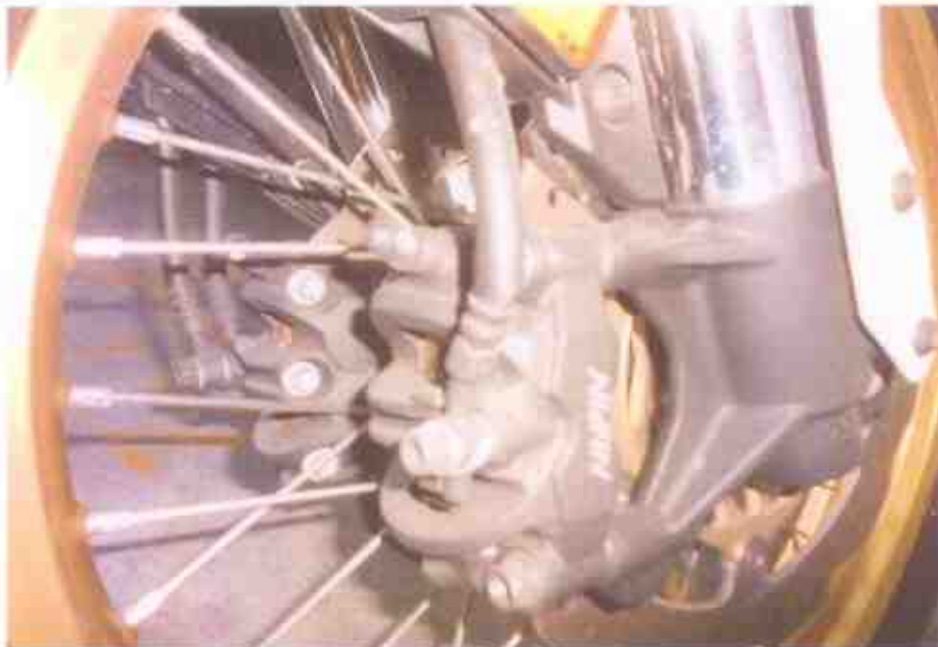
**Photo 19** shows the braking system for the front brake. It was observed to be in serviceable condition at time of our inspection. The braking components were found to be intact unaffected by the accident's impact collision.

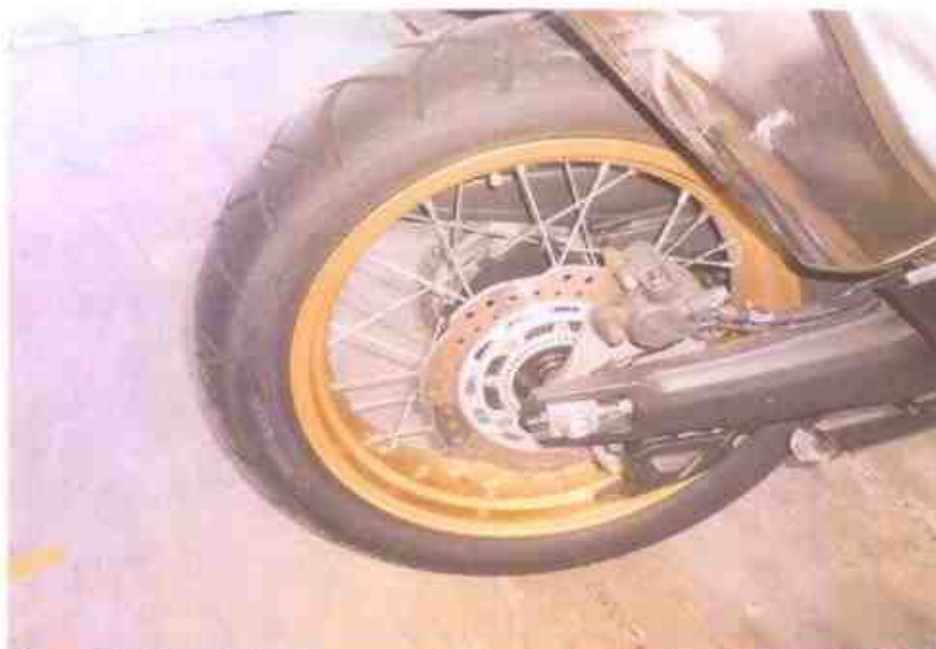
Photo 20 shows the braking system for the rear brake. It was observed to be in serviceable condition at time of our inspection. The braking components were found to be intact unaffected by the accident's impact collision.

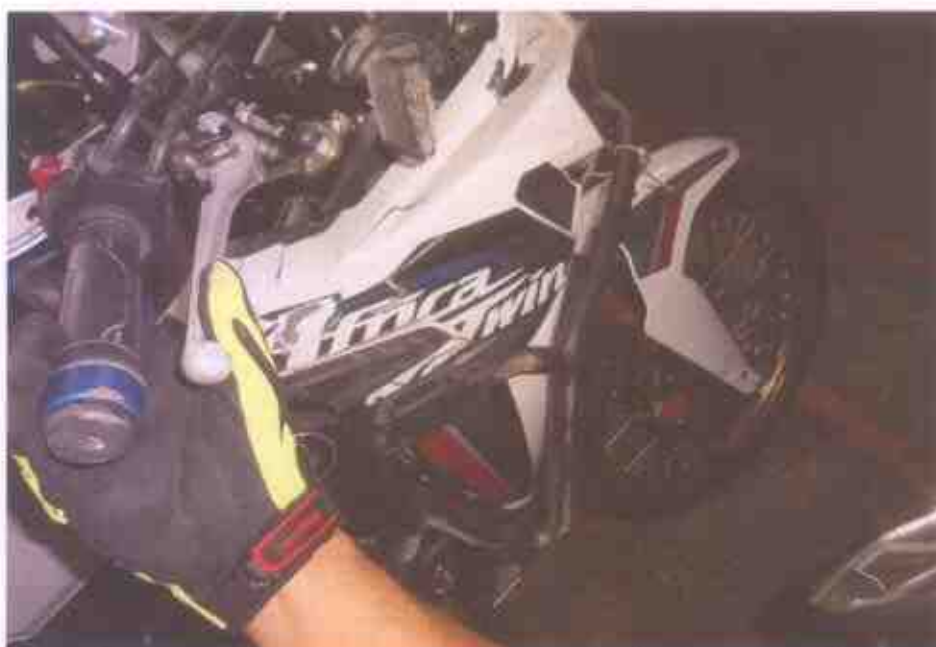
Photo 21 shows testing of the braking of the front brake in progress. There was some resistance felt (spongy like feel) upon pressing the brake lever.
