Your Ref: TP/IP/32353/2018
Our Ref : CI/TPD18011356/Z

14th September 2018

MECHANICAL INSPECTION REPORT OF MOTOR LORRY GY 1421Y

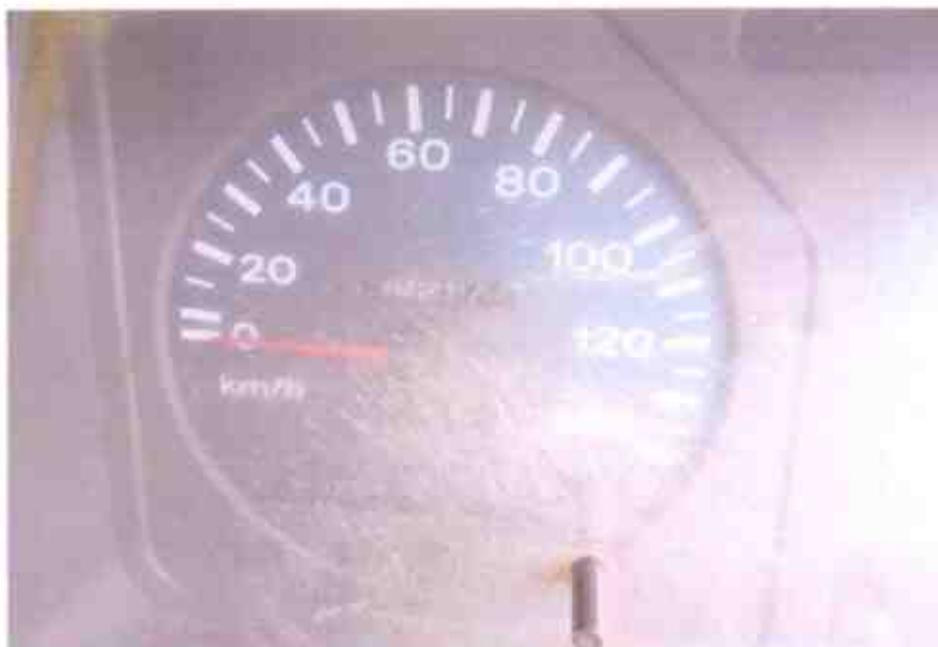
Photo 1 shows the mileage of the Motor Lorry at the time of our inspection was recorded as 455031km.

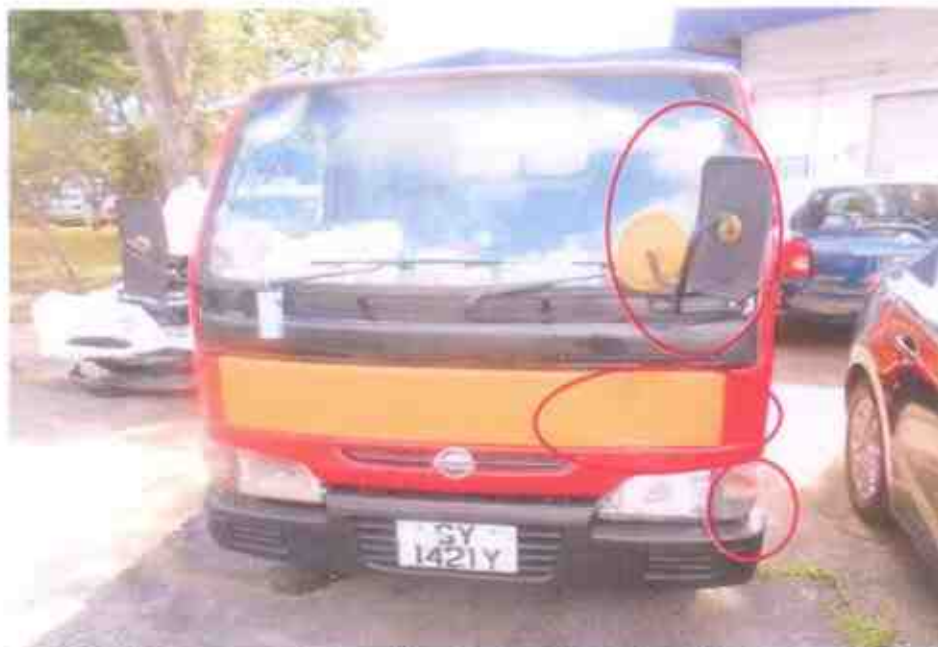
Photo 2 shows a general view of the front portion of the Motor Lorry at the time of our inspection. The Motor Lorry was observed to have sustained minor damage at its front left signal lamp and its front panel were amongst the body parts that were damaged as a result of the accident.

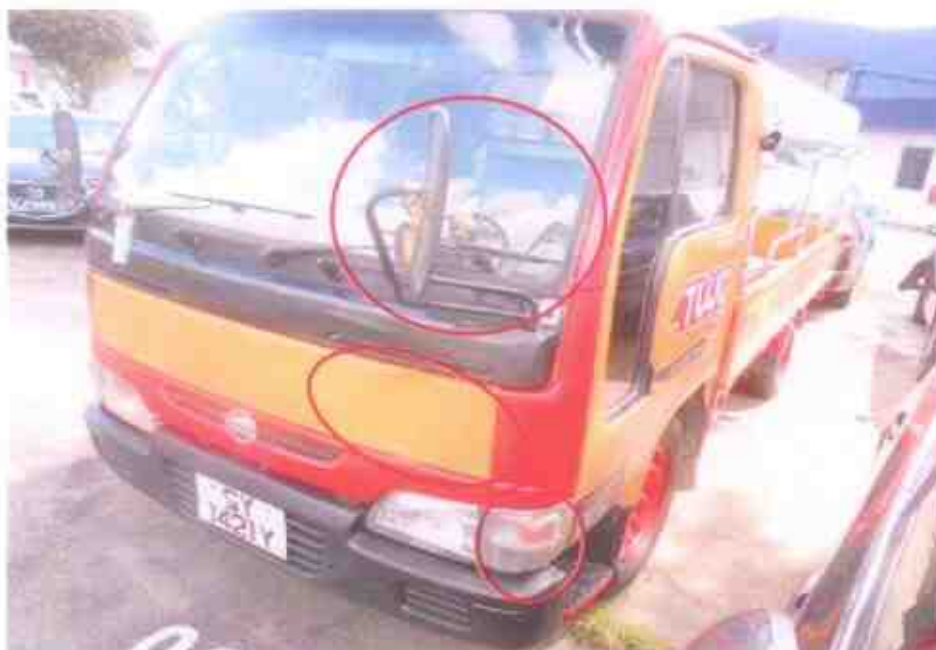
Photo 3 shows a general view of the front left portion of the Motor Lorry at the time of our inspection. The Motor Lorry was observed to have sustained minor damage at its front lower bumper and its front panel were amongst the body parts that were damaged as a result of the accident.

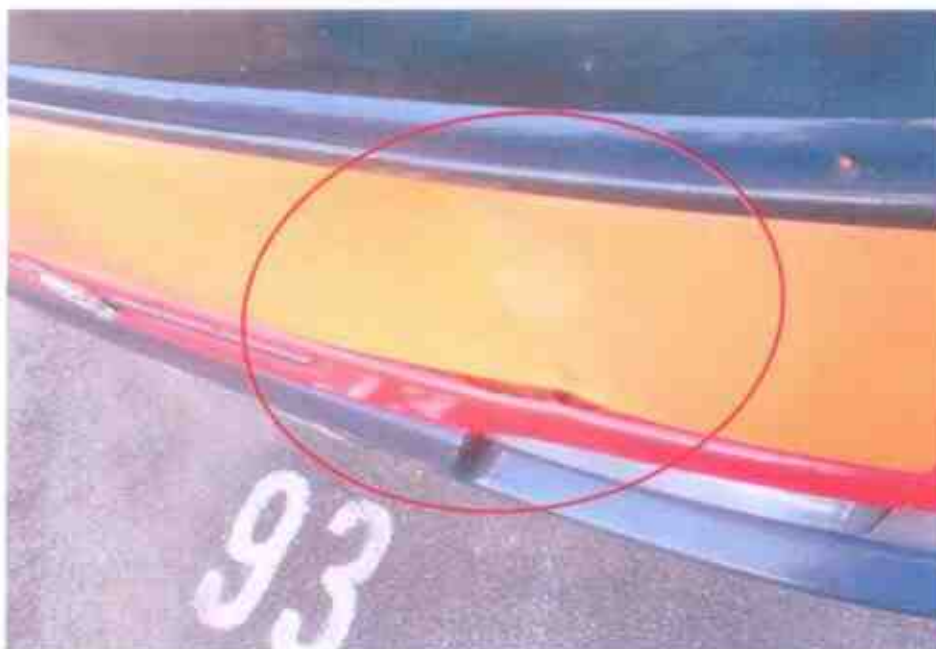
Photo 4 shows a damaged front panel likely due to the accident's impact.

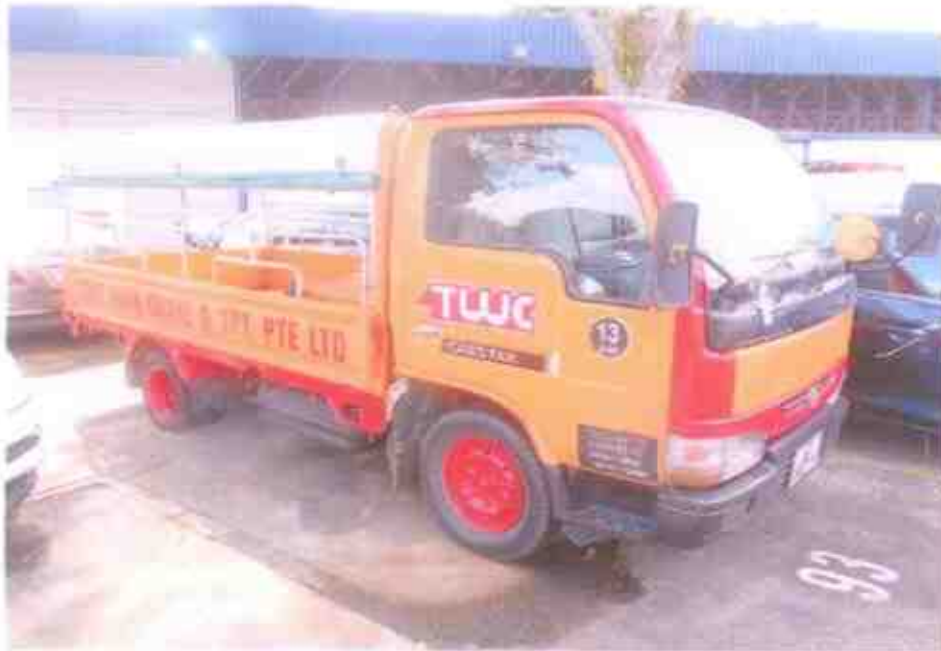
Photo 6 shows a general view of the front right portion of the Motor Lorry at the time of our inspection. The Motor Lorry was observed to be in good condition unaffected by the accident's impact.

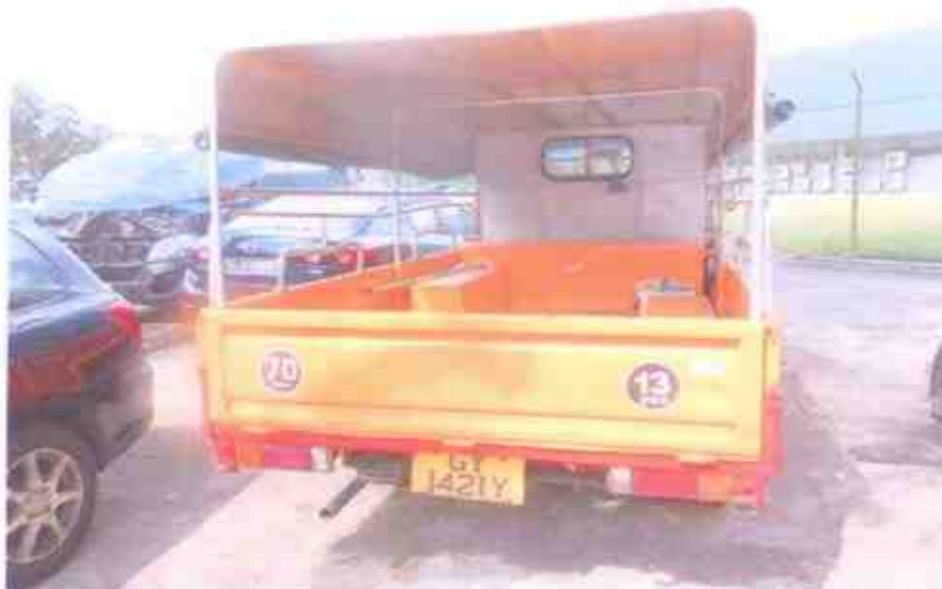
Photo 7 shows a general view of the Motor Lorry's rear body at the time of our inspection. There was no damage found to the rear portion of the Motor Lorry.

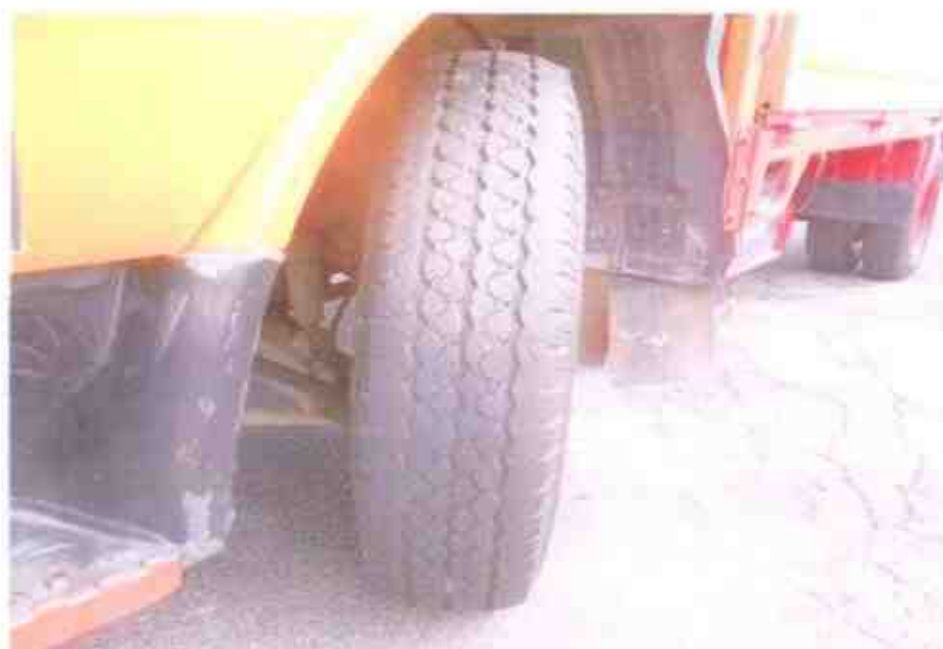
Photo 8 shows the condition of the front left tyre of the Motor Lorry, which was observed to be in serviceable condition with remaining tread depth of approximately 6mm. The tyre, which was wrapped around standard alloy wheel rim, was also observed to be sufficiently inflated for vehicular operation.

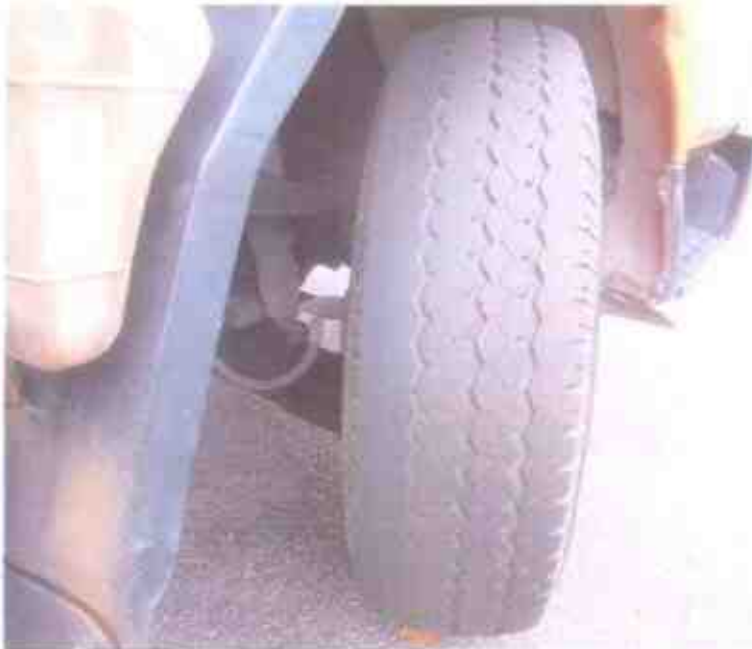
Photo 9 shows the condition of the front right tyre of the Motor Lorry, which was observed to be in serviceable condition with remaining tread depth of approximately 5mm. The tyre, which was wrapped around standard alloy wheel rim, was also observed to be sufficiently inflated for vehicular operation.

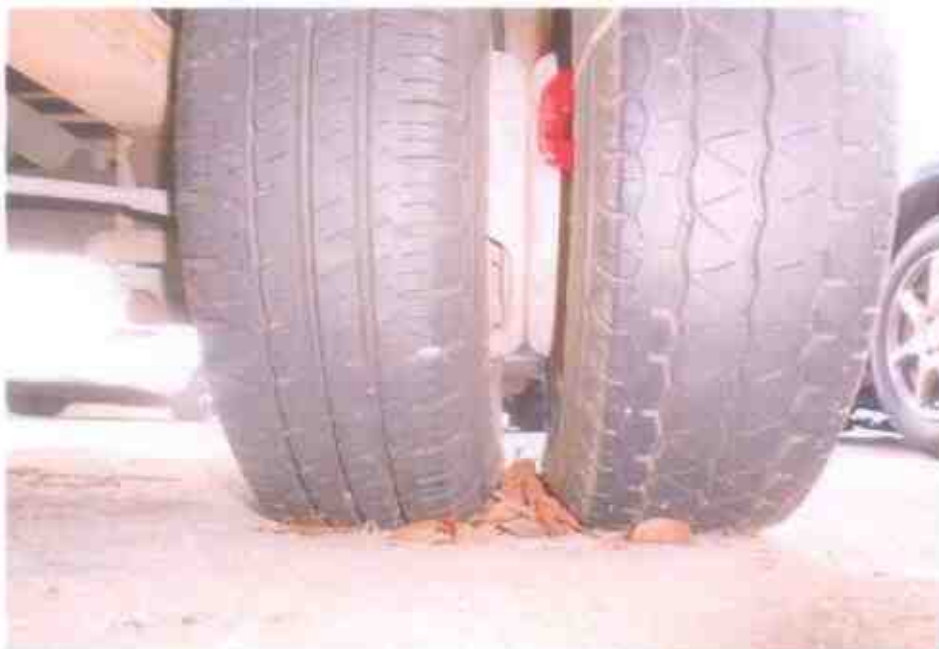
Photo 10 shows the condition of the rear left tyres of the Motor Lorry, which was observed to be in serviceable condition with remaining tread depth of approximately 5mm. The tyres, which were wrapped around standard alloy wheel rim, were also observed to be sufficiently inflated for vehicular operation.

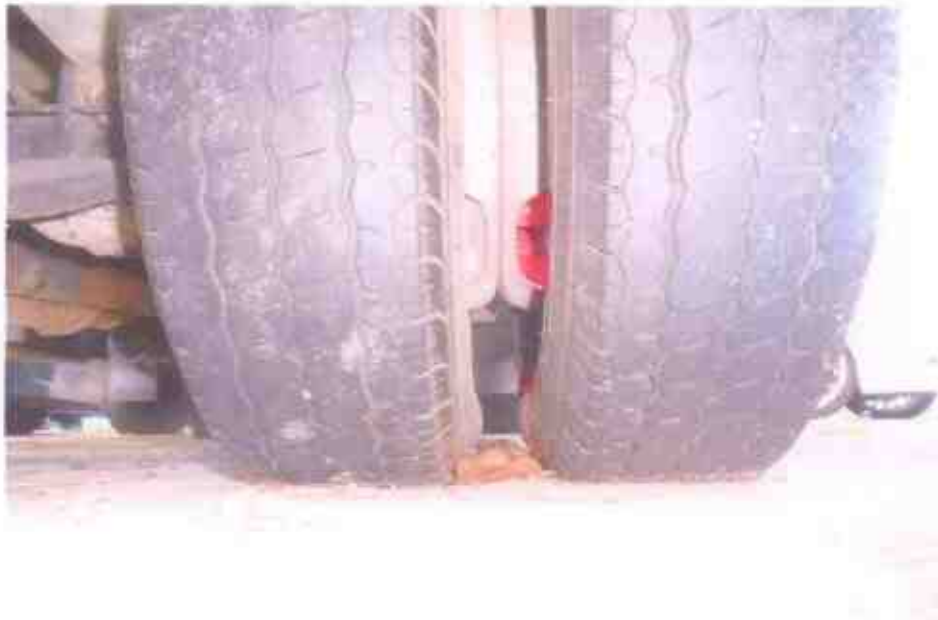
Photo 11 shows the condition of the rear right tyres of the Motor Lorry, which were observed to be in serviceable condition with remaining tread depth of approximately 5mm.

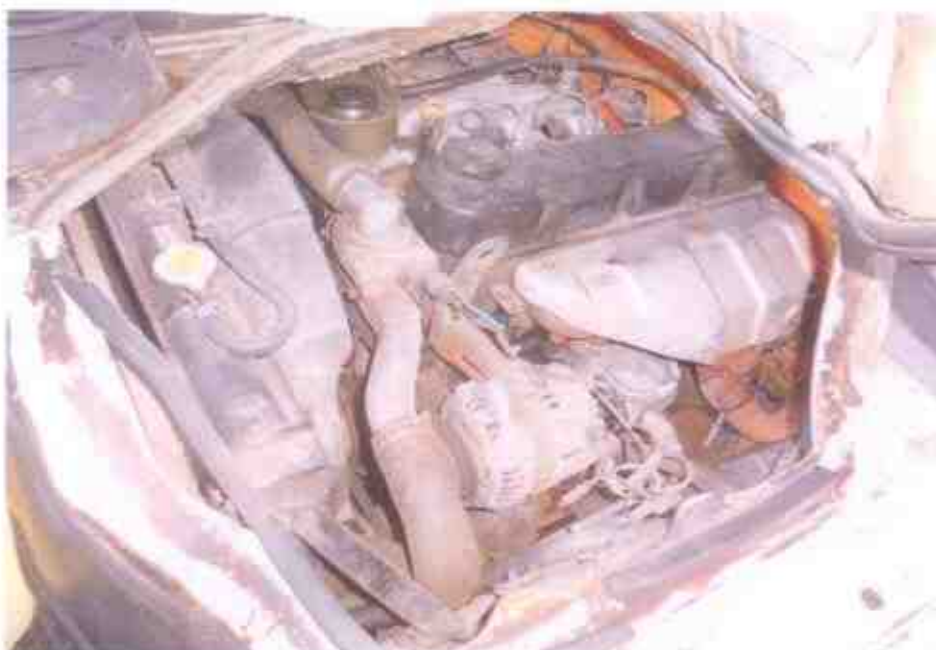
Photo 12 shows a general view of the Motor Lorry's engine compartment, which was accessed by lifting the front cabin of the Motor Lorry. The various parts and components inside the engine compartment were unaffected by the accident. There was also no sign(s) or indication(s) of fresh fluid leakage and/or fluid stain within the engine.

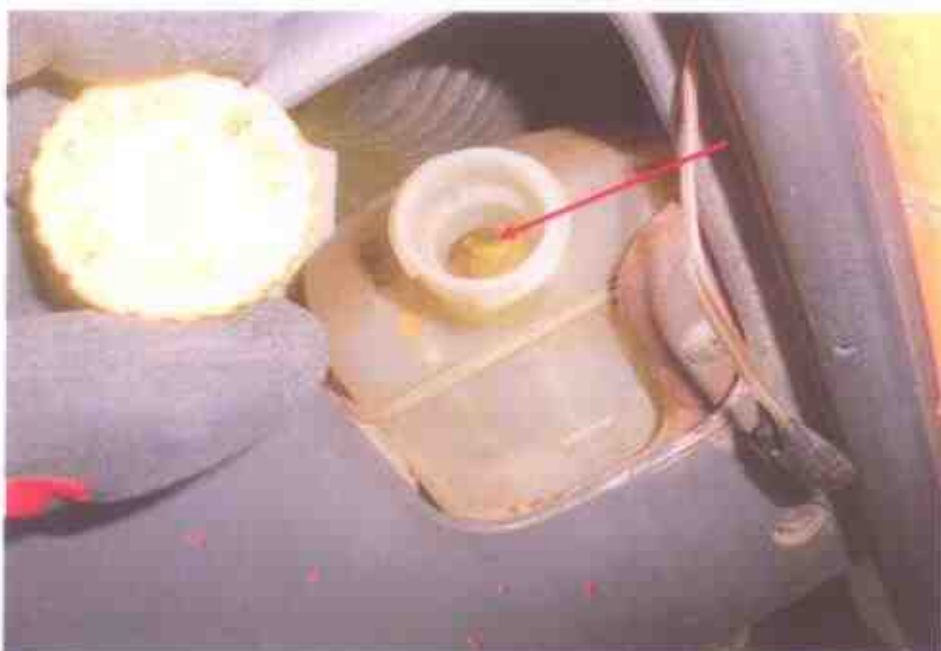
Photo 13 shows the brake fluid reservoir of the Motor Lorry at the time of our inspection. The brake fluid was observed to be of sufficient level and without any visible contamination (arrowed).

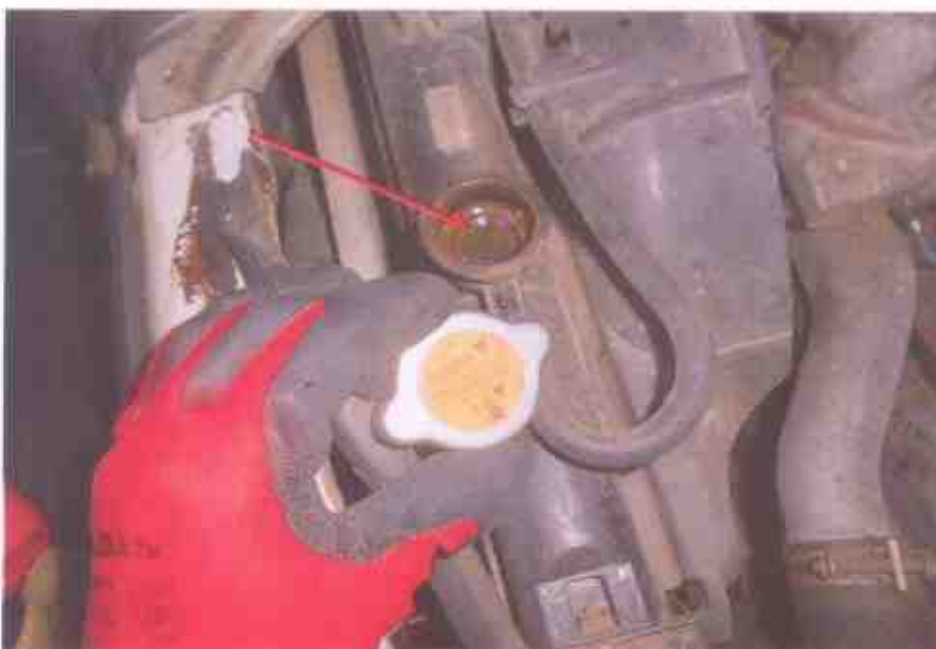
Photo 14 shows the engine coolant reservoir of the Motor Lorry at the time of our inspection. The engine coolant was observed to be of sufficient level and without any visible contamination (arrowed).

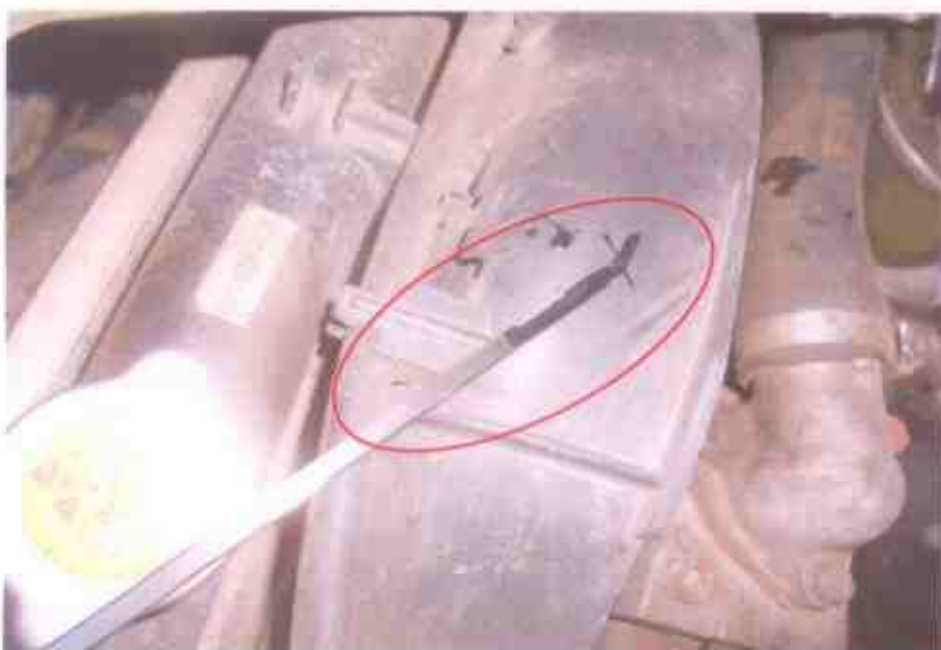
Photo 15 shows the engine dip stick of the Motor Lorry at the time of our inspection. The engine oil was observed to be of sufficient level and without any visible contamination (circled).

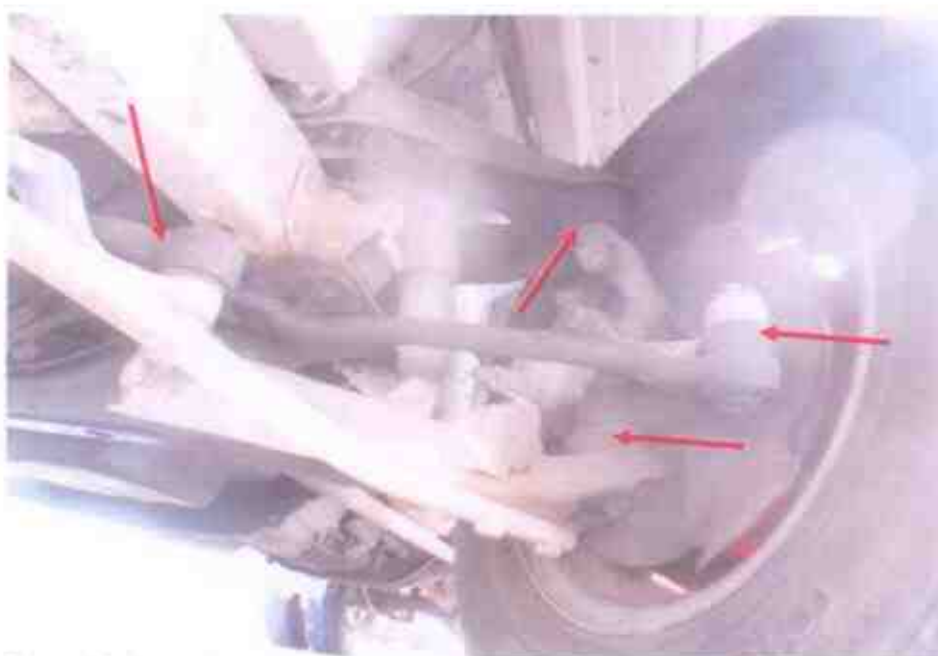
Photo 16 shows the various undercarriage components at the front left wheel of the Motor Lorry, in particular the steering tie rod end (arrowed). The various undercarriage components of the Motor Lorry were all found to be intact without any visible damage. There was also no sign of fluid stain(s) observed on the various undercarriage components.

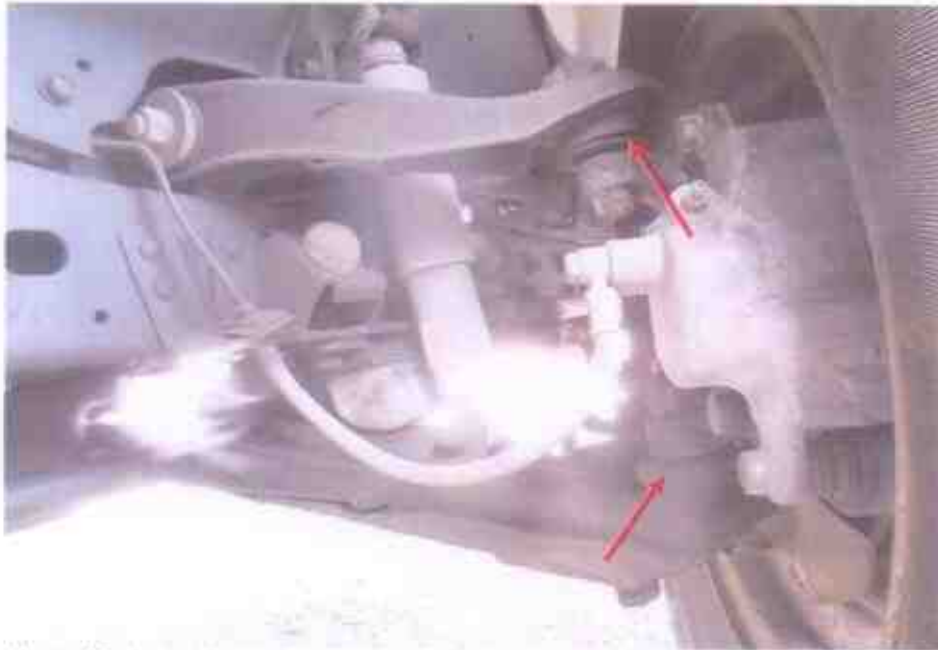
Photo 17 shows the various undercarriage components at the front right wheel of the Motor Lorry, in particular the steering tie rod end (arrowed). The various undercarriage components of the Motor Lorry were all found to be intact without any visible damage. There was also no sign of fluid stain(s) observed on the various undercarriage components.

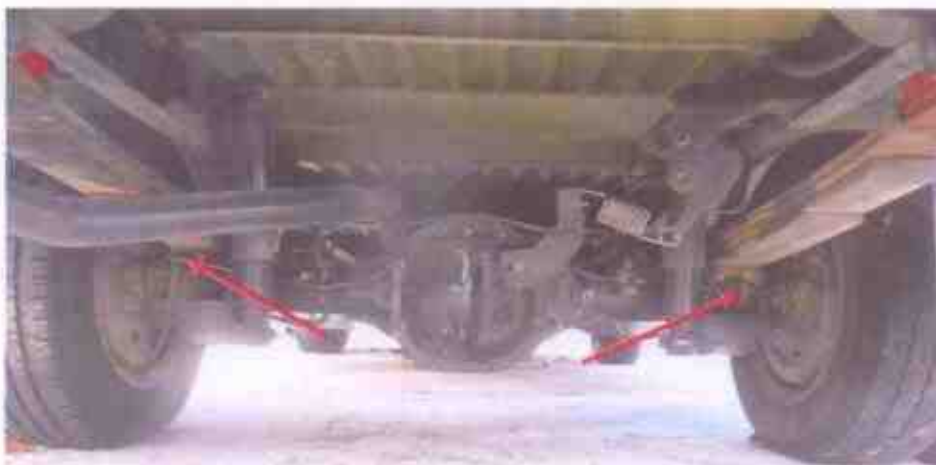
15. Checks on the brake shoes (brake pads) at the rear wheels of the Motor Lorry revealed that the brake shoes (brake pads) were in serviceable condition with sufficient frictional material for operational purposes. In general, our visual inspection of the mechanical components of the Motor Lorry's braking system appear to suggest that its braking system was in serviceable condition at the material time of accident. See photo 18 below.

Photo 18 shows the various undercarriage components at the rear wheels of the Motor Lorry. There was no sign(s) of brake fluid leakage along the brake hoses and brake pipes.

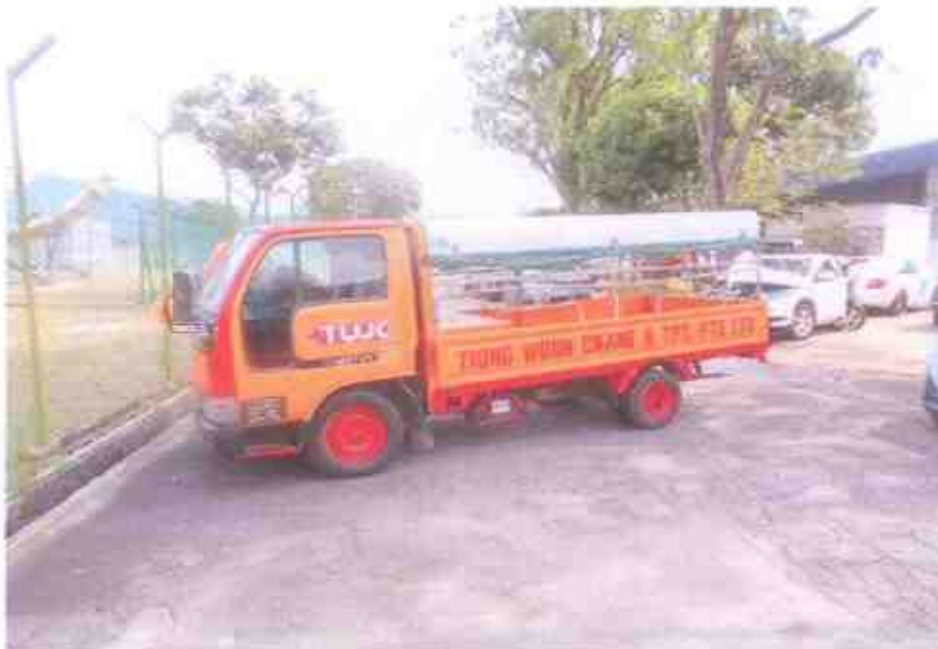
Photo 19 shows the operational test on the Motor Lorry. It was observed to be in serviceable condition. Operational test such as moving forward, turn left & right and also braking test on the Motor Lorry was conducted successfully.
