20th September 2018

Fatal Accident Investigation Team

MECHANICAL INSPECTION REPORT OF MOTOR TRAILER XD 8794/ TRC 7350P

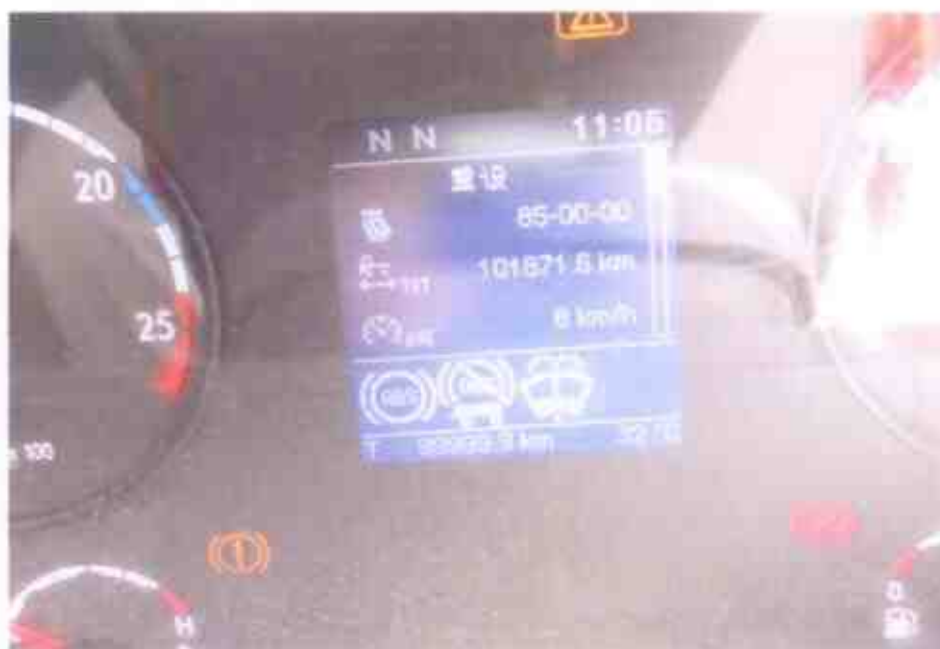
Photo 1 shows the mileage of the Motor Trailer at the time of our inspection was recorded at 101871.6 km.

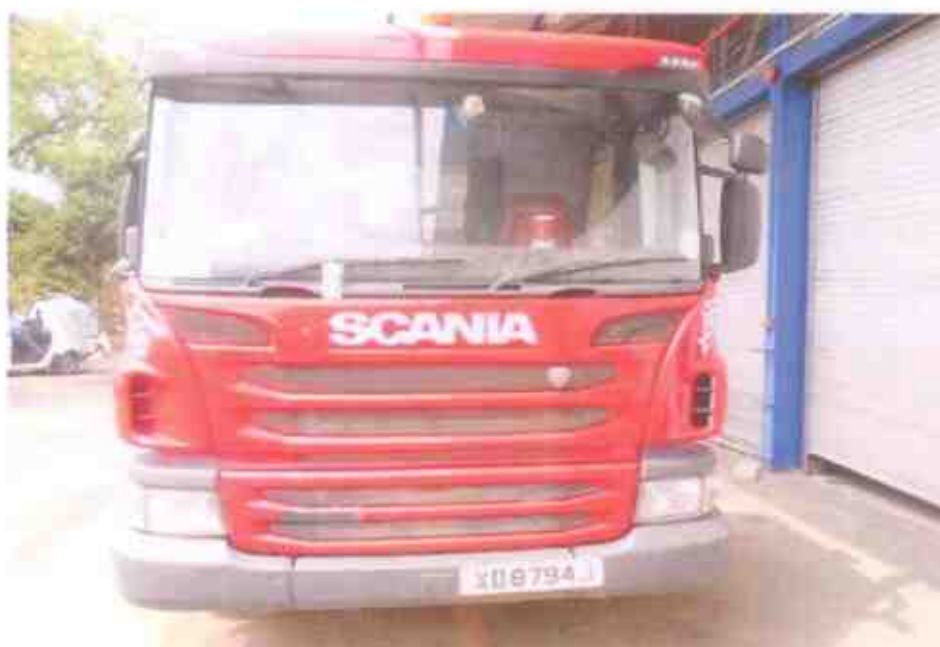
Photo 2 shows a general view of the front body of the Motor Trailer at the time of our inspection. It was observed to be in good condition unaffected by the accident.

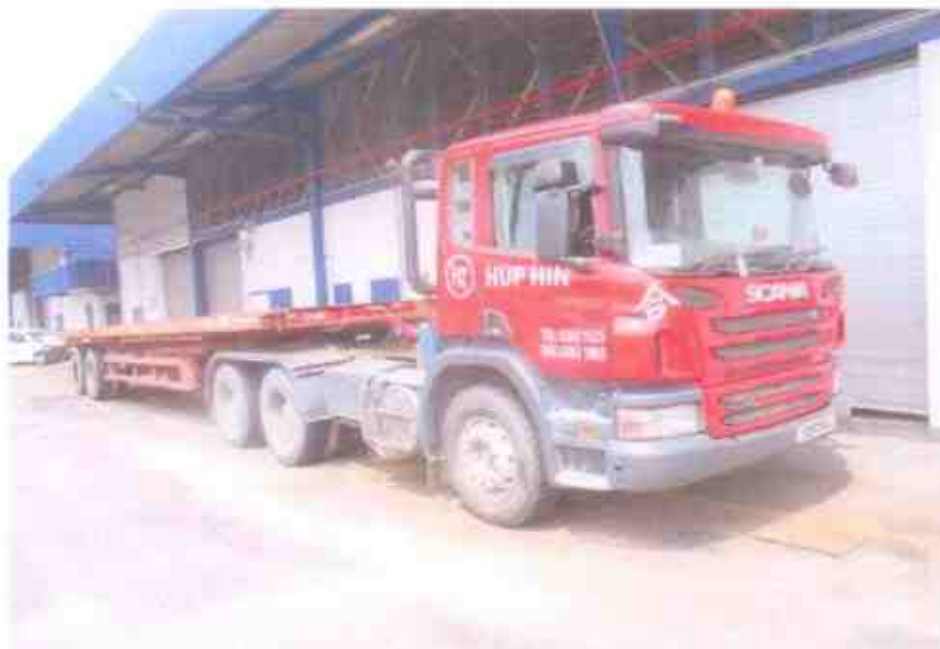
Photo 3 shows a general view of the front right body of the Motor Trailer at the time of our inspection. It was observed to be in good condition unaffected by the accident.

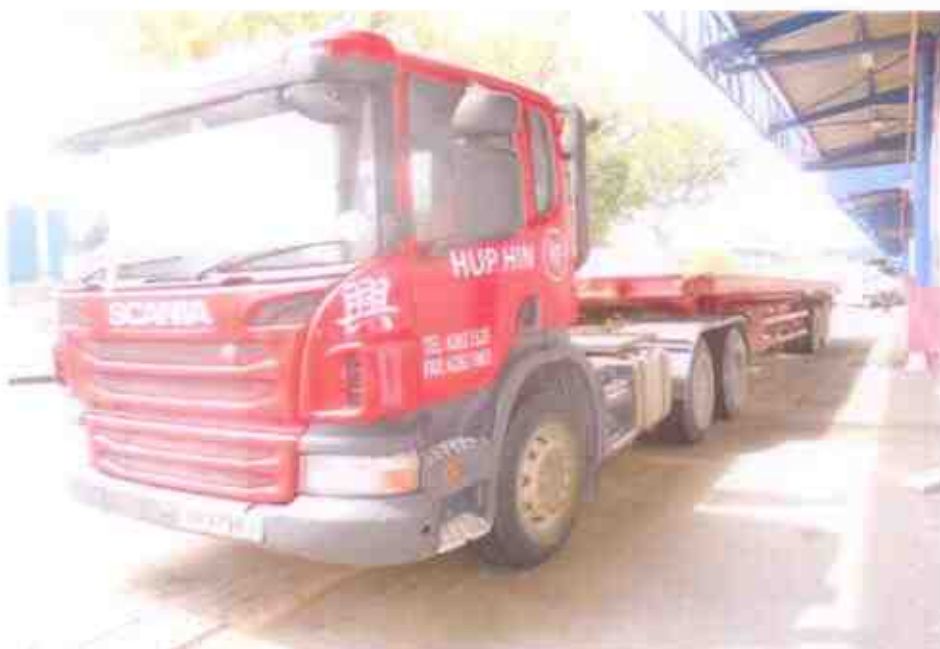
Photo 4 shows a general view of the front left body of the Motor Trailer at the time of our inspection. It was observed to be in good condition unaffected by the accident.

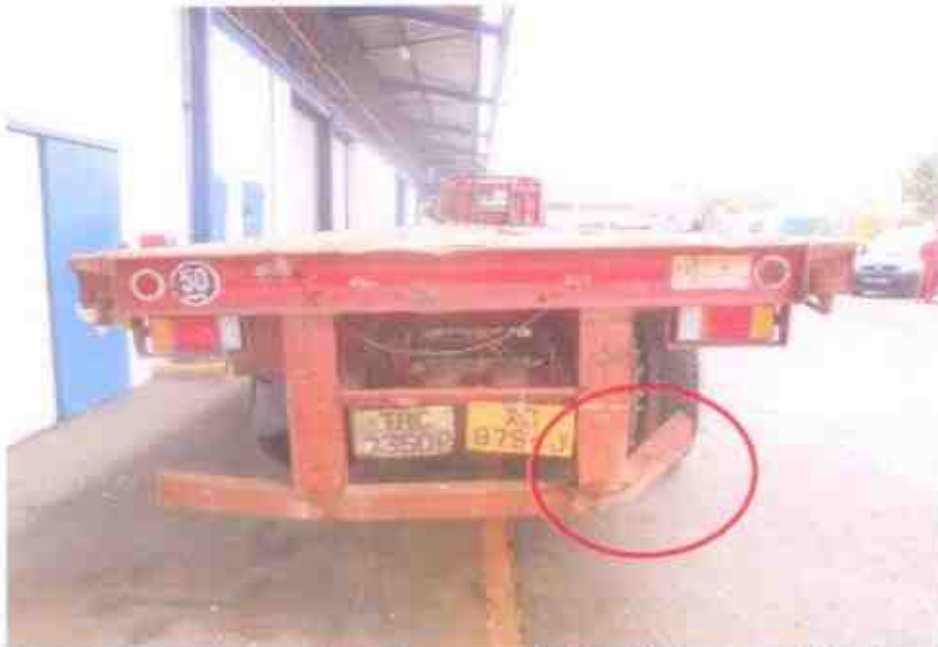
4. The mileage of the Motor Trailer at the time of our inspection was recorded at 101871.6 km.
5. The Motor Trailer was found to sustained minor damages on the rear right portion at the time of our inspection. Its steel crash bar was observed to be dented inwards & its rear right mud guard was found to be pushed towards the last rear tyre as a result of the accident.
6. This was likely due to the consistency of the accident's case facts that on 29th May 2018 at about 0623hrs along ECP towards Airport, a motorcycle (JQV4563) had collided onto the rear of the Motor Trailer. See photo 1 to 7.

Photo 5 shows a general view of the rear body of the Motor Trailer at the time of our inspection. It was observed to have sustained minor damages on the rear right crash bar due to the accident's impact collision.

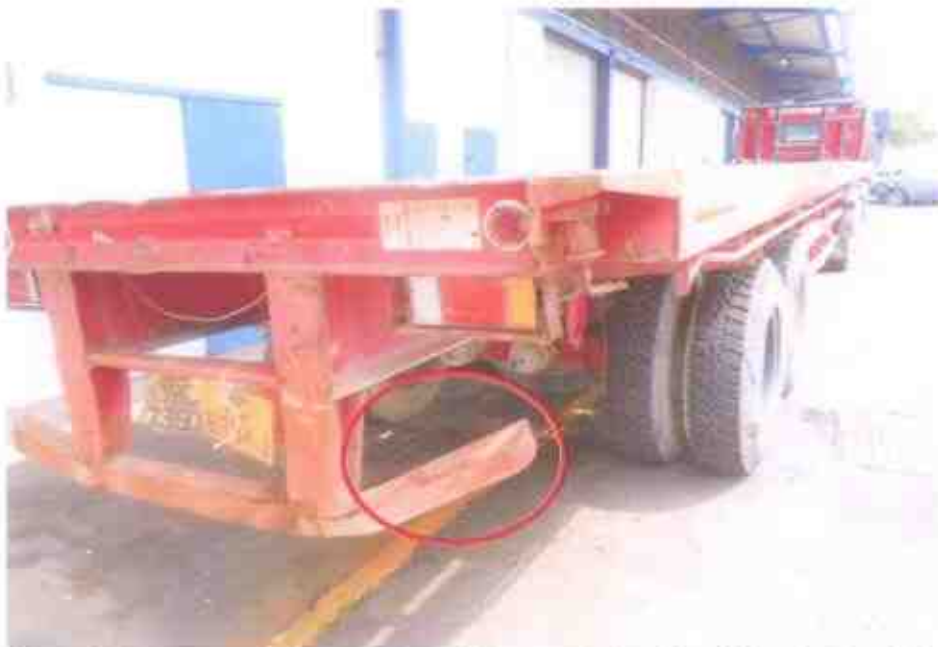
Photo 6 shows a semi-close-up view of the rear body of the Motor Trailer at the time of our inspection. It was observed to have sustained minor damages on the rear right crash bar due to the accident's impact collision.

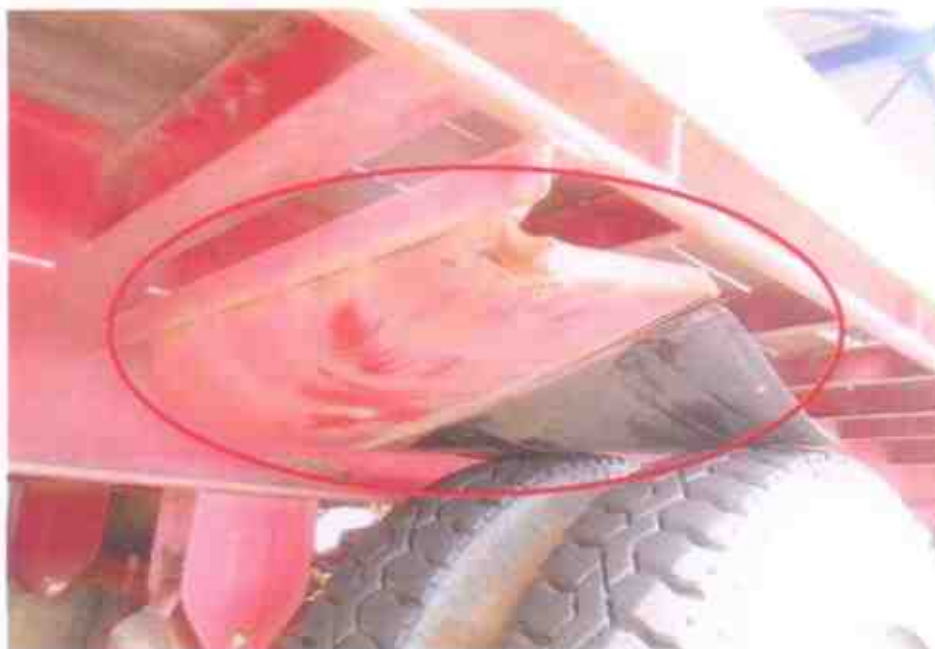
Photo 7 shows a close-up view of the rear right steel mud guard of the Motor Trailer at the time of our inspection. It was observed to have sustained minor damages due to the accident's impact collision.

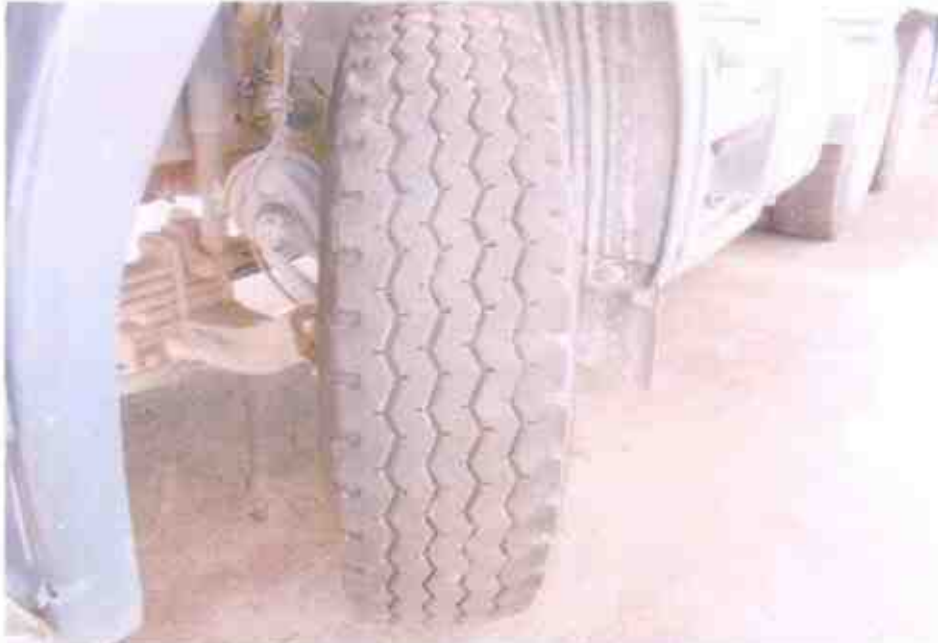
Photo 8 shows the condition of the front left tyre of the Motor Trailer, which was observed to be in serviceable condition with remaining tread depth of approximately 9mm.

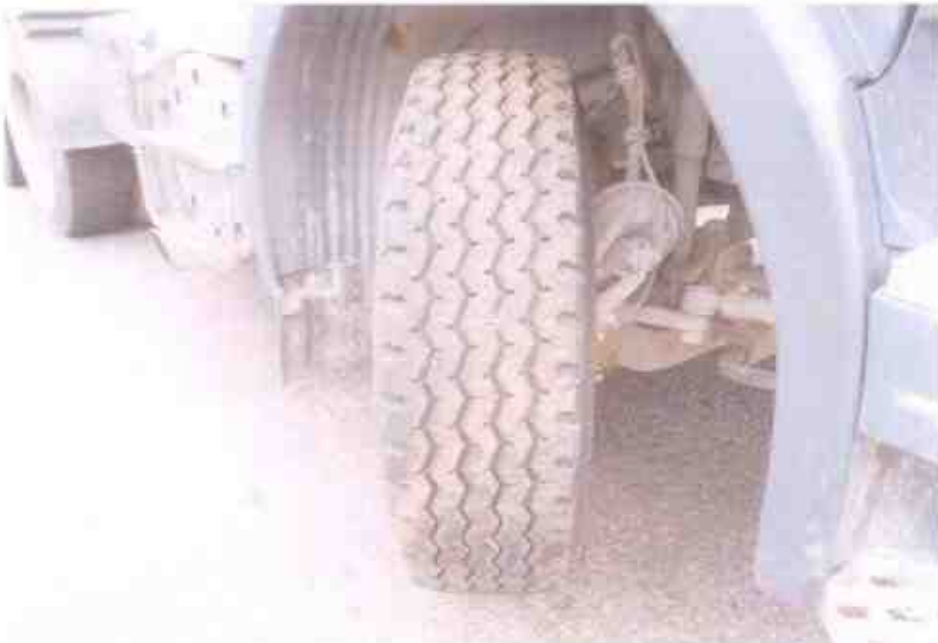
Photo 9 shows the condition of the front right tyre of the Motor Trailer, which was observed to be in serviceable condition with remaining tread depth of approximately 9mm.

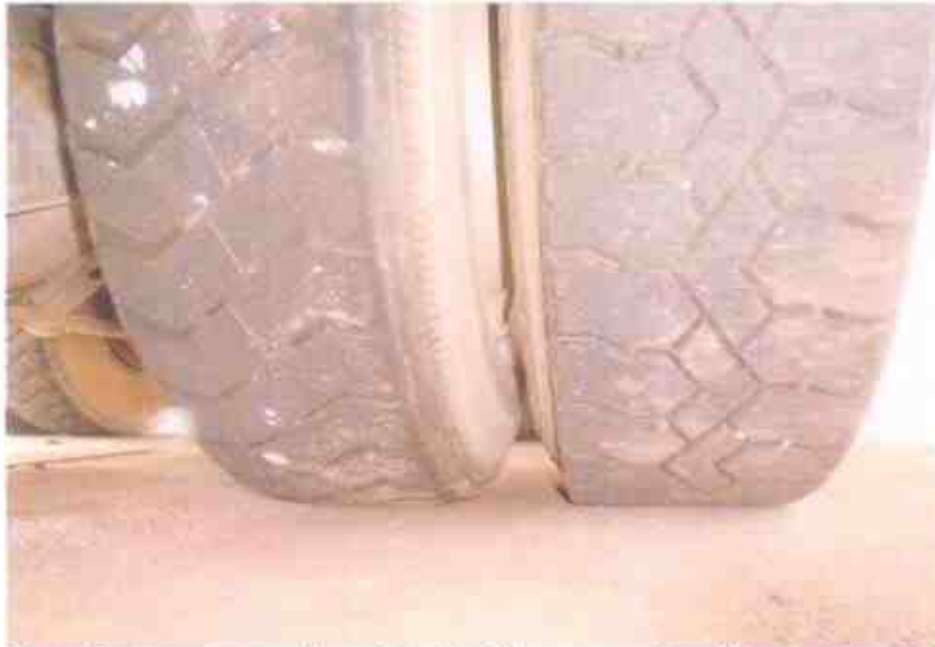
Photo 10 shows the condition of the left 2nd row tyres of the Motor Trailer, which were observed to be in serviceable condition with remaining tread depth of approximately 6mm. The tyres were also observed to be sufficiently inflated for vehicular operation.

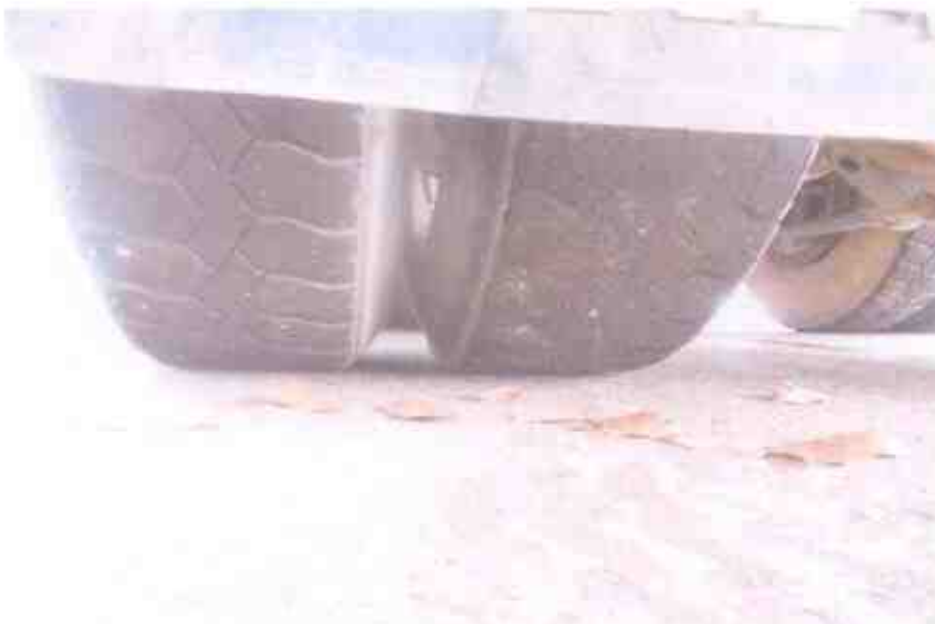
Photo 11 shows the condition of the left 3rd row tyres of the Motor Trailer, which were observed to be in serviceable condition with remaining tread depth of approximately 5mm. The tyres were also observed to be sufficiently inflated for vehicular operation.

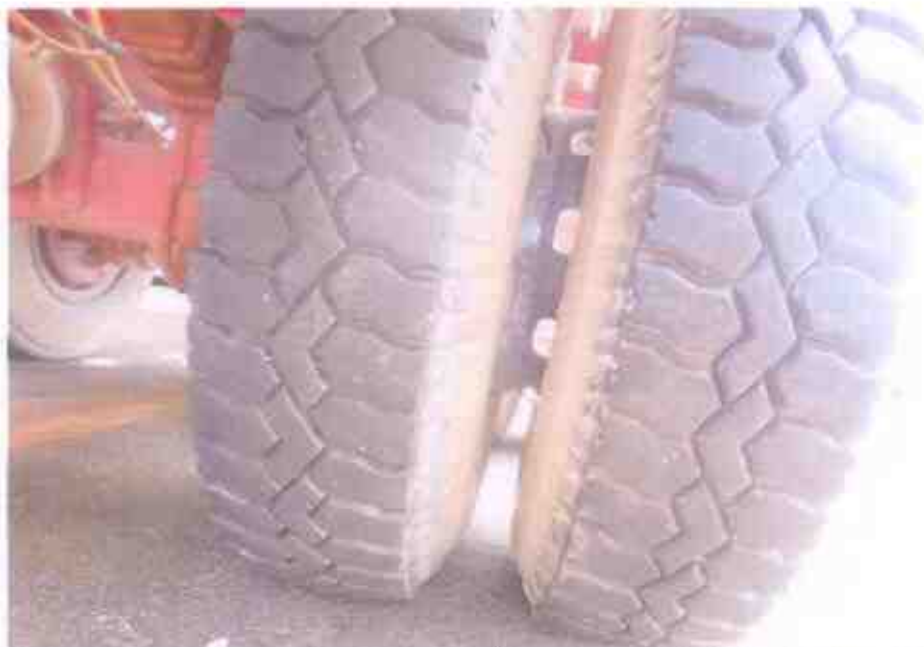
Photo 12 shows the condition of the left 4th row tyres of the Motor Trailer, which were observed to be in serviceable condition with remaining tread depth of approximately 5mm. The tyres were also observed to be sufficiently inflated for vehicular operation.

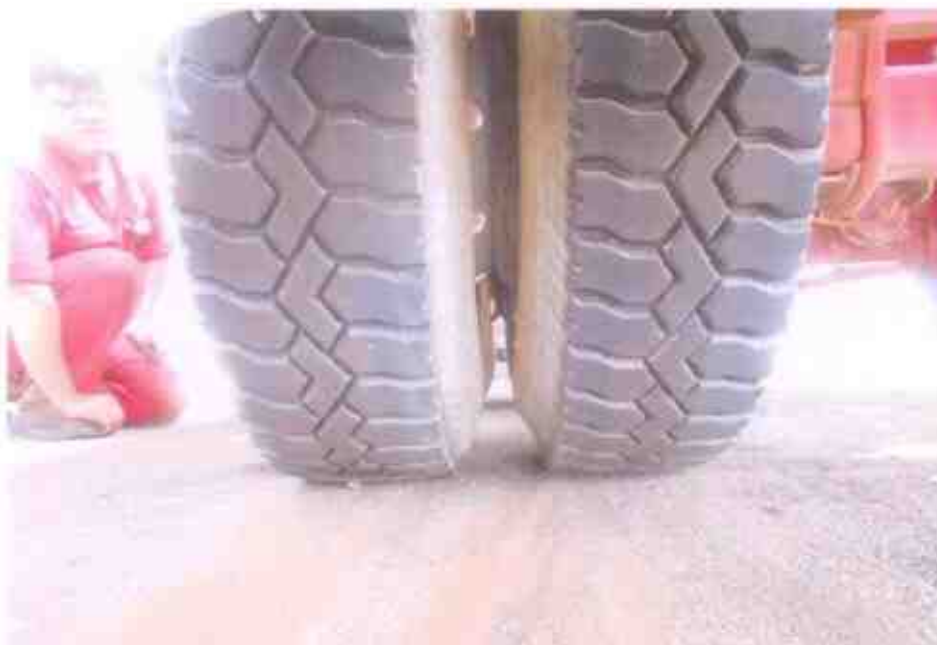
Photo 13 shows the condition of the rear left tyres of the Motor Trailer, which were observed to be in serviceable condition with remaining tread depth of approximately 8mm. The tyres, which were wrapped around standard alloy wheel rims, were also observed to be sufficiently inflated for vehicular operation.

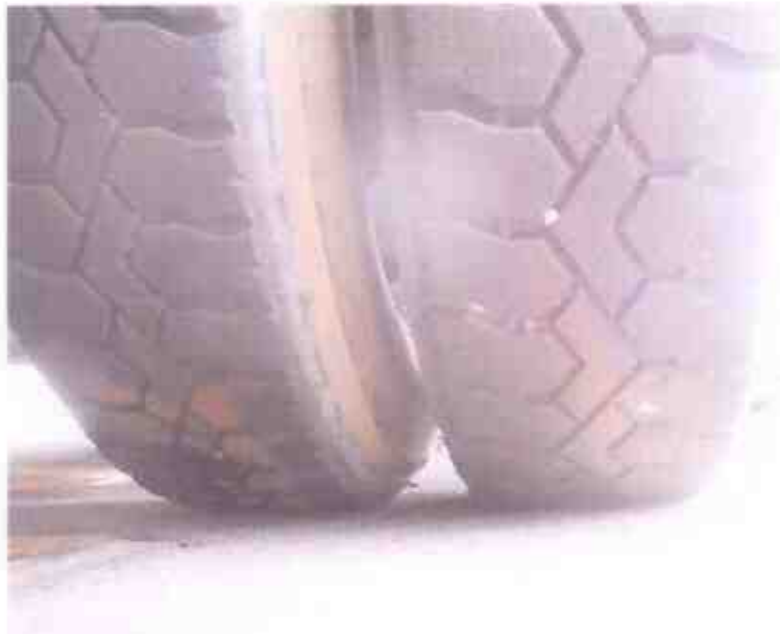
Photo 14 shows the condition of the right 2nd row tyres of the Motor Trailer, which were observed to be in serviceable condition with remaining tread depth of approximately 7mm. The tyres were also observed to be sufficiently inflated for vehicular operation.

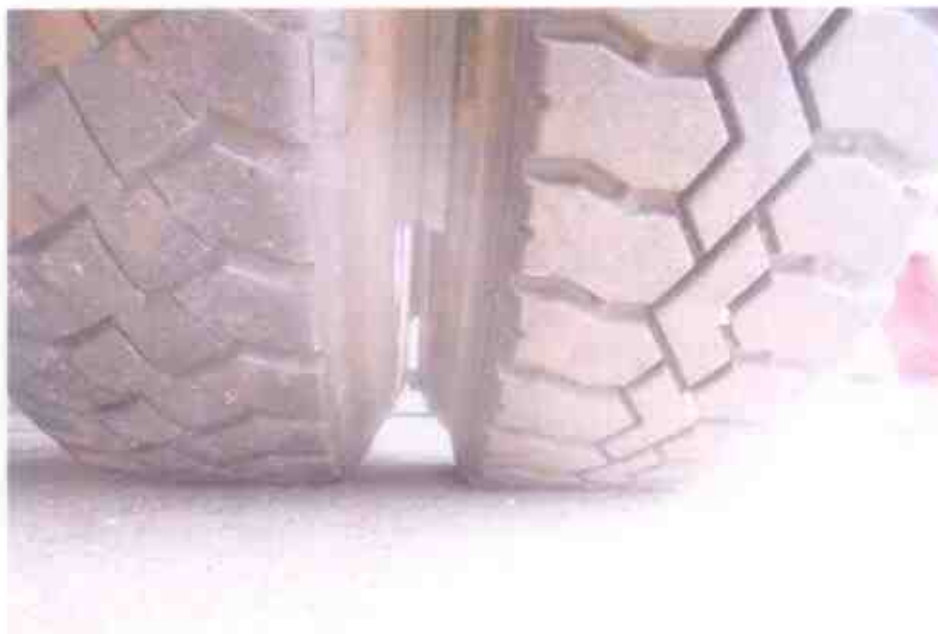
Photo 15 shows the condition of the right 3rd row tyres of the Motor Trailer, which were observed to be in serviceable condition with remaining tread depth of approximately 8mm. The tyres were also observed to be sufficiently inflated for vehicular operation.

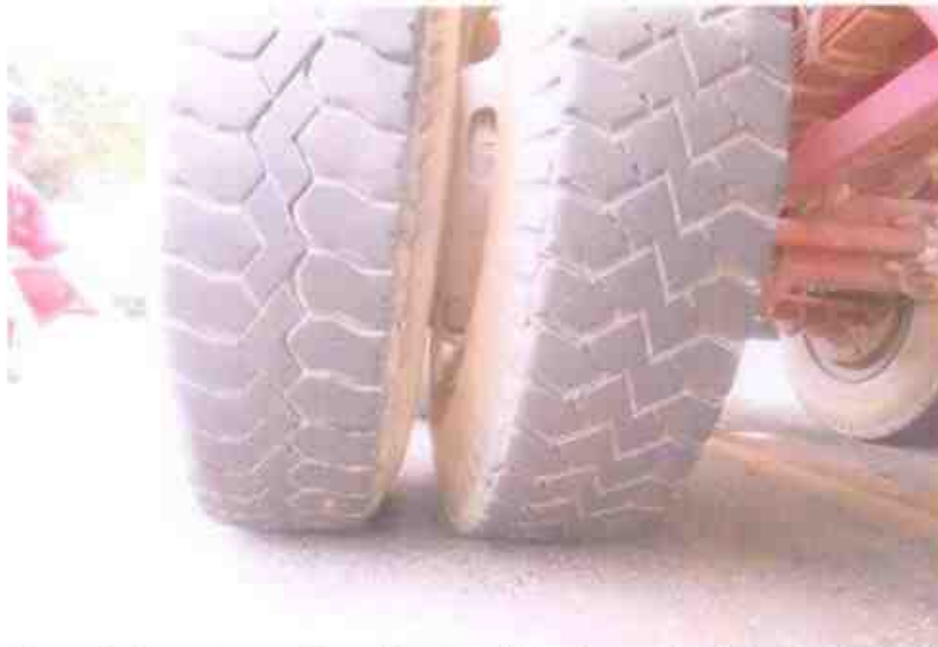
Photo 16 shows the condition of the right 4th row tyres of the Motor Trailer, which were observed to be in serviceable condition with remaining tread depth of approximately 5mm. The tyres were also observed to be sufficiently inflated for vehicular operation.

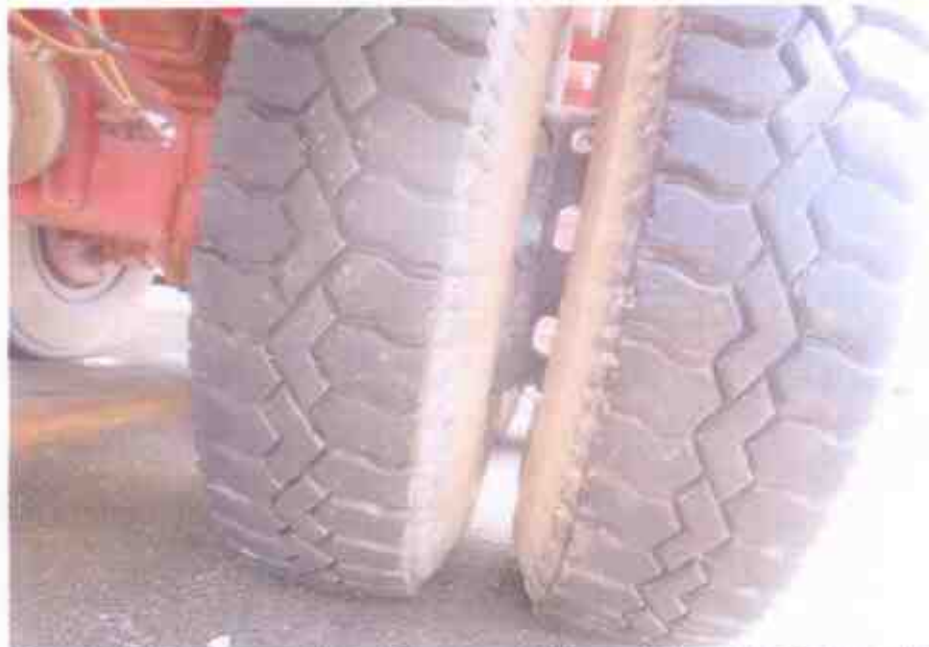
Photo 17 shows the condition of the rear right tyres of the Motor Trailer, which were observed to be in serviceable condition with remaining tread depth of approximately 8mm. The tyres, which were wrapped around standard alloy wheel rims, were also observed to be sufficiently inflated for vehicular operation.

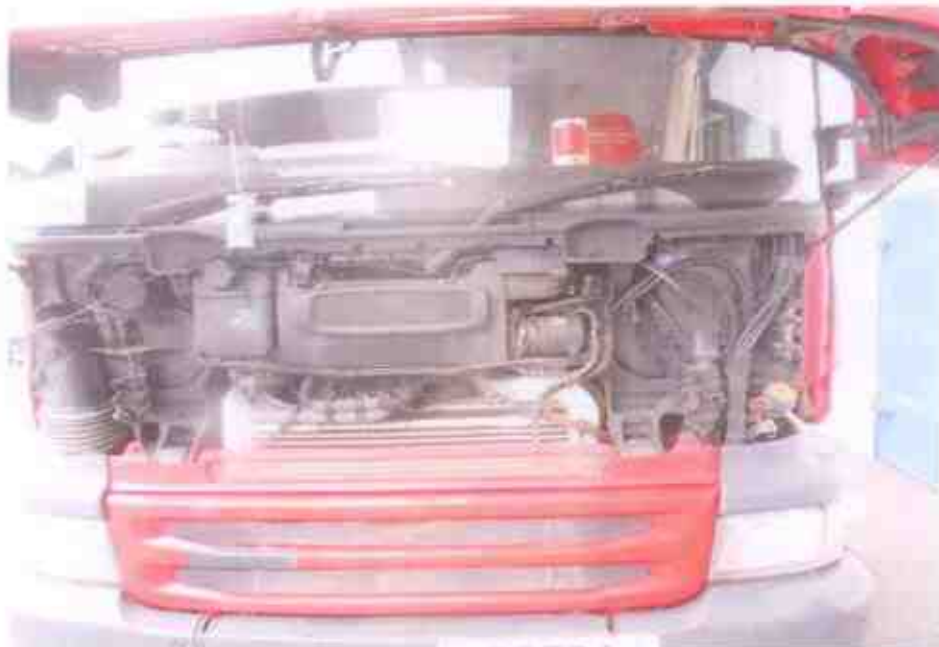
Photo 18 shows a general view of the engine compartment area from the front bonnet of the Motor Trailer. It was observed to be intact and unaffected by the collision. There was also no sign(s) or indication(s) of fluid leak and/or fluid stain found.

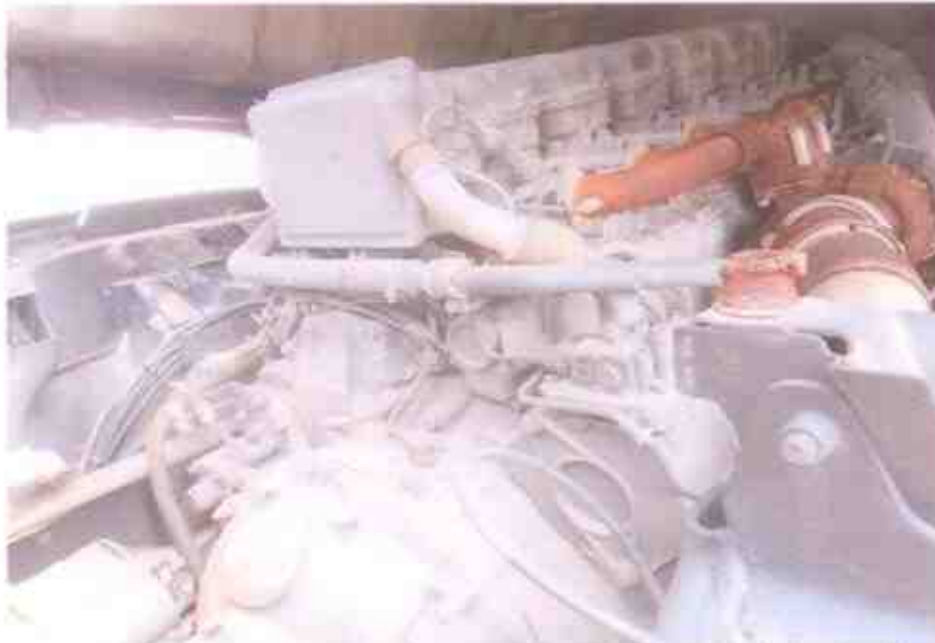
Photo 19 shows a general view of the engine area from under the front cabin of the Motor Trailer. The engine assembly and transmission assembly of the Motor Trailer were both observed to be intact and unaffected by the collision. There was also no sign(s) or indication(s) of fluid leak and/or fluid stain found.

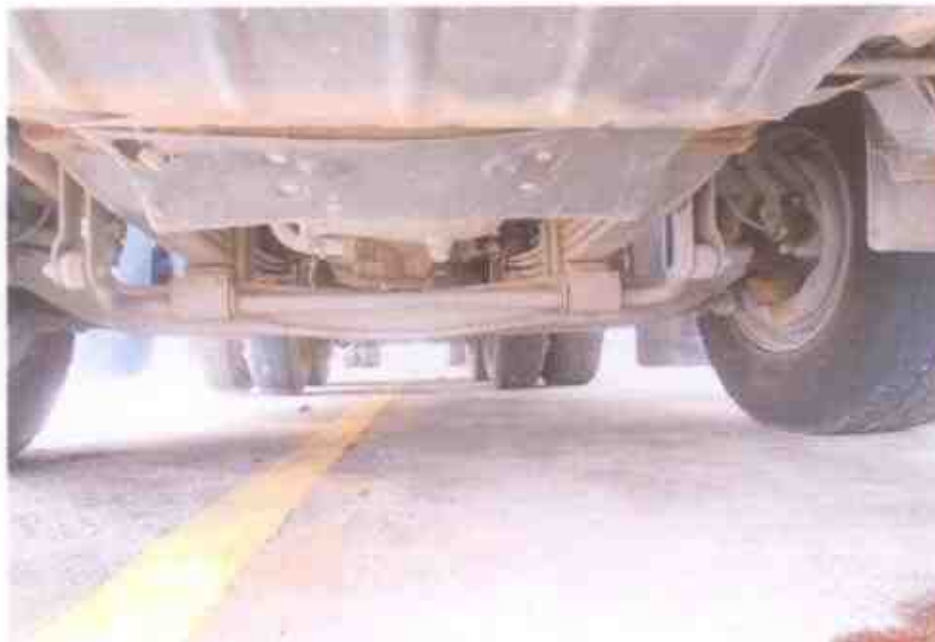
Photo 20 shows a general view of the engine area from the underside of the Motor Trailer. The engine assembly and transmission assembly of the Motor Trailer were both observed to be intact and unaffected by the collision. There was also no sign(s) or indication(s) of fluid leak and/or fluid stain found.

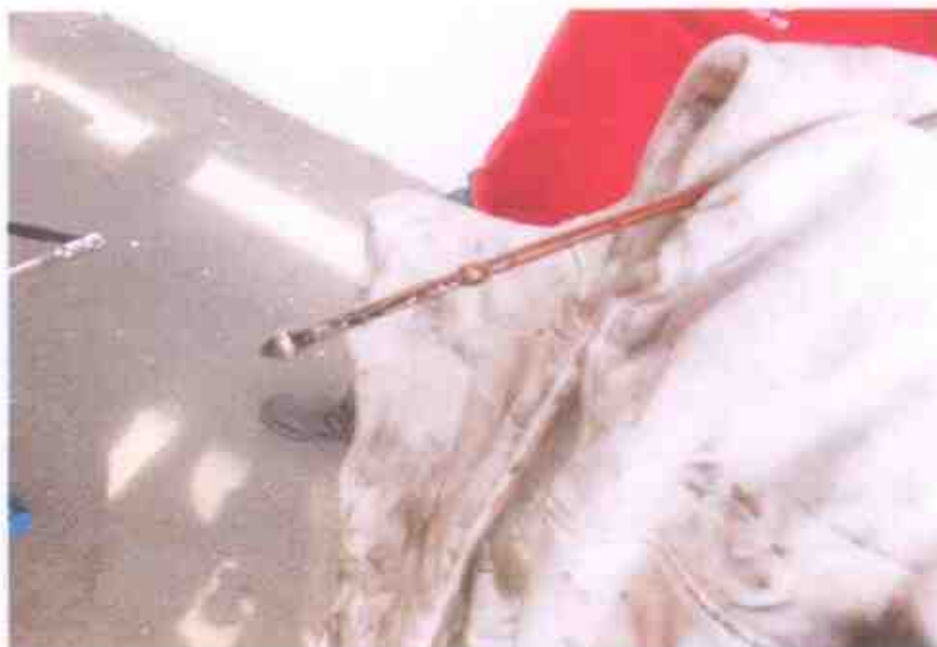
Photo 21 shows the engine dip stick at the time of our inspection. The engine fluid was observed to be of sufficient level and without any visible contamination for operational purposes.

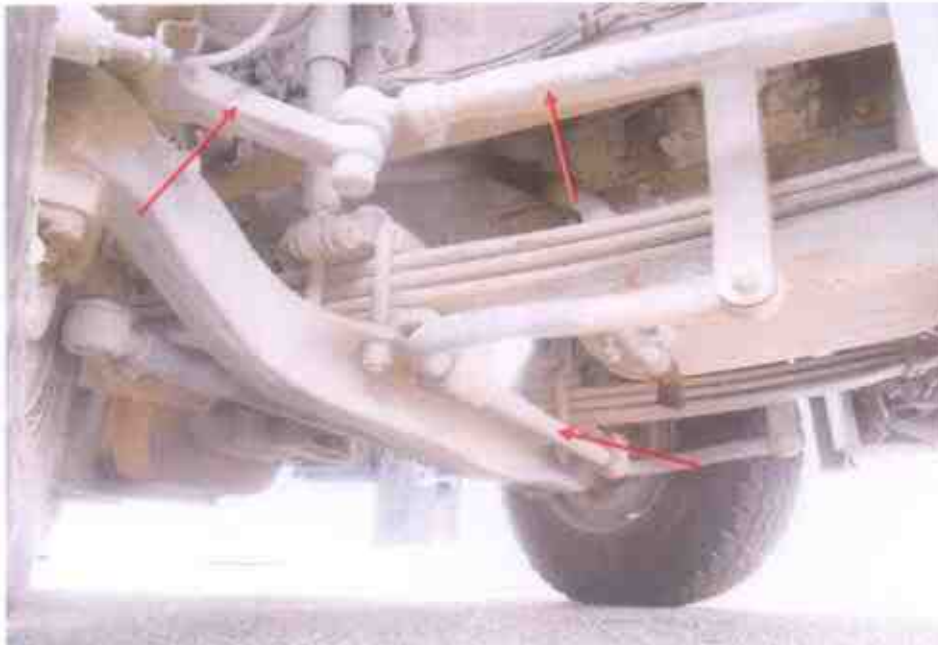
Photo 22 shows some of the mechanical components (arrowed) of the Motor Trailer's steering system. Our visual checks on the various mechanical components of the steering system revealed all to be intact and in good condition. The steering system of the Motor Trailer is hence likely to be in serviceable condition at the time of accident.

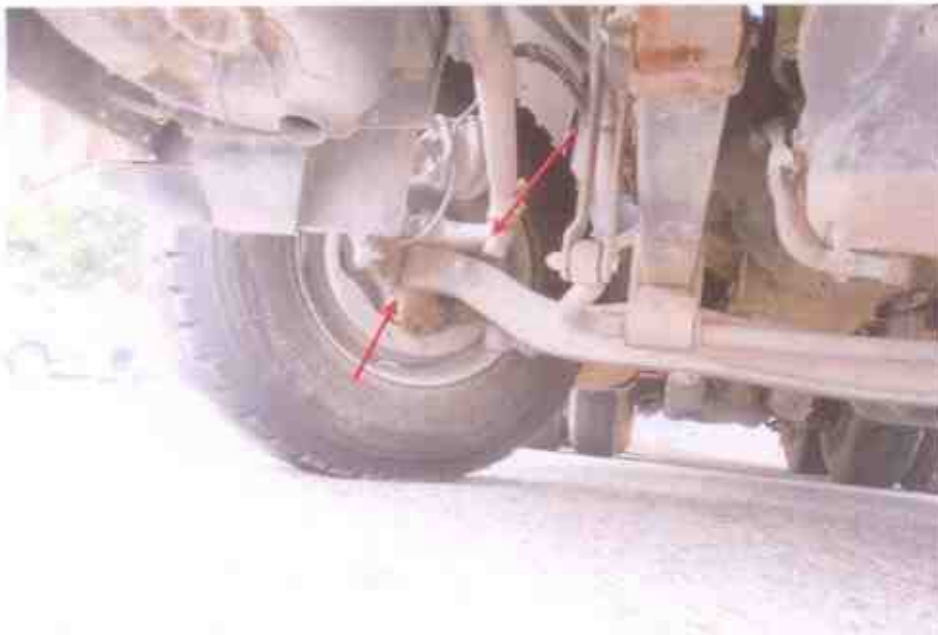
Photo 23 shows the undercarriage components at the front right wheel of the Motor Trailer. The various undercarriage components of the Motor Trailer were all observed to be intact and without any visible damage. This had included the steering rack and steering linkages (arrowed) of the Motor Trailer.

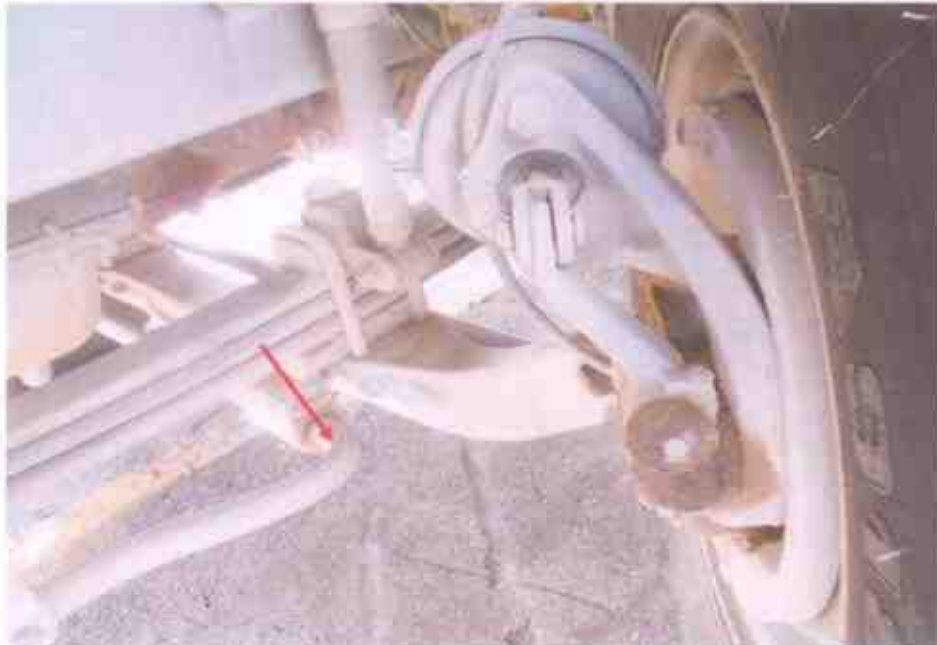
Photo 24 shows the undercarriage components at the front left wheel of the Motor Trailer. The various undercarriage components of the Motor Trailer were all observed to be intact and without any visible damage. This had included the steering rack (arrowed) of the Motor Trailer, which was observed to be securely attached to the front left wheel and front right wheel.

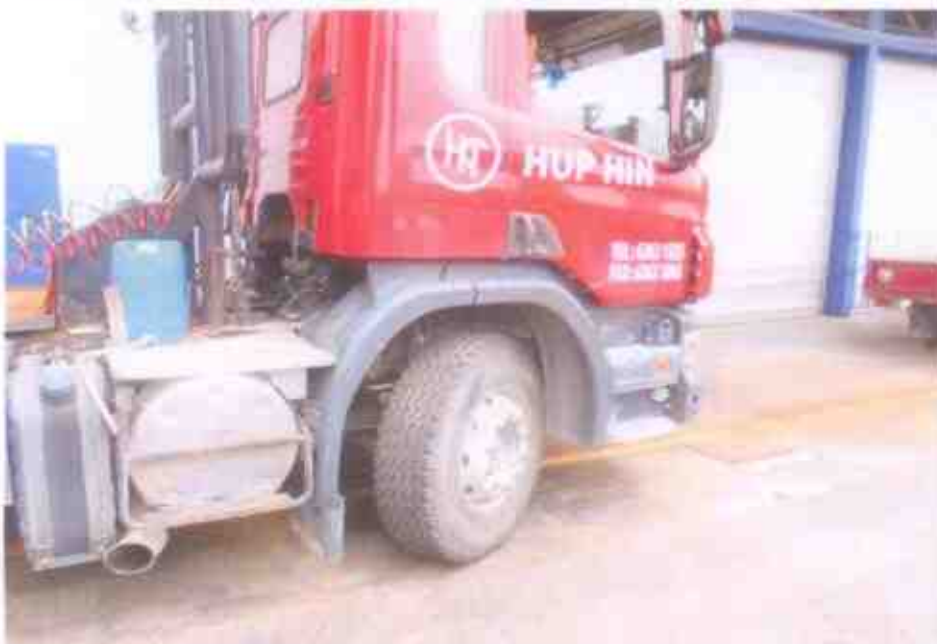
Photo 25 shows that we did not experience any abnormal free play and/or other resistance when turning the steering wheel left and right to full lock positions.

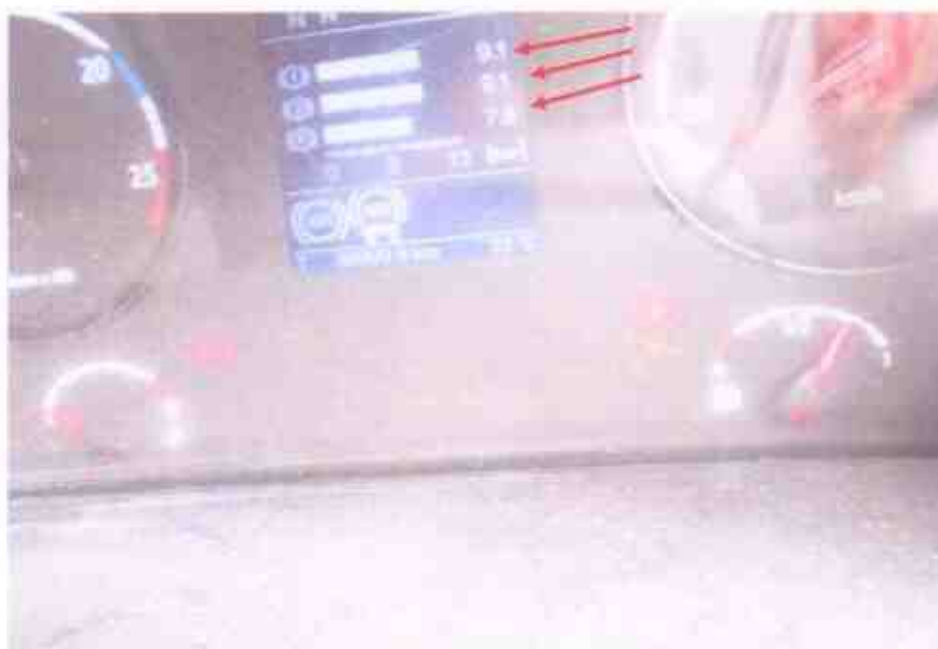
15. 2 numbers of air tanks in particular were observed to be also in serviceable condition. Air built up to an acceptable level which is level 9.1 (On the display panel) for both air tanks for operational ready status after a warming up session prior the operational test. Both air tanks were monitored for about 10 minutes for an observation of any abnormalities. Both air tanks pressure found to be normal without any drop in pressure during the course of our monitoring session. This would indicate that there was no leak of air pressure from the air braking system of the Motor Trailer. See photo 26 below.

Photo 26 shows the compressed air meters for braking system. This shows that there's no dropped of pressure. Hence, revealed that no air leakage at the time of our inspection.

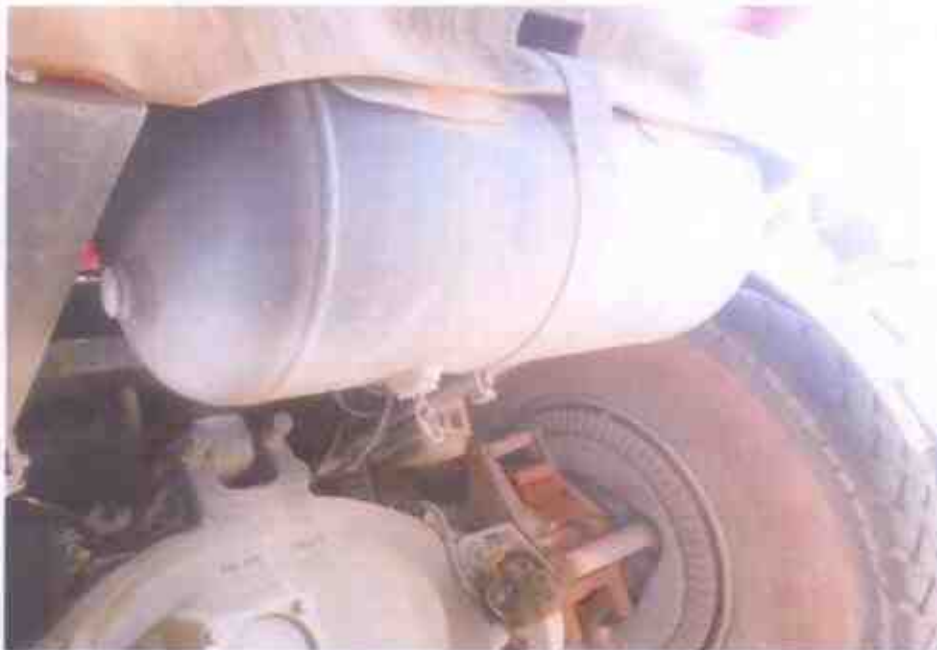
Photo 27 shows the air tanks, valves, pipes and hoses, which are some of the components for the full air-assisted braking system of the Motor Trailer. These components were mainly located at the underside of the Motor Trailer and were unaffected by the accident.

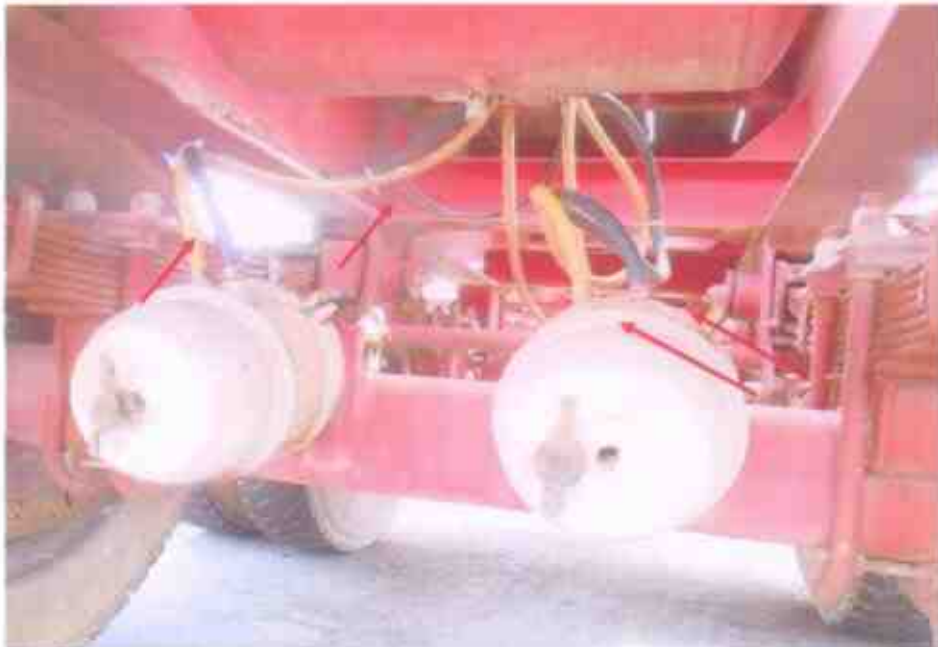
Photo 28 shows the valves, brake hoses and pipes, which are some of the components for the air-assisted braking system of the Motor Trailer. These components were observed to be unaffected by the accident. Our visual examination of these parts revealed all to be in good general condition and securely fitted.

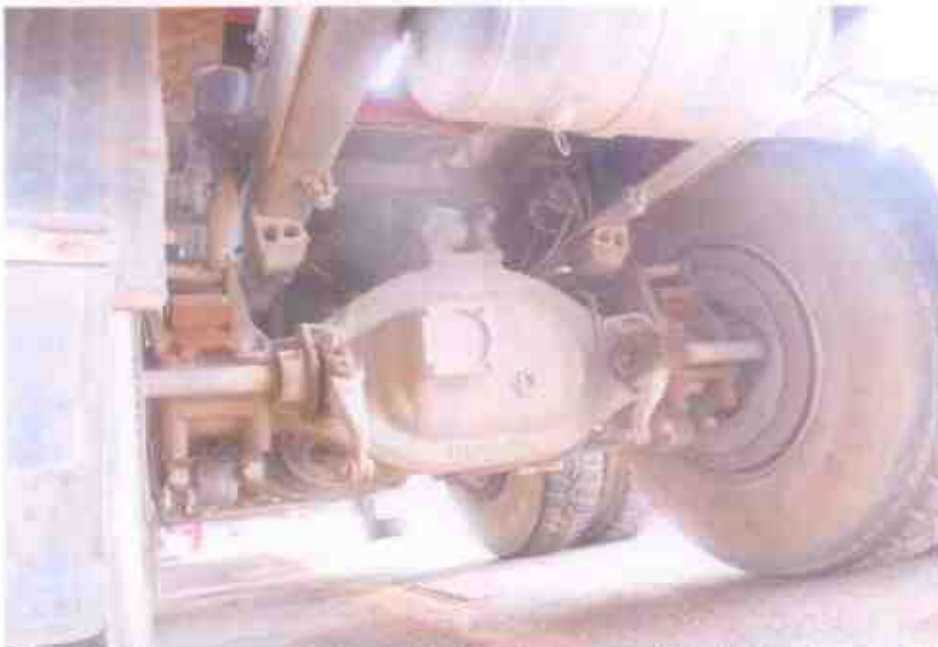
Photo 29 shows the brake hoses leading to the rear left wheel and rear right wheel of the Motor Trailer. At the time of our inspection, the various mechanical components of the air-assisted hydraulic braking system of the Motor Trailer were all found to be in good general condition and securely fitted.

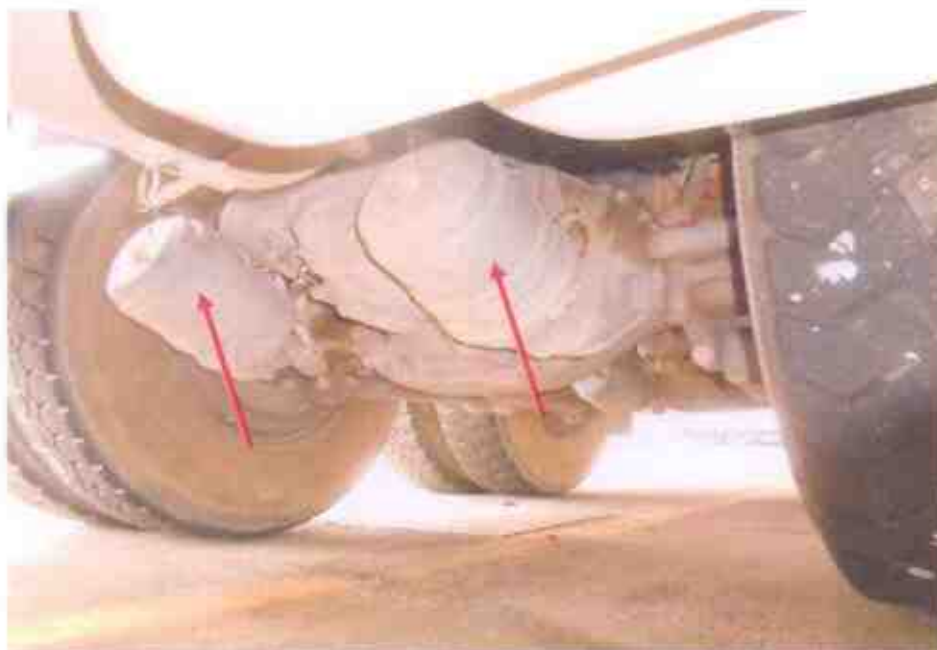
Photo 30 shows the brake air cylinder (arrowed) at the rear left rear wheel of the Motor Trailer. Such air cylinder, which is amongst the various components for the air-assisted hydraulic braking system, can be found attached to all the front wheels and all the rear wheels of the Motor Trailer. Upon our checks, we had found all the brake air cylinders to be undamaged and securely fitted to all the wheels of the Motor Trailer.

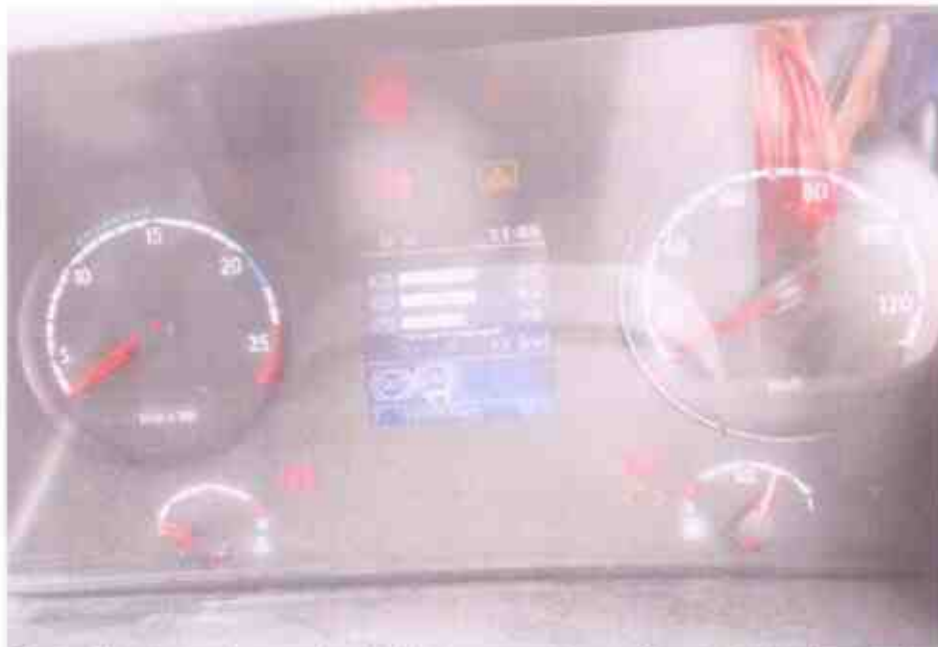
Photo 31 shows the warning indicator was observed to be lighted up before cranking of the engine.

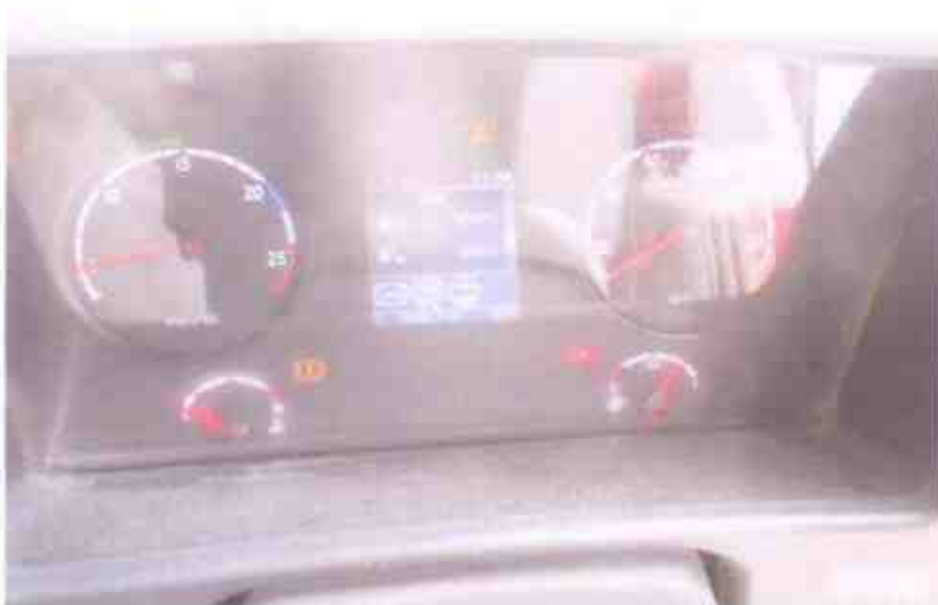
Photo 32 shows some warning indicators were observed to be disappearing during the idling speed of the engine.
