Auto
Consultants
Pte Ltd

Your Ref: TP/IP/31275/2018
Our Ref : CI/TPD18011358/Z

20th August 2018

MECHANICAL INSPECTION REPORT OF MOTOR BUS SBS 5095U

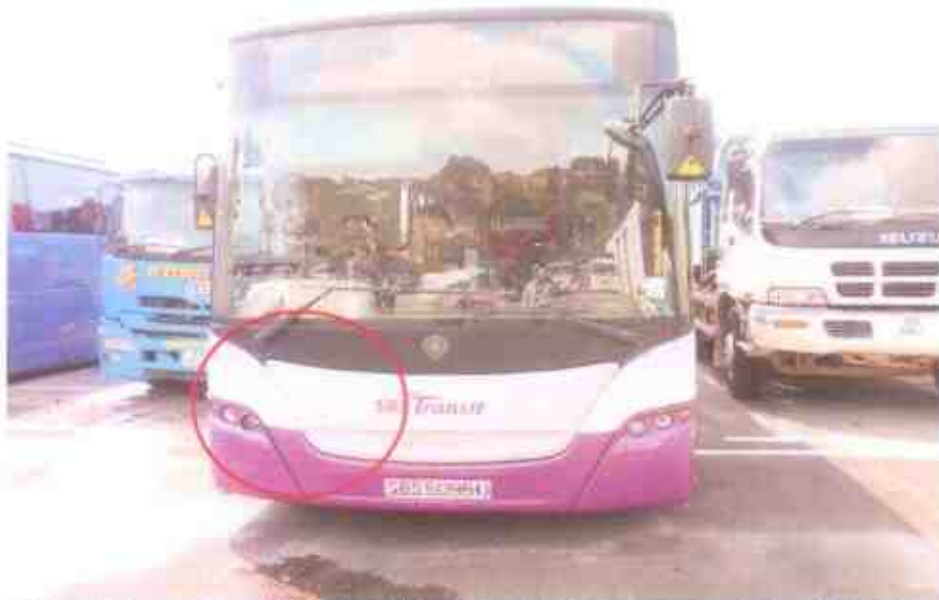
7. The damages under paragraph 5 were consistent with the accidents case fact that the Motor Bus was travelling along Lavender Street when it collided onto a pedestrian who was crossing from the right along Lavender Street. See photo 1 – 6 below.

Photo 1 shows a general view of the Motor Bus that sustained minor damages at its front right portion as a result of the accident's collision.

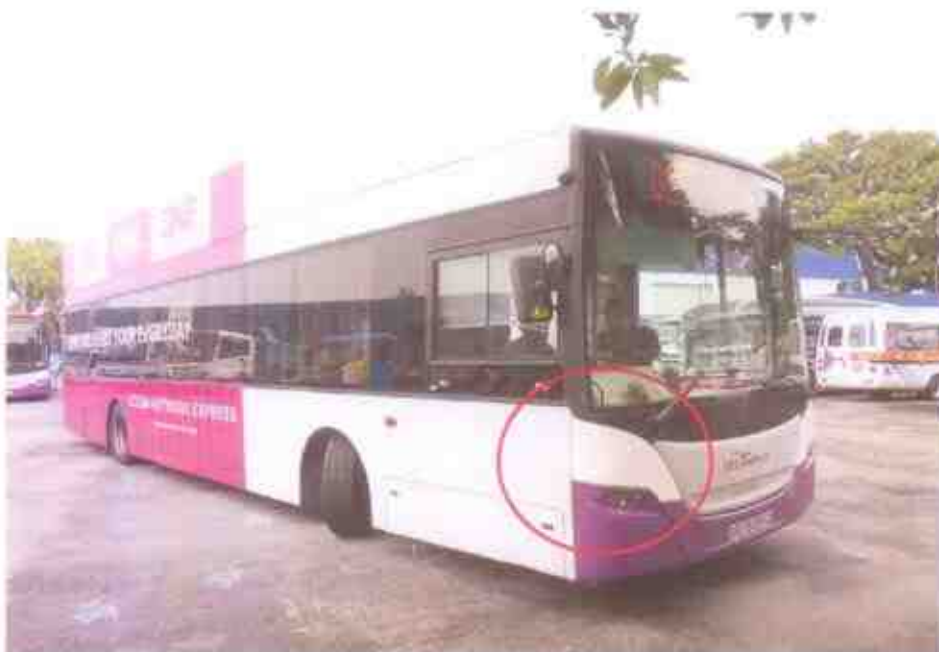
Photo 2 shows a general view of the Motor Bus that sustained minor damages at its front right portion as a result of the accident's collision.

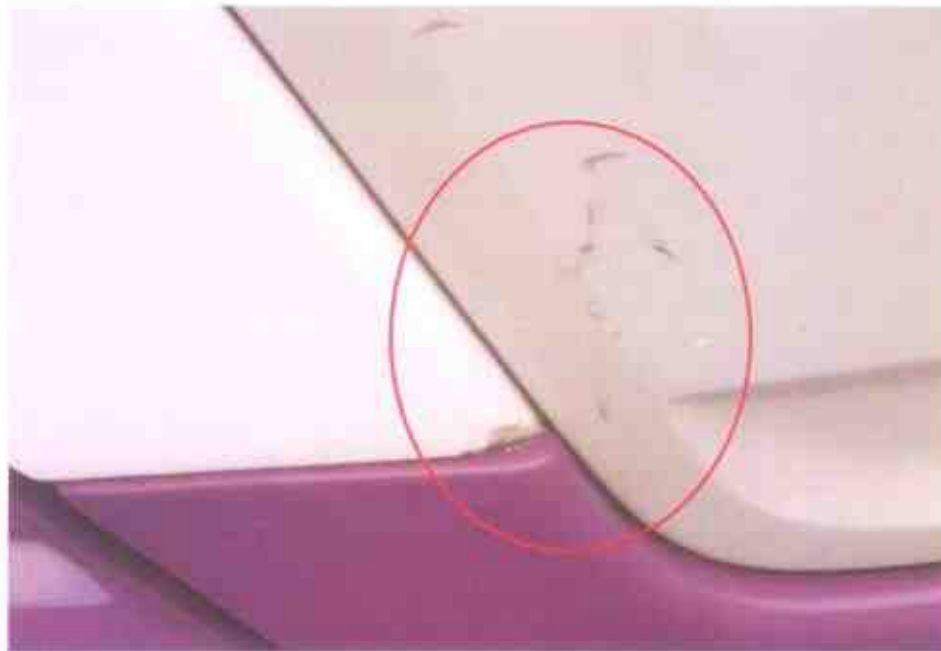
Photo 3 shows a close-up view of the front right body of the Motor Bus at the time of our inspection. The Motor Bus was observed to sustained minor damages due to the accident's impact.

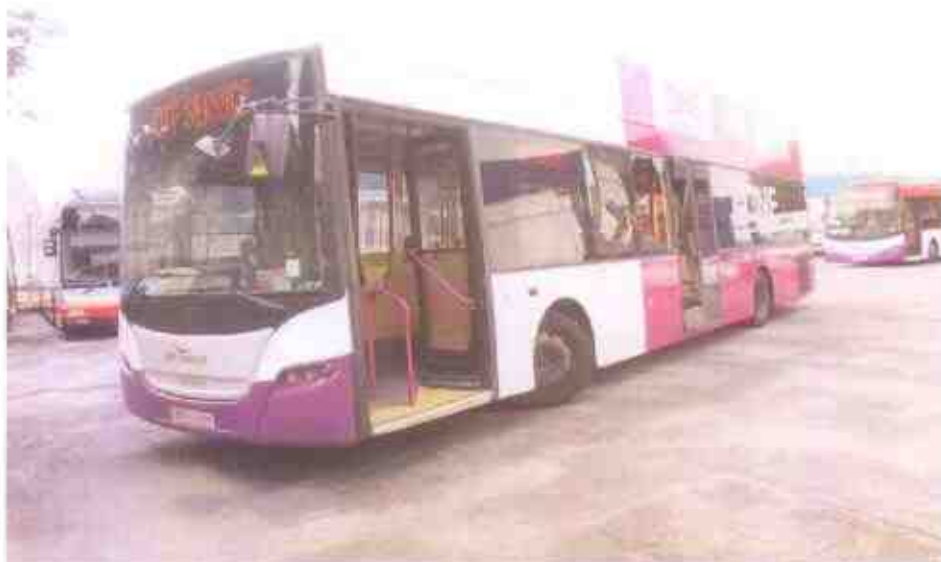
4. The mileage of the Motor Bus at the time of our inspection was recorded as 642441.4km.
5. The Motor Bus was observed to have sustained minor damages at its frontal right portion. Its front panel was observed to sustained minor chipped off & some minor scratches were noted at other nearby areas at time of our inspection.
6. Further observation on the damages sustained on the Motor Bus, we found that the left side of the Motor Bus sustained damages not consistent to the accident's case fact which includes shattering window glass & damaged passenger rear door. Investigation reveals that it was hit by a Motor Lorry bearing registration no. XE 1061G while trying to parked beside the Motor Bus in the vicinity of Traffic Police Pound. Details were recorded by Traffic Police Pound personnel. Investigation Officer in-charge was informed of this incident & he acknowledged.

Photo 4 shows a general view of the Motor Bus front left portion that was observed with damages not consistent to the accident's case fact. Window glass & rear passenger door found to be damaged at time of our inspection. Refer to paragraph 6 for details.

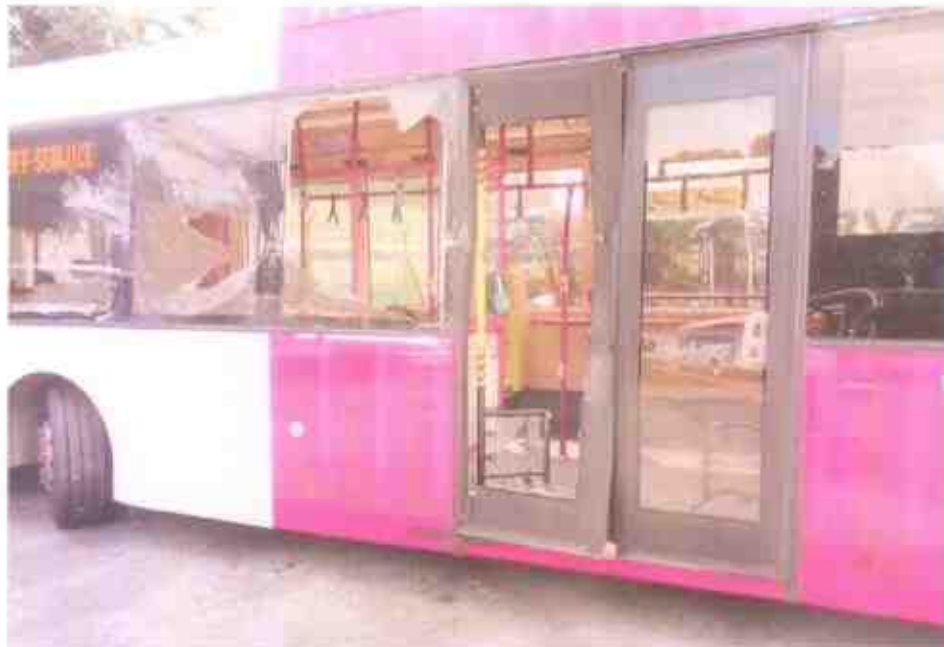
Photo 5 shows a semi close-up view of the damages on the left portion of the Motor Bus.

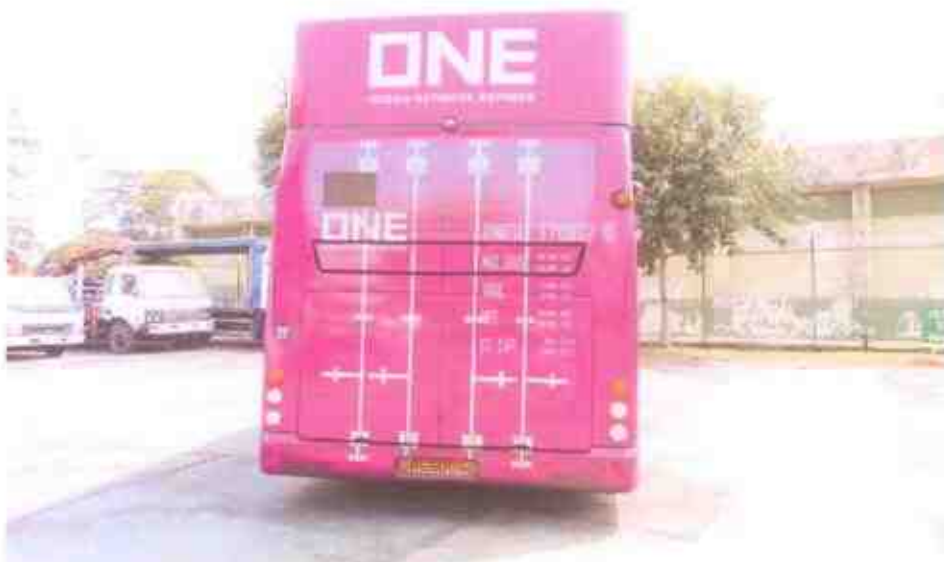
Photo 6 shows a general view of the Motor Bus rear portion that was not affected by the accident's collision.

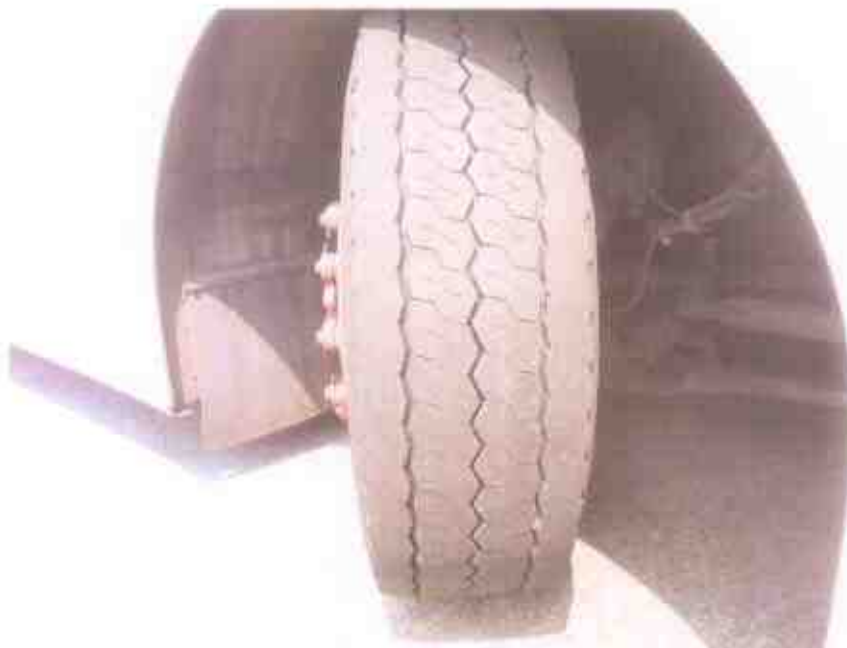
Photo 7 shows the condition of the front right tyre of the Motor Bus, which was observed to be in serviceable condition with remaining tread depth of approximately 8mm. The tyre was also observed to be sufficiently inflated for vehicular operation.

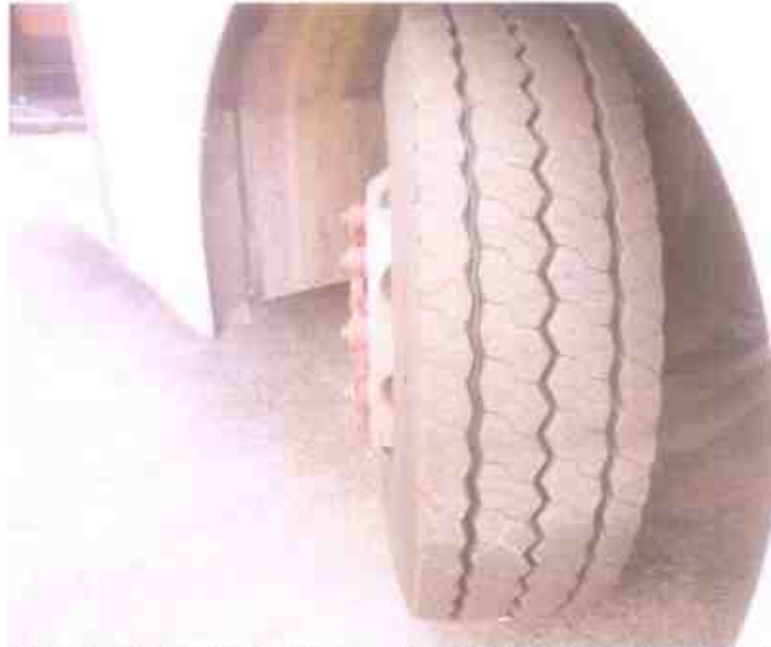
Photo 8 shows the condition of the front left tyre of the Motor Bus, which was observed to be in serviceable condition with remaining tread depth of approximately 9mm. The tyre was also observed to be sufficiently inflated for vehicular operation.

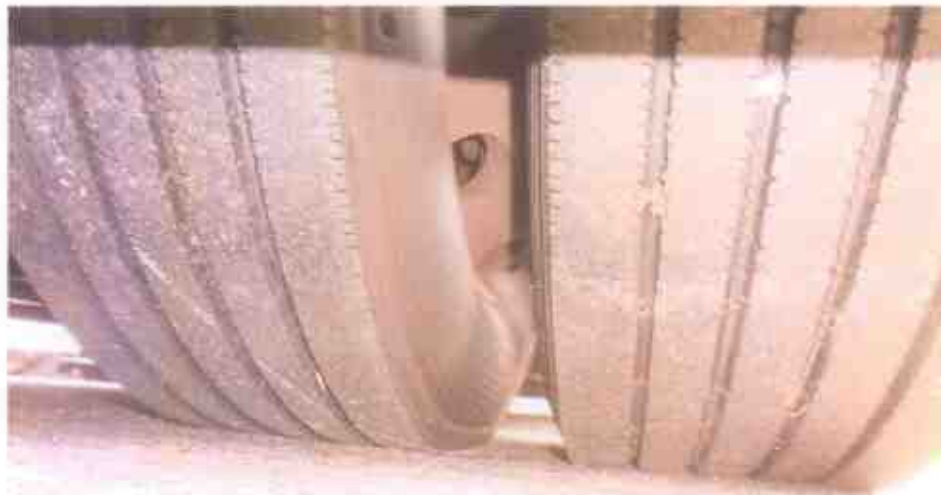
Photo 9 shows the condition of the rear right tyres of the Motor Bus, which were observed to be in serviceable condition with remaining tread depth of approximately 9mm. The tyres, which were wrapped around standard alloy wheels rims, were also observed to be sufficiently inflated for vehicular operation.

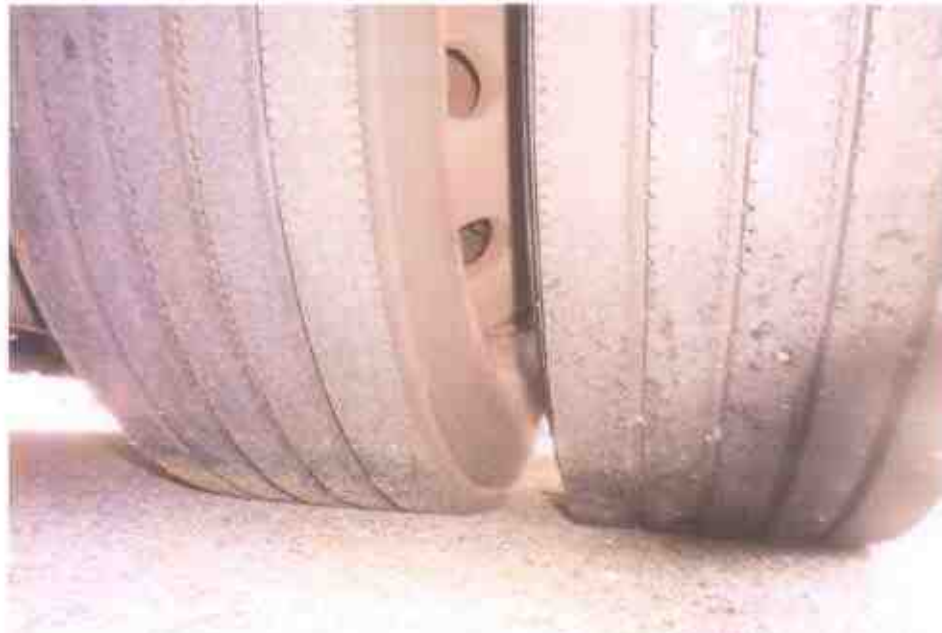
Photo 10 shows the condition of the rear left tyres of the Motor Bus, which were observed to be in serviceable condition with remaining tread depth of approximately 8mm. The tyres, which were wrapped around standard alloy wheel rims, were also observed to be sufficiently inflated for vehicular operation.

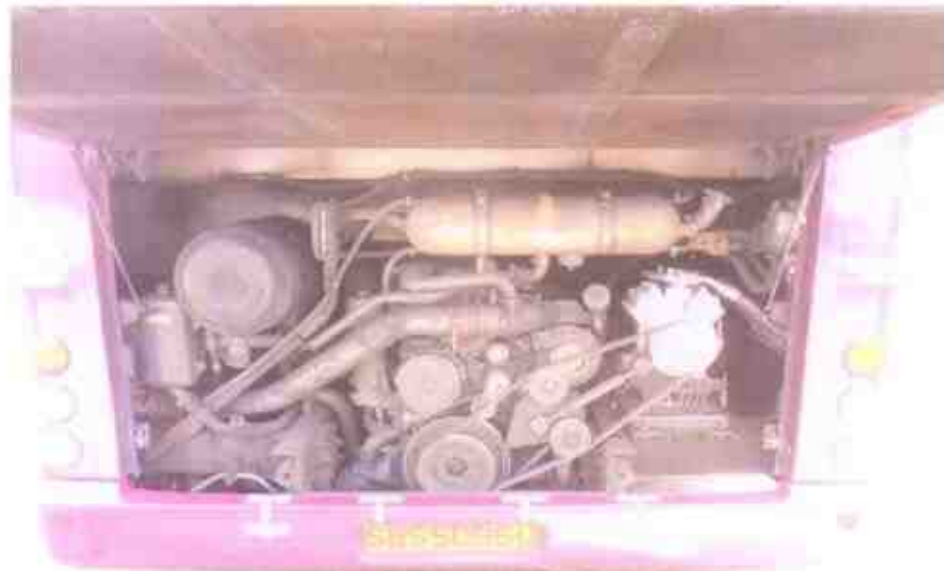
10. Upon examination of the engine compartment of the Motor Bus, we had observed all the parts and components inside the engine compartment to be intact and unaffected by the accident. The engine oil and steering fluid were all found to be of sufficient level for operating purposes. Visually, there was also no contamination found to these fluids.

Photo 11 shows the engine compartment of the Motor Bus was located at the rear of the Motor Bus.

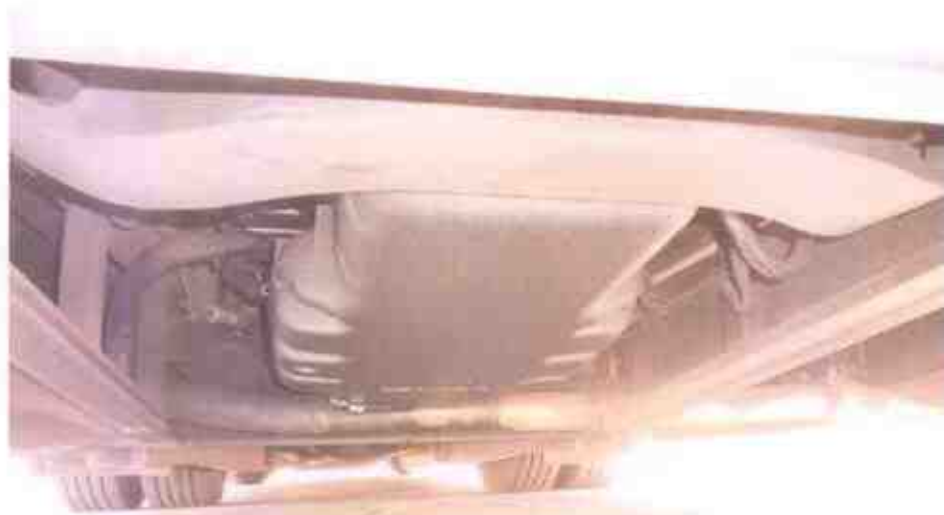
12. Our subsequent checks on the underside of the Motor Bus reveals some fluid stain sighted under the engine compartment. Further investigation found that the fluid stain was a pre-existed prior the accident & not a fresh fluid. This was due to some dirt observed on the fluid stain. Conclusively, it is not likely to be related to the accident. Visually, the various undercarriage components of the Motor Bus were observed to be intact and without any visible damage except for the damages caused by the accident. See photo 11 – 16 below.

Photo 12 shows the engine undercarriage of the Motor Bus. Some pre-existed fluid was observed at time of our inspection.

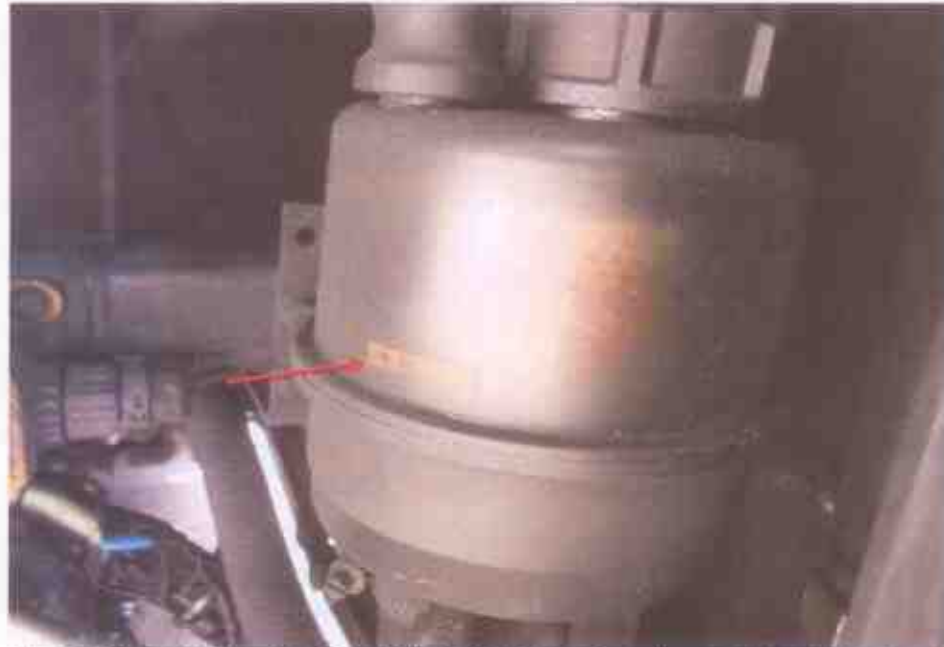
Photo 13 shows the steering fluid of the Motor Bus. It was observed to be of sufficient level without any contamination at time of our inspection.

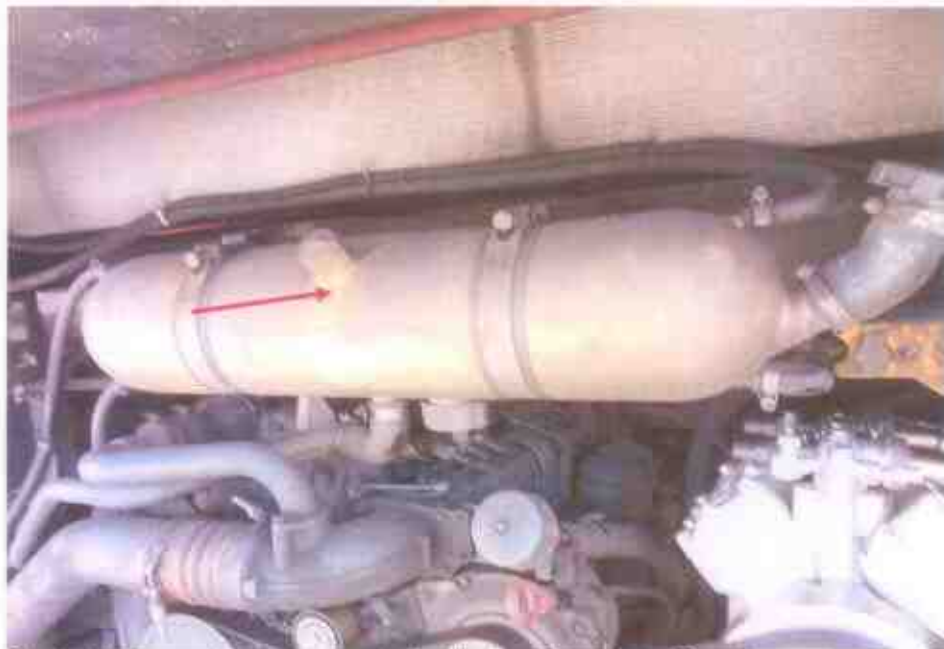
Photo 14 shows the engine coolant cylinder of the Motor Bus. It was observed to be of sufficient level without any contamination at time of our inspection.

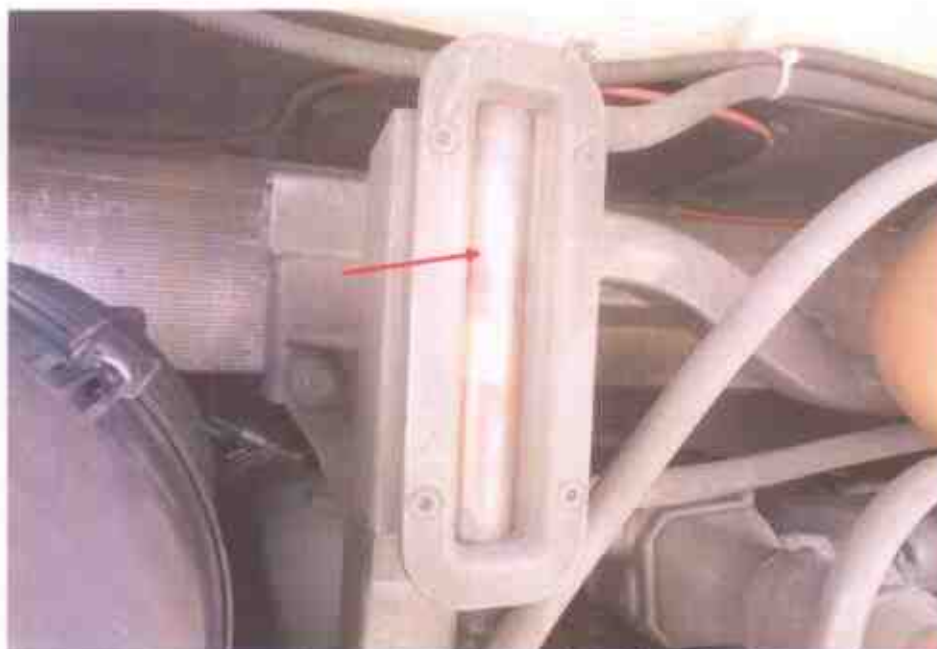
Photo 15 shows the engine coolant indicator of the Motor Bus. It was observed to be of sufficient level without any contamination at time of our inspection.

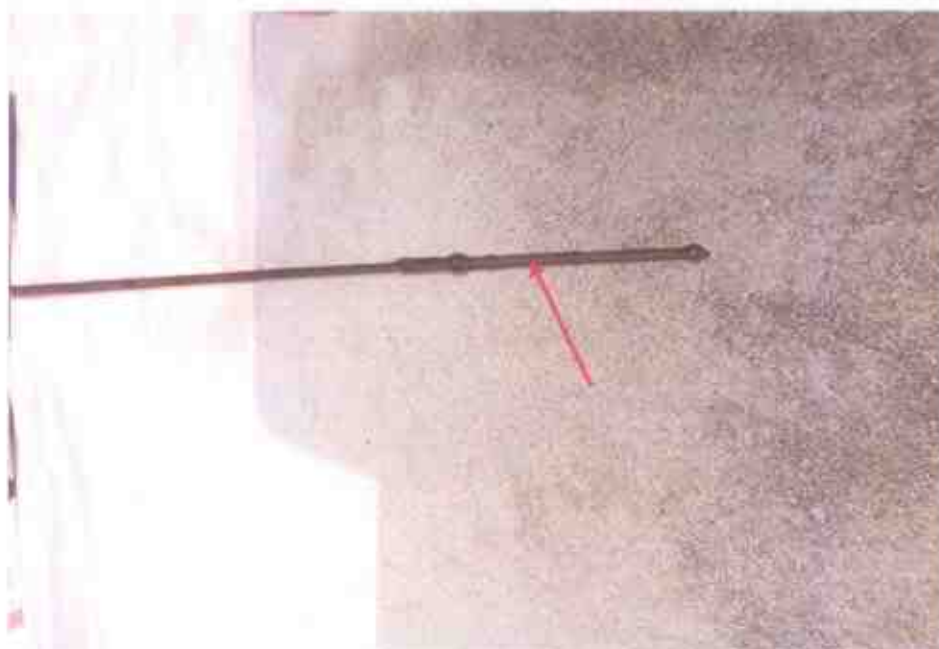
Photo 16 shows the engine fluid on the dip stick of the Motor Bus. It was observed to be of sufficient level without any contamination at time of our inspection.

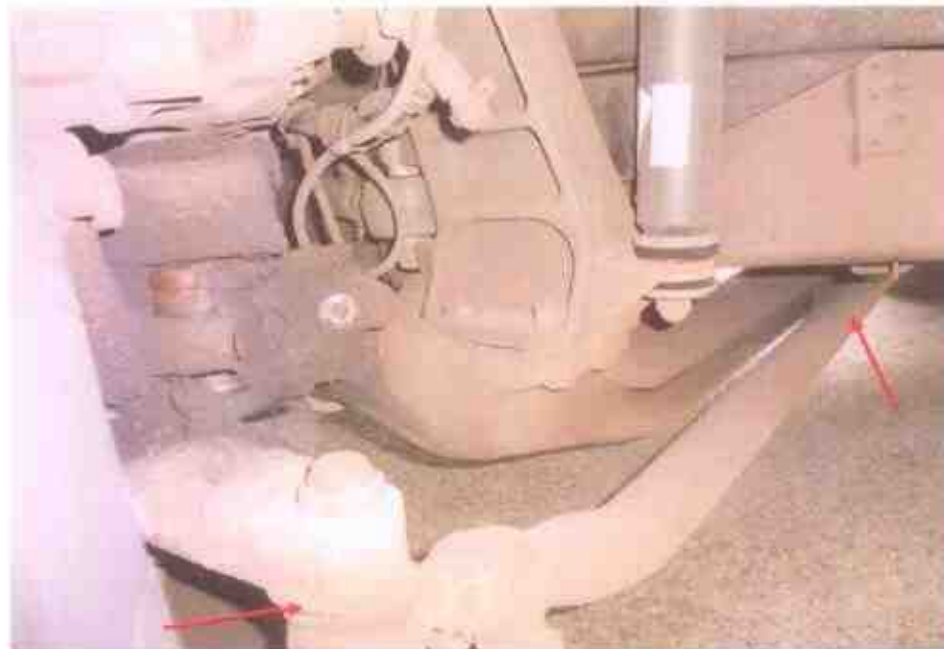
13. The mechanical components of the Motor Bus's steering system were all found to be visually intact and undamaged. Static test on the steering system of the Motor Bus also revealed no abnormality to the steering system. We did not experience any abnormal free play and/or other resistance when turning the steering wheel left and right to full lock positions. Our visual examination of the various steering components which had included the rack and pinion, tie rods, tie rod ends and ball joints had revealed that these components were all generally in good condition. See photo 17 & 18 below.

Photo 17 shows some of the mechanical components (arrowed) of the Motor Bus's steering system. Our visual check on the various mechanical components of the steering system revealed all to be intact and in good condition. The steering system of the Motor Bus likely to be in serviceable condition at the time of accident.

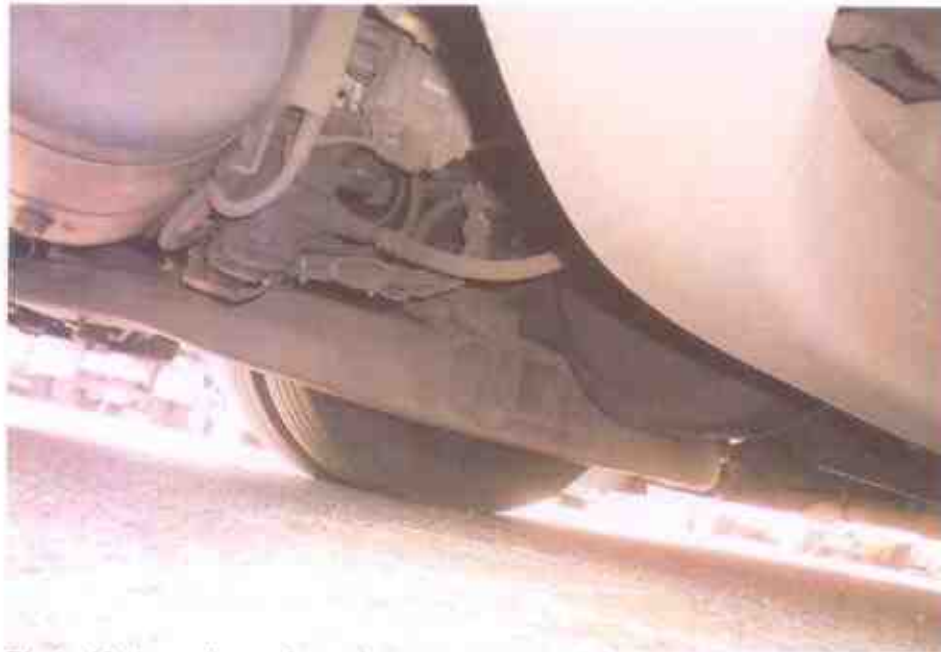
Photo 18 shows the undercarriage components at the rear steering system of the Motor Bus. The various undercarriage components of the Motor Bus were all observed to be intact and without any visible damage. This had included the transmission system of the Motor Bus, which were observed to be securely attached to the rear wheels.

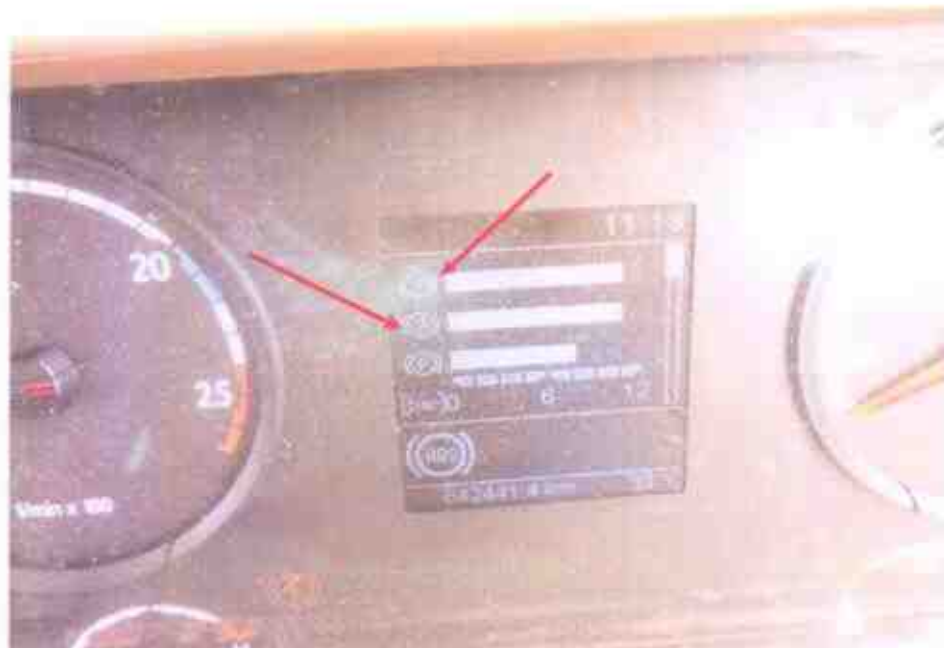
- 15.2 numbers of air tanks in particular were observed to be also in serviceable condition. Air built up to the fullest level which is level 10 (On the display panel) for both air tanks for operational ready status after a warming up session prior the operational test. Both air tanks were monitored for about 10 minutes for an observation of any abnormalities. Both air tanks pressure found to be normal without any drop in pressure during the course of our monitoring session. This would indicate that there was no leak of air pressure from the air braking system of the Motor Bus. See photo 19 below.

Photo 19 shows pressure tank 1 & tank 2 were observed to be pressurised up to 10bars after the engine start-up. No drop in the pressure after a few minutes which means there's no air leakage from the air-braking system.

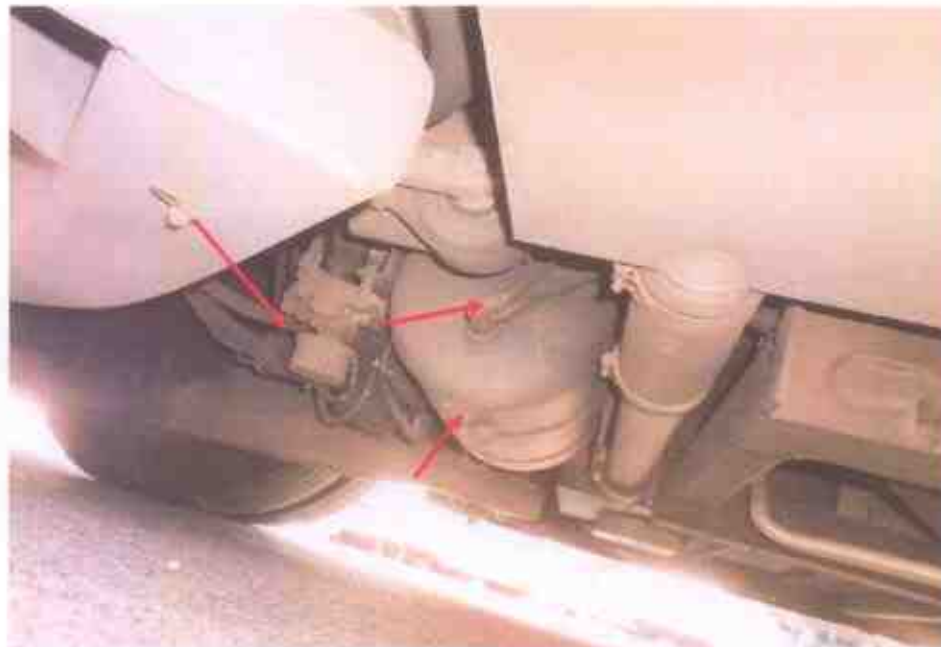
16. Static brake tests conducted on the Motor Bus revealed no abnormality. The brake booster had responded well to the various tests conducted. There was also no abnormal movement of the brake pedal when it was depressed. In general, the static brake tests had suggested that there was no internal leakage of pressure/vacuum in the braking system of the Motor Bus. The braking system of the Motor Bus was likely to be in serviceable condition at the material time of our inspection.
17. In general, our visual inspection of the mechanical components of the Motor Bus's braking system appear to suggest that its braking system was in serviceable condition at the material time of accident. See photo 20 - 22 below.

Photo 20 shows a general view of the air tank, valves, pipes and hoses, which are some of the components for the air-assisted braking system of the Motor Bus. This was at the underside of the Motor Bus's body. There were no damages observed at time of our inspection.

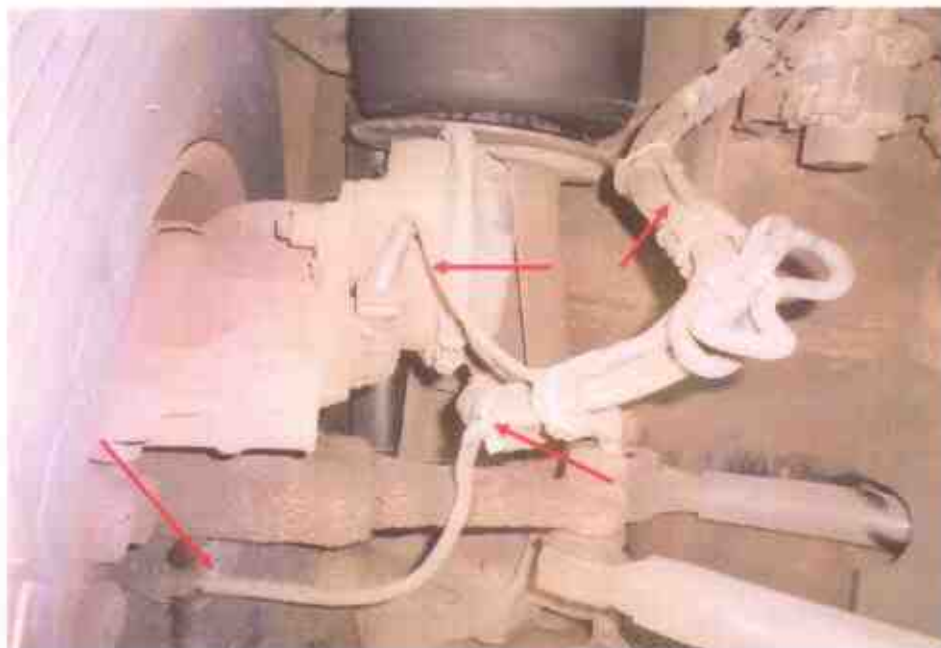
Photo 21 shows some of the mechanical components (arrowed) of the Motor Bus's braking system. Our visual check on the various mechanical components revealed all to be intact and in good condition. It was in serviceable condition at the time of accident.

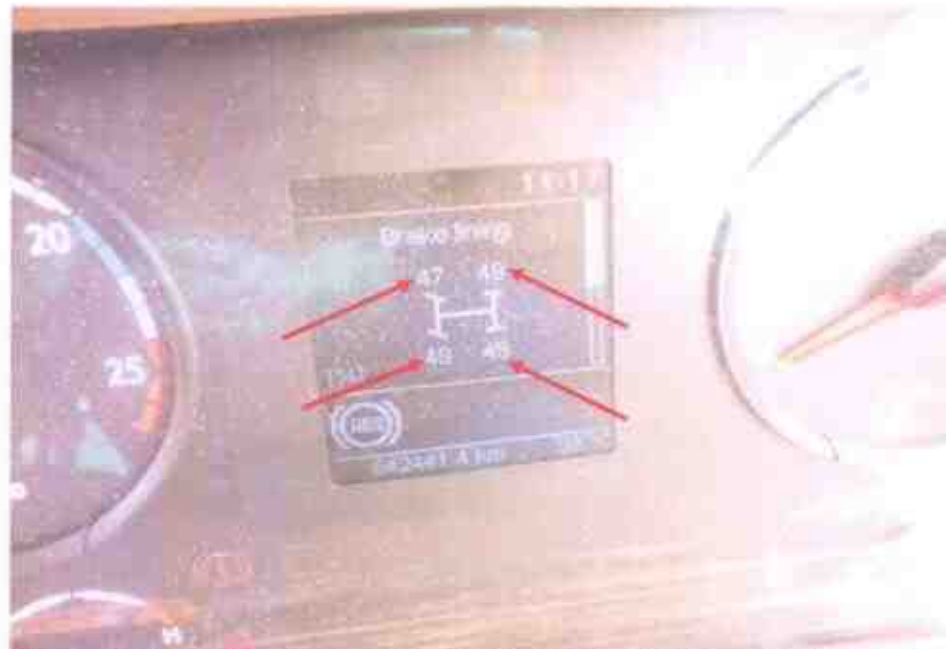
Photo 22 shows the brake pad on the electronic indicator of the Motor Bus's braking system. It shows the material percentage of the brake pad which indicating an acceptable range on the frictional material prior the accident.

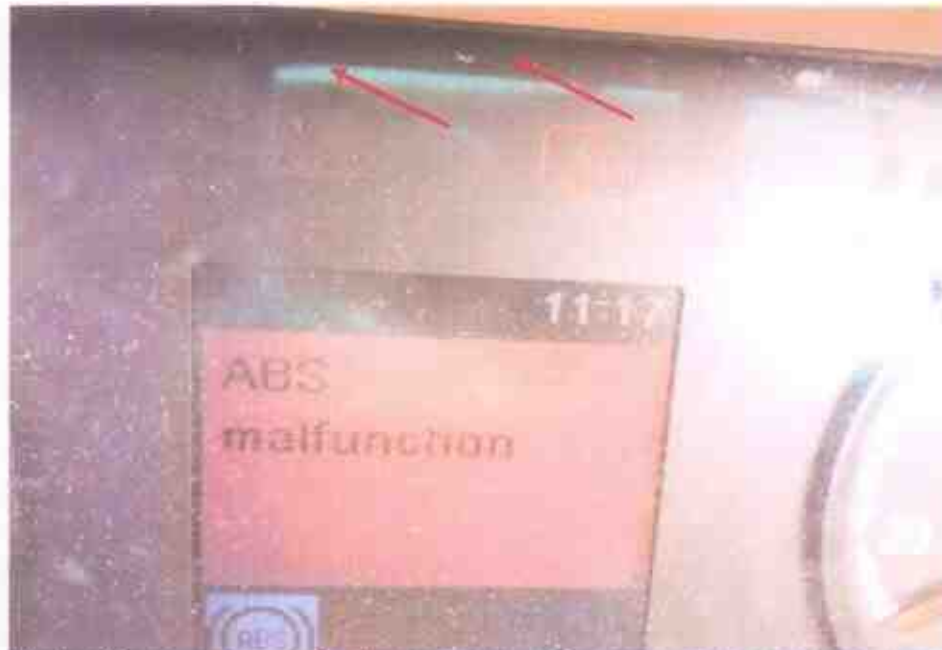
18. The Motor Bus's automatic self-test of the functionality of its various electronic operating systems like the Battery checked indicator, engine checked indicator, Anti-Locking Braking System ABS indicator, Parking light indicator & Diesel Particulate Filter Warning. During cranking of the engine had indicated that these systems were in working condition and without abnormality. This can be established from the warning lights disappearing from the instrument panel after the self-test. However, only the Anti-Locking Braking System (ABS) warning light stayed lighted up amongst others. See photo 23 & 25 below.

Photo 23 shows the warning lights for the various electronic operating systems of the Motor Bus appearing on its instrument panel during the self-test when the engine was cranked. However, only the Anti-Locking Braking System (ABS) stayed lighted up amongst others.

22. Notwithstanding that the Anti-Locking Braking System (ABS) warning light lighted up, the braking system was found to be in working condition as the Motor Bus was able to slow down and come to a complete stop upon depressing of the brake pedal during our short operational test.

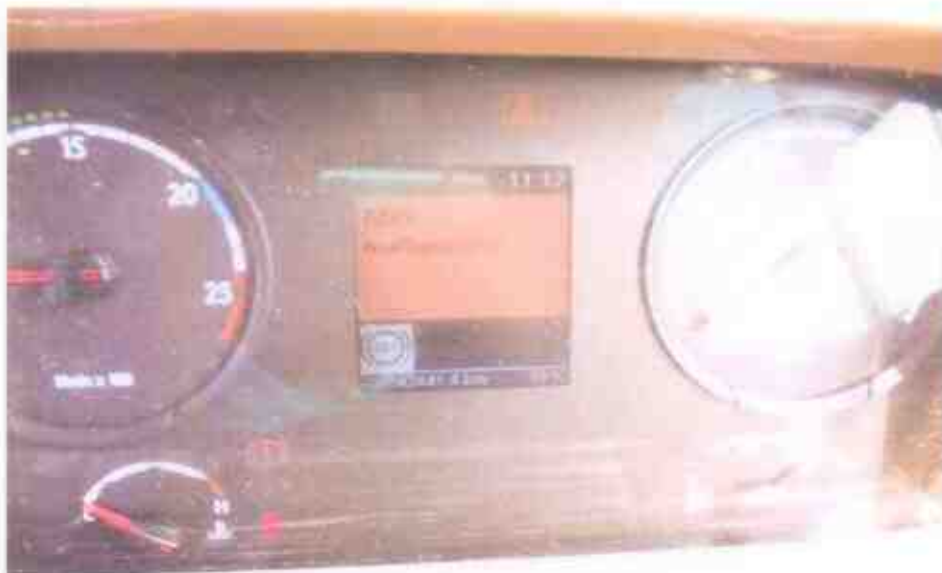
Photo 24 shows the indicators at the driver's seat, these systems were in working condition. This can be established from the warning lights disappearing from the instrument panel after the self-test. However, only the Anti-Locking Braking System (ABS) stayed lighted up amongst others.

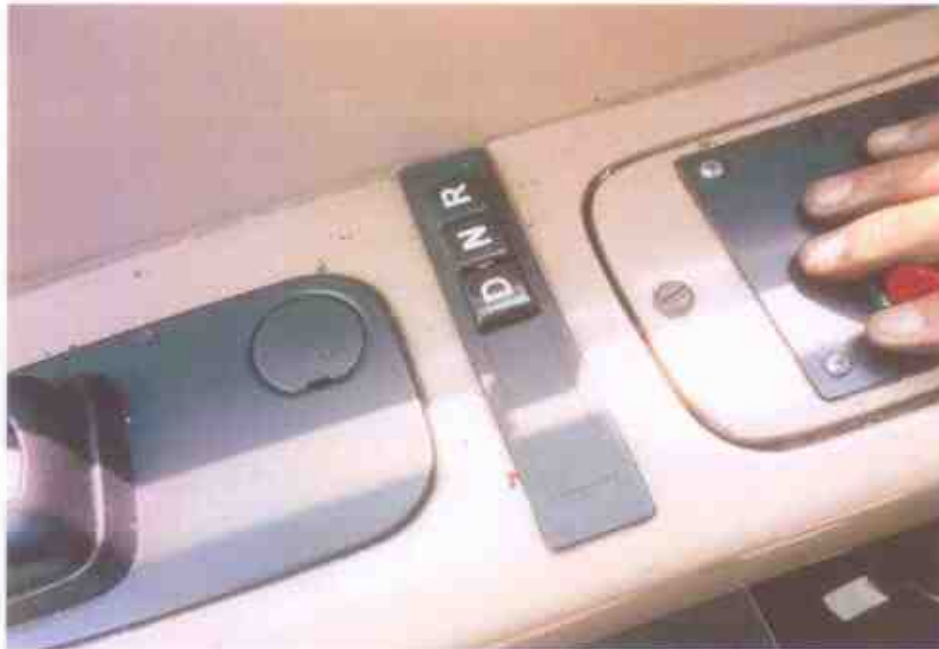
Photo 25 shows the operational selectors at the driver's seat. It was observed to be unaffected by the accident's collision. Hence enabling an operational test to be conducted via activating the selectors.

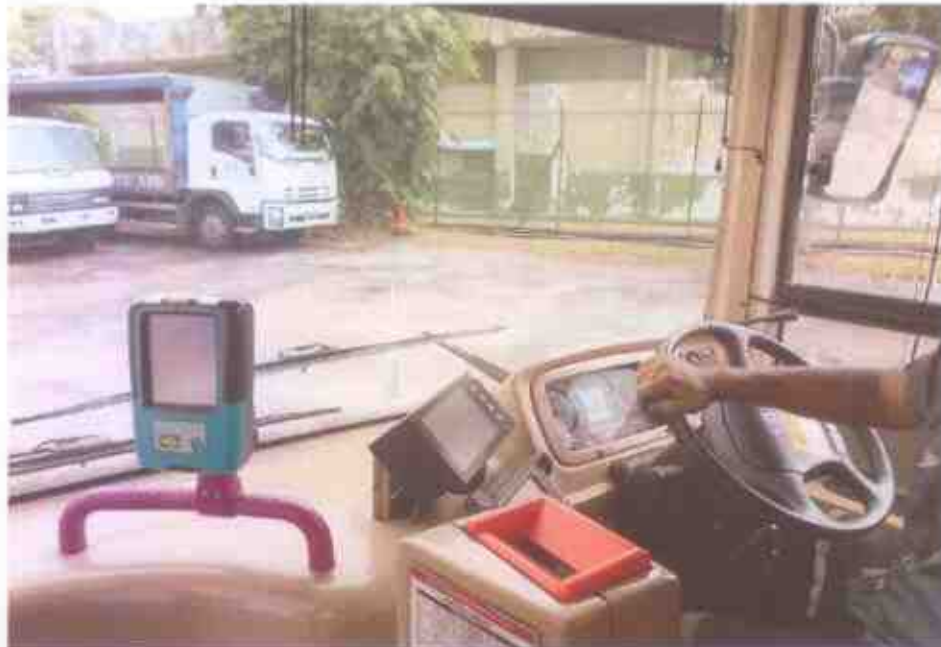
Photo 26 shows the SBS driver while conducting the operational test.

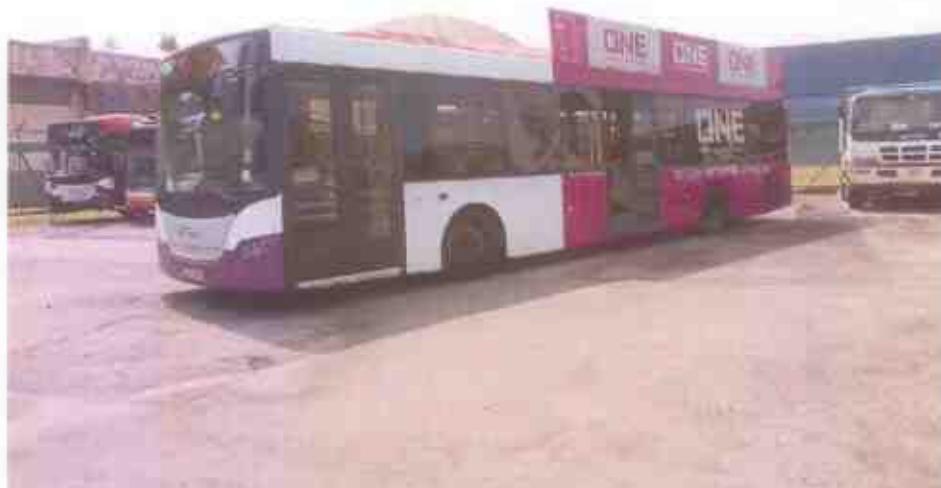
20. During the operational test, the various transmission gears of the Motor Bus were able to be engaged without any difficulty by manually shifting the gear selector. There were no abnormal sounds heard and/or abnormal behaviour of the Motor Bus's engine system. It was able to move forward and backward normally. Notwithstanding that the Anti-Locking Braking System (ABS) warning light lighted up, the braking system was found to be in working condition as the Motor Bus was able to slow down and come to a complete stop upon depressing of the brake pedal. See photo 26 & 27 below.

Photo 27 shows the operational test on the Motor Bus. SBS driver were able to move the Motor Bus forward, backward, turning left & right & stopping without any abnormalities.
