Your Ref: TP/IP/33377/2018  
Our Ref :CI/TPD18011360/Z

**Fatal Accident Investigation Team**

**MECHANICAL INSPECTION REPORT OF MOTORCYCLE JRY 8130**

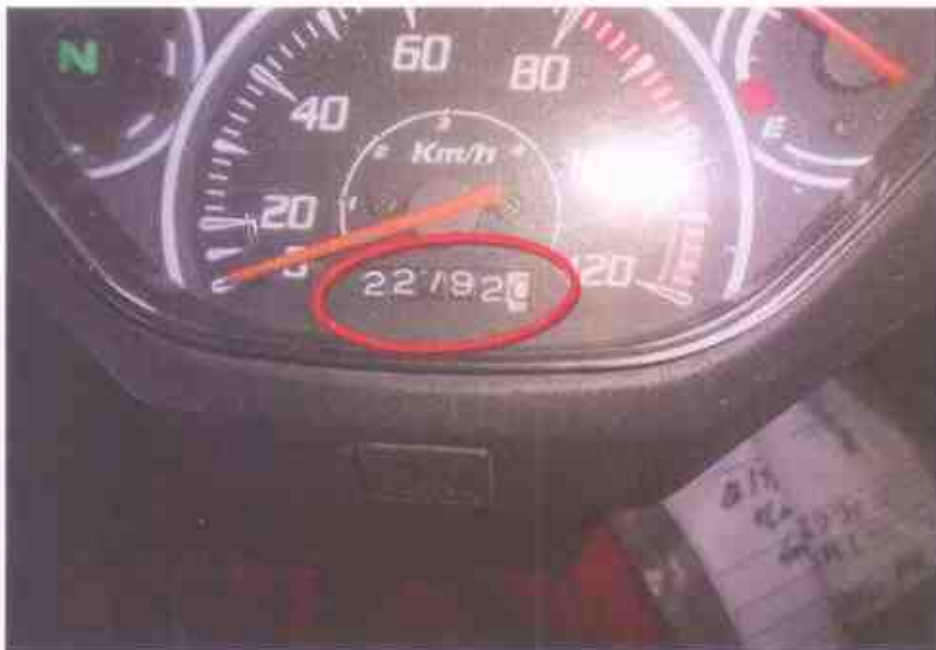
**Photo 1** shows the mileage of the Motorcycle recorded at time of our inspection was 227920km.

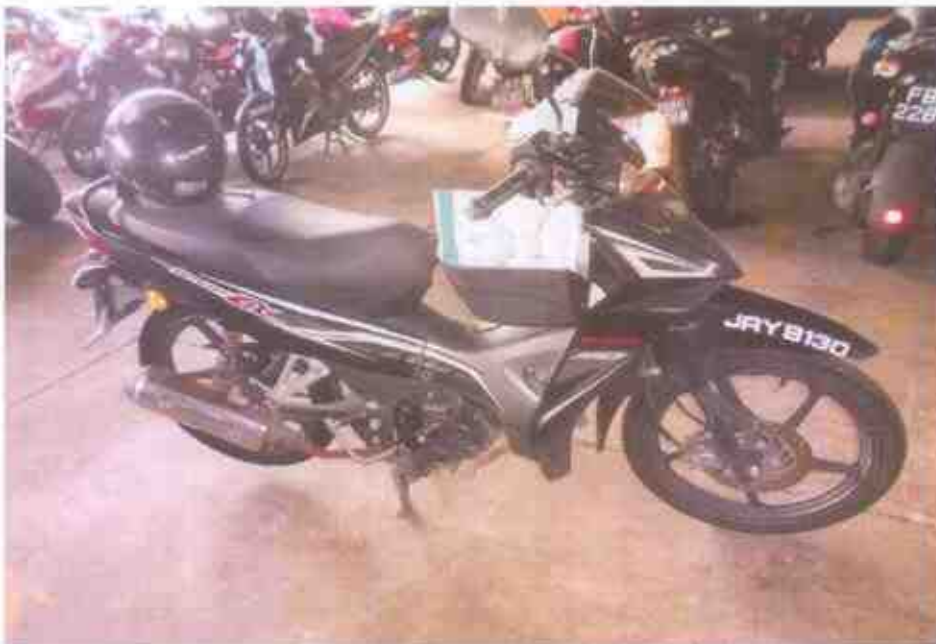
**Photo 2** shows a general view of the front right body of the Motorcycle at the time of our inspection. The Motorcycle was observed to be in good general condition at time of inspection.

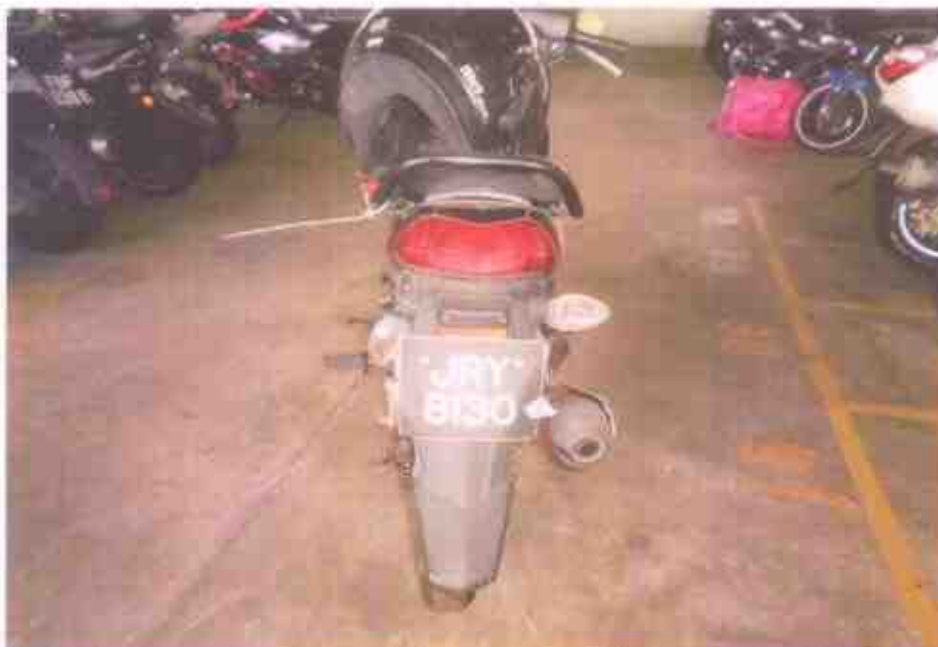
Photo 3 shows a general view of the rear body of the Motorcycle at the time of our inspection. The Motorcycle was observed to sustained minor damage at the rear left signal lamp at time of inspection.

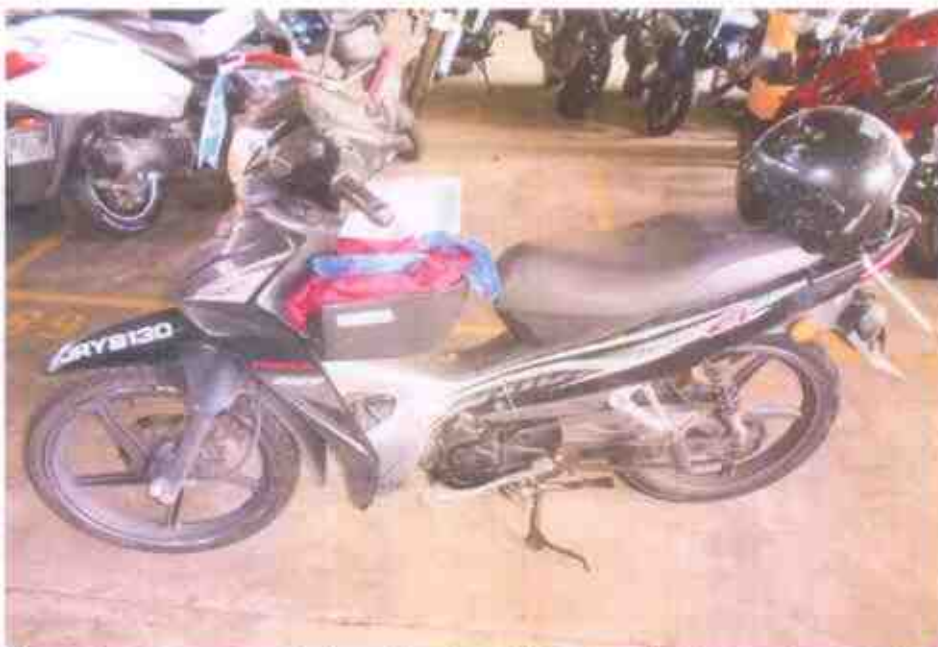
Photo 4 shows a general view of the front left body of the Motorcycle at the time of our inspection. The Motorcycle was observed to have sustained minor damages on the rear portion at time of inspection.

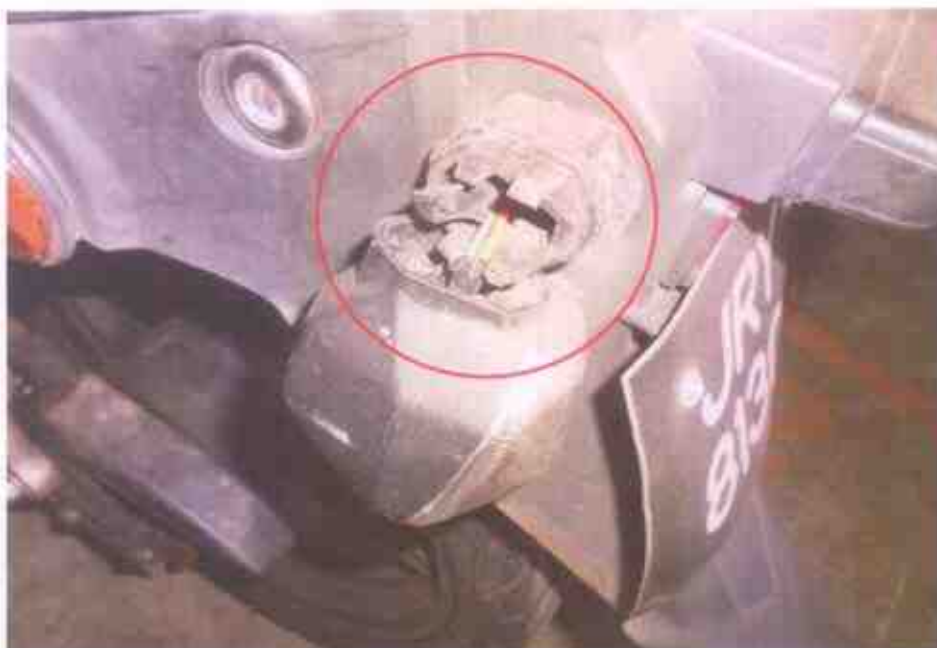
4. The mileage of the Motorcycle recorded at time of our inspection was 227920km.
5. The Motorcycle was observed to have sustained minor damages at the rear left portion. The body parts that were found to have been damaged was its rear left signal lamp & missing wing mirror as a result of the accident.
6. This was likely to be the consistency of the accident's case fact that on 06<sup>th</sup> June 2018 at about 0704hrs, the motorcyclist was riding along Upper Jurong Road towards Pioneer Road North on the left most lane of 3 lanes road when he lost control of the Motorcycle, skidded & landed on the grass patch. See photo 1 to 5 below.

Photo 5 shows a closer view of the rear left signal lamp of the Motorcycle at the time of our inspection. It was observed to be damage likely due to the accident. (Circled)

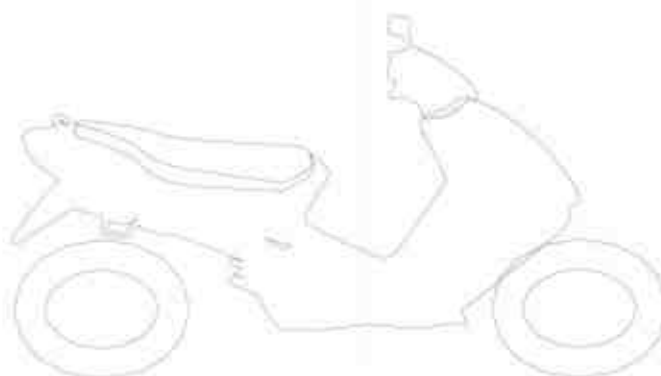
7. The condition of the Motorcycle's 2 tyres was observed to be in serviceable condition. The tread pattern of the 2 tyres was clearly visible. We did not observe any tear, burst mark(s) and/or punctured hole(s) on the sidewalls as well as across the tread of the 2 tyres. The 2 tyres were both observed to be sufficiently inflated for vehicular operation. The tyre brand, tyre size and remaining tread depth of the 2 tyres were recorded as follows:-

Speedy Boy 80/90 - R17  
(3mm)

Dunlop T100 70/90 - R17  
(3mm)

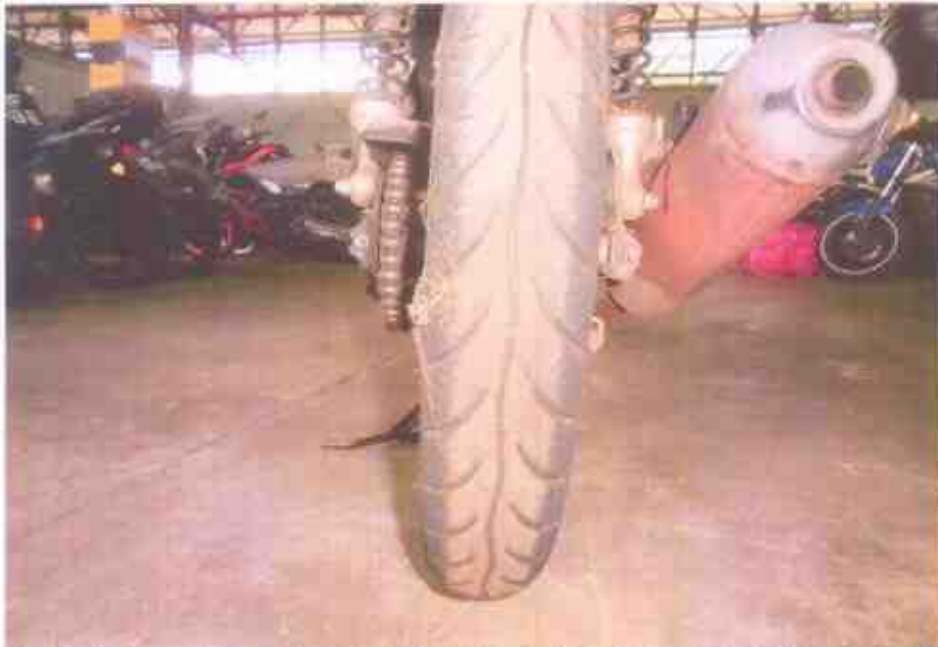
**Photo 6** shows the rear tyre of the Motorcycle. The rear tyre was observed to be in serviceable condition with remaining tread depth of approximately 3mm. The tyre was also observed to be sufficiently inflated for vehicular operation.

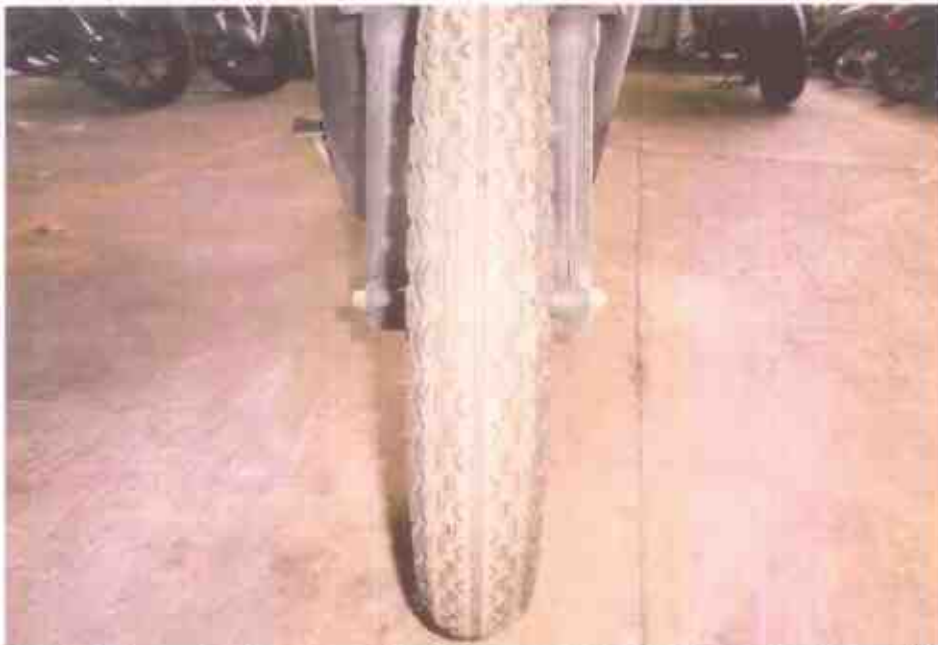
**Photo 7** shows the front tyre of the Motorcycle. The front tyre was observed to be in serviceable condition with remaining tread depth of approximately 3mm. The tyre was also observed to be sufficiently inflated for vehicular operation.

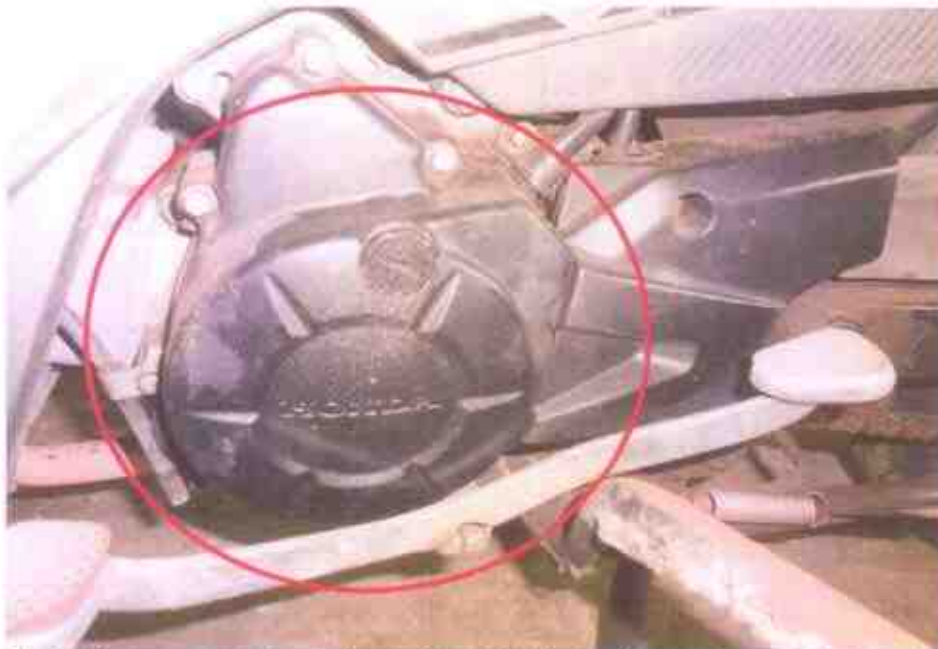
9. Upon examination of the Motorcycle's engine area, we had observed that the various engine related parts and components were intact with no visible damage. However, there was sign(s) or indication(s) of fluid leak observed around the left side of the engine area of the Motorcycle.
10. The gear chain of the motorcycle was found to be intact without any misalignment. It was also adequately lubricated for operating purposes. Free play tension test was also conducted & found adequately acceptable. See photo 8 to 11 below.

**Photo 8** shows sign(s) or indication(s) of fluid leak observed around the left side of the engine area of the Motorcycle.

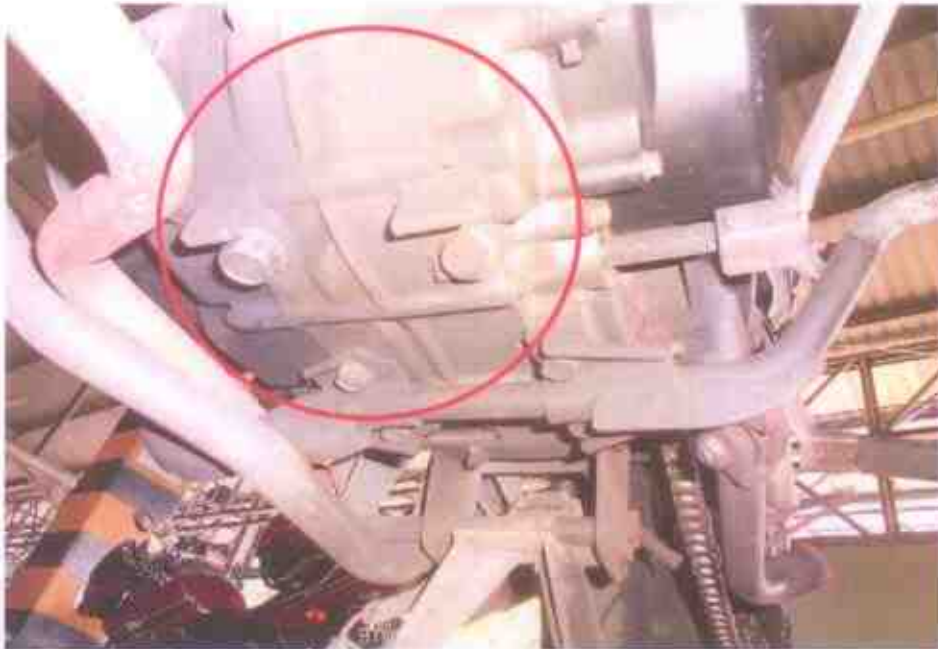
**Photo 9** shows no sign(s) or indication(s) of fluid leakage stain observed undercarriage of the engine area of the Motorcycle.

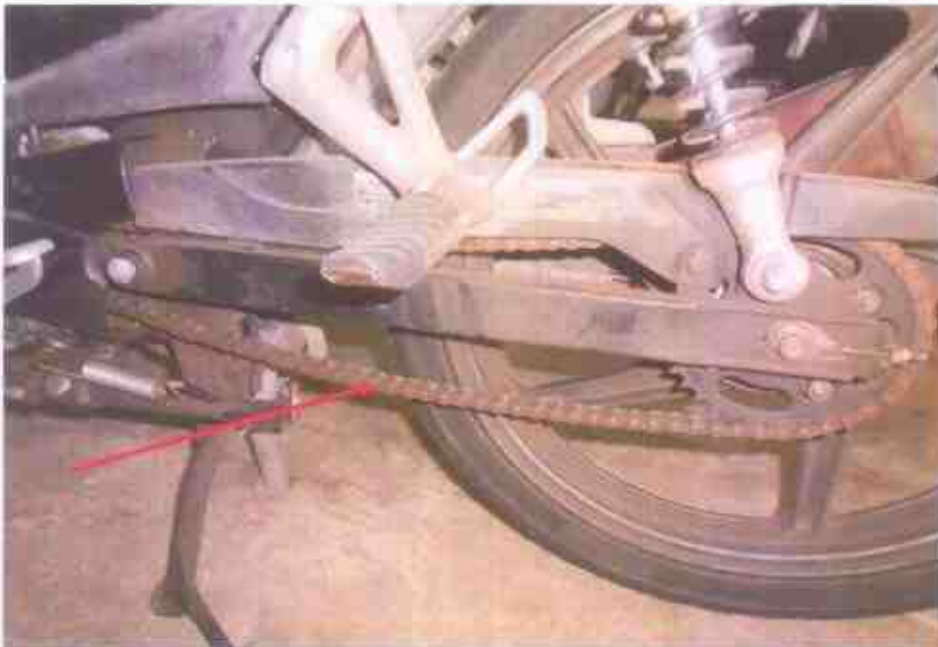
**Photo 10** shows the general view of the gear train (arrowed) of the Motorcycle, which was observed to be intact with no misalignment. It was also adequately lubricated for operating purposes.

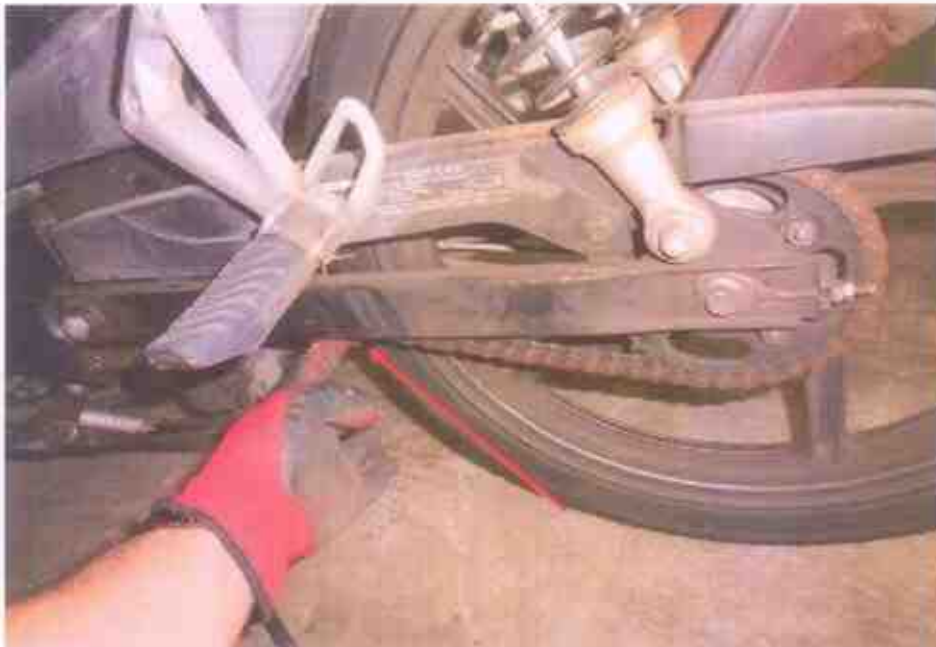
**Photo 11** shows the general view of the gear train (arrowed) of the Motorcycle, which was observed to be intact with no misalignment. It was also adequately lubricated for operating purposes. Free play tension was also observed & found adequately acceptable.

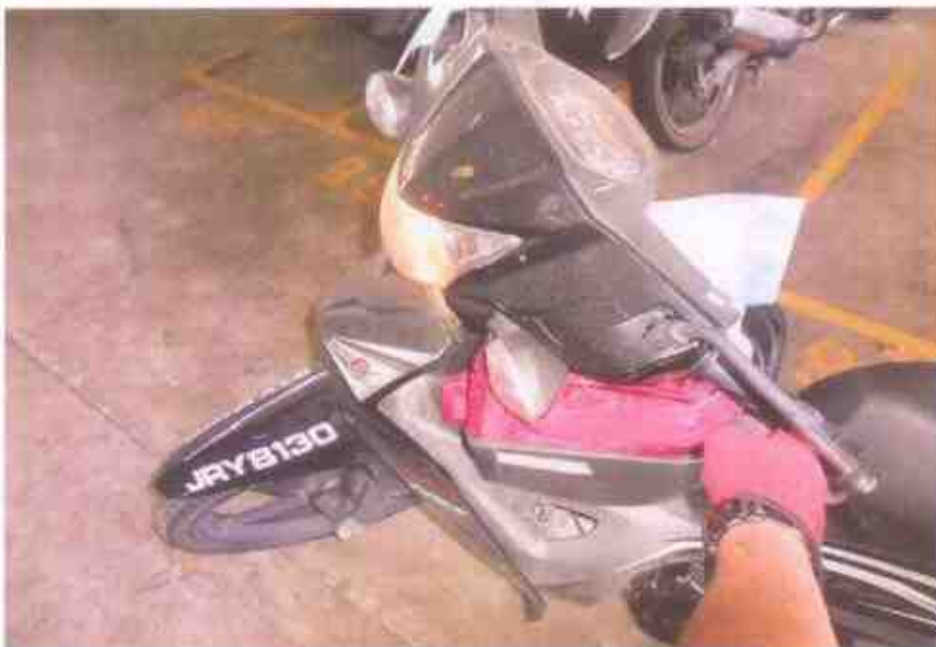
**Photo 12** shows the steering system was observed to be in a serviceable condition. It was able to be steered to the full left at time of our inspection.

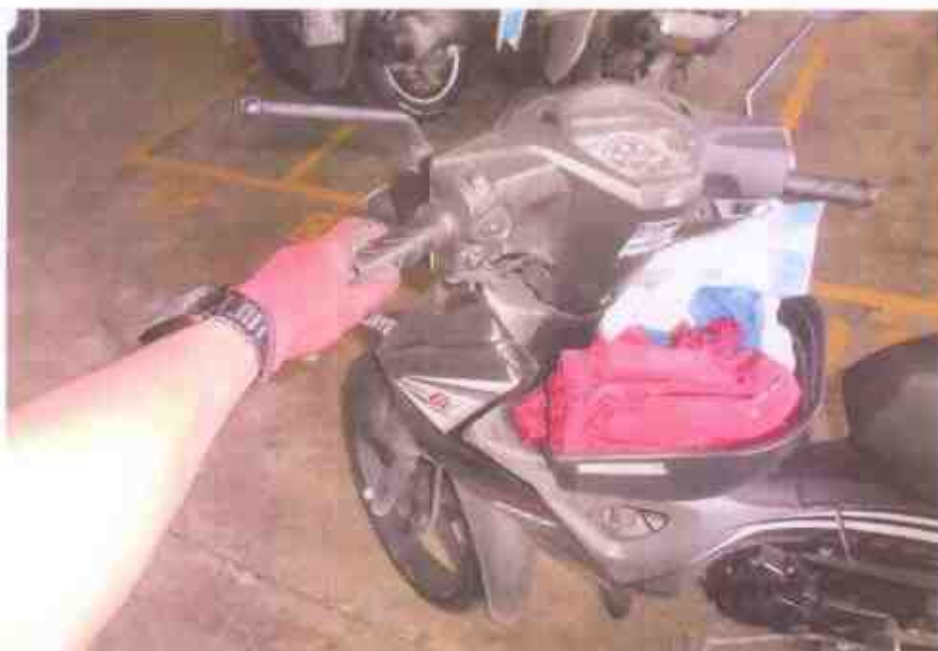
Photo 13 shows the steering system was observed to be in a serviceable condition. It was able to be steered to the full right at time of our inspection.

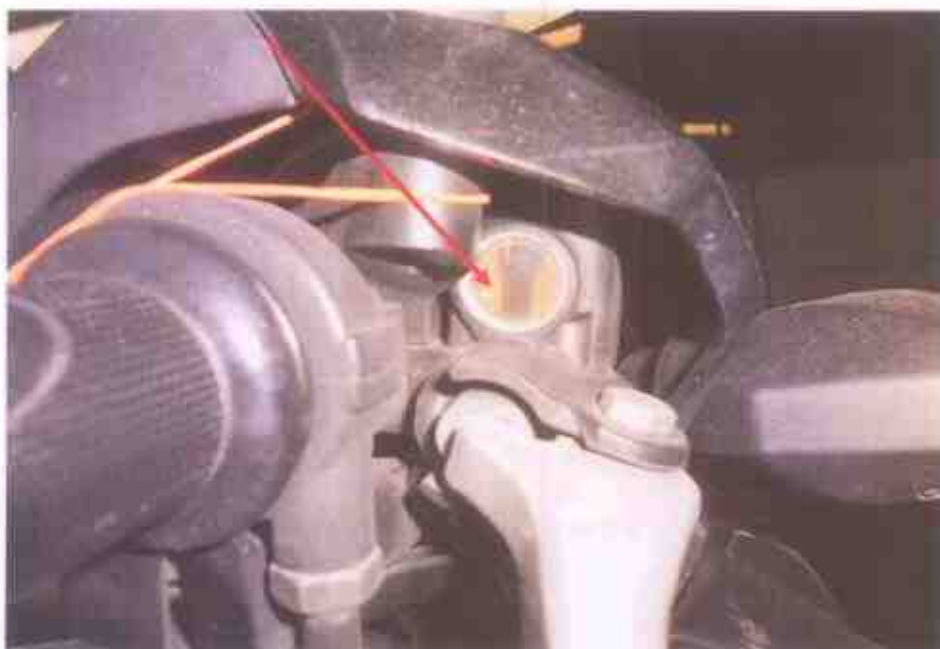
Photo 14 shows our checks on the brake fluid reservoir had also indicated that the brake fluid was of sufficient level for operational purposes, and without contamination.

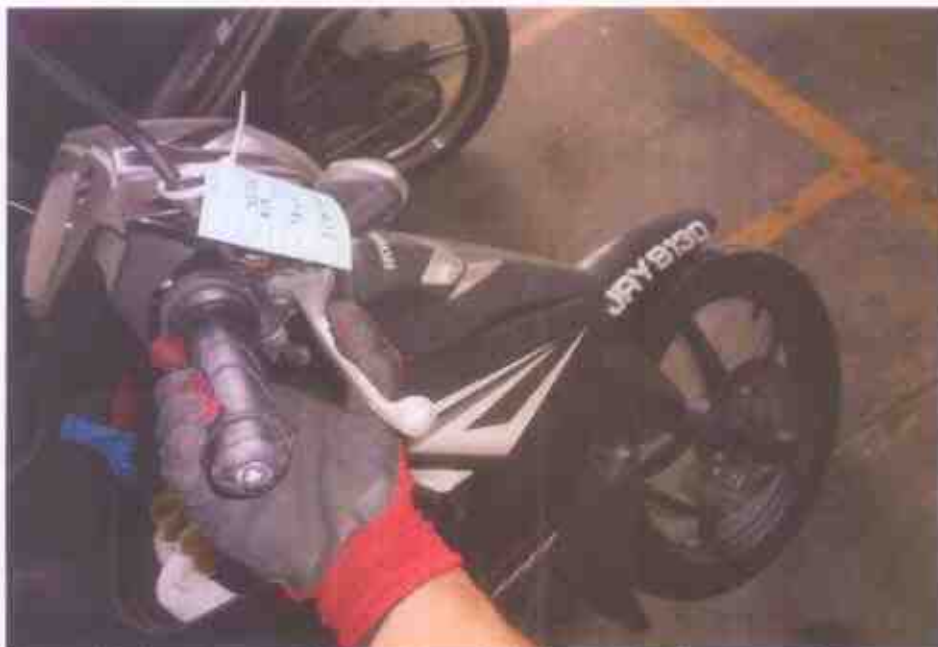
**Photo 15** shows testing of the braking of the front brake in progress. There was some resistance felt (spongy like feel) upon pressing the brake lever.

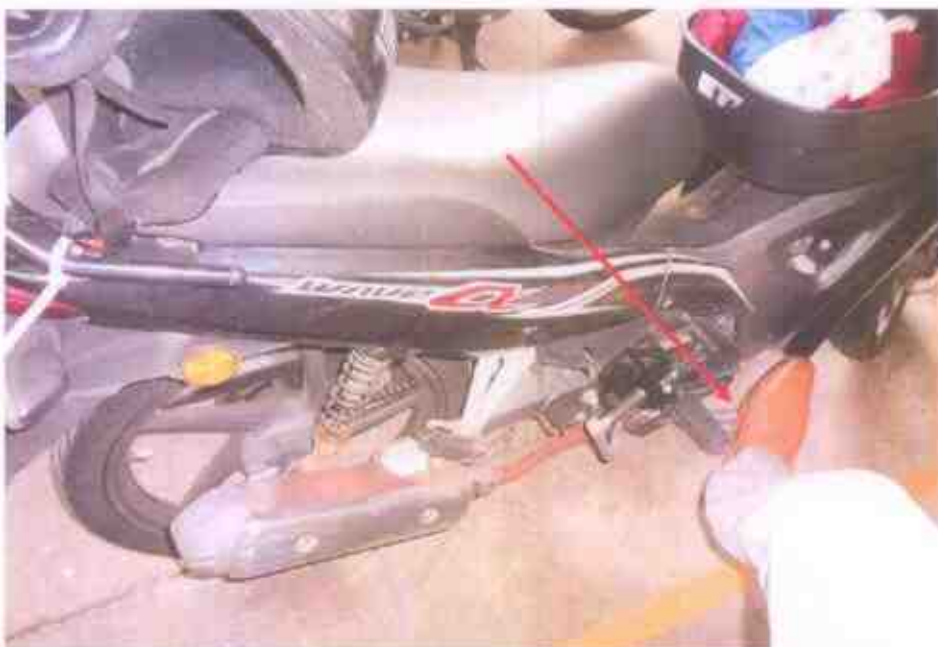
**Photo 16** shows testing of the braking of the rear brake in progress. There was some resistance felt (spongy like feel) upon stepping on the brake pedal.
