Your Ref: TP/IP/32343/2018
Our Ref : CI/TPD18011361/Z

30th August 2018

MECHANICAL INSPECTION REPORT OF MOTORCYCLE FBL 1917L

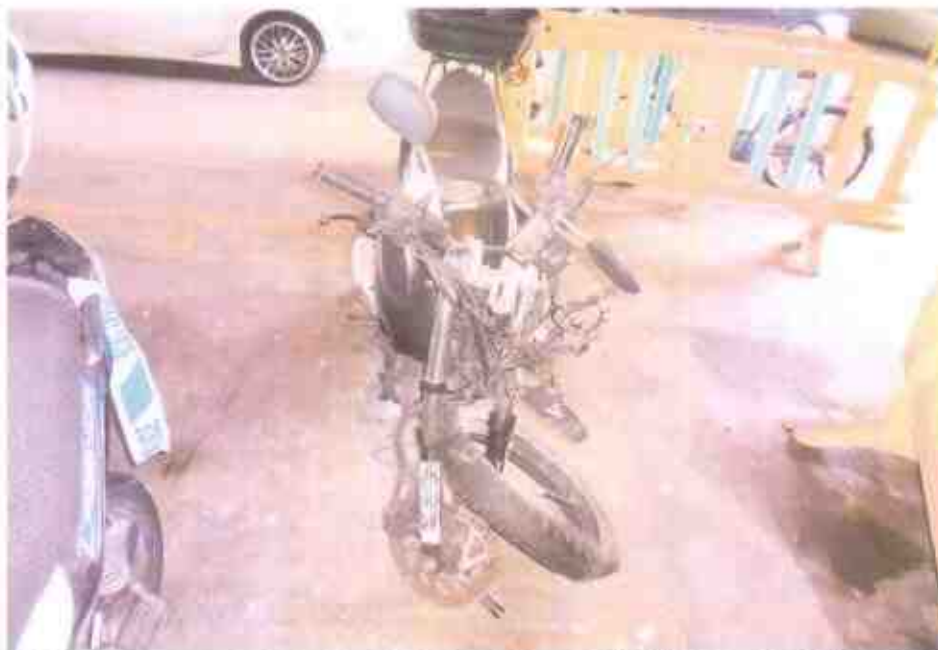
Photo 1 shows a general view of the front body of the Motorcycle at the time of our inspection. The Motorcycle was observed to have sustained with severe damages as a result of the accident.

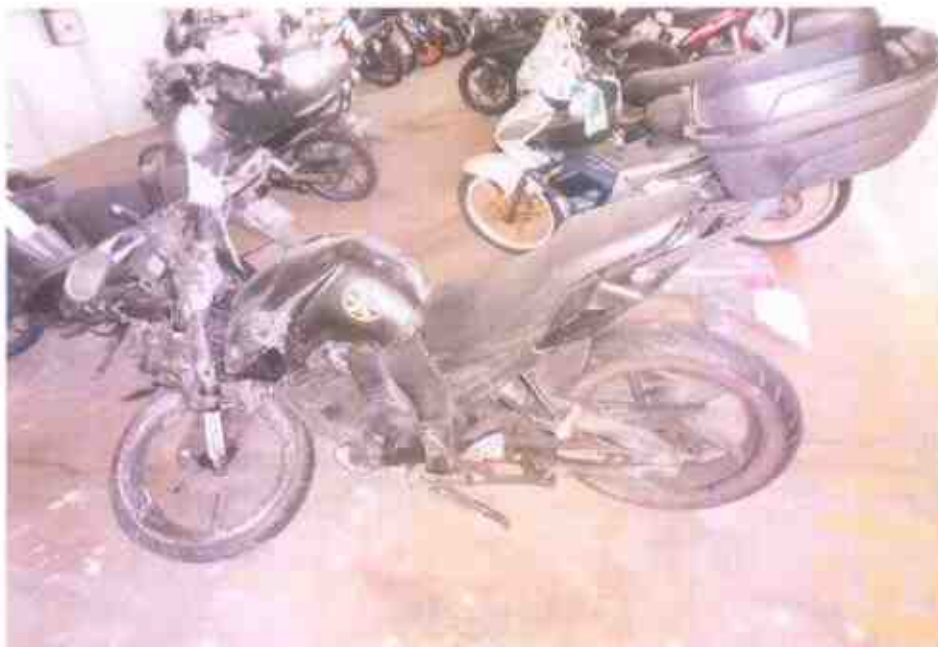
Photo 2 shows a general view of the left side body of the Motorcycle at the time of our inspection. The Motorcycle was observed to have sustained with severe damages as a result of the accident.

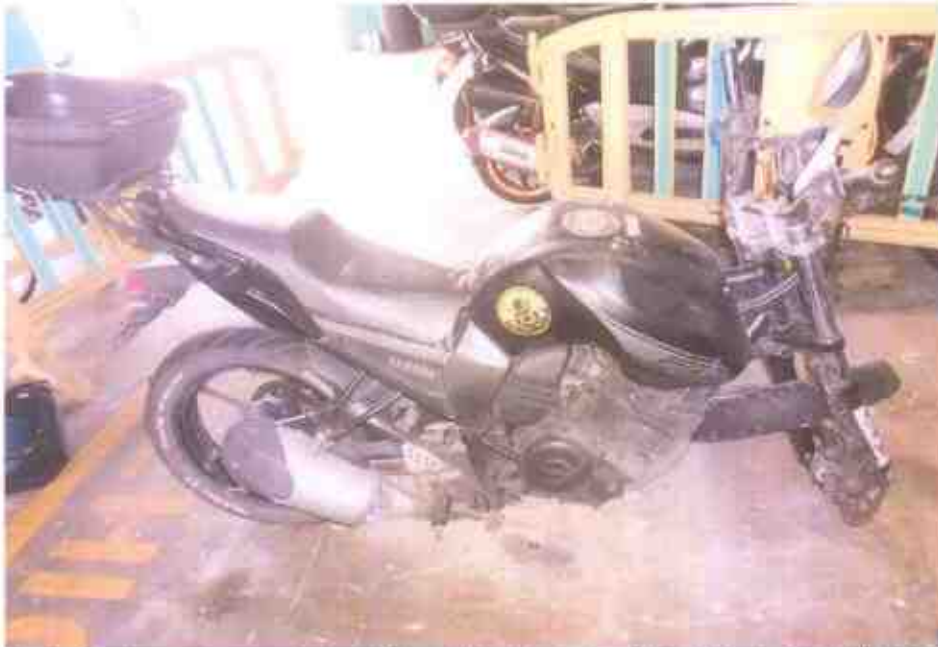
Photo 3 shows a general view of the right side body of the Motorcycle at the time of our inspection. The Motorcycle was observed to have sustained with severe damages as a result of the accident.

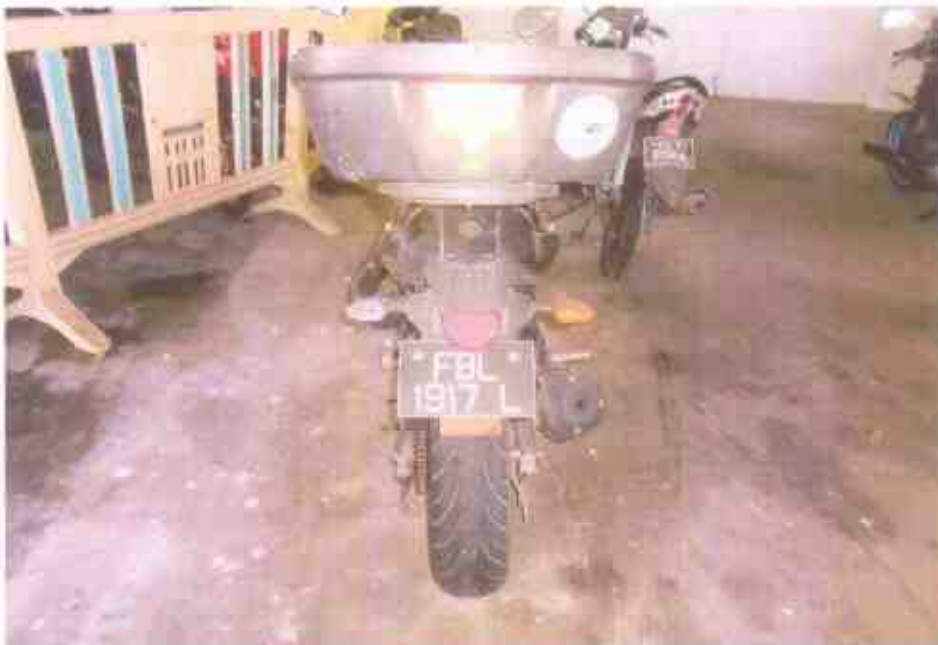
Photo 4 shows a general view of the rear portion of the Motorcycle at the time of our inspection. The Motorcycle was observed to have sustained with relatively minor impact due to the accident collision. This includes damages on its left signal lamp & rear compartment box.

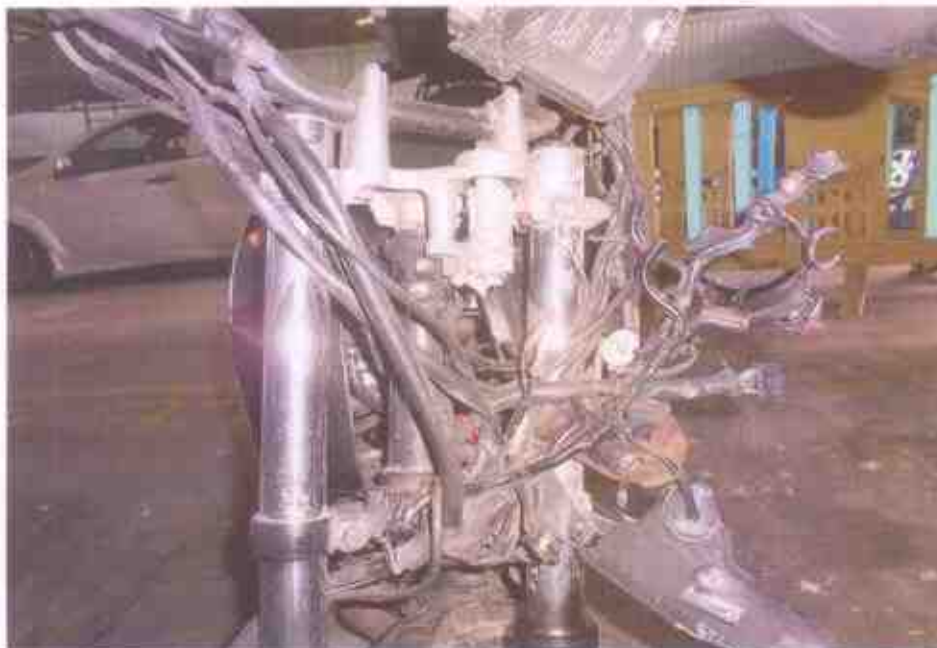
Photo 5 shows a close-up view of the missing headlamp & missing speedometer of the Motorcycle due to the accident collision.

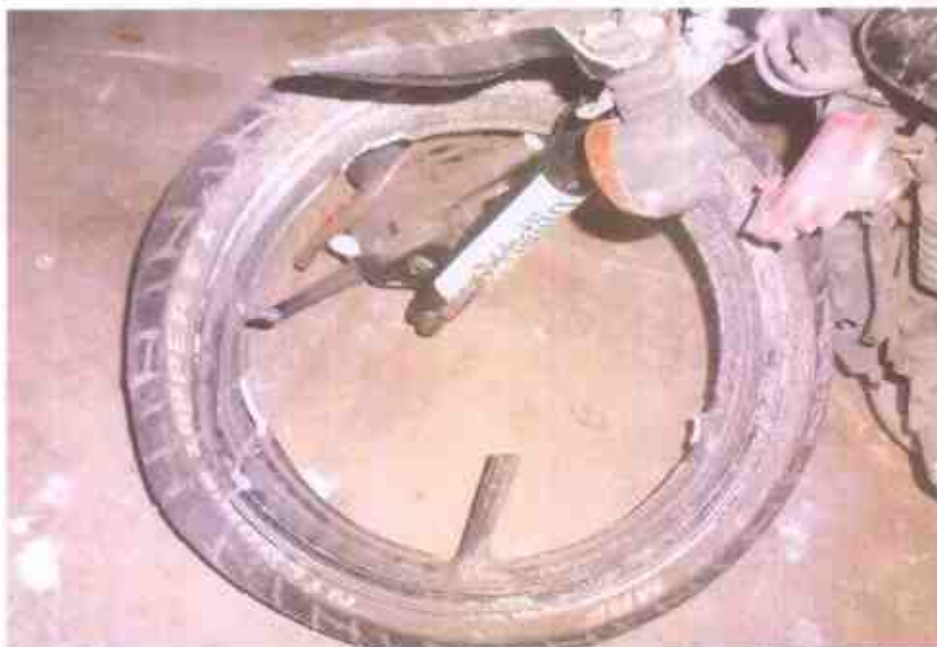
Photo 6 shows a close-up view of the broken front wheel rim of the Motorcycle due to the accident collision.

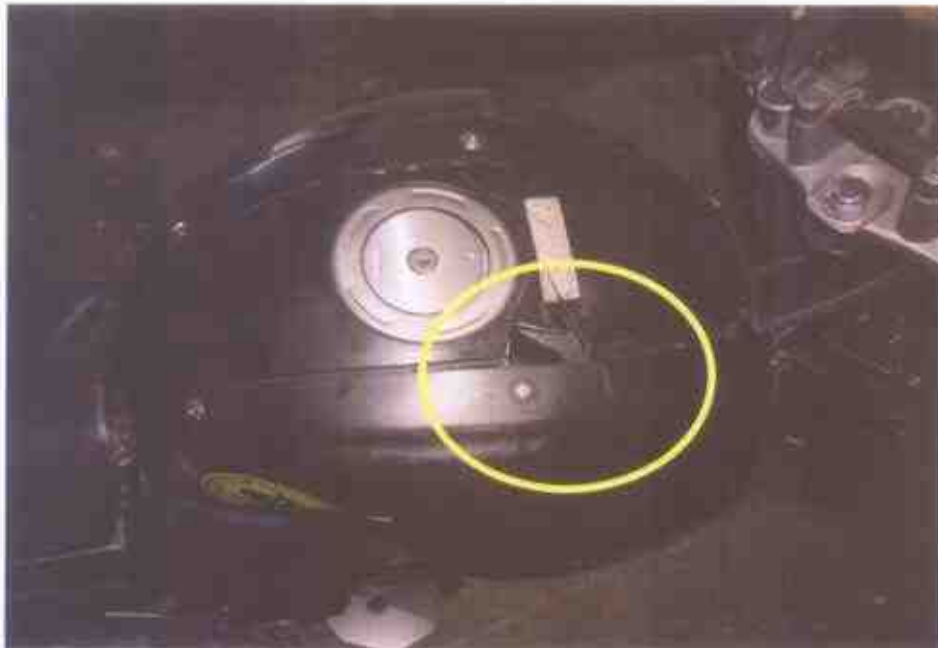
Photo 7 shows a close-up view of the crack mark on the fuel tank of the Motorcycle due to the accident collision.

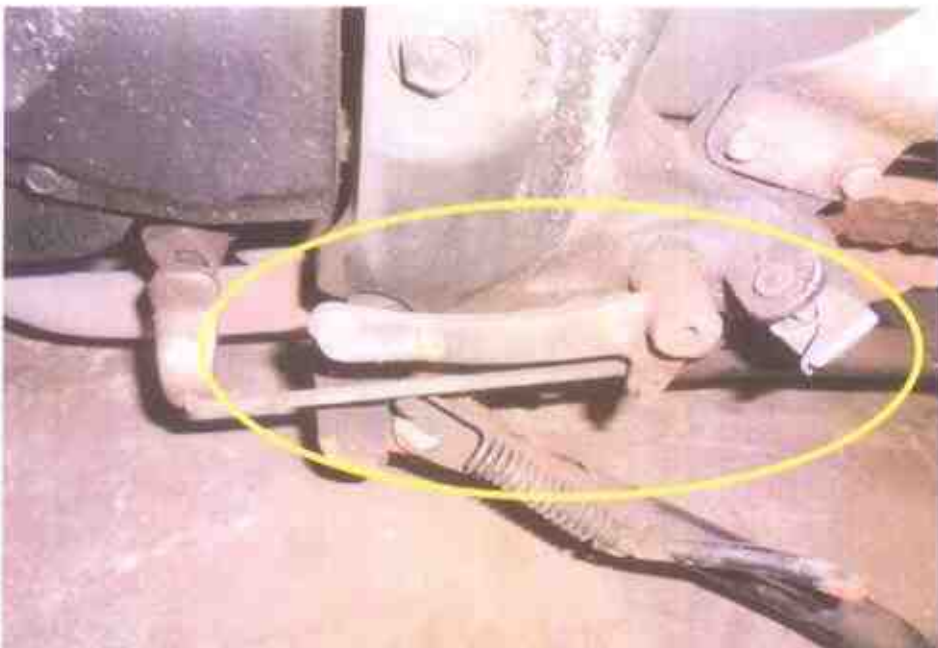
Photo 8 shows a close-up view of the damages on the foot rest & gear shift pedal of the Motorcycle due to the accident collision.

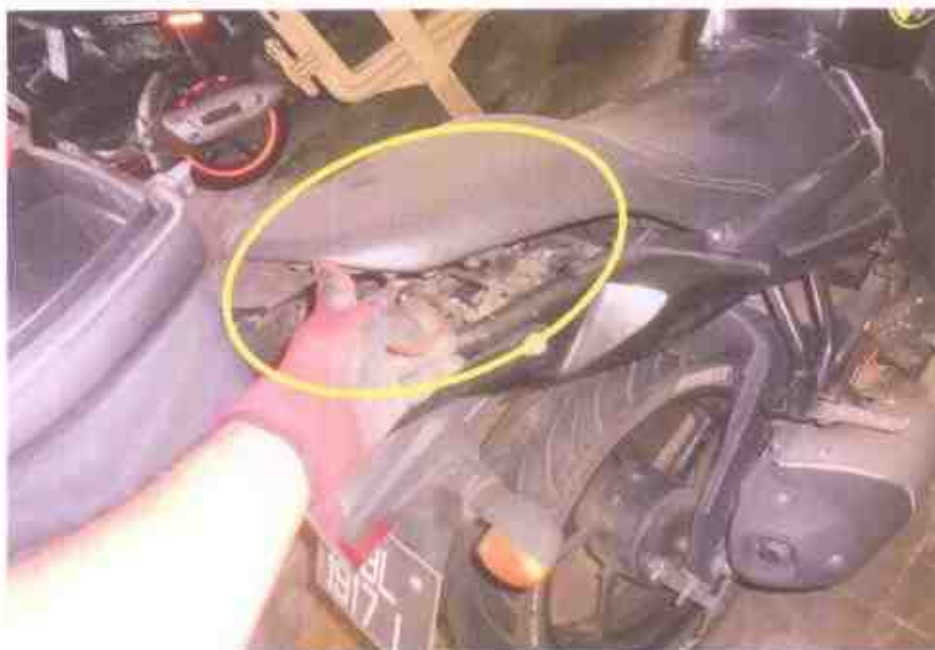
Photo 9 shows a close-up view of the damage seat assembly of the Motorcycle due to the accident collision.

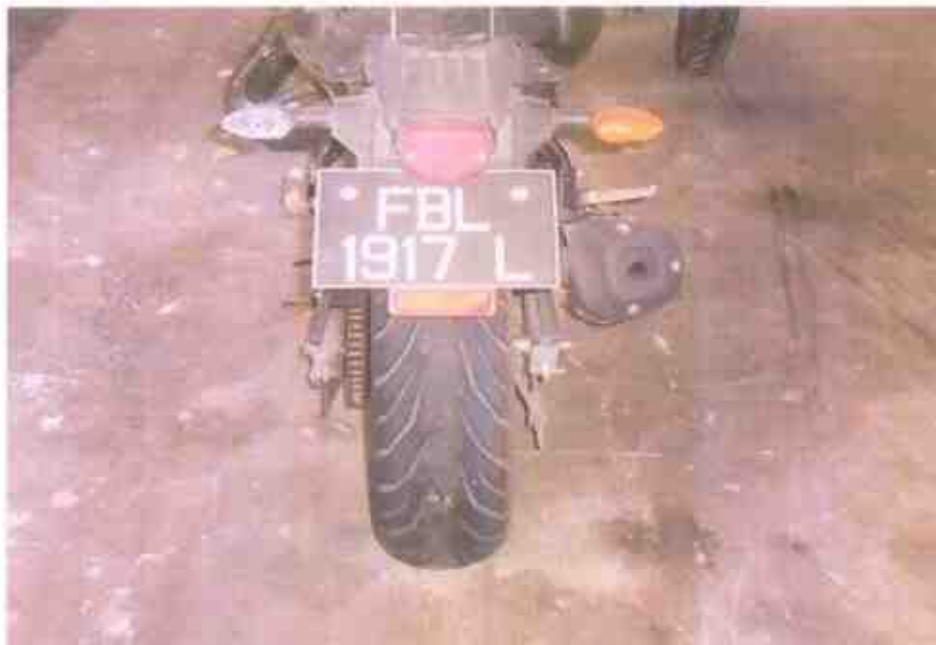
Photo 10 shows the rear tyre of the Motorcycle was observed to be in serviceable condition with remaining tread depth of approximately 4mm. The tyre was also observed to be sufficiently inflated for vehicular operation. There was no significant damage observed on the rear wheel rim & tyre.

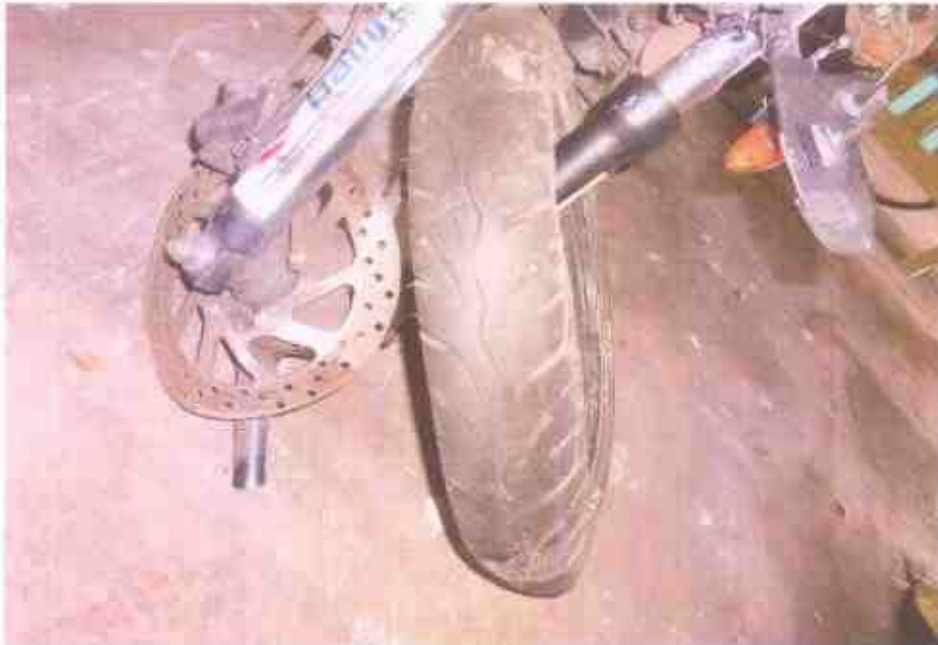
Photo 11 shows the Motorcycle's front tyre, it was observed to be dislodged from the broken wheel rim & deflated due to the accident's impact collision. However, the tread pattern of the front tyre was clearly visible. We did not observe any tear, burst mark(s) and/or punctured hole(s) on the sidewalls as well as across the tread of the rear tyres

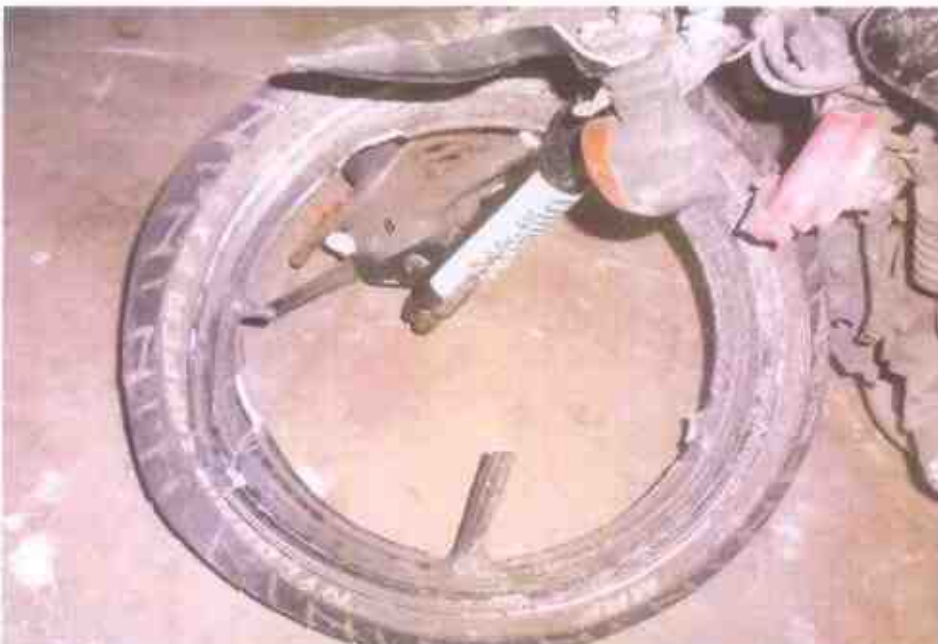
Photo 12 shows the Motorcycle's front wheel rim, it was observed to be broken due to the accident's impact collision. However, the tread pattern of the front tyre was clearly visible. We did not observe any tear, burst mark(s) and/or punctured hole(s) on the sidewalls as well as across the tread of the rear tyres

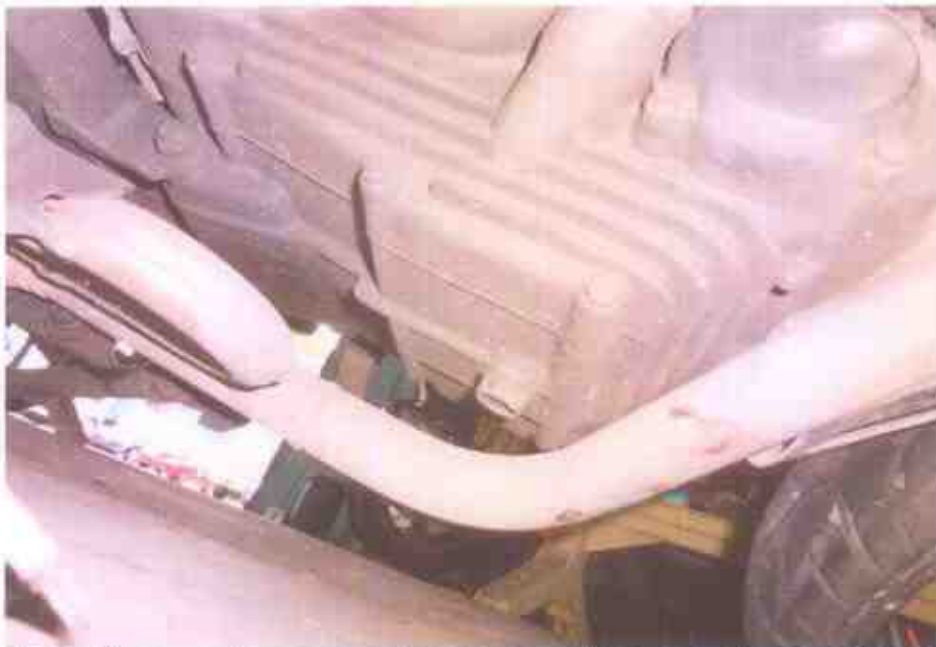
Photo 13 shows the engine underside view. There was also no sign(s) or indication(s) of fluid leak observed around the engine area of the Motorcycle.

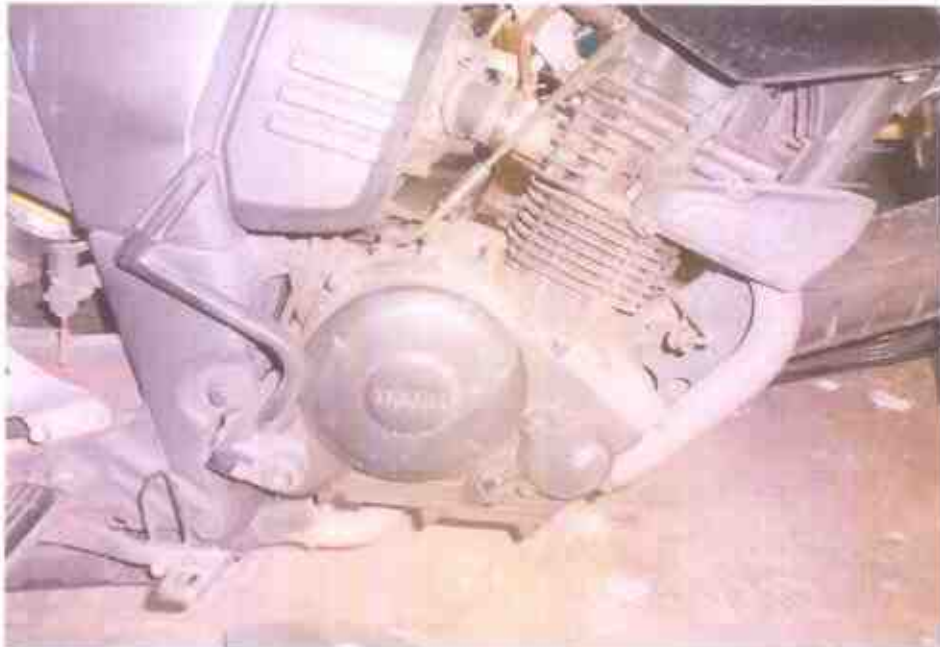
Photo 14 shows the engine area view. There was also no sign(s) or indication(s) of fluid leak observed around the engine area of the Motorcycle.

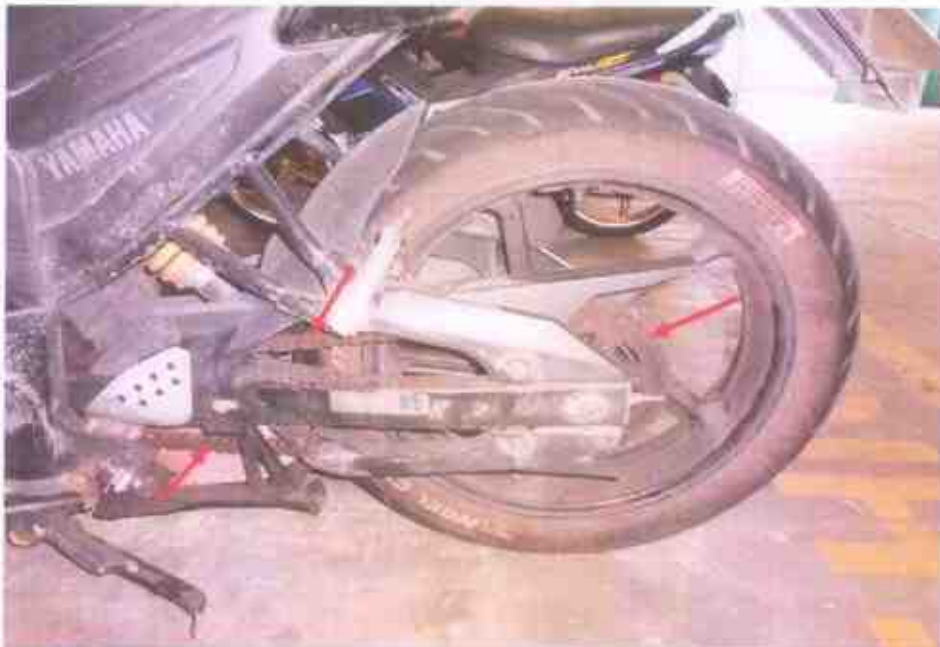
Photo 15 shows the general view of the gear train (arrowed) of the Motorcycle, which was observed to be intact with no misalignment. It was also adequately lubricated for operating purposes.

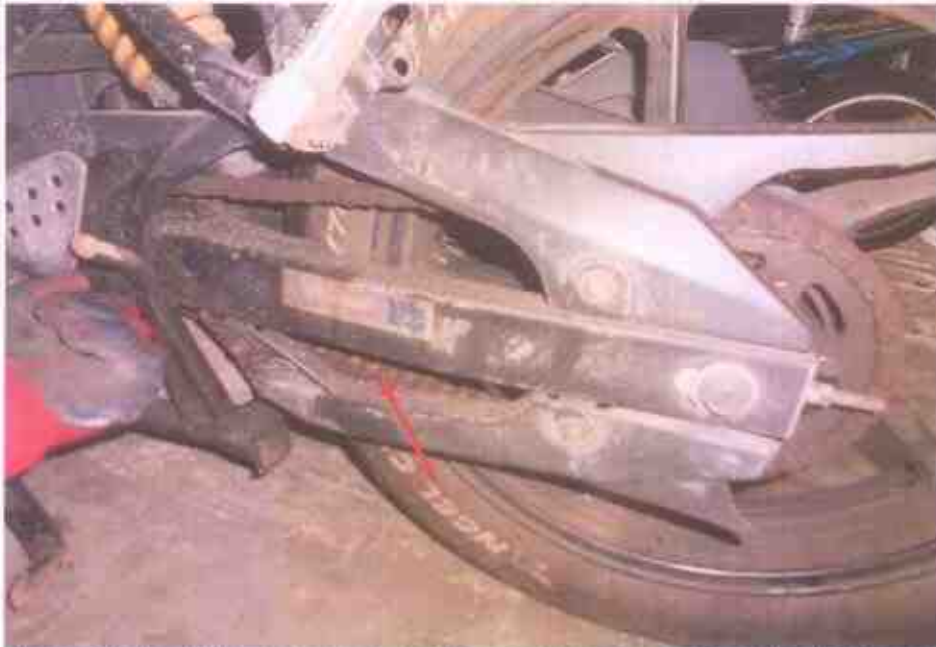
Photo 16 shows the general view of the gear train (arrowed) of the Motorcycle, which was observed to be intact with no misalignment. It was also adequately lubricated for operating purposes. Free play tension was also observed & found adequately acceptable.

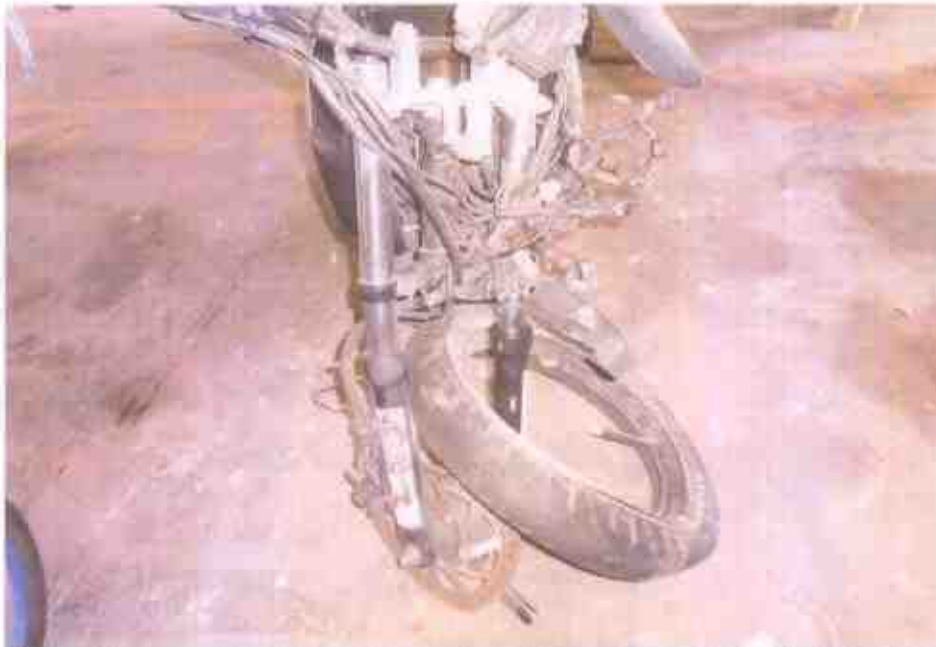
14. For this case, we were not able to conduct any test(s) on the steering system of the Motorcycle due to the damage on its front fork. Its front fork assembly was observed to be severely damaged as a result of the accident.

Photo 17 shows the front fork was observed to have sustained with severe damages as a result of the accident. Hence, we are not able to conduct any tests on the steering system of the Motorcycle.

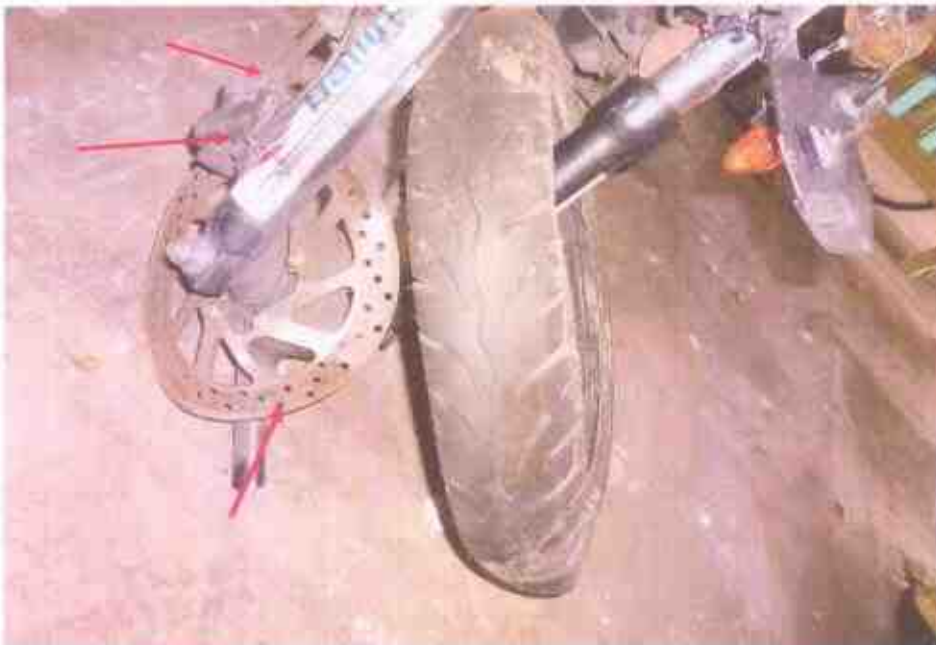
Photo 18 shows the front brake calliper, front brake disc and front brake hose of the Motorcycle (arrowed), which are all part of the components in the front brake system of the Motorcycle. Our visual checks of these various components had revealed that only the brake disc was damaged due to the accident. No leakage of brake fluid was also observed.

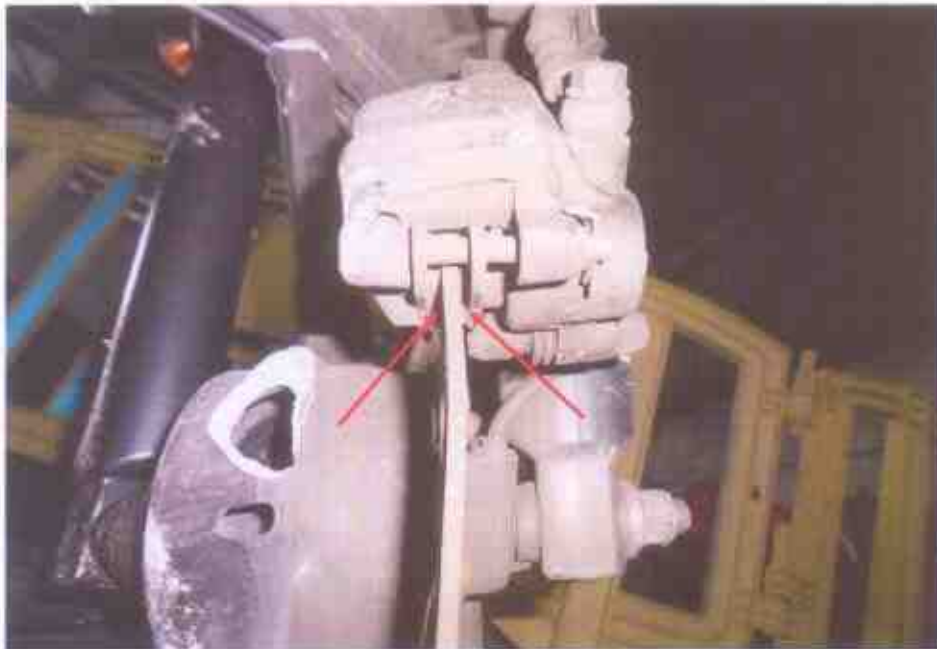
Photo 19 shows the front brake pad of the Motorcycle (arrowed). Our visual checks of the front brake pad had revealed that it is in serviceable condition.

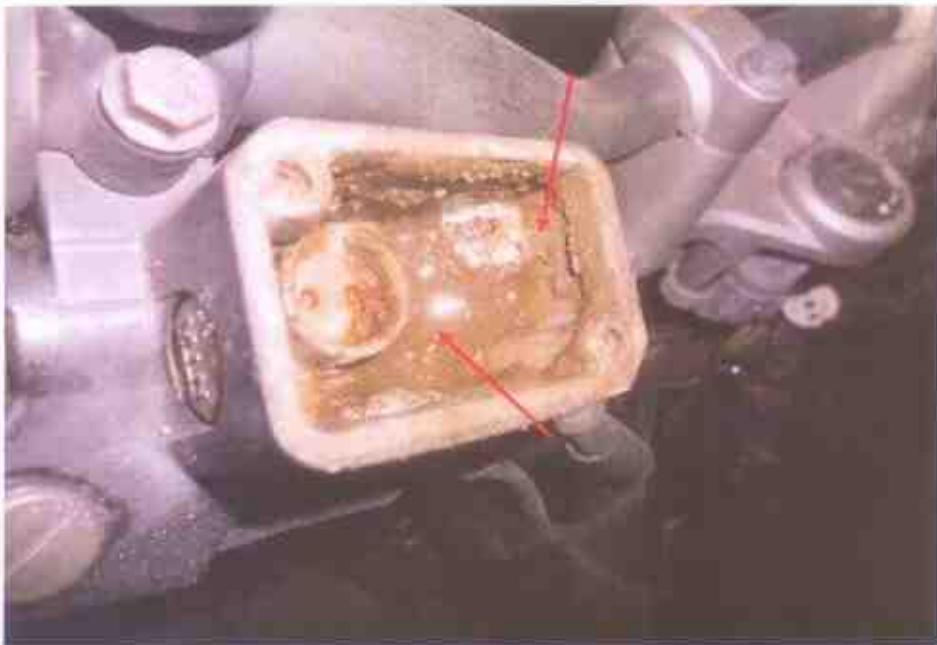
17. Further investigation on the front brake fluids from the brake fluid reservoir found that it was contaminated and insufficient. Upon dismantling of the front brake reservoir cover, a sludge like substance noted to be filling the brake fluid reservoir.

19. However, this contamination was likely due to moisture developing in the system after a period of time. Heat element might contribute to this reaction. Hence, conclusively the front brake was likely not in serviceable condition prior the material time of the accident.

Photo 20 shows after opening of the front brake fluid reservoir of the Motorcycle (arrowed). We found that the brake fluid turned into sludge like substance. Hence, indicates it had been contaminated prior to the accident.

24. For this particular case, we are of the opinion that the front brake fluids contamination was likely due to moisture developing in the system after a period of time. Heat element might contribute to this reaction and caused contamination to the brake fluid turning it into sludge like substance. Hence, conclusively the contaminated front brake fluids could have contributed to the accident by means of chocking the braking system and making it ineffective at the material time of the accident.

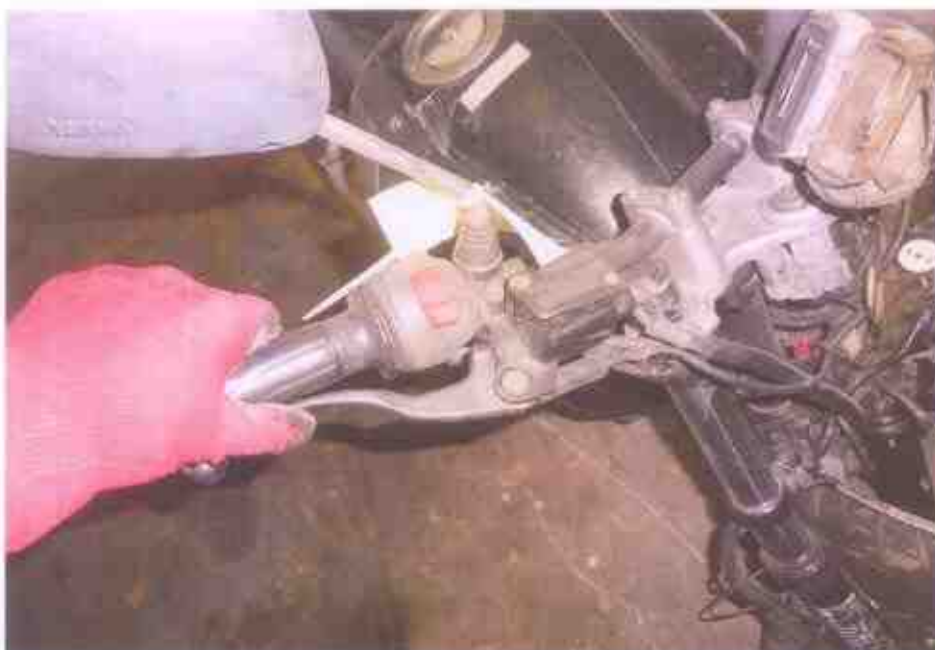
20. Static brake test for the front brake was conducted on the Motorcycle. It was found that there was no resistance felt (spongy like feel) upon gripping the hand brake lever. This would indicate that there's evidence of abnormalities occurred while performing static brake test on the front brake of the motorcycle.

Photo 21 shows the front brake static test. It was observed to be not in serviceable condition at time of our inspection. The brake lever was found to be without resistance (spongy like feel). However, no brake fluid leakage was observed at time of our inspection.

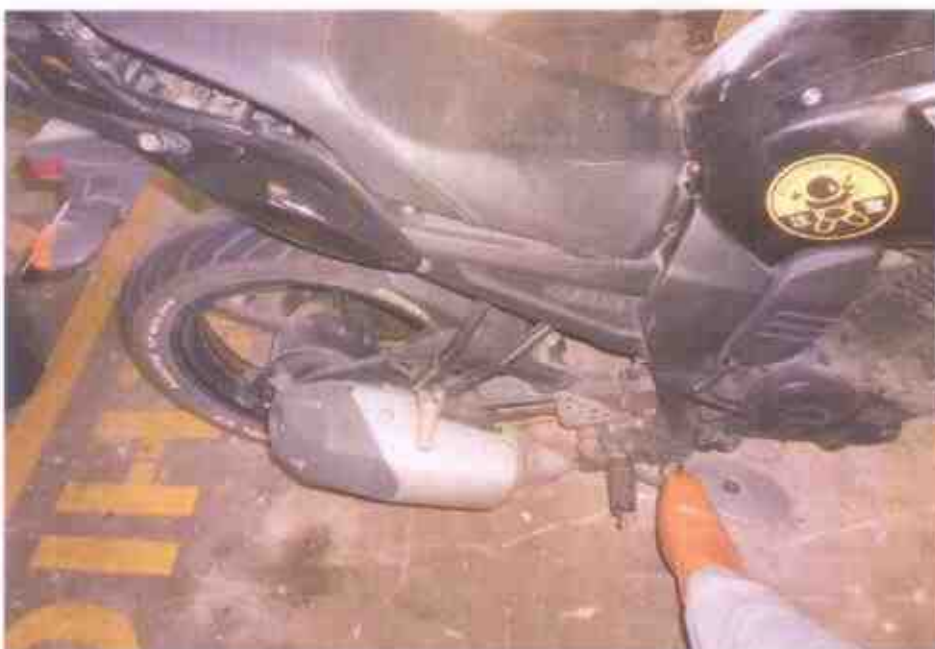
21. Static brake test however was conducted on the Motorcycle rear brake had appeared to indicate that it was in serviceable condition. There was some resistance felt (spongy like feel) upon stepping on the rear brake foot pedal. This would indicate that there were no abnormalities in the rear brake system mechanical parts.

Photo 22 shows the rear brake static test of the Motorcycle. The type of brake system for the rear wheel was of mechanical type, controlled by the brake foot pedal of the Motorcycle. Our static brake test revealed that the rear brake system of the Motorcycle was in serviceable condition without damage.
