Your Ref: TP/IP/31959/2018
Our Ref :CI/TPD18011363/Z

Fatal Accident Investigation Team

MECHANICAL INSPECTION REPORT OF MOTORCYCLE FX 9207P

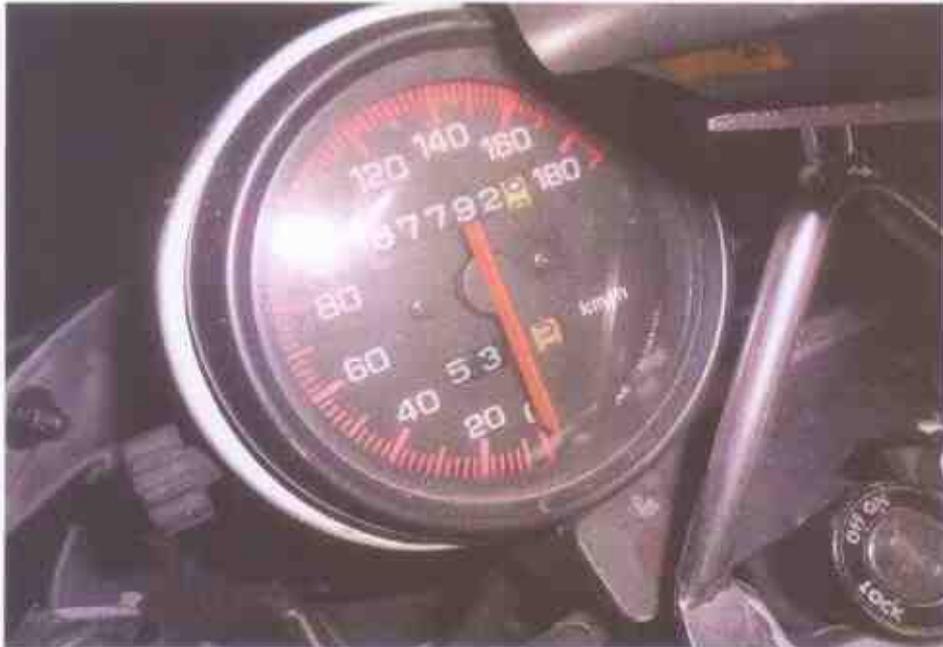
Photo 1 shows a close-up view of the mileage meter at time of our inspection. The mileage was recorded at 877926km.

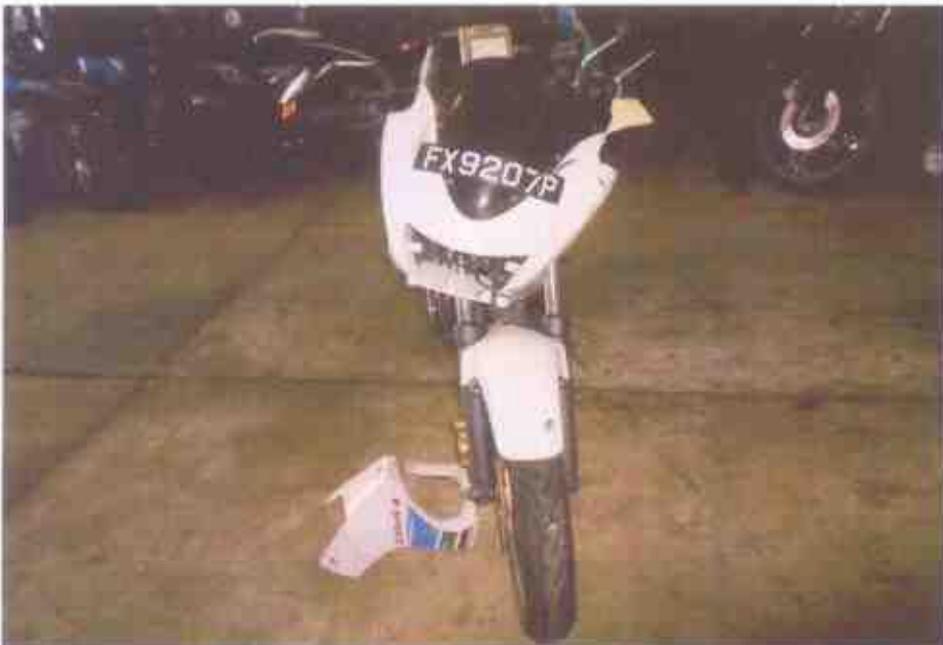
Photo 2 shows a general view of the front body of the Motorcycle at the time of our inspection. The Motorcycle was observed to have sustained relatively minor damages at time of inspection.

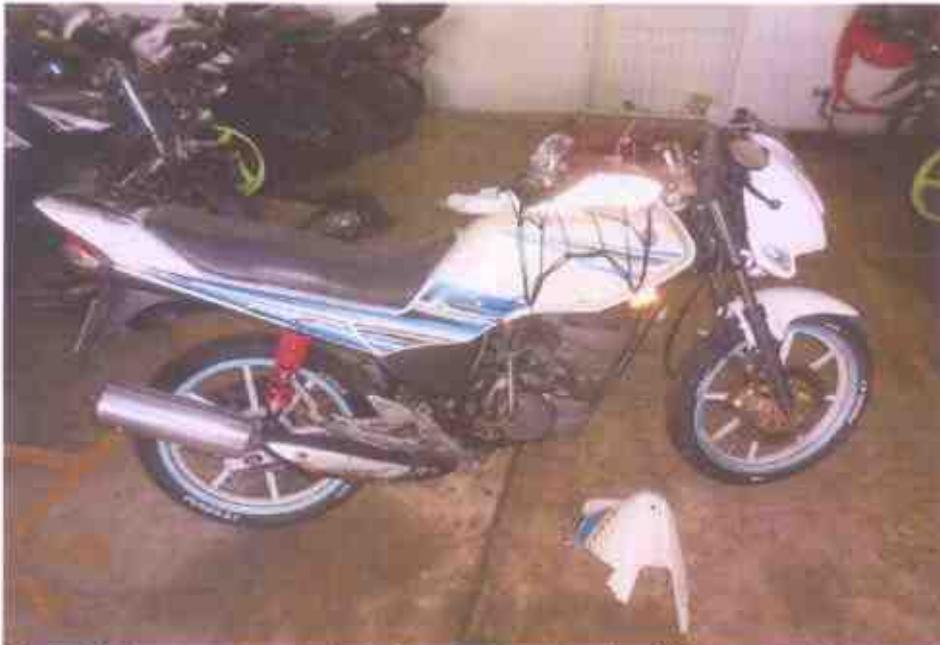
Photo 3 shows a general view of the right body of the Motorcycle at the time of our inspection. The Motorcycle was observed to have sustained relatively minor damages on the right side fairing at time of our inspection.

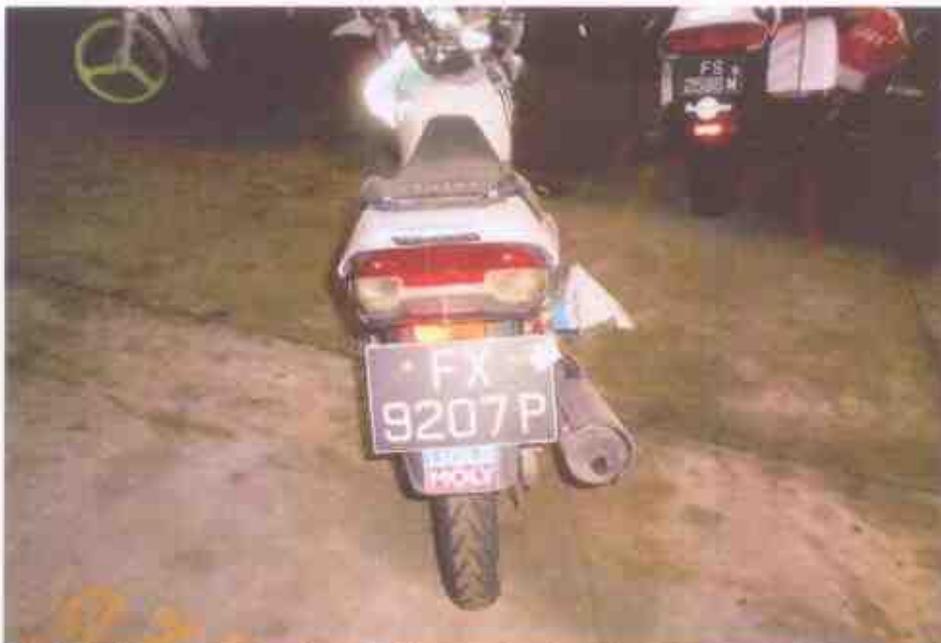
Photo 4 shows a general view of the rear body of the Motorcycle at the time of our inspection. The Motorcycle was observed to in good condition unaffected by the accident.

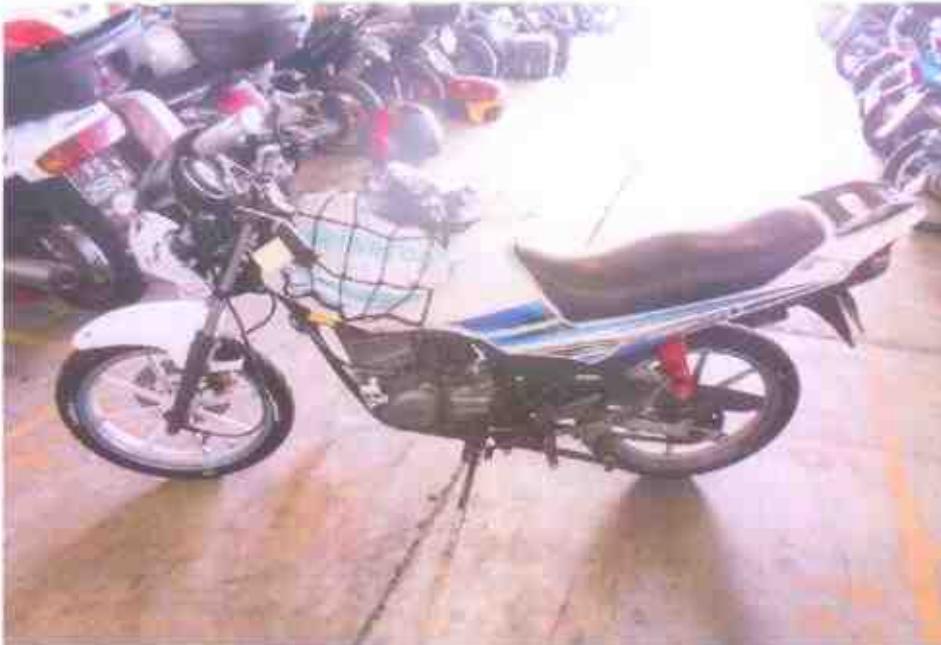
Photo 5 shows a general view of the left body of the Motorcycle at the time of our inspection. The Motorcycle was observed to have sustained relatively minor damages on the front fairing & component amongst others at time of our inspection.

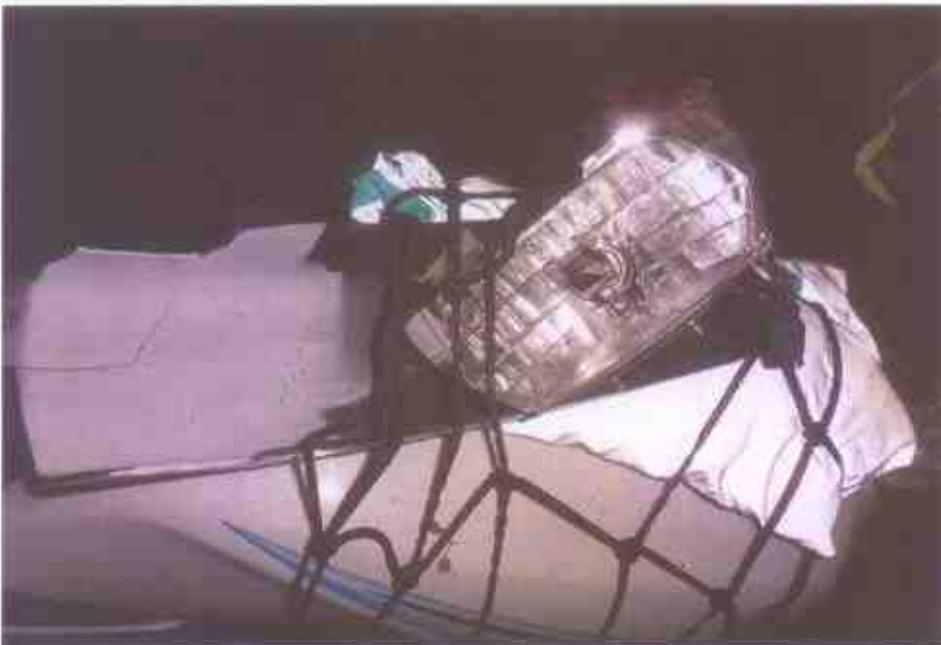
Photo 6 shows a closer view of the dislodged headlamp as a result of the accident.

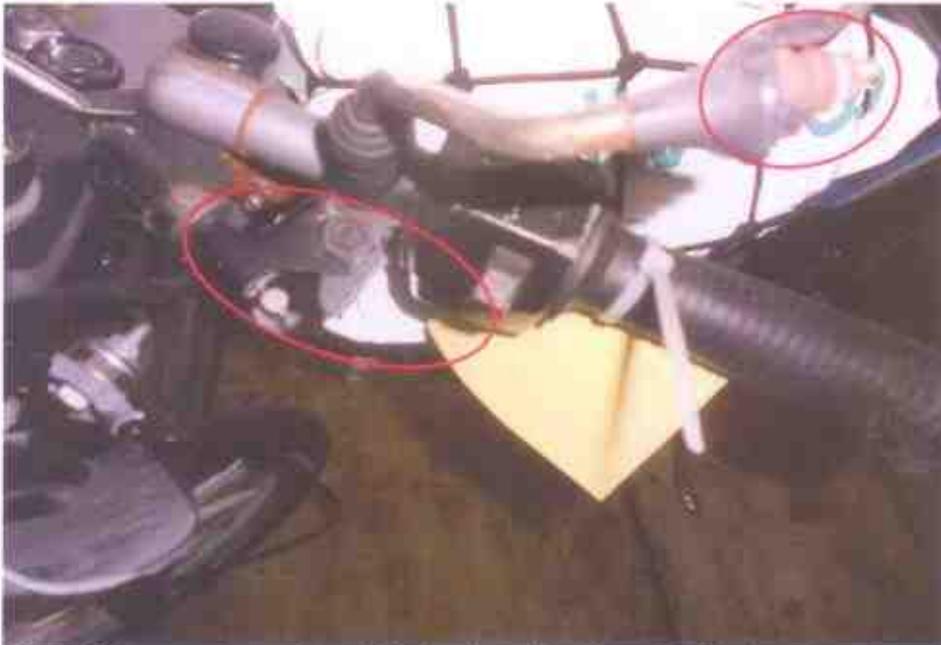
Photo 7 shows a closer view of the broken clutch lever & missing wing mirror of the Motorcycle at the time of our inspection. The Motorcycle was observed to have sustained with relatively minor damages due to the accident's collision. (Circled)

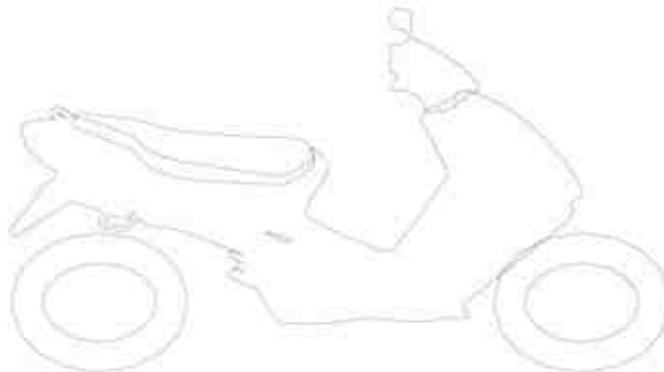
- The condition of the Motorcycle's 2 tyres was observed to be in serviceable condition. The tread pattern of the 2 tyres was clearly visible. We did not observe any tear, burst mark(s) and/or punctured hole(s) on the sidewalls as well as across the tread of the 2 tyres. The 2 tyres were both observed to be sufficiently inflated for vehicular operation. The tyre brand, tyre size and remaining tread depth of the 2 tyres were recorded as follows:-

Pirelli 80/90 - R17 (4mm)

Pirelli 80/90 - R17 (5mm)

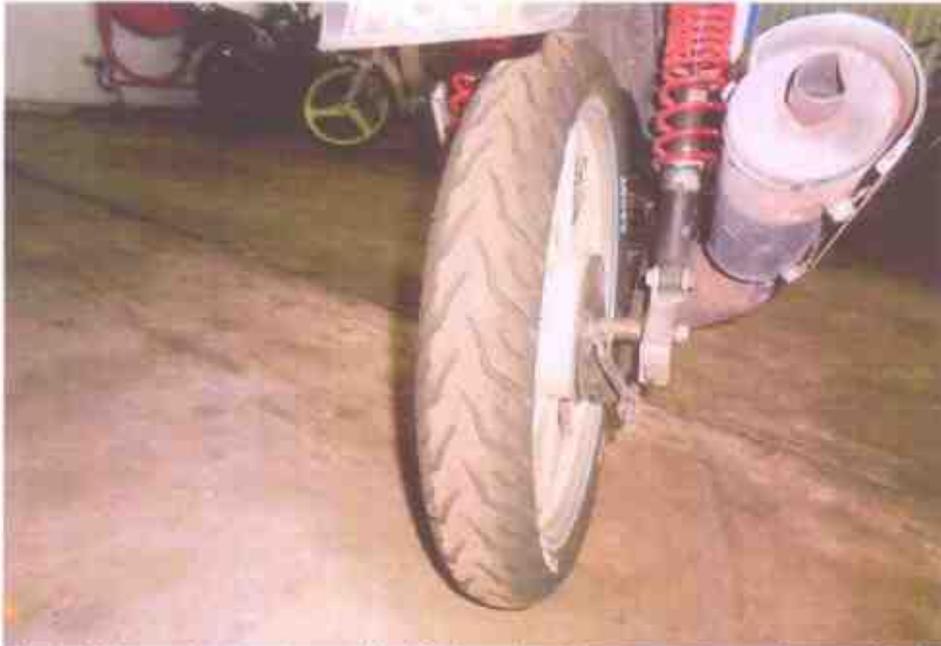
Photo 8 shows the rear tyre of the Motorcycle. The rear tyre was observed to be in serviceable condition with remaining tread depth of approximately 4mm. The tyre was also observed to be sufficiently inflated for vehicular operation.

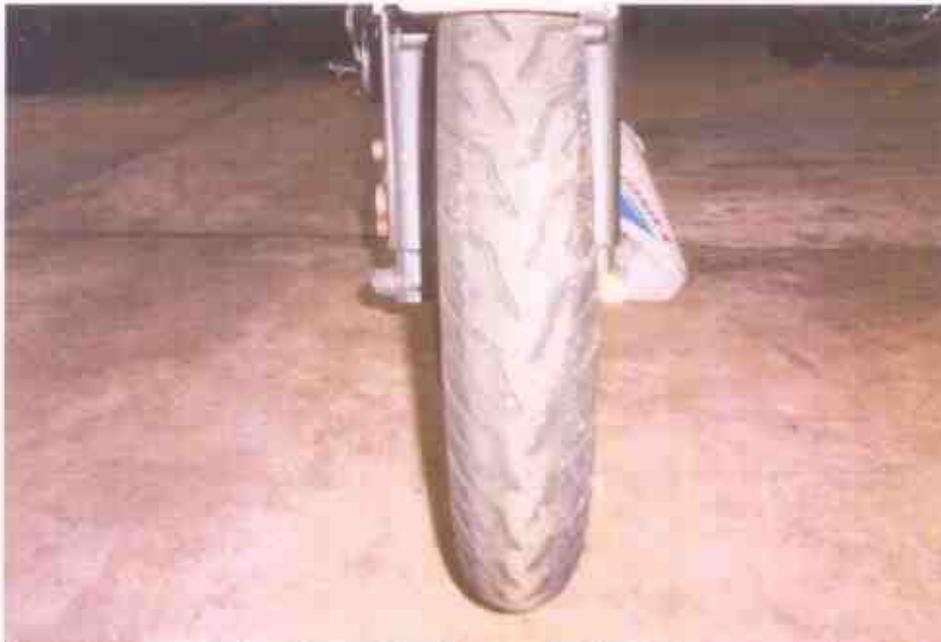
Photo 9 shows the front tyre of the Motorcycle. The front tyre was observed to be in serviceable condition with remaining tread depth of approximately 5mm. The tyre was also observed to be sufficiently inflated for vehicular operation.

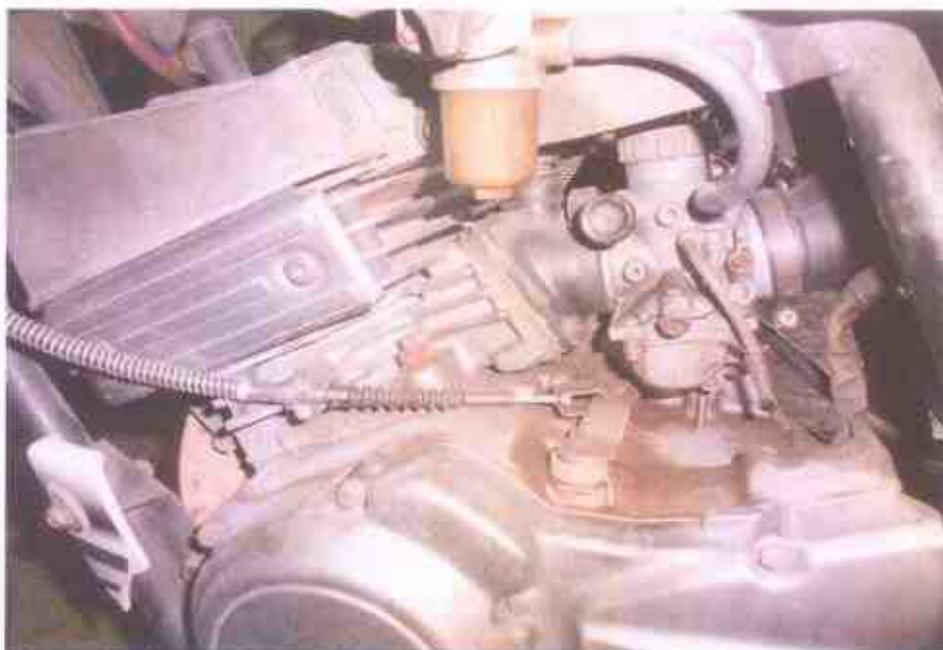
Photo 10 shows no sign(s) or indication(s) of fluid leak observed around the underside of the engine area of the Motorcycle.

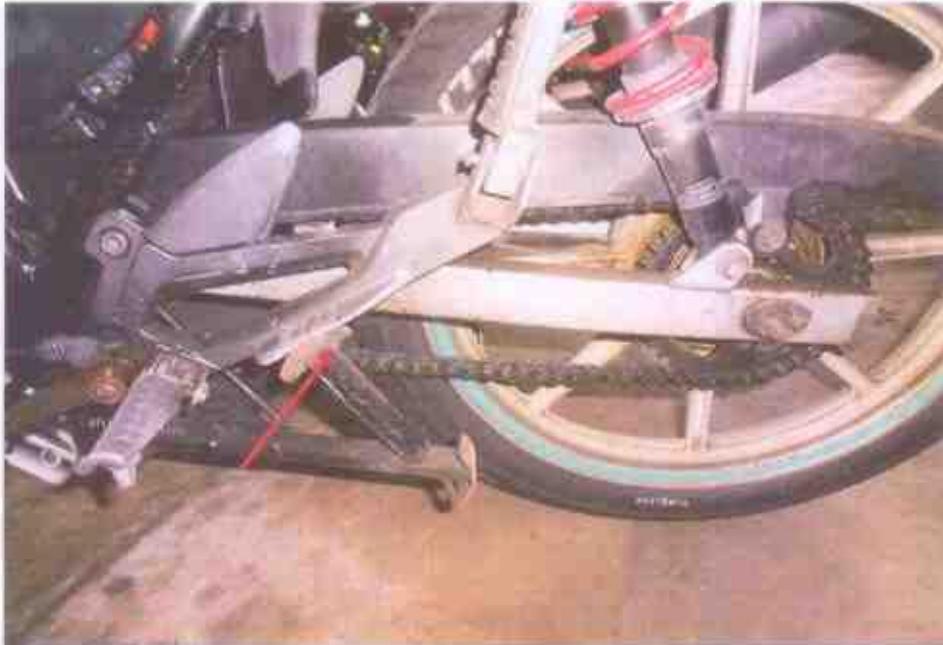
Photo 11 shows the general view of the gear train (arrowed) of the Motorcycle, which was observed to be intact with no misalignment. It was also adequately lubricated for operating purposes.

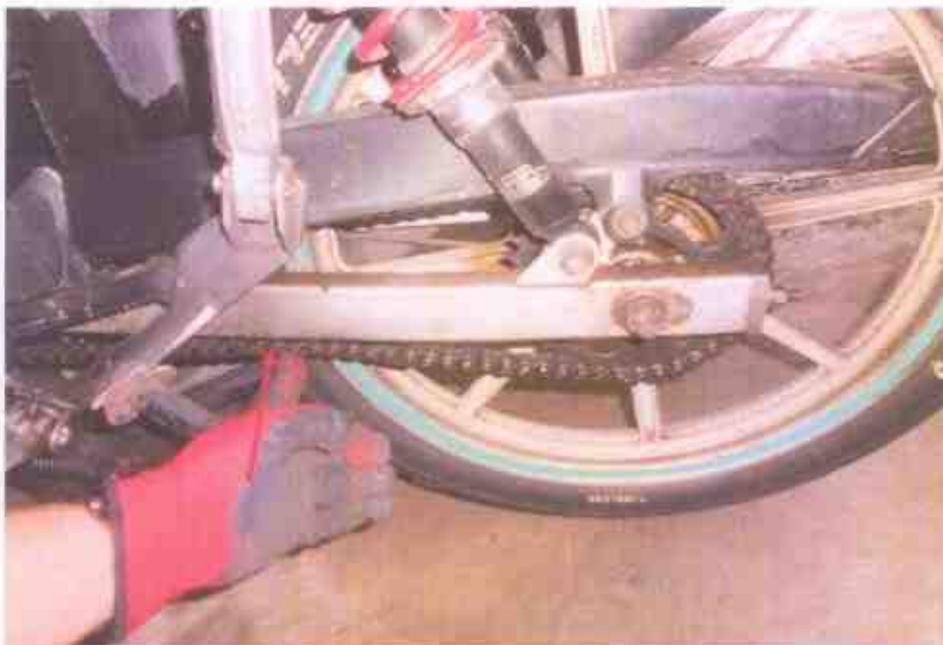
Photo 12 shows the general view of the gear train (arrowed) of the Motorcycle, which was observed to be intact with no misalignment. It was also adequately lubricated for operating purposes. Free play tension was also observed & found adequately acceptable.

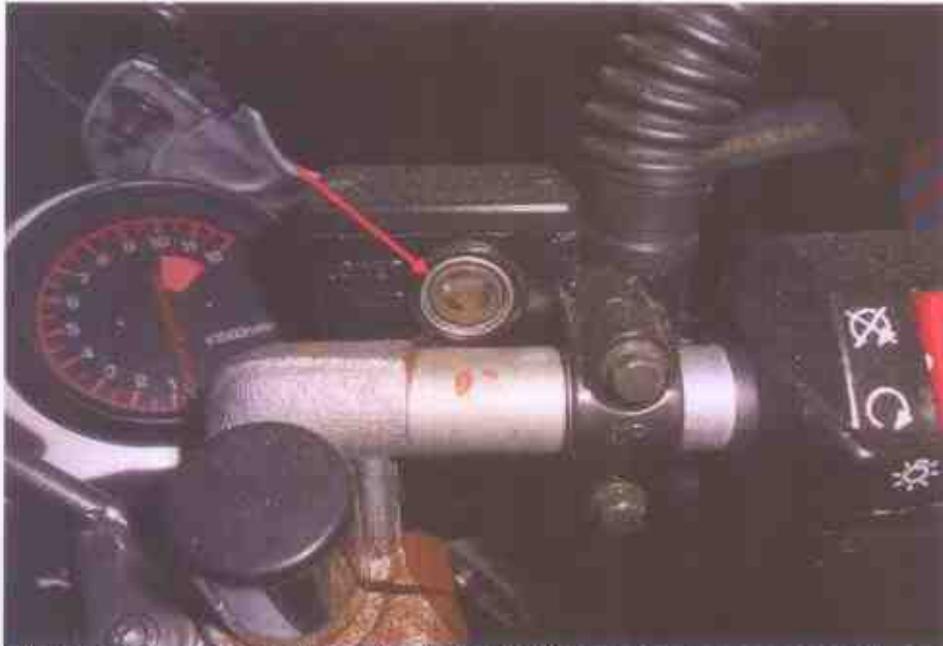
Photo 13 shows our checks on the brake fluid (front) reservoir had also indicated that the brake fluid was of sufficient level for operational purposes, and without contamination.

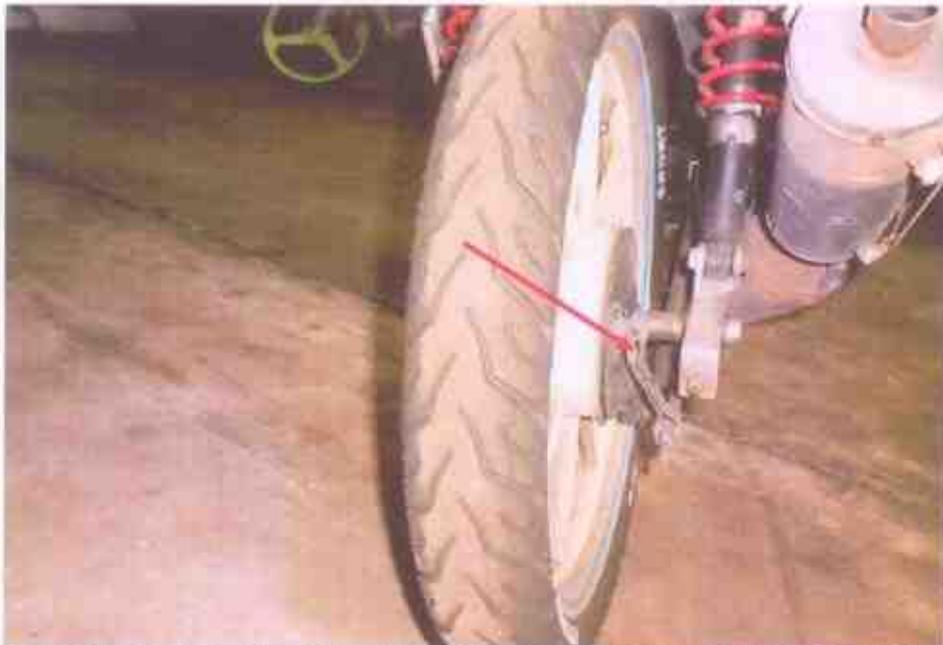
Photo 14 shows our checks on the rear brake component had also indicated that the mechanical components were in serviceable condition unaffected by the accident's impact.

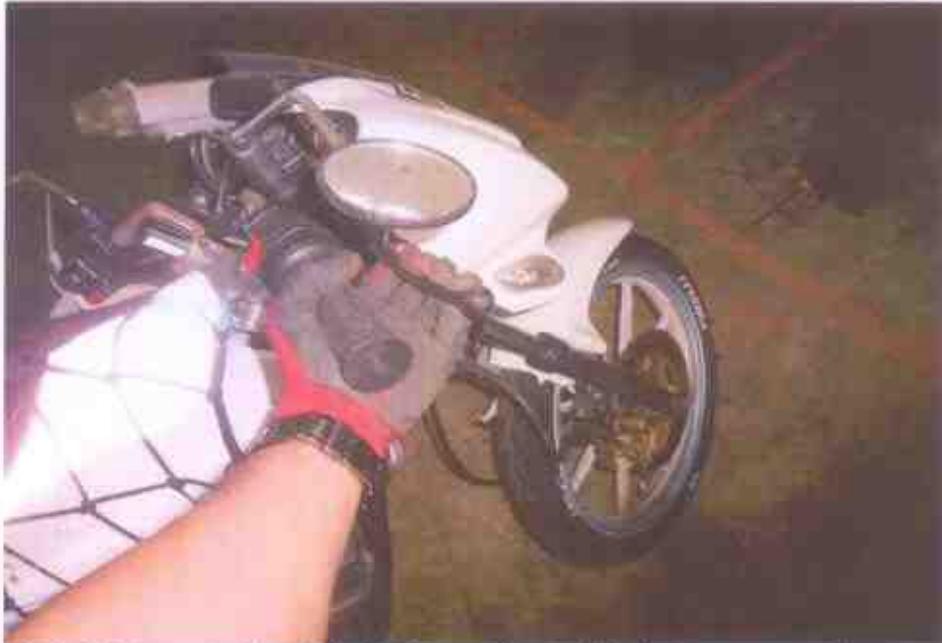
Photo 15 shows testing of the braking of the front brake in progress. There was some resistance felt (spongy like feel) upon pressing the brake lever.

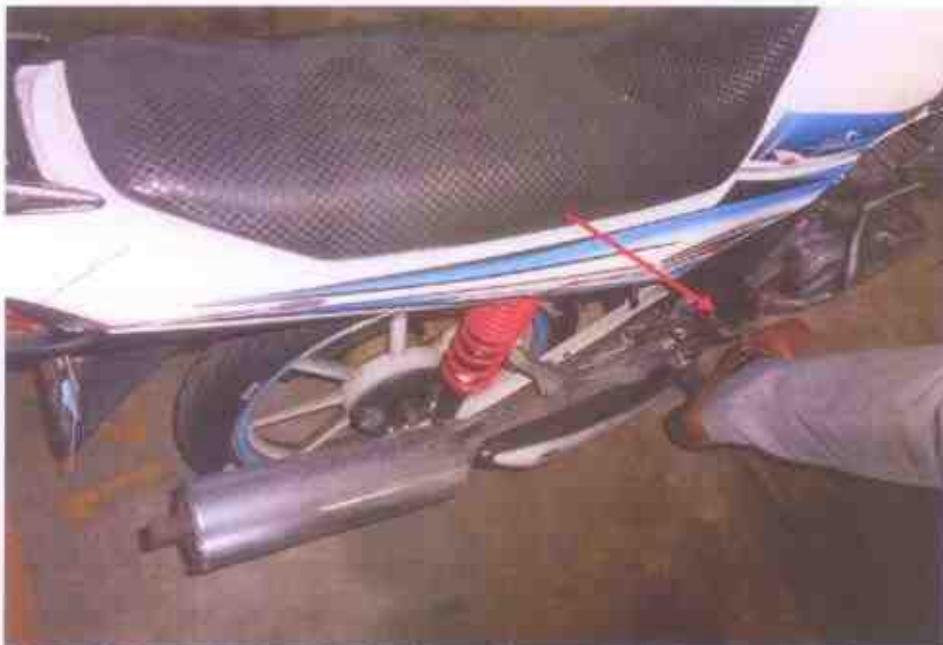
Photo 16 shows testing of the braking of the rear brake in progress. There was some resistance felt (spongy like feel) upon stepping on the brake pedal.

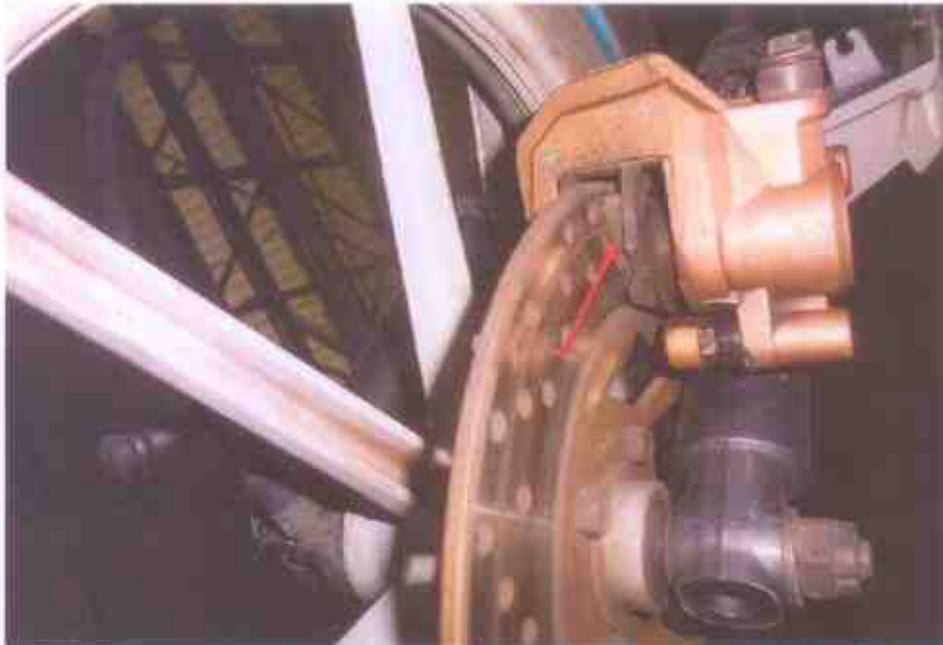
Photo 17 shows the front brake pad at time of our inspection. The frictional material was observed to be sufficient for operational purposes.
