Your Ref: TP/IP/31659/2018
Our Ref :CI/TPD18011364/Z

Fatal Accident Investigation Team

MECHANICAL INSPECTION REPORT OF MOTORCYCLE JQV 4563

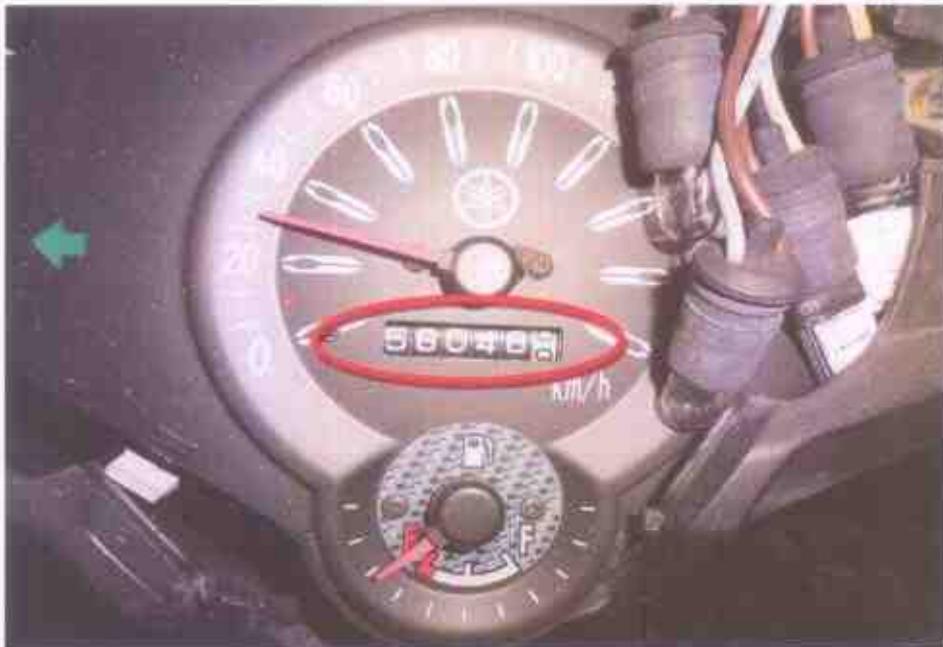
Photo 1 shows the mileage at the time of inspection was recorded to be 560489km.

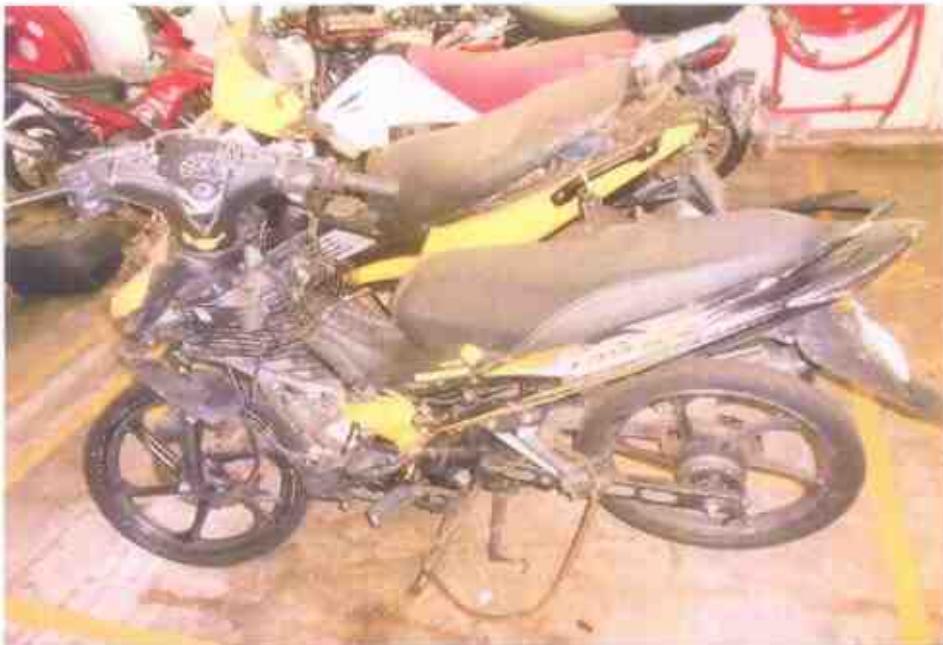
Photo 2 shows a general view of the front left body of the Motorcycle at the time of our inspection. The Motorcycle was observed to be sustained with relatively extensive impact due to the accident collision. Amongst the body parts damaged was its front fork, which was observed to be bent to the left.

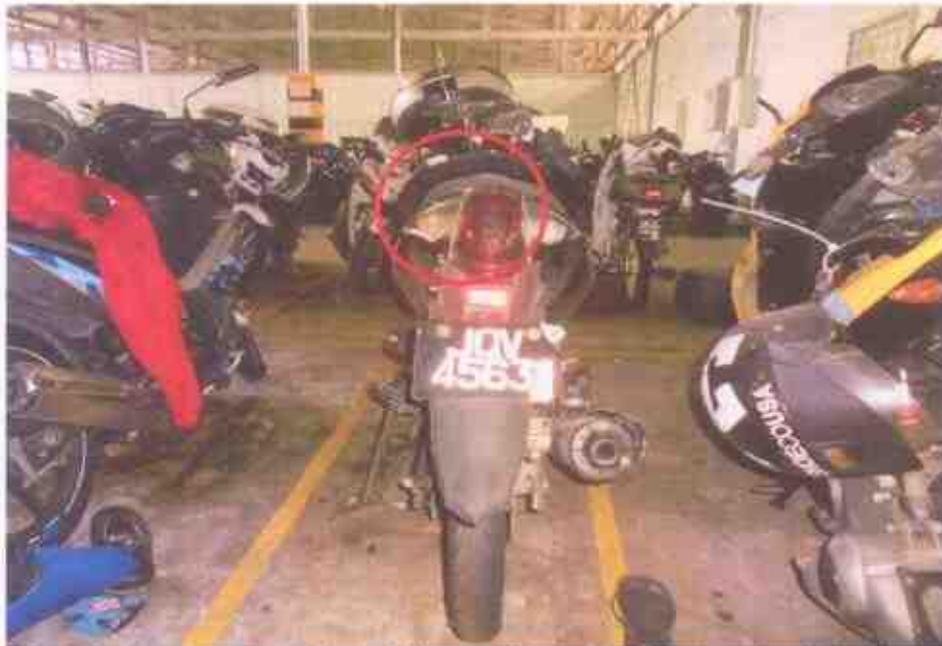
Photo 3 shows a general view of the rear body of the Motorcycle at the time of our inspection. The Motorcycle was observed to have sustained damages at the rear portion.

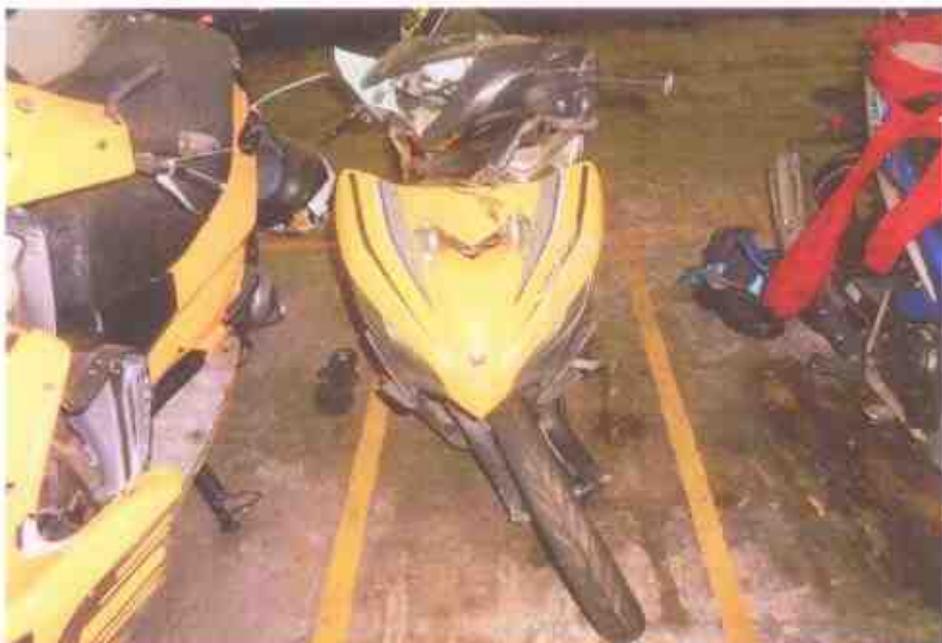
Photo 4 shows a general view of the frontal portion of the Motorcycle at the time of our inspection. The Motorcycle was observed to be sustained with relatively extensive impact due to the accident collision.

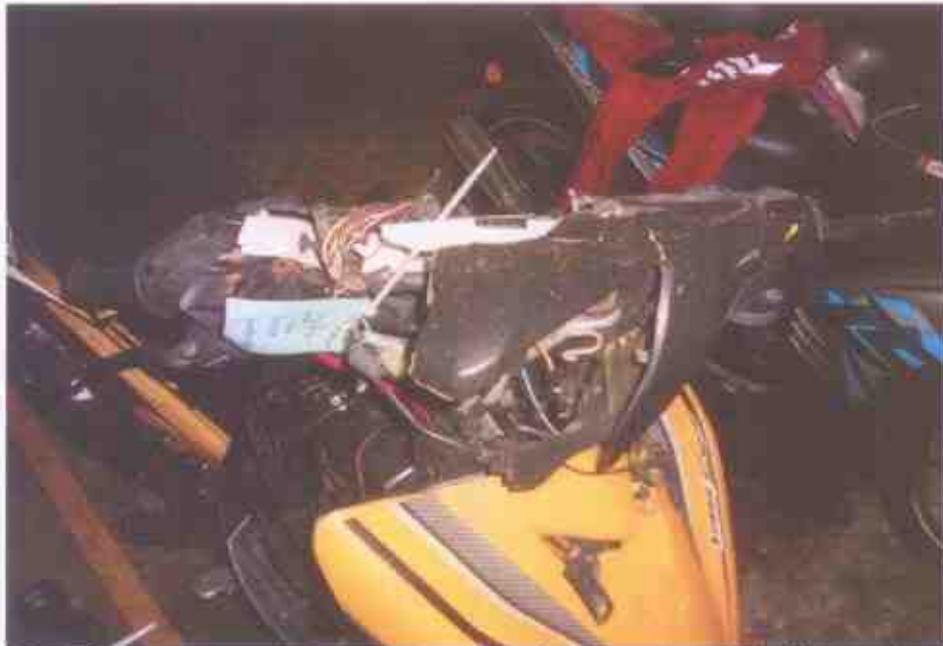
Photo 5 shows a semi close-up view of the frontal portion of the Motorcycle at the time of our inspection. The Motorcycle was observed to be sustained with relatively extensive impact due to the accident collision.

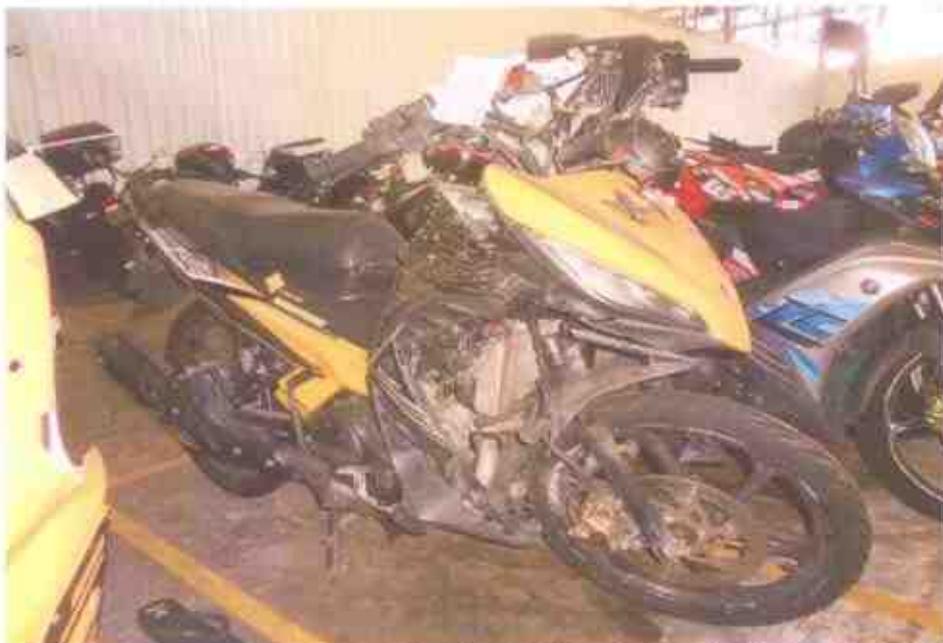
Photo 6 shows a general view of the front right portion of the Motorcycle at the time of our inspection. The Motorcycle was observed to be sustained with relatively extensive impact due to the accident collision.

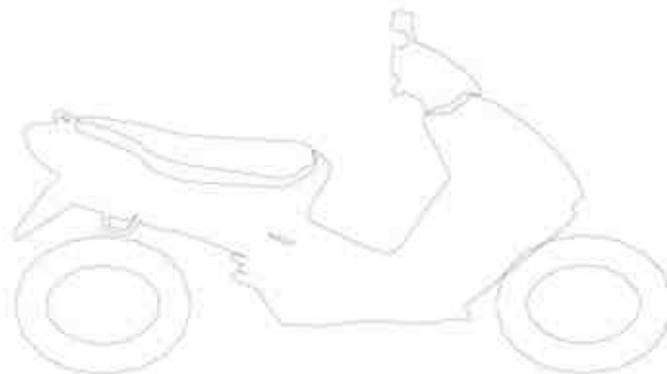
7. The condition of the Motorcycle's rear tyre was observed to be in serviceable condition whereas the front tyre was found to be deflated likely due to the accident impact. However, the tread pattern of the 2 tyres was clearly visible. We did not observe any tear, burst mark(s) and/or punctured hole(s) on the sidewalls as well as across the tread of the 2 tyres. The rear tyre was observed to be sufficiently inflated for vehicular operation. The tyre brand, tyre size and remaining tread depth of the 2 tyres were recorded as follows:-

Maxxis Diamond MA-3D
70/90 - 17 (4mm)

Maxxis Diamond MA-3D
70/90 - 17 (3mm)

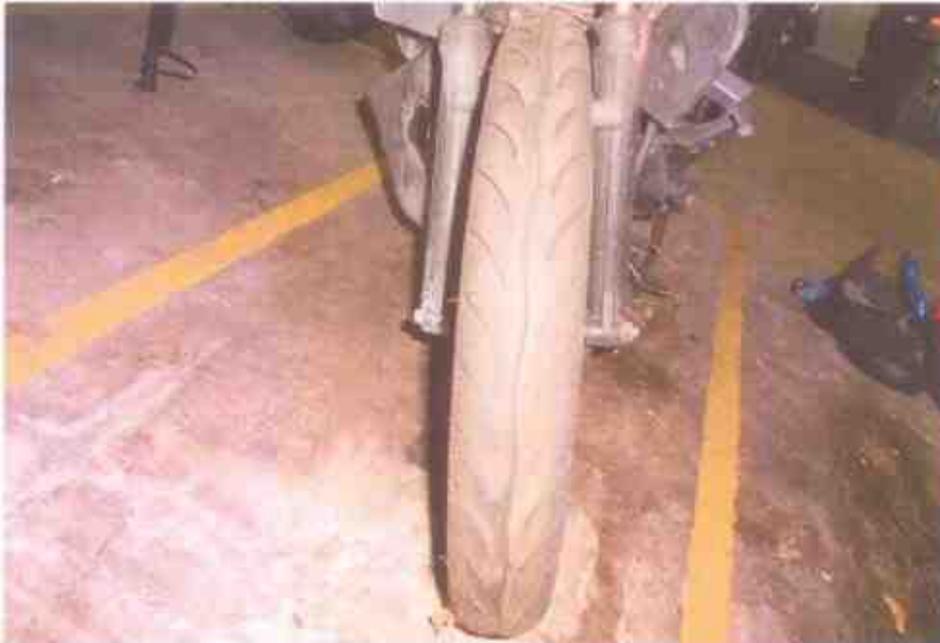
Photo 7 shows the front tyre of the Motorcycle at the time of our inspection. The rear tyre was observed to be in serviceable condition with remaining tread depth of approximately 3mm. The tyre was observed to be deflated as a result of the accident. However, there was no significant damage observed on the front wheel rim & tyre.

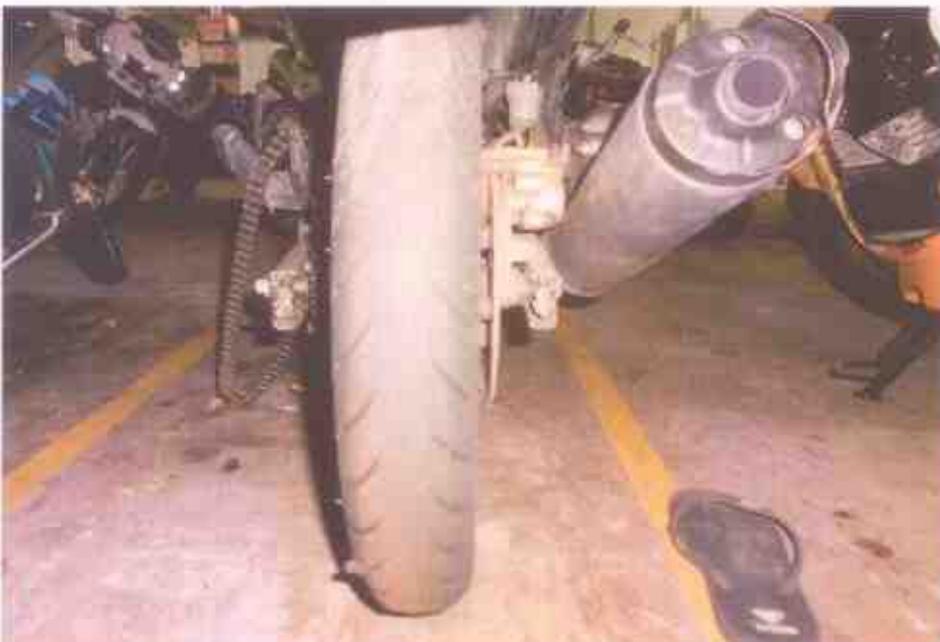
Photo 8 shows the rear tyre of the Motorcycle. The pattern of the tread was clearly visible with remaining tread depth of about 4mm. There was no tear, burst mark(s) and/or punctured hole(s) on the sidewalls as well as across the tread of the rear tyre unaffected by the accident's impact collision.

18. The rear tyre of the Motorcycle was found to be in a serviceable condition. There was no tear, cut or burst mark(s) on the outer and the inner sidewalls as well as across the tread of the tyre. It was sufficiently inflated for vehicular operation with remaining tread depth of approximately 4mm. Except for the front tyre that was deflated at time of our inspection likely due to the accident's collision impact. However, it was found to be in a serviceable condition. There was no tear, cut or burst mark(s) on the outer and the inner sidewalls as well as across the tread of the tyre & tread depth of approximately 3mm.

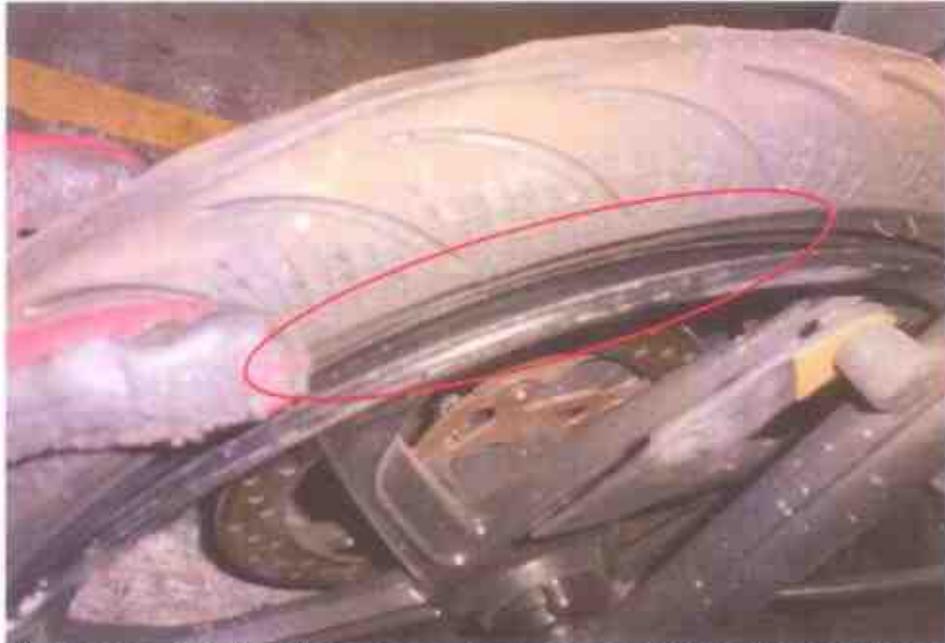
Photo 9 shows further observation on the front tyre that was deflated at time of our inspection likely due to the accident's collision impact.

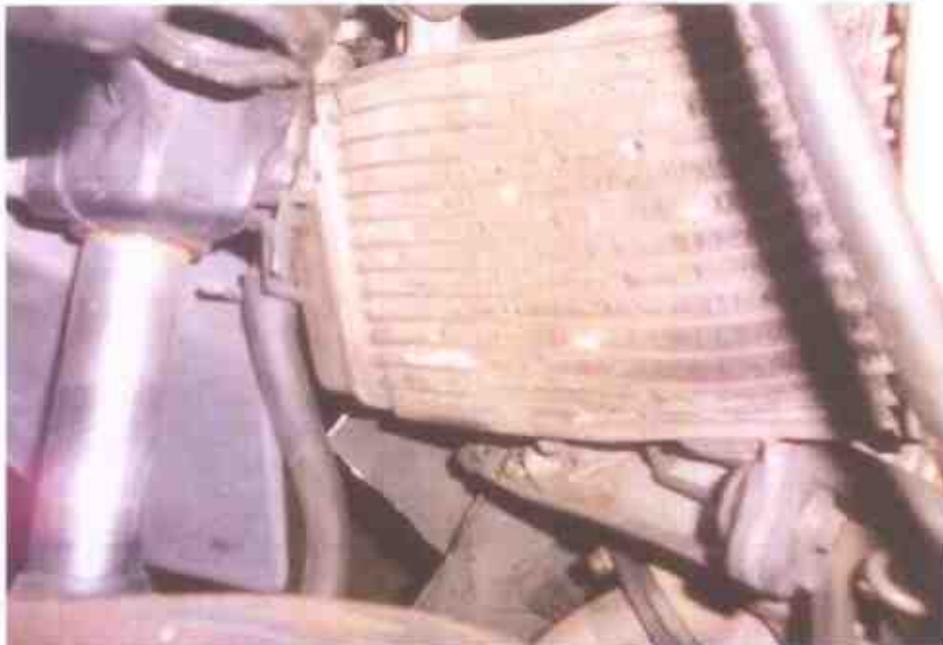
Photo 10 shows the damaged (corrugated) radiator as a result of the accident's impact collision.

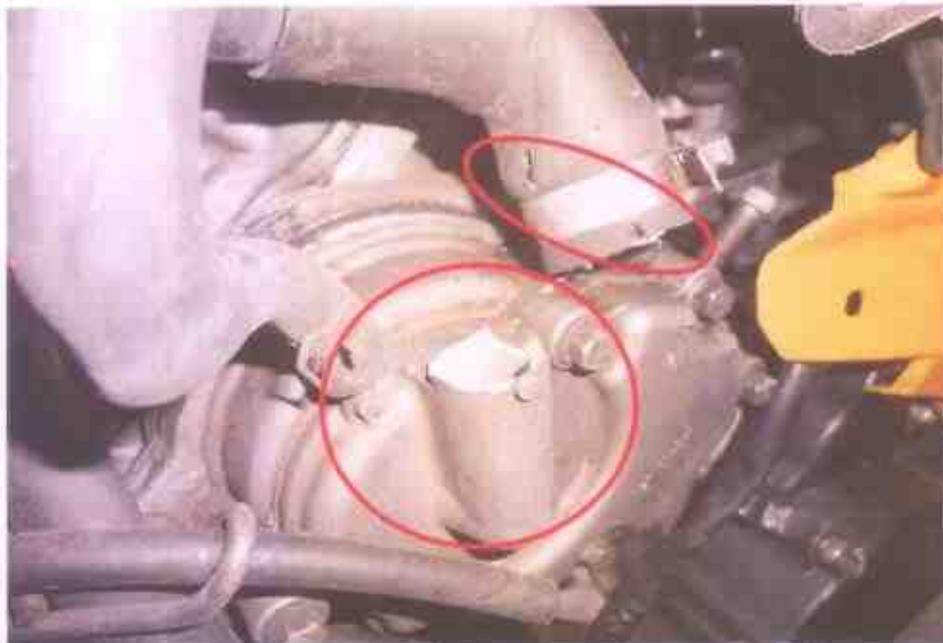
Photo 11 shows the damages sustained on the engine compartment as a result of the accident's collision.

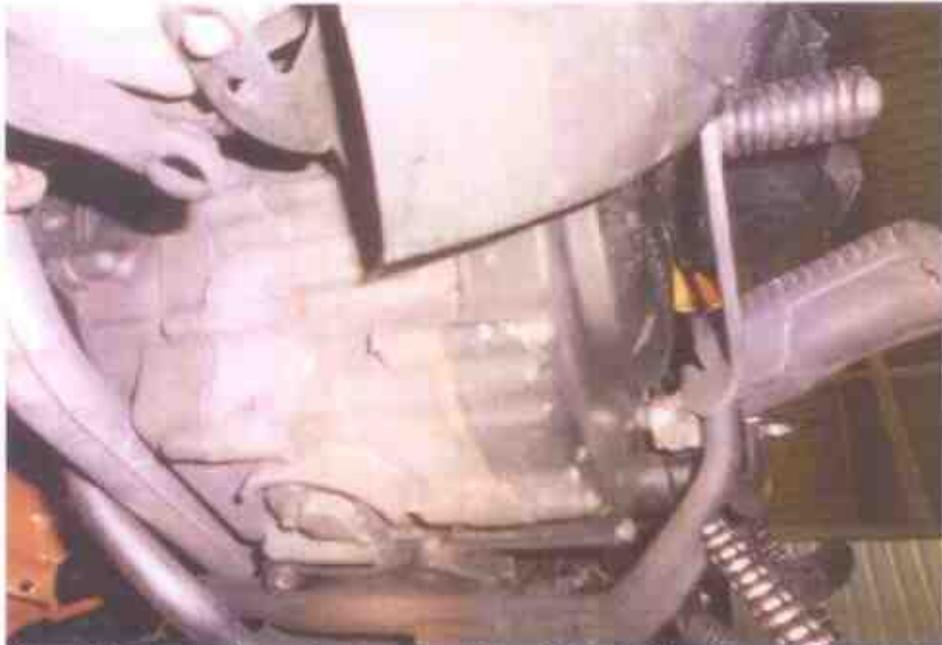
Photo 12 shows the undercarriage of the Motorcycle's engine. No signs or indication of any engine leakage at time of our inspection.

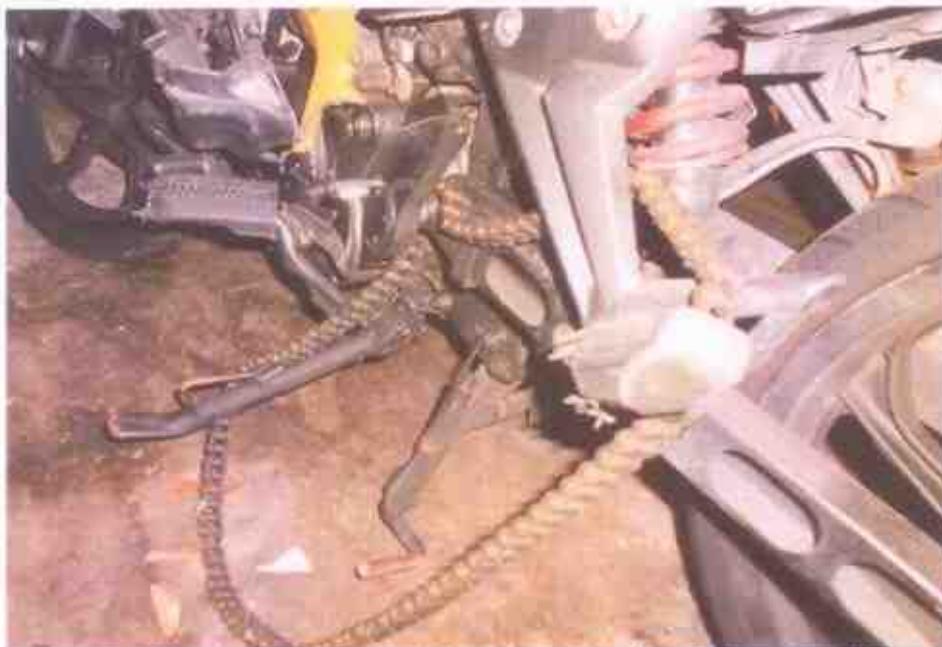
Photo 13 shows the general view of the gear chain of the Motorcycle, which was observed to be dislodged from the rear sprocket as a result of the accident's impact collision.

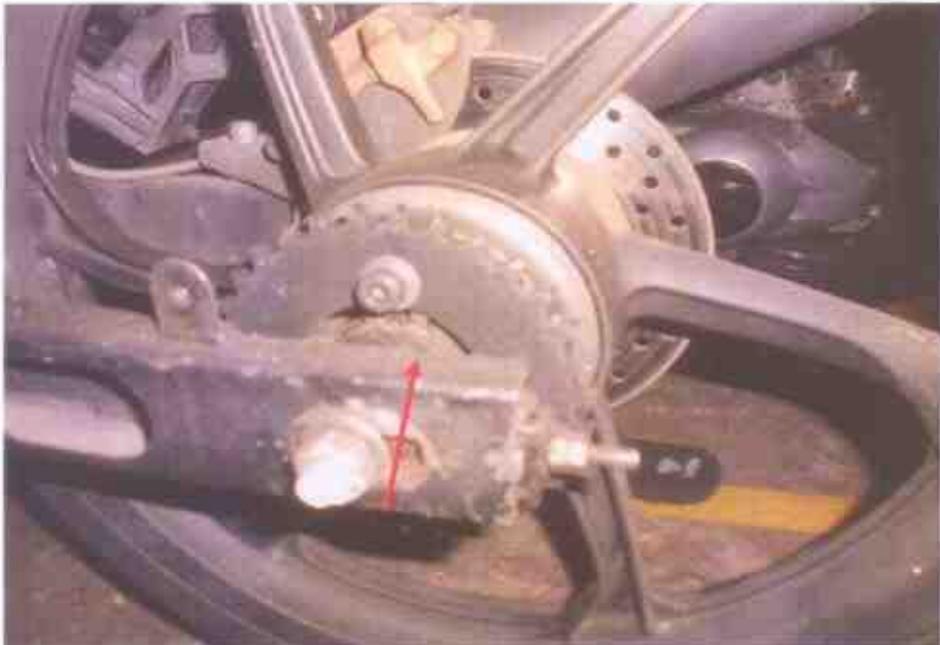
Photo 14 shows the general view of the rear sprocket (arrowed) of the Motorcycle, which was observed to be undamaged despite its separation with the gear chain as a result of the accident's impact collision.

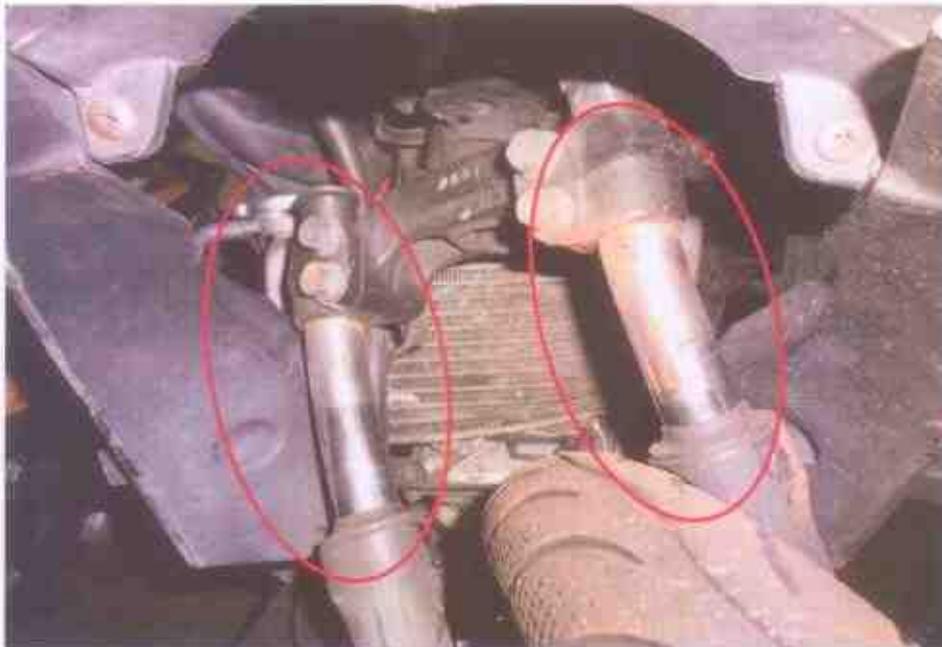
11. For this case, we were not able to conduct any test(s) on the steering system of the Motorcycle due to the damage on its front fork. The front fork was found to be buckled to the left side as a result of the accident, hence causing the whole steering system to be in a state of immobility.
12. The braking system of the Motorcycle was observed to be of a full hydraulic type, where hydraulic (brake fluid) pressure controls the brake for the front wheel and rear wheel. The brake for the front wheel is engaged by pulling the brake lever at the right side of the Motorcycle's handle bar while the brake for the rear wheel is engaged by stepping on the brake pedal at the right side foot rest of the Motorcycle.

Photo 15 shows the front fork (circled) was observed to be buckled to the left side as a result of the accident. Hence, we are not able to conduct any tests on the steering system of the Motorcycle.

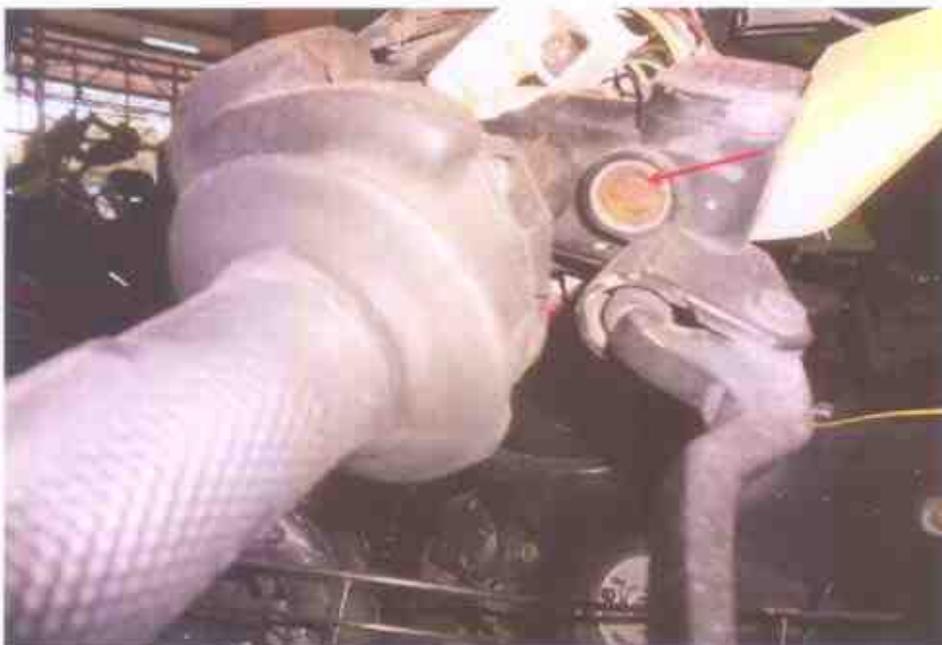
Photo 16 shows the front brake fluid reservoir had indicated that the brake fluid was of sufficient level for operational purposes, and without contamination.

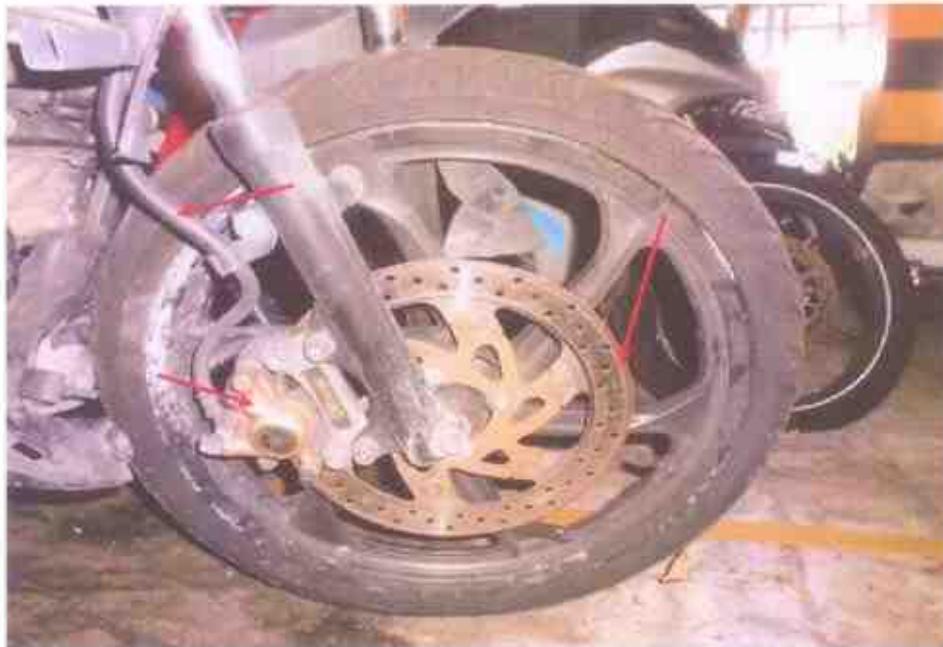
14. Whereas for the front brake despite the damages sustained on the steering system, we were able to conduct static brake test. There was some resistance felt (spongy like feel) upon pressing the brake lever at the right side of the handle bar. This would indicate that there's no leakage of pressure/vacuum in the brake system. Our checks on the brake fluid had also indicated that the brake fluid was of sufficient level for operational purposes, and without contamination. It's braking system like the brake discs, brake callipers, brake pad and brake hoses revealed all to be intact and without damage.

Photo 17 shows the front brake calliper, front brake disc, front brake pad and front brake hose of the Motorcycle, which are all part of the components in the front brake system of the Motorcycle. Our observation found that the front braking components were unaffected by the accident.

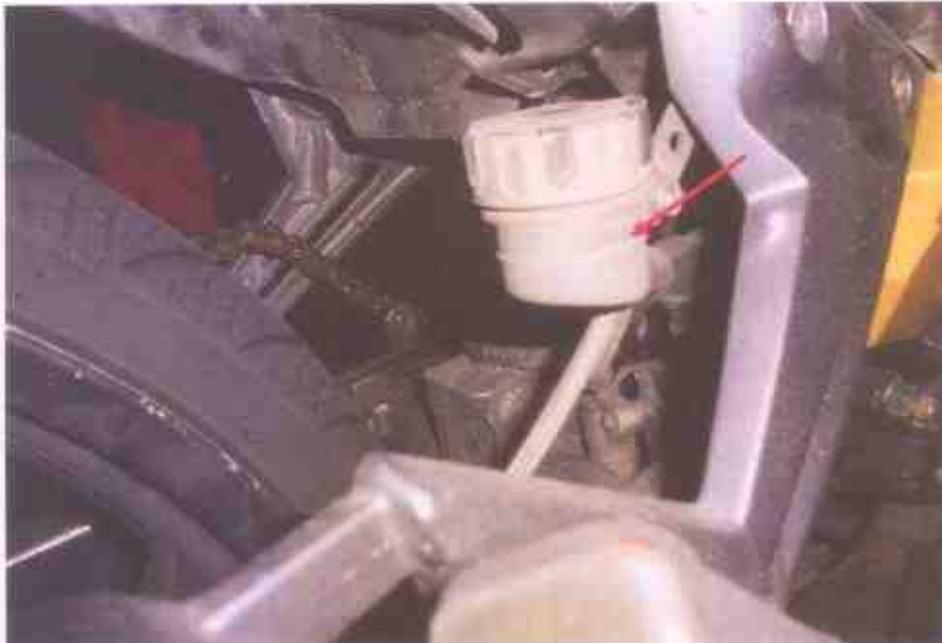
13. A static brake test was unable to be conducted on the Motorcycle's rear brake due to the brake pedal was stuck likely due to the accident. However, our checks on the brake fluid had indicated that the brake fluid was of sufficient level for operational purposes, and without contamination. The Motorcycle's rear braking system like the brake discs, brake callipers, brake pad and brake hoses revealed all to be intact and without damage.

Photo 19 shows the rear brake fluid reservoir of the Motorcycle. It was found to be at a sufficient level at time our inspection.

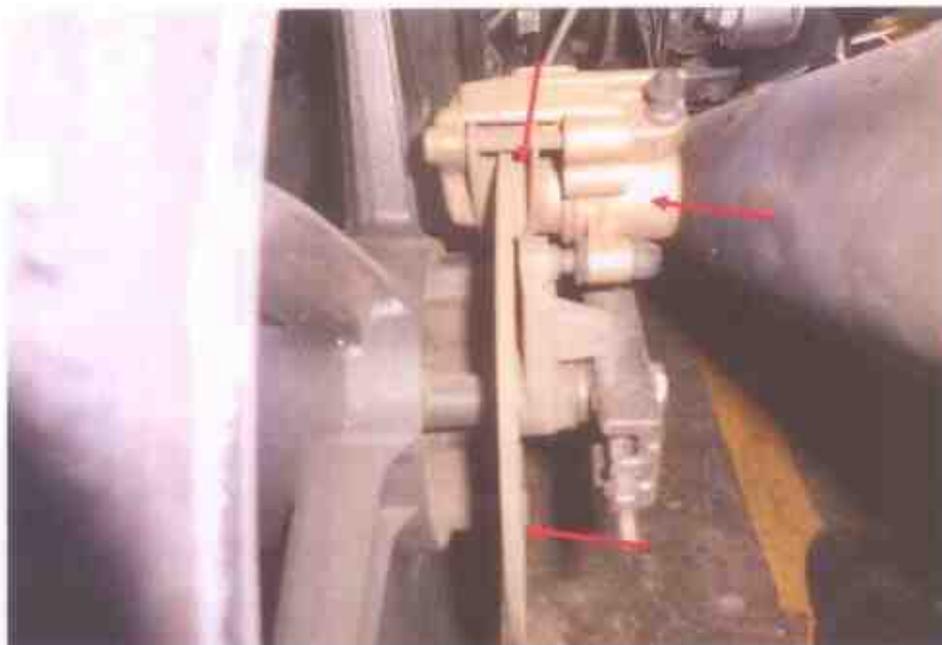
Photo 20 shows the rear brake calliper, brake disc and brake pad of the Motorcycle (arrowed), which are all part of the components in the rear brake system of the Motorcycle reveal all to be intact and without damage.
