Your Ref: TP/IP/35301/2018
Our Ref : CI/TPD18011457/Z

15th October 2018

MECHANICAL INSPECTION REPORT OF MINI MOTOR BUS PA 7839G.

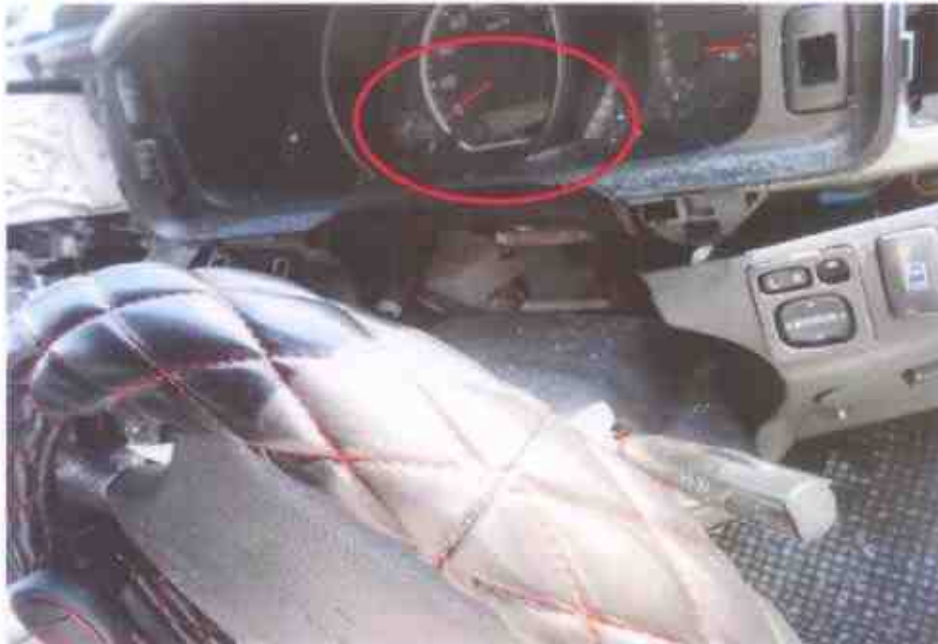
Photo 1 shows the mileage of the Motor Bus was not recorded due to the damages sustained on the ignition system as a result of the accident.

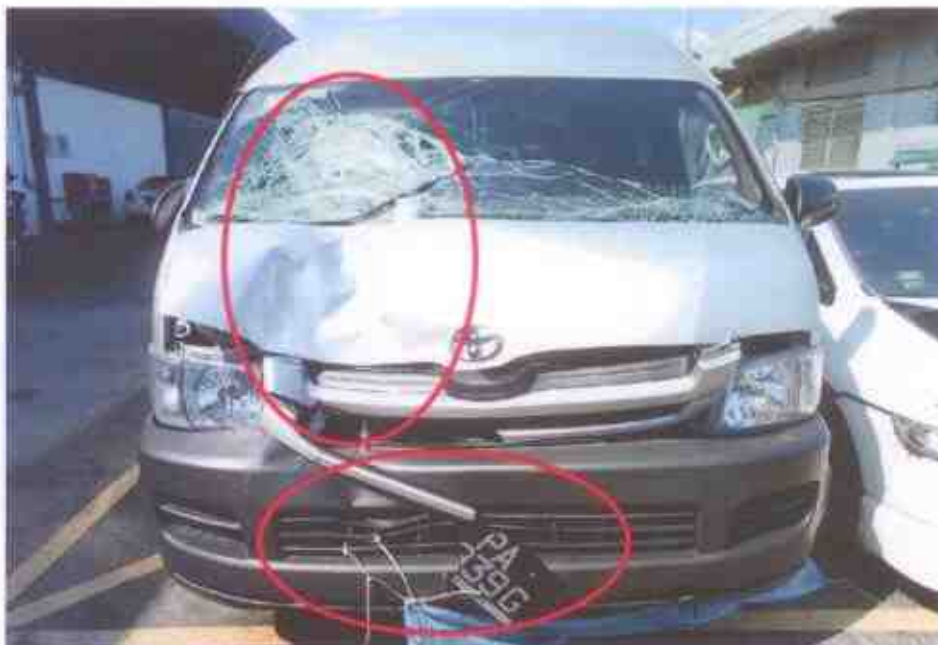
Photo 2 shows a general view of the front body of the Motor Bus at the time of our inspection. The Motor Bus was observed to sustained damages at the front right portion due to the accident's impact.

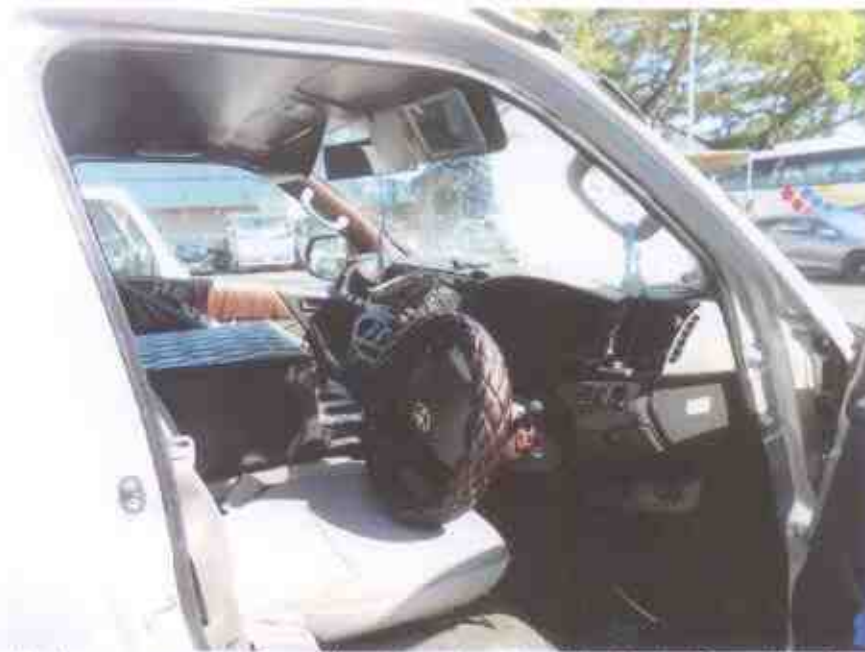
Photo 3 shows a general view of the internal cabin of the Motor Bus at the time of our inspection. The Motor Bus was observed to sustained damages at the internal cabin due to the accident's impact.

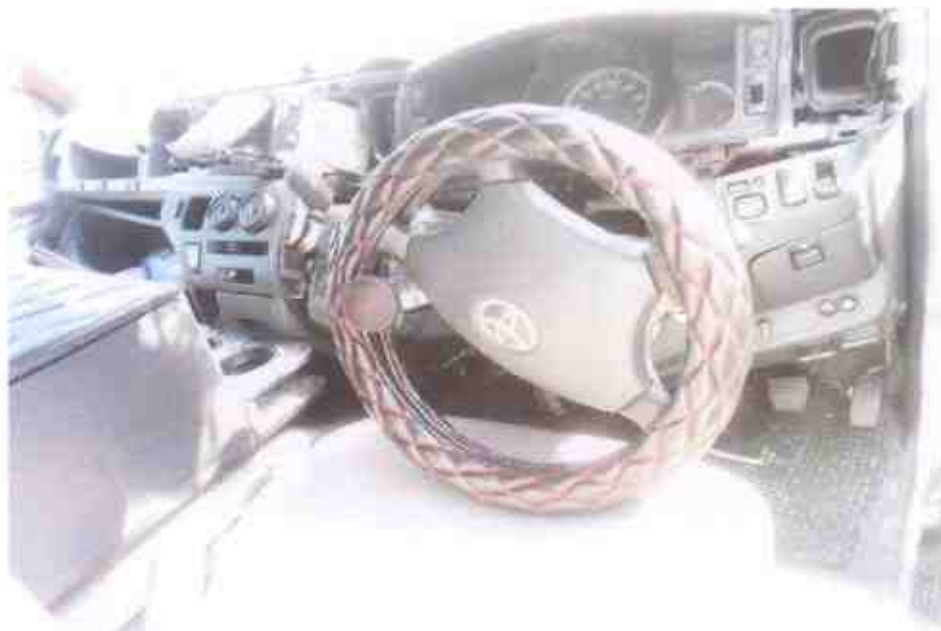
Photo 4 shows a semi-close up view of the internal cabin of the Motor Bus at the time of our inspection. The Motor Bus was observed to sustained damages at the internal cabin due to the accident's impact.

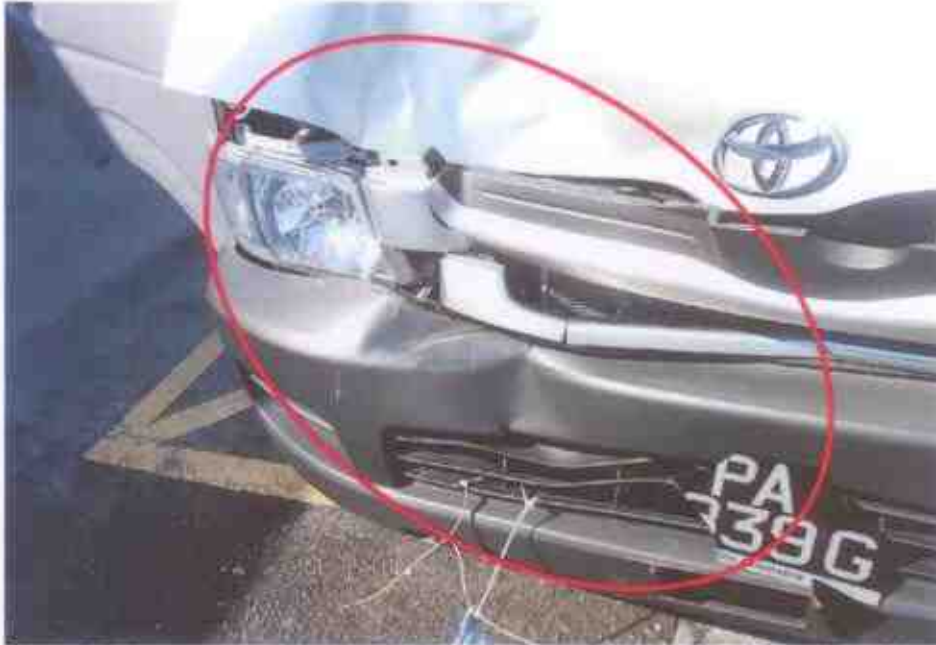
Photo 5 shows a close-up view of the damages on the right portion of the Motor Bus at the time of our inspection. It was likely due to the accident's impact collision.

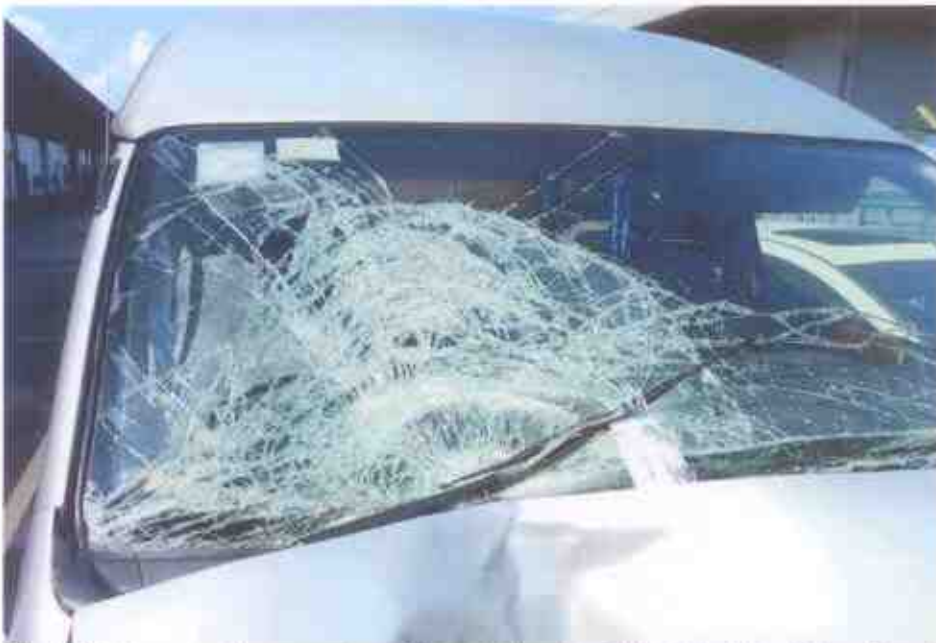
Photo 6 shows a close-up view of the shattered windshield of the Motor Bus at the time of our inspection. It was likely due to the accident's impact collision.

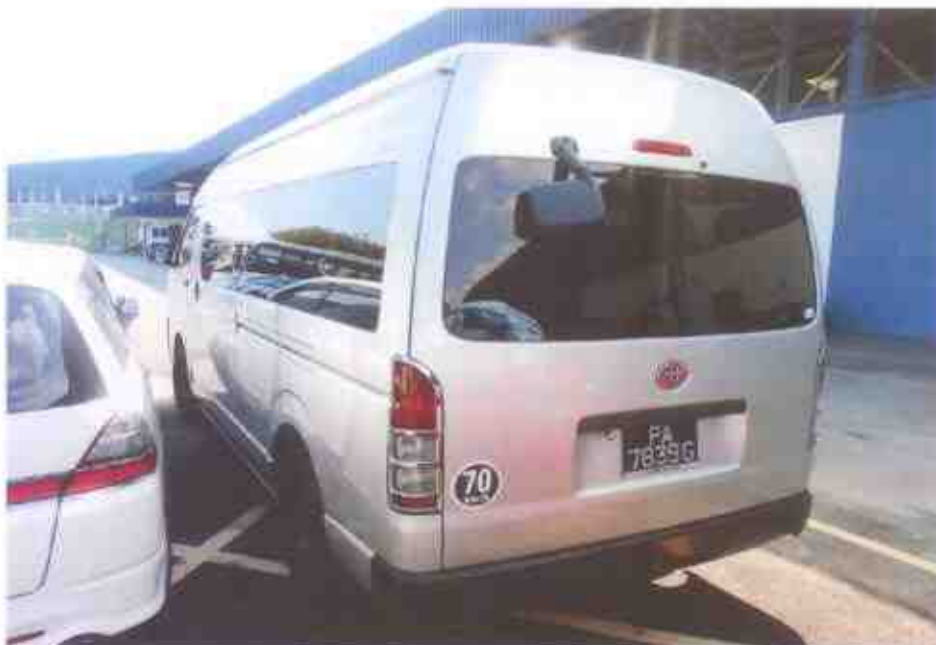
Photo 7 shows a general view of the rear left body of the Motor Bus at the time of our inspection. The Motor Bus was observed to be in good general condition at time of inspection.

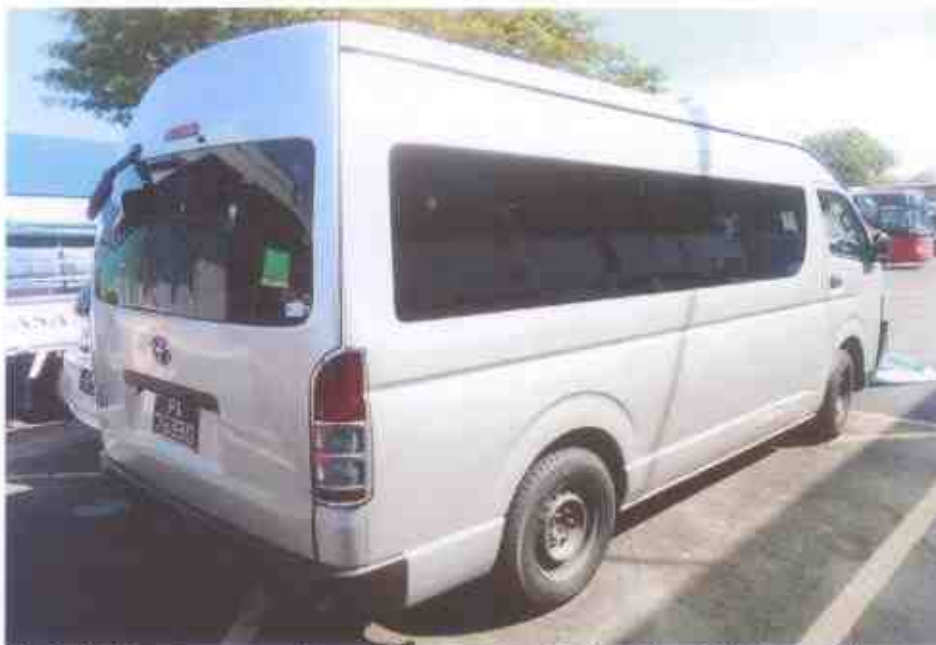
Photo 8 shows a general view of the rear right body of the Motor Bus at the time of our inspection. The Motor Bus was observed to be in good general condition at time of inspection.

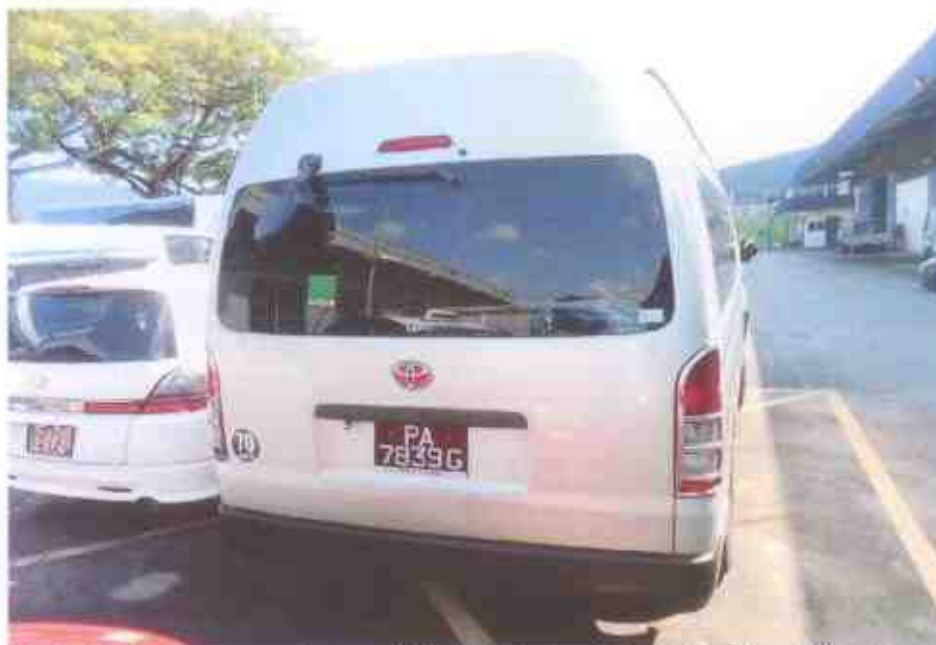
Photo 9 shows a general view of the rear body of the Motor Bus at the time of our inspection. The Motor Bus was observed to be in good general condition at time of inspection.

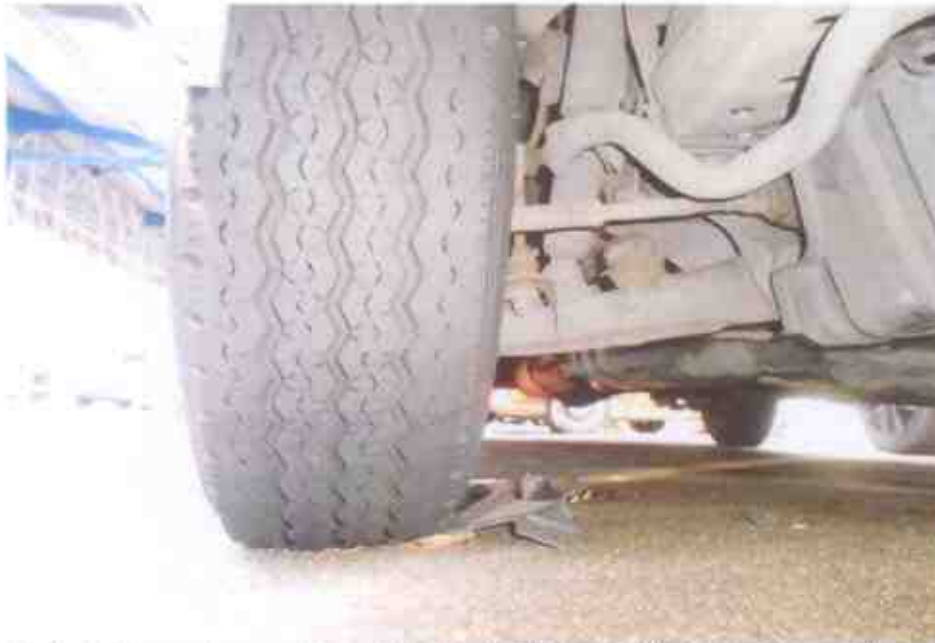
Photo 10 shows the condition of the front right tyre of the Motor Bus, which was observed to be in serviceable condition with remaining tread depth of approximately 7mm. The tyres were all observed to be sufficiently inflated for vehicular operation with no tear, cut or burst mark(s) on the outer and the inner sidewalls as well as across the tread.

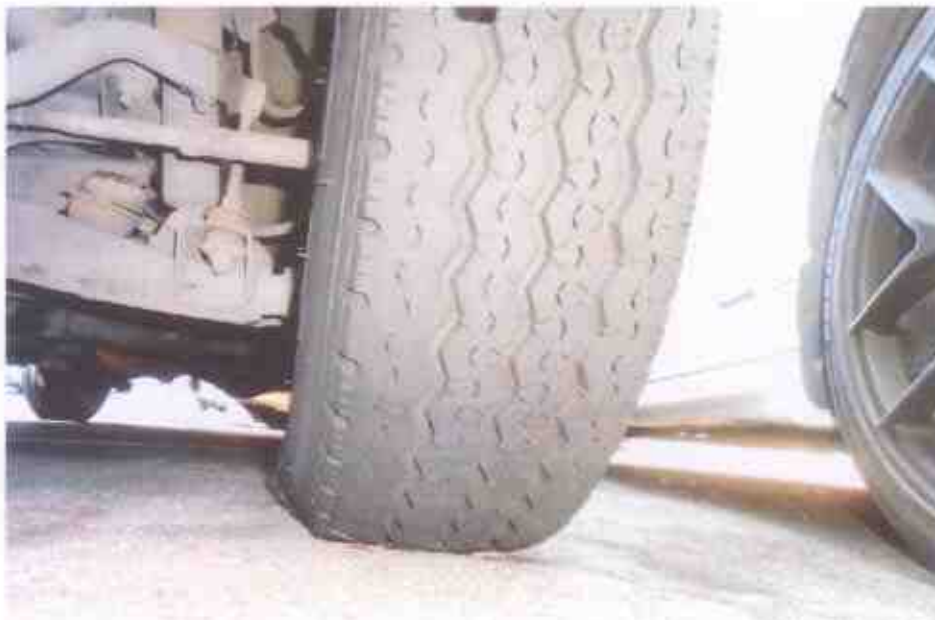
Photo 11 shows the condition of the front left tyre of the Motor Bus, which was observed to be in serviceable condition with remaining tread depth of approximately 7mm. The tyre, which was wrapped around standard wheel rim, was also observed to be sufficiently inflated for vehicular operation.

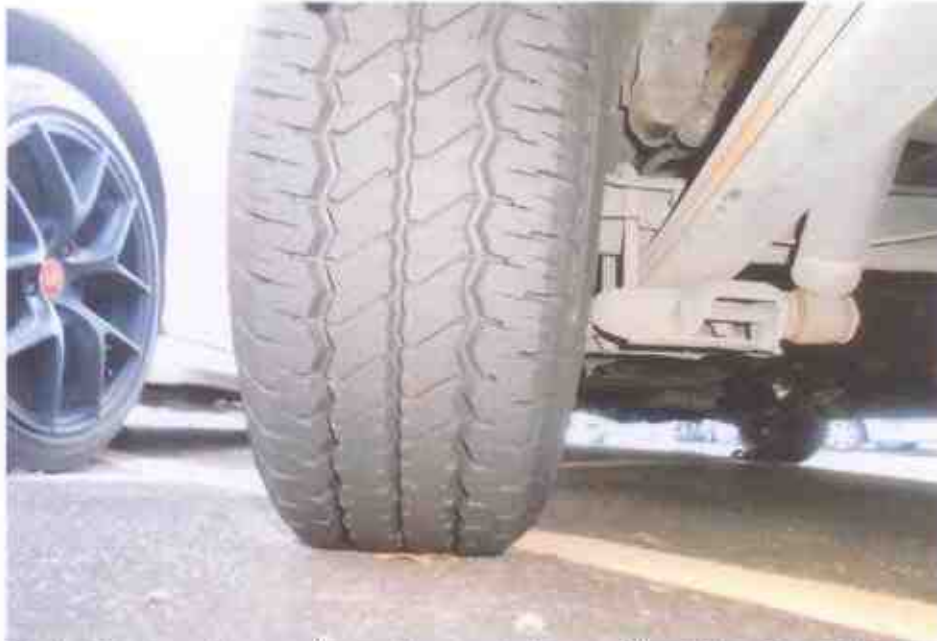
Photo 12 shows the condition of the rear left tyre of the Motor Bus, which was observed to be in serviceable condition with remaining tread depth of approximately 8mm. The tyre, which was wrapped around standard wheel rim, was also observed to be sufficiently inflated for vehicular operation. There was also no significant damage found on the 4 wheel rims of the Motor Bus.

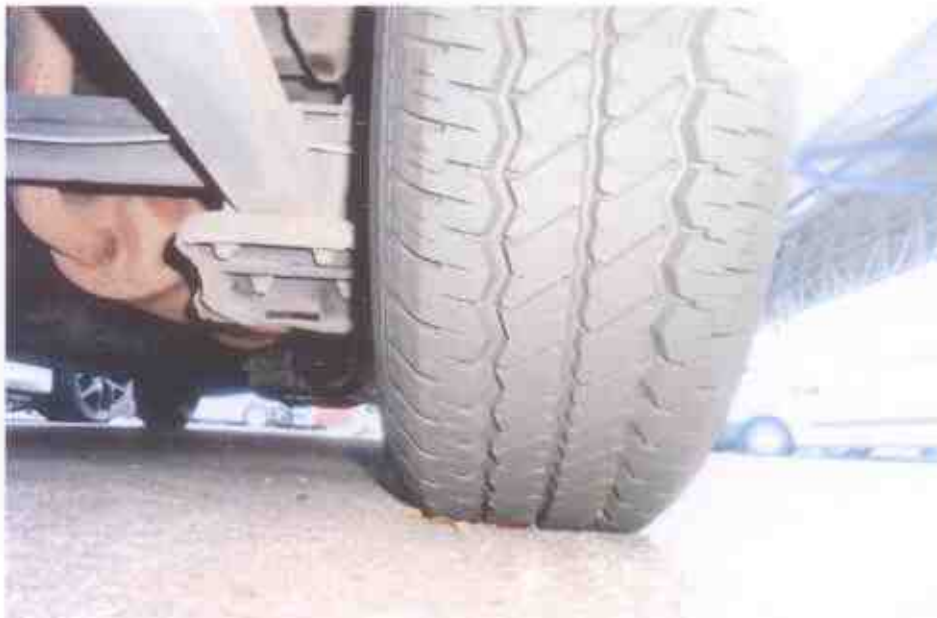
Photo 13 shows the condition of the rear right tyre of the Motor Bus, which was observed to be in serviceable condition with remaining tread depth of approximately 8mm. There was also no tear, cut or burst mark(s) on the outer and the inner sidewalls as well as across the tread of the tyre, which was also sufficiently inflated for vehicular operation.

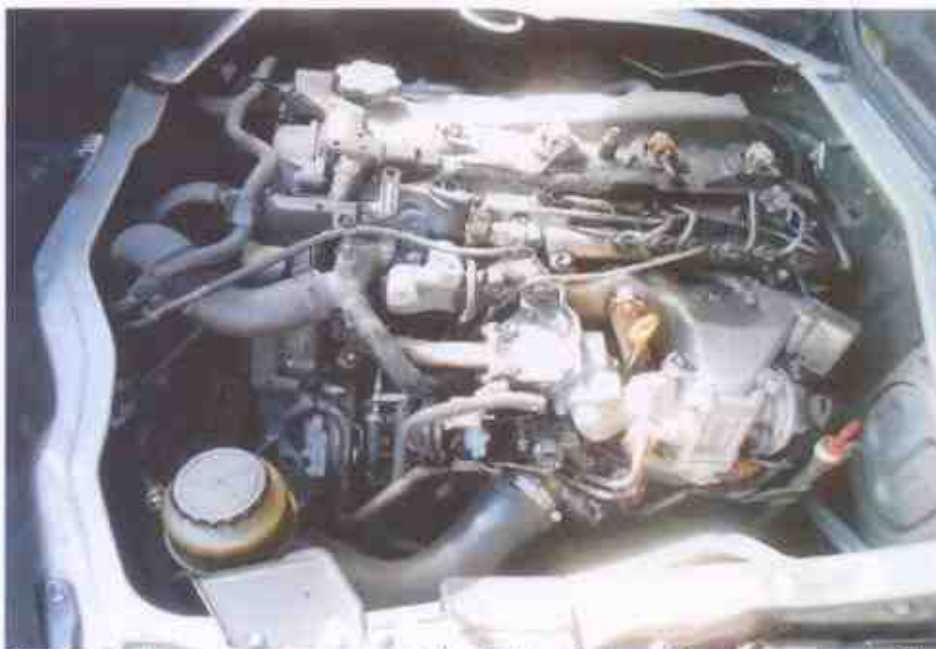
Photo 14 shows a general view of the Motor Bus's engine compartment. The various parts and components inside the engine compartment were unaffected by the accident. There was also no sign(s) or indication(s) of fluid leakage and/or fluid stain within the engine compartment.

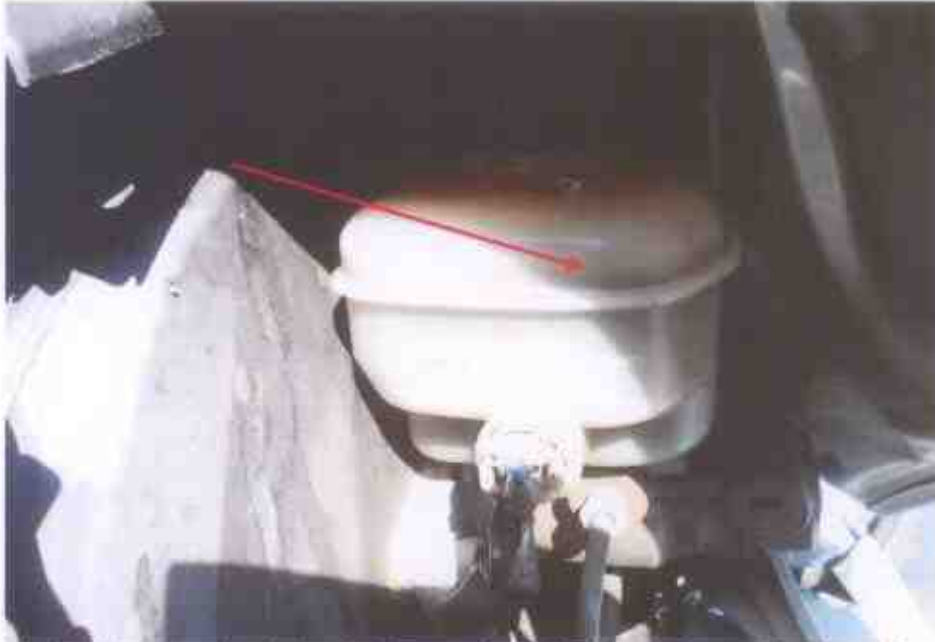
Photo 15 shows the brake fluid reservoir of the Motor Bus at the time of our inspection. The brake fluid was observed to be of sufficient level and without any visible contamination.

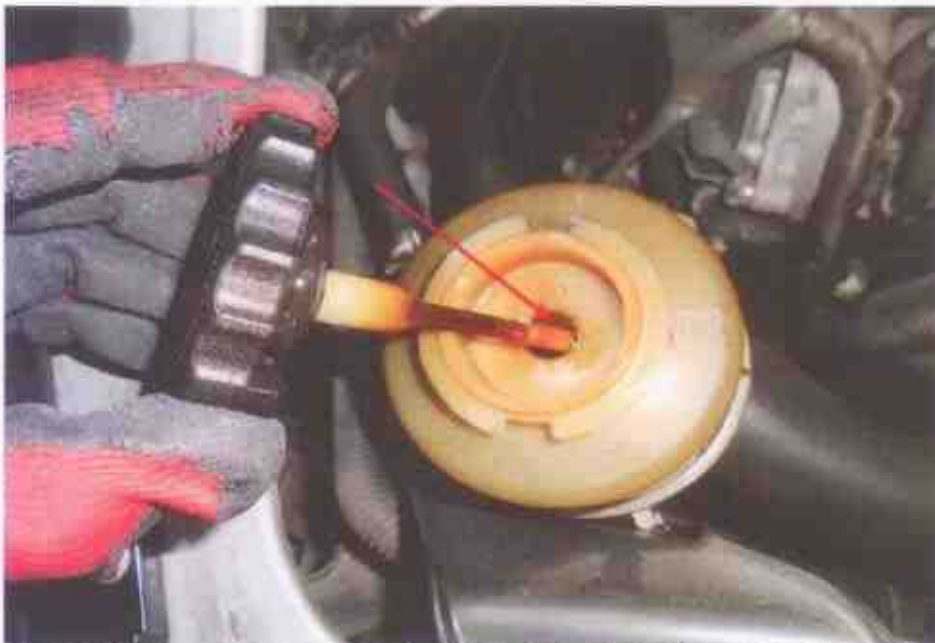
Photo 16 shows the power steering fluid of the Motor Bus at the time of our inspection. It was observed to be of sufficient level and without any visible contamination.

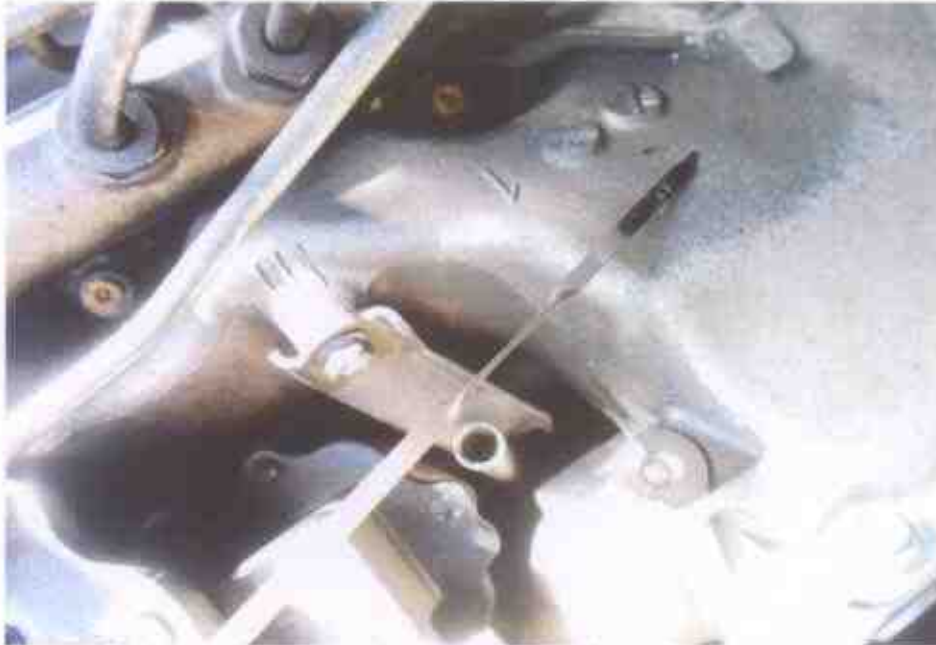
Photo 17 shows the engine dip stick of the Motor Bus at the time of our inspection. The engine oil was observed to be of sufficient level and without any visible contamination.

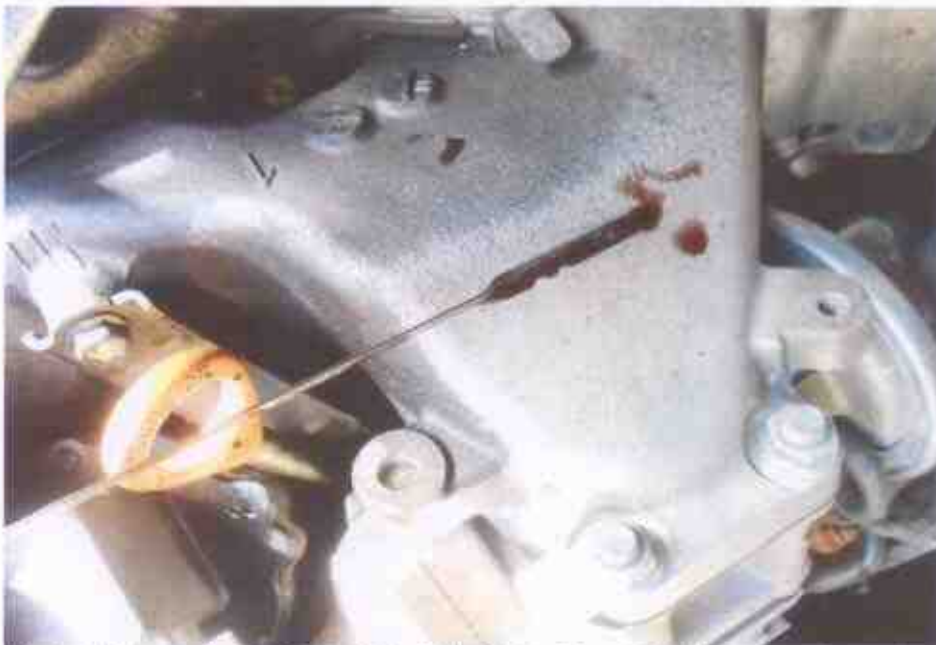
Photo 18 shows the ATF dip stick of the Motor Bus at the time of our inspection. The ATF was observed to be of sufficient level and without any visible contamination.

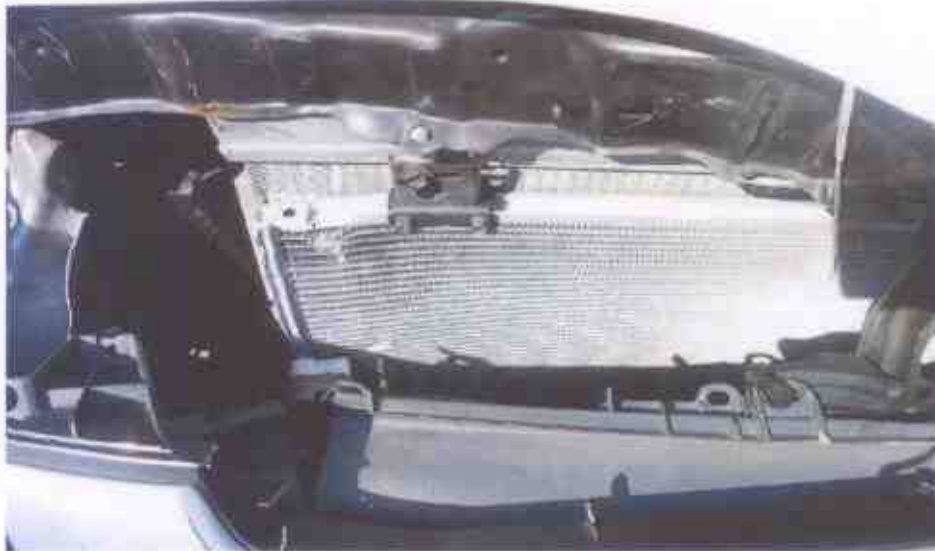
9. Upon examination of the Motor Bus's engine compartment, we had observed most of the parts and components inside the engine compartment to be intact and unaffected by the accident, except for damage sustained to the radiator as a result of the accident. Its brake fluid, engine oil, ATF fluid and power steering fluid were all found to be of sufficient level for operating purposes. Visually, there was also no contamination found to these fluids.
10. Further examination of the engine compartment revealed no sign(s) or indication(s) of fluid leakage and/or fluid stain within the engine compartment of the Motor Bus.
11. Our subsequent checks on the underside of the Motor Bus revealed no fluid stain. Visually, the various undercarriage components of the Motor Bus were all observed to be intact and without any visible damage. See photo 14 – 19 below.

Photo 19 shows the damaged radiator as a result of the accident.

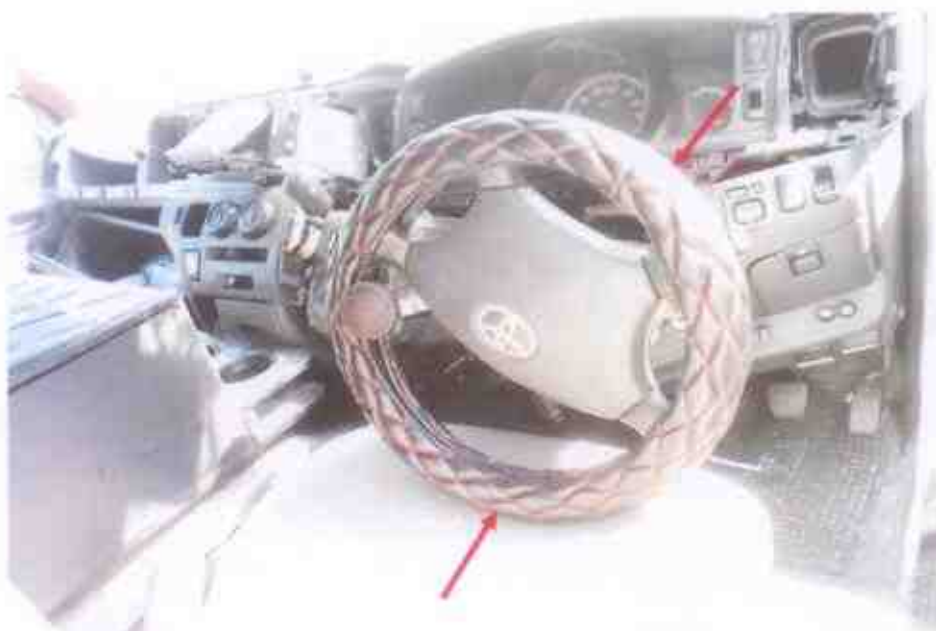
12. The mechanical components of the Motor Bus's steering system were found to be damaged as a result of the accident. Particularly the steering wheel supporting components. However, steering column, steering rack and ball joints of the Motor Bus were observed to be intact and securely attached to the front left wheel and front right wheel.

13. Static test on the steering system of the Motor Bus was unable to be conducted due to the damage sustained on the steering wheel as a result of the accident. However, our visual examination of the various steering components which had included the rack and pinion, tie rods, tie rod ends and ball joints had revealed that these components were all generally in good condition.

Photo 20 shows the damaged steering wheel at the time of our inspection of the Motor Bus. It was observed to be pushed inwards from the front portion.

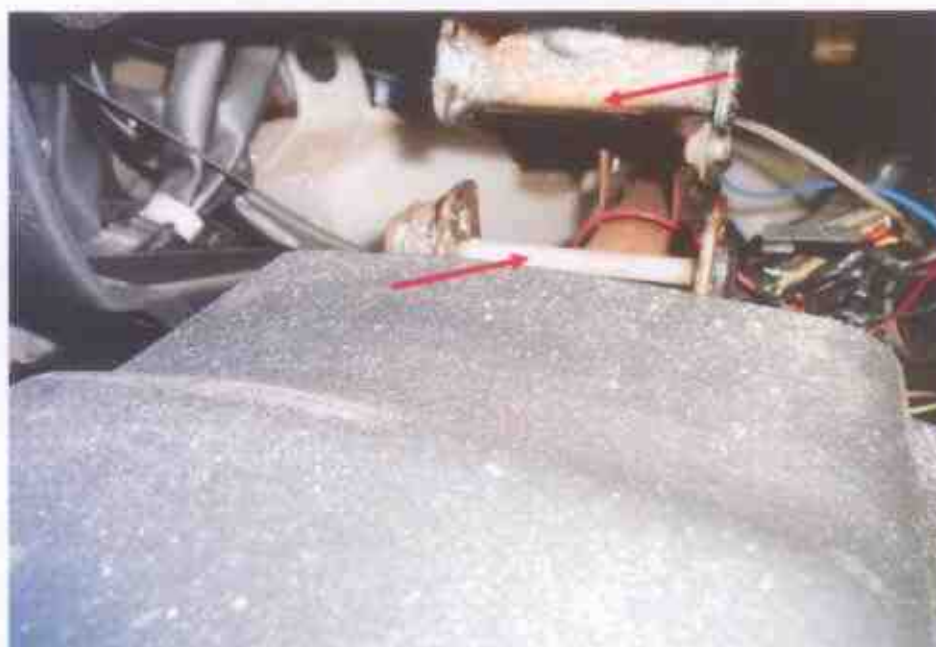
Photo 21 shows the damaged steering wheel supporting component at the time of our inspection of the Motor Bus. It was observed to be dislodged from the original installation.

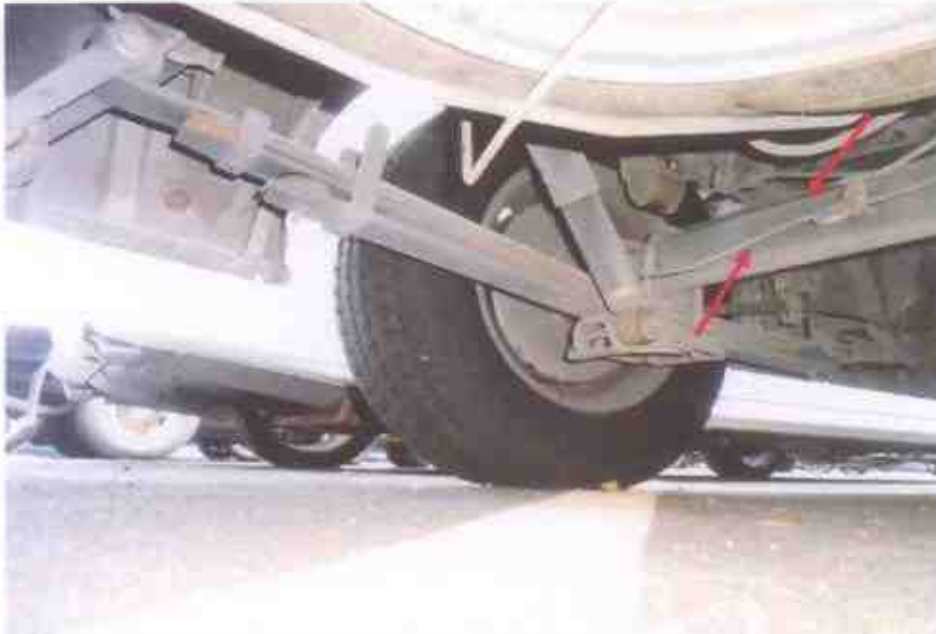
Photo 22 shows the various undercarriage components at the rear left wheel of the Motor Bus, in particular the brake hose (arrowed). We did not observe any leakage of brake fluid at the time of our inspection of the Motor Bus.

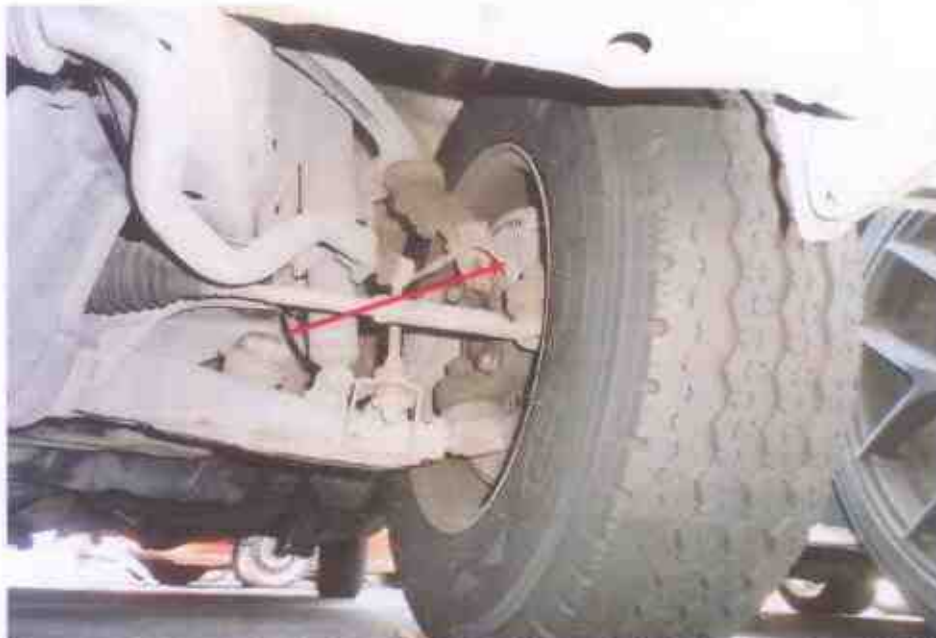
Photo 23 shows the brake hose at the front left wheel of the Motor Bus. We did not observe any leakage of brake fluid. Our visual inspection of the various mechanical components of the Motor Bus's braking system revealed all to be intact and without visible damage, indicating that the braking system was likely to be in serviceable condition at the material time of accident.

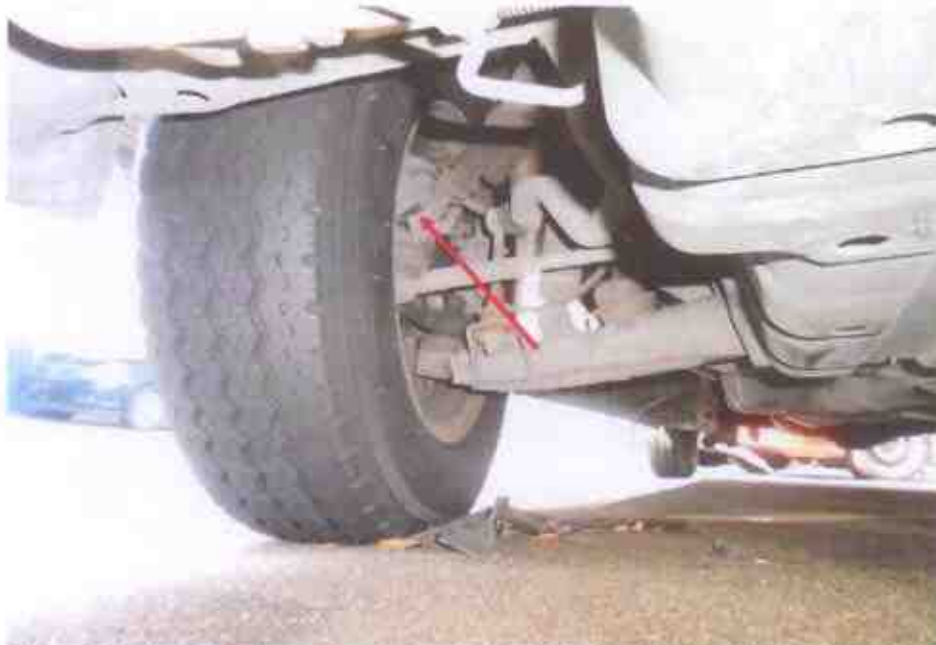
Photo 24 shows the brake hose (arrowed) at the front right wheel of the Motor Bus. We did not observe any leakage of brake fluid at the time of our inspection of the Motor Bus. Our visual inspection of the various mechanical components of the Motor Van's braking system, including its brake calliper, revealed all to be intact and without visible damage.

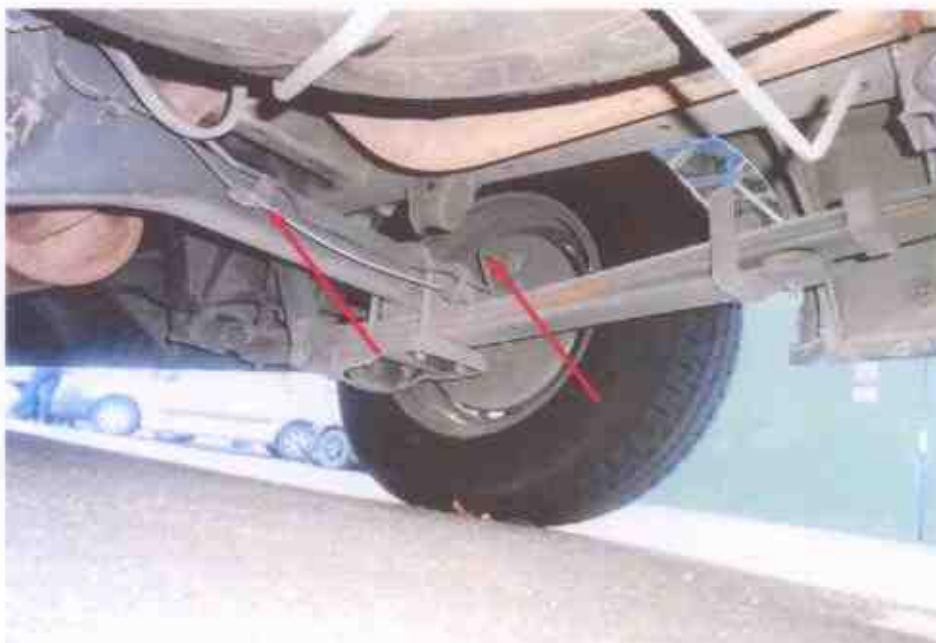
Photo 25 shows the various undercarriage components at the rear right wheel of the Motor Bus. The various steering components were all found to be intact, suggesting that the steering system of the Motor Bus was likely to be in serviceable condition at the material time of accident. There was also no sign of fluid stain(s) observed on the various undercarriage components at the 4 wheels of the Motor Bus.
