Your Ref: TP/IP/33771/2018  
Our Ref : CI/TPD18011458/Z

11<sup>th</sup> September 2018

### **MECHANICAL INSPECTION REPORT OF MOTOR TAXI SHC 4347M**

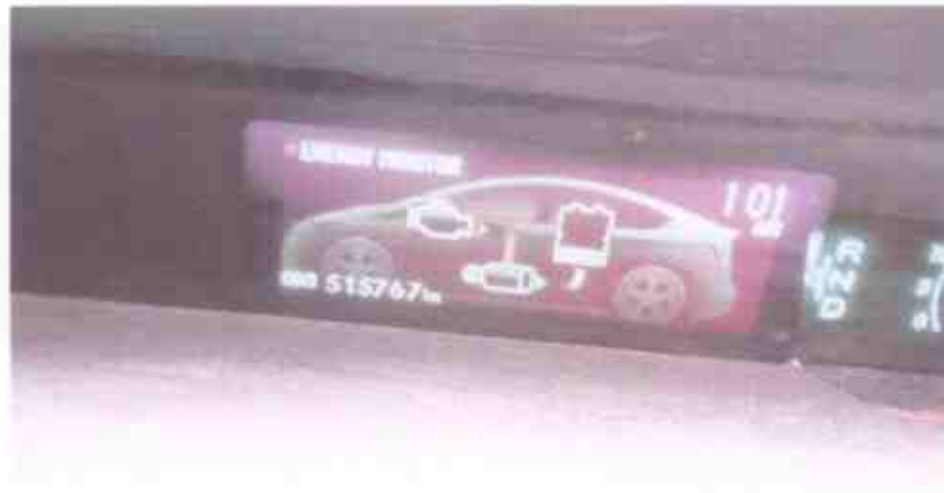
Photo 1 shows the mileage of the Motor Taxi was 515767 km.

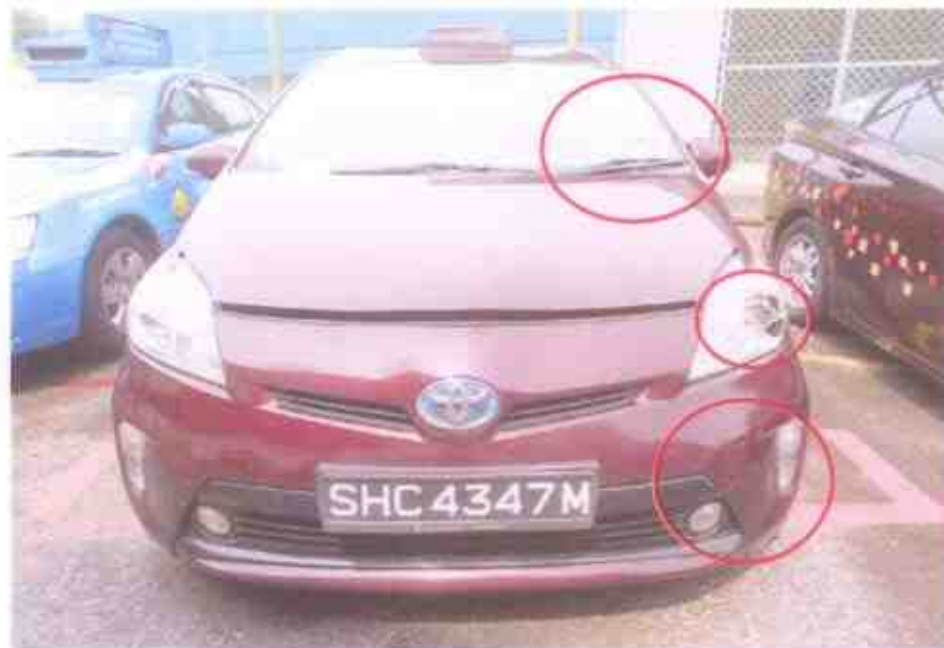
Photo 2 shows a general view of the front body of the Motor Taxi at the time of our inspection. The Motor Taxi was observed to be in good general condition except for minor damages at the frontal left portion.

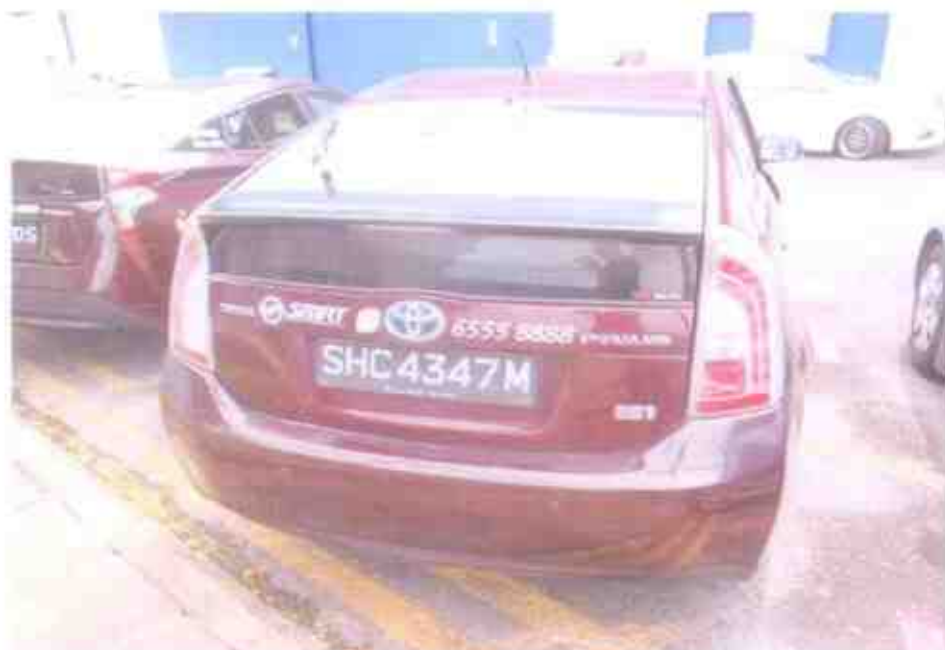
**Photo 3** shows a general view of the rear body of the Motor Taxi at the time of our inspection. The Motor Taxi was observed to be in good general condition.

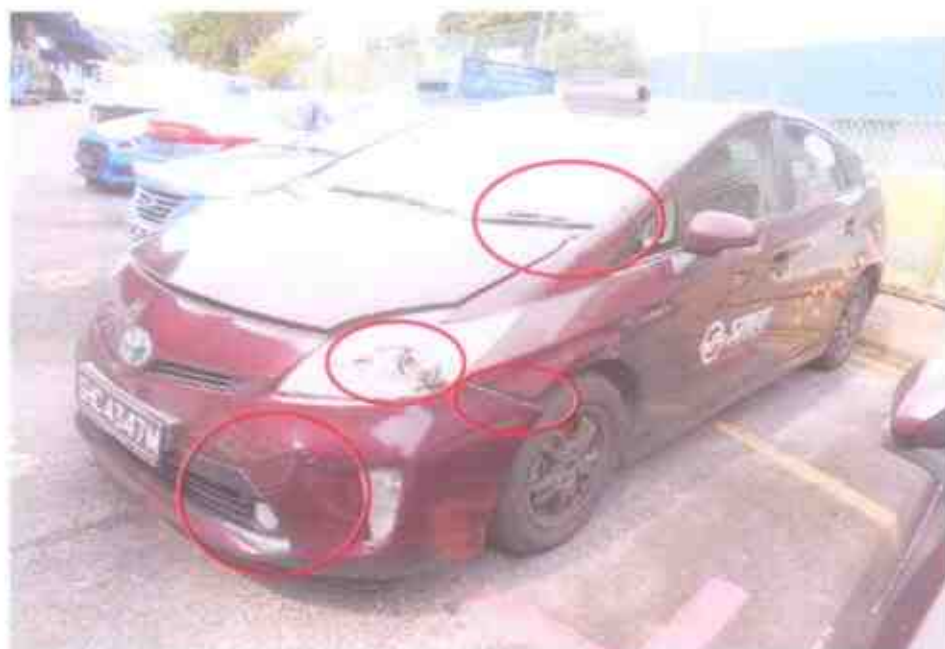
**Photo 4** shows a general view of the front left body of the Motor Taxi at the time of our inspection. The Motor Taxi was observed to be in good general condition except for minor damages at the front left portion.

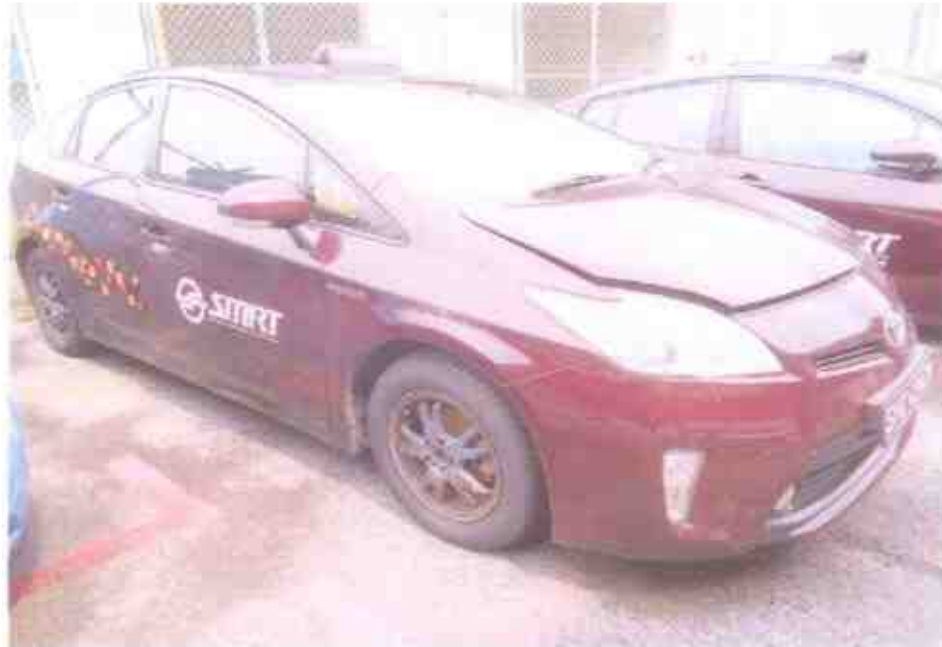
**Photo 5** shows a general view of the front right body of the Motor Taxi at the time of our inspection. The Motor Taxi was observed to be in good general condition except for minor damages at the front right portion.

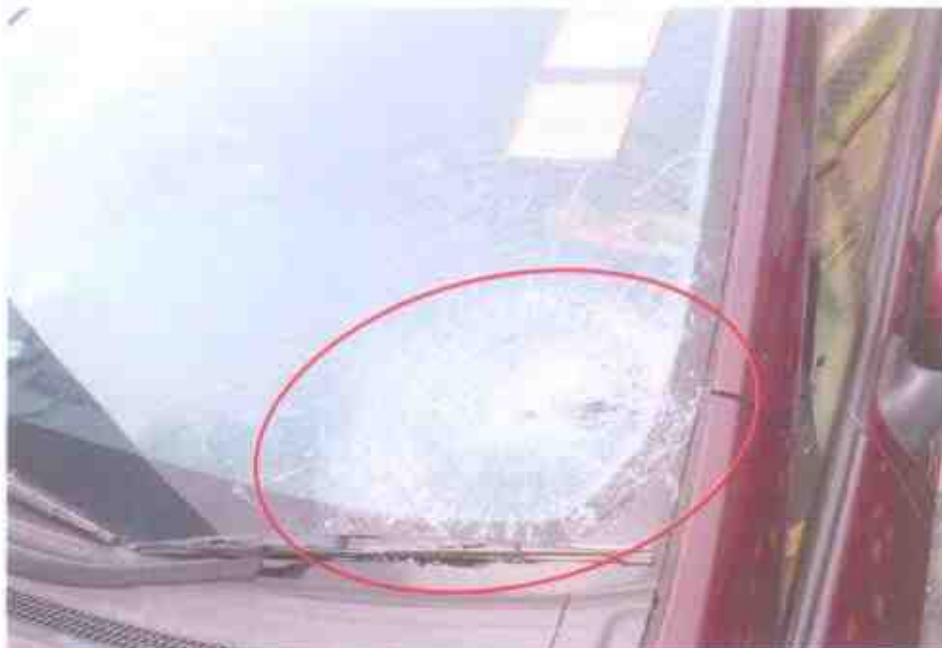
**Photo 6** shows a close up view of the front left windshield of the Motor Taxi at the time of our inspection. The Motor Taxi had sustained shattering cracks on its lower left of the windshield.

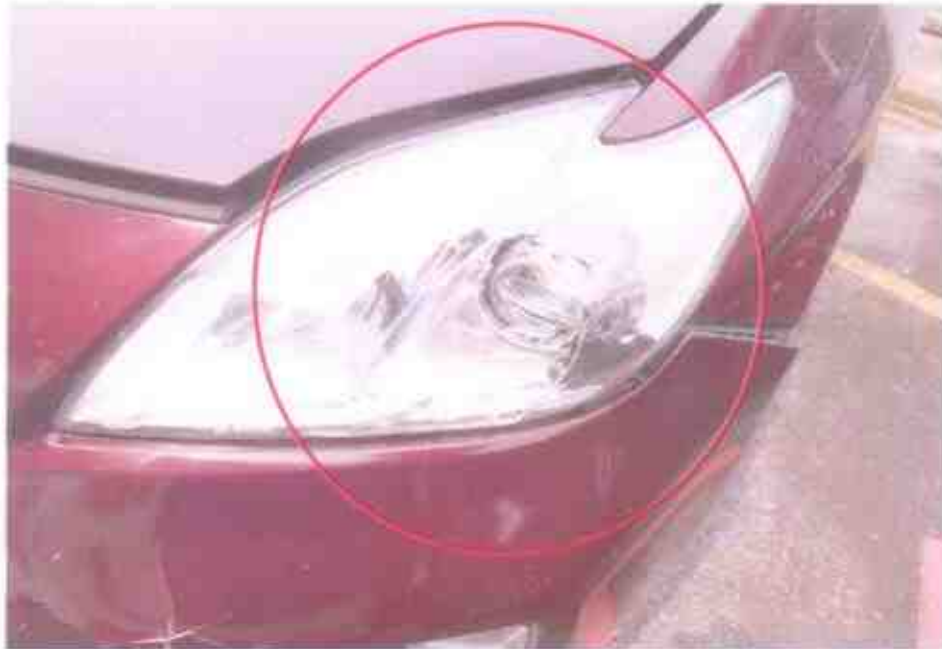
**Photo 7** shows a close up view of the front left headlamp of the Motor Taxi at the time of our inspection. The Motor Taxi had sustained relatively minor impact at the front left headlamp as a result of the accident.

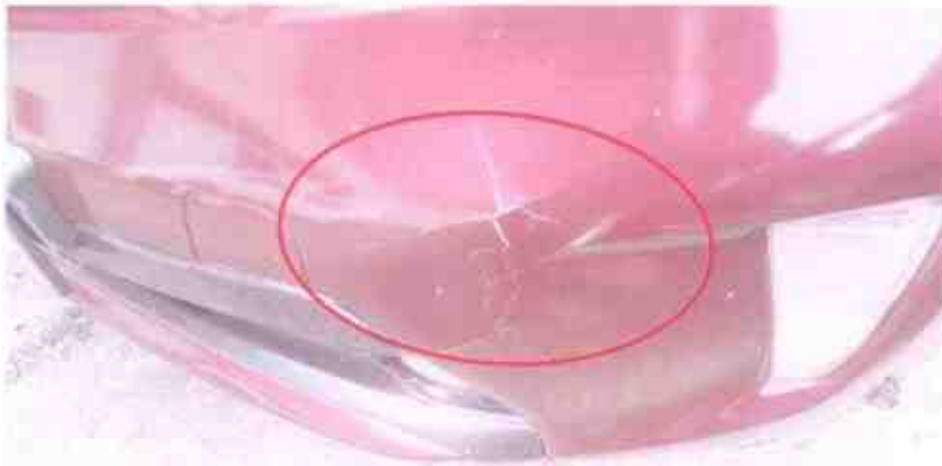
**Photo 8** shows a close up view of the front left lower bumper of the Motor Taxi at the time of our inspection. The Motor Taxi had sustained relatively minor cracks at the front left lower bumper portion.

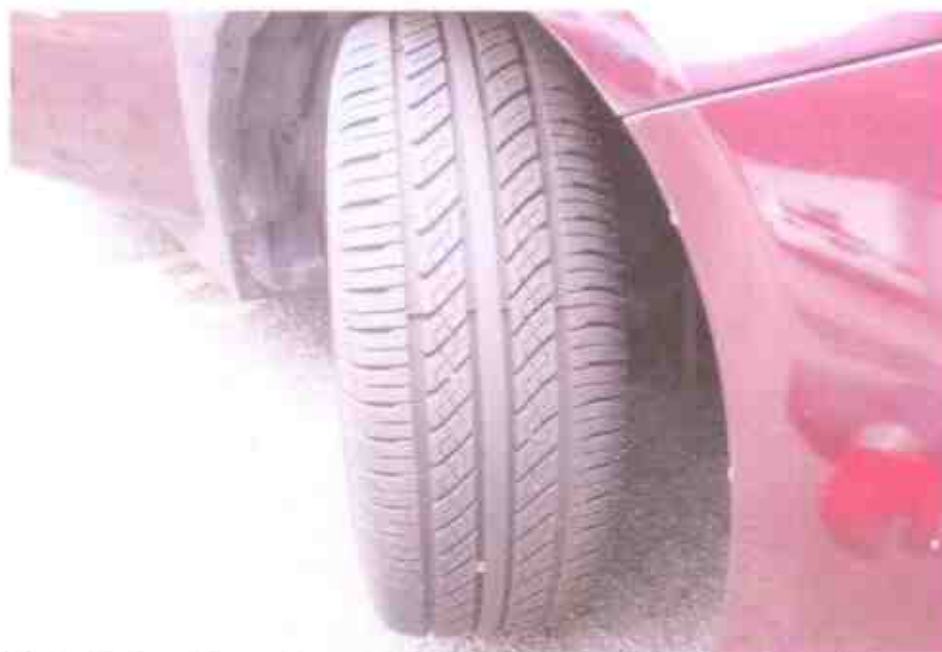
**Photo 9** shows the condition of the front right tyre of the Motor Taxi, which was observed to be in serviceable condition with remaining tread depth of approximately 6mm. There was no tear, cut or burst mark(s) on the outer and the inner sidewalls.

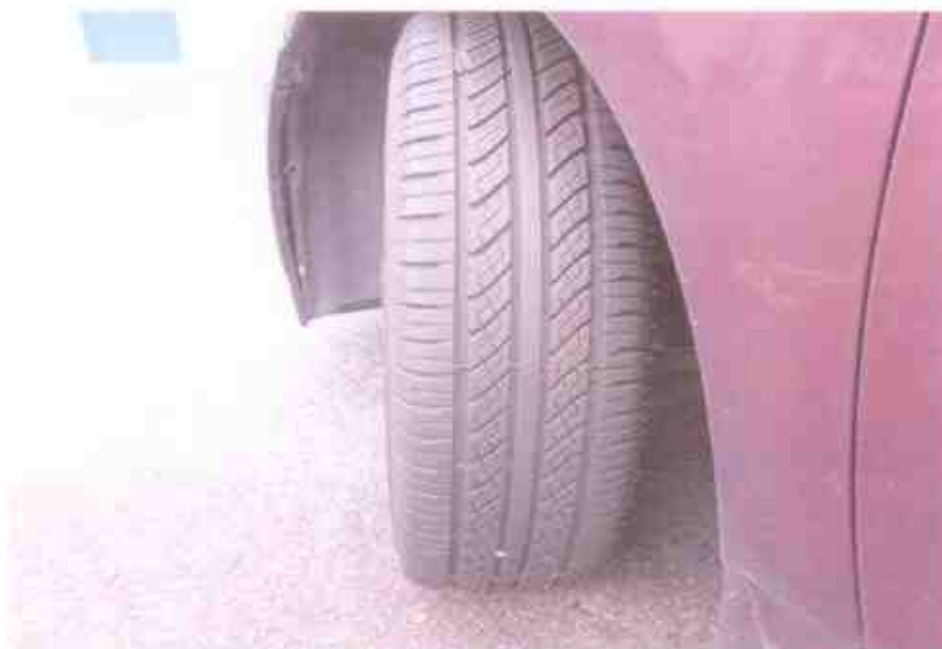
**Photo 10** shows the condition of the front left tyre of the Motor Taxi, which was observed to be in serviceable condition with remaining tread depth of approximately 5mm. The tyre, which was wrapped around alloy wheel rim, was also observed to be sufficiently inflated for vehicular operation.

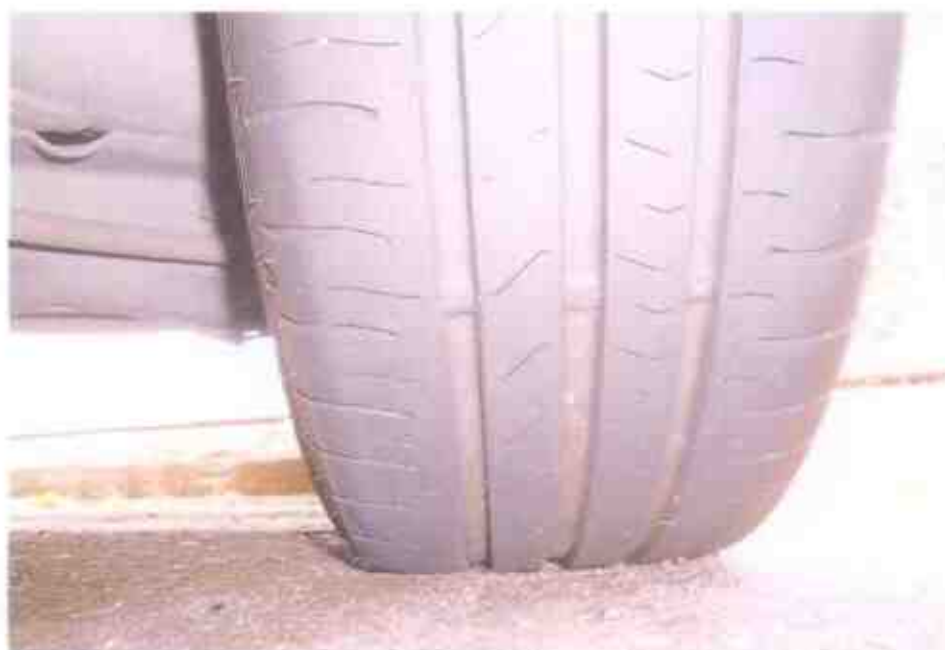
**Photo 11** shows the condition of the rear left tyre of the Motor Taxi, which was observed to be in serviceable condition with remaining tread depth of approximately 5mm. The tyre, which was wrapped around alloy wheel rim, was also observed to be sufficiently inflated for vehicular operation.

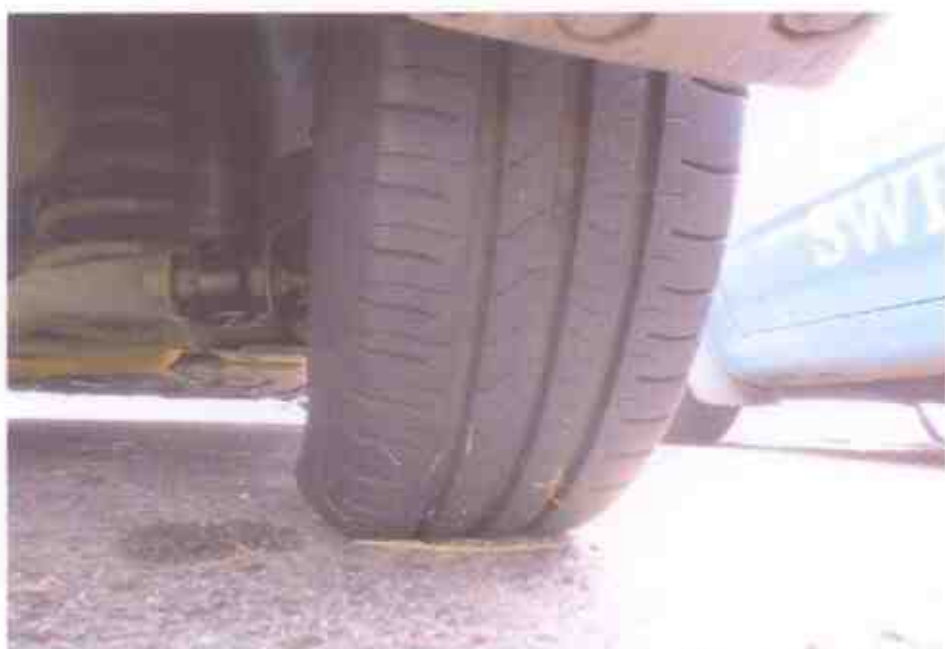
**Photo 12** shows the condition of the rear right tyre of the Motor Taxi, which was observed to be in serviceable condition with remaining tread depth of approximately 5mm. There was also no tear, cut or burst mark(s) on the outer and the inner sidewalls as well as across the tread of the 4 tyres.

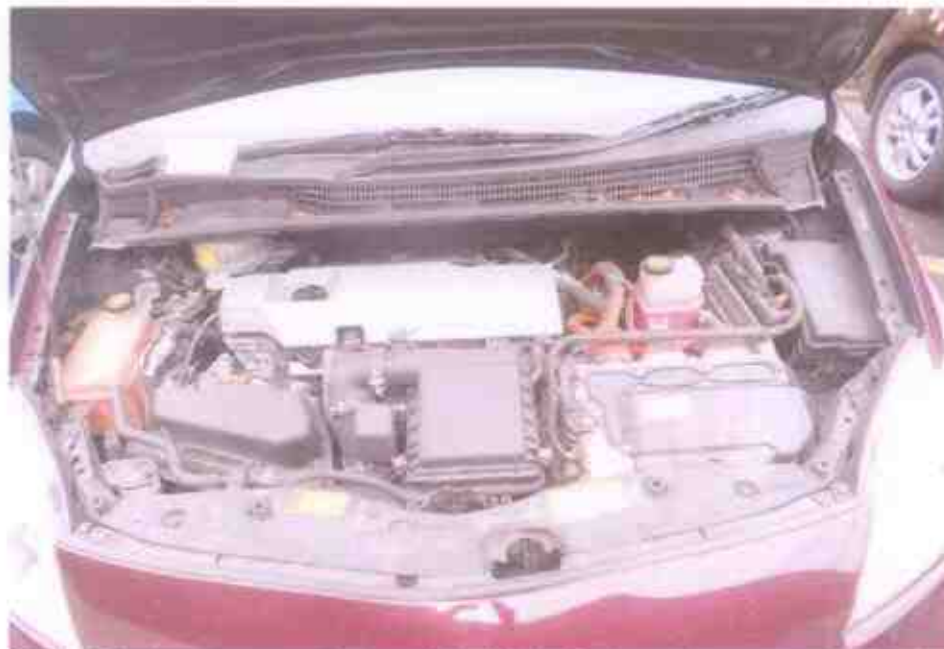
**Photo 13** shows a general view of the Motor Car's engine compartment. The various parts and components inside the engine compartment were unaffected by the accident. There was also no sign(s) or indication(s) of fluid leakage and/or fluid stain within the engine compartment.

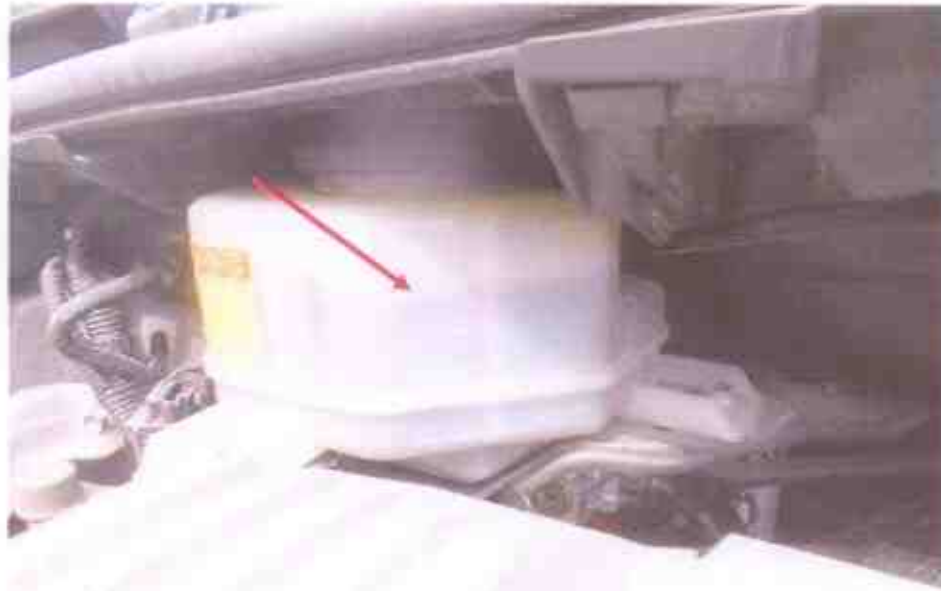
**Photo 14** shows the brake fluid reservoir of the Motor Taxi at the time of our inspection. The brake fluid was observed to be of sufficient level (arrowed) and without any visible contamination.

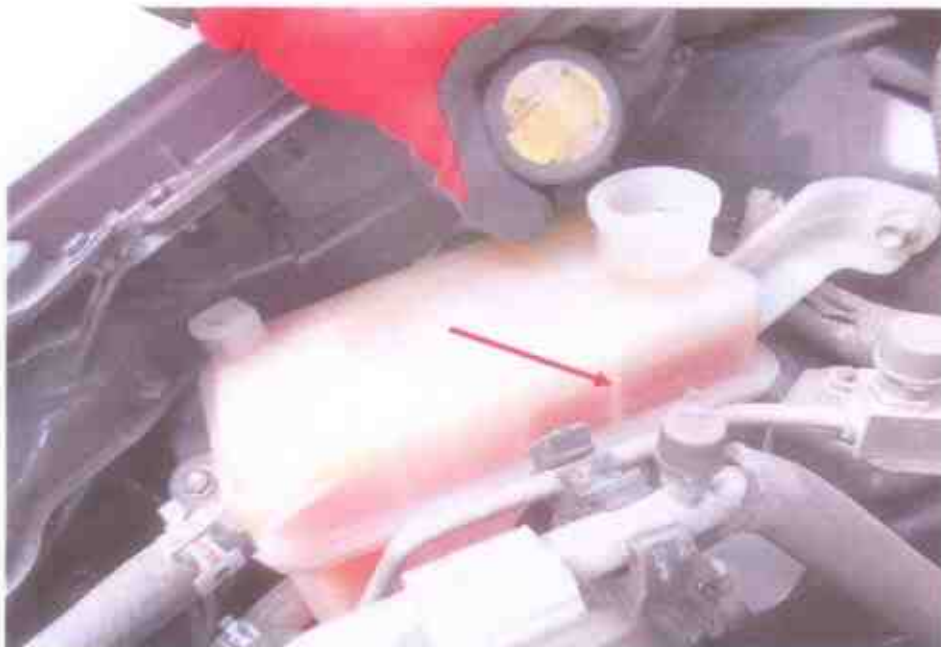
**Photo 15** shows the engine coolant fluid reservoir of the Motor Taxi at the time of our inspection. The engine coolant fluid was observed to be of sufficient level and without any visible contamination.

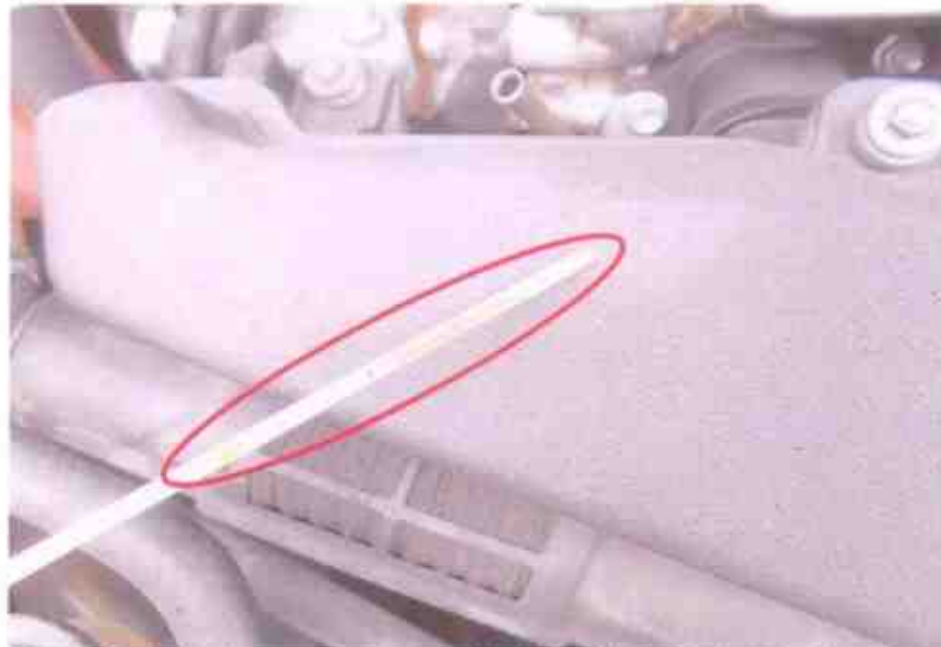
**Photo 16** shows the engine oil dip stick of the Motor Taxi at the time of our inspection. The engine oil was observed to be of sufficient level and without any visible contamination.

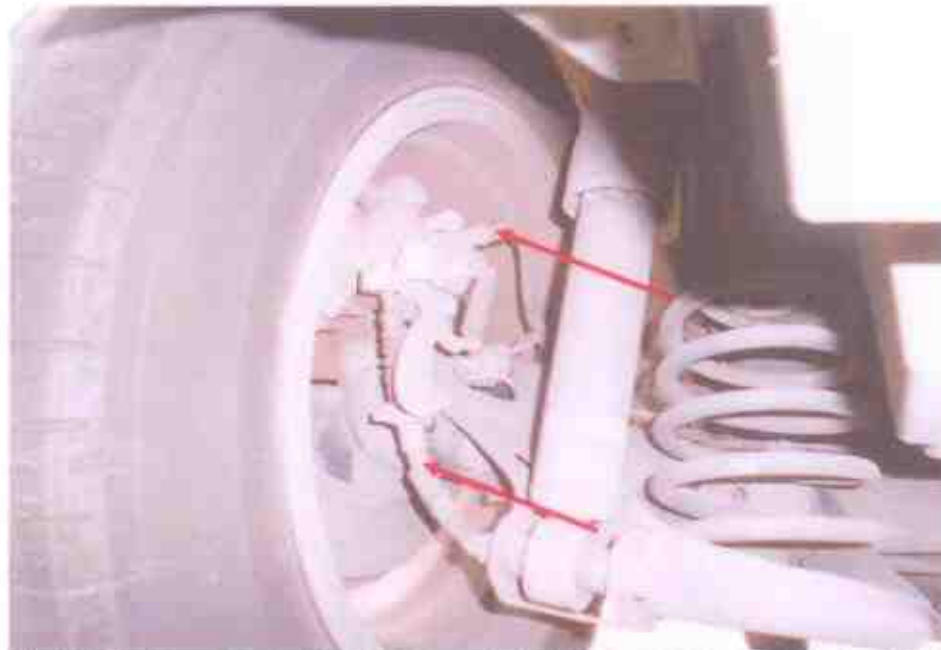
Photo 17 shows the brake hose (arrowed) at the rear left wheel of the Motor Taxi. We did not observe any leakage of brake fluid at the time of our inspection of the Motor Taxi. Our visual inspection of the various mechanical components of the Motor Taxi's braking system revealed all to be intact and without visible damage.

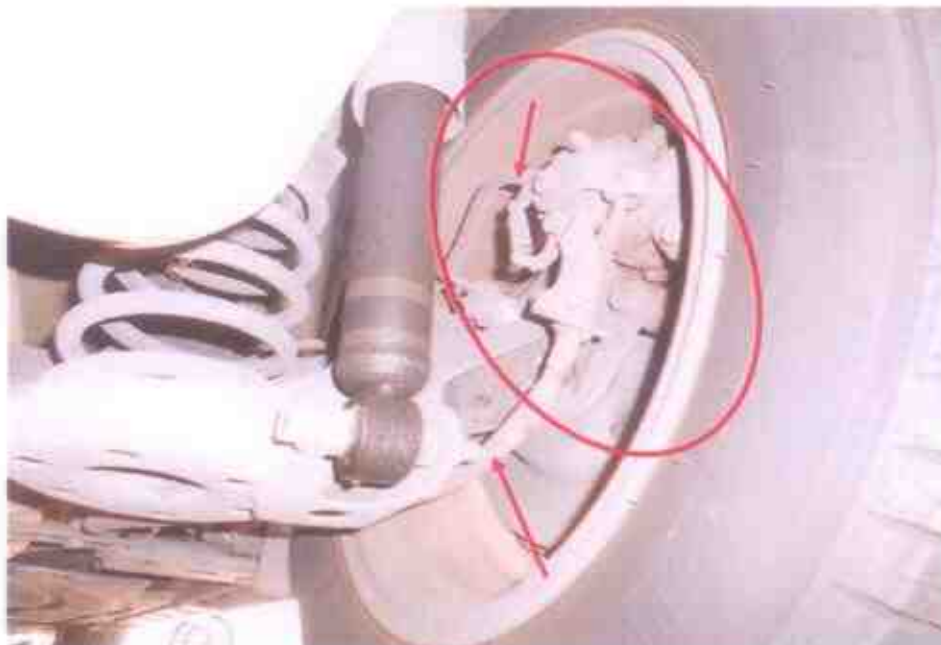
Photo 18 shows the brake hose (arrowed) at the rear right wheel of the Motor Taxi. We did not observe any leakage of brake fluid at the time of our inspection of the Motor Taxi. Our visual inspection of the various mechanical components of the Motor Taxi's braking system, including its brake calliper (circled), revealed all to be intact and without visible damage.

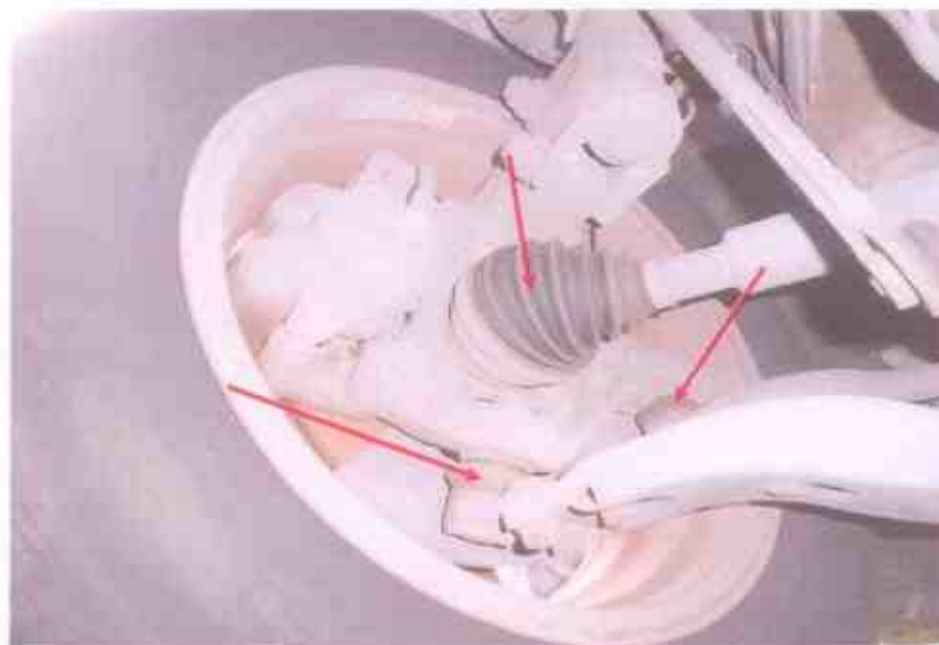
**Photo 19** shows the various undercarriage components at the front right wheel of the Motor Taxi, in particular the steering tie rod (arrowed). The various steering components were all found to be intact, suggesting that the steering system of the Motor Taxi was likely to be in serviceable condition.

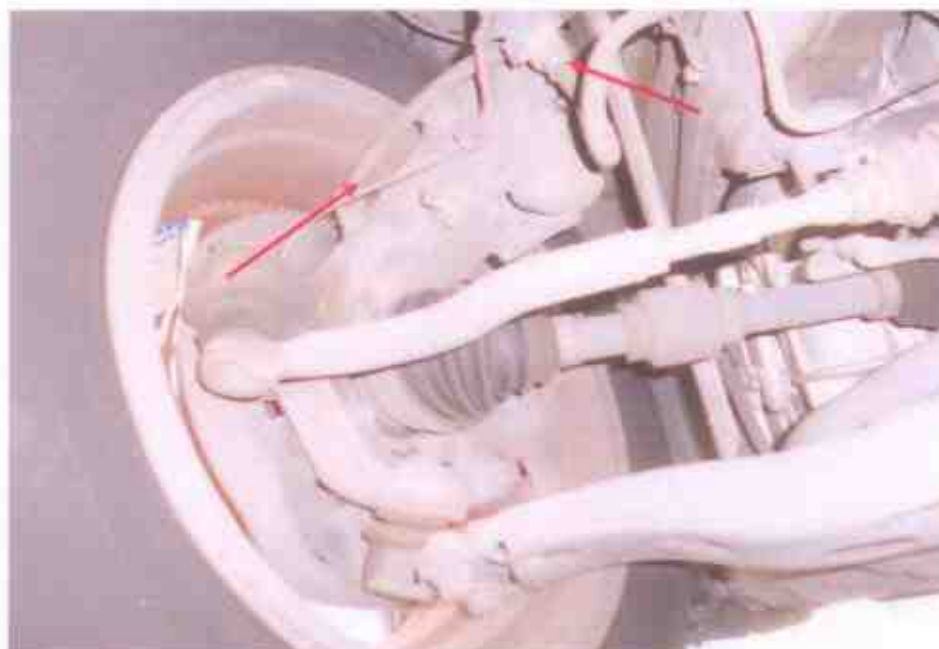
**Photo 20** shows the steering system at the front left wheel of the Motor Taxi. We did not observe any leakage of brake fluid (arrowed) at the time of our inspection of the Motor Taxi. Our visual inspection of the various mechanical components of the Motor Taxi's braking system revealed all to be intact and without visible damage, indicating that the braking system was likely to be in serviceable condition at the material time of accident.

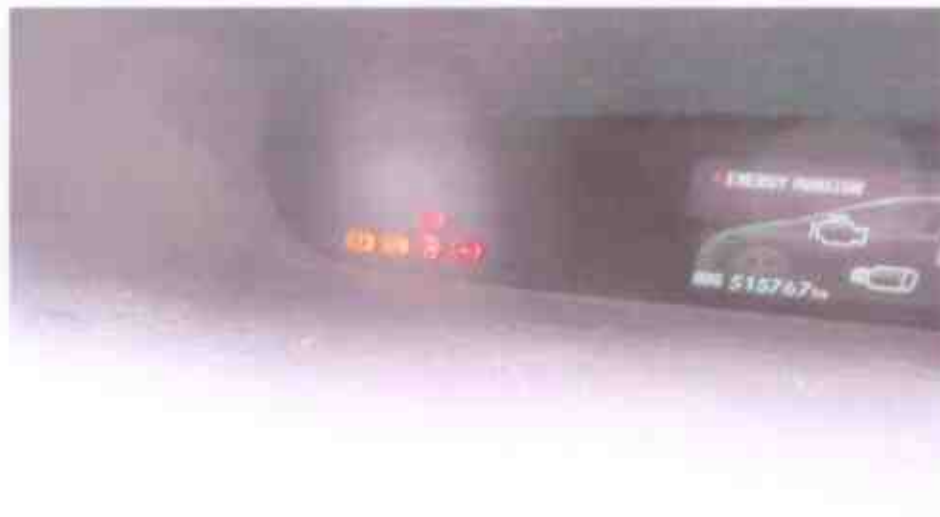
**Photo 21** shows the warning lights for the various electronic operating systems of the Motor Taxi appearing on its instrument panel during the self-test when the engine is cranked, in particular the ABS light and steering warning light.

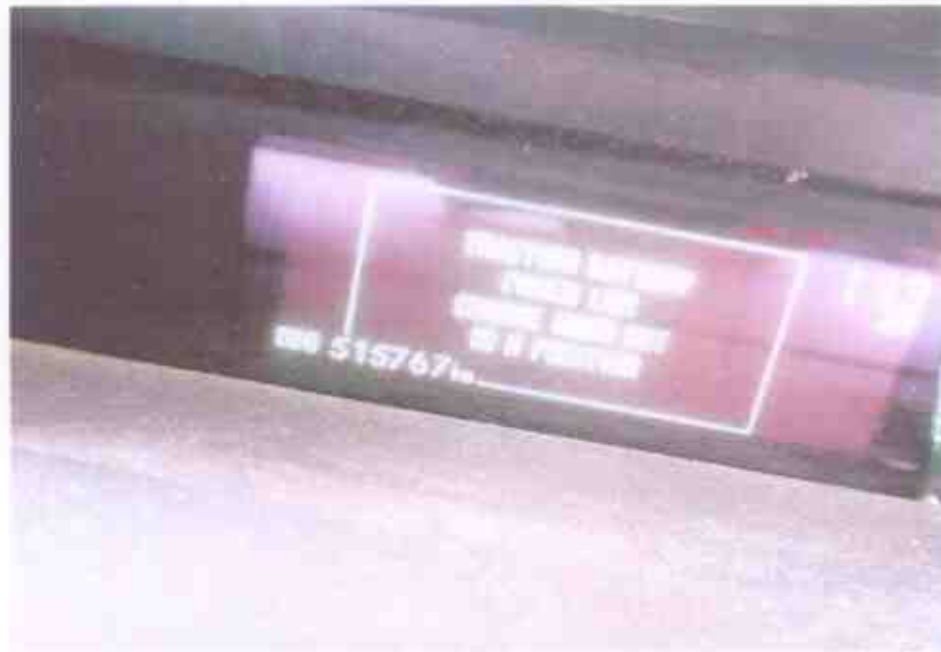
**Photo 22** shows warning indicators illuminated on the instrument panel of the Motor Taxi after the engine was cranked. This would suggest that there was abnormality to the electronic operating systems of the Motor Taxi likely due to low battery power.

16. Notwithstanding that electronic warning indicator appeared such as 'Traction Battery Power Low' & other warning lights not disappearing from the Motor taxi panel, a short operational test of the Motor Taxi, to primarily determine whether there was any abnormality to its engine system, its transmission system and braking system was subsequently carried out.

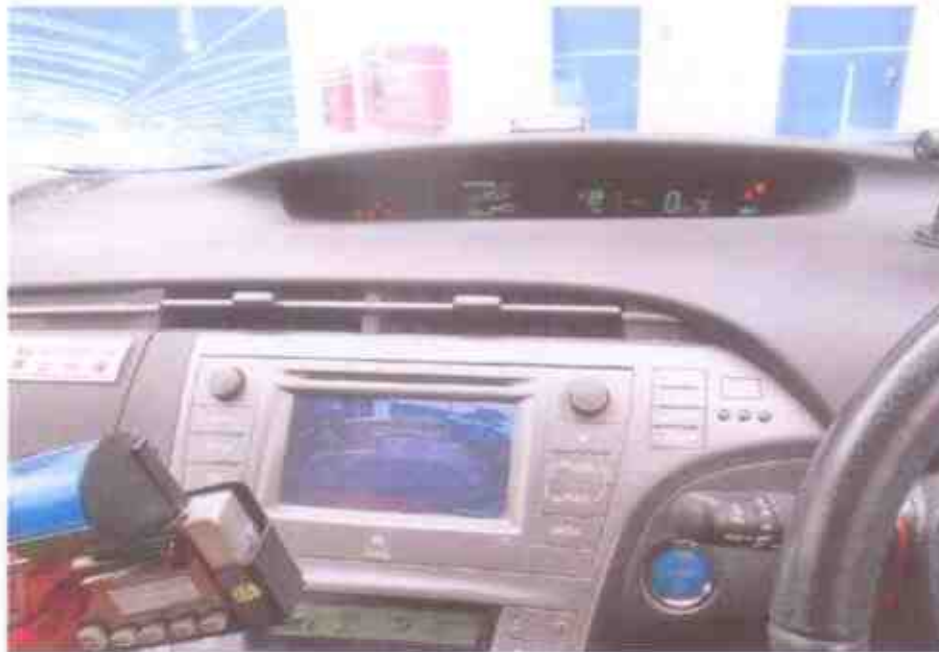
**Photo 23** shows reverse sensor camera on the LCD panel of the Motor Taxi while performing operational test. This would suggest that it was able to move forward and backward normally

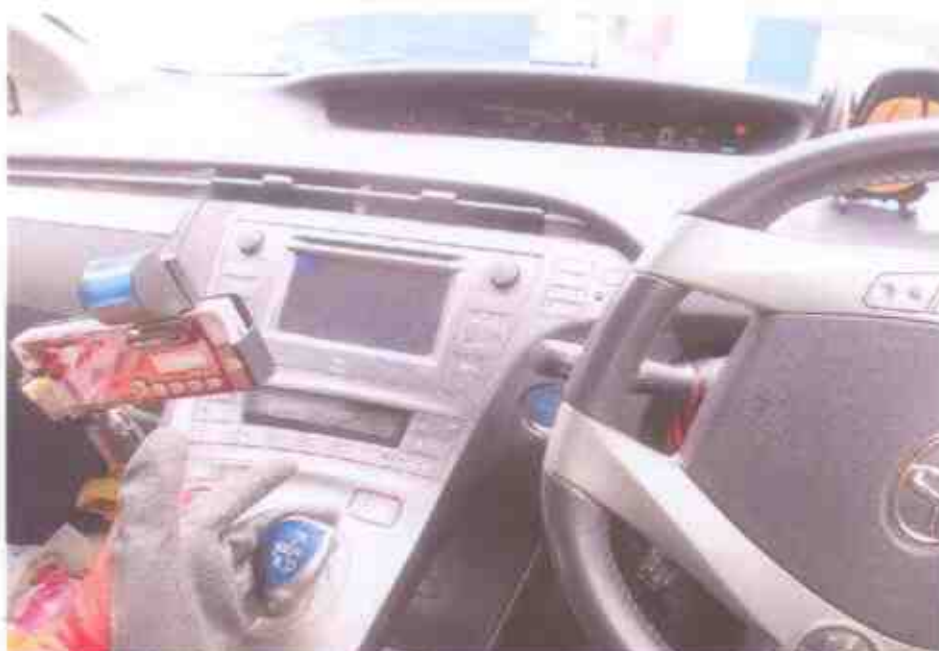
**Photo 24** shows neutral mode on the LCD panel of the Motor Taxi while performing operational test. This would suggest that it was able to move forward and backward normally

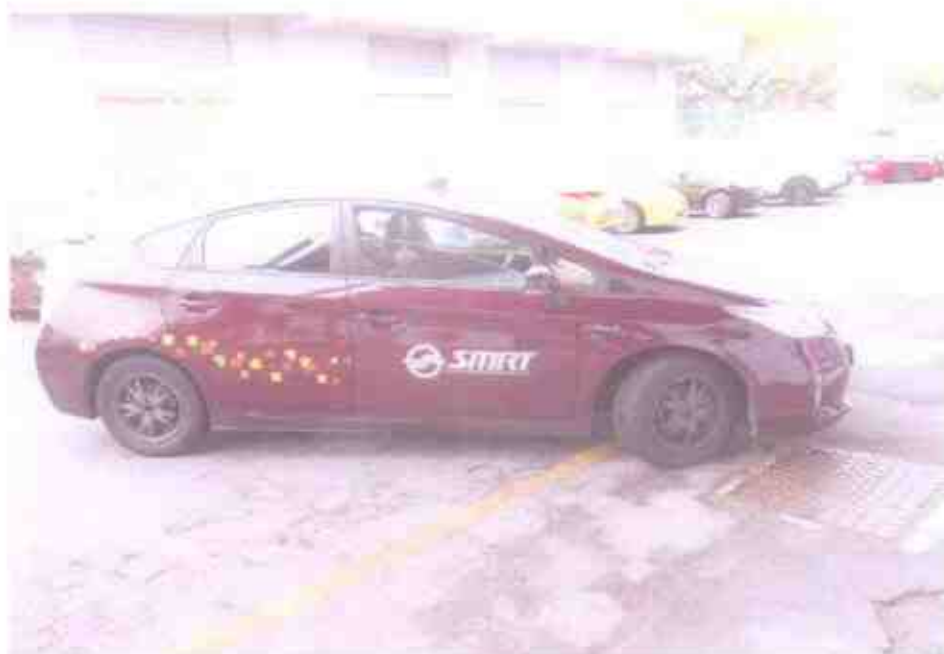
**Photo 25** shows a short operational test were conducted on the Motor Taxi to primarily determine whether there was any abnormality to its engine system, its transmission system and braking system
