Your Ref: S8M00LXD  
Our Ref :CS/ASM18011493/D

10 July 2018

**TECHNICAL INVESTIGATION REPORT OF FIRE INCIDENT INVOLVING THE  
INSURED VEHICLE SGD 9562G ON 25 JUNE 2018**

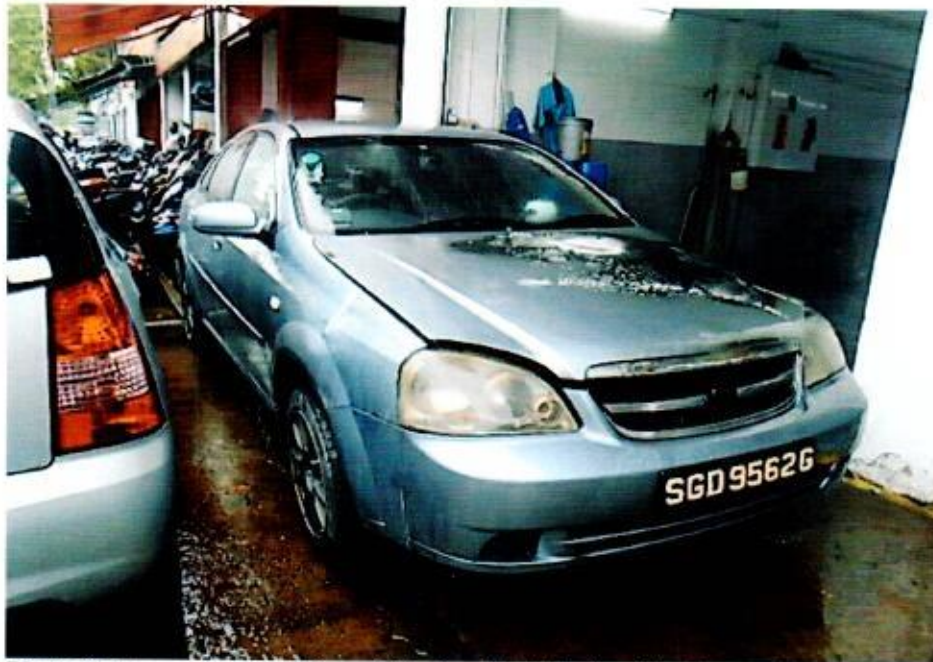
**Photo 1** shows a general view of the front right body of the Insured Vehicle at the time of inspection. The Insured Vehicle was observed to have sustained fire damage that was confined to its frontal body. Its front bonnet, front radiator grille, front right headlamp and front right fender were amongst the body parts that were found to have been burnt as a result of the fire.

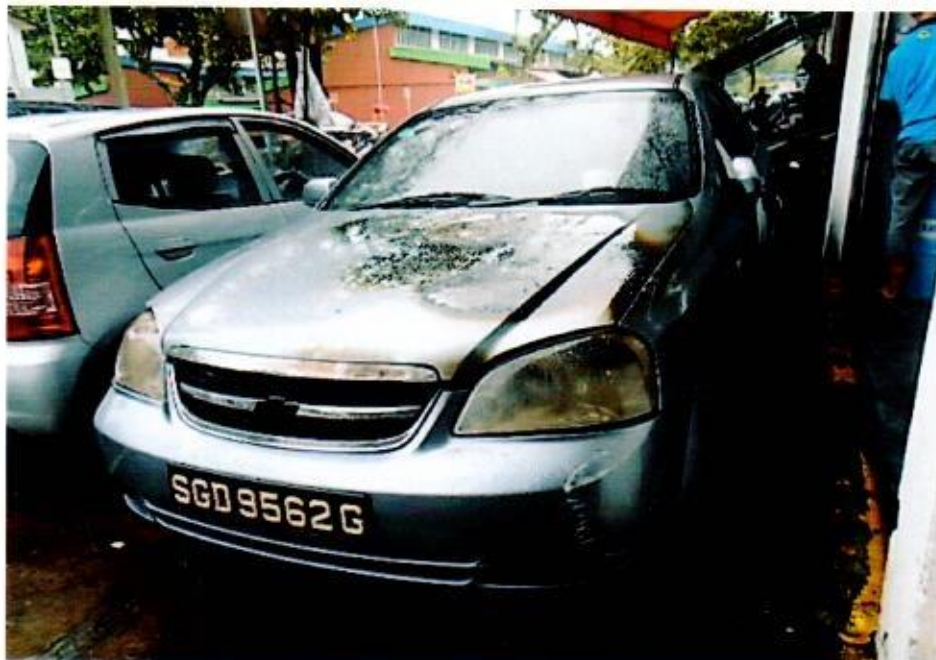
**Photo 2** shows a general view of the front left body of the Insured Vehicle at the time of inspection. The Insured Vehicle was observed to have sustained fire damage at its frontal body. Its front left fender, front left headlamp and front bonnet were amongst the body parts that were found to have been burnt as a result of the fire.

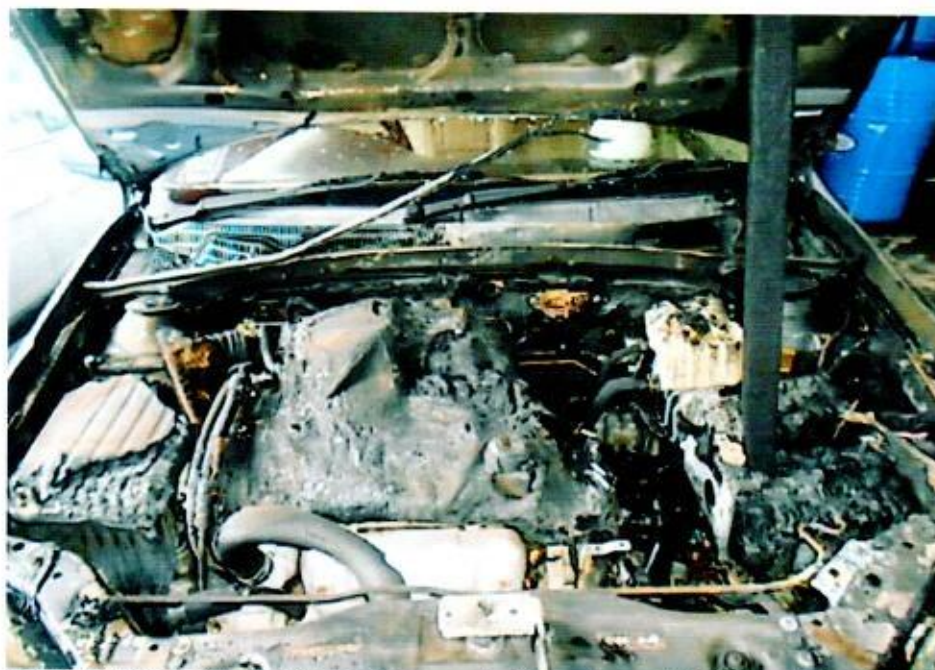
**Photo 3** shows the engine compartment of the Insured Vehicle at the time of inspection. Almost all the parts inside the engine compartment were observed to have been burnt and/or melted as a result of the fire. These parts had included its radiator, air condenser, cooling fan, intake manifold, fuse box, battery, air duct, hoses and pipes amongst others.

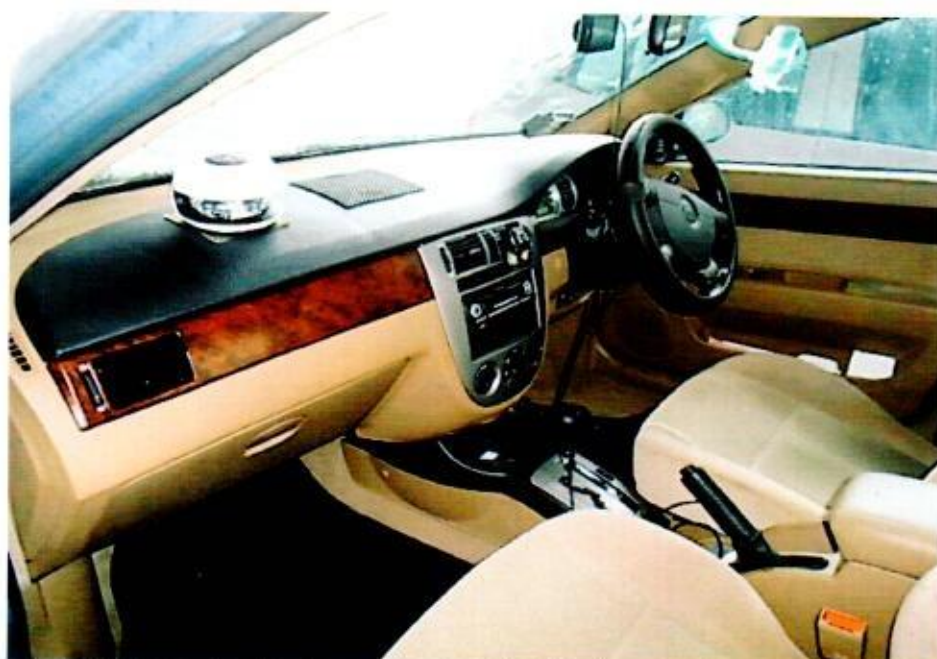
**Photo 4** shows the interior compartment of the Insured Vehicle. The interior compartment and rear body of the Insured Vehicle were unaffected by the incident.

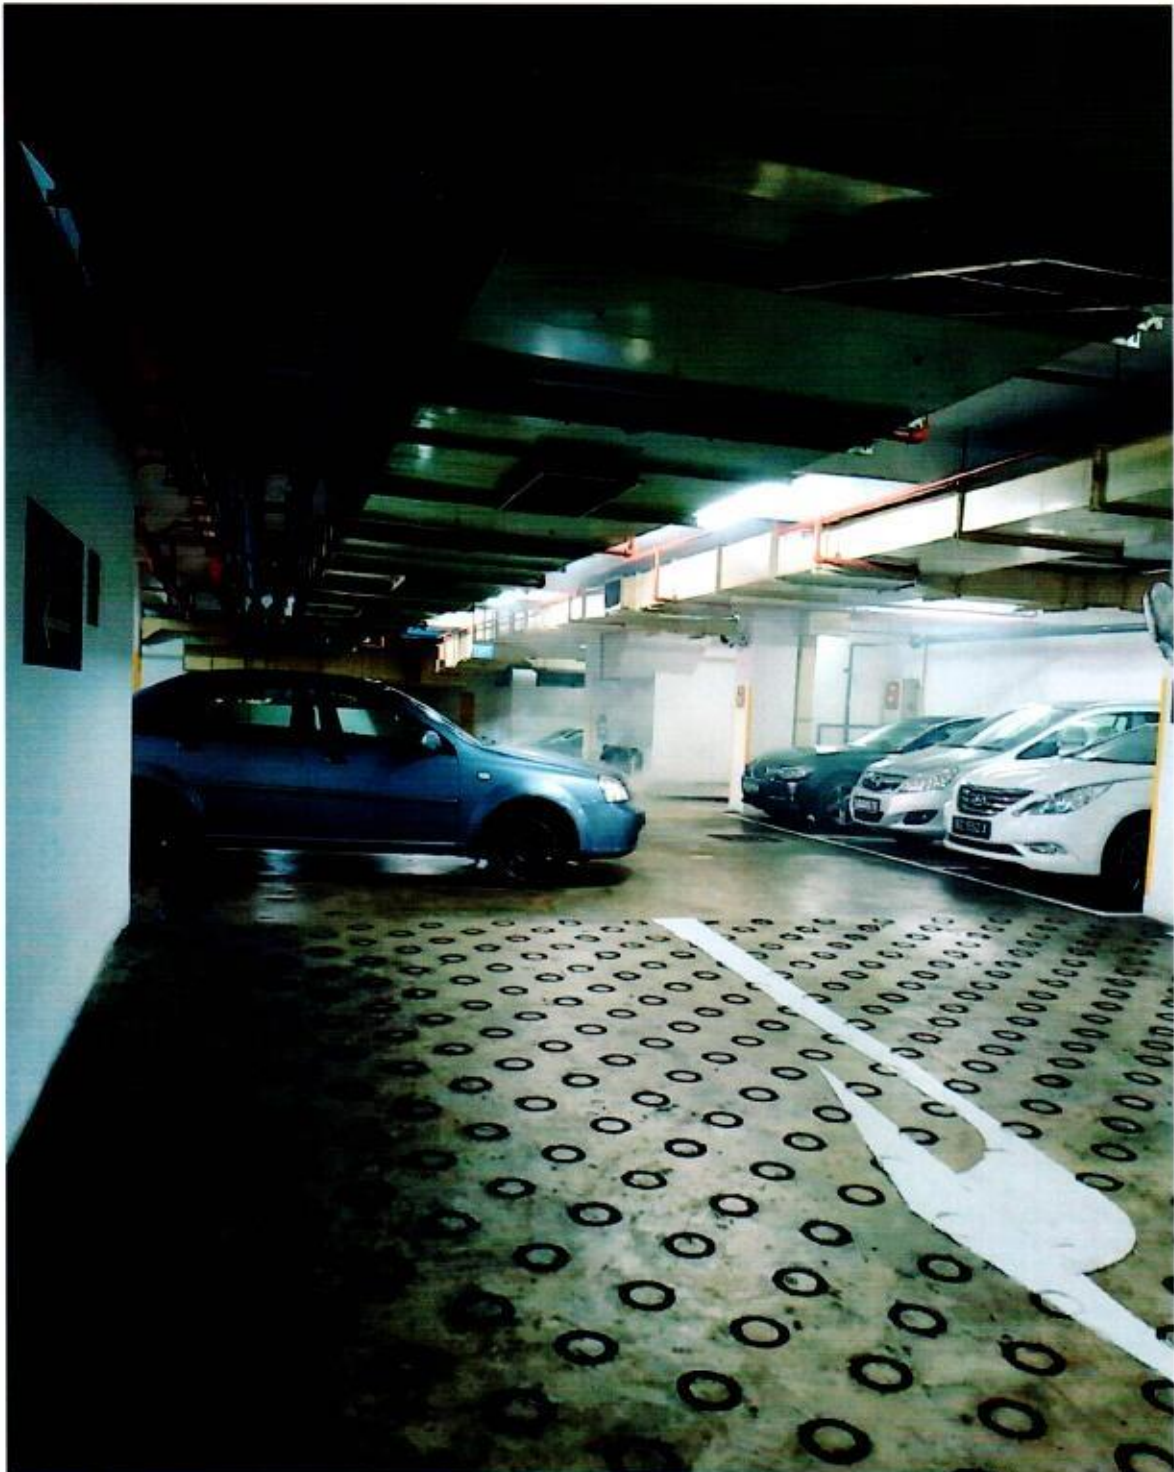
16. The photographs provided to me had showed the Insured Vehicle stopped at the top of an upslope ramp leading into the driveway of a sheltered carpark. Whitish smoke could be seen coming out from the engine compartment of the Insured Vehicle, through the gaps at the front bonnet and front radiator grille. Upon closer examination of the photographs provided, I had noted that there was no unusual foreign material(s), object(s) and/or fluid accumulation on the ground where the Insured Vehicle had stopped.

**Photo 5** shows the Insured Vehicle at the incident location with whitish smoke emitting out from the gaps surrounding its front bonnet and front radiator grille. There was no unusual foreign material(s) or object(s) and/or fluid accumulation on the ground where the Insured Vehicle had stopped. In general, the observations gathered from my review of the photographs that were taken by Mr Leng at the incident scene had corresponded to the description of events that he had related to me during our conversation on 02 July 2018.

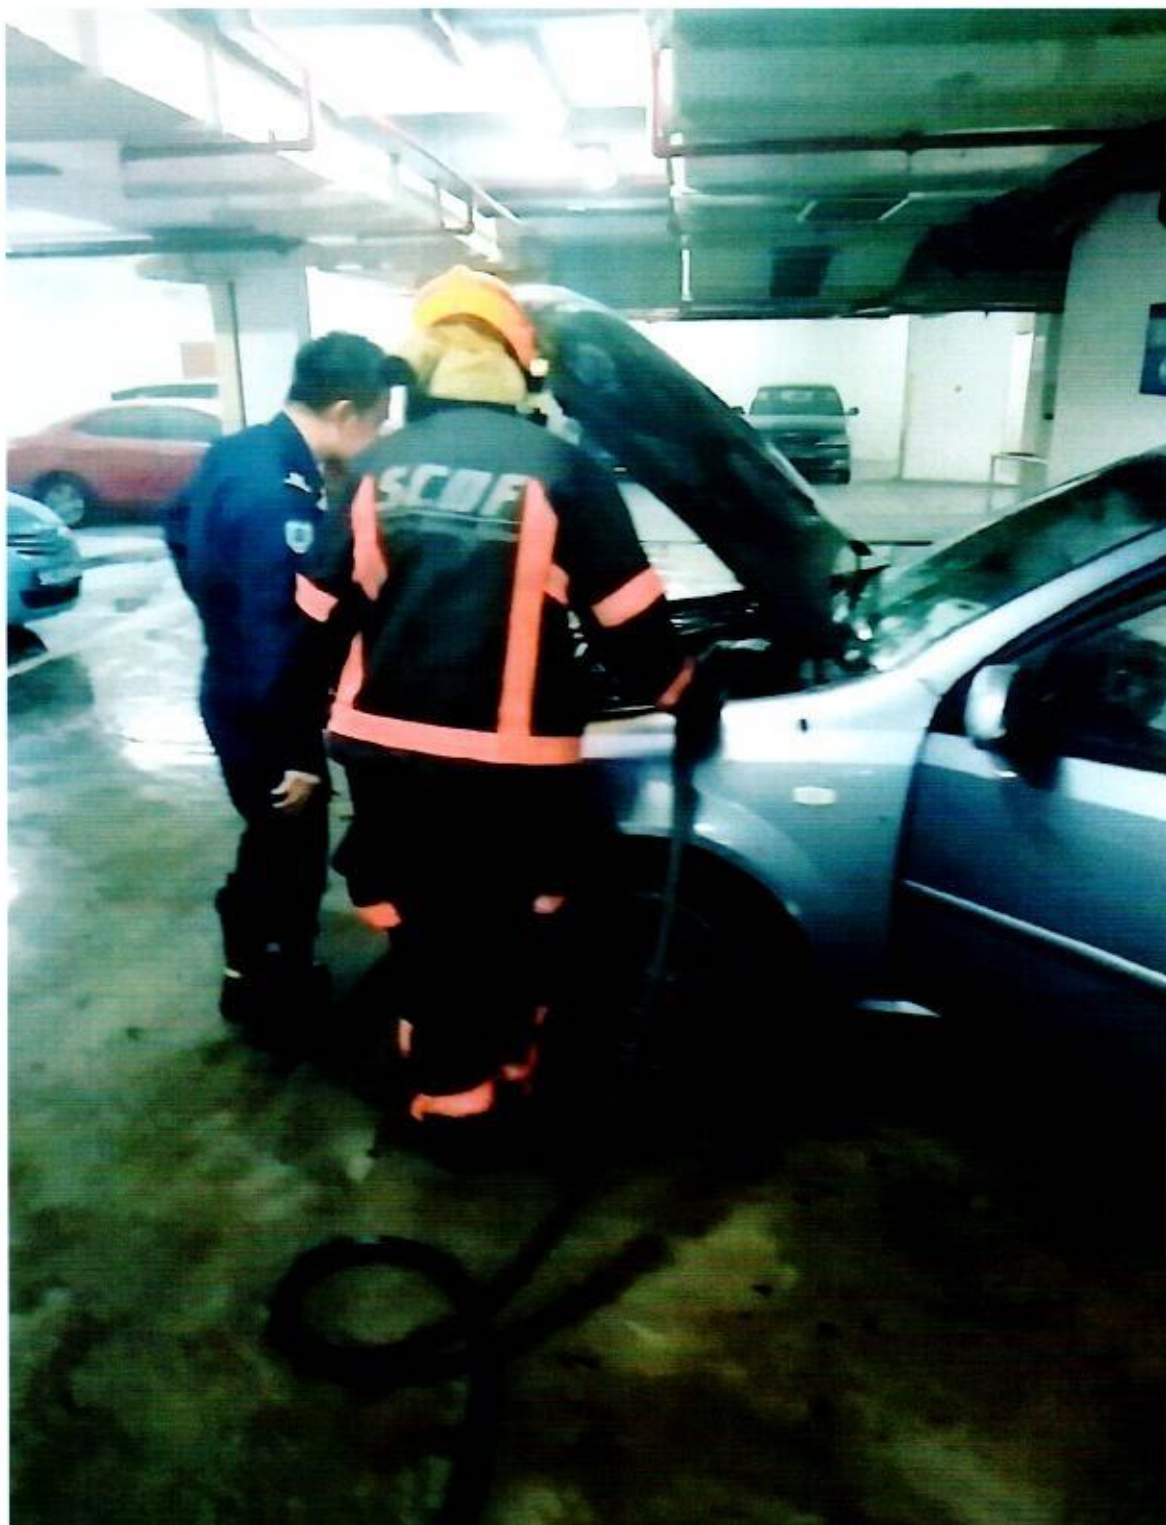
**Photo 6** shows SCDF officers examining the engine compartment of the Insured Vehicle after the fire was extinguished.

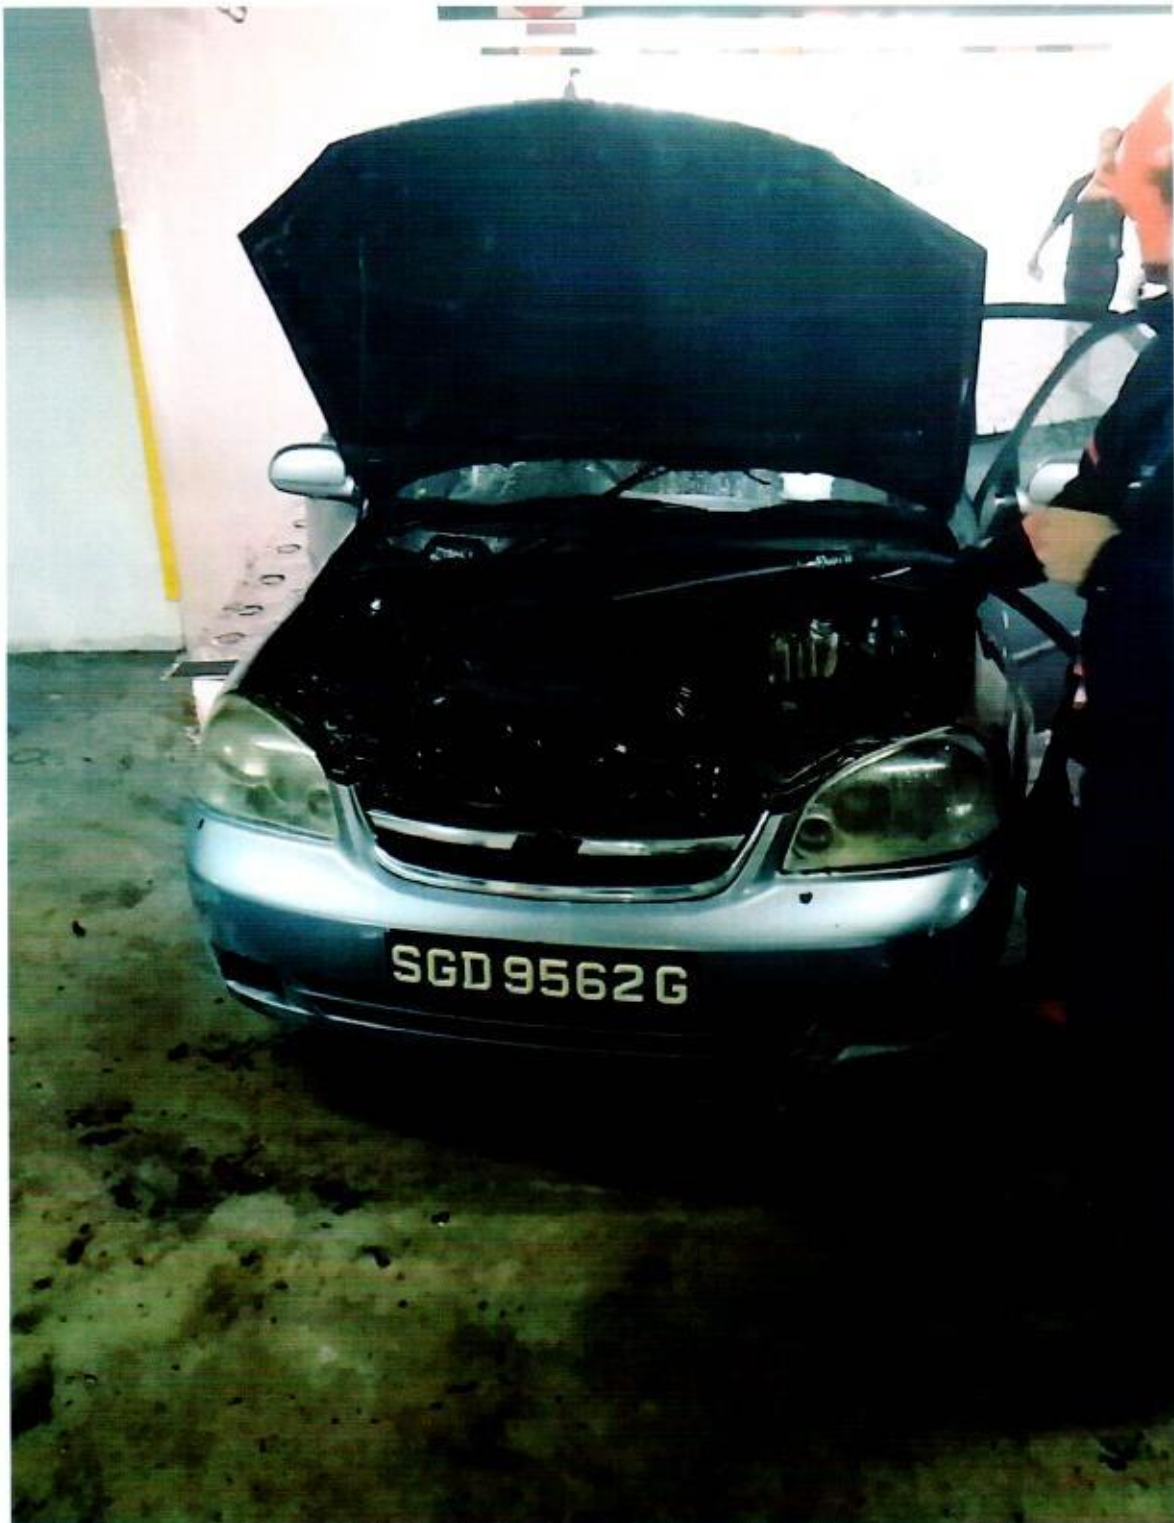
17. SCDF officers could also be seen examining the engine compartment of the Insured Vehicle after the fire was extinguished. The damage of fire nature to the Insured Vehicle, as seen from the photographs provided, was observed to be similar to what I had observed during my inspection of the Insured Vehicle.

**Photo 7** shows the Insured Vehicle after the fire was extinguished. The damage of fire nature to the Insured Vehicle, as seen from the photographs provided, was observed to be similar to what I had observed during my inspection of the Insured Vehicle. In general, the observations gathered from my review of the photographs that were taken by Mr Leng at the incident scene had corresponded to the description of events that he had related to me during our conversation on 02 July 2018.

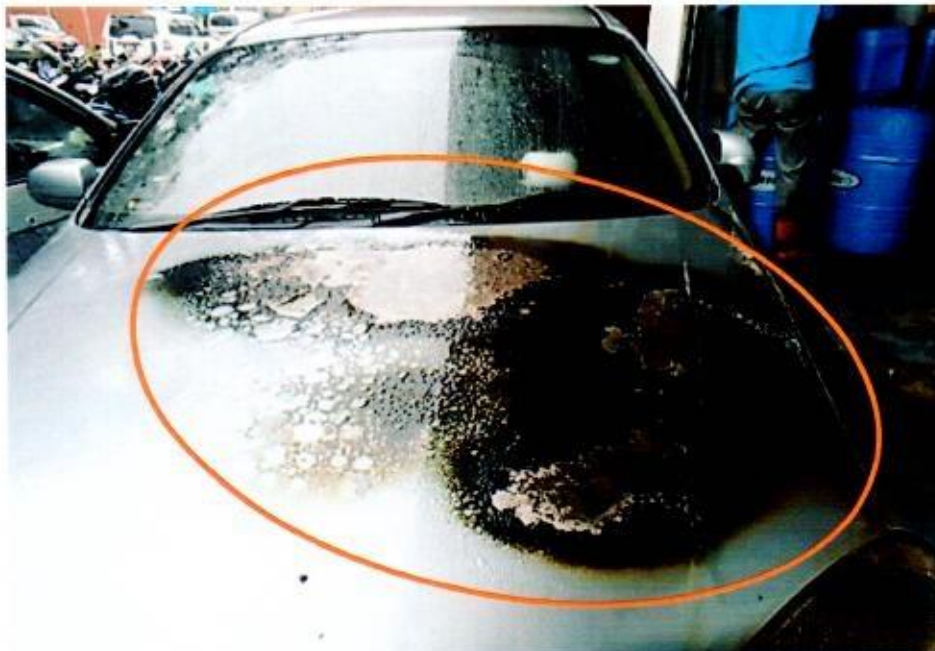
19. For this case, intense burn marks were found on a single area on the Insured Vehicle. This was at the centre left of the front bonnet. The burn marks were seen on the front bonnet of the Insured Vehicle immediately after the fire was extinguished. Such marks are normally formed on steel/metal material body parts that had been exposed to prolong high heat intensity, and can usually be used to determine the origin of the fire. Given the characteristic of heat (hot air rises), the origin of fire can then be determined to be at the centre left area of the engine compartment, below the area where the intense burn marks were found on the Insured Vehicle's front bonnet.

**Photo 8** shows the intense burn marks (circled) that were found on the centre left of the front bonnet. Such marks are normally formed on steel/metal material body parts that had been exposed to prolong high heat intensity, and can usually determine the origin of the fire.

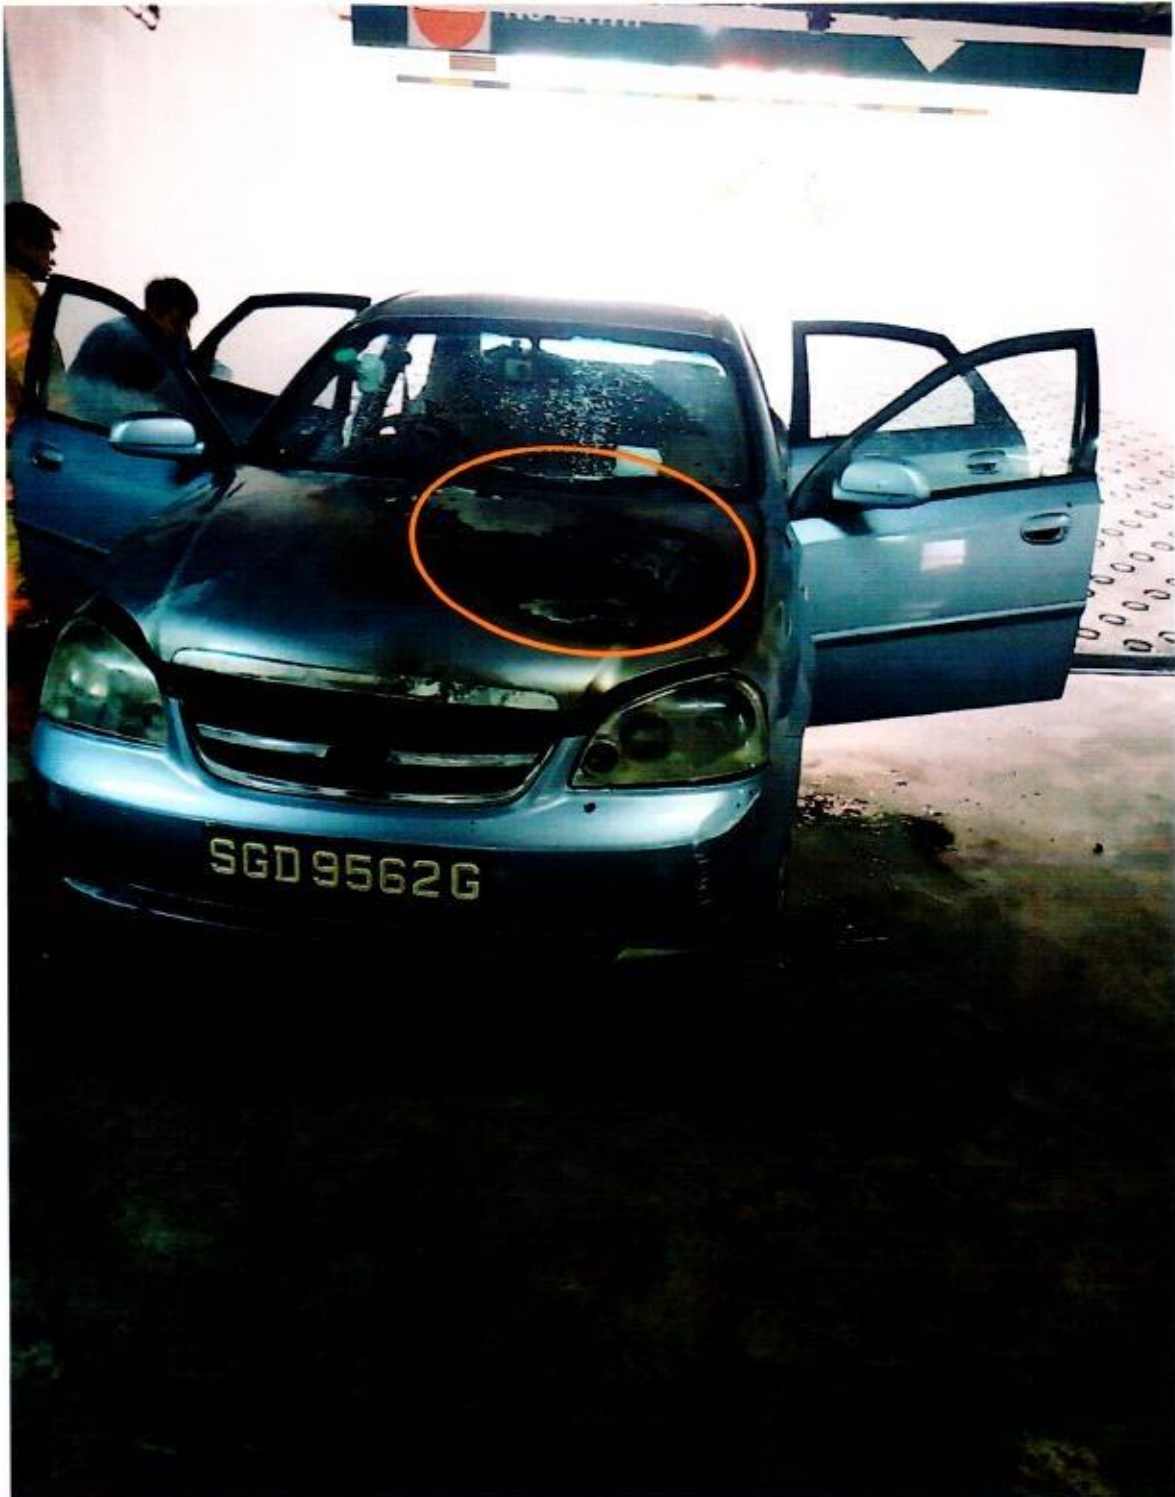
**Photo 9** shows the Insured Vehicle at the incident scene after the fire was extinguished. Intense burn marks (circled) were seen on the front bonnet of the Insured Vehicle immediately after the fire was extinguished. Such marks are normally formed on steel/metal material body parts that had been exposed to prolong high heat intensity, and can usually determine the origin of the fire. For this case, the fire had originated at the centre left area of the Insured Vehicle's engine compartment.

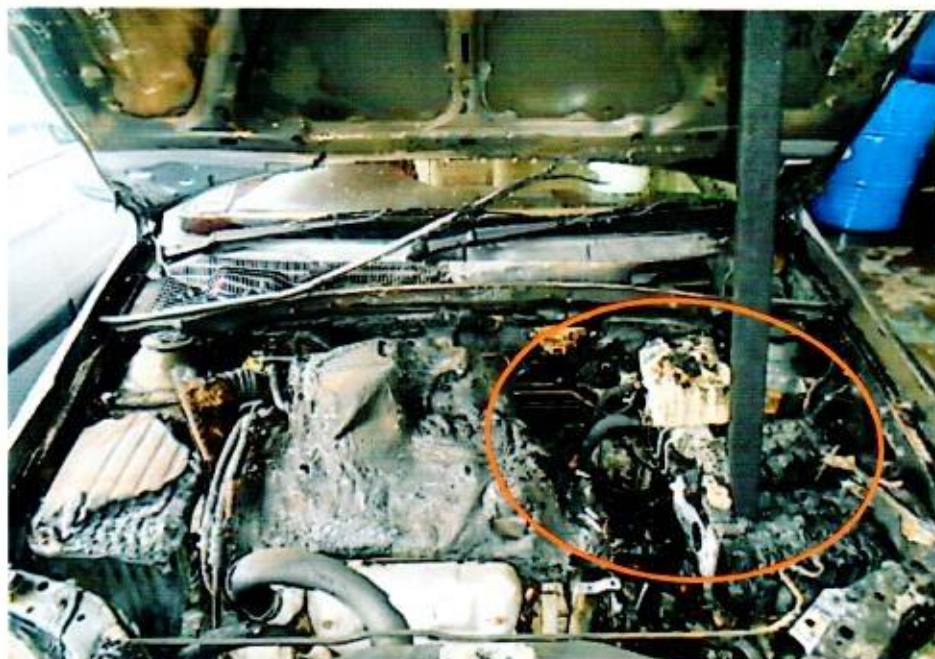
**Photo 10** shows the engine compartment of the Insured Vehicle at the time of my inspection. Following the location where intense burn marks were found, the origin of fire was determined to be at the centre left area (circled) of the Insured Vehicle's engine compartment.

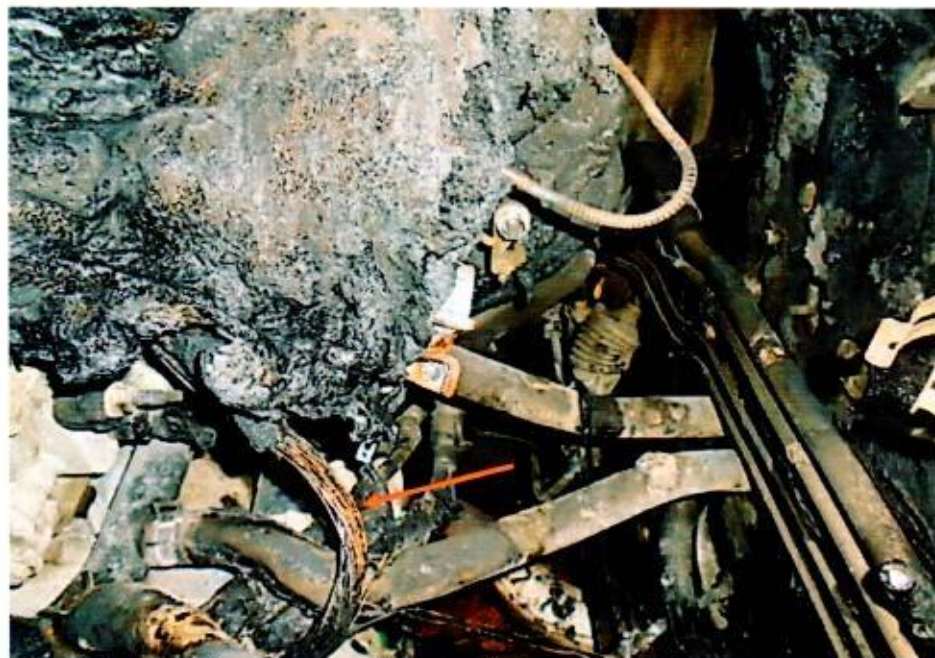
20. My examination of the centre left area of the engine compartment, during my inspection of the Insured Vehicle, revealed wirings that were completely burned to its bare copper state. The bright reddish colour of the copper wires suggest that the wirings were exposed to high heat. Such condition normally indicates internal heating of copper wires, which is a sign of an electrical short circuit occurring. Hence the physical condition of the wirings at the area where the fire had originated indicates that the cause of fire to the Insured Vehicle was due to electrical in nature. See photo 8 - 12 below.

**Photo 11** shows the wirings at the centre left area of the Insured Vehicle's engine compartment. Upon closer examination of the area where the fire had originated, I had found wirings (arrowed) that were completely burned to its bare copper state. The bright reddish colour of the copper wires suggest that the wirings were exposed to high heat. Such condition normally indicates internal heating of copper wires, which is a sign of an electrical short circuit occurring.

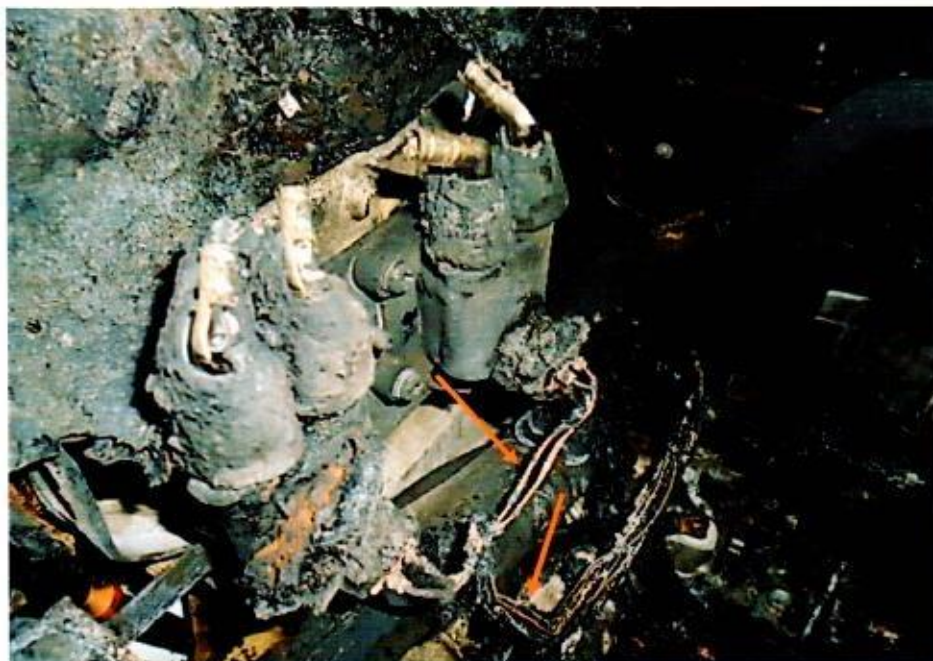
**Photo 12** shows another stretch of wiring around the centre left area of the Insured Vehicle's engine compartment. The wirings (arrowed) were found to be completely burned to its bare copper state. Such condition normally indicates internal heating of copper wires, which is a sign of an electrical short circuit occurring. This then indicates that the cause of fire to the Insured Vehicle was of electrical nature.

22. Having investigated and technically analysed the damages of burnt nature to the Insured Vehicle, I am of the view that the cause of fire to the Insured Vehicle was of electrical in nature. For this particular case, the fire had originated along the wirings inside the engine compartment, at the centre left area of the engine compartment. The wirings were original factory wirings.
23. I did not find any evidence which had suggested that the cause of fire to the Insured Vehicle was due to poor maintenance and/or recurring electrical problem.
24. There was no modification (s) and/or additional electronic and/or electrical component(s) fitted on the Insured Vehicle at the time of my inspection of the Insured Vehicle.
25. My investigations also revealed that at the time of writing this report, there is no manufacturer recall of similar make and model vehicle as the Insured Vehicle.
