Your Ref: S8M00LXD
Our Ref :CS/ASM18011493/D

10 July 2018

**TECHNICAL INVESTIGATION REPORT OF FIRE INCIDENT INVOLVING THE
INSURED VEHICLE SGD 9562G ON 25 JUNE 2018**

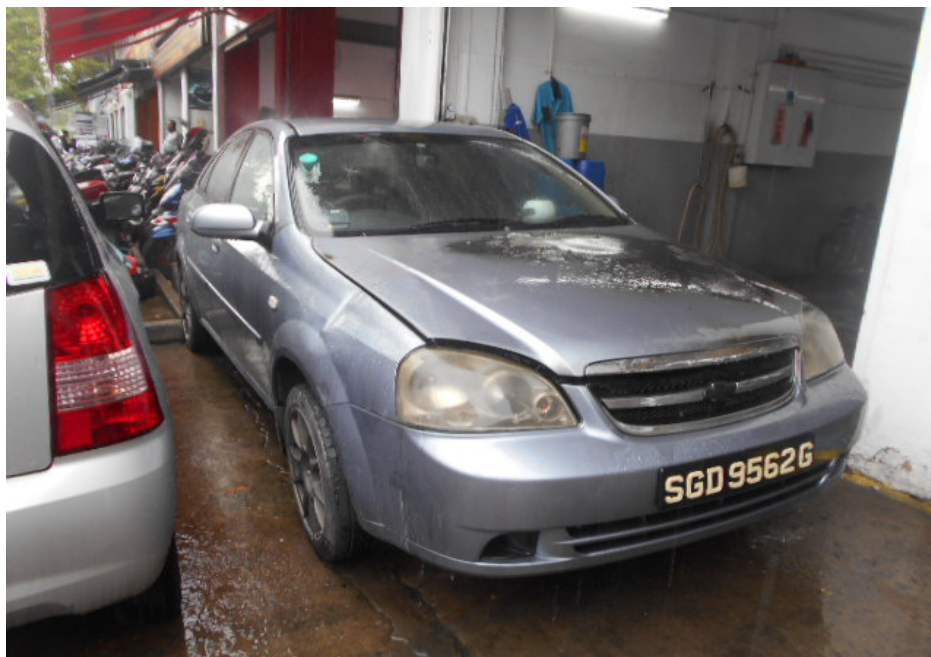
Photo 1 shows a general view of the front right body of the Insured Vehicle at the time of inspection. The Insured Vehicle was observed to have sustained fire damage that was confined to its frontal body. Its front bonnet, front radiator grille, front right headlamp and front right fender were amongst the body parts that were found to have been burnt as a result of the fire.

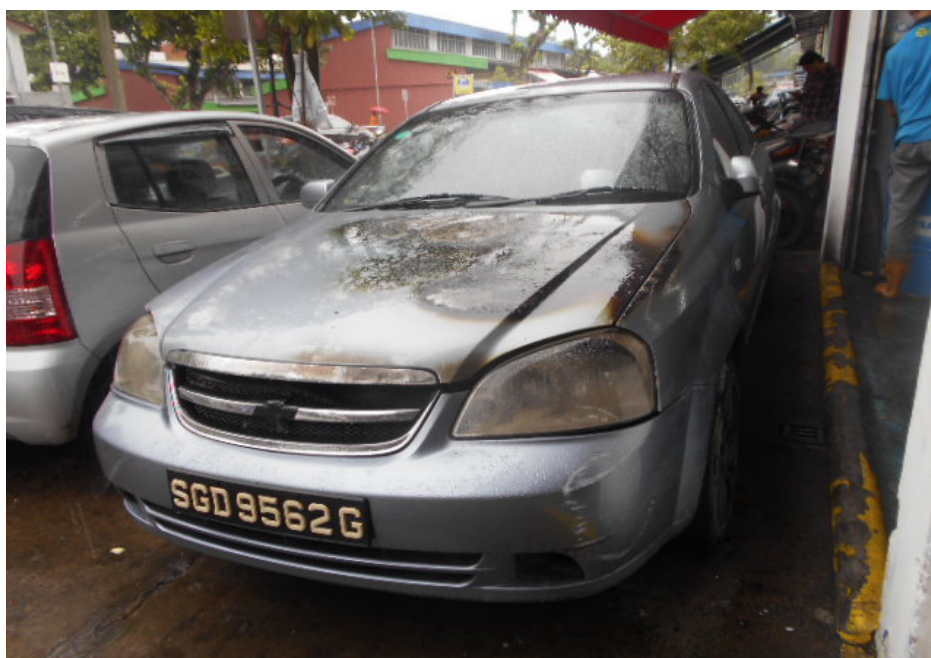
Photo 2 shows a general view of the front left body of the Insured Vehicle at the time of inspection. The Insured Vehicle was observed to have sustained fire damage at its frontal body. Its front left fender, front left headlamp and front bonnet were amongst the body parts that were found to have been burnt as a result of the fire.

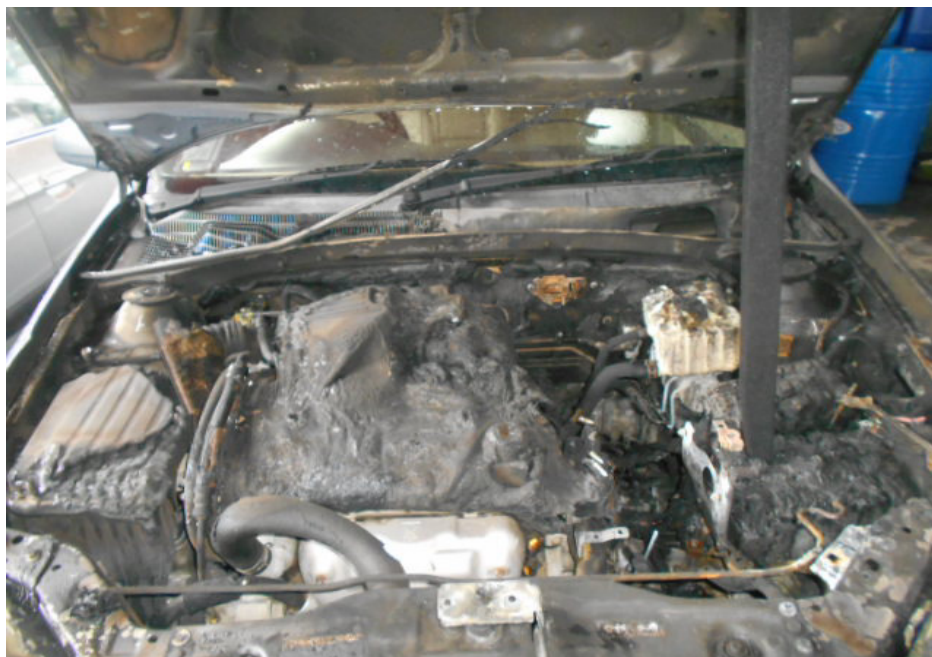
Photo 3 shows the engine compartment of the Insured Vehicle at the time of inspection. Almost all the parts inside the engine compartment were observed to have been burnt and/or melted as a result of the fire. These parts had included its radiator, air condenser, cooling fan, intake manifold, fuse box, battery, air duct, hoses and pipes amongst others.

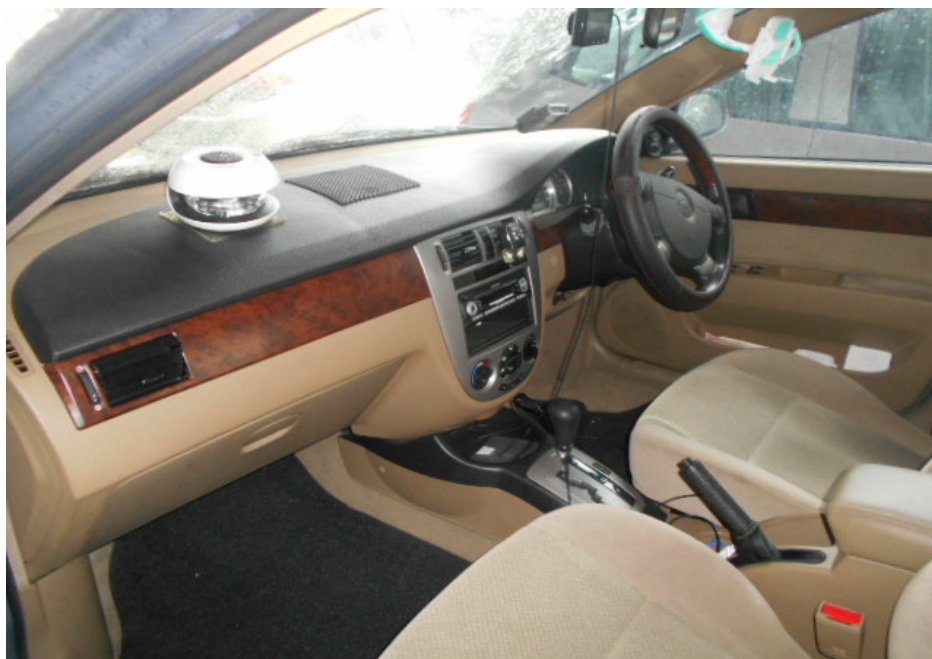
Photo 4 shows the interior compartment of the Insured Vehicle. The interior compartment and rear body of the Insured Vehicle were unaffected by the incident.

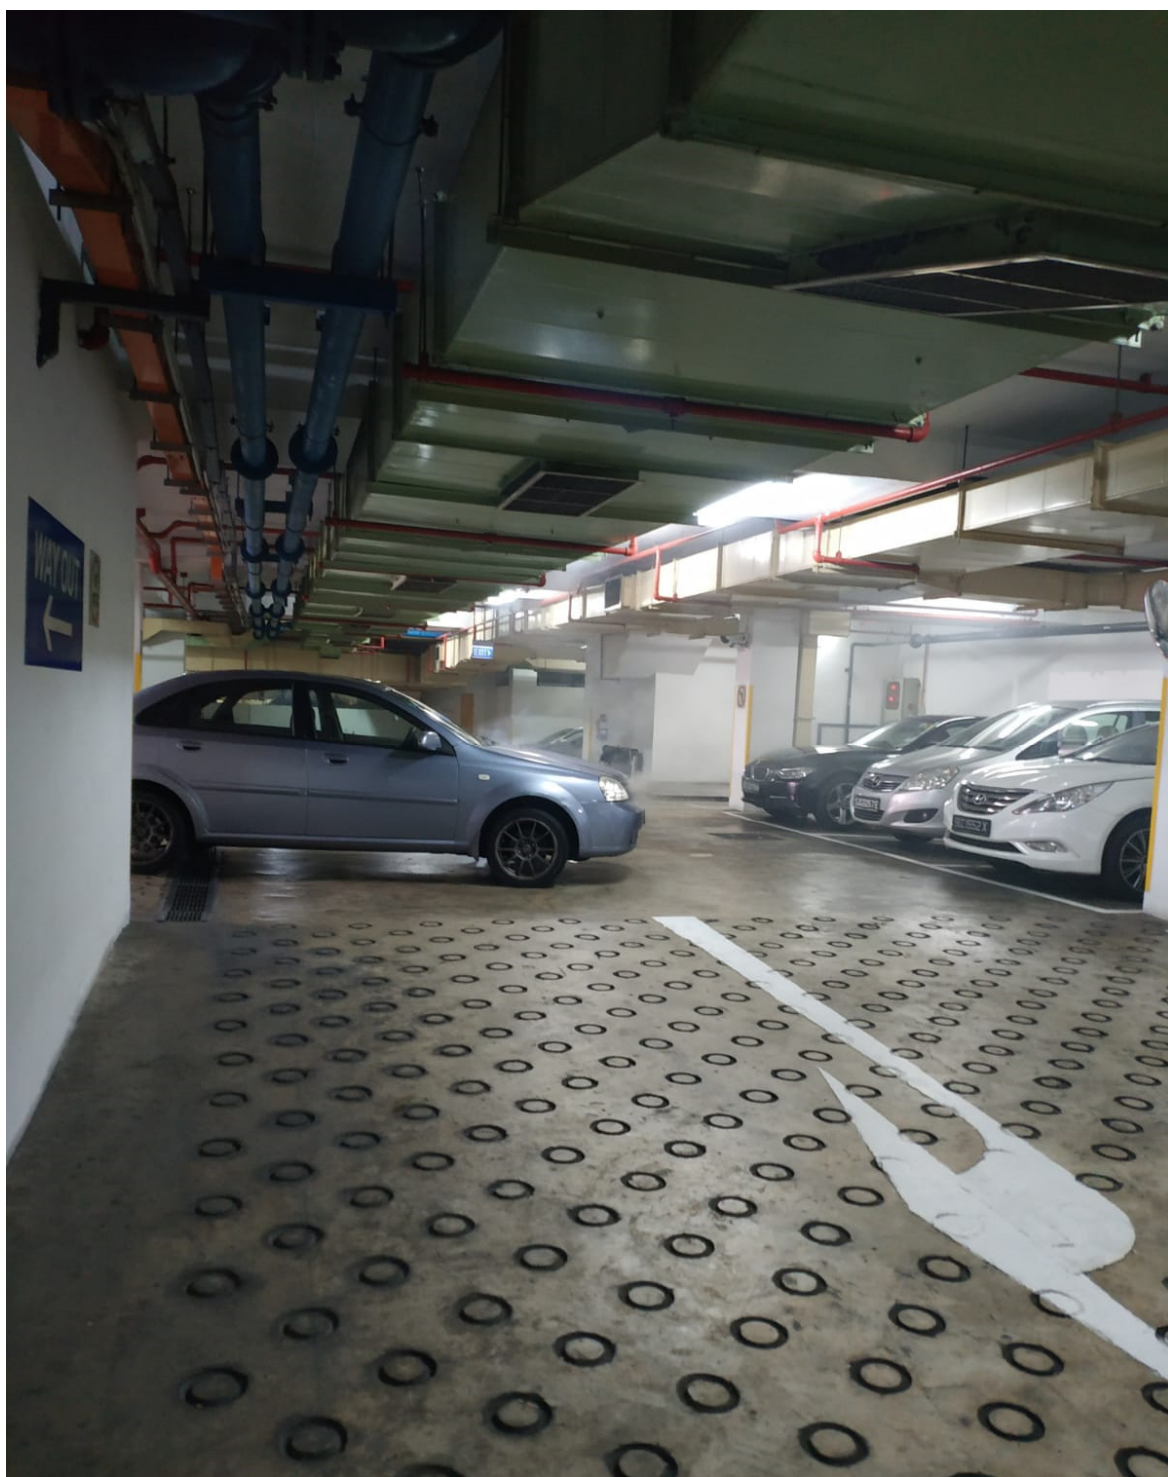
16. The photographs provided to me had showed the Insured Vehicle stopped at the top of an upslope ramp leading into the driveway of a sheltered carpark. Whitish smoke could be seen coming out from the engine compartment of the Insured Vehicle, through the gaps at the front bonnet and front radiator grille. Upon closer examination of the photographs provided, I had noted that there was no unusual foreign material(s), object(s) and/or fluid accumulation on the ground where the Insured Vehicle had stopped.

Photo 5 shows the Insured Vehicle at the incident location with whitish smoke emitting out from the gaps surrounding its front bonnet and front radiator grille. There was no unusual foreign material(s) or object(s) and/or fluid accumulation on the ground where the Insured Vehicle had stopped. In general, the observations gathered from my review of the photographs that were taken by Mr Leng at the incident scene had corresponded to the description of events that he had related to me during our conversation on 02 July 2018.

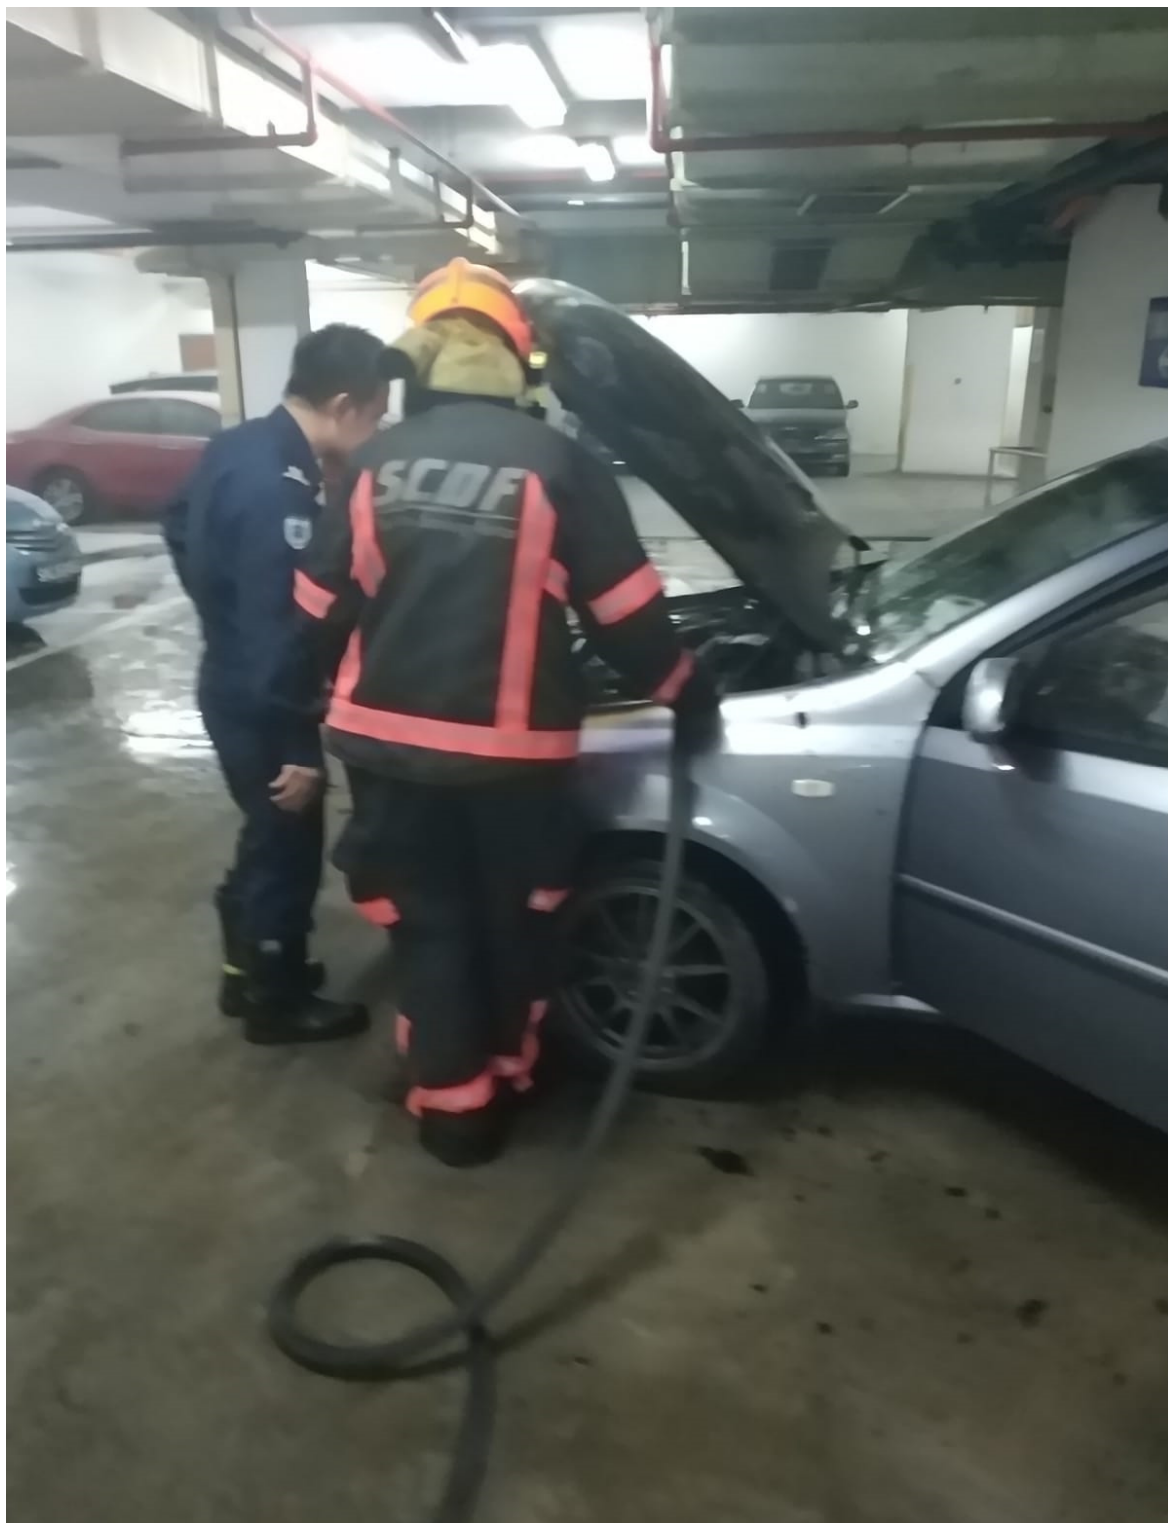
Photo 6 shows SCDF officers examining the engine compartment of the Insured Vehicle after the fire was extinguished.

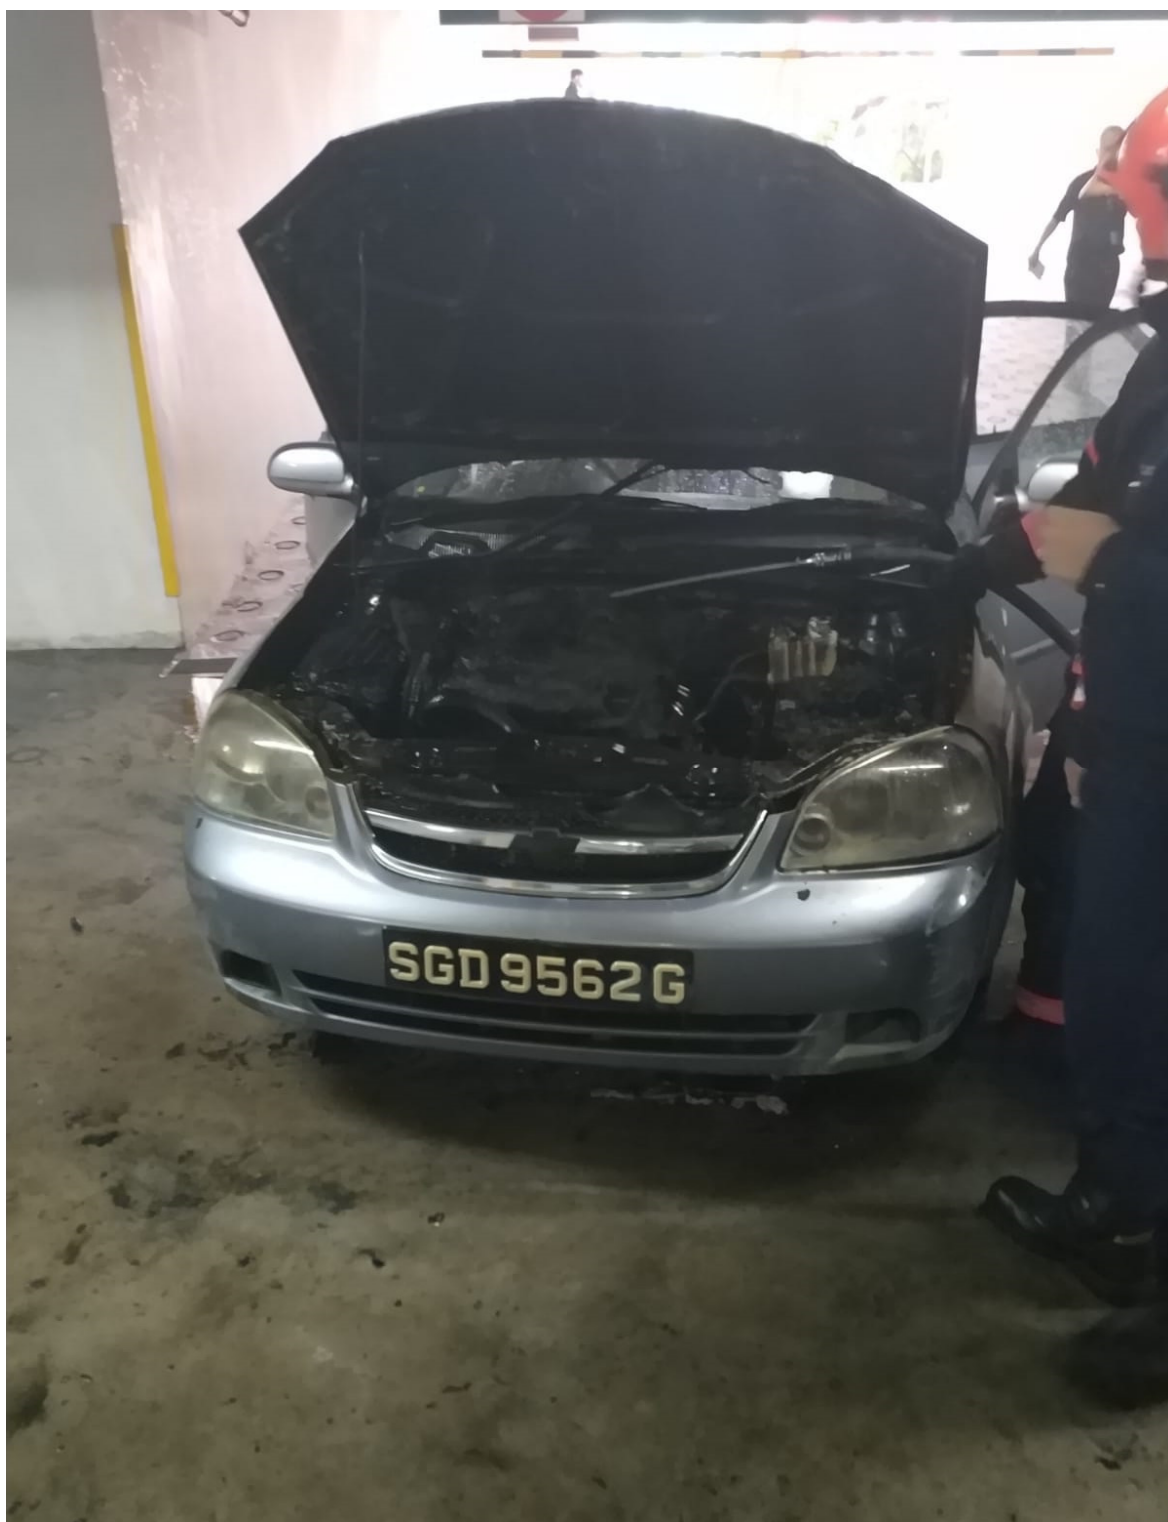
17. SCDF officers could also be seen examining the engine compartment of the Insured Vehicle after the fire was extinguished. The damage of fire nature to the Insured Vehicle, as seen from the photographs provided, was observed to be similar to what I had observed during my inspection of the Insured Vehicle.

Photo 7 shows the Insured Vehicle after the fire was extinguished. The damage of fire nature to the Insured Vehicle, as seen from the photographs provided, was observed to be similar to what I had observed during my inspection of the Insured Vehicle. In general, the observations gathered from my review of the photographs that were taken by Mr Leng at the incident scene had corresponded to the description of events that he had related to me during our conversation on 02 July 2018.

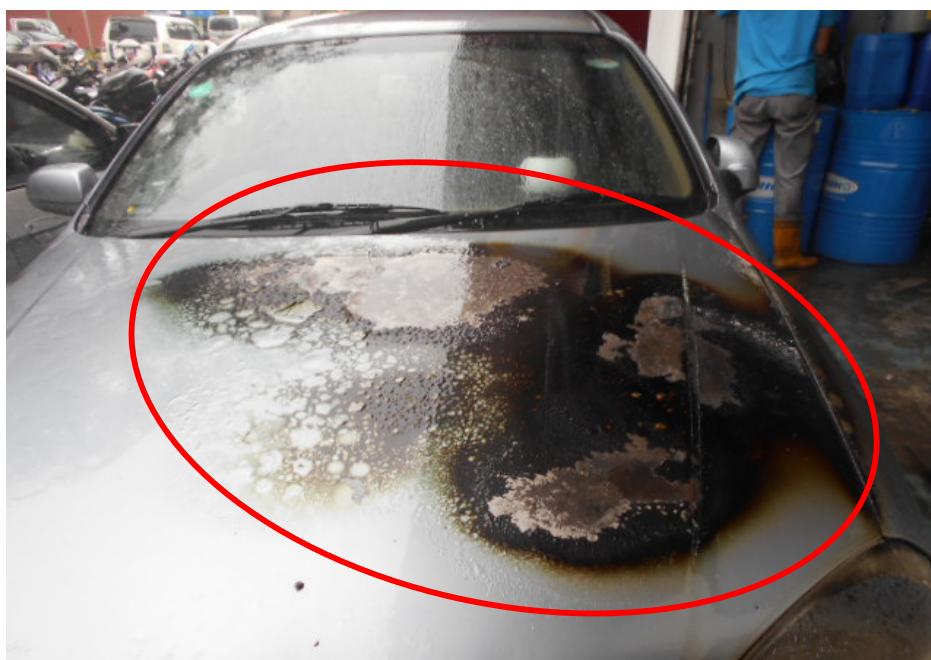
19. For this case, intense burn marks were found on a single area on the Insured Vehicle. This was at the centre left of the front bonnet. The burn marks were seen on the front bonnet of the Insured Vehicle immediately after the fire was extinguished. Such marks are normally formed on steel/metal material body parts that had been exposed to prolong high heat intensity, and can usually be used to determine the origin of the fire. Given the characteristic of heat (hot air rises), the origin of fire can then be determined to be at the centre left area of the engine compartment, below the area where the intense burn marks were found on the Insured Vehicle's front bonnet.

Photo 8 shows the intense burn marks (circled) that were found on the centre left of the front bonnet. Such marks are normally formed on steel/metal material body parts that had been exposed to prolong high heat intensity, and can usually determine the origin of the fire.

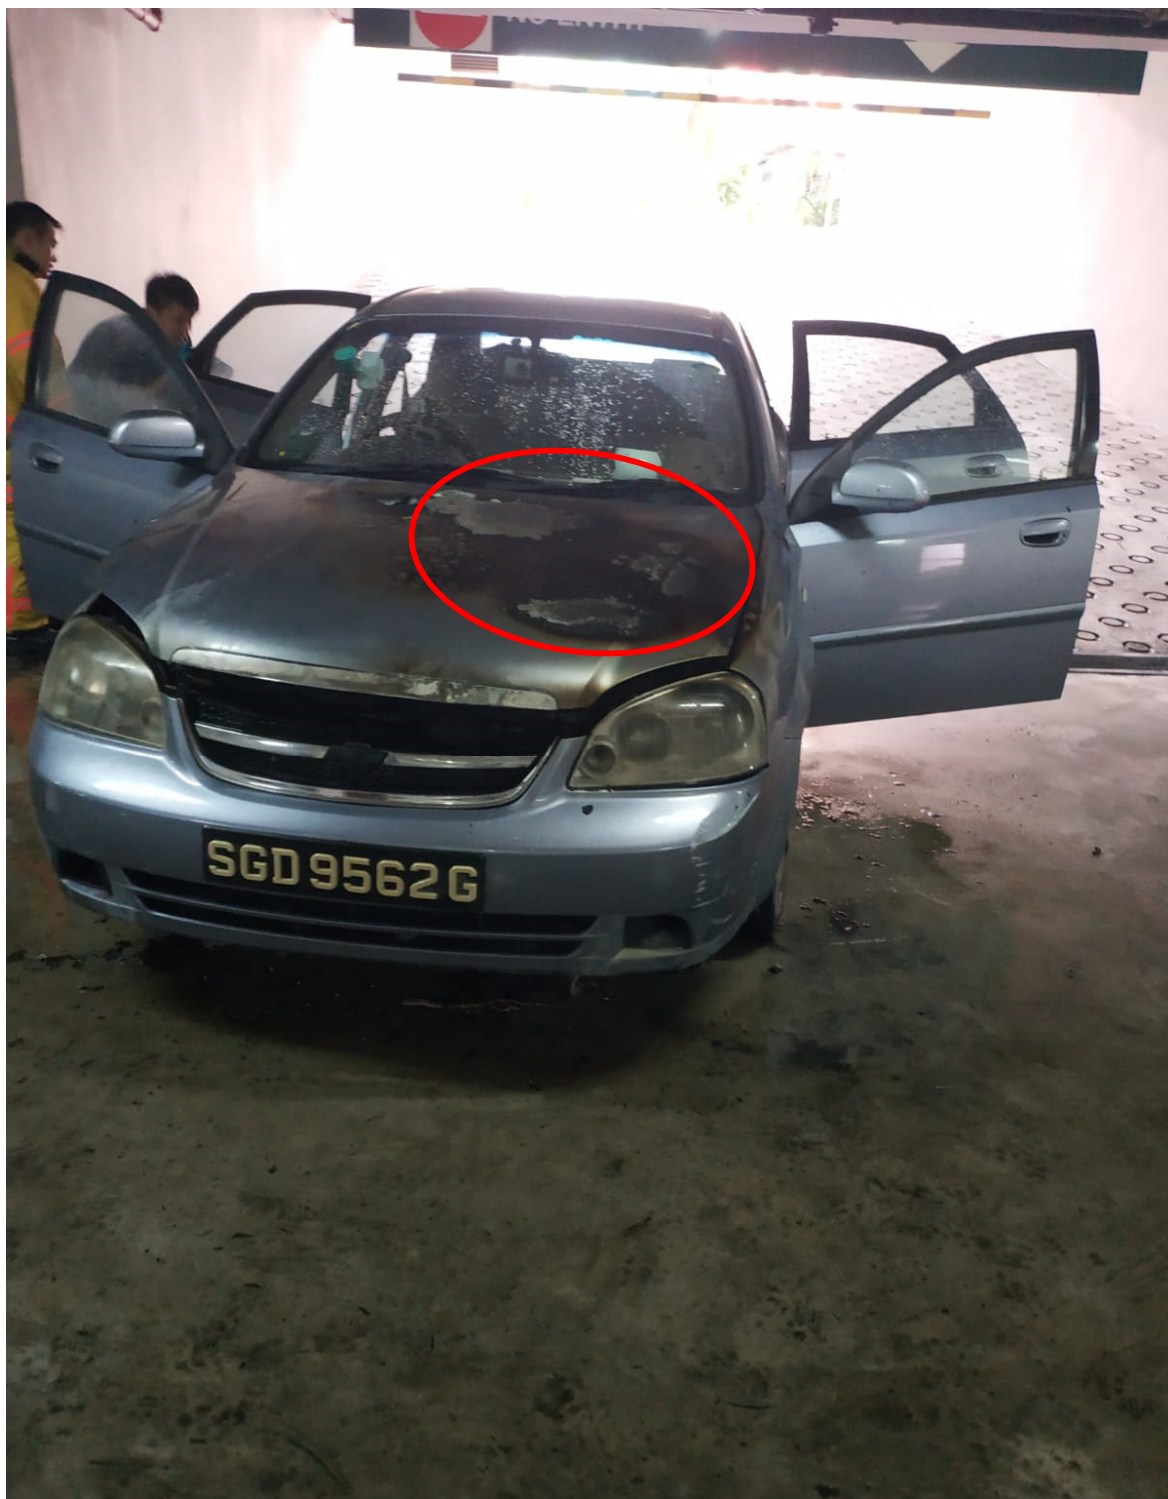
Photo 9 shows the Insured Vehicle at the incident scene after the fire was extinguished. Intense burn marks (circled) were seen on the front bonnet of the Insured Vehicle immediately after the fire was extinguished. Such marks are normally formed on steel/metal material body parts that had been exposed to prolong high heat intensity, and can usually determine the origin of the fire. For this case, the fire had originated at the centre left area of the Insured Vehicle's engine compartment.

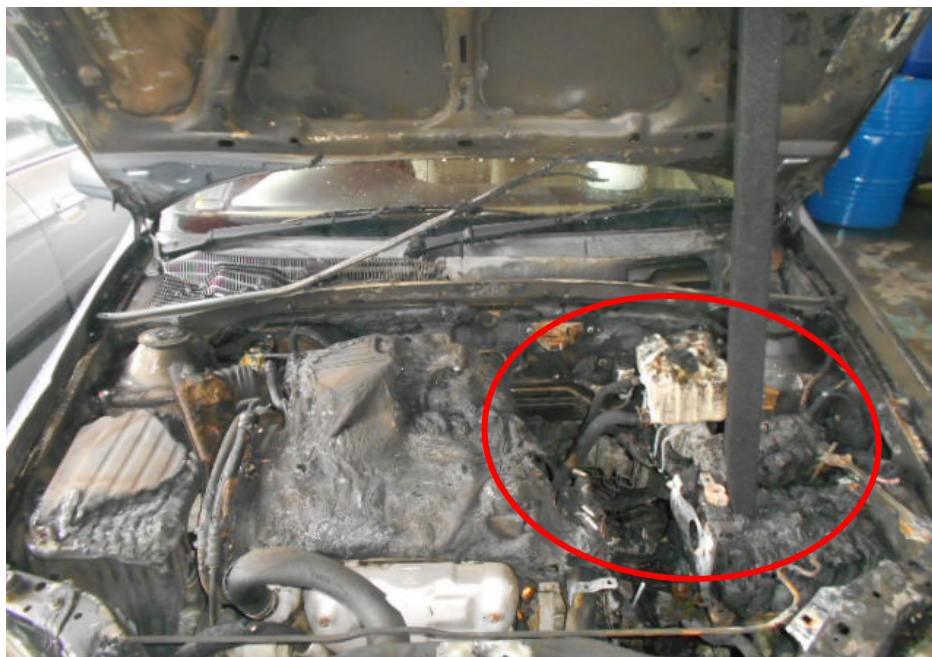
Photo 10 shows the engine compartment of the Insured Vehicle at the time of my inspection. Following the location where intense burn marks were found, the origin of fire was determined to be at the centre left area (circled) of the Insured Vehicle's engine compartment.

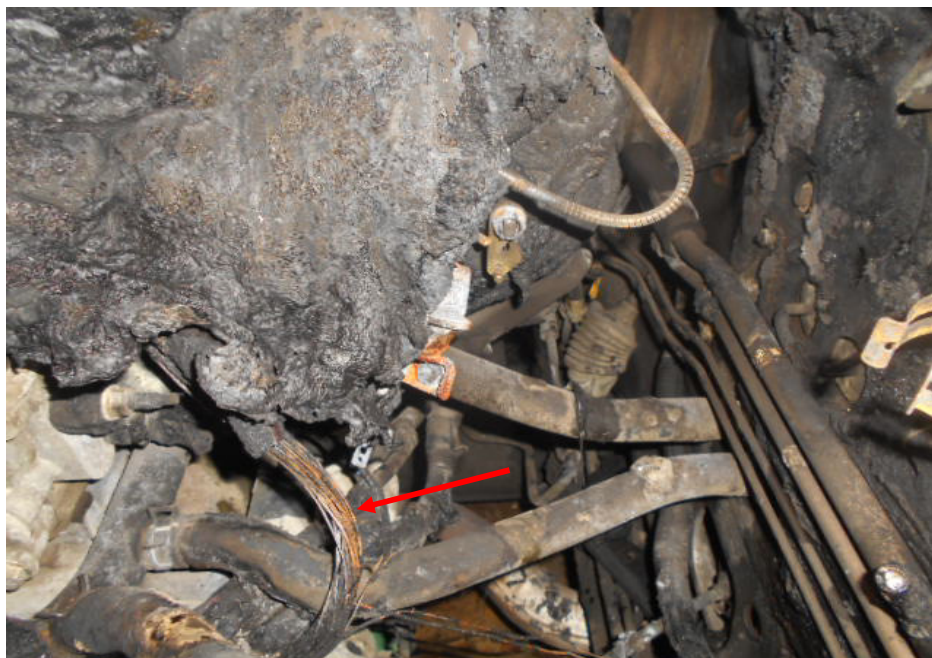
20. My examination of the centre left area of the engine compartment, during my inspection of the Insured Vehicle, revealed wirings that were completely burned to its bare copper state. The bright reddish colour of the copper wires suggest that the wirings were exposed to high heat. Such condition normally indicates internal heating of copper wires, which is a sign of an electrical short circuit occurring. Hence the physical condition of the wirings at the area where the fire had originated indicates that the cause of fire to the Insured Vehicle was due to electrical in nature. See photo 8 - 12 below.

Photo 11 shows the wirings at the centre left area of the Insured Vehicle's engine compartment. Upon closer examination of the area where the fire had originated, I had found wirings (arrowed) that were completely burned to its bare copper state. The bright reddish colour of the copper wires suggest that the wirings were exposed to high heat. Such condition normally indicates internal heating of copper wires, which is a sign of an electrical short circuit occurring.

22. Having investigated and technically analysed the damages of burnt nature to the Insured Vehicle, I am of the view that the cause of fire to the Insured Vehicle was of electrical in nature. For this particular case, the fire had originated along the wirings inside the engine compartment, at the centre left area of the engine compartment. The wirings were original factory wirings.
23. I did not find any evidence which had suggested that the cause of fire to the Insured Vehicle was due to poor maintenance and/or recurring electrical problem.
24. There was no modification (s) and/or additional electronic and/or electrical component(s) fitted on the Insured Vehicle at the time of my inspection of the Insured Vehicle.
25. My investigations also revealed that at the time of writing this report, there is no manufacturer recall of similar make and model vehicle as the Insured Vehicle.

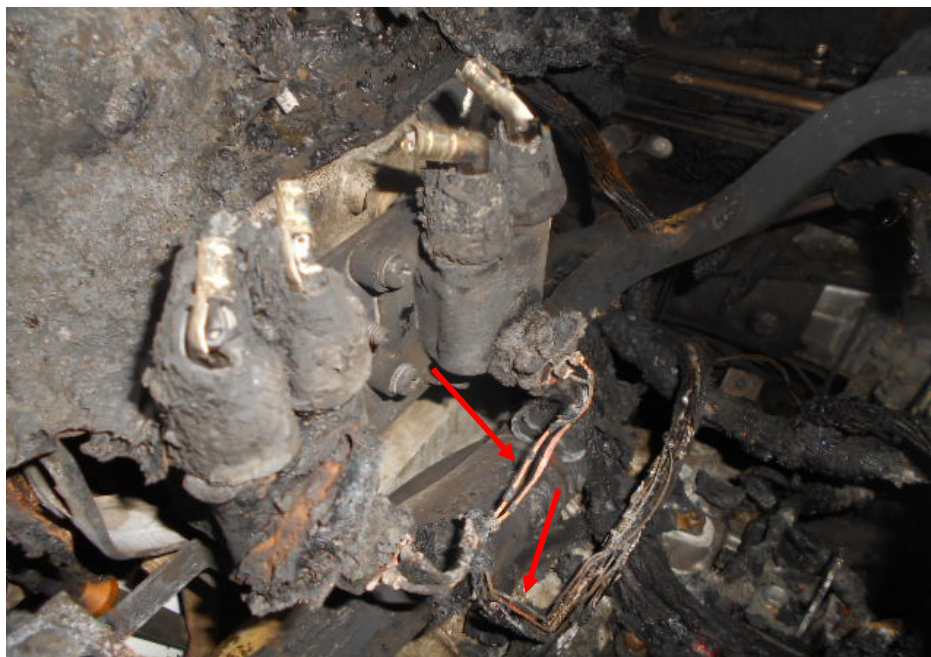
Photo 12 shows another stretch of wiring around the centre left area of the Insured Vehicle's engine compartment. The wirings (arrowed) were found to be completely burned to its bare copper state. Such condition normally indicates internal heating of copper wires, which is a sign of an electrical short circuit occurring. This then indicates that the cause of fire to the Insured Vehicle was of electrical nature.
