RE: My car SGY9819G accident with Meres car ET9933J report and pictures

## 1. Policy Particulars :- THIRD PARTY CLAIM

## ADJUSTMENT ON REPAIR COST FOR VEHICLE NO. ET 9933J

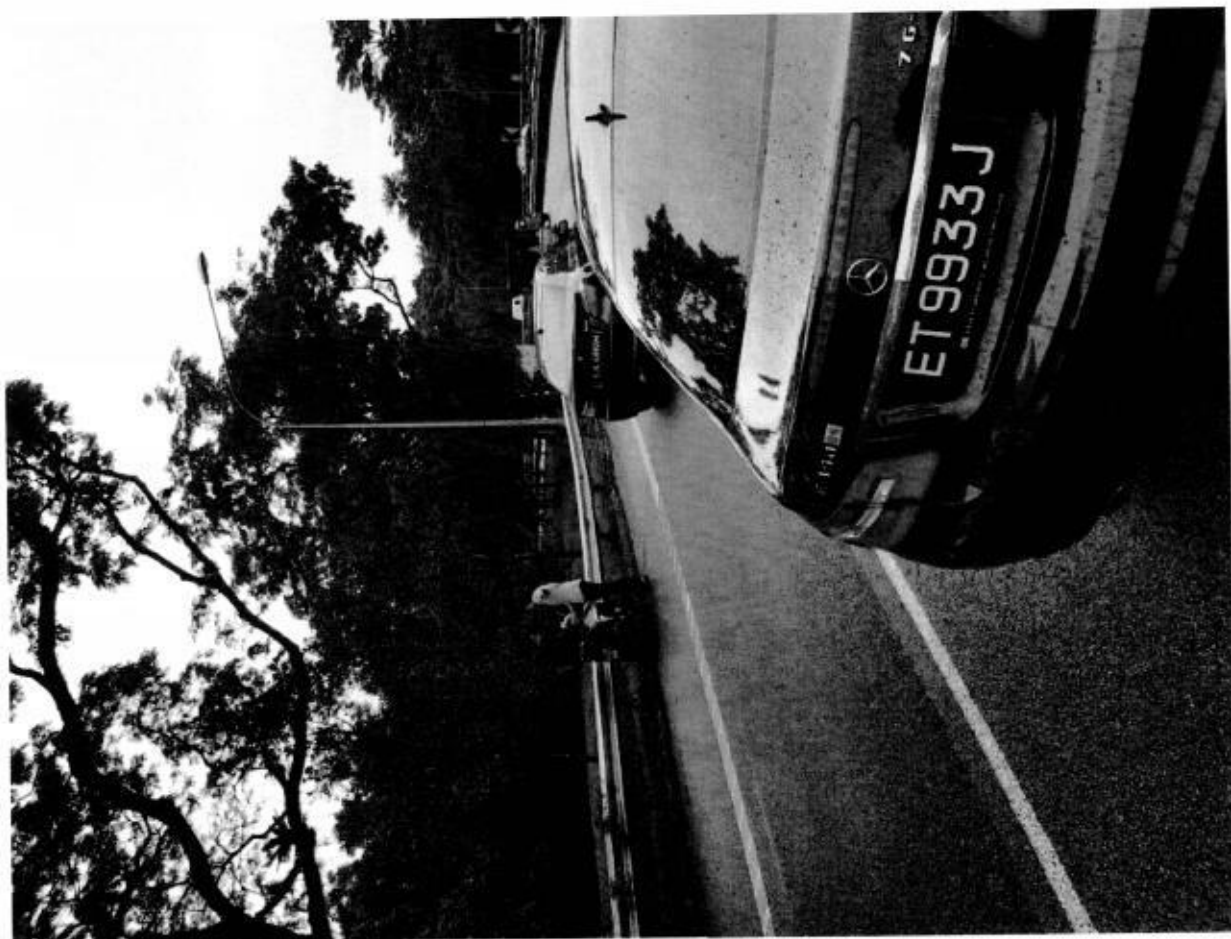
pic 2- biker skid and fell down himself. Meres and my Toyota car e-brake to stopped. All parties no injuries. Merc car passenger alighted to take pictures of my car and scene while Merc car driver and myself helped biker up- no injuries of all parties. **Important Note to insurer surveyor: Merc's car rear slight dented and slight cracked, no damage on seat's rest at all at the accident scene. Meres driver and passenger alighted to take pics of my car and drove off, after that Merc's driver whatsapp me pictures he took from somewhere off the accident of the seat head rest purposely flipped up possibility to exaggerate claims on my insurance. There is possible an inflated claims by this Merc's driver, whom had an insurance company named Accord insurance agency and Accord auto services workshop of his own according to what Meres driver said and gave me his name card.**

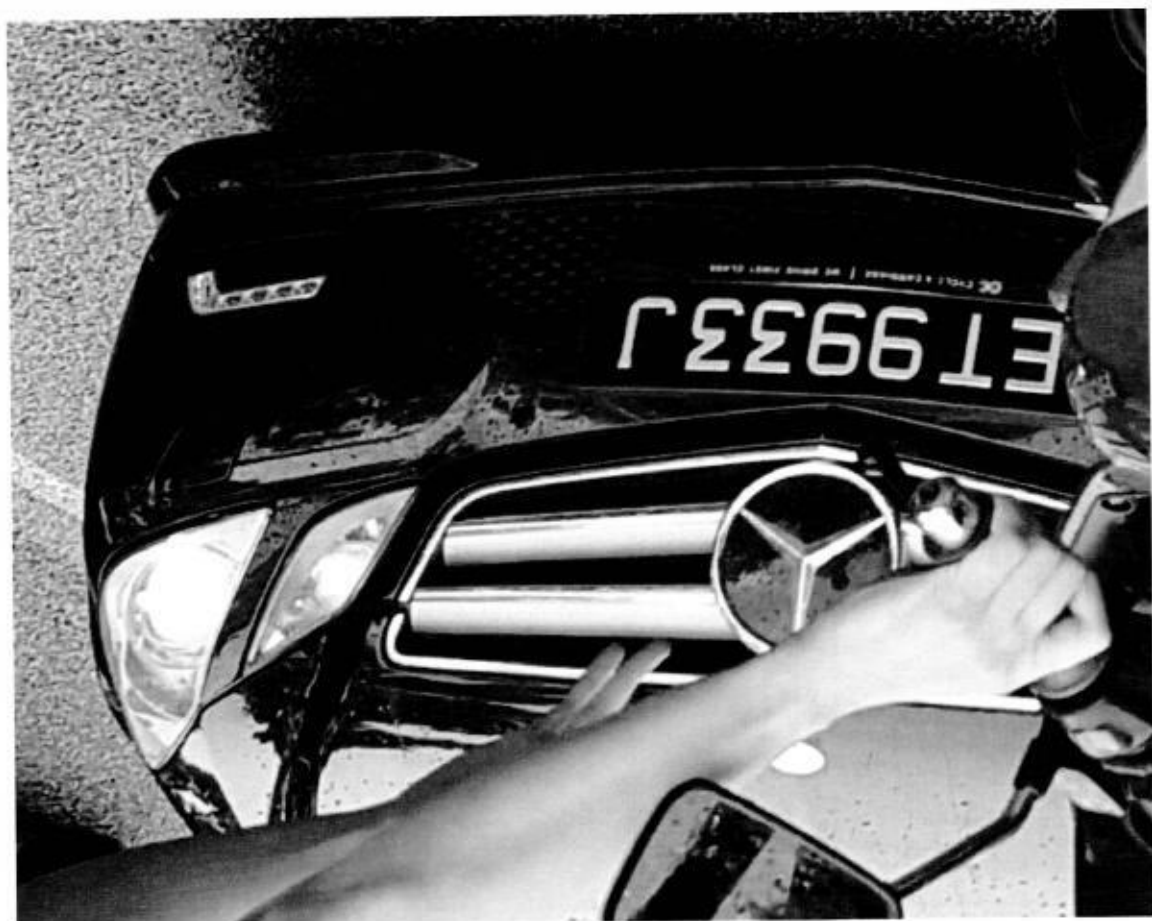
pic3-Exploded view of Meres front view-possible scratches on his own last time or he hit the bike as he cant stop in time.

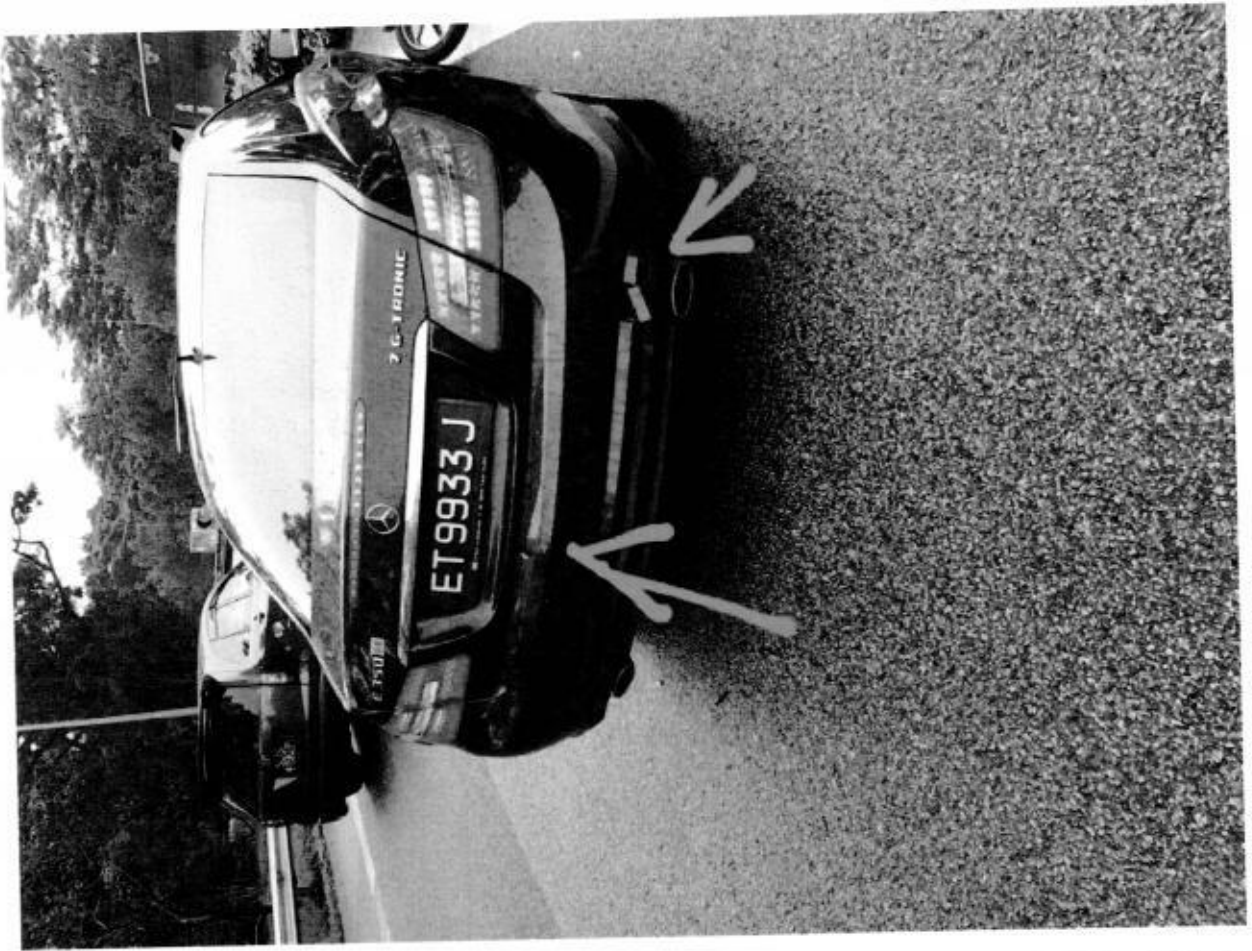
pic5- Meres ET 9933J slight dent and slight cracked at bumper

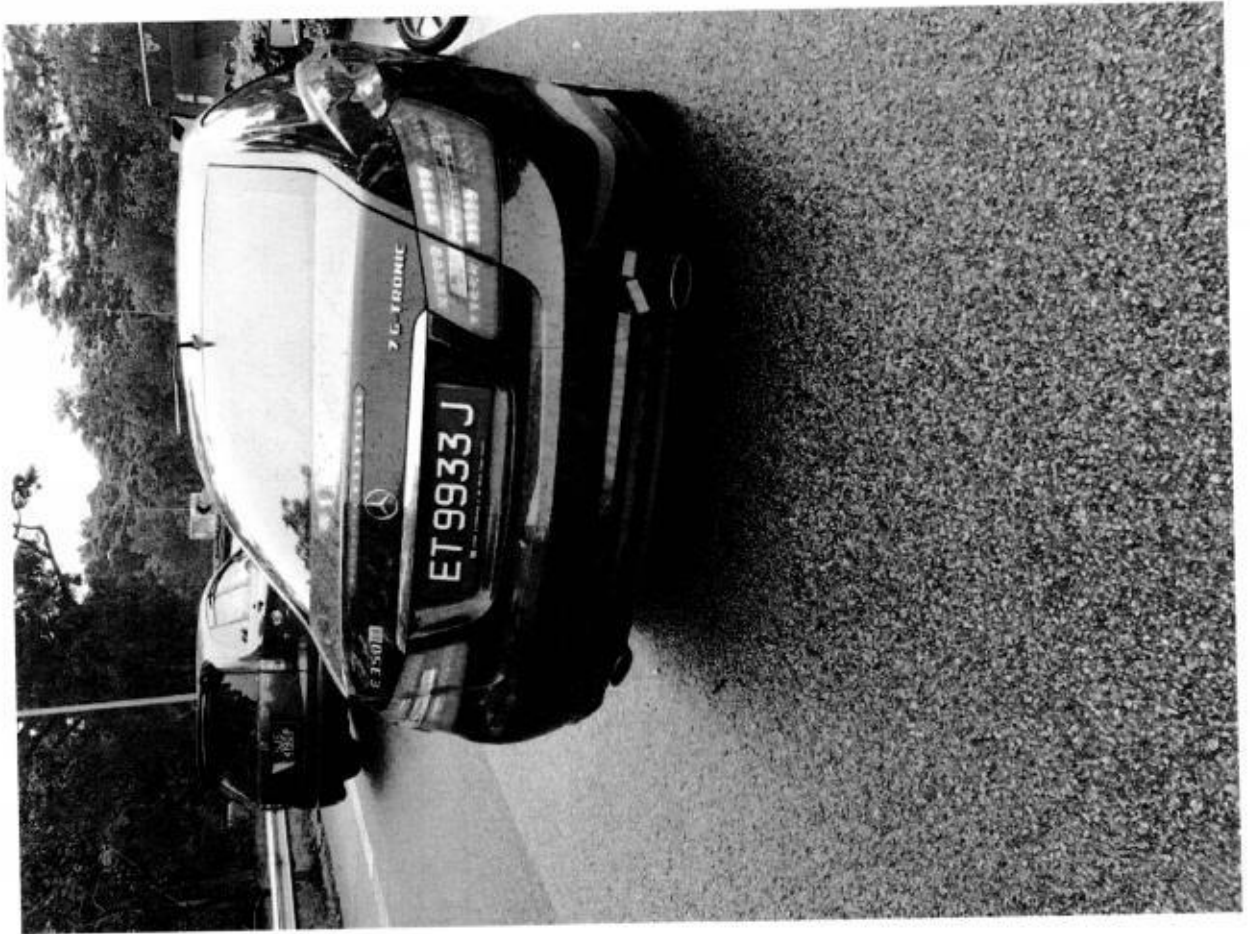
pic 6 -Meres ET 9933J slight dent and slight cracked at bumper as shown in arrows

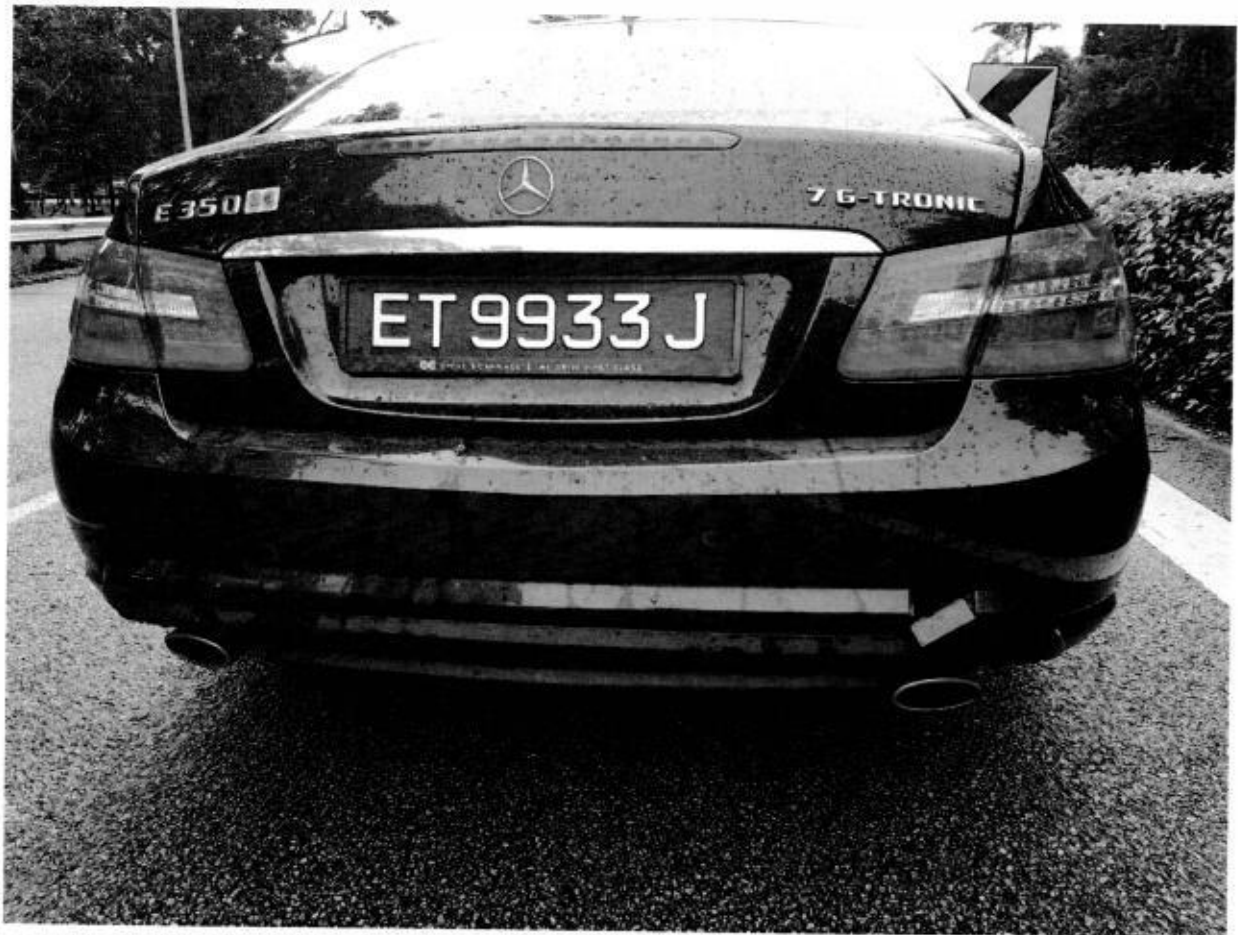
pic7-Meres ET 9933J slight dent and slight cracked at bumper full back view- no dents and cracks on Merc's sides as my car only kissed Merc's rear

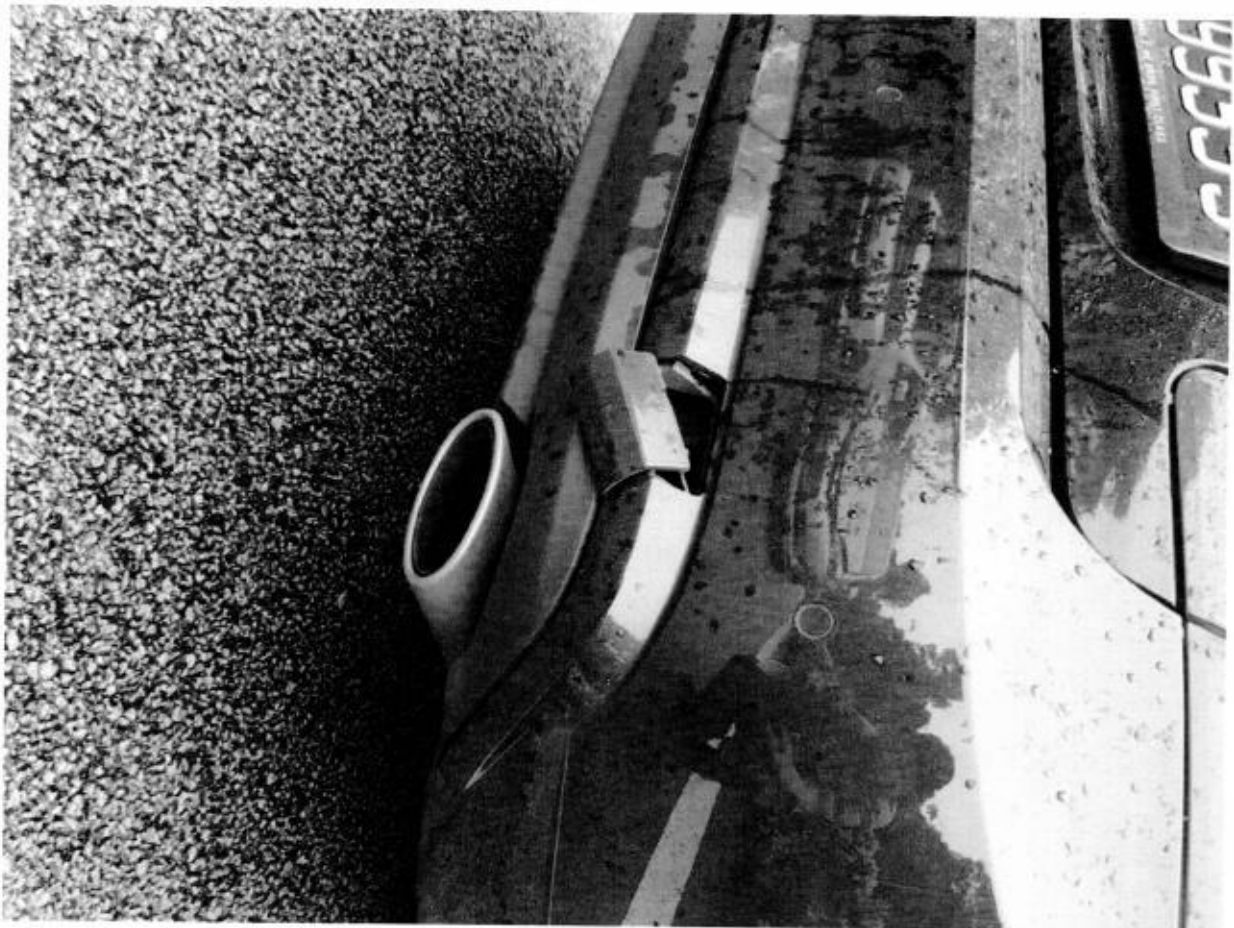
pic 8 - Meres ET 9933J slight cracked at bumper

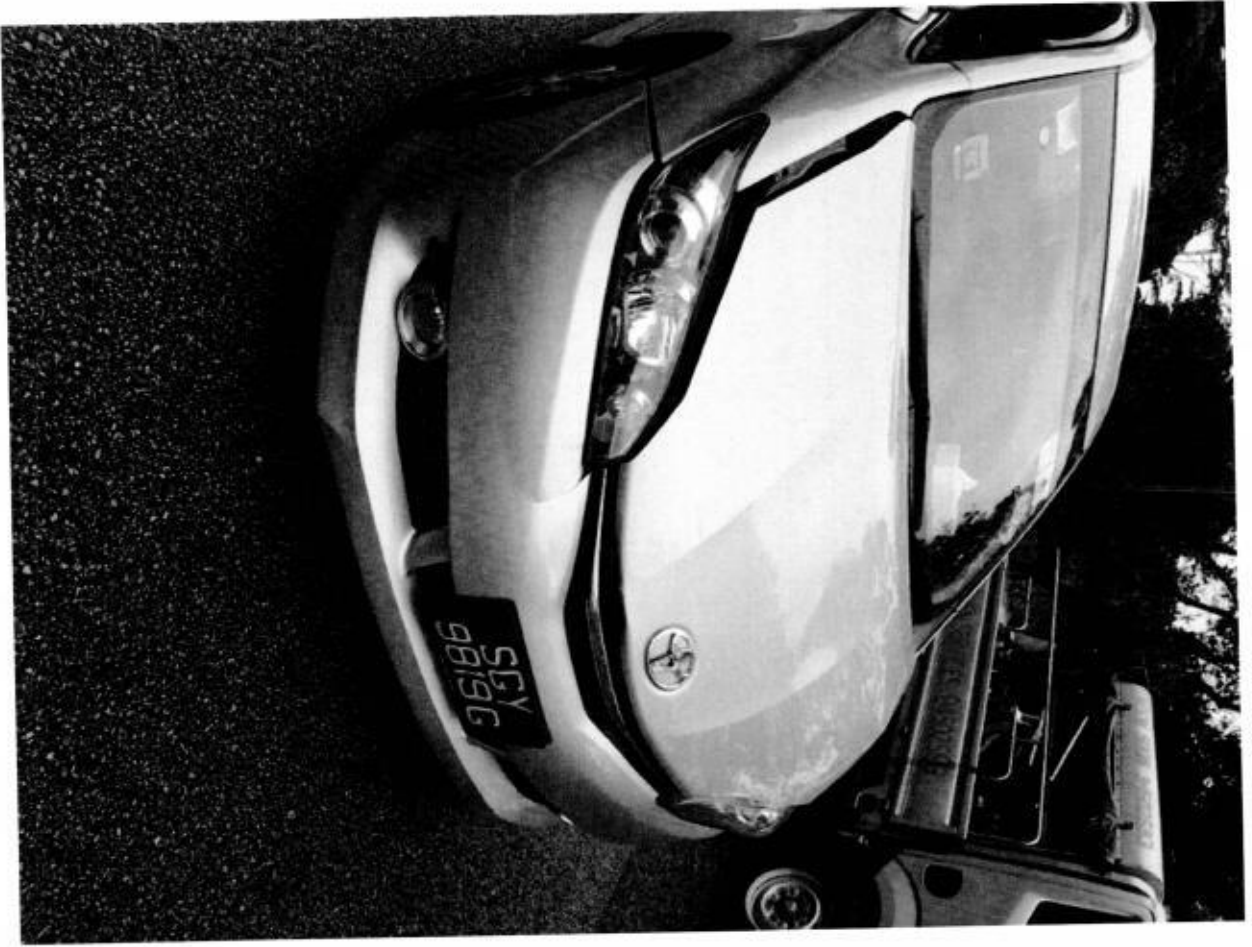
pic 9- my car SGY9819G front bonnet and bumper dented as tyres unable to grip

My car is Toyota wish, Jap car, front bonnet damaged because I hit slightly Meres car ET9933J rear upon both cars emergency brake when biker skid and fell on his own. Meres car got slightly dent and slightly cracked as it is Meres hard metal as shown in the above pictures. No much damage to Meres car rear. No damage on sides.
