LKK Auto Consultants Pte Ltd

Vehicle No. SJL 3144S
Insured Veh. SJP 712B
Claim No. DM18HO01416/JT
Policy No. DMPPHQ18-001203
Accident Date 02/06/2018
Inspection Date 25/06/2018

ADJUSTMENT ON REPAIR COST FOR VEHICLE NO. SJL 3144S

PHOTOGRAPHS FOR VEHICLE NO. SJL 3144S

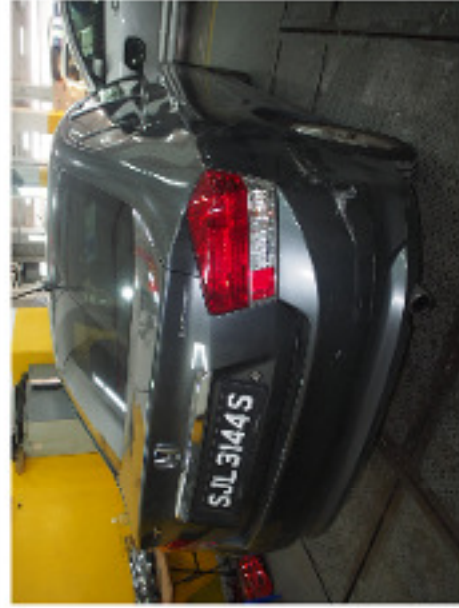
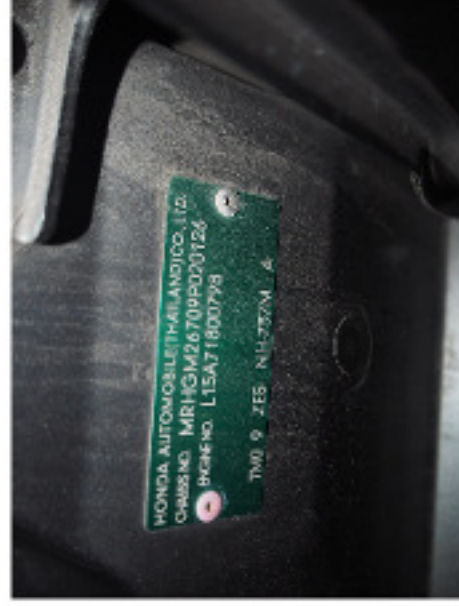
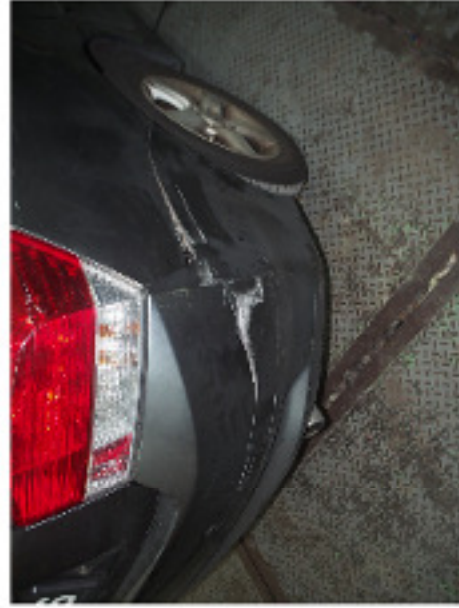
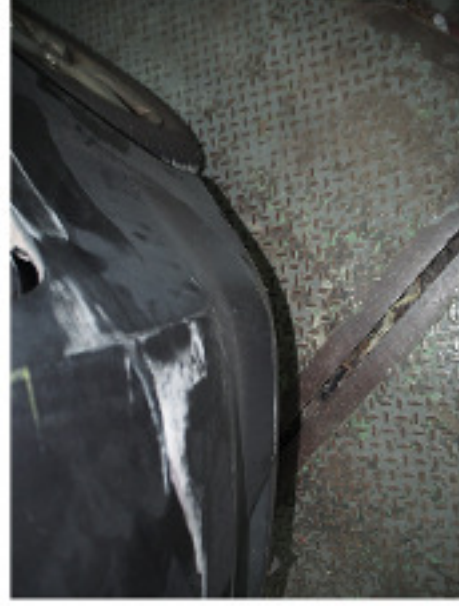
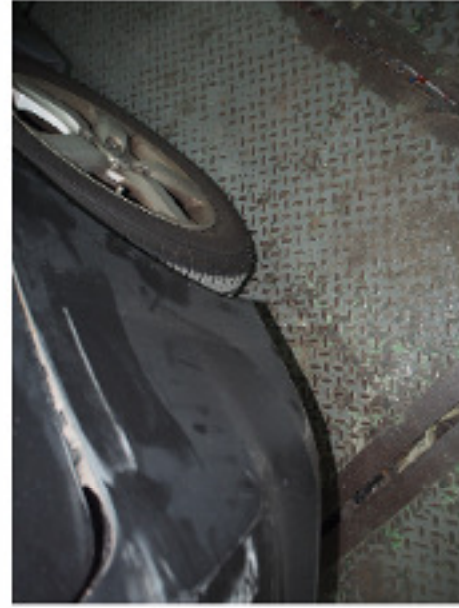
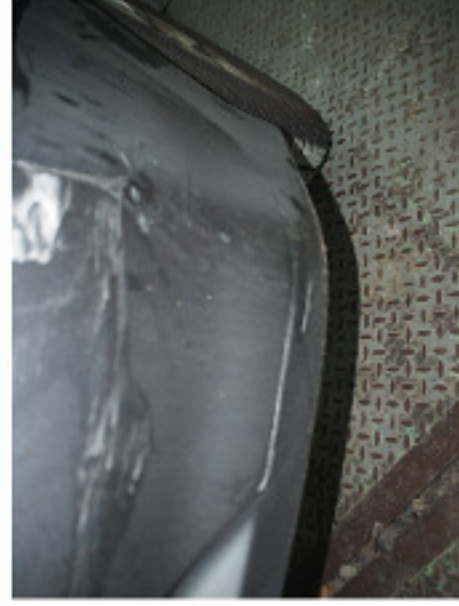
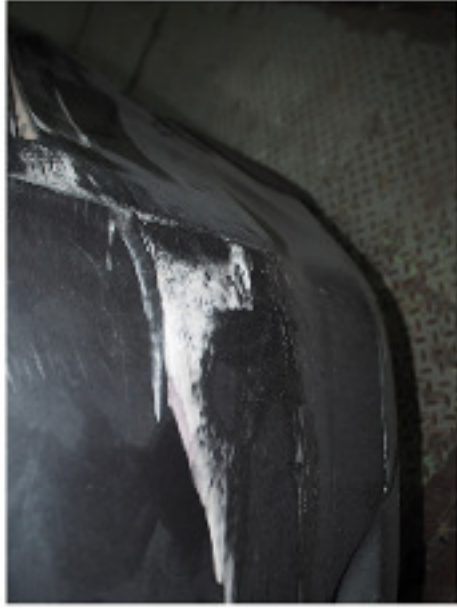
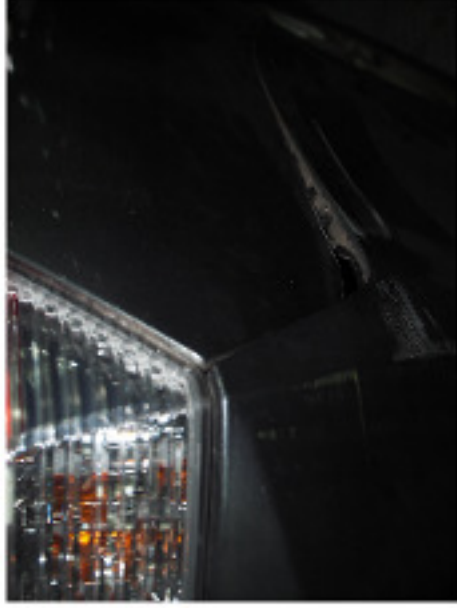
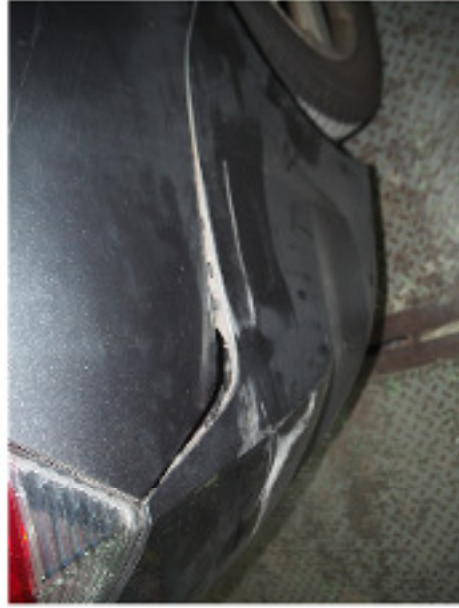
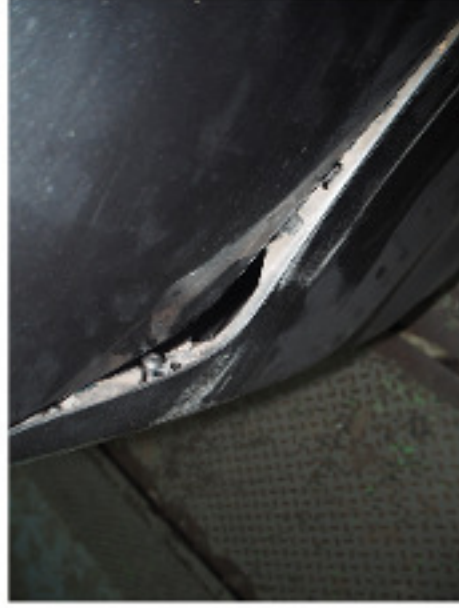
4. Description of Damages				
	THE VEHICLE SUSTAINED DAMAGES AT THE REAR O/S PORTION. DAMAGES SEE DETAILS.			
5. General Information				
	Accident Date	02/06/2018	Inspection Date	25/06/2018
	Survey held at	MG SOLUTION PTE LTD 23 KAKI BUKIT AVE 4 (SOUTH WING) #02-03B VICOM INSPECTION CENTRE, SINGAPORE 415933		
5a. Remarks				
	A)THE INSPECTION WAS CONDUCTED ON A"WITHOUT PREJUDICE" BASIS. B)IN ACCORDANCE TO YOUR INSTRUCTIONS, WE HAVE NOT AUTHORISED REPAIRS.			
5b. Estimate Days of Repair				
	ESTIMATED NORMAL PERIOD FOR REPAIR:		3 Working Days

Qty	Description of Parts	Condition	Estimate By Workshop (\$))	Our Adjusted (\$)
	<u>REPLACEMENT OF PARTS</u>			
1	REAR BUMPER	DEFORMED	611.20	463.70
1	REAR BUMPER SIDE RETAINER RH	NECESSARY	62.40	32.00
1	TAILLAMP	NOT NECESSARY	422.30	-
1	TAILLAMP LOWER BRACKET	NOT NECESSARY	62.00	-
1	REAR FENDER RH	TO REPAIR SEE LABOUR	912.20	-
1	REAR FENDER COWLING	NOT NECESSARY	369.20	-
1	REAR FENDER AIR VENT RH	NOT NECESSARY	90.20	-
	LESS 20% DISCOUNT		-505.90	-99.14
			2,023.60	396.56
	<u>SPECIAL NETT ITEMS</u>			
1	SET REAR BUMPER CLIP (SN)	NECESSARY	25.00	25.00
1	SET TAIL LAMP CLIP (SN)	NOT NECESSARY	25.00	-
1	SET REAR FENDER COWLING CLIP (SN)	NOT NECESSARY	25.00	-
1	REVERSE SENSOR (SN)	NOT NECESSARY	220.00	-

295.00	25.00
	<u>LABOUR</u>			
	PANEL BEATING ,REMOVING AND REPLACING PARTS.INCLUSIVE OF THE REPAIR OF REAR FENDER RH .		1,400.00	200.00
	SPRAY PAINTING TO AFFECTED AREA.		1,200.00	400.00
	TUFF COAT.	NOT NECESSARY	250.00	-
	WIRING CHECK .		180.00	30.00
	TO REMOVE AND REFIX REVERSE SENSOR .		150.00	50.00
	DISTANCE SETTING FOR REVERSE SENSOR .	NOT NECESSARY	80.00	-
