From: Shirley Hiew (LKK Auto) <ShirleyHiew@lkkauto.com>
Sent: Thursday, 16 August 2018 5:42 PM
To: 'Irene Tan'
Cc: kklau@lkkauto.com; 'Bryan Ang (LKKAuto)'; 'Olivia Lau (LKKAuto)'; 'Shiau Chan (LKKAuto)'; 'assignments'; 'Admin-D (LKKAuto)'; 'SUR'; 'Jason Sim'
Subject: RE: Mr Muhd Nazril Bin Abdullah's final survey report on SJU2535G; Our claim no.: 558290/IT

Subject: Mr Muhd Nazril Bin Abdullah's final survey report on SJU2535G; Our claim no.: 558290/IT

We refer to your final survey report on the subject vehicle dated 31.7.18.

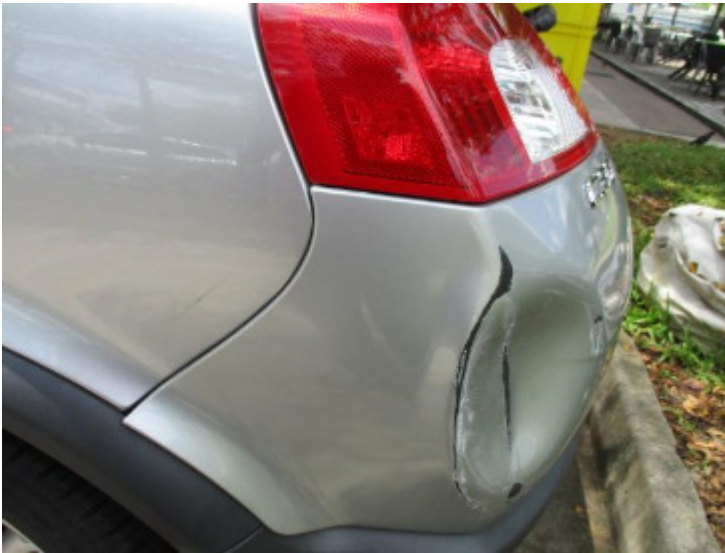
- a) there is no damage to the tail light and tail lamp above the rear bumper. See picture under point 1 below. If there is, please circle the damage for us to convince our insured; and
- b) There is no damage on the rear panel behind the rear bumper that could have caused the rear bumper push-up causing "the deformation to the tail lamp(no damage as seen in your surveyor's pictures) and causing induced damage" (where is the induced damage that caused the deformation to the tail lamp?). See picture under point 2 below.

- 1) Picture showing the deeply dented rear bumper but no damage on the tail light

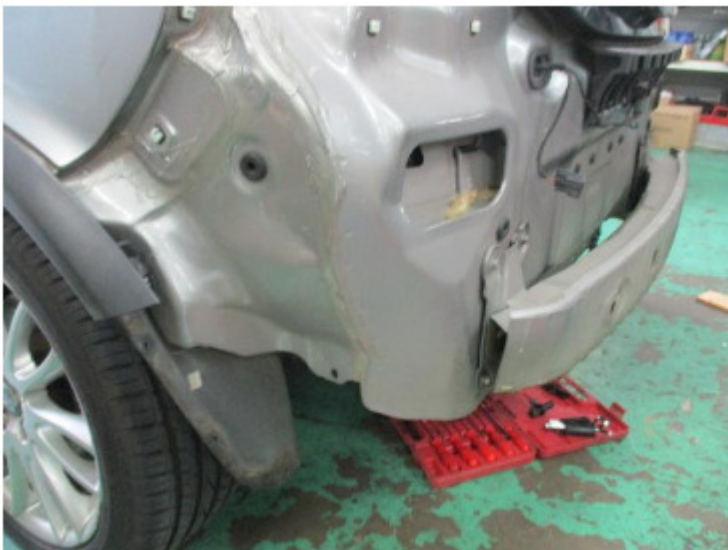
2) Picture showing no damage to its rear panel behind the dented rear bumper

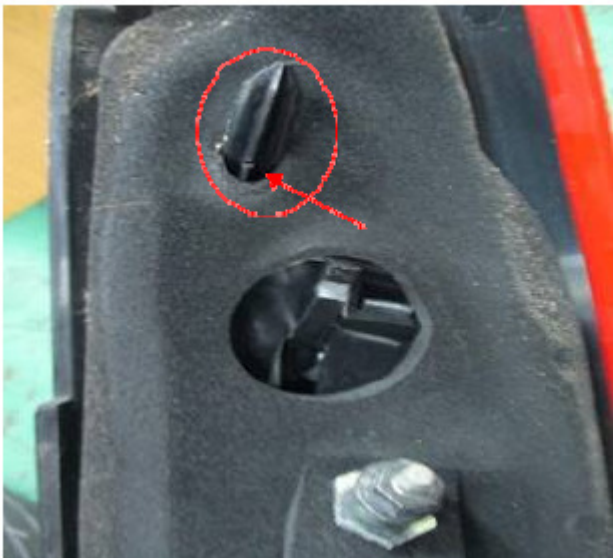
1) Picture from Veron's email dated 10.8.18

She informed that the plastic mounting at the back of the rear left tailamp was observed to be cut/bent as shown on the picture under point 1. Please look at her picture with the red arrow pointing at a red circle.

Upon your receipt, please arrange to have Part no.8 removed from your survey report immediately, re-adjust the total repair costs and upload your amended survey report in the Merimen.

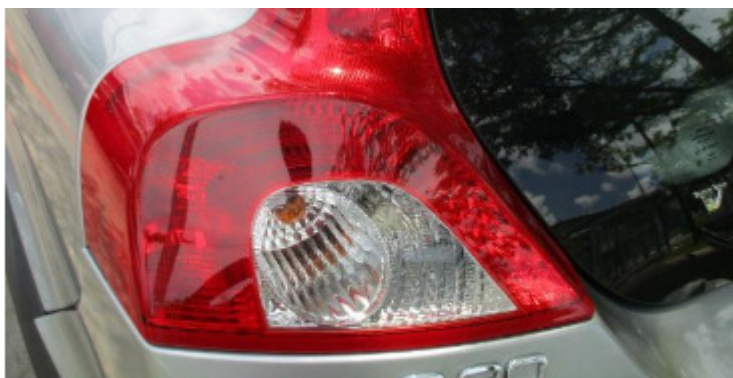
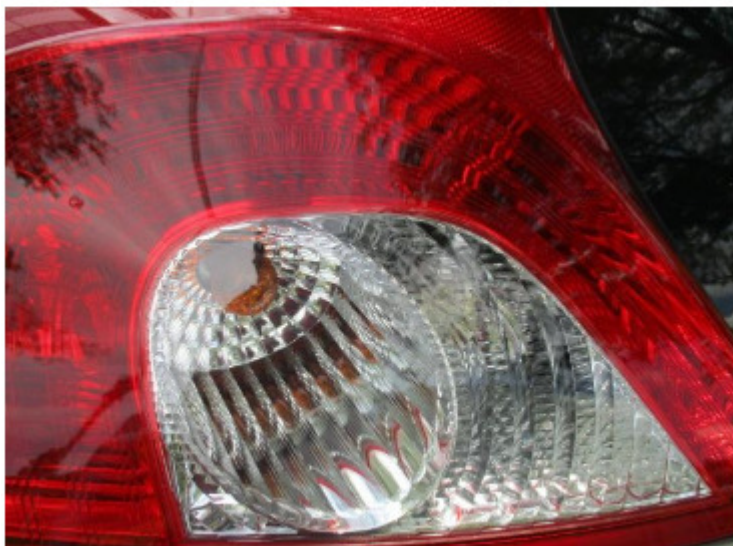
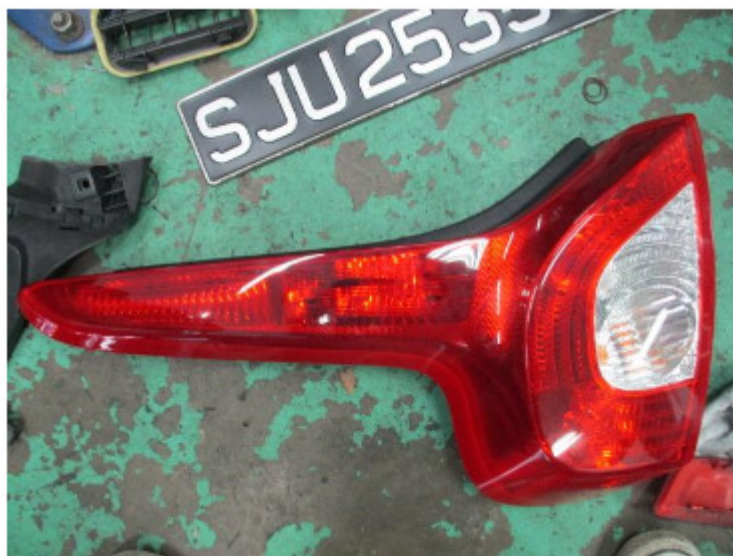
As your surveyor's 3 survey pictures showing no damage on the tail lamp are re-produced under point 2 for your easy reference, please circle on any of the 3 pictures to show which part of the tail lamp that its corresponding back of the rear left tailamp was observed to be cut/bent as advised by your surveyor?

We are of the view that the your surveyor's recommendation to replace Part no. 8 Rear Left Tail lamp @\$490 is not consistent because if the rear left tail lamp is not damaged, how can the back of the same undamaged rear left tail lamp be damaged?

2) Pictures on tail lamp with no damage seen

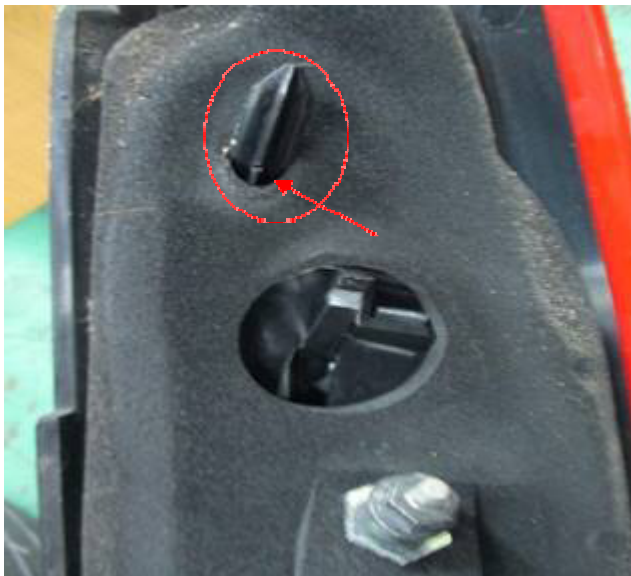
According to surveyor, the plastic mounting at the back of the rear left taillamp was observed to be cut/bent, consistent to the same impact force at the rear left of TP vehicle.

See photo below and merimen photo no 31.

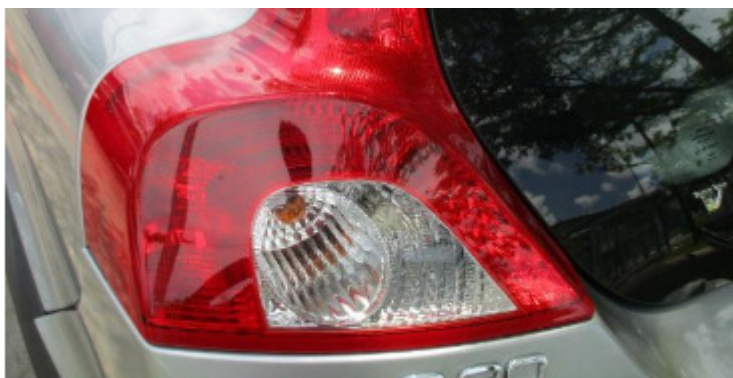
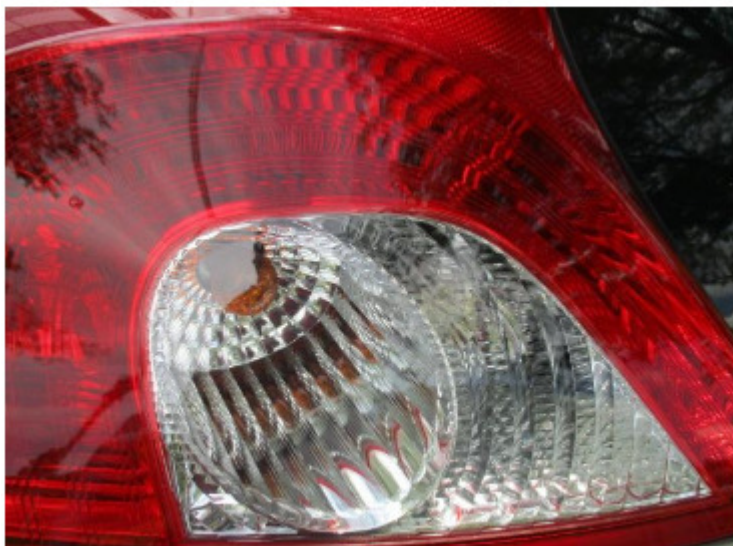
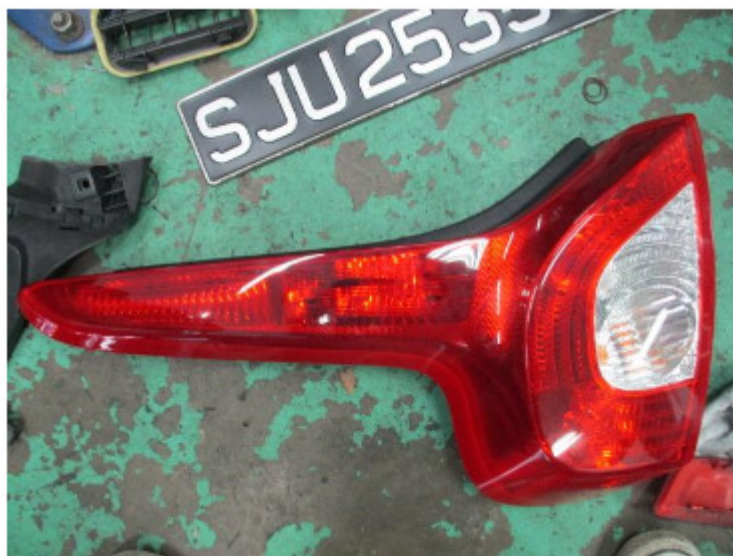
We are unable to see any cut/bent damage on the tail lamp on your surveyor's colour pictures under point no. 2. Please circle the area that is cut/bent or damaged and email back to us **asap or within the next 2 days by 12noon, Friday, 10.8.18** because we need to revert to our insured who wants to see the damage before giving us approval to offer to the 3rd party's lawyer.

2) Pictures on tail lamp with no damage seen
