Your Ref: TP/IP/15479/2018  
Our Ref : CI/TPD18011871/Z

**Fatal Accident Investigation Team**  
Traffic Police Department  
Singapore Police Force  
10 Ubi Avenue 3  
Singapore 408865

### **MECHANICAL INSPECTION REPORT OF MOTOR CAR SGH 1678M**

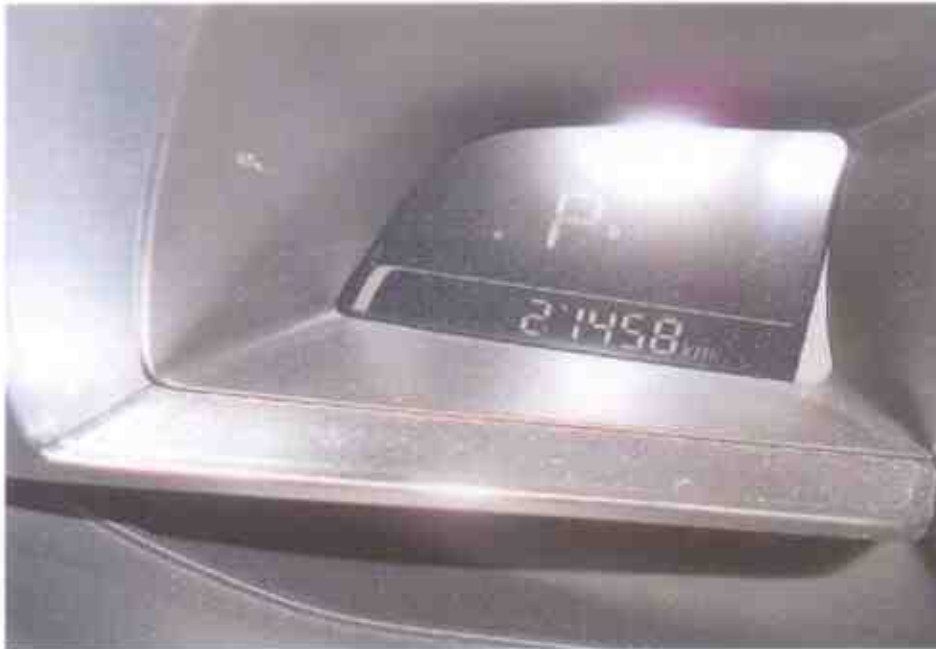
**Photo 1** shows the mileage of the Motor Car was 21458 km.

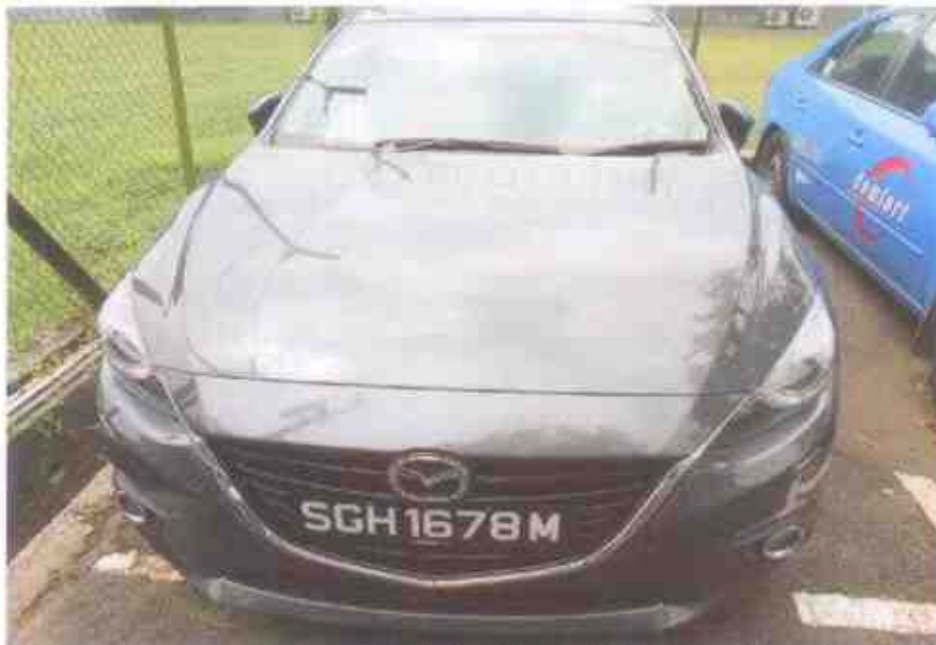
**Photo 2** shows a general view of the front body of the Motor Car at the time of our inspection. The Motor Car was observed to be in good general condition except for minor damages at the right side portion.

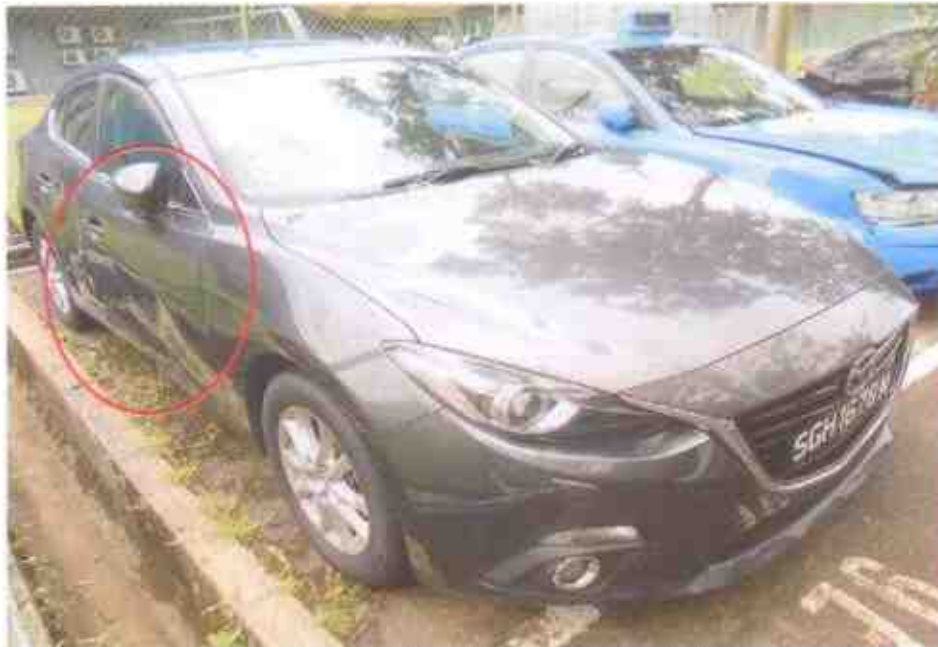
**Photo 3** shows a general view of the right front body of the Motor Car at the time of our inspection. The Motor Car was observed to be in good general condition except for minor damages at the right side portion.

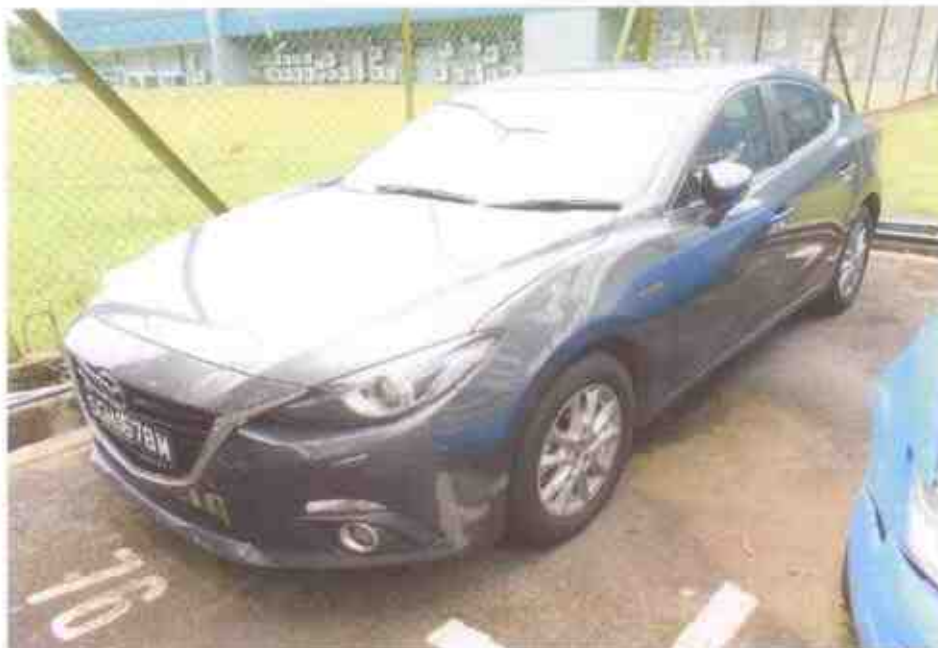
**Photo 4** shows a general view of the front left body of the Motor Car at the time of our inspection. The Motor Car was observed to be in good condition unaffected by the accident.

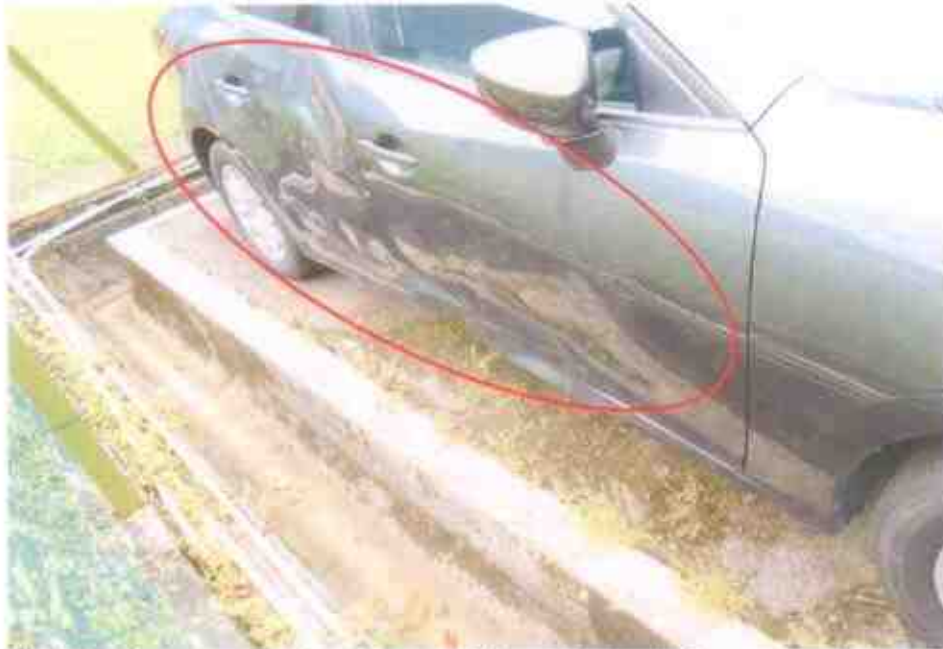
4. The mileage of the Motor Car at the time of our inspection was 21458 km.
5. The Motor Car had sustained a relatively minor impact damages that was confined to its right portion. Their right side portions which consist of driver's & passenger's doors were observed to have been corrugated amongst others.
6. This was likely due to the consistency of the accident's case facts that a Motorcycle that was travelling along Nicoll Drive towards the direction of Changi Coast Road was unable to brake in time had collided onto the Motor Car (SGH 1678M) which was driving out of carpark no. 5, making a right turn into Nicoll Drive towards Loyang Avenue. See photo 1 to 6 below.

**Photo 5** shows a semi-close up view of the right driver's & passenger's door of the Motor Car at the time of our inspection. It had sustained damages due to the accident.

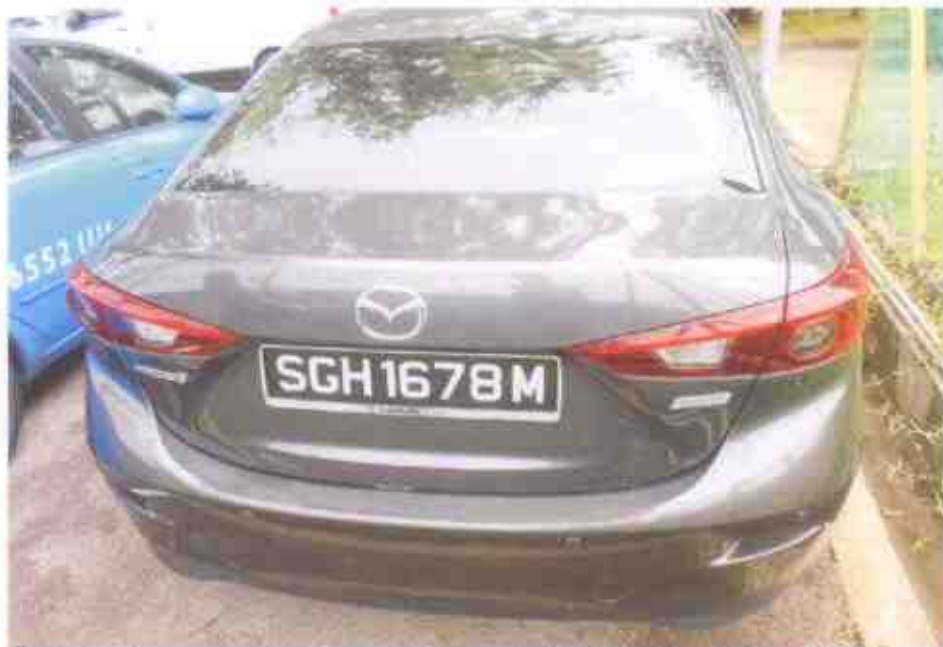
**Photo 6** shows a general view of the rear body of the Motor Car at the time of our inspection. The Motor Car was observed to be in good general condition.

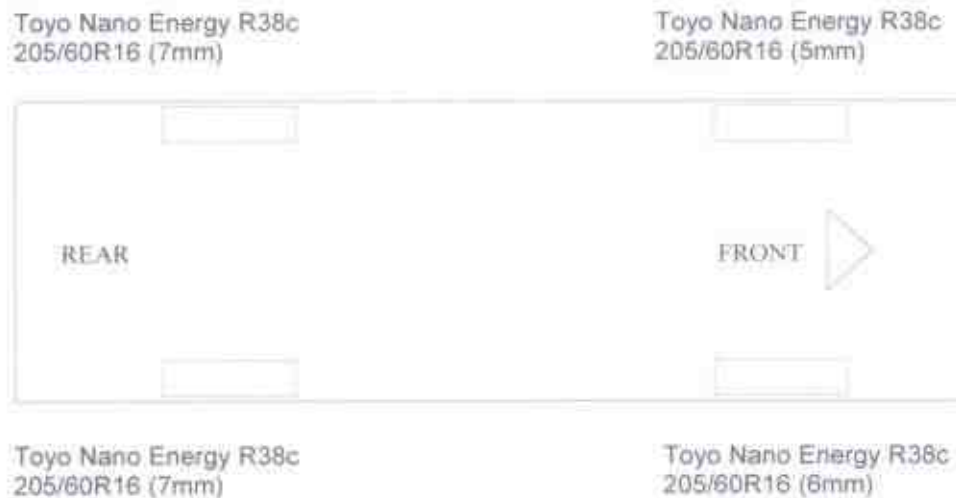
7. The condition of the Motor Car's 4 tyres was observed to be in serviceable condition. We did not find any tear, cut or burst mark(s) on the outer and the inner sidewalls as well as across the tread of the 4 tyres. The 4 tyres were also observed to be sufficiently inflated for vehicular operation. The tyre brand, tyre size and remaining tread depth of the 4 tyres were recorded as follows:-

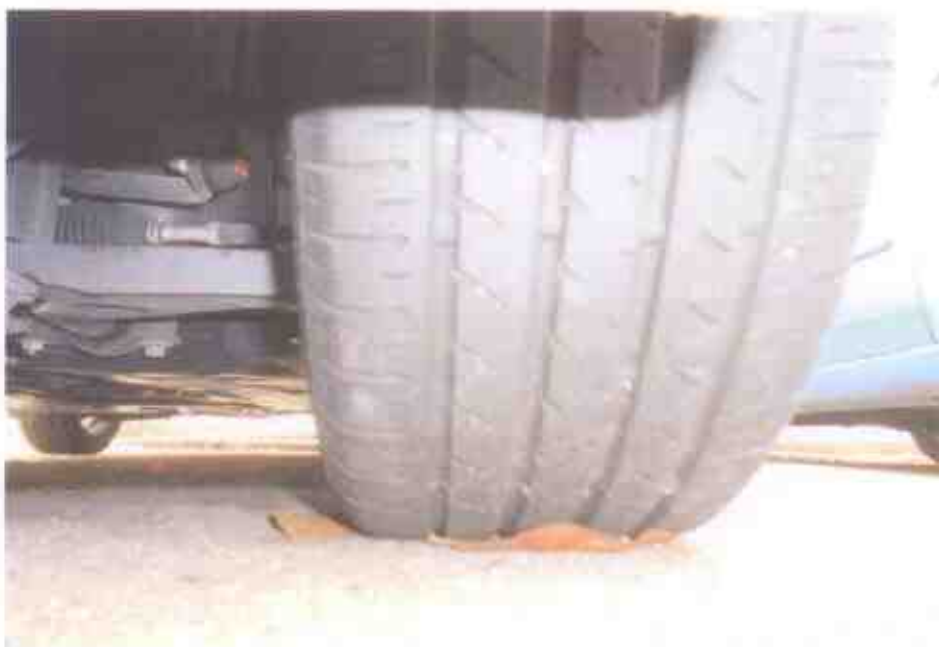
**Photo 7** shows the condition of the front left tyre of the Motor Car, which was observed to be in serviceable condition with remaining tread depth of approximately 5mm. The tyre was also observed to be sufficiently inflated for vehicular operation.

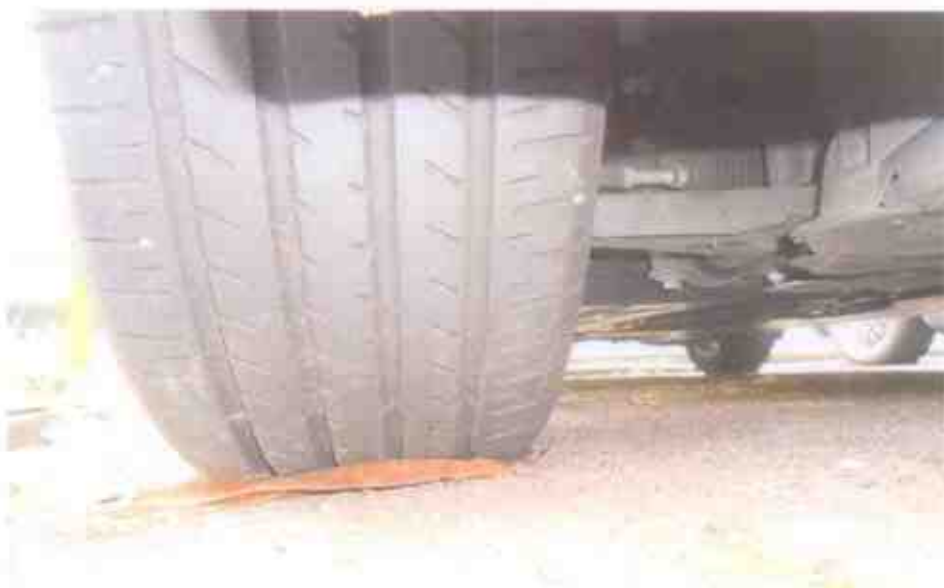
**Photo 8** shows the condition of the front right tyre of the Motor Car, which was observed to be in serviceable condition with remaining tread depth of approximately 6mm. The tyre was also observed to be sufficiently inflated for vehicular operation.

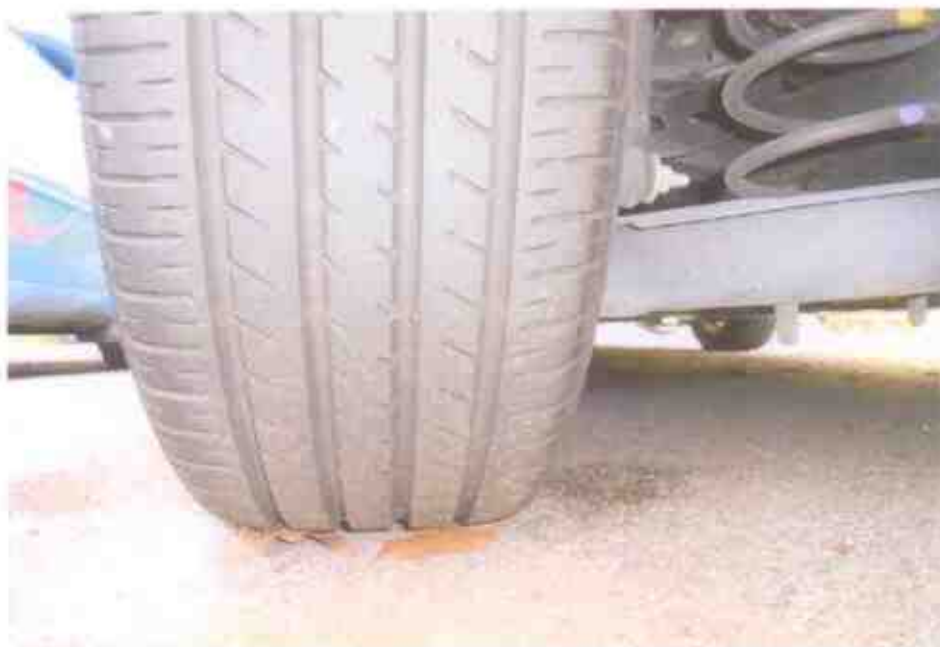
**Photo 9** shows the condition of the rear left tyre of the Motor Car, which was observed to be in serviceable condition with remaining tread depth of approximately 7mm. The tyre was also observed to be sufficiently inflated for vehicular operation.

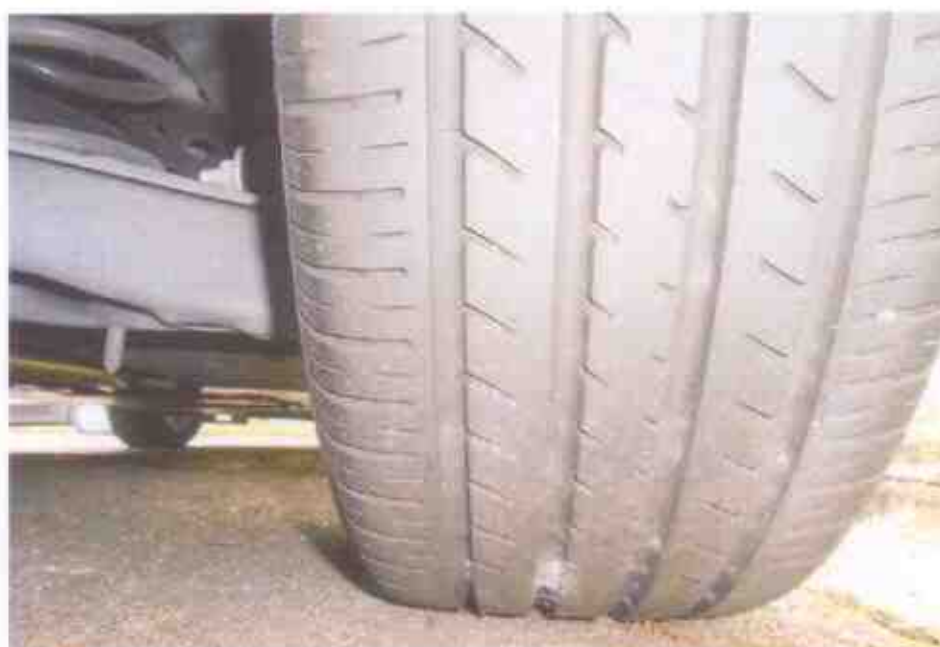
**Photo 10** shows the condition of the rear right tyre of the Motor Car, which was observed to be in serviceable condition with remaining tread depth of approximately 7mm.

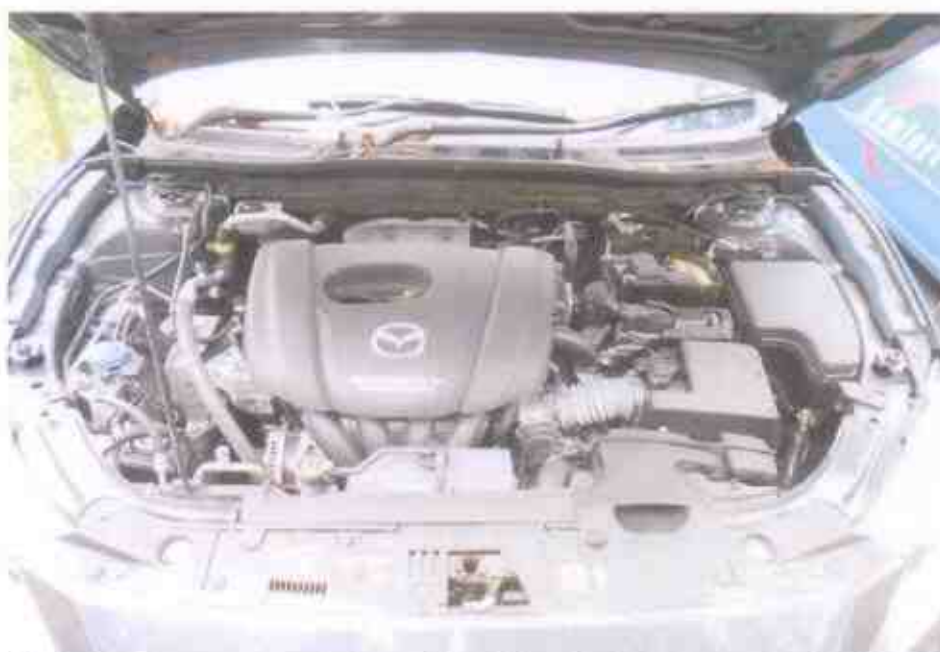
**Photo 11** shows a general view of the Motor Car's engine compartment. The various parts and components inside the engine compartment were unaffected by the accident. There was also no sign(s) or indication(s) of fluid leakage and/or fluid stain within the engine compartment.

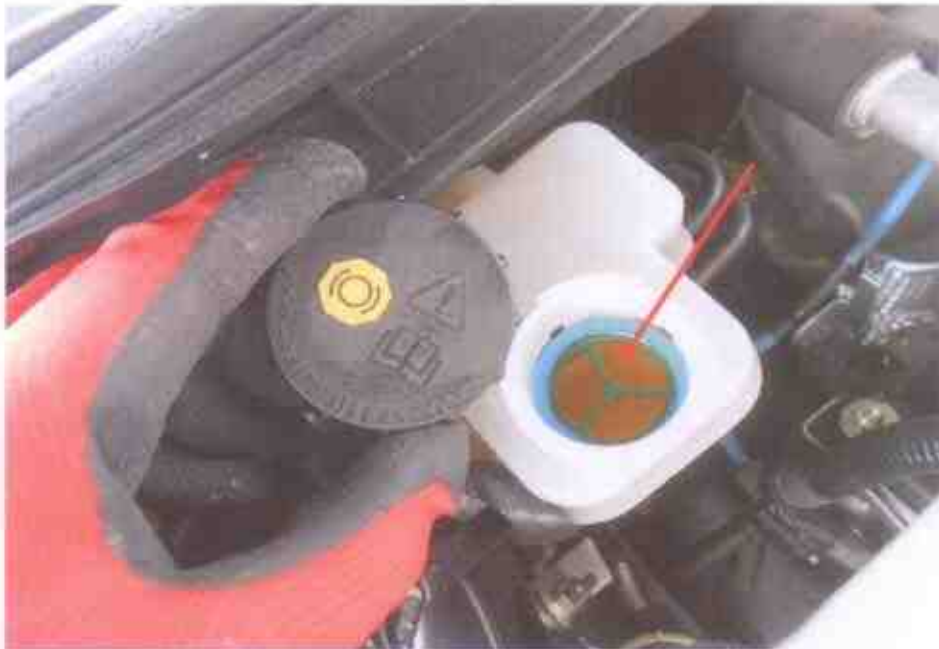
**Photo 12** shows the brake fluid reservoir of the Motor Car at the time of our inspection. The brake fluid was observed to be of sufficient level (arrowed) and without any visible contamination.

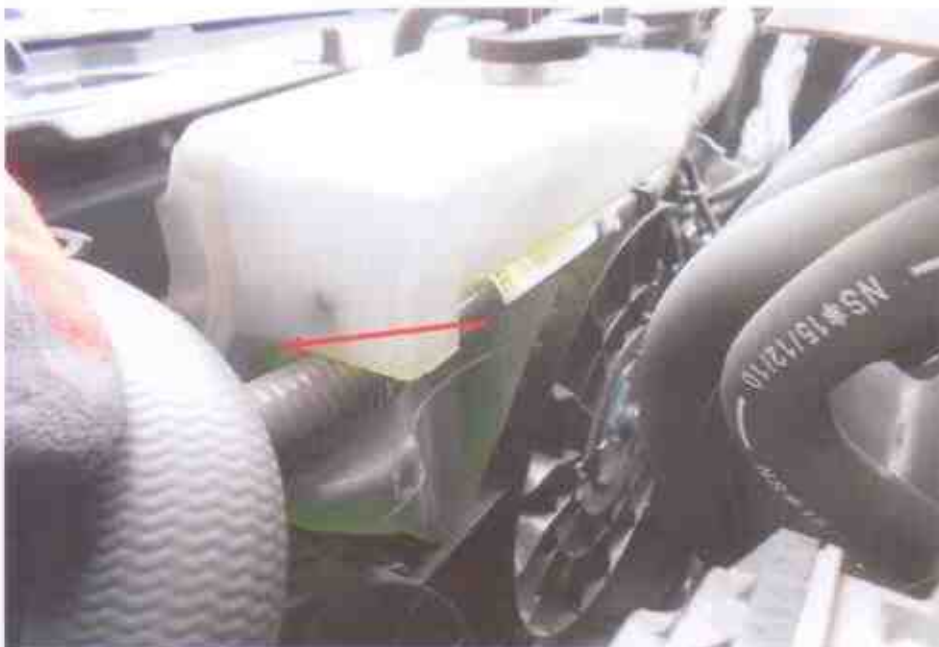
**Photo 13** shows the coolant fluid reservoir of the Motor Car at the time of our inspection. The coolant fluid was observed to be of sufficient level and without any visible contamination.

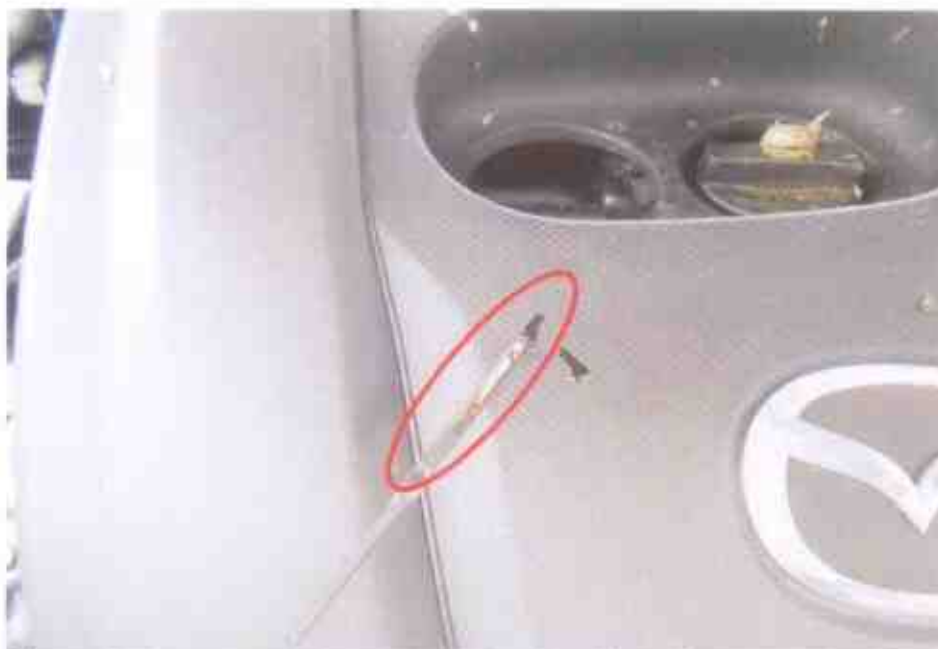
**Photo 14** shows the engine oil dip stick of the Motor Car at the time of our inspection. The engine oil was observed to be of sufficient level and without any visible contamination.

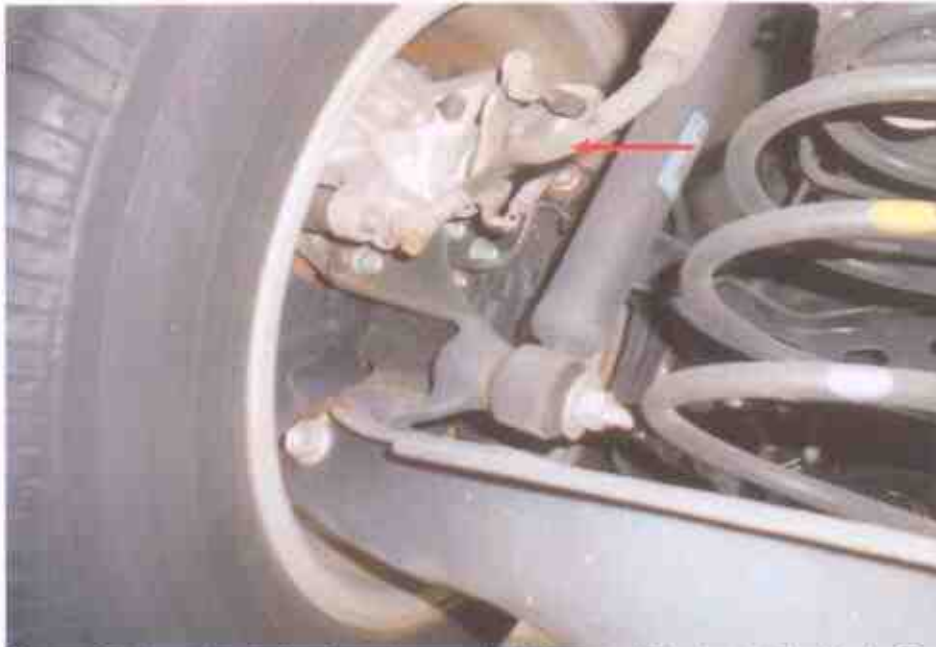
**Photo 15** shows the brake hose (arrowed) at the rear left wheel of the Motor Car. Our visual inspection of the various mechanical components of the Motor Car's braking system revealed all to be intact and without visible damage, indicating that the braking system was likely to be in serviceable condition at the material time of accident.

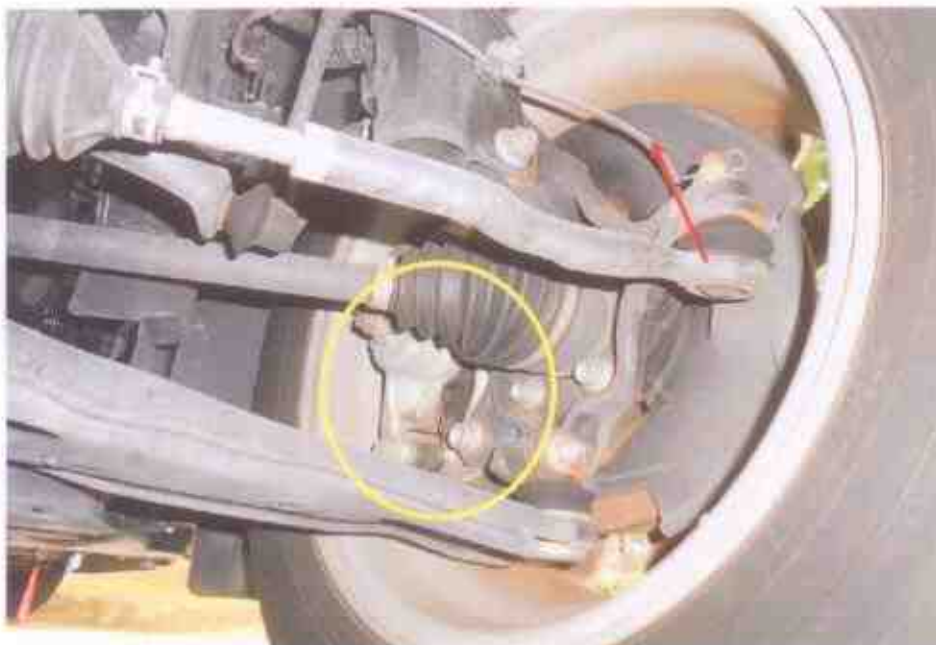
**Photo 16** shows the brake hose (arrowed) at the front right wheel of the Motor Car. Our visual inspection of the various mechanical components of the Motor Car's braking system, including its brake calliper (circled), revealed all to be intact and without visible damage, indicating that the braking system was likely to be in serviceable condition at the material time of accident.

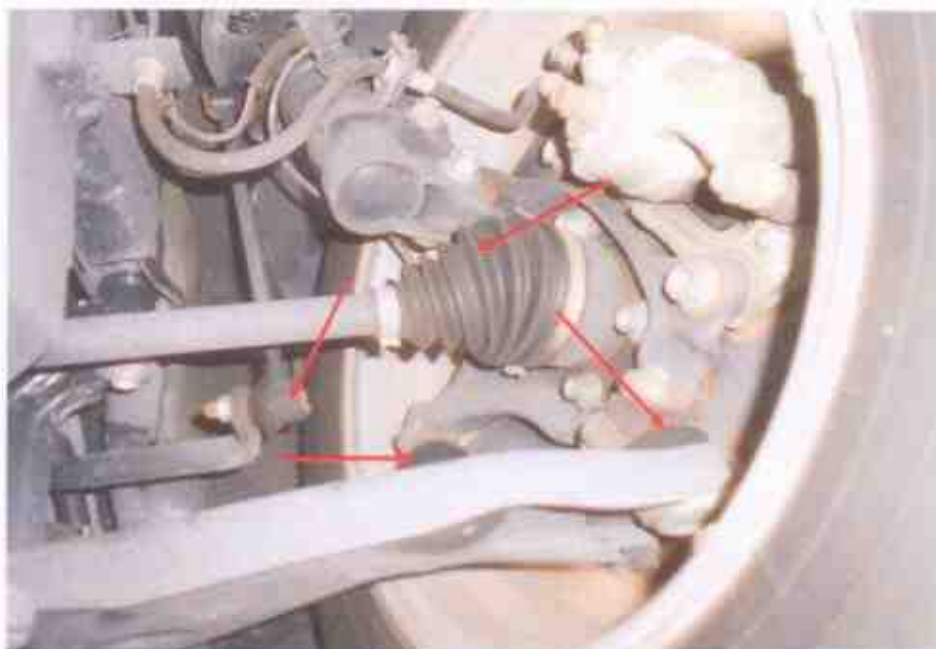
**Photo 17** shows the various undercarriage components at the front left wheel of the Motor Car, in particular the steering tie rod (arrowed). The various steering components were all found to be intact, suggesting that the steering system of the Motor Car was likely to be in serviceable condition.

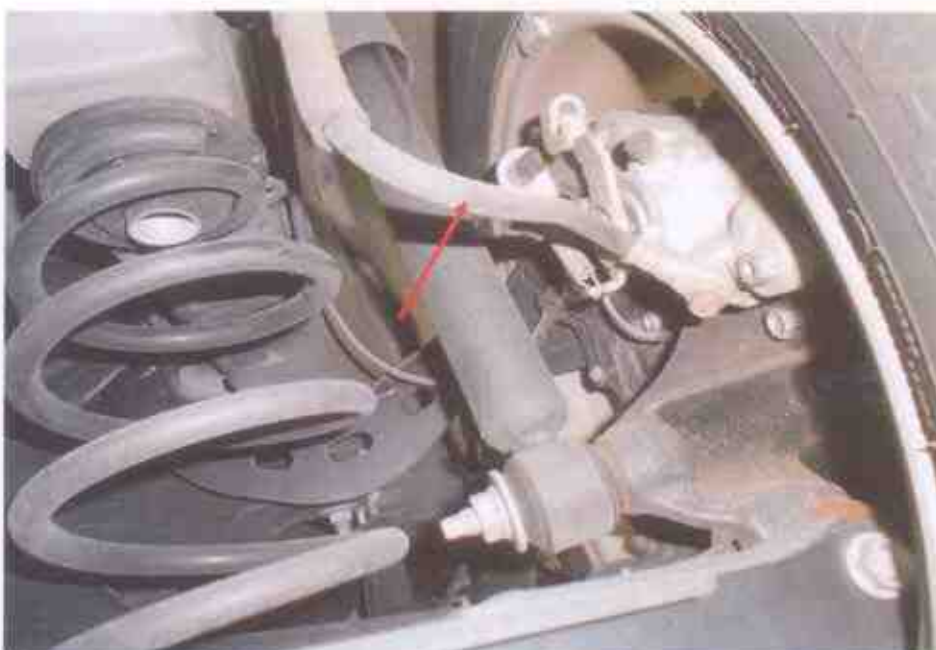
**Photo 18** shows the various undercarriage components at the rear right wheel of the Motor Car. We did not observe any leakage of brake fluid at the time of our inspection of the Motor Car. Our visual inspection of the various mechanical components of the Motor Car's braking system revealed all to be intact and without visible damage, indicating that the braking system was likely to be in serviceable condition at the material time of accident.

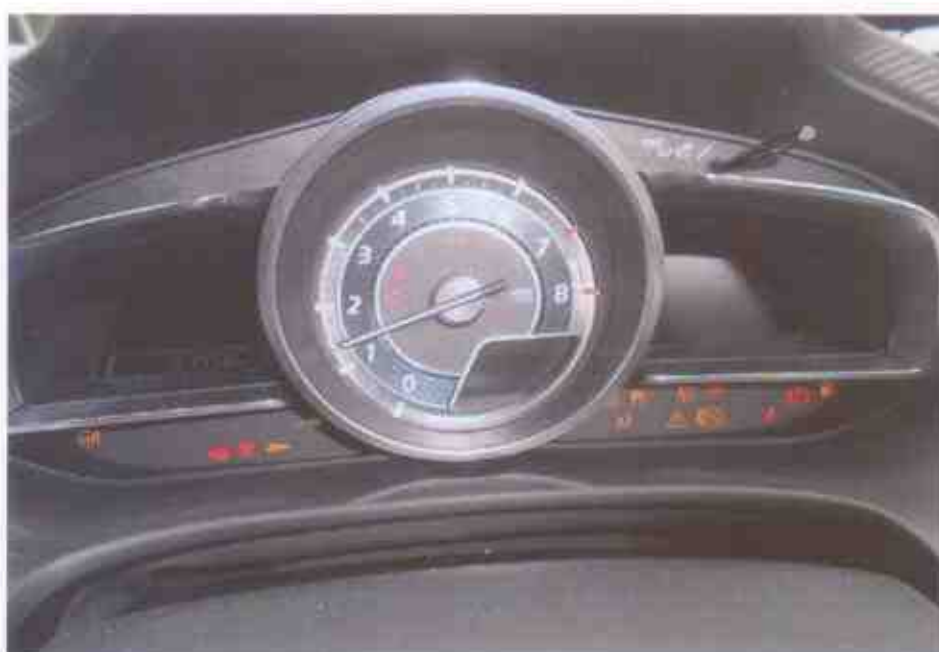
Photo 19 shows the warning lights for the various electronic operating systems of the Motor Car appearing on its instrument panel during the self-test when the engine is cranked, in particular the ABS light and SRS light.

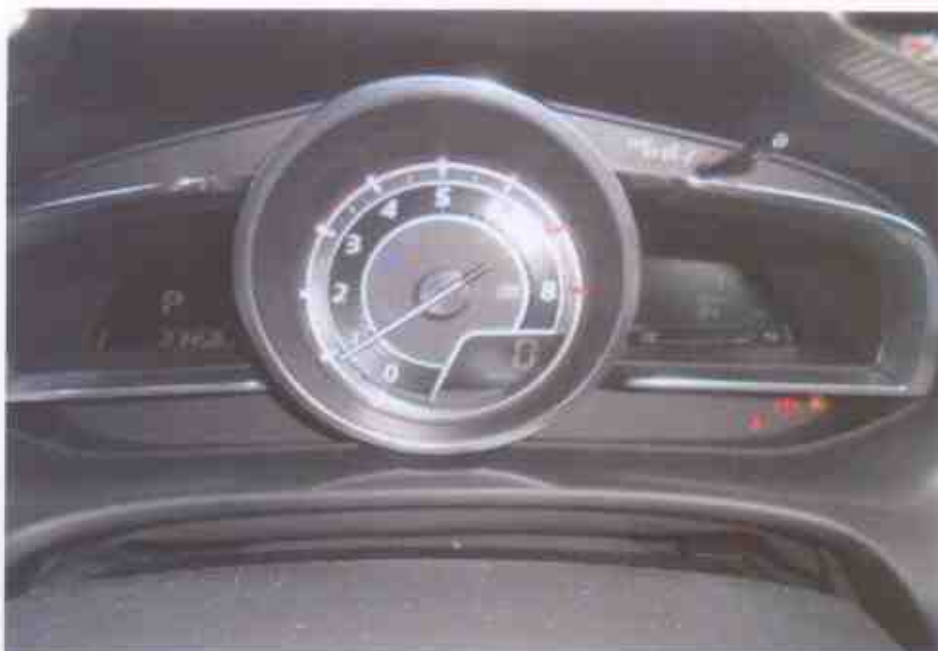
Photo 20 shows no warning lights illuminated on the instrument panel of the Motor Car after the engine was cranked. This would suggest that there was no abnormality to the various electronic operating systems of the Motor Car, like the ABS and SRS.

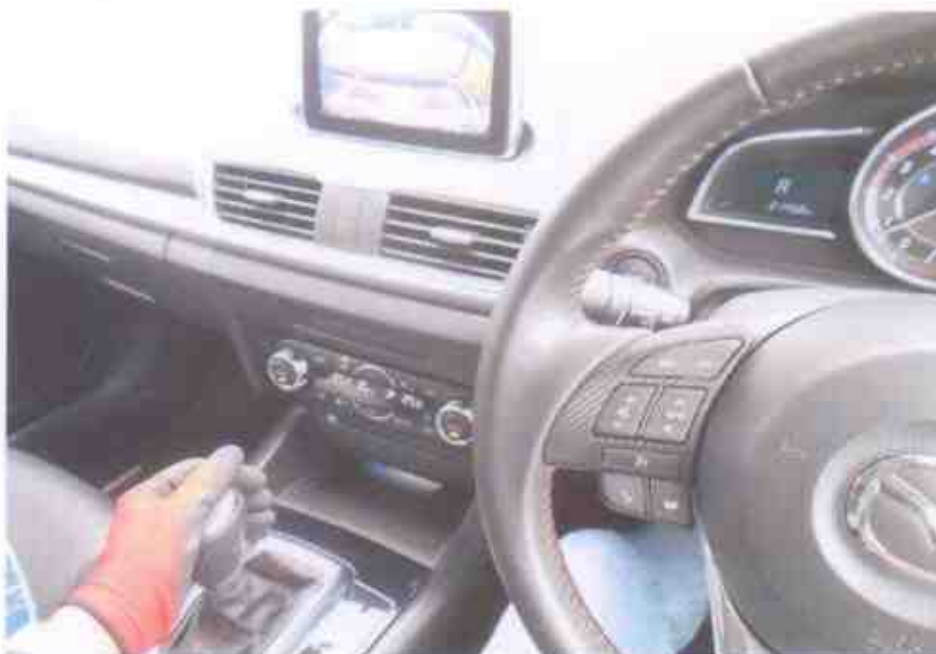
**Photo 21** shows a short operational test of the Motor Car, to primarily determine whether there was any abnormality to its engine system, its transmission system and braking system was subsequently carried out.

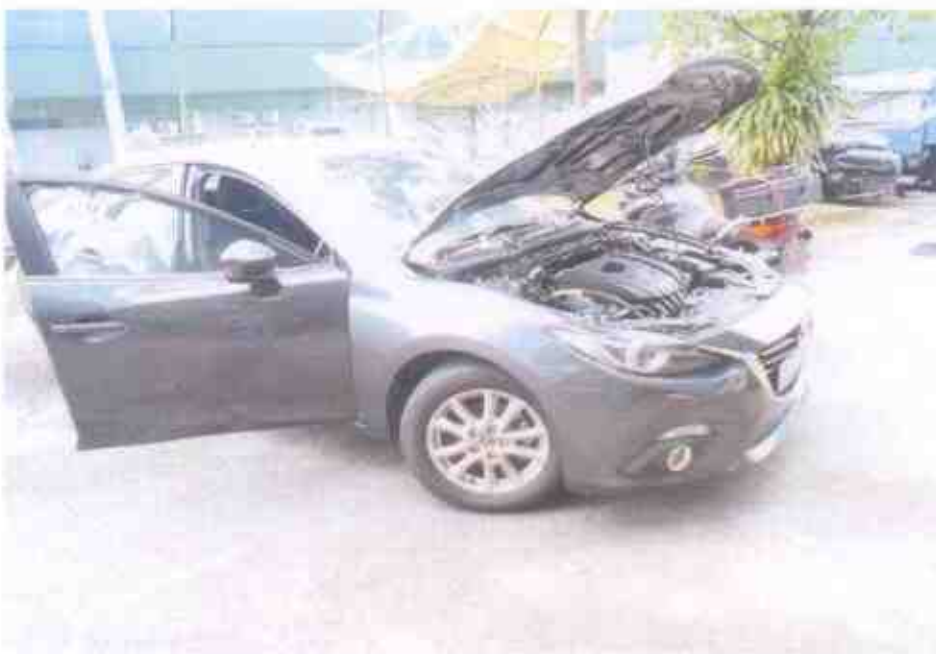
**Photo 22** shows a short operational test of the Motor Car, to primarily determine whether there was any abnormality to its engine system, its transmission system and braking system was subsequently carried out.
