Your Ref: TP/IP/21857/2018  
Our Ref : CI/TPD18011989/Z

**Fatal Accident Investigation Team**  
Traffic Police Department  
Singapore Police Force  
10 Ubi Avenue 3  
Singapore 408865

**MECHANICAL INSPECTION REPORT OF MOTOR VAN GBA 1055G.**

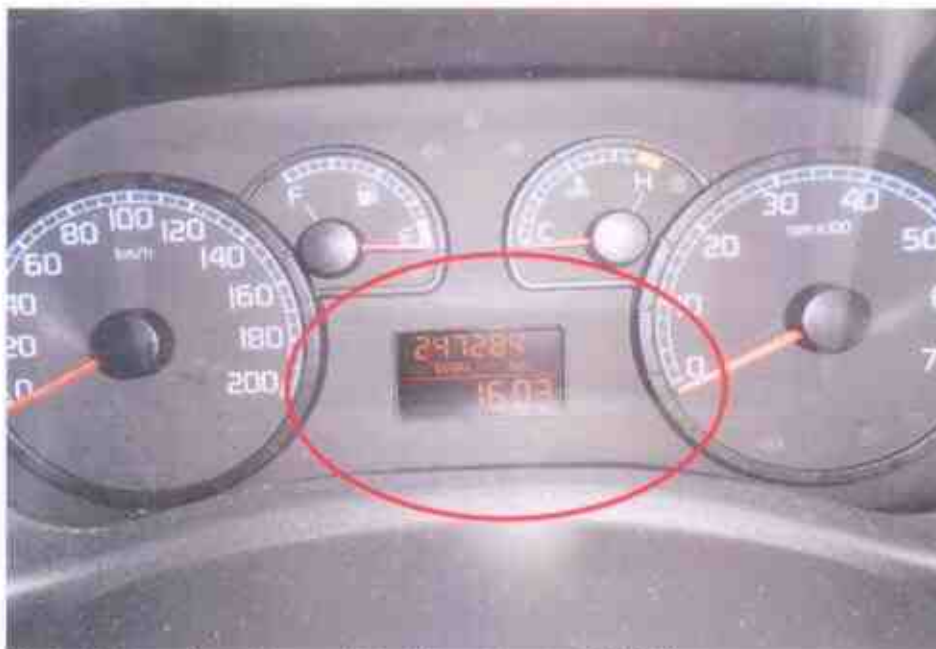
**Photo 1** shows the mileage of the Motor Van was 247284km.

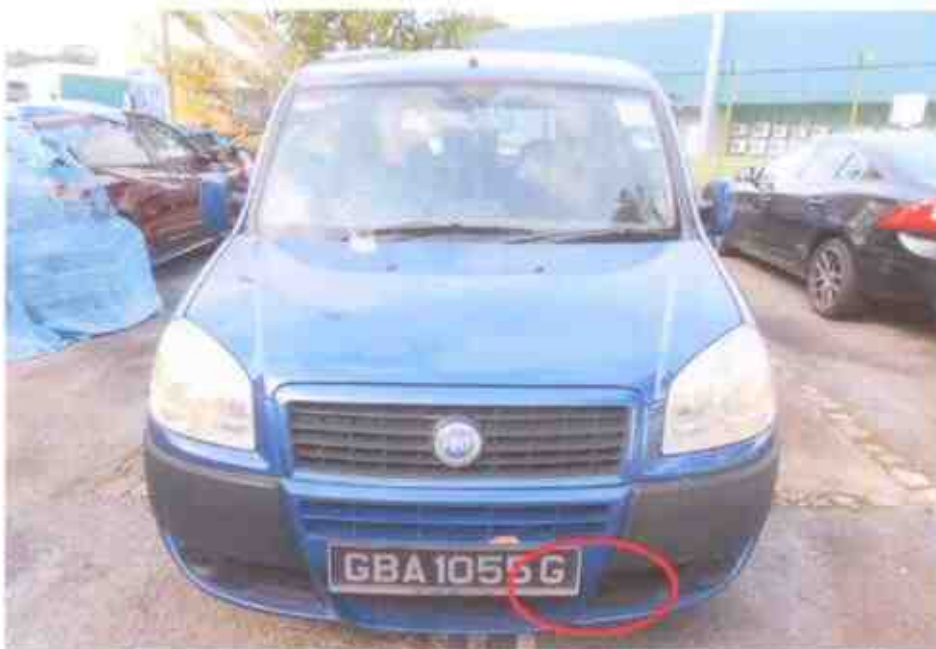
4. The mileage of the Motor Van at the time of our inspection was 247284km.
5. The Motor Van was observed to have sustained minor scratches at its front left lower bumper amongst others likely due to the accident.
6. This was likely due to the consistency of the accident's case facts that the Motor Van's driver was found unconscious in the driver's seat where half of his Motor Van (left) was found on the left kerb and another half (right) was found on the road with engine running along Seletar Road towards TPE. See photo 1 to 7 below.

**Photo 2** shows a general view of the front right body of the Motor Van at the time of our inspection. The Motor Van was observed to sustained minor damage at the front left lower bumper.

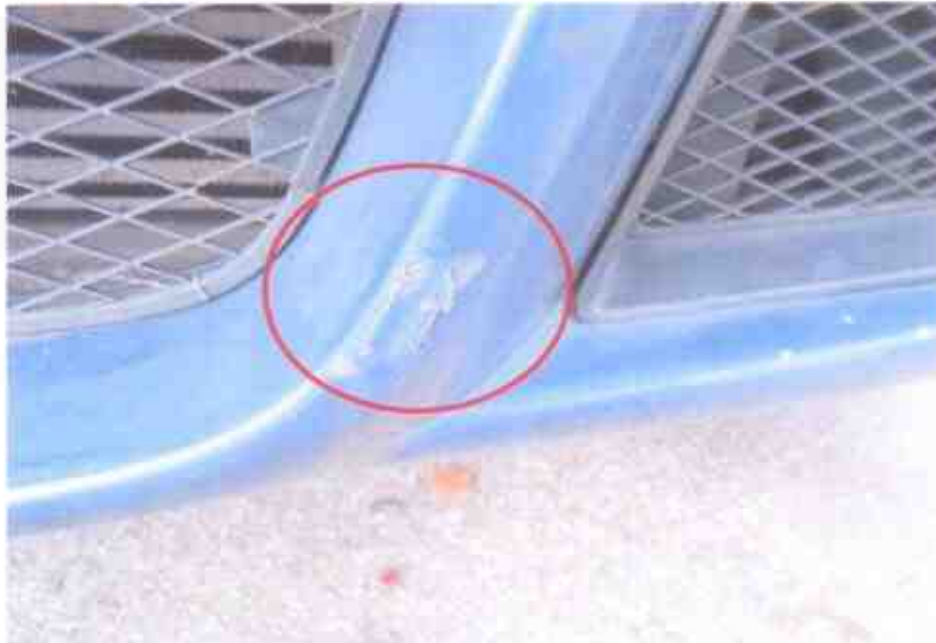
**Photo 3** shows a close-up view of the scratches on the front left lower bumper of the Motor Van at the time of our inspection. It was observed to have sustained with minor damage likely due to the accident.

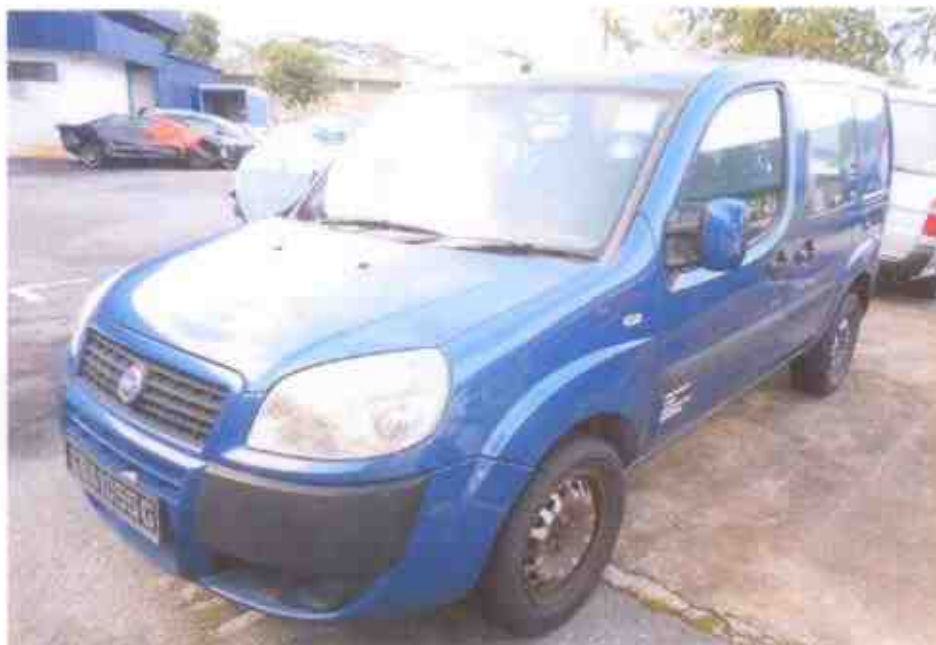
**Photo 4** shows a general view of the front left body of the Motor Van at the time of our inspection. The Motor Van was observed to be in good condition unaffected by the accident.

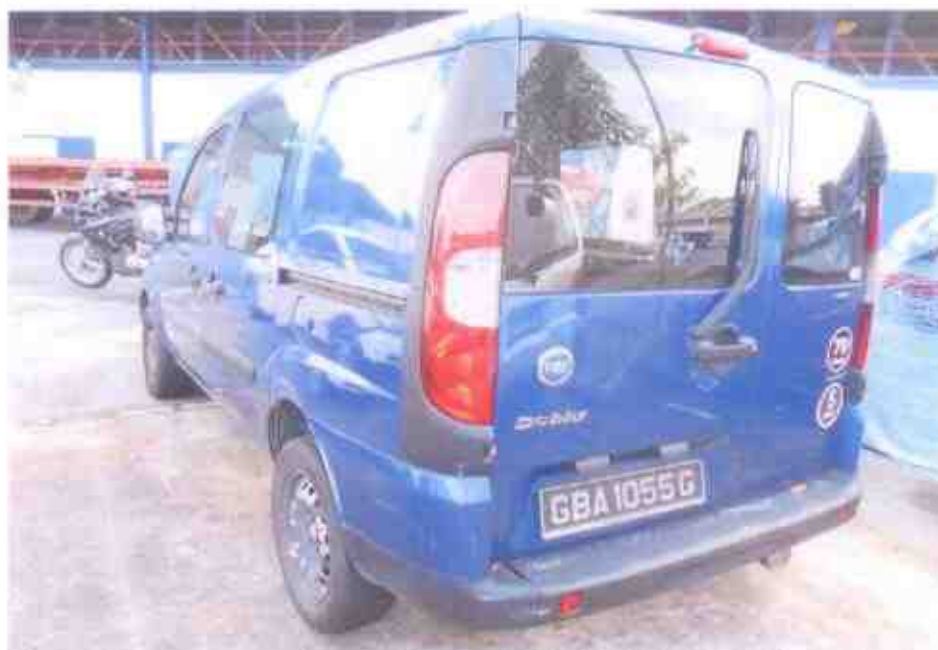
**Photo 5** shows a general view of the rear left body of the Motor Van at the time of our inspection. The Motor Van was observed to be in good general condition at time of inspection.

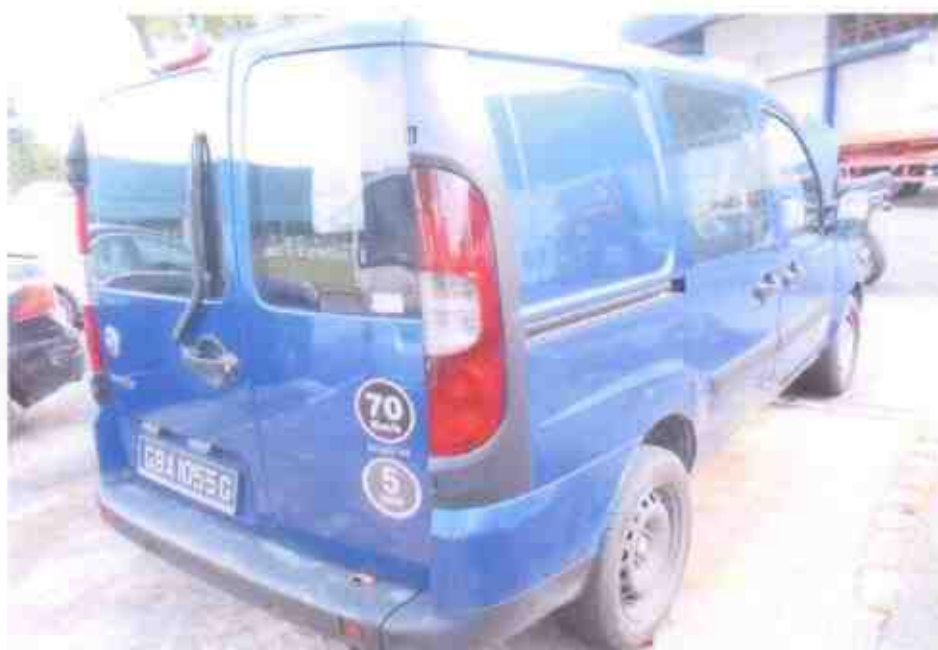
**Photo 6** shows a general view of the front rear right body of the Motor Van at the time of our inspection. The Motor Van was observed to be in good general condition at time of inspection.

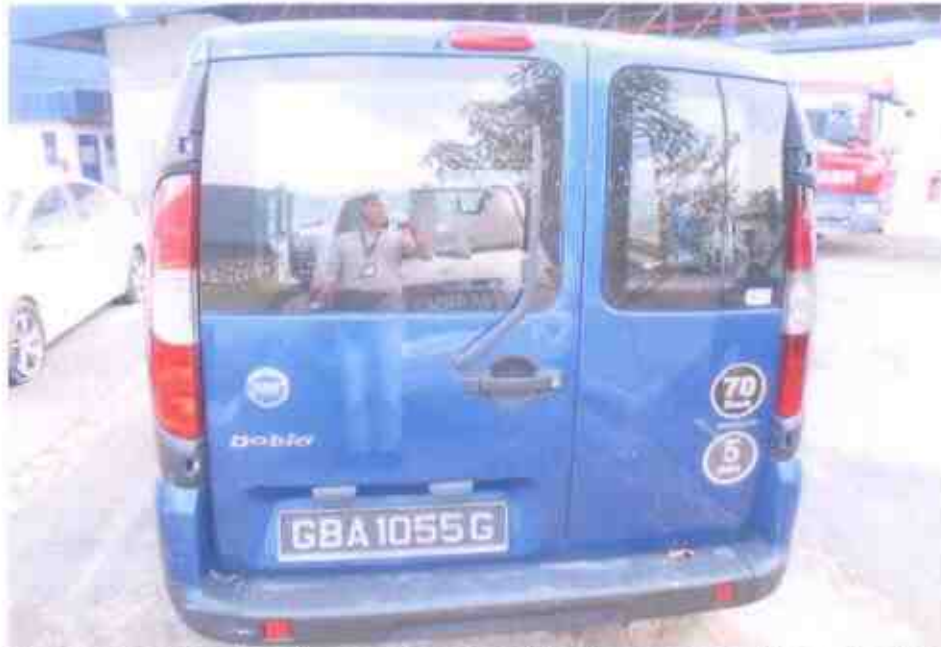
Photo 7 shows a general view of the rear left body of the Motor Van at the time of our inspection. The Motor Van was observed to be in good general condition at time of inspection.

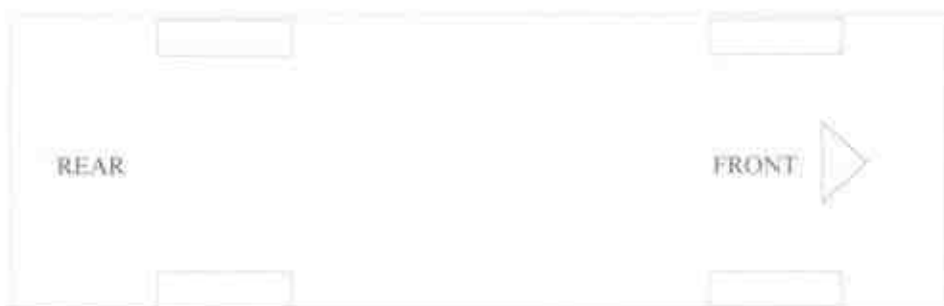
7. The 4 tyres were observed to be in serviceable condition and sufficiently inflated for vehicular operation. We did not find any tear, cut or burst mark(s) on the outer and the inner sidewalls as well as across the tread of the 4 tyres. The tyre brand, tyre size and remaining tread depth of the 4 tyres of the Motor Van were recorded as follows:-

Firestone TZ700 185/65R15  
(6mm)

Kumho Sulos KH 17 185/65 R15  
(7mm)

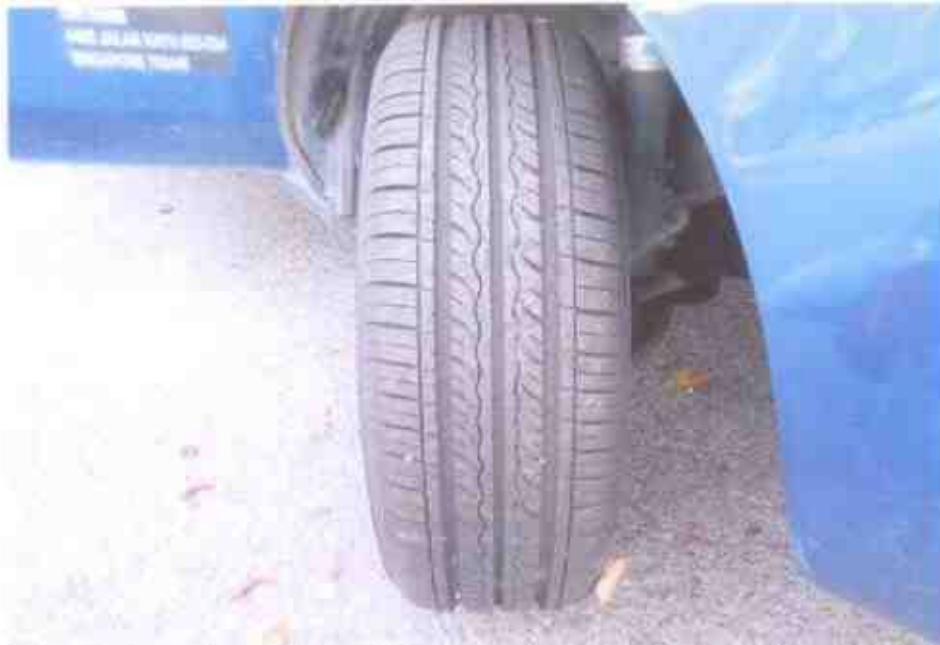
**Photo 8** shows the condition of the front right tyre of the Motor Van, which was observed to be in serviceable condition with remaining tread depth of approximately 7mm. The tyres were all observed to be sufficiently inflated for vehicular operation with no tear, cut or burst mark(s) on the outer and the inner sidewalls as well as across the tread.

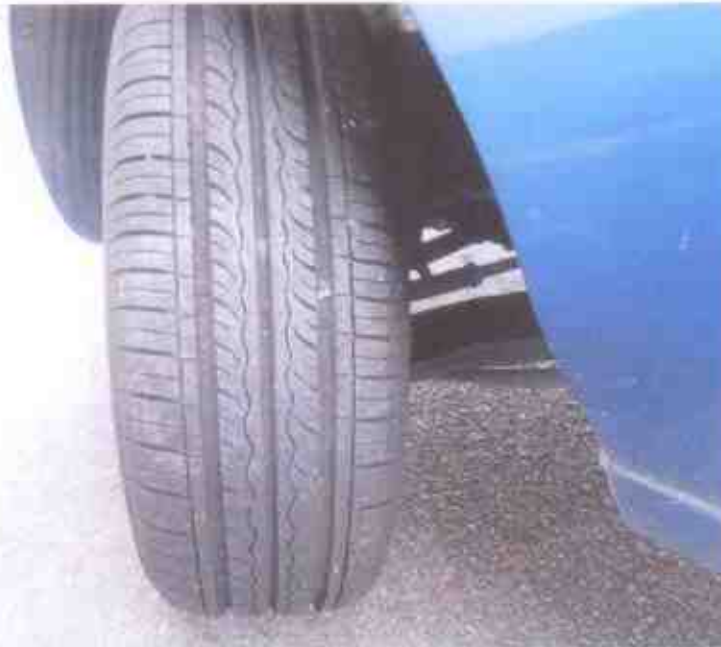
**Photo 9** shows the condition of the front left tyre of the Motor Van, which was observed to be in serviceable condition with remaining tread depth of approximately 7mm. The tyre, which was wrapped around standard wheel rim, was also observed to be sufficiently inflated for vehicular operation.

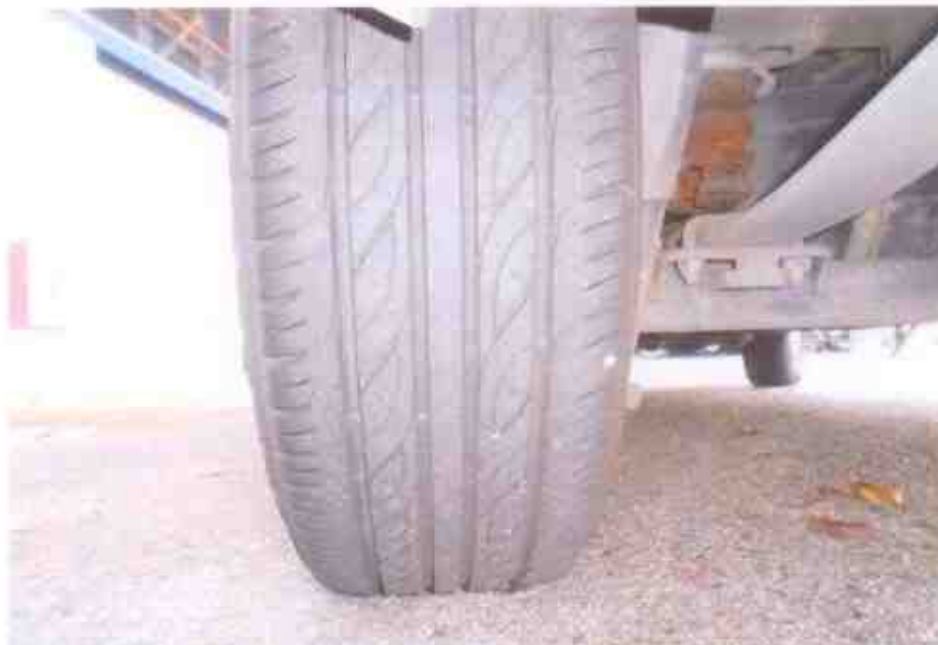
**Photo 10** shows the condition of the rear left tyre of the Motor Van, which was observed to be in serviceable condition with remaining tread depth of approximately 6mm. The tyre, which was wrapped around standard wheel rim, was also observed to be sufficiently inflated for vehicular operation. There was also no significant damage found on the 4 wheel rims of the Motor Van.

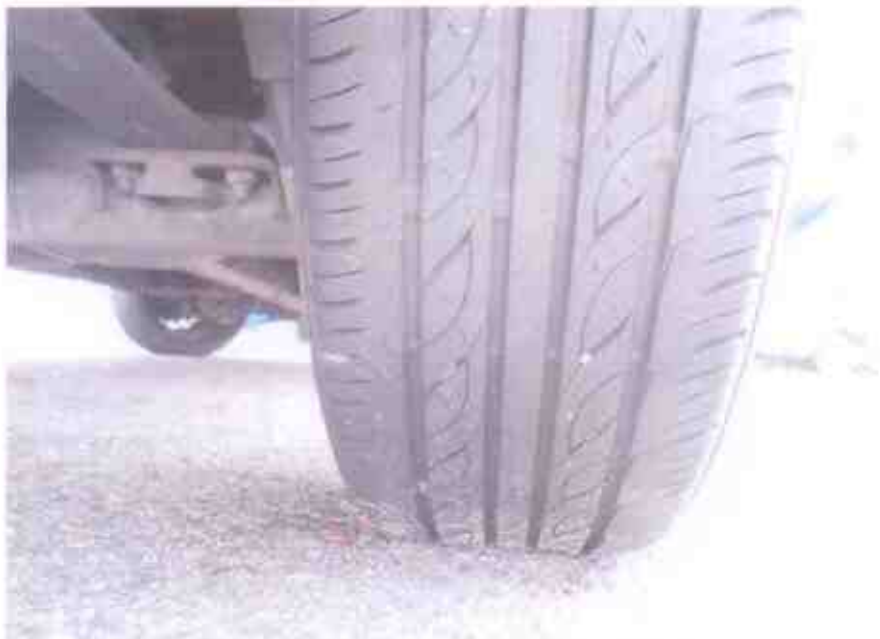
**Photo 11** shows the condition of the rear right tyre of the Motor Van, which was observed to be in serviceable condition with remaining tread depth of approximately 6mm. There was also no tear, cut or burst mark(s) on the outer and the inner sidewalls as well as across the tread of the tyre, which was also sufficiently inflated for vehicular operation.

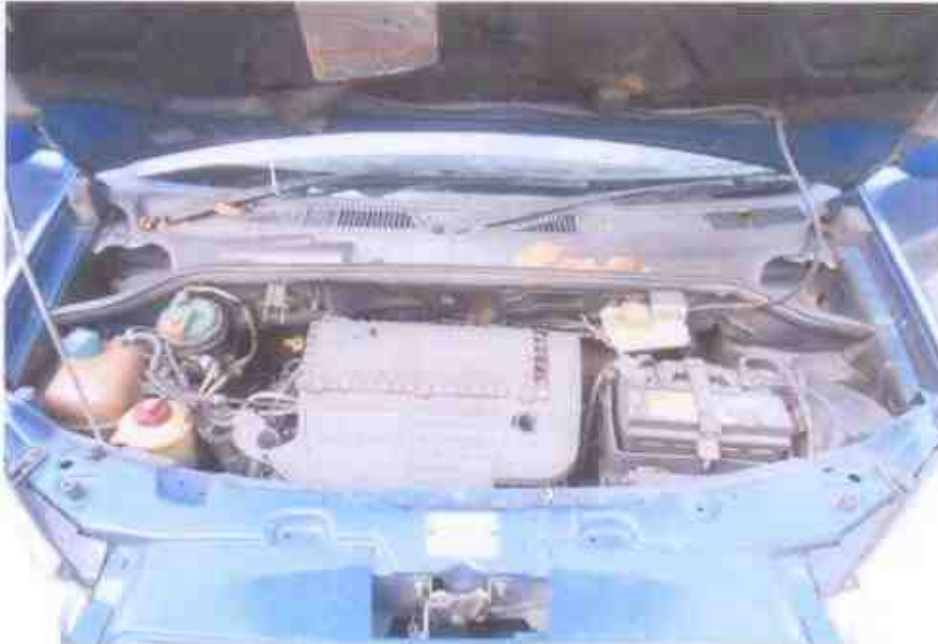
**Photo 12** shows a general view of the Motor Van's engine compartment. The various parts and components inside the engine compartment were unaffected by the accident. There was also no sign(s) or indication(s) of fluid leakage and/or fluid stain within the engine compartment.

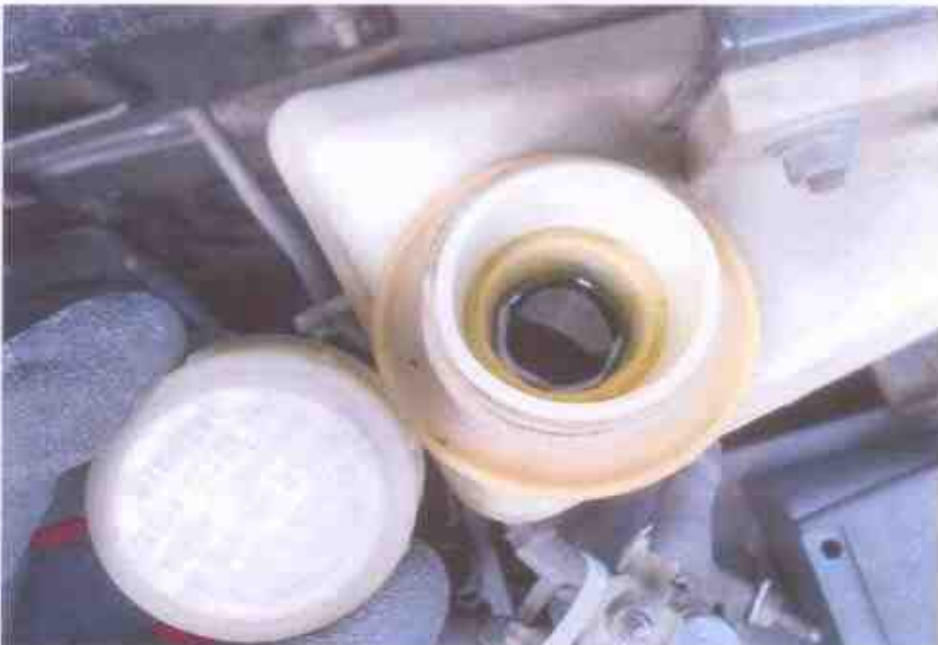
**Photo 13** shows the brake fluid reservoir of the Motor Van at the time of our inspection. The brake fluid was observed to be of sufficient level and without any visible contamination.

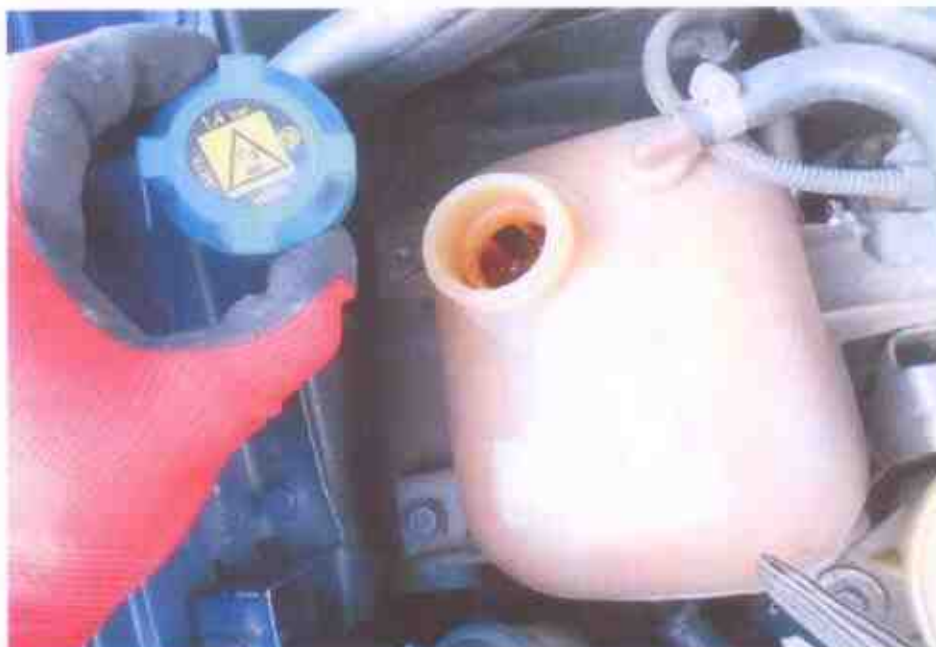
**Photo 14** shows the engine coolant reservoir of the Motor Van at the time of our inspection. The engine coolant was observed to be of sufficient level and without any visible contamination.

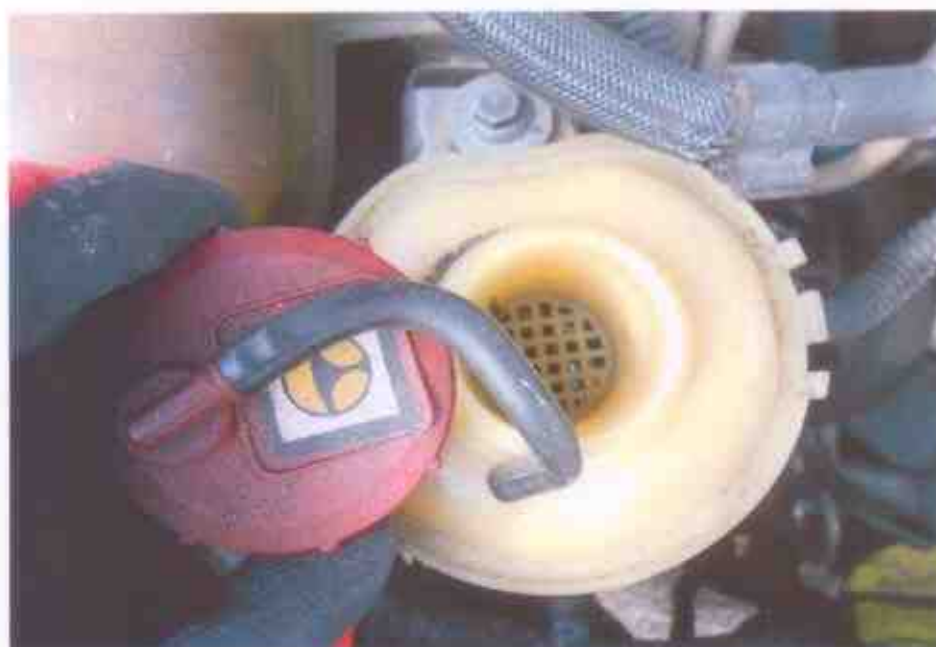
**Photo 15** shows the power steering reservoir of the Motor Van at the time of our inspection. It was observed to be of sufficient level and without any visible contamination.

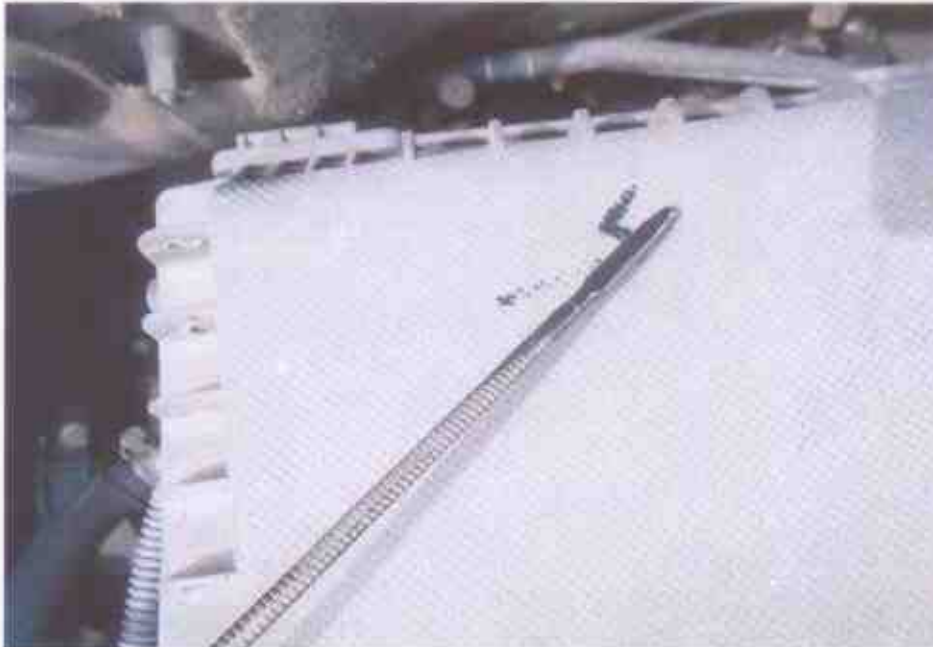
**Photo 16** shows the engine dip stick of the Motor Van at the time of our inspection. The engine oil was observed to be of sufficient level and without any visible contamination.

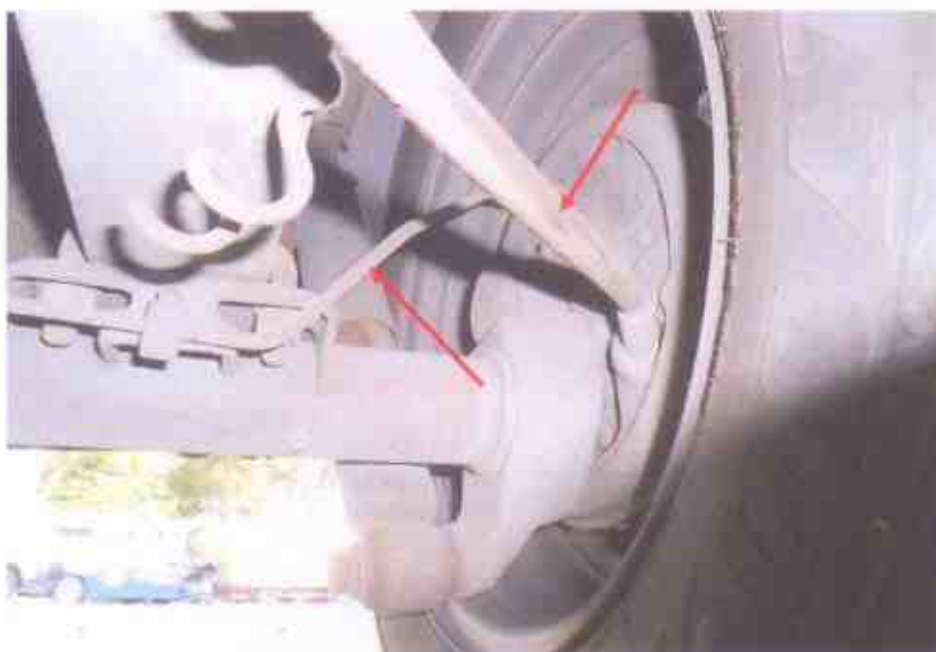
**Photo 17** shows the various undercarriage components at the rear left wheel of the Motor Van, in particular the brake hose (arrowed). We did not observe any leakage of brake fluid at the time of our inspection of the Motor Van.

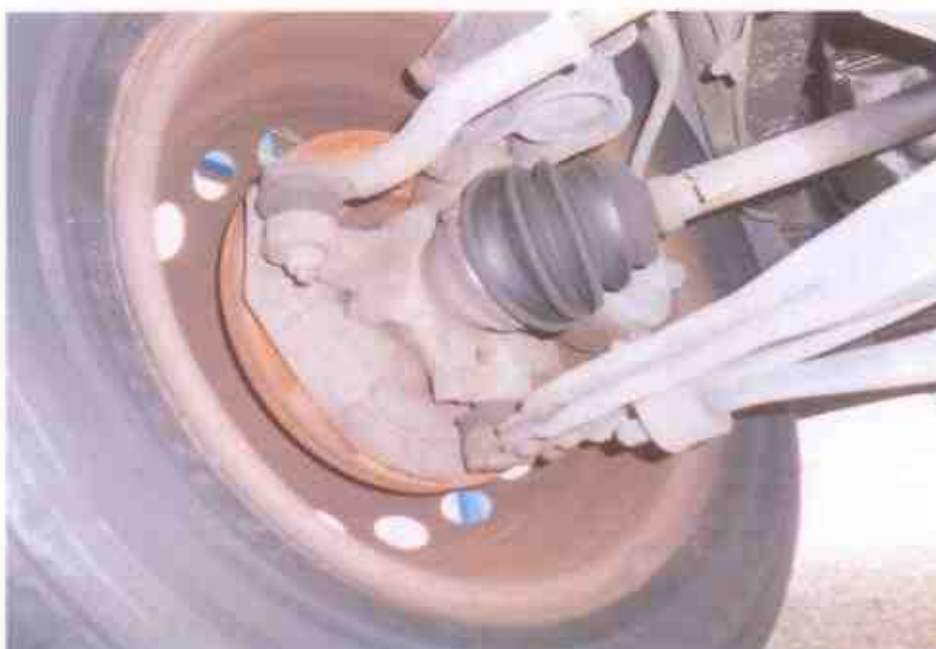
**Photo 18** shows the brake hose at the front left wheel of the Motor Van. We did not observe any leakage of brake fluid. Our visual inspection of the various mechanical components of the Motor Van's braking system revealed all to be intact and without visible damage, indicating that the braking system was likely to be in serviceable condition at the material time of accident.

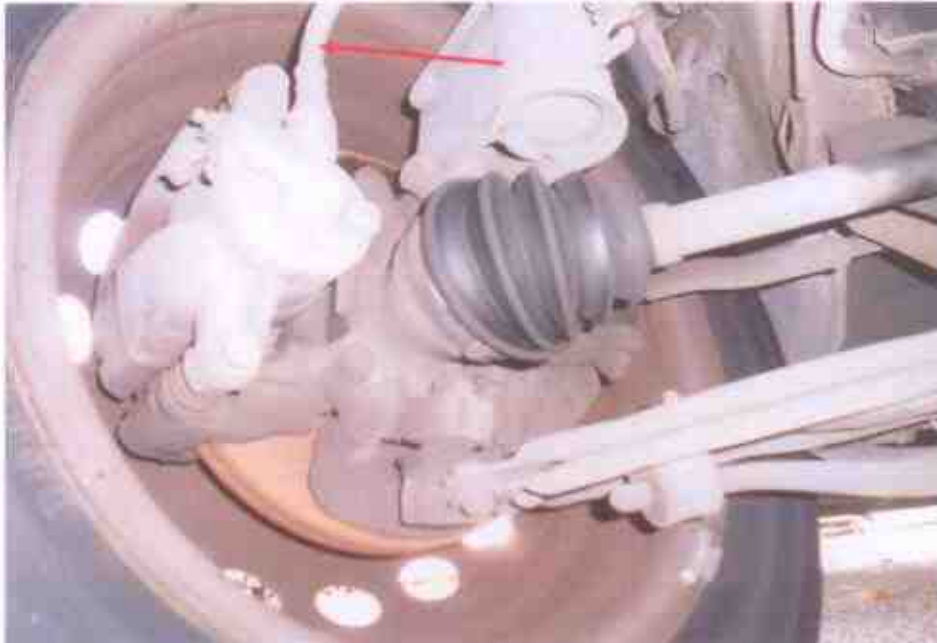
**Photo 19** shows the brake hose (arrowed) at the front right wheel of the Motor Van. We did not observe any leakage of brake fluid at the time of our inspection of the Motor Van. Our visual inspection of the various mechanical components of the Motor Van's braking system, including its brake calliper, revealed all to be intact and without visible damage.

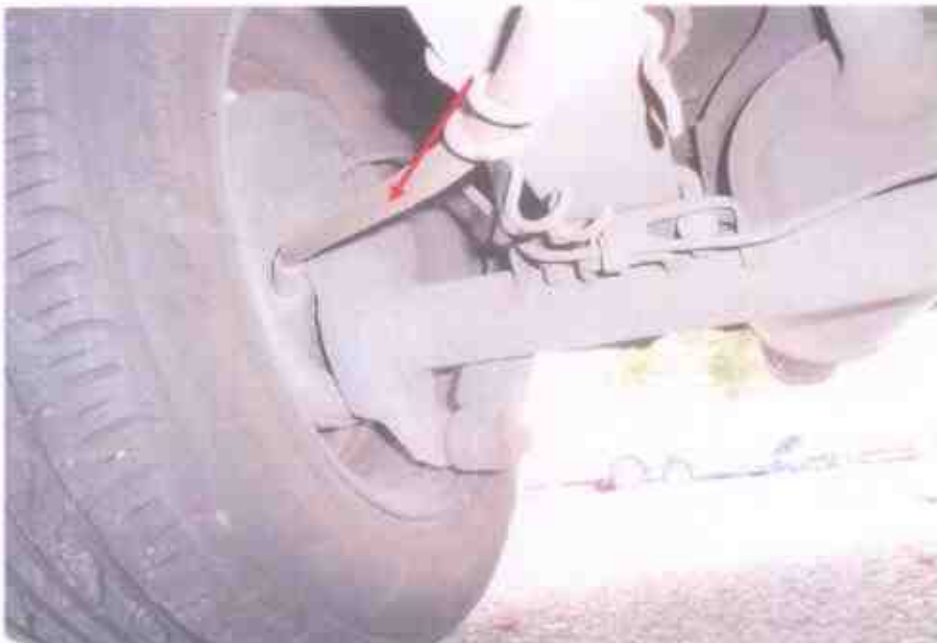
**Photo 20** shows the various undercarriage components at the rear right wheel of the Motor Van. The various steering components were all found to be intact, suggesting that the steering system of the Motor Van was likely to be in serviceable condition at the material time of accident. There was also no sign of fluid stain(s) observed on the various undercarriage components at the 4 wheels of the Motor Van.

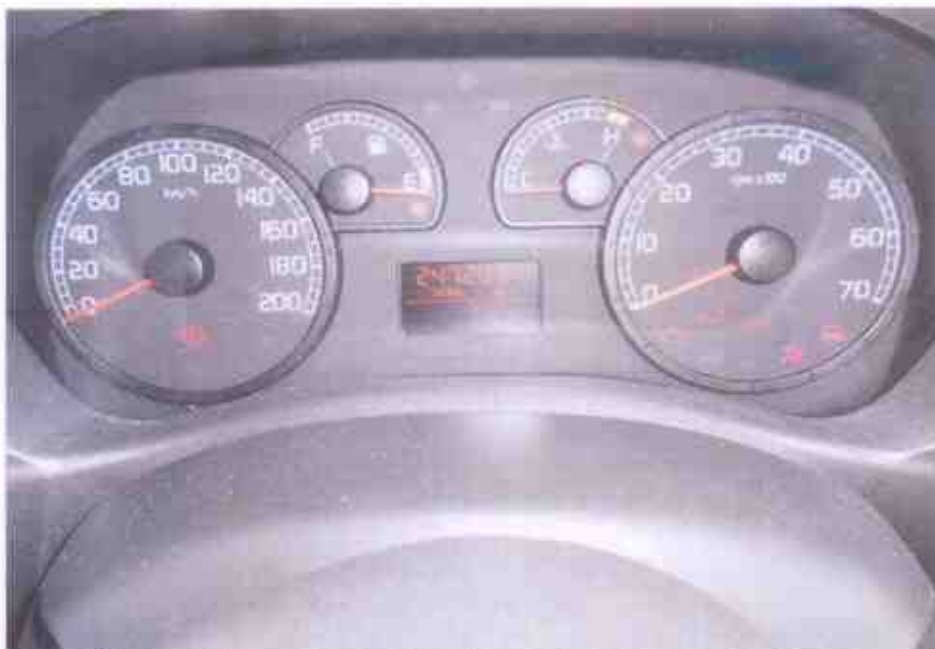
**Photo 21** shows the warning lights for the various electronic operating systems of the Motor Car appearing on its instrument panel during the self-test when the engine was cranked.

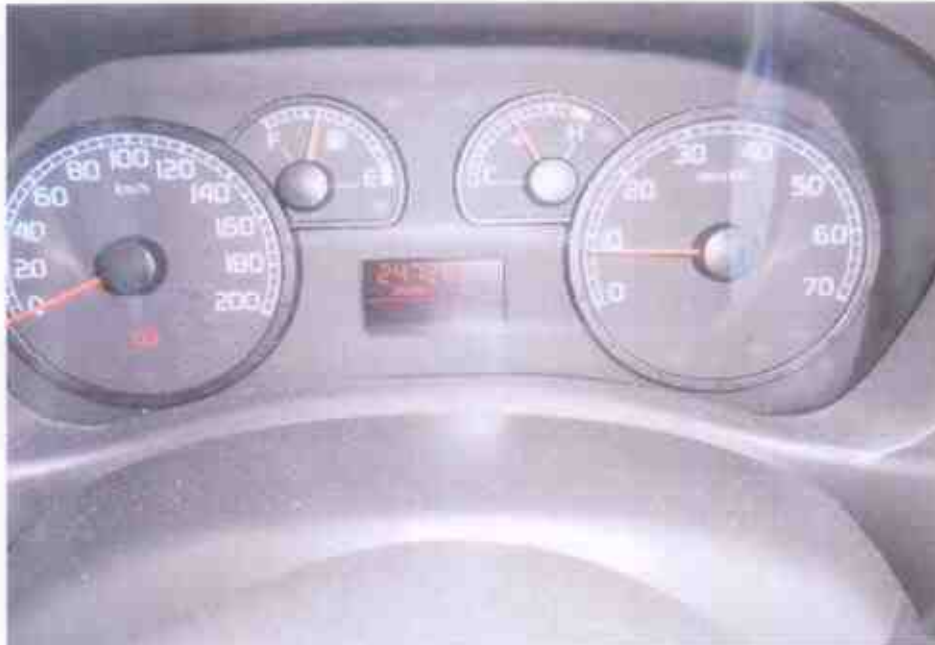
Photo 22 shows no warning lights illuminated on the instrument panel of the Motor Van after the engine was cranked. This would suggest that there was no abnormality to the various electronic operating systems of the Motor Car.

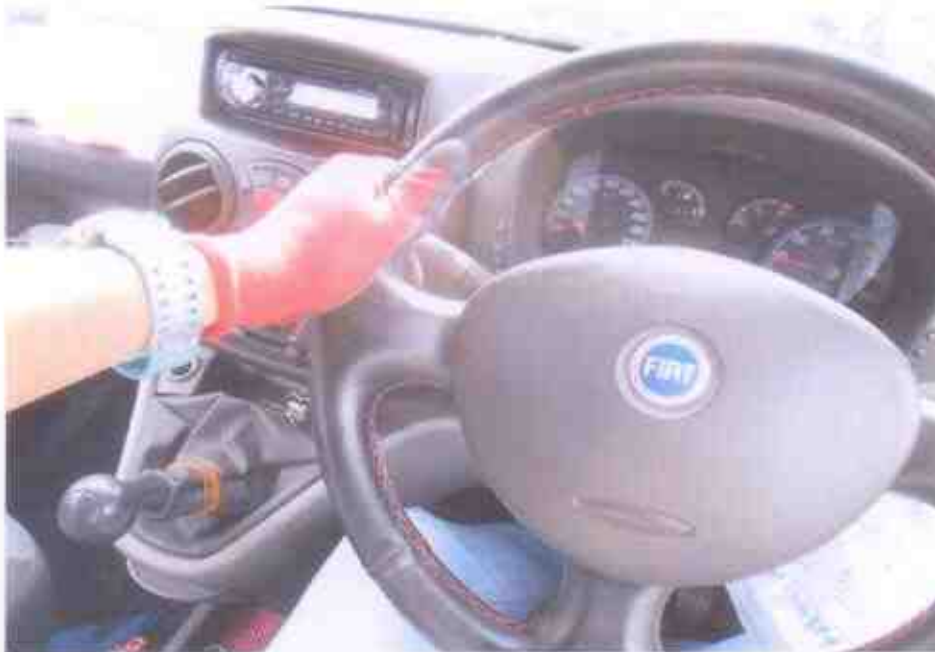
**Photo 23** shows a short operational test of the Motor Van, to primarily determine whether there was any abnormality to its various operating systems like its engine system, its transmission system, steering system and braking system was subsequently carried out. The test was conducted by driving the Motor Van forward, stopping, before reversing and coming to a stop again.

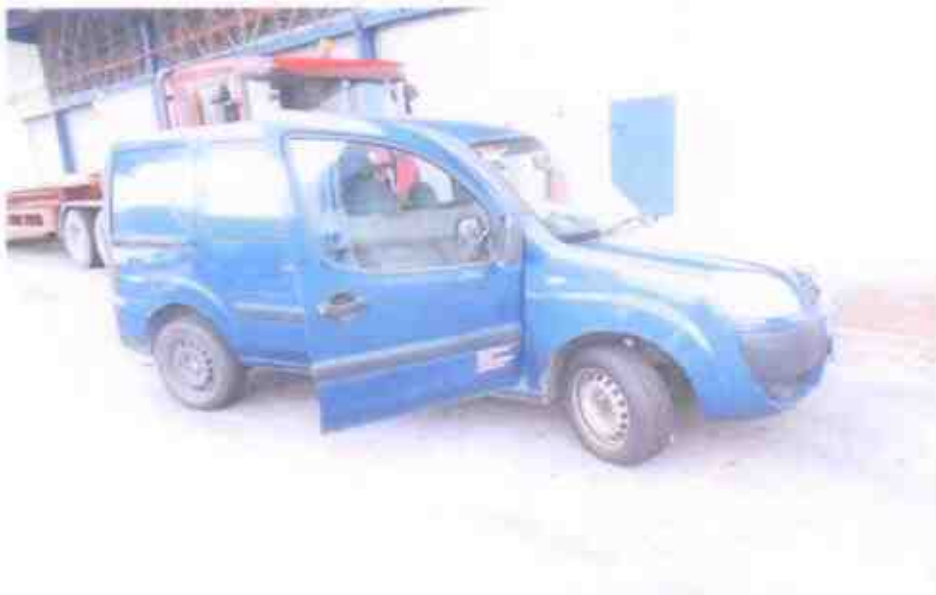
**Photo 24** shows a short operational test of the Motor Van, the test was conducted by driving the Motor Van forward, stopping, before reversing and coming to a stop again.
