Your Ref: A28834218MKC
Our Ref :CS/MSG18012062/Z

11th July 2018

**TECHNICAL INVESTIGATION REPORT OF FIRE INCIDENT INVOLVING THE
INSURED VEHICLE GX8189C ON 28th June 2018**

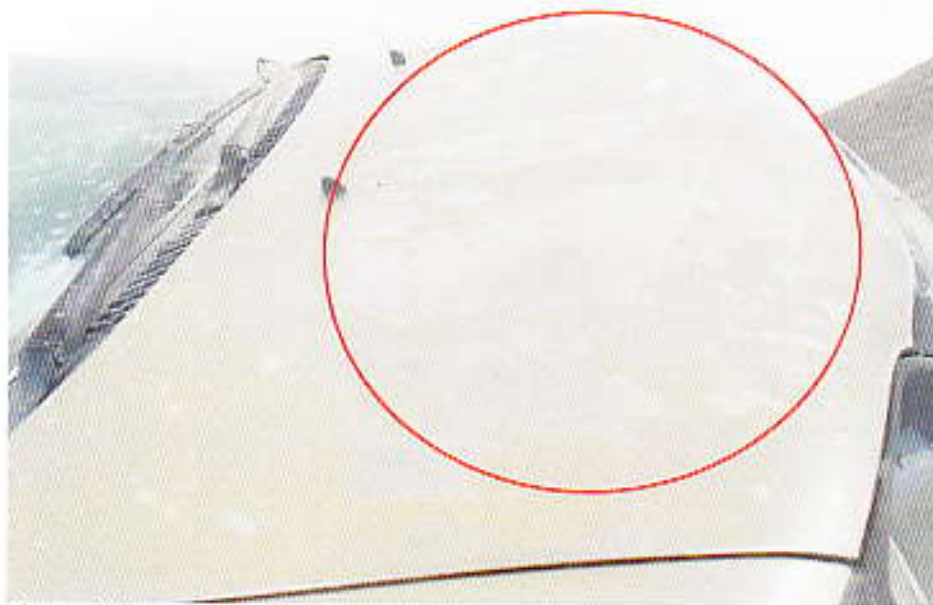
Photo 1 shows the general view of the front portion of the Insured Vehicle at the time of our inspection. The fire damage to the Insured Vehicle was confined to its front top bonnet & at the centre area as a result of the fire.

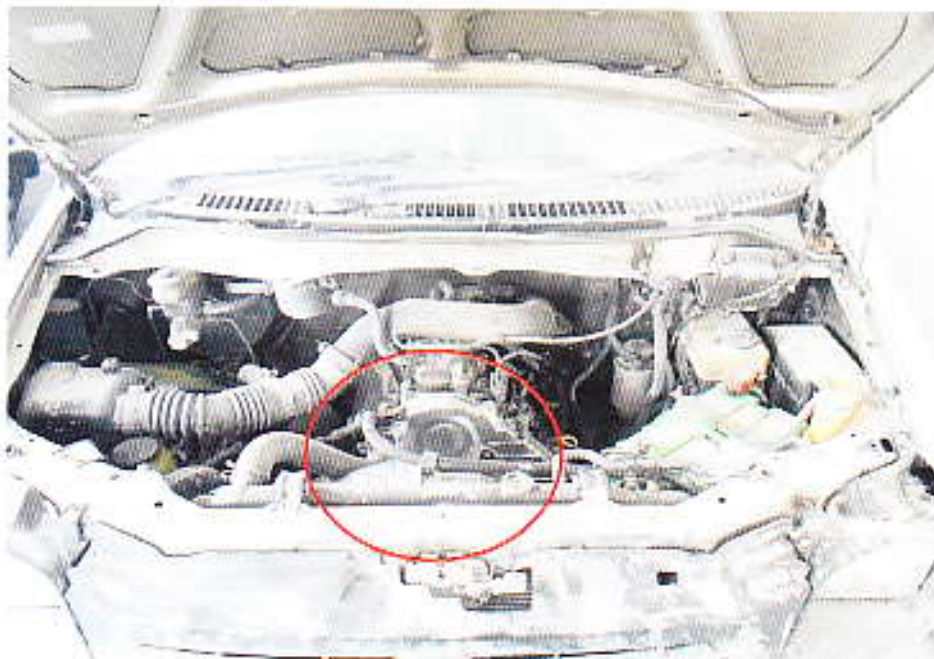
Photo 2 shows the general view of the front centre portion of the Insured Vehicle at the time of our inspection. The fire damage to the Insured Vehicle was confined to its front bonnet, at the centre area; engine parts were amongst the body parts that were found to have been affected as a result of the fire.

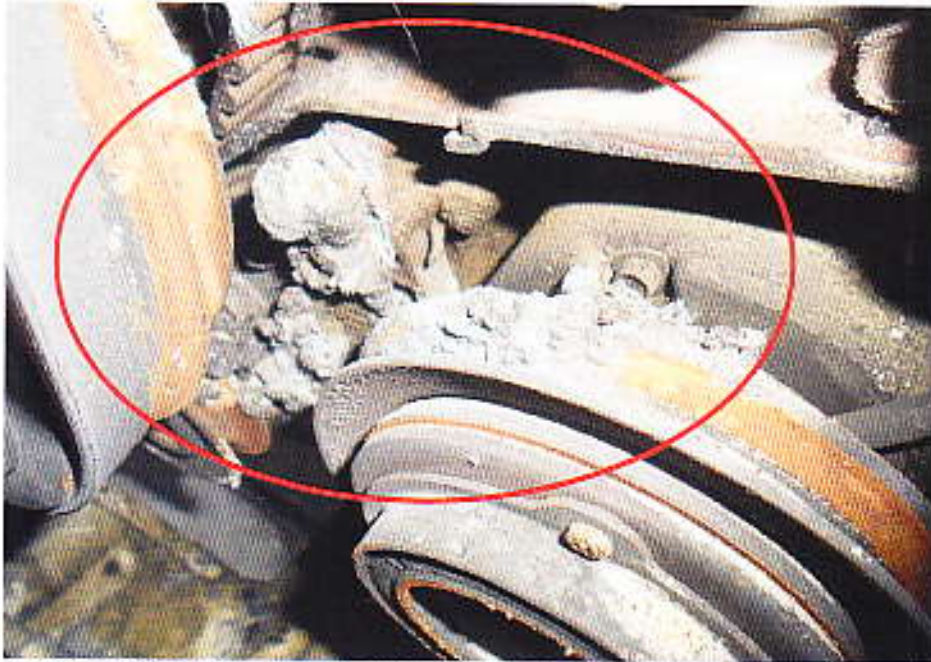
Photo 3 shows the close-up view of the air-condition compressor from the Insured Vehicle at the time of our inspection. It was observed to sustain with burnt damages.

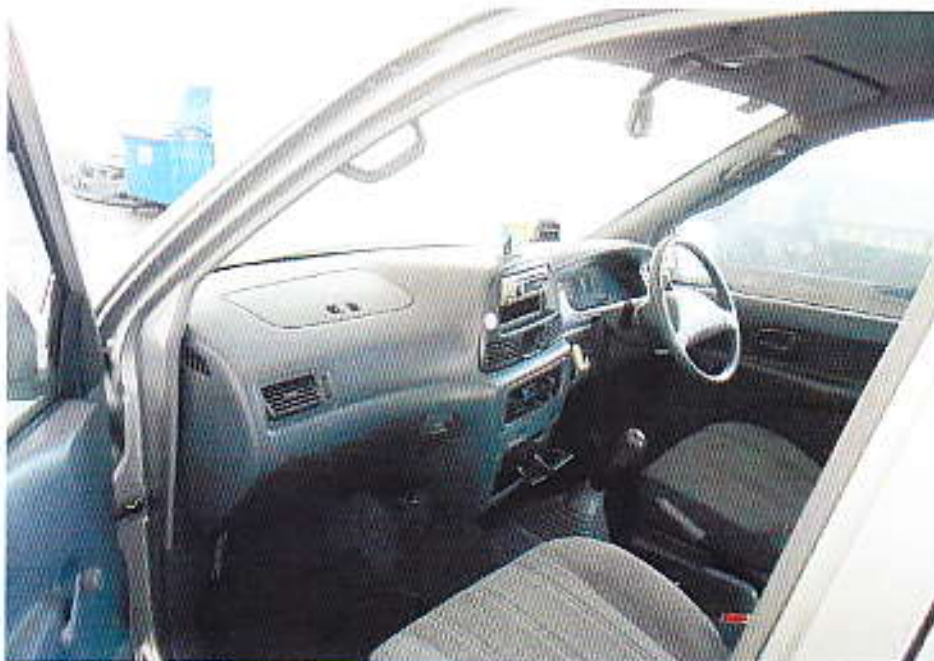
Photo 4 shows the interior compartment of the Insured Vehicle, which was observed to be unaffected by the fire incident.

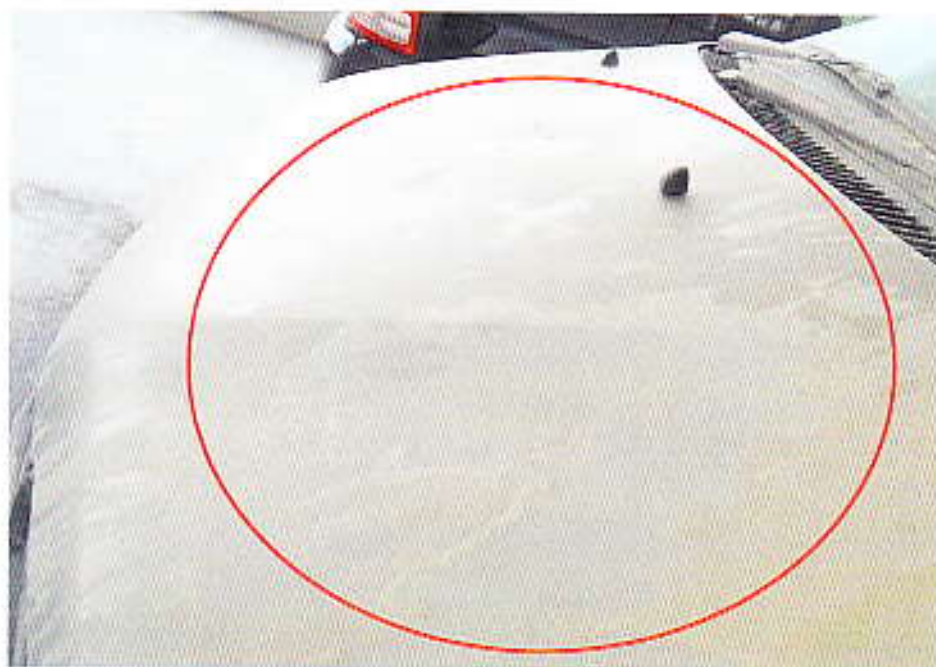
8. For this particular case, the fire appears to have originated within the engine compartment of the Insured Vehicle, somewhere around its centre portion at the engine compartment. This can be determined from the burn pattern and the high heat intensity burn marks found on the internal compartment of the front bonnet of the Insured Vehicle; at the engine centre front portion and also given that there was no other area of the Insured Vehicle that were found with damage of burnt nature.
9. These (peeling) burn marks are a result of exposure to prolong heat intensity. However, due to non-extensive burnt rust did not develop around these areas. The fire did not penetrate to the base metal that causes steel/metal material body parts to be exposed to natural environmental condition. See photo 5 & 6 below.

Photo 5 shows the burn pattern and peeling burn marks (circled) that were found on the topside of the front bonnet of the Insured Vehicle. Such peeling burn marks are a result of exposure to prolong heat intensity, which may indicate where the fire had started.

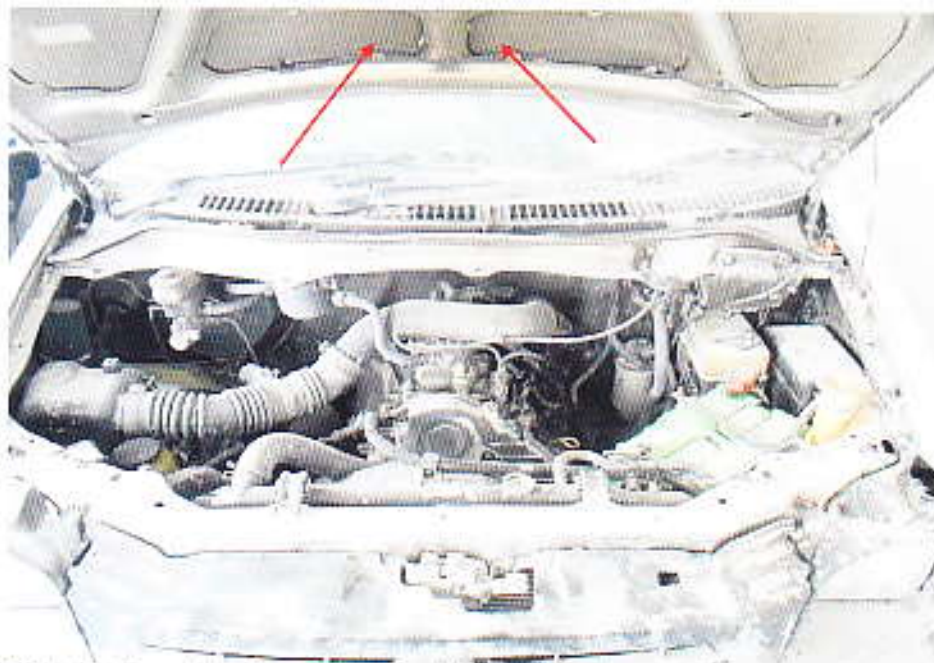
Photo 6 shows the burn pattern and burn marks (arrowed) that were found on the underside of the front bonnet of the Insured Vehicle. Such burn marks are a result of exposure to heat intensity, which may indicate where the fire had started.

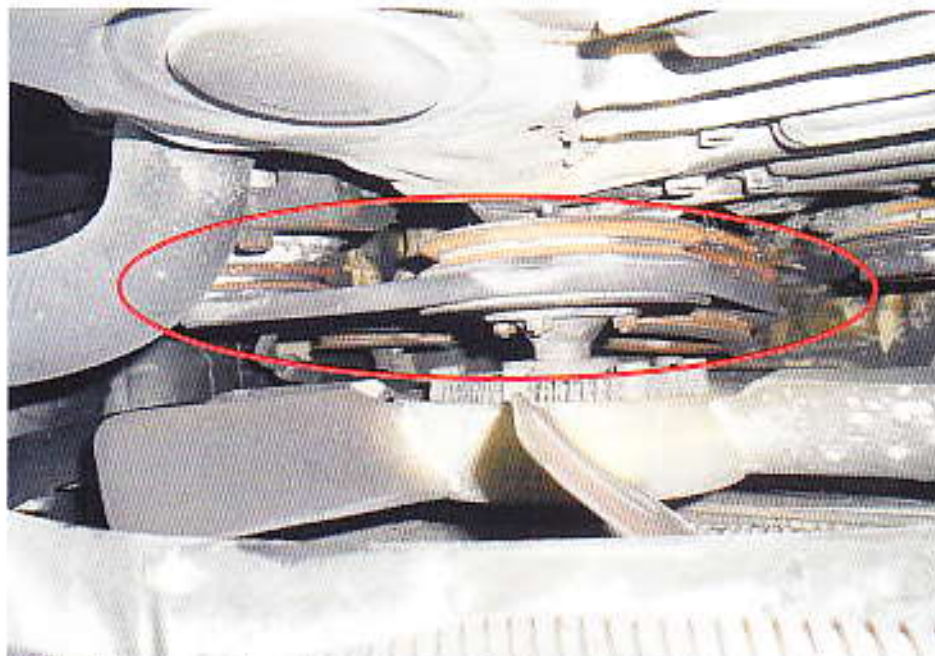
10. Upon closer examination of the area around the centre of the engine compartment, which was in the immediate vicinity of where the fire to the Insured Vehicle had likely started, we had found burnt belting that linked the main pulley crankshaft & air-condition compressor. A misalignment was observed on the components affected.

11. Such misalignment condition normally indicate a mal-function on the air-condition compressor which probably had stuck & causes friction to the rubber belting hence creates heat due to the continuous pulley movements from the main crankshaft prior to the fire incident. A prolonged friction will eventually cause fire to ignite. Due to its location that was near & also in contact with combustible materials such as rubber, plastic & fuel. Therefore, such entities possibly contribute to the fire incident. This would then appear to suggest that the cause of fire to the Insured Vehicle could have possibly been due to mechanical in nature. See photo 7 & 8 below.

Photo 7 shows the close-up view of the misalignment on the affected components such as air-condition compressor, main pulley crankshaft & alternator where it was link by rubber belting & as a result of the fire incident.

33. The possibility of the fire being due to mechanical in nature would then seem more likely given that engine overheating and external factor would both seem unlikely. The fire being due to mechanical nature is also supported by the condition of the misaligned compressor & belting that we had found while conducting our physical investigation on the Insured Vehicle. The continuous friction from the misaligned compressor might cause sparked ignition to start a fire which was earlier discussed in paragraph 10 & 11 above.

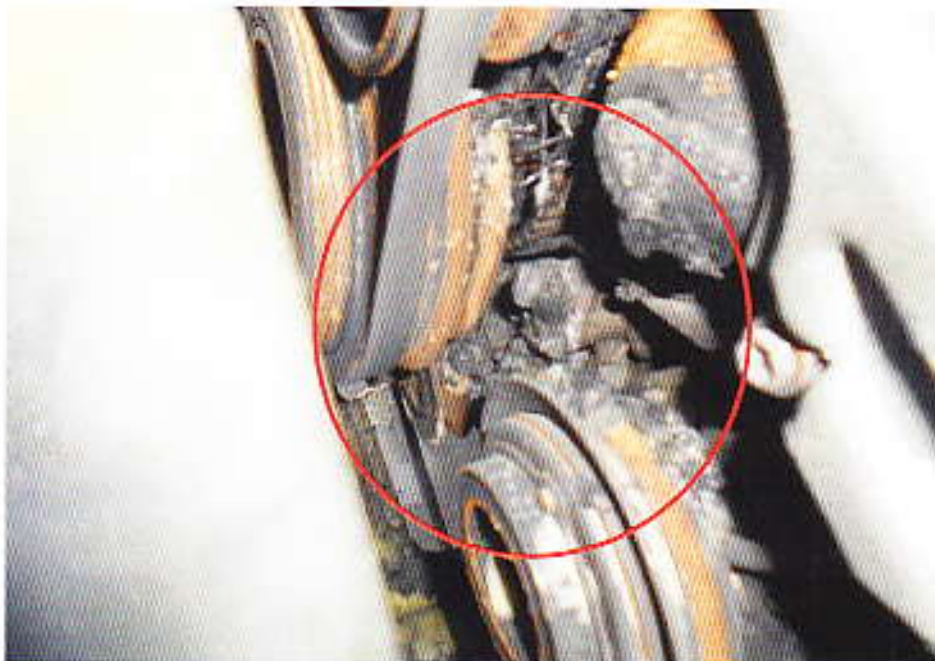
Photo 8 shows the close-up view of the melted rubber materials as a result of the fire incident. This would indicate where the fire had started at time of the fire incident.

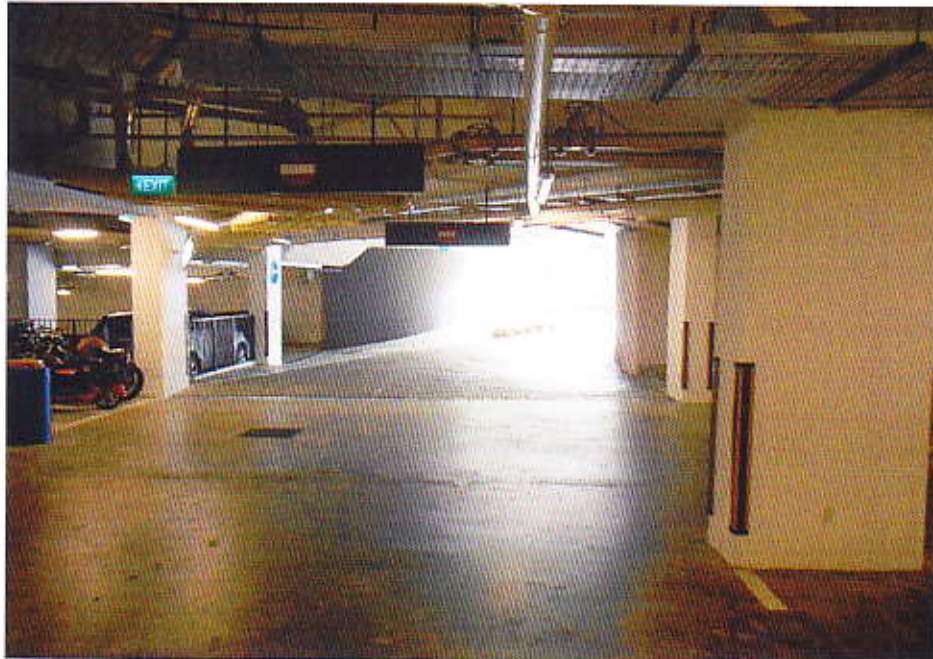
Photo 9 shows the general view of the entrance of "River Else" basement car park.

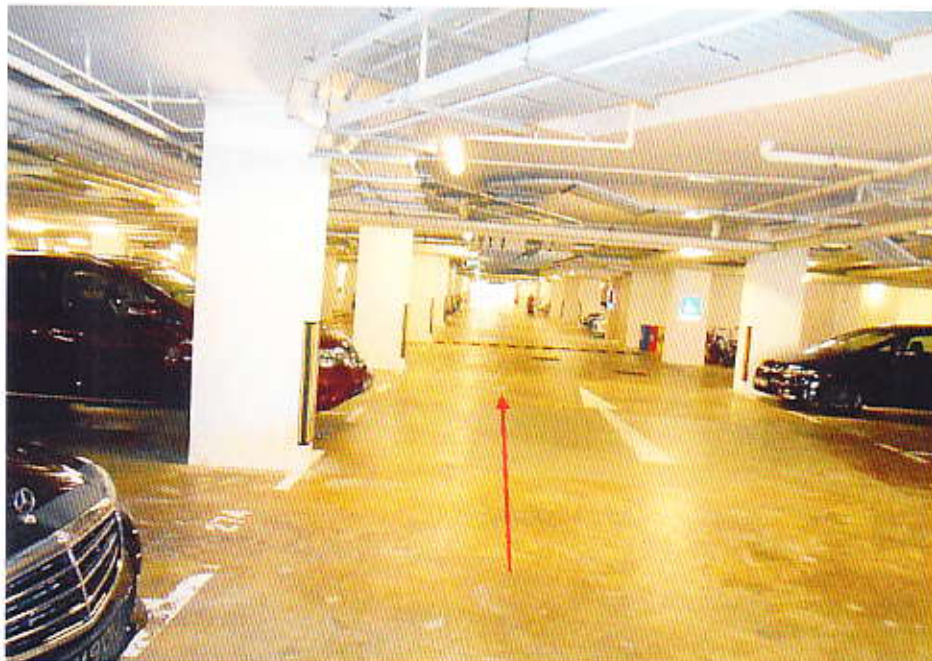
Photo 10 shows the general view of "River Esle" basement car park when we drive in. The fire location was on the left side of the car park.

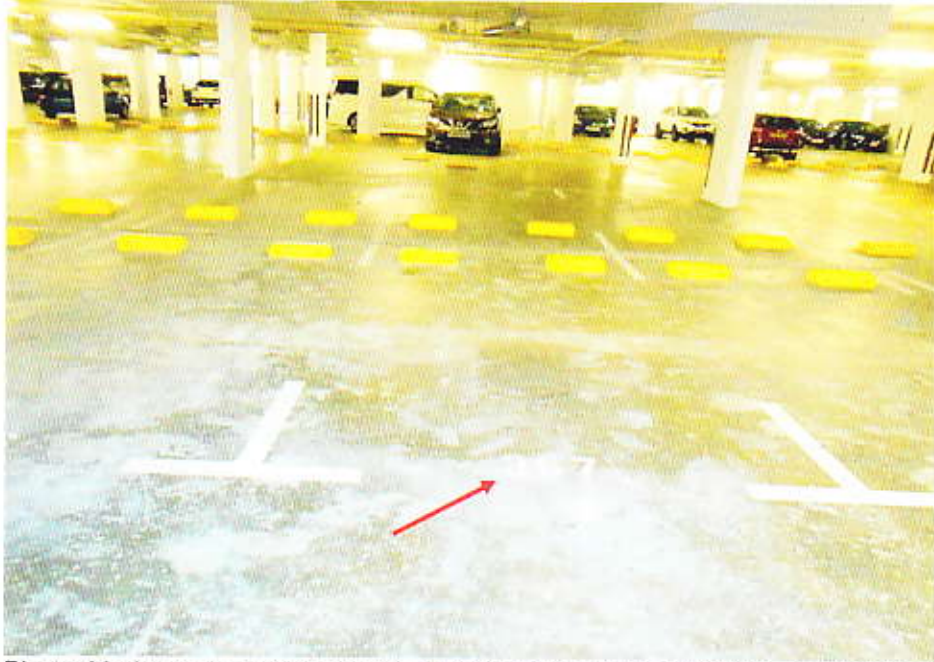
Photo 11 shows the parking lot no. 367 where the Insured Vehicle was parked at time of the fire incident.

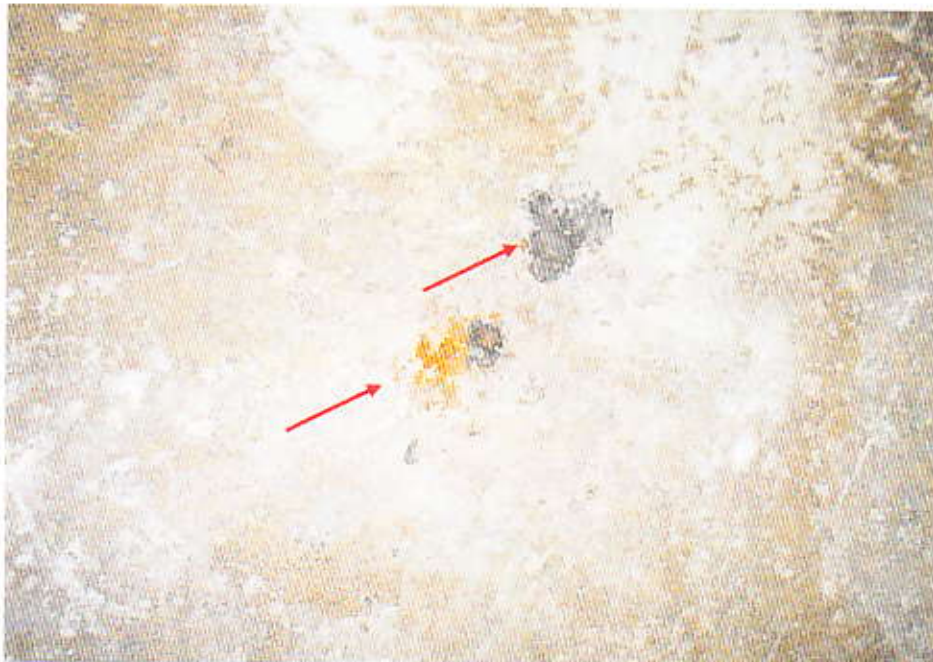
25. At the time of our visit, we were able to clearly see burnt marks / residual remains on the ground inside the parking lot. Notwithstanding that it was a non-extensive fire; we found melted materials on the parking lot floor which was believed to be part of material from the burnt Insured Vehicle that had occurred at the time of incident. We did not find any nearby foreign material or object that relates to the fire incident. However, from the burnt materials that we found on the parking lot floor conclusively that a fire incident did happen at the said location.

Photo 12 shows the close-up view of the melted burnt substance believed to be from the burnt Insured Vehicle.

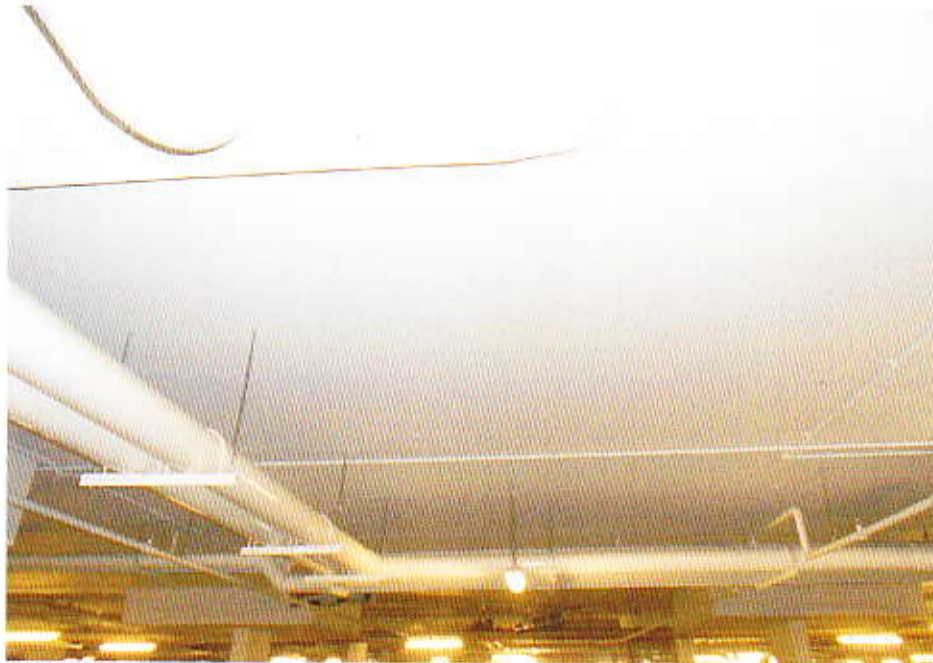
Photo 13 shows the general view of the ceiling above parking lot no. 367 that was said to be the where the fire incident had happened. It was observed to be un-affected by the fire incident.

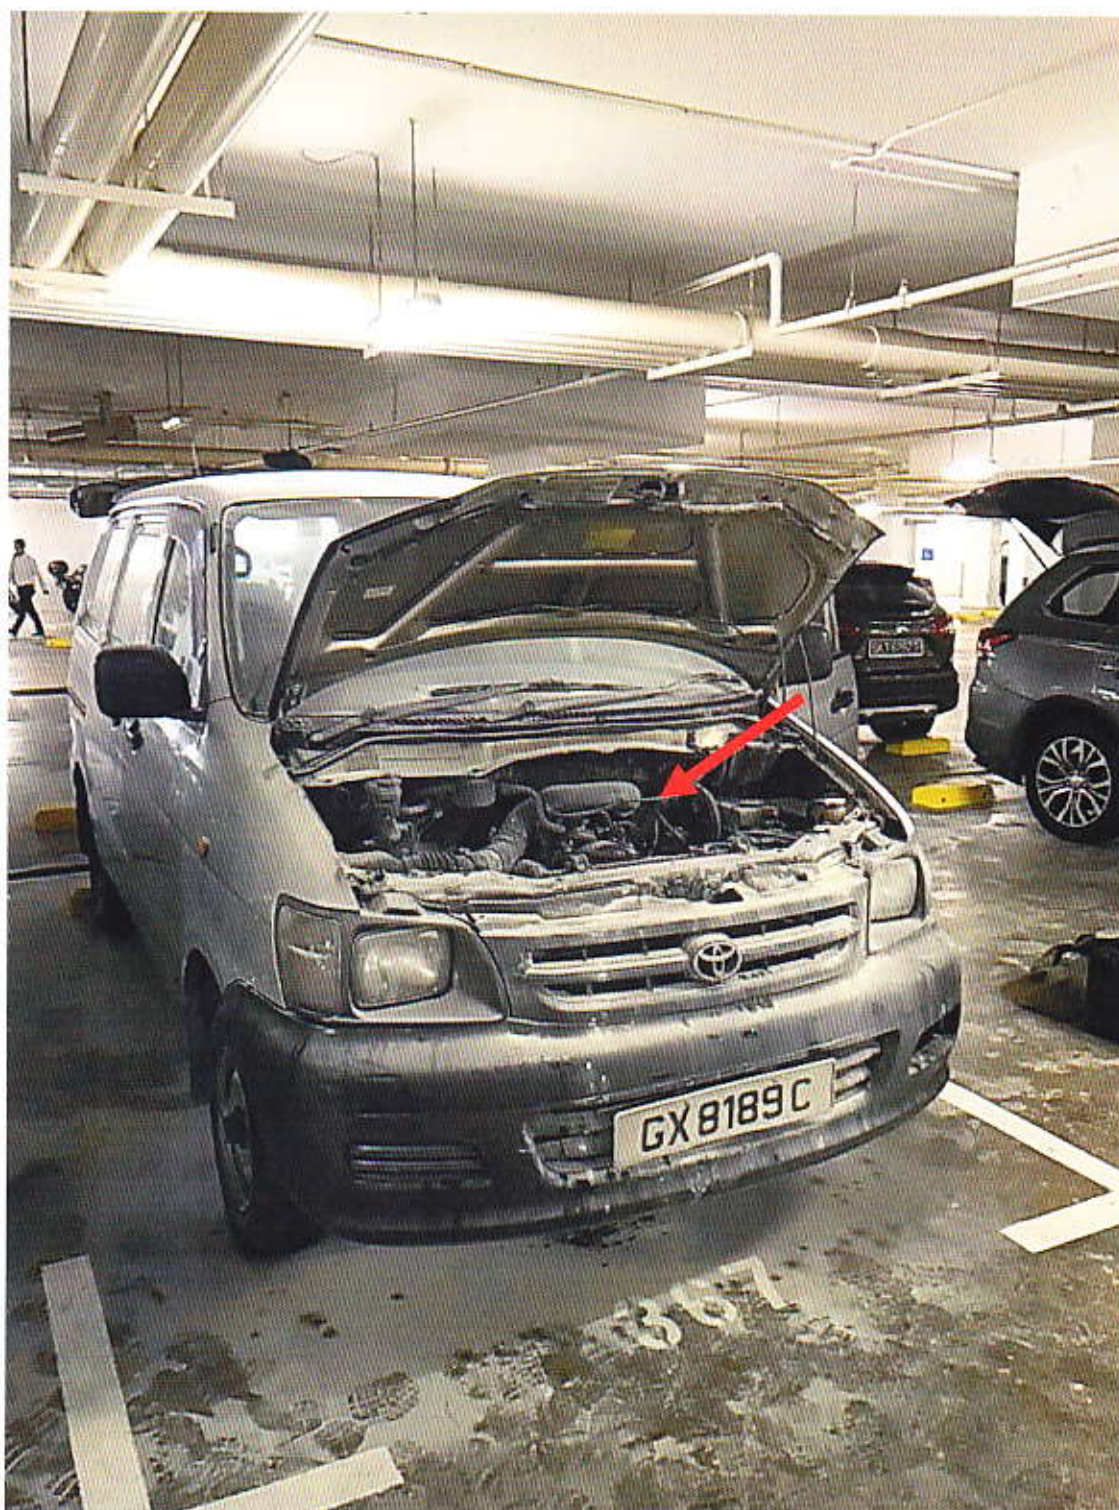
Photo 14 shows the Insured Vehicle at the fire incident scene after the fire was extinguished. There appears to be no abnormal foreign material(s) and/or object(s) found on the ground in the immediate area where the Insured Vehicle was parked. In general, the information that could be gathered from these photographs had corresponded to the events that were related to us by Mr Tan & Mr Kamal.

30. The possibility of the fire being due to external factor (foreign material(s) stuck on hot surfaces, arson and sabotage amongst others) would also seem unlikely given that our examination of the available incident scene photographs did not reveal any unusual material(s)/object(s) found on the ground near where the Insured Vehicle was parked.
