Your Ref: Audi TT  
(chassis number TRUZZZFV5H1005758)  
Our Ref : CI/TP18012402/D

09 July 2018

**INSPECTION REPORT OF AN UNREGISTERD AUDI TT MOTOR CAR WITH CHASSIS NUMBER TRUZZZFV5H1005758**

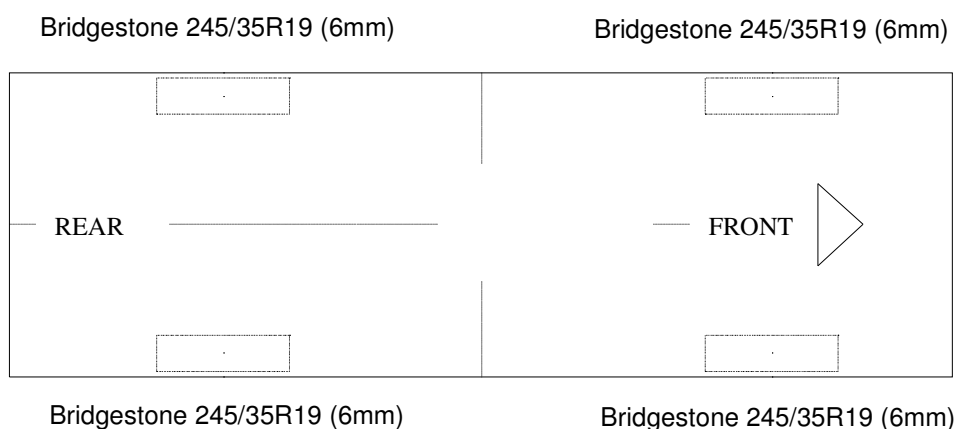
7. It was fitted with 19inch sport wheel rims that were wrapped with tyres that were observed to be of serviceable condition. The tyres were also sufficiently inflated for vehicular operation. The tyre brand, tyre size and approximate remaining tread depth of the 4 tyres of the Motor Car were recorded as follows: -

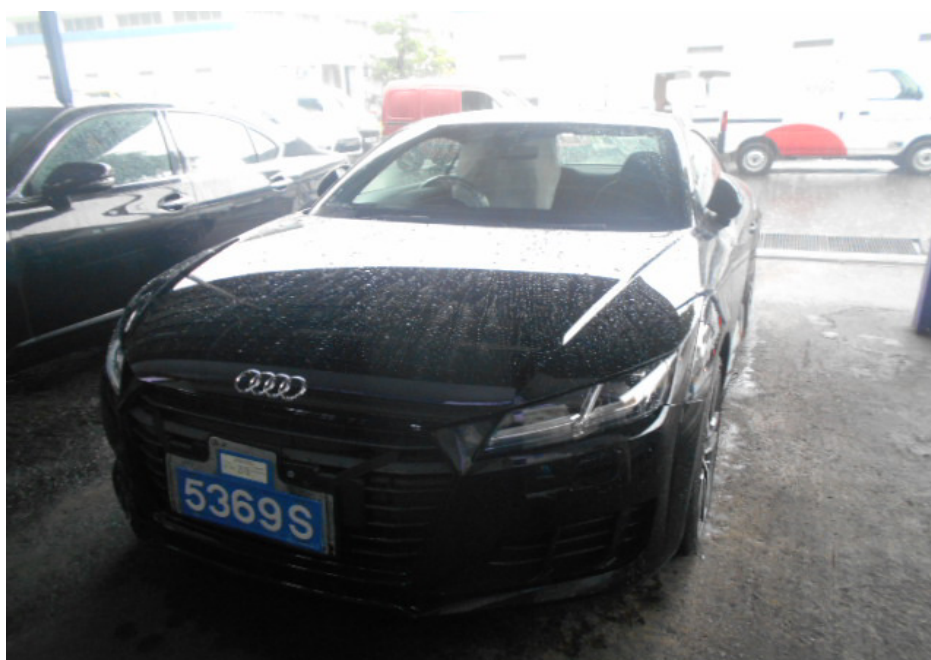
**Photo 1** shows a general view of the front left body of the Motor Car at the time of my inspection. The Motor Car was observed to be in relatively good general condition with no loose exterior fittings.

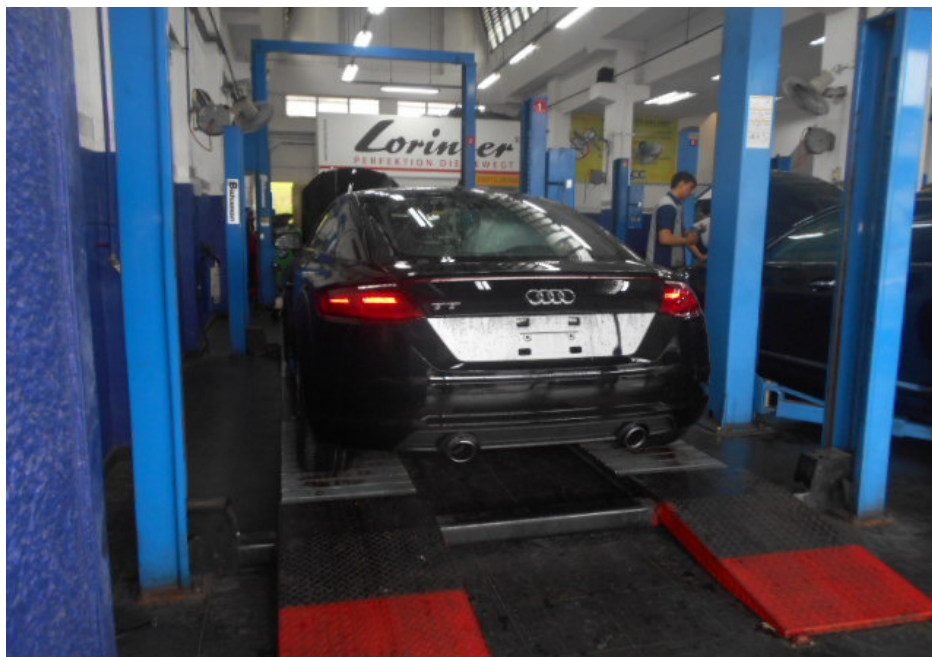
**Photo 2** shows a general view of the rear left body of the Motor Car at the time of my inspection. The Motor Car was observed to be in relatively good general condition with no loose exterior fittings. It was also hoisted up during my inspection for checks on its underside.

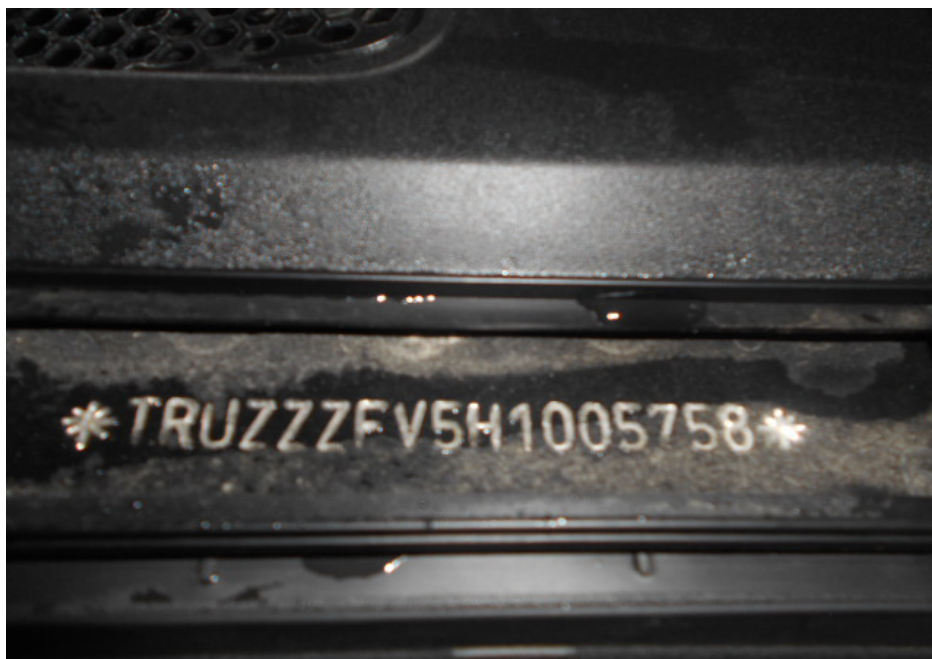
**Photo 3** shows the chassis number of the Motor Car. The chassis number recorded was TRUZZZFV5H1005758.

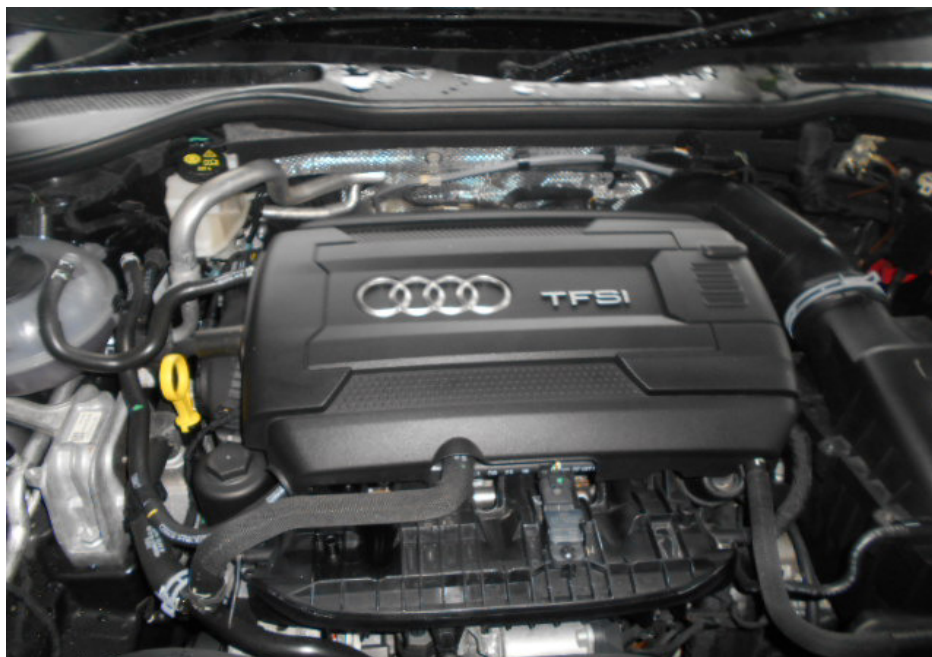
13. My examination of the Motor Car's engine compartment revealed that the various parts and components inside the engine compartment were all intact and properly fitted. The engine oil, brake fluid and engine coolant were all found to be of sufficient level for operating purposes. Visually, there was also no contamination found to these fluids.
14. My checks on the underside of the Motor Car revealed no sign(s) or indication(s) of fluid leakage and/or fluid stain(s). The engine block and automatic transmission assembly were both secured properly. They were not mounted onto the chassis body or any integral body part of the Motor Car. All undercarriage components of the Motor Car were also observed to be intact and secured in an appropriate manner.

**Photo 4** shows the engine compartment of the Motor Car. The various parts and components inside the engine compartment were all observed to be intact and properly fitted. There was no sign(s) or indication(s) of fluid leak and/or fluid stain found inside the engine compartment. The engine oil, brake fluid and engine coolant were all checked and found to be of sufficient level for operating purposes. Visually, there was no contamination found to these fluids.

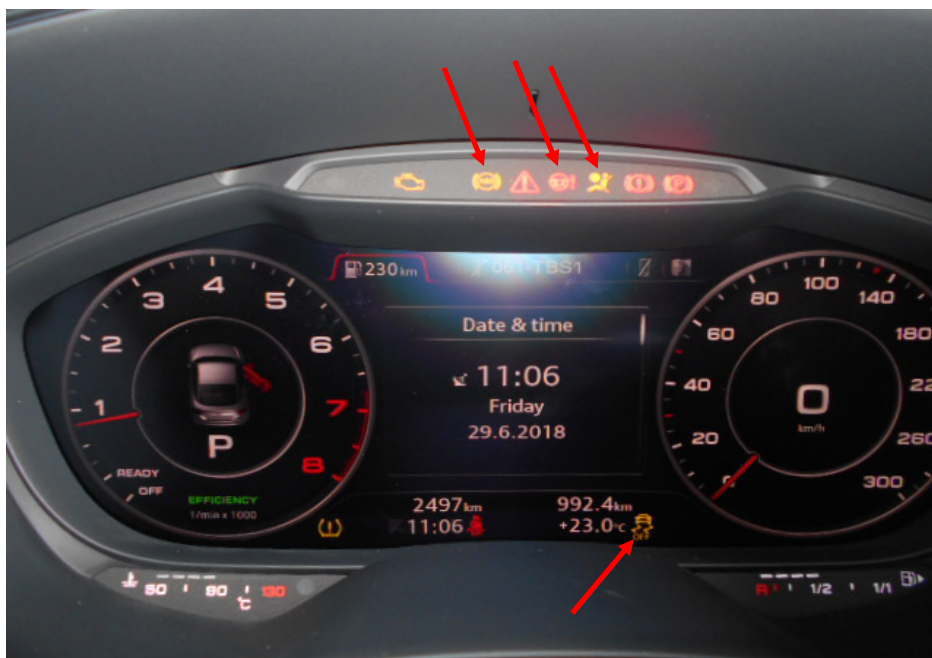
**Photo 5** shows the warning lights for the various electronic safety features appearing on the instrument panel of the Motor Car during its self-test when the engine is cranked, in particular the Anti-Brake Lock System (ABS), Supplemental Restraint System (SRS), Electric Power Steering (EPS) and Traction Control System (TCS) (arrowed).

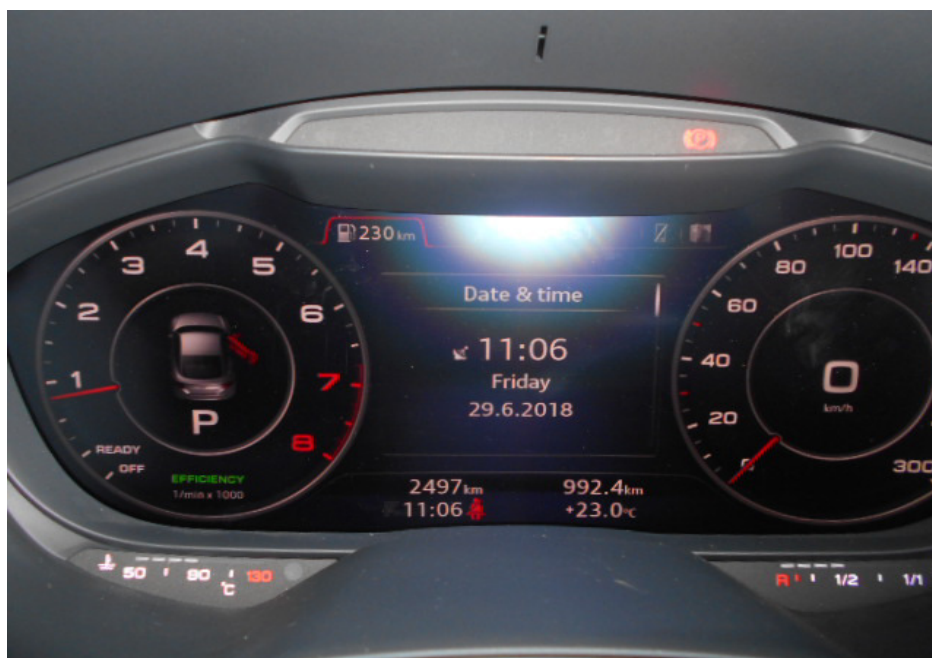
12. The Motor Car's automatic self-test of the functionality of its various electronic safety features like the Anti-Brake Lock System (ABS), Supplemental Restraint System (SRS), Electric Power Steering (EPS) and Traction Control System (TCS) during cranking of the engine had indicated that these systems were in working condition. This was determined from the respective warning lights disappearing from the instrument panel after the self-test.

**Photo 6** shows the respective warning lights no longer illuminated, indicating that there is no fault detected to the ABS, SRS, EPS and TCS systems of the Motor Car during the self-test. These electronic safety features were hence in working condition at the time of my inspection.

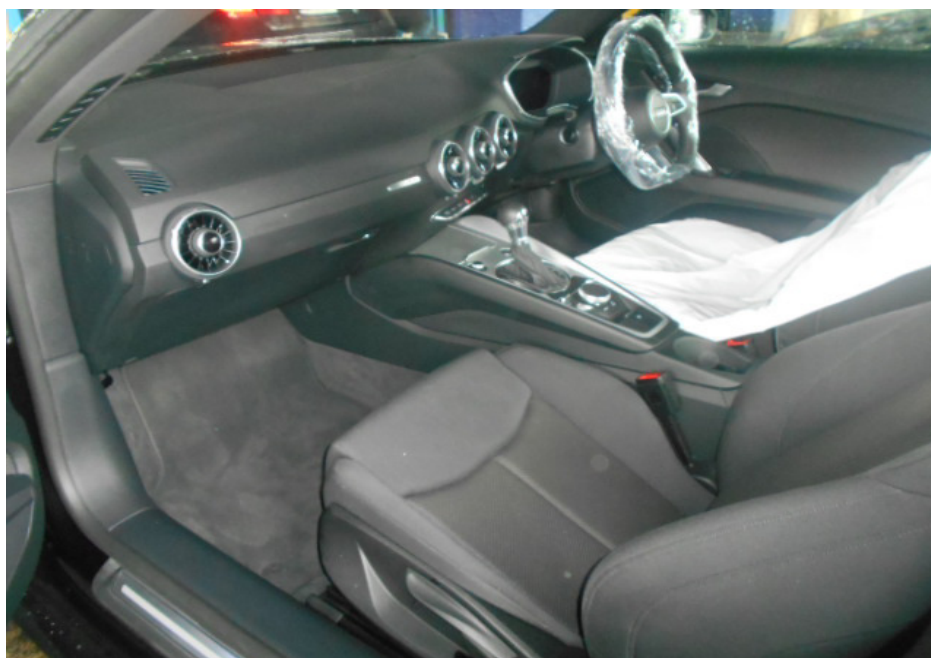
11. The seats of the Motor Car were found to be secured to the floor panel of the Motor Car via seat rails bolted onto the floor board. Retractable seat belt reels and pre-tensioners were fitted on all seats of the Motor Car. The seat belt reels were able to be fastened securely to the respective pre-tensioner that is fixed to the side of all the seats.

**Photo 7** shows the interior compartment of the Motor Car. The seats of the Motor Car were found to be secured to the floor panel of the Motor Car via seat rails bolted onto the floor board. Retractable seat belt reels and pre-tensioners were fitted on all seats of the Motor Car. The seat belt reels were able to be fastened securely to the respective pre-tensioner that is fixed to the side of all the seats.

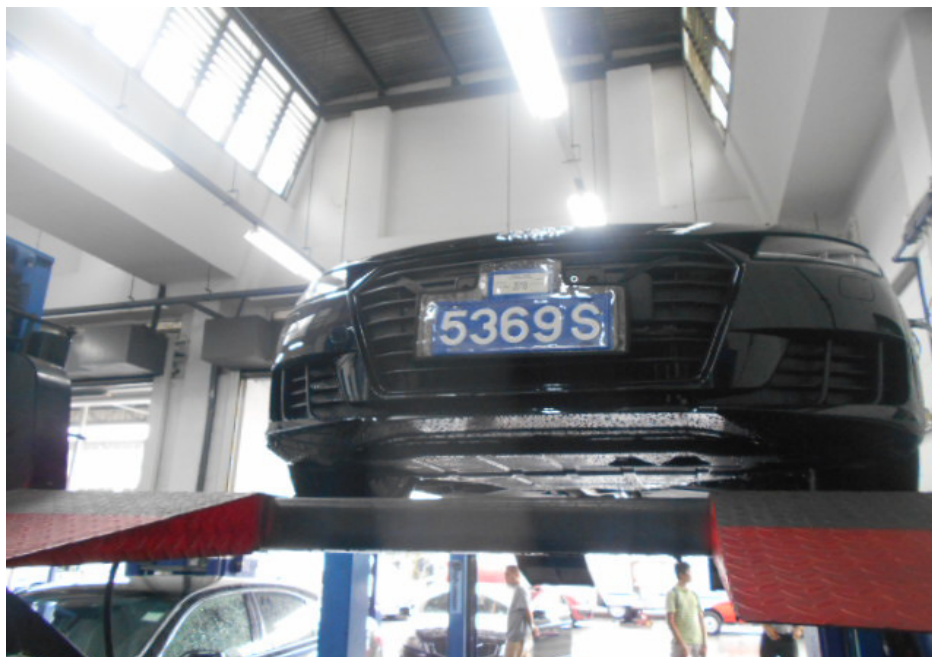
**Photo 8** shows the Motor Car hoisted up for checks on its undercarriage. The undercarriage components of the Motor Car were all observed to be intact and secured in an appropriate manner. There was also no sign(s) or indication(s) of fluid leakage and/or fluid stain(s).

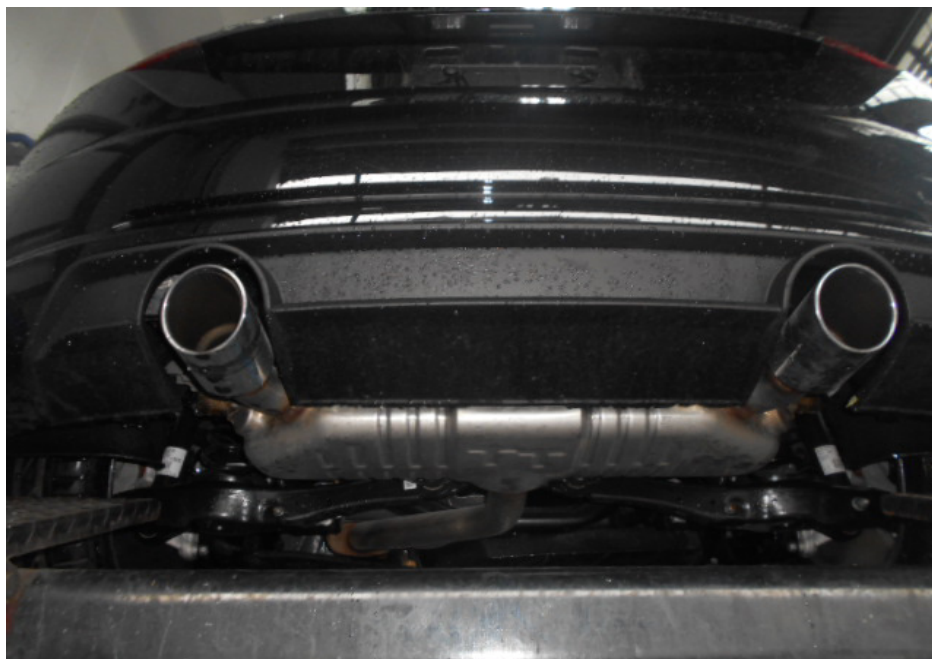
**Photo 9** shows the rear exhaust muffler of the Motor Car. There was no sign(s) or indication(s) of any cut or weld marks along the exhaust pipes and on the rear muffler.

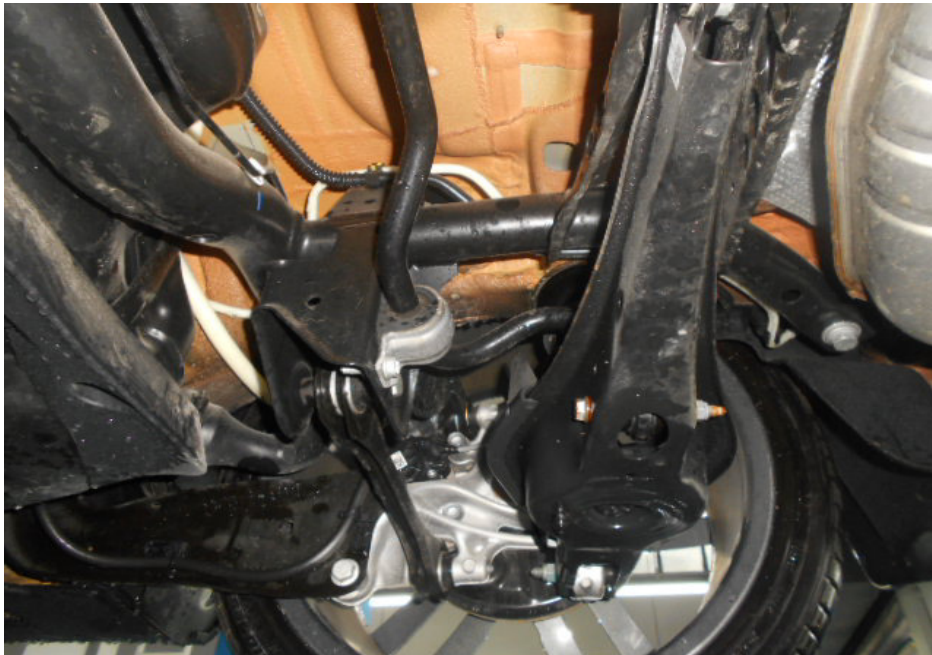
**Photo 10** shows the various undercarriage components at the rear right wheel of the Motor Car. The mechanical components, control arms and linkages were all found to be intact and secured in an appropriate manner. There was also no sign(s) or indication(s) of fluid leakage and/or fluid stain(s).

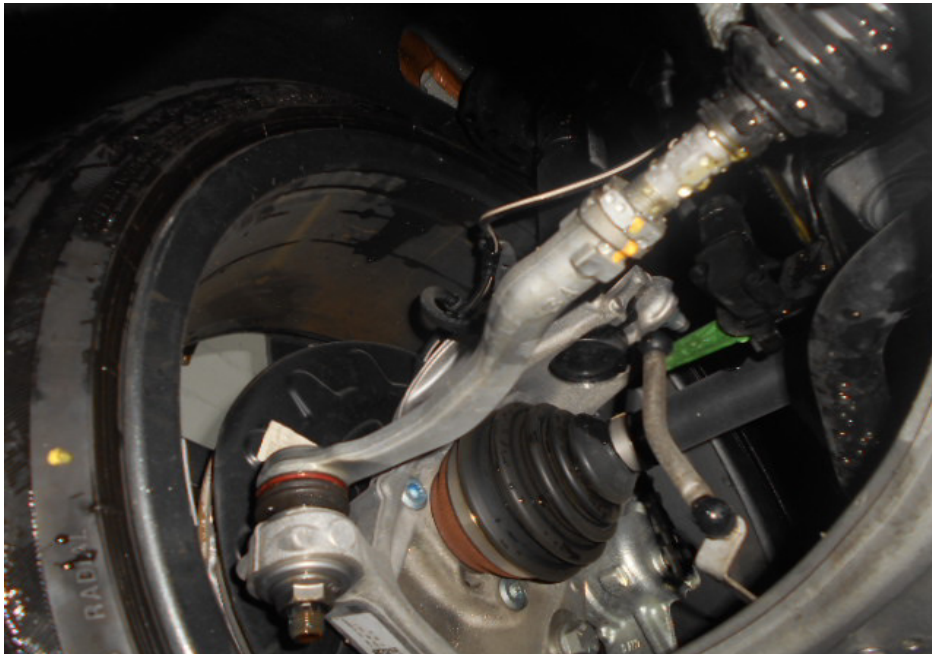
**Photo 11** shows the various undercarriage components at the front left wheel of the Motor Car. The mechanical components, control arms and linkages were all found to be intact and secured in an appropriate manner.

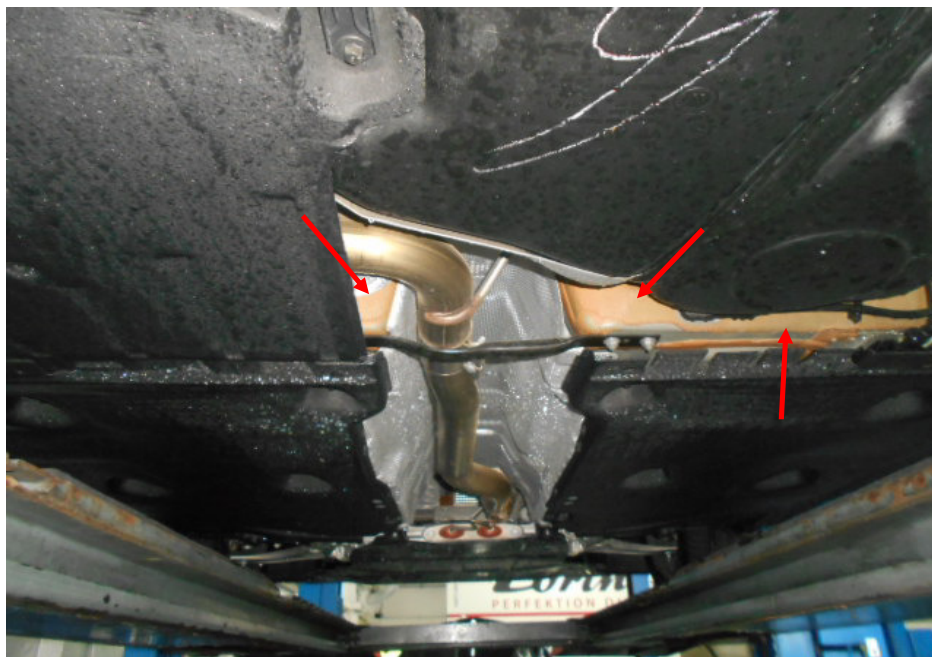
**Photo 12** shows the structural body/floor panel at the centre of the Motor Car. Visually, I did not find any weld marks, other than original spot weld marks, on the body panels of the Motor Car. The original factory sealant (arrowed) at the joints along the body panels were also untouched, indicating no work was done on the body panels of the Motor Car and that the structural body was originally fitted.

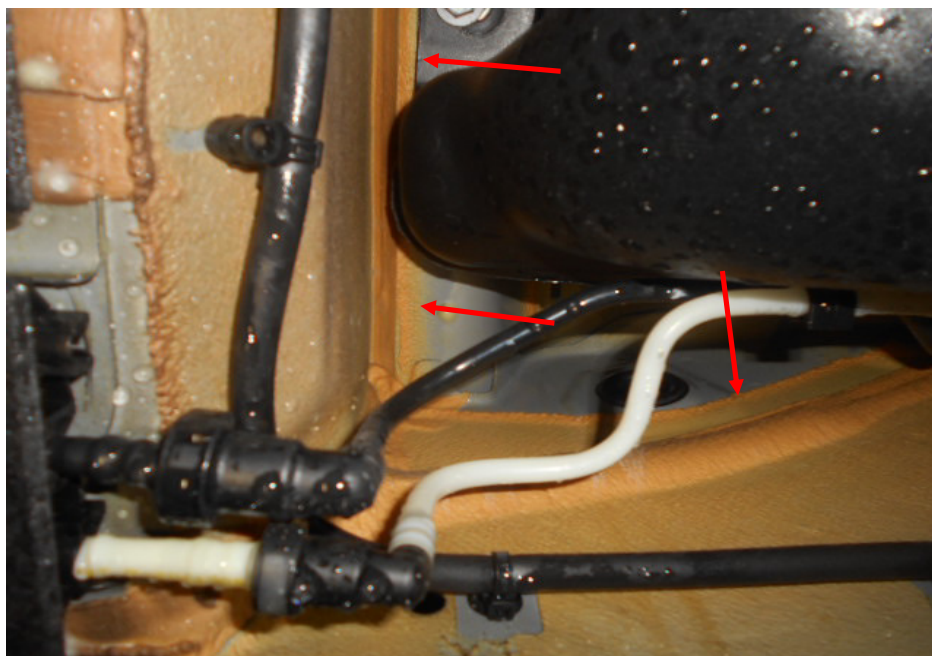
**Photo 13** shows the structural body/floor panel at the centre right of the Motor Car. I did not find any weld marks, other than original spot weld marks, on the body panels of the Motor Car. The original factory sealant (arrowed) at the joints along the body panels were also untouched, indicating no work was done on the body panels of the Motor Car and that the structural body was originally fitted.

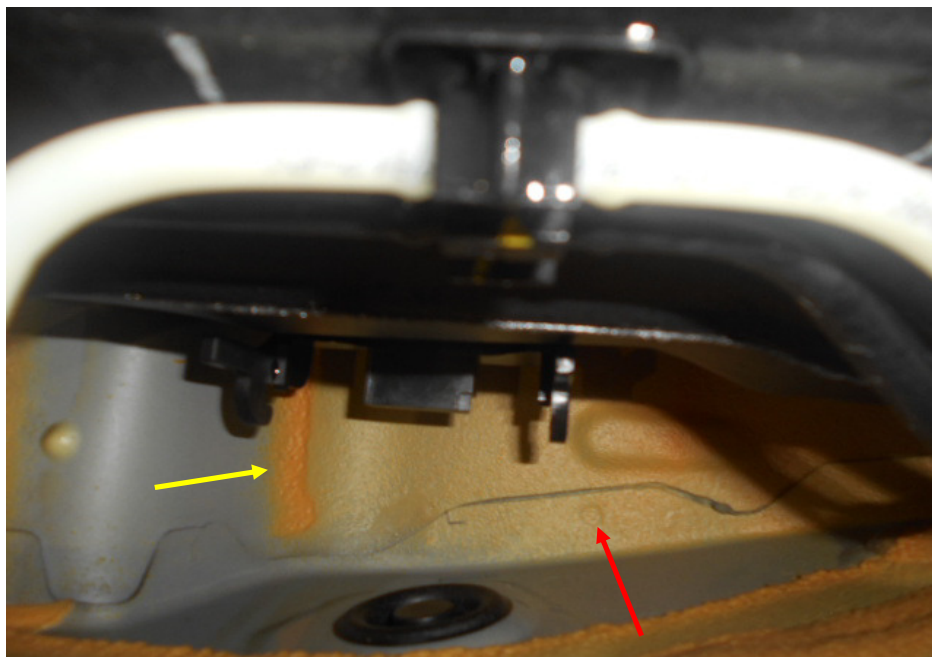
**Photo 14** shows a closer view of the structural body/floor panel at the centre right of the Motor Car. I did not find any weld marks, other than original spot weld marks (red arrow), on the body panels of the Motor Car. The original factory sealant (yellow arrow) at the joints along the body panels were also untouched, indicating no work was done on the body panels of the Motor Car.

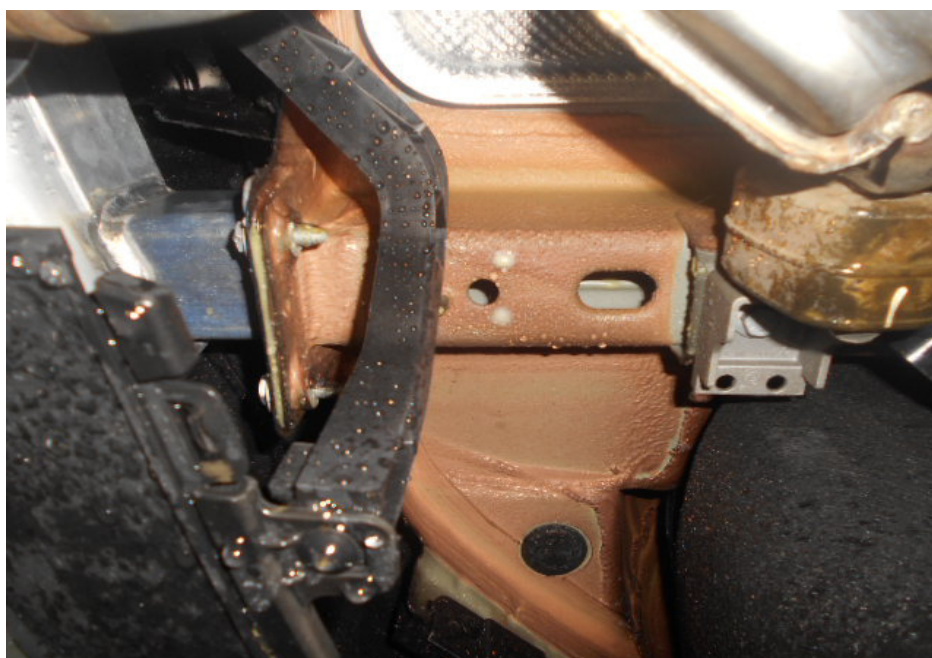
**Photo 15** shows the structural body at the rear left of the Motor Car. Visually, I did not find any weld marks, other than original spot weld marks on the body panels of the Motor Car. The joints along the body panels were also untouched, indicating no work was done on the body panels of the Motor Car and that the structural body was originally fitted.

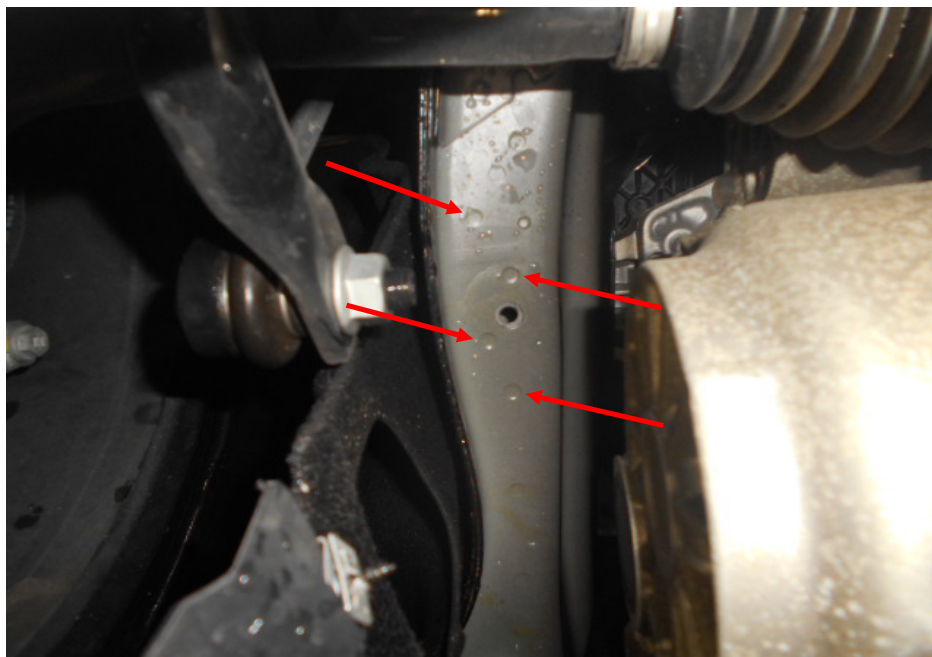
**Photo 16** shows the structural body at the front left of the Motor Car. Visually, I did not find any weld marks, other than original spot weld marks (arrowed), on the body panels of the Motor Car. The joints along the body panels were also untouched, indicating no work was done on the body panels of the Motor Car and that the structural body was originally fitted.

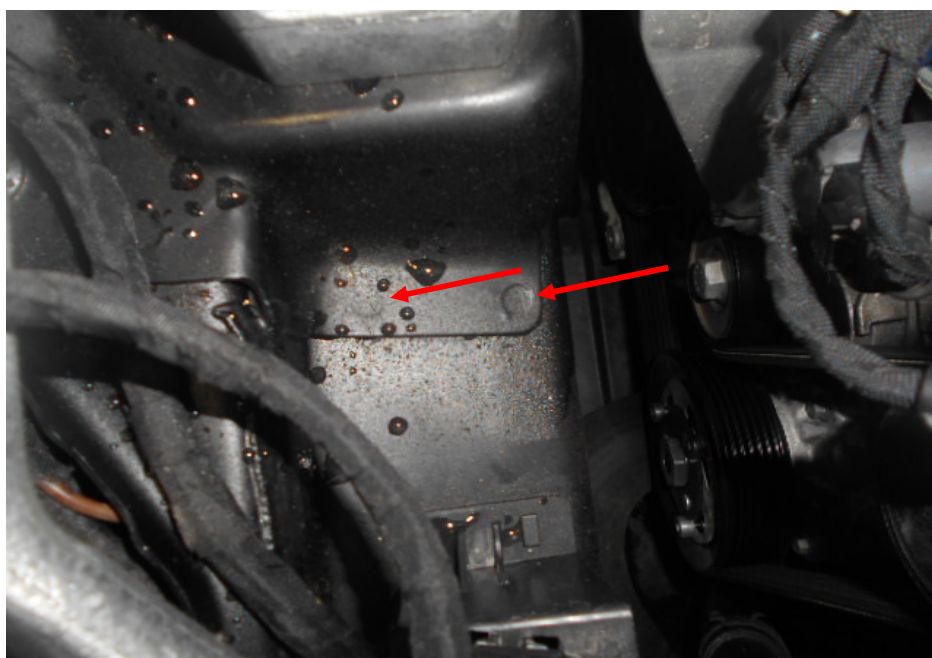
**Photo 17** shows the structural body at the front right of the Motor Car. Visually, I did not find any weld marks, other than original spot weld marks (arrowed), on the body panels of the Motor Car. The joints along the body panels were also untouched, indicating no work was done on the body panels of the Motor Car and that the structural body was originally fitted.

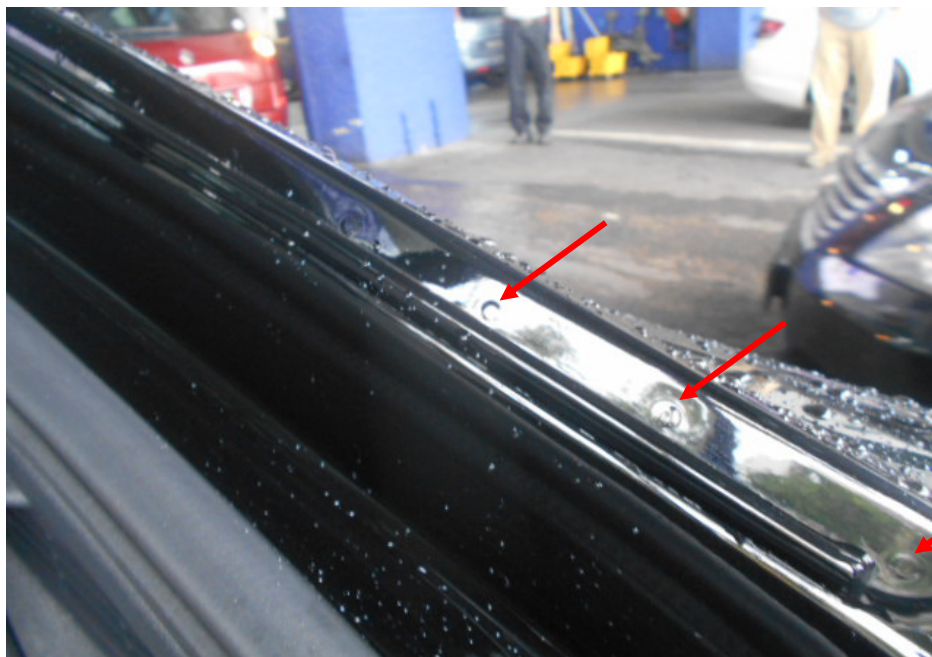
**Photo 18** shows the right rear body panel of the Motor Car. The original spot weld marks (arrowed) was found to be untouched, indicating no work was done on the right rear body panel of the Motor Car.
