Your Ref: Audi TT  
(chassis number TRUZZZFV5H1005758)  
Our Ref : CI/TP18012402/D

**INSPECTION REPORT OF AN UNREGISTERD AUDI TT MOTOR CAR WITH CHASSIS NUMBER TRUZZZFV5H1005758**

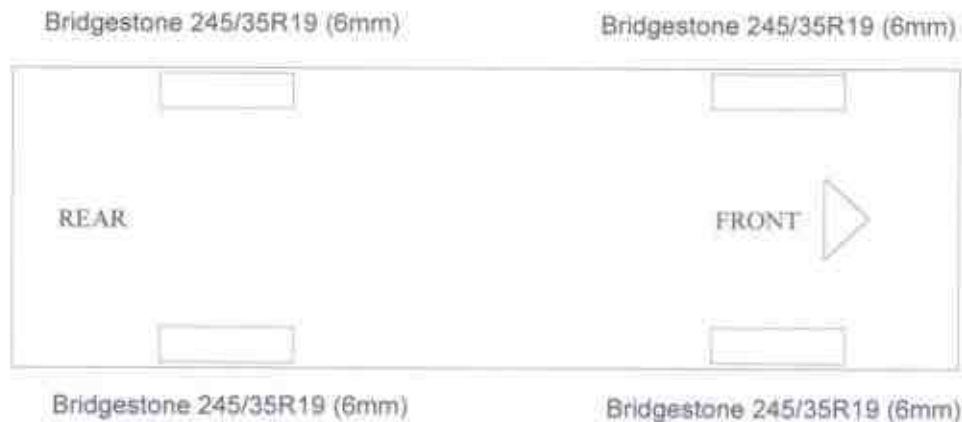
7. It was fitted with 19inch sport wheel rims that were wrapped with tyres that were observed to be of serviceable condition. The tyres were also sufficiently inflated for vehicular operation. The tyre brand, tyre size and approximate remaining tread depth of the 4 tyres of the Motor Car were recorded as follows: -

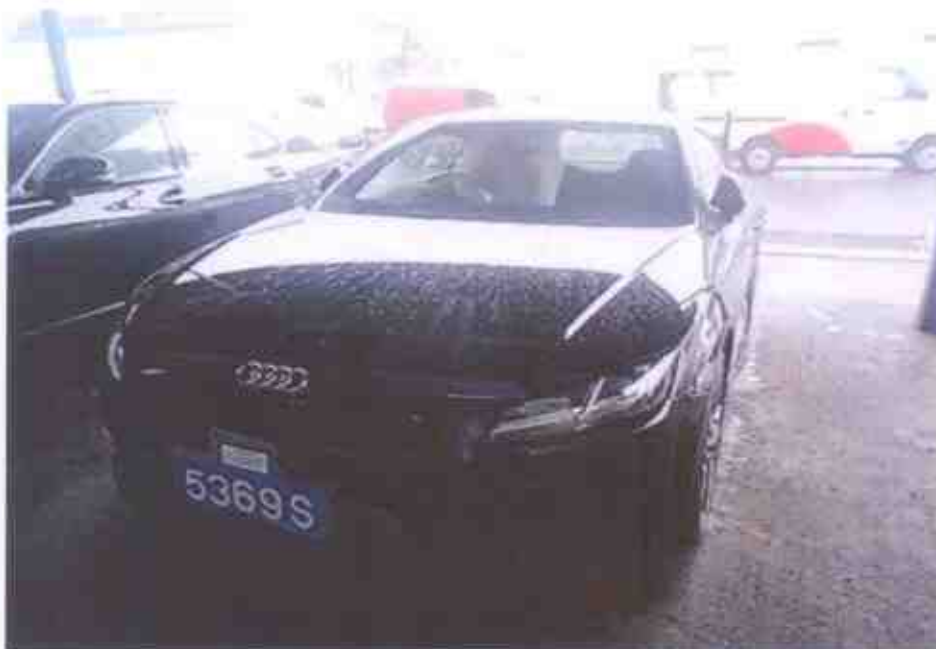
**Photo 1** shows a general view of the front left body of the Motor Car at the time of my inspection. The Motor Car was observed to be in relatively good general condition with no loose exterior fittings.

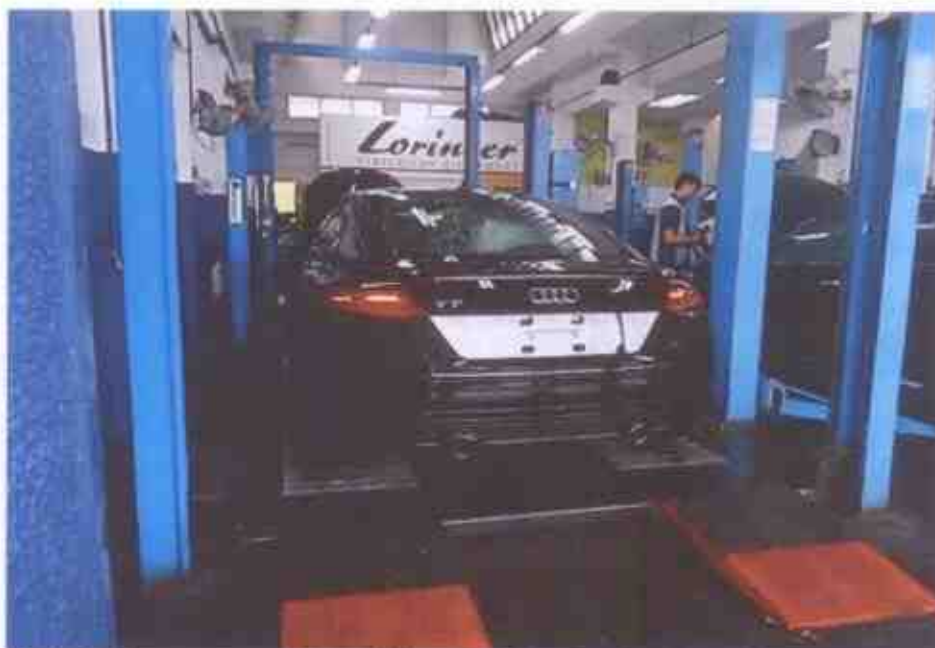
**Photo 2** shows a general view of the rear left body of the Motor Car at the time of my inspection. The Motor Car was observed to be in relatively good general condition with no loose exterior fittings. It was also hoisted up during my inspection for checks on its underside.

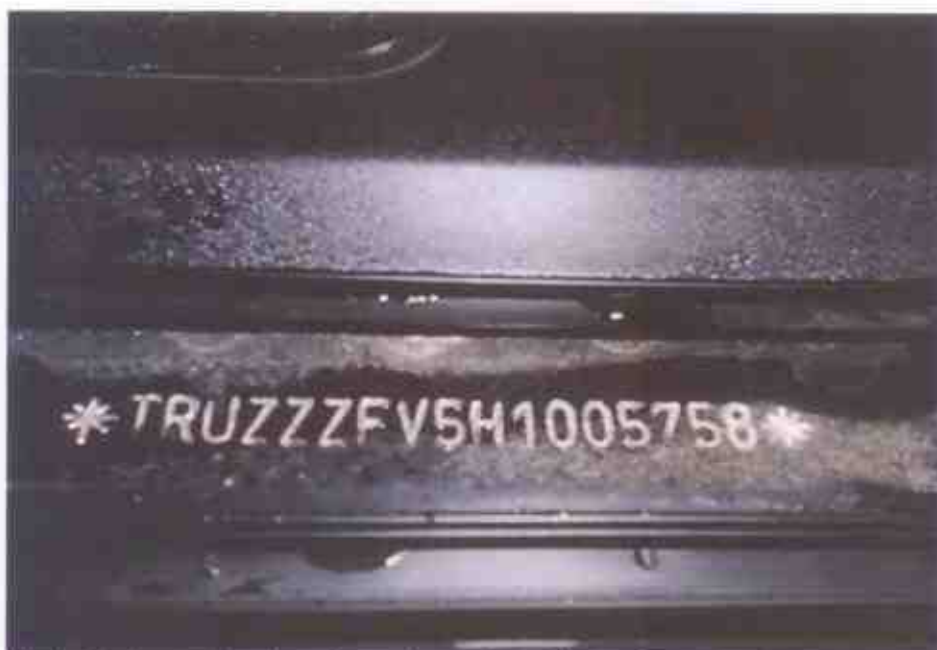
**Photo 3** shows the chassis number of the Motor Car. The chassis number recorded was TRUZZZ FV5H1005758.

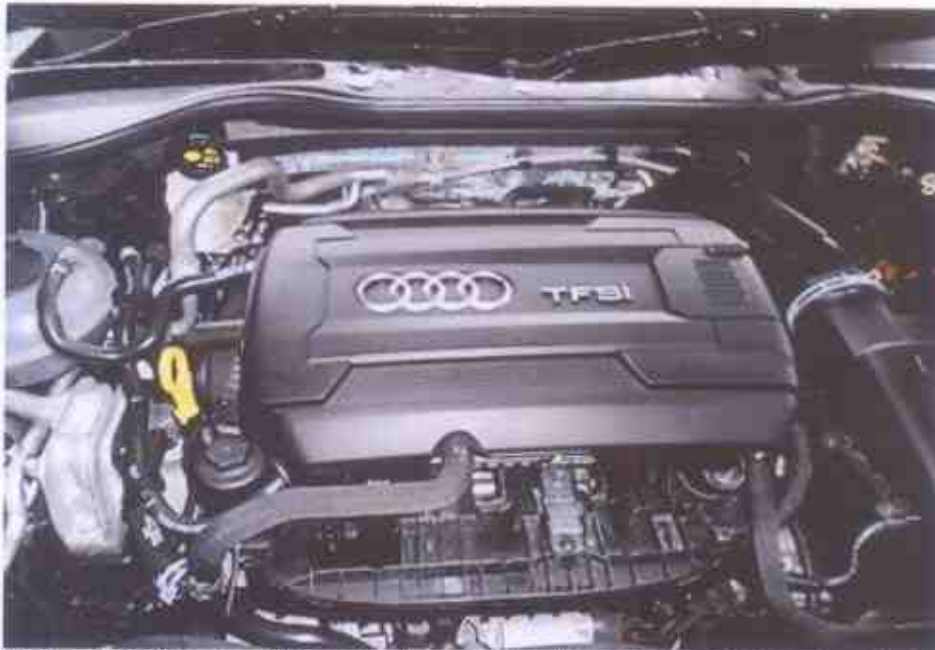
13. My examination of the Motor Car's engine compartment revealed that the various parts and components inside the engine compartment were all intact and properly fitted. The engine oil, brake fluid and engine coolant were all found to be of sufficient level for operating purposes. Visually, there was also no contamination found to these fluids.
14. My checks on the underside of the Motor Car revealed no sign(s) or indication(s) of fluid leakage and/or fluid stain(s). The engine block and automatic transmission assembly were both secured properly. They were not mounted onto the chassis body or any integral body part of the Motor Car. All undercarriage components of the Motor Car were also observed to be intact and secured in an appropriate manner.

Photo 4 shows the engine compartment of the Motor Car. The various parts and components inside the engine compartment were all observed to be intact and properly fitted. There was no sign(s) or indication(s) of fluid leak and/or fluid stain found inside the engine compartment. The engine oil, brake fluid and engine coolant were all checked and found to be of sufficient level for operating purposes. Visually, there was no contamination found to these fluids.

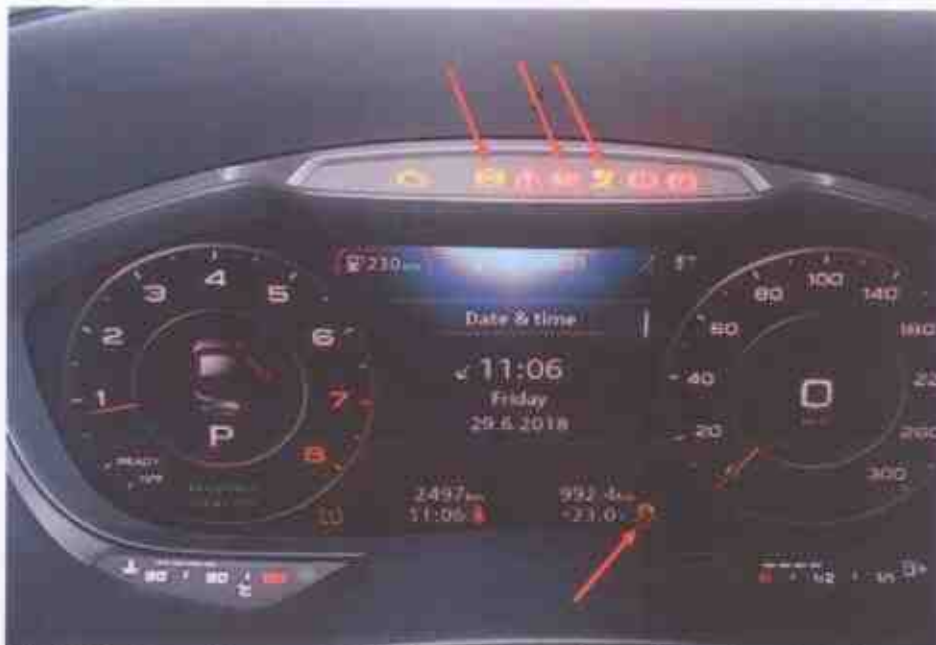
Photo 5 shows the warning lights for the various electronic safety features appearing on the instrument panel of the Motor Car during its self-test when the engine is cranked, in particular the Anti-Brake Lock System (ABS), Supplemental Restraint System (SRS), Electric Power Steering (EPS) and Traction Control System (TCS) (arrowed).

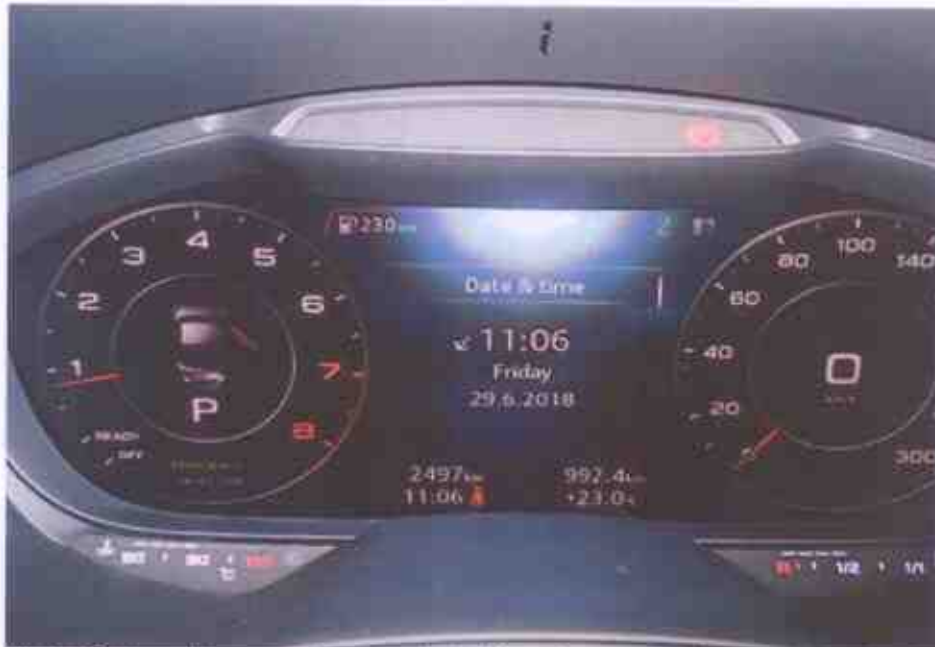
12. The Motor Car's automatic self-test of the functionality of its various electronic safety features like the Anti-Brake Lock System (ABS), Supplemental Restraint System (SRS), Electric Power Steering (EPS) and Traction Control System (TCS) during cranking of the engine had indicated that these systems were in working condition. This was determined from the respective warning lights disappearing from the instrument panel after the self-test.

**Photo 6** shows the respective warning lights no longer illuminated, indicating that there is no fault detected to the ABS, SRS, EPS and TCS systems of the Motor Car during the self-test. These electronic safety features were hence in working condition at the time of my inspection.

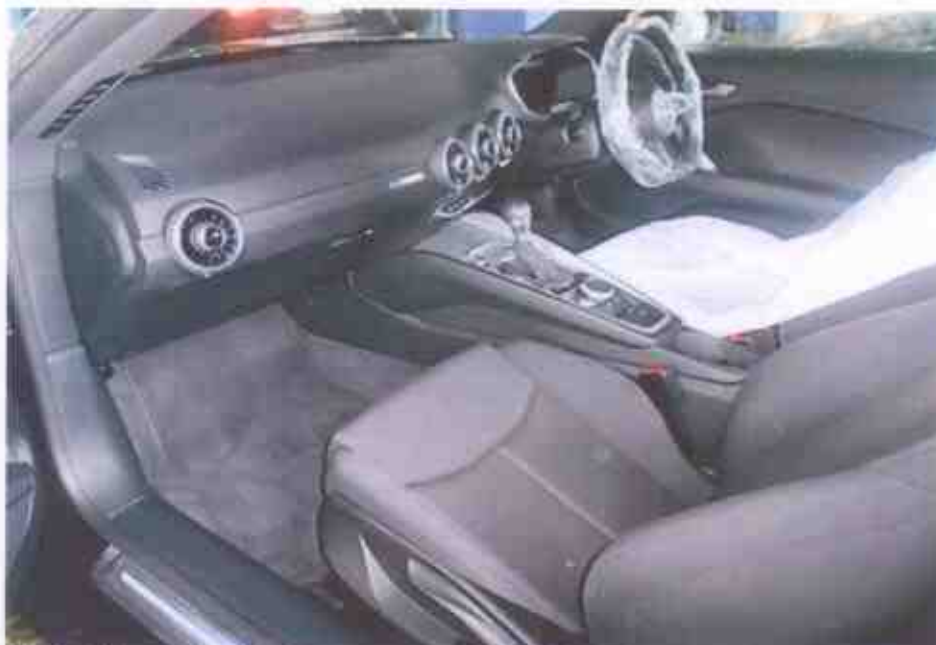
11. The seats of the Motor Car were found to be secured to the floor panel of the Motor Car via seat rails bolted onto the floor board. Retractable seat belt reels and pre-tensioners were fitted on all seats of the Motor Car. The seat belt reels were able to be fastened securely to the respective pre-tensioner that is fixed to the side of all the seats.

**Photo 7** shows the interior compartment of the Motor Car. The seats of the Motor Car were found to be secured to the floor panel of the Motor Car via seat rails bolted onto the floor board. Retractable seat belt reels and pre-tensioners were fitted on all seats of the Motor Car. The seat belt reels were able to be fastened securely to the respective pre-tensioner that is fixed to the side of all the seats.

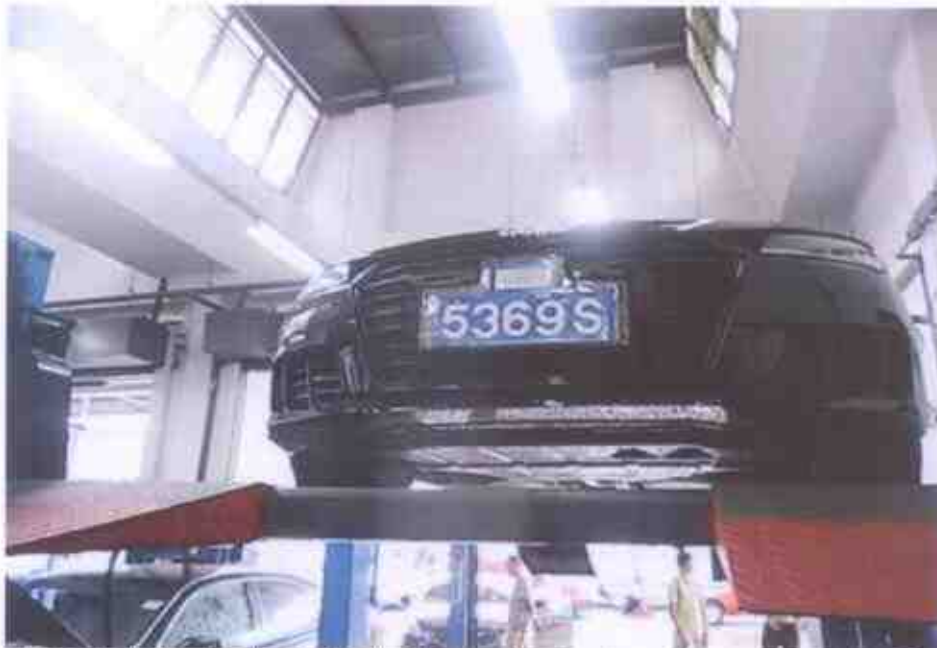
Photo 8 shows the Motor Car hoisted up for checks on its undercarriage. The undercarriage components of the Motor Car were all observed to be intact and secured in an appropriate manner. There was also no sign(s) or indication(s) of fluid leakage and/or fluid stain(s).

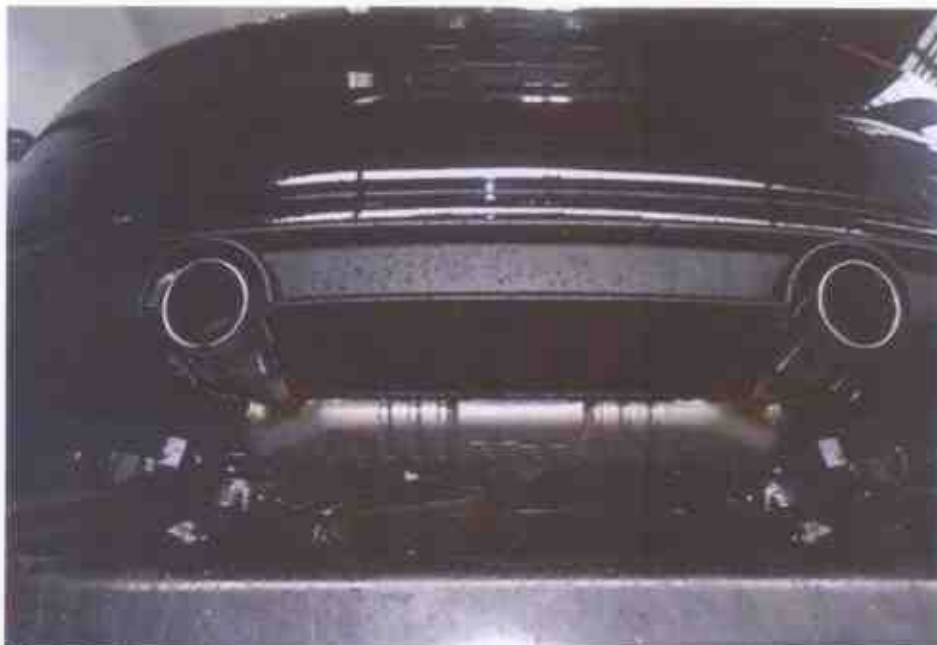
Photo 9 shows the rear exhaust muffler of the Motor Car. There was no sign(s) or indication(s) of any cut or weld marks along the exhaust pipes and on the rear muffler.

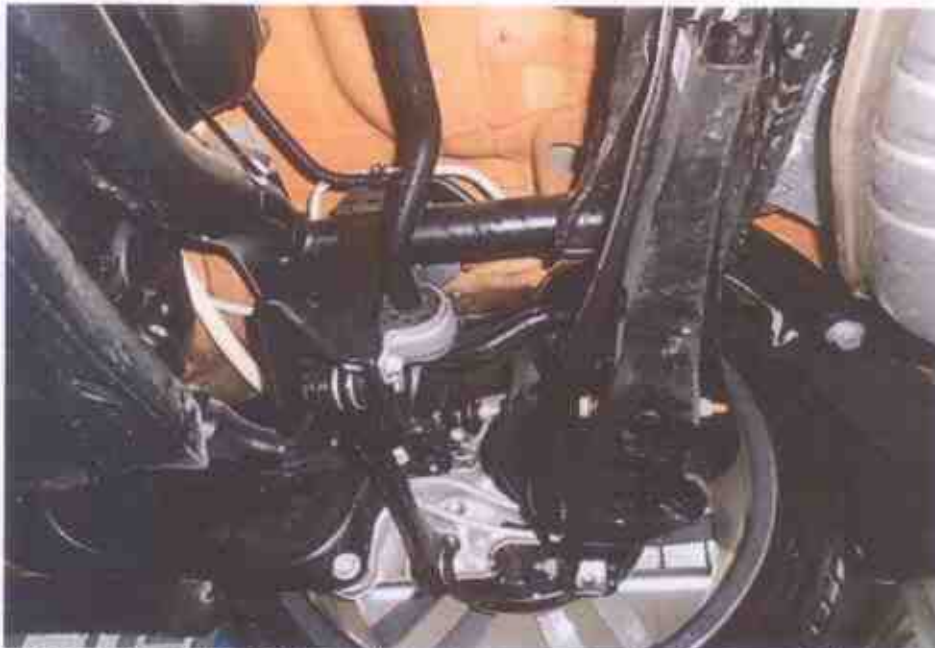
Photo 10 shows the various undercarriage components at the rear right wheel of the Motor Car. The mechanical components, control arms and linkages were all found to be intact and secured in an appropriate manner. There was also no sign(s) or indication(s) of fluid leakage and/or fluid stain(s).

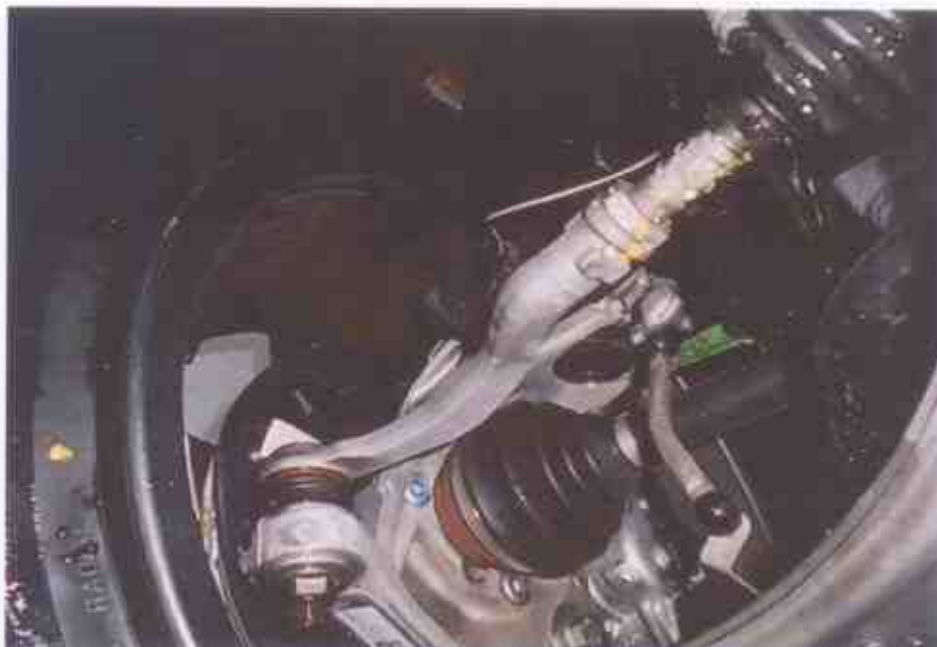
Photo 11 shows the various undercarriage components at the front left wheel of the Motor Car. The mechanical components, control arms and linkages were all found to be intact and secured in an appropriate manner.

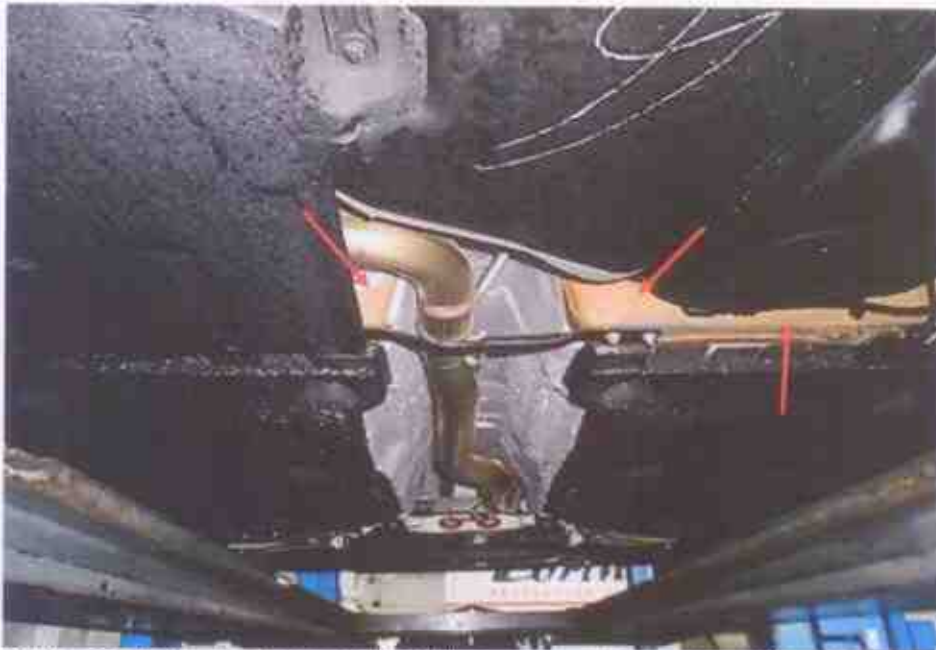
Photo 12 shows the structural body/floor panel at the centre of the Motor Car. Visually, I did not find any weld marks, other than original spot weld marks, on the body panels of the Motor Car. The original factory sealant (arrowed) at the joints along the body panels were also untouched, indicating no work was done on the body panels of the Motor Car and that the structural body was originally fitted.

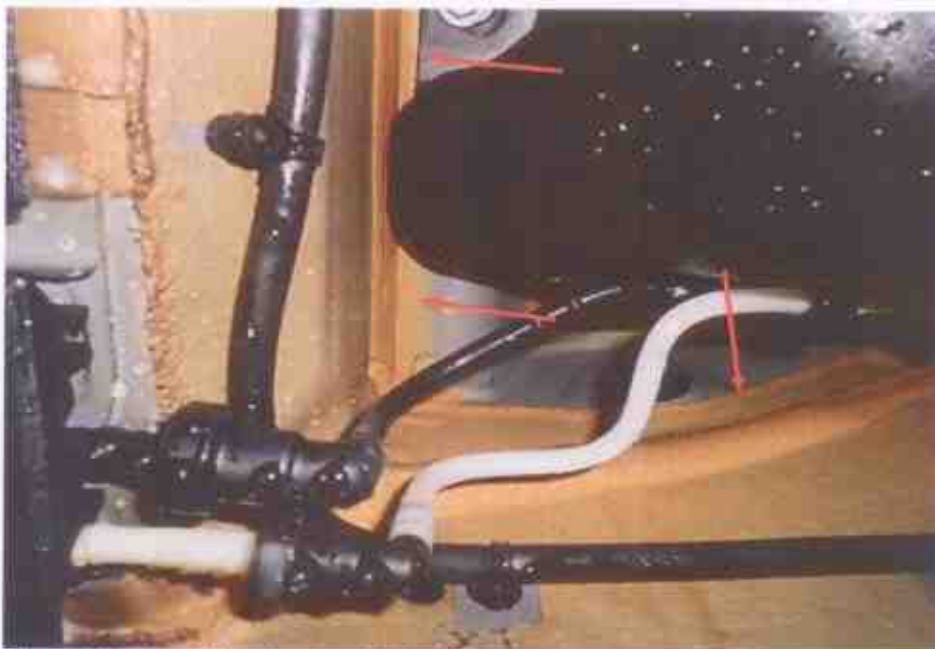
Photo 13 shows the structural body/floor panel at the centre right of the Motor Car. I did not find any weld marks, other than original spot weld marks, on the body panels of the Motor Car. The original factory sealant (arrowed) at the joints along the body panels were also untouched, indicating no work was done on the body panels of the Motor Car and that the structural body was originally fitted.

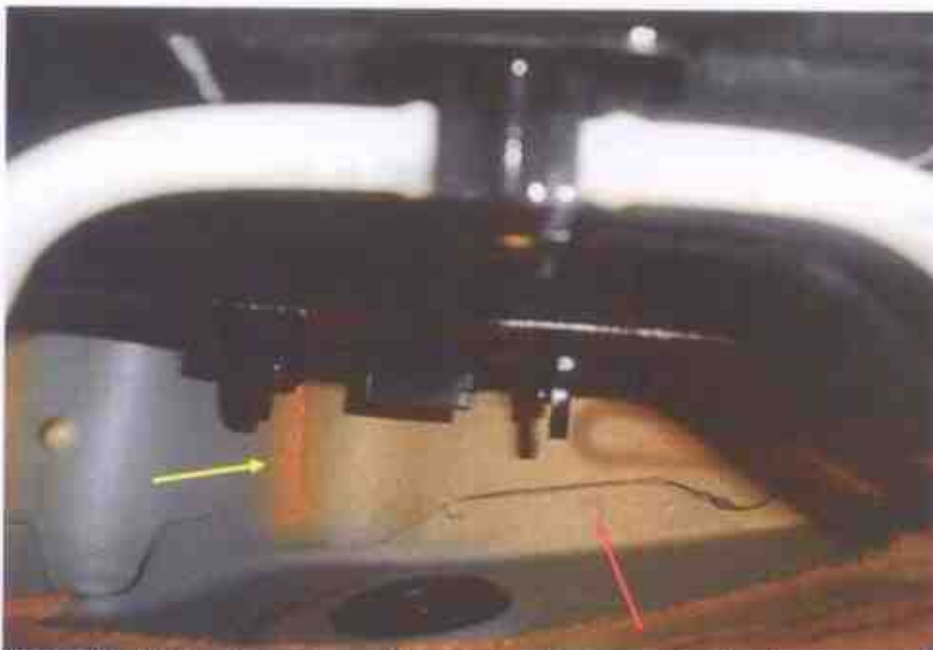
**Photo 14** shows a closer view of the structural body/floor panel at the centre right of the Motor Car. I did not find any weld marks, other than original spot weld marks (red arrow), on the body panels of the Motor Car. The original factory sealant (yellow arrow) at the joints along the body panels were also untouched, indicating no work was done on the body panels of the Motor Car.

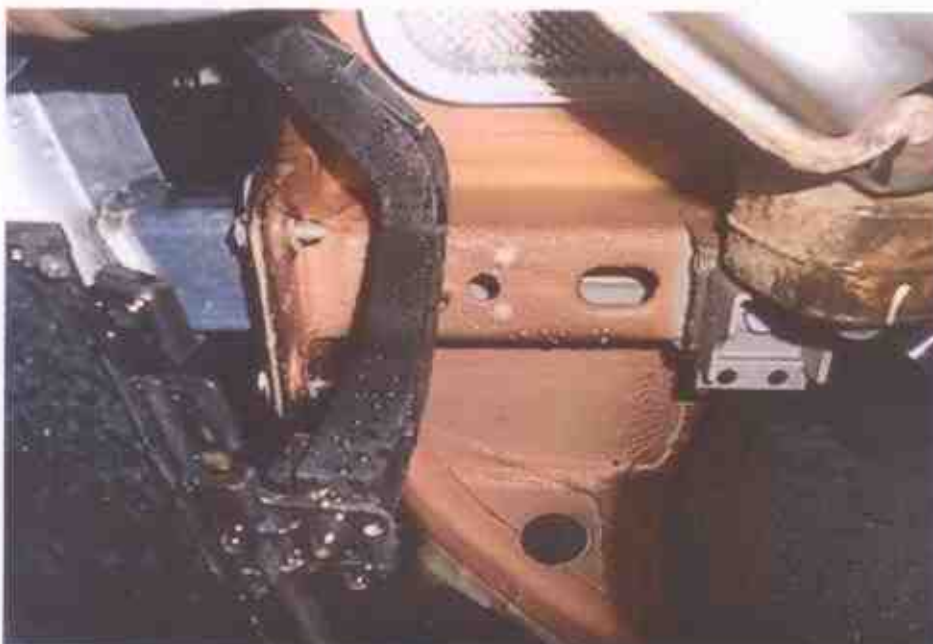
**Photo 15** shows the structural body at the rear left of the Motor Car. Visually, I did not find any weld marks, other than original spot weld marks on the body panels of the Motor Car. The joints along the body panels were also untouched, indicating no work was done on the body panels of the Motor Car and that the structural body was originally fitted.

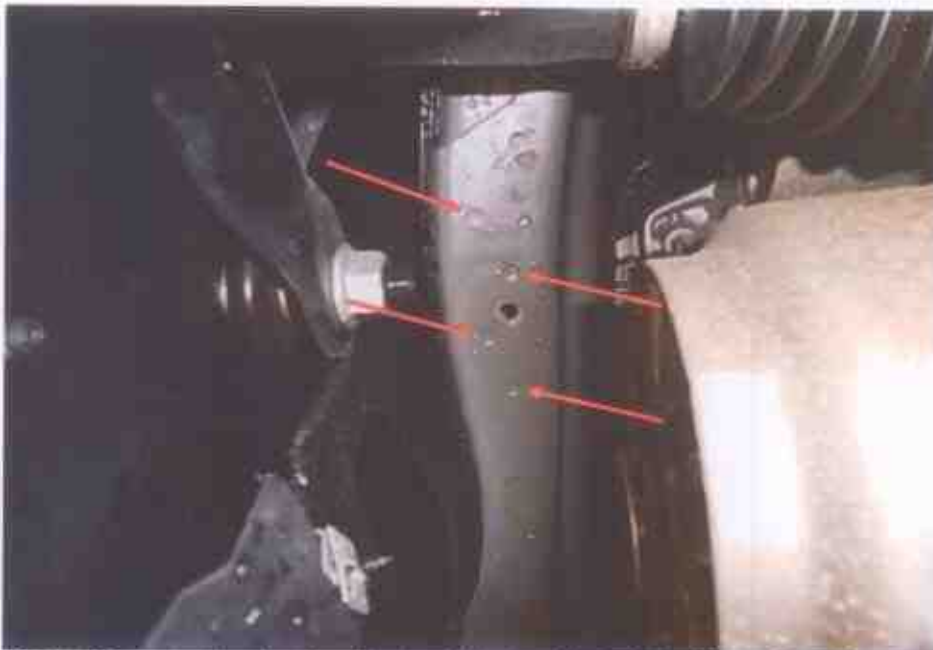
Photo 16 shows the structural body at the front left of the Motor Car. Visually, I did not find any weld marks, other than original spot weld marks (arrowed), on the body panels of the Motor Car. The joints along the body panels were also untouched, indicating no work was done on the body panels of the Motor Car and that the structural body was originally fitted.

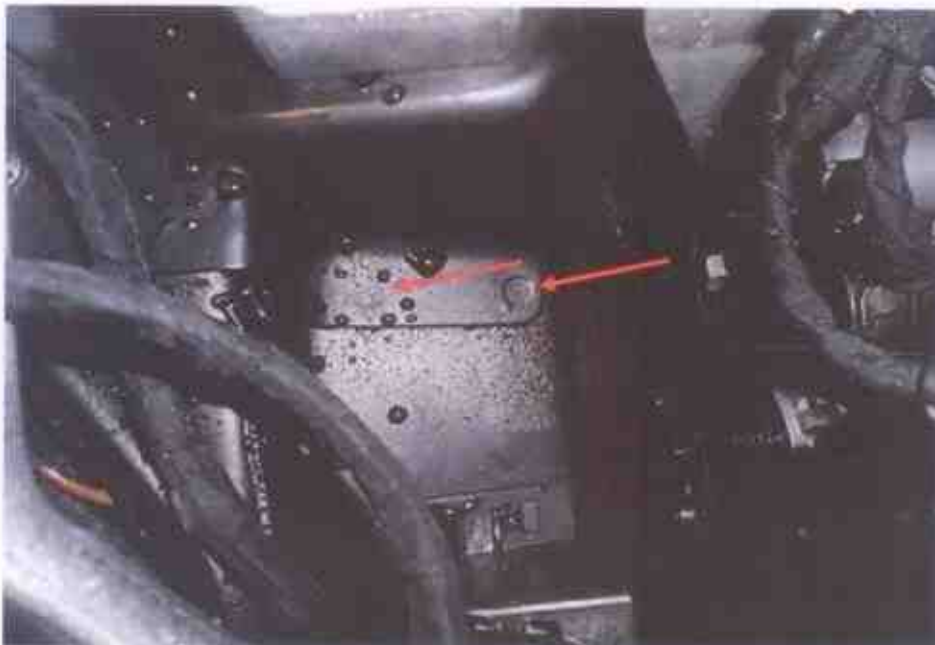
Photo 17 shows the structural body at the front right of the Motor Car. Visually, I did not find any weld marks, other than original spot weld marks (arrowed), on the body panels of the Motor Car. The joints along the body panels were also untouched, indicating no work was done on the body panels of the Motor Car and that the structural body was originally fitted.

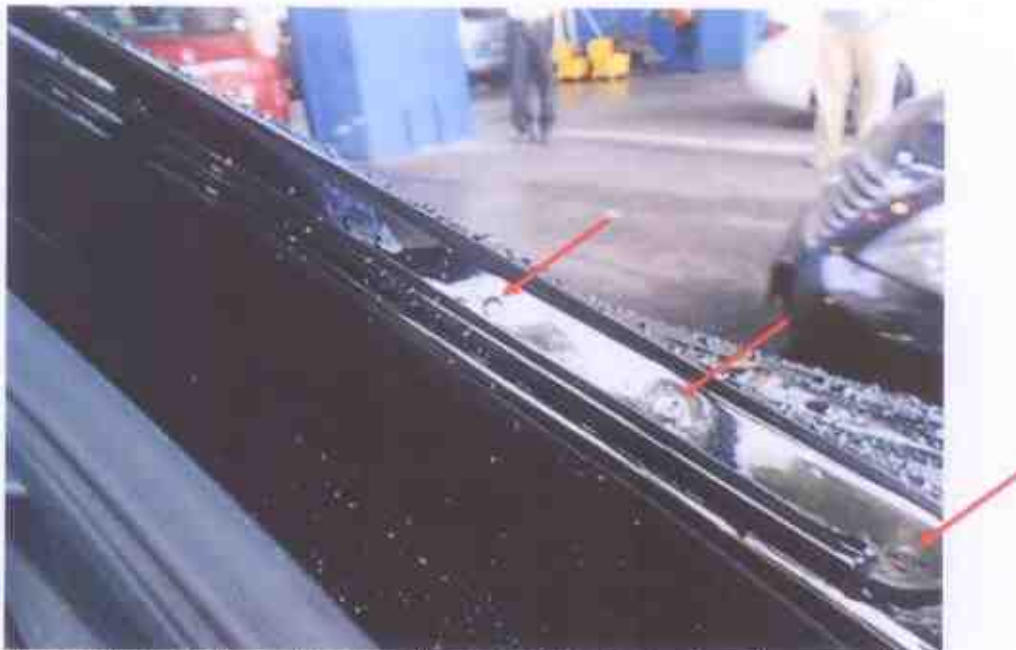
Photo 18 shows the right rear body panel of the Motor Car. The original spot weld marks (arrowed) was found to be untouched, indicating no work was done on the right rear body panel of the Motor Car.
