Your Ref: Mercedes Benz E200  
(chassis number WDD2130422A028173)  
Our Ref : CI/TP18012403/D

10 July 2018

**INSPECTION REPORT OF AN UNREGISTERED MERCEDES BENZ E200 MOTOR CAR WITH CHASSIS NUMBER WDD2130422A028173**

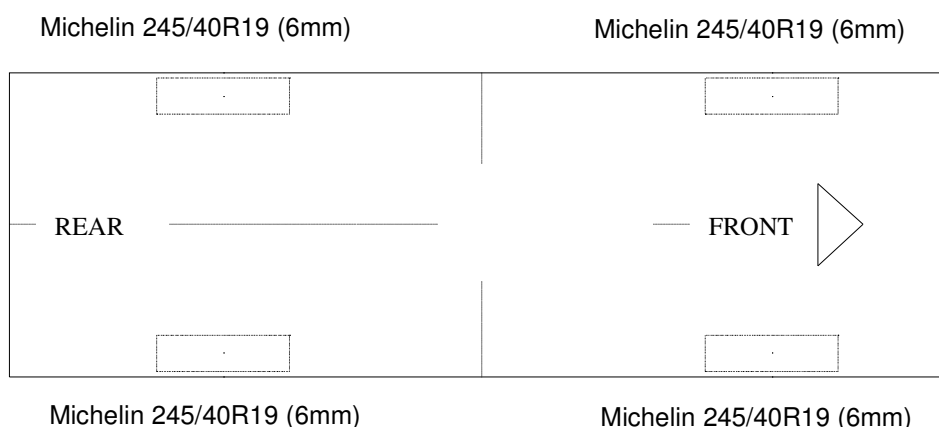
7. It was fitted with 19inch sport wheel rims that were wrapped with tyres that were observed to be of serviceable condition. The tyres were also sufficiently inflated for vehicular operation. The tyre brand, tyre size and approximate remaining tread depth of the 4 tyres of the Motor Car were recorded as follows: -

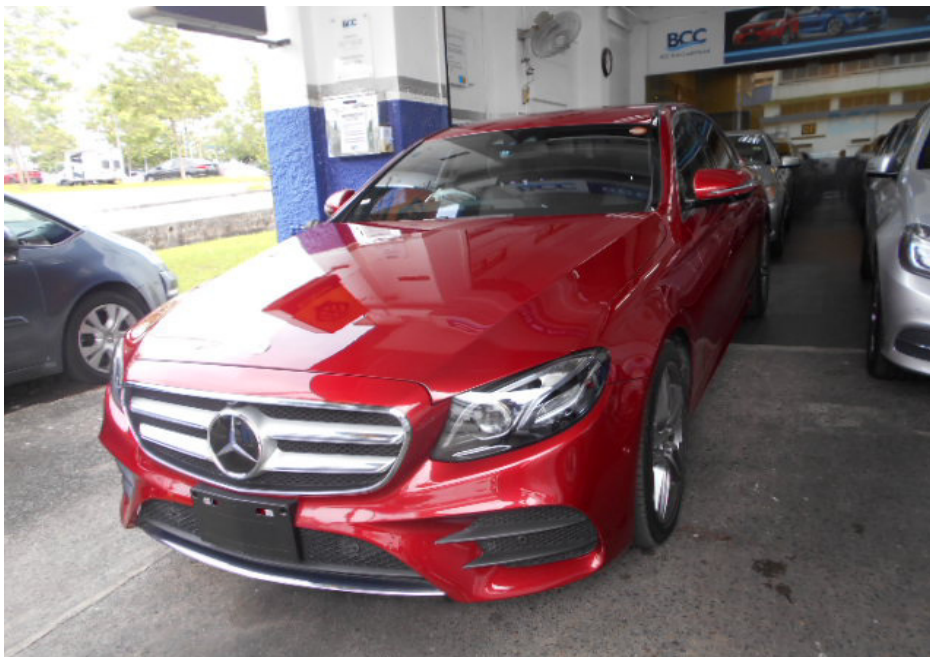
6. The Motor Car was observed to be in a relatively good general condition with no loose exterior fittings observed.

**Photo 1** shows a general view of the front left body of the Motor Car at the time of my inspection. The Motor Car was observed to be in relatively good general condition with no loose exterior fittings observed.

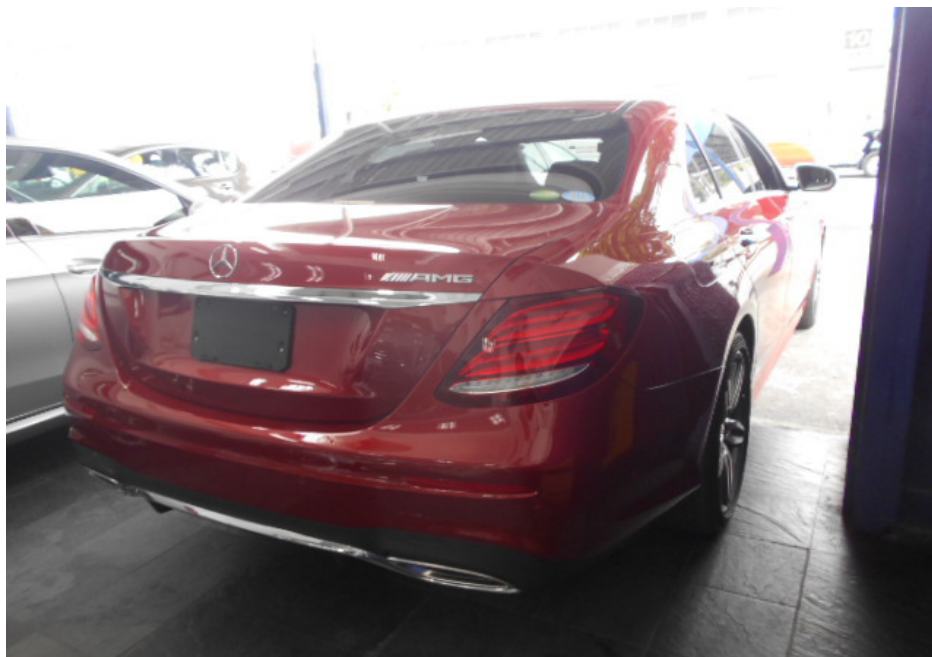
**Photo 2** shows a general view of the rear right body of the Motor Car at the time of my inspection. The Motor Car was observed to be in relatively good general condition with no loose exterior fittings observed. It was also hoisted up during my inspection for checks on its underside.

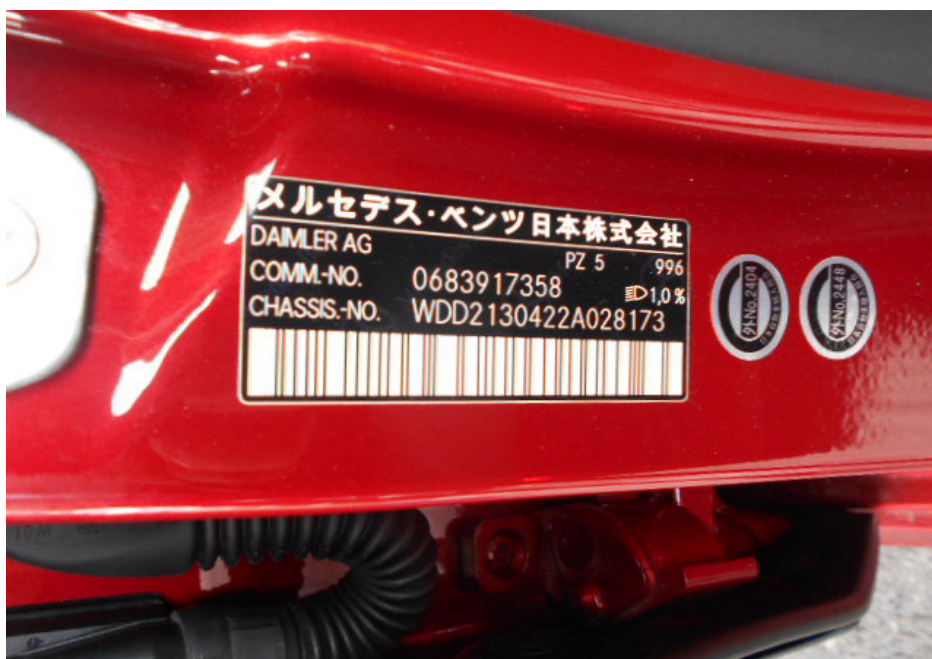
**Photo 3** shows the chassis number of the Motor Car. The chassis number recorded was WDD2130422A028173.

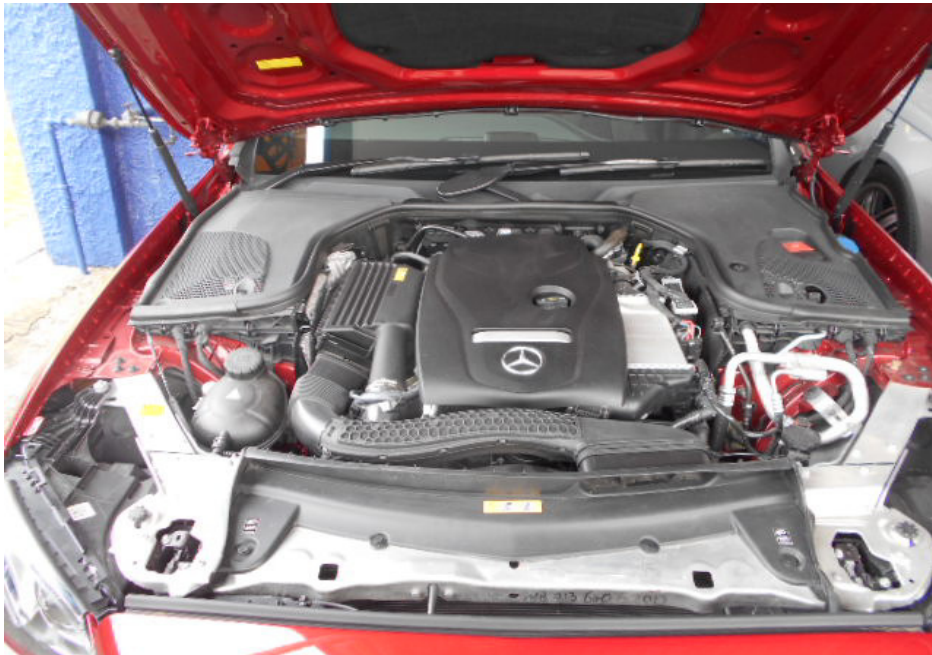
13. My examination of the Motor Car's engine compartment revealed that the various parts and components inside the engine compartment were all intact and properly fitted. The engine oil, brake fluid and engine coolant were all found to be of sufficient level for operating purposes. Visually, there was also no contamination found to these fluids.
14. My checks on the underside of the Motor Car revealed no sign(s) or indication(s) of fluid leakage and/or fluid stain(s). The engine block and automatic transmission assembly were both secured properly. They were not mounted onto the chassis body or any integral body part of the Motor Car. All undercarriage components of the Motor Car were also observed to be intact and secured in an appropriate manner.

**Photo 4** shows the engine compartment of the Motor Car. The various parts and components inside the engine compartment were all observed to be intact and properly fitted. There was also no sign(s) or indication(s) of fluid leak and/or fluid stain found inside the engine compartment. The engine oil, brake fluid and engine coolant were all checked and found to be of sufficient level for operating purposes. Visually, there was also no contamination found to these fluids.

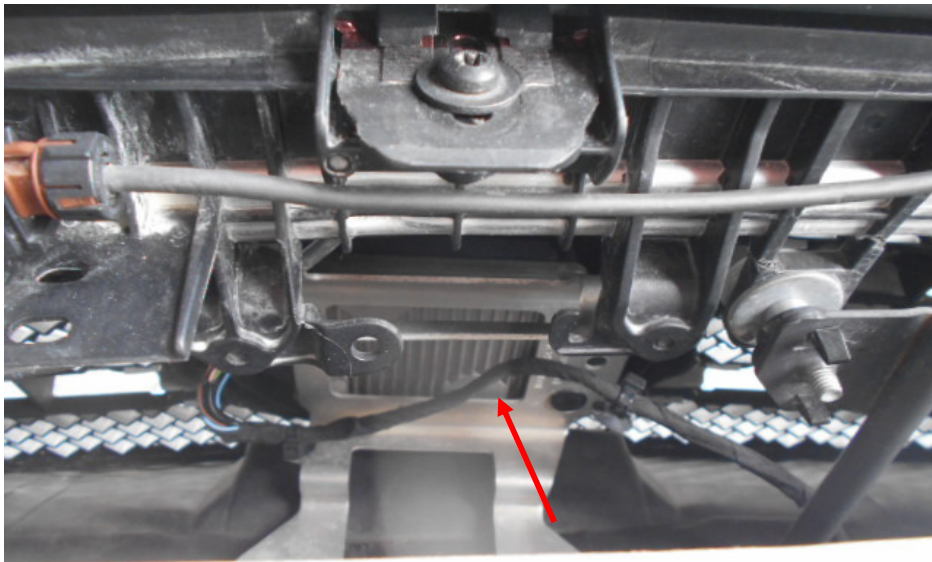
**Photo 5** shows the radar sensor (arrowed) fitted behind the front grille of the Motor Car. The radar sensor and its related wiring were observed to be securely fitted/connected.

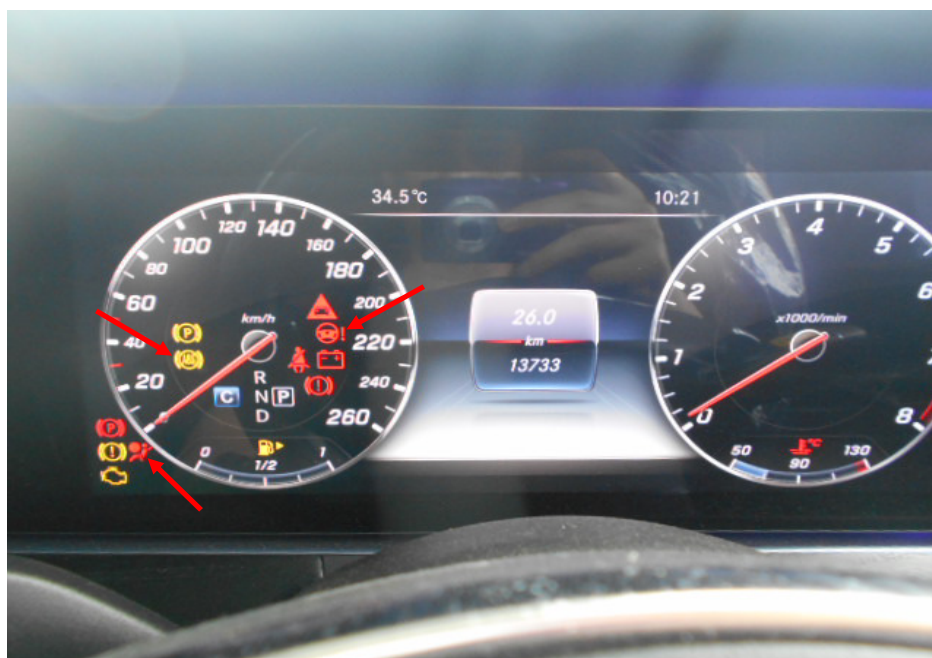
**Photo 6** shows the warning lights for the various electronic safety features appearing on the instrument panel of the Motor Car during its self-test when the engine is cranked, in particular the Anti-Brake Lock System (ABS), Supplemental Restraint System (SRS) and Power Steering Assist (PSA) (arrowed).

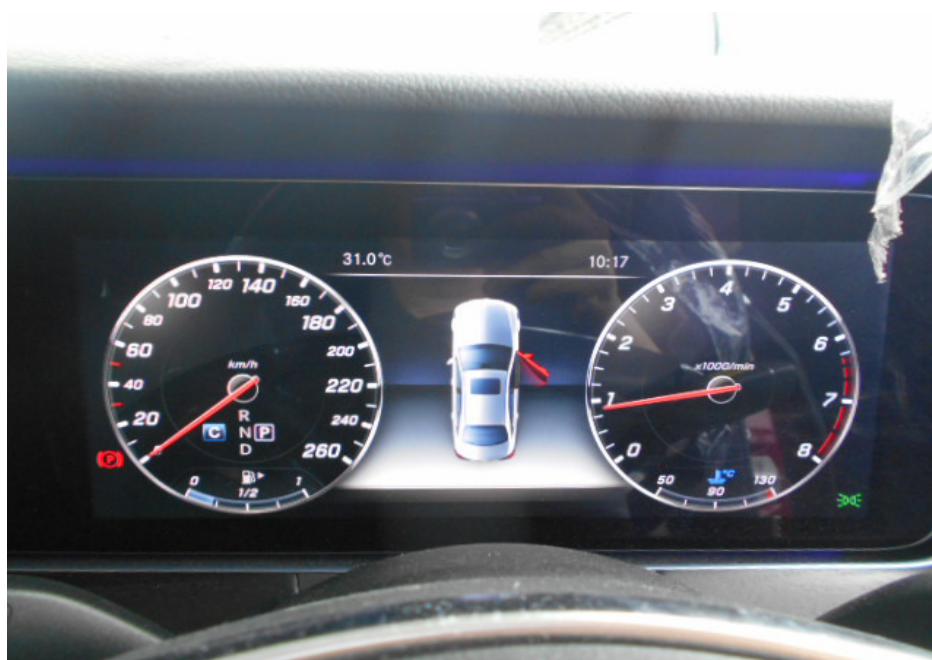
12. The Motor Car's automatic self-test of the functionality of its various electronic safety features like the Anti-Brake Lock System (ABS), Supplemental Restraint System (SRS), Power Steering Assist (PSA) and Traction Control System (TCS) during cranking of the engine had indicated that these systems were in working condition. This was determined from the respective warning lights disappearing from the instrument panel after the self-test.

**Photo 7** shows the respective warning lights no longer illuminated, indicating that there is no fault detected to the ABS, SRS and PSA systems of the Motor Car during the self-test. These electronic safety features were hence in working condition at the time of my inspection.

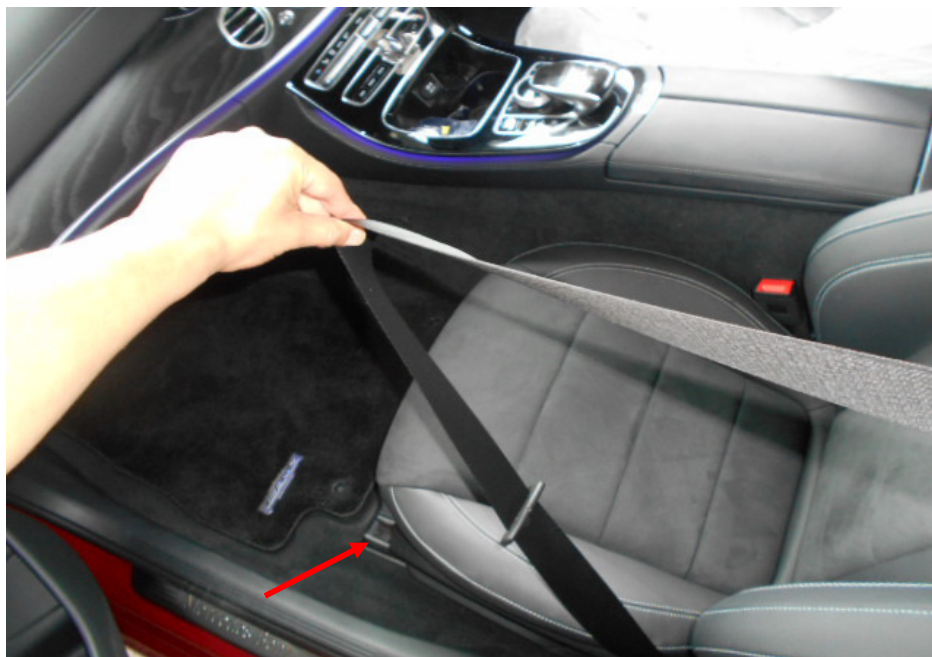
11. The seats of the Motor Car were found to be secured to the floor panel of the Motor Car via seat rails bolted onto the floor board. Retractable seat belt reels and pre-tensioners were fitted on all seats of the Motor Car. The seat belt reels were able to be fastened securely to the respective pre-tensioner that is fixed to the side of all the seats.

**Photo 8** shows the interior compartment of the Motor Car. The seats of the Motor Car were found to be secured to the floor panel of the Motor Car via seat rails (arrowed) that were bolted onto the floor board. Retractable seat belt reels and pre-tensioners were fitted on all seats of the Motor Car. The seat belt reels were able to be fastened securely to the respective pre-tensioner that is fixed to the side of all the seats.

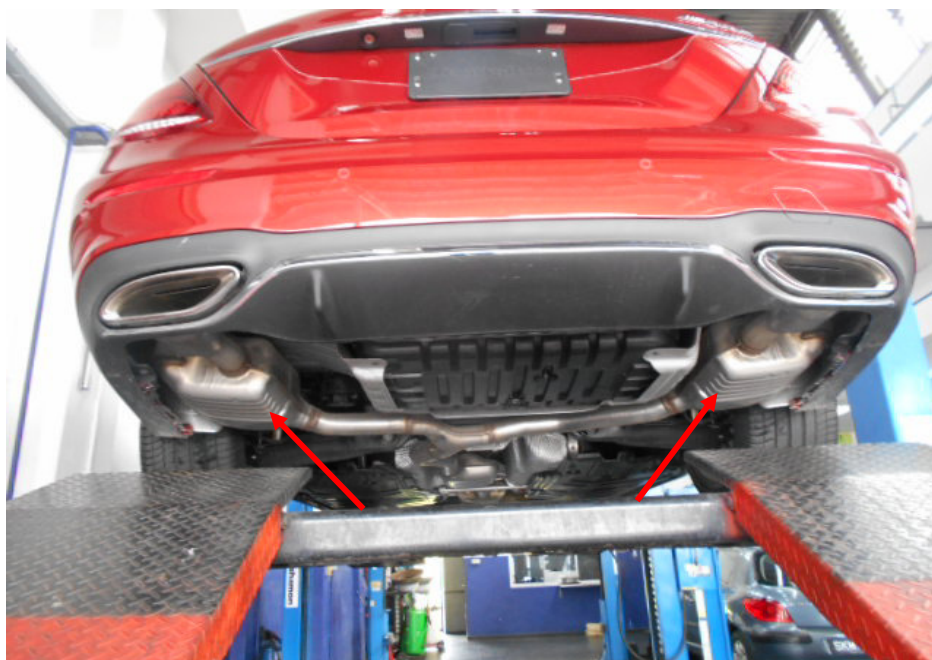
**Photo 9** shows the Motor Car hoisted up for checks on its undercarriage. My examination of the Motor Car's exhaust system revealed no sign(s) or indication(s) of any cut or weld marks along its exhaust pipes and on its rear muffler (arrowed).

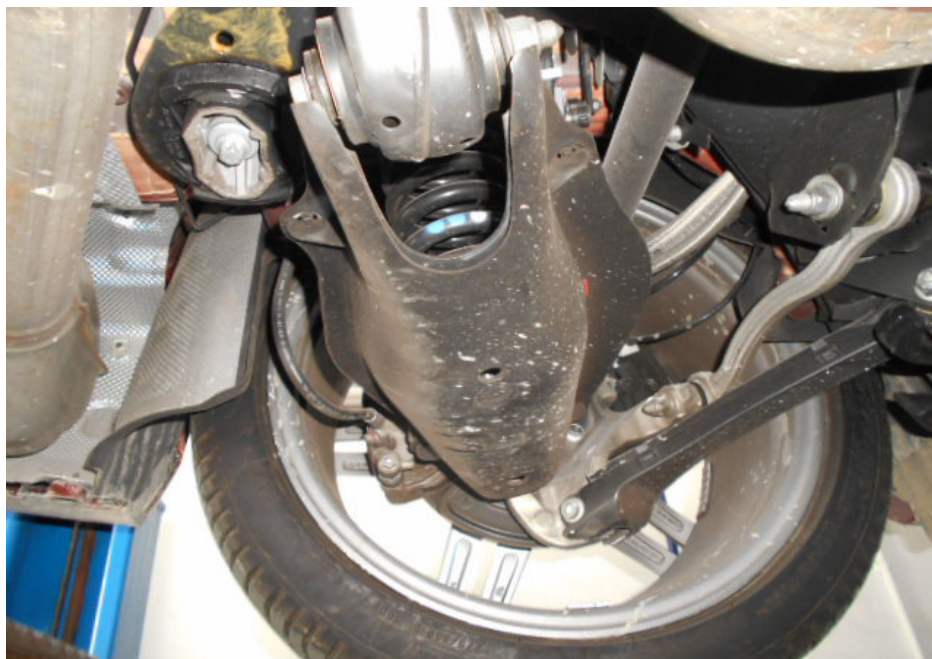
**Photo 10** shows the various undercarriage components at the rear left wheel of the Motor Car. The mechanical components, control arms and linkages were all found to be intact and secured in an appropriate manner. There was also no sign(s) or indication(s) of fluid leakage and/or fluid stain(s).

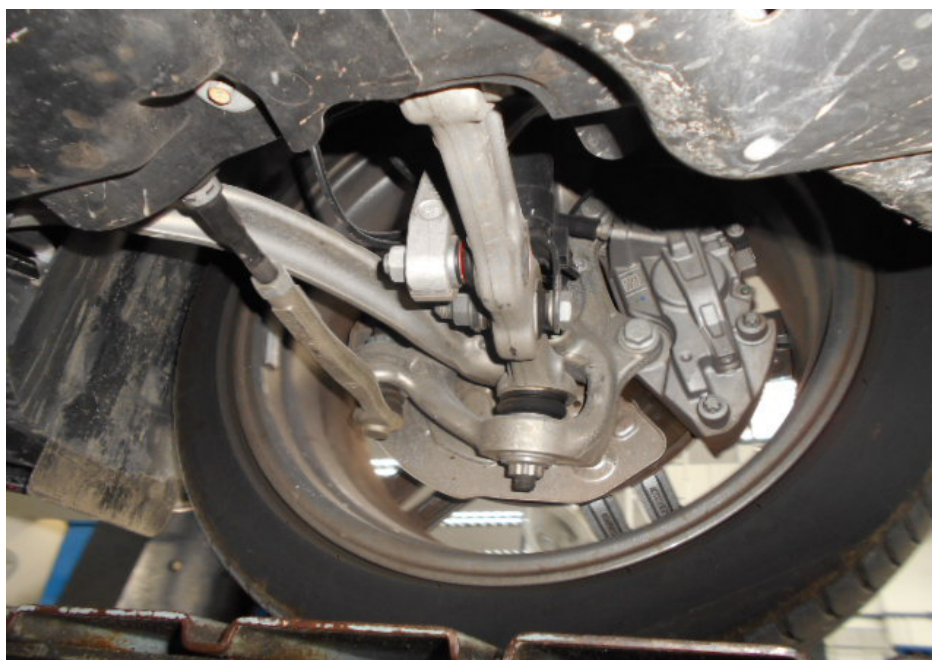
**Photo 11** shows the various undercarriage components at the front right wheel of the Motor Car. The mechanical components, control arms and linkages were all found to be intact and secured in an appropriate manner. There was also no fluid leak and/or fluid stain observed on the underside of the Motor Car.

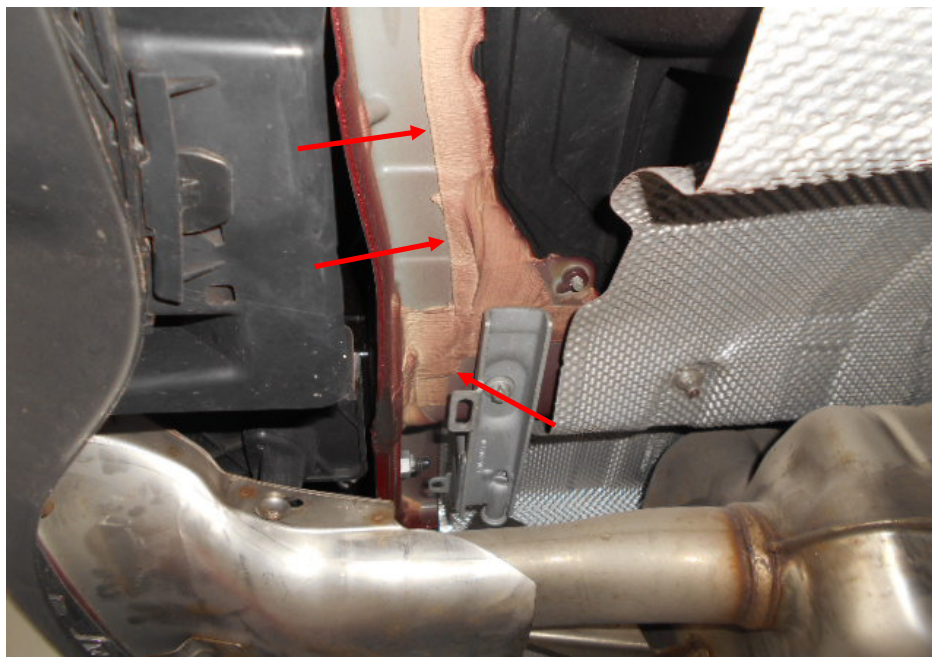
**Photo 12** shows the structural body/floor panel at the rear of the Motor Car. The original factory sealant (arrowed) at the joints along the body panels were observed to be untouched, indicating no work was done on the rear body panel(s) of the Motor Car and that the structural body was originally fitted.

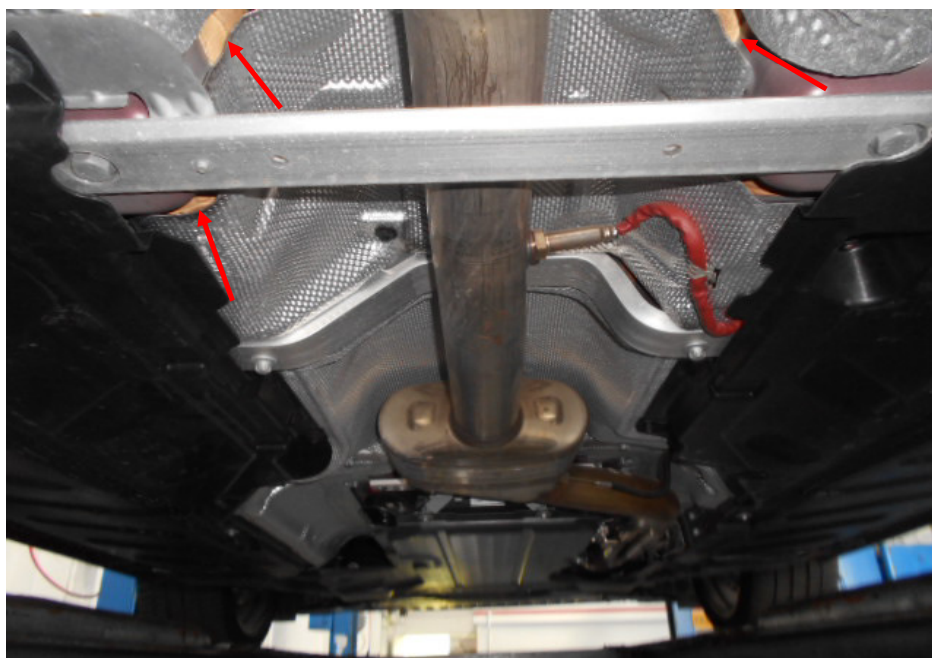
10. Visually, I did not find any weld marks, other than the original spot weld marks, on the chassis body of the Motor Car. The original factory sealant at the joints along the chassis was also untouched, again indicating that no replacement of the chassis body was carried out; and that the chassis body was originally fitted.

**Photo 13** shows the structural body/floor panel at the centre of the Motor Car. I did not find any weld marks, other than original spot weld marks, on the body panels of the Motor Car. The original factory sealant (arrowed) at the joints along the body panels were also untouched, indicating no work was done on the body panels of the Motor Car and that the structural body was originally fitted.

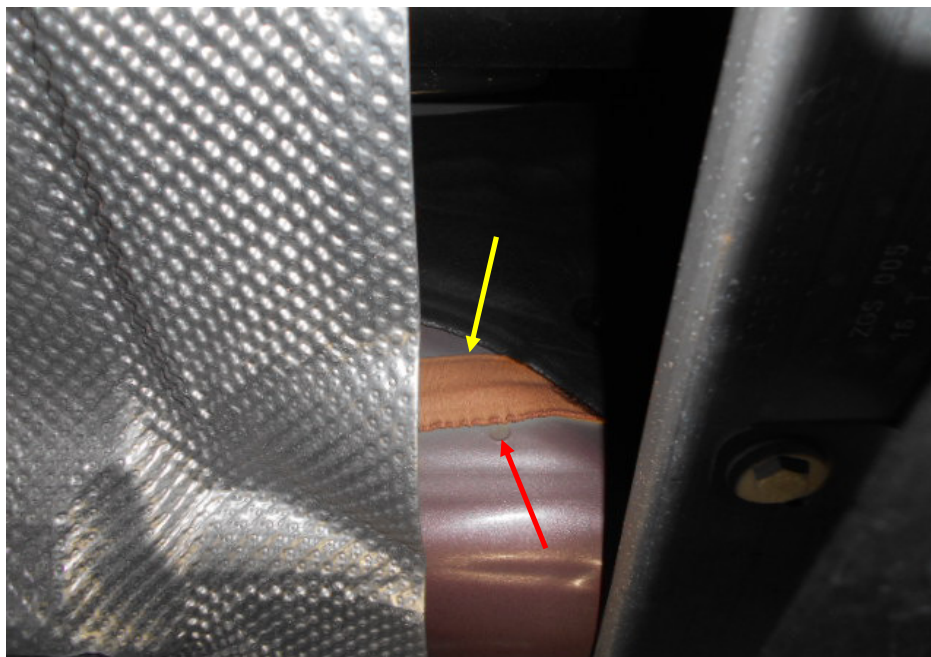
**Photo 14** shows a closer view of the structural body/floor panel at the centre of the Motor Car. I did not find any weld marks, other than original spot weld marks (red arrow), on the body panels of the Motor Car. The original factory sealant (yellow arrow) at the joints along the body panels were also untouched, indicating no work was done on the body panels of the Motor Car.

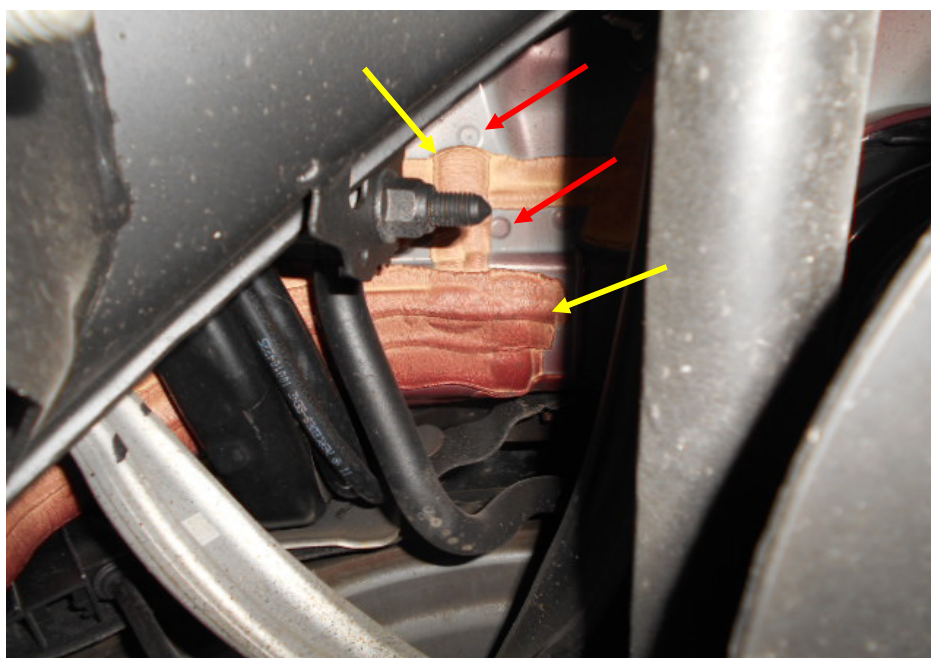
**Photo 15** shows a closer view of the structural body/floor panel at the rear right of the Motor Car. I did not find any weld marks, other than original spot weld marks (red arrow), on the body panels of the Motor Car. The original factory sealant (yellow arrow) at the joints along the body panels were also untouched, indicating no work was done on the body panels of the Motor Car.

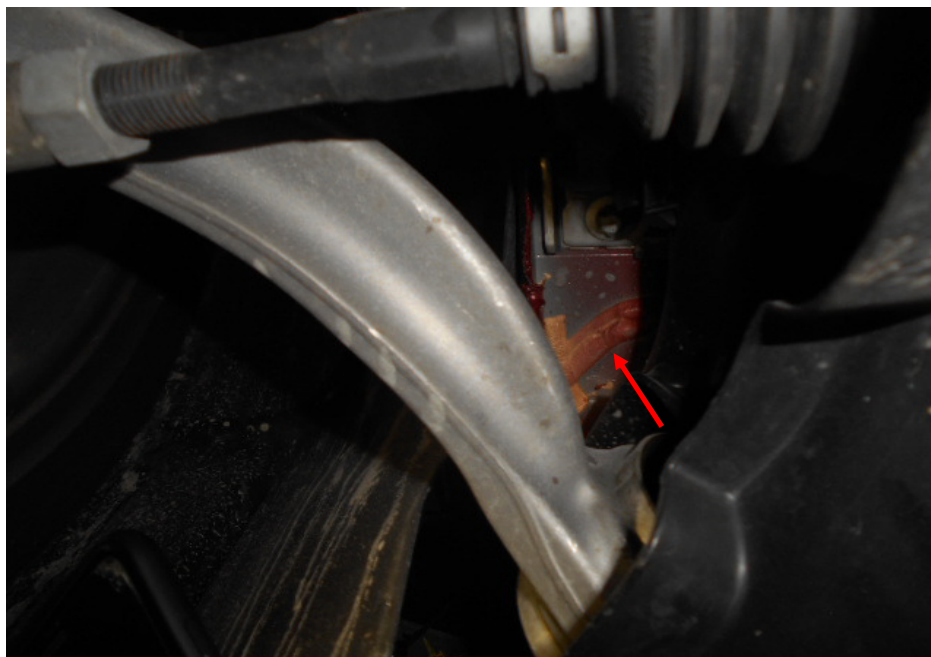
**Photo 16** shows the structural body at the front left of the Motor Car. Visually, I did not find any weld marks, other than original spot weld marks on the body panels of the Motor Car. The joints (arrowed) along the body panels were also untouched, indicating no work was done on the body panels of the Motor Car and that the structural body was originally fitted.
