Your Ref: Mercedes Benz E200
(chassis number WDD2130422A028173)
Our Ref : CI/TP18012403/D

10 July 2018

INSPECTION REPORT OF AN UNREGISTERD MERCEDES BENZ E200 MOTOR CAR WITH CHASSIS NUMBER WDD2130422A028173

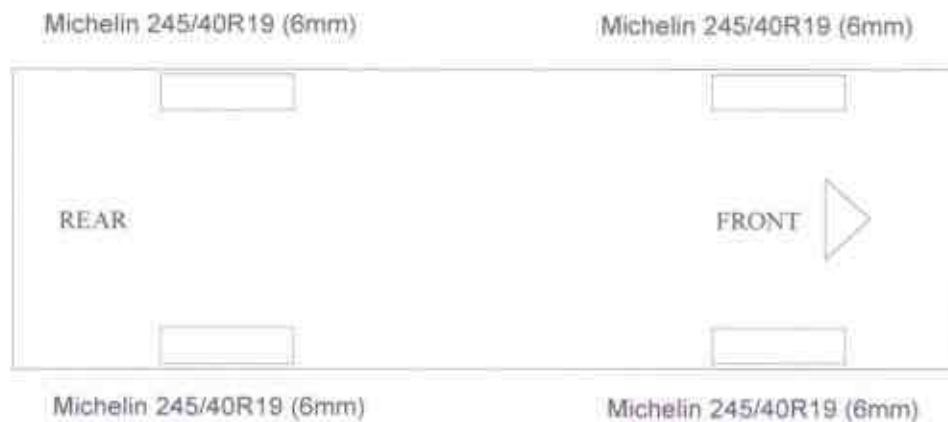
7. It was fitted with 19inch sport wheel rims that were wrapped with tyres that were observed to be of serviceable condition. The tyres were also sufficiently inflated for vehicular operation. The tyre brand, tyre size and approximate remaining tread depth of the 4 tyres of the Motor Car were recorded as follows: -

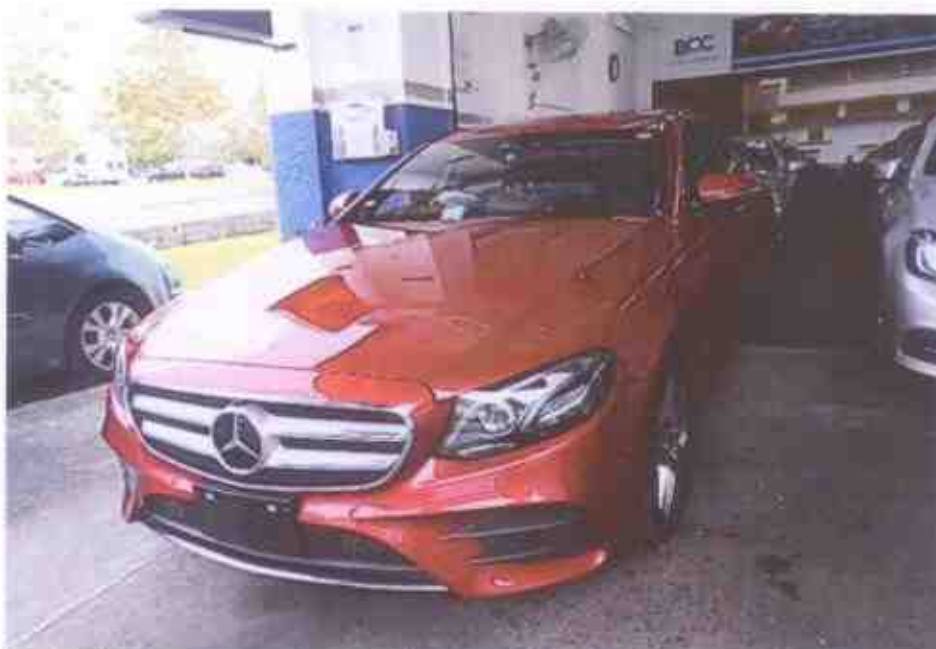
Photo 1 shows a general view of the front left body of the Motor Car at the time of my inspection. The Motor Car was observed to be in relatively good general condition with no loose exterior fittings observed.

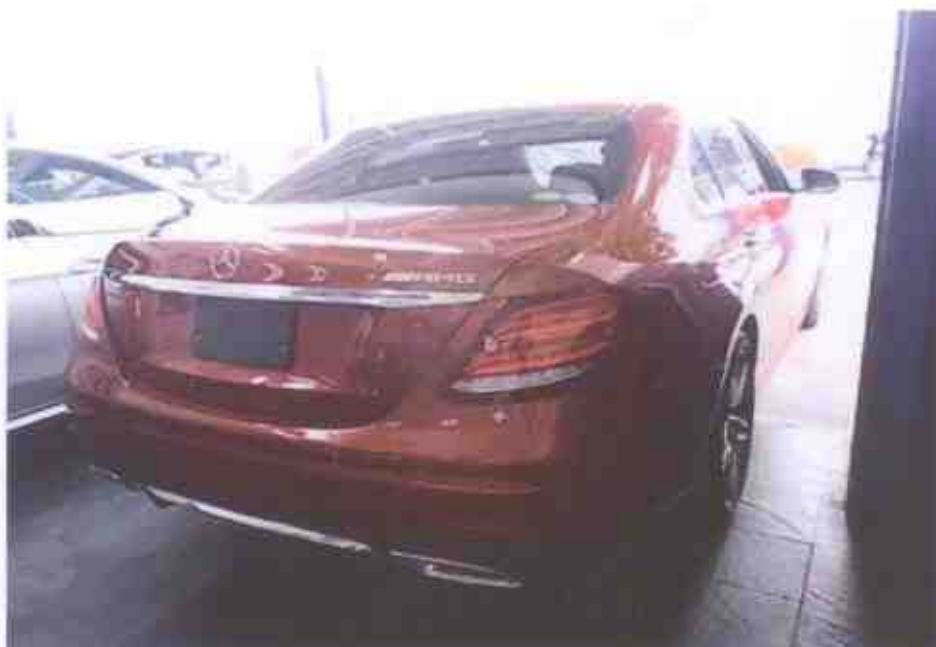
Photo 2 shows a general view of the rear right body of the Motor Car at the time of my inspection. The Motor Car was observed to be in relatively good general condition with no loose exterior fittings observed. It was also hoisted up during my inspection for checks on its underside.

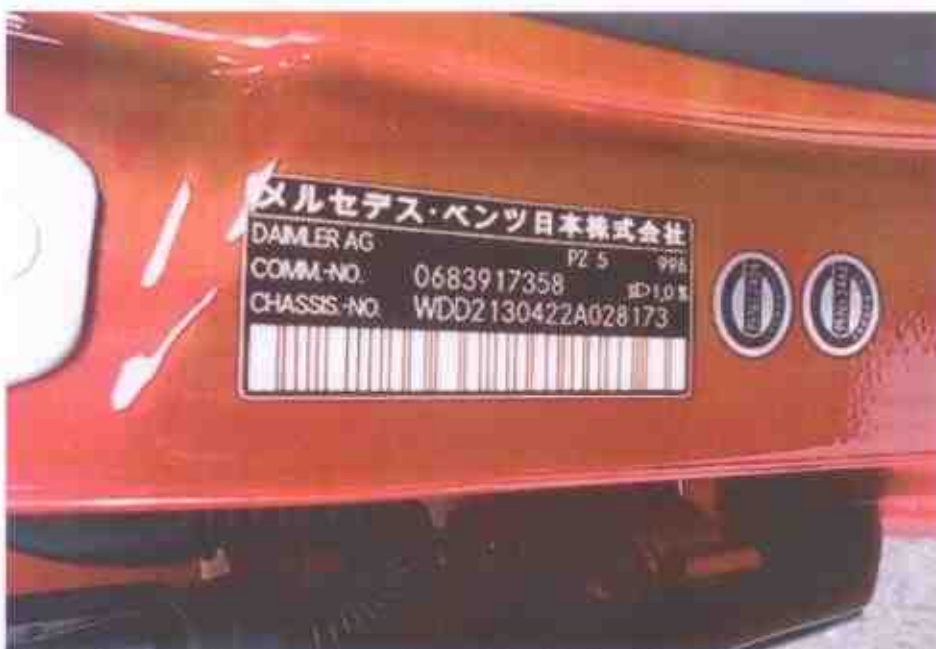
Photo 3 shows the chassis number of the Motor Car. The chassis number recorded was WDD2130422A028173.

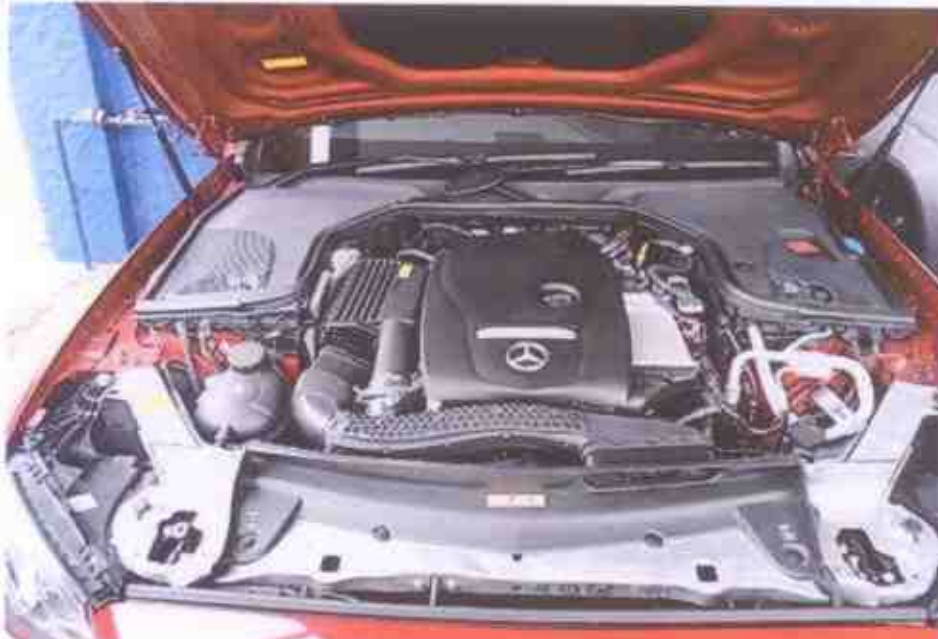
13. My examination of the Motor Car's engine compartment revealed that the various parts and components inside the engine compartment were all intact and properly fitted. The engine oil, brake fluid and engine coolant were all found to be of sufficient level for operating purposes. Visually, there was also no contamination found to these fluids.
14. My checks on the underside of the Motor Car revealed no sign(s) or indication(s) of fluid leakage and/or fluid stain(s). The engine block and automatic transmission assembly were both secured properly. They were not mounted onto the chassis body or any integral body part of the Motor Car. All undercarriage components of the Motor Car were also observed to be intact and secured in an appropriate manner.

Photo 4 shows the engine compartment of the Motor Car. The various parts and components inside the engine compartment were all observed to be intact and properly fitted. There was also no sign(s) or indication(s) of fluid leak and/or fluid stain found inside the engine compartment. The engine oil, brake fluid and engine coolant were all checked and found to be of sufficient level for operating purposes. Visually, there was also no contamination found to these fluids.

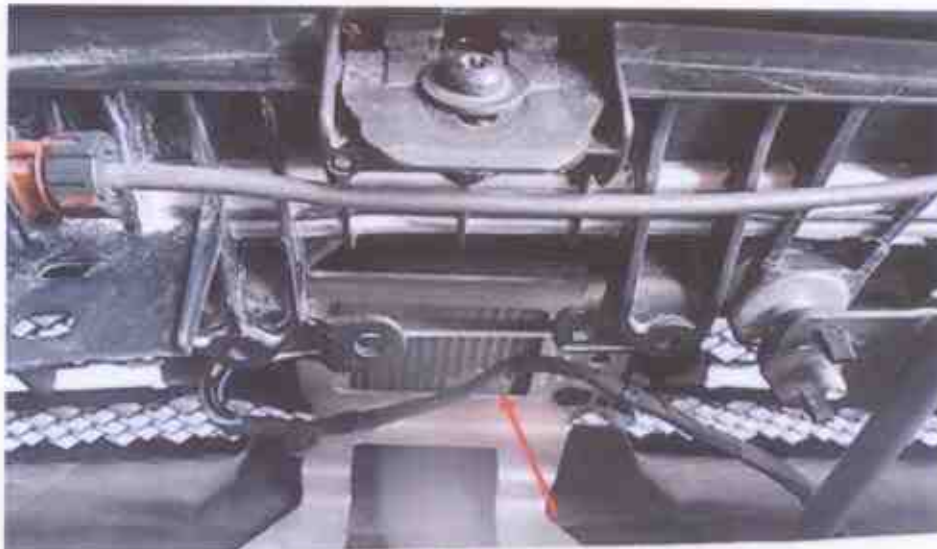
Photo 5 shows the radar sensor (arrowed) fitted behind the front grille of the Motor Car. The radar sensor and its related wiring were observed to be securely fitted/connected.

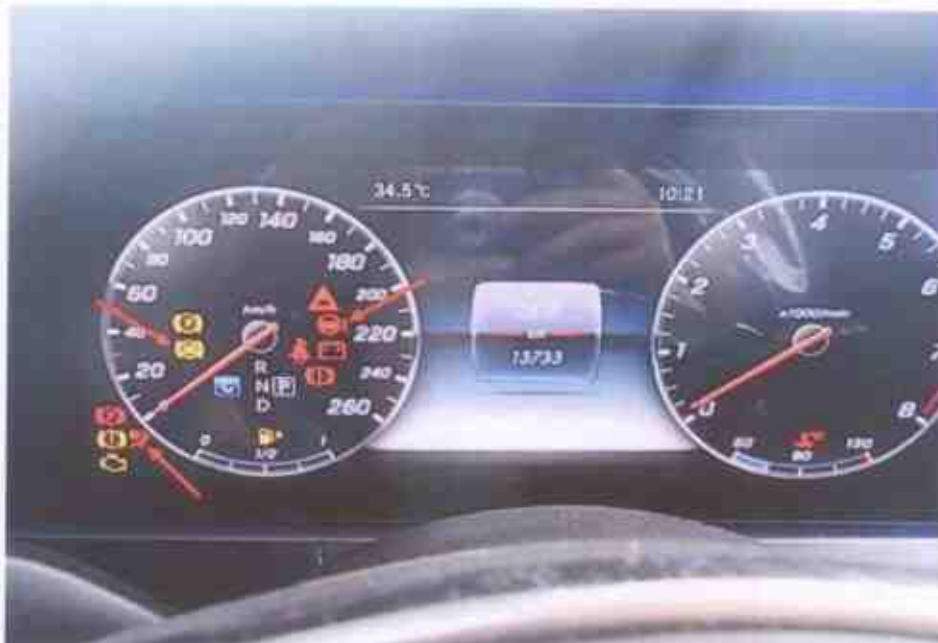
Photo 6 shows the warning lights for the various electronic safety features appearing on the instrument panel of the Motor Car during its self-test when the engine is cranked, in particular the Anti-Brake Lock System (ABS), Supplemental Restraint System (SRS) and Power Steering Assist (PSA) (arrowed).

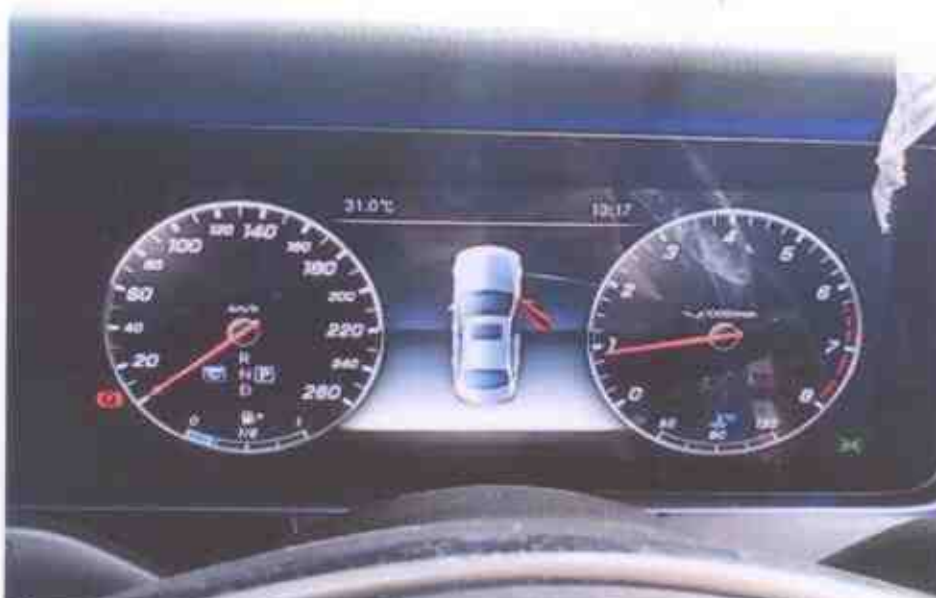
12. The Motor Car's automatic self-test of the functionality of its various electronic safety features like the Anti-Brake Lock System (ABS), Supplemental Restraint System (SRS), Power Steering Assist (PSA) and Traction Control System (TCS) during cranking of the engine had indicated that these systems were in working condition. This was determined from the respective warning lights disappearing from the instrument panel after the self-test.

Photo 7 shows the respective warning lights no longer illuminated, indicating that there is no fault detected to the ABS, SRS and PSA systems of the Motor Car during the self-test. These electronic safety features were hence in working condition at the time of my inspection.

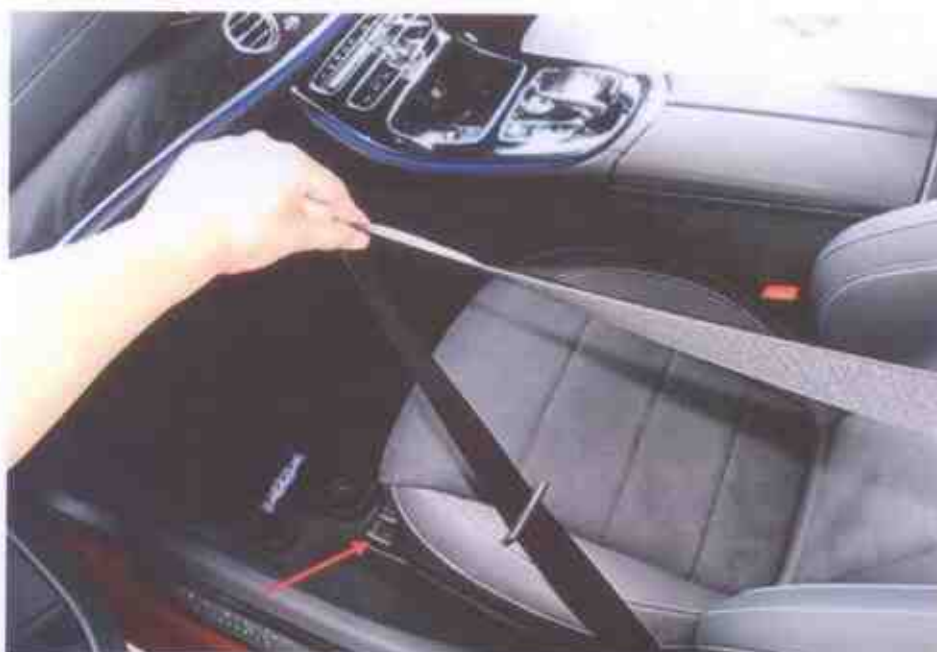
11. The seats of the Motor Car were found to be secured to the floor panel of the Motor Car via seat rails bolted onto the floor board. Retractable seat belt reels and pre-tensioners were fitted on all seats of the Motor Car. The seat belt reels were able to be fastened securely to the respective pre-tensioner that is fixed to the side of all the seats.

Photo 8 shows the interior compartment of the Motor Car. The seats of the Motor Car were found to be secured to the floor panel of the Motor Car via seat rails (arrowed) that were bolted onto the floor board. Retractable seat belt reels and pre-tensioners were fitted on all seats of the Motor Car. The seat belt reels were able to be fastened securely to the respective pre-tensioner that is fixed to the side of all the seats.

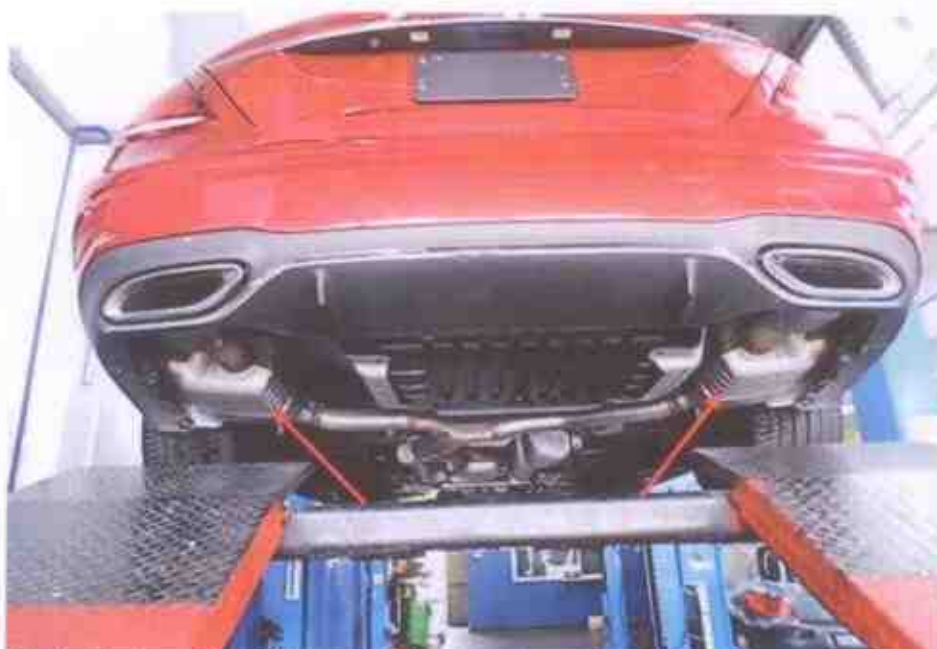
Photo 9 shows the Motor Car hoisted up for checks on its undercarriage. My examination of the Motor Car's exhaust system revealed no sign(s) or indication(s) of any cut or weld marks along its exhaust pipes and on its rear muffler (arrowed).

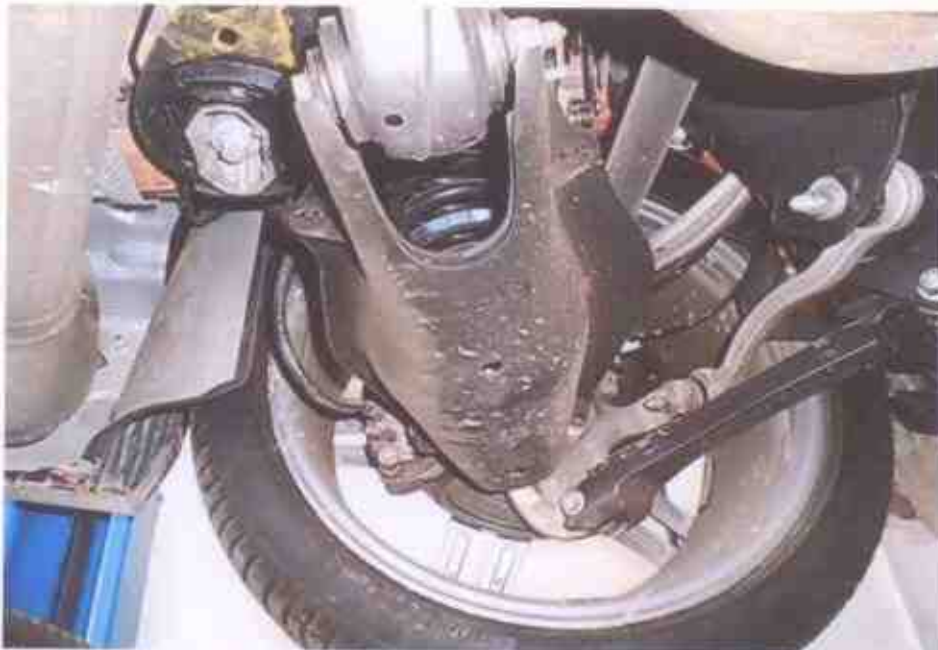
Photo 10 shows the various undercarriage components at the rear left wheel of the Motor Car. The mechanical components, control arms and linkages were all found to be intact and secured in an appropriate manner. There was also no sign(s) or indication(s) of fluid leakage and/or fluid stain(s).

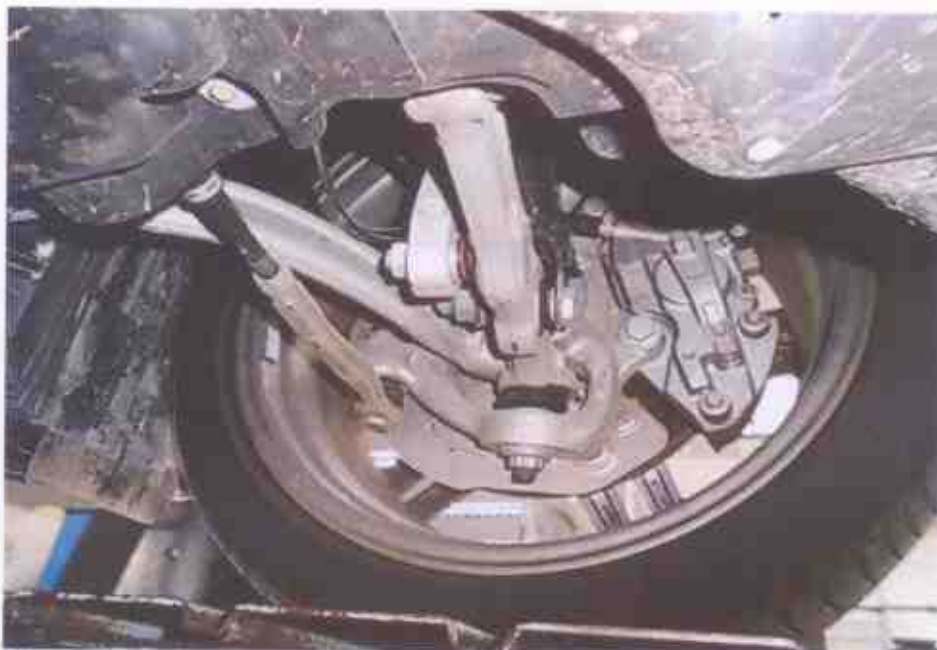
Photo 11 shows the various undercarriage components at the front right wheel of the Motor Car. The mechanical components, control arms and linkages were all found to be intact and secured in an appropriate manner. There was also no fluid leak and/or fluid stain observed on the underside of the Motor Car.

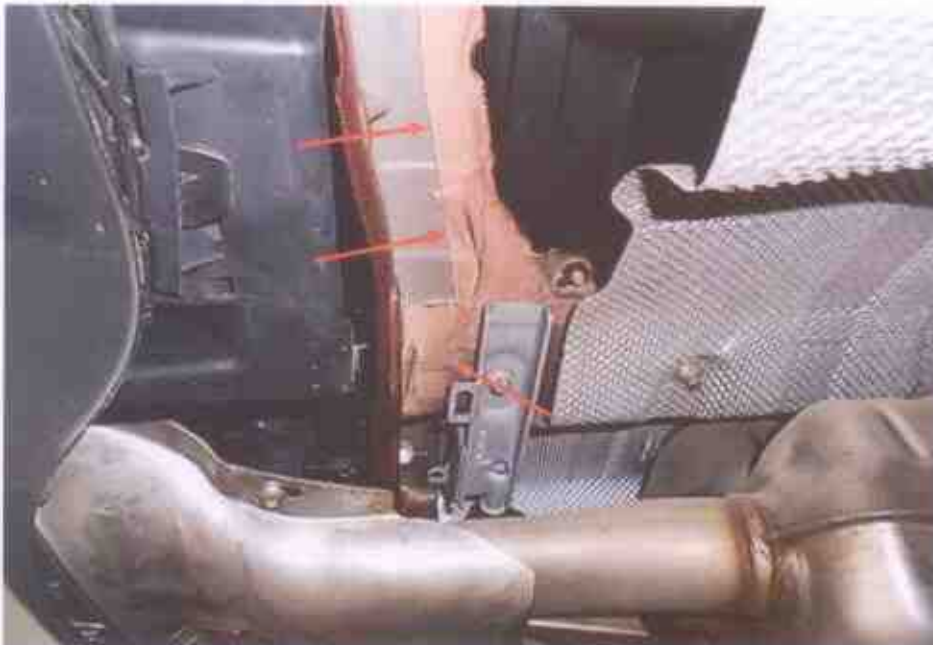
Photo 12 shows the structural body/floor panel at the rear of the Motor Car. The original factory sealant (arrowed) at the joints along the body panels were observed to be untouched, indicating no work was done on the rear body panel(s) of the Motor Car and that the structural body was originally fitted.

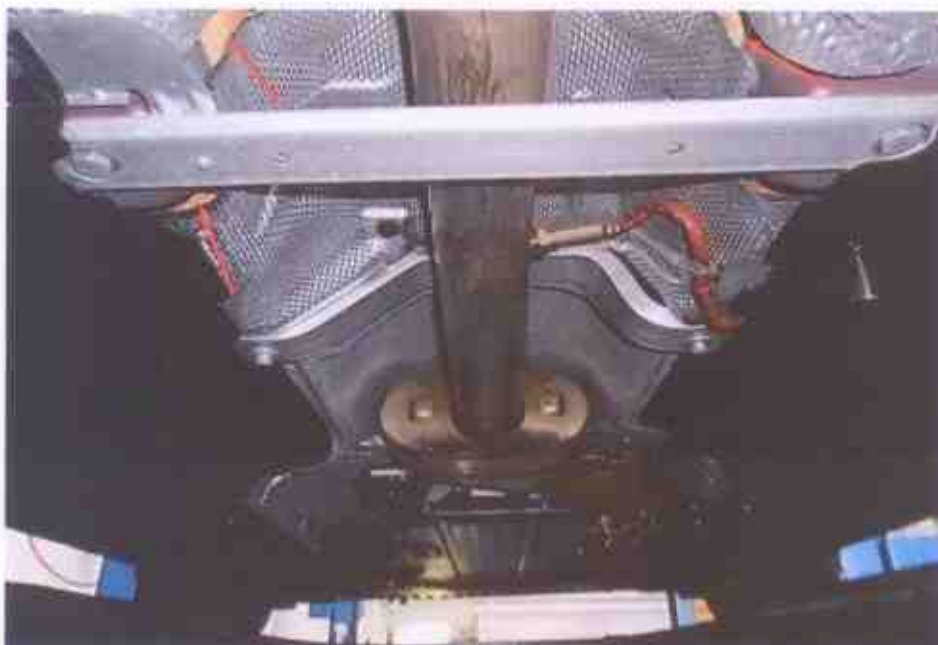
Photo 13 shows the structural body/floor panel at the centre of the Motor Car. I did not find any weld marks, other than original spot weld marks, on the body panels of the Motor Car. The original factory sealant (arrowed) at the joints along the body panels were also untouched, indicating no work was done on the body panels of the Motor Car and that the structural body was originally fitted.

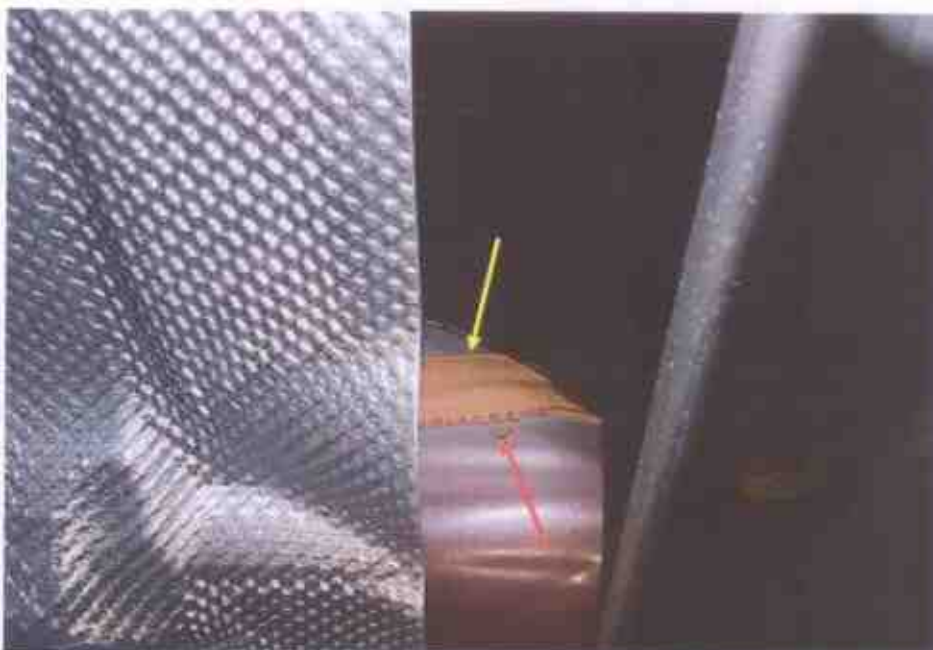
Photo 14 shows a closer view of the structural body/floor panel at the centre of the Motor Car. I did not find any weld marks, other than original spot weld marks (red arrow), on the body panels of the Motor Car. The original factory sealant (yellow arrow) at the joints along the body panels were also untouched, indicating no work was done on the body panels of the Motor Car.

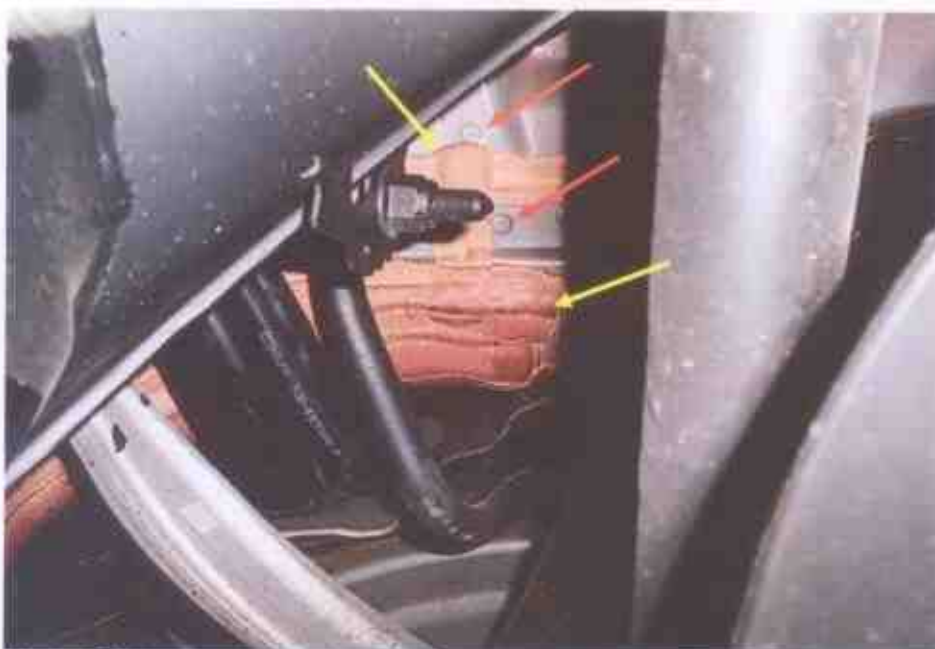
Photo 15 shows a closer view of the structural body/floor panel at the rear right of the Motor Car. I did not find any weld marks, other than original spot weld marks (red arrow), on the body panels of the Motor Car. The original factory sealant (yellow arrow) at the joints along the body panels were also untouched, indicating no work was done on the body panels of the Motor Car.

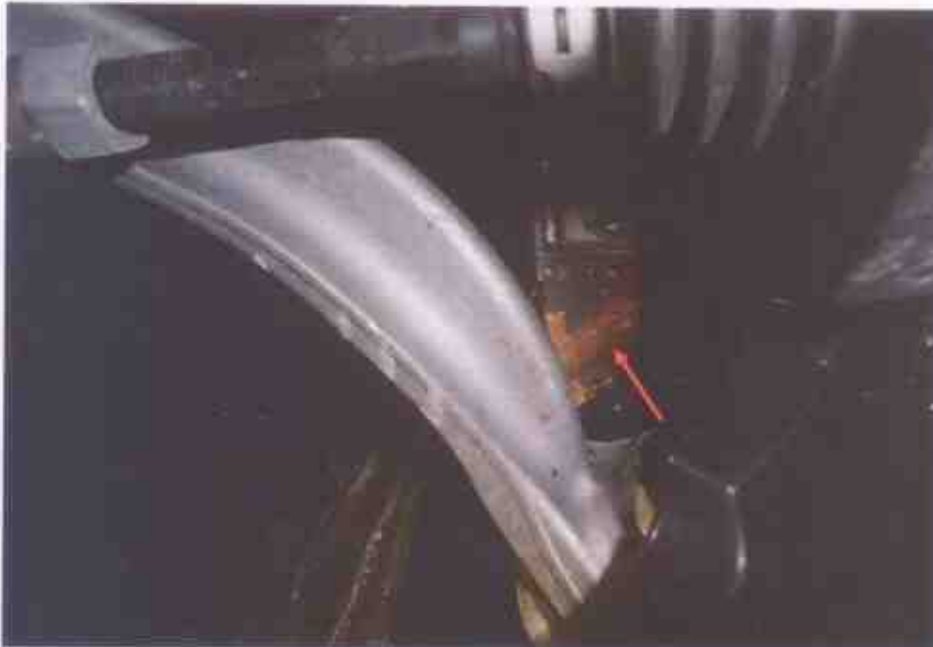
Photo 16 shows the structural body at the front left of the Motor Car. Visually, I did not find any weld marks, other than original spot weld marks on the body panels of the Motor Car. The joints (arrowed) along the body panels were also untouched, indicating no work was done on the body panels of the Motor Car and that the structural body was originally fitted.
